NATIONAL TRANSPORTATION SAFETY BOARD

MATERIALS LABORATORY FACTUAL REPORT

Report No. 19-028

Place : Dallas, Texas
Date : February 23, 2018
Vehicle : Pipeline operated by Atmos Energy
NTSB No. : PLD18FR002
Investigator : Sara Lyons²

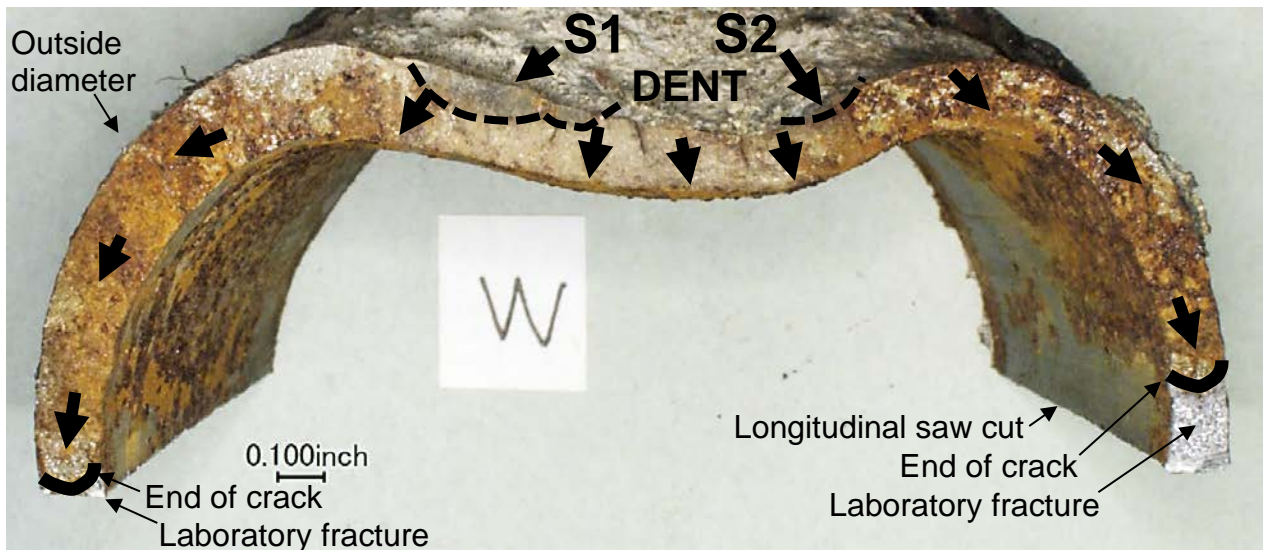
Figure 1 shows a photograph of the west face of the fracture prior to cleaning. The fracture face at two isolated areas contained a barely visible black regions adjacent to the dent on the external surface, in the areas indicated by regions "S1" and "S2" in figure 1. The west face of the fracture was cleaned with cellulose acetate replica tape. Figure 2 shows the face of the fracture after the replica tape cleaning procedure was repeated four times. The cleaning improved clarity of the black regions and their boundaries. The black regions extended between the outer surface and as deep as approximately 0.07 inch below the surface, to the approximate areas indicated by black dashed lines in figures 1 through 5. The black regions appeared similar to thumbnail-like patterns.

SEM examination of the west face of the fracture, after the four-step acetate tape cleaning process described earlier, revealed the outer surface at isolated areas contained evidence of minor shear lips, including areas in the black regions. The inner surface contained minor shear lips outside of the major shear lip regions reported in Materials Laboratory Factual Report 18-067. The general direction of fracture propagation is indicated by arrows in figure 1. The exposed fracture face contained evidence of cleavage fracture features that were pitted. The fracture face contained no evidence of crack arrest fracture features within the black thumbnail region or areas that corresponded to the outline of the black thumbnail-like regions. The crack terminated in the areas indicated by solid lines in figure 1. The fracture features outside of the solid lines in figure 1 were laboratory induced fractures.

Figure 1. West face of the fracture after separating the mating faces of the circumferential crack, prior to cleaning. General direction of fracture propagation is indicated by unmarked arrows and termini of crack is indicated by a solid lines.

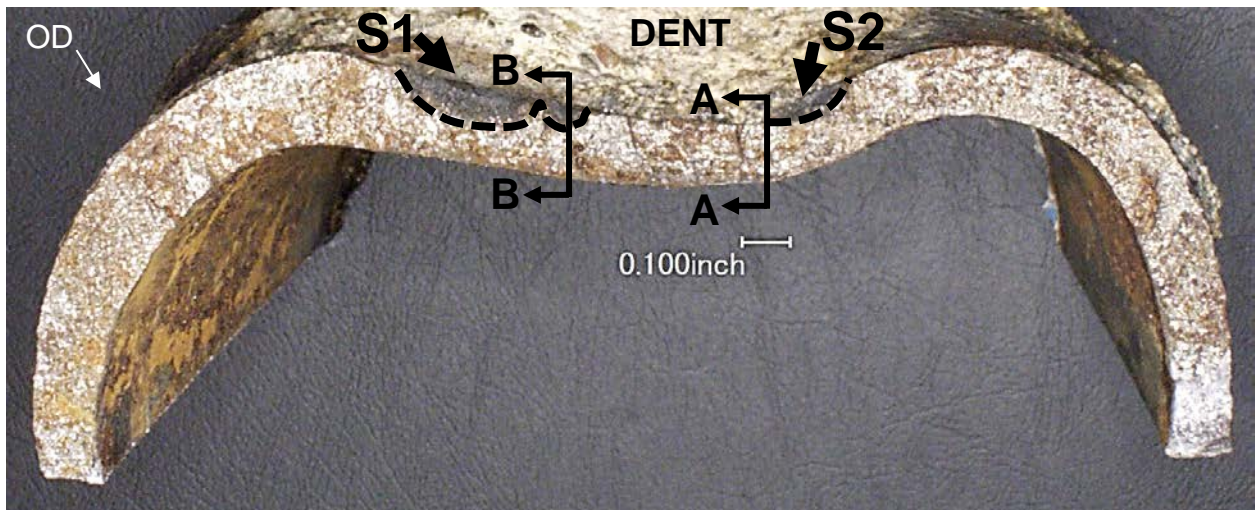
Appendix 1B shows an EDS spectrum of the fracture face prior to cleaning prior to cleaning (it is area located outside of the black region). This EDS spectrum was overlapped with an EDS spectrum of the black region, "S1" in figure 2, after replica tape cleaning procedure was repeated four times. The EDS spectrum from the fracture face located outside of the black region (prior to cleaning) contained major elemental peaks of calcium, oxygen, silicon, iron, and carbon, and minor elemental peaks of magnesium, sulfur, potassium, titanium, aluminum, manganese, and zinc. The EDS spectrum from the black deposit contained major elemental peaks of iron, oxygen, and carbon. The elemental peak zinc was found only on the fracture face, prior to and after cleaning with replica tape.

A longitudinal-radial section was made through the west face of the fracture in the area that intersected the dent, indicated by section lines "A-A" in figure 2. Another longitudinal-radial section was made through the fracture face in the area that intersected a black region and the dent, indicated by section line "B-B" in figure 2. The prepared sections were ground, polished and etched with 4% Nital reagent. Examination of the sections revealed the outer surface contained evidence of severe metal flow deformation. Figures 6 and 7 show severe metal deformation on the outer surface of the dent in section "A-A". Appendix 2A at the upper left corner of the page shows an SEM image of a portion of section "B-B" in the area that intersected the outer surface of the main. Appendix 2B at the upper left corner of the page shows an SEM image of a portion of section "B-B" in the area that intersected the fracture face and outer diameter surface. The outer surface of section "B-B" exhibited metal flow deformation.

Figure 2. West face of the fracture, after the replica tape cleaning procedure was repeated four times, exposing black regions "S1" and "S2". Refer to the previous figure to determine the relative positions of the black regions prior to fracture cleaning.

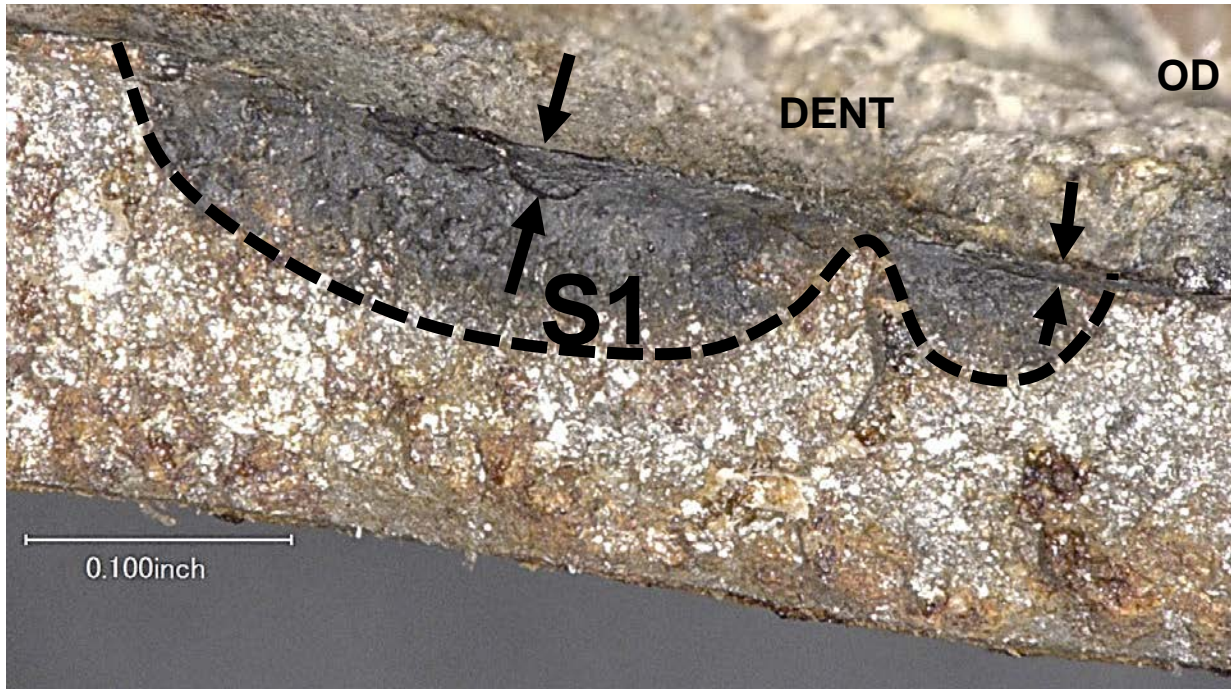
Figure 3. Close-up view of black region “S1” in figure 2. Minor shear lips on outer face of fracture are located between arrows.

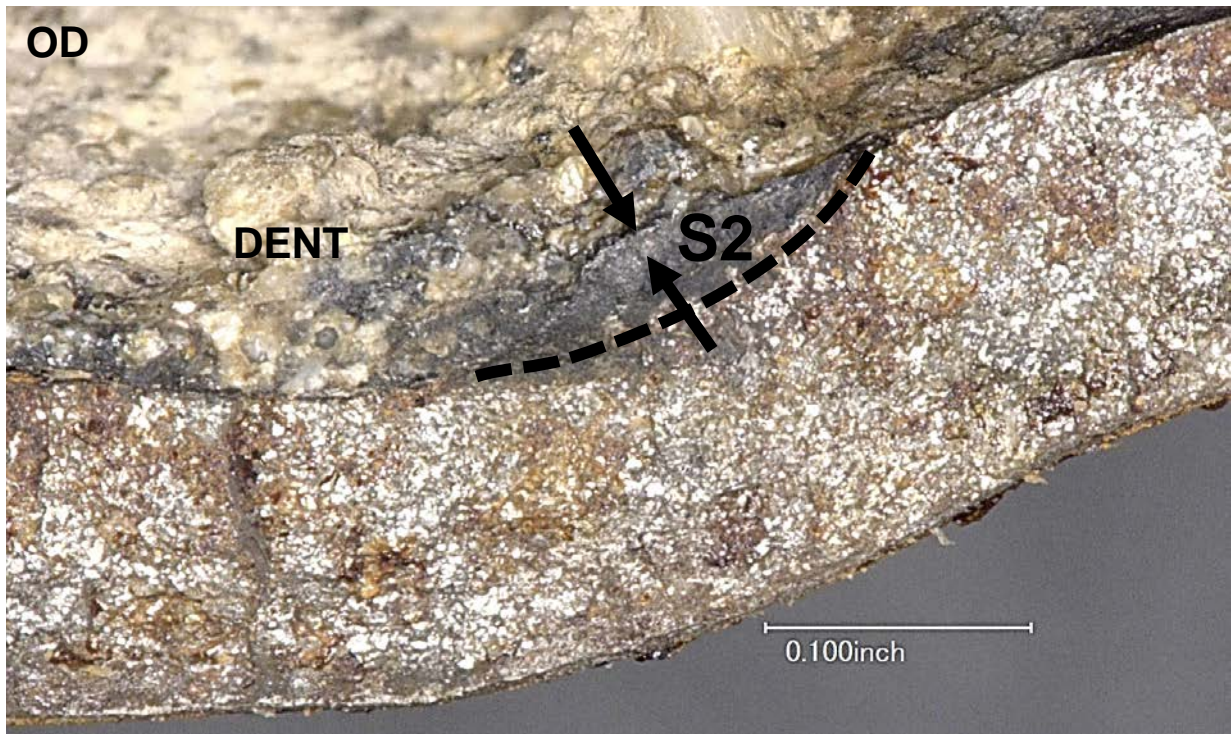
Figure 4. Close-up view of black region “S2” in figure 2. Minor shear lips on outer face of fracture are located between arrows.

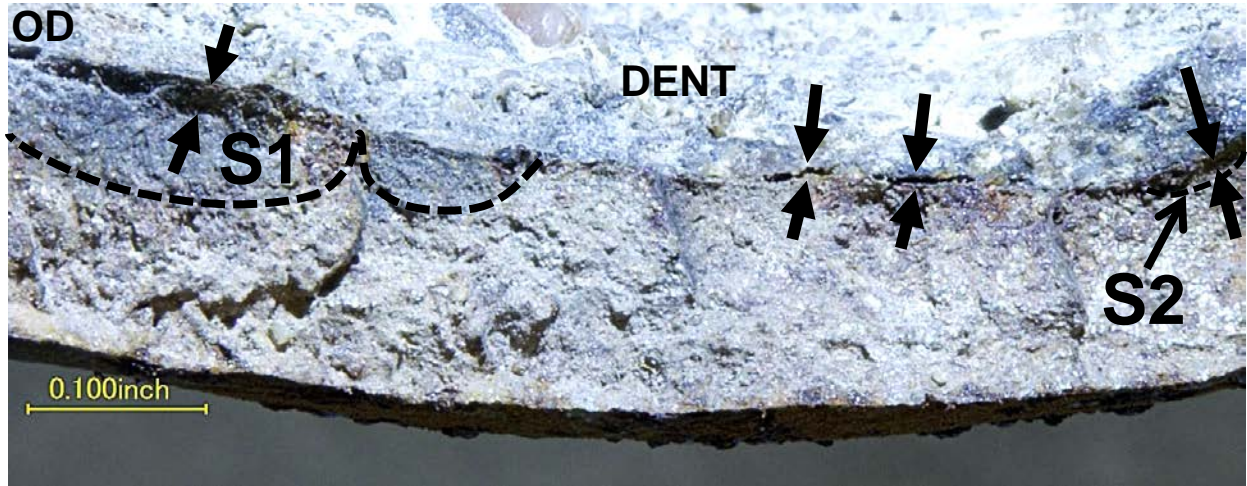
Figure 5. West face of the fracture in the area near the center of the dent. In this image, side lighting highlighted minor shear lips at the outer surface between unmarked arrows.

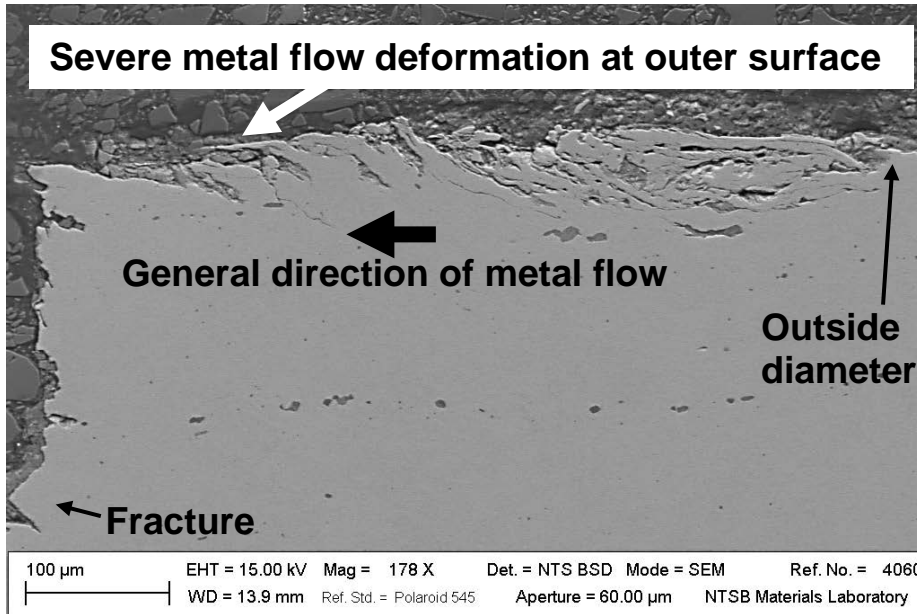
Figure 6. SEM image of a cross section “A-A” in figure 2 in an area adjacent to the fracture showing severe metal flow deformation at the outer surface, as-polished. Metal flow deformation is toward the fracture in the direction indicated by an arrow.

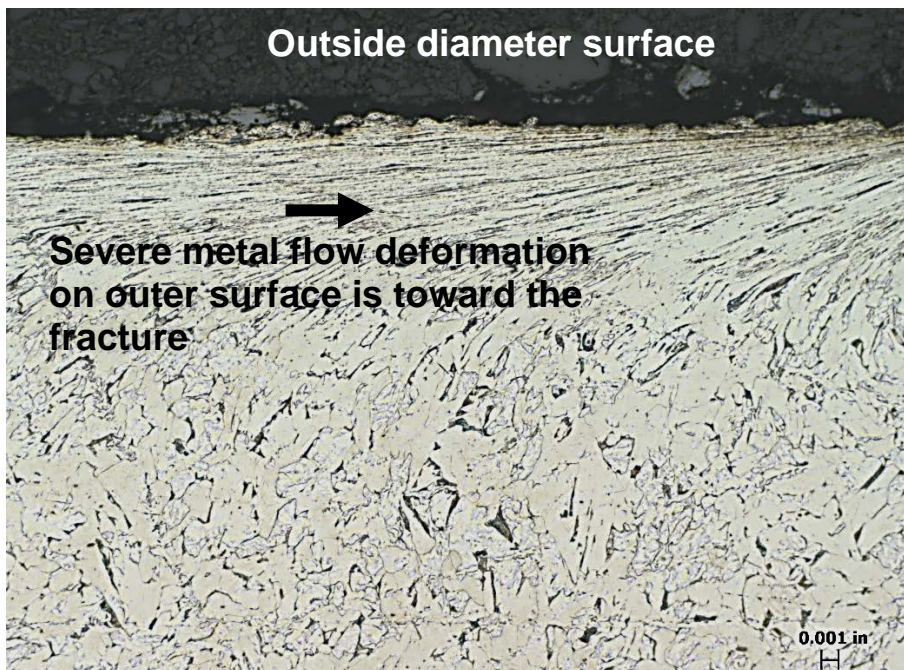
Figure 7. Cross section “A-A” showing metal flow deformation at the outer diameter surface in an area near the fracture but outside of the region shown in figure 6. Metal flow deformation is toward the fracture in the direction indicated by an arrow. The metallographic cross section shown above was made on a Zeiss metallograph that produces a mirror image of actual cross section, thus, metal flow deformation shown here is in opposite direction of SEM image. Etched with 2% Nital.

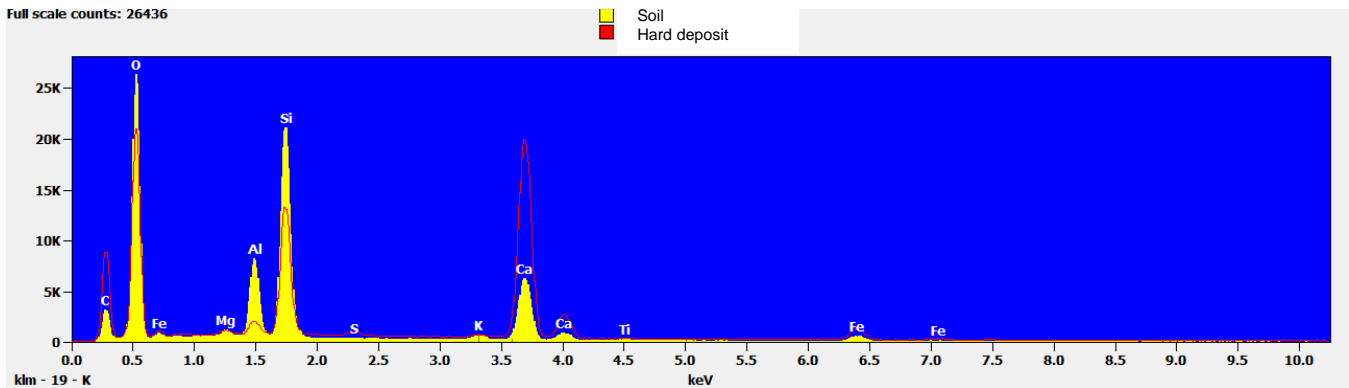
Appendix 1A shows the overlapping EDS spectra of the two materials (soil sample "14A" and hard deposit "B1"). EDS analysis of soil sample "14A" produced a spectrum that contained major elemental peaks of oxygen (O), silicon (Si), aluminum (Al), calcium (Ca), and carbon (C) and minor elemental peaks of iron (Fe), magnesium (Mg), potassium (K), and titanium (Ti). The EDS spectrum of hard deposit "B1" contained the same elemental peaks as soil sample "14A" with the exception that the hard deposit "B1" contained an elemental peak of sulfur (S) but no evidence of a magnesium peak. The height of the respective elemental peaks varied between the two samples. The EDS spectrum of the hard deposit "B1" contained a calcium peak that was three times greater, and a carbon peak that was twice as great, compared to those same respective elemental peaks that were found in soil sample "14A".

Appendix 1A. EDS spectrum of soil sample "14A" (solid yellow) overlapped with EDS spectrum of hard deposit found on top of gouge "B1" (red outline).

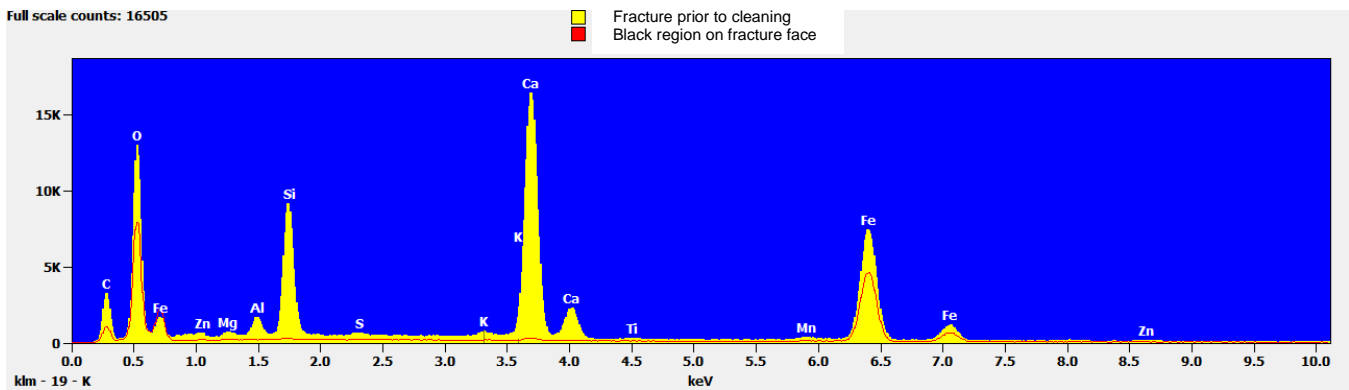
Appendix 1B. EDS spectrum of fracture face prior to cleaning (solid yellow) overlapped with EDS spectrum of fracture face after cleaning with replica tape and exposing black region "S1" (red outline).

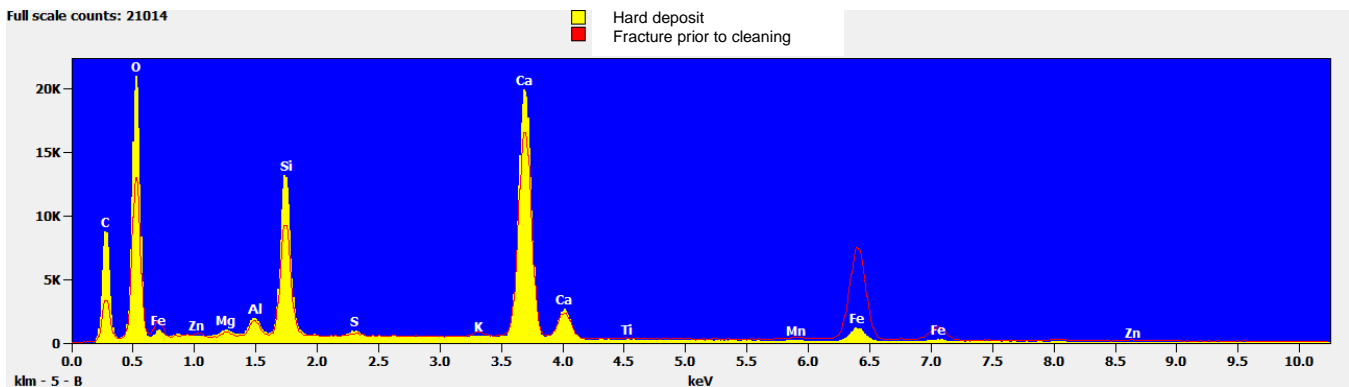
Appendix 1C shows an EDS spectrum of the hard deposit "B1" overlapped with an EDS spectrum from the fracture face prior to cleaning. As a general observation, the EDS spectrum from the fracture face prior to cleaning contained the same elemental peaks as those found on the hard deposit "B1". The elemental peak intensity of iron on the fracture face (prior to cleaning) was more than three times greater than the intensity of the same peak on the EDS spectrum of the hard deposit. Elemental peak of sulfur was found on the hard deposit and fracture face.

Appendix 1C. EDS spectrum of hard deposit found on top of gouge "B1" (solid yellow) overlapped with EDS spectrum of fracture face prior to cleaning (red outline).

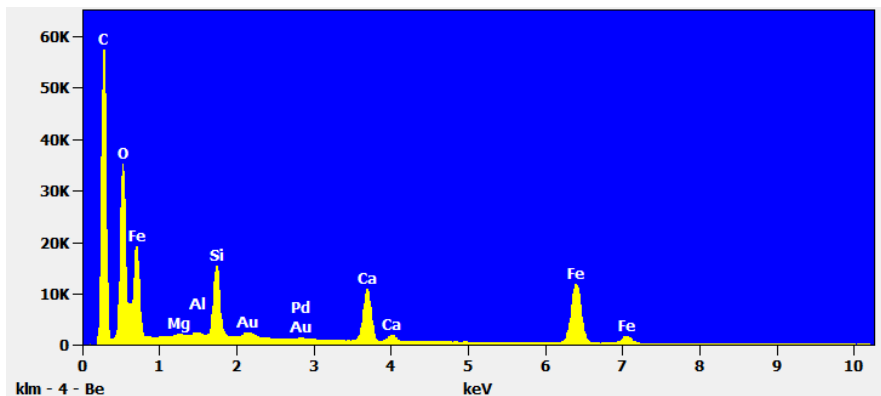
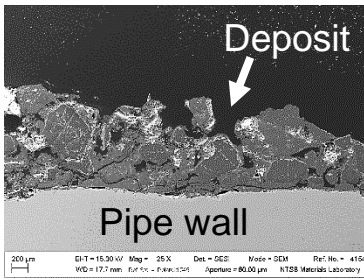
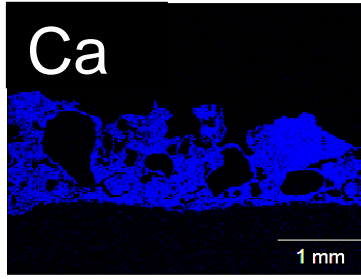
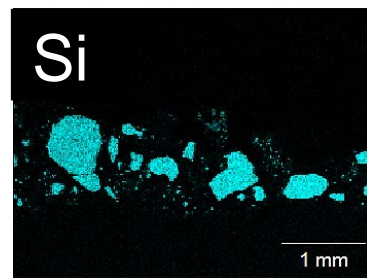
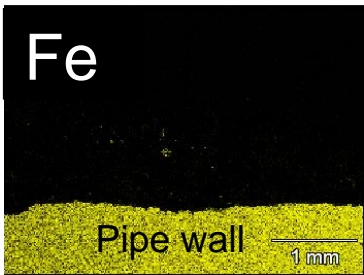
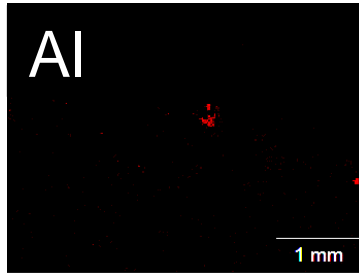
Appendix 2A shows an X-ray dot map of the hard deposit that was found on the surface of the dent, in the area indicated by cross section "B-B" in figure 2. The section was encased in plastic and coated by vapor deposition with gold-palladium. The major portion of the hard deposit contained calcium (element with the greatest distribution throughout the matrix). The hard deposit contained irregular-isolated areas of silicon with the same respective locations containing oxygen, consistent with particles of silicon oxide. The hard deposit also contained carbon, and minor amounts of aluminum and magnesium, but these three elements appeared did not share the same respective positions. The X-ray dot map showed that the wall of the main was primarily iron consistent with a main that was made from a ferrous alloy such as steel.

Appendix 2A. X-ray dot map (upper images) and spectrum (lower image) of the hard deposit that was found on the outer surface of the main in the area indicated by section line “B-B” in figure 2. Section was mounted in transparent plastic and coated by vapor deposition method with gold-palladium to prevent charging in the SEM.

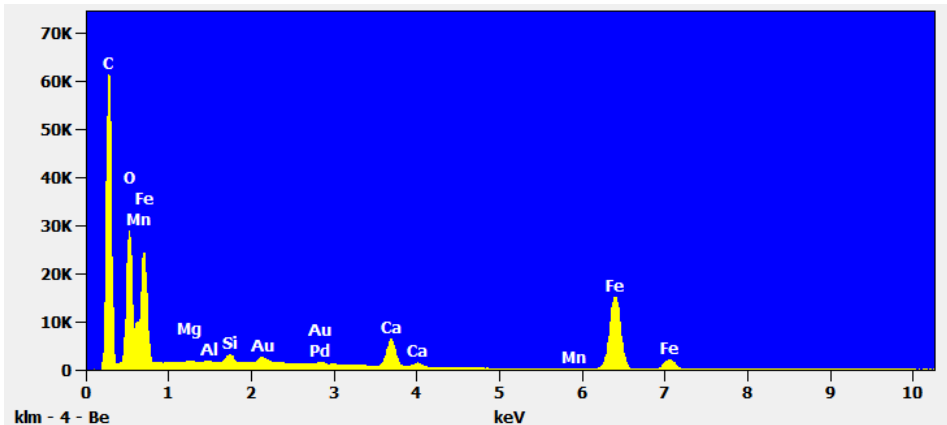
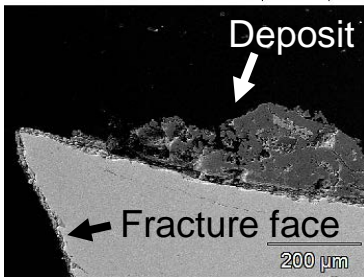
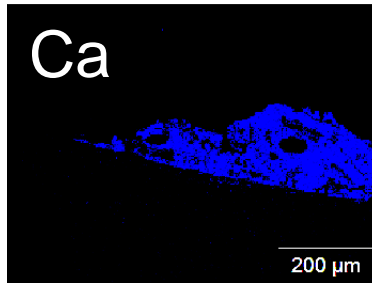
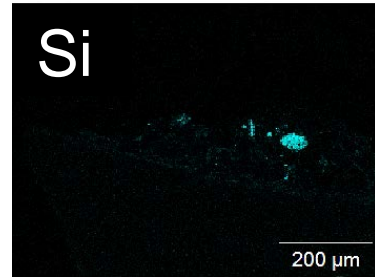
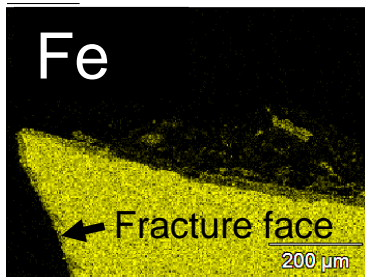
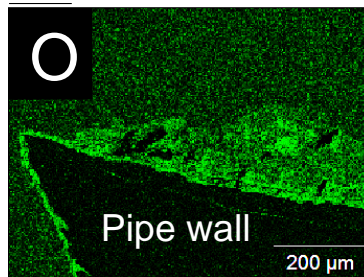
Appendix 2B shows X-ray dot map of a portion of the fracture face where it intersected the outer surface of the main, prepared from cross section "B-B" in figure 2. The X-ray dot map showed that the wall of the main was primarily iron consistent with a main that was made from a ferrous alloy such as steel. The fracture face contained a layer of oxygen in the form of an oxide (consistent with a layer of iron oxide).

Appendix 2B. X-ray dot map (upper images) and spectrum (lower image) of the fracture face where it intersected the outer surface of the main in the area indicated by section line “B-B” in figure 2. Section was mounted in transparent plastic and coated by vapor deposition method with gold-palladium to prevent charging in the SEM.

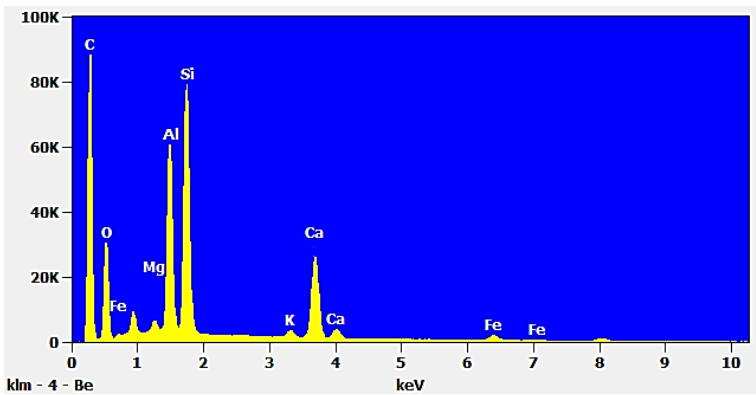
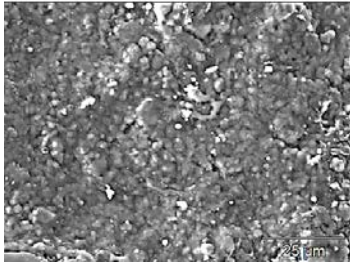
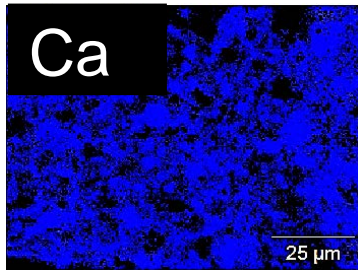
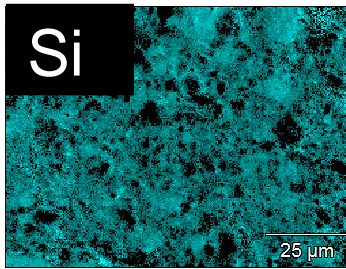
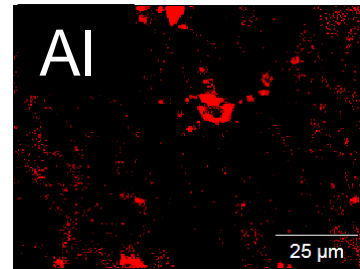
Appendix 2C shows an X-ray dot map of a portion of soil sample "14A". The soil sample was coated by vapor deposition with carbon. The major elements found in the soil were silicon, aluminum, calcium, oxygen, and carbon (the source of the carbon was the vapor deposited carbon coating). The EDS spectrum showed that minor elements of iron, potassium, and magnesium were found in the soil sample.

Appendix 2C. X-ray dot map (upper images) and spectrum of soil sample “14A” showing the distribution of individual major elements. The sample was coated by vapor deposition method with carbon to prevent charging in the SEM.

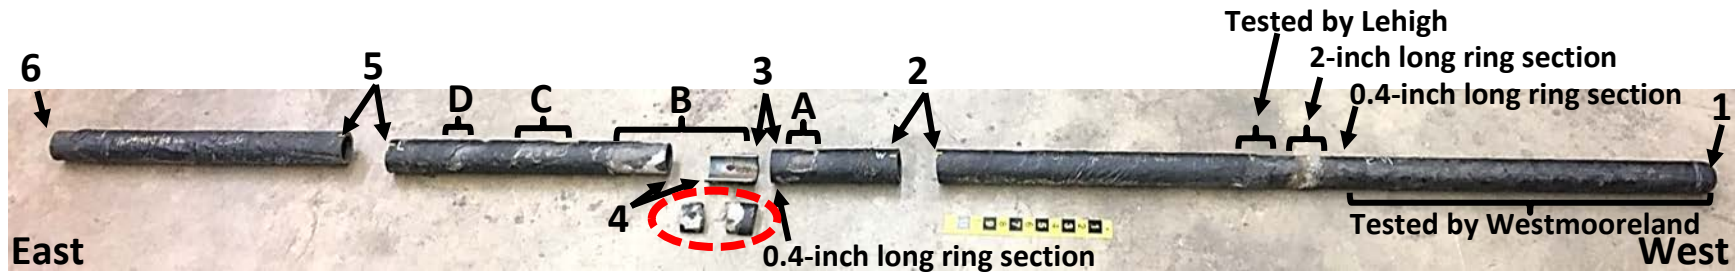
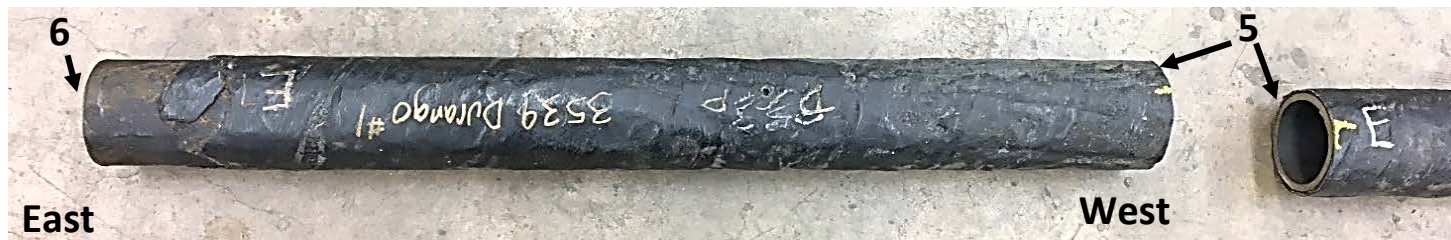
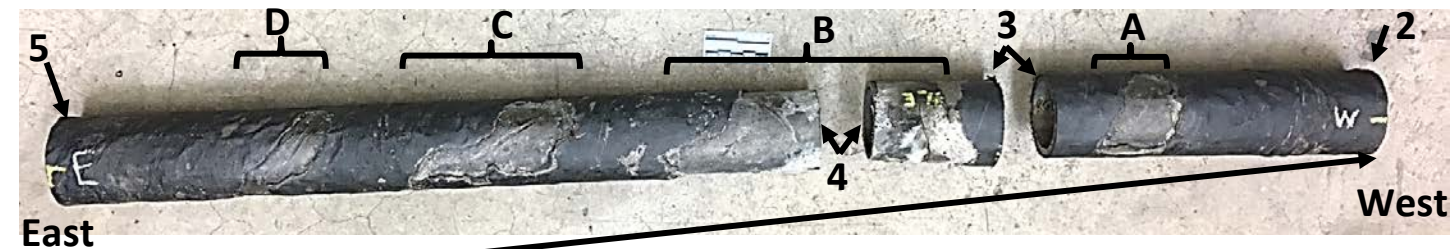
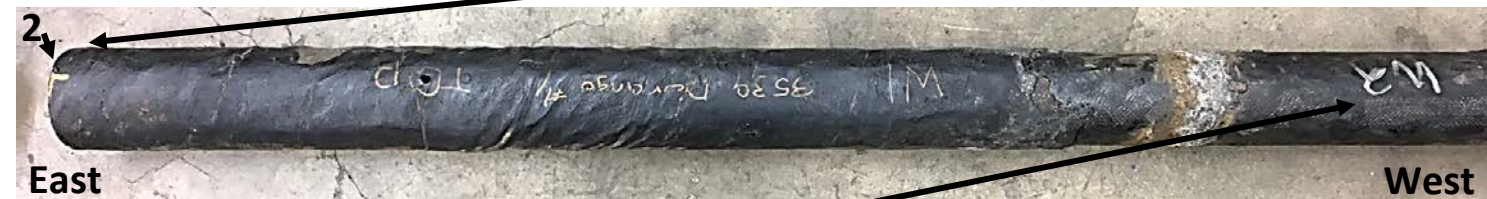
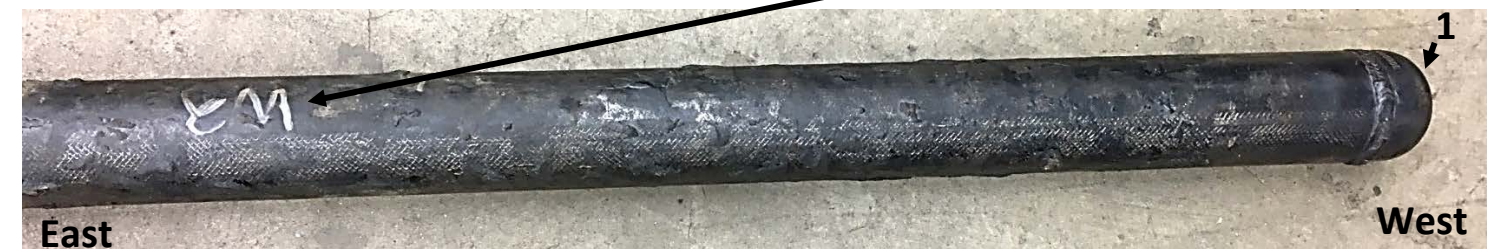
Main
Saw Cut Locations
(1 Page)

Appendix 4 show photographs of the main and the location of saw cuts that were made by the NTSB Materials Laboratory. Several saw cuts were made to remove ring sections for metallographic evaluation or to facilitate shipping portions of the main to contractor laboratories for tensile testing/chemical analysis.

Appendix 4. Photographs of the 10-foot main segment of the main that was located behind dwelling 3539 Durango Drive showing exposed areas with damaged coating indicated by brackets "A", "B", "C", and "D". Saw cuts made by NTSB lab are identified by arrows "2" through "5". Field cut is identified by arrow "6". Weld cap end made on-site is indicated by arrow "1". Ring sections cut by NTSB lab and portions tested by Lehigh and Westmoreland laboratories are indicated on the top photograph. Area "B" contains the dent and crack. Dashed circle indicates location where a longitudinal saw cut was made by NTSB lab through the main causing the top half of the main to separate from the bottom half and exposing the crack that intersected dent "B". Refer to NTSB Materials Laboratory Factual Report No. 18-067 for photographs of the as-received main segment.
