# NATIONAL TRANSPORTATION SAFETY BOARD

**MATERIALS LABORATORY FACTUAL REPORT**

Report No. 19-032

Place : Fellsmere, Florida  
Date : March 5, 2019  
Vehicle : Piper PA-28-161, N556PU  
NTSB No. : ERA19FA116  
Investigator : Leah Read

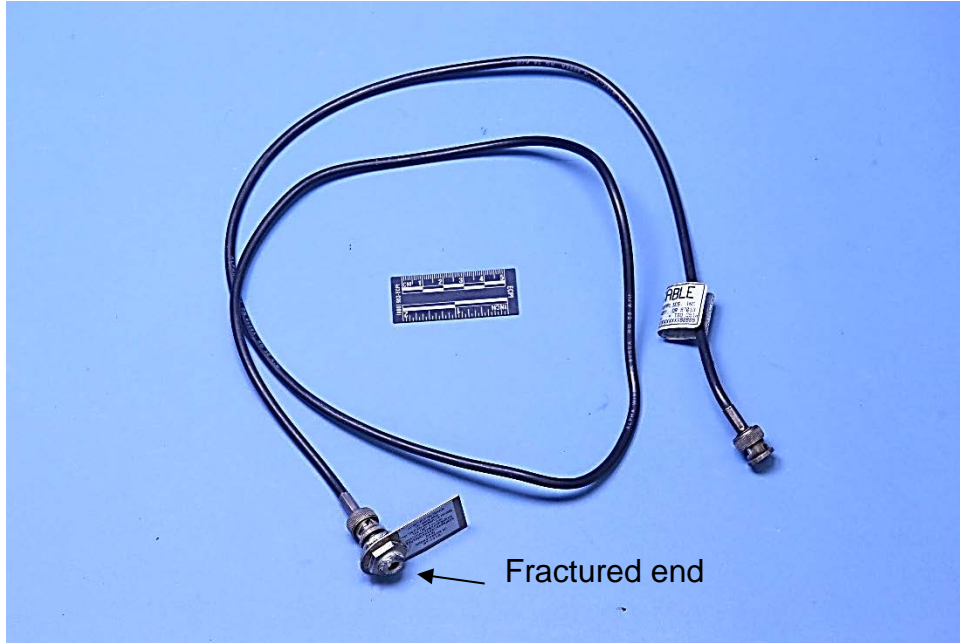
Figure 1 shows a photograph of the as-received ELT antenna cable with fractured section that attaches to the antenna at the airframe. The adapter assembly at the fractured end was disassembled to facilitate handling and examination. The core of the adapter assembly contained a plastic tube-like portion that was fractured on a slant plane relative to its longitudinal axis, consistent with overstress separation. The disassembled adapter assembly was ultrasonic cleaned with a mild detergent solution. The fracture face of the plastic portion was coated with gold-palladium by vapor deposition method, as preparation for scanning electron microscope (SEM) examination. SEM examination of the plastic fracture face revealed no evidence of fatigue cracks (crack arrest marks).

Figure 1. As-received ELT antenna cable with fractured section that attaches to the antenna at the airframe.
