NATIONAL TRANSPORTATION SAFETY BOARD

MATERIALS LABORATORY FACTUAL REPORT

Report No. 19-056

Place : Lady Lake, Florida
Date : September 6, 2019
Vehicle : Vans RV-12, N767FS
NTSB No. : ERA19FA265
Investigator : Lynn Spencer, AS-ERA

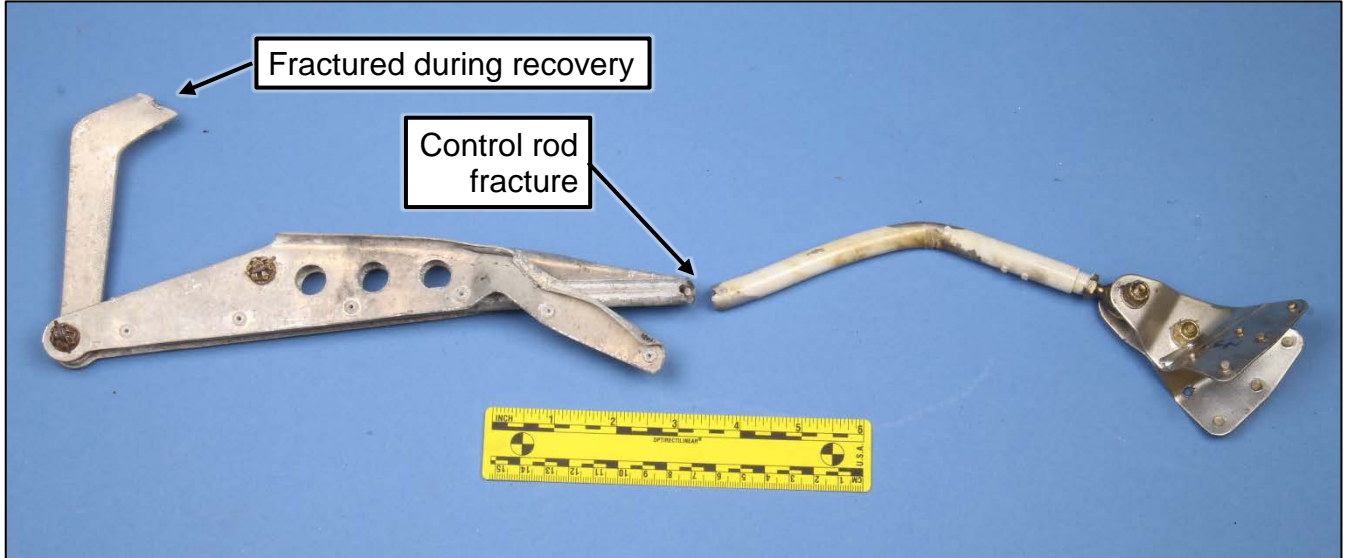
An overall view of the submitted elevator trim actuator control assembly is shown in figure 1. The arm shown at the left in figure 1 was fractured, and documentation from the investigator in charge indicated that it had been fractured during recovery.

The control rod was fractured at the location shown in figure 1, and the rod was bent at a location approximately midway between the fracture and the end fitting. The fracture surfaces on the control rod were on slant angles consistent with ductile overstress fracture, and the rod was deformed adjacent to the fracture consistent with bending deformation. The bending deformation at the fracture and the mid-point were in opposite directions, consistent with a buckling failure under compression loading.

Figure 1. Overall view of the submitted elevator trim actuator control assembly.
