# NATIONAL TRANSPORTATION SAFETY BOARD

MATERIALS LABORATORY FACTUAL REPORT

Report No. 19-064

Place : Danville, Kentucky  
Date : August 1, 2019  
Vehicle : 30-inch natural gas transmission pipe operated by Enbridge  
NTSB No. : PLD19FR002  
Investigator : Alexandria Colletti (RPH)

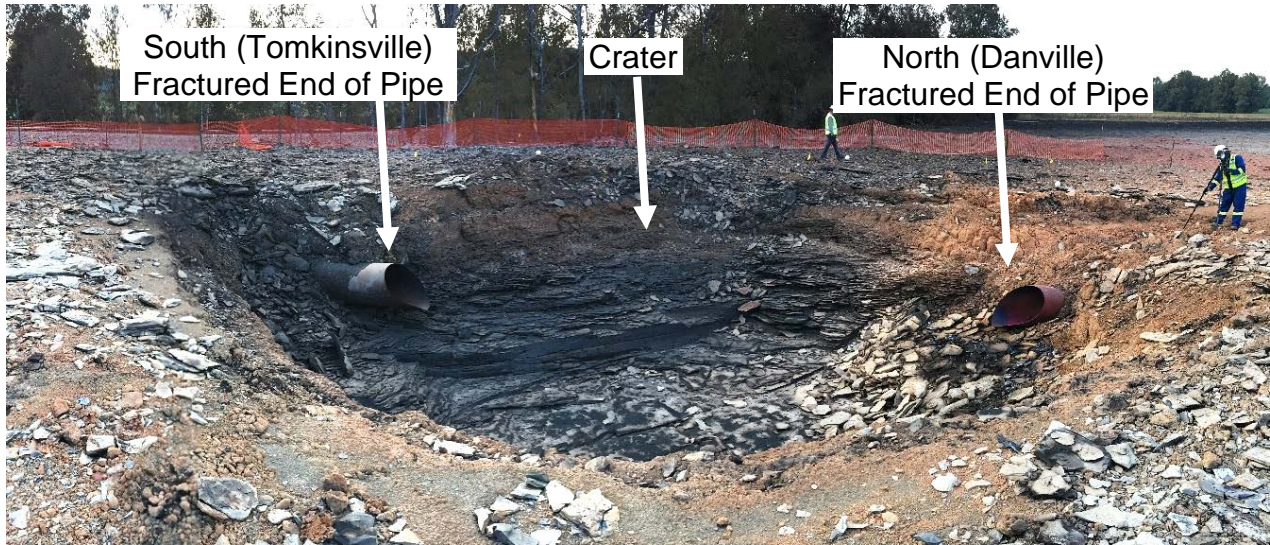
A visual survey of the accident location disclosed that the pipe at the rupture location was installed underground. The in-service rupture occurred on Tompkinsville to Danville Line 15, leaving a crater in the ground, see figure 1.<sup>1</sup> The size of the crater measured approximately 43.4 feet long, 30 feet wide, and 9.6 feet deep. The fractured ends of the pipe located within

Figure 1. Photograph of the two fractured ends of the ruptured gas transmission pipe within the crater. The fractured end of the pipe extending from the Danville pumping station is referred to as the north end.

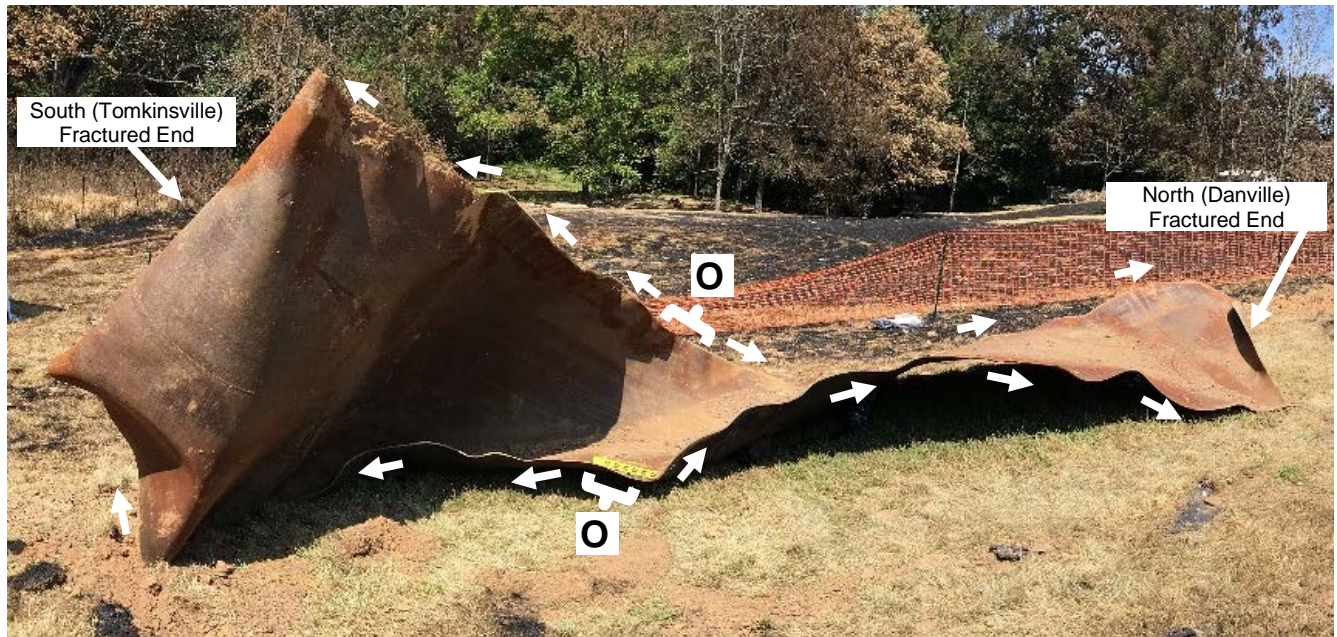
Figure 2. Photographs of the ejected segment of pipe that was found 481 feet from the crater showing the inner surface. The origin of the fracture is located in the area indicated by brackets "O" (mating fractures), and the general direction of fracture propagation is indicated by white unmarked arrows. The origin of the fracture is located approximately at the 4 o'clock position looking north.

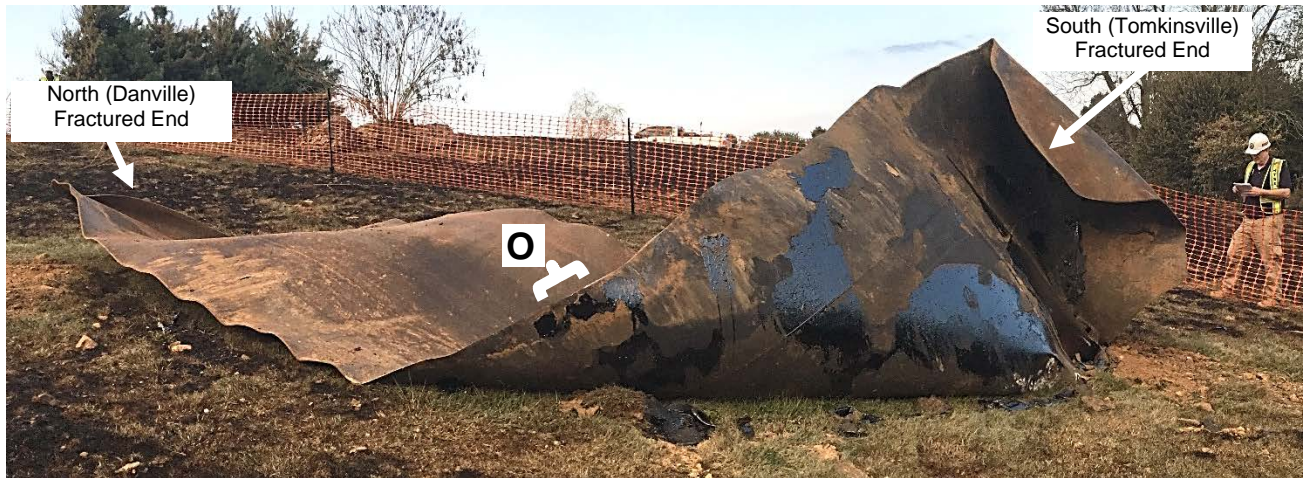
Figure 3. Photographs of the ejected segment of pipe that was found 481 feet from the crater showing the inner surface on the upper left side of photograph and for the most part the outer surface on the right side of the photograph. The origin of the fracture was located in the area indicated by brackets "O" (they are mating fractures).

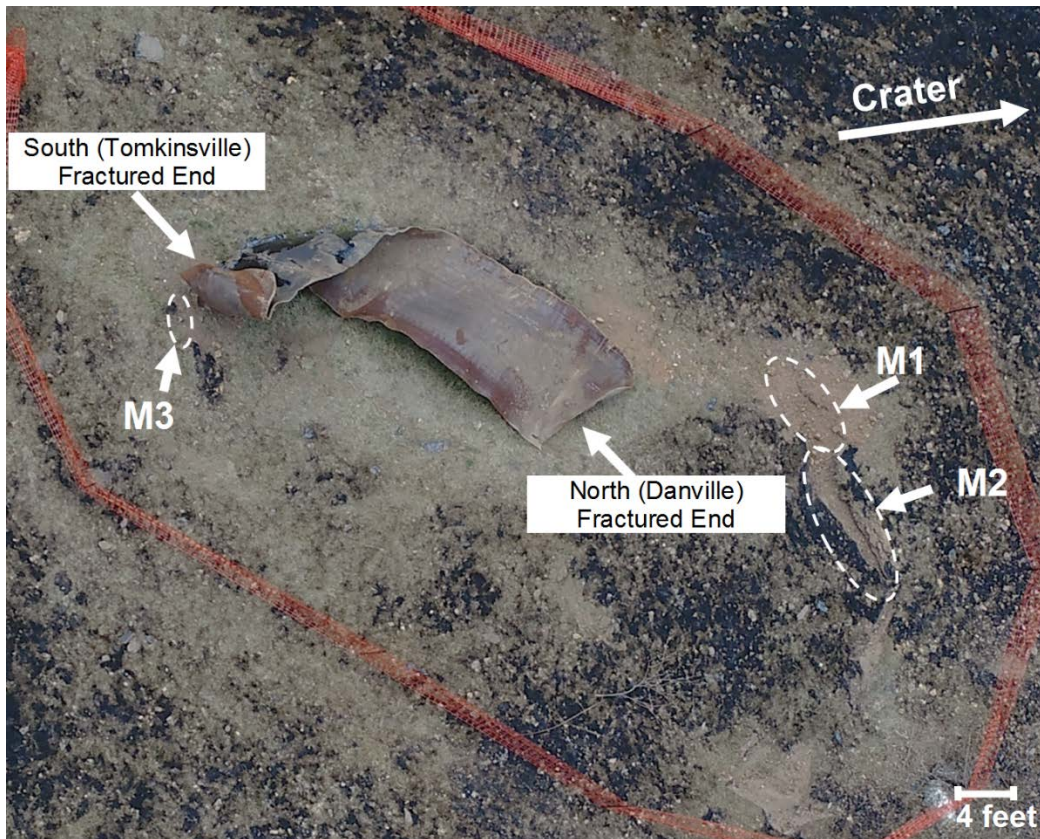
Figure 4. Aerial photograph by NTSB drone of the ejected piece of pipe that was discovered approximately 481 feet from the rupture location (crater). Ground impact marks were found on the ground near the pipe in the areas indicated by arrows "M1" through "M3". Each ground impact mark exhibited a linear-like impression.

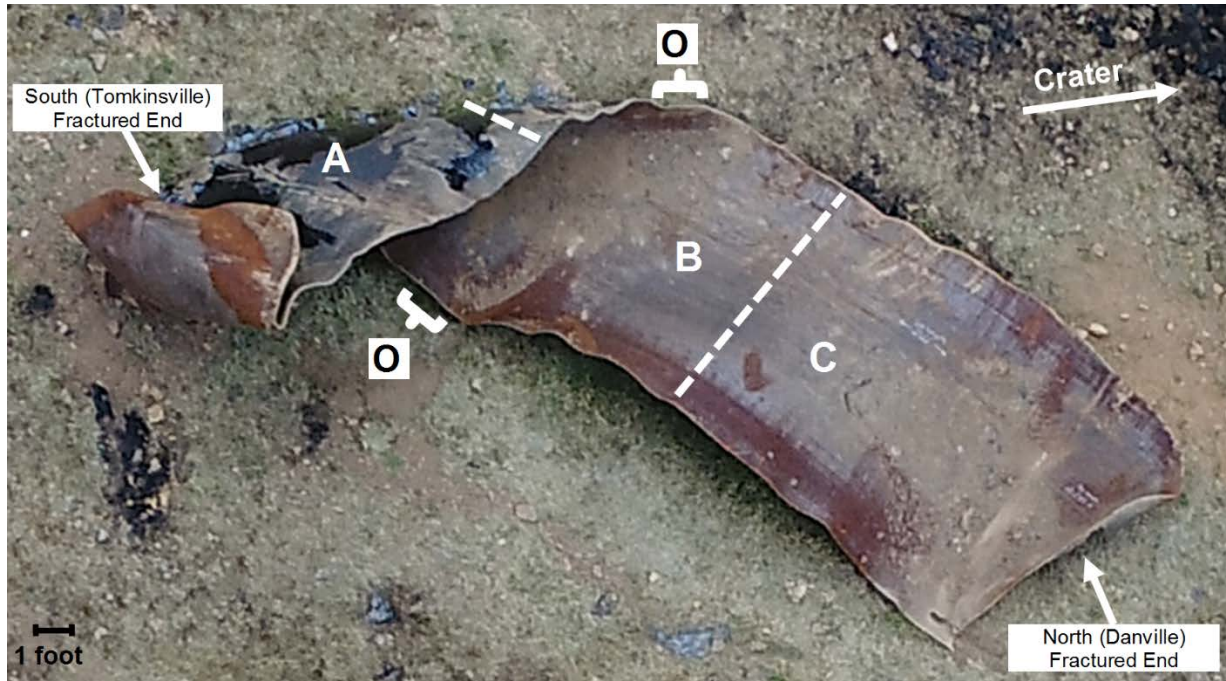
Figure 5. Aerial photograph by NTSB drone of the ejected piece of pipe that was discovered approximately 481 feet from the rupture location showing predominantly the inner surface (light brown areas) and the outer surface (black area). The fracture origin area indicated by brackets "O".

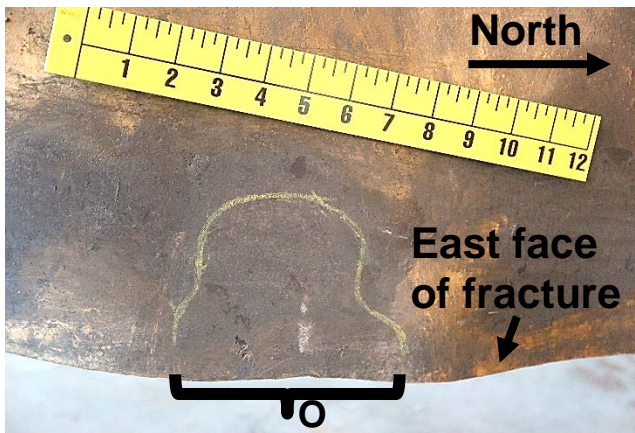
A straight edge, plastic ruler, was placed on the outer surface of the ejected pipe segment to check for evidence of flat spots (isolated flat areas). Inspection of the outer surface was made with the straight edge aligned parallel to the length of the pipe and with the straight edge aligned perpendicular to the length of the pipe. Isolated flat areas were found on the outer surface on both sides of the fracture face, in areas adjacent to the origin of the fracture, only for conditions where the ruler was oriented in the longitudinal or circumferential orientation and not in both orientations, see figures 6 and 7.

Figure 6. Photograph of the outer surface of the pipe at the east face of the fracture (fracture face is facing down) showing the fracture origin area, indicated by bracket "O". The outer surface adjacent to the fracture origin contained an isolated area that was flat when a straight edge was placed parallel to the length of the pipe, restricted to the area bound by the yellow line. The outer surface at the same isolated area exhibited a deformed curvature when a straight edge was placed perpendicular to the length of the pipe. The area marked in yellow measured as great as approximately 5 inches along the length of the pipe and it extended approximately 4 inches along the circumference.

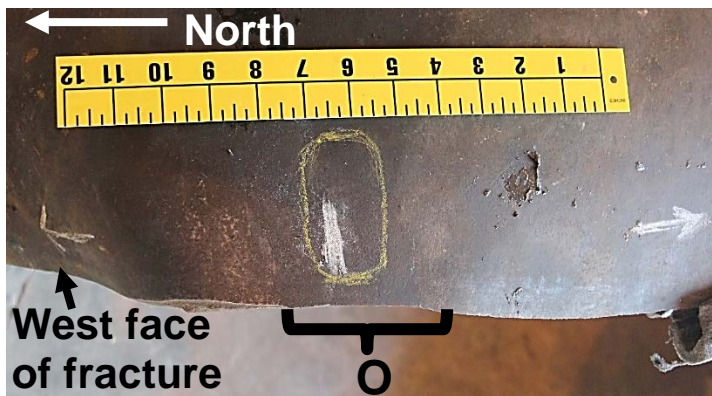
Figure 7. Photograph of the outer surface of the pipe at the west face of the fracture (fracture face is facing down) showing the fracture origin area, indicated by bracket "O". The outer surface adjacent to the fracture origin exhibited an isolated area that was flat when a straight edge was placed perpendicular to the length of the pipe for the area enclosed by the yellow line, but the outer surface on the same area exhibited evidence outward bending deformation when a straight edge was placed parallel to the length of the pipe. The area marked in yellow measured approximately 2 inches along the length of the pipe and approximately 3 inches along the circumference.

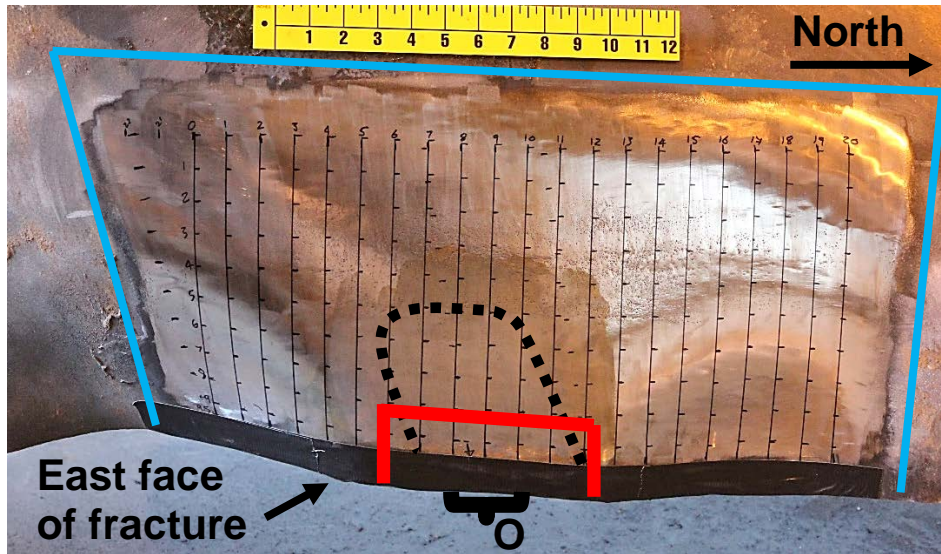
Figure 8. Photograph of the outer surface of the pipe at the east face of the fracture after polishing and etching followed by surface hardness testing. Origin of the fracture is indicated by bracket "O". Grid patterns are at one-inch interval. A darker etching region was located between the fracture face and area indicated by the black dashed line. A one-inch wide portion along the fracture was masked with black tape and was not polished/etched. The 6-inch segment indicated by red lines was cut from the pipe for fracture examination.

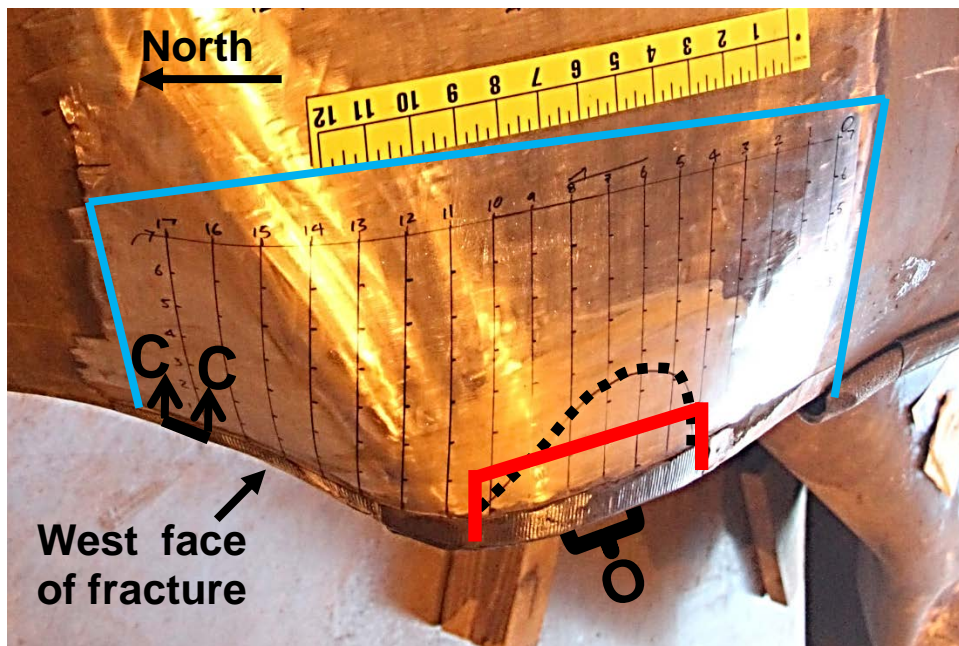
A longitudinal-radial section was made through the wall in an area located approximately 10 inches north of the fracture origin, indicated by section line "C-C" in figure 9. Section "C-C" was polished and etched with 2% Nital reagent. Examination of etched section "C-C" revealed the wall contained a microstructure of ferrite and banded pearlite typical of a hot rolled steel, see figure 24.

Figure 9. Photograph of the outer surface of the pipe at the west face of the fracture after polishing and etching followed by surface hardness testing. The origin of fracture is indicated by bracket "O". A darker etching region is located between the fracture face and the area indicated by a black dashed line. A one-inch wide portion along the fracture face was masked with tape and was not polished/etched. The 6-inch segment indicated by red lines was cut from the pipe for fracture examination.

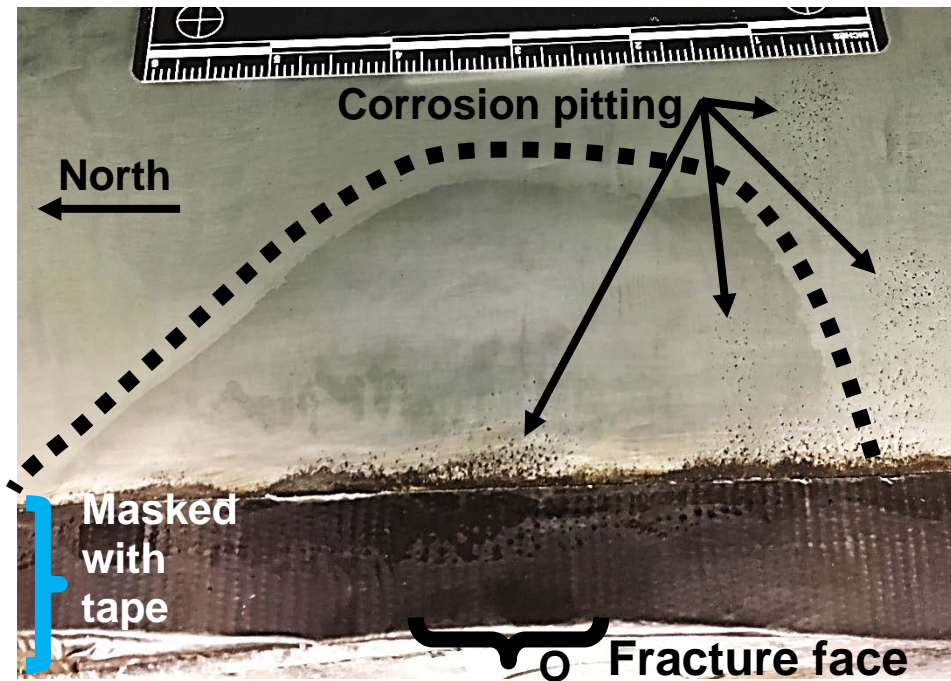
The NTSB Materials Laboratory contracted Mears Group Inc (Mears), Rosebush, Michigan, to perform hardness testing on the outer surface of the pipe in the general area of the fracture origin area with a portable hardness tester using the Leeb Rebound Probe test method to determine the presence of hard spots (elevated hardness relative to the base metal). Portable hardness testing was performed on the outer surface of the pipe at each side of the fracture corresponding to the origin of the fracture, with the exception of a 1-inch wide portion of the outer surface that ran along the length of each fracture face that was masked with duct tape. The masked areas were preserved for detailed fracture examination of the origin area (fracture examination is discussed in section 3.2 titled "Examination of the Fracture Origin Area at the NTSB Materials Laboratory, Washington, DC"). The outer surface was ground and polished prior to measuring the hardness with a portable hardness tester. The portable hardness testing showed evidence of elevated hardness relative to the surrounding areas in the general area of the fracture origin area (see Mears report in Appendix 5). The greatest measured hardness value was 336 Brinell Hardness Number (BHN). The areas of elevated hardness on the outer surface of the pipe corresponded to the general area of hard spot indications "2" and "3" reported by Global NDT, see Appendix 2. The outer surface at the areas of elevated hardness were etched with 10% Nital reagent. The etching procedure revealed a darker etching region compared to the surrounding area that was consistent with a hard spot in the general area of the fracture origin area, see Mears report in Appendix 5 and figure 10 in this

report. Corrosion pitting with a maximum depth of 0.013 inch, which is approximately 3.5% of the nominal wall thickness, was noted in the general area of the fracture origin.

Figure 10. Photograph of the outer surface of the pipe at the west face of the fracture showing the origin area, indicated by bracket "O", and a darker etching region (border is indicated by a dashed line), same area as indicated by dashed line in figure 9. A one-inch wide portion along the fracture face was masked with tape (protected the fracture face from polishing and etching procedure). Evidence of corrosion pitting was clearly visible in polished areas. Polished and re-etched by NTSB.

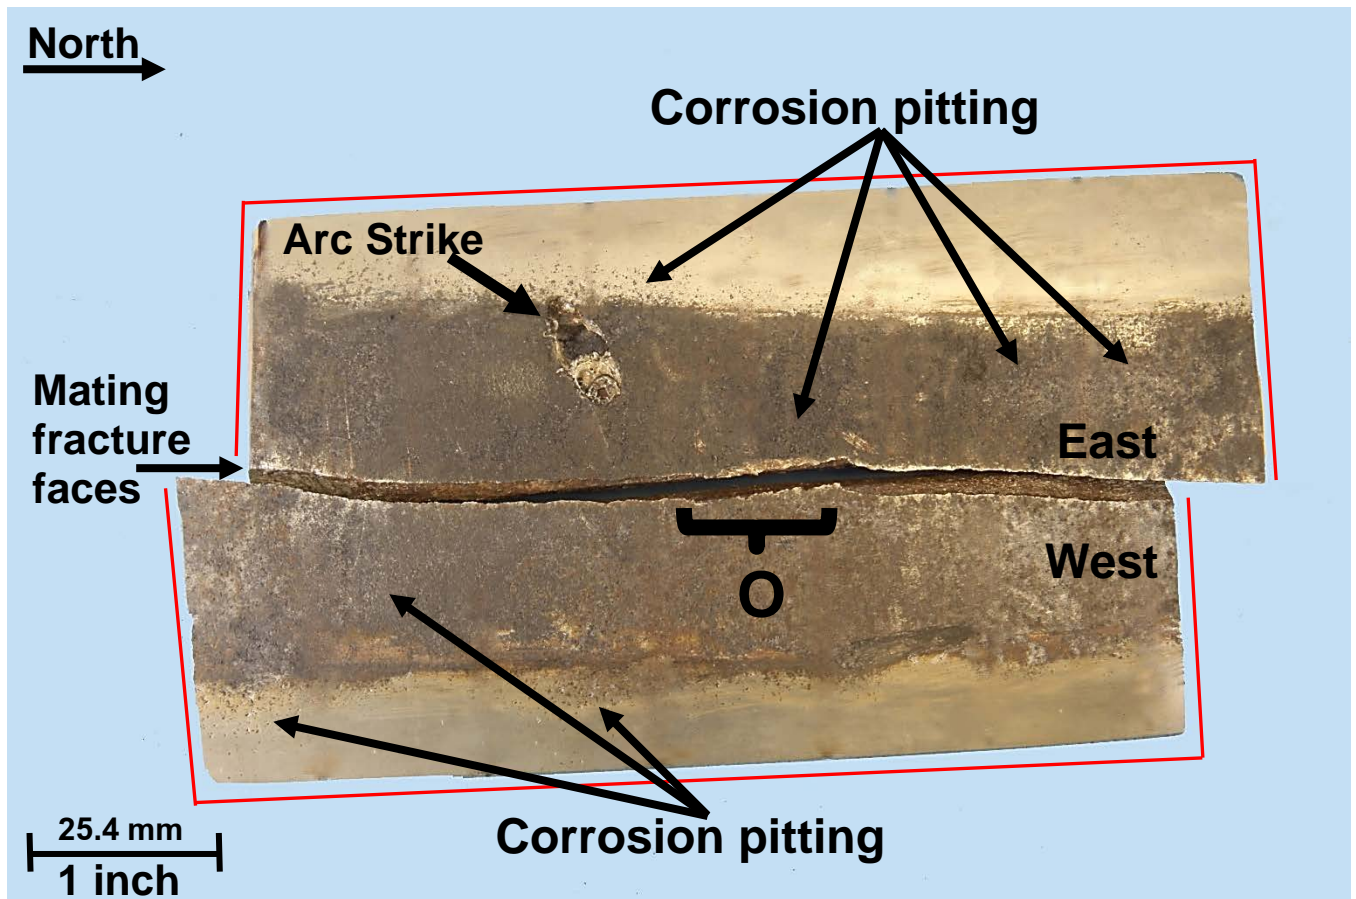
Bench binocular microscope examination of the 6-inch long portion of the east face of the fracture revealed the fracture emanated from the outer surface of the pipe in the area indicated by bracket "O" in figures 11 and 12. The face of the fracture was covered with brown oxide. Portions of the origin contained evidence of minor scratches. No evidence of a gouge or dent was found at the origin. The origin of the fracture was on a linear plane, did not emanate from multiple points, and showed no evidence of ratchet marks. The outer surface in many areas exhibited evidence of corrosion pitting. The corrosion pitting areas were clearly visible in areas that were polished prior to portable hardness testing (see figures 10 and 11 and Appendix 5). The length of the origin at the outer surface measured approximately 0.8 inch and shear lips extended from both ends of the origin. The fracture face at the inner surface (opposite of the origin) contained a minor shear lip. The thickness of the shear lip at the inner surface measured approximately 0.04 inch. An isolated area of the fracture face that extended below the origin was on a flat plane and exhibited a rough texture, area enclosed by a yellow line in figure 12. The flat fracture area was bound by the shear lip regions at the outer and inner surfaces of the pipe. The length of the flat fracture in the area between the inner and outer surface measured approximately 5 inches. The flat fracture region in the area that coincides with the origin of the fracture extended through the majority of the wall cross section. The fracture areas located outside of the north and south ends of the flat fracture region were on a slant plane and contained a river pattern.

The outer surface near the fracture face contained an isolated, smooth, globule-like, irregular feature consistent with solidified metal when compared to the surrounding surface, consistent with an arc burn (arc strike).<sup>7</sup> Figures 11 and 19 show the arc strike on the outer surface of the pipe.

Figure 11. Photograph of the 6-inch long cut-out portion of the east fracture face and similar cut-out from the mating fracture face positioned next to each other as if intact showing the outer face of the pipe and the fracture origin area indicated by bracket "O". The cut-out portions outlined by red lines in this photograph correspond to the same areas indicated by red lines in figures 8 and 9. Corrosion pitting was noted in the general area of the fracture origin and surrounding areas on both sides of the fracture, such as in the areas indicated by arrows. The corrosion pitting areas are clearly visible in areas that were polished prior to hardness testing. An arc strike was located near the fracture.

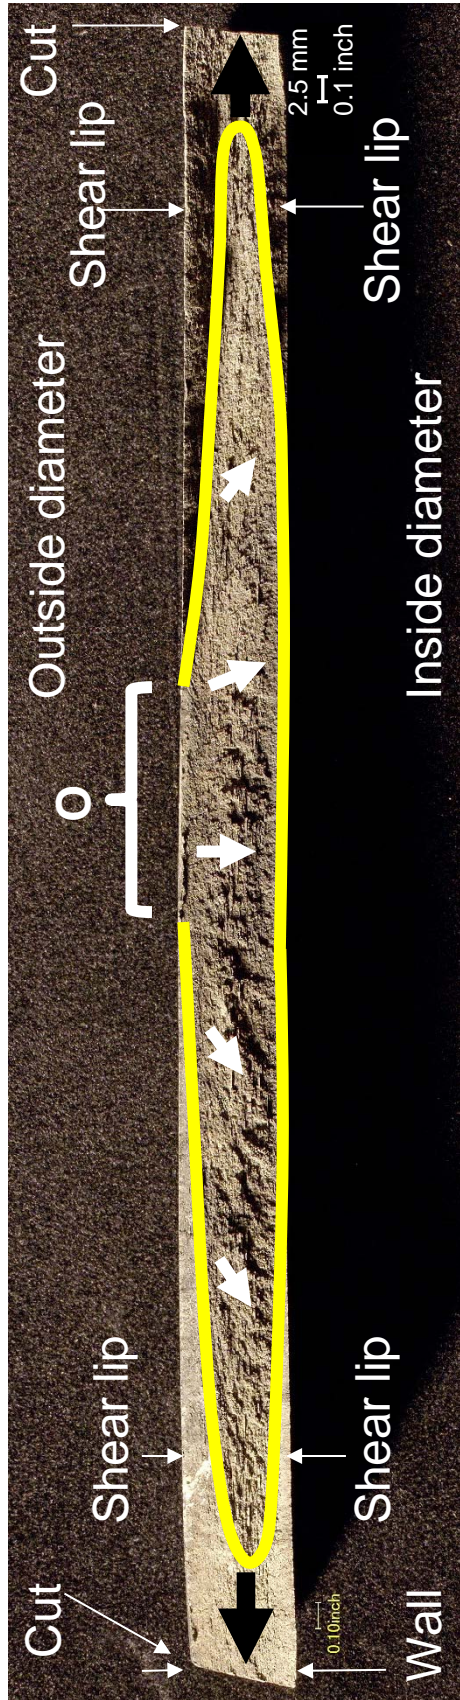
Figure 12. Optical composite photograph of the east face of the fracture showing the origin at the outer surface in the area indicated by bracket "O", between two shear lips. The origin of the fracture and an area extending below the origin contained a flat region with a rough texture, indicated by a yellow line. Fracture propagation was in the general direction indicated by arrowheads.

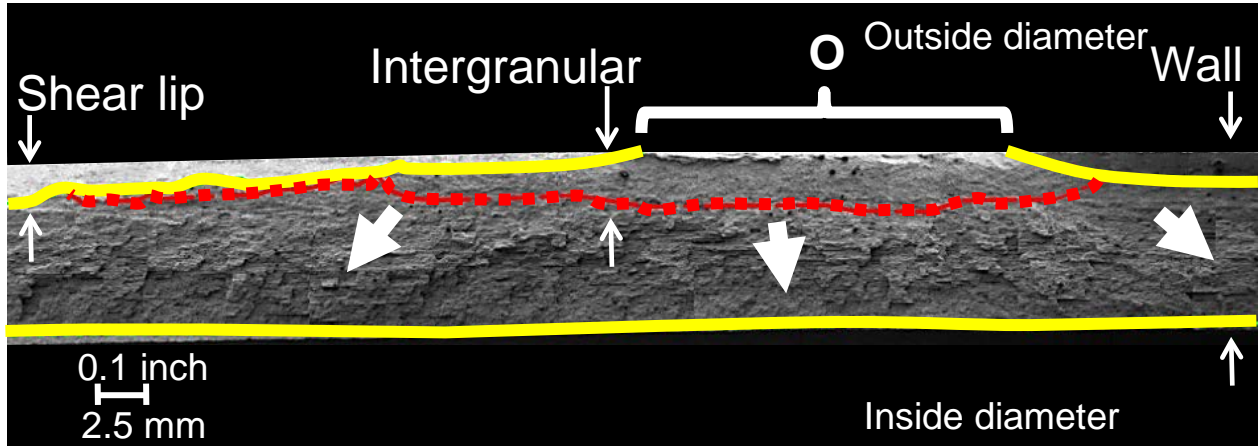
SEM examination of the east face of the fracture revealed the cleaning procedure exposed the fine fracture features. Detailed SEM examination of the fracture face revealed the origin exhibited intergranular fracture features, see figures 13 through 15. Shear lips extended from both ends of the origin. Within the flat fracture region described earlier, the intergranular fracture features extended between the outer surface and approximately 0.1 inch below the outer surface to the areas indicated by a red dashed line in figure 13, which calculates to a depth of approximately 30% of the nominal wall thickness. The flat fracture region in the area

Figure 13. SEM composite photograph of the east face of the fracture showing the origin at the outer surface of the pipe in the area indicated by bracket "O". Fracture propagation was in the general direction indicated by arrowheads. The intergranular region extended from the outer surface to the area indicated by a red dashed line. Portion of the flat region is outlined by yellow lines.

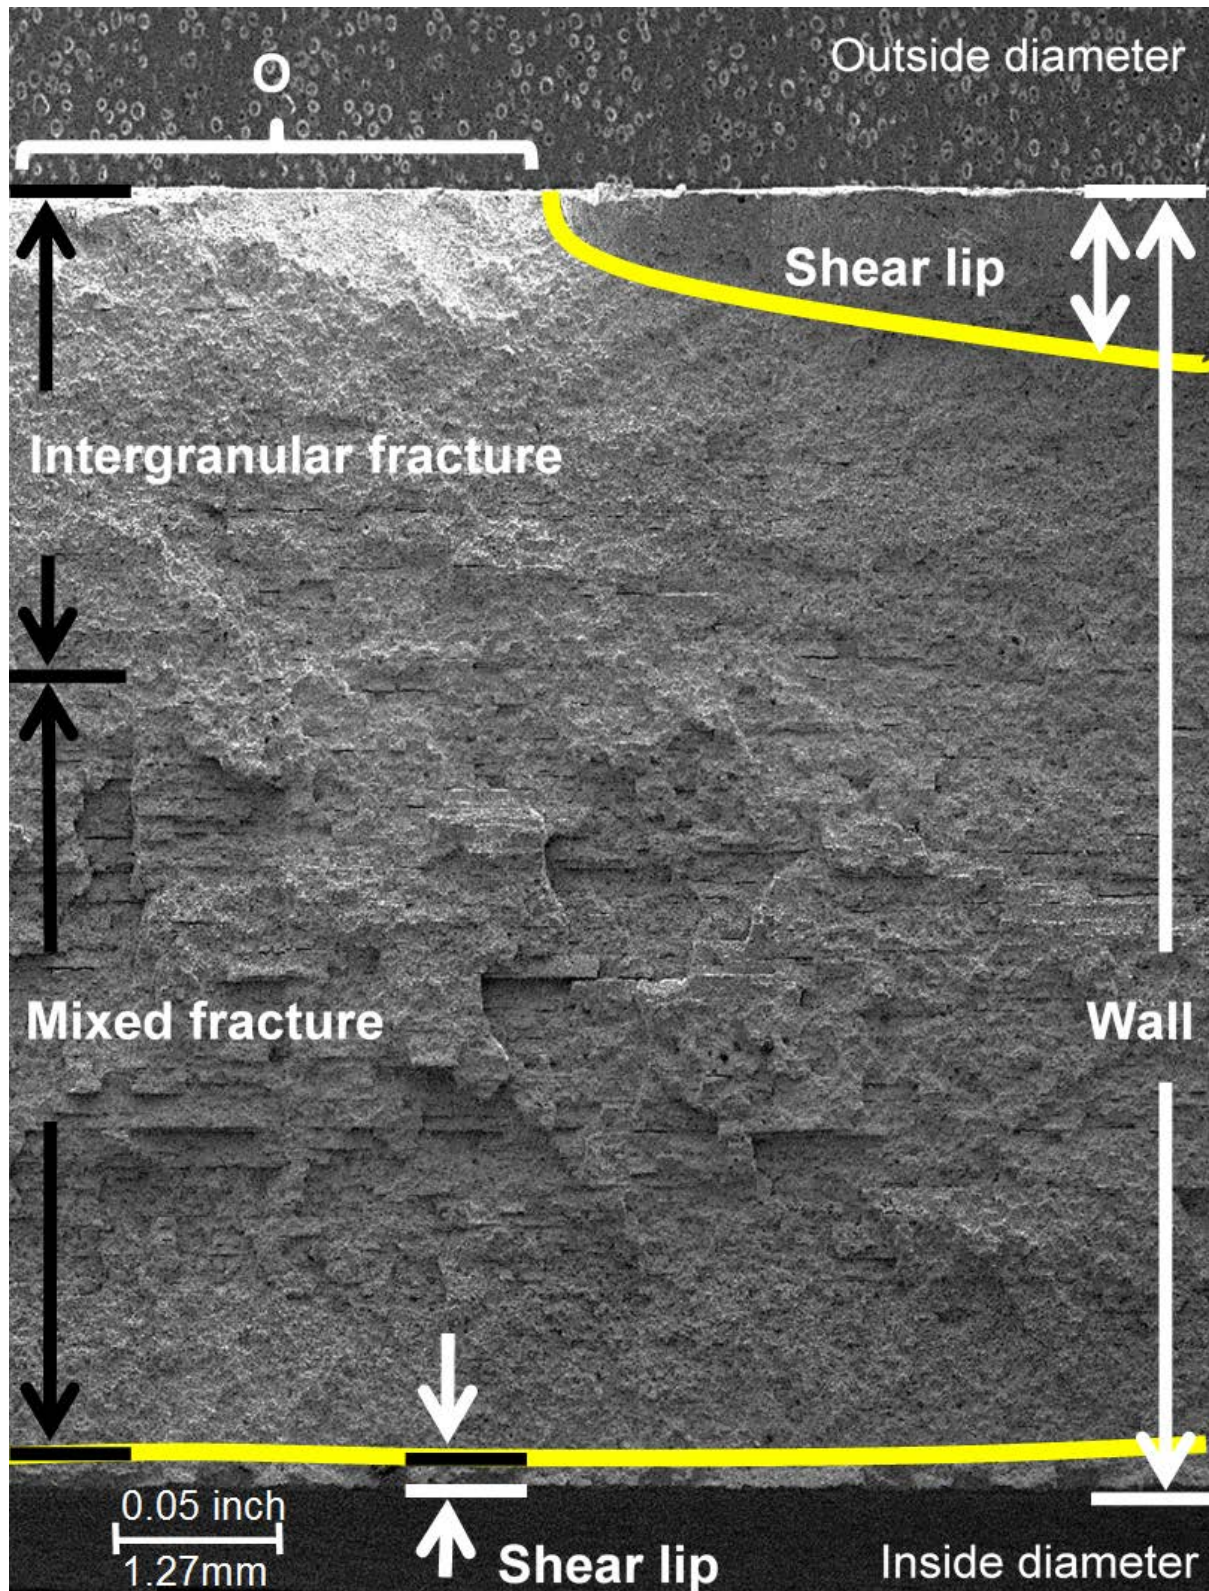
that extended between 0.1 inch from the outer surface and the shear lip region at the inner surface exhibited a mixed fracture, consisting of intergranular and woody fracture features.<sup>8</sup> Figure 14 shows a close-up composite photograph of the mixed fracture region. The amount of intergranular fracture features decreased toward the inner surface. Within the mixed fracture region, the areas closer to the outer surface exhibited a greater amount of intergranular fracture features compared to the woody fracture features (see figure 16). The mixed fracture region at the mid wall location and at many areas closer to the inner surface exhibited a greater amount of woody fracture (see figure 17) compared to other fracture areas. The shear lip at the inner surface exhibited micro-void coalescence fracture features typical of ductile overstress separation (see figure 18).

Figure 14. SEM composite photograph of the east face of the fracture and a portion of the fracture origin area at the outer surface next to the start of a shear lip. The flat region is located between the yellow lines.

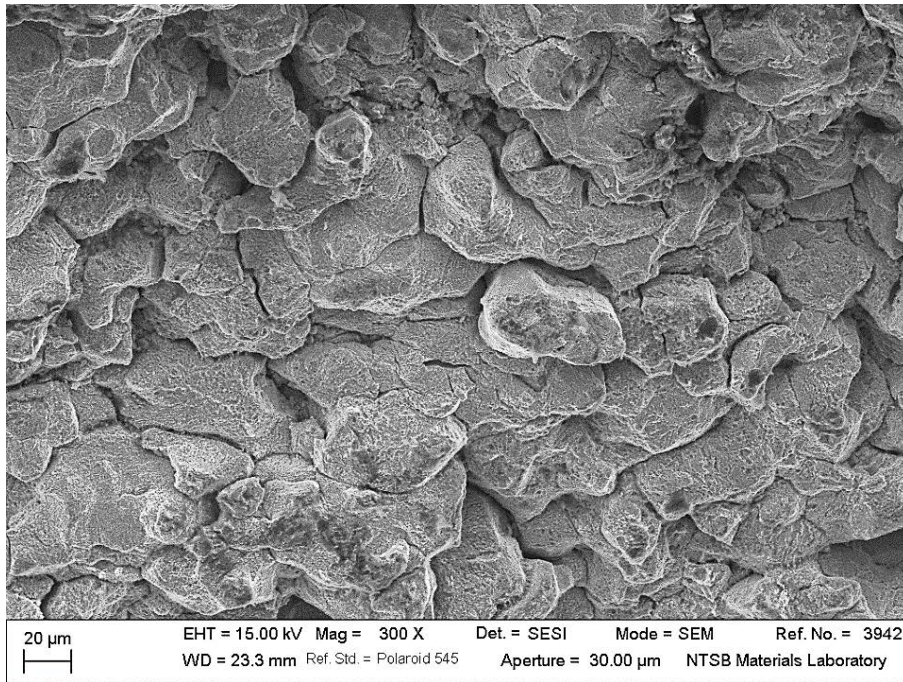
Figure 15. SEM photograph of the east fracture face at the origin of the fracture showing intergranular fracture features.

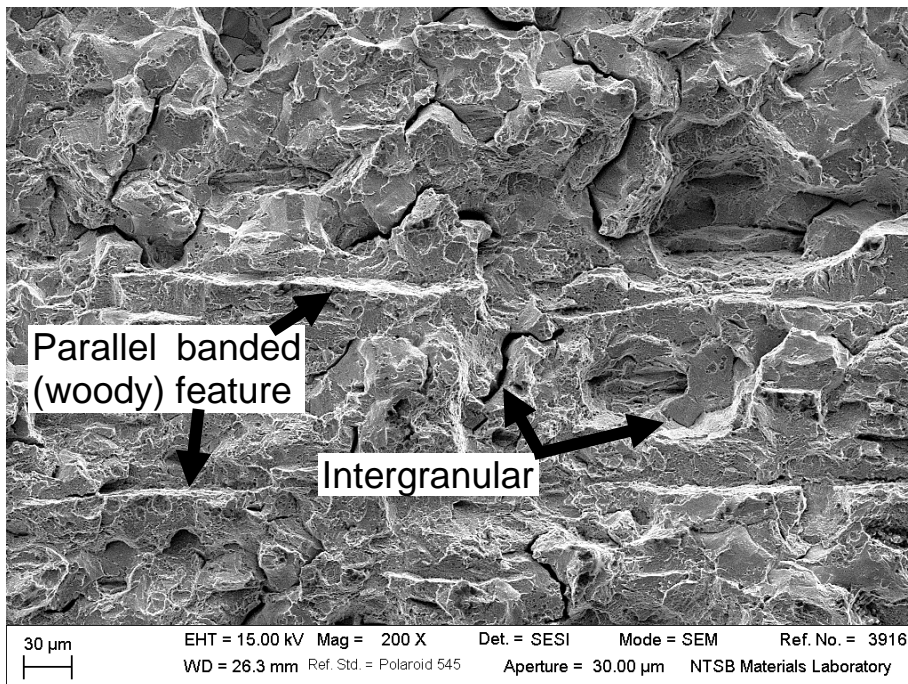
Figure 16. SEM photograph of the east fracture face at the mixed fracture region in an area near the intergranular region showing intergranular fracture features and includes a parallel banded (woody) feature that is associated with vintage hot rolled steel having a banded ferrite-pearlite microstructure.

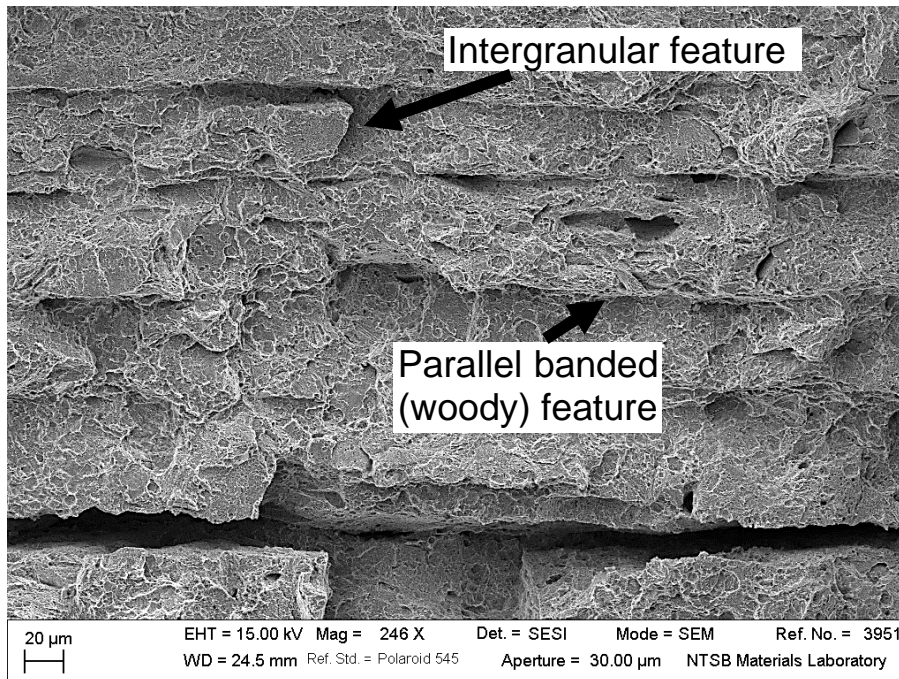
Figure 17. SEM photograph of the east fracture face at the mixed fracture region in an area located midway between the outer and inner wall surfaces showing intergranular and micro-void coalescence features and includes a parallel banded (woody) feature that is associated with vintage hot rolled steel having a banded ferrite-pearlite microstructure.

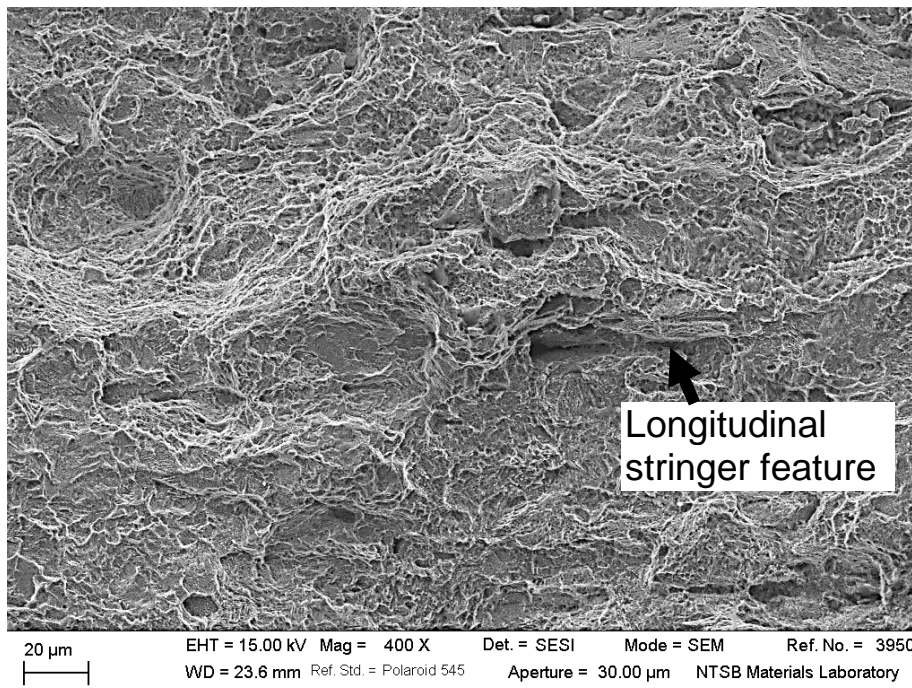
Figure 18. SEM photograph of the east fracture face at the mixed fracture region in an area near the shear lip at the inner surface showing micro-void coalescence features with several longitudinal stringer features.

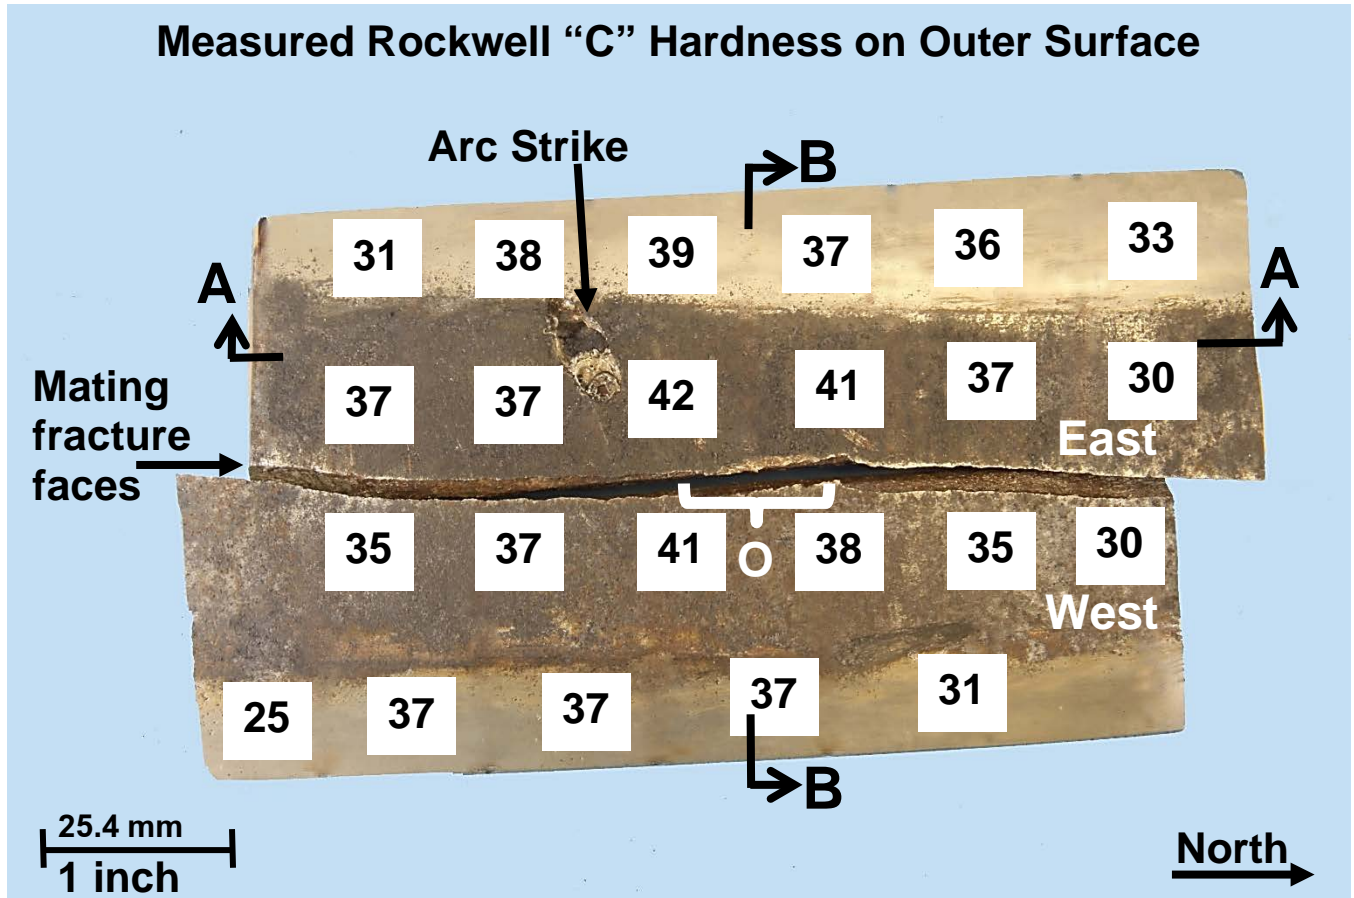
A circumferential-radial section was made through the wall that intersected the origin of the fracture, represented by section line "B-B" in figure 19. Microhardness testing of section "B-B" in areas located approximately 0.01 inch below the outer surface produced continuous hardness values in the range between 39 HRC and 41 HRC for a width of approximately 3 inches, consistent with a hard spot. The measured hardness profile through the thickness of the wall was similar to those in section "A-A". Diagram of the hardness profile for section "B-B" is not displayed. Based on the microhardness measurements, the origin of the fracture intersected a hard spot area whose hardness adjacent to the outer surface was between 39 HRC and 41 HRC (362 and 381 Brinell) and for this hardness range measured approximately 5.85 inches by approximately 3 inches. According to recent versions of API 5L Specifications this hard spot is classified as a defect because the dimension of the hard spot exceeded 2 inches in either direction and the hardness was greater than or equal to 35 HRC (327 HB).

Figure 19. Photograph of the 6-inch long cut-out portion of the east fracture face and similar cut-out from the mating fracture face positioned next to each other as if intact showing the outer face of the pipe and the origin area indicated by bracket "O". Rockwell hardness testing was performed on the outer surface by the NTSB Materials Laboratory. Results are reported in Rockwell "C" hardness values (HRC). The position of each hardness reading reflects the approximate position of the measured hardness. A longitudinal-radial section was made in the area indicated by section line "A-A", and a circumferential-radial section was made in the area indicated by section line "B-B".

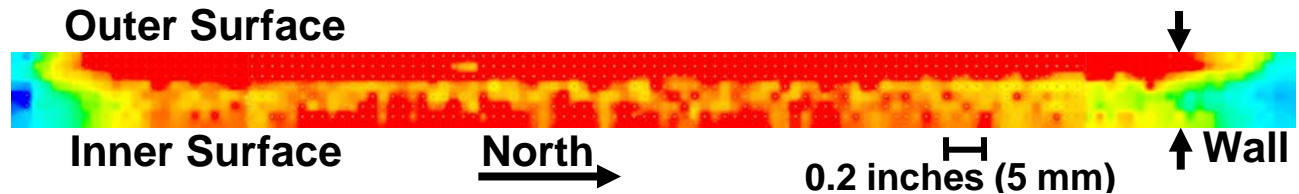
Figure 20. Diagram of longitudinal-radial cross section “A-A” showing the measured traverse hardness profile of the hard spot using color pattern to represent various ranges of hardness. The measured hardness is represented by the colors red, dark yellow, light yellow, green, light blue, and dark blue (greatest to least hardness, respectively). The measured hardness and colors that correspond to the measured hardness is shown in table 3. This section was made parallel and approximately 0.8 inch away from the origin of the fracture. The center of the section is aligned with the origin of the fracture.

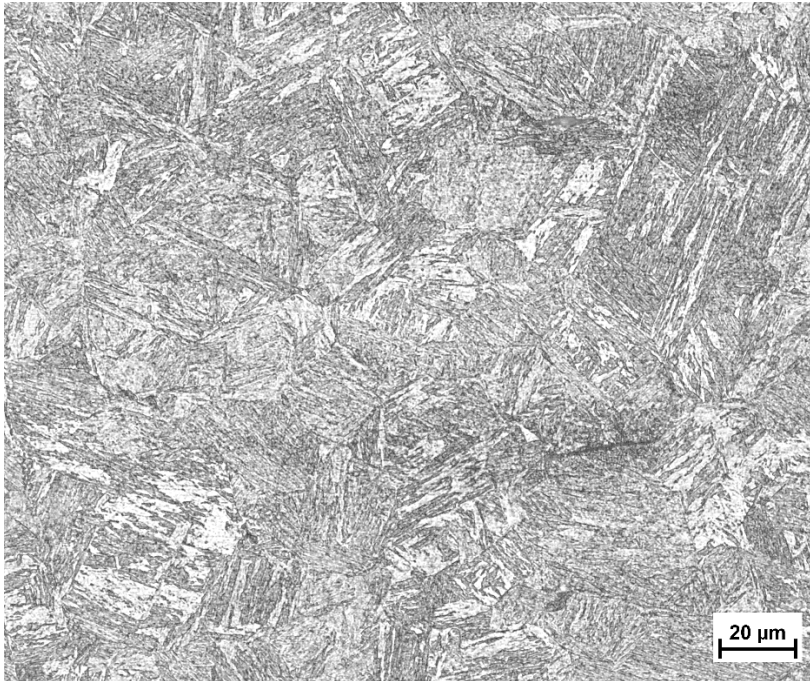
Sections "A-A" and "B-B" were polished and etched with 2% Nital reagent. Examination of sections "A-A" and "B-B" revealed the wall of the pipe in an area with elevated hardness values contained a microstructure of martensite. The wall of the pipe in the area that extended between the outer surface and approximately 0.1 inch below the outer surface contained a microstructure of martensite, see figure 21, whereas, the remaining wall portion showed a microstructure of martensite with a precipitating second phase at the grain boundaries, see figure 22. In section "B-B", the origin of the fracture showed evidence of intergranular fracture features, see figure 23. The origin of the fracture showed no evidence of branching cracks.

Figure 21. Typical microstructure of the hard spot in the area adjacent to the outer surface showing martensite. (2% Nital etch)

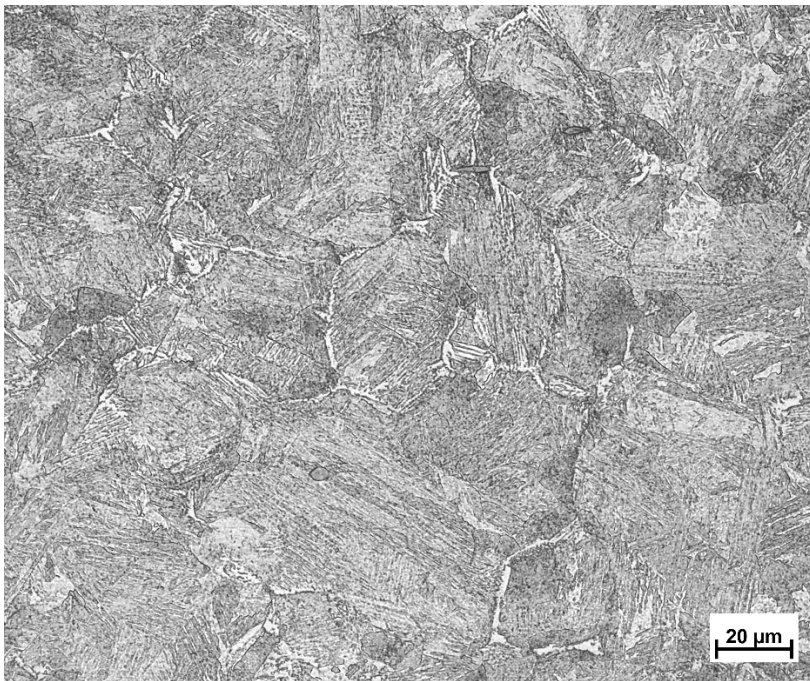
Figure 22. Typical microstructure of the hard spot in the area between the outer and inner surface showing martensite with second phase at the grain boundaries. (2% Nital etch)

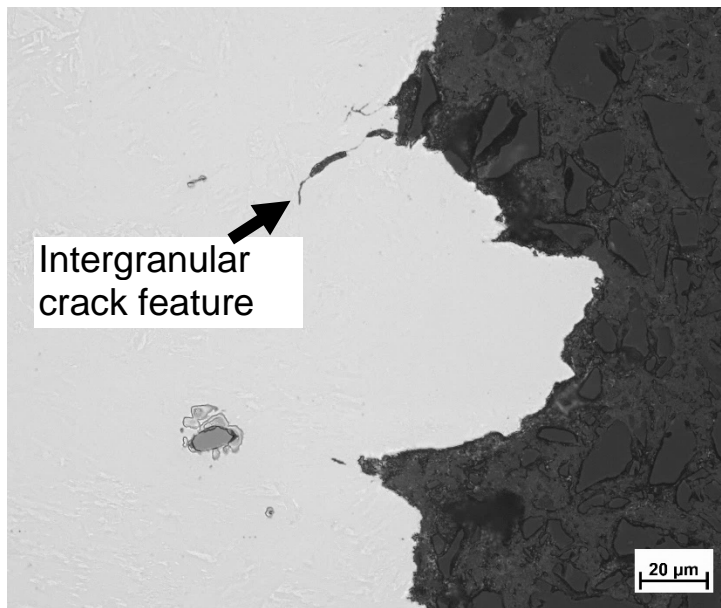
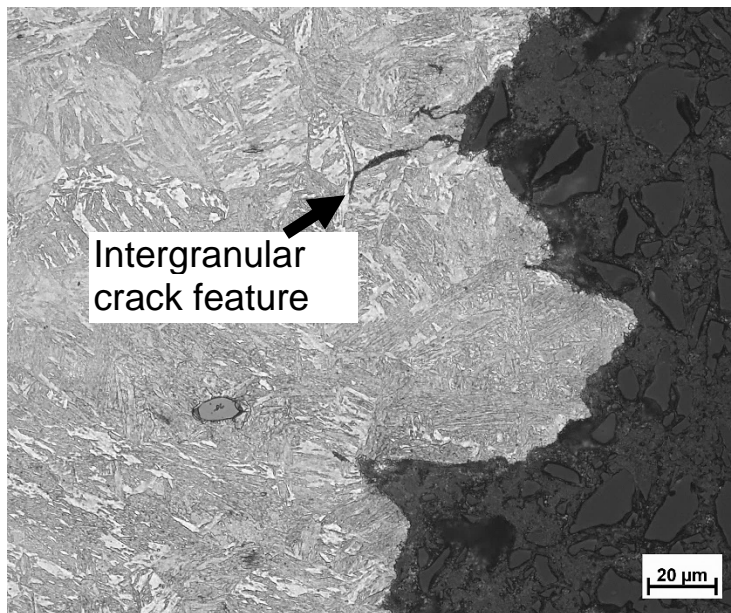
Figure 23. Cross section through the origin of the fracture showing intergranular fracture features before etching (upper side of page) and after 2% Nital etch (lower side page).

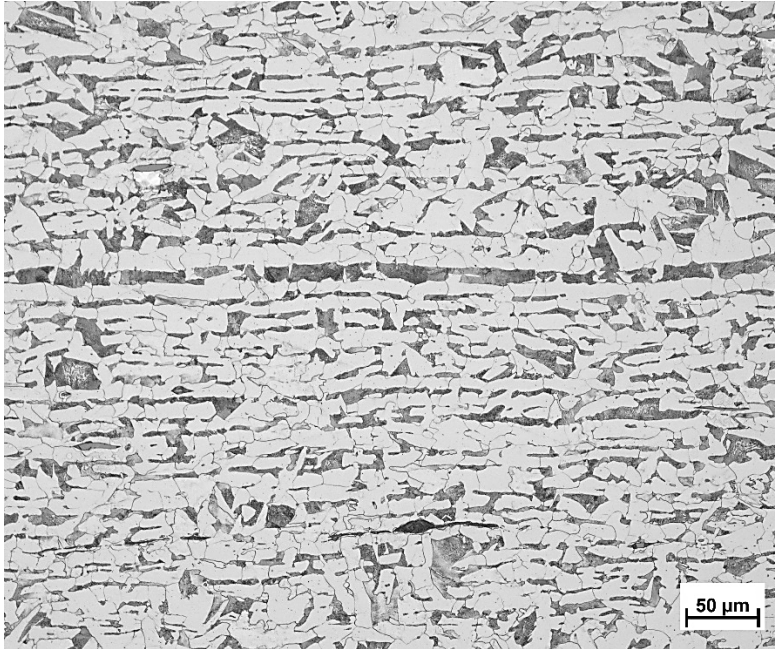
Figure 24. Typical microstructure of the pipe wall in metallurgical section “C-C” showing ferrite and banded pearlite grains with longitudinal manganese sulfide stringers. (2% Nital etch)
