# NATIONAL TRANSPORTATION SAFETY BOARD

MATERIALS LABORATORY FACTUAL REPORT

Report No. 19-064

Place : Danville, Kentucky  
Date : August 1, 2019  
Vehicle : 30-inch natural gas transmission pipe operated by Enbridge  
NTSB No. : PLD19FR002  
Investigator : Alexandria Colletti (RPH)

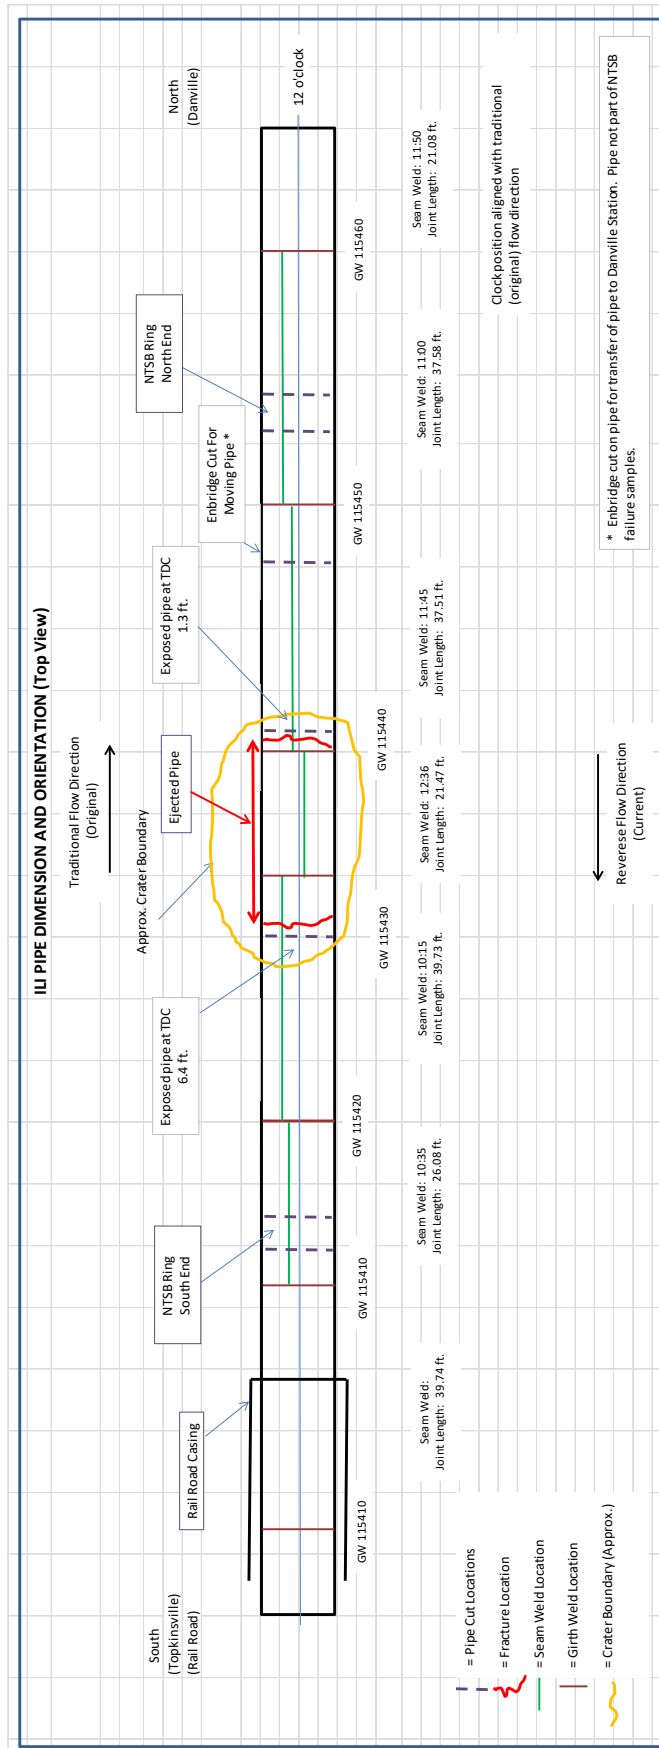
Appendix 1 shows a diagram of the pipe with the relative position of the girth welds, longitudinal seam welds, clock position of the seam welds relative to the TDC when looking north toward Dansville, fractured ends of the pipe, and the approximate position of the crater. The longitudinal portion of the fracture intersected two girth welds (GW 115430 and GW 115440) but it did not intersect the longitudinal seam weld portions of the pipe. The longitudinal length between the two girth welds that were intersected by the fracture measured approximately 21.6 feet. The origin of the fracture was not associated with a girth weld or a seam weld.

Appendix 1. Diagram of the pipe showing the location of the welds and fracture locations.

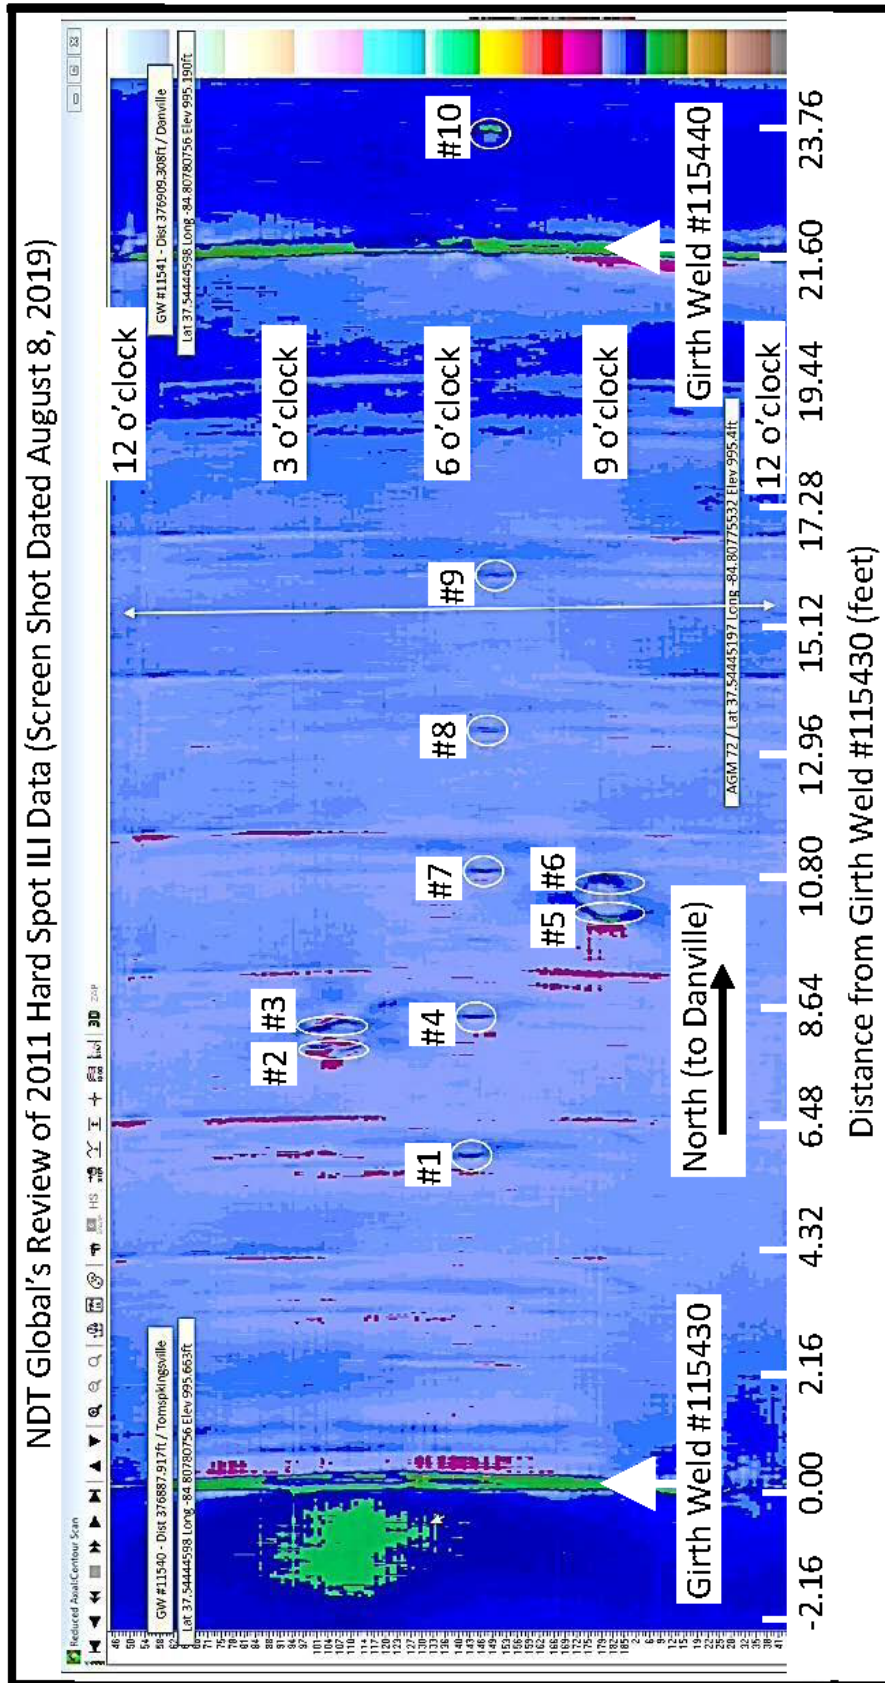
Appendix 2. Diagram of NDT Global's screen shot dated August 8, 2019 showing 10 hard spot indications (from review of the 2011 hard spot inline inspection [ILI] data). Hard spot indications are enclosed by a circle and they are numbered #1 through #10. The length between girth welds 115430 and 115440 measured approximately 21.6 feet.

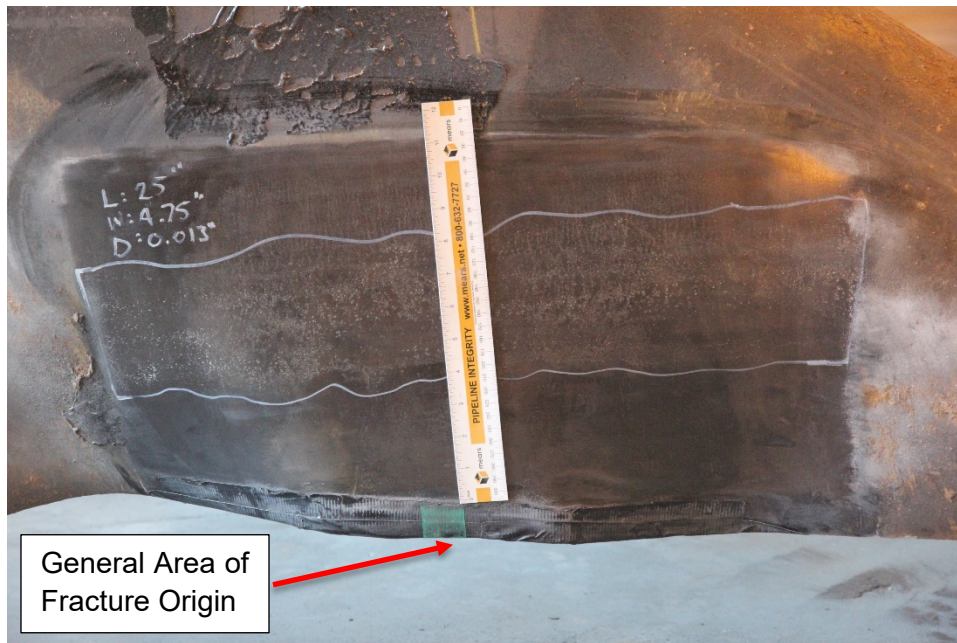
After the surface was prepared, visual inspection noted surface corrosion pitting within the East sample inspection area. This is shown in Figure 2 and Figure 3. The surface corrosion pitting was considered interacting and covered an area 25-inches long, by 4.75-inches wide. It was noted that the surface pitting continued both upstream and downstream of the East inspection area. The maximum depth of corrosion pitting was measured using a manual pit gauge and was measured at 0.013-inches. No visible mechanical damage wall loss was identified on the pipe surface in all three inspection areas.

**Figure 2: Surface Corrosion Pitting on East Inspection Area. Photo by NTSB**

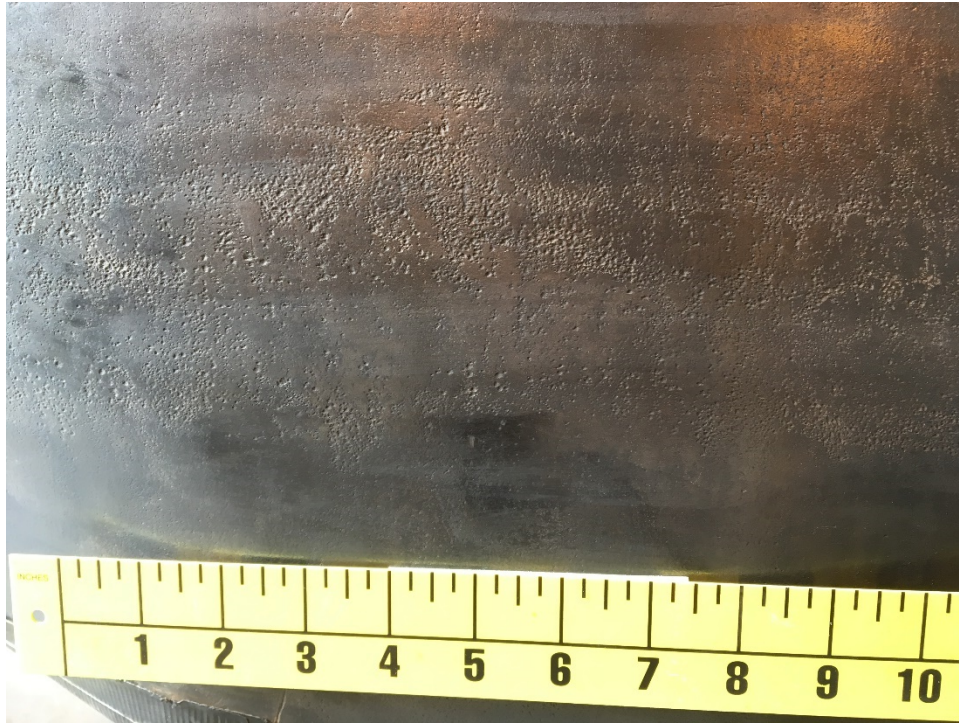
**Figure 3: Zoomed View of Surface corrosion Pitting within East Inspection Area. Photo by NTSB**

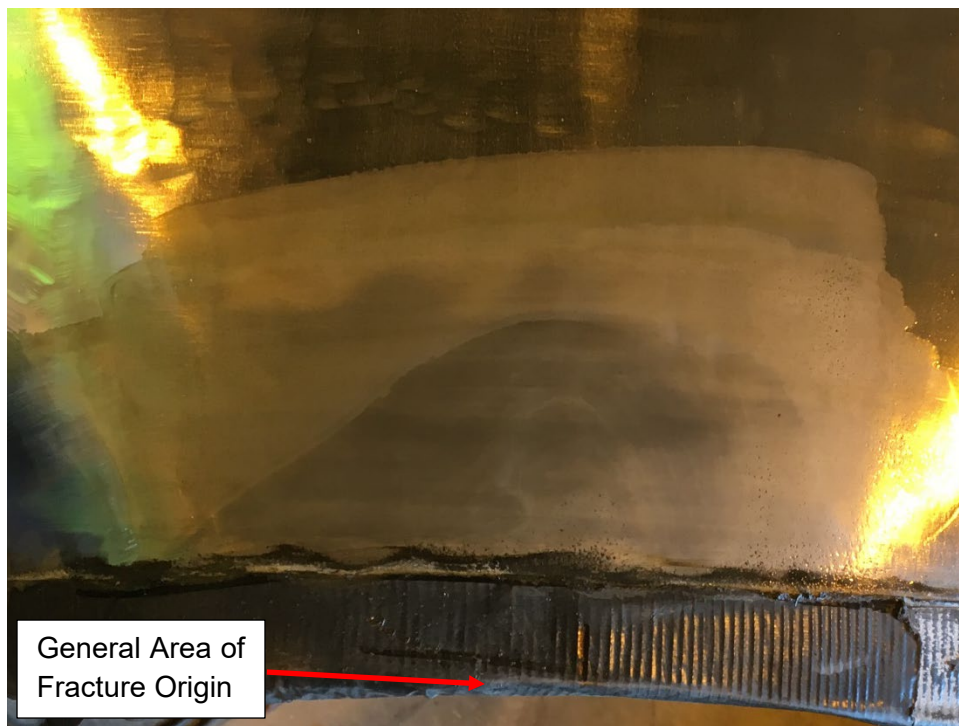
Darker areas on both the East and West sample that correlated with elevated hardness values were identified. These darker areas were more prominent when the etchant was applied and still wet. This is shown in Figure 4 and Figure 5. In Figure 4, the etchant had been applied and the surface was still wet which showed the darker areas of the pipe surface. After the surface was etched multiple times and wiped clean with a dry cloth the darker area was still present (Figure 5), however it was not as prominent. This was also the case for the East Inspection area; however, the darker area was not as prominent as the West sample for both cases (wet/dry).

Figure 4: West Area with Etchant Applied. Photo by NTSB

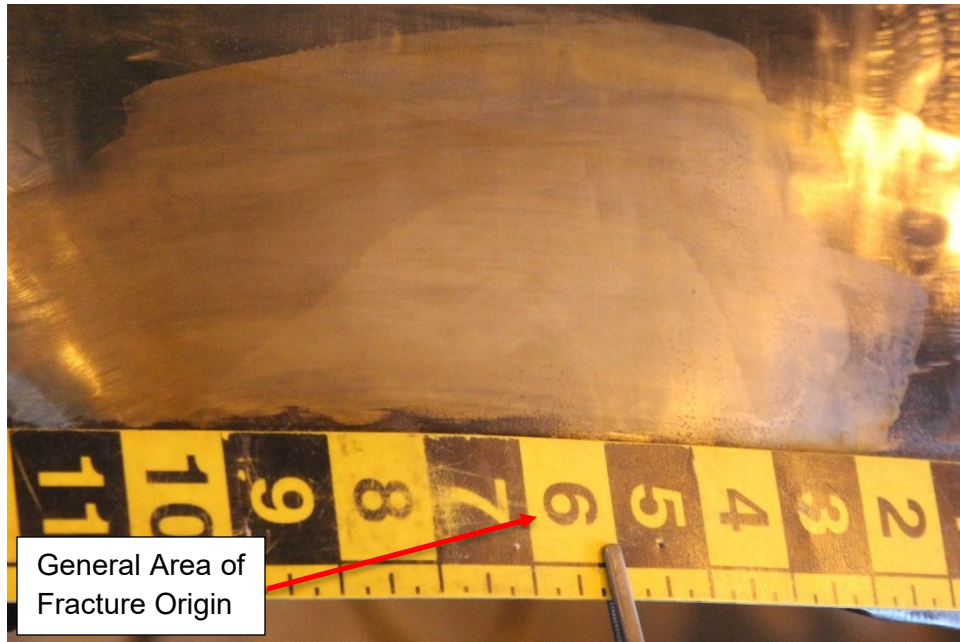
**Figure 5: West Area After Etchant was Removed and Surface Clean/Dry. Photo by NTSB**
