NATIONAL TRANSPORTATION SAFETY BOARD

MATERIALS LABORATORY FACTUAL REPORT

Report No. 19-075

Place : Oxford, Mississippi
Date : July 6, 2019
Vehicle : Cessna 172, N994CP
NTSB No. : CEN19FA212
Investigator : Ed Malinowski, AS-CEN

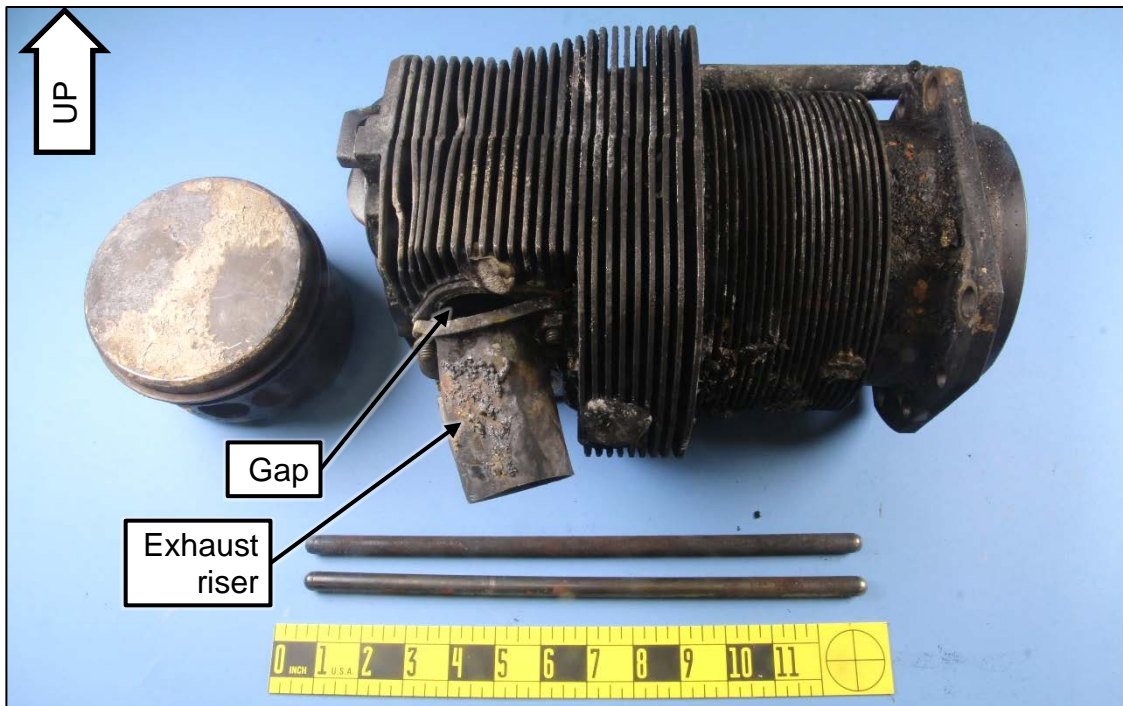
An overall view of the submitted components is shown in figure 1. The components were generally discolored with deposits on the surface consistent with fire damage. A piece of the exhaust riser remained attached to the cylinder assembly as shown in figure 1. The exhaust riser was deformed, and a gap was present where the riser attached to the cylinder head.

Figure 1. Overall view of the submitted components.

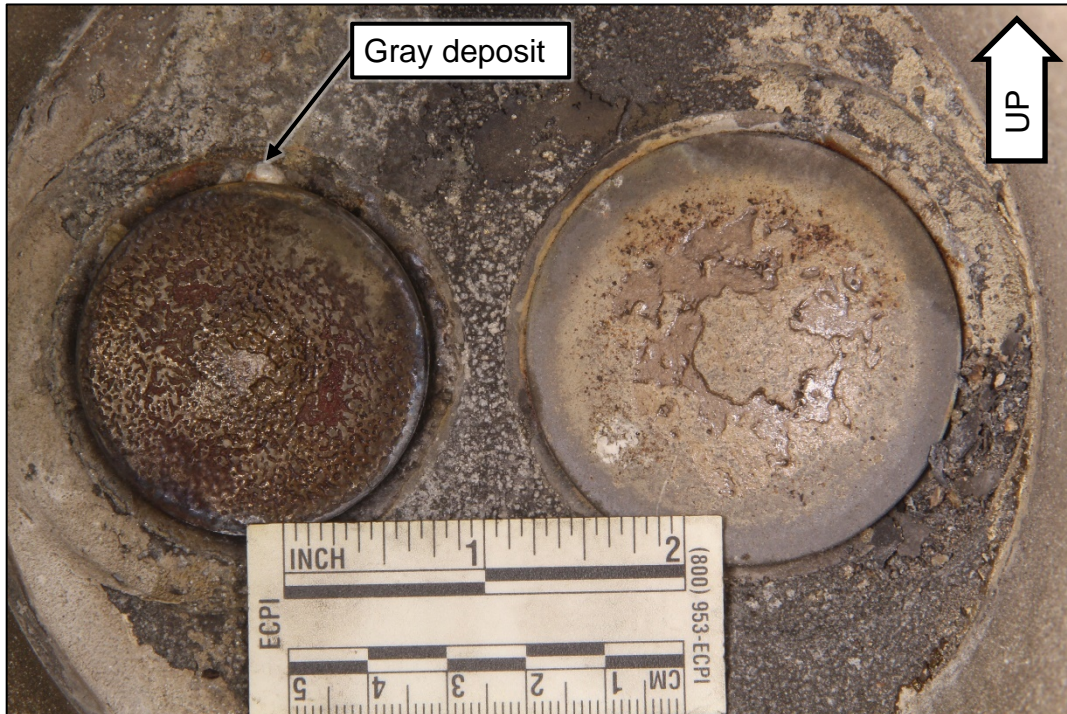
The interior of the cylinder is shown in figure 2. Tan deposits were observed on the interior surfaces consistent with combustion deposits. Oxidation and combustion patterns on the exhaust valves had a uniform appearance around the circumference consistent with normal valve operation. The exhaust valve was slightly open with a gap between the valve head and the valve seat. A gray deposit was observed within the gap on the upper side of the exhaust valve.

Figure 2. Interior surfaces of the cylinder head. The location of a gray metallic deposit between the exhaust valve head and seat is noted.

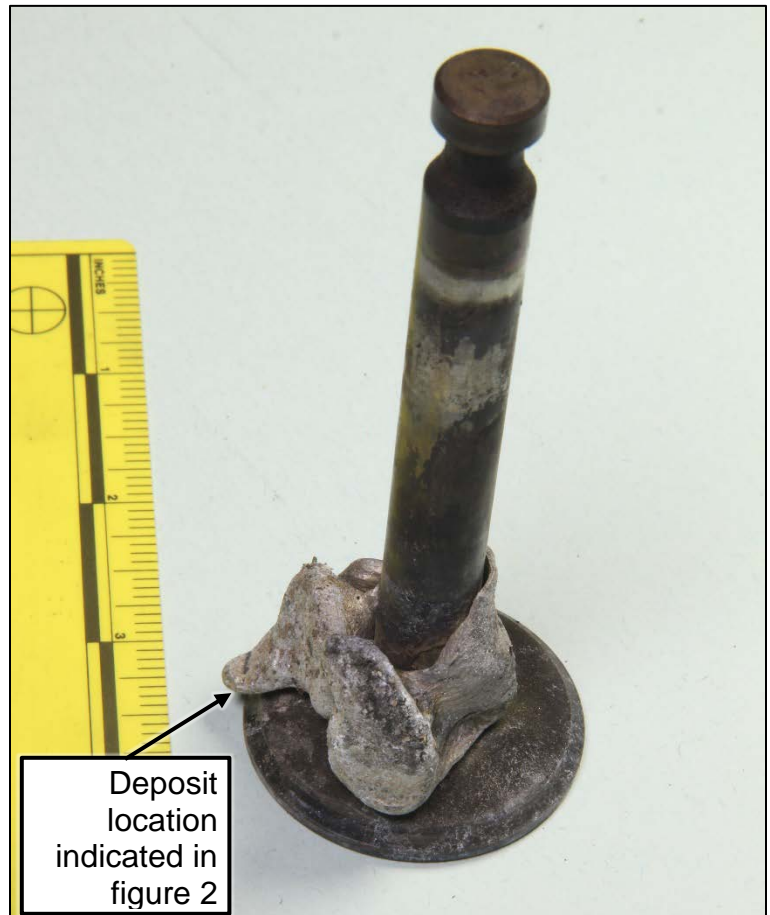
The exhaust valve was disassembled from the cylinder assembly, and a photograph of the removed exhaust valve is shown in figure 1. Dull gray deposits with smooth surface features were observed around the valve stem and on the valve head and had an appearance consistent with previously molten aluminum alloy. The overall geometry of the deposit was consistent with flow over the lower side of the valve stem, accumulating on the upper surfaces of the exhaust port and valve seat. At the accident scene, the engine was reportedly found inverted, and portions of the fuselage were melted, deformed, and discolored by fire.

Figure 3. Overall view of the exhaust valve after removal from the assembly. The portion of the deposit visible as indicated in figure 2 is noted.
