ENGINE EXAMINATION REPORT

ENGINE MODEL	GTSIO-520-D
ENGINE SERIAL NUMBER	219099-72-D-R
AIRCRAFT MAKE & MODEL	Cessna 421
AIRCRAFT SERIAL NUMBER	421-0164
AIRCRAFT REGISTRATION	N731PF
FILE NUMBER	19-104

ENGINE FIELD INSPECTION REPORT

EXAMINATION		ACCIDENT DATA	
DATE	10/02/2019	NTSB ACCIDENT #	ERA19FA283
FACILITY	Florida Air Recovery	NTSB INVESTIGATOR	Eric Alleyne
ADDRESS	7403 Philips Hwy Jacksonville, FL 32256	FAA INVESTIGATOR	Antonia Gonzalez
		ACCIDENT DATE	09/29/2019
		ACCIDENT LOCATION	Deland, Florida

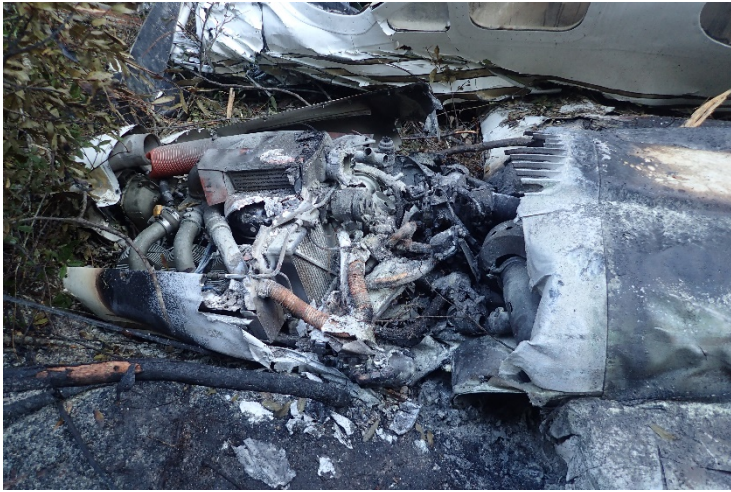
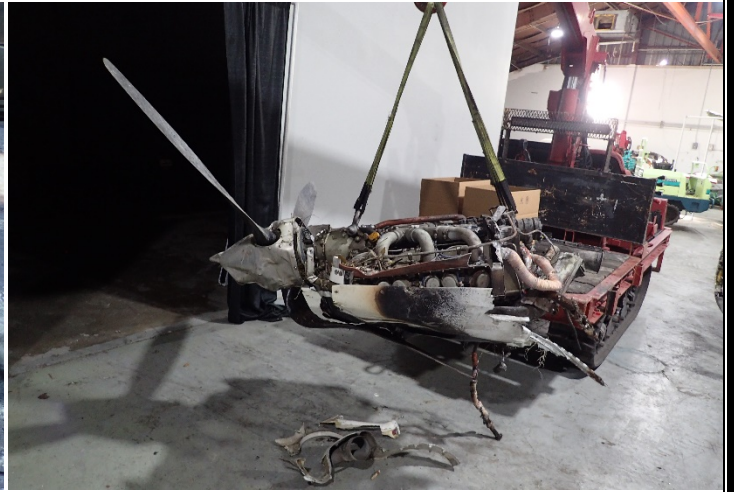
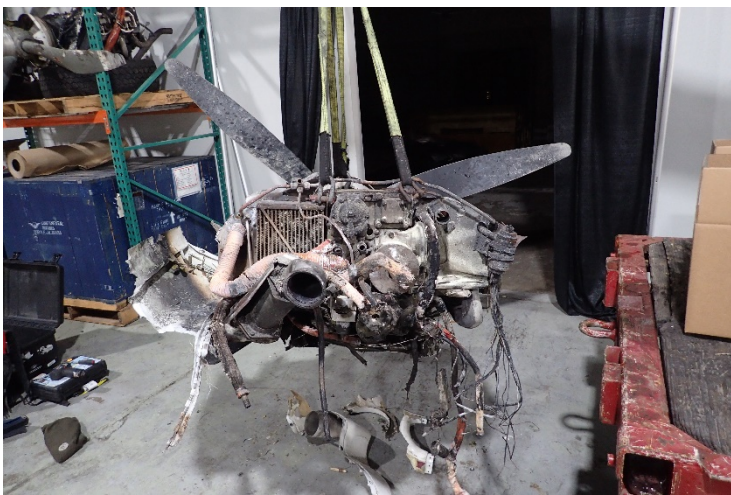
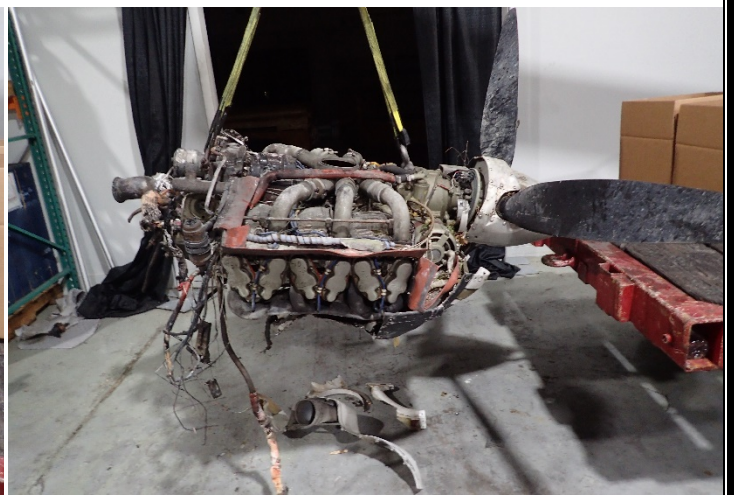
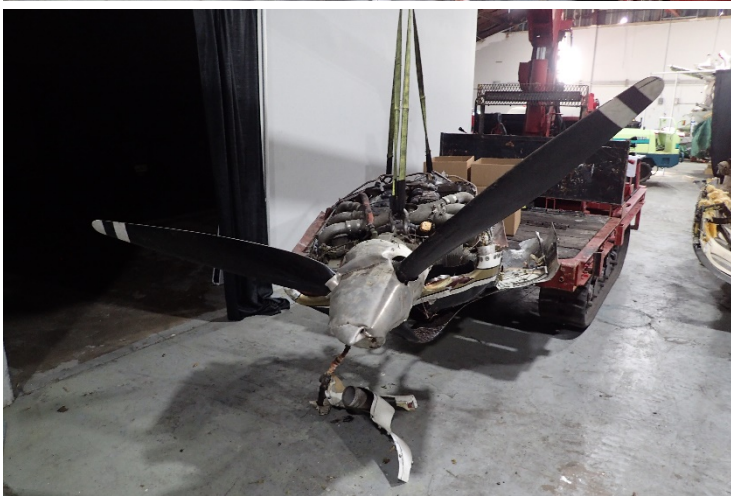
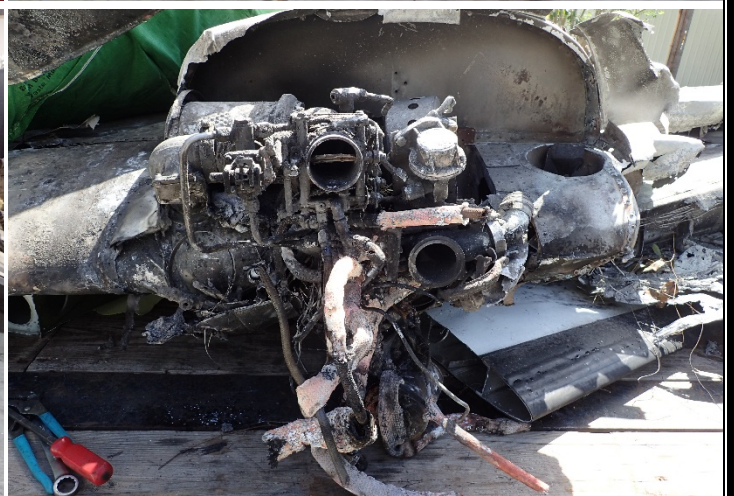
The engine remained partially attached to the airframe and displayed impact and thermal damage signatures; the majority of the impact damage was concentrated to the bottom of the engine. The crankcase remained intact and displayed thermal discoloration towards the rear of the crankcase. There were no holes in the crankcase that would indicate a catastrophic internal engine failure. The propeller flange remained attached to the propeller shaft and displayed impact damage signatures. All six cylinders remained attached to their cylinder bays and displayed varying amounts of impact and thermal damage. The three-blade, constant speed propeller remained attached to the propeller shaft and displayed impact damage signatures.

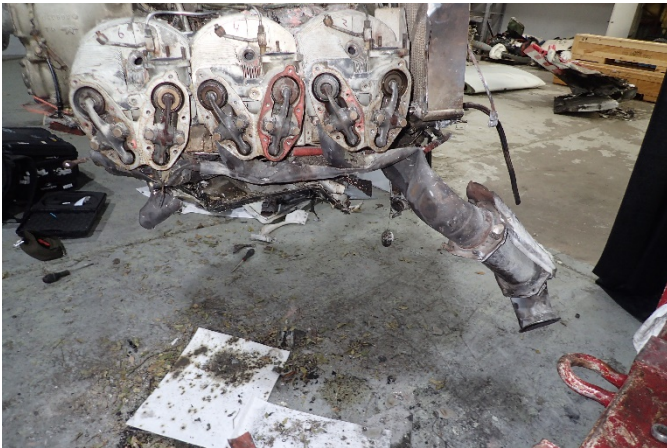
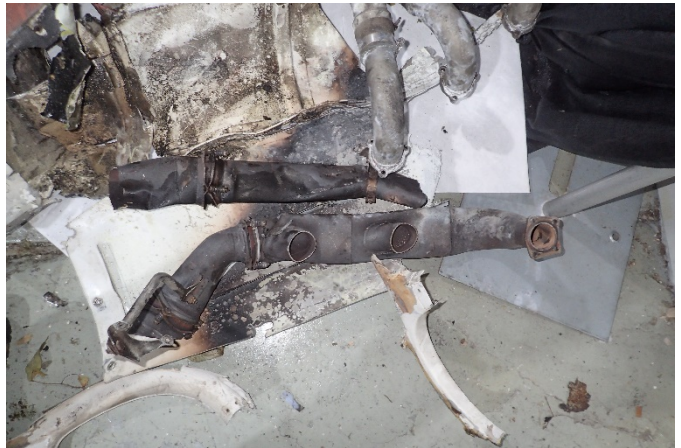
EXHAUST SYSTEM

The exhaust system displayed significant impact damage with most of the damage occurring to the exhaust risers. There were no signs of exhaust leaks or blockages observed.

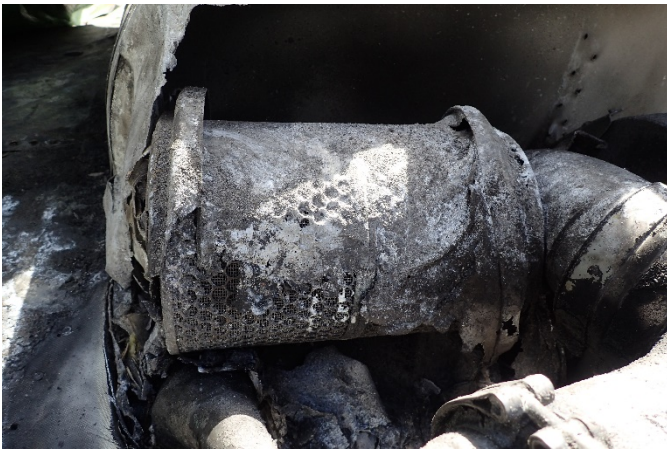
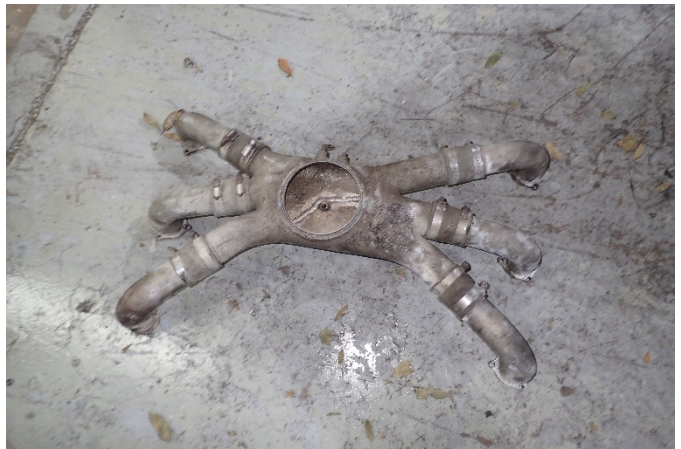
INDUCTION SYSTEM

The induction system displayed impact and thermal damage signatures. There were no signs of induction leaks or blockages noted. The induction air filter displayed significant thermal damage signatures and portions of the induction air filter housing had melted onto the filter element.

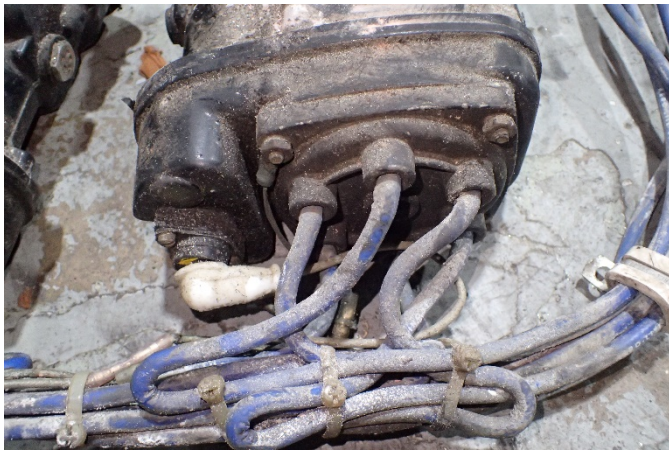
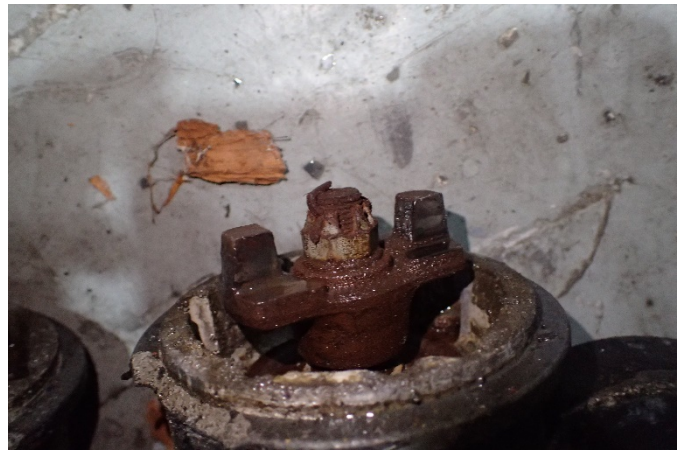
LEFT MAGNETO	Manufacturer: TCM	P/N: 10-349220-4R	S/N: B061619
---------------------	-------------------	-------------------	--------------

Condition: The magneto remained attached to its installation point and displayed thermal damage signatures. The magneto was removed, and it was noted that the driveshaft was capable of rotation. The magneto drive was rotated using a drill and it was observed that the magneto was capable of producing a spark to each ignition lead in the correct firing order. There were no anomalies observed.

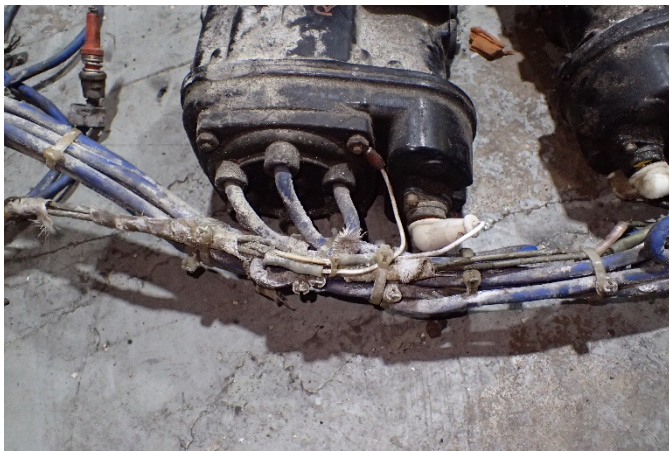
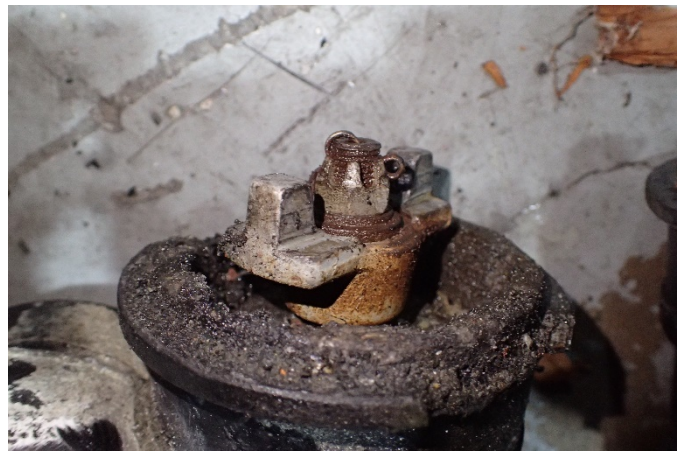
RIGHT MAGNETO	Manufacturer: TCM	P/N: 10-349260-7R	S/N: B060105
----------------------	-------------------	-------------------	--------------

Condition: The magneto remained attached to its installation point and displayed thermal damage signatures. The magneto was removed, and it was noted that the driveshaft was capable of rotation. The magneto drive was rotated using a drill and it was observed that the magneto was capable of producing a spark to each ignition lead in the correct firing order. There were no anomalies observed.

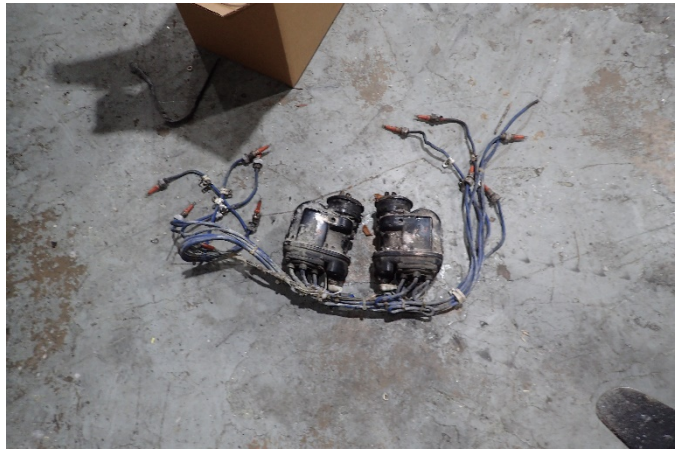
IGNITION HARNESS	Manufacturer: Skytronics	P/N: Not observed	S/N: Not observed
-------------------------	--------------------------	-------------------	-------------------

Condition: The ignition harness displayed impact and thermal damage signatures. During magneto operation, it was observed that the ignition harness was capable of conducting a spark from the magneto to each ignition lead end or to the first portion of impact damage. There were no anomalies observed.

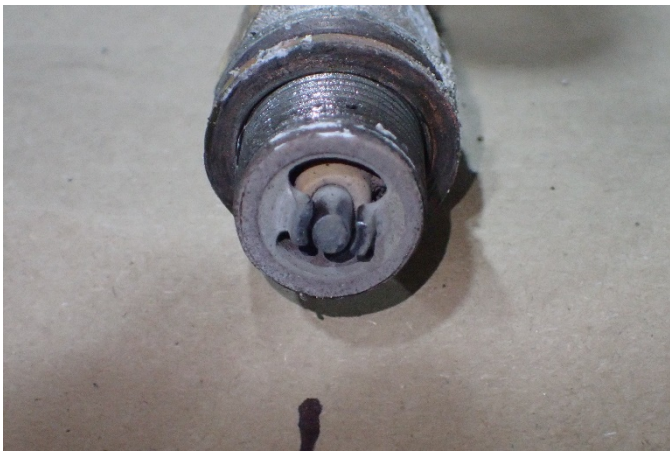
#1 Top Spark Plug

Condition: The spark plugs displayed varying amounts of impact and thermal damage signatures. The top spark plugs were removed for examination and the bottom spark plug electrodes were examined using a lighted borescope. The electrodes displayed normal operating and some of the spark plugs were in a normal worn out condition. There were no anomalies observed.

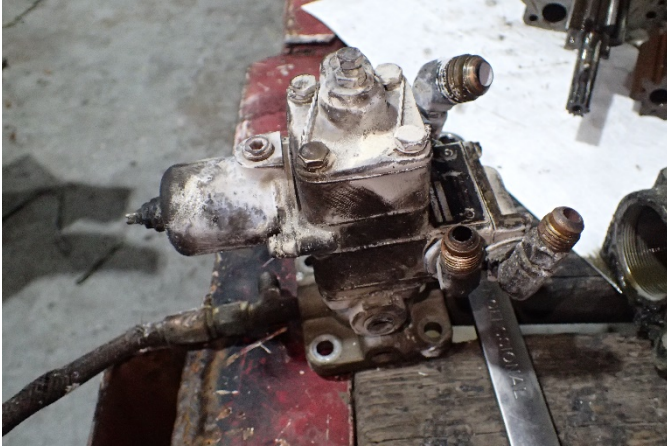
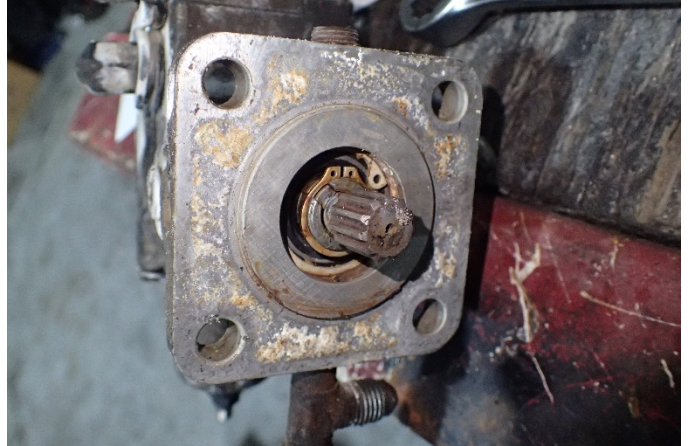
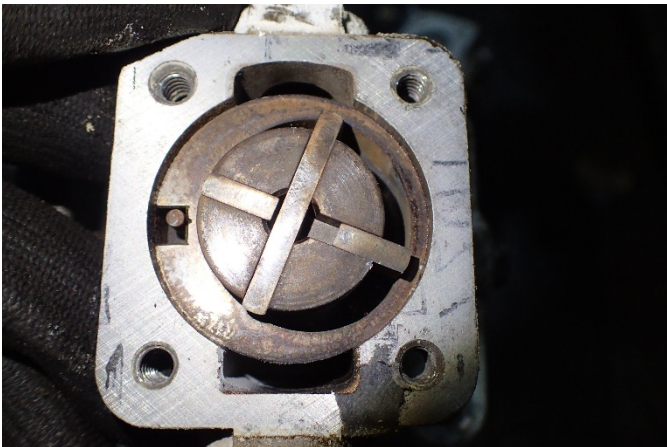
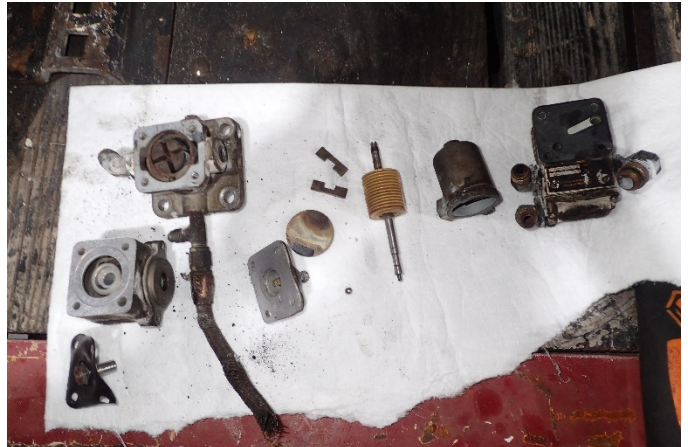
FUEL PUMP	Manufacturer: TCM	P/N: 630751-4	S/N: I137204
------------------	-------------------	---------------	--------------

Condition: The fuel pump remained attached to its installation point and displayed thermal and impact damage signatures. The fuel pump was removed, and it was noted that the drive coupling remained intact. The fuel pump was disassembled, and the internal components displayed thermal damage signatures as well as normal operating signatures.

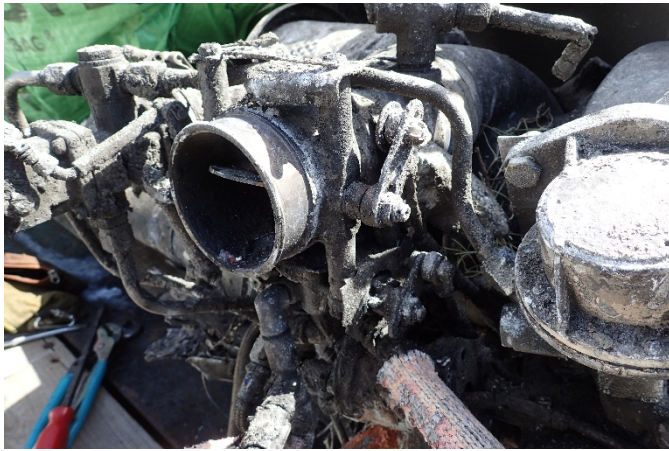
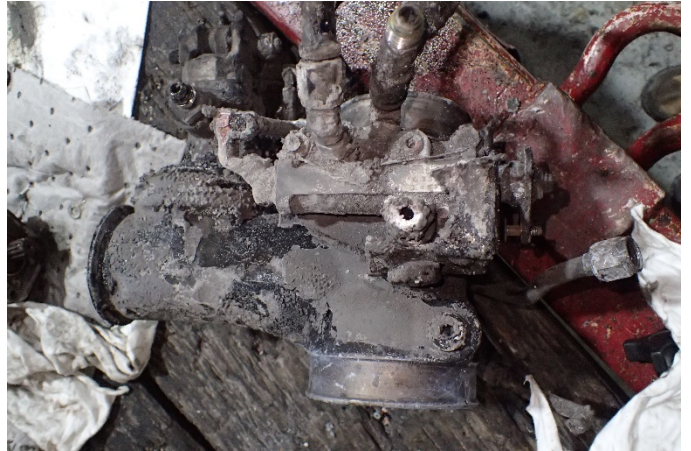
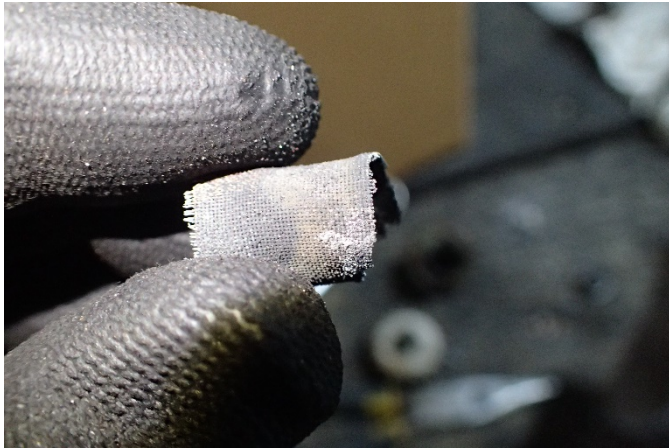
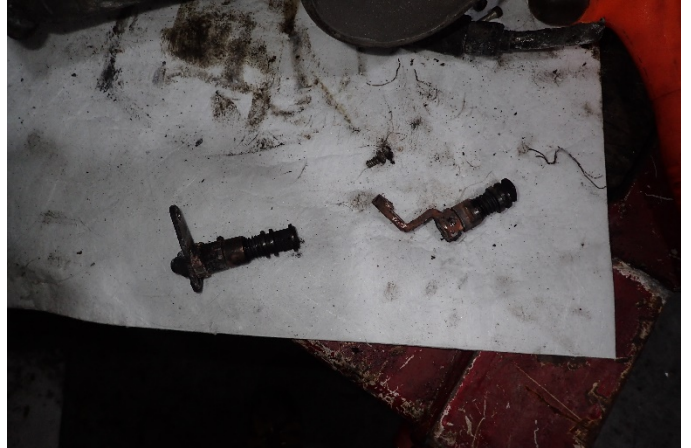
**THROTTLE BODY
METERING UNIT**

The throttle and metering assembly remained attached to its installation point in the engine nacelle. The assembly displayed significant thermal damage signatures to the entire assembly. The mixture and throttle control cable rod ends remained attached to the control arms and were properly secured. The assembly was removed and disassembled; the internal components displayed thermal damage signatures as well as normal operating signatures. The fuel inlet screen was removed and was noted to be significantly damaged by thermal forces. There were no anomalies observed.

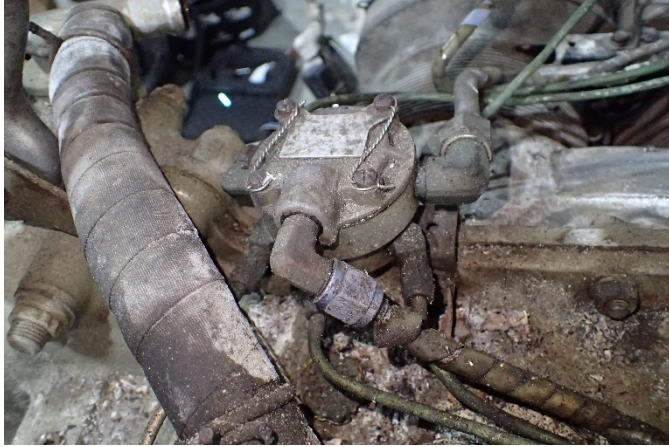
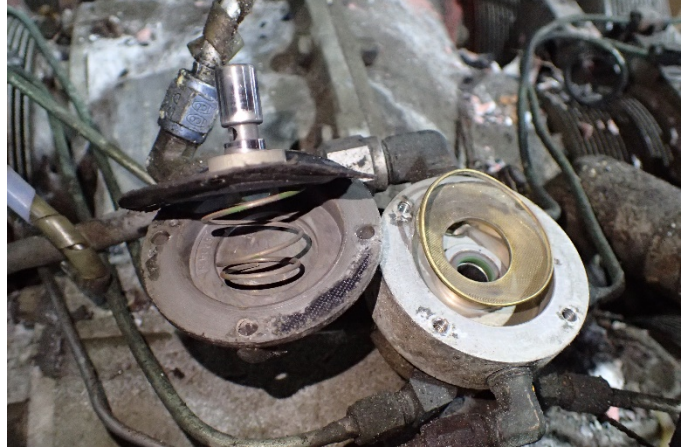
FUEL MANIFOLD VALVE

The fuel manifold valve remained attached to its installation point and displayed thermal damage signatures. The valve was disassembled, and the internal components displayed some thermal damage as well as normal operating signatures.

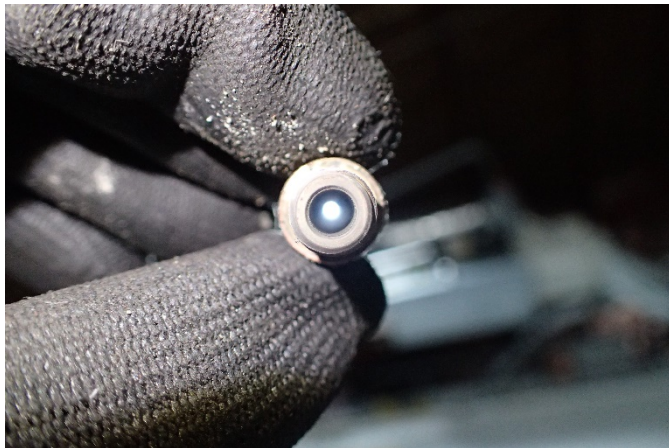
#1 Nozzle

The nozzles remained installed in their cylinders and displayed varying amounts of thermal damage. The nozzles were removed and were observed to be clear of any obstructions. There were no anomalies observed.

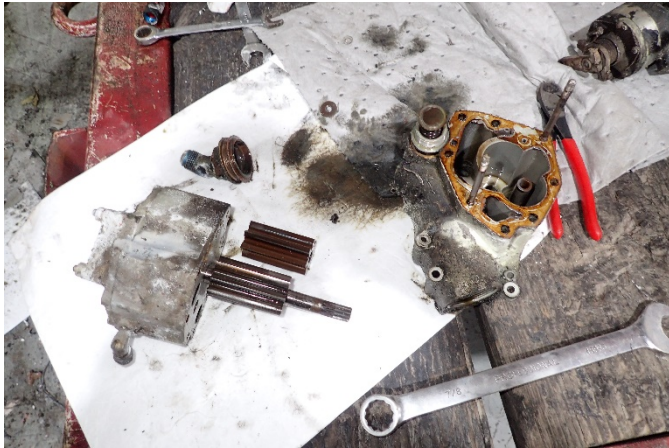
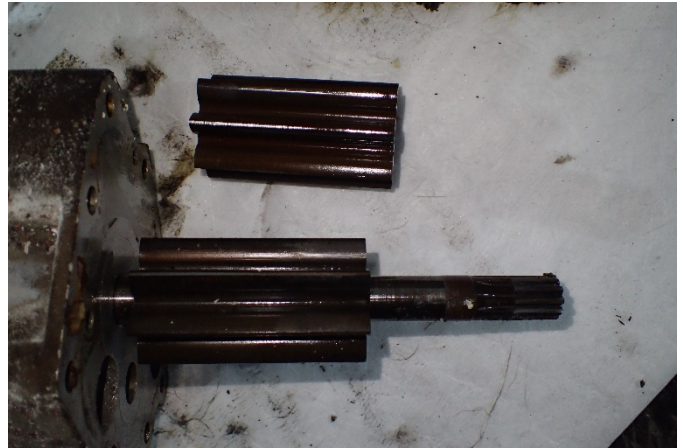
OIL PUMP

Condition: The oil pump was removed and visually inspected. The oil pump gears, and oil pressure relief valve displayed normal operating signatures. The oil pump housing displayed minor scoring consistent with hard particle passage.

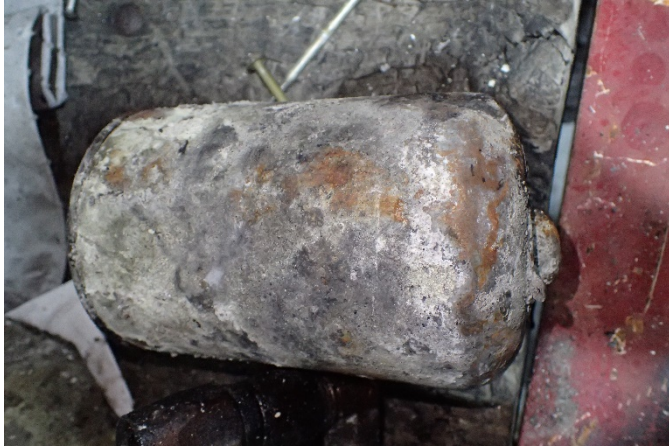
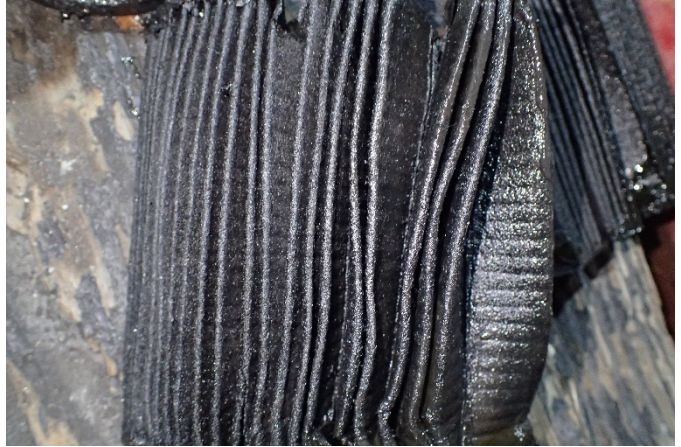
OIL FILTER	Manufacturer: Illegible	P/N: Illegible
Condition:	The oil filter and adapter had broken free from its installation point and displayed significant thermal damage. The oil filter housing was cut open and the filter pleats were removed. The pleats were thermally damaged; however, there were no signs of metallic material within the filter pleats.

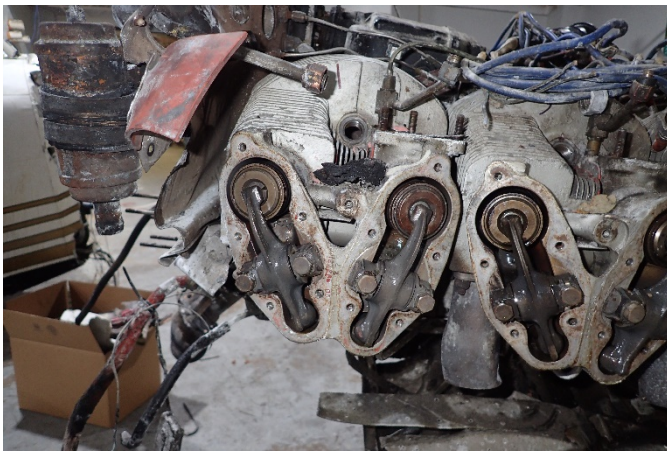
#1 Cylinder Overhead

Condition: All six cylinders remained attached to their cylinder bays and displayed varying amounts of thermal and impact damage. The cylinders were inspected using a lighted borescope; the piston faces, cylinder bores, and valve heads displayed normal operating and combustion signatures. During crankshaft rotation the #5 cylinder did not have any compression, it was noted that the exhaust pushrod housing was impact damaged and was significantly bent; the rocker arm was tapped closed and the cylinder would then display thumb compression and suction. The rest of the cylinders displayed good thumb compression and suction during crankshaft rotation.

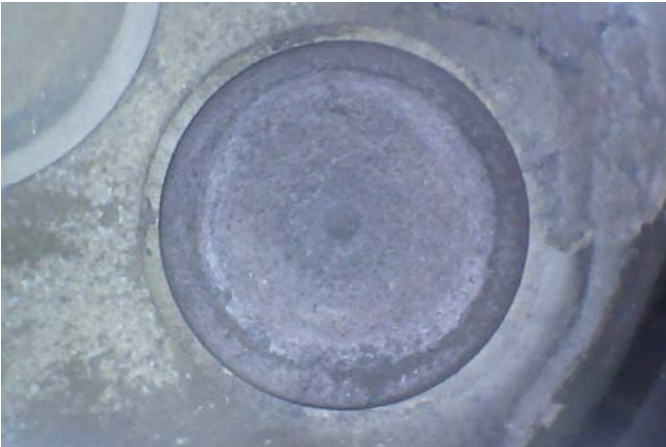
#1 Exhaust Valve

The valve heads were inspected using a lighted borescope. The valve heads displayed normal operating and combustion signatures. During crankshaft rotation, the #5 exhaust valve would not close completely which was consistent with impact damage to the push rod, the rest of the valves operated normally.

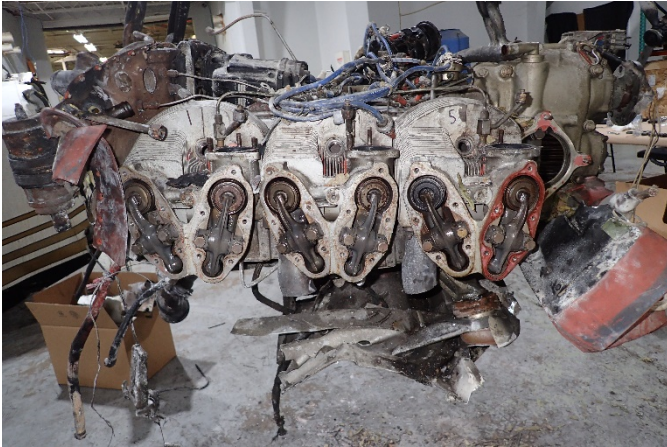
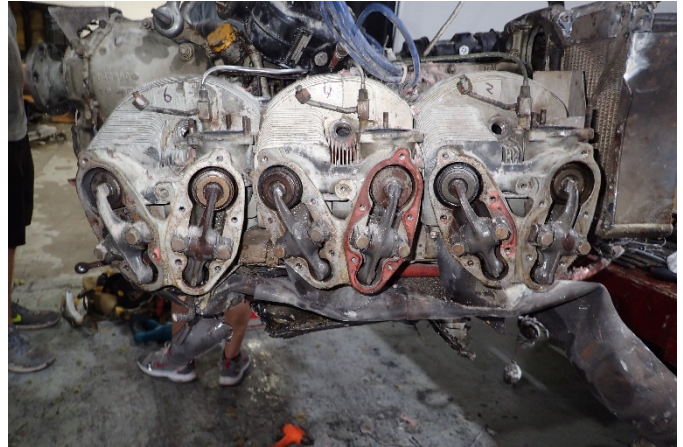
**ROCKER ARMS AND
SHAFTS**

The rocker arms displayed normal operating and lubrication signatures. During crankshaft rotation, the #5 exhaust rocker arm would not move completely to the closed position which was consistent with the impact damage to the #5 exhaust pushrod and housing; the rest of the rocker arms operated normally during crankshaft rotation.

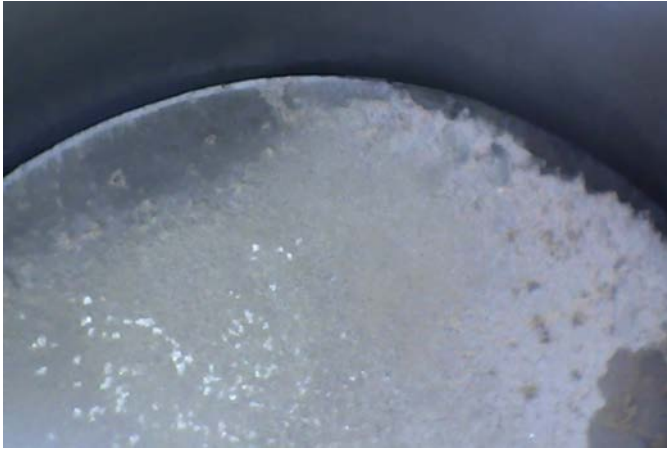
#1 Piston

All of the piston faces were inspected using a lighted borescope; the piston faces displayed normal operating and combustion signatures. During crankshaft rotation all of the pistons operated normally.

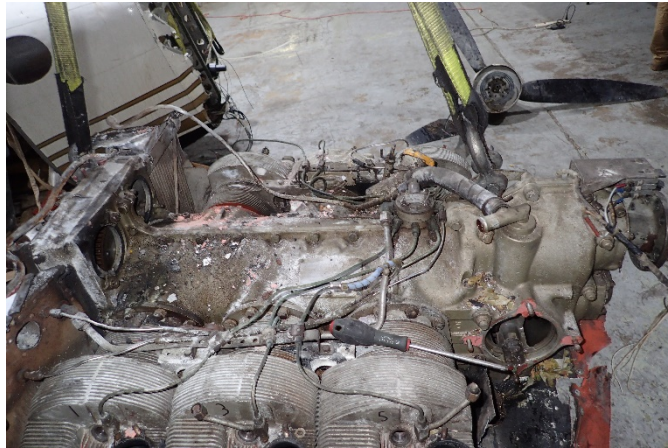
CRANKCASE	Casting Number:	1-3-5: Not observed	2-4-6: 640980	S/N: J6A-861 0 R
Condition:	The crankcase remained intact and displayed impact and thermal damage signatures. There were no holes in the crankcase that would indicate a catastrophic internal engine failure. There were no anomalies observed.

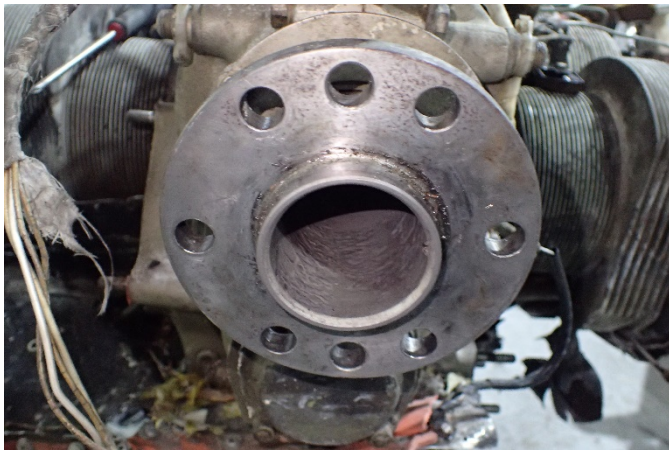
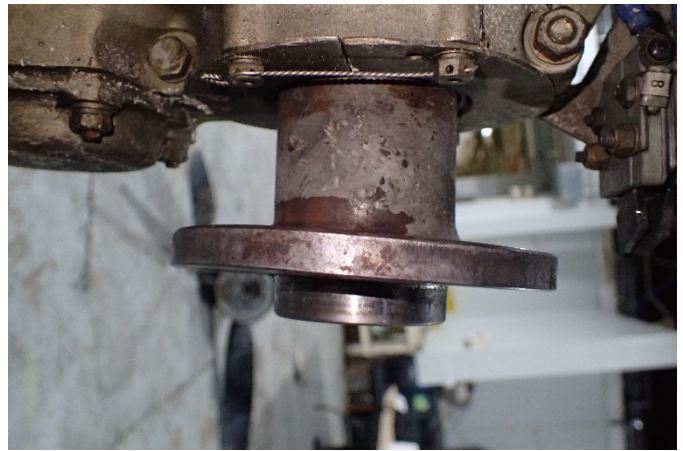
PROPELLER SHAFT	Forging Number: Inaccessible	S/N: Not observed	Heat Code: Inaccessible
Condition:	The propeller flange remained attached to the propeller shaft and displayed impact damage signatures. The propeller shaft gear was partially visible after removing the alternator and displayed normal operating signatures. The propeller shaft was rotated using a hand tool and continuity was established between the propeller shaft, reduction gear, quill shaft, crankshaft, camshaft, connecting rods, and associated components. There were no anomalies observed.

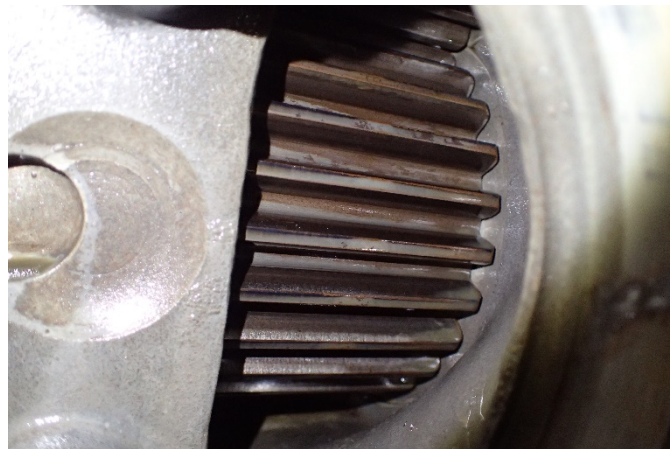
REDUCTION GEAR	Forging Number: Inaccessible	S/N: Inaccessible	Heat Code: Inaccessible
Condition:	The reduction gear was partially visible after removing the alternator and the gear displayed normal operating signatures. During propeller shaft rotation the reduction gear operated normally.

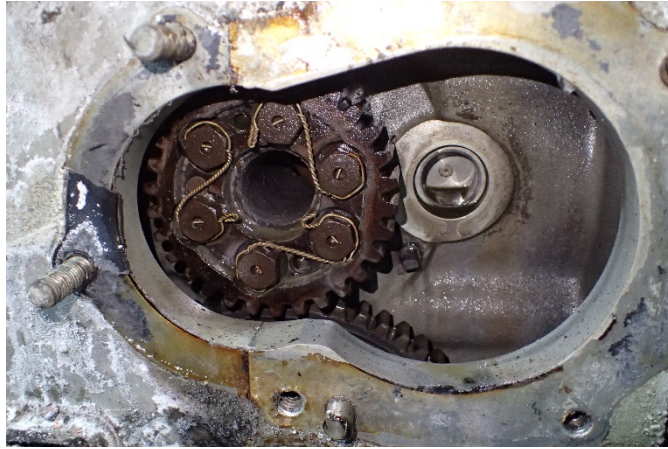
CRANKSHAFT	Forging Number: Inaccessible	S/N: Inaccessible	Heat code: Inaccessible
-------------------	---------------------------------	-------------------	-------------------------

Condition: The crankshaft gear was observed after removing the starter adapter; the gear remained secure, was undamaged, and displayed normal operating signatures. Operation of the crankshaft was verified by rotating the propeller flange and observing piston movement; the crankshaft operated normally.

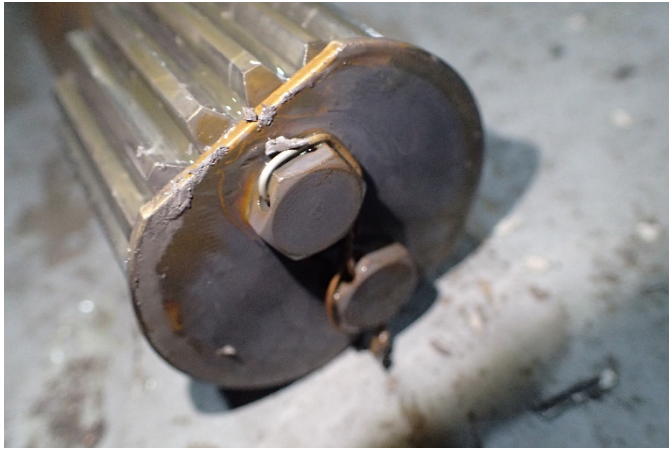
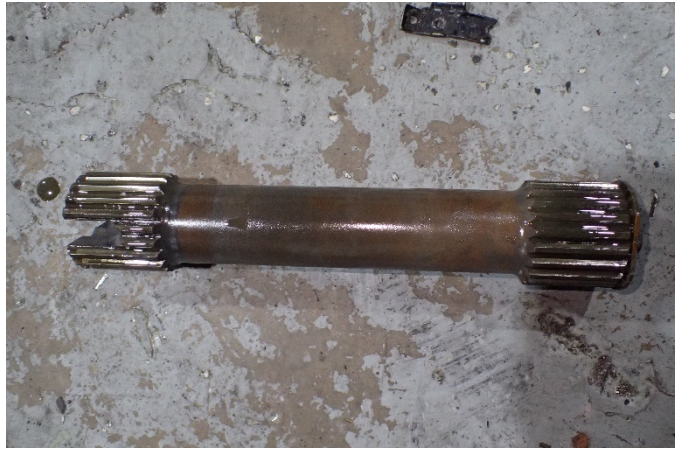
QUILL SHAFT	
--------------------	--

Condition: Operation of the quill shaft was verified by rotating the quill shaft and observing the crankshaft gear operation; the quill shaft operated normally. The quill shaft was removed, and the shaft displayed normal operating signatures.

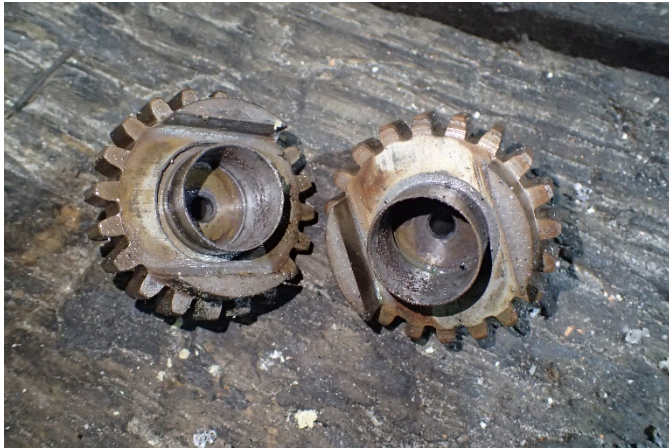
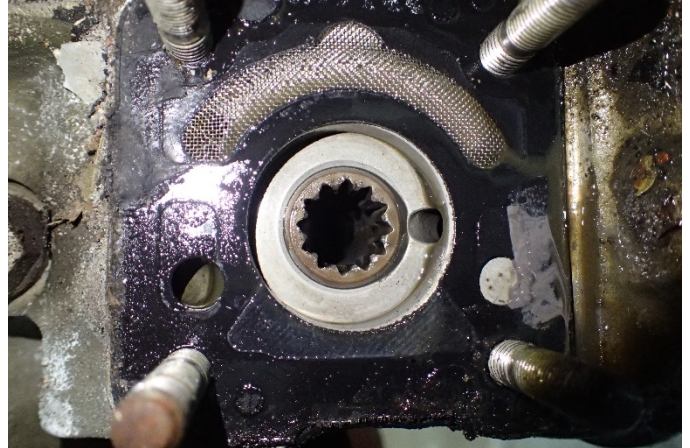
CAMSHAFT	P/N: Inaccessible	S/N: Inaccessible
Condition:	Operation of the camshaft was verified by rotating the propeller shaft and observing rocker arm movement. The camshaft operated normally.	
ACCESSORY GEARS		
Condition:	The magneto drive gears were observed after the magnetos were removed and displayed normal operating signatures. The propeller governor gear was observed after removing the governor and it displayed normal operating signatures. The accessory gears operated normally during propeller shaft rotation.

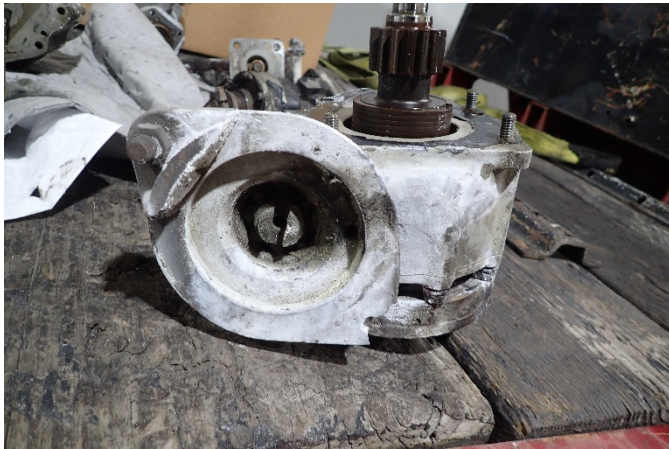
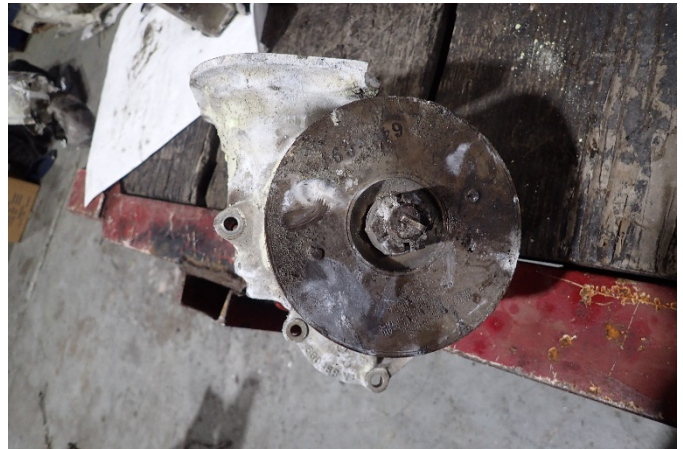
STARTER	Manufacturer: Not observed	P/N: Not observed	S/N: Not observed
Condition:	The starter had broken free from its installation point and displayed impact and thermal damage signatures.		
STARTER ADAPTER	P/N: Illegible		
Condition:	The starter adapter remained attached to its installation point and displayed impact damage and some thermal damage signatures. The dampener remained secured to the starter adapter shaft and displayed thermal damage signatures. The starter adapter was removed, and it was observed that the drive gear was undamaged, and the shaft was capable of normal movement.

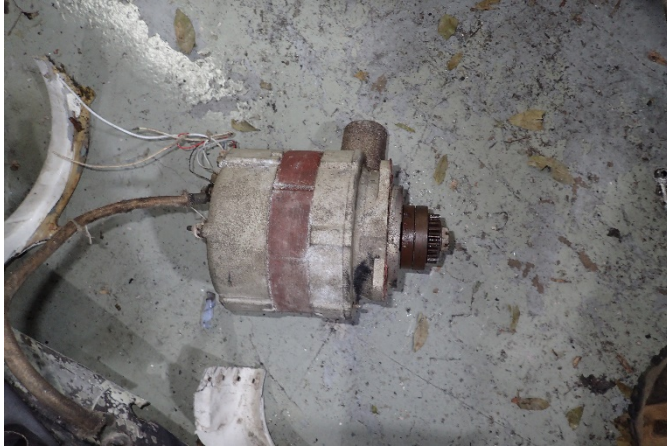
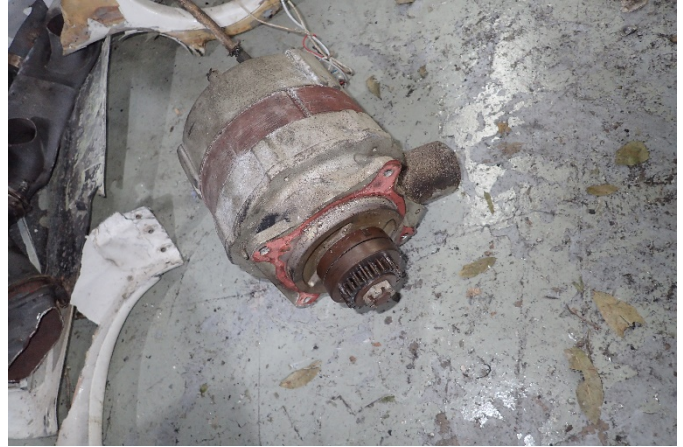
ALTERNATOR

The alternator remained attached to its installation point and displayed impact damage signatures. The alternator was removed, and it was observed that the alternator drive remained intact; however it was not capable of rotation which was consistent with impact damage.

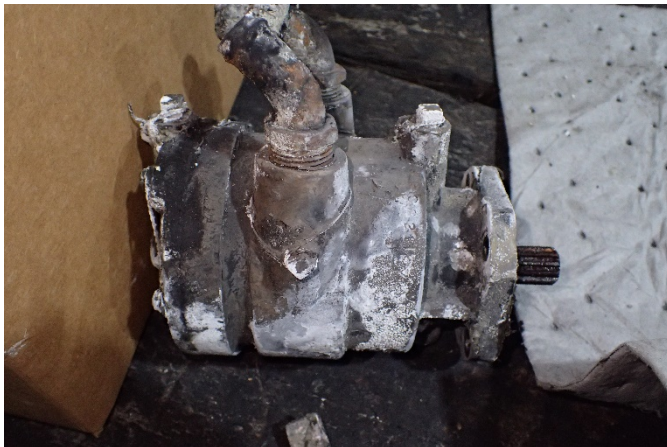
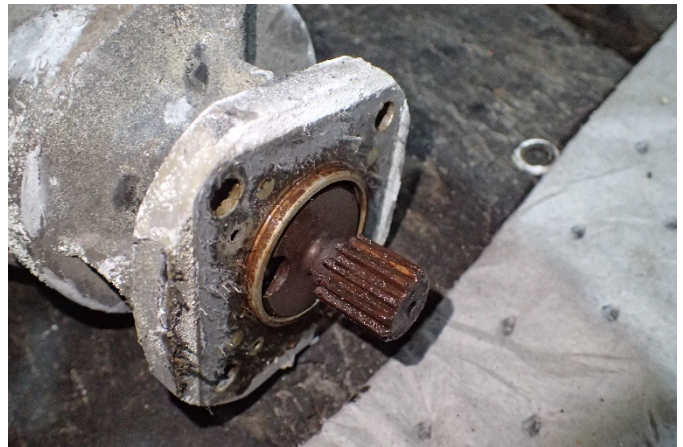
VACUUM PUMP

The vacuum pump remained attached to its installation point and displayed thermal damage signatures. The vacuum pump was removed, and the driveshaft was noted to have remained intact.

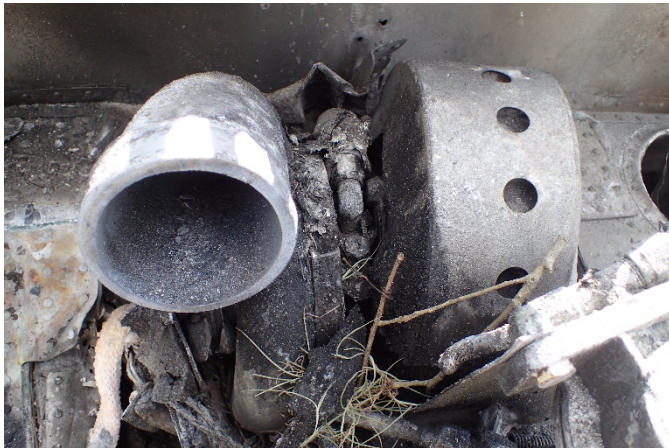
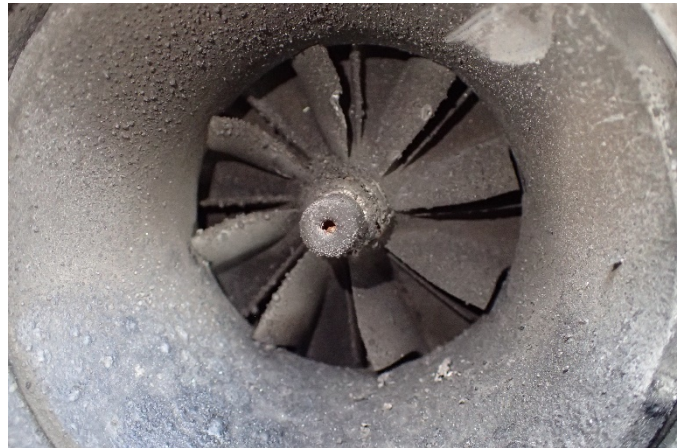
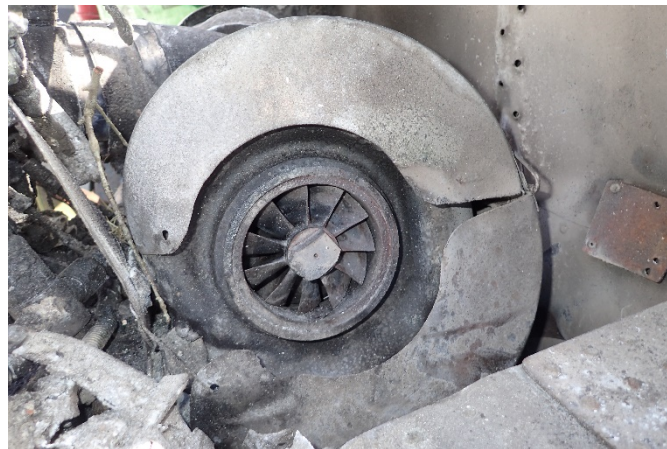
TURBO

The turbocharger displayed impact and thermal damage signatures and remained partially attached to its installation point. The tailpipe and compressor inlet were removed, and the turbocharger was examined. It was observed that the compressor wheel was partially displaced and several of the blades were bent in the opposite direction of rotation and there was a gouge in the leading edges of one of the blades. The turbine blades were undamaged and displayed normal operating signatures. The turbocharger turbine and compressor were incapable of rotation consistent with the observed impact damage.

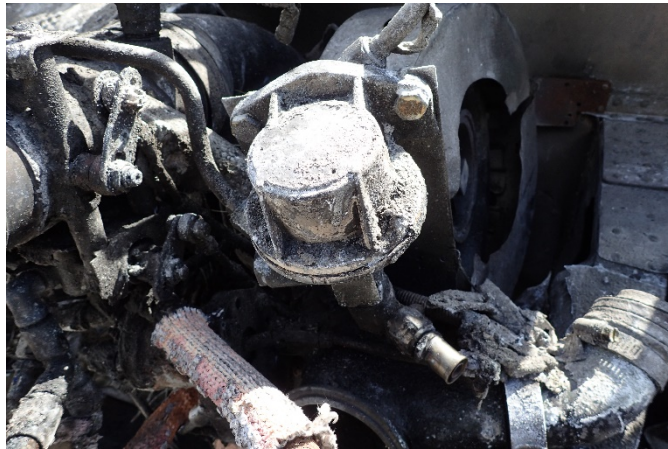
TURBO RATE CONTROLLER	Manufacturer: Garrett	P/N: C165004-0301	S/N: 00914
------------------------------	-----------------------	-------------------	------------

Condition: The turbocharger controller remained attached to its installation point and displayed significant thermal damage signatures.

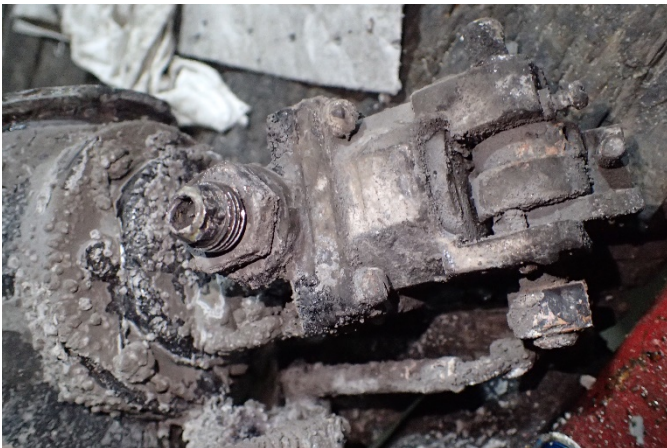
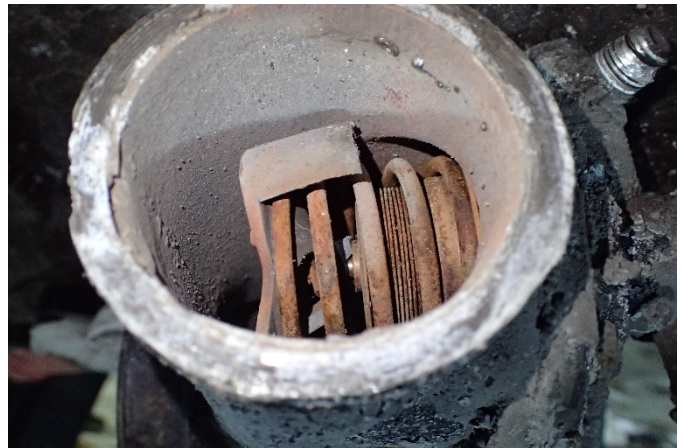
TURBO CONTROLLER	Manufacturer: Not observed	P/N: Not observed	S/N: Not observed
-------------------------	----------------------------	-------------------	-------------------

Condition: The turbocharger controller remained attached to its installation point and displayed significant thermal damage signatures.

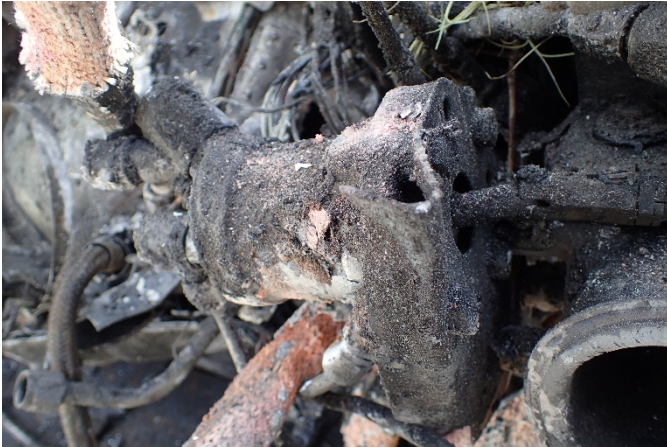
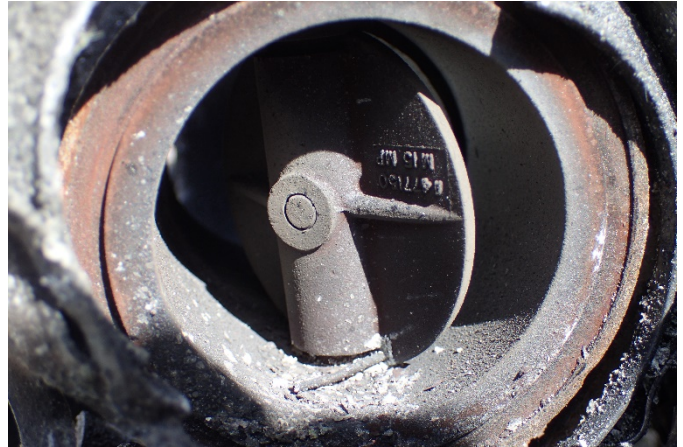
WASTEGATE

The wastegate remained attached to its installation point and displayed thermal damage signatures. It was observed that the wastegate actuator arm remained attached to the wastegate valve. The wastegate valve was observed in a midrange opening position.

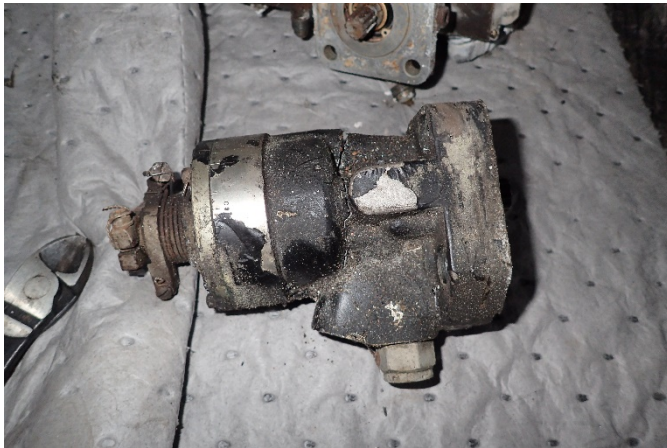
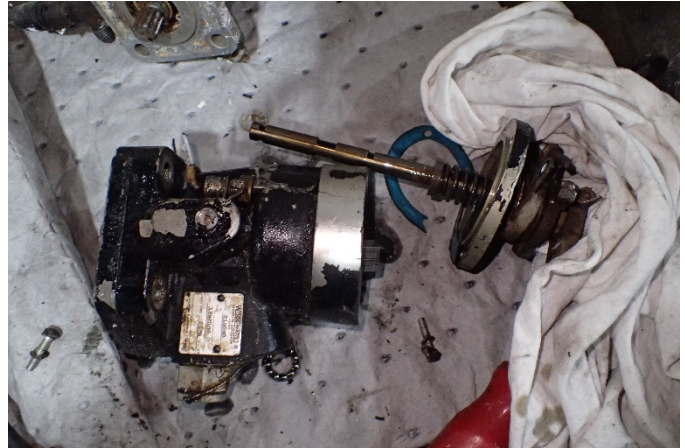
PROPELLER GOVERNOR	Manufacturer: Woodward	P/N: 210595	S/N: 1292580 D
---------------------------	------------------------	-------------	----------------

Condition: The governor remained attached to its installation point and displayed significant impact damage signatures. The governor was removed, and the governor's gasket screen was observed to be clear of any contaminants. The governor was partially disassembled, and the internal components displayed normal operating signatures as well as impact damage signatures.
