ENGINE EXAMINATION REPORT

ENGINE MODEL	GTSIO-520-D
ENGINE SERIAL NUMBER	219099-72-D-R
AIRCRAFT MAKE & MODEL	Cessna 421
AIRCRAFT SERIAL NUMBER	421-0164
AIRCRAFT REGISTRATION	N731PF
FILE NUMBER	19-104

ENGINE FIELD INSPECTION REPORT

EXAMINATION		ACCIDENT DATA	
DATE	10/02/2019	NTSB ACCIDENT #	ERA19FA283
FACILITY	Florida Air Recovery	NTSB INVESTIGATOR	Eric Alleyne
ADDRESS	7403 Philips Hwy Jacksonville, FL 32256	FAA INVESTIGATOR	Antonia Gonzalez
		ACCIDENT DATE	09/29/2019
		ACCIDENT LOCATION	Deland, Florida

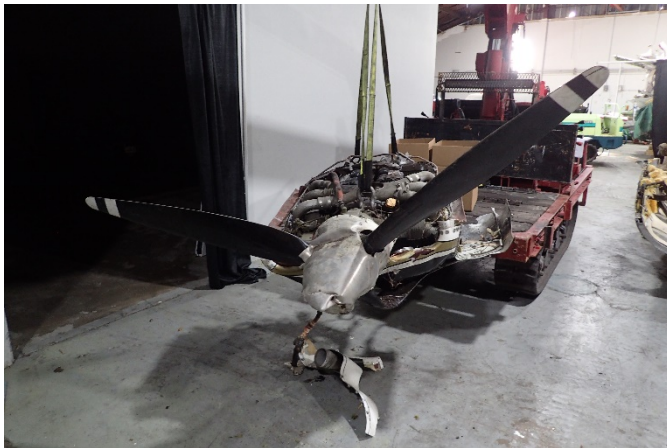
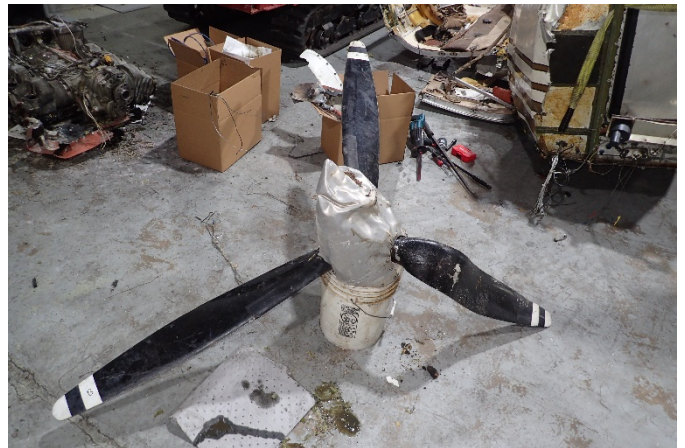
Condition: The three-blade, constant speed propeller remained partially attached to the propeller flange and displayed impact damage signatures. The propeller blade marked "A" displayed minor damage to the rubber boot. The propeller blade marked "B" displayed minor impact damage near the root of the blade. Propeller blade marked "C" displayed minor S-bending as well as significant aft bending deformation. During the on-scene portion of the investigation, several tree branches were found with clean approximate 45-degree angle cuts and appeared to have black paint transfer.
