ENGINE EXAMINATION REPORT

ENGINE MODEL	GTSIO-520-D
ENGINE SERIAL NUMBER	188783-9-D
AIRCRAFT MAKE & MODEL	Cessna 421
AIRCRAFT SERIAL NUMBER	421-0164
AIRCRAFT REGISTRATION	N731PF
FILE NUMBER	19-104

EXAMINATION		ACCIDENT DATA	
DATE	10/03/2019	NTSB ACCIDENT #	ERA19FA283
FACILITY	Florida Air Recovery	NTSB INVESTIGATOR	Eric Alleyne
ADDRESS	7403 Philips Hwy Jacksonville, FL 32256	FAA INVESTIGATOR	Antonia Gonzalez
		ACCIDENT DATE	09/29/2019
		ACCIDENT LOCATION	Deland, Florida

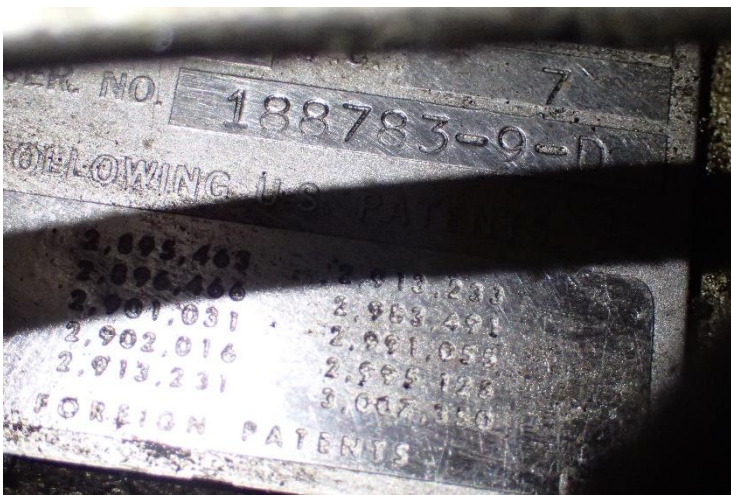
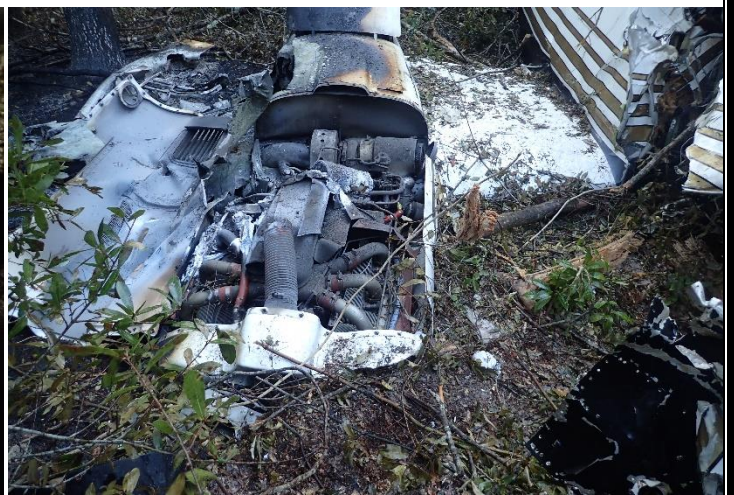
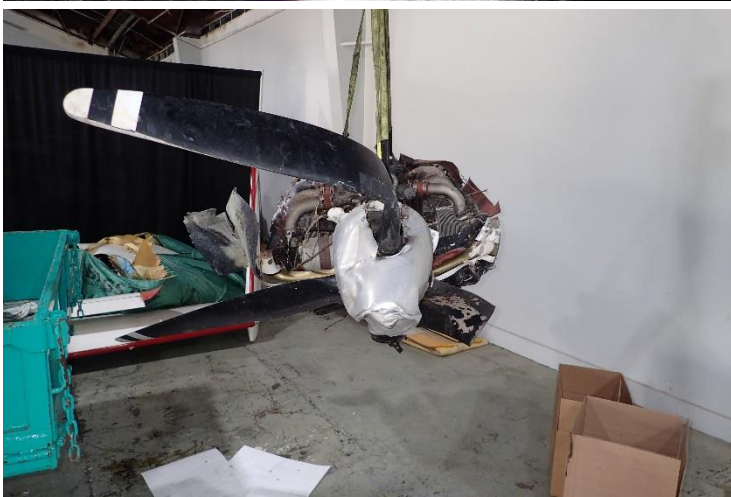
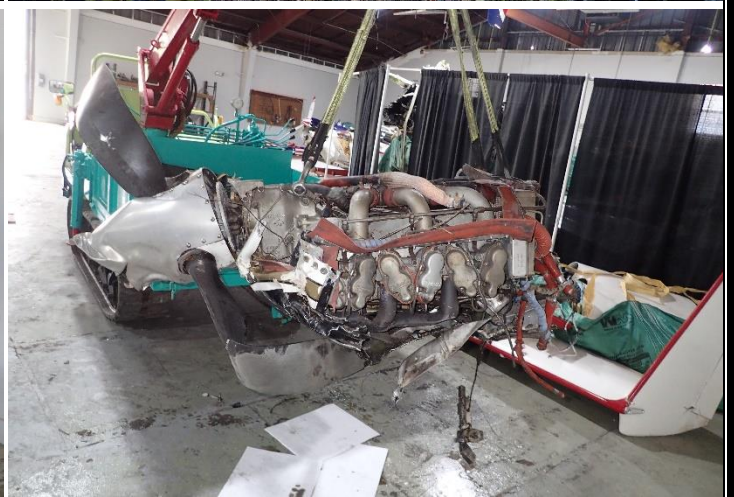
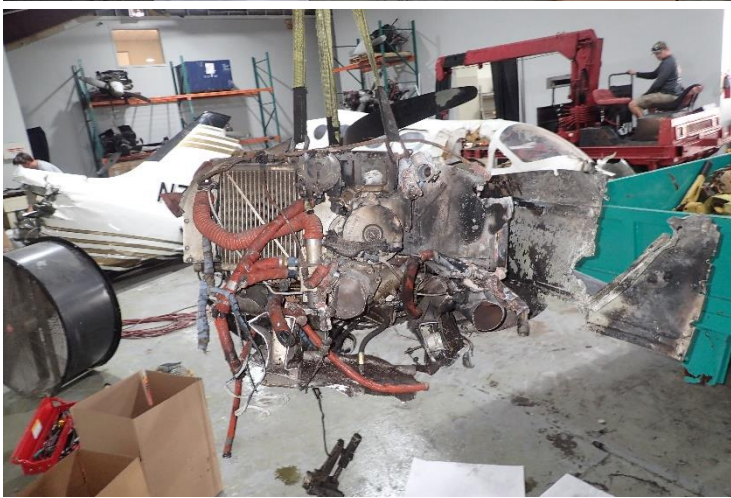
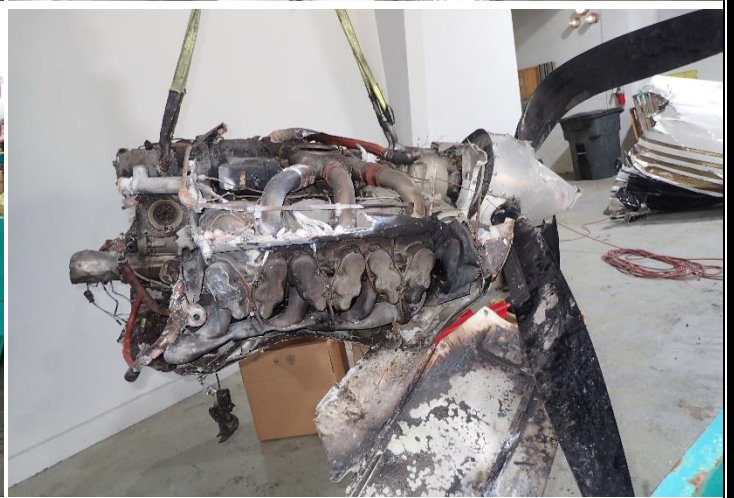
The engine remained partially attached to the airframe and displayed significant impact and thermal damage signatures. Most of the impact damage occurred to the bottom of the engine and most of the thermal damage occurred to the rear portions of the engine. The crankcase remained intact and displayed thermal discoloration; there were no holes in the crankcase that would indicate a catastrophic internal engine failure. The propeller flange remained attached to the rest of the propeller shaft and displayed impact damage signatures. All six cylinders remained attached to their cylinder bays and displayed varying amounts of impact and thermal damage signatures. The three-blade, constant speed propeller remained attached to the propeller shaft and displayed impact damage signatures.

Both magnetos remained attached to their installation points and displayed thermal damage signatures. The ignition harness remained attached to both magnetos and to the spark plugs and displayed significant thermal damage to all of the ignition leads. All of the spark plugs remained installed in their cylinders and displayed varying amounts of impact damage.

The fuel pump remained attached to its installation point and displayed thermal damage signatures as well as impact damage signatures. The throttle and metering assembly displayed significant thermal damage signatures and remained attached to its installation point on the engine nacelle. The fuel manifold valve remained attached to its installation point and displayed minor thermal damage signatures. There were no signs of fuel leaks observed with any of the fuel components.

The exhaust system displayed a significant amount of impact damage signatures; the risers and tubes were bent and crushed in several locations. There were no external signs of exhaust leaks observed. The induction system displayed thermal and impact damage signatures. There were no visible signs of intake leaks observed.

The turbocharger remained attached to its installation point and displayed impact and thermal damage signatures; the V-band clamp was noted to be installed and was secure. The wastegate, turbocharger controller, and turbocharger regulator displayed thermal damage signatures.

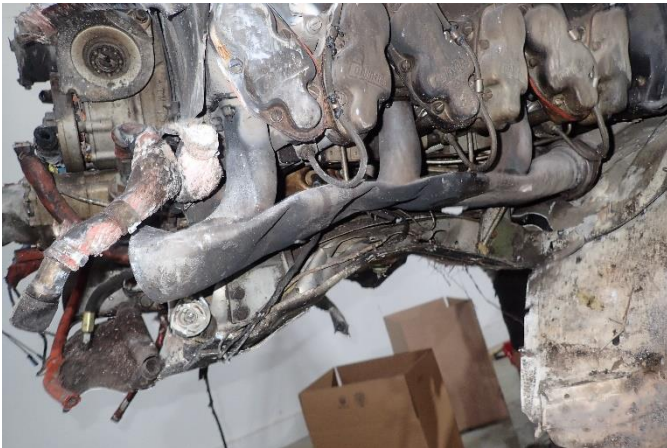
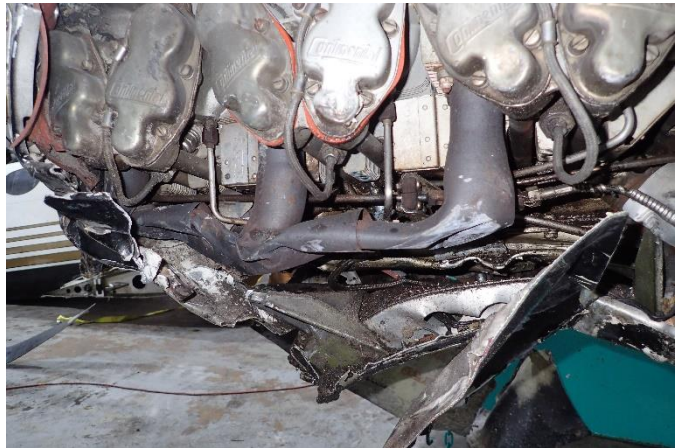
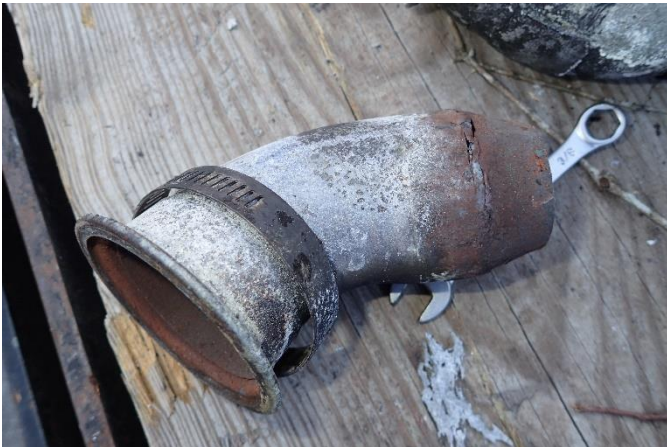
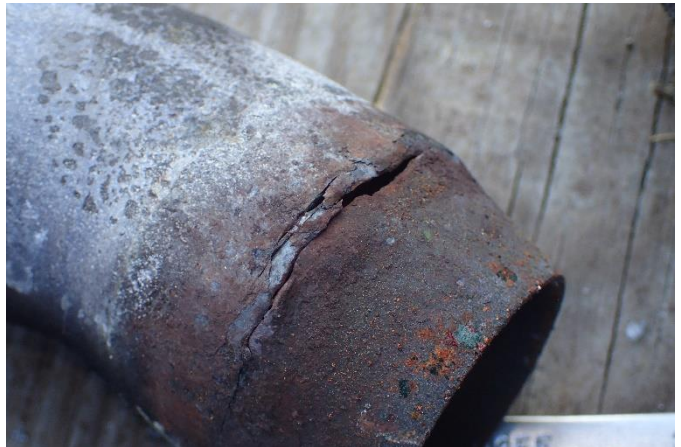
EXHAUST SYSTEM

The exhaust system displayed significant impact damage signatures with the most damage occurring to the risers and balance tube. The exhaust tube that attaches to the wastegate was noted to contain several cracks that were not consistent with impact damage.

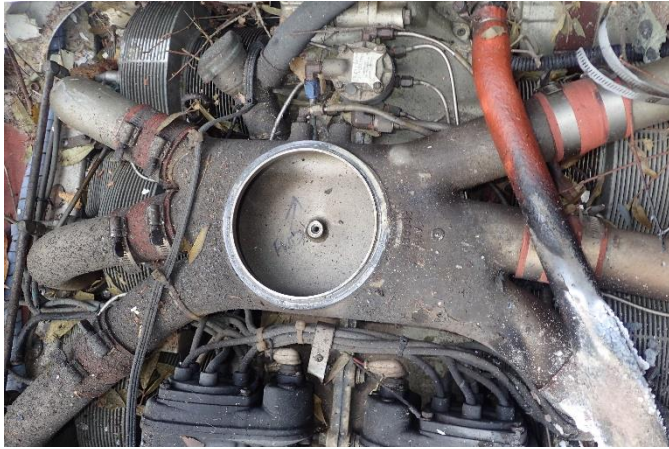
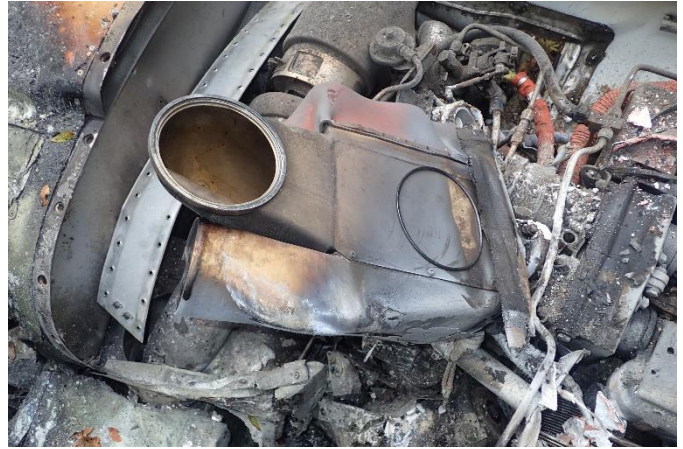
**INDUCTION
SYSTEM**

The induction system displayed impact and thermal damage signatures with the most damage occurring to the induction tubes at the rear of the engine and attached to the engine nacelle. There were no signs of intake leaks or obstructions noted.

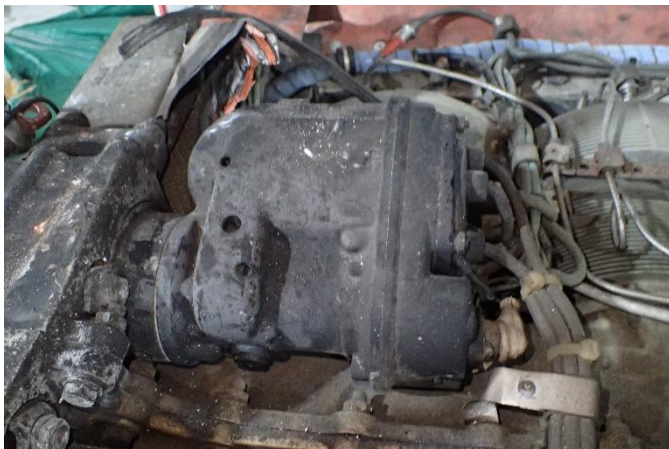
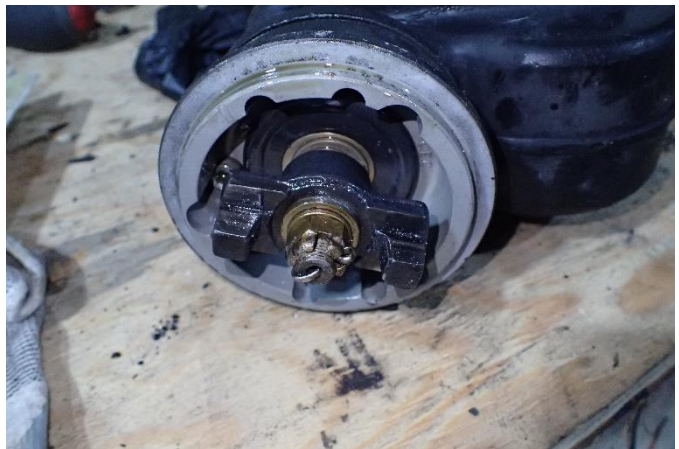
LEFT MAGNETO	Manufacturer: TCM	P/N: 10-349220-4	S/N: C010372
---------------------	-------------------	------------------	--------------

Condition: The magneto remained attached to its installation point and displayed thermal damage signatures. The magneto was removed, and it was observed that the driveshaft was capable of rotation. The driveshaft was rotated using a drill and the magneto was observed to be capable of producing a spark on all six posts in the correct firing order.

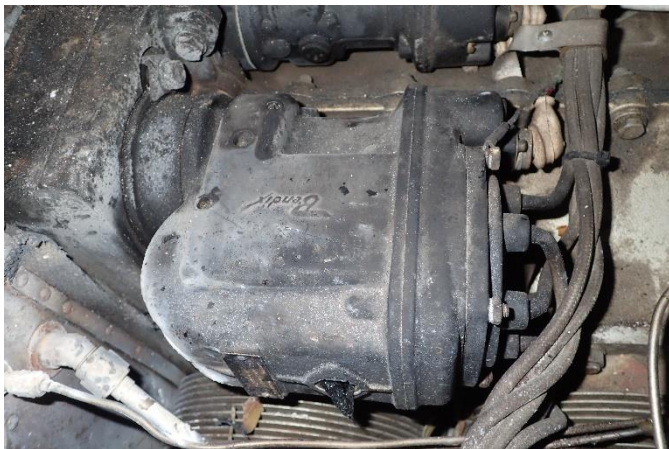
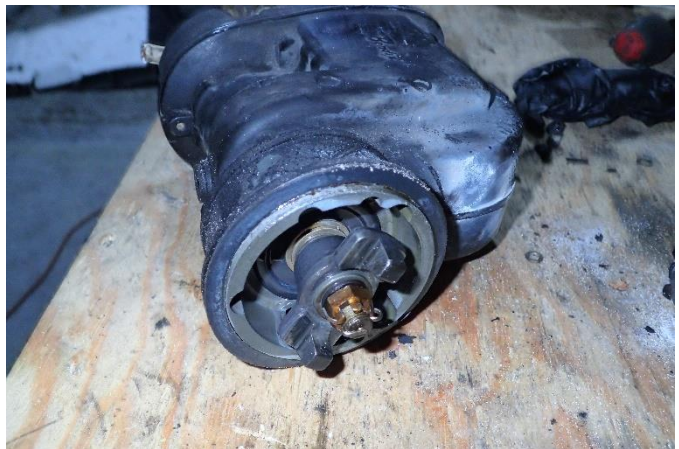
RIGHT MAGNETO	Manufacturer: TCM	P/N: 10-349260-7R	S/N: C043045
----------------------	-------------------	-------------------	--------------

Condition: The magneto remained attached to its installation point and displayed thermal damage signatures. The magneto was removed, and it was observed that the driveshaft was capable of rotation. The driveshaft was rotated using a drill and the magneto was observed to be capable of producing a spark on all six posts in the correct firing order.

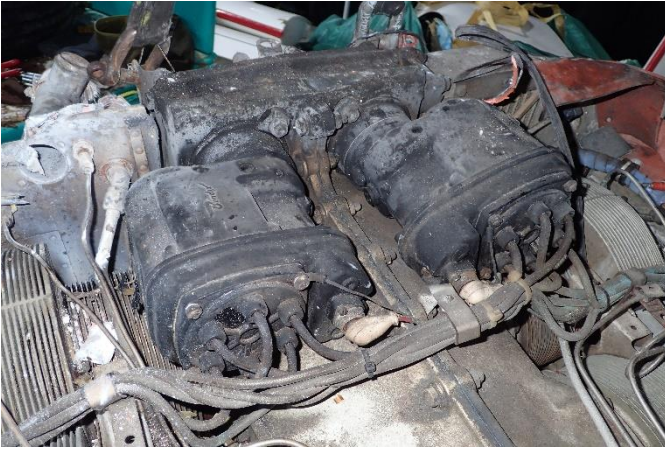
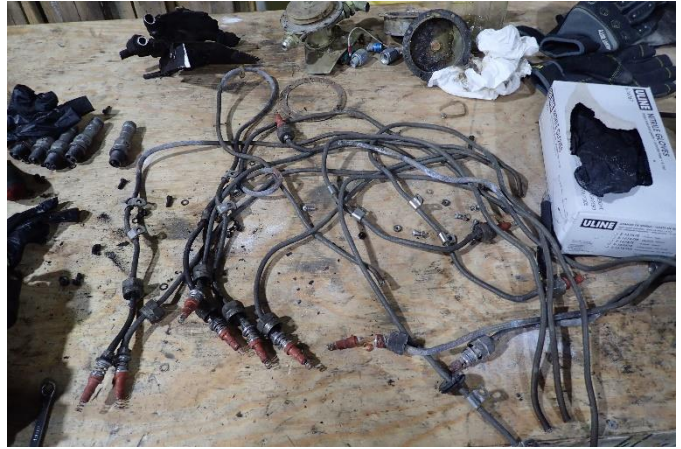
IGNITION HARNESS

The ignition harness displayed significant thermal damage signatures; the harness insulation was burned in several locations. There were no anomalies observed.

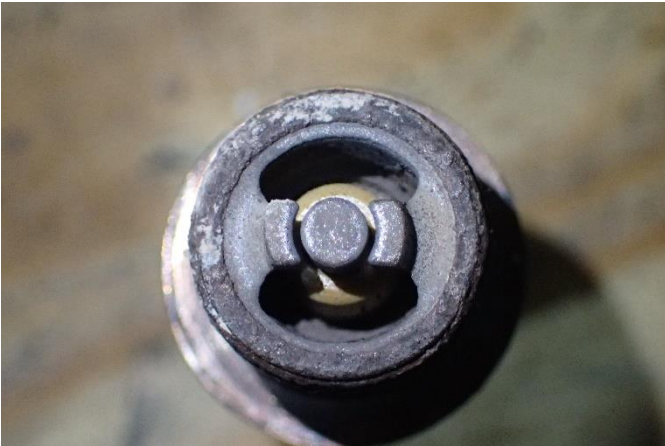
#1 Top Spark Plug

The spark plugs remained installed in their cylinders and displayed varying amounts of impact damage. The top spark plugs were removed for examination and the bottom spark plug electrodes were examined using a lighted borescope. The electrodes displayed normal operating and a few of the spark plugs were in a normal worn-out condition when compared with Champion Aviation Service Manual AV6-R.

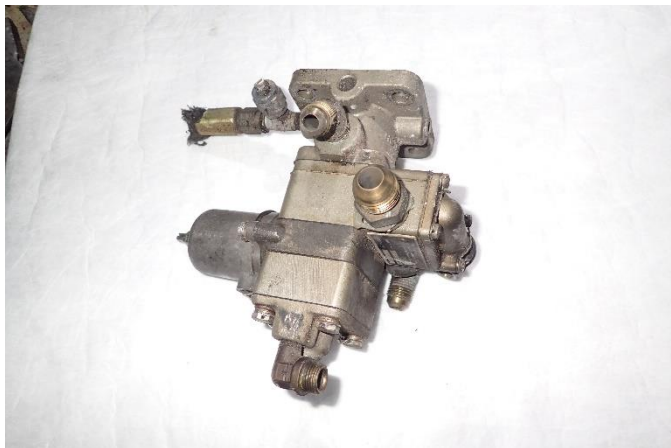
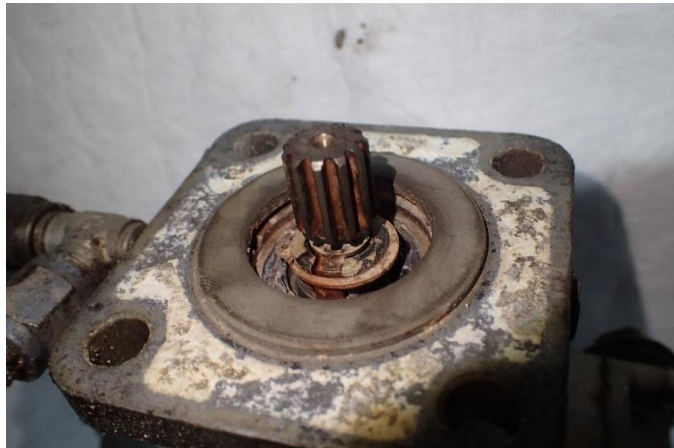
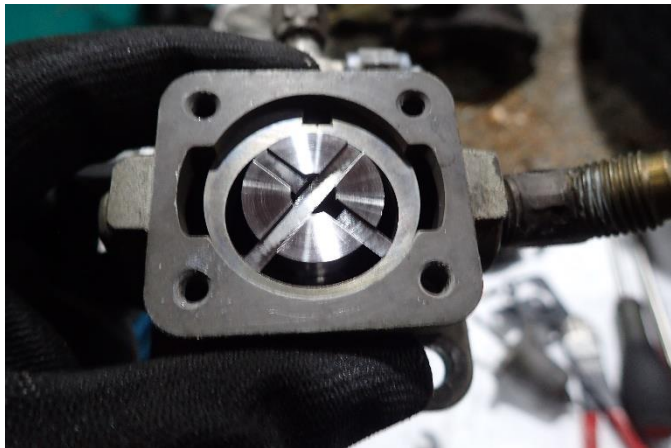
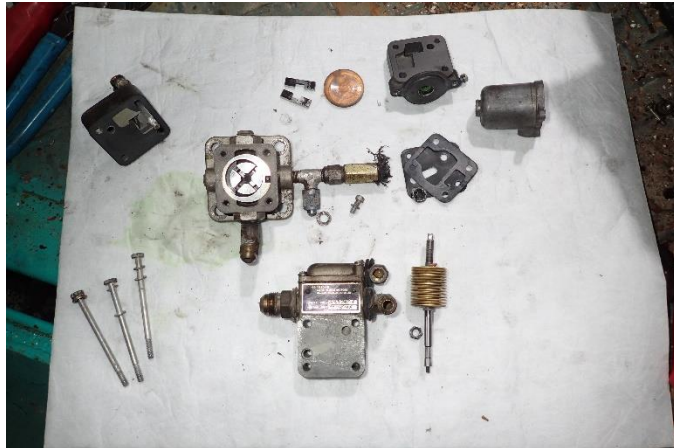
FUEL PUMP	Manufacturer: TCM	P/N: 630751-4	S/N: C217519B
Condition:	The fuel pump remained attached to its installation point and displayed minor thermal and impact damage signatures. The pump was removed, and the driveshaft was observed to be intact and capable of normal rotation. The fuel pump was disassembled, and the internal components displayed normal operating signatures. There was a small amount of fluid inside the fuel pump that smelled similar to fuel.

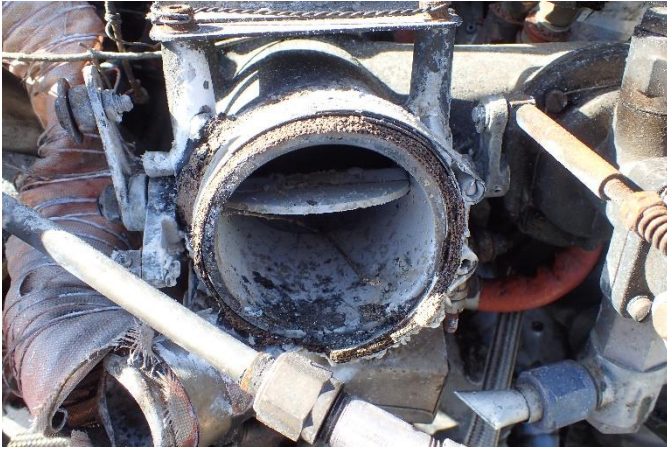
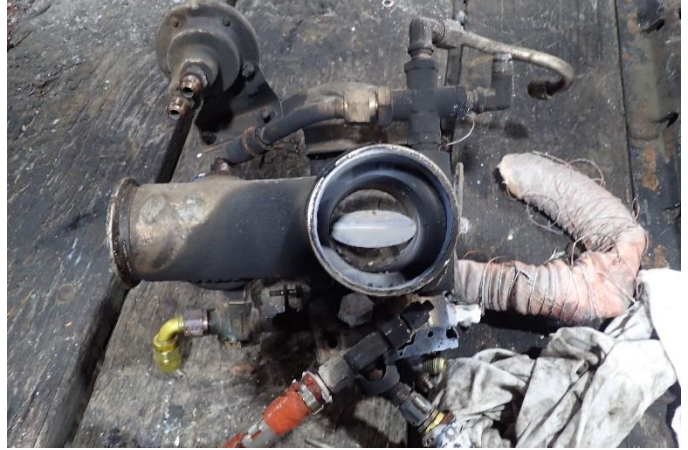
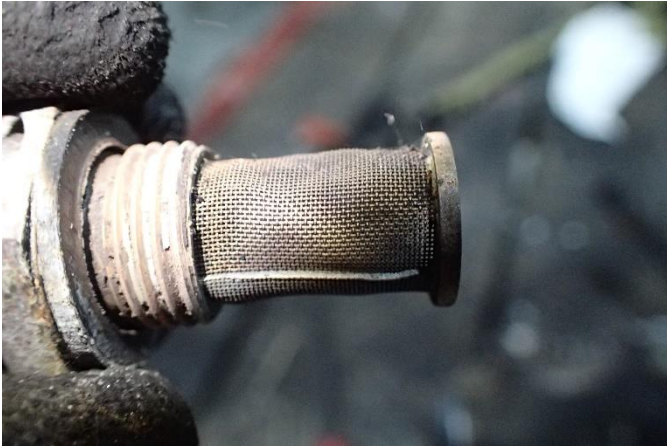
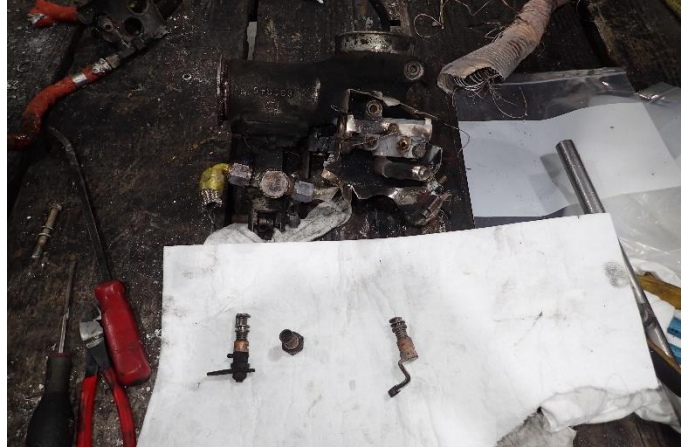
THROTTLE BODY
METERING UNIT

The throttle and metering assembly remained attached to its installation point and displayed significant thermal damage signatures. The assembly was removed, and the metering assembly was disassembled. The internal components displayed thermal damage signatures as well as normal operating signatures. The fuel inlet screen contained a small amount of debris; however, the screen was not blocked.

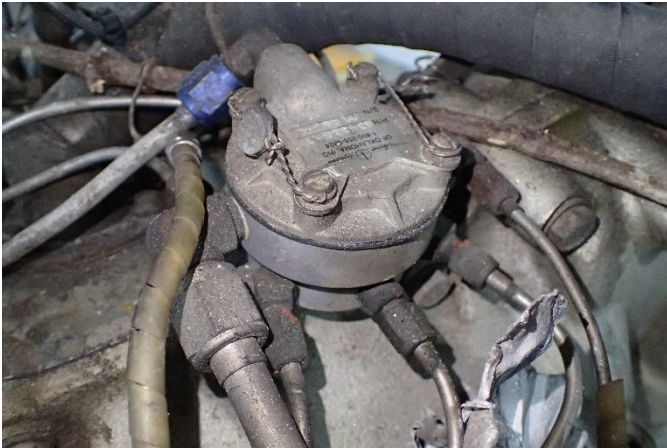
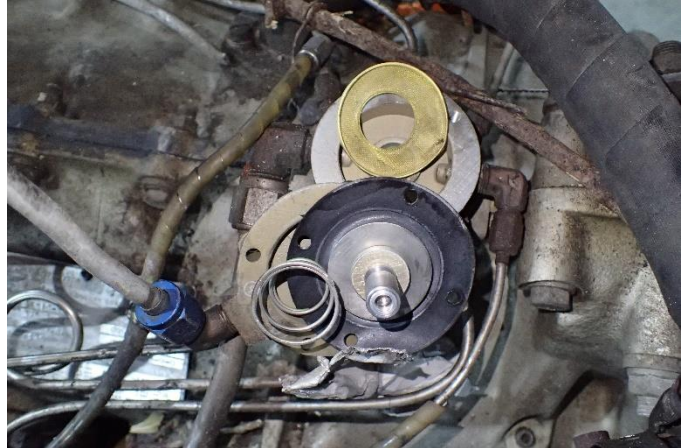
FUEL MANIFOLD VALVE

Condition: The fuel manifold valve remained attached to its installation point and displayed minor thermal damage signatures. The valve was disassembled, and the internal components were visually inspected. There was a small amount of fluid noted on both the wet and dry side of the manifold valve; however, there were no tears or cracks observed in the diaphragm. The remaining components displayed normal operating signatures and the screen was clear of debris.

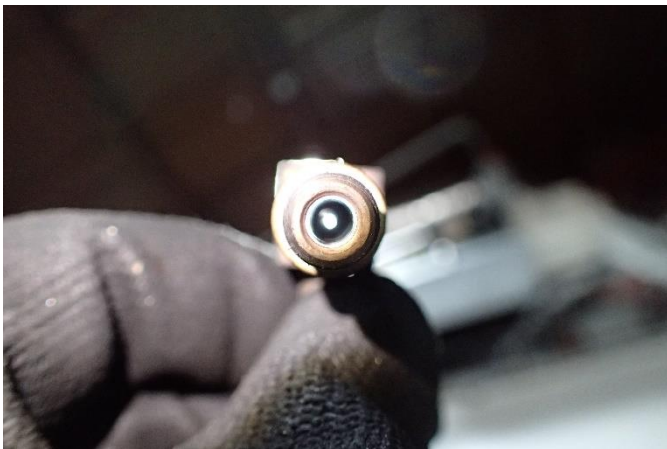
#1 Nozzle

Condition: The fuel nozzles remained installed in their cylinders and displayed varying amounts of thermal damage. The nozzles were removed and were observed to be clear of obstructions.

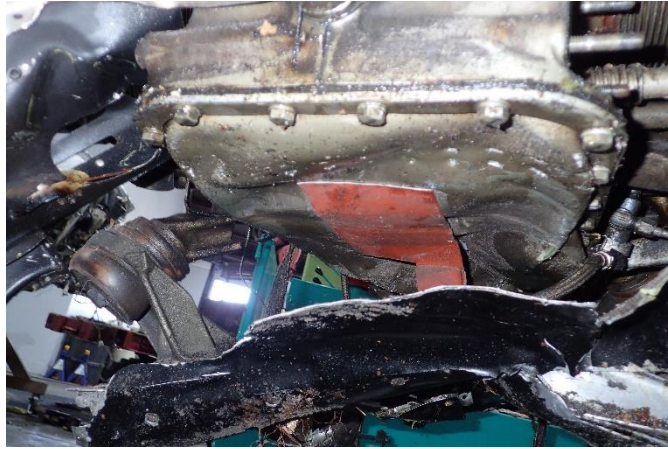
OIL SUMP

The oil sump displayed impact damage signatures and was crushed upwards.

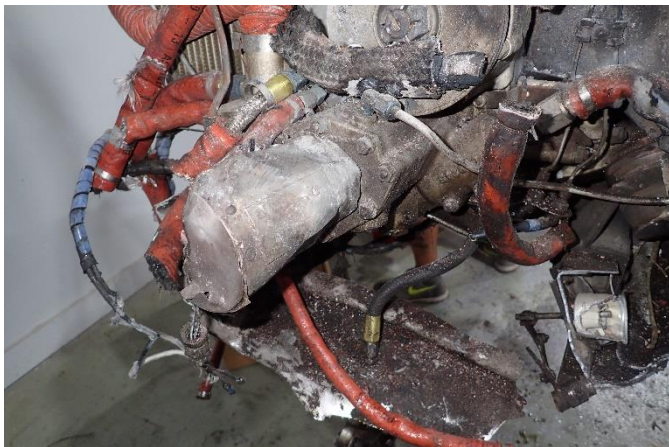
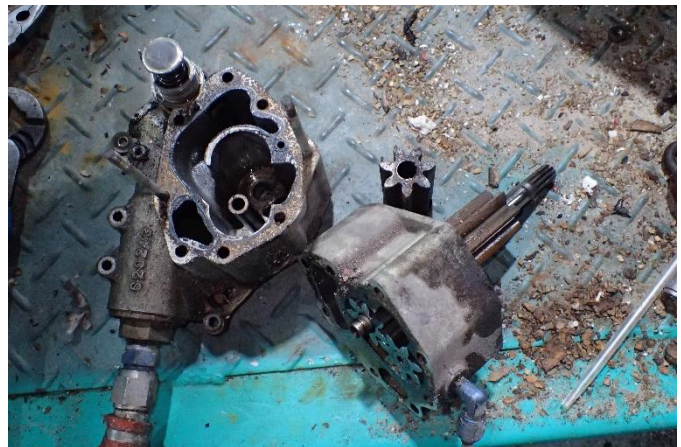
OIL PUMP

The oil pump remained attached to its installation point and displayed thermal damage signatures. The oil pump was removed and disassembled; the oil pump gears, housing, oil pressure relief valve, and scavenge pump displayed normal operating signatures.

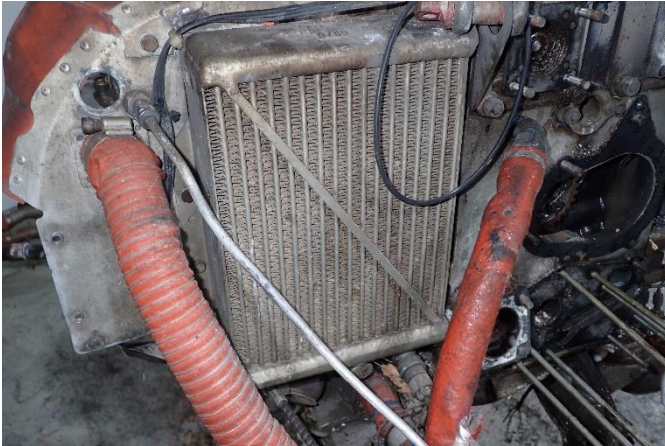
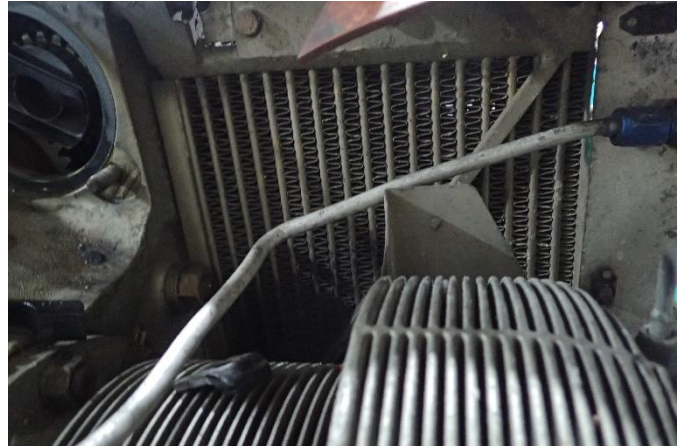
OIL COOLER

The oil cooler remained attached to its installation point and displayed thermal damage signatures. There were no oil leaks noted around the oil cooler.

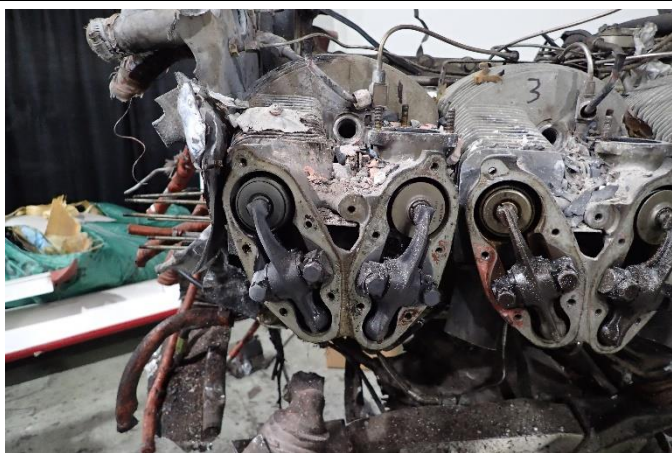
#1 Cylinder Overhead

All six cylinders remained attached to their cylinder bays and displayed varying amounts of impact and thermal damage. The cylinders were inspected using a lighted borescope; the piston faces, cylinder bores, and valve heads displayed normal operating and combustion signatures, some of the cylinder bores also displayed minor surface corrosion. During crankshaft rotation all of the cylinders displayed good thumb compression and suction. The overhead components (valves, springs, and rocker arms) displayed normal operating and lubrication signatures; the overhead components operated normally during crankshaft rotation.

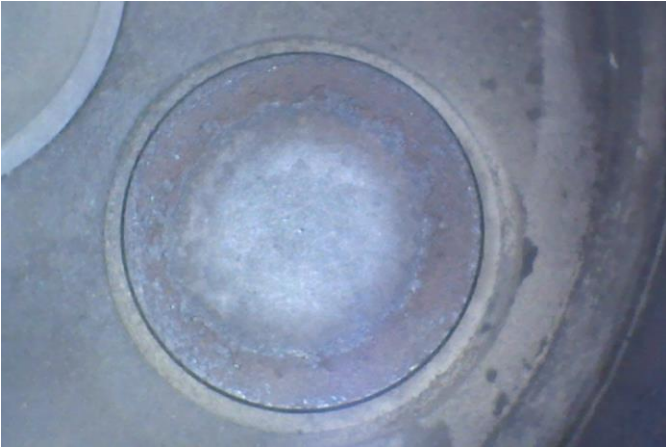
#1 Exhaust Valve

The valve heads were inspected using a lighted borescope. The valve heads displayed normal operating and combustion signatures. During crankshaft rotation all of the valves operated normally.

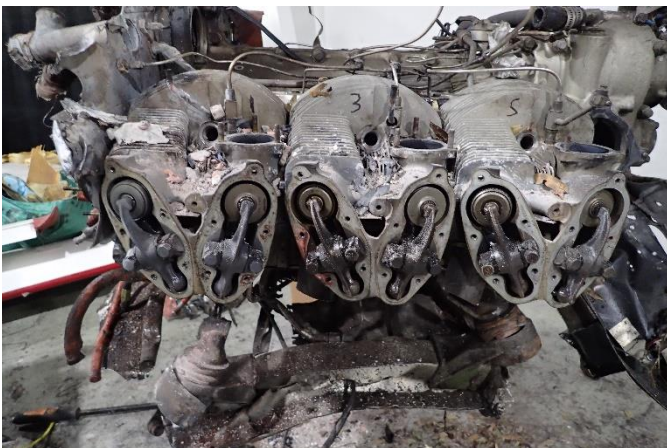
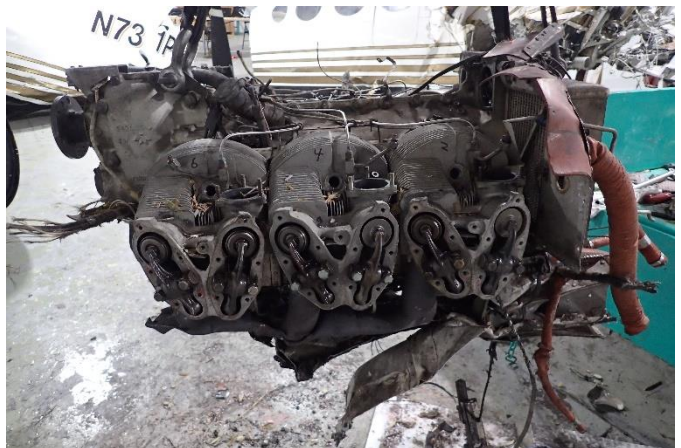
ROCKER ARMS AND SHAFTS

The rocker arms displayed normal operating and lubrication signatures. During crankshaft rotation, the rocker arms operated normally.

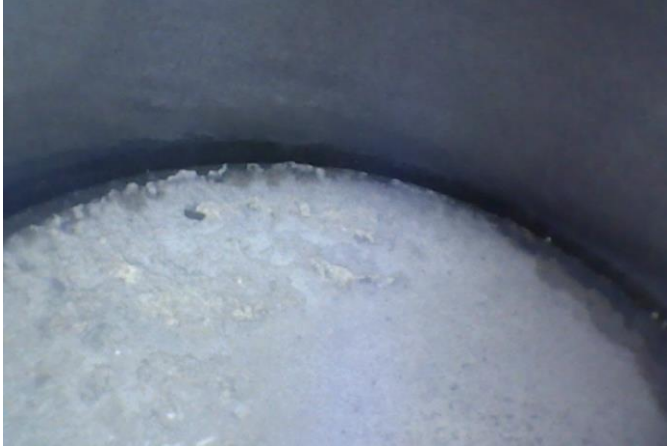
#1 Piston

The piston faces were inspected using a lighted borescope. The piston faces displayed normal operating and combustion signatures. During crankshaft rotation the pistons operated normally.

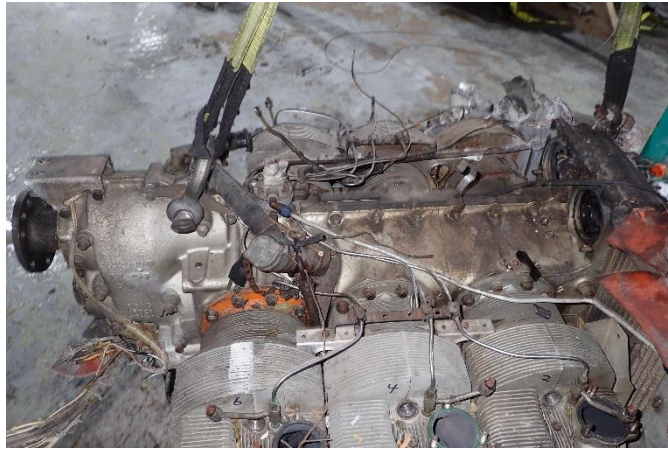
CRANKCASE	Casting Number:	1-3-5: 642081	2-4-6: 642080	S/N: J9A-3534-OR-B
Condition:	The crankcase remained intact and displayed thermal damage signatures concentrated to the rear of the crankcase. There were no holes in the crankcase that would indicate a catastrophic internal engine failure.

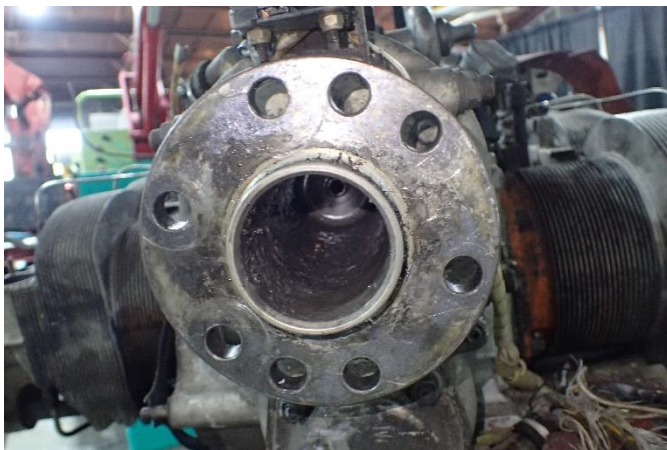
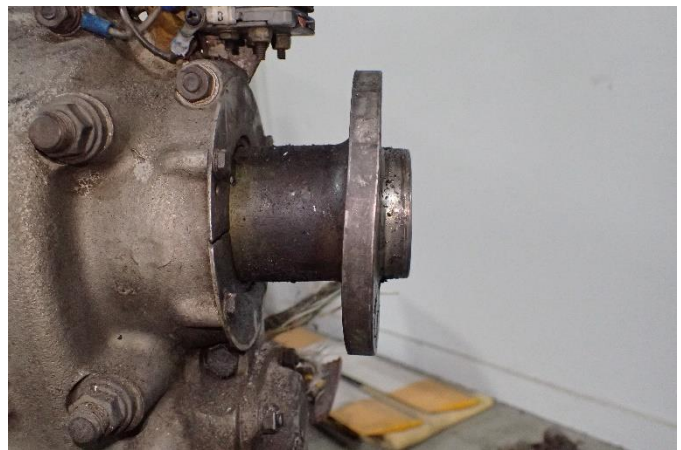
PROPELLER SHAFT

Condition: The propeller flange remained attached to the propeller shaft and displayed impact damage signatures. The propeller shaft gear was partially visible after removing the alternator and displayed normal operating signatures. The propeller shaft was rotated using a hand tool and continuity was established between the propeller shaft, reduction gear, quill shaft, crankshaft, camshaft, connecting rods, and associated components. There were no anomalies observed.

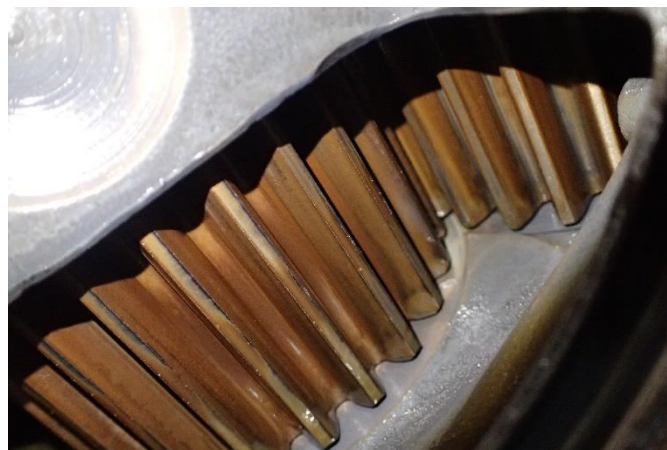
REDUCTION GEAR

Condition: The reduction gear was partially visible after removing the alternator and the gear displayed normal operating signatures. During propeller shaft rotation the reduction gear operated normally.

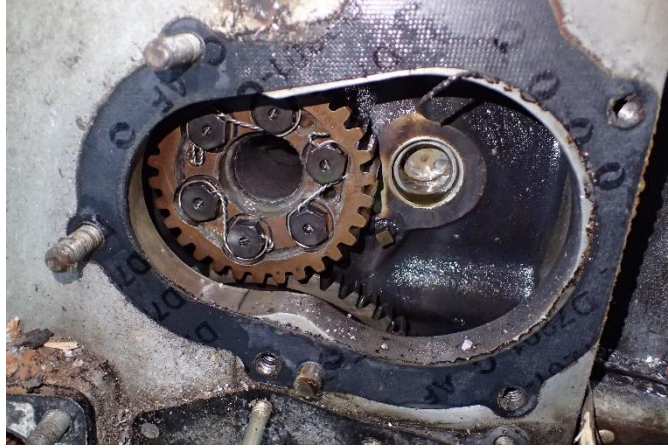
CRANKSHAFT

The crankshaft gear was observed after removing the starter adapter; the gear remained secure, was undamaged, and displayed normal operating signatures. The operation of the crankshaft was verified by rotating the propeller flange and observing piston movement; the crankshaft operated normally.

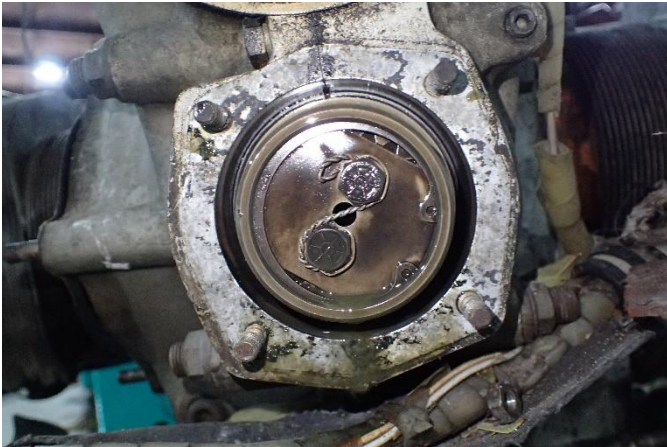
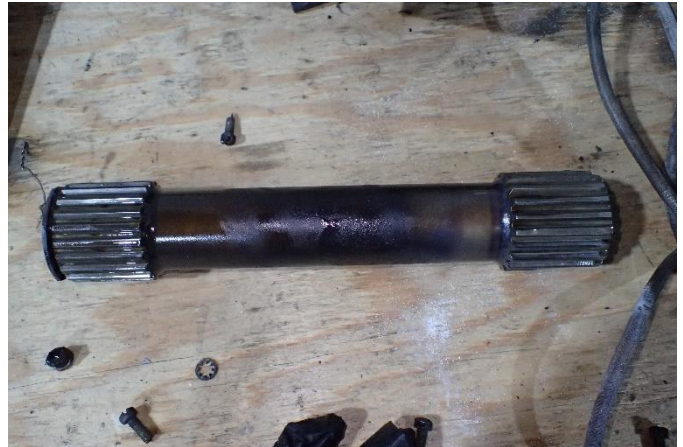
QUILL SHAFT

The operation of the quill shaft was verified by rotating the quill shaft and observing the crankshaft gear operation; the quill shaft operated normally. The quill shaft was removed, and the shaft displayed normal operating signatures.

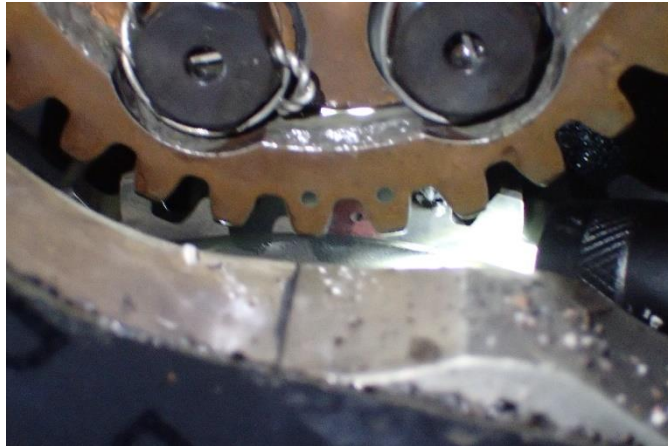
INTERNAL TIMING	
------------------------	--

Condition:	The internal timing was verified to be correct.
-------------------	---

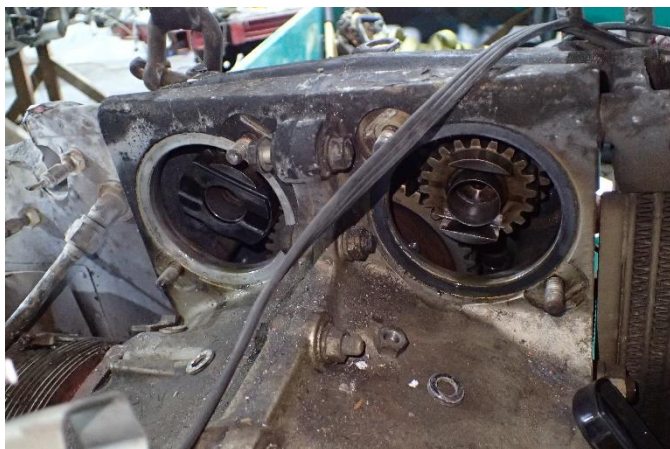
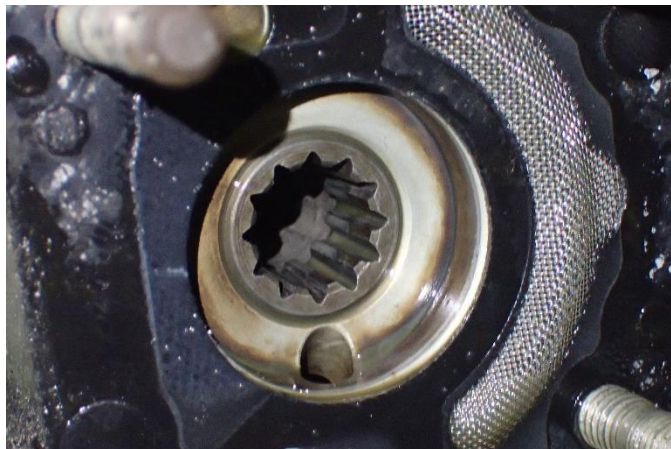
CAMSHAFT	P/N: Inaccessible	S/N: Inaccessible
Condition:	The operation of the camshaft was verified by rotating the propeller shaft and observing rocker arm movement. The camshaft operated normally.	
ACCESSORY GEARS		
Condition:	The magneto and governor drive gears displayed normal operating signatures and rotated normally while rotating the propeller shaft.

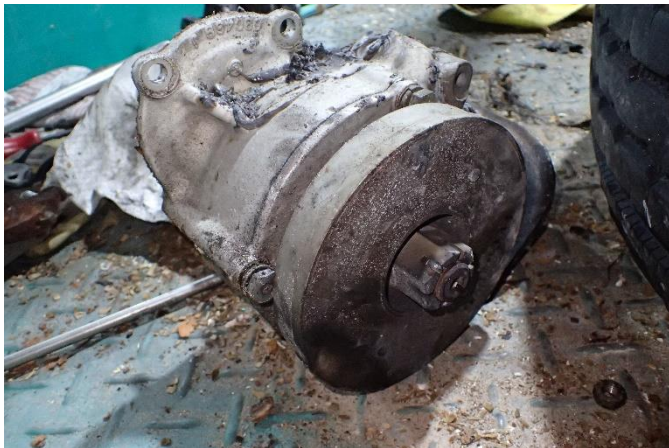
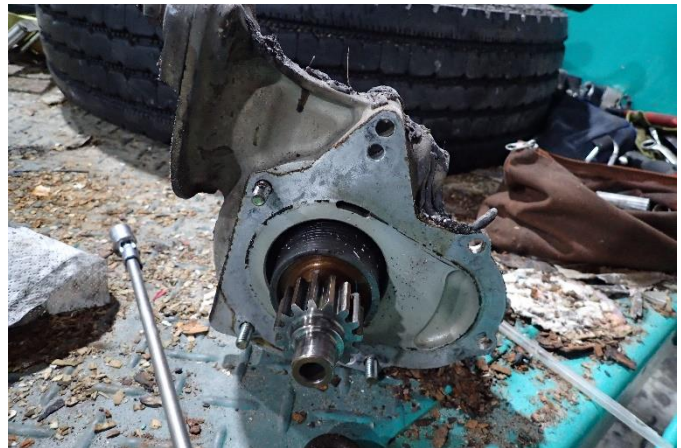
STARTER ADAPTER	P/N: Not observed
------------------------	-------------------

Condition: The starter adapter remained attached to its installation point and displayed impact and thermal damage signatures; it was observed that the dampener remained secured to the starter adapter. The adapter was removed, and it was observed that the gear displayed normal operating signatures and was capable of normal rotation.

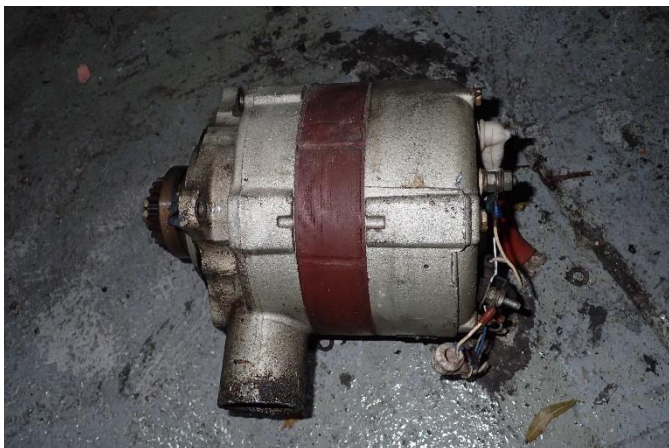
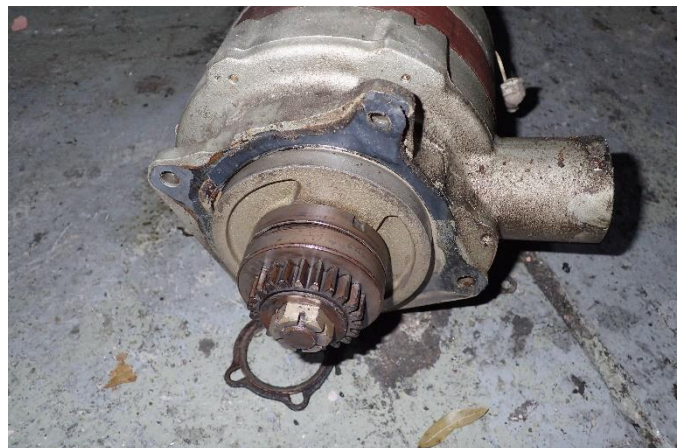
Condition: The alternator remained attached to its installation point and displayed impact damage signatures. The alternator was removed, and the drive coupling was observed to have remained intact and the alternator drive was capable of normal rotation.

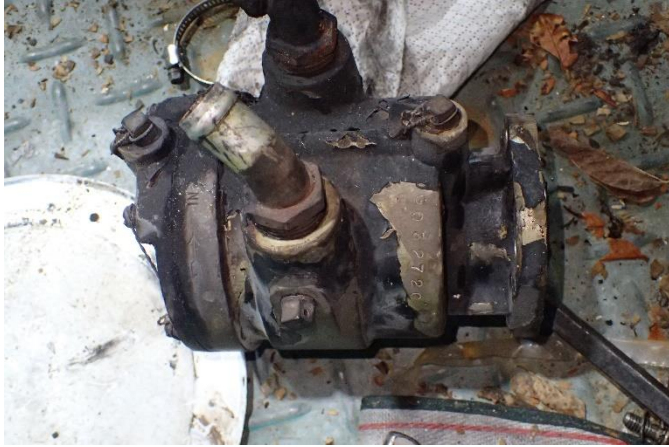
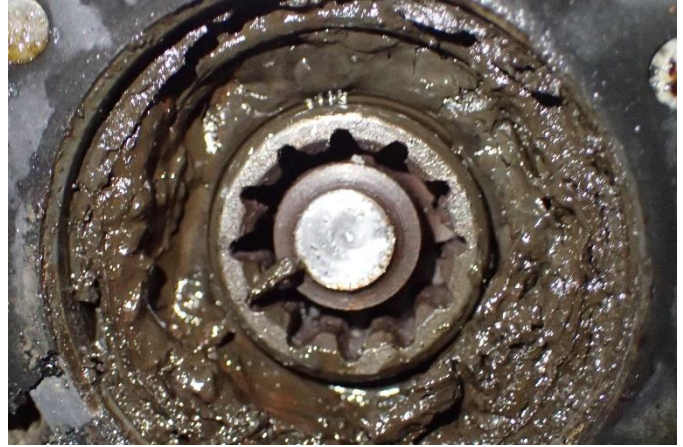
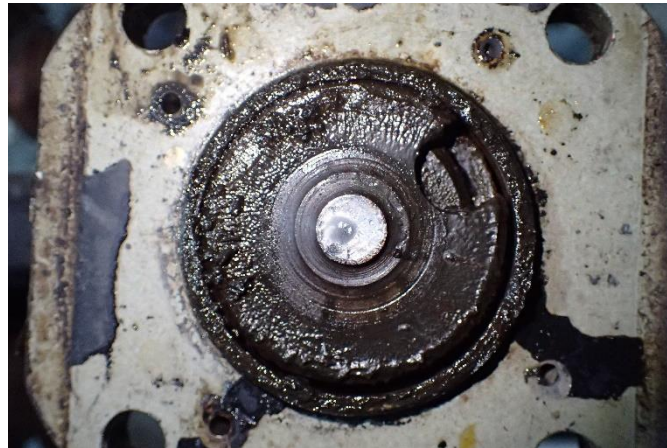
VACUUM PUMP

The vacuum pump remained attached to its installation point and displayed thermal damage signatures. The vacuum pump was removed, and it was observed that the drive coupling was sheared.

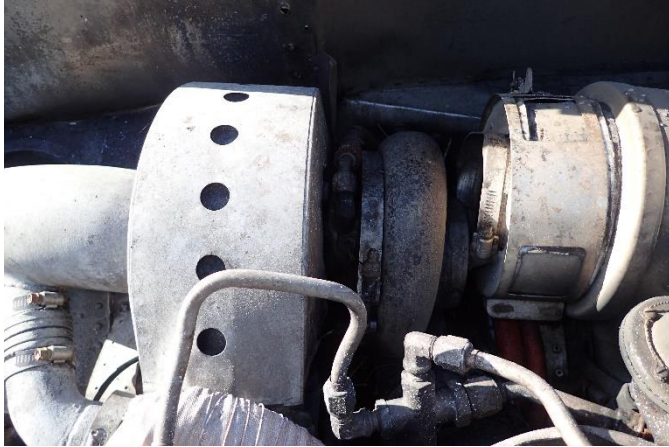
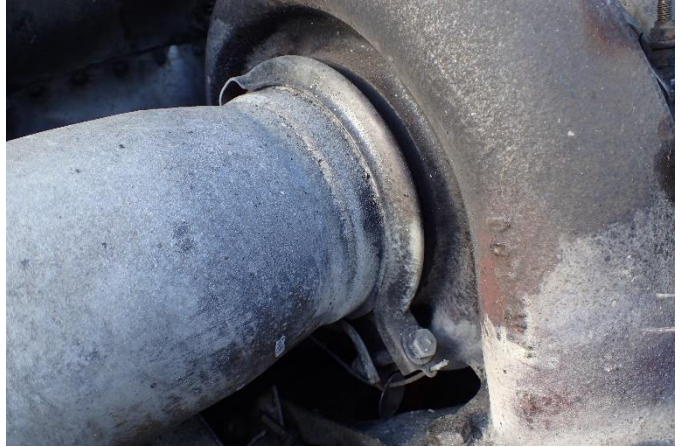
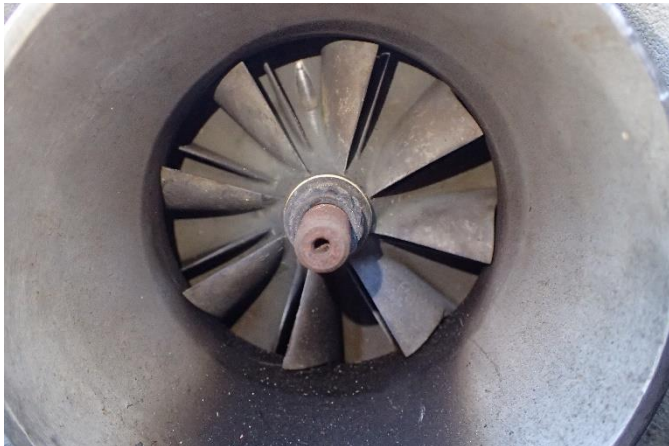
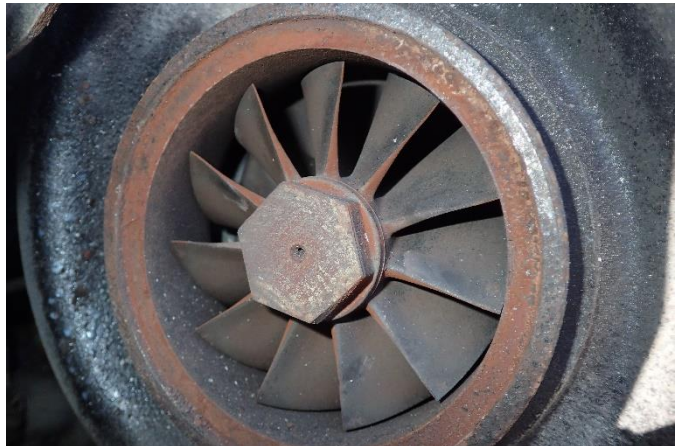
TURBO

The turbocharger remained partially attached to its installation point and displayed impact and thermal damage signatures. The tailpipe and the compressor inlet airbox were removed and the turbine and compressor were examined. The turbine and compressor blades displayed normal operating signatures and were capable of normal rotation.

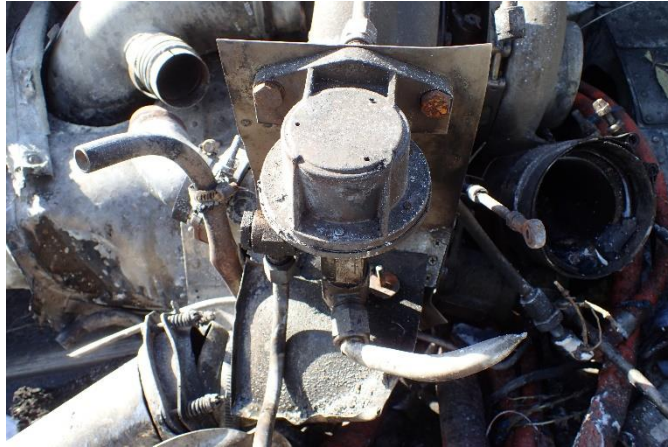
Condition: The controller remained attached to its installation point and displayed significant thermal damage signatures.

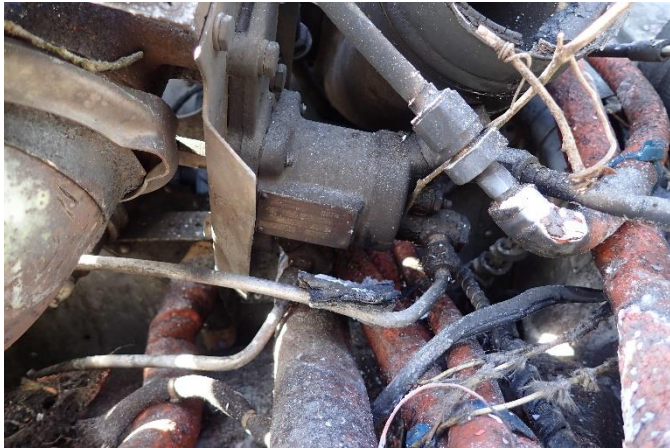
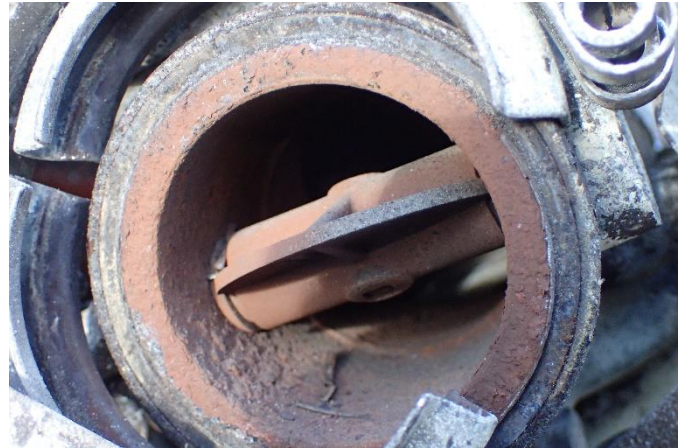
Condition: The wastegate remained attached to its installation point and displayed thermal damage signatures. The wastegate actuator arm remained secured to the wastegate valve and the valve was found to be in the approximate full open position.
