ENGINE EXAMINATION REPORT

ENGINE MODEL	GTSIO-520-D
ENGINE SERIAL NUMBER	188783-9-D
AIRCRAFT MAKE & MODEL	Cessna 421
AIRCRAFT SERIAL NUMBER	421-0164
AIRCRAFT REGISTRATION	N731PF
FILE NUMBER	19-104

EXAMINATION		ACCIDENT DATA	
DATE	10/03/2019	NTSB ACCIDENT #	ERA19FA283
FACILITY	Florida Air Recovery	NTSB INVESTIGATOR	Eric Alleyne
ADDRESS	7403 Philips Hwy Jacksonville, FL 32256	FAA INVESTIGATOR	Antonia Gonzalez
		ACCIDENT DATE	09/29/2019
		ACCIDENT LOCATION	Deland, Florida

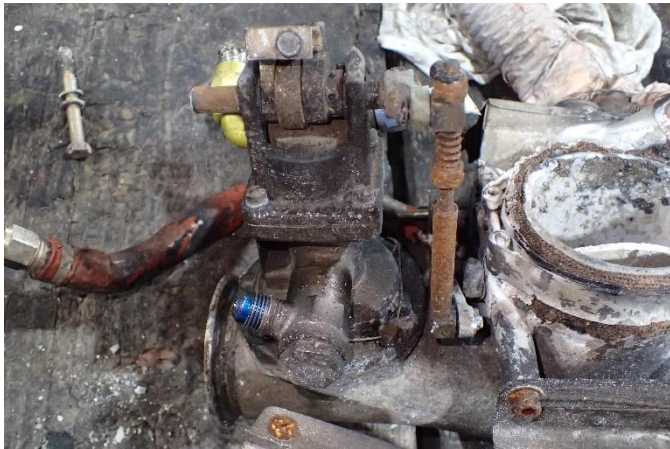
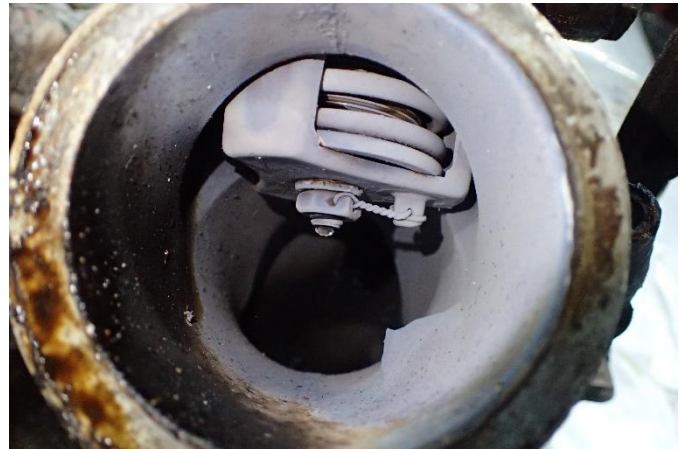
TURBO CONTROLLER	Manufacturer: Not observed	P/N: Not observed	S/N: Not observed
Condition:	The controller remained attached to its installation point and displayed thermal damage signatures.

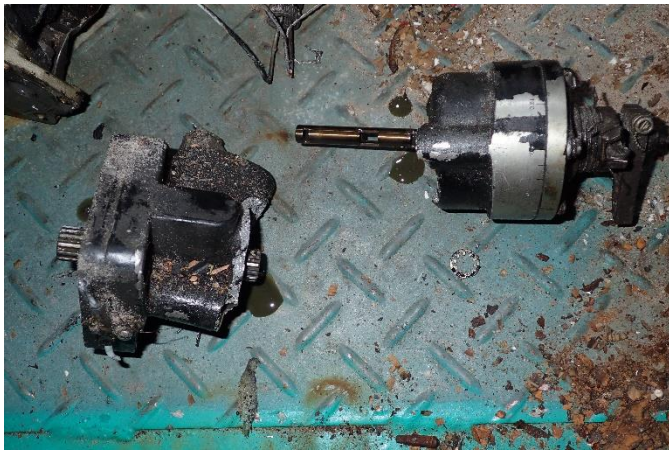
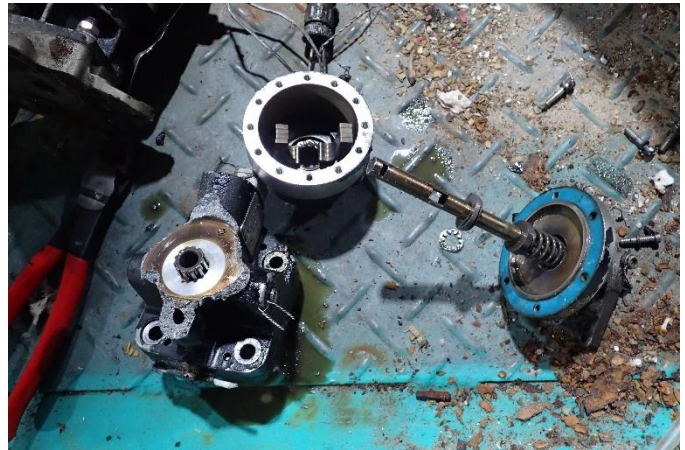
Condition: The governor remained attached to its installation point and displayed impact damage signatures. The governor was removed, and the governor gasket screen was noted to be clear of any metallic material. The driveshaft was observed to be intact; however, it was seized which was consistent with the impact damage to the governor. The governor was partially disassembled, and the observed internal components displayed normal operating signatures.

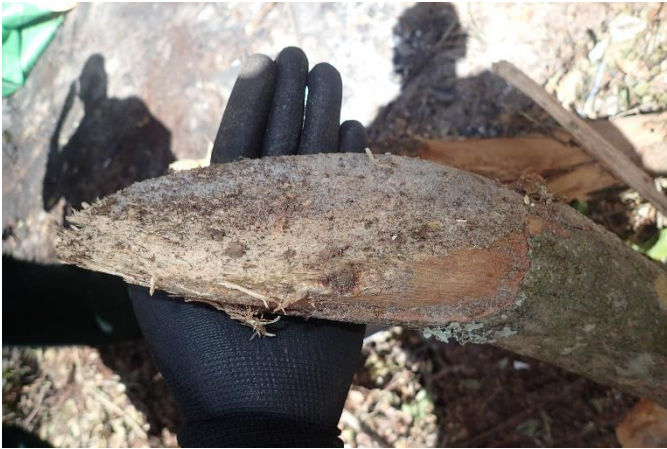
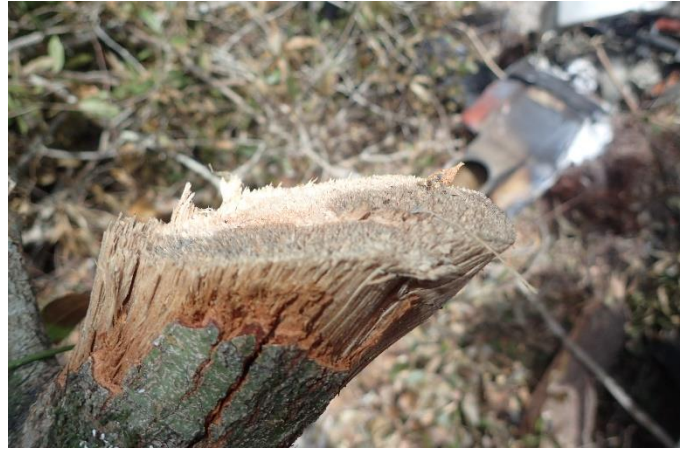
Condition: The three-blade, constant speed propeller remained partially attached to the propeller flange and displayed impact damage signatures. The propeller blade marked "A" displayed minor impact damage to the blade root and was not bent. The propeller blade marked "B" displayed S-bending, twisting, and aft bending deformation as well as significant polishing of the cambered side. The propeller blade marked "C" displayed aft bending deformation and leading-edge polishing near the tip. During the on-scene portion of the investigation, several tree branches were found with clean approximate 45-degree angle cuts and appeared to have black paint transfer.

Cut branches found at the accident site
