Subject: Boeing Submission for the RED Air MD-82 HI1064 Landing Gear Collapse in Miami, Florida, 21 June 2022

Red Air MD-82 HI1064  
Landing Gear Collapse and Runway Excursion  
at Miami International Airport, Florida  
21 June, 2022

**The Boeing Company**  
**25 August 2023**

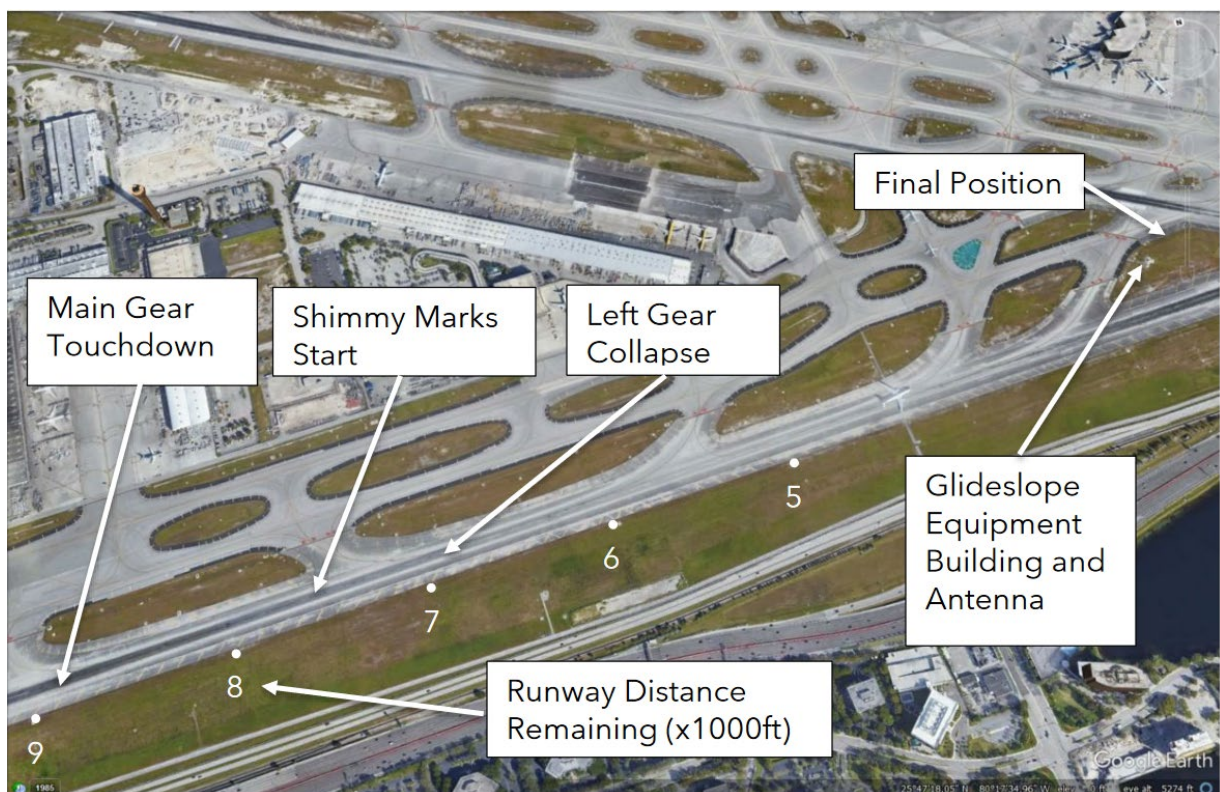
Figure 1 Runway 09 overview

From video evidence, the airplane touched down on runway 09 with approximately 8900 feet remaining. Tire deposits on the runway, which started about 1300 ft later, showed evidence of left main gear shimmy. The amplitude of the shimmy steadily increased until the left main landing gear collapsed under the airplane about 675 feet further down the runway. The airplane continued down the runway skidding on the left wing. The airplane veered left and impacted an FAA glideslope equipment building and antenna. Both the nose gear and right main gear then collapsed, and the airplane came to a stop.

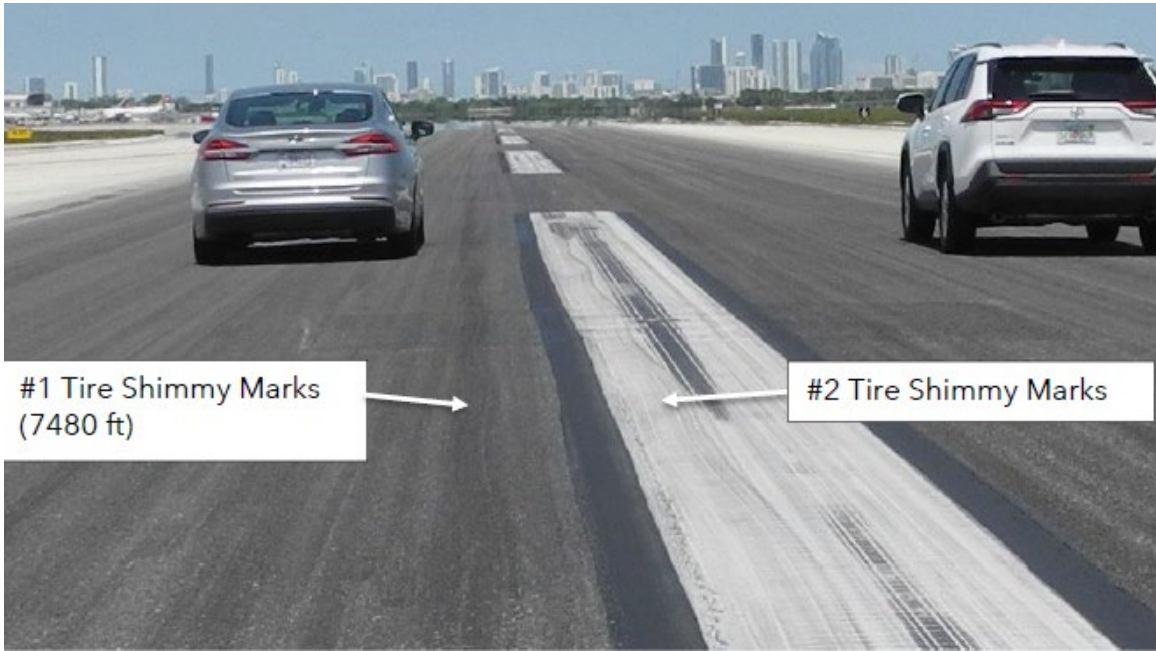
**Figure 2 Start of left main gear shimmy marks**

Figures 2 – 7<sup>8</sup> show how the rubber deposits on the runway for the left main gear tires started with a small oscillation and grew in amplitude (increasing shimmy). The labels with distance indicate approximate distance of runway 09 remaining. The tire marks changed in appearance. The initial markings were continuous and consistent with side-to-side oscillations (Figures 2 through 6). Figure 5 shows the location of the first debris found on the runway (approximately 7060 ft of runway remaining). The debris was a small piece of rubber, later determined to be from the outboard side of the #2 tire. The markings then were more arched and non-continuous, consistent with the axle/wheels turning about the vertical axis (Figure 6). The markings then changed from a two-tire pattern to a single tire pattern, and to the opposite side of the runway centerline, consistent with the tire sidewall contacting the runway after the left main landing gear collapse (Figure 7).

The tire marks on the runway confirm that a shimmy condition developed in the left main landing gear shortly after touchdown. The magnitude of the shimmy grew as the aircraft traveled down the runway, until it reached the point that the left main gear failed and collapsed.

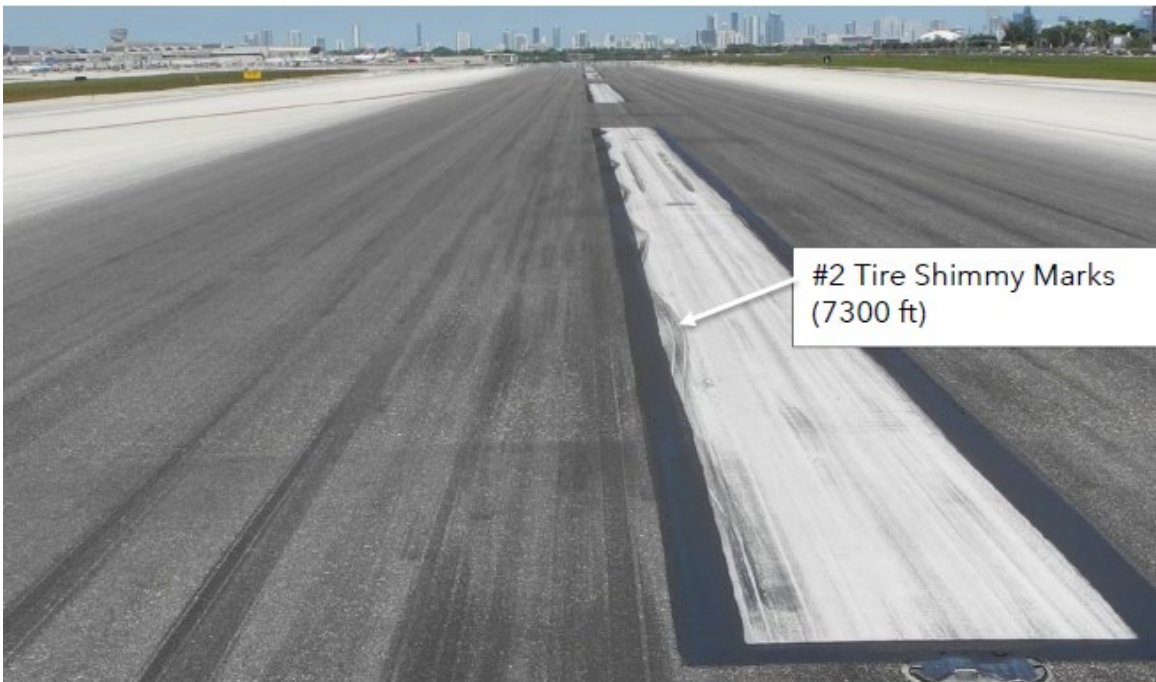
**Figure 3 Shimmy marks continue**

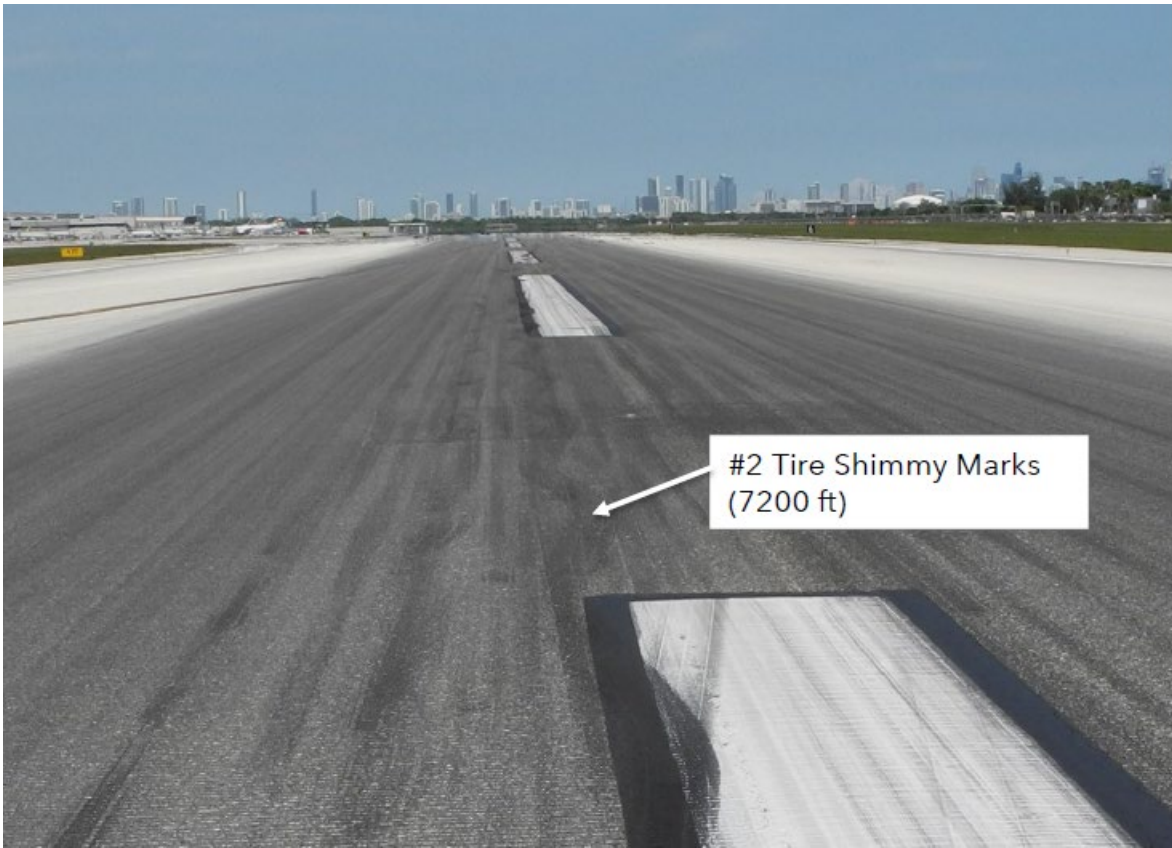
Figure 4 Shimmy marks continue

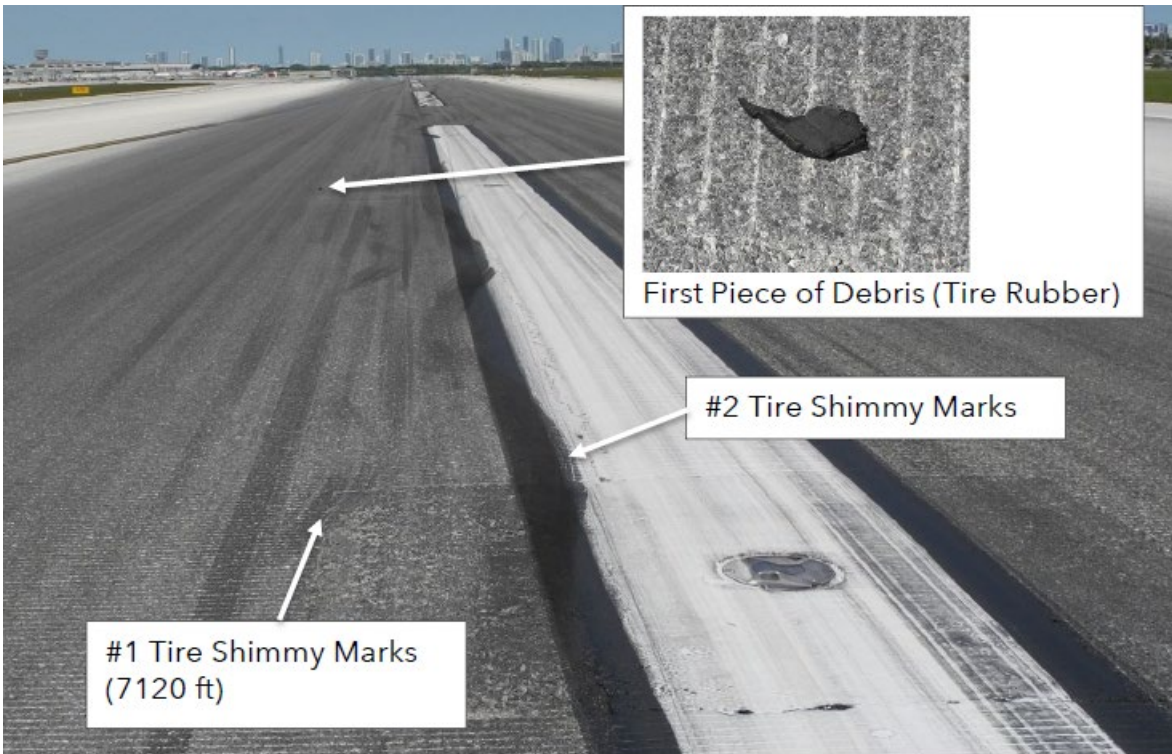
Figure 5 Shimmy marks continue

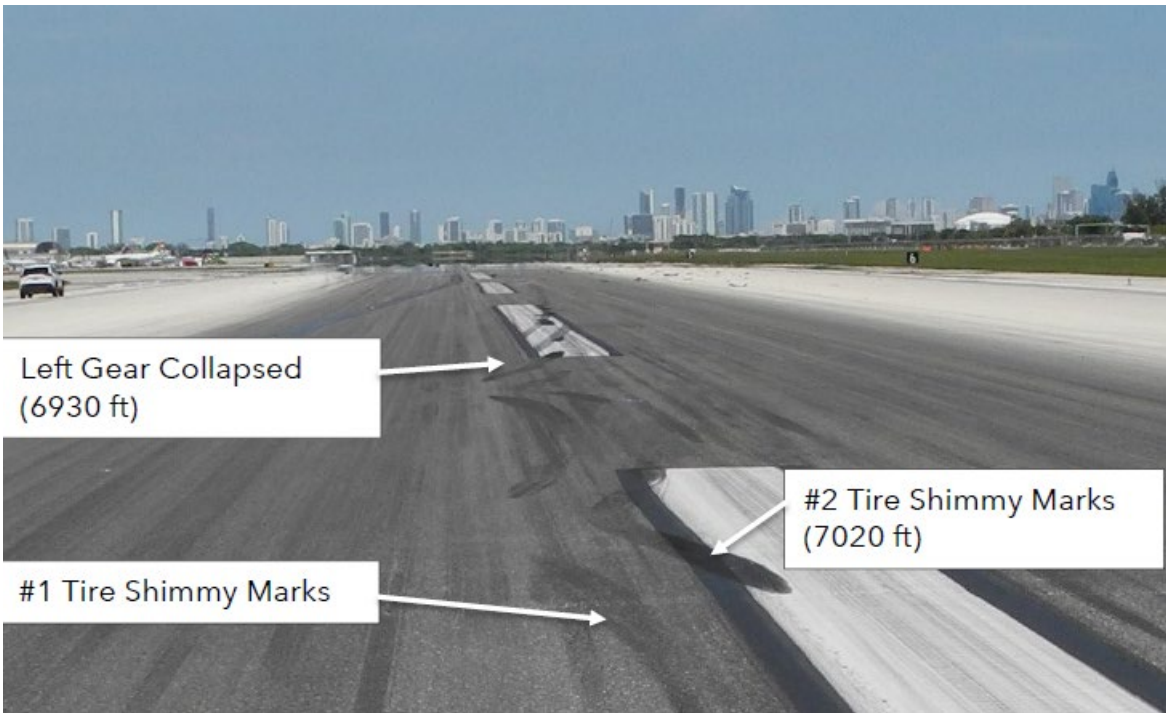
Figure 6 Shimmy marks continue

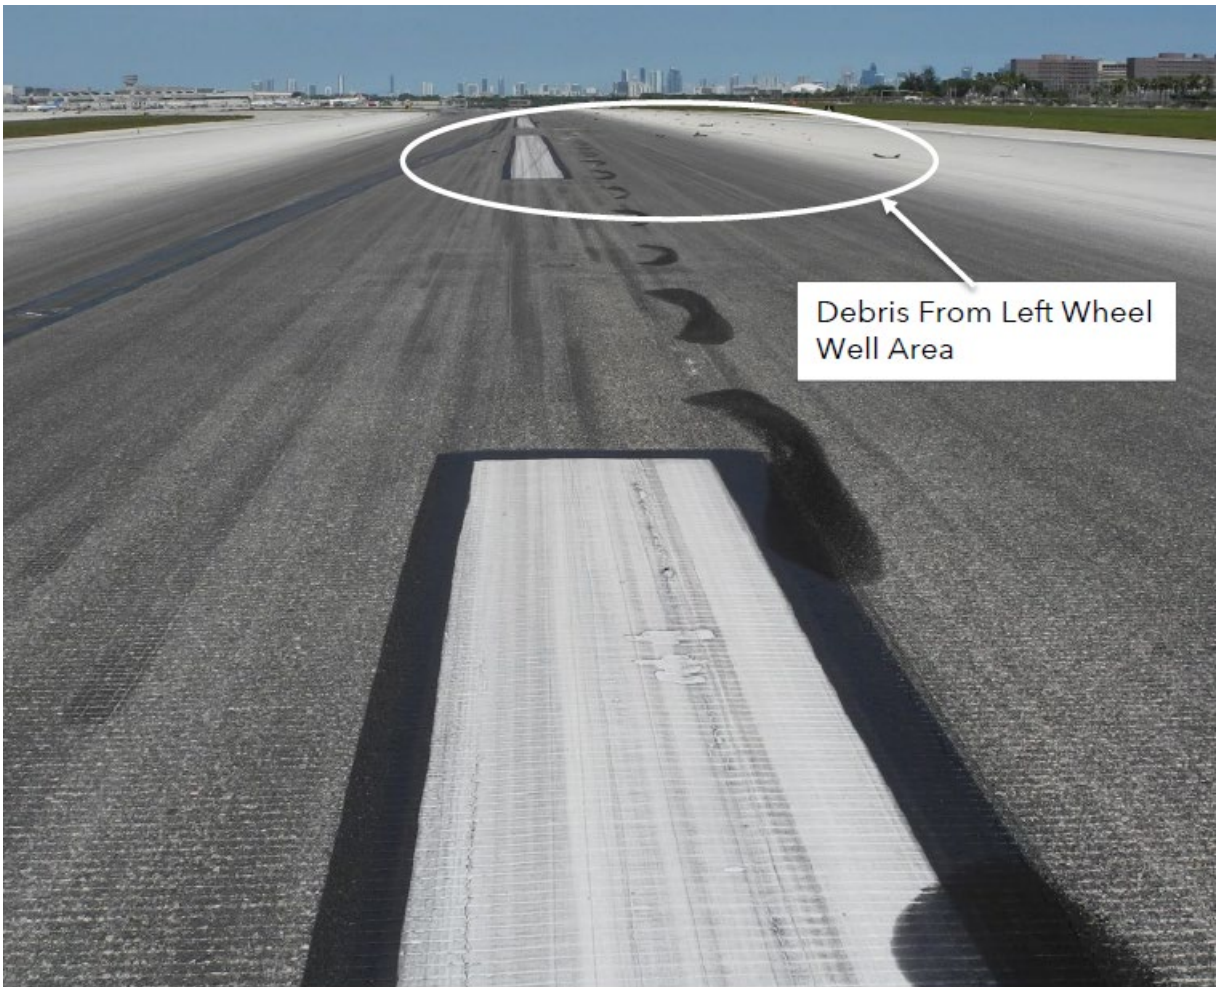
Figure 7 Shimmy marks continue

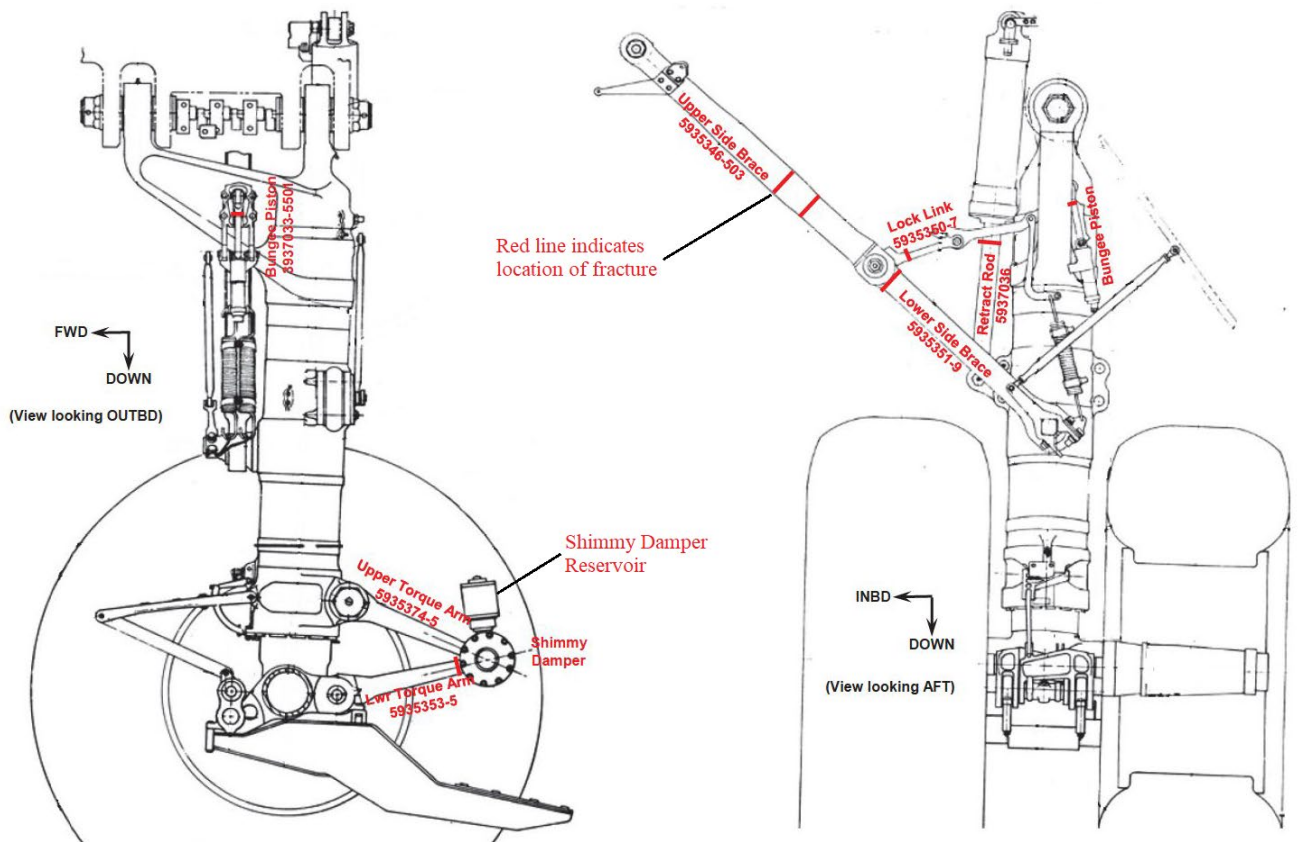
**Figure 8 Locations of Fractures on Left Main Gear**

The left main landing gear was found collapsed into the wheel well. When the airplane was lifted, the gear extended and the axle was found to be rotated 90 degrees outboard (see Figure 9). The lower side brace fractured below the joint of the upper and lower side braces. The upper side brace fractured into three pieces with the largest upper piece remaining attached to the airplane while the two smaller pieces were found in the debris field.

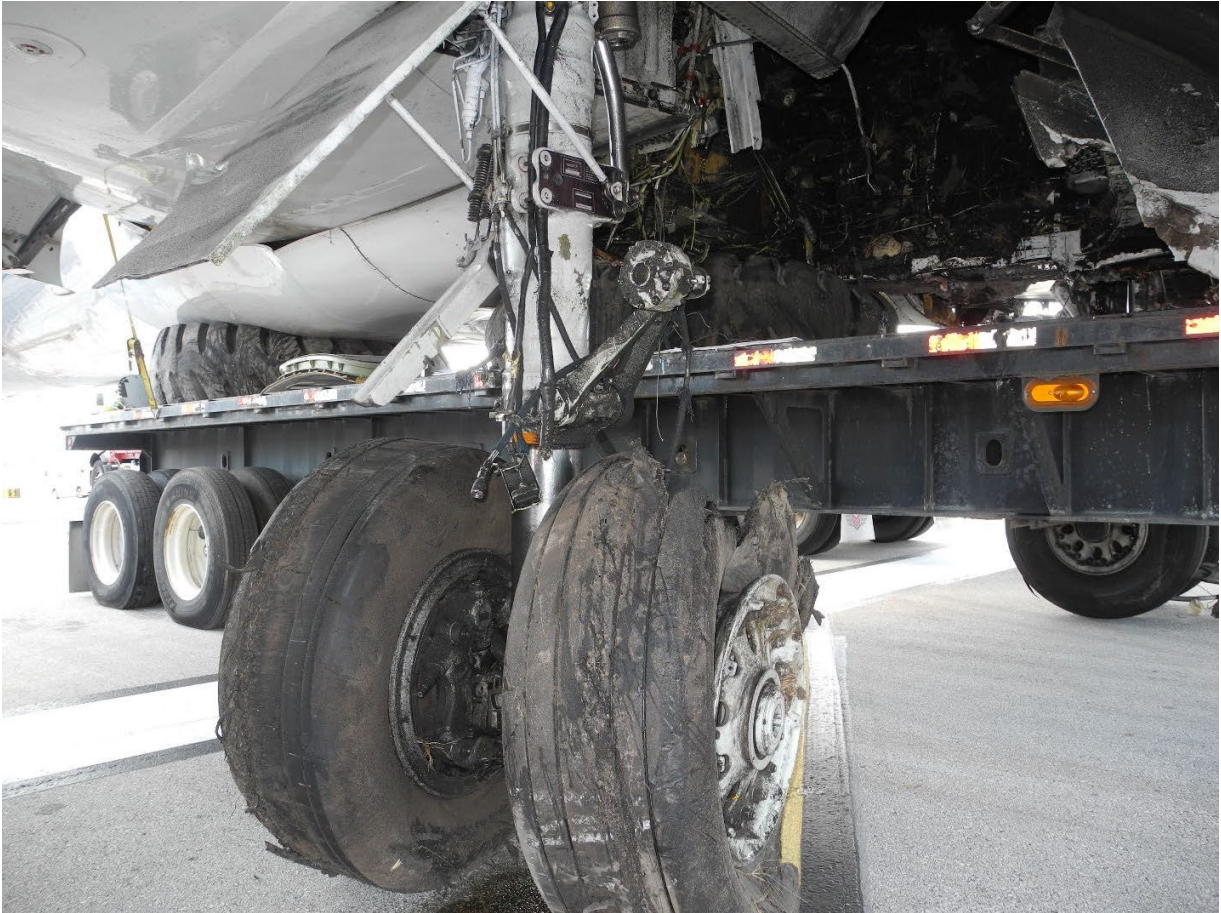
**Figure 9 Left Main Gear**

The upper torque link remained attached to the inner cylinder, with the shimmy damper housing attached to it. The bulk of the lower torque link remained attached to the landing gear axle, with the end fractured where it should attach to the upper torque link.

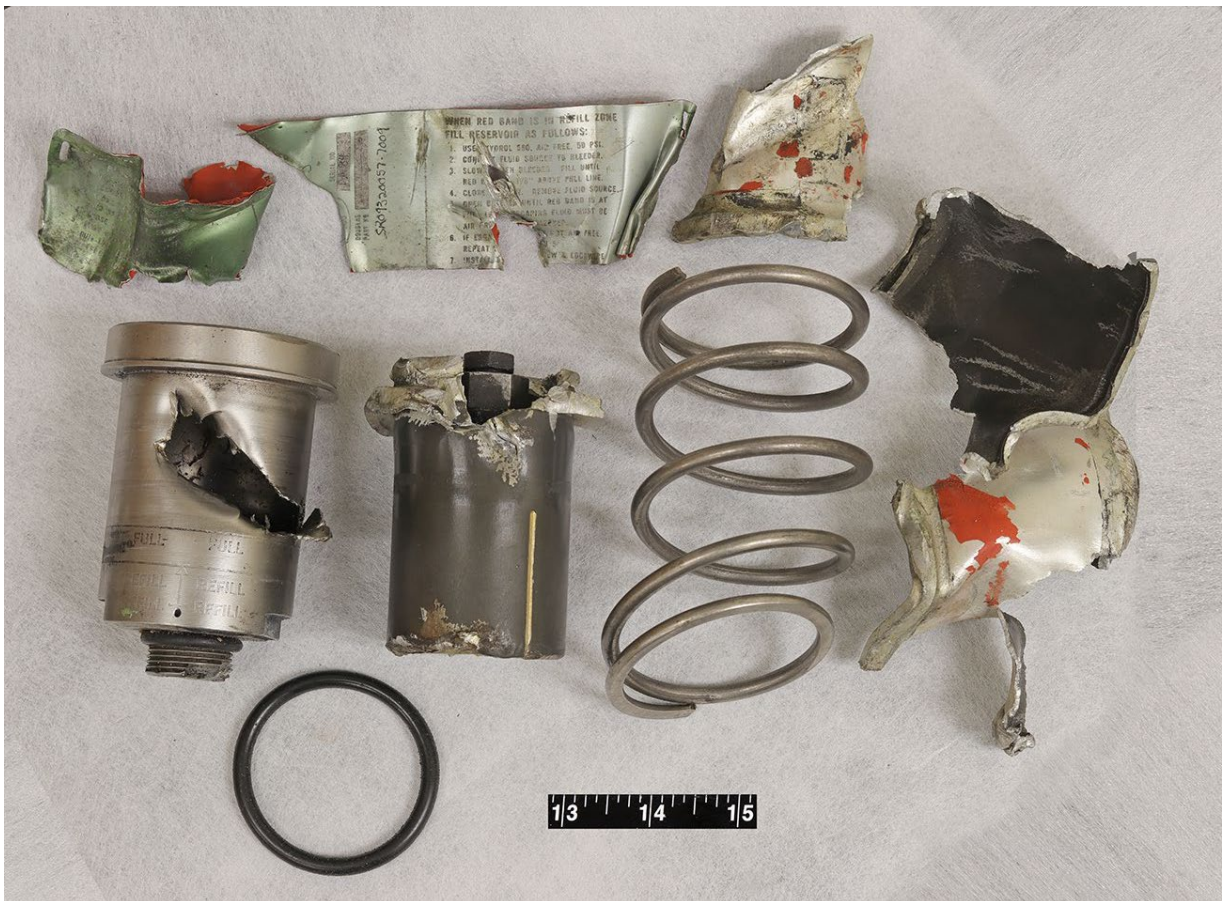
The left main landing gear shimmy damper hydraulic fluid reservoir became detached from the damper during the accident sequence. During a search of the runway area, pieces of the reservoir were found in the recently mowed grass area adjacent to the runway. The reservoir was in many pieces and appeared to have damage consistent with impact from mower blades as shown in Figure 10. The area where the reservoir is threaded into the damper housing had a large impact mark which deformed the area, and the threads were stripped.<sup>9</sup>

**Figure 10 Shimmy damper hydraulic reservoir pieces**

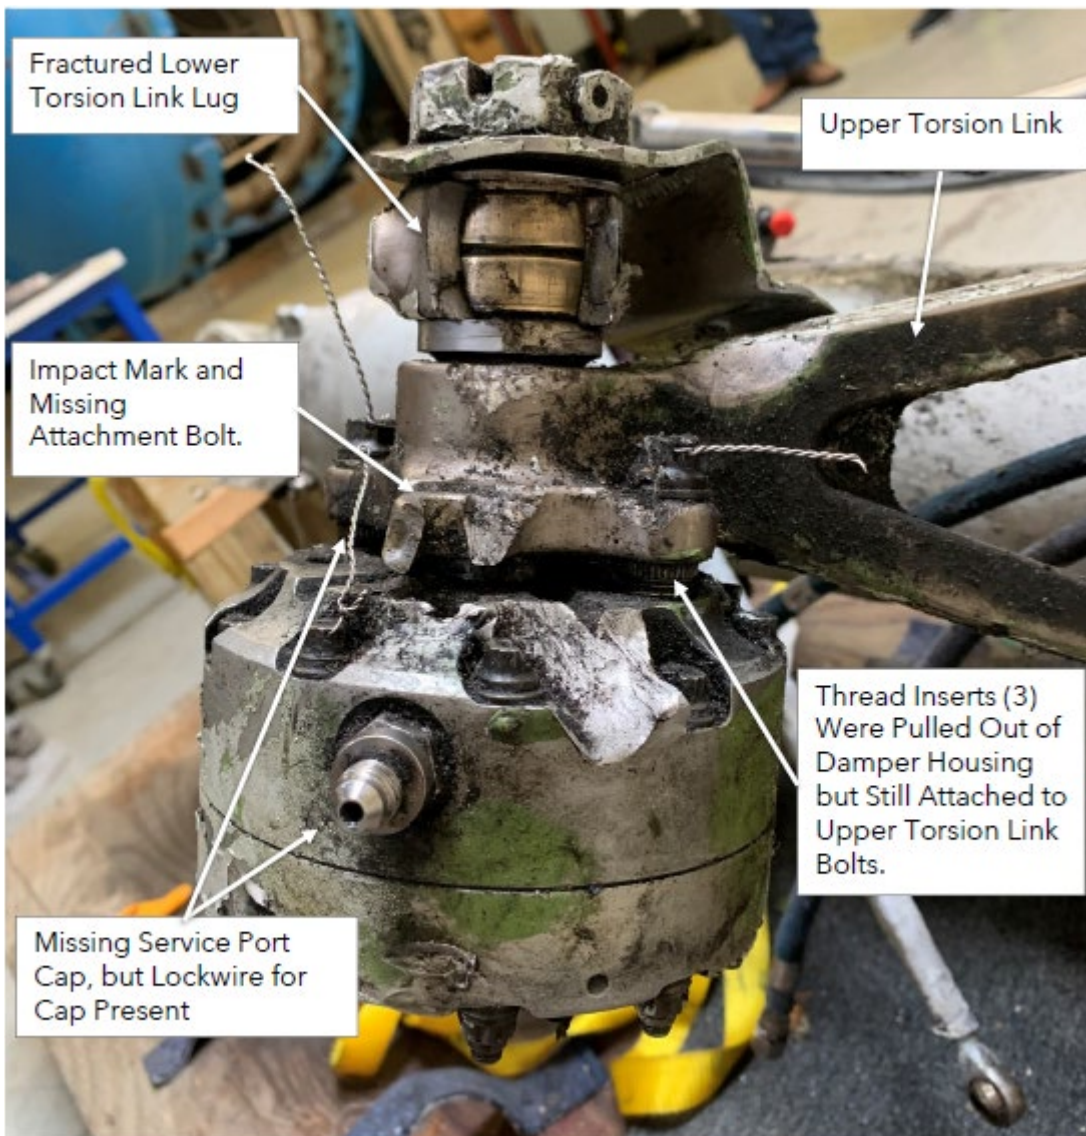
Figure 11 Shimmy Damper Examination<sup>18</sup>

The exterior of the shimmy damper housing showed several significant impact marks (Figure 11). The cap was noted to be missing from the servicing port, however the lockwire was still attached to the housing with an intact loop which would have been connected to the cap.

The shimmy damper housing was disassembled, and the apex bolt was found to be bent and had to be cut. The internal components of the shimmy damper were found to be installed properly and undamaged with the exception of one Belleville washer which was found fractured. The fracture in the washer was examined and found to be ductile separation. The fluid passages in the damper were checked and confirmed to be unblocked.

In general, the internal components of the shimmy damper were found to be properly installed. No damage or defects were discovered which would have negatively impacted the shimmy damper's performance.
