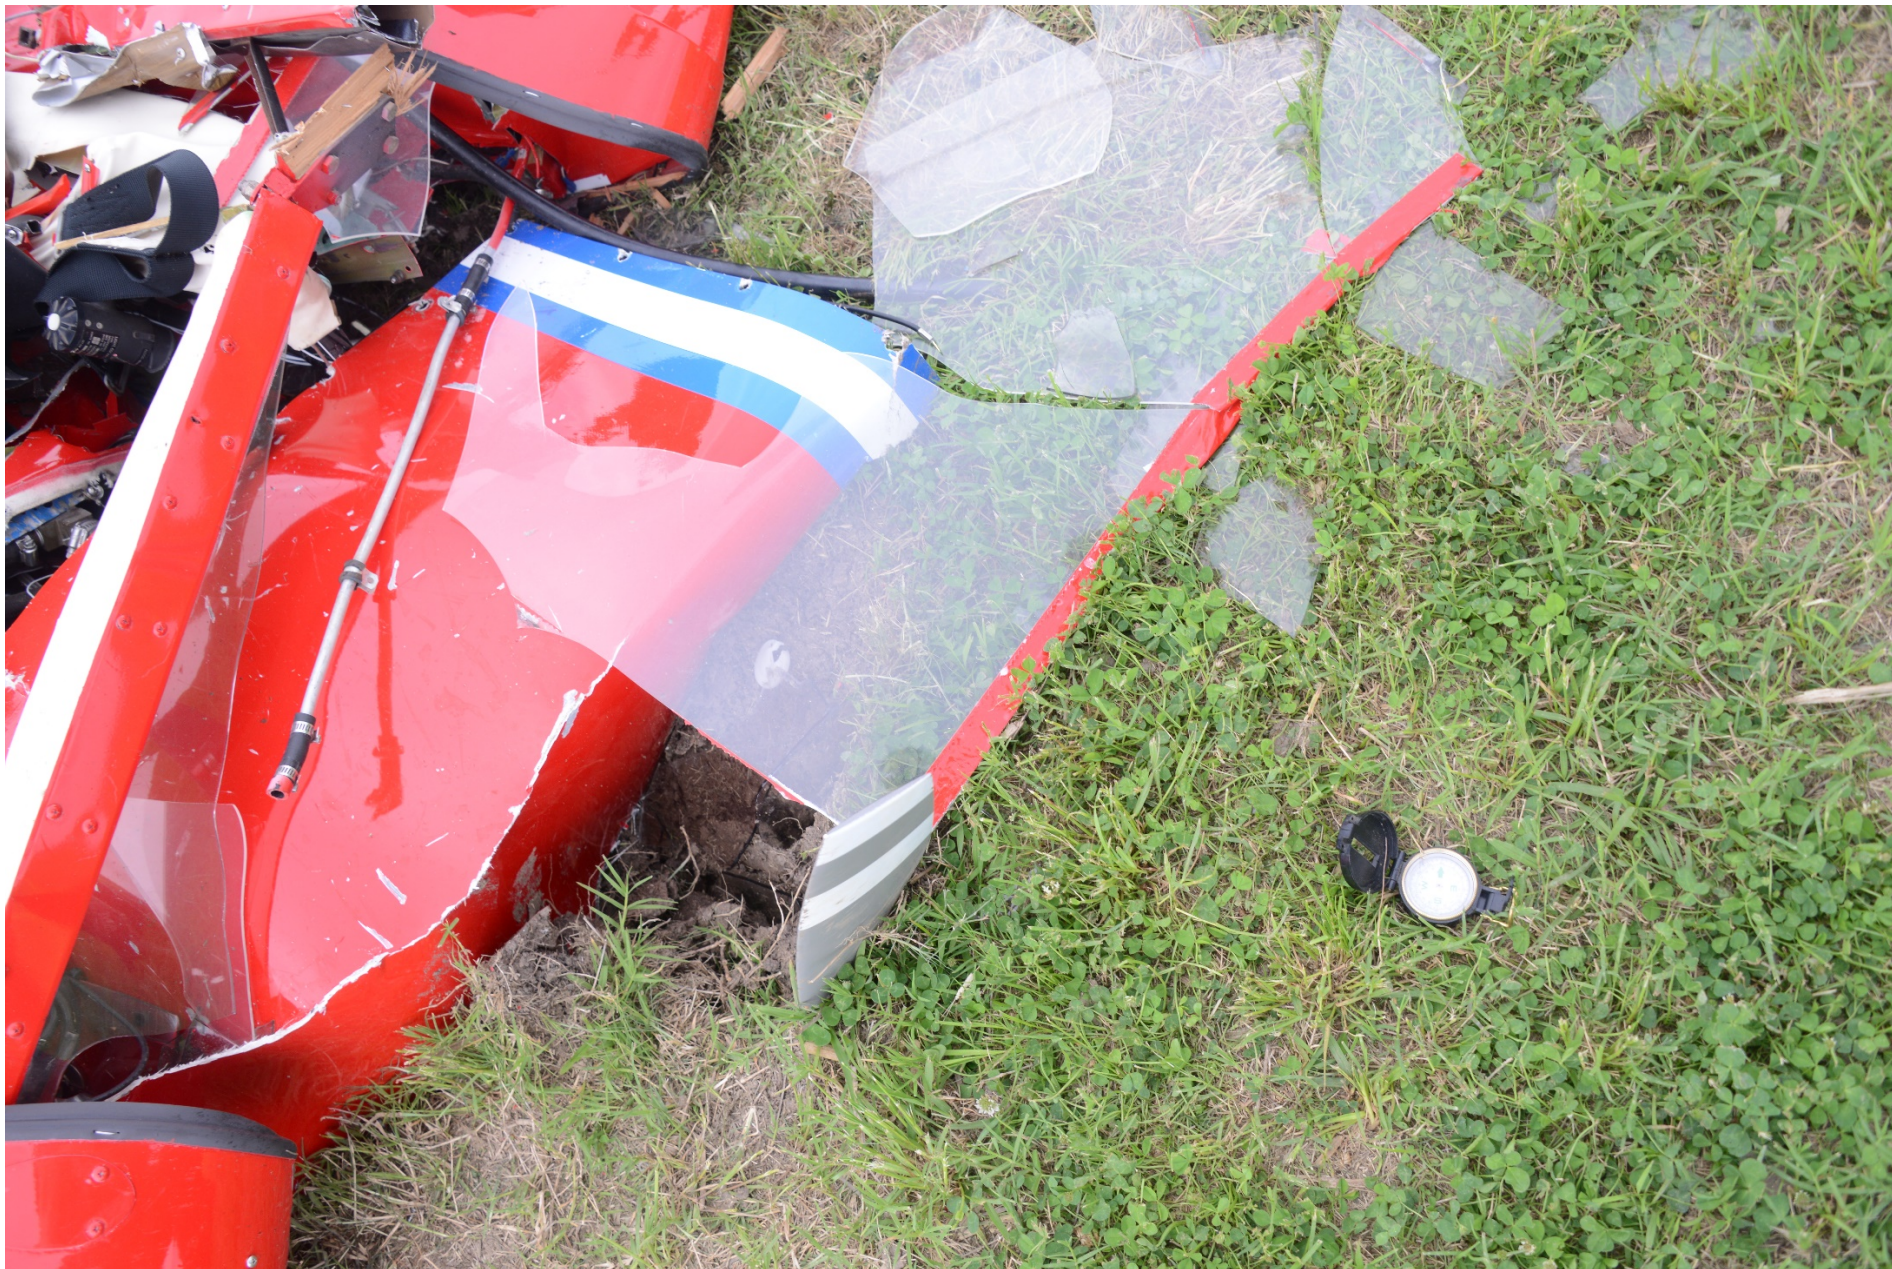
**Photo 1 – View of the airplane nose impacted in terrain and a section of exposed propeller blade.**

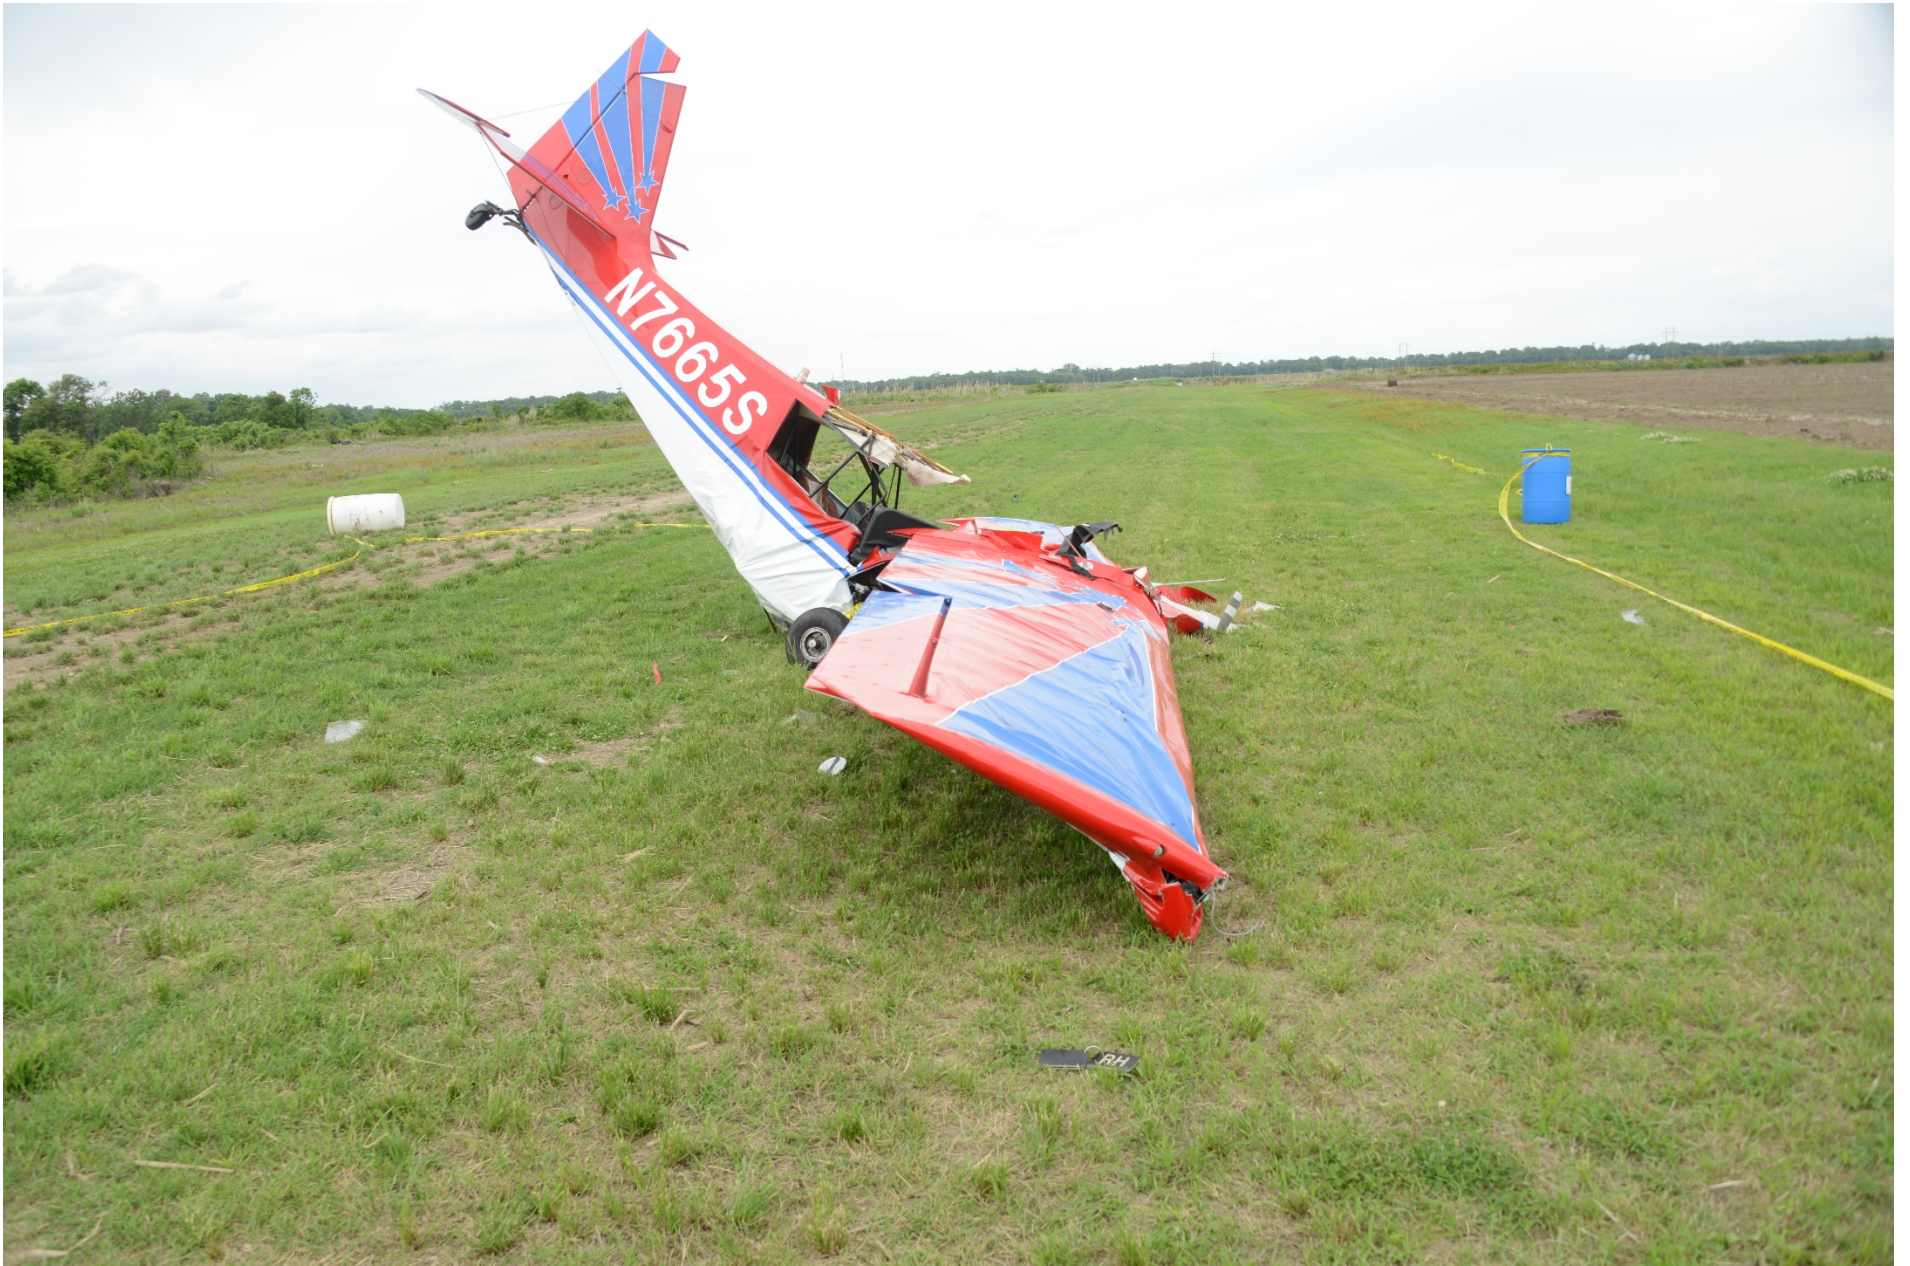
**Photo 2 - View of the right side of the airplane.**

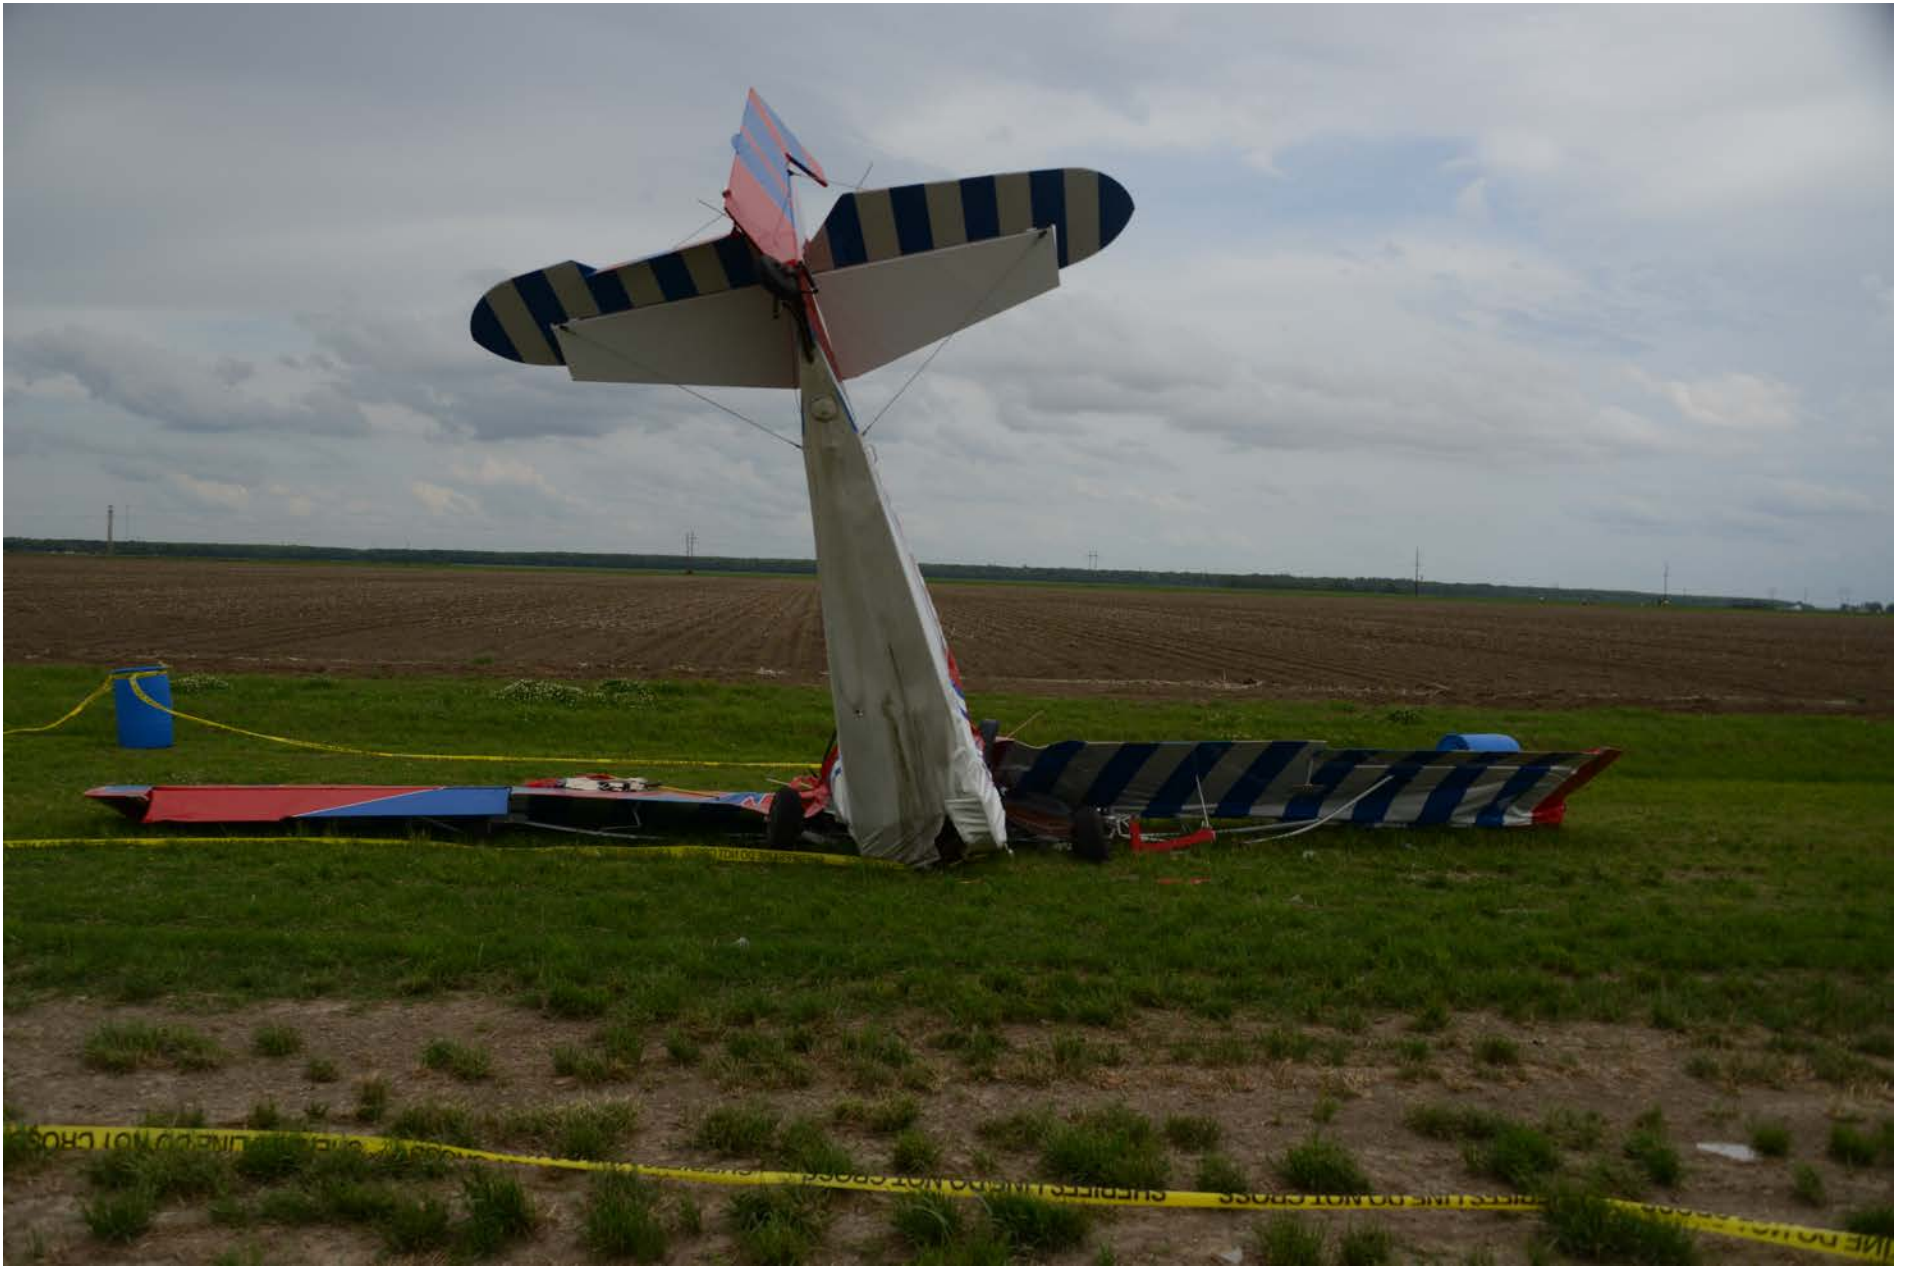
**Photo 3 - View of the aft side of the airplane.**

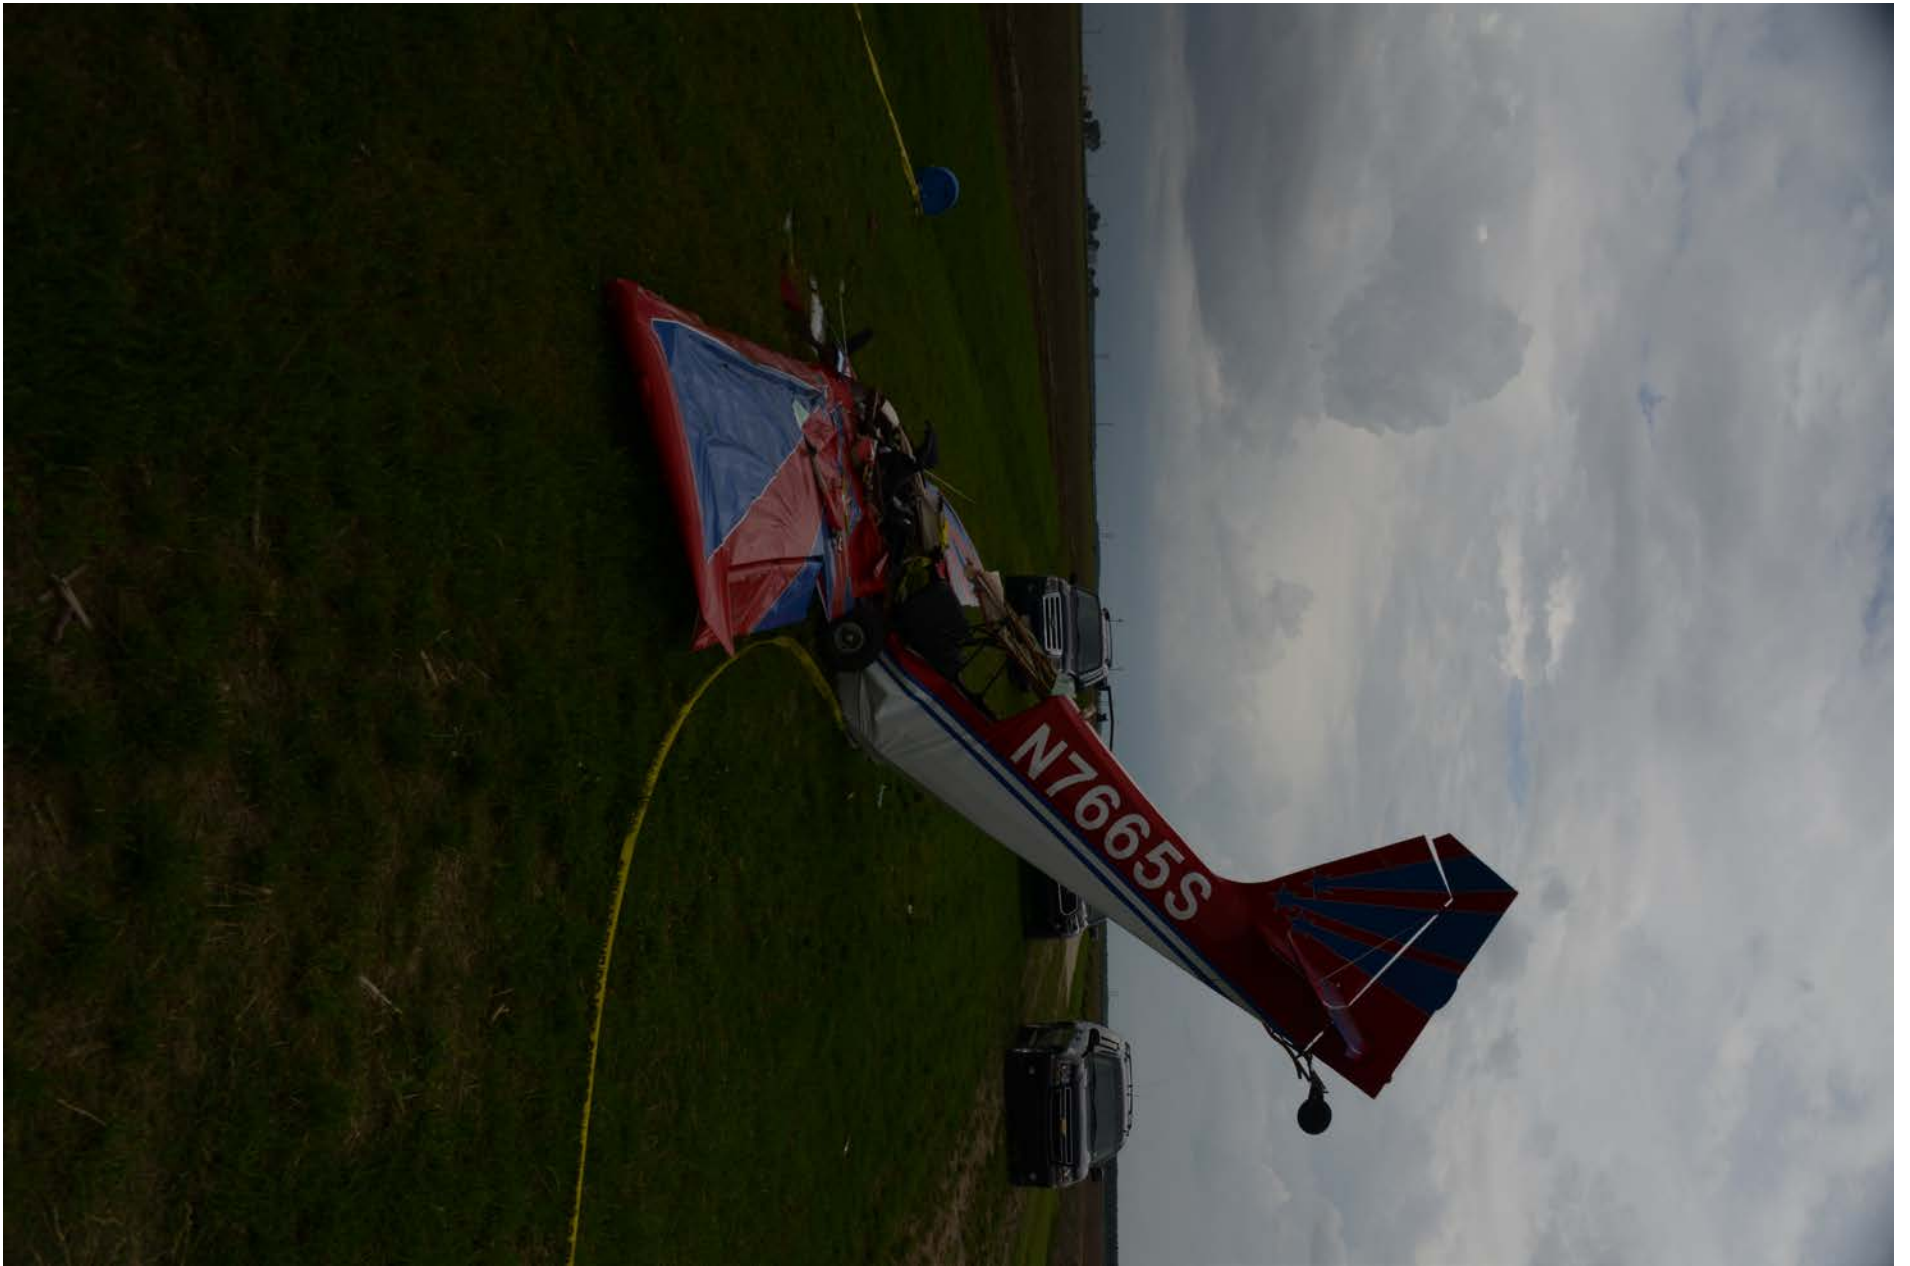
**Photo 4 - View of the left side of the airplane.**

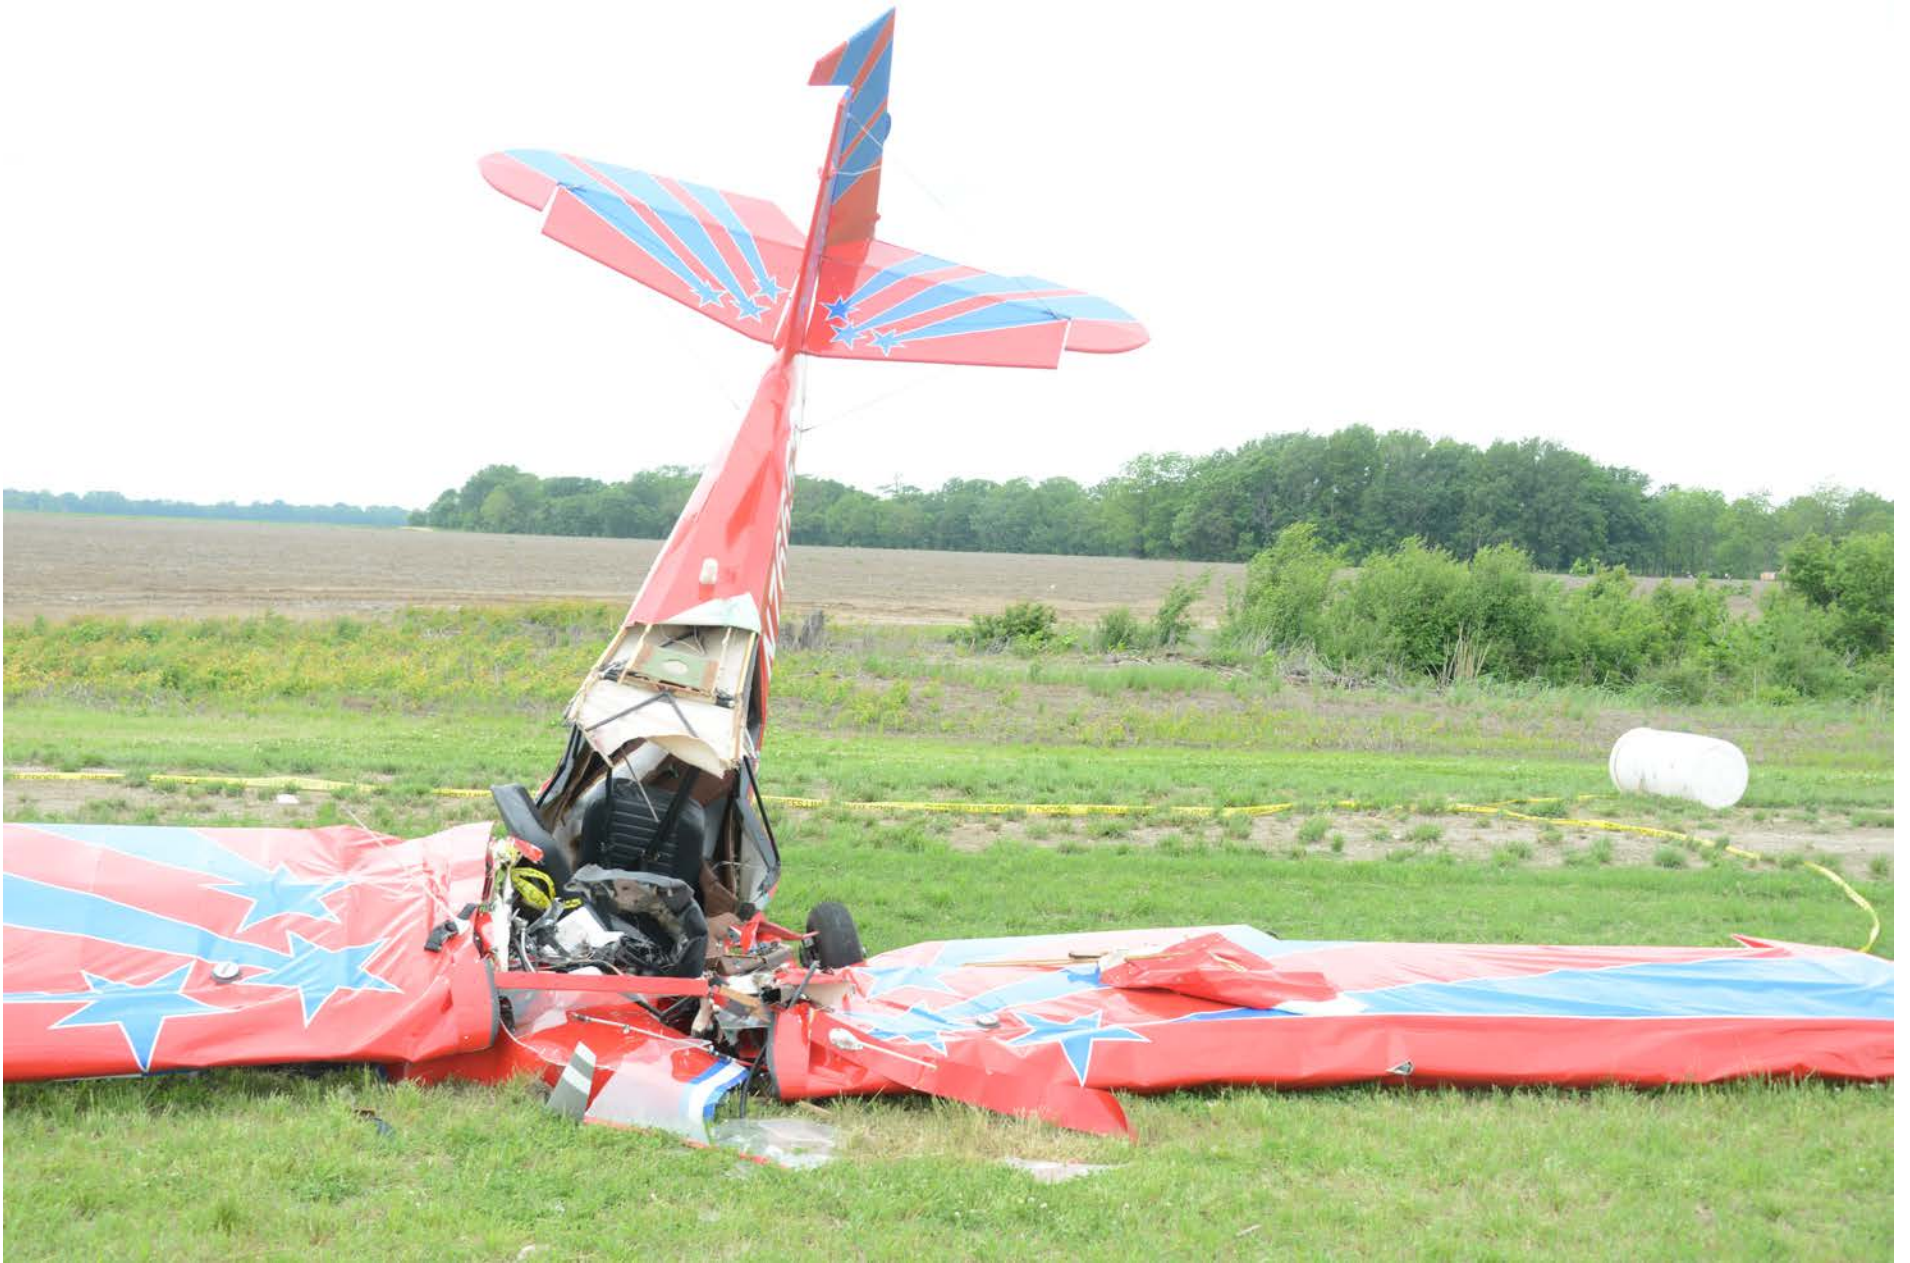
**Photo 5 - View of the front side of the airplane.**

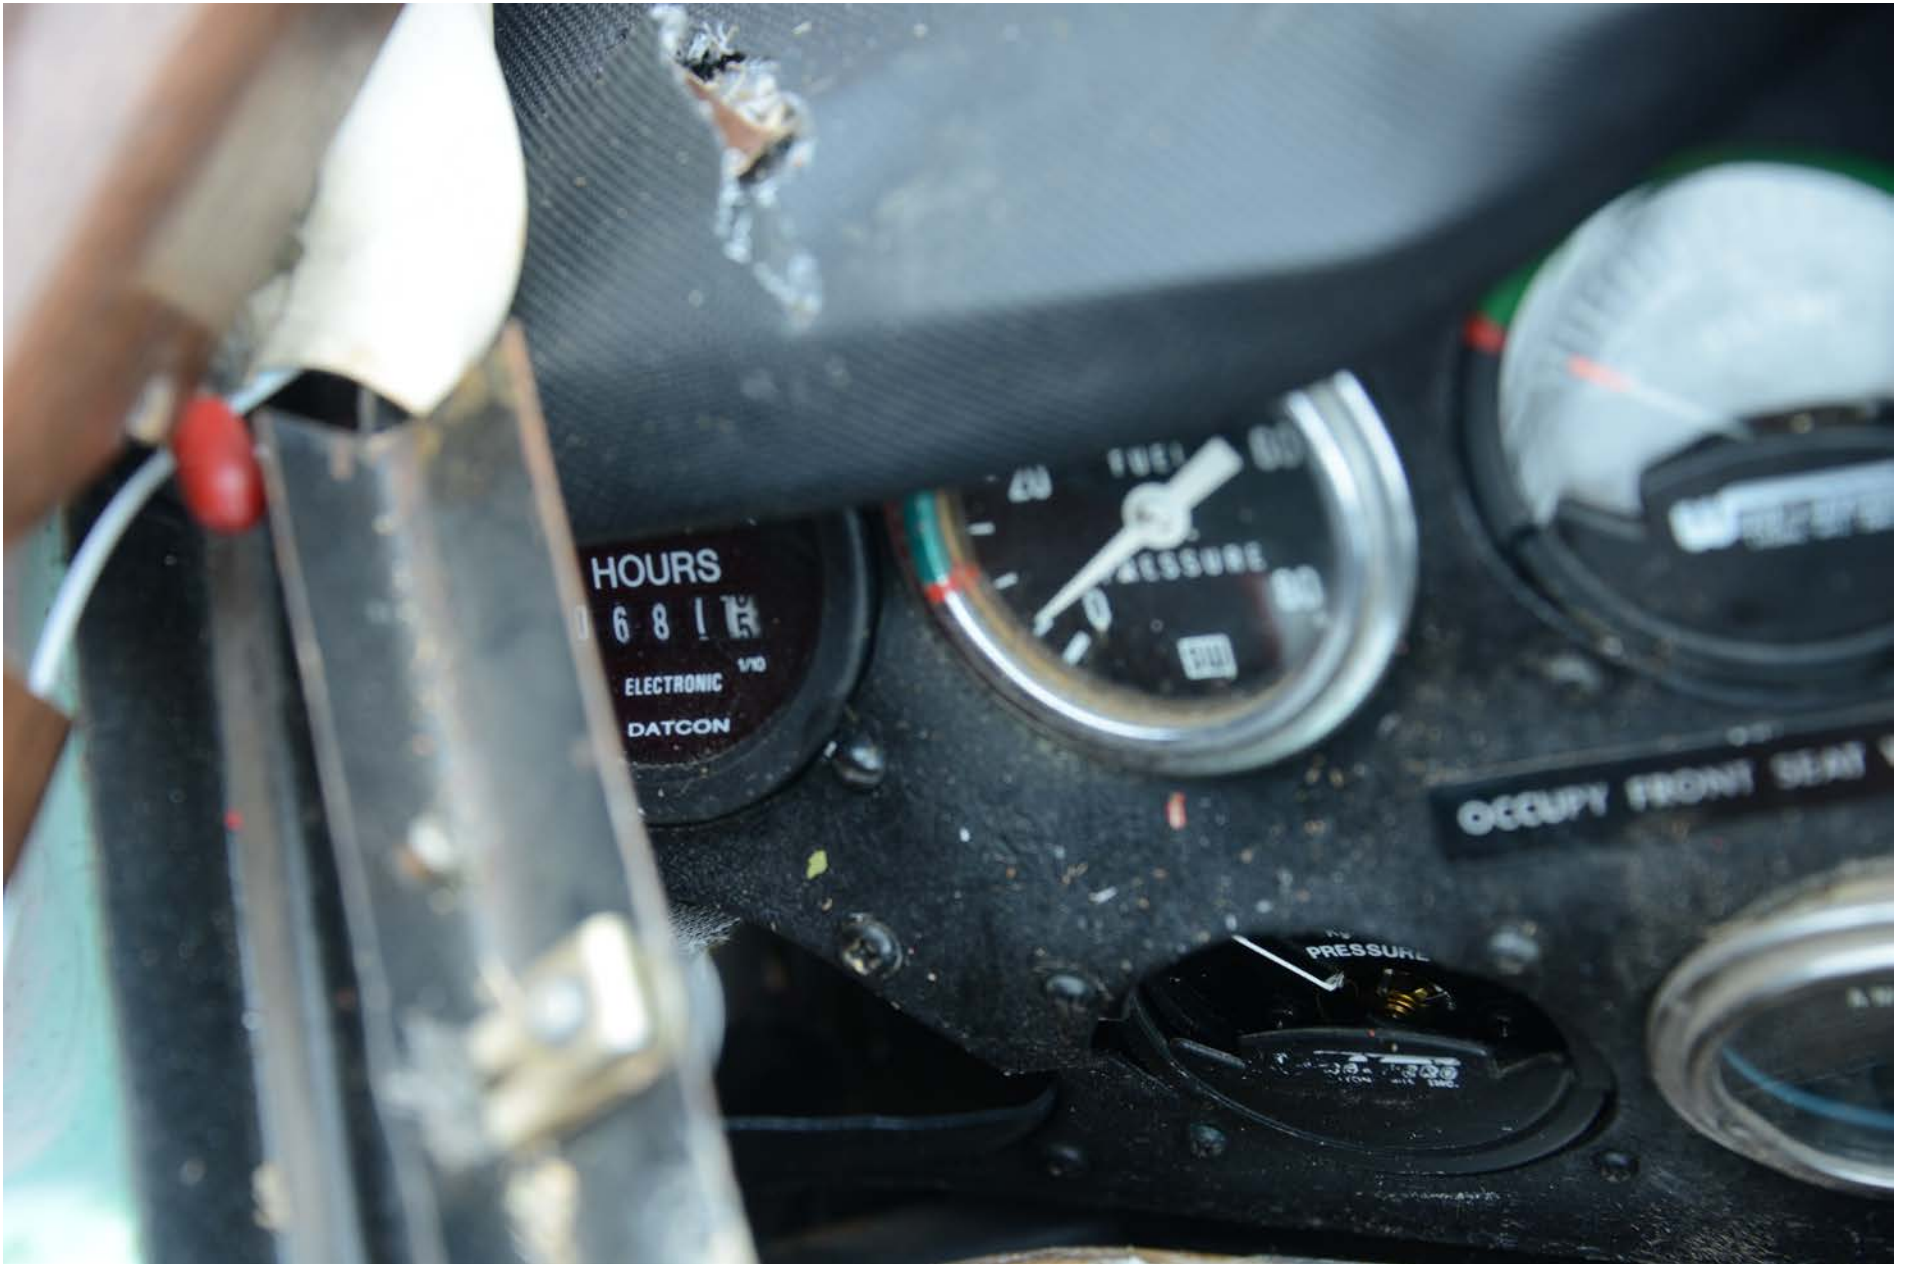
**Photo 6 - View of the cockpit instruments to include an hour meter indicating 0681.5 hours.**

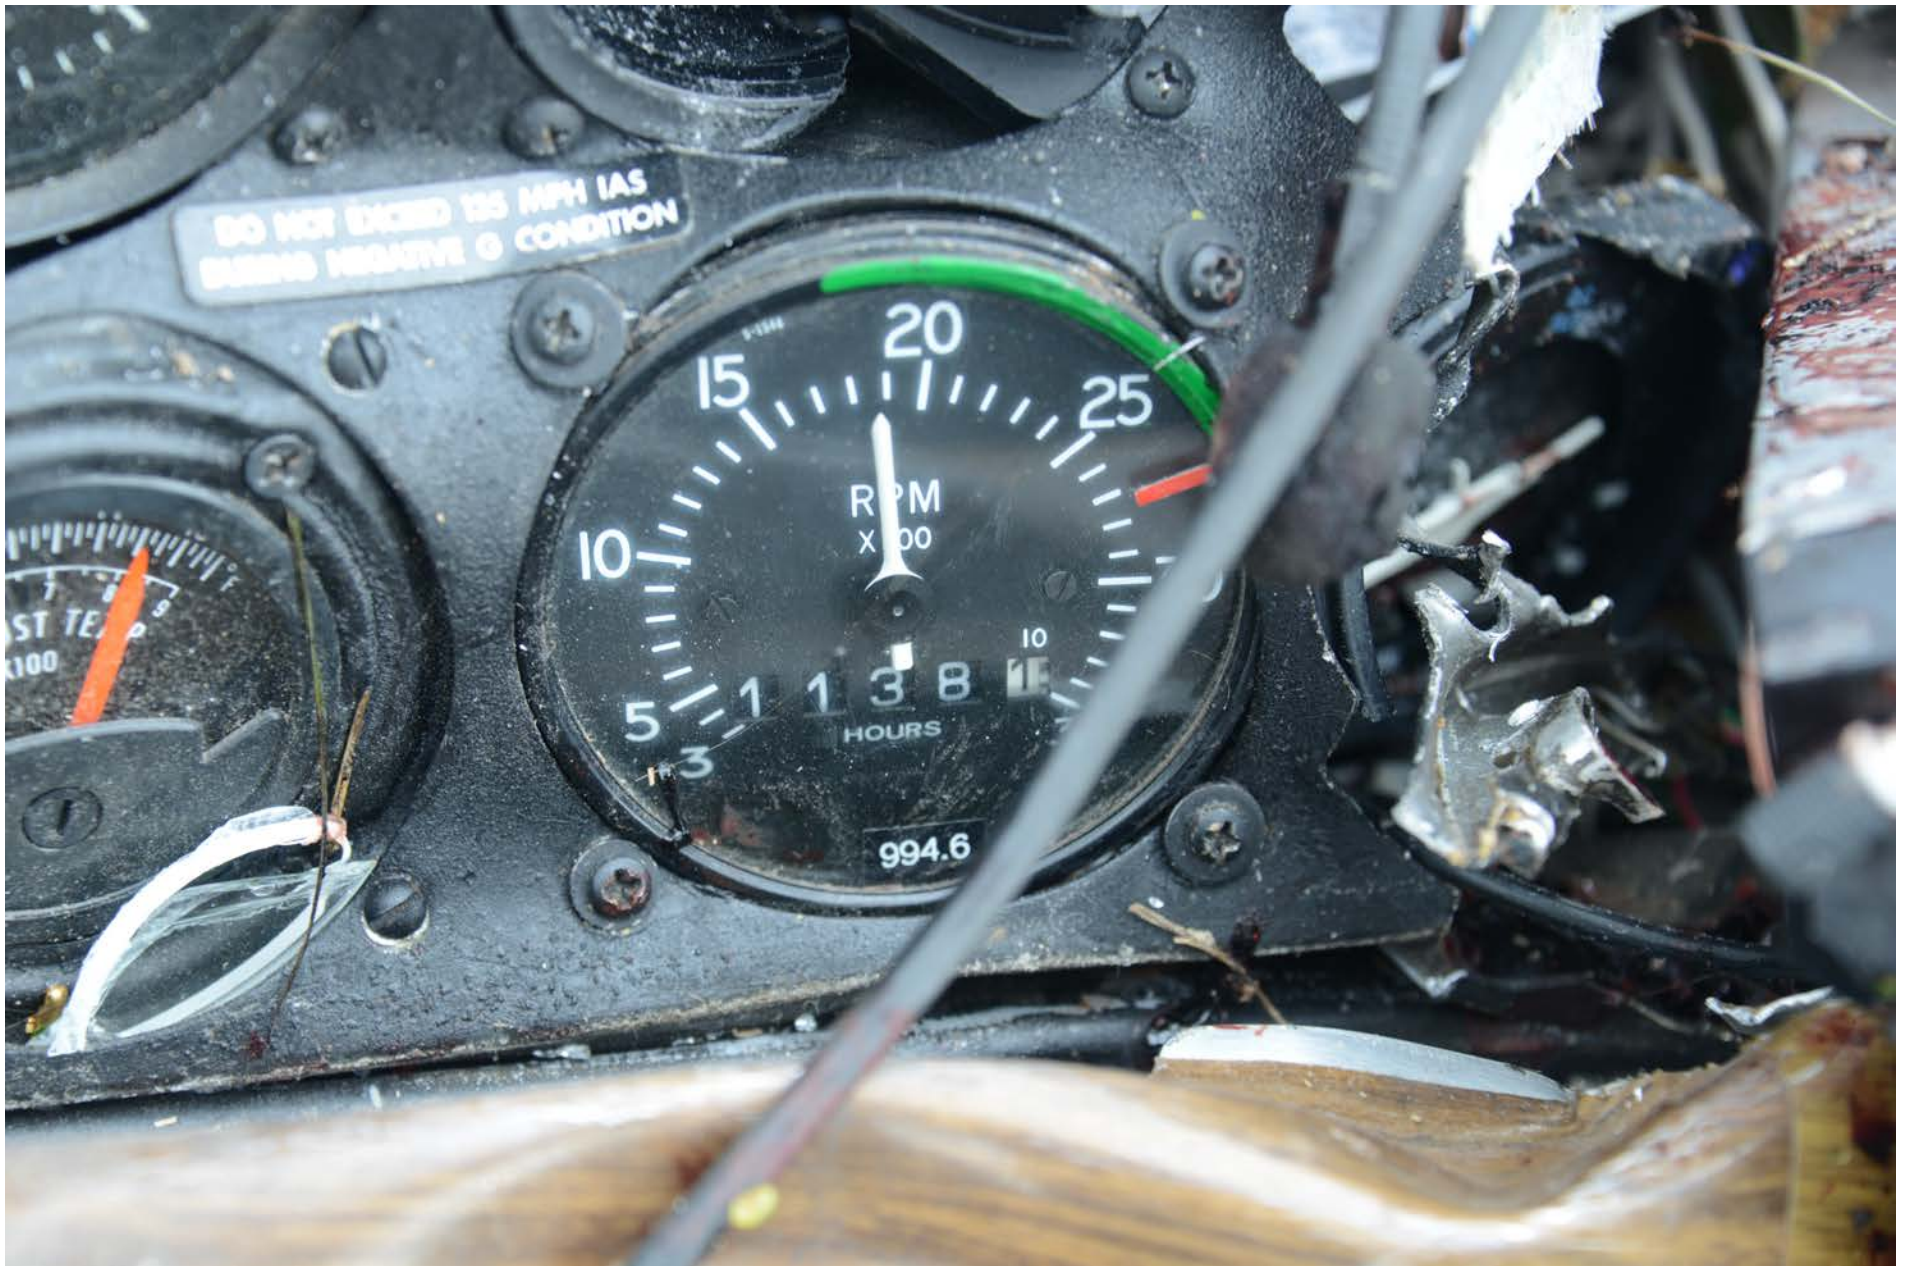
**Photo 7 - View of the cockpit instruments to include a tachometer indicating about 1,875 RPM and 1138.1 hours.**

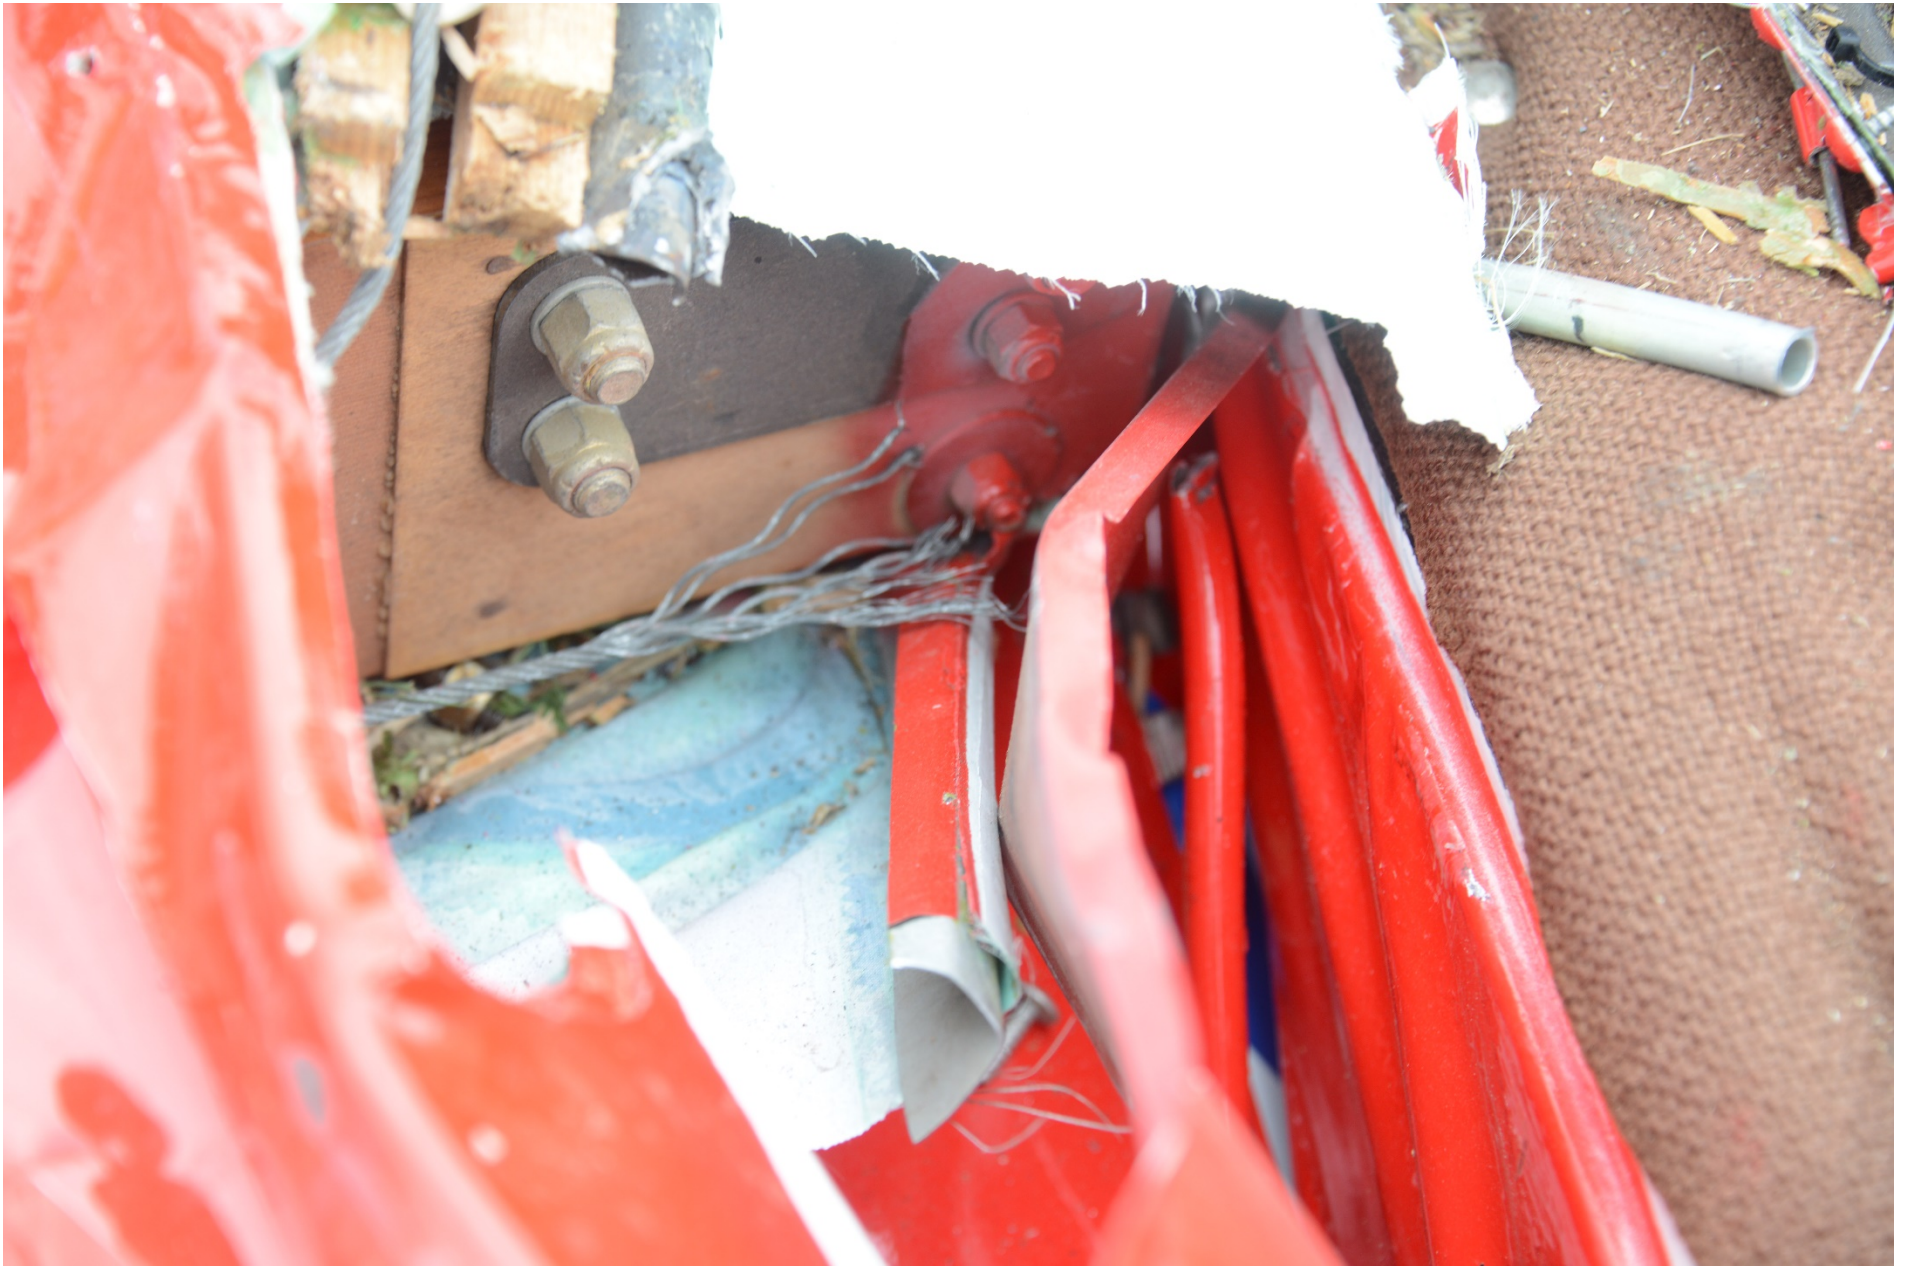
**Photo 8 - View of a separated flight control cable exhibiting a broomstraw appearance.**

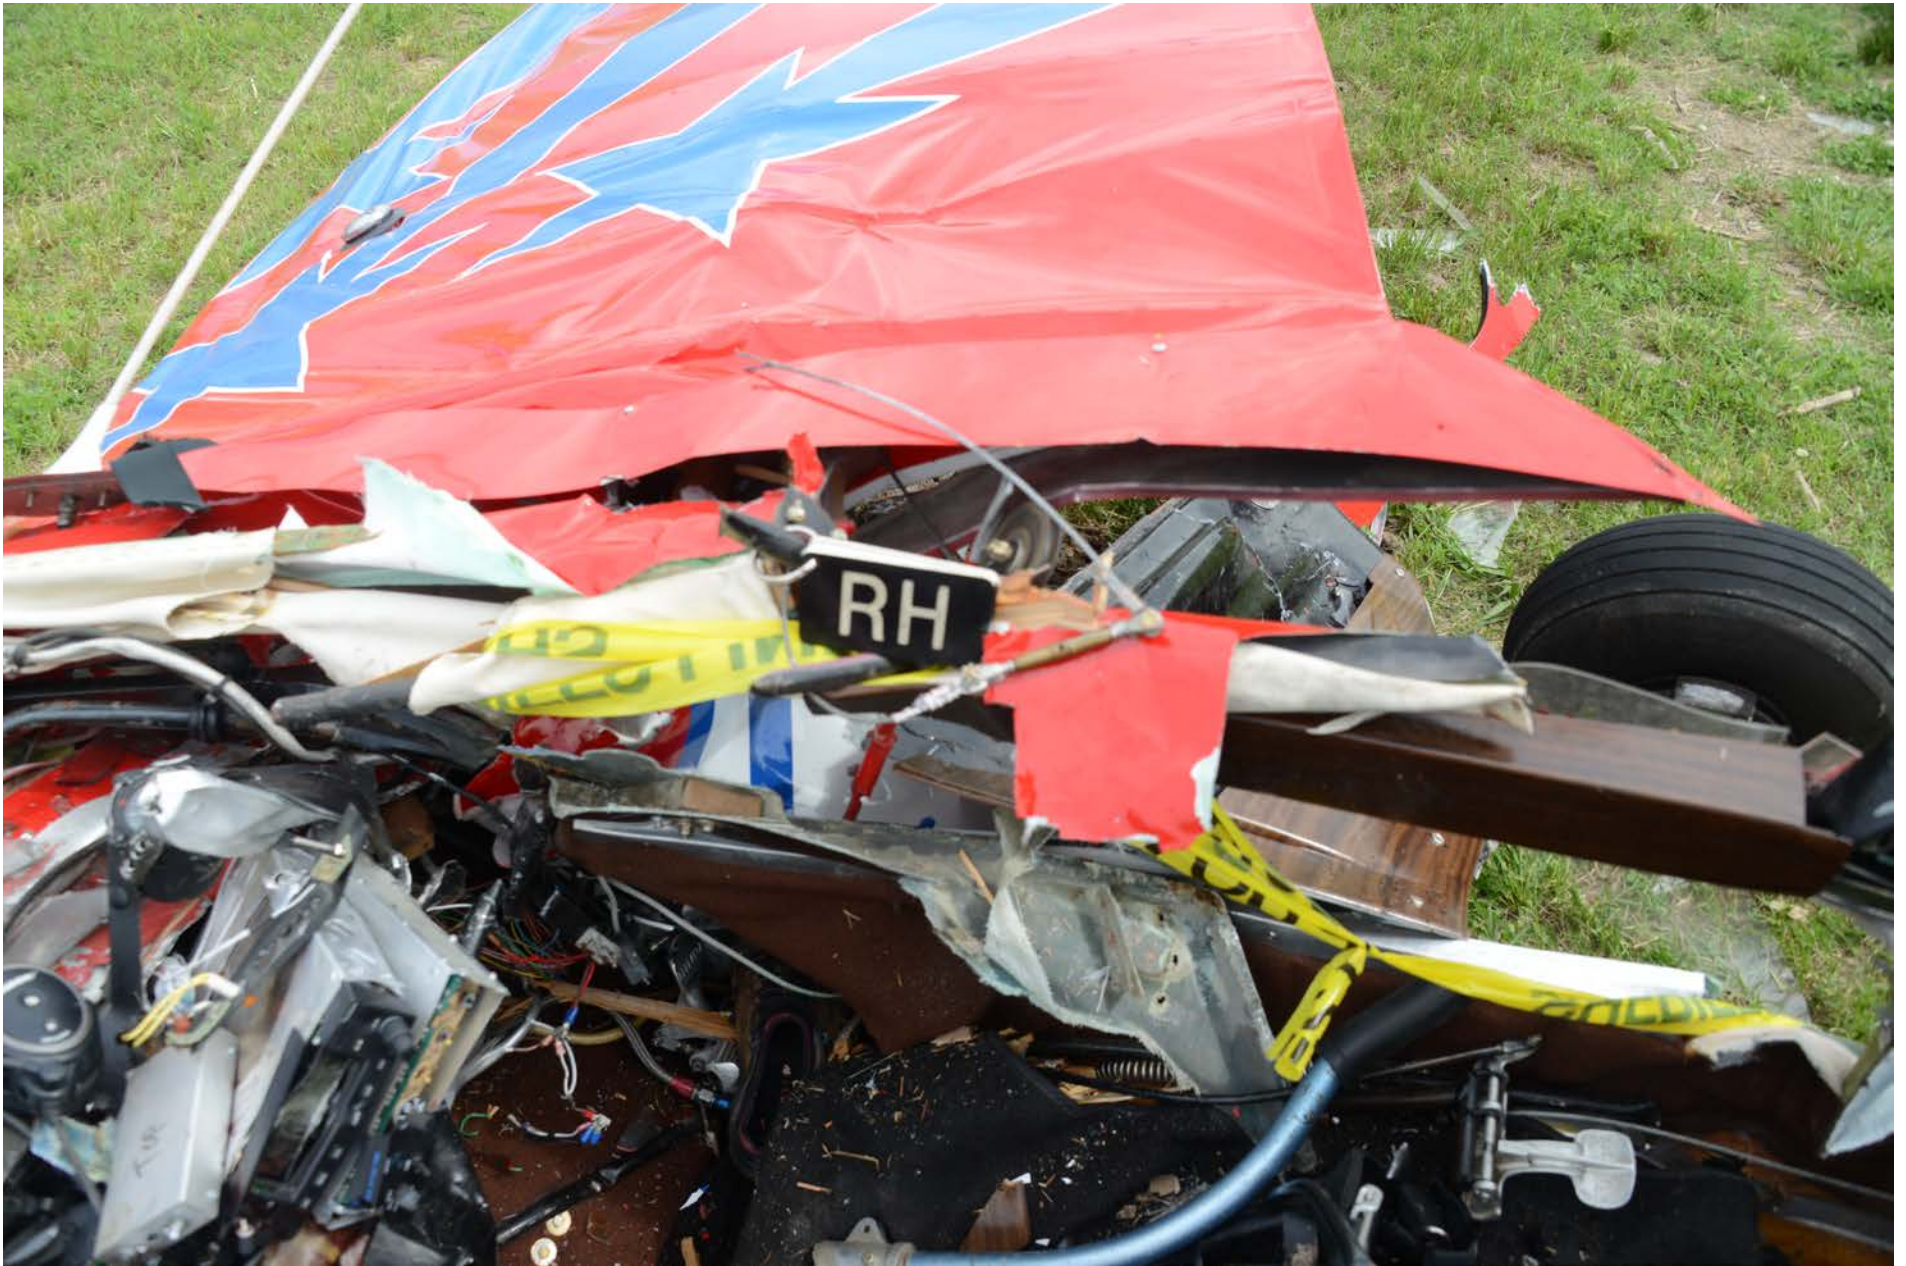
**Photo 9 - View of a separated flight control cable exhibiting a broomstraw appearance.**
