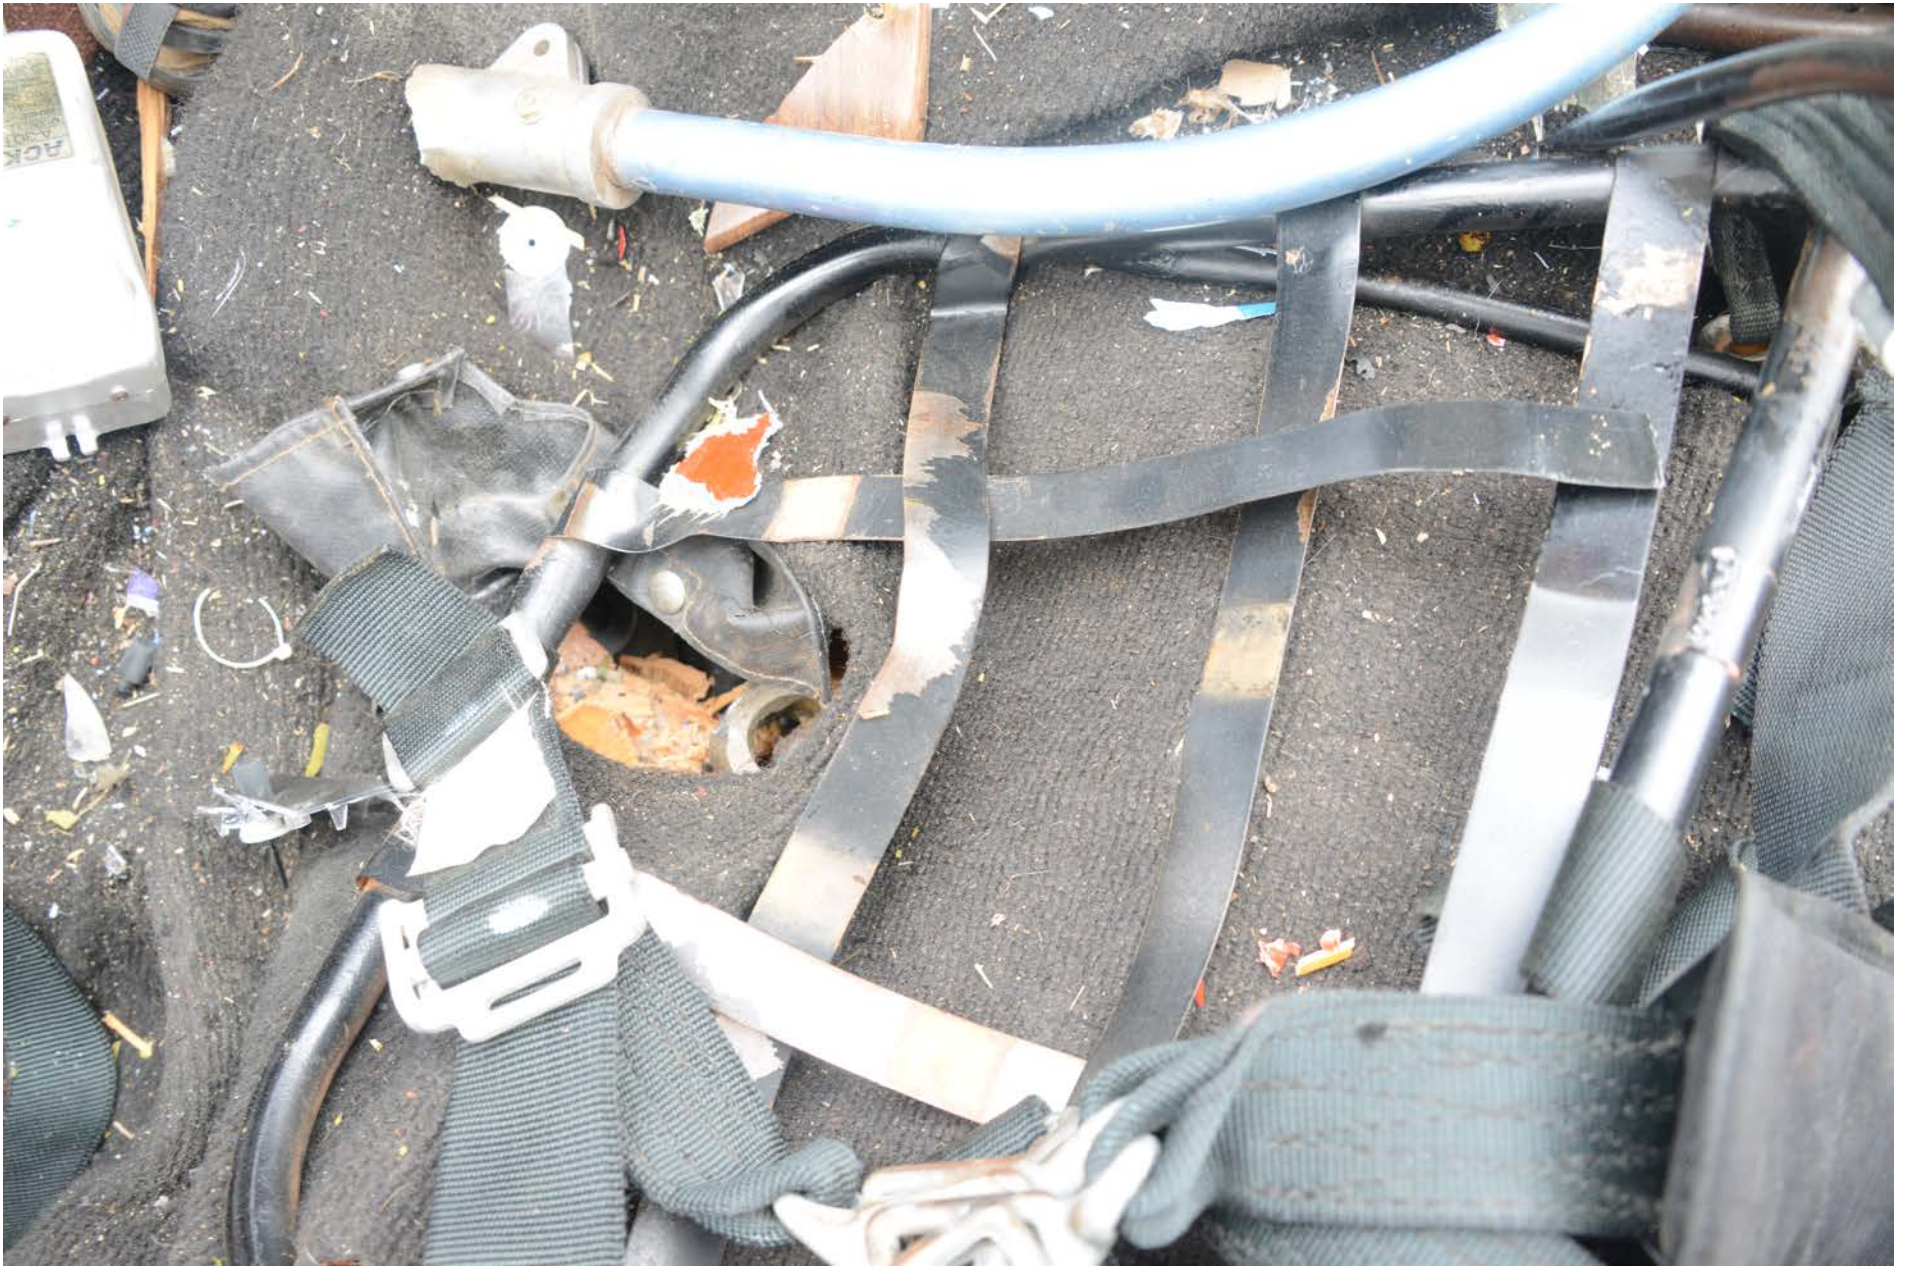
**Photo 10 - View of the front control stick and an attached section of its stick socket as found separated from its stick socket assembly.**

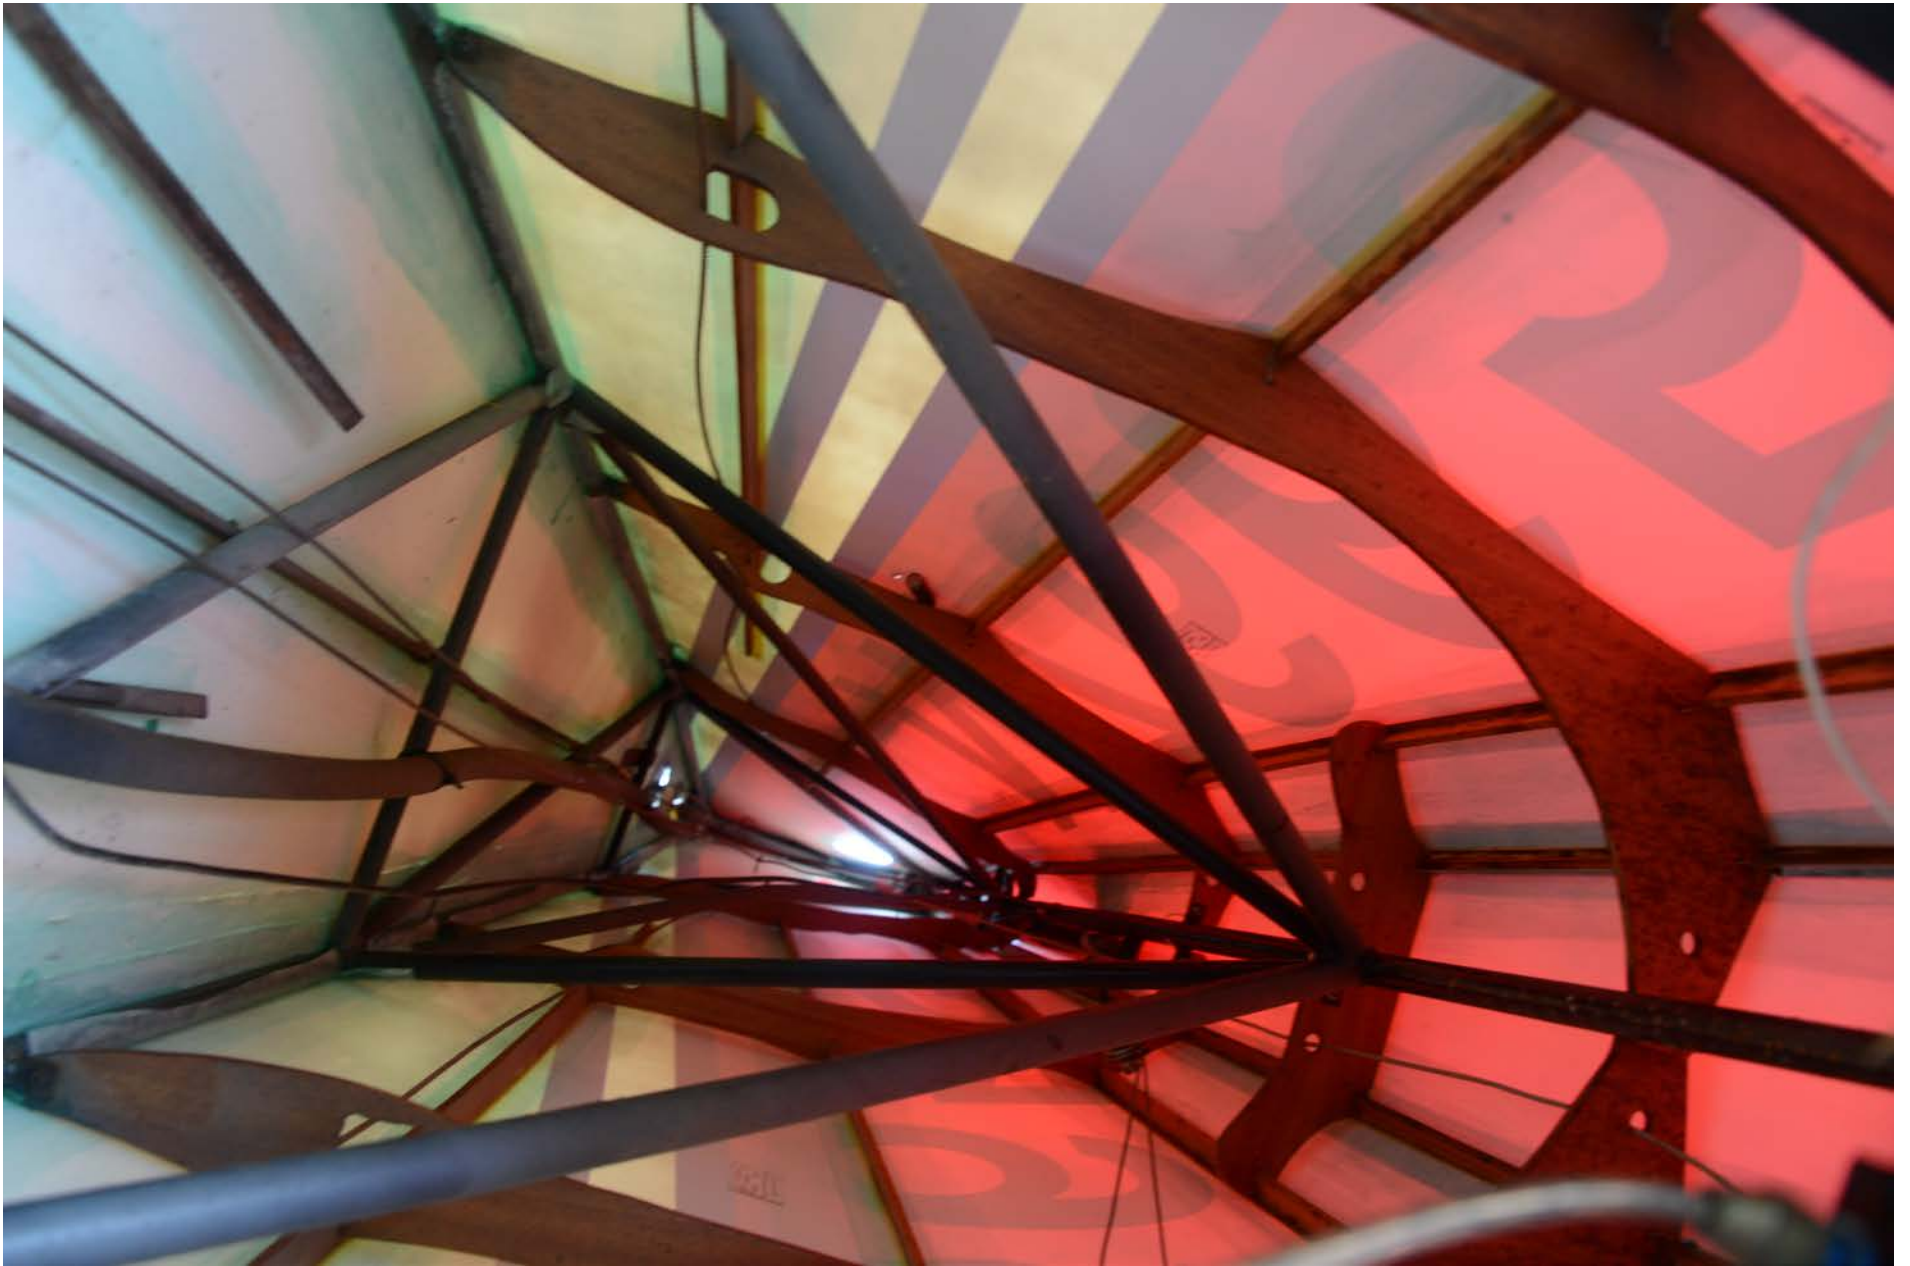
**Photo 11 - View inside the fuselage.**

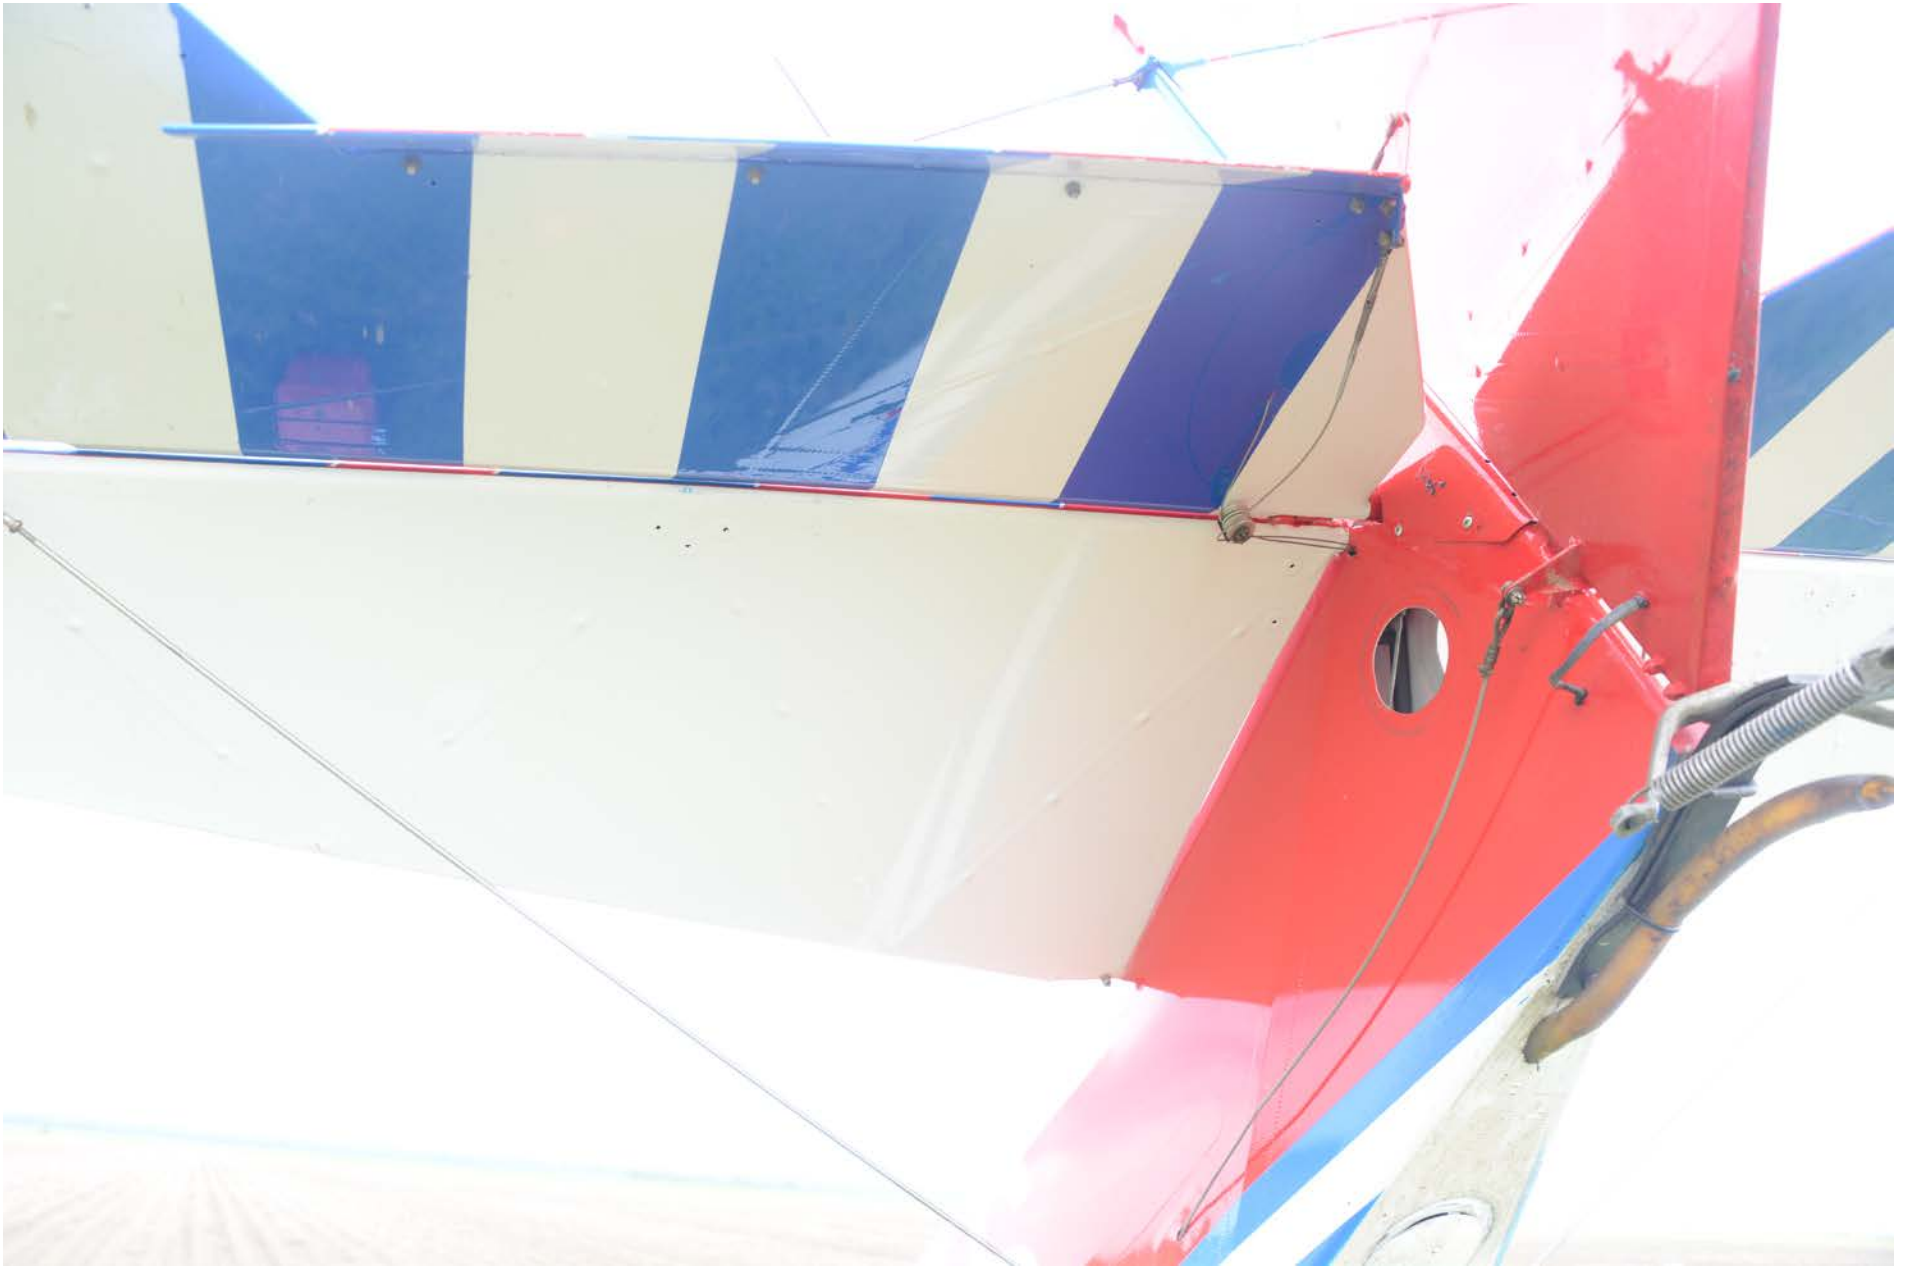
**Photo 12 - View of the left lower side of the empennage.**

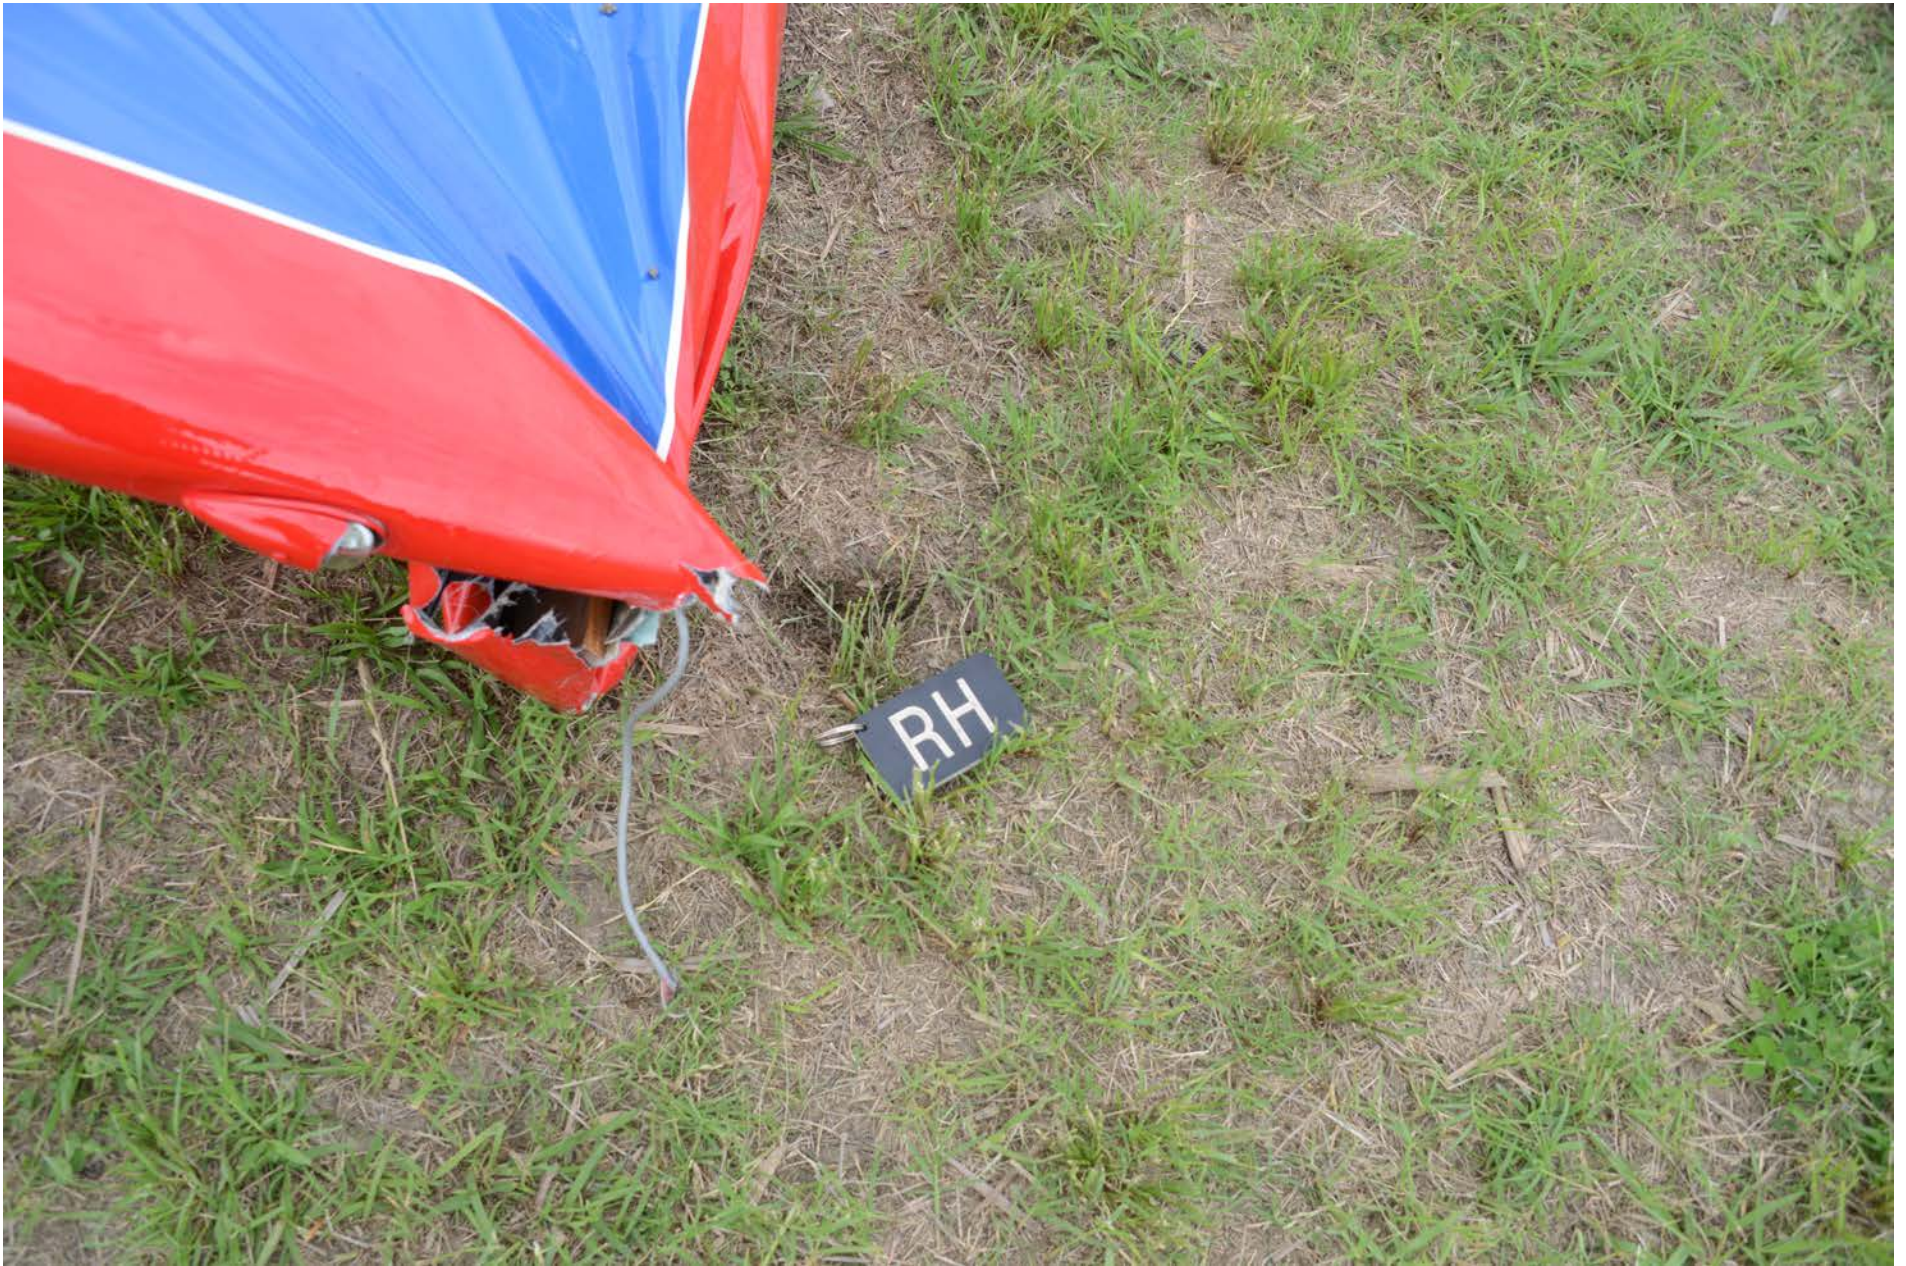
**Photo 13 - View of the right wing tip and witness mark in the ground.**

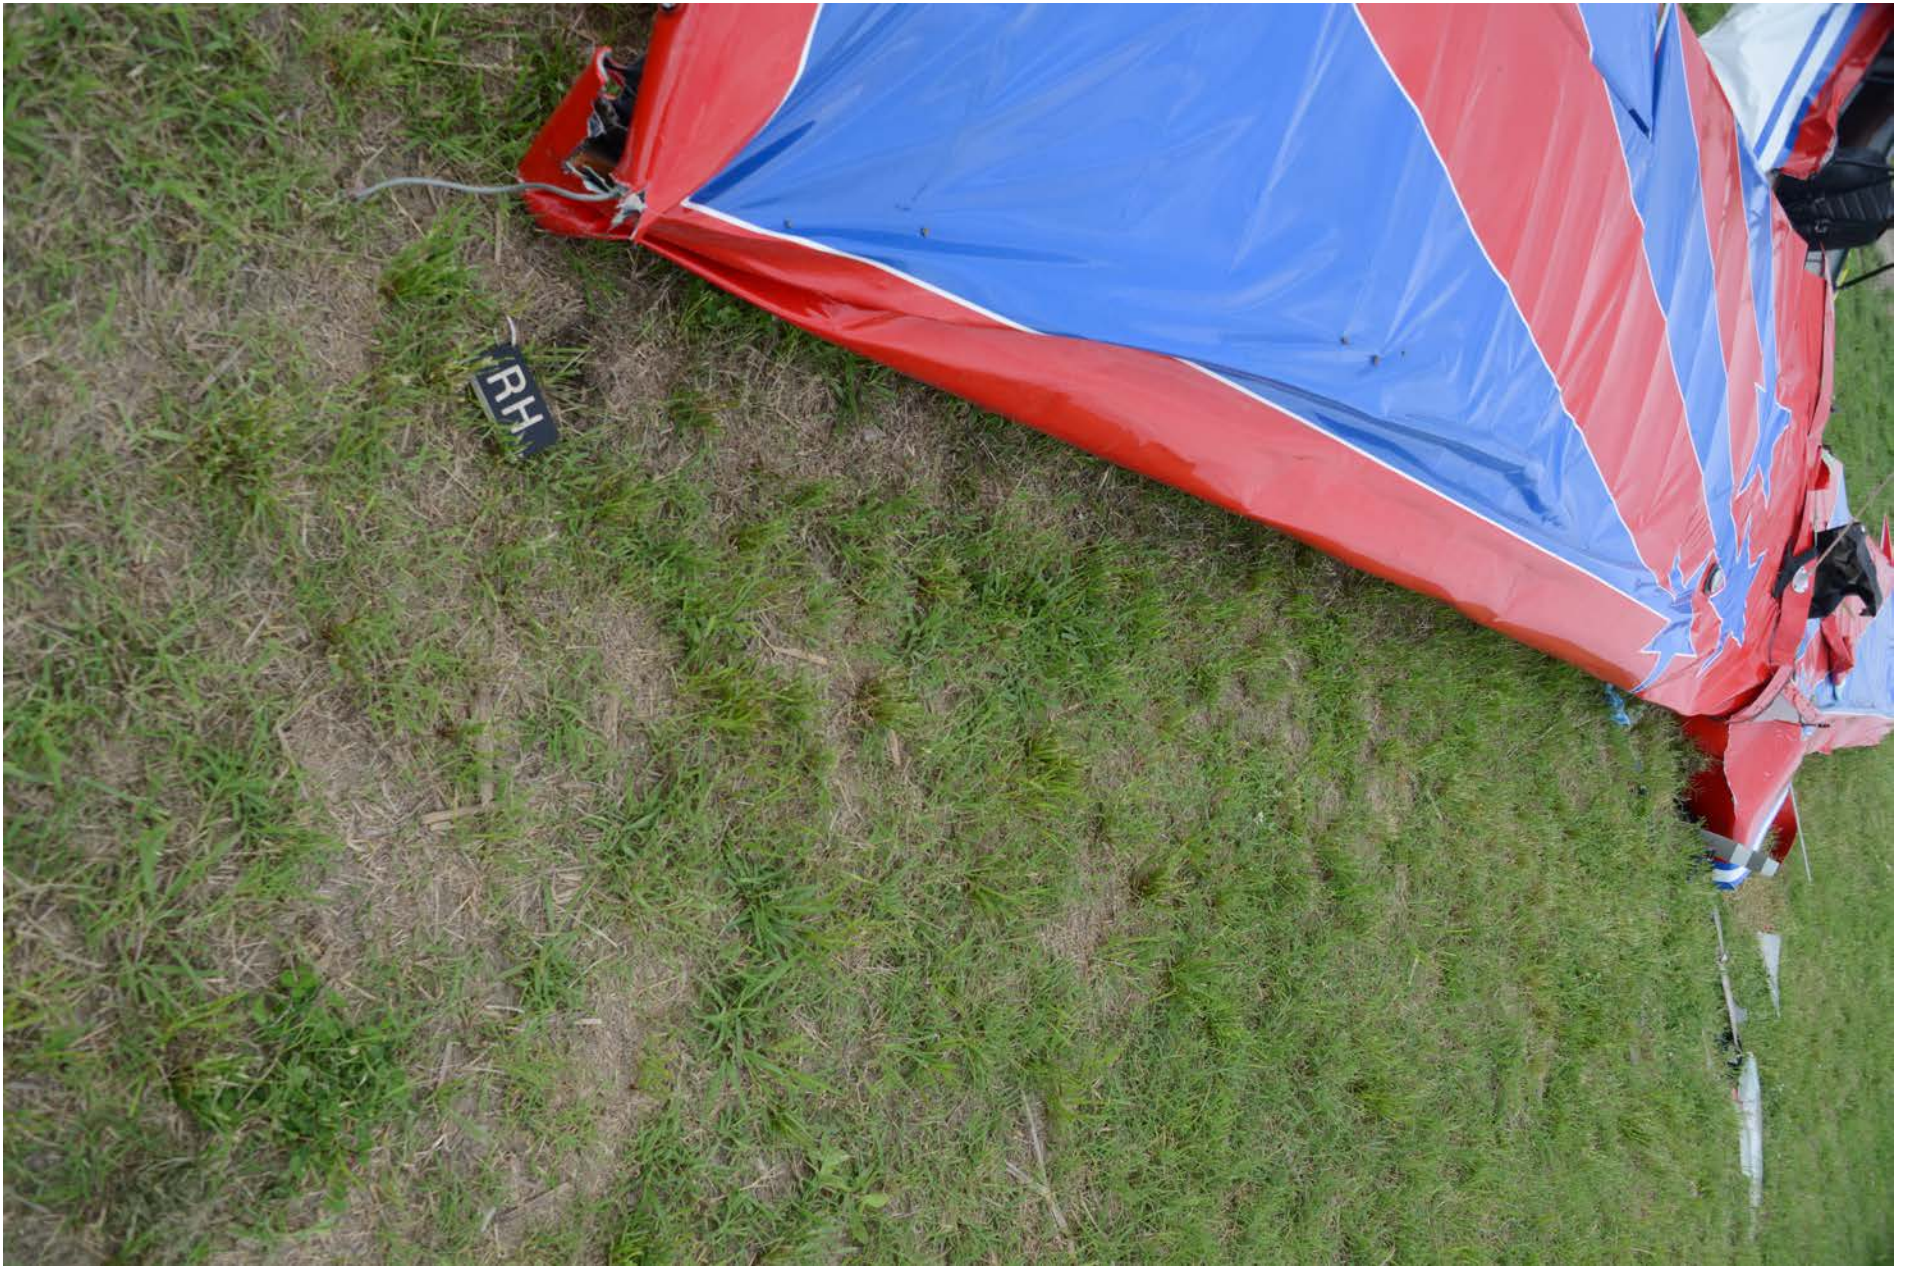
**Photo 14 - View of the right wing and witness marks in the ground.**

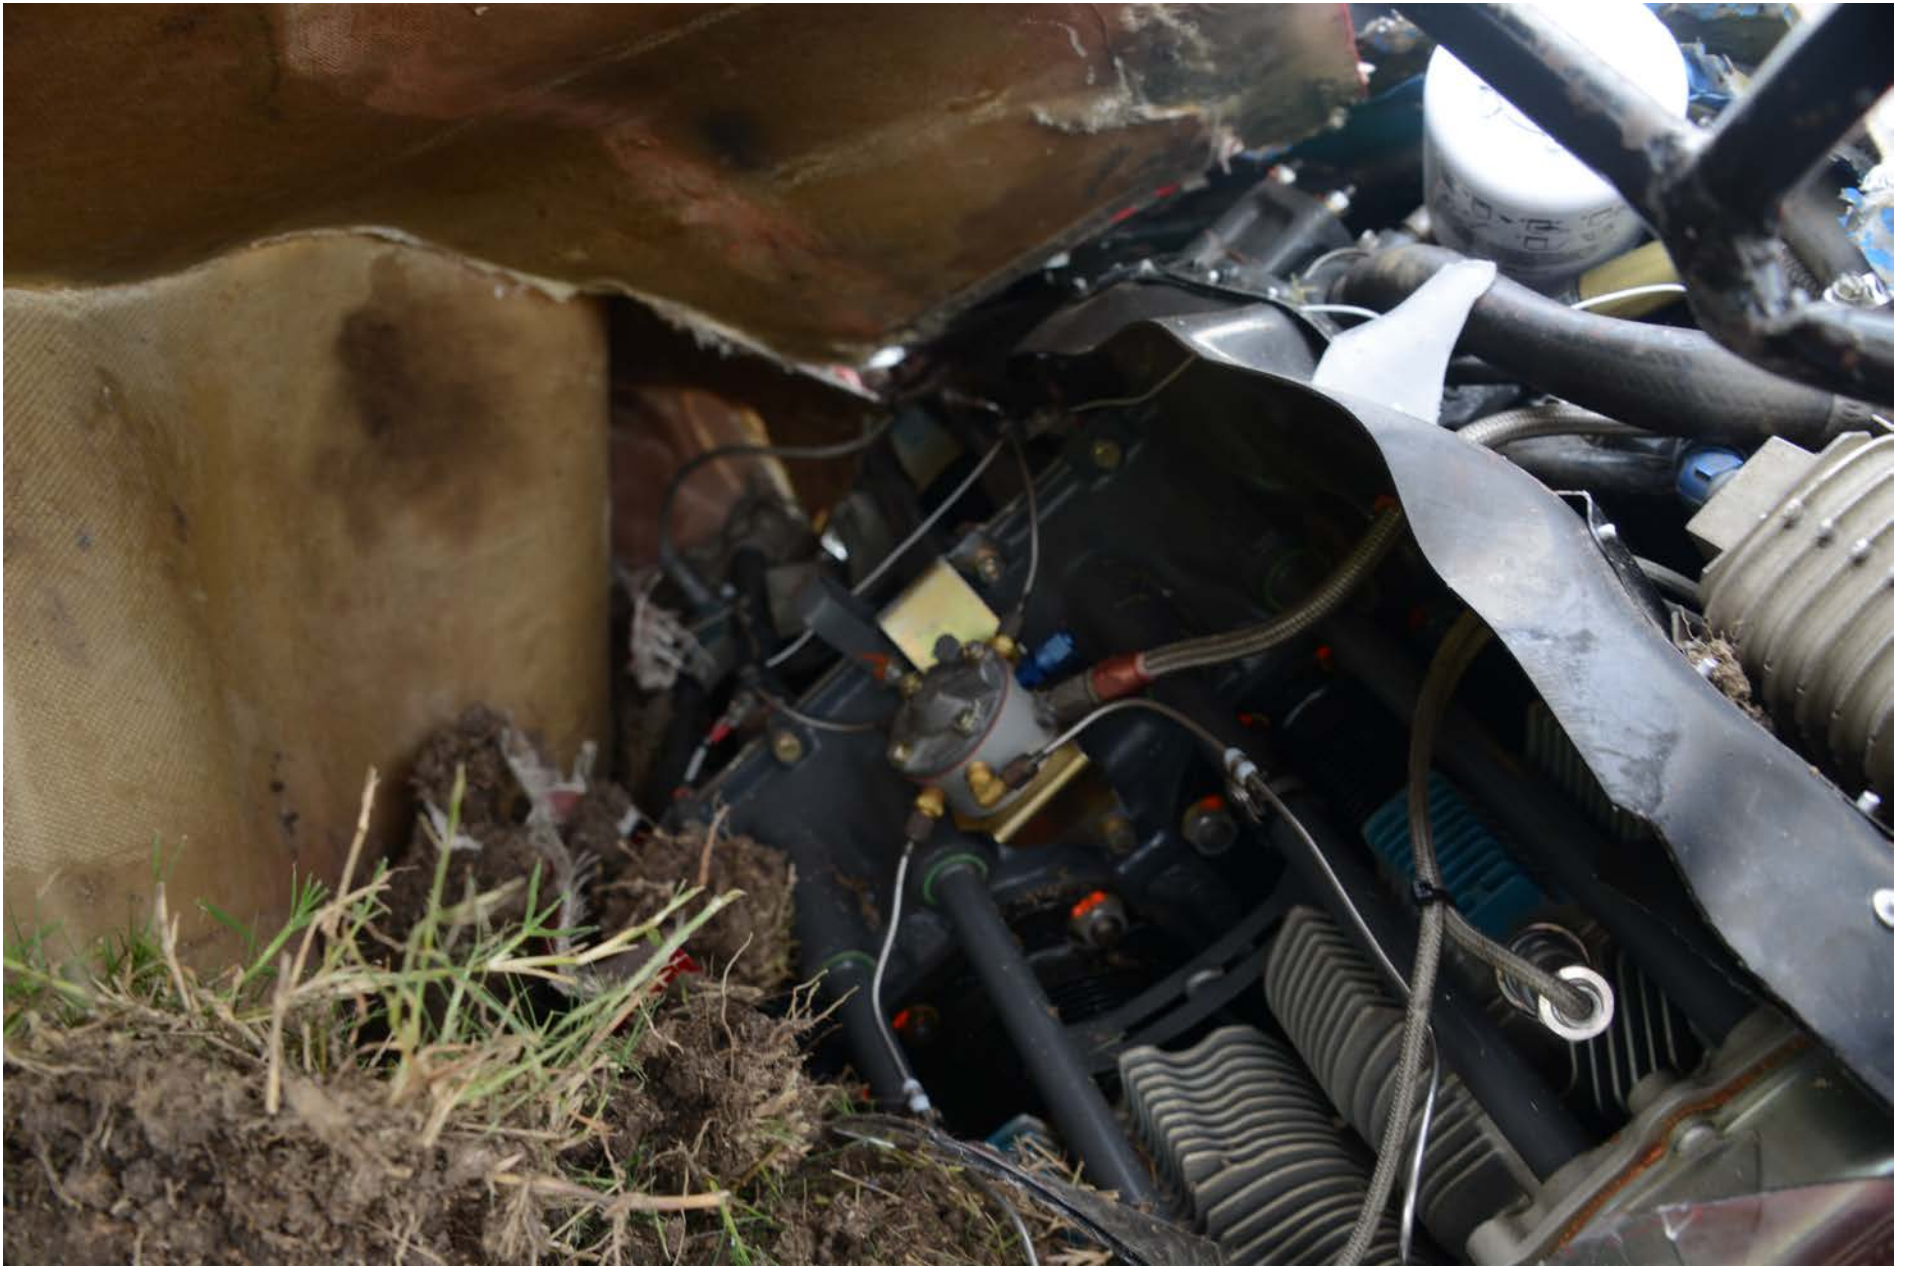
**Photo 15 - View of the top side of the engine.**

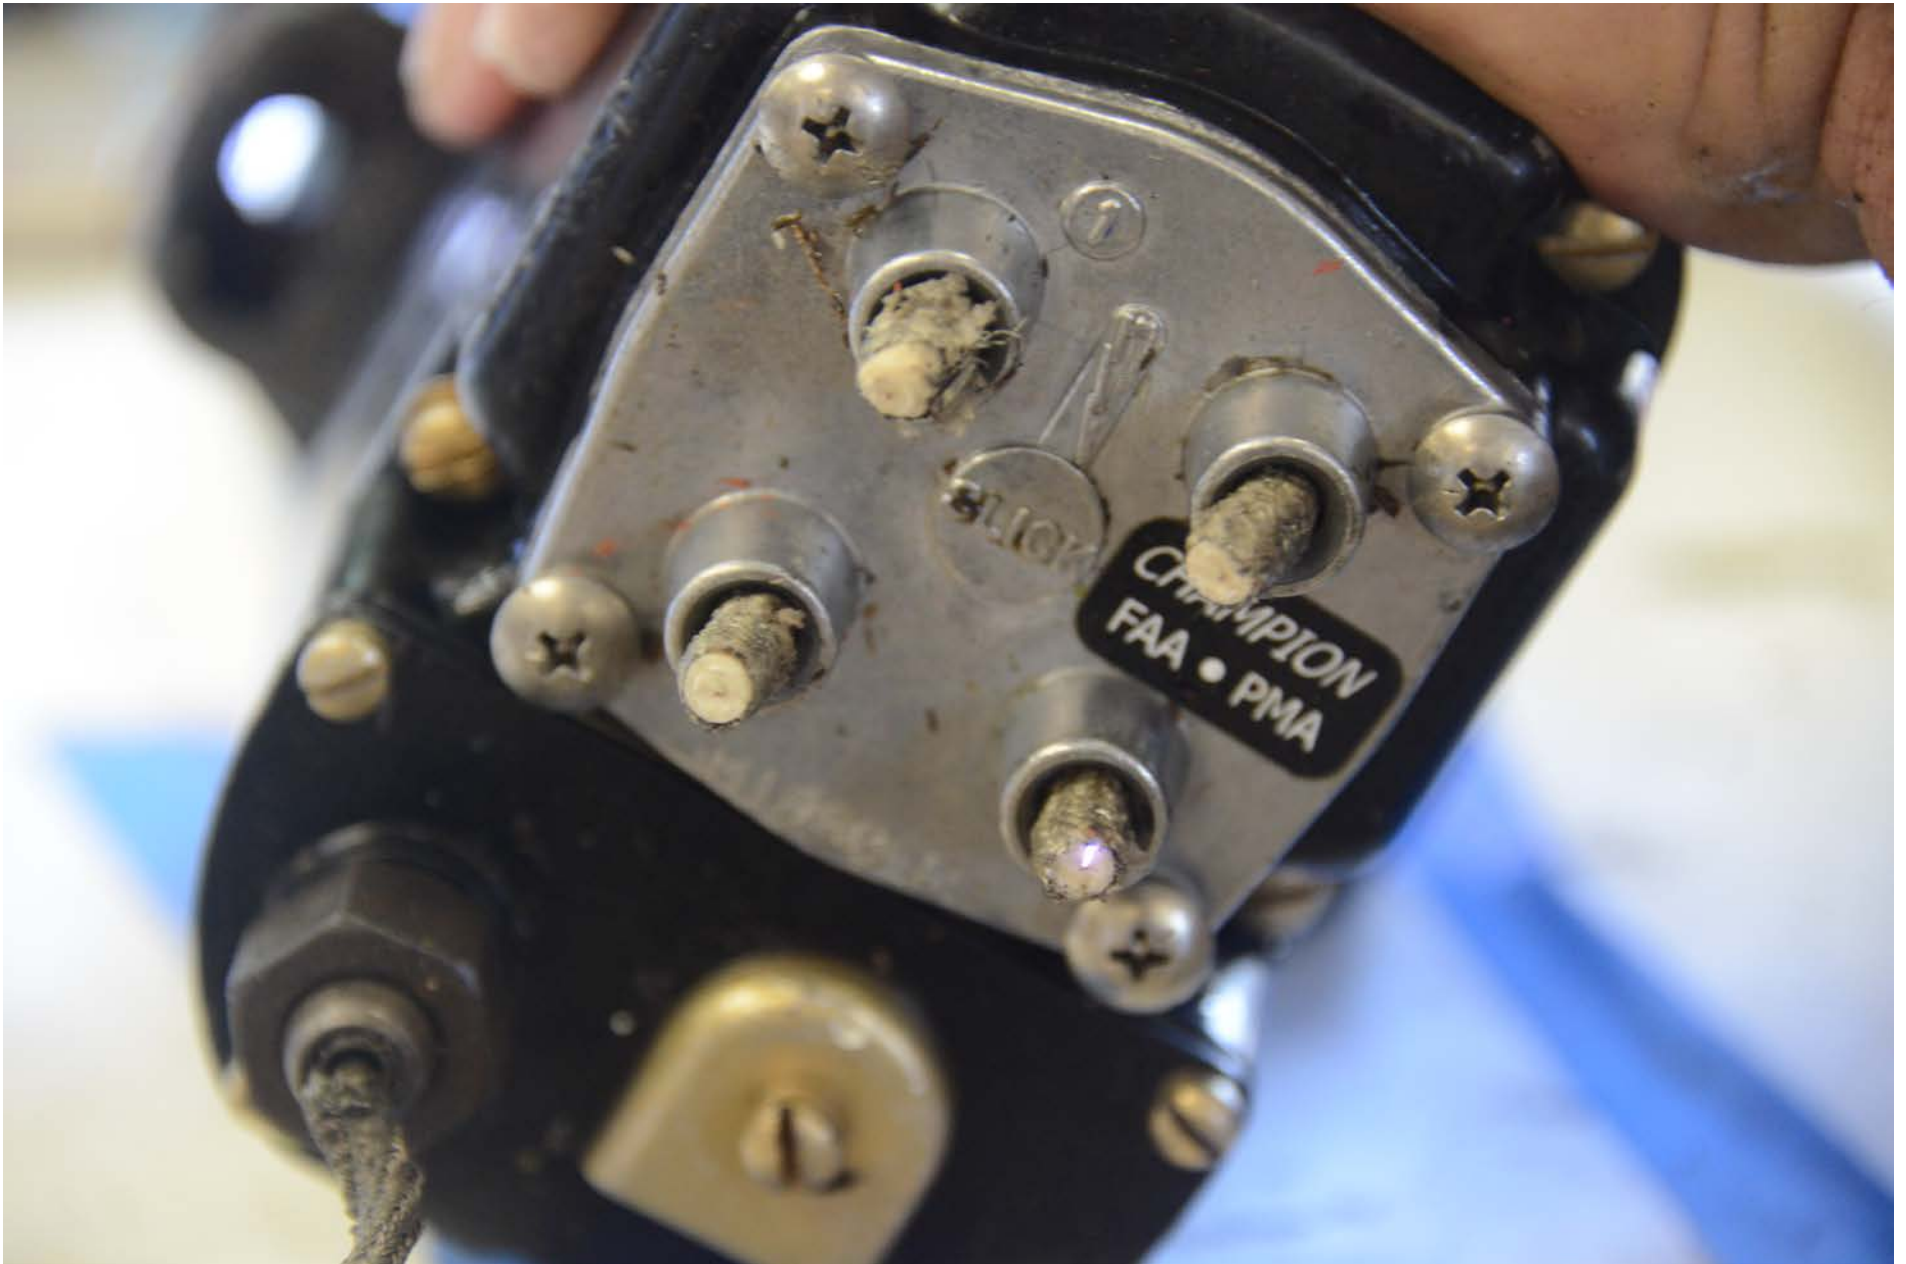
**Photo 16 – Left magneto exhibiting a spark when its drive gear was rotated.**

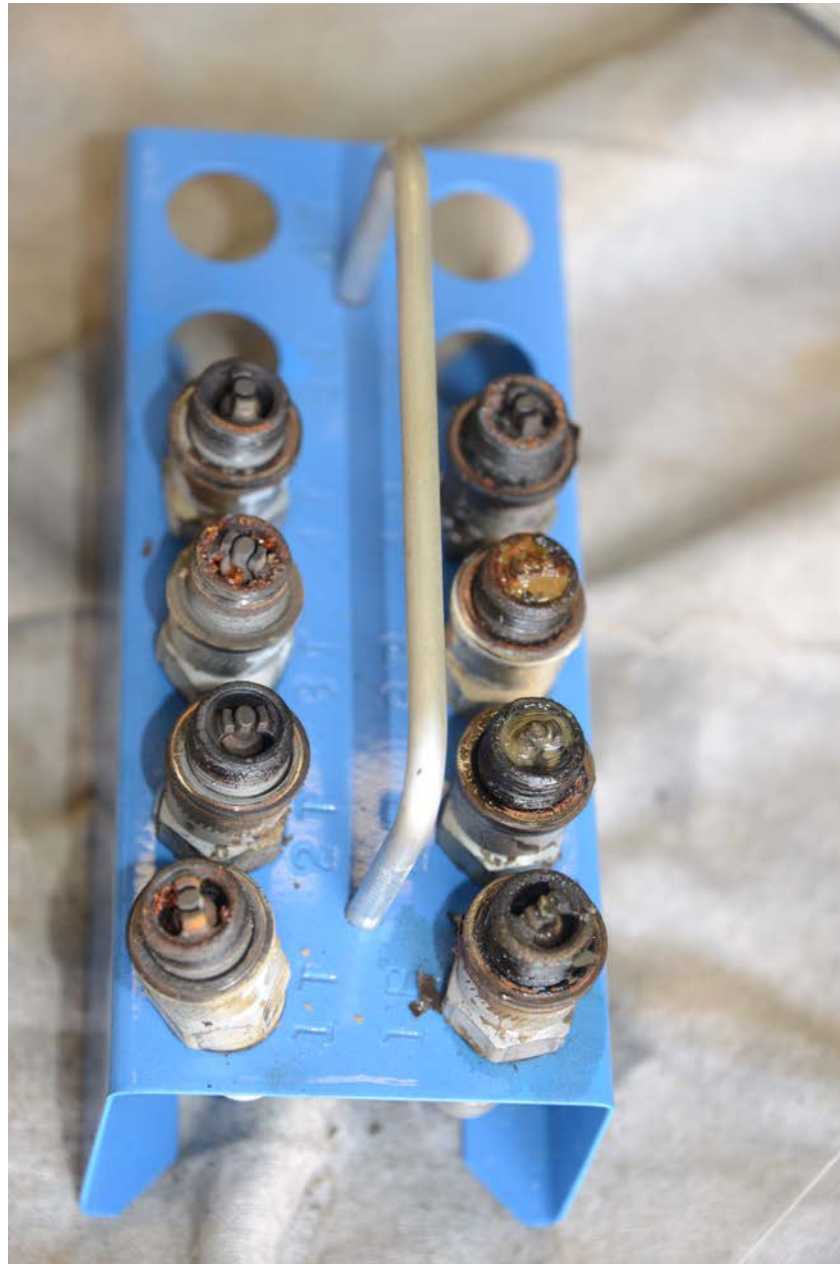
**Photo 17 - View of removed sparkplugs.**

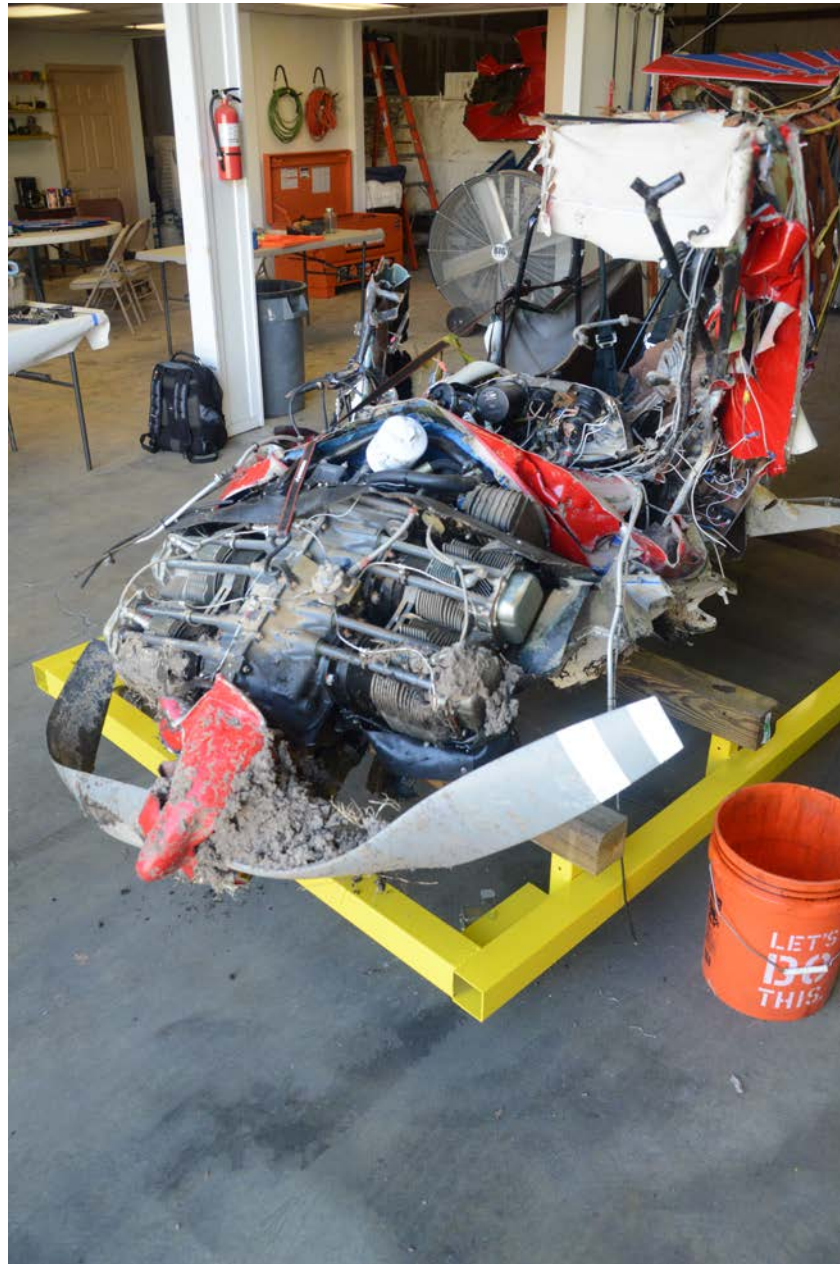
**Photo 18 - View of the recovered engine.**

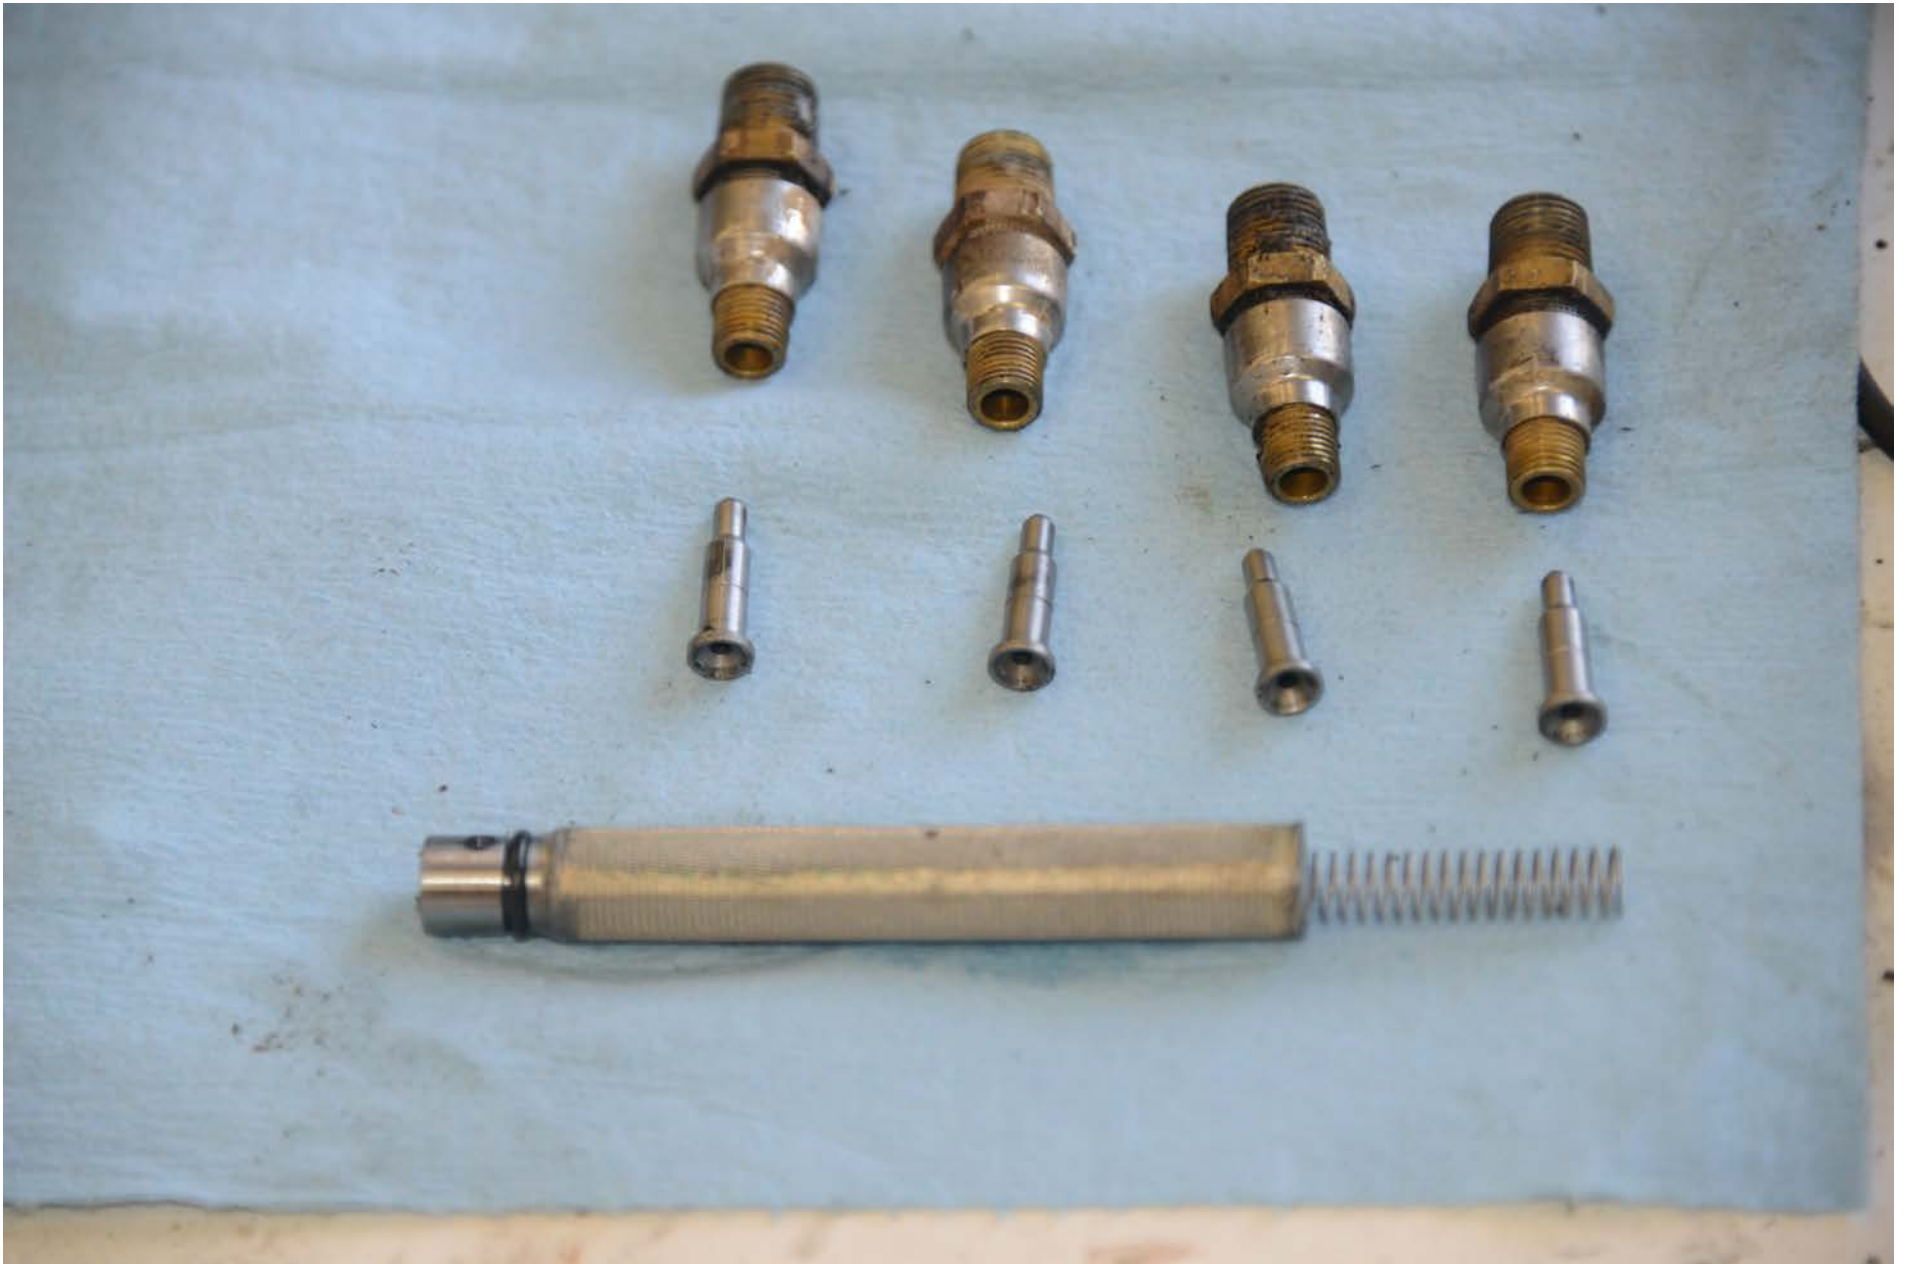
**Photo 19 - View of the removed fuel injectors and fuel servo filter.**

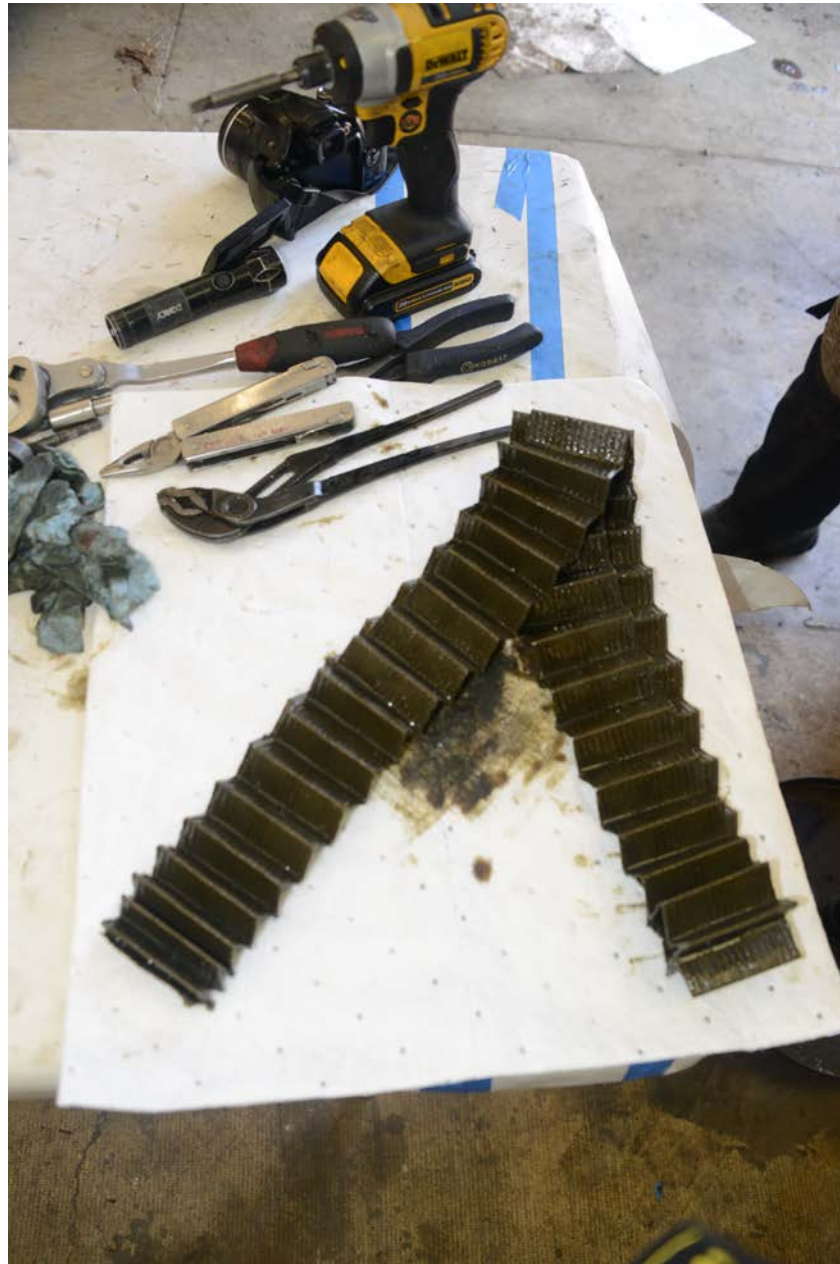
**Photo 20 - View of the removed oil filter element.**
