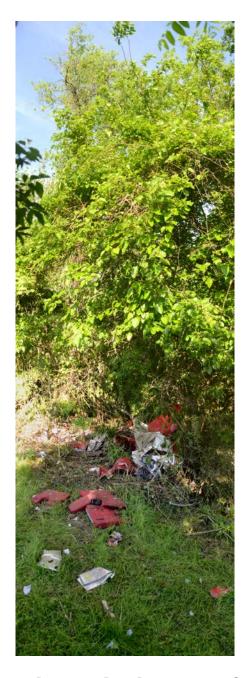
Photo 1- View of the wreckage under the canopy of trees in a wooded area.

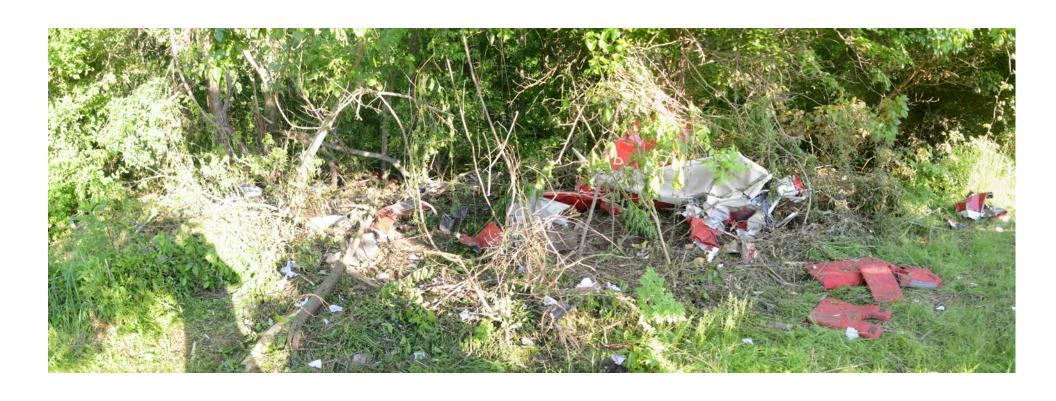
Photo 2 - View of the wreckage under the canopy of trees in a wooded area.

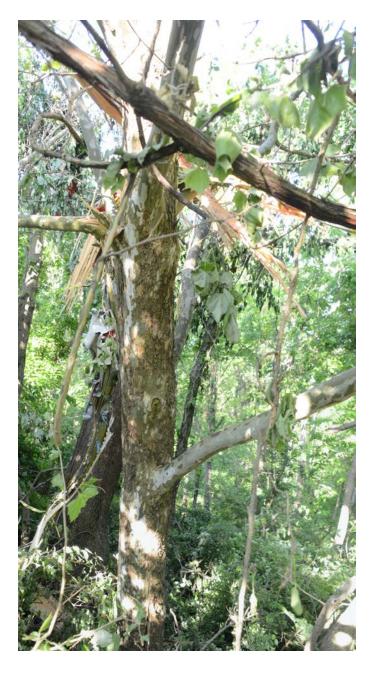
Photo 3 - View of a separated tree trunk under the canopy of trees in a wooded area.

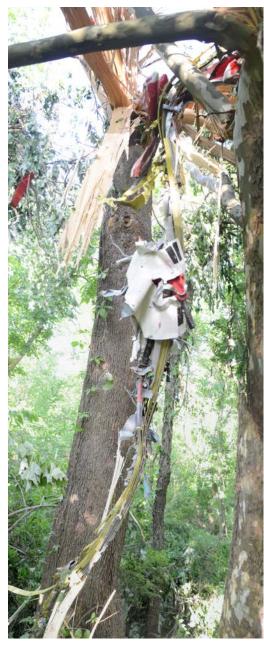
Photo 4 - View of a separated tree trunk and separated airplane parts lodged in the tree trunk under the canopy of trees in a wooded area.

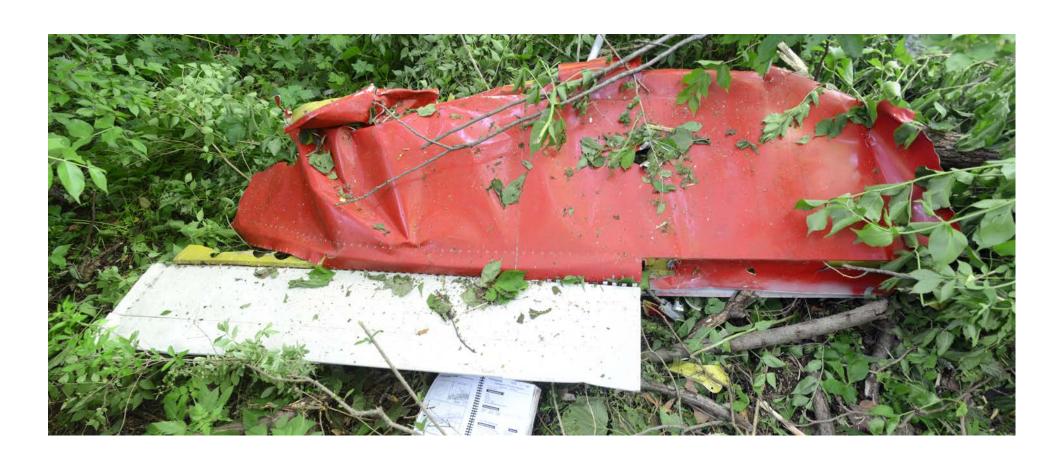
Photo 5 - View of a separated wing.

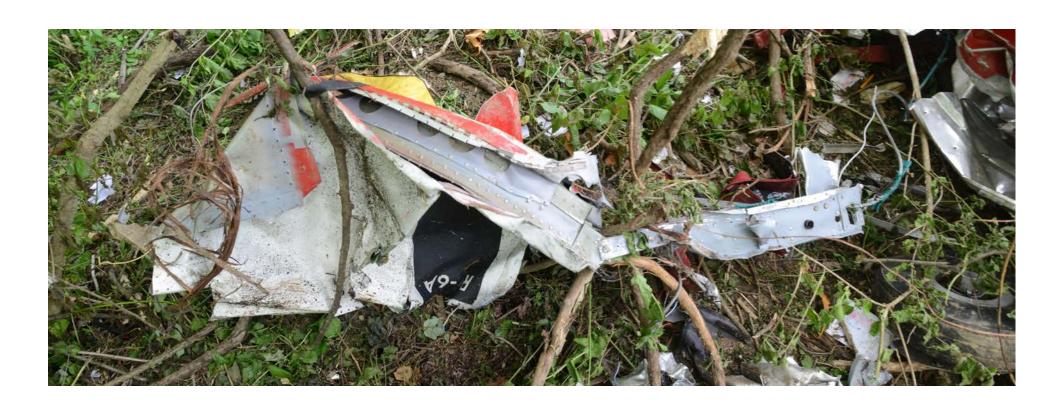
Photo 6 - View of a separated wing section.

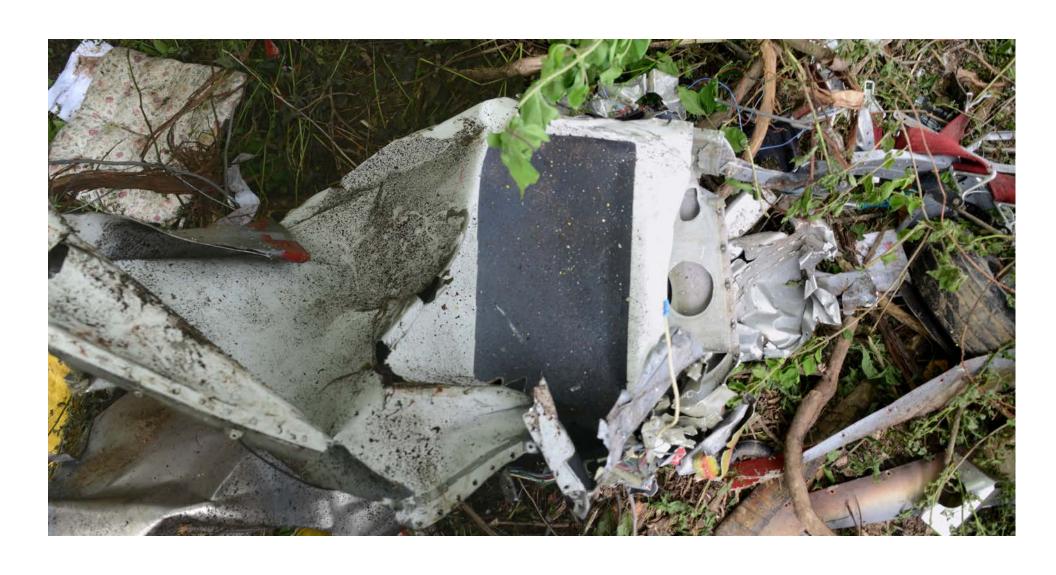
Photo 7 - View of a separated wing section.

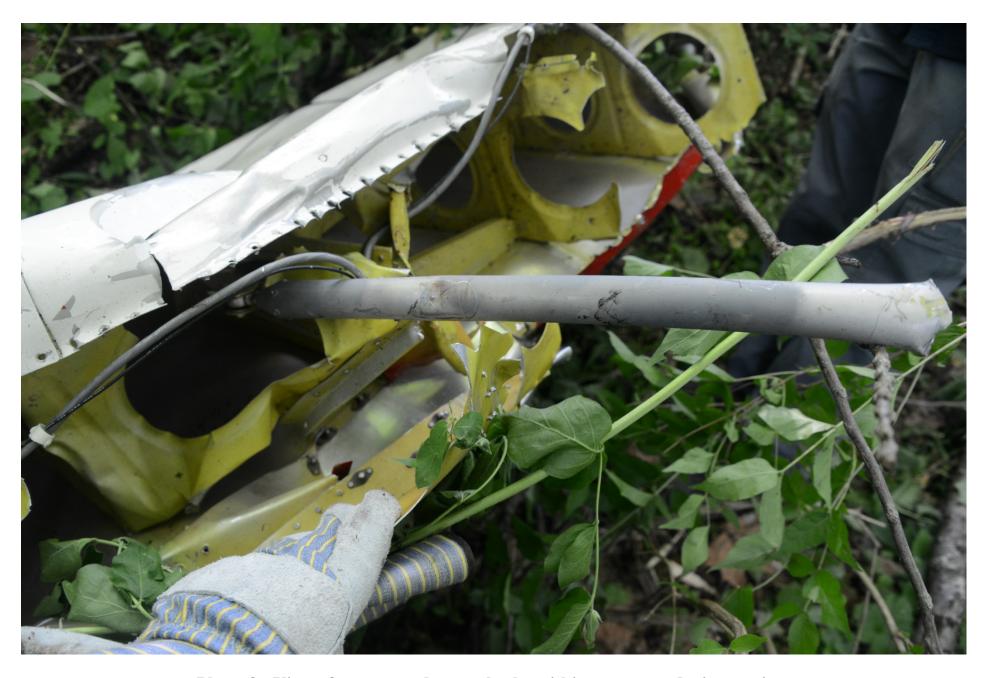
Photo 8 - View of a separated control tube within a separated wing section.

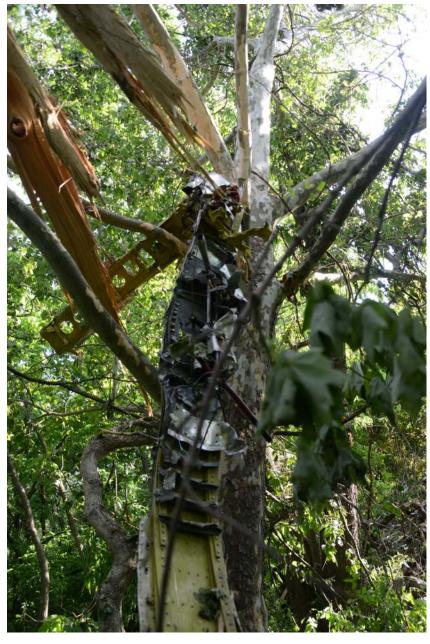
Photo 9 - Close-up view of a separated tree trunk and separated airplane parts lodged in the tree trunk under the canopy of trees in a wooded area.

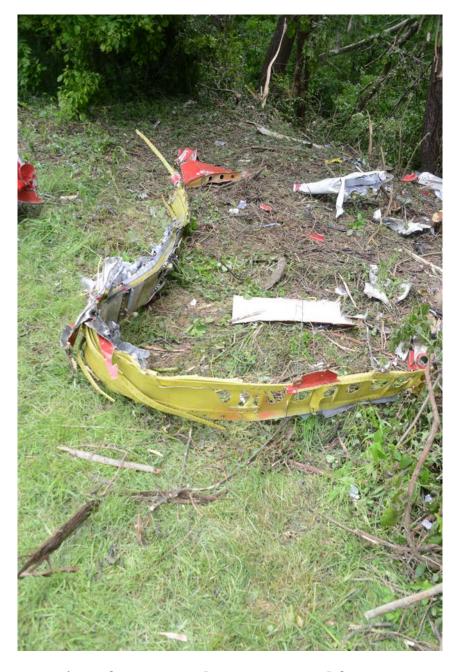
Photo 10 - Close-up view of a separated spar recovered from a separated tree trunk.

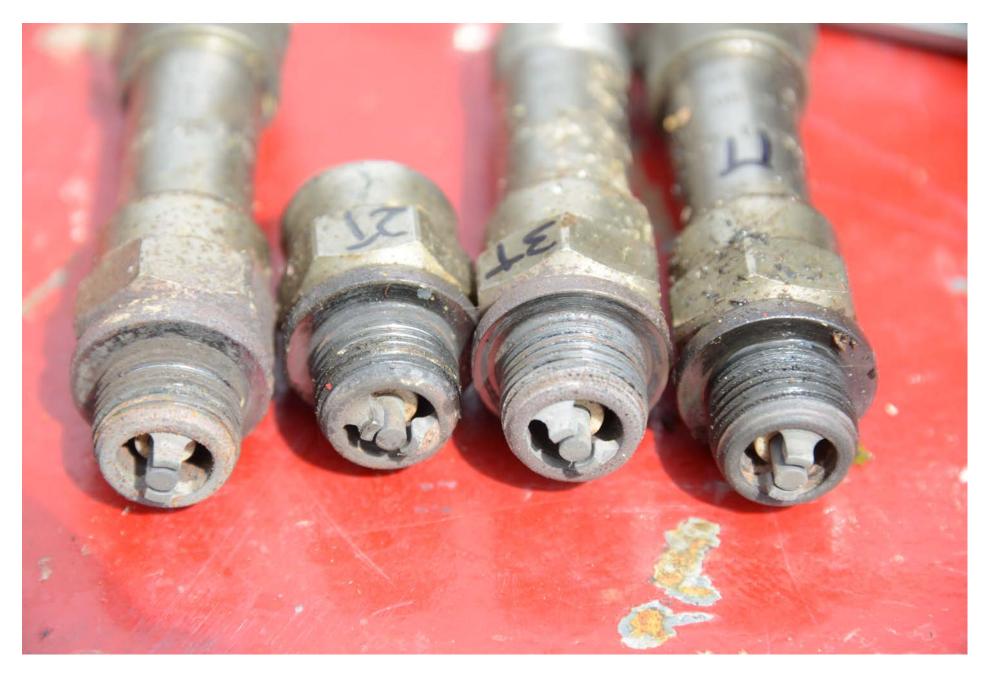
Photo 11 - View of removed sparkplugs.

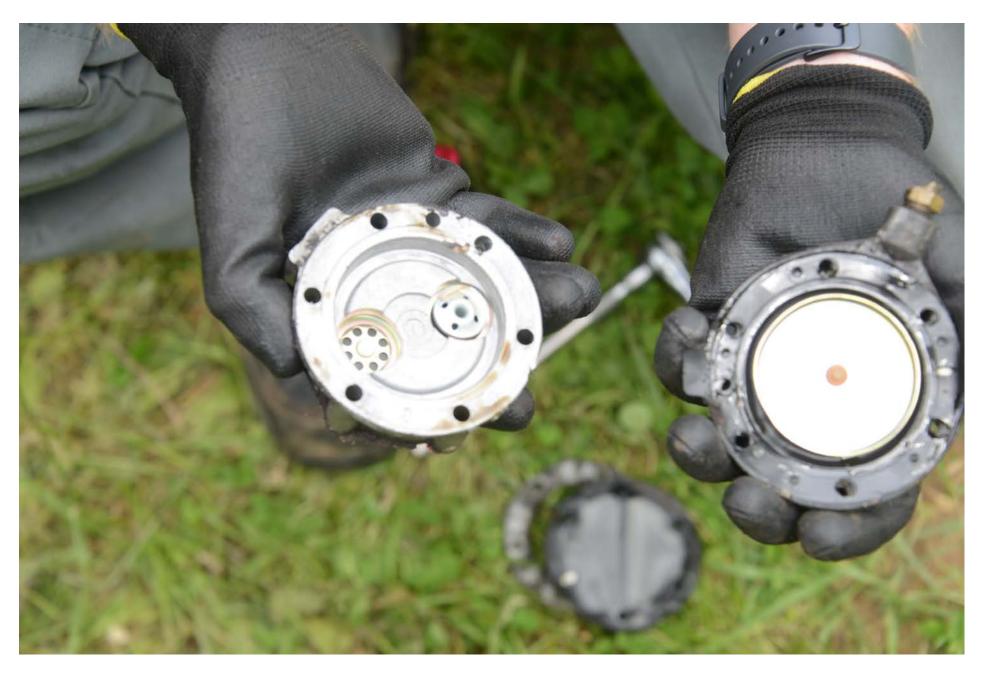
Photo 12 - View of the disassembled engine driven fuel pump.

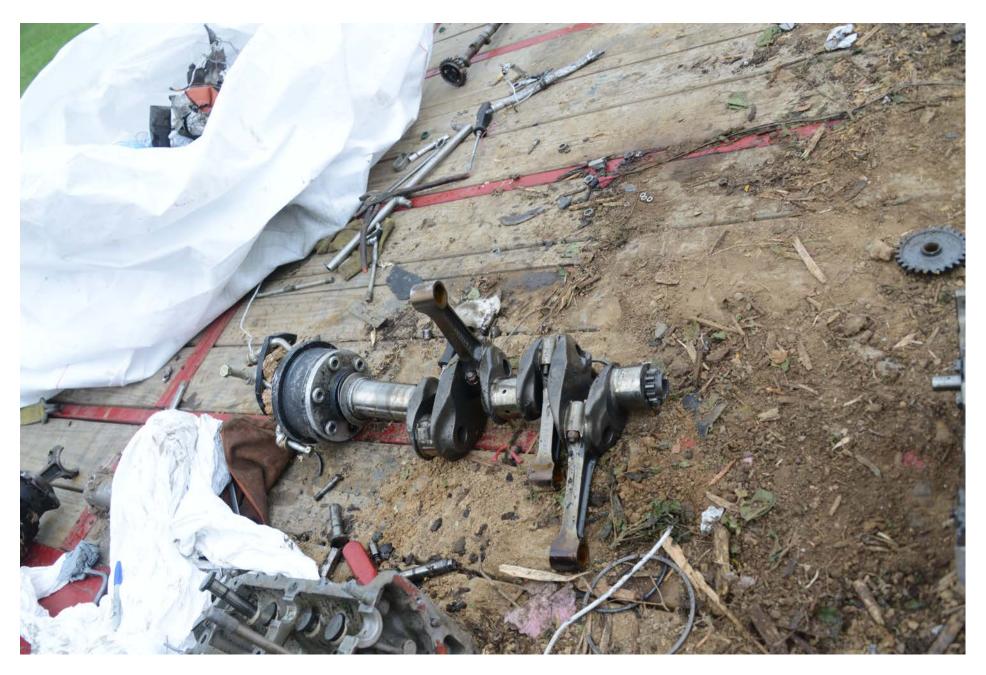
Photo 13 - View of the crankshaft from the disassembled engine.

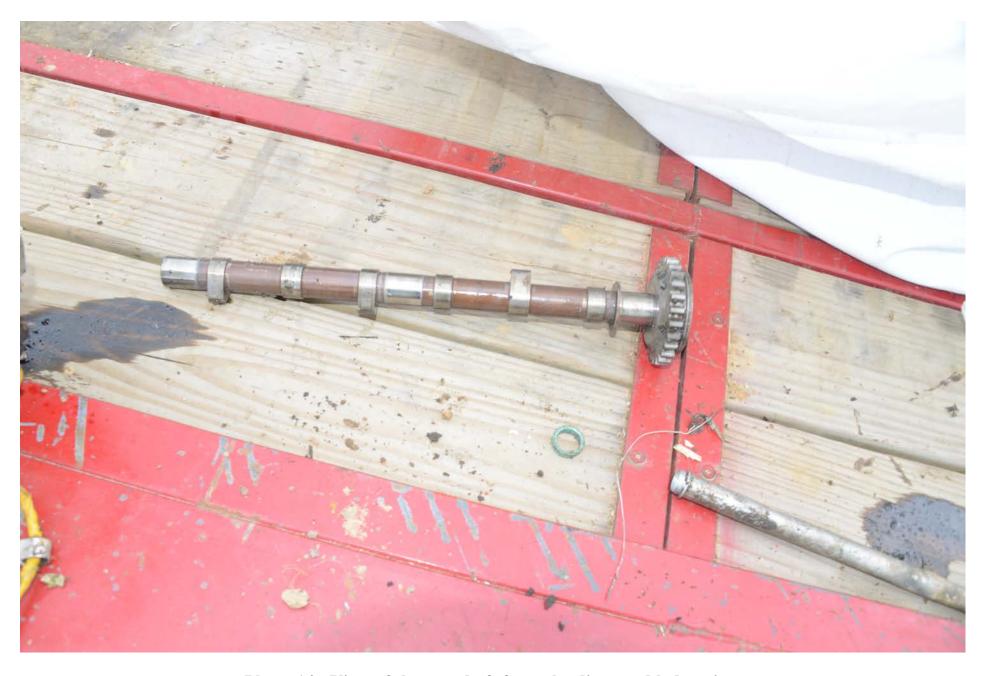
Photo 14 - View of the camshaft from the disassembled engine.

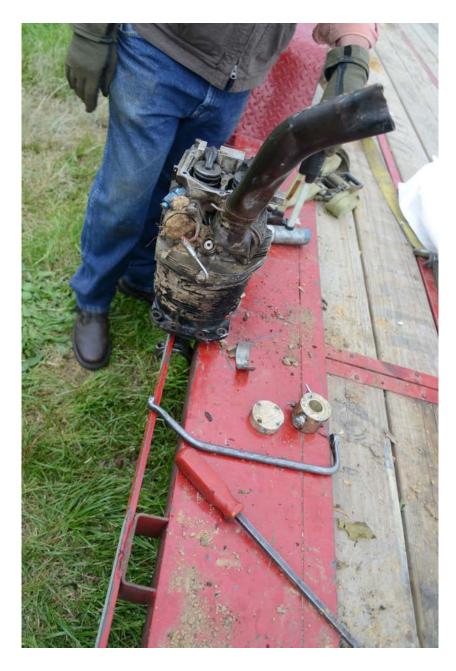
Photo 15 - View of a removed cylinder.

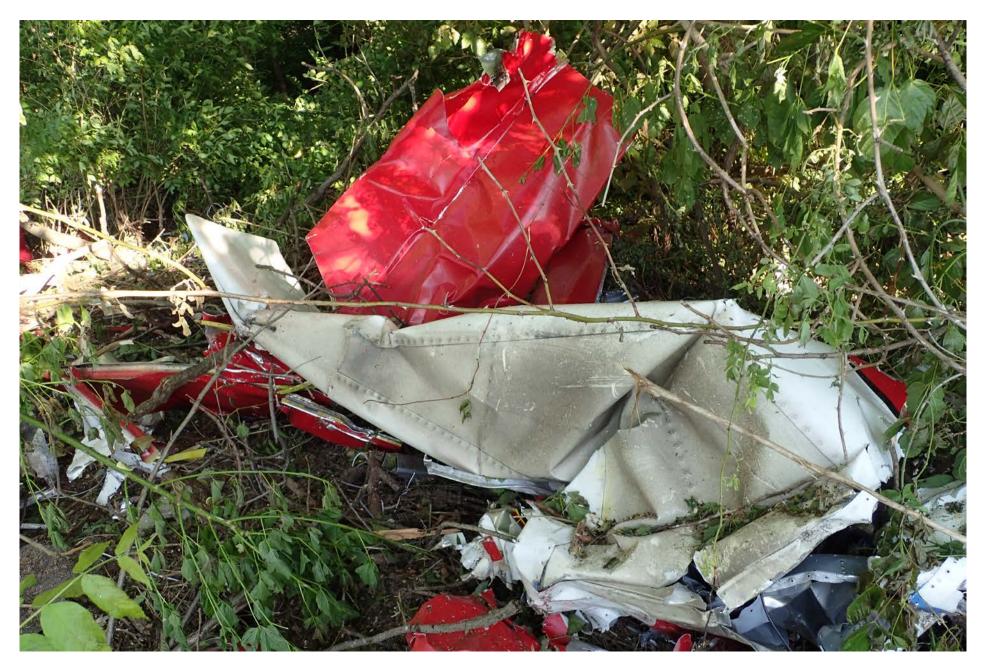
Photo 16 - View of the underside of the fuselage and empennage.

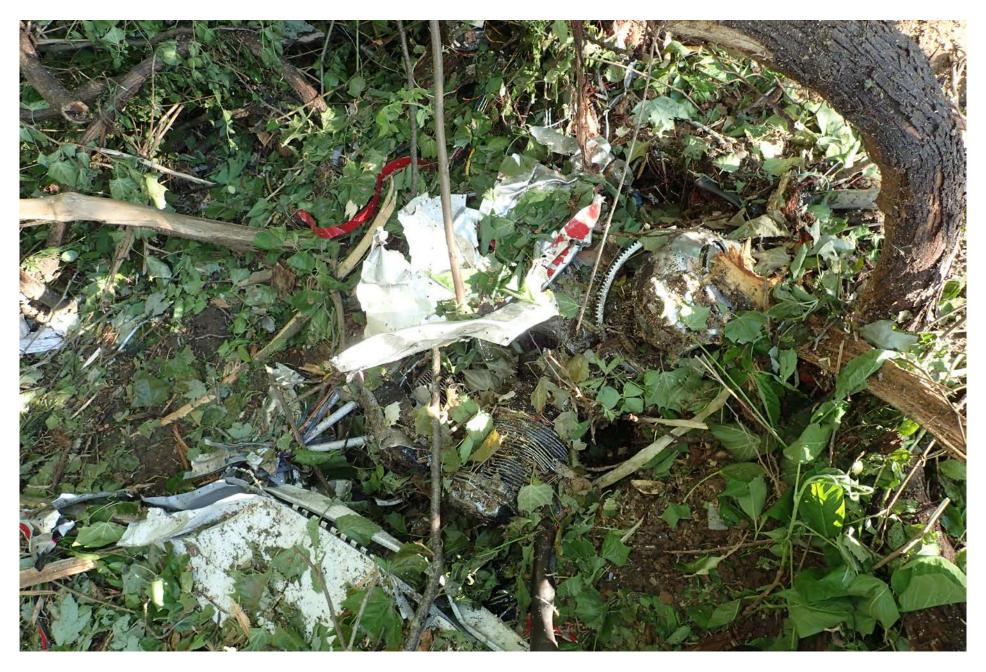
Photo 17 - View of the engine embedded in terrain.

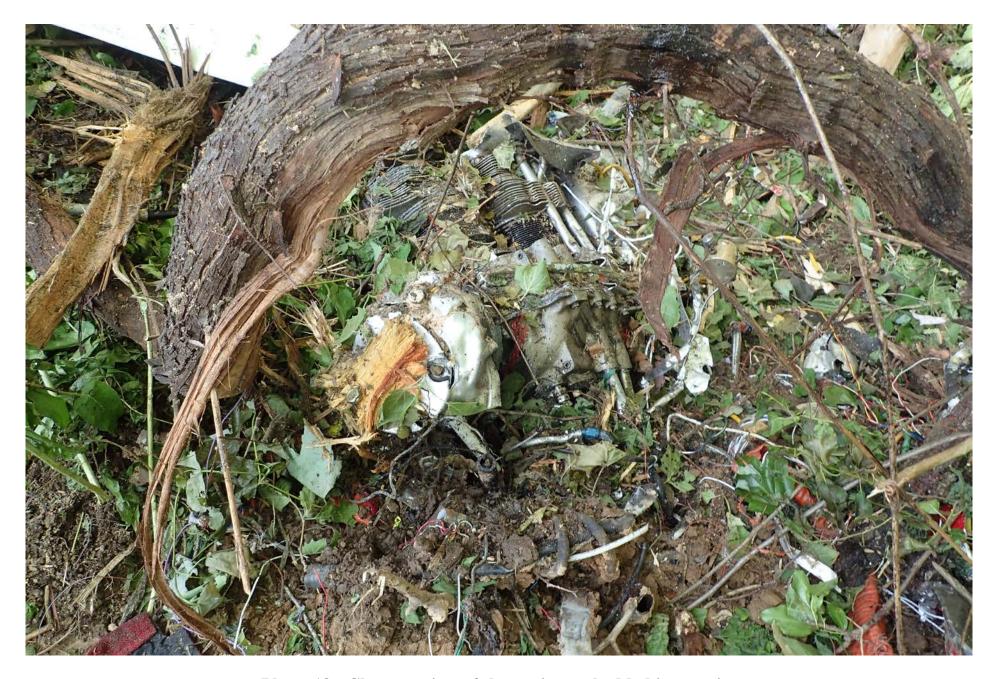
Photo 18 - Close-up view of the engine embedded in terrain.

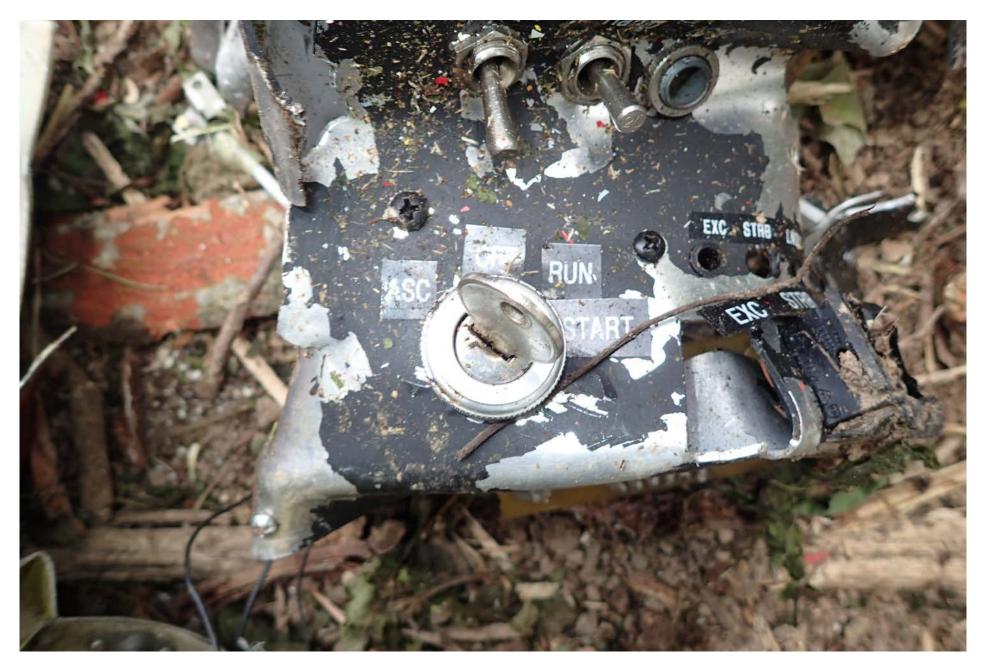
Photo 19 - Close-up view of the ignition switch.

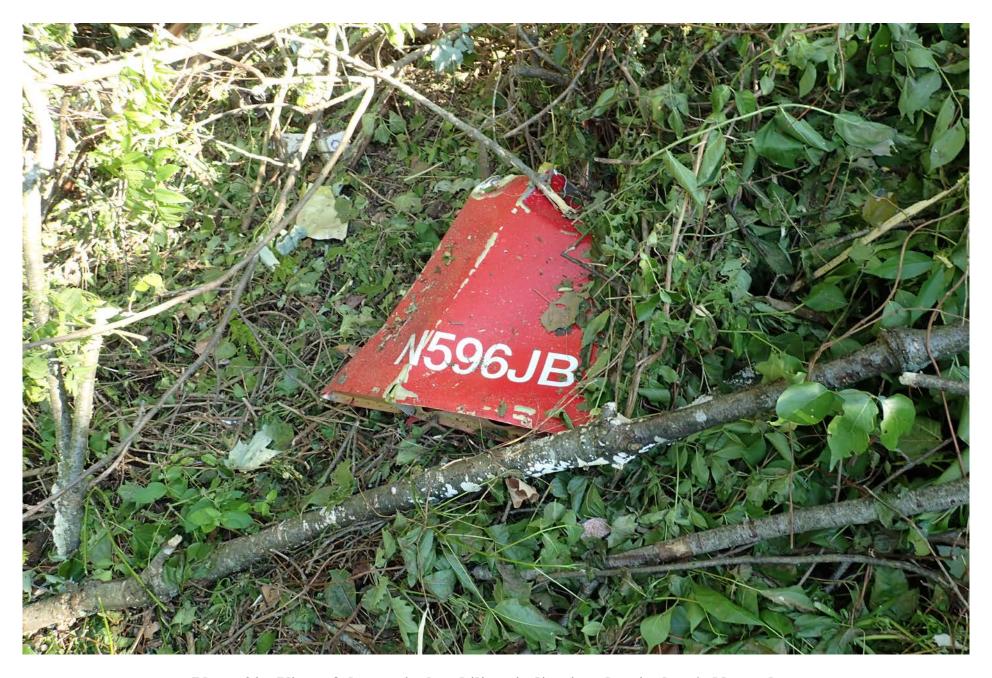
Photo  ${\bf 20}$  - View of the vertical stabilizer indicating the airplane's N-number.
