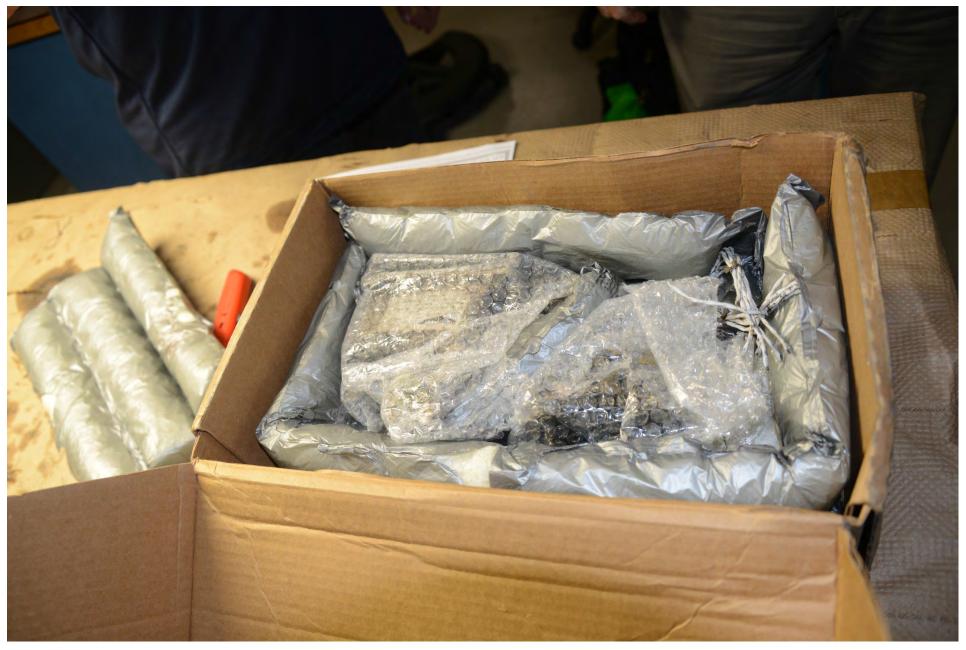
Photo 1 – View of the open as received package containing the FADEC Master Power Control unit (MPC) and speed sensor.

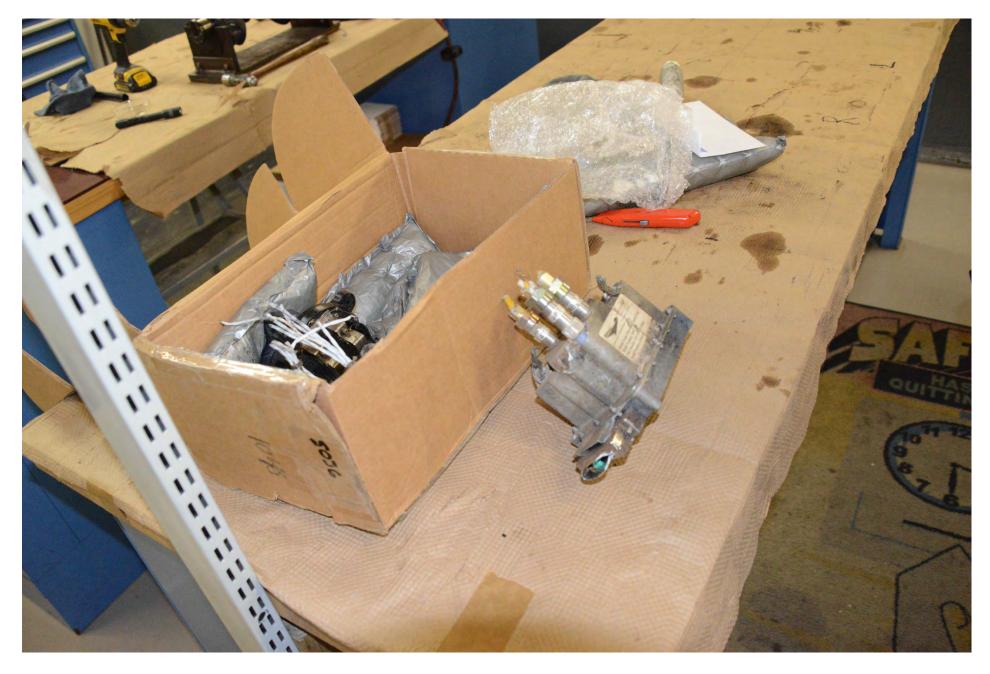
Photo 2 - View of the open as received package containing the FADEC MPC unit and speed sensor.

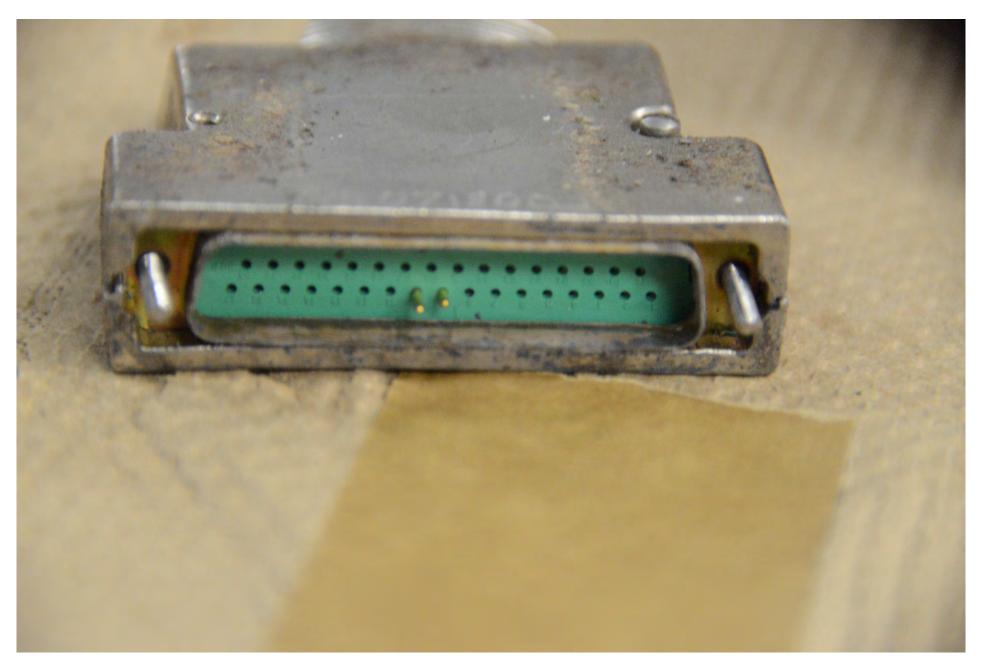
Photo 3 - View of the wiring connector to the FADEC MPC unit.

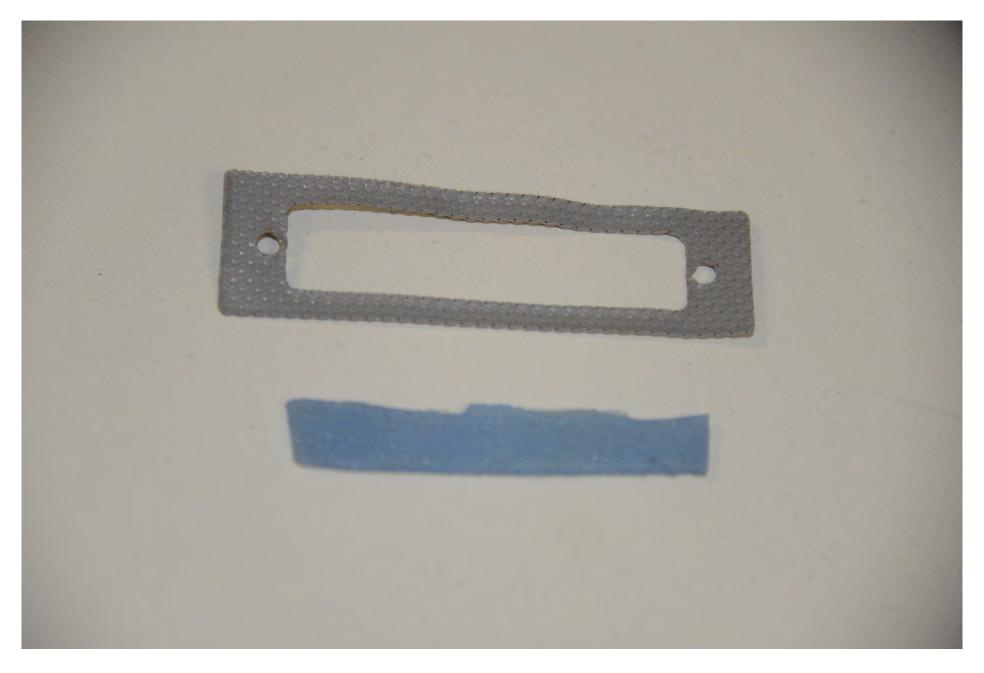
Photo 4 - View of the electromagnetic interference (EMI) gasket and sealant strip associated with the connector.

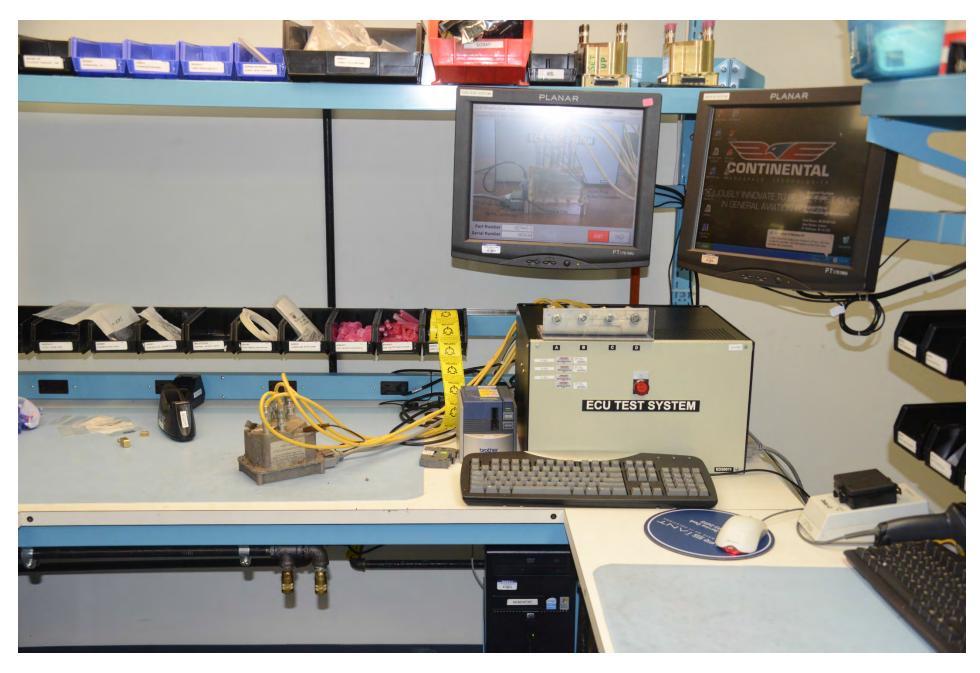
Photo 5 - View of an accident FADEC MPC connected to a testing system.

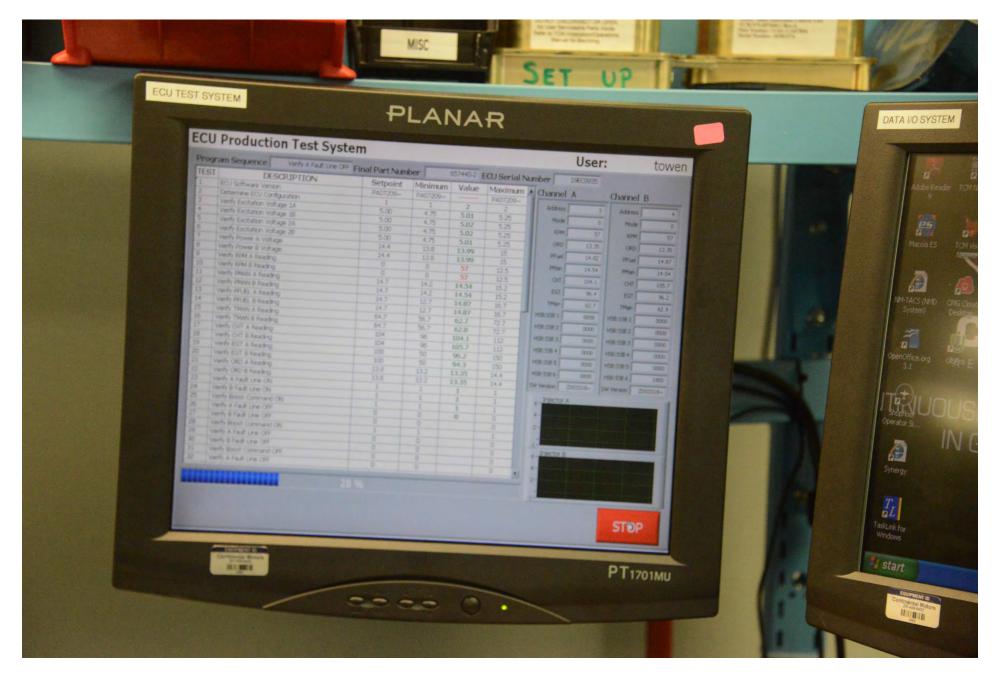
Photo 6 - View of the data associated with testing the accident FADEC MPC.

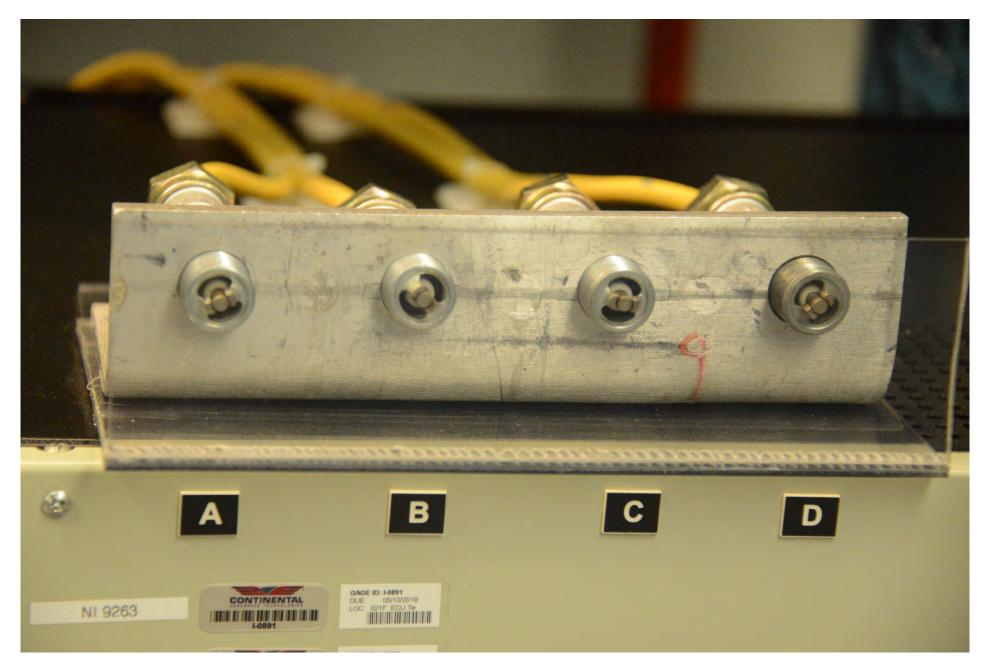
Photo 7 - View of sparkplugs attached to the accident FADEC MPC.

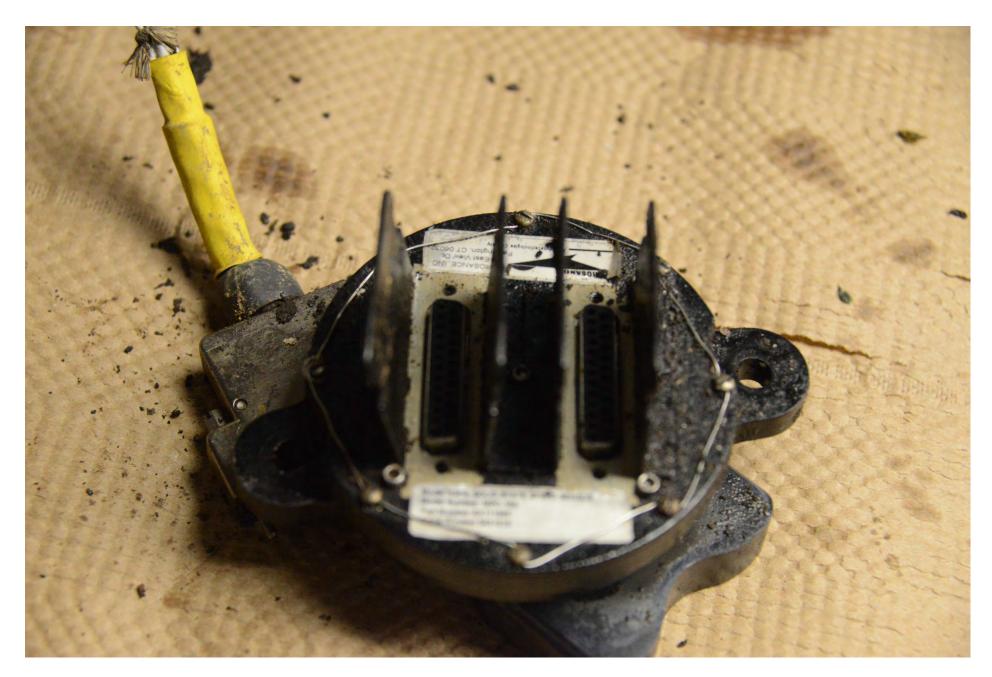
Photo 8 - View of the speed sensor.

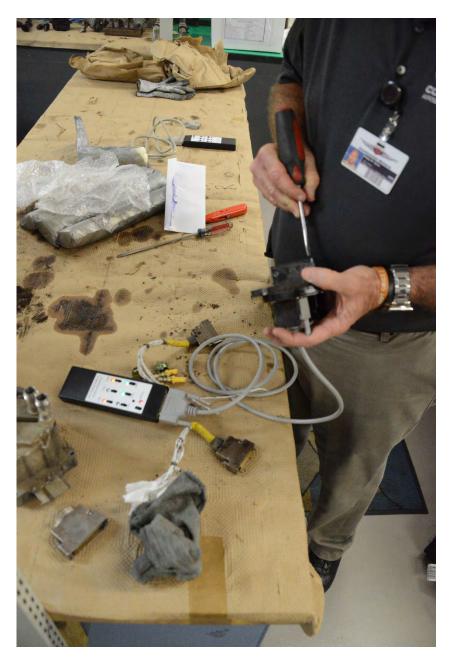
Photo 9 - View of the speed sensor connected to a testing system.

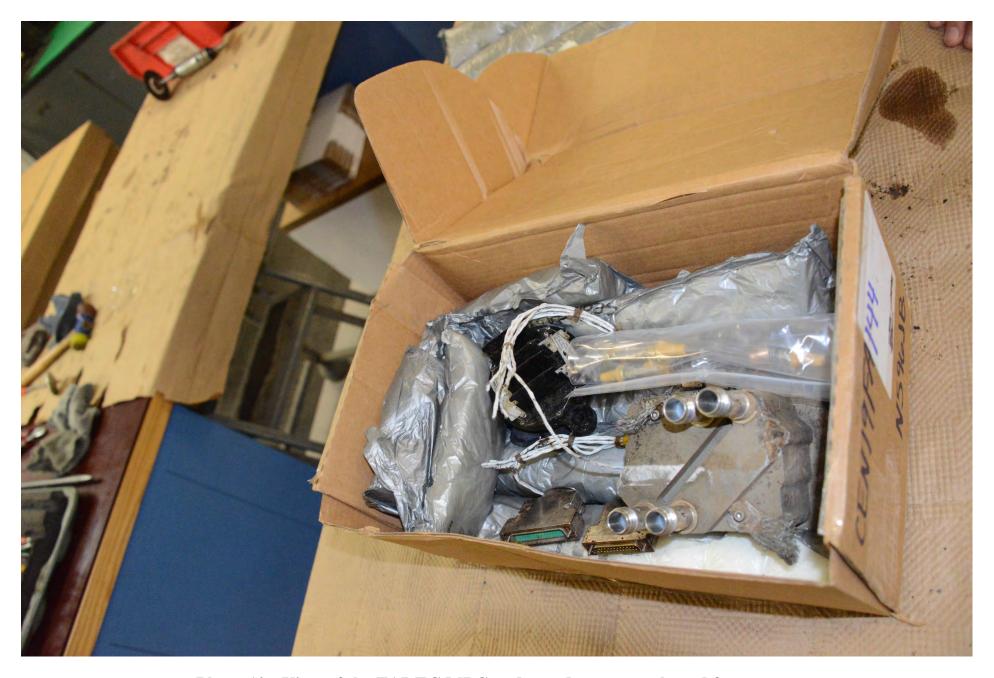
Photo ${\bf 10}$ - View of the FADEC MPC and speed sensor packaged for return.
