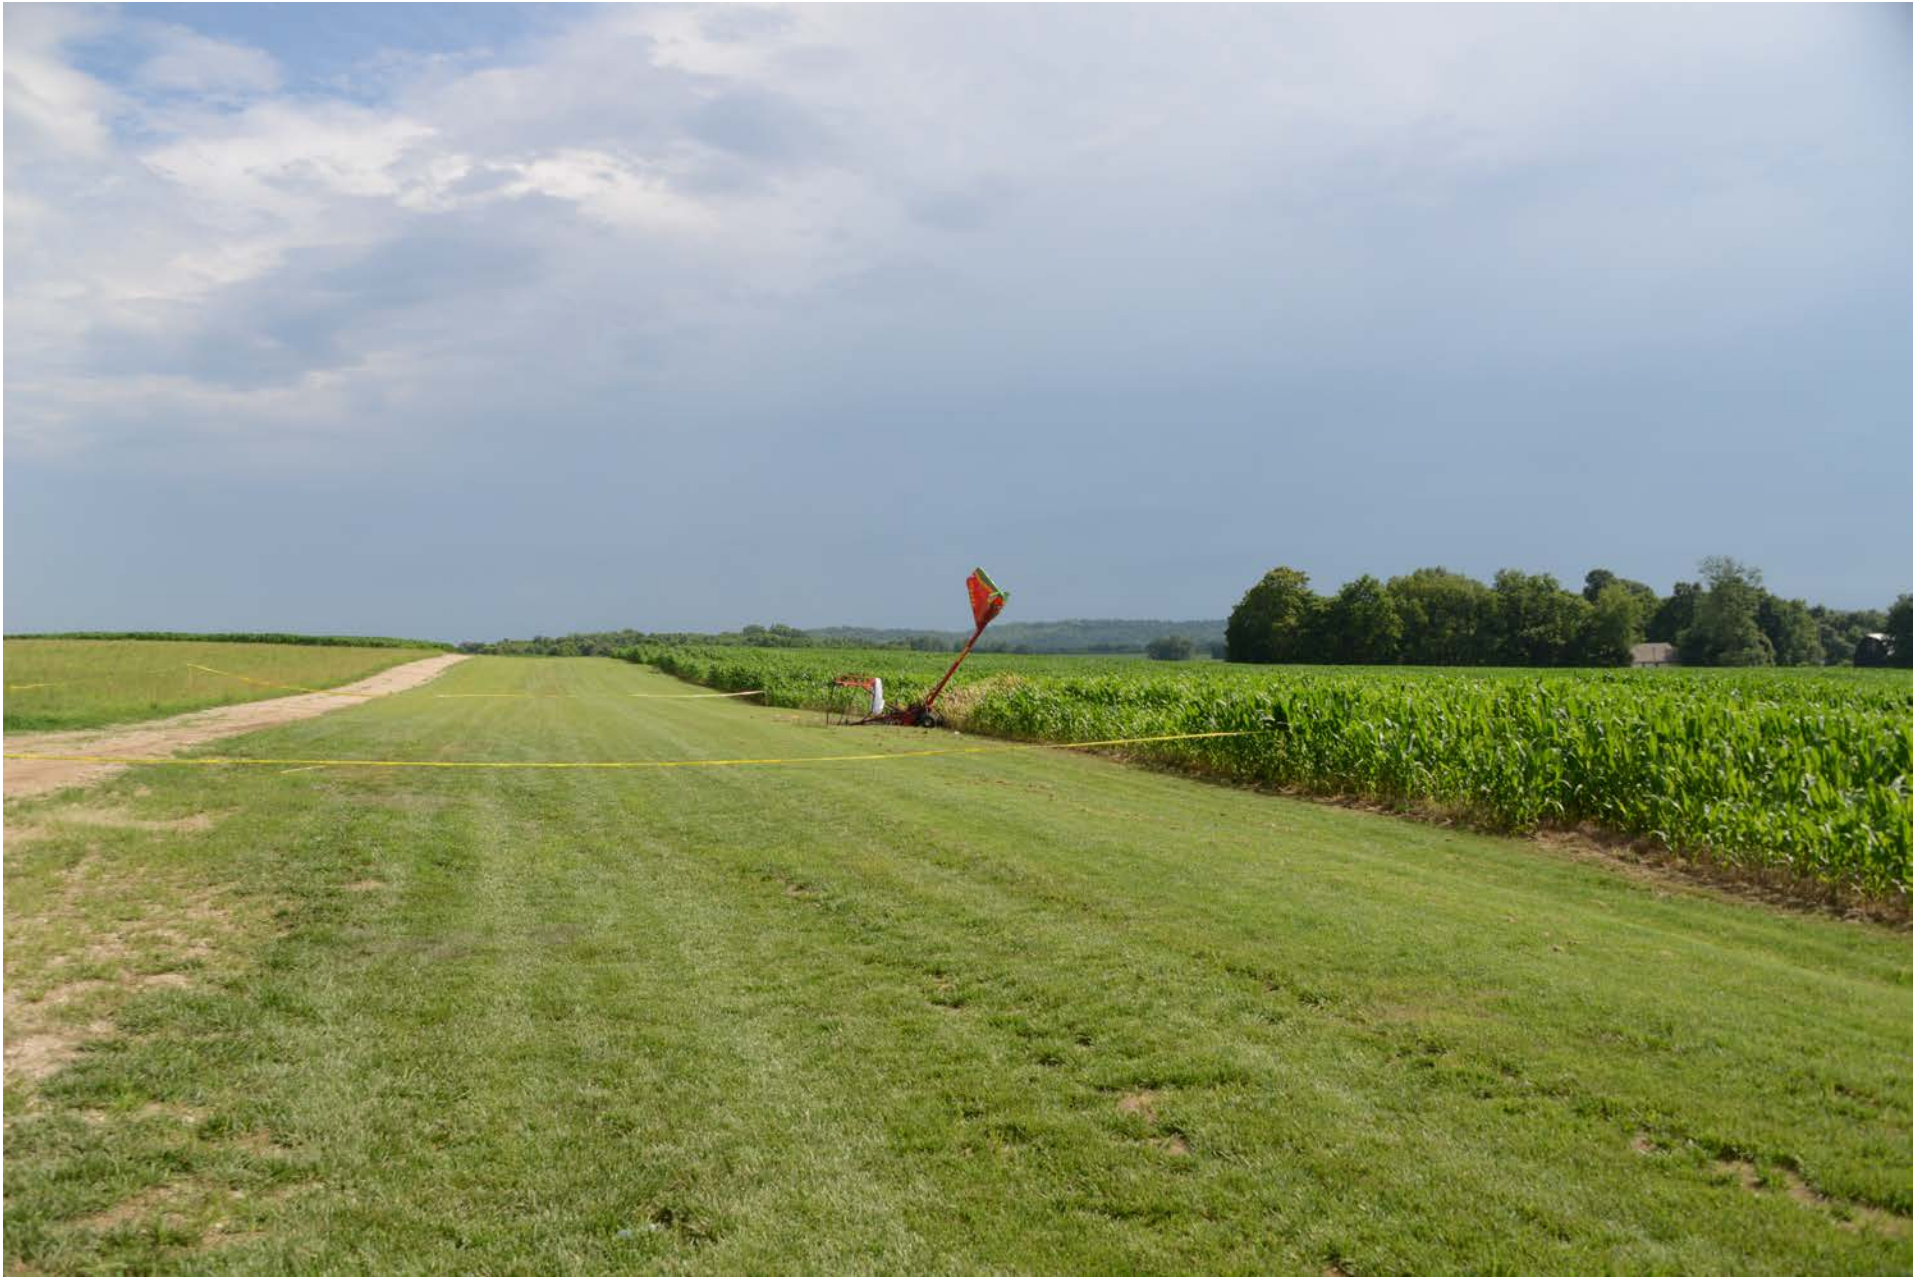
Photo 1 – View, looking south, of the runway and airplane wreckage.

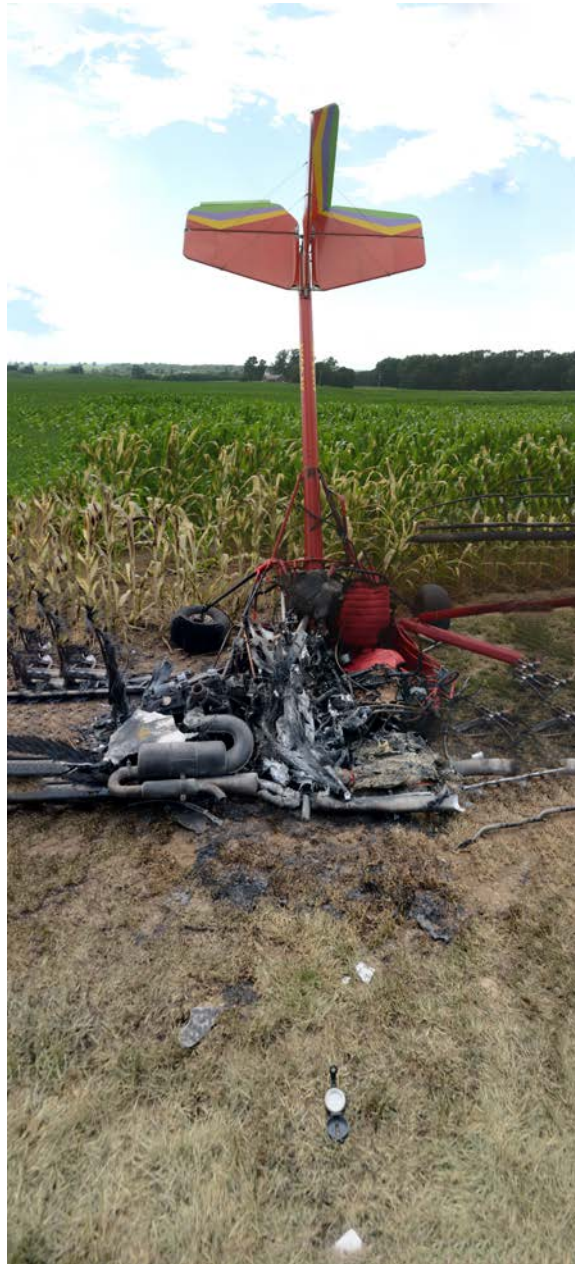
Photo 2 - View, looking west, of the wreckage.

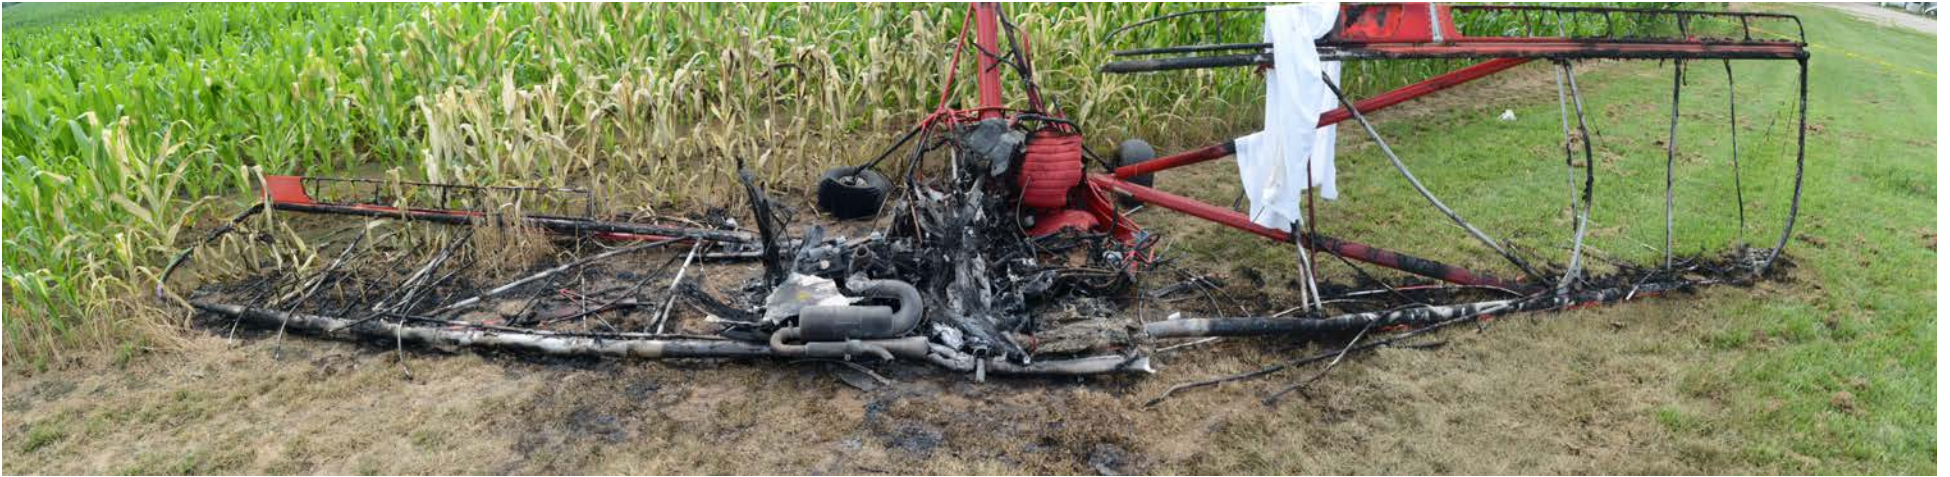
Photo 3 - View of the wings.

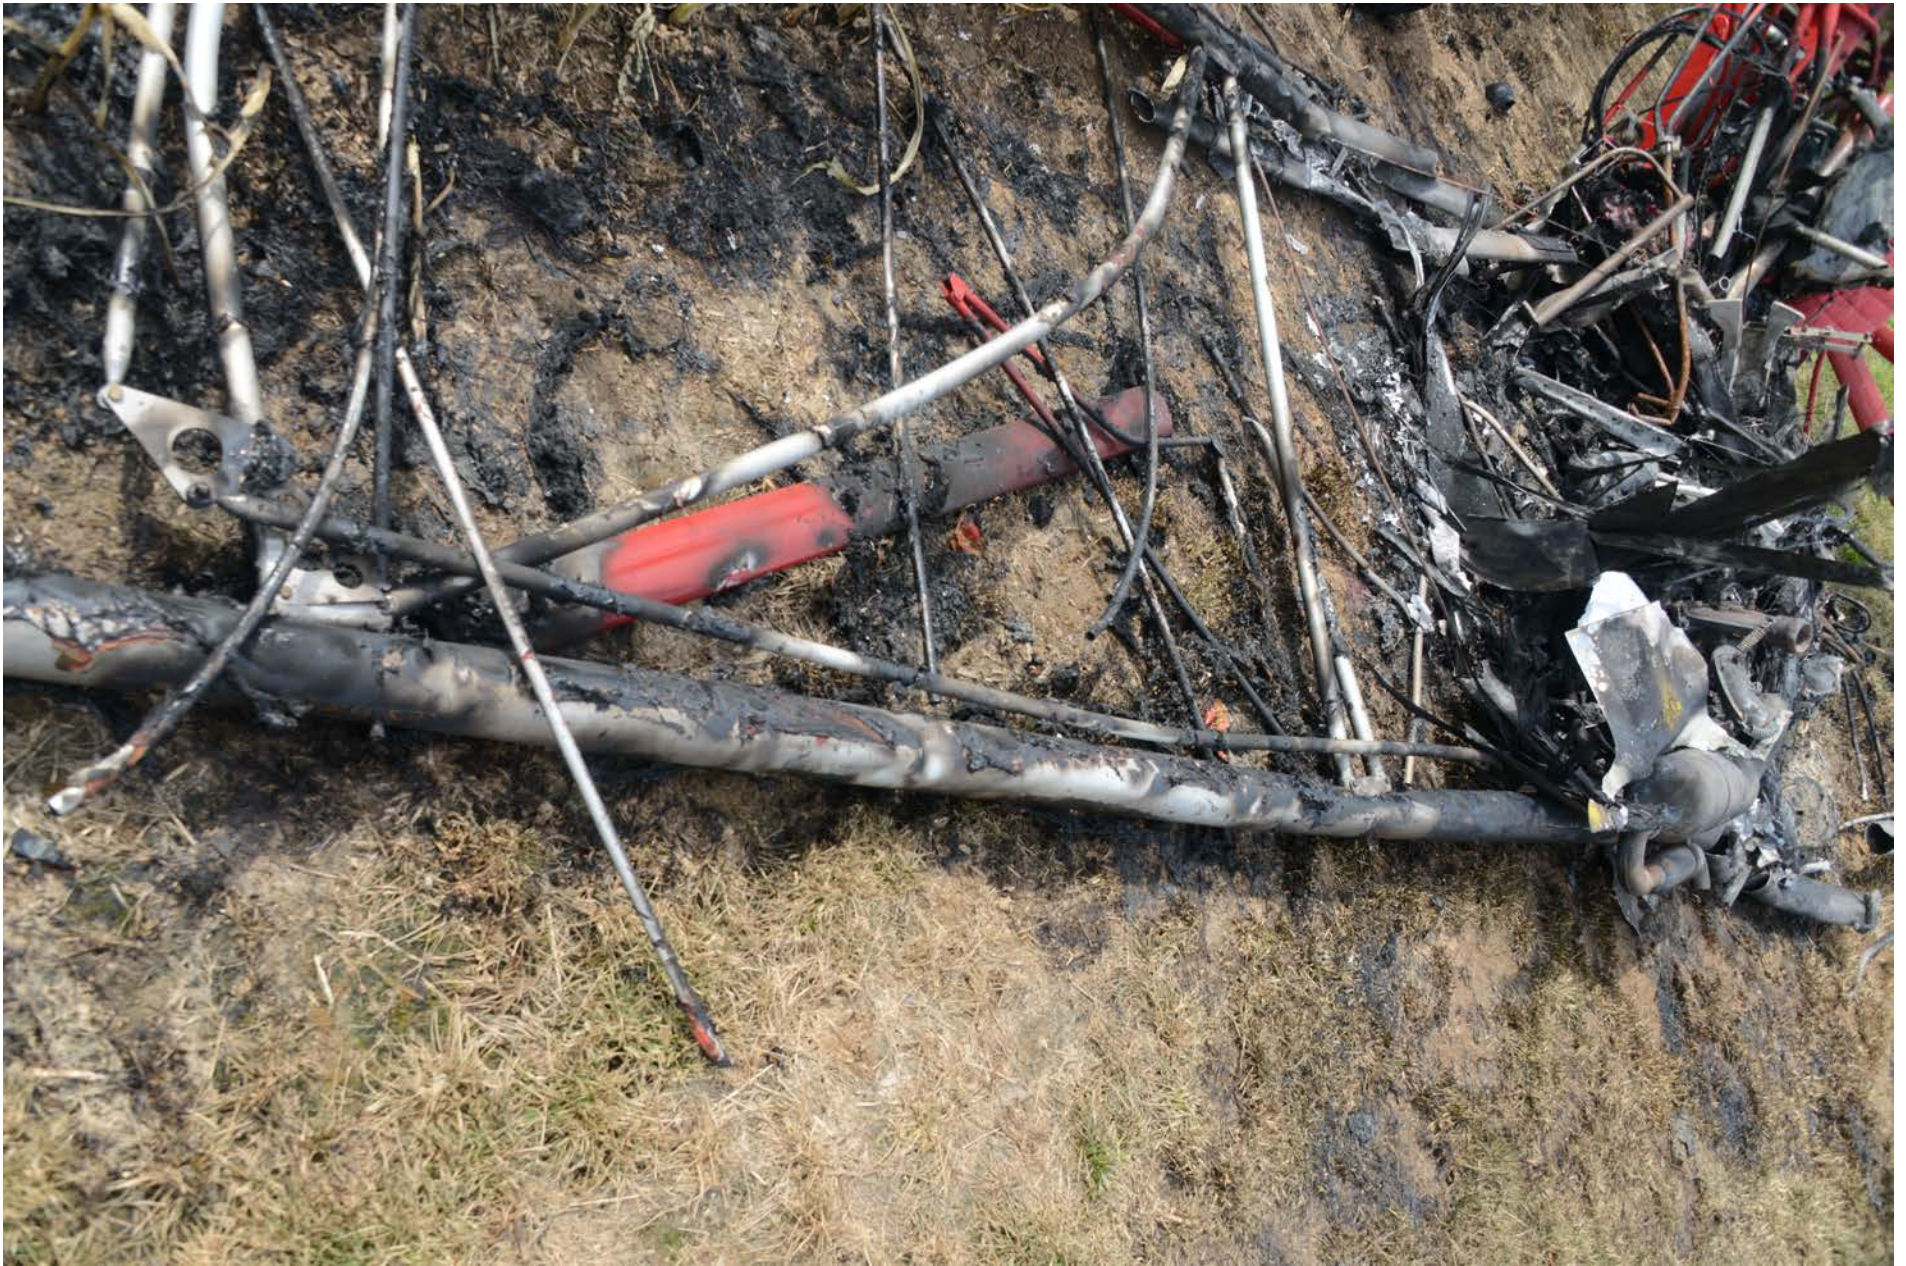
Photo 4 - Close-up view of the right wing showing the flight control tubes.

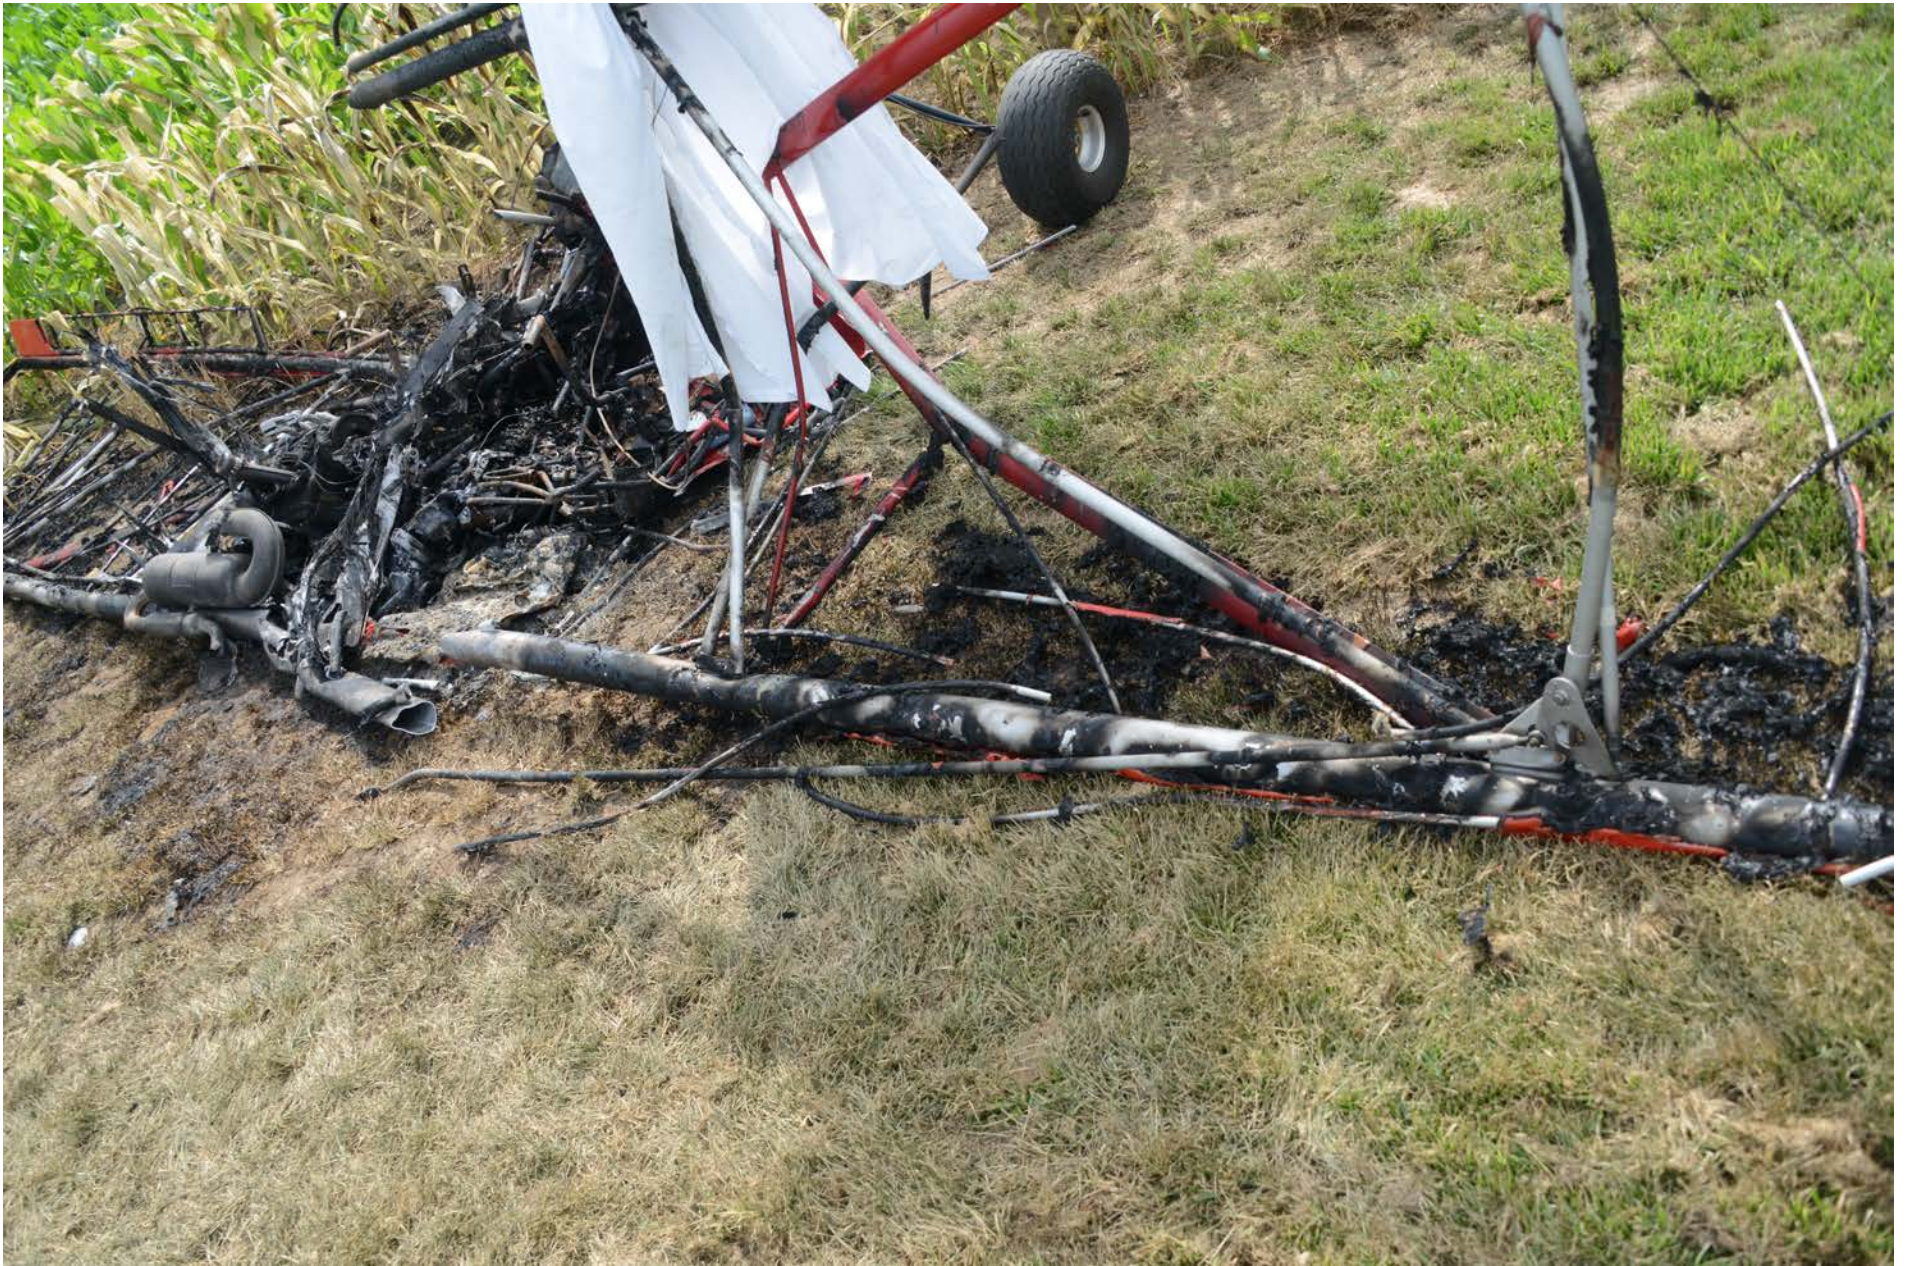
Photo 5 - Close-up view of the left wing showing the flight control tubes.

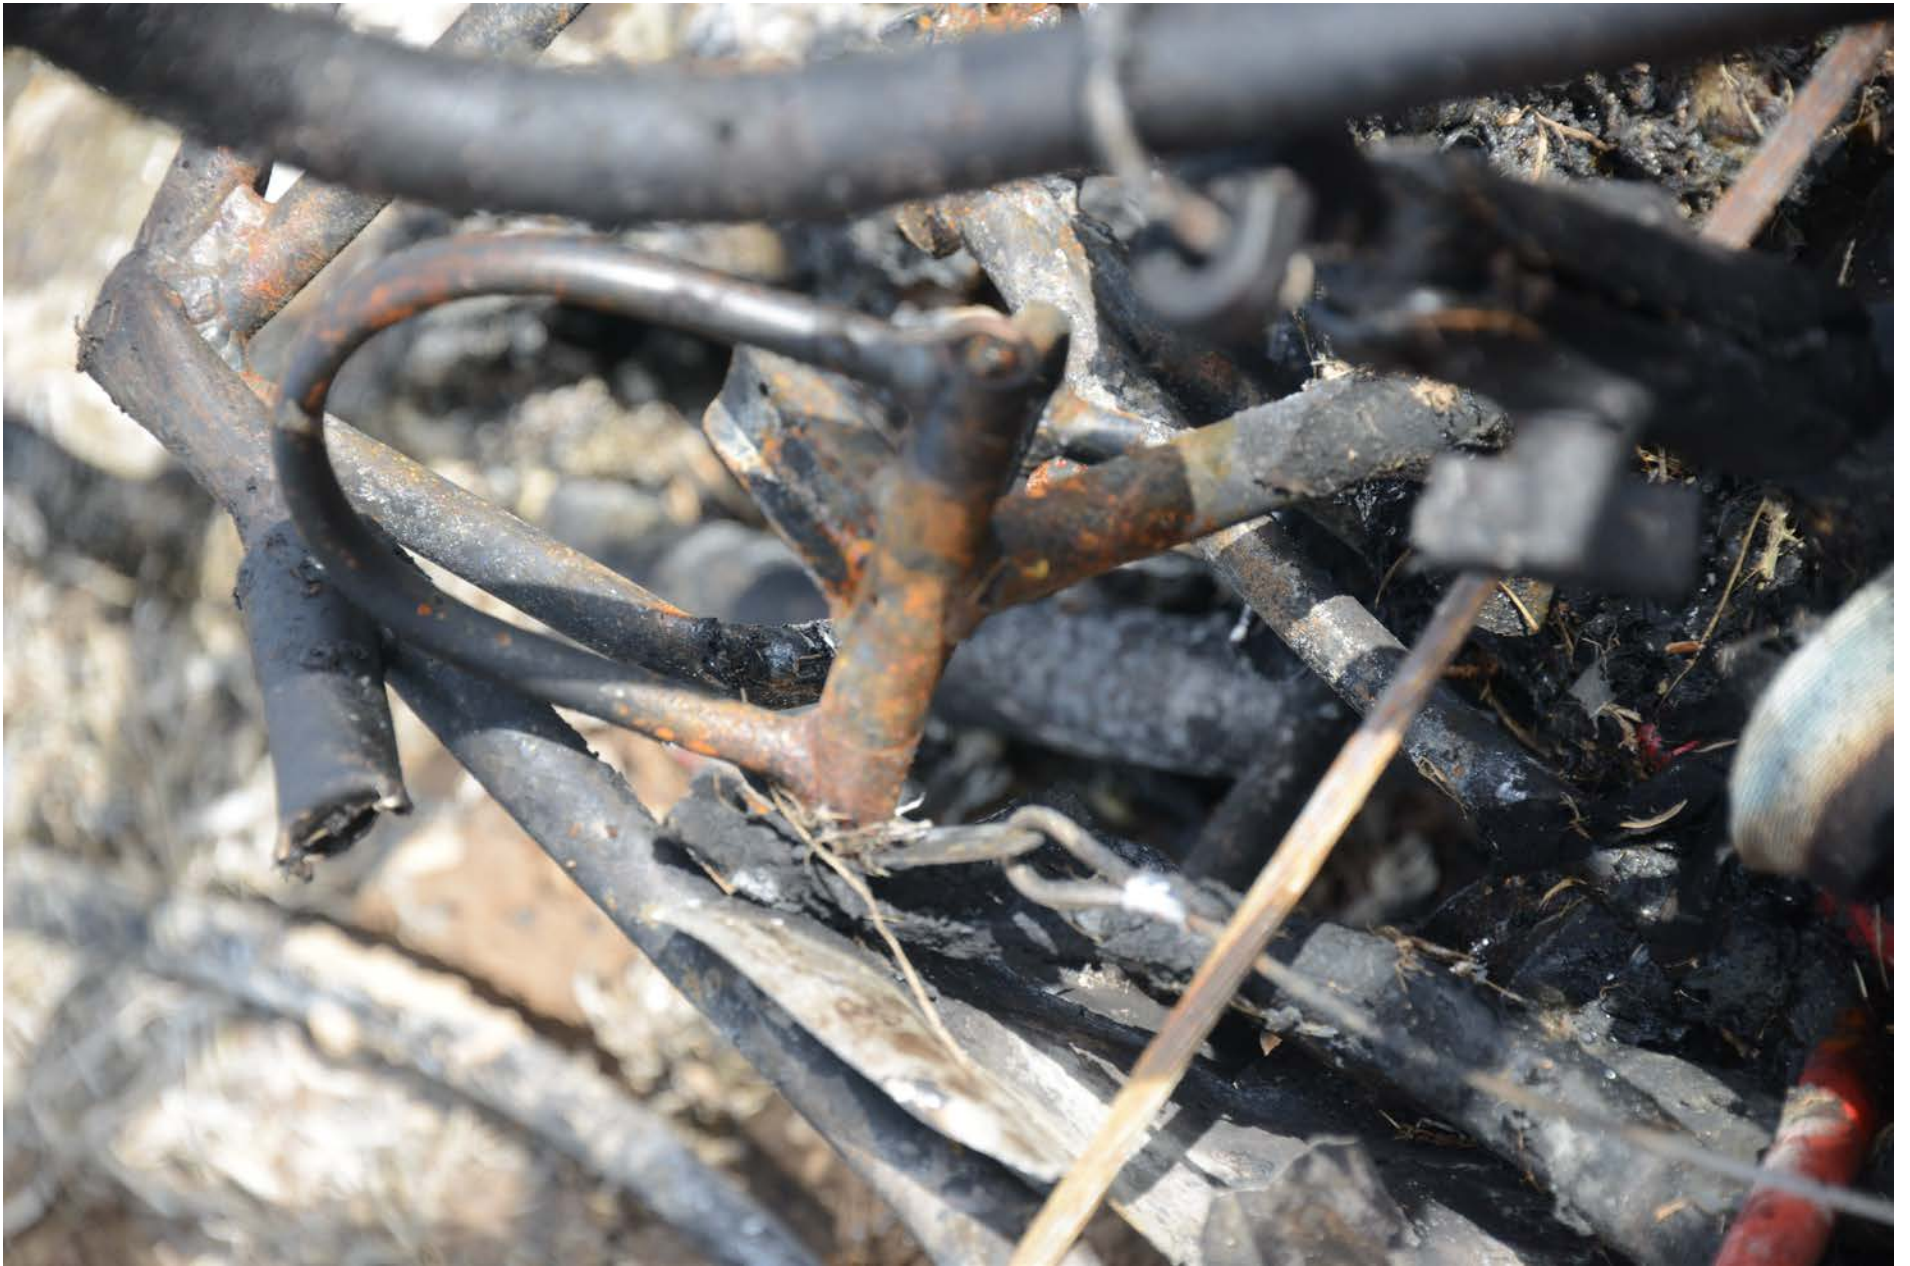
Photo 6 - Close-up view of a rudder pedal and connected rudder cable.

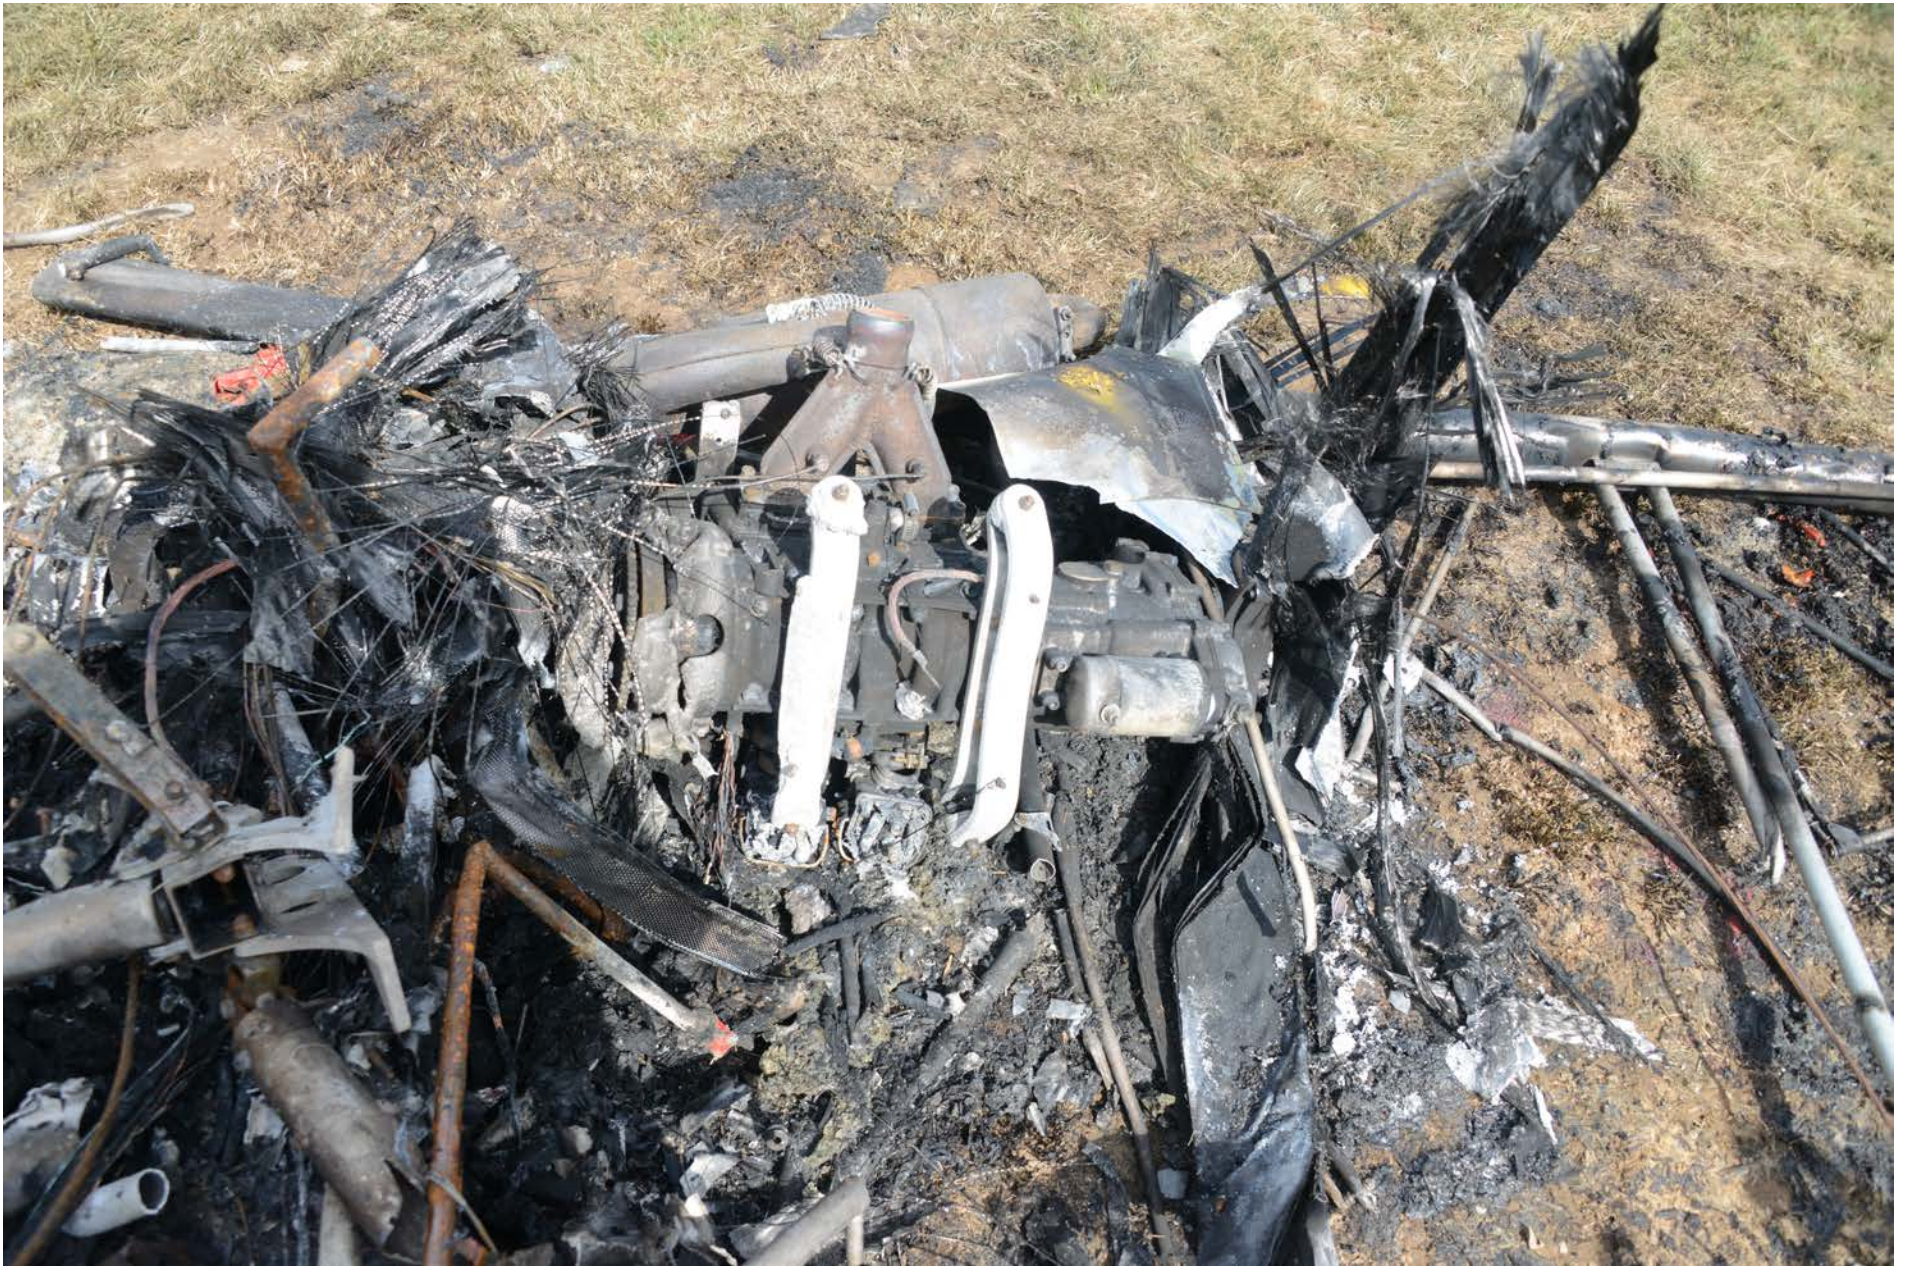
Photo 7 - Close-up view of the engine.

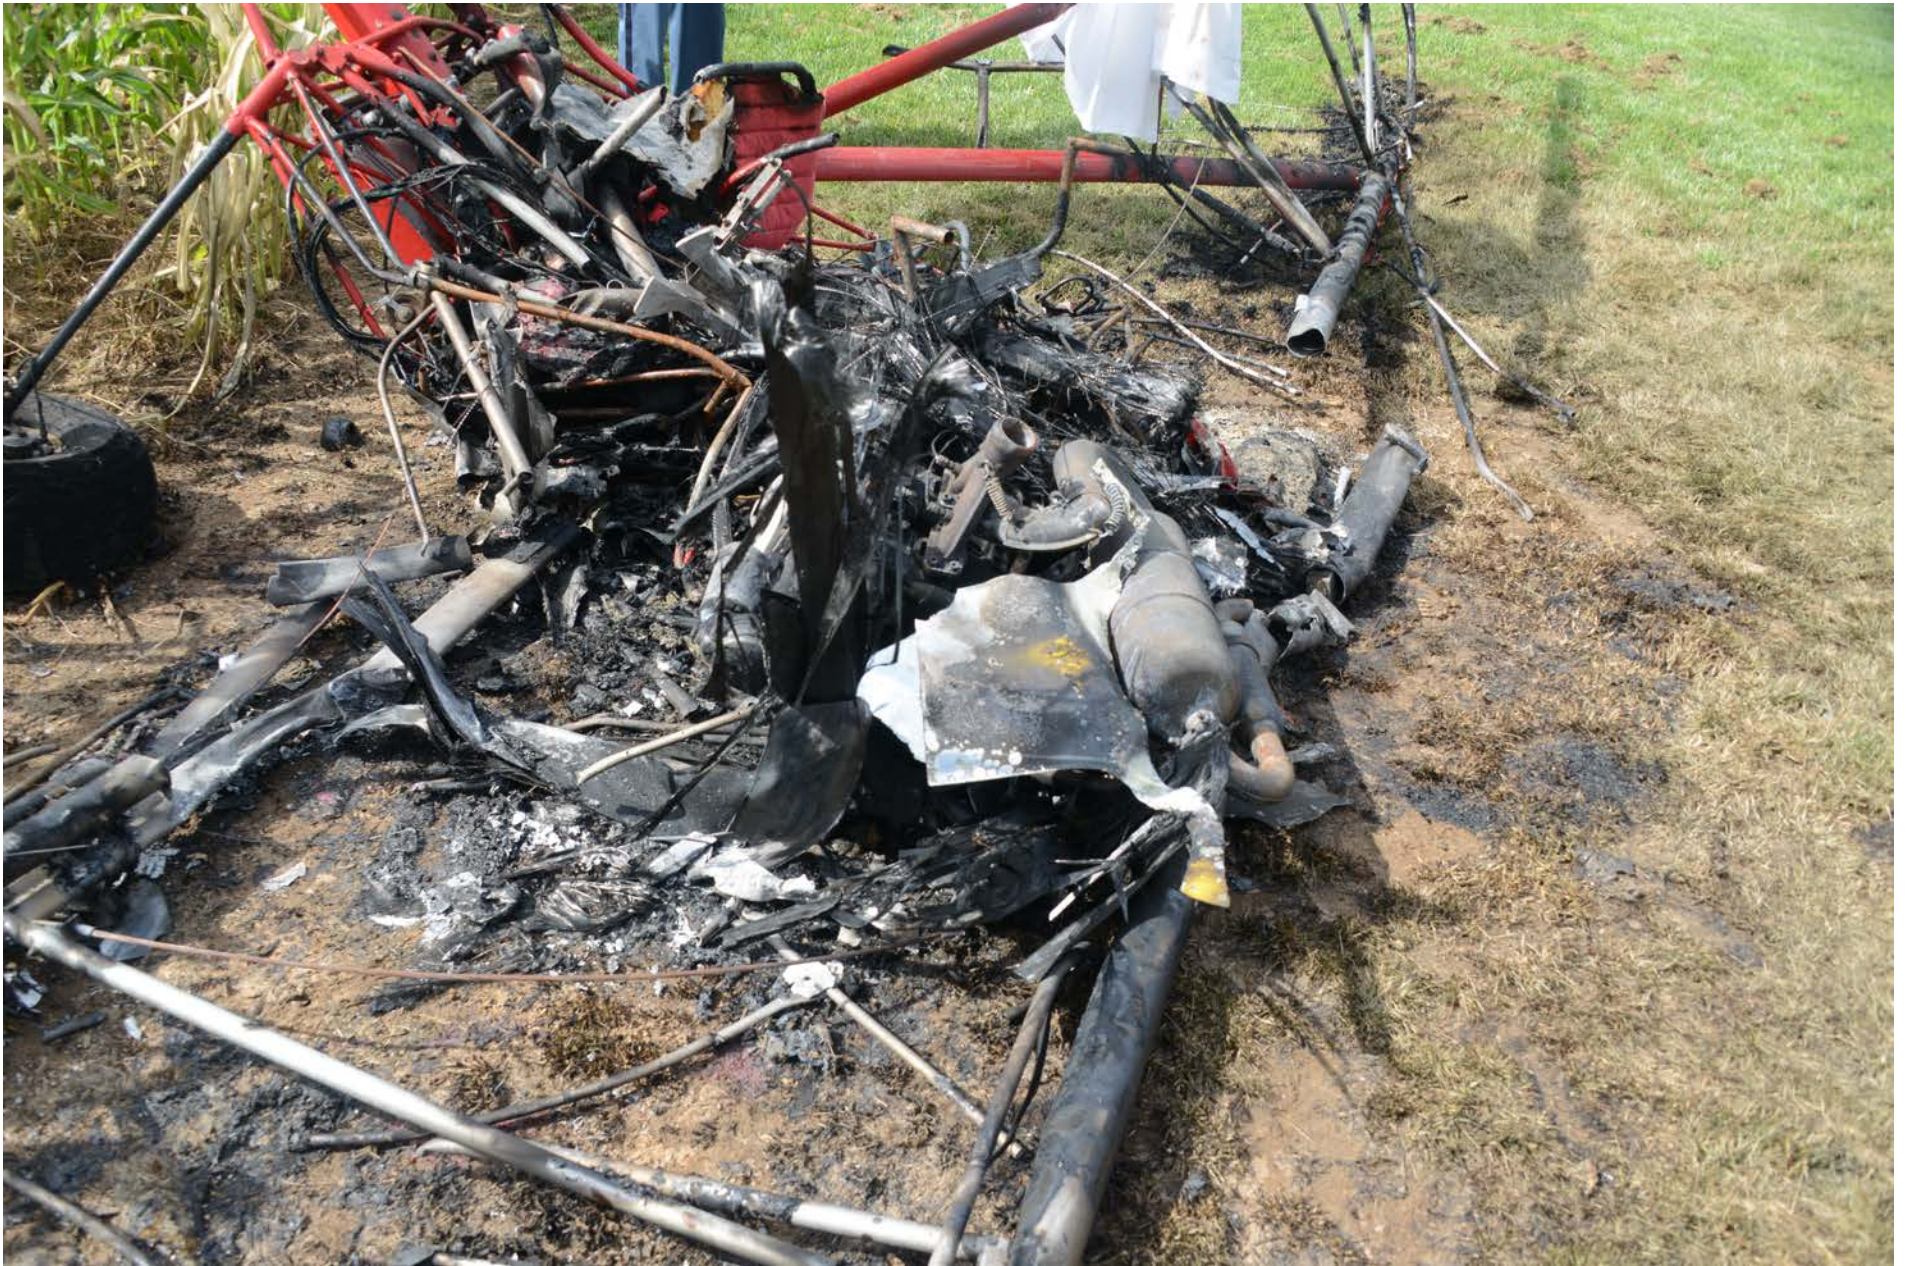
Photo 8 - Close-up view of the engine.

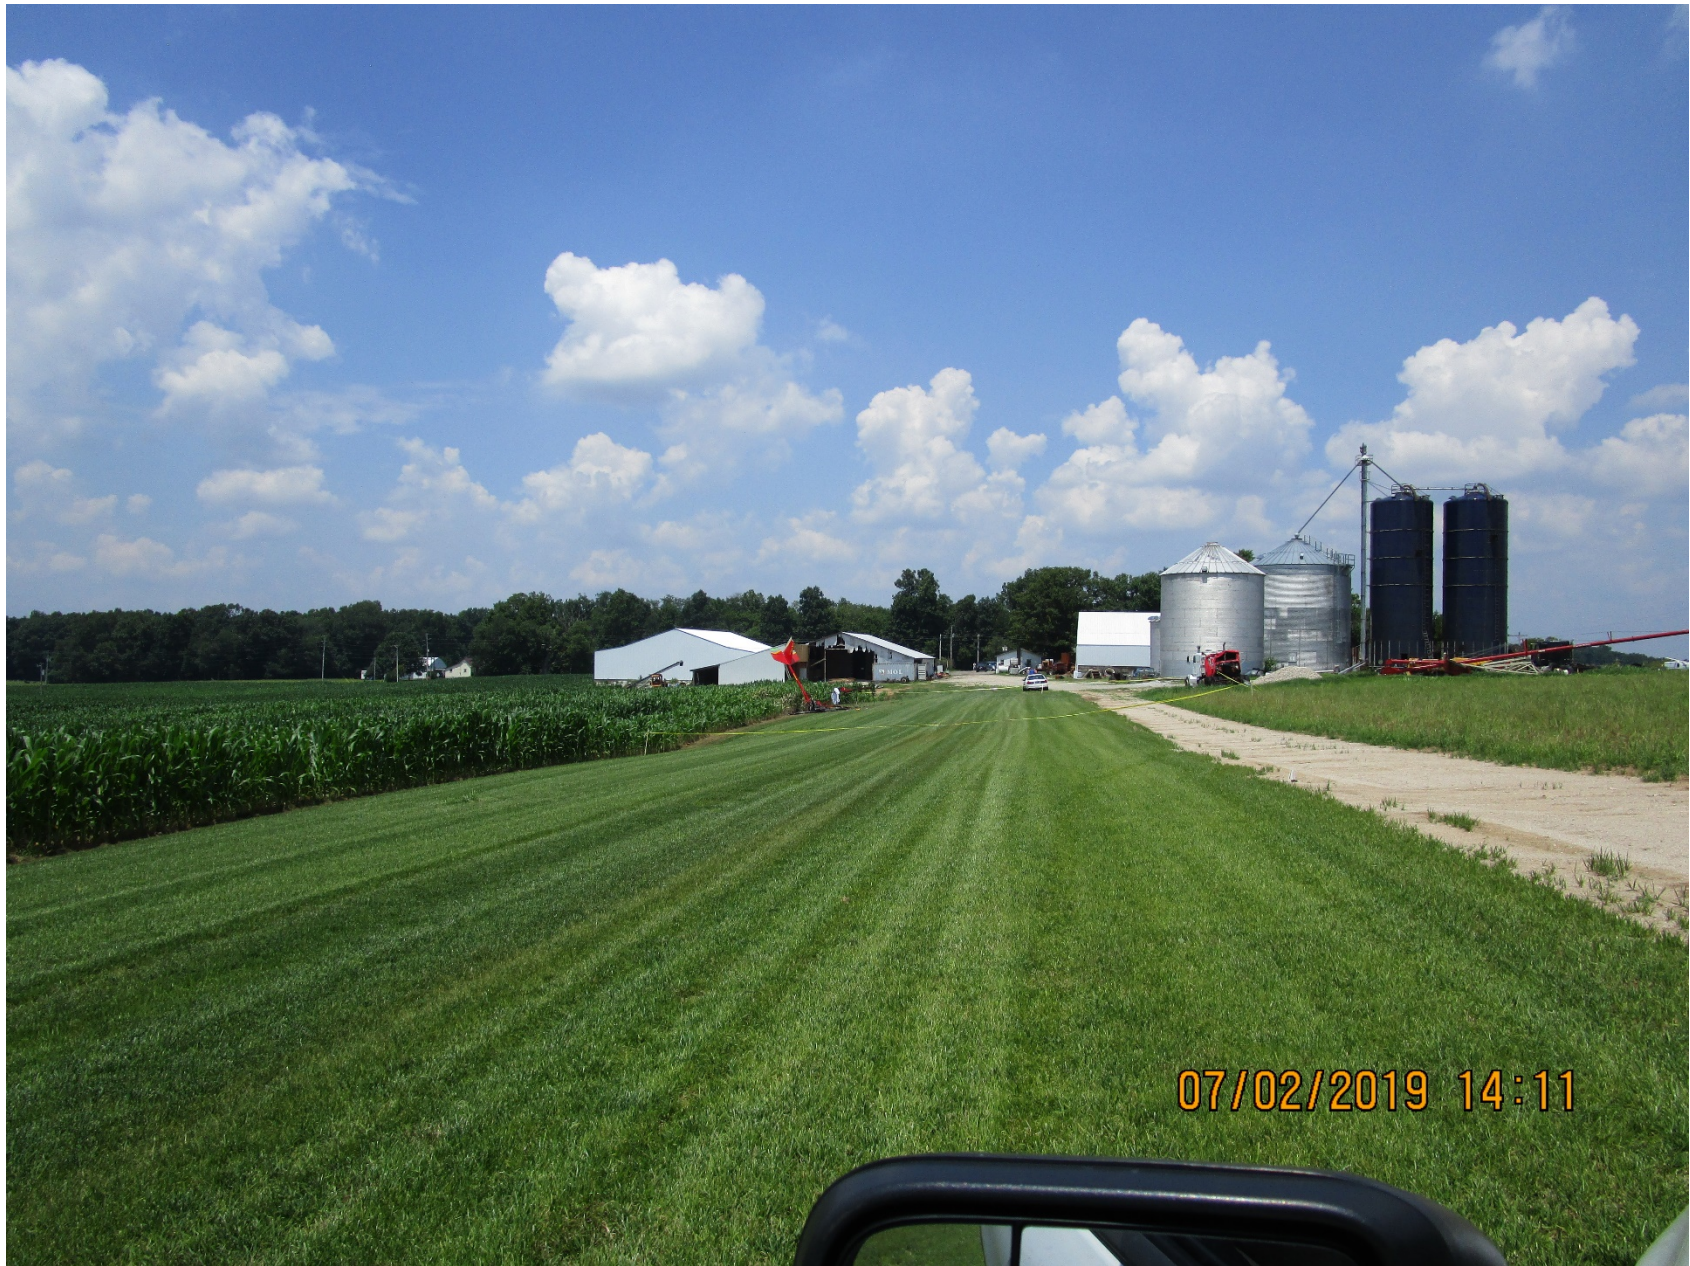
Photo 9 - FAA supplied view, to the north, of the runway and wreckage.

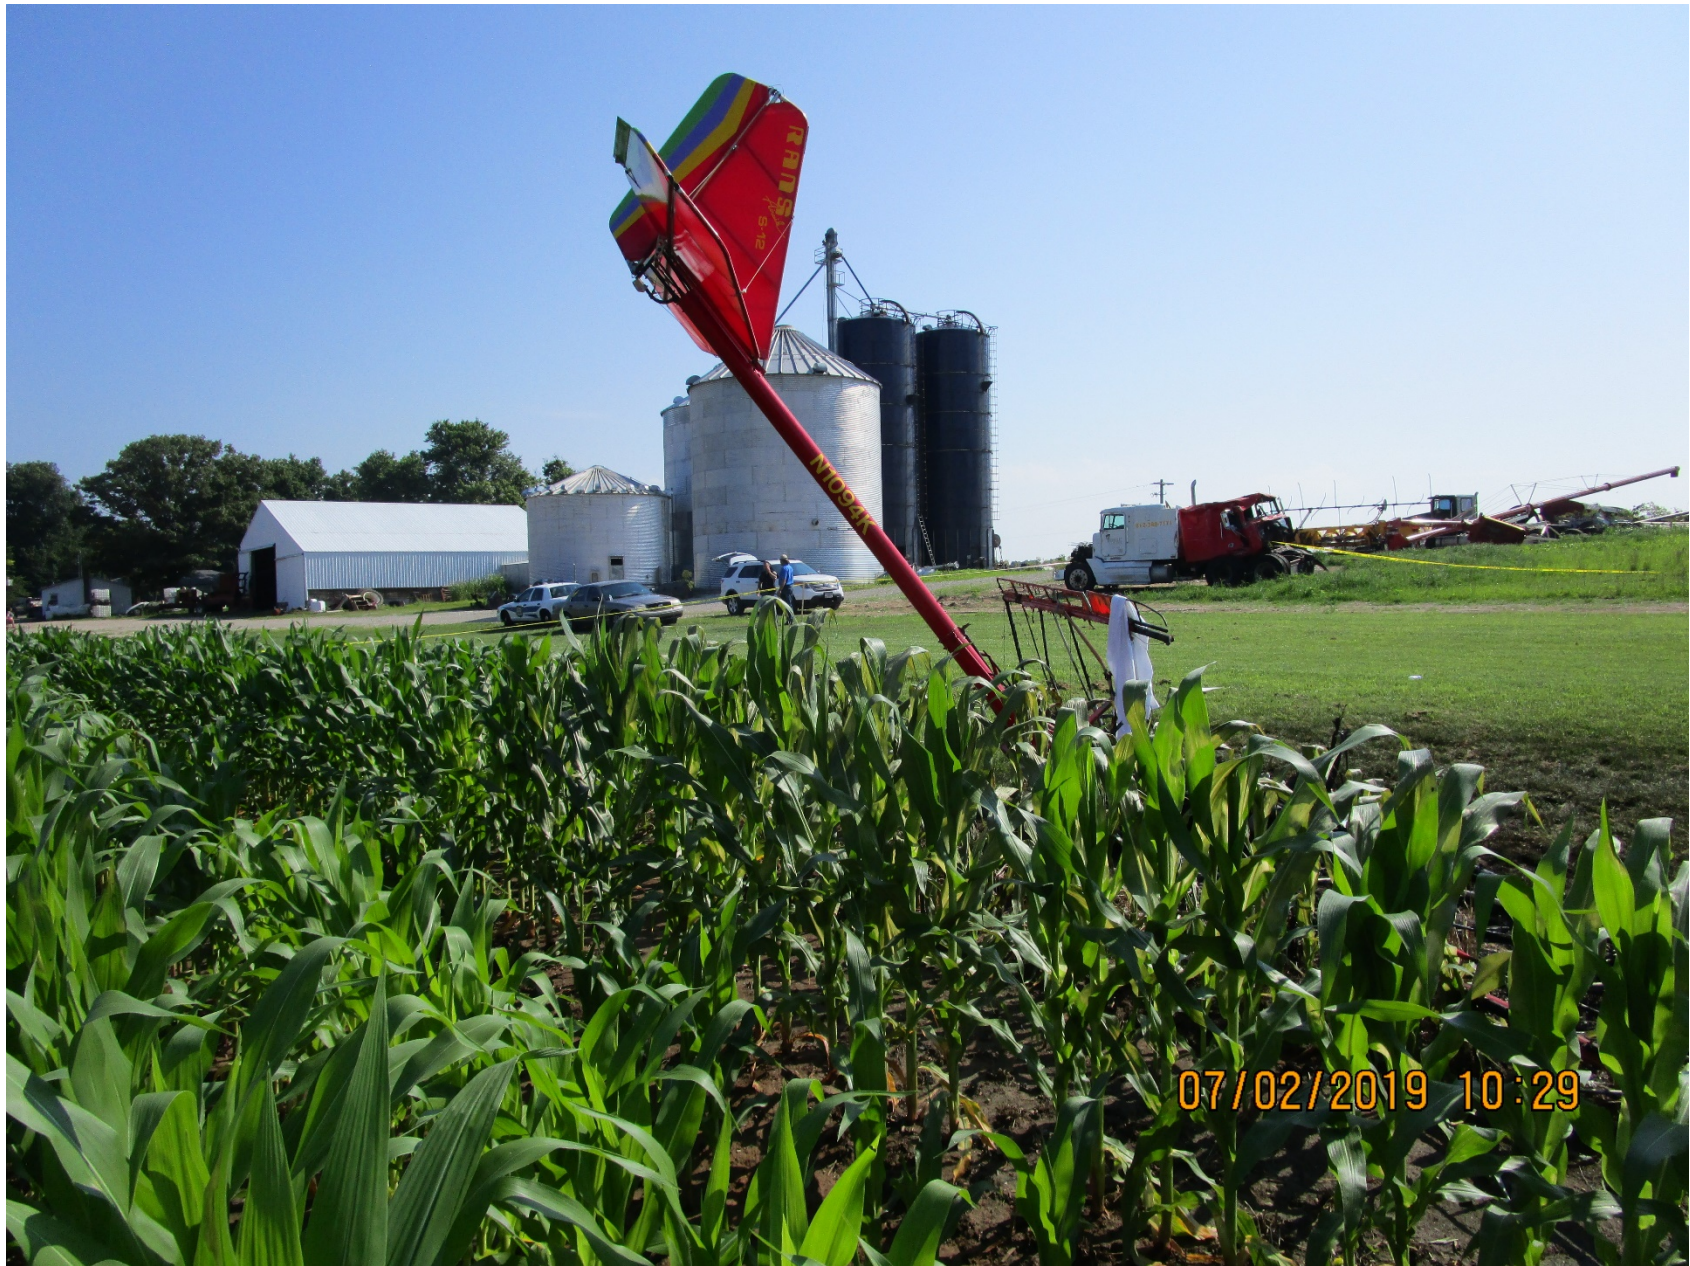
Photo 10 - FAA supplied view, to the east, of the wreckage.

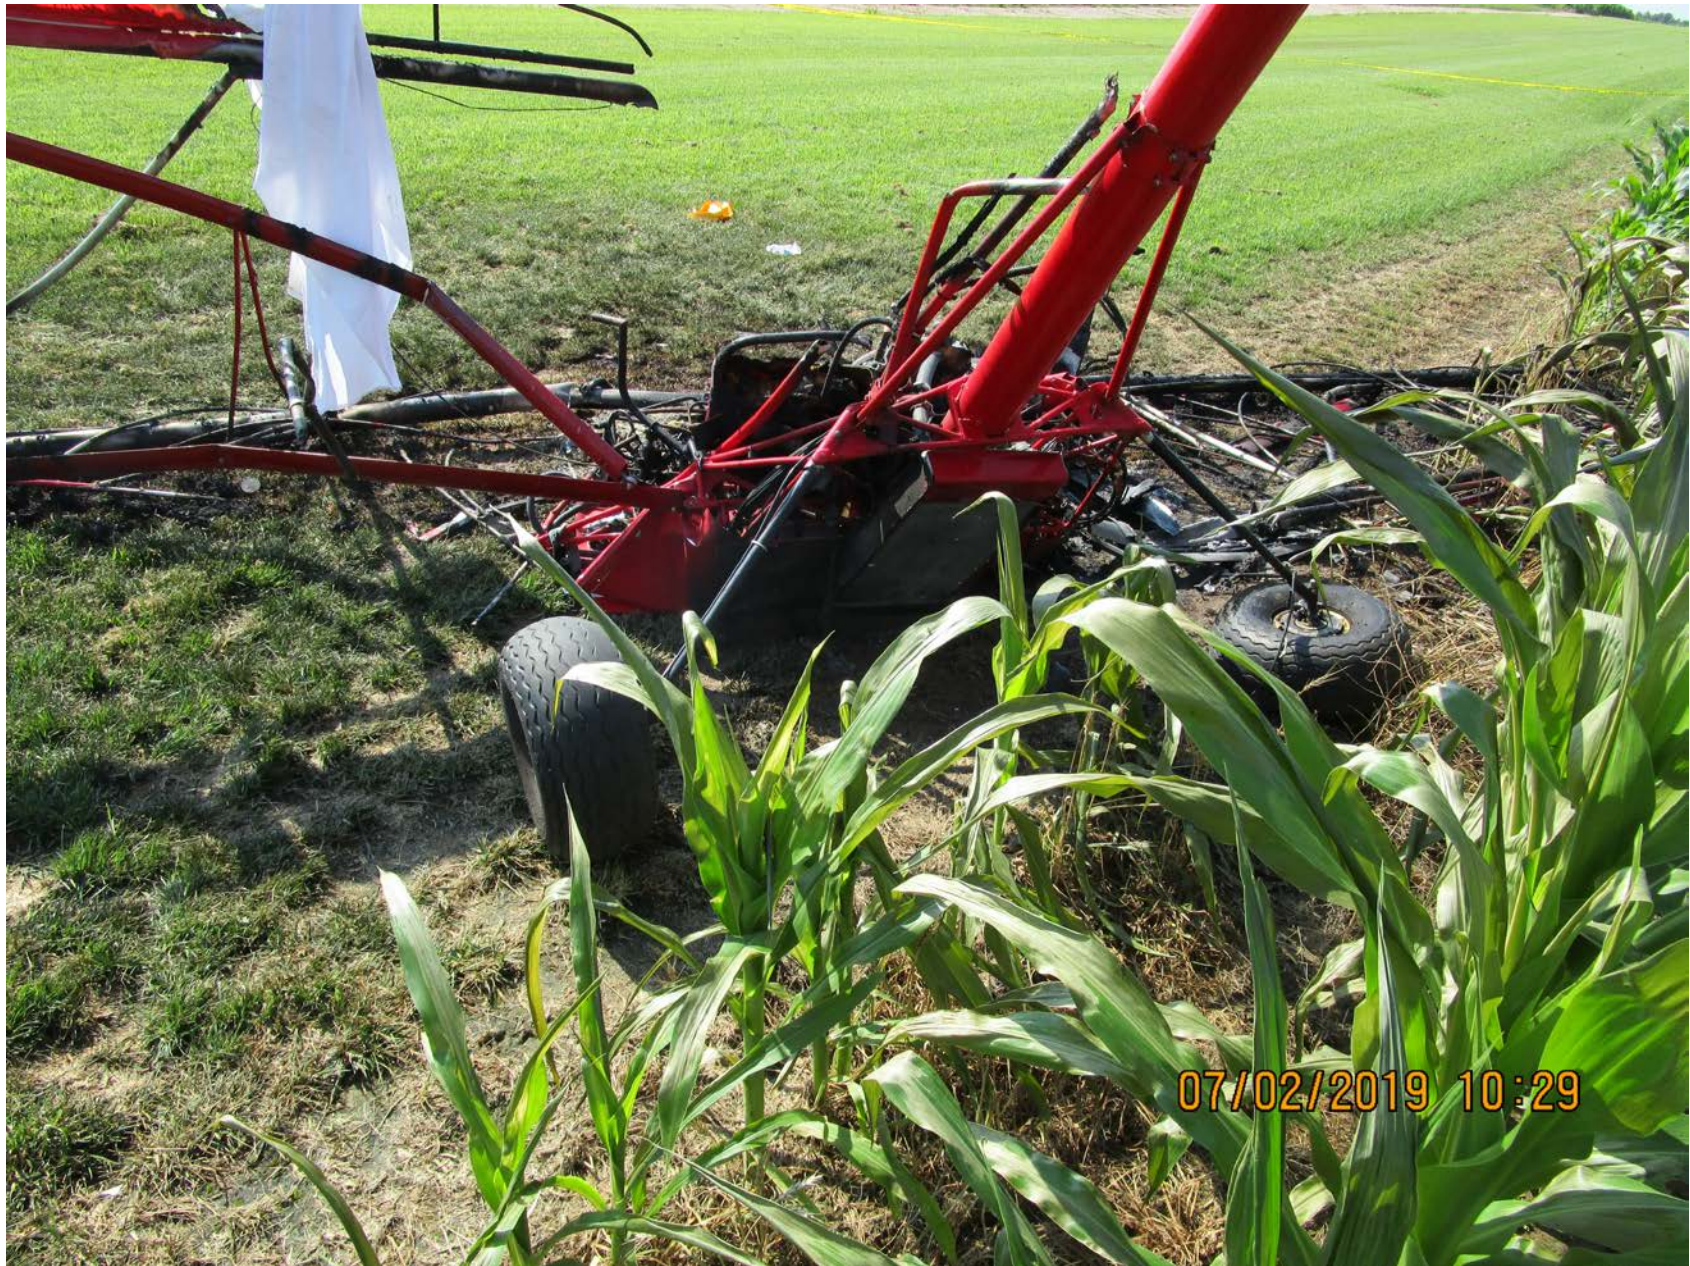
Photo 11 - FAA supplied close-up view of the fuselage and boom.
