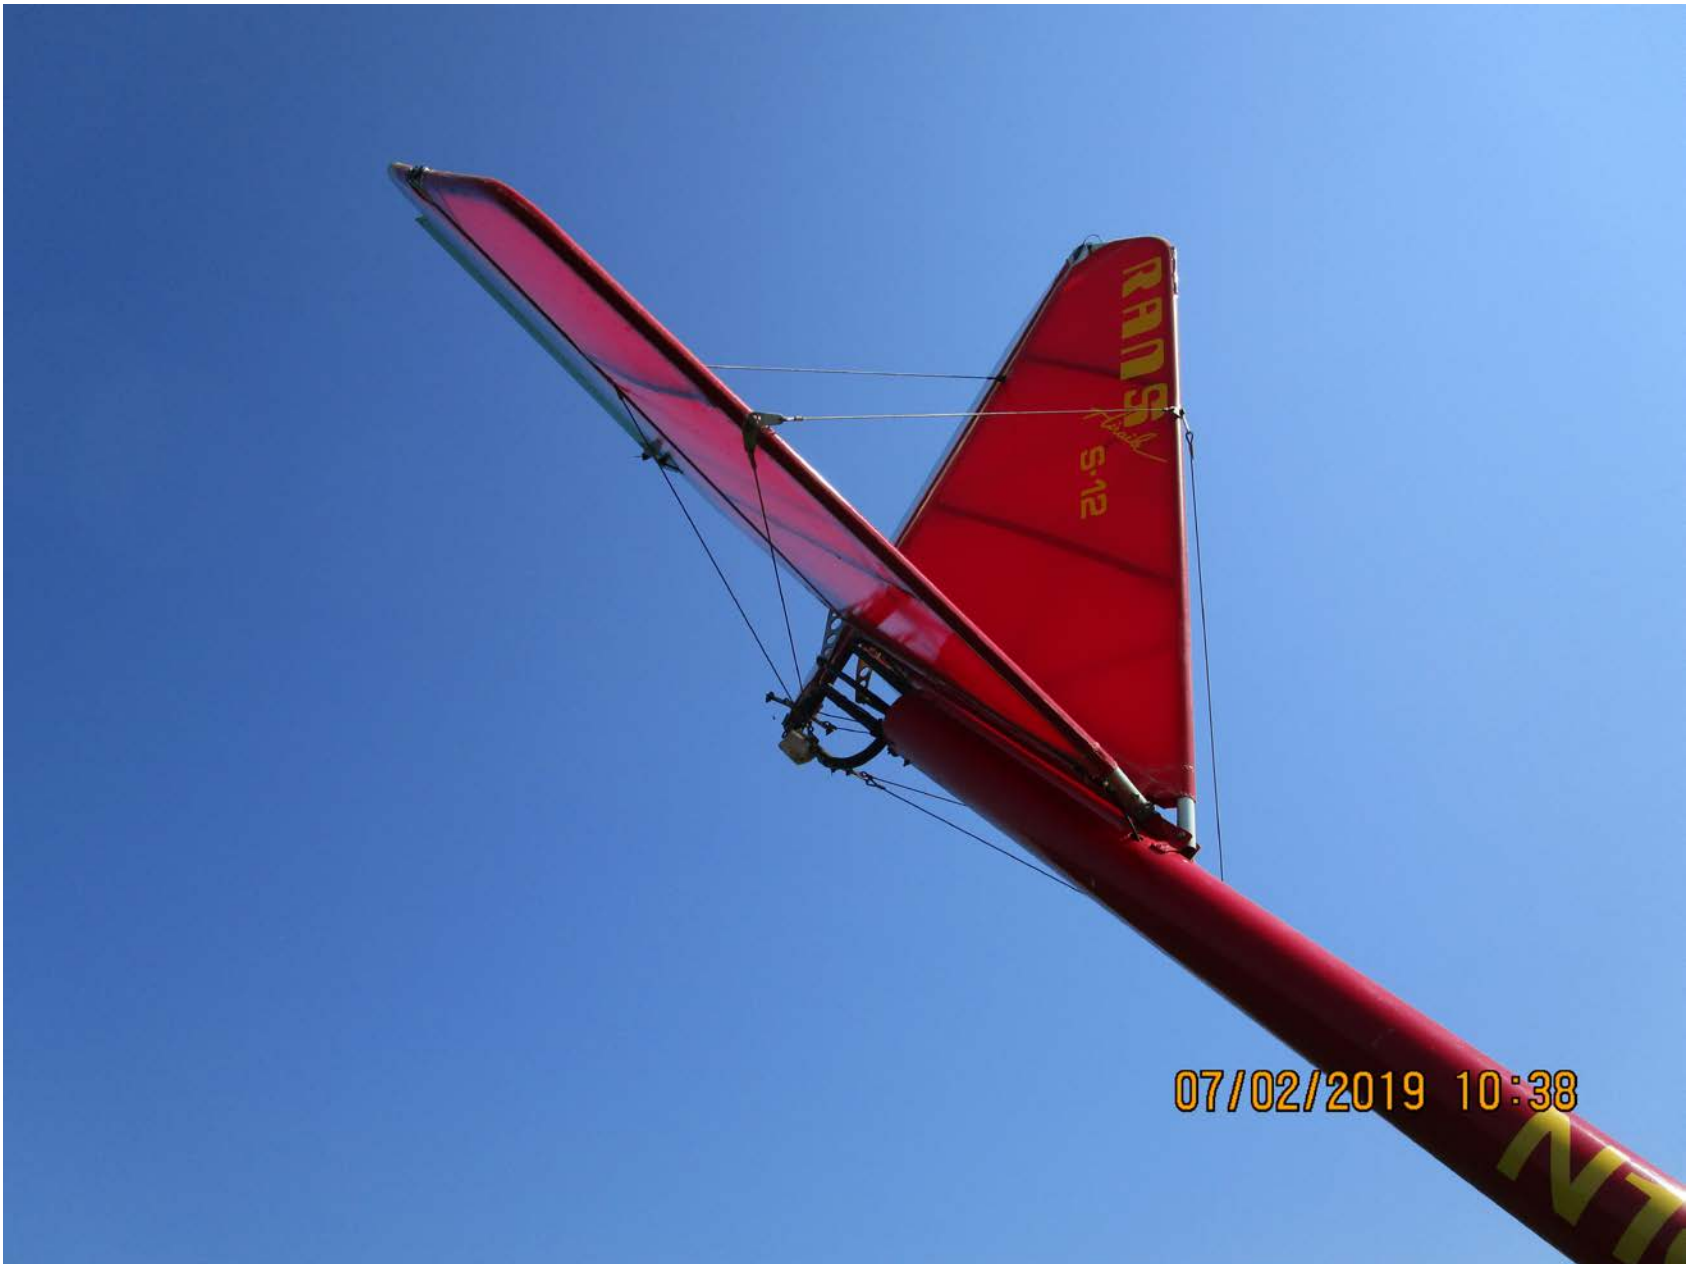
Photo 12 - FAA supplied close-up view of the right side of the empennage.

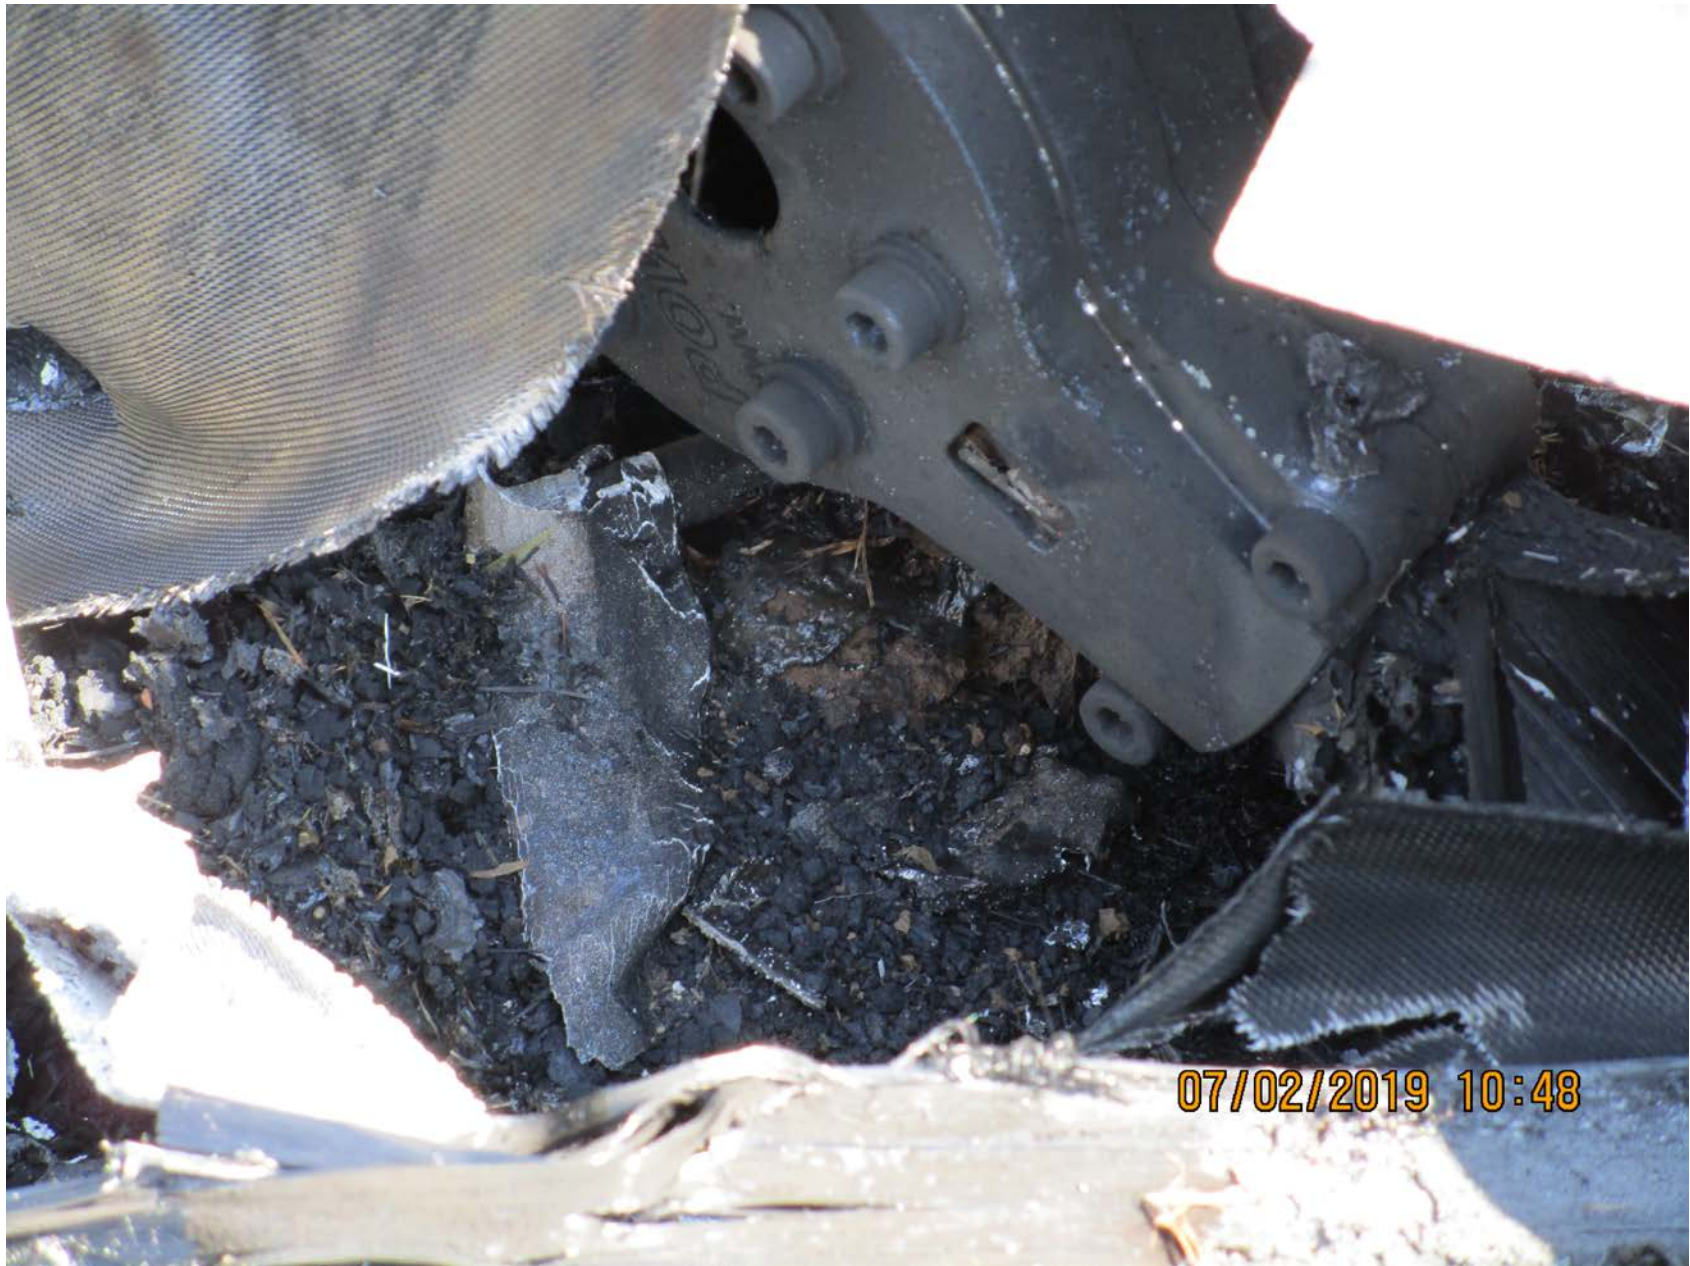
Photo 13 - FAA supplied close-up view of the propeller hub.

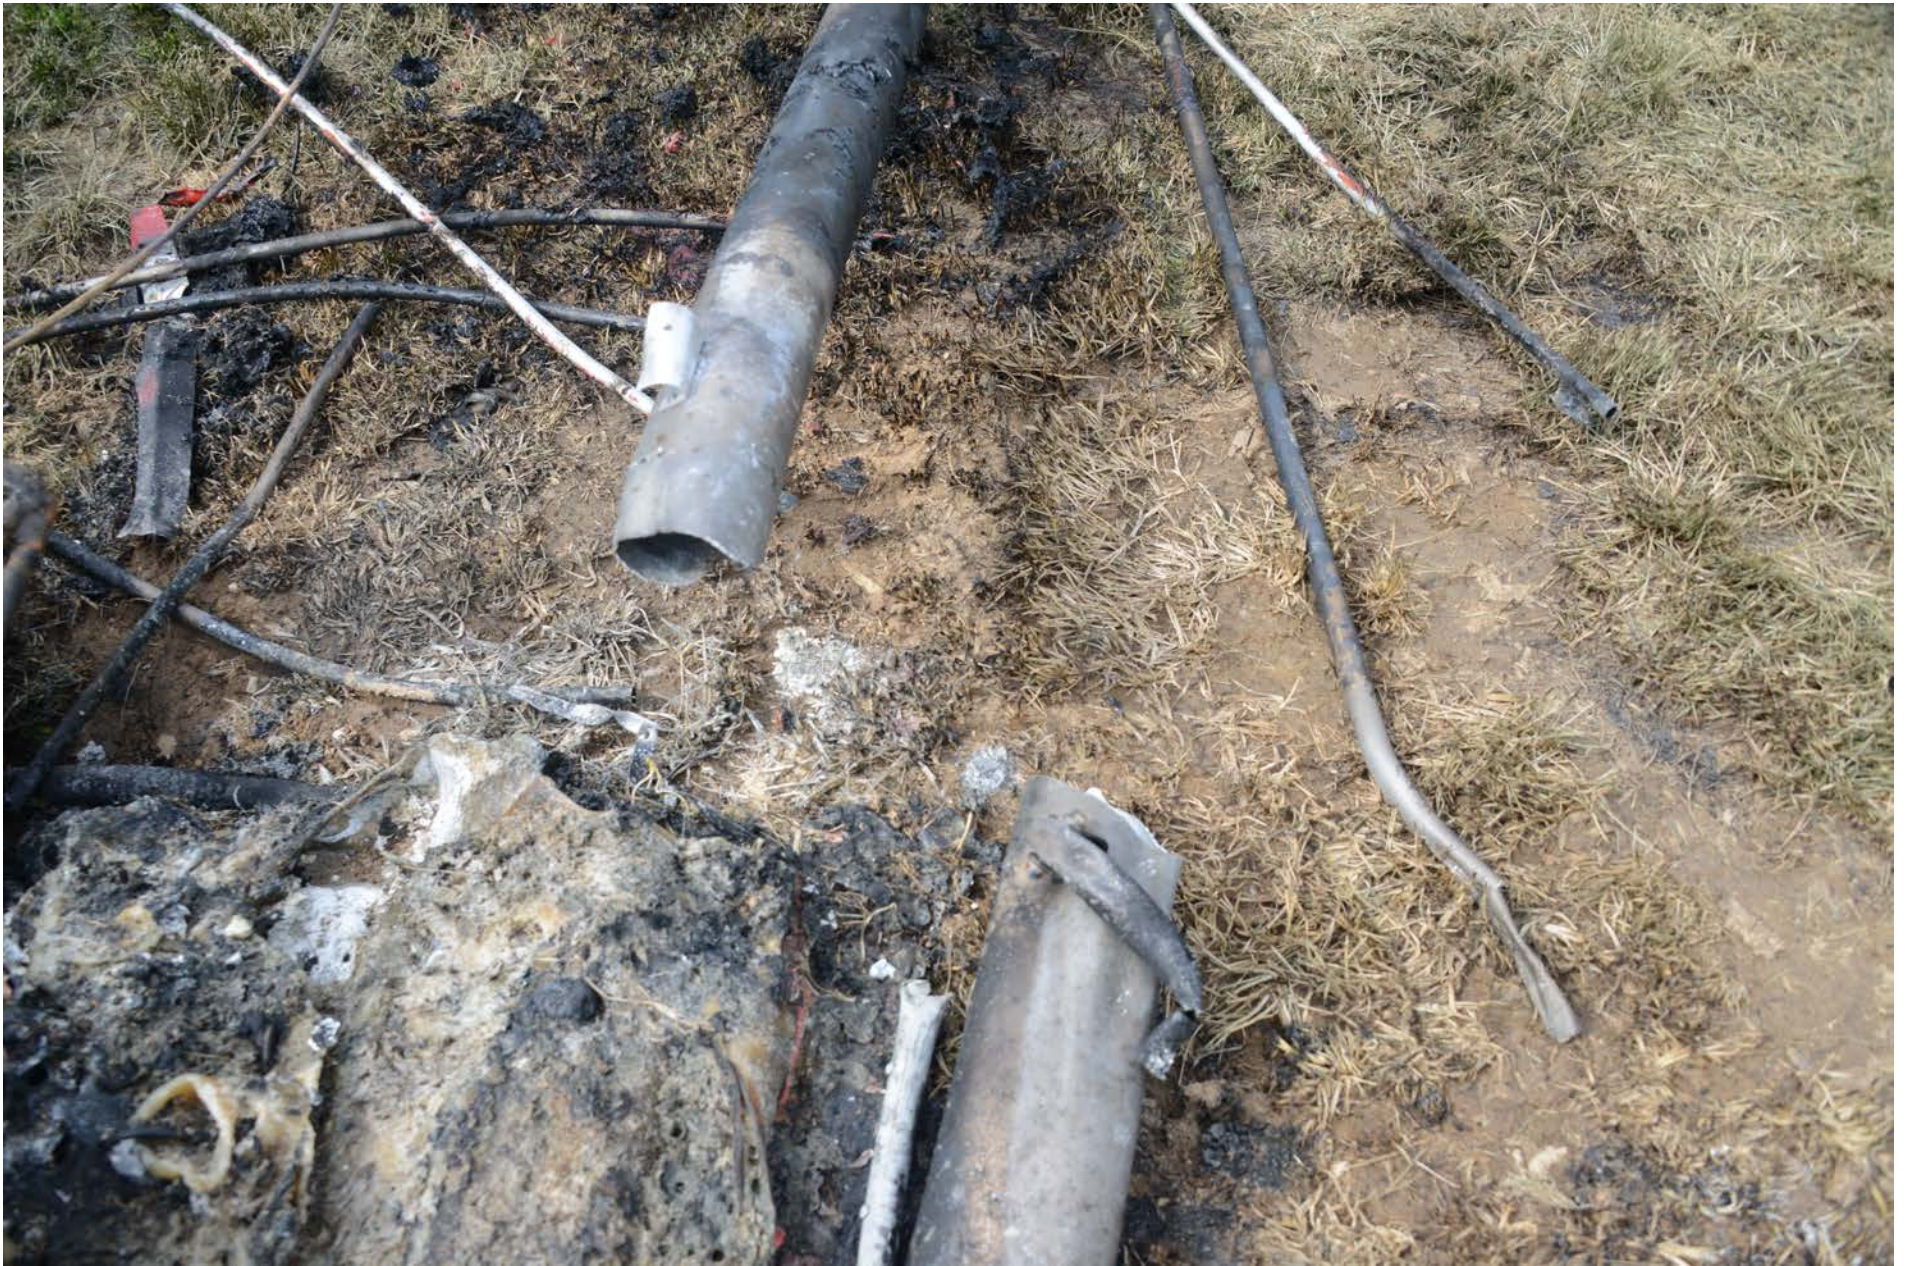
Photo 14 - Close-up view of a separation in the left wing spar. The separation surfaces exhibit an appearance consistent with overload.

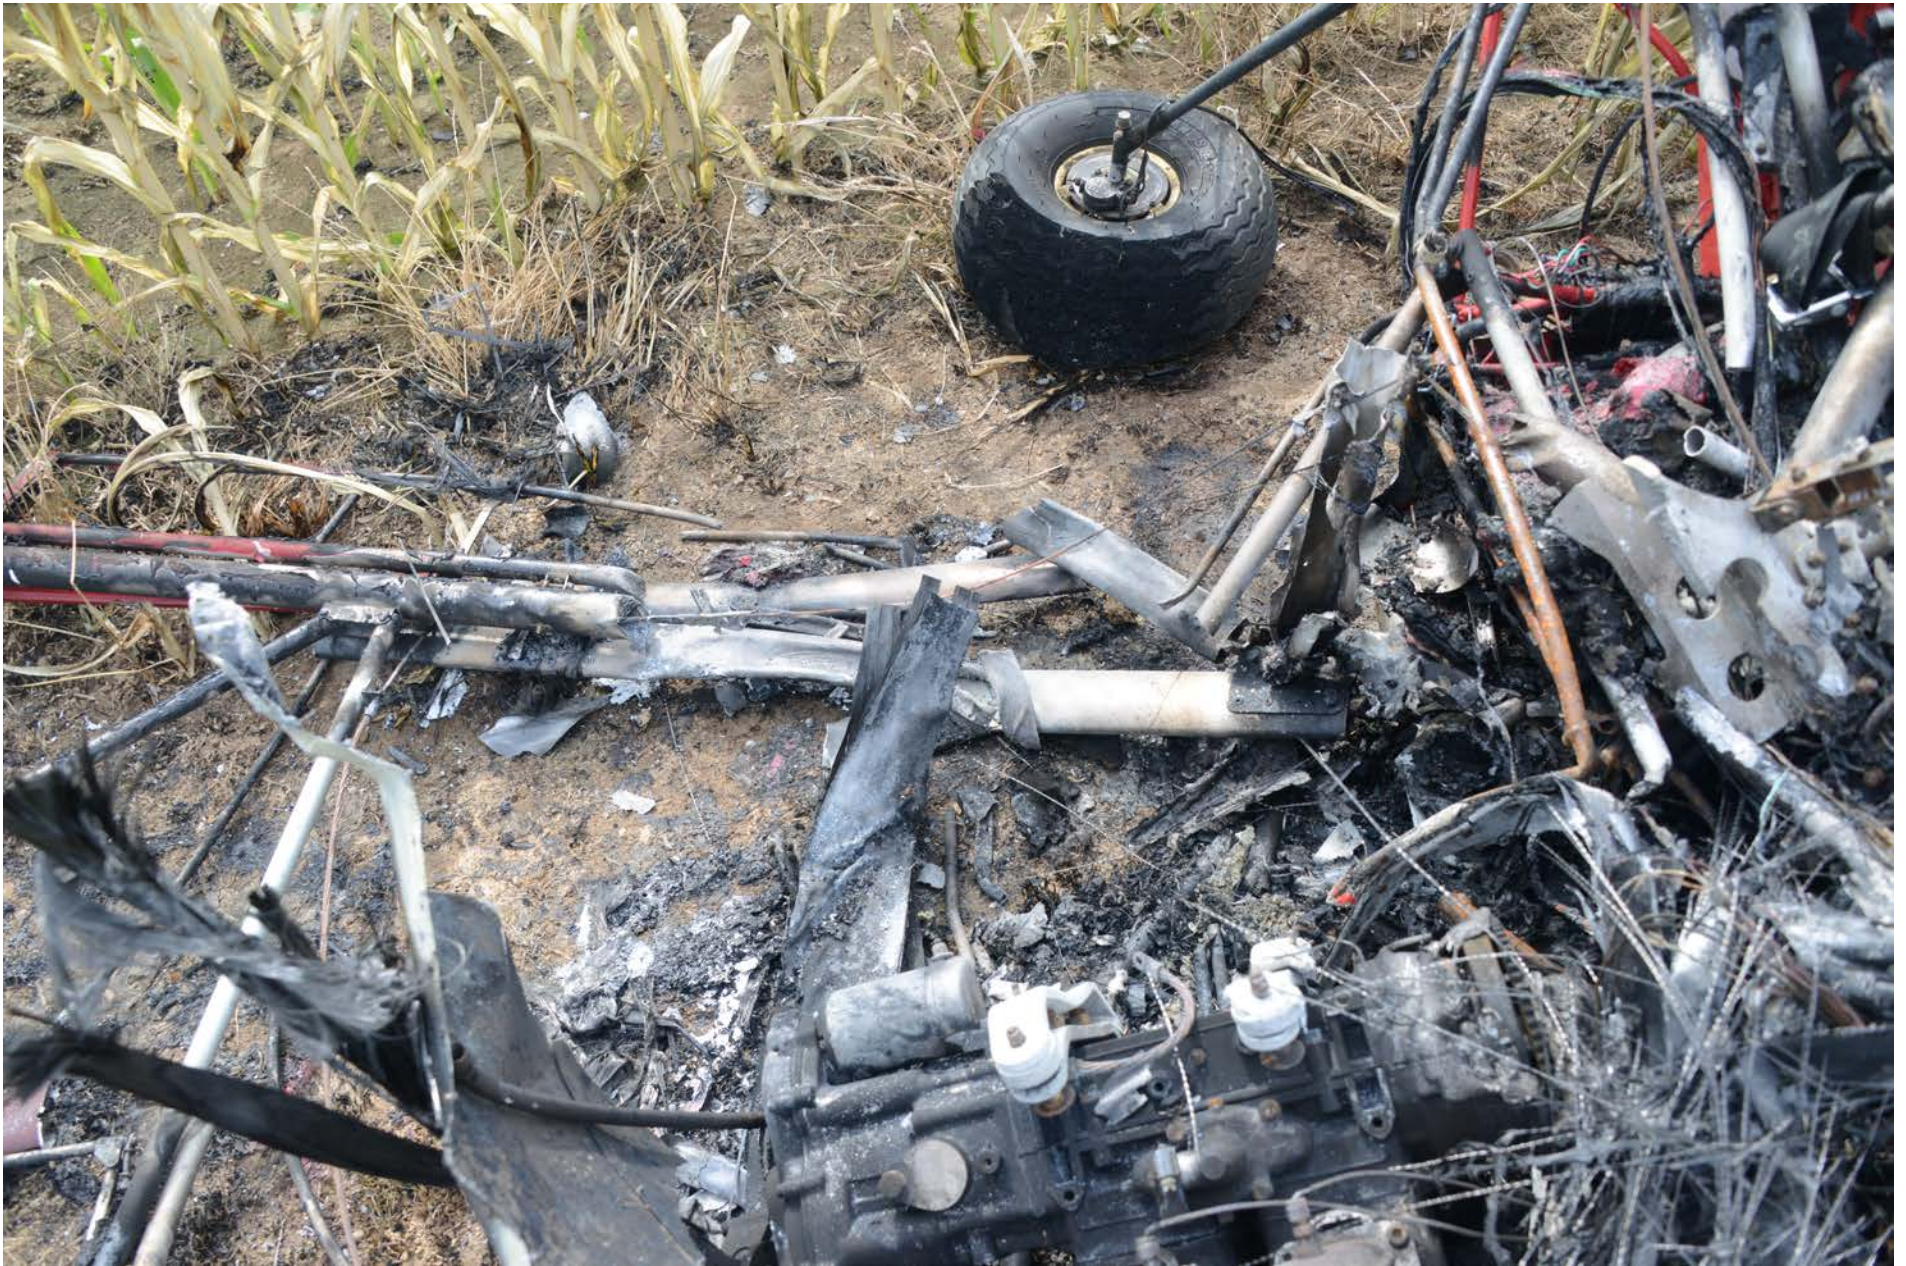
Photo 15 - Close-up view of a separation in the right wing. The separation surfaces exhibit an appearance consistent with overload and with thermal damage.

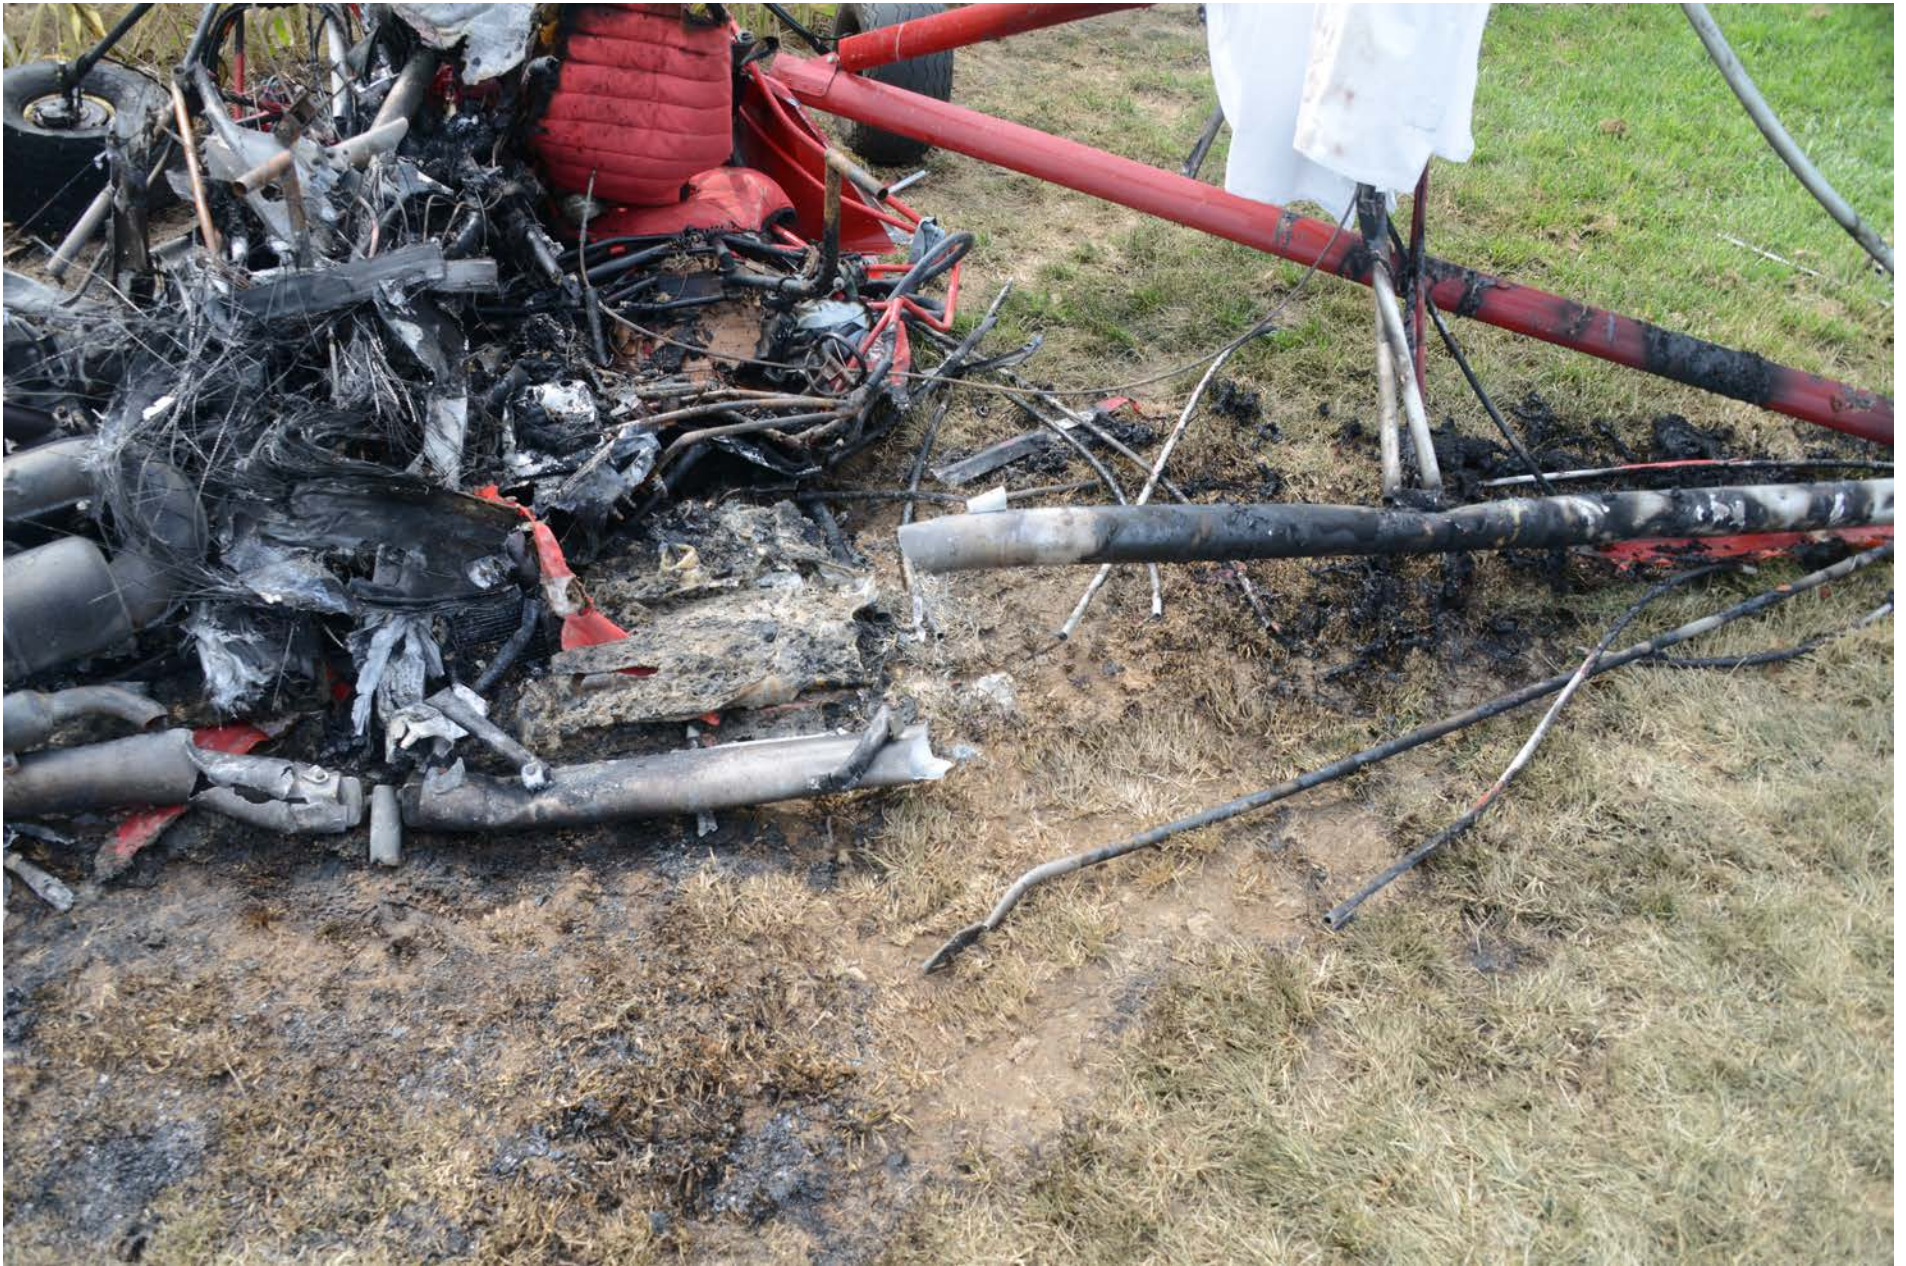
Photo 16 - Close-up view of a separation in the left wing. The separation surfaces exhibit an appearance consistent with overload.

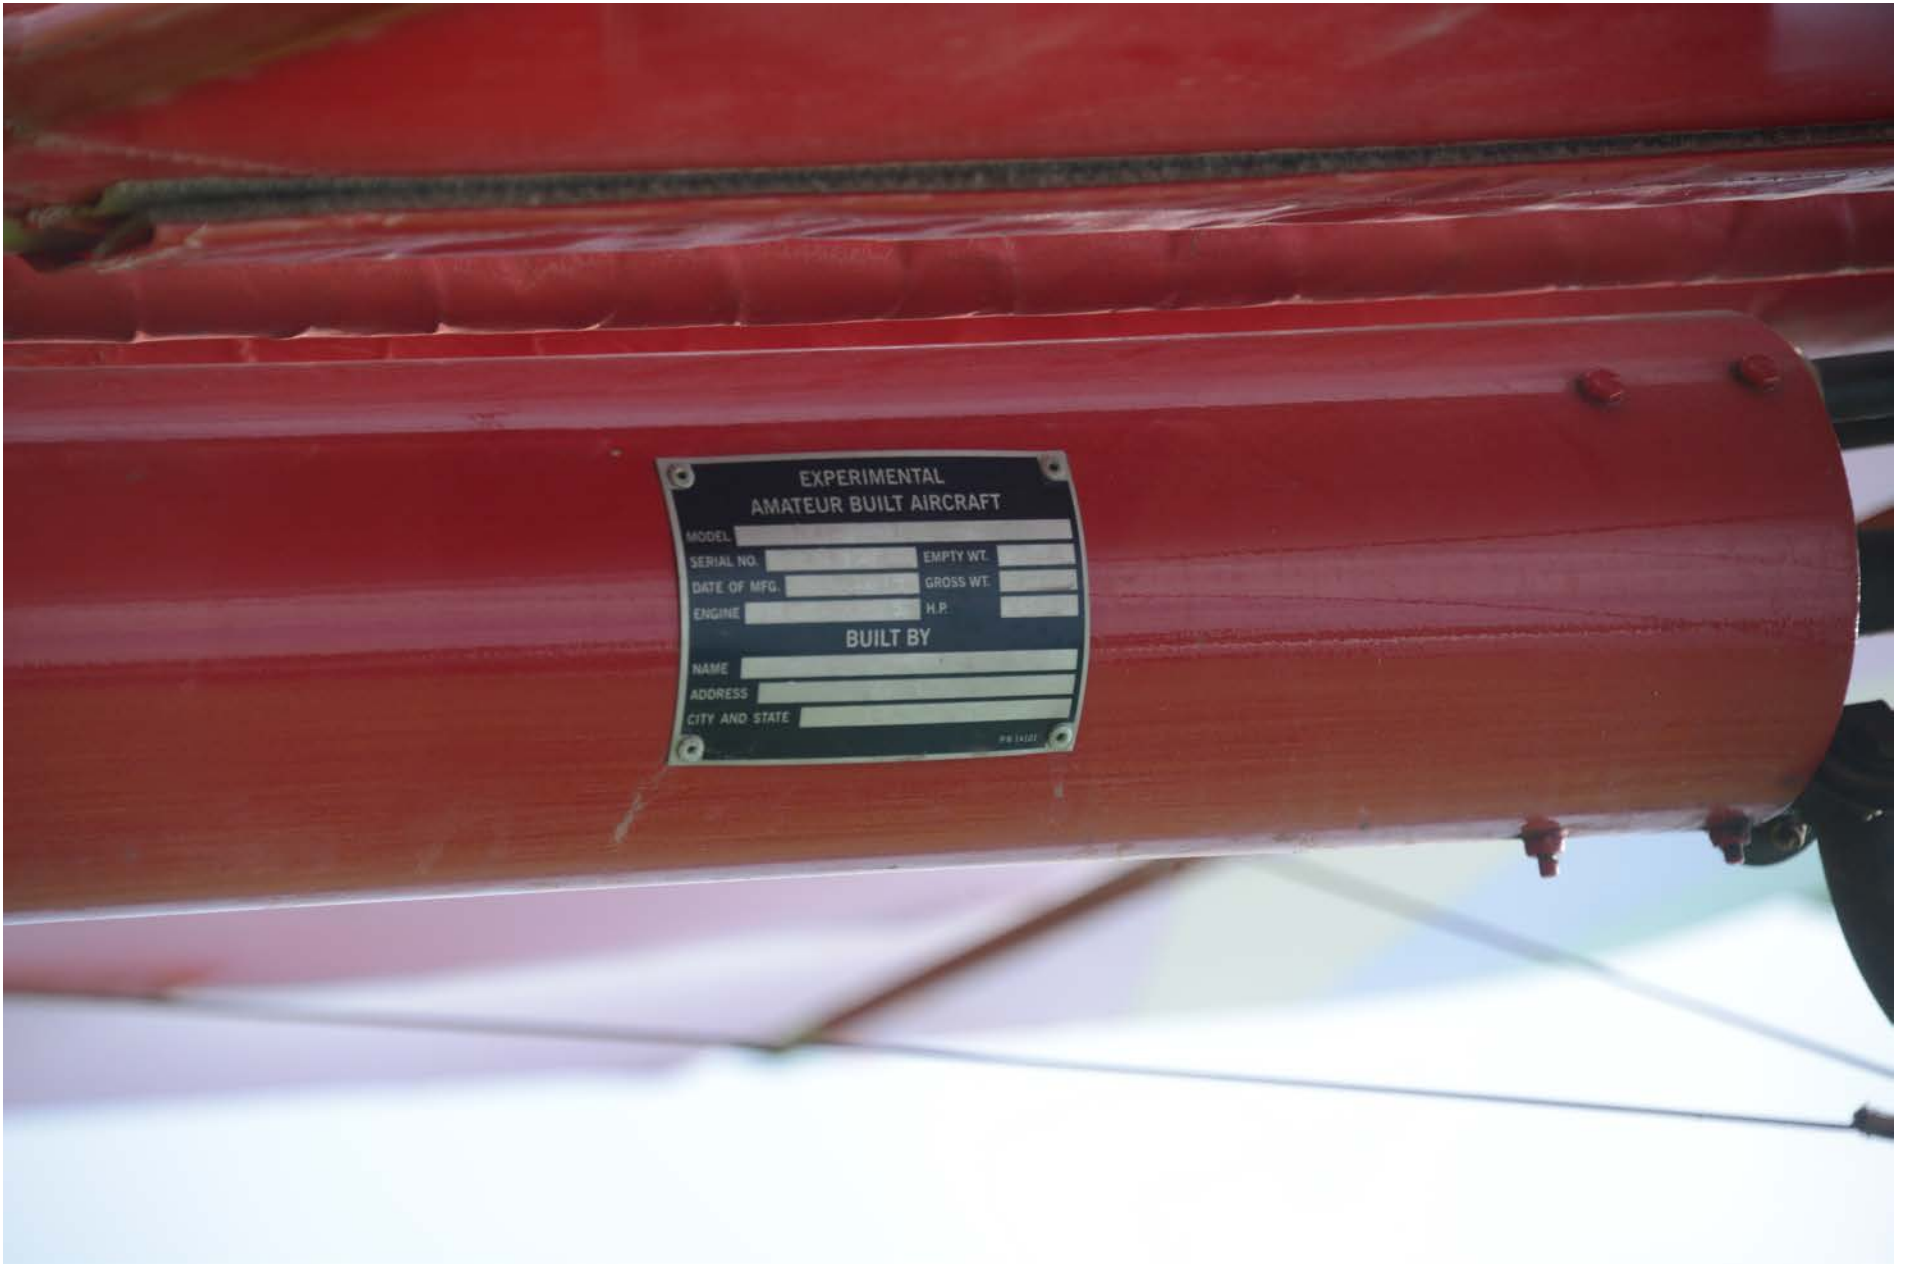
Photo 17 - Close-up view of the airplane data plate.

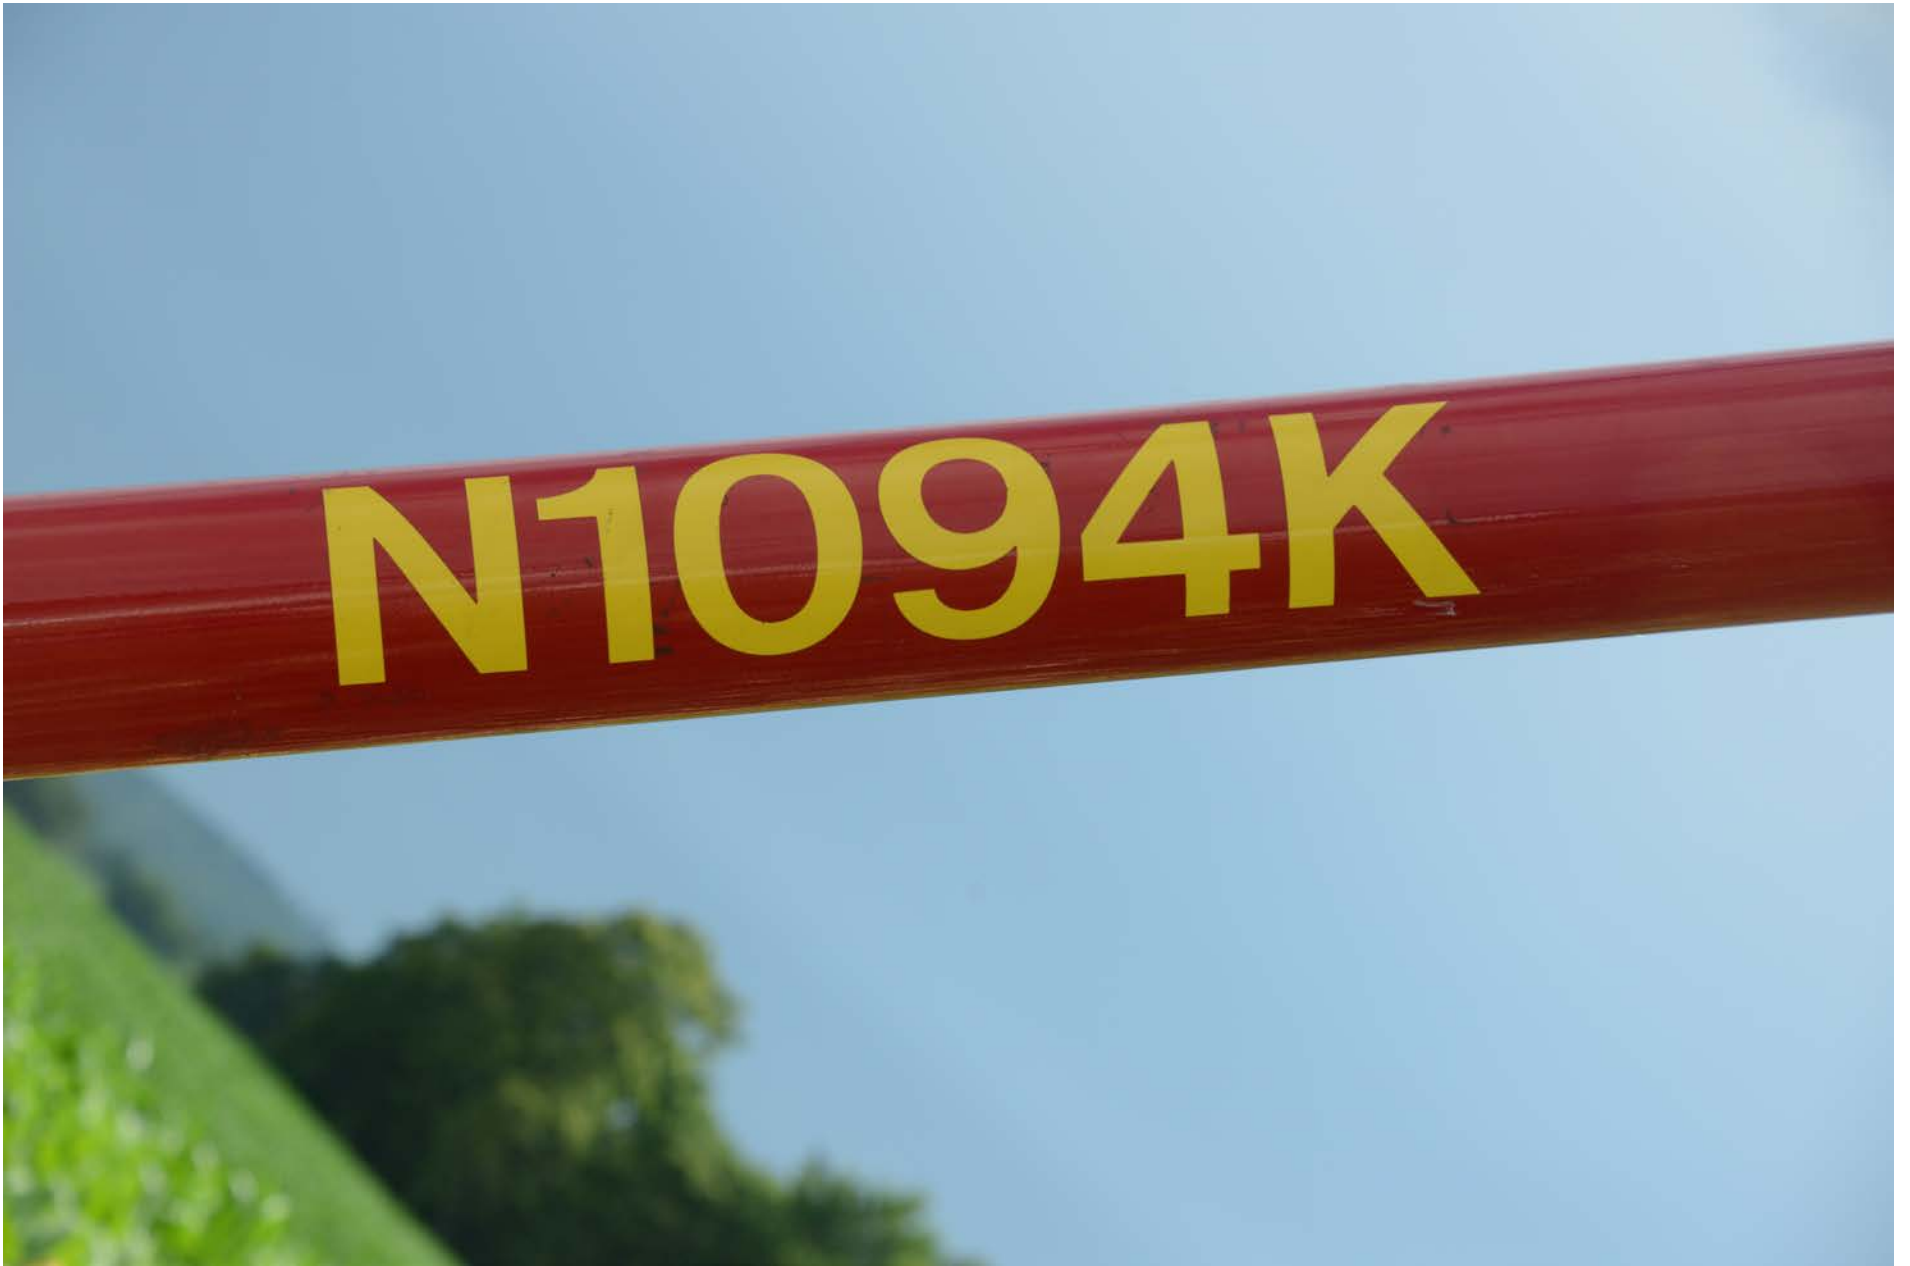
Photo 18 - Close-up view of the N-number on the airplane's boom.

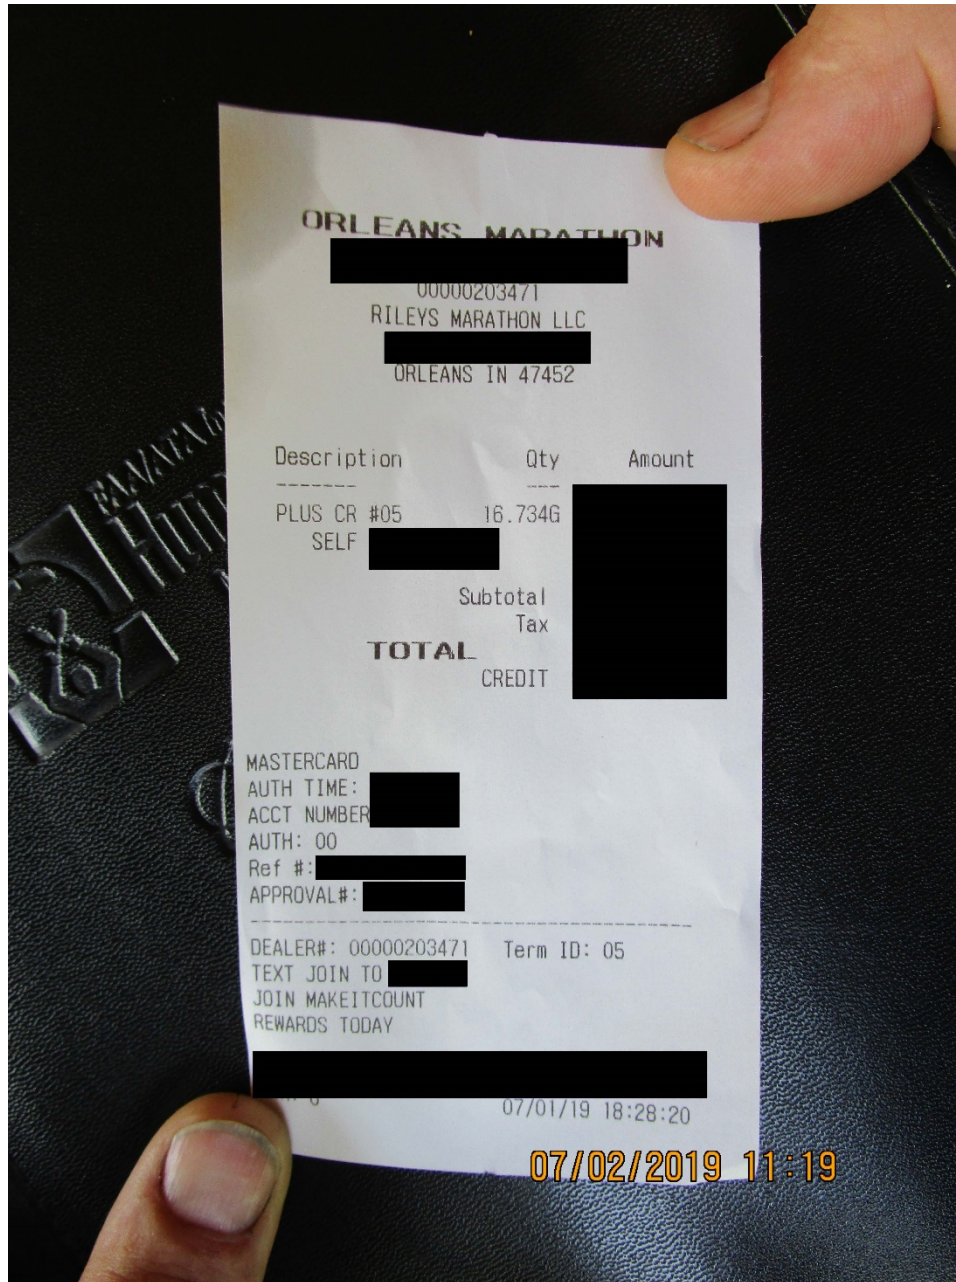
Photo 19 - FAA supplied close-up view of a fuel receipt.
