**On Scene Images
WPR19FA124**

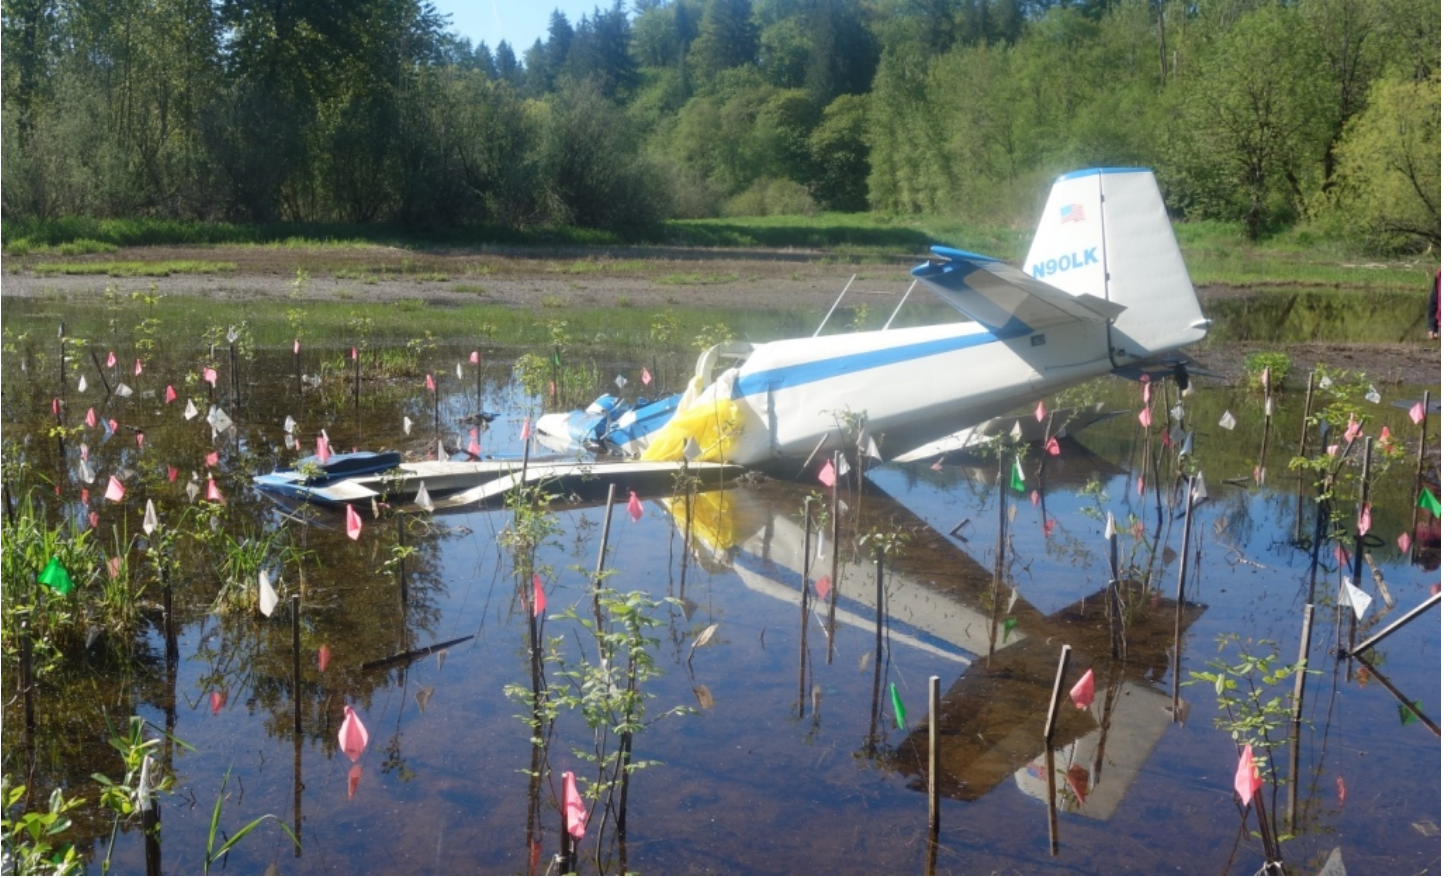
Figure 1 - Airplane at Impact Location

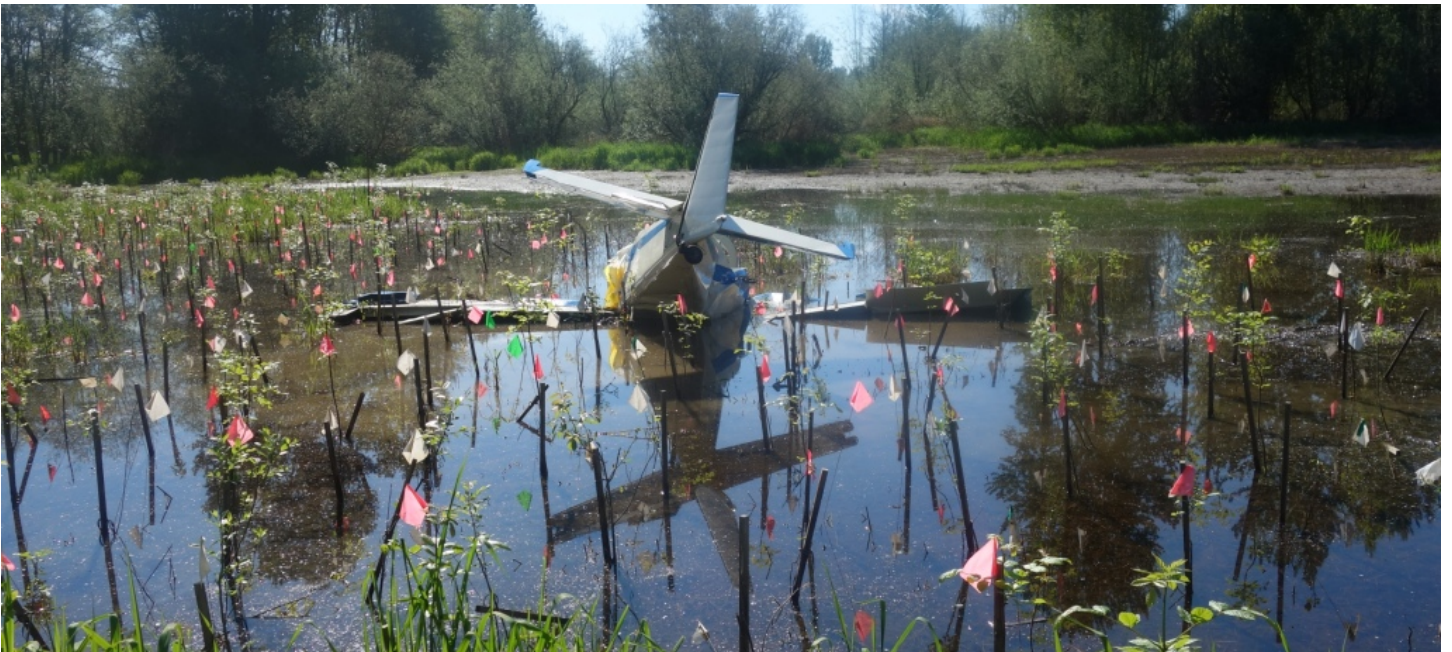
Figure 2 - Impact Location

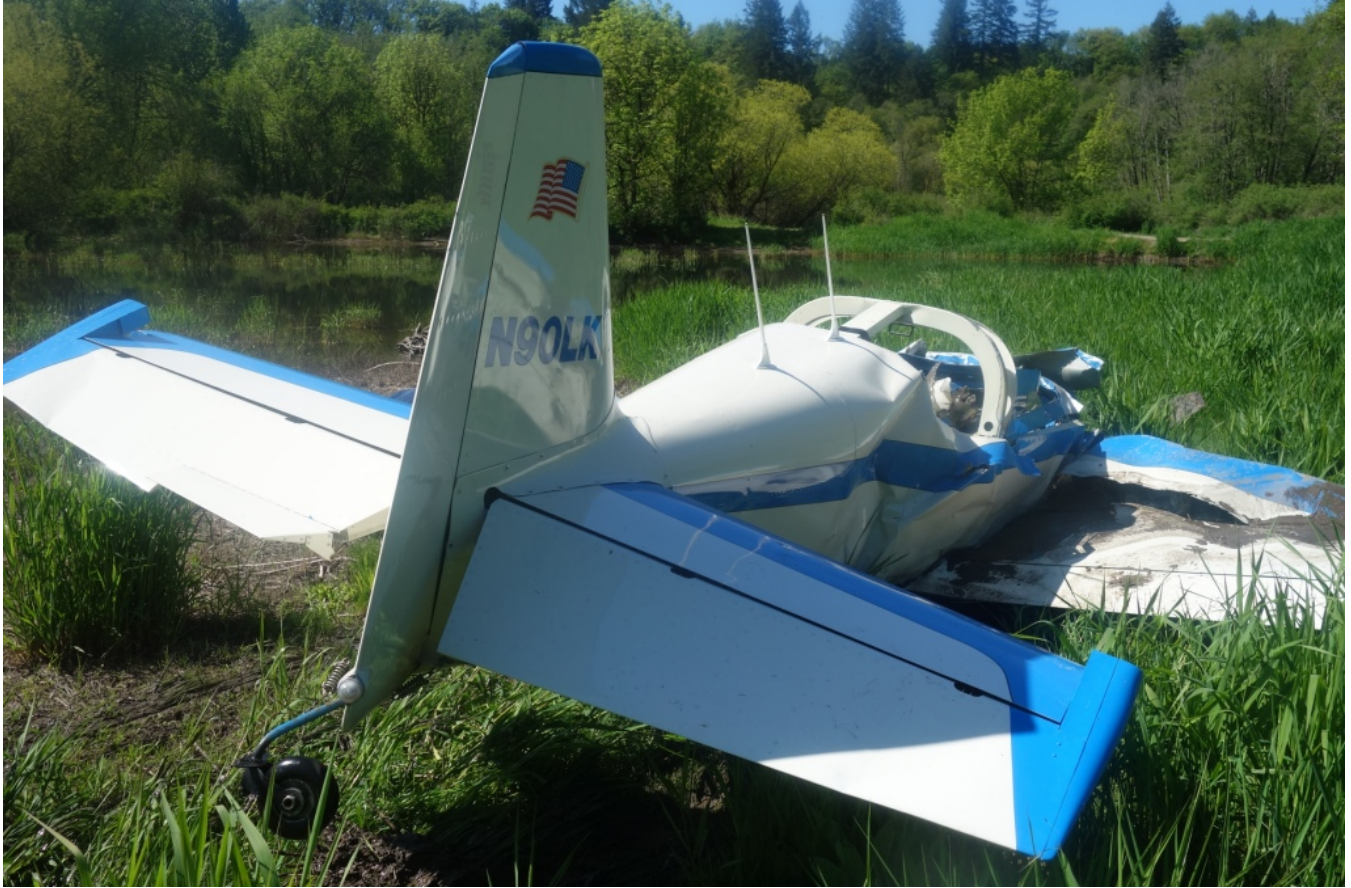
Figure 3 - After Removal From Pond

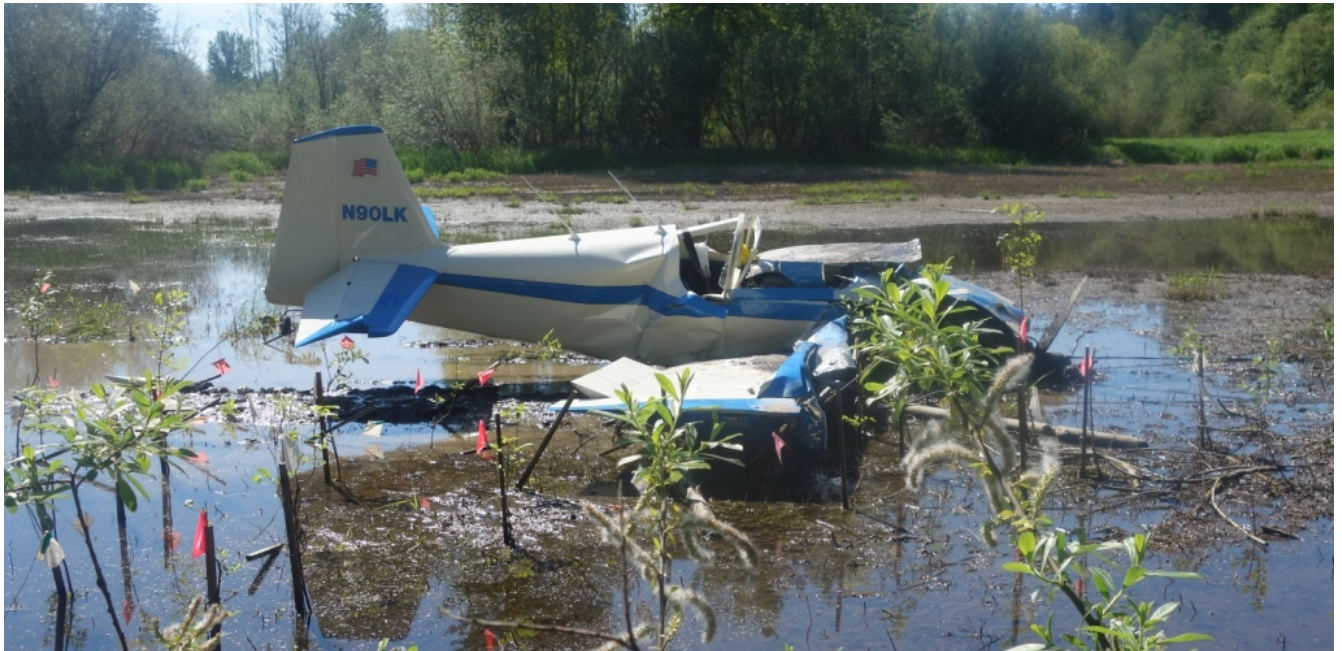
Figure 4 - Impact Location

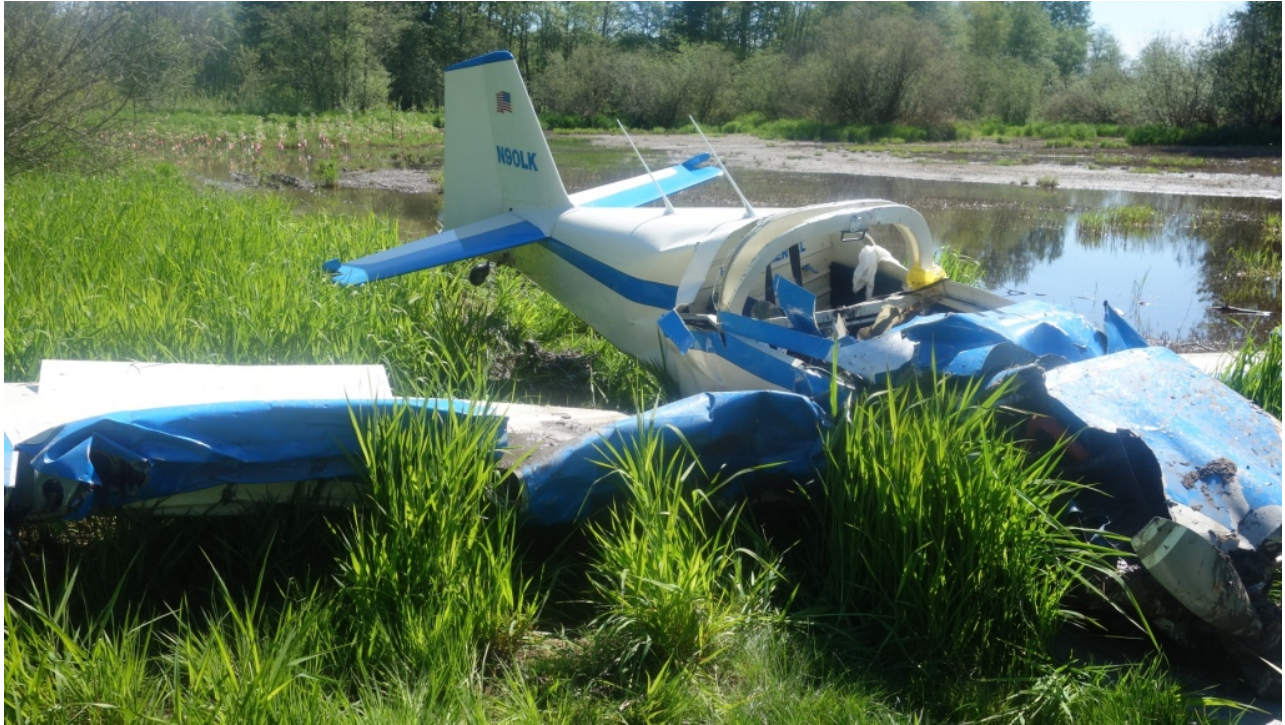
Figure 5 - After Removal From Pond

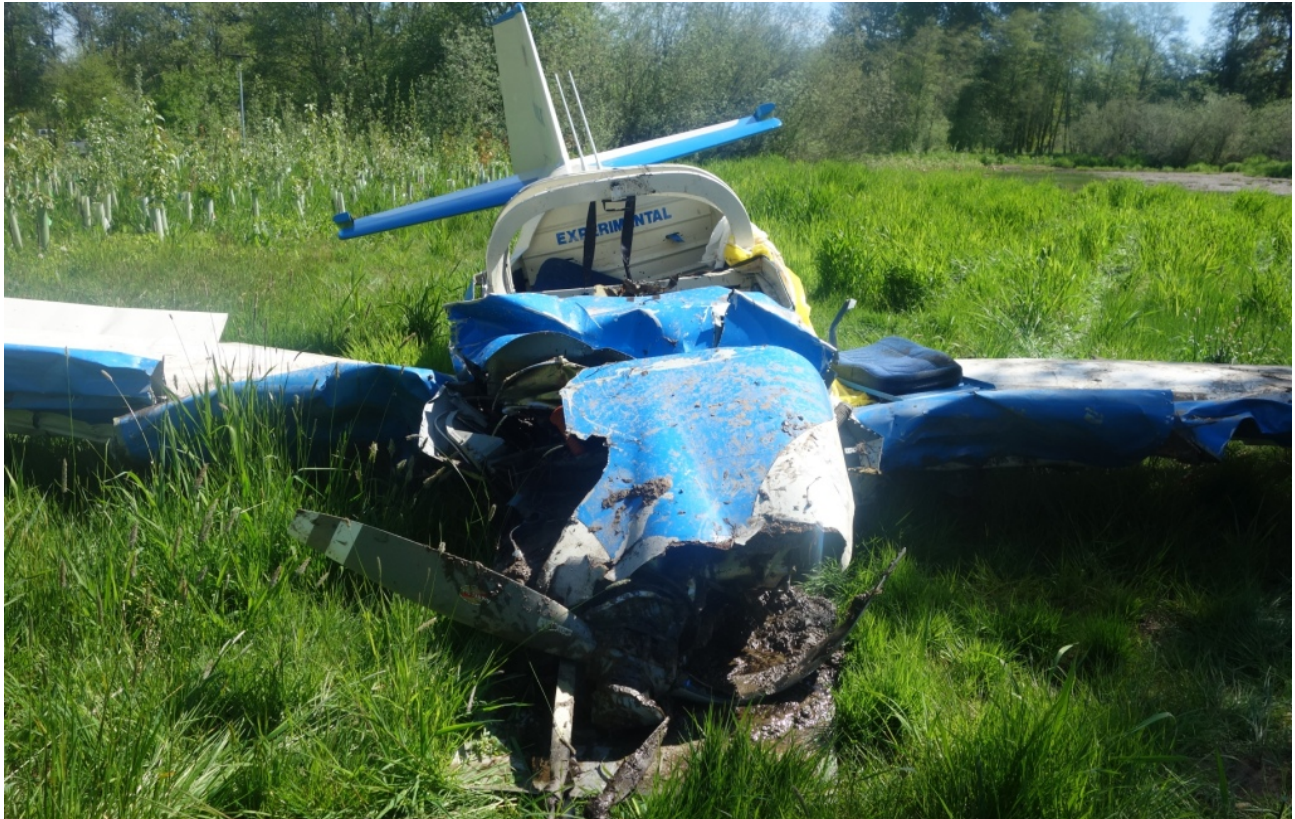
Figure 6 - After Removal From Pond

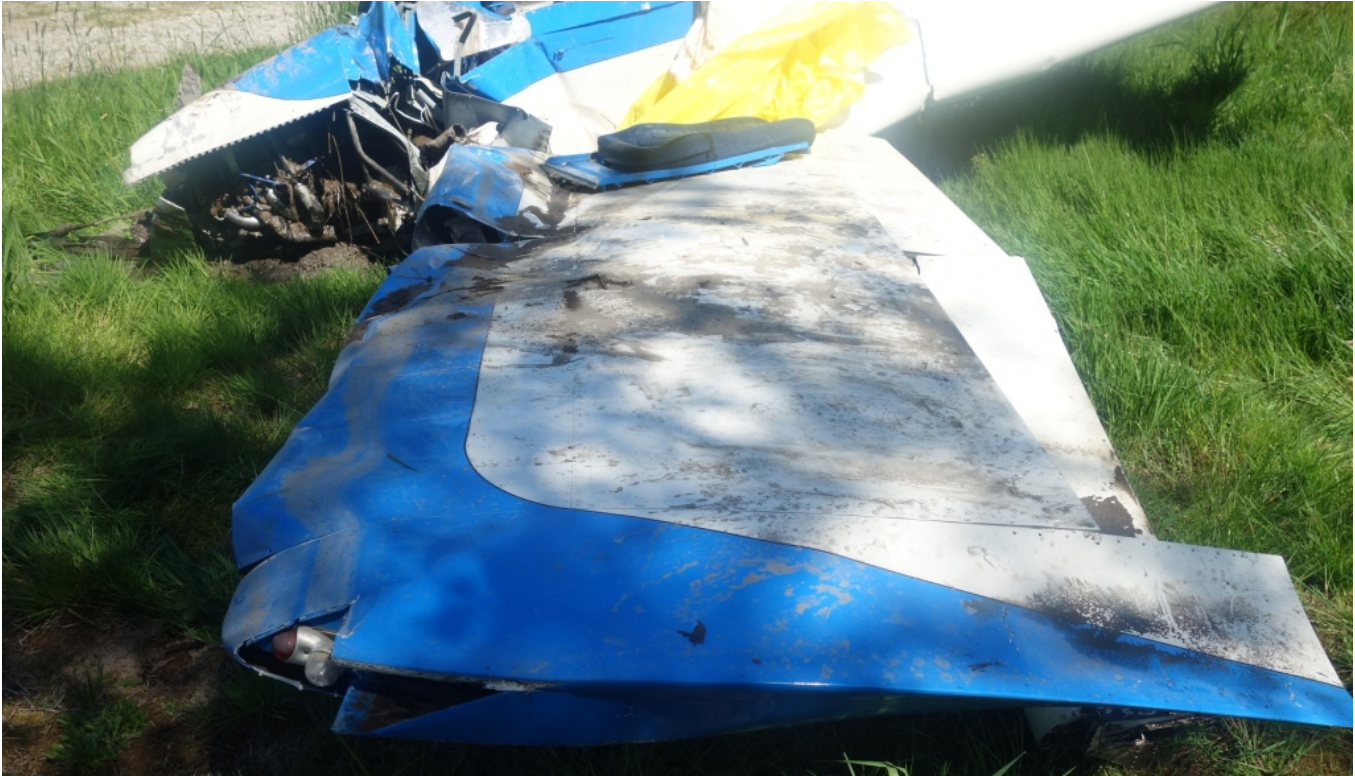
Figure 7 - Left Wing

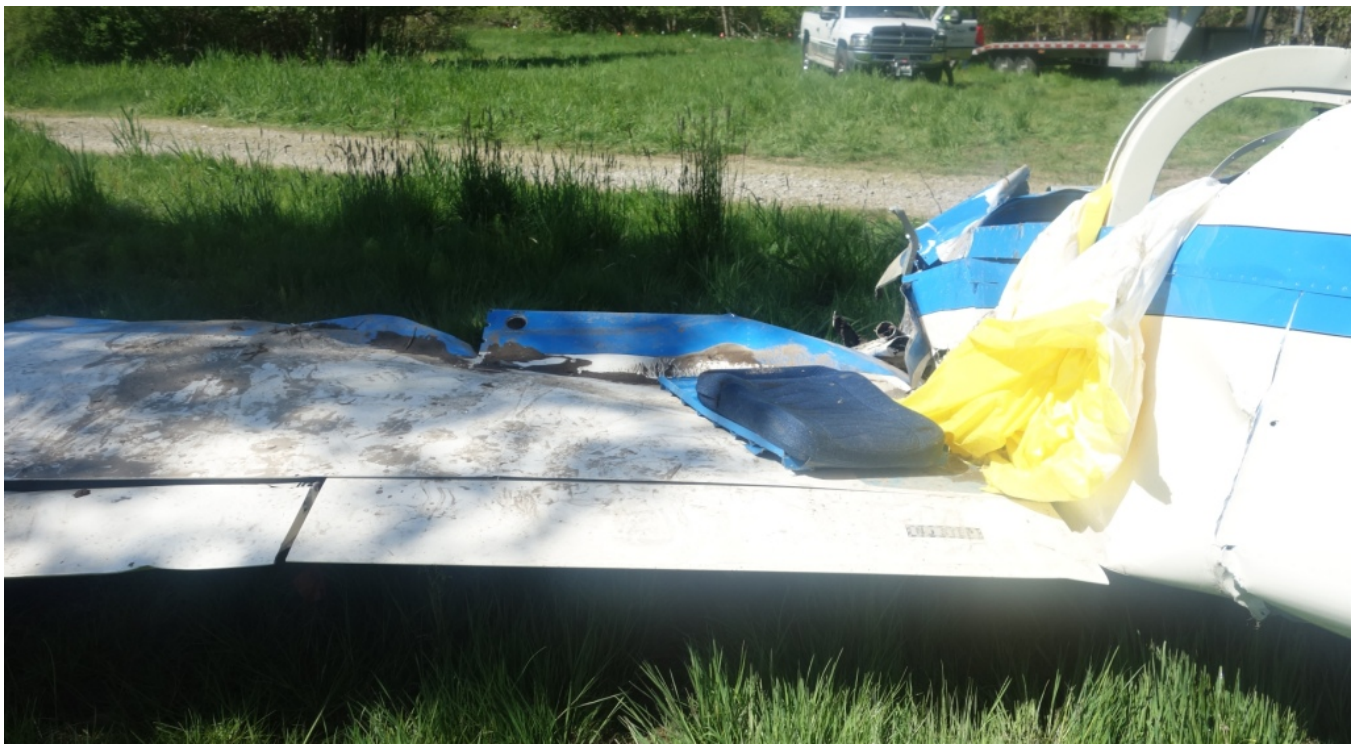
Figure 8 - Left Wing and Retracted Flap

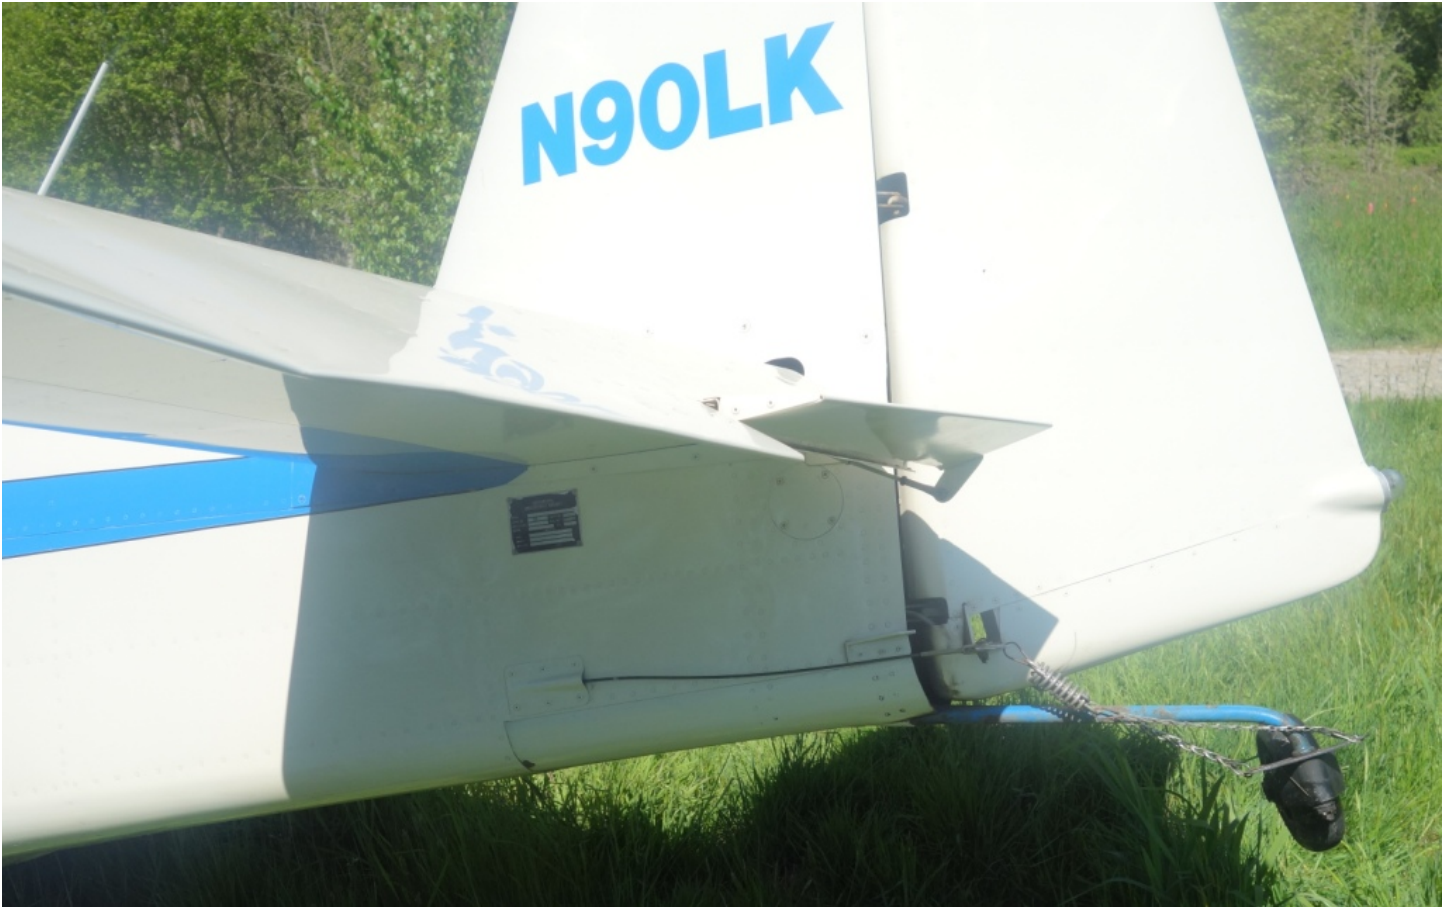
Figure 9 - Deflected Pitch Trim Tab

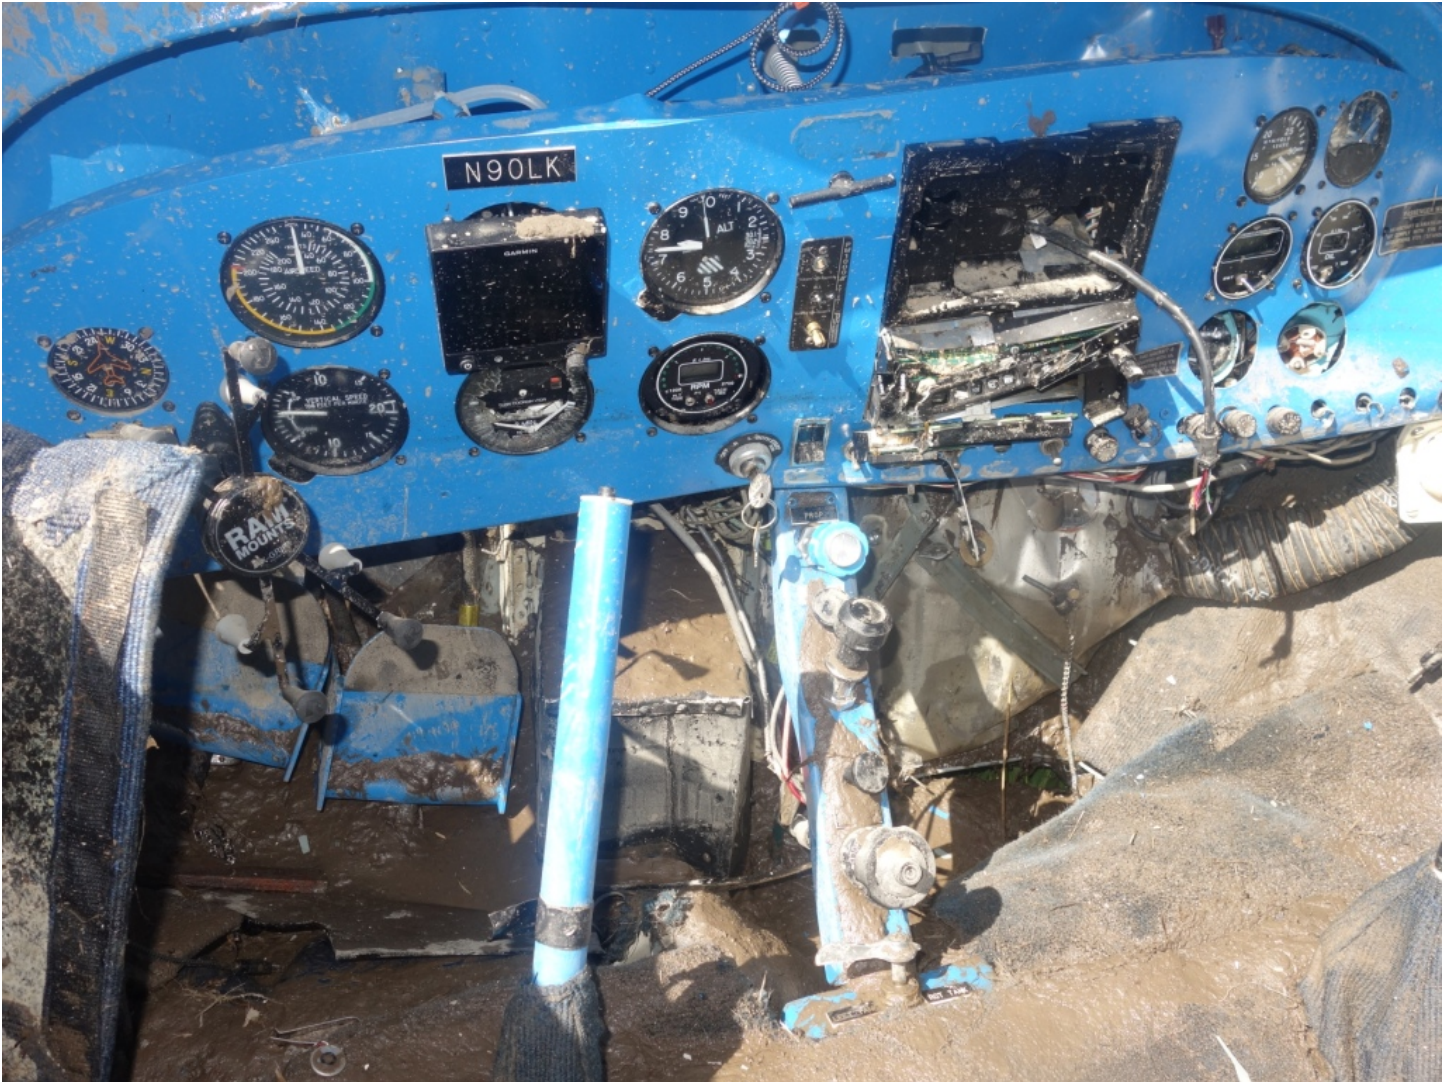
Figure 10 - Instrument Panel

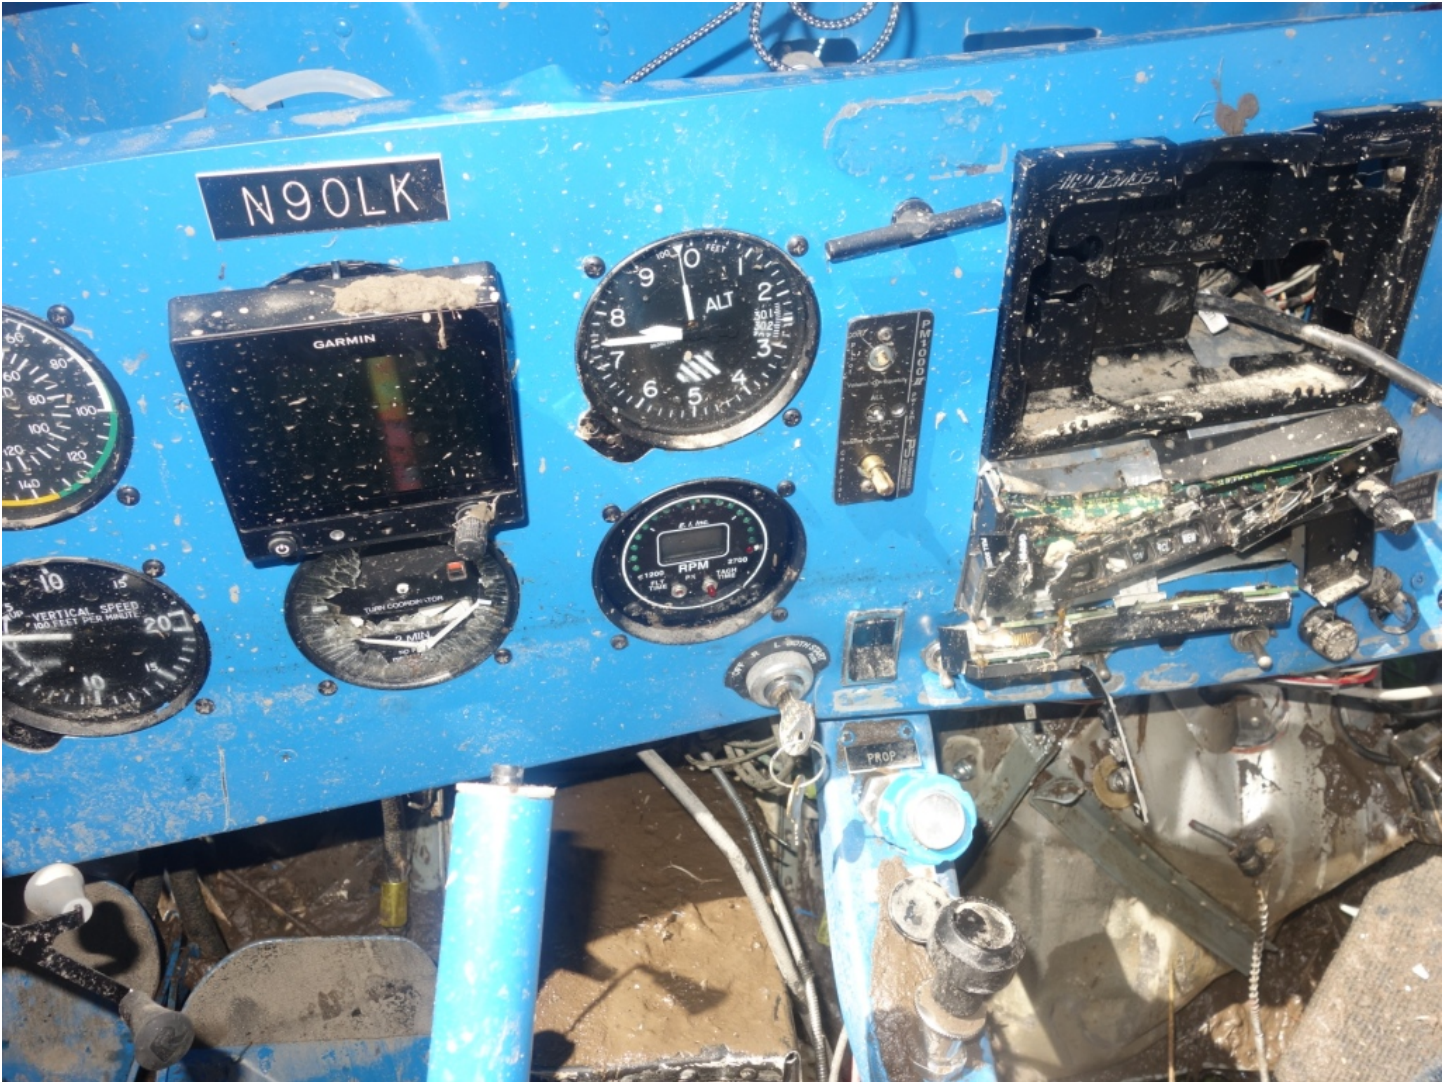
Figure 11 - Instrument Panel

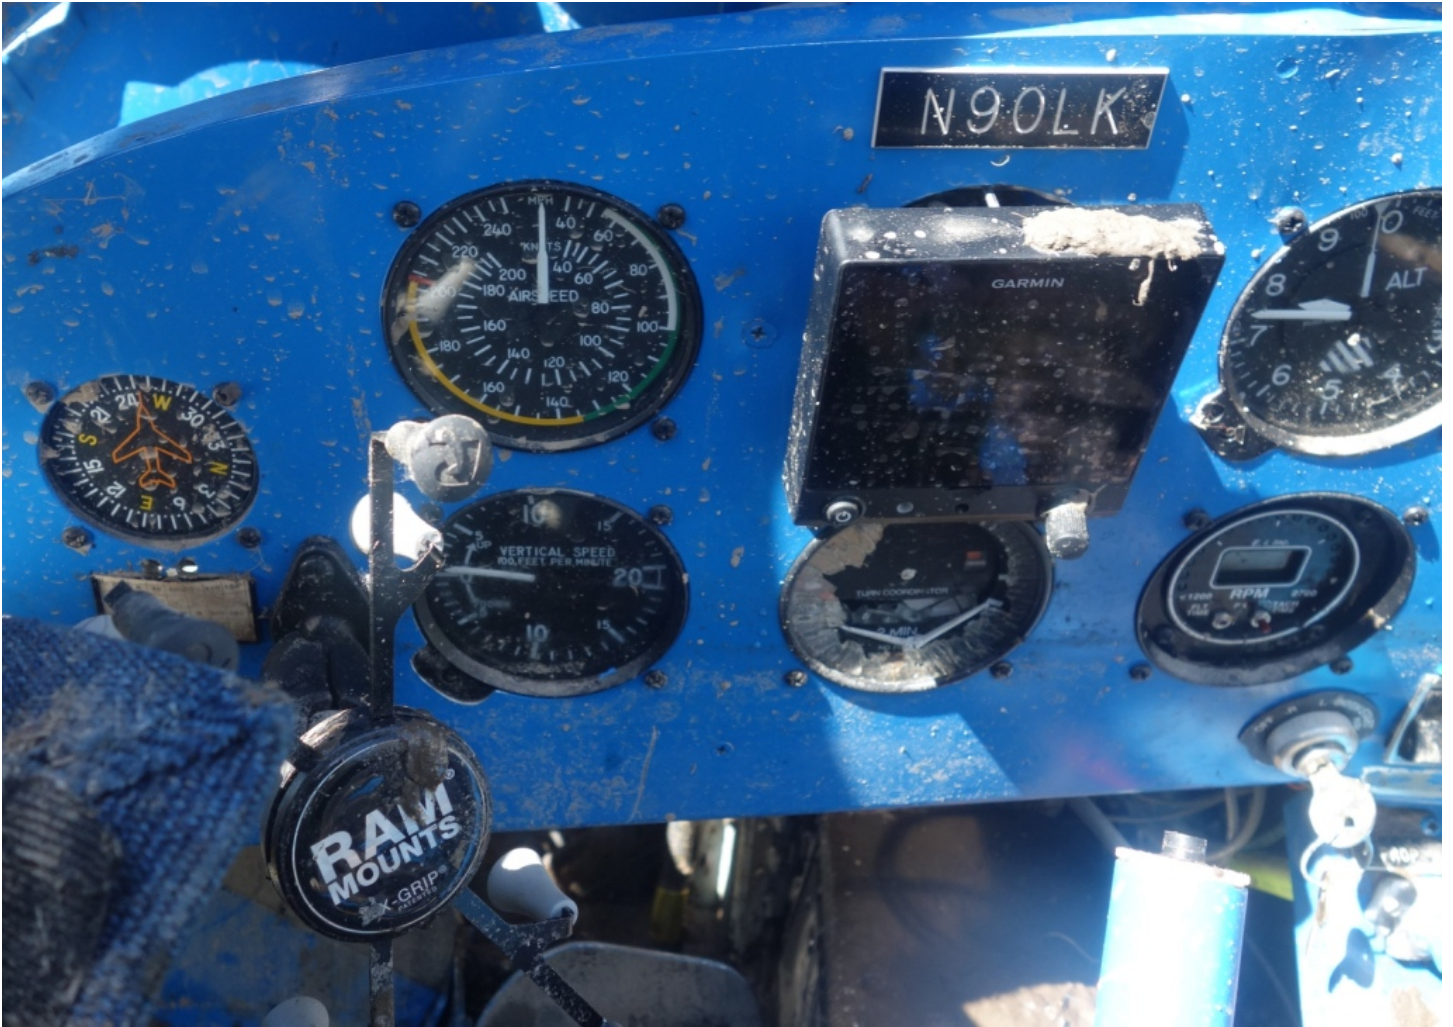
Figure 12 - Left Instrument Panel

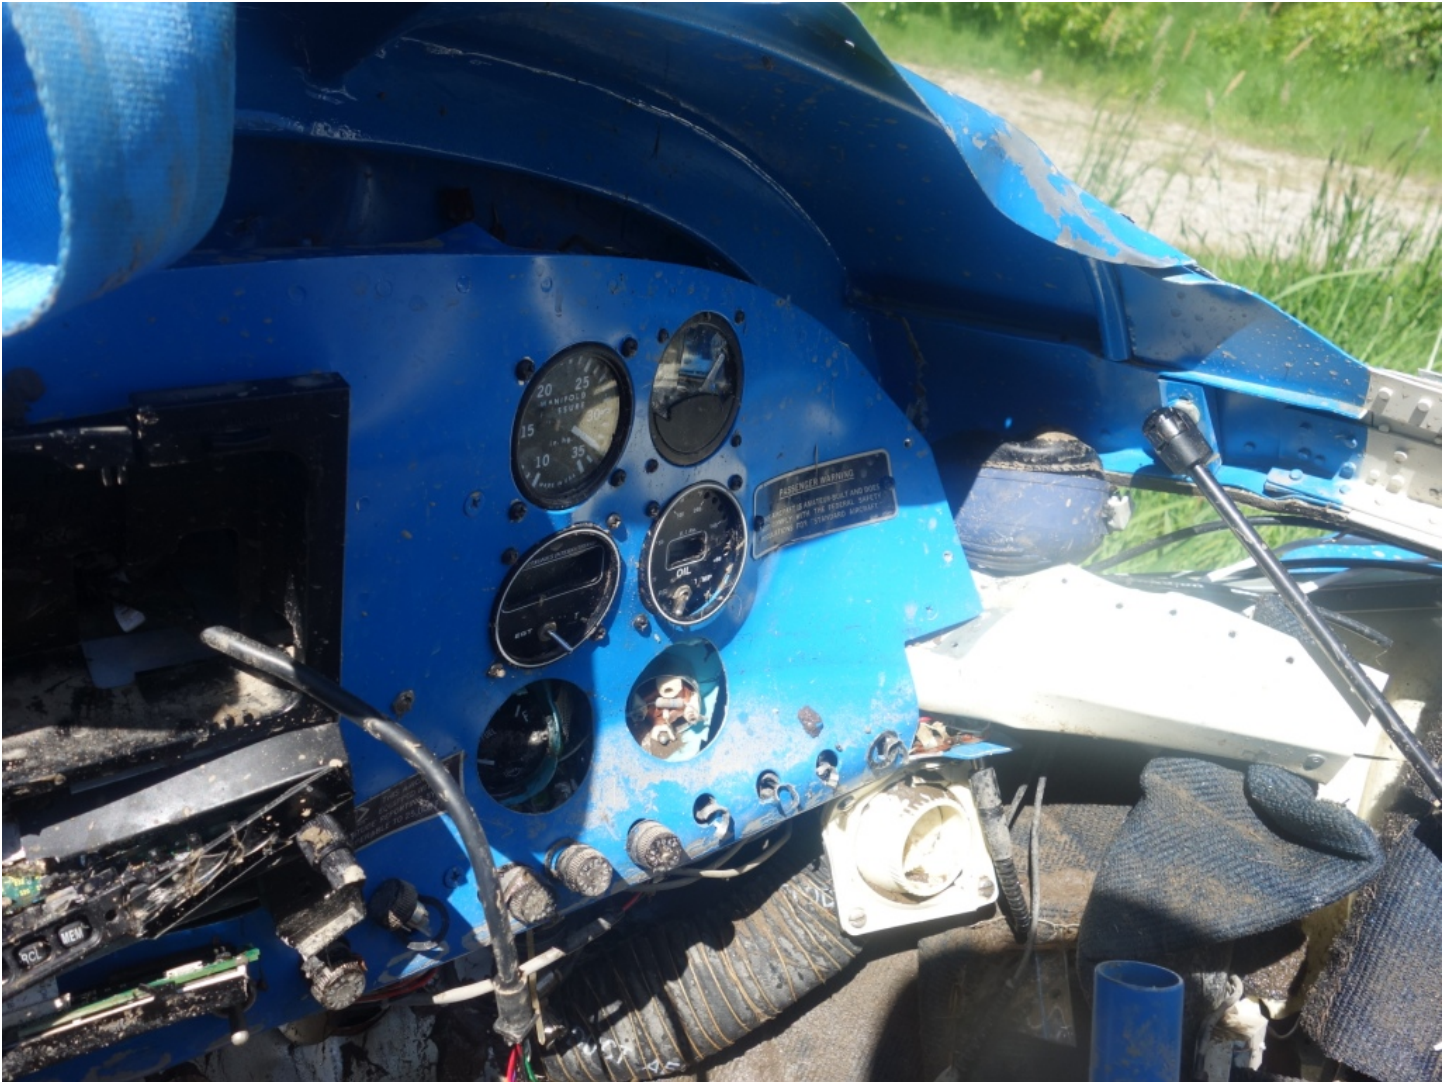
Figure 13 - Right Instrument Panel

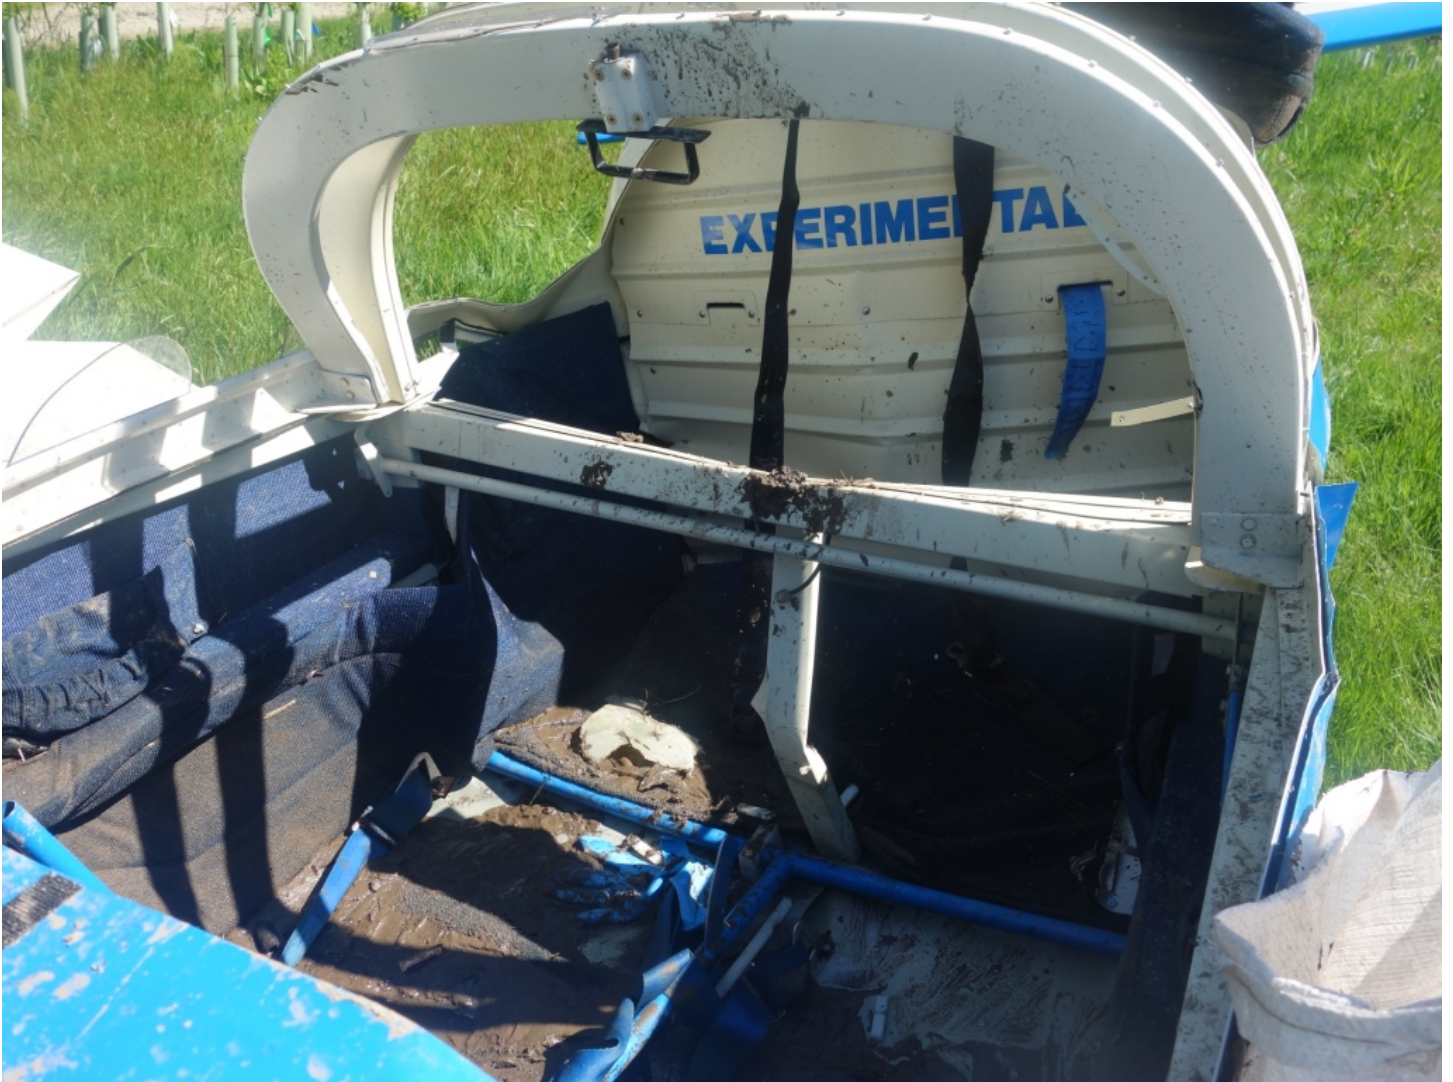
Figure 14 - Canopy Frame and Aft Bulkhead

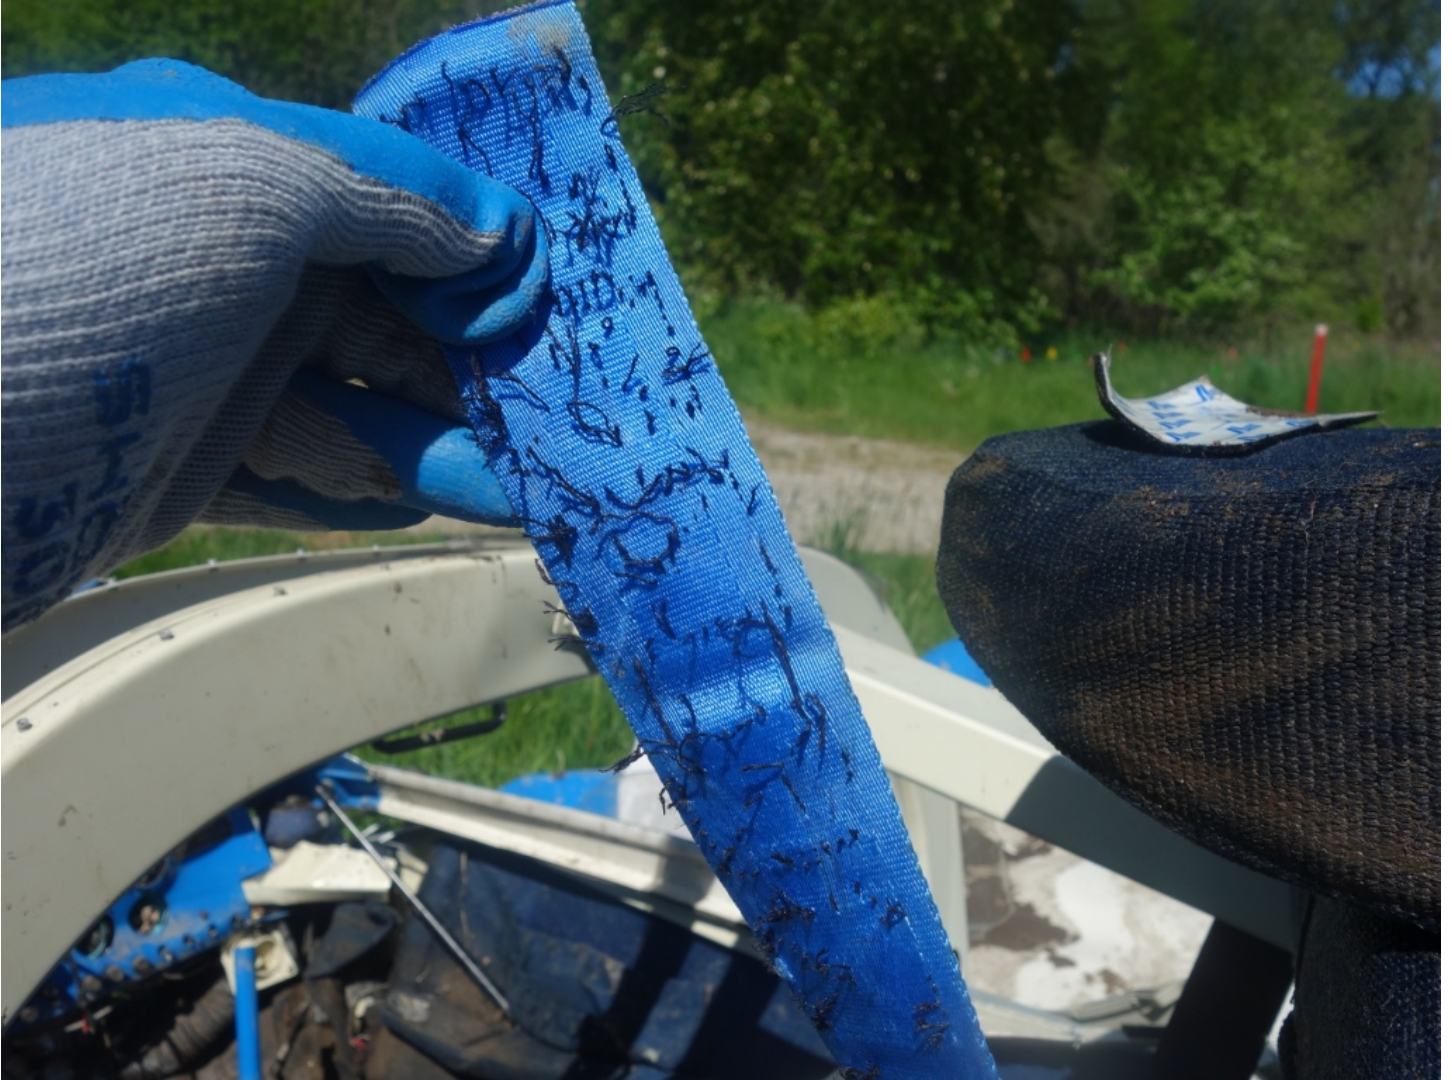
Figure 15 - Pilot's Shoulder Harness
