**NATIONAL TRANSPORTATION SAFETY BOARD
OFFICE OF MARINE SAFETY
WASHINGTON, D.C. 20594**

**Nautical Operations, Human Performance, and System Safety
Group
Factual Report**

Dredge Waymon Boyd

**Explosion and Fire following Propane Pipeline Strike
Near EPIC Dock, Corpus Christi Ship Channel
Corpus Christi, Texas**

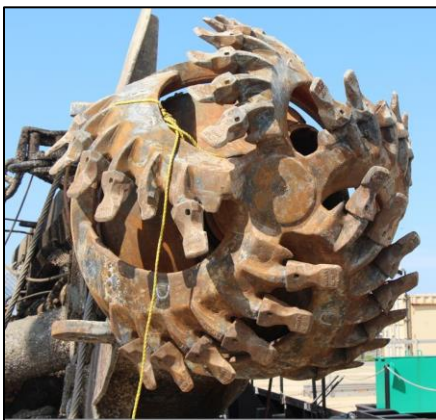
Figure 6. *Waymon Boyd* cutter-head postaccident. The yellow nylon line was attached during salvage and not part of original equipment (Source: US Coast Guard)

When the cutterhead was salvaged, investigators found one tooth was damaged and another was missing. Rocks and pieces of cement were discovered in the ladder-pump strainer clean-out box.

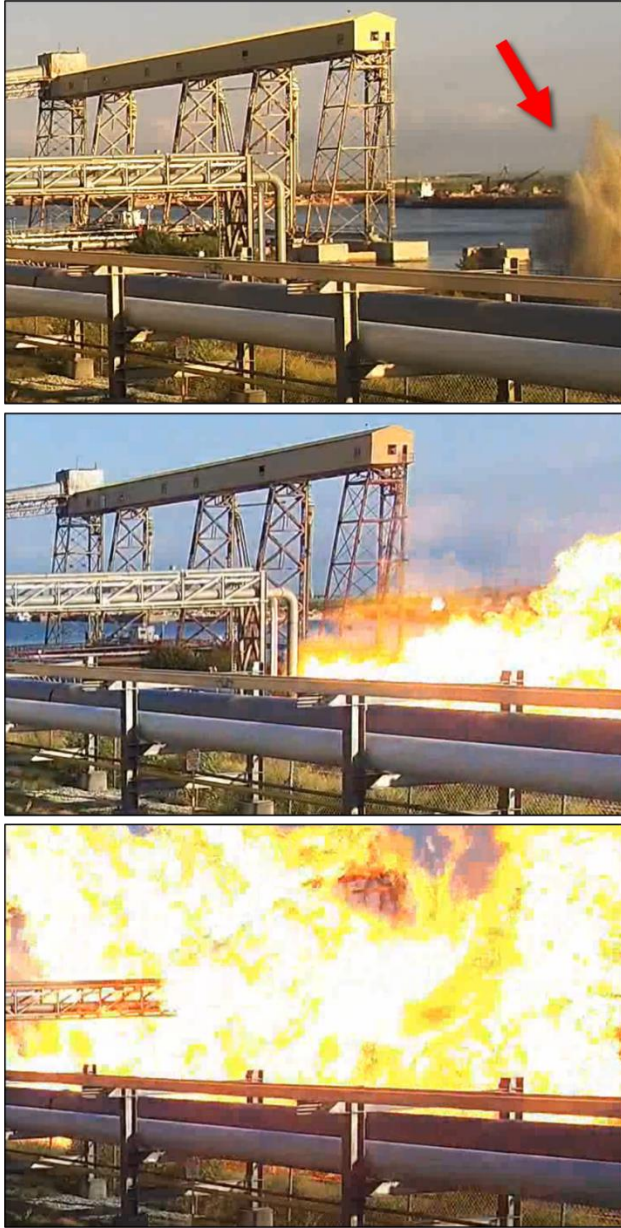
Figure 8. Screen captures from security camera footage showing, from top to bottom, the water and gas eruption prior to the explosion (as noted by red arrow), the initial explosion, and the ensuing fireball. The *Waymon Boyd* is outside of the frame of the camera. (Source: EPIC Crude Terminal Company)

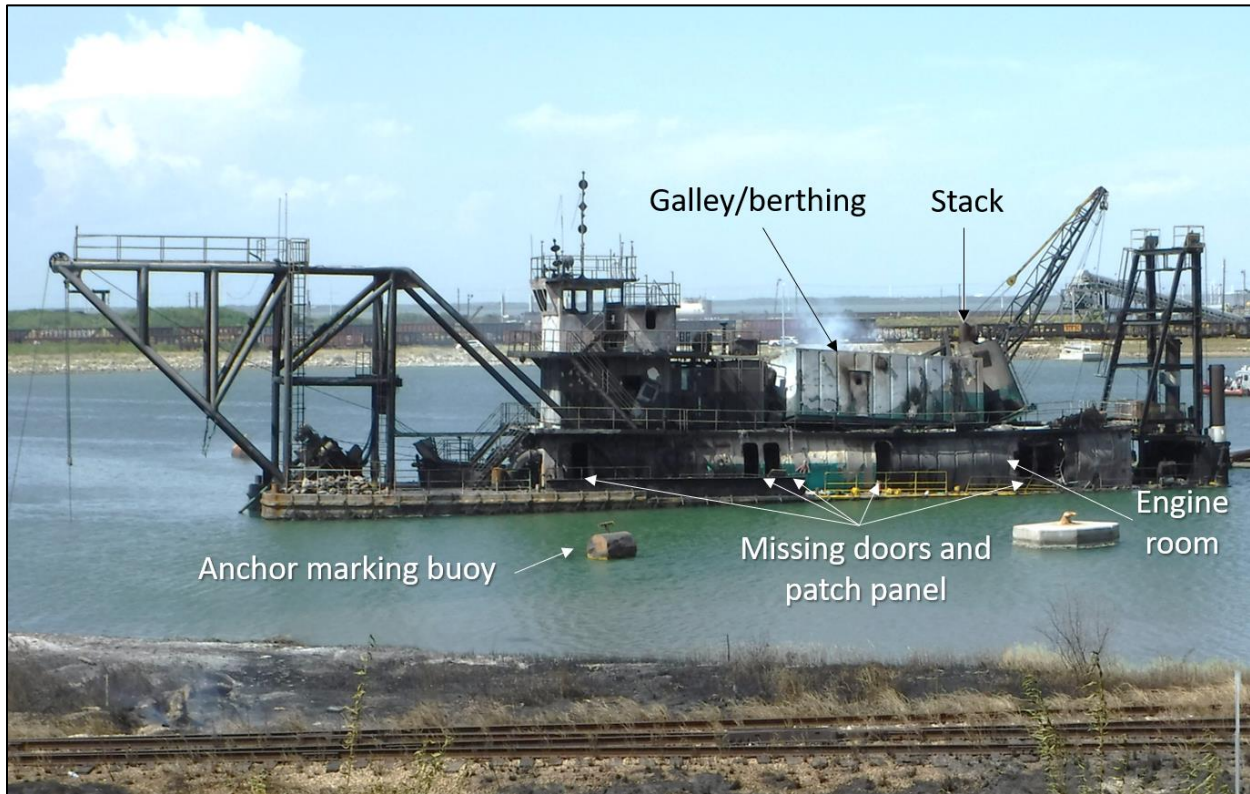
A photo of the *Waymon Boyd* taken after the fire had been extinguished and before the vessel sank shows the engine room bulkheads on the port side bowed outwards (see figure 12). The draw works and engine room doors are missing, along with a bolted-on bulkhead patch panel. The main deck railing outboard of the opening created by the missing patch panel is bent outward. The aft deck above the first level of the superstructure, upon which the stack sits, is bent upward and forward. The galley and berthing compartment is displaced from its normal position on the first level and sits at an angle on the deck. Fire and smoke damage is visible throughout the vessel.

Figure 12. Postaccident photo of the *Waymon Boyd*, prior to sinking. (Source: Coast Guard)

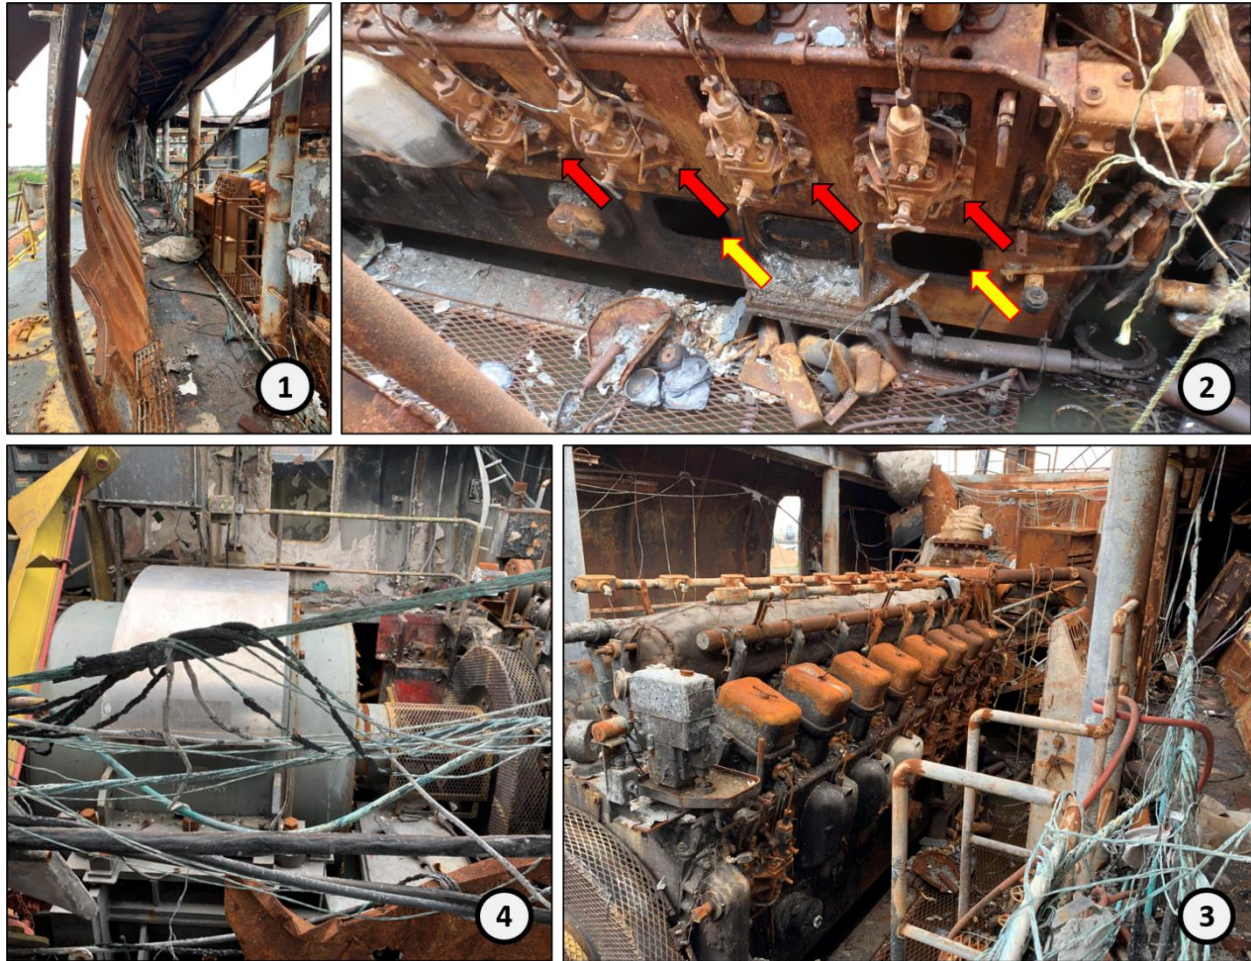
During a post-salvage examination of the vessel, investigators confirmed that the bulkheads on both the port and starboard sides of the engine room were bowed outwards (see figure 13). Inside the engine room, four fuel valve and two crankcase covers on the port side, aft end of the main generator engine were missing, while the covers on the forward end of the engine remained in place. A beam in the overhead of the space above the engine's turbocharger and exhaust system was bent upward. Paint was not visible on the aft part of the engine, but increasingly more paint was visible moving forward. The generator alternator, sitting forward of the engine block, was largely undamaged, although a gantry crane had fallen from the overhead and laid across it.

Figure 13. Post-salvage images of the *Waymon Boyd* engine room. Clockwise from top left: 1. Bowed portside bulkhead; 2. Aft generator engine block with missing fuel valve covers (red arrows) and crankcase covers (yellow arrow); 3. Generator engine forward, looking aft; 4. Generator alternator, with fallen wiring in the foreground and gantry crane to the left of the image.

Investigators also found that a door to an electrical equipment box forward and above the main generator alternator was caved inward. The standby generator aft of the main generator engine had been displaced from its mounts. The fuel system had no visible breaches in either the piping system or the tanks.

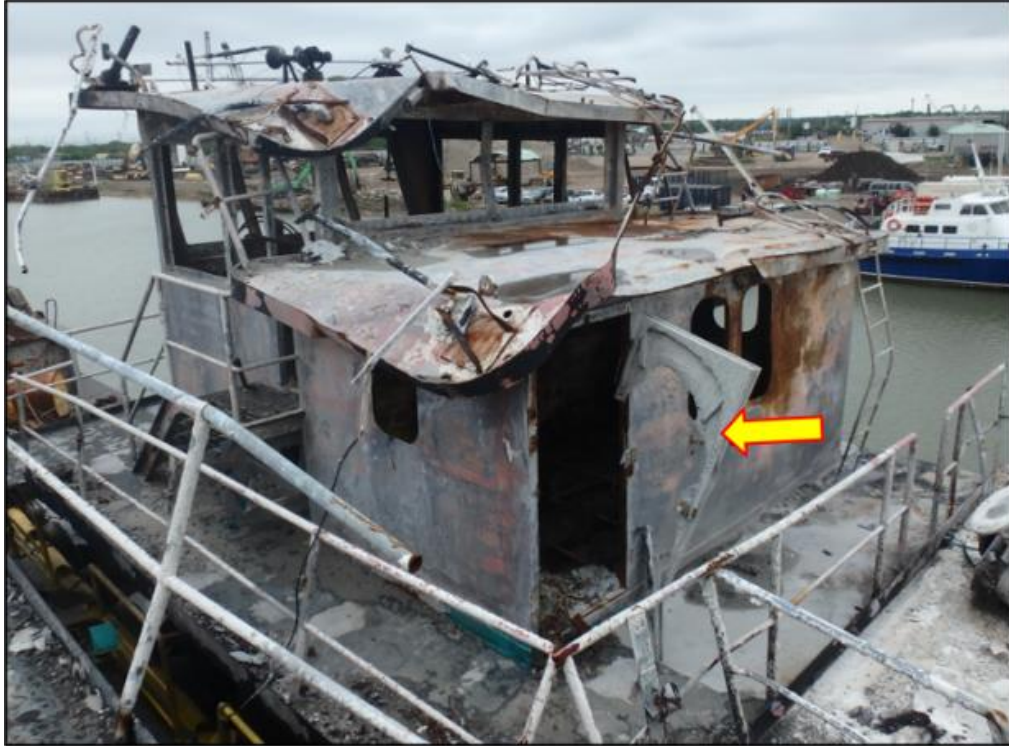
On the top two levels of the *Waymon Boyd's* superstructure, which had broken free of the dredge when it sank, all exterior paint had been burned away, and the aluminum door to the captain's office was almost completely melted (see figure 14). The starboard aft corners of the lever room and captain's office roofs were bent downward; however, an Orion representative stated that this damage had occurred during salvage.

Figure 14. The lever room and captain's office post-salvage. The arrow shows the remnants of the office door, which had melted in the fire.

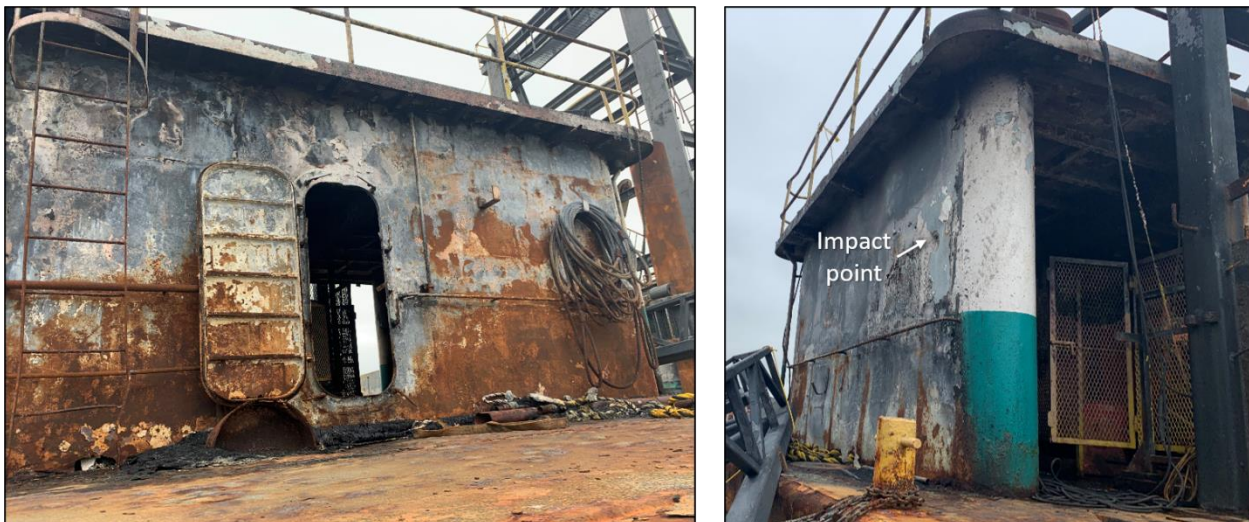
An anchor barge had been moored on the starboard side aft of the *Waymon Boyd* when the accident occurred. During a postaccident examination of the barge, investigators observed that steel plating on the starboard side deckhouse bulkhead, which was facing the *Waymon Boyd's* starboard side (the dredge and barge were oriented in opposite directions), was inset (see figure 15). Additionally, the deckhouse sustained impact damage to plating forward on the starboard side bulkhead. The entire stern and starboard sides of the barge were scorched and buckled.

Figure 15. Stern (left) and starboard (right) bulkheads of anchor barge deckhouse.

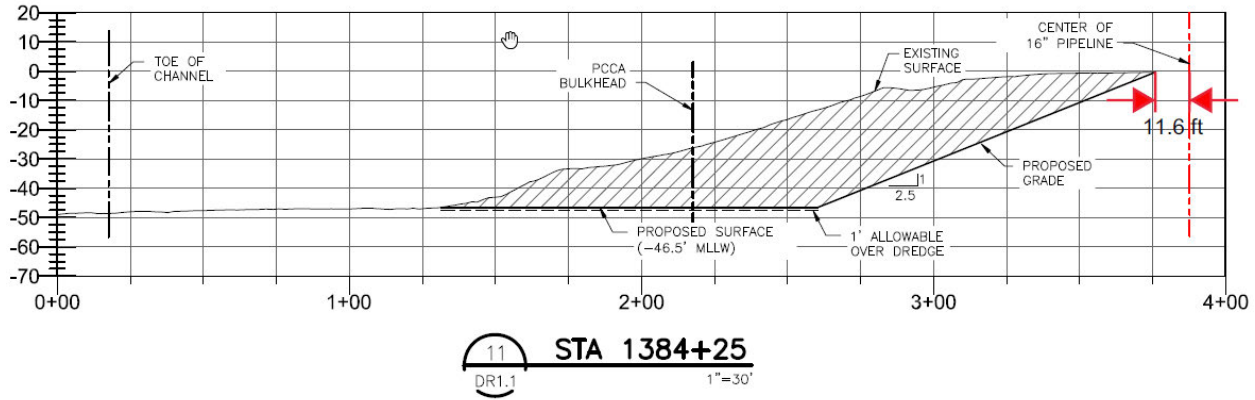
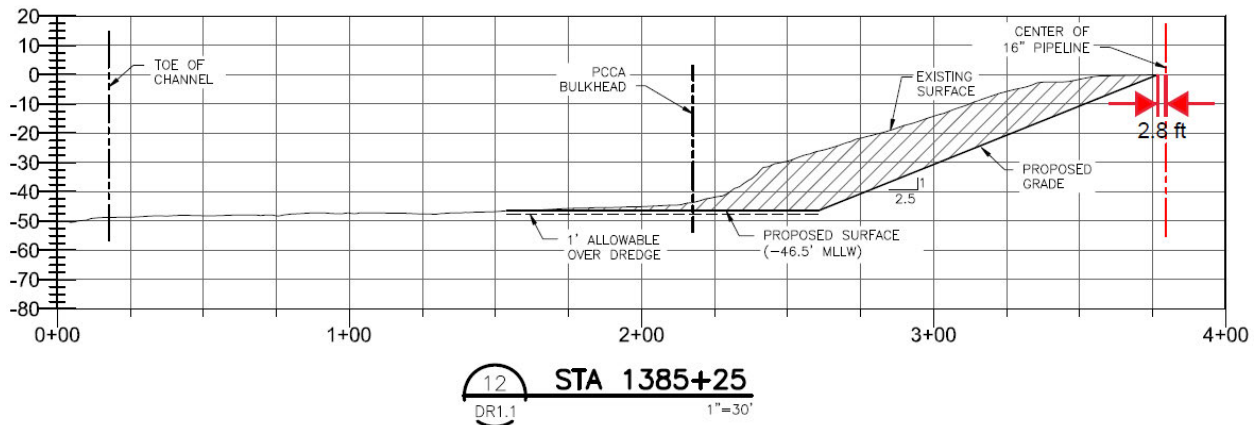
The Schneider design engineer stated that he determined that pipeline TX219 was outside the dredge template by 8–10 feet by measuring the distance in an AutoCAD 2-dimensional plan (overhead) view of the project. When investigators requested documentation showing this measurement, they were provided a cross-sectional drawing that was generated on August 24, 2020, three days after the accident. The company did not respond to requests for preaccident documentation of the measurement. In the August 24 cross-sectional drawing, the location of the center of pipeline TX219 relative to the dredge template was depicted by a dotted red line. Investigators measured the distance between the dotted line and the top of the slope in the template. Assuming that the drawing was to scale, this distance in cross-section 11 (station 1384+25 – about 40 feet to the east of the accident site) was measured at 11.6 feet. The distance in cross section 12 (station 1385+25 – about 60 feet to the west of the accident site) was 2.8 feet (see figure 24).

Figure 24. Cross-sectional drawings showing proximity of the center of pipeline TX219 to the dredge template. Red dotted line depicting pipeline center is original to the document. Measurement information added by NTSB using measurement tool in Adobe Acrobat Pro DC. (Source: Schneider Engineering and Consulting)

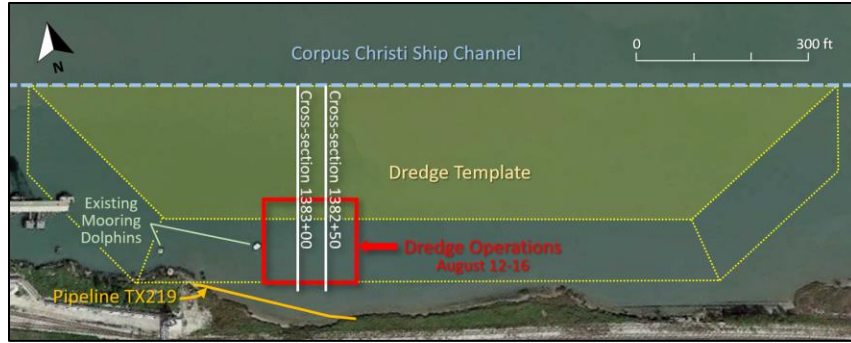
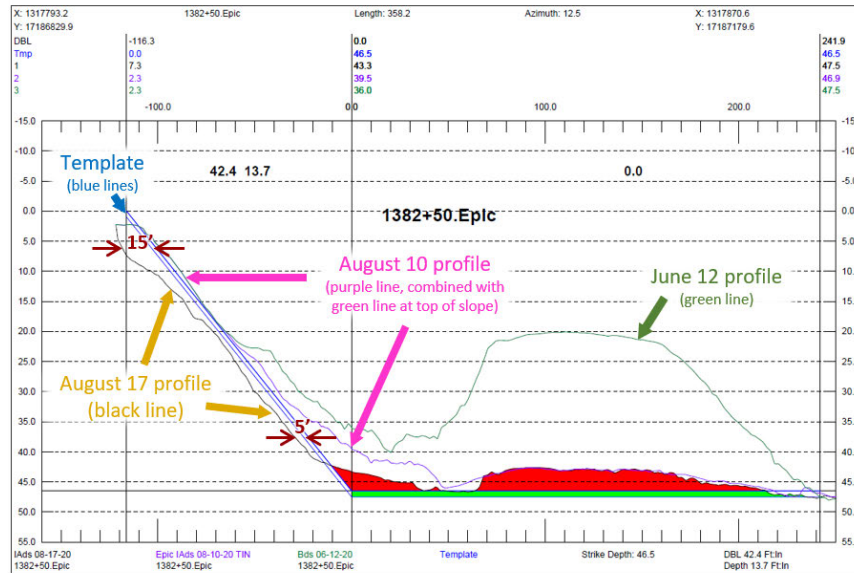
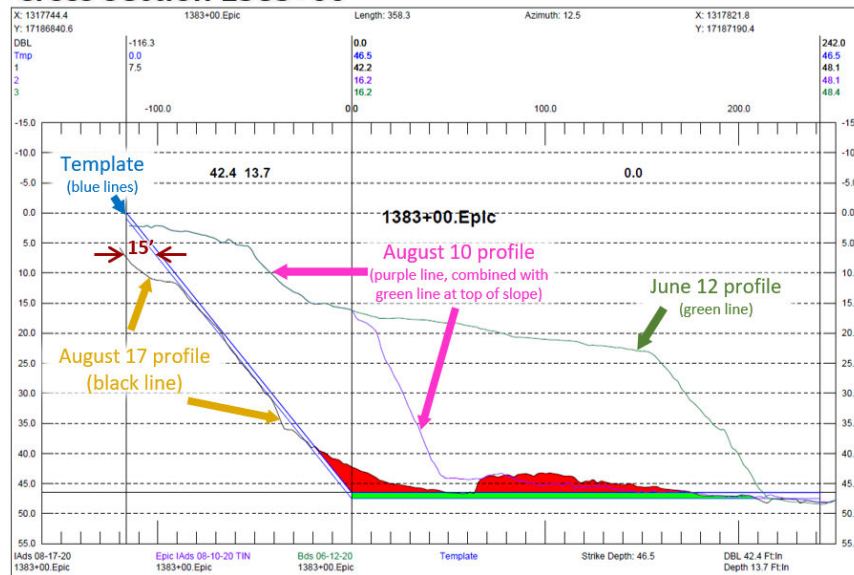
Figure 28. Cross-sectional survey data from dredging operations conducted August 12–16, 2020. Colored lines show the profile of the bottom topography in relation to the dredge template during the pre-dredge survey (June 12) and periodic project surveys (August 10 and 17). Red fill indicates material remaining to be dredged within the template. (Source: Orion Marine Group, with annotations by NTSB.)

In view 1382+50, it appears material has been removed outside of the template by 15 feet at the top of the slope and by 5 feet for the remainder of the slope. The Orion survey superintendent stated that, while the removal of excess material could have been caused by over-dredging, it could also be the result of soft or loose material on the slope that collapsed after dredging to the template. He noted the additional material at the toe (bottom) of the slope, which may have come from the collapsed slope. The leverman stated similarly that the material outside the template “maybe just cave in” after the cutterhead excavated along the shoulder of the template.

In cross-sectional view 1383+00, the dredged area roughly follows the template until 12 feet from the top of the slope. In this area, material loss exceeds the template by about 15 feet. Cross-sectional views of the slope on the eastern side of the template—areas which had been dredged during phase 1 of the EPIC East Dock project—show profiles similar to cross-section 1383+00: the contours roughly follow the template, except at the top of the slope where material has been removed in excess of the template by about 15 feet (see figure 29). The superintendent explained that the additional loss of material at the top of the slope could be the result of wave action and other forces created by passing ships in the channel.

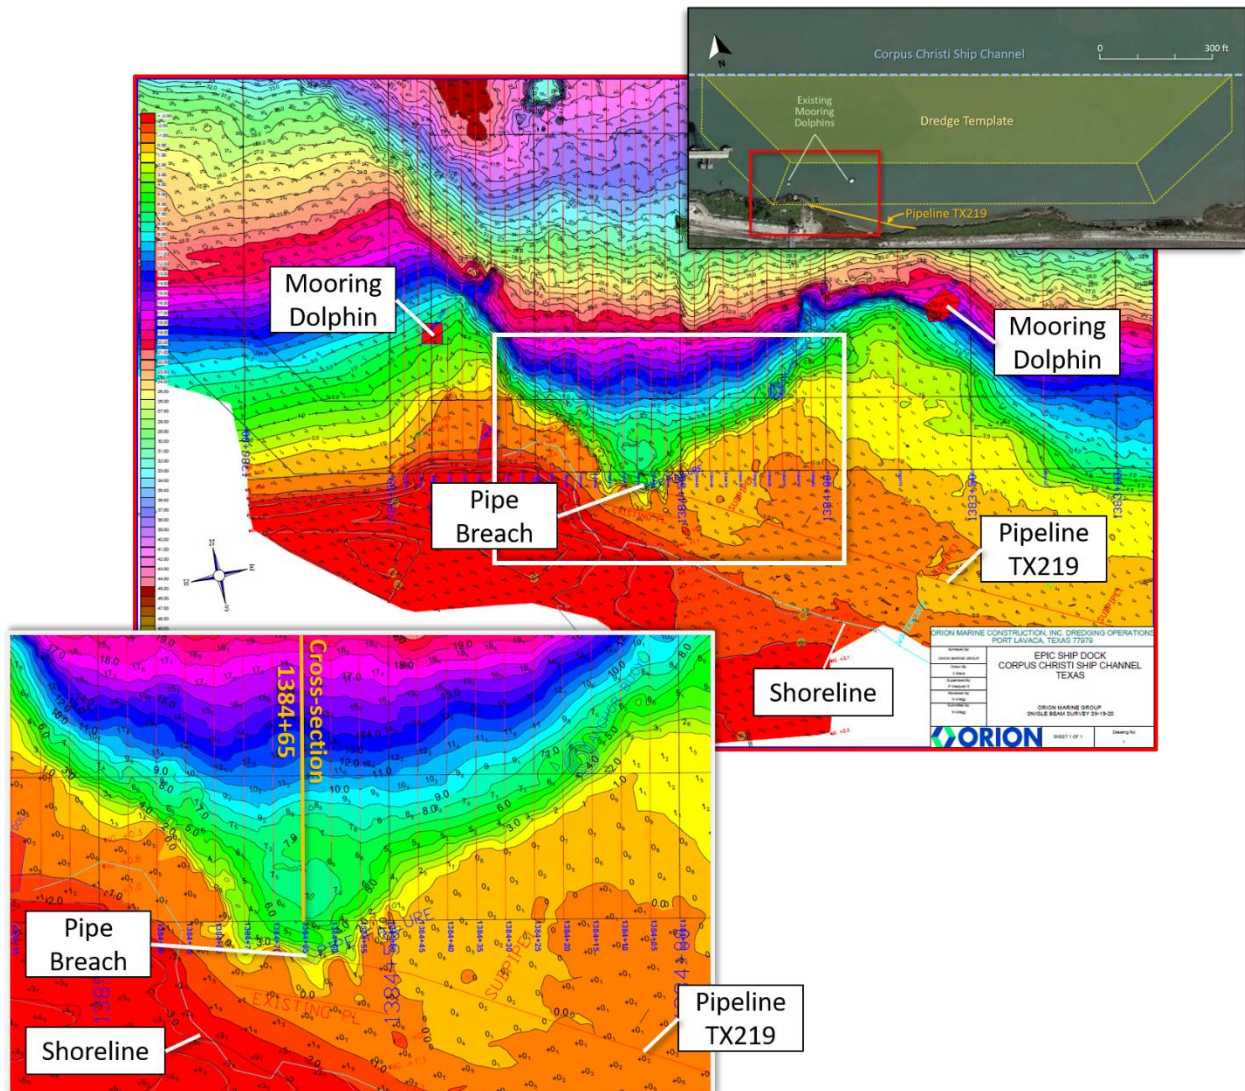
Postaccident Survey. On September 19, 2020, Orion personnel conducted a postaccident survey of the project site. They also surveyed the damaged pipeline using a real-time-kinetic (RTK) GPS-enabled probe to physically determine its location (see Figure 30). Data shows an arc of deeper water between the two existing mooring dolphins, sloping up toward the bank. The pipe breach is located at the apex of the arc.

Figure 30. Results of September 19, 2020 hydrographic survey of accident site. Inset top shows survey area. Inset bottom is an exploded view of the accident area. (Source: Orion Marine Group, with annotations by NTSB)

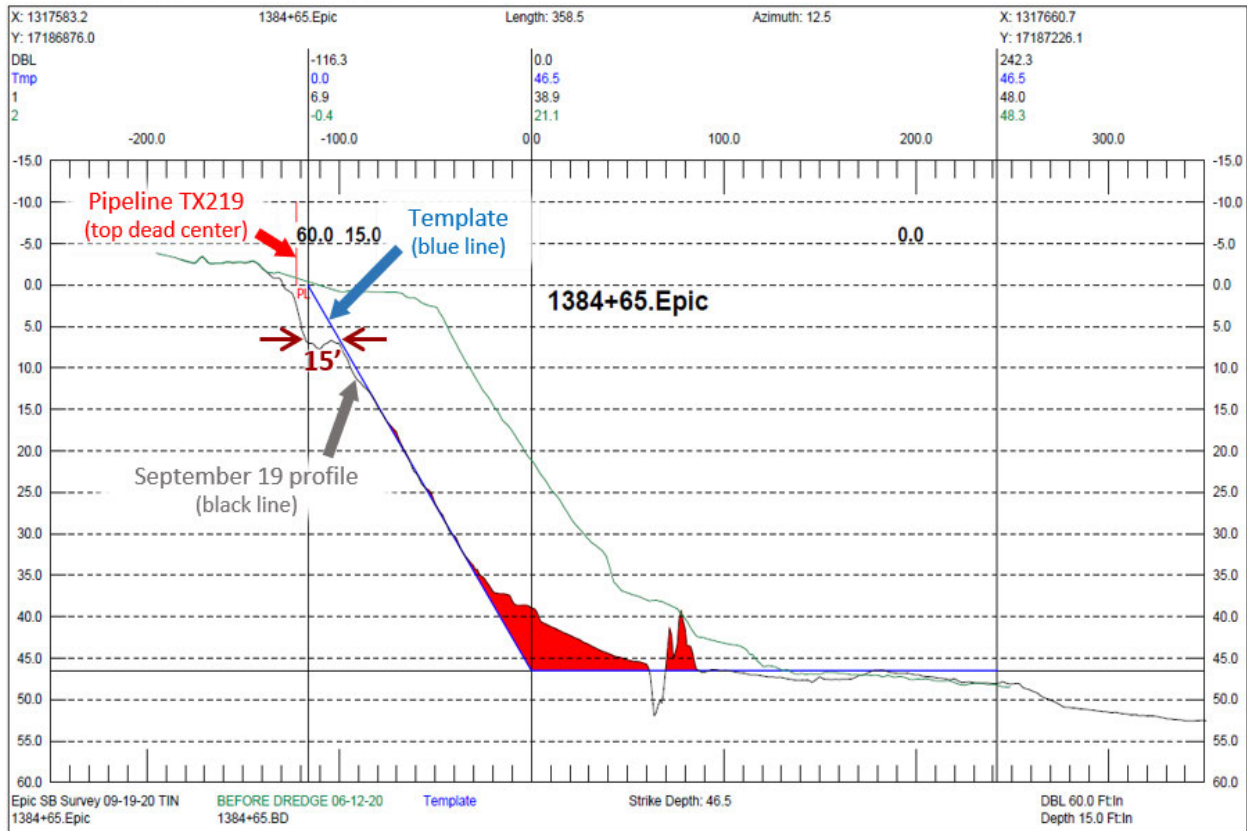
Cross Section 1384+65

The cross-sectional view at the accident site shows that, similar to cross-sections from earlier dredging, the excavation follows the template except at the top of the slope where material has been removed in excess of the template (see figure 31). Unlike the previous cross sections, however, the area where material has been removed at the top of the slope forms a pocket vice a smooth curve. The pocket lies directly below the damaged pipeline, labeled in figure 31 as “PL.”

Figure 31. Cross sectional view of dredging area at accident location from September 19, 2020, survey. Red line and “PL,” which appear in the original document, denote top dead center of pipeline as located by Orion personnel during the survey.
