NATIONAL TRANSPORTATION SAFETY BOARD

Group Chairman's Factual Report

Operations

Location: Off Channel Islands; 26 nautical miles offshore of Ventura, California
Date: September 2, 2019
Type: Fire/explosion
NTSB #: DCA19MM047

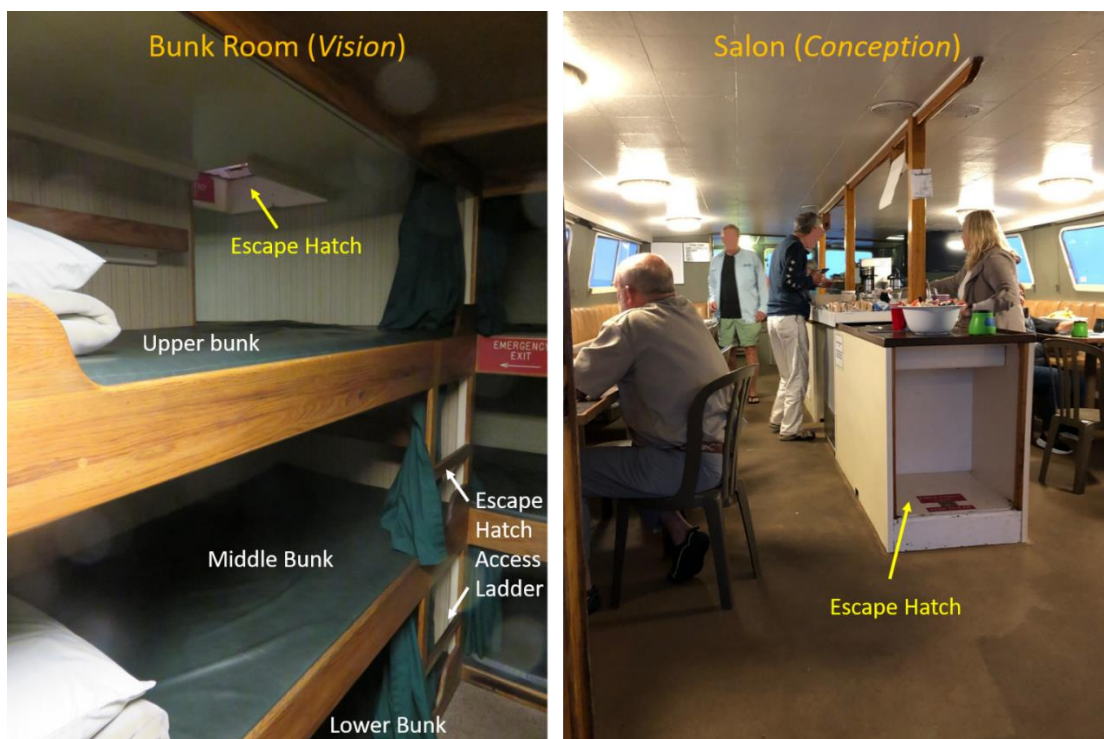
An escape hatch provided an alternate means of exiting the bunkroom (the stairway at the forward end was the primary means). The escape hatch, which consisted of a removeable wooden panel that was about 22-inches-by-22-inches in size, was located in the overhead between the aftmost centerline bunks.³ It could be reached from either aisle by climbing a wooden ladder installed on the side of each centerline aft set of bunks. The hatch exited into the rear of the salon, and thus both escape routes from the bunkroom exited into the salon. When the *Conception* was constructed and underwent sea trials in 1981, the Coast Guard “Sea Trials; T new construction and conversion” inspection form required the attending Coast Guard inspector to “physically use each emergency escape on board.” The inspection item was checked as completed on the form. The inspector wrote on the signed form that the sea trials were satisfactory.

Figure 4. Photo left is the escape hatch, viewed from the bunkroom, on the *Vision*, a Truth Aquatics dive vessel with arrangements nearly the same as the *Conception*. (Source: NTSB) Photo right is the

escape hatch, viewed from aft in the salon, on the *Conception*. (Source: J. Palmer)

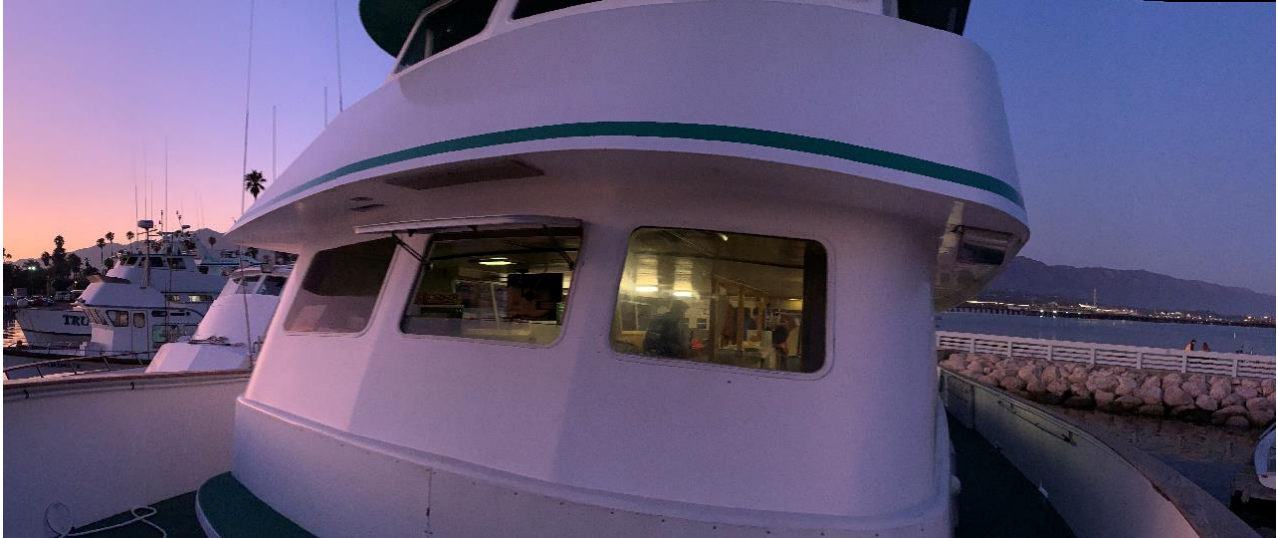
After the first deckhand had lowered himself down to the main deck, he looked aft and saw that the port exterior walkway was blocked by smoke and flames coming out of the salon windows and wrapping around the sun deck above. He proceeded to the bow and tried to open the center window on the forward bulkhead of the salon. The deckhand, aided by the second galleyhand, struggled to pry the window open, but could not. The two crewmembers told investigators that the window was warm, but not hot, and when they looked through the window, the view was completely obscured by thick black smoke.

Figure 6. Preaccident photo of *Conception* forward salon windows. In this photo the center window is open. However, during the accident, the window was closed and secured as the crew attempted to access the space. The port and starboard windows were not designed to be opened. (Source: T. Thompson)

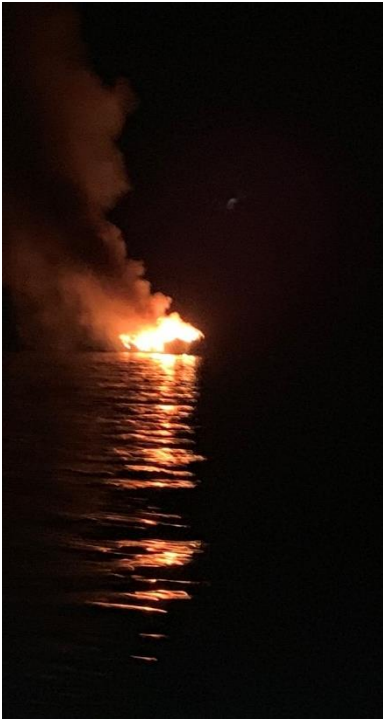
Figure 7. Cell phone photo of *Conception* on fire, taken from sportfisher *Grape Escape*. (Source: S. Hansen)
