**Fracture and
leak on the No.
4 CPP Blade.**

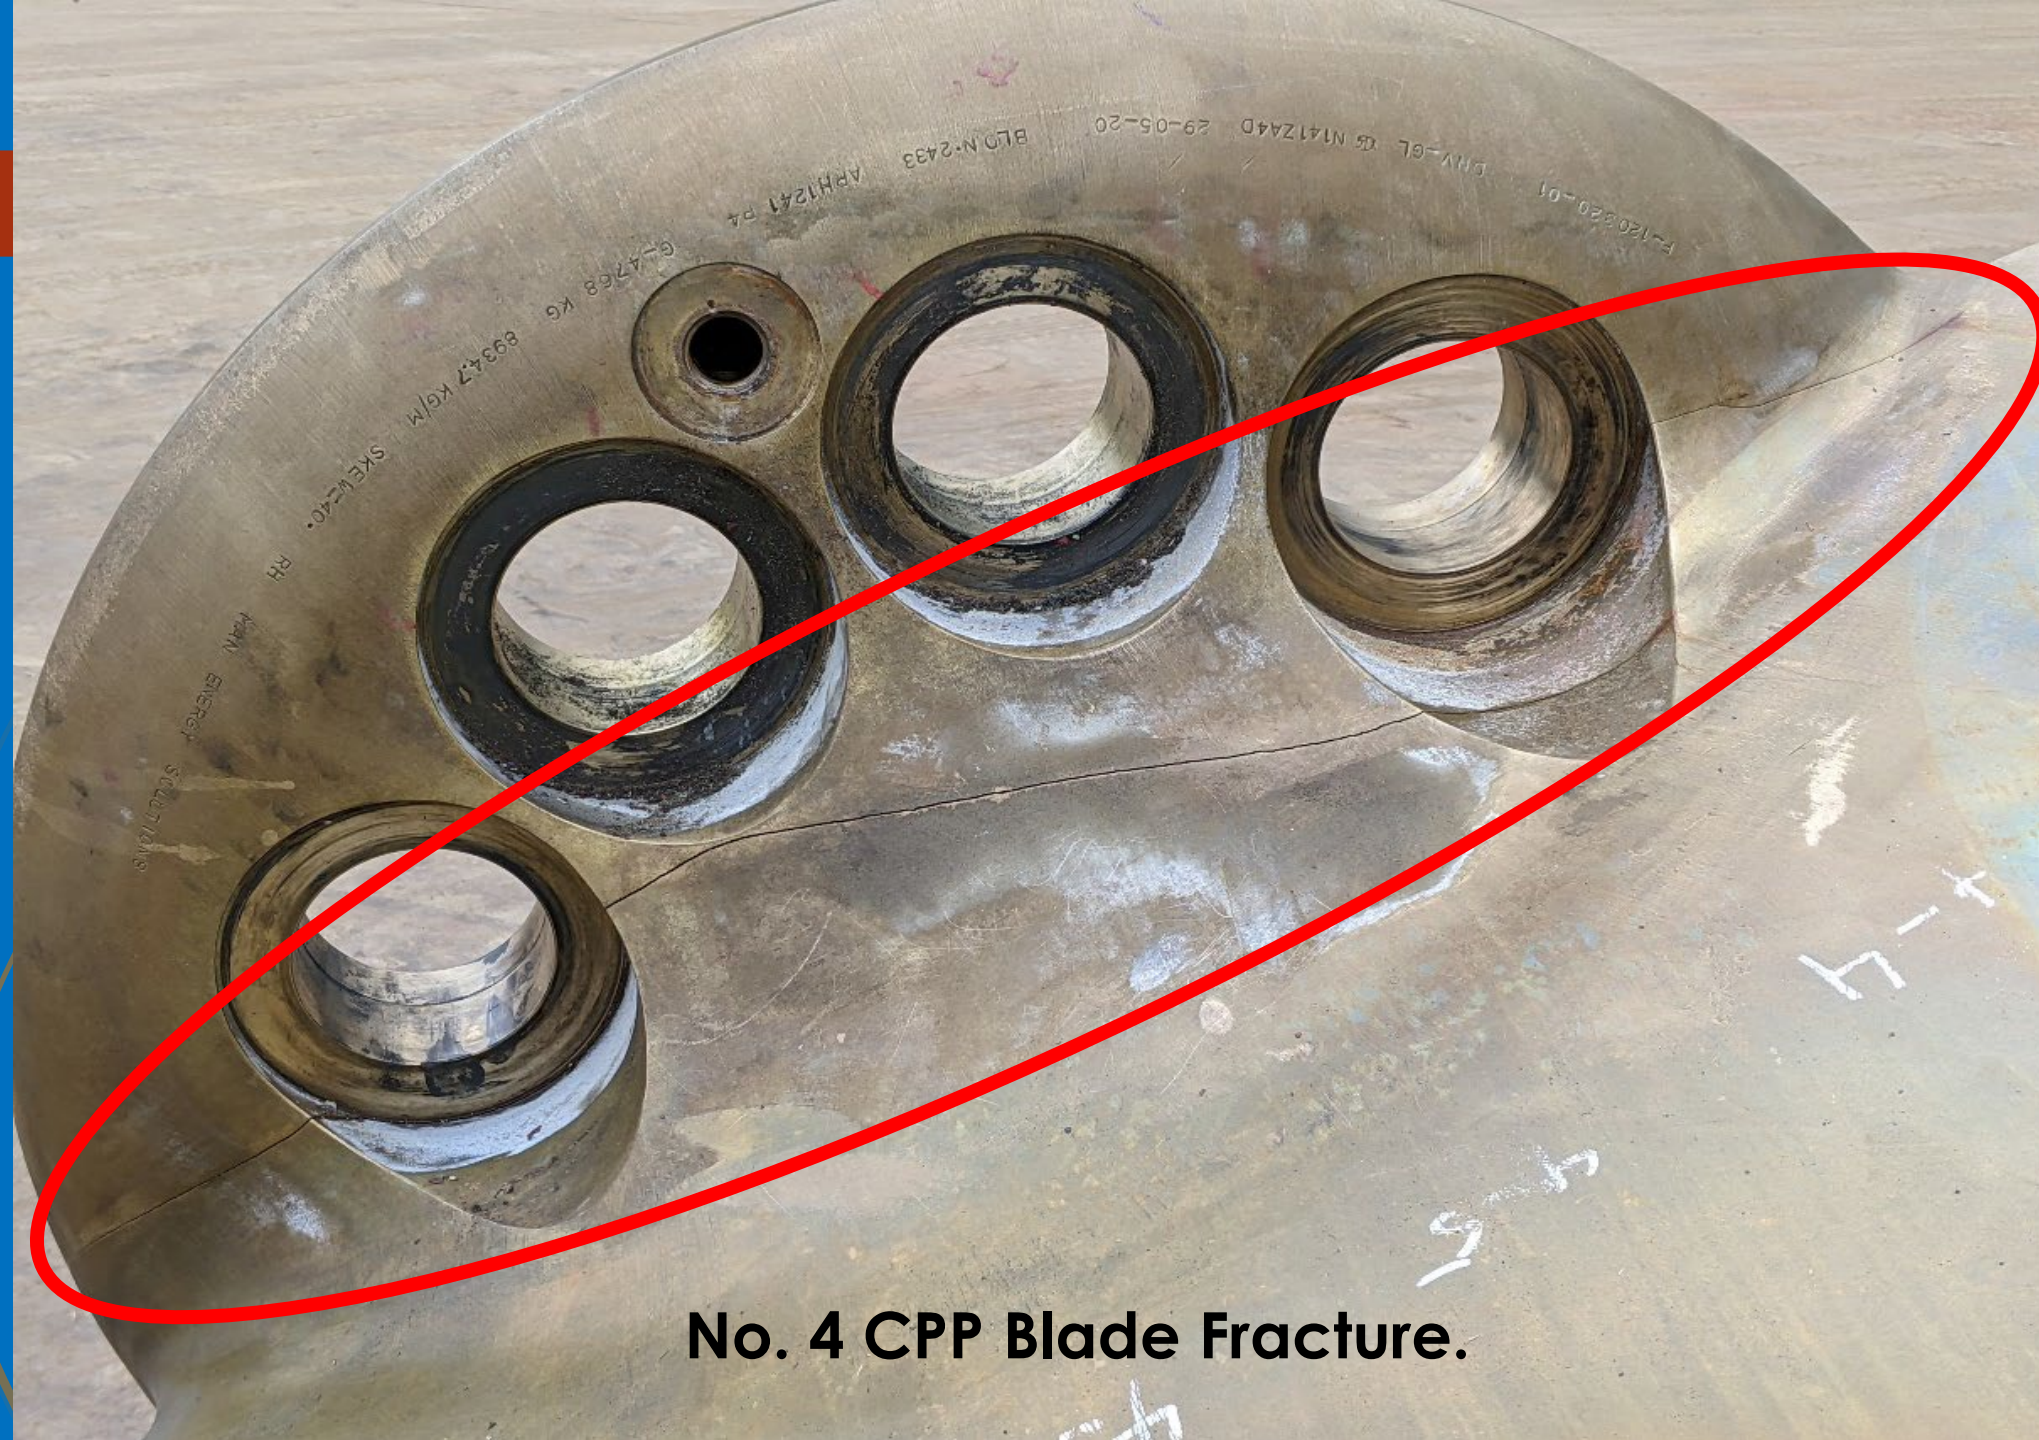
No. 4 CPP Blade Fracture.

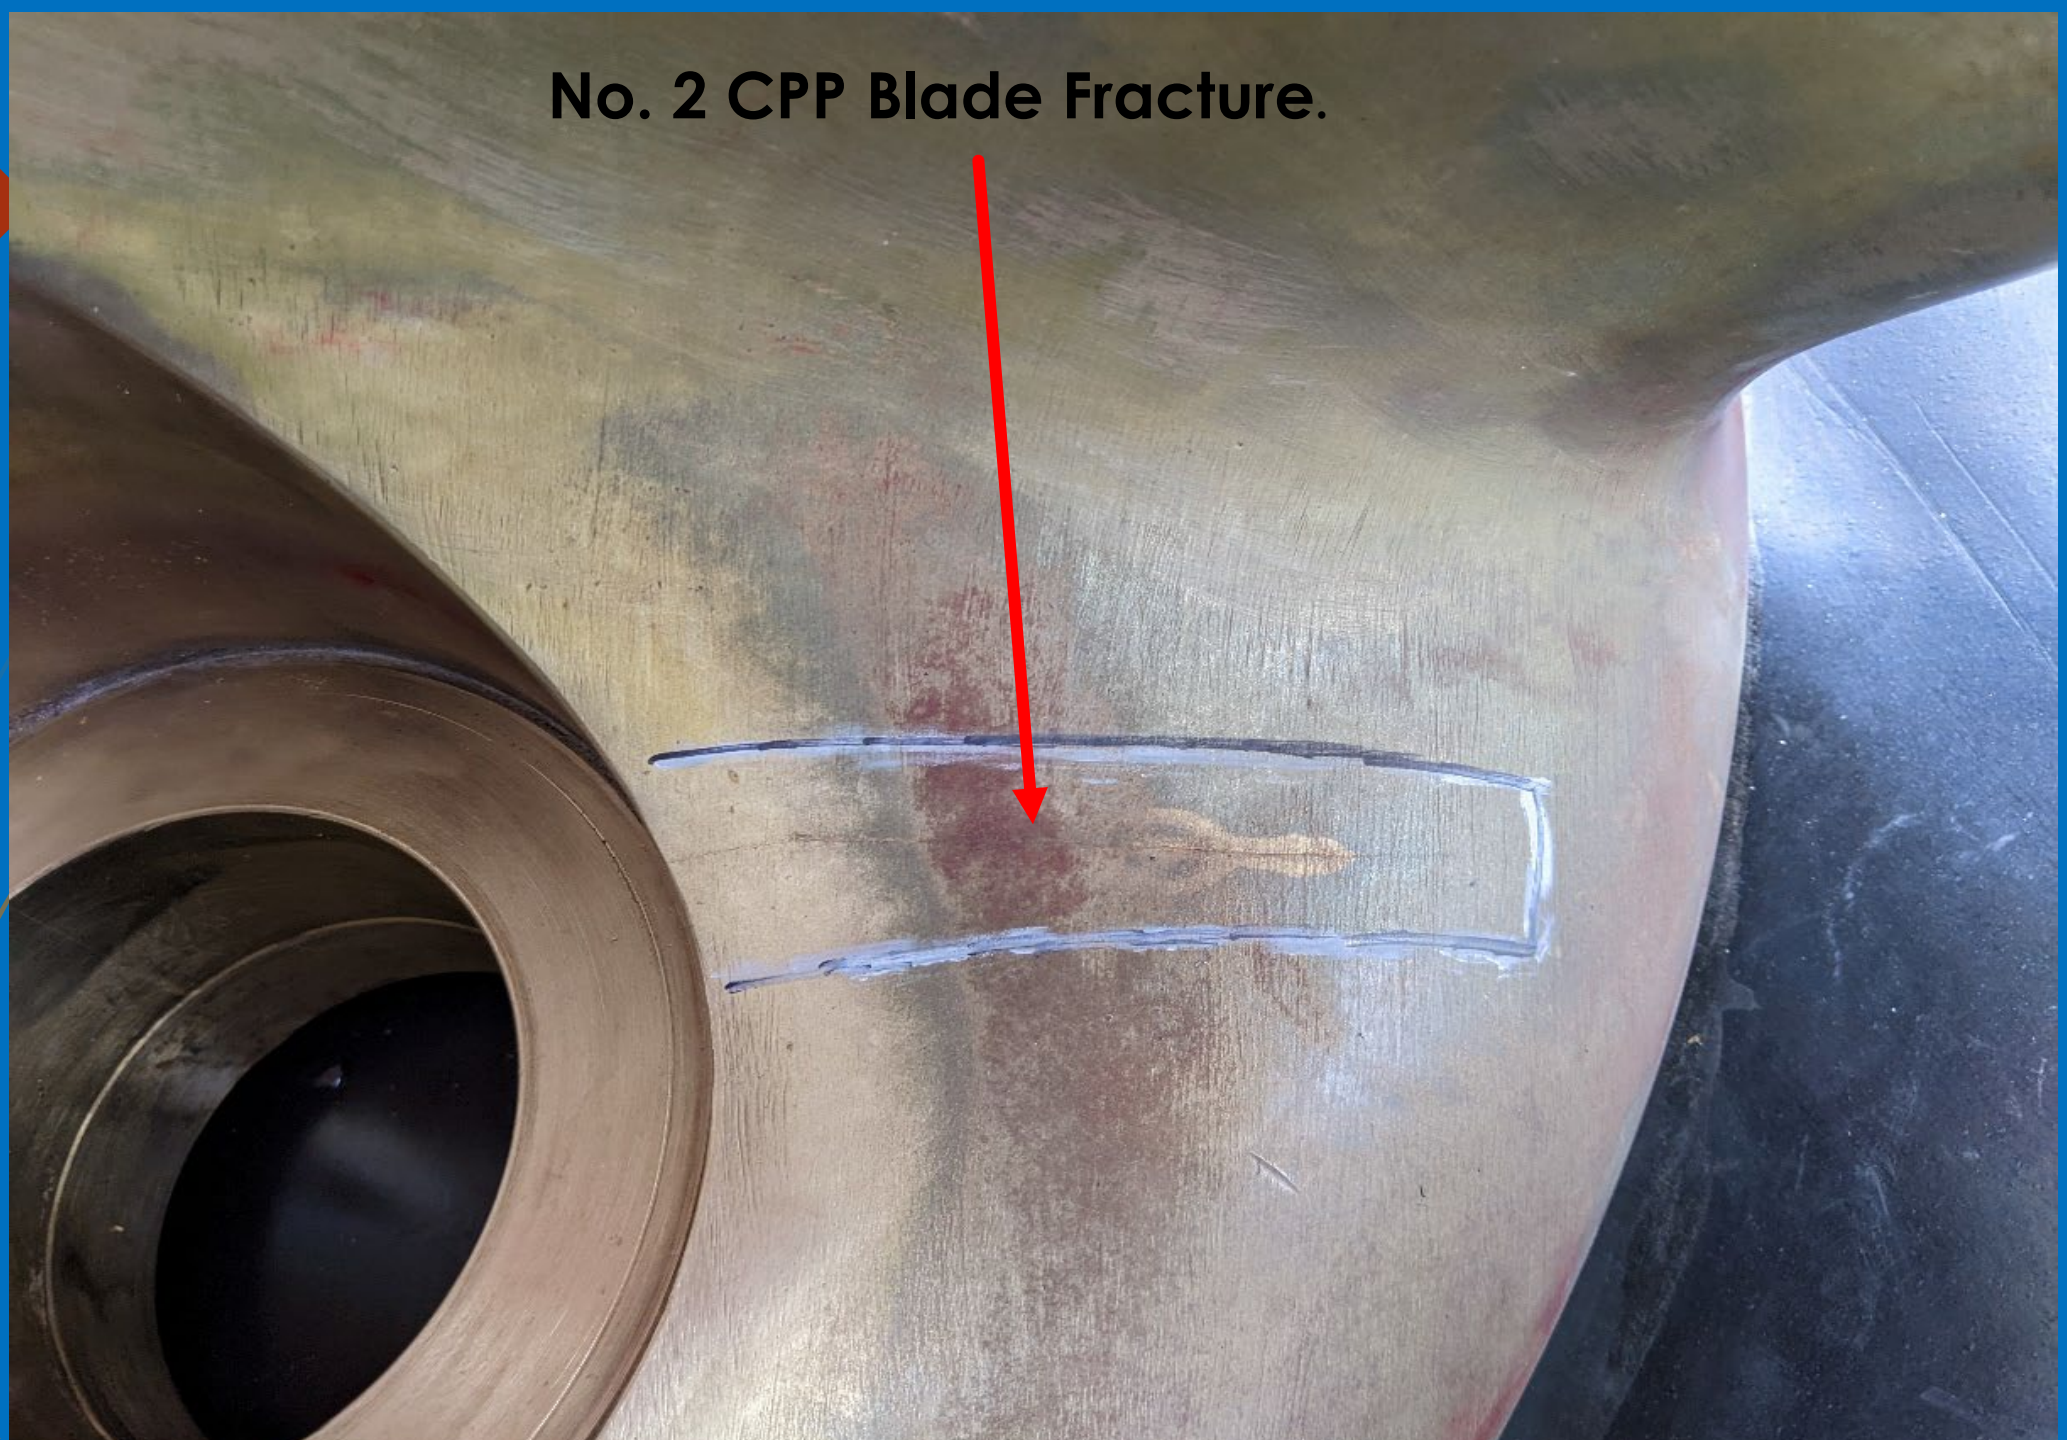
No. 2 CPP Blade Fracture.

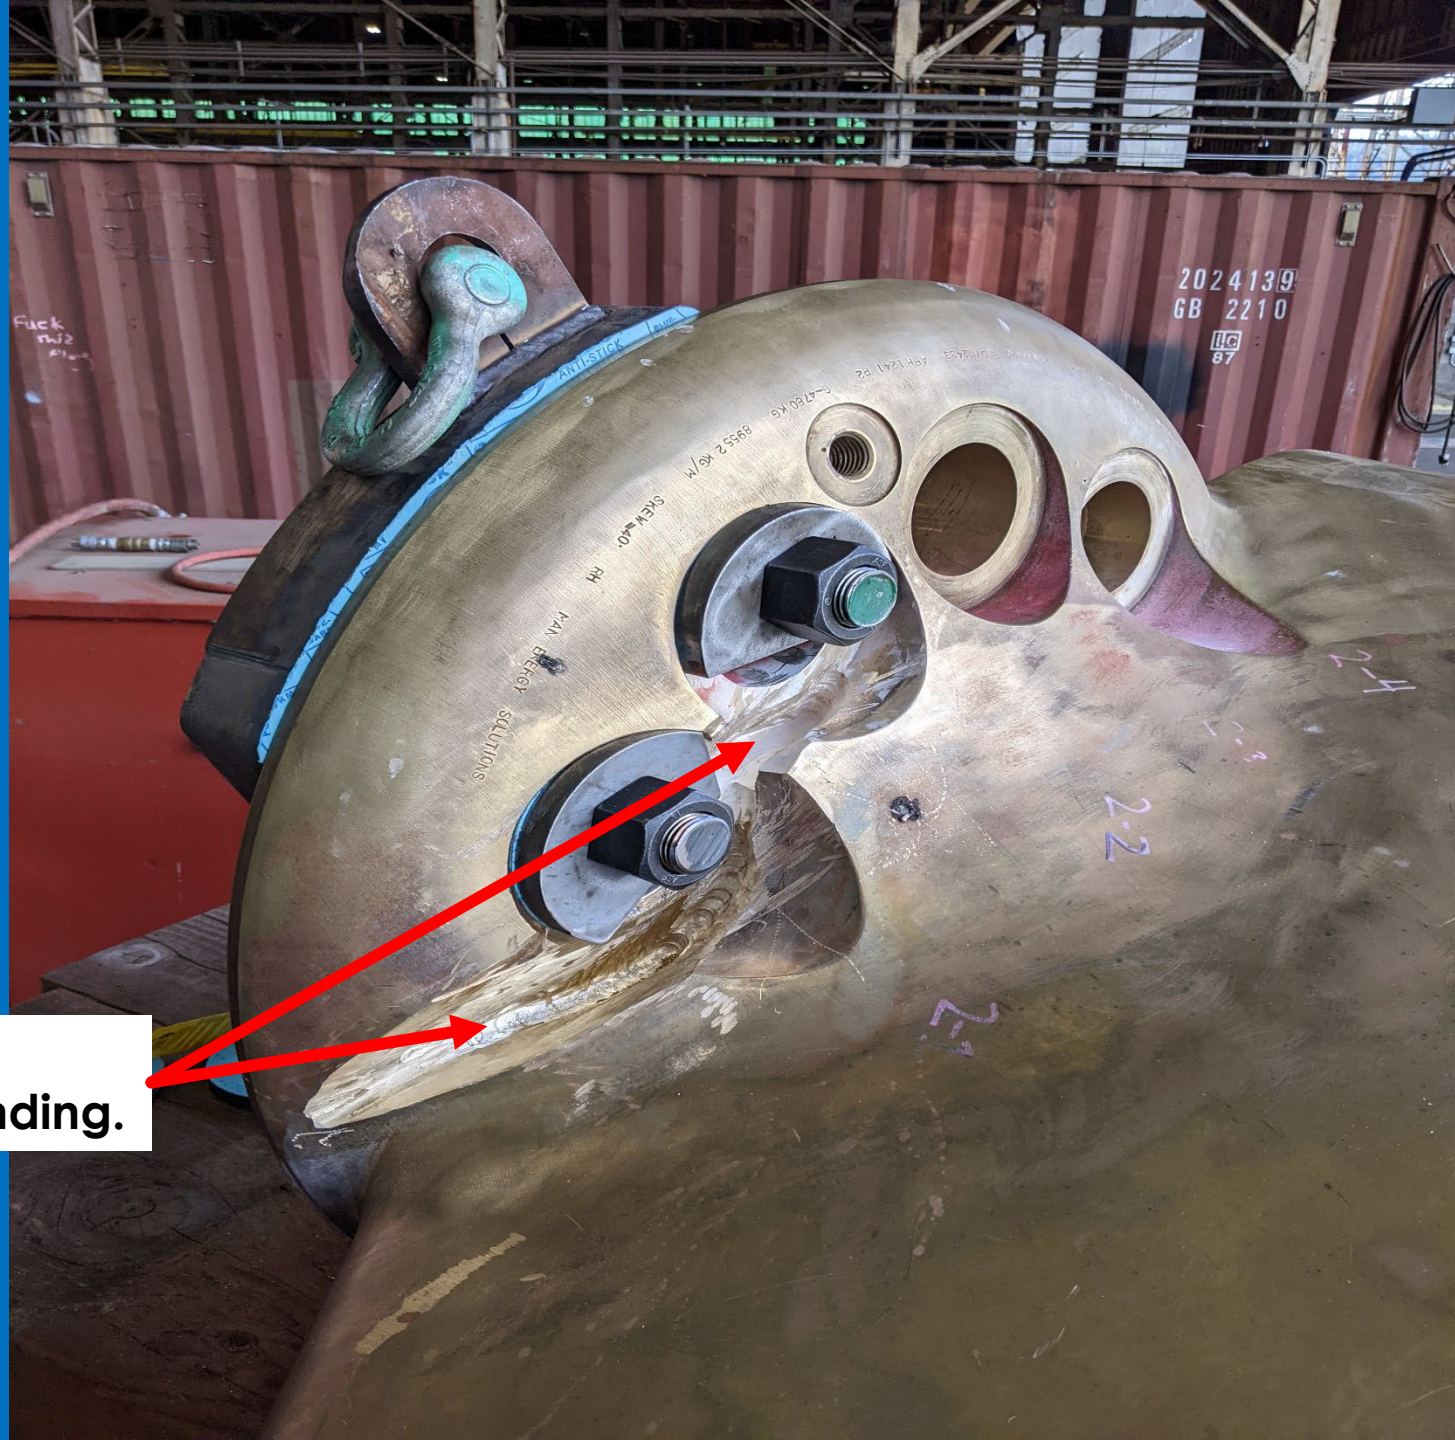
No. 2 CPP Blade; fracture removed via gouging/grinding.

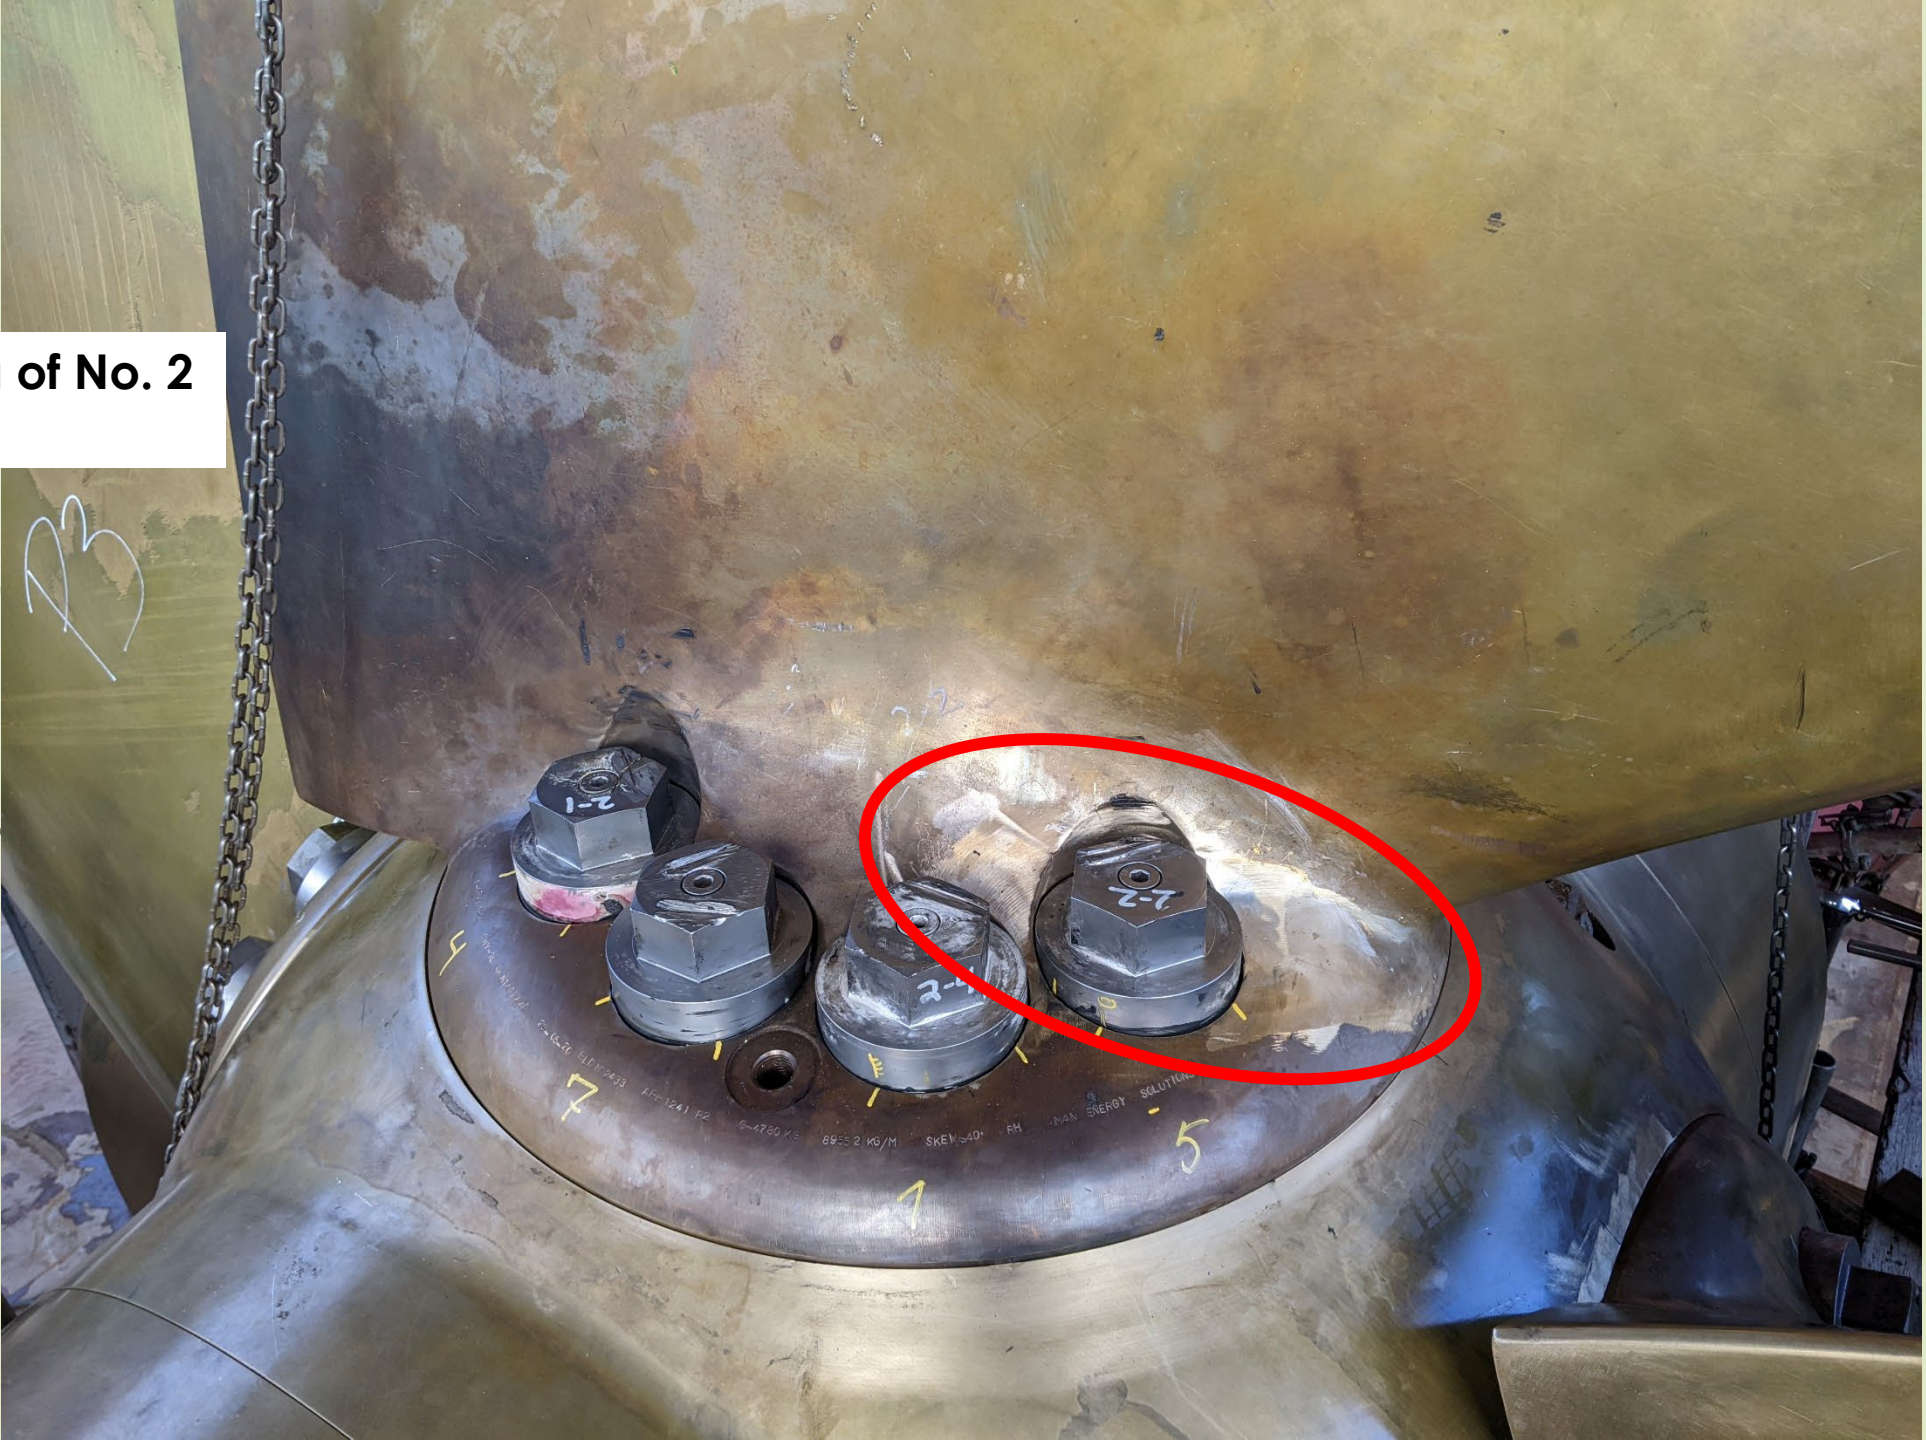
Repaired area of No. 2
CPP Blade.
