# **National Transportation Safety Board**

### **Group Chairman's Factual Report of the Investigation**

**Natural Gas-Fueled Explosion During Routine Maintenance**

**Farmersville, Texas**

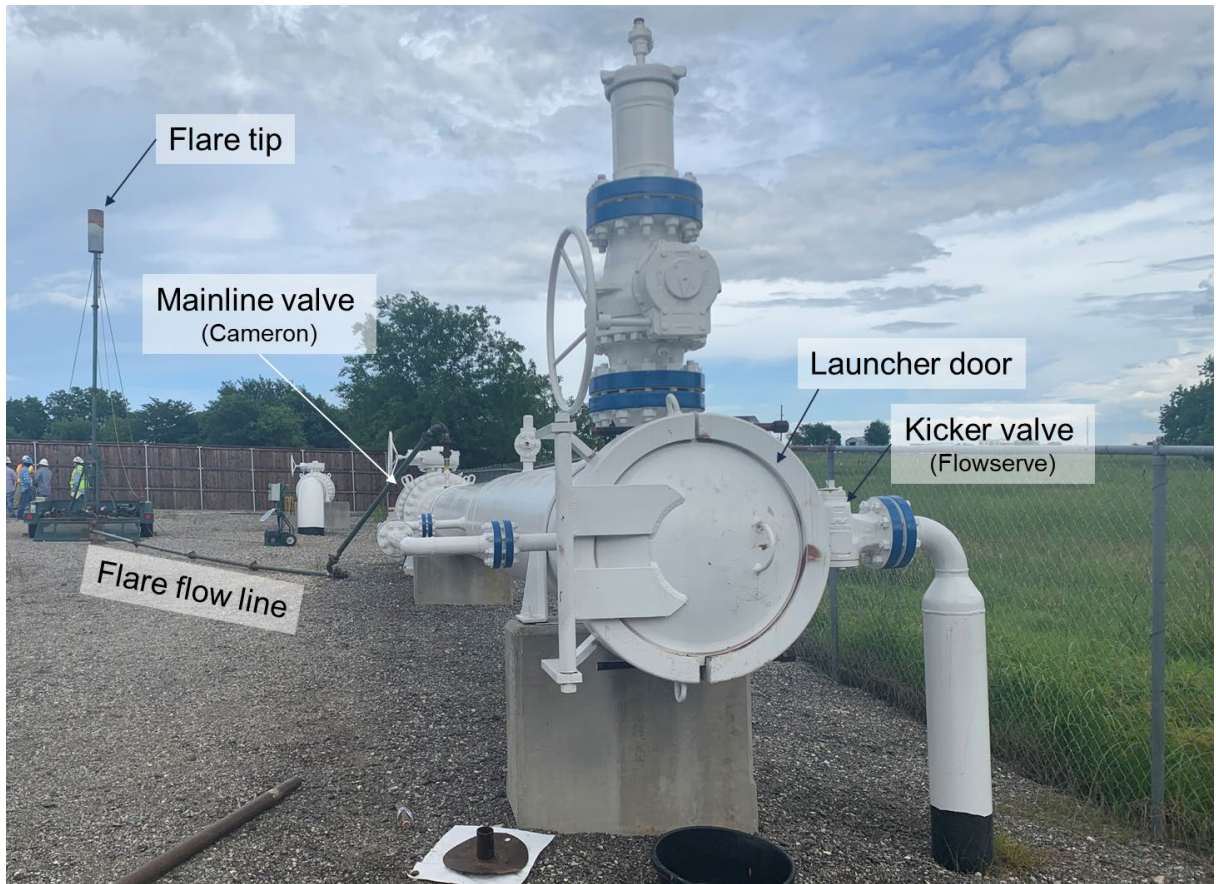
**Figure 2.** Front View of Pig Launcher Involved in the Accident

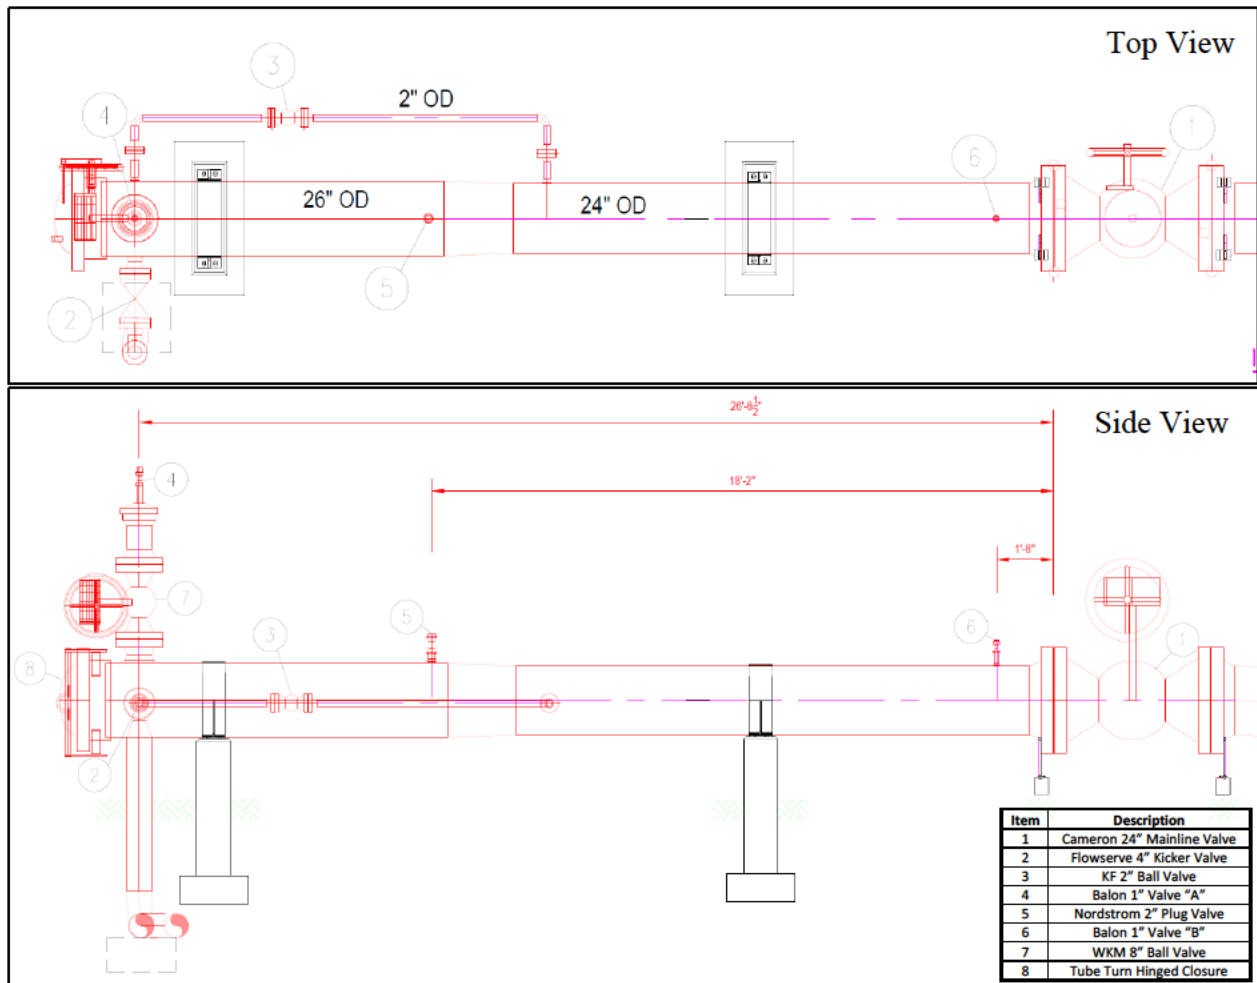
Figure 4. Launcher Configuration with Valves Indicated (Courtesy of Atmos)<sup>26</sup>

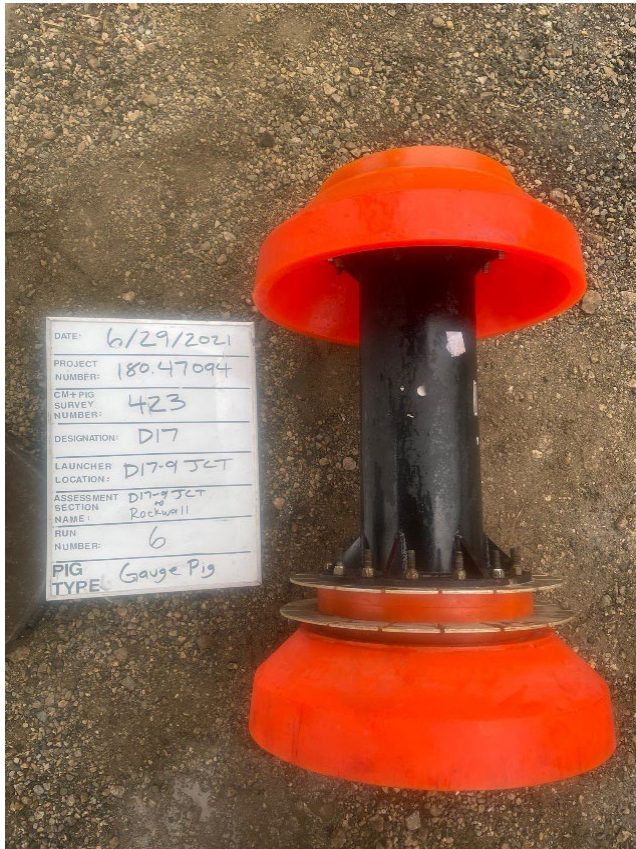
**Figure 5.** Photograph of gauge pig under umbrella prior to loading into the launcher. Taken 6/28/2021 at 3:28 PM. (Courtesy of Bobcat)

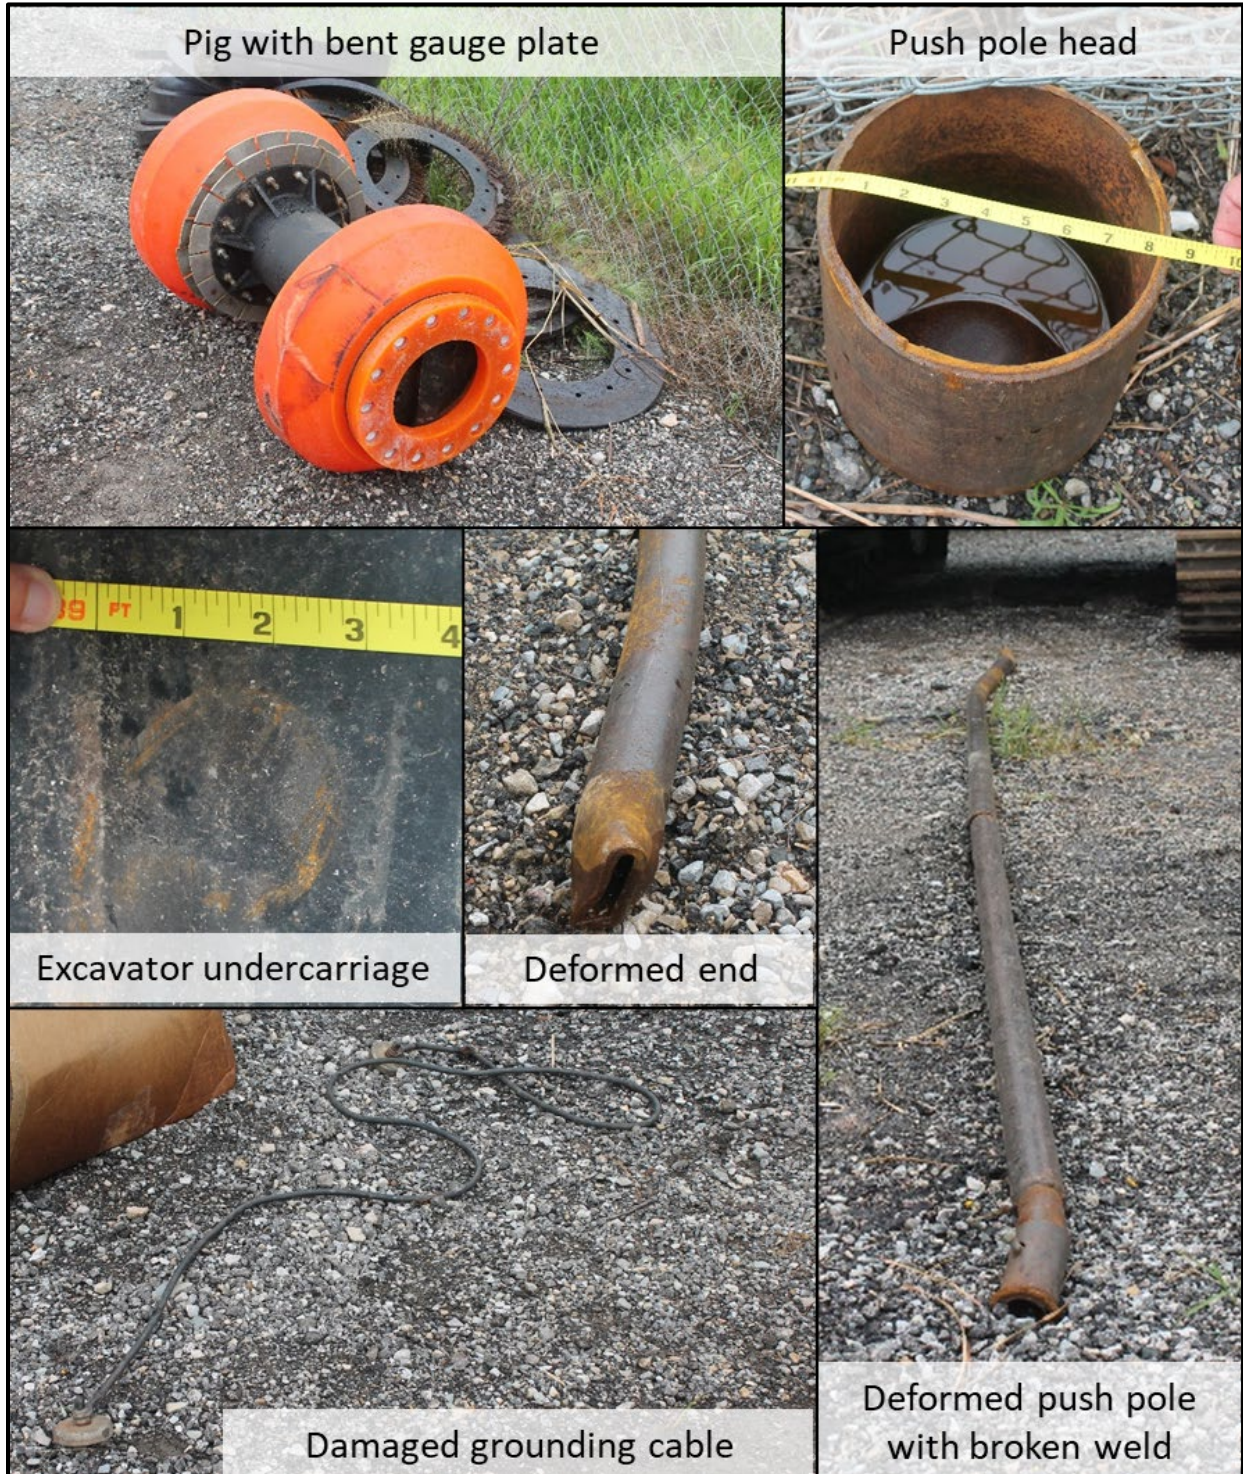
**Figure 6.** Site Assessment, July 2, 2021

- The launcher door was fully closed and secure.
- No work notes or job safety analyses were found onsite.
- No gas was leaking from the flare connection at Valve 6, along the 2-inch flare flow line, or from the flare stack except at the flare tip.<sup>47</sup>

- The welded connection between the push pole head and pole was broken.
- The plate that was welded to the push pole head was deformed (concave, not flat).

- The blind flange on the back of the pig was deformed on one side.
- Insulation on the grounding cable was damaged in several locations.
- Valve 1 had scribe marks nearly in the center of the "SHUT" location.

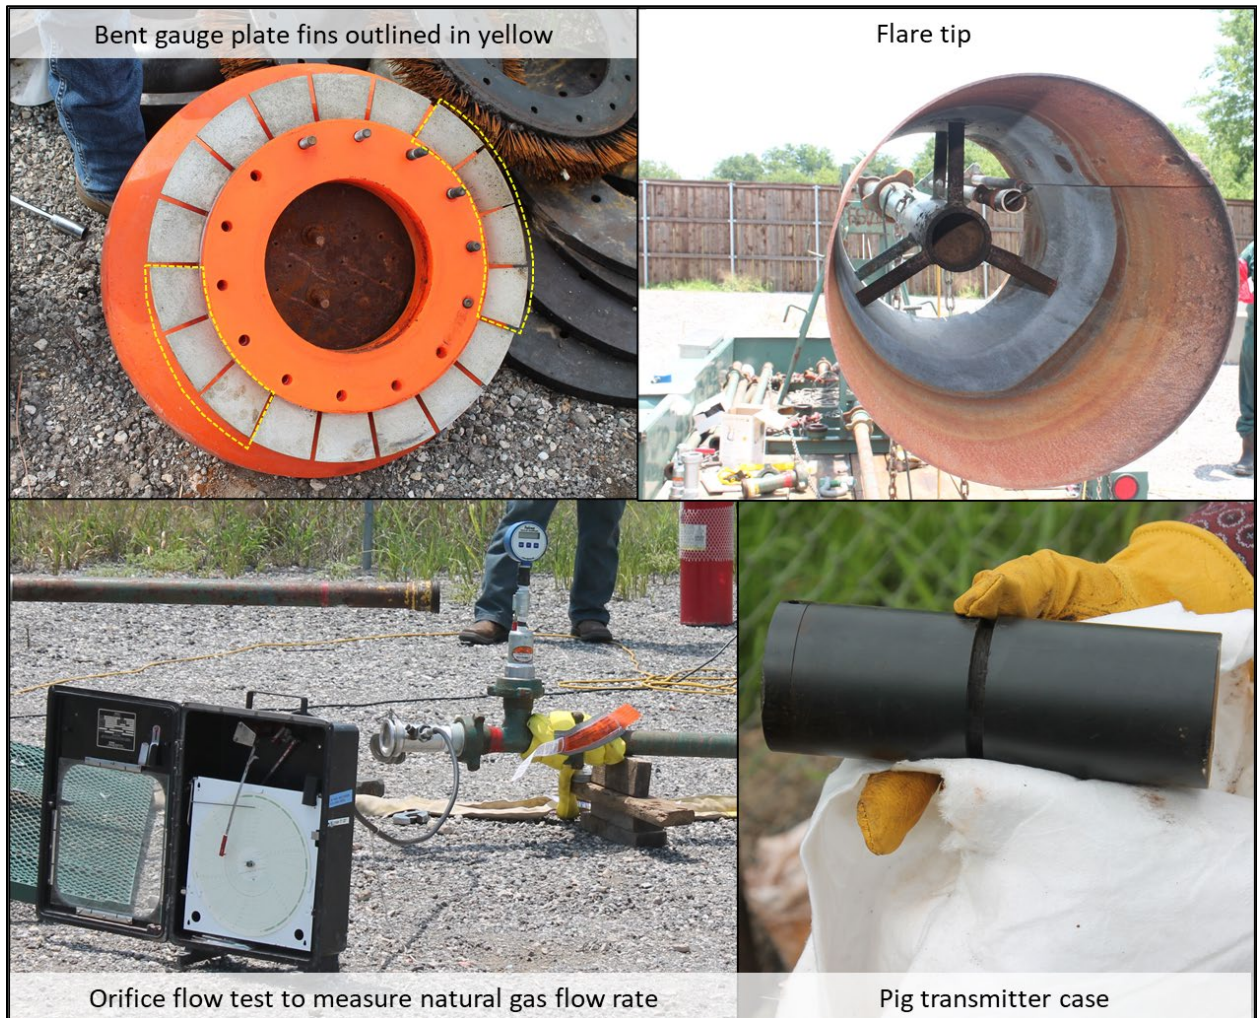
**Figure 7.** Site Assessment, July 5, 2021

- Visual inspection of pig
  - Four fins on the larger gauge plate were bent forward on one side and three on the other.
  - One fin on the smaller gauge plate was bent backwards.
  - Packing inside pig no visible evidence of ignition, burning, or soot.

- Forward, chamfered edge of pig appeared to have been locally heated.
- No significant damage to transmitter case was apparent.
- Orifice flow testing<sup>48</sup>
  - Prior to orifice flow testing, pressure in the launcher was measured at Valve 4 and recorded as 0.2 psig. This measurement was taken with the flare flow line venting from through Valve 6 and to the flare flow line to the flare tip.
  - Steady state flow was observed through a 1/8-inch diameter orifice plate at a pressure of 9 inches water column. This corresponds to an estimated natural gas flow rate of 1590 cubic feet per day.
- Visual inspection of flare tip
  - Nothing unusual observed.
  - Some corrosion and heat affect areas were observed.
- Flare system ignition<sup>49</sup>
  - Flare ignited without difficulty
  - Igniter was powered off after initial ignition
  - Flames were visible throughout 20-minute hold

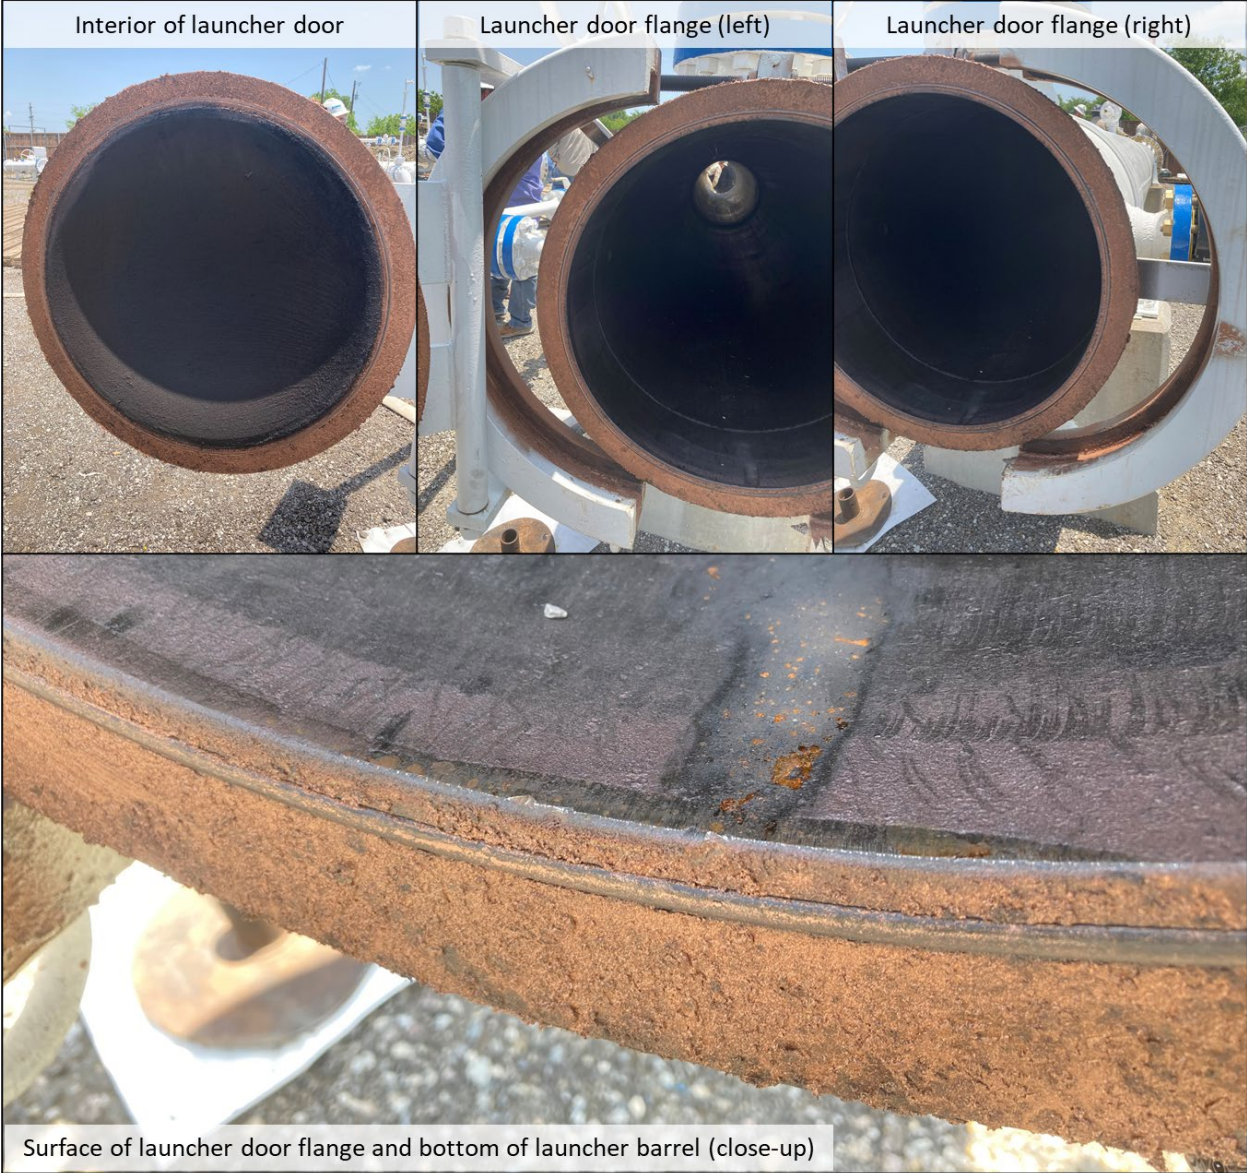
Photographs of the launcher door's mating surfaces taken on July 13, 2021 indicate that the surfaces were corroded (Figure 8).

**Figure 8.** Corrosion on launcher door mating surfaces, July 13, 2021 (Courtesy of RRC)
