# NATIONAL TRANSPORTATION SAFETY BOARD

## MATERIALS LABORATORY FACTUAL REPORT

Report No. 20-006

Place : Los Angeles, CA  
Date : December 4, 2019  
Vehicle : Eurocopter AS350 B2, N71HD  
NTSB No. : DCA20NA034AB  
Investigator : Bill English, AS-10

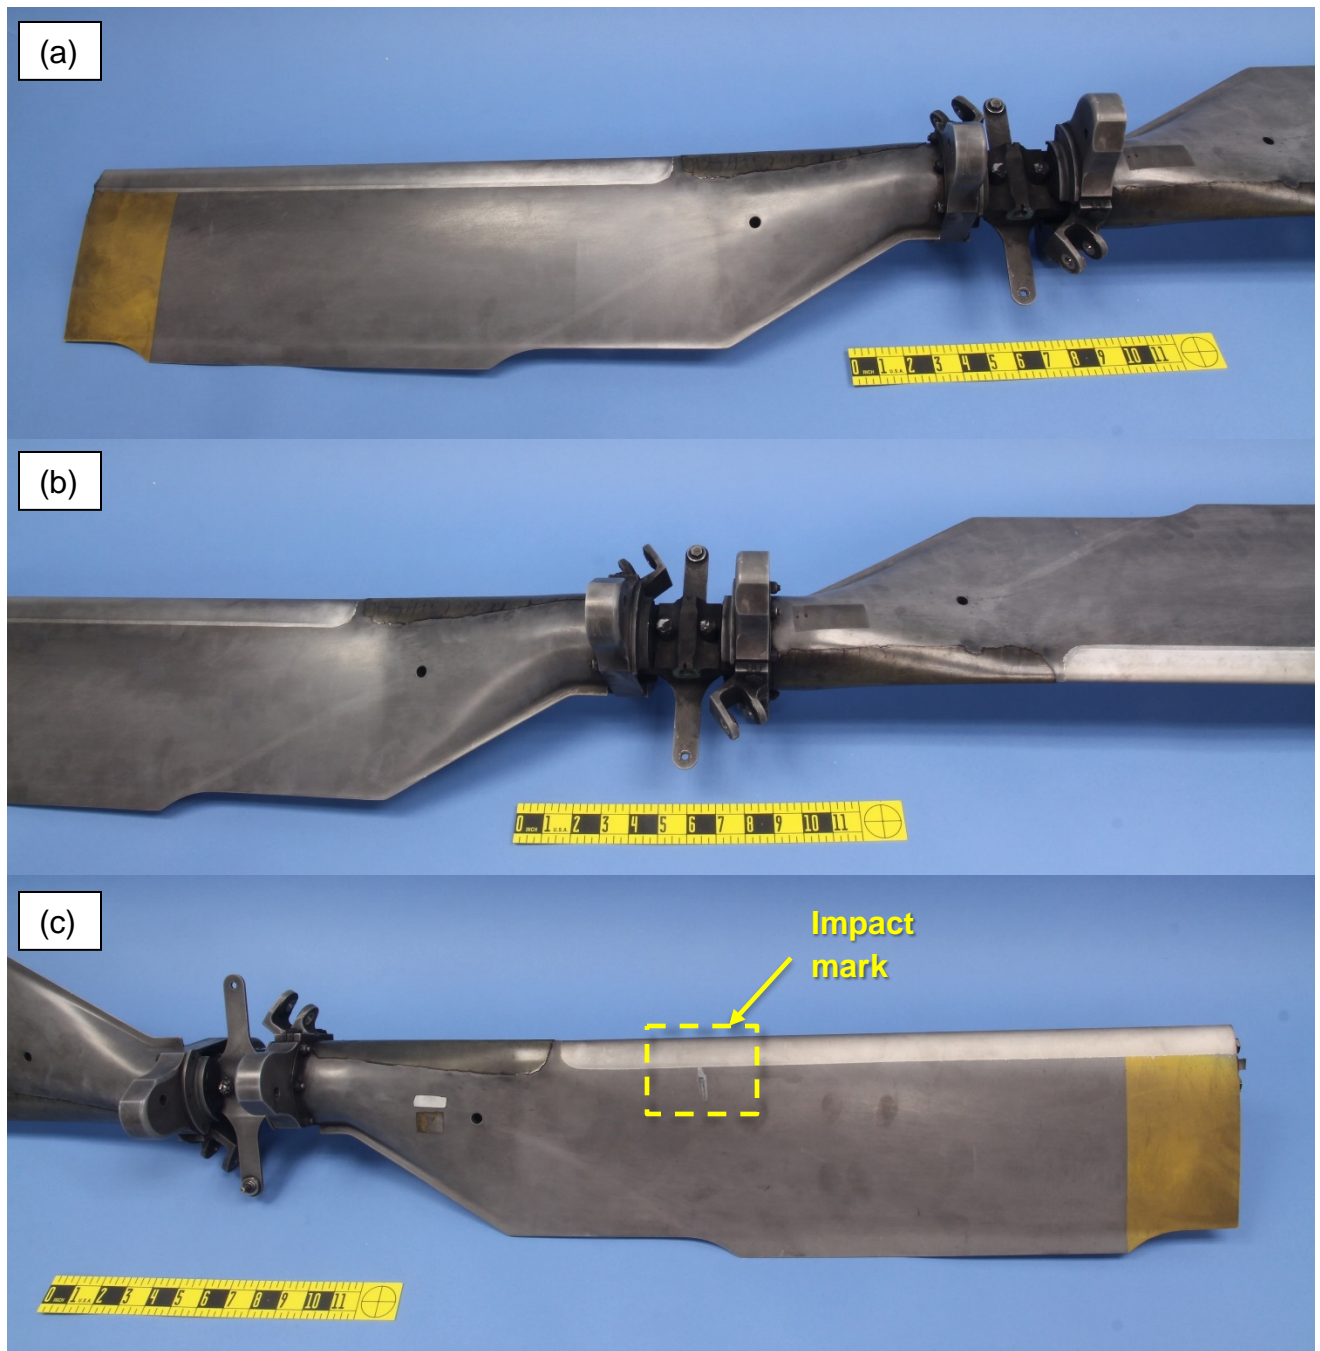
The Materials Laboratory received portions of the tail rotor assembly and the horizontal stabilizer from the aircraft. Figure 1 shows the portion of the tail rotor blade assembly, as received. Of note on the tail rotor blades was an impact mark, denoted in Figure 1c and highlighted in Figure 2.

Figure 1 – The tail rotor blade assembly, shown from left to right in (a), (b), and (c). The boxed area in (c) is highlighted in Figure 2.

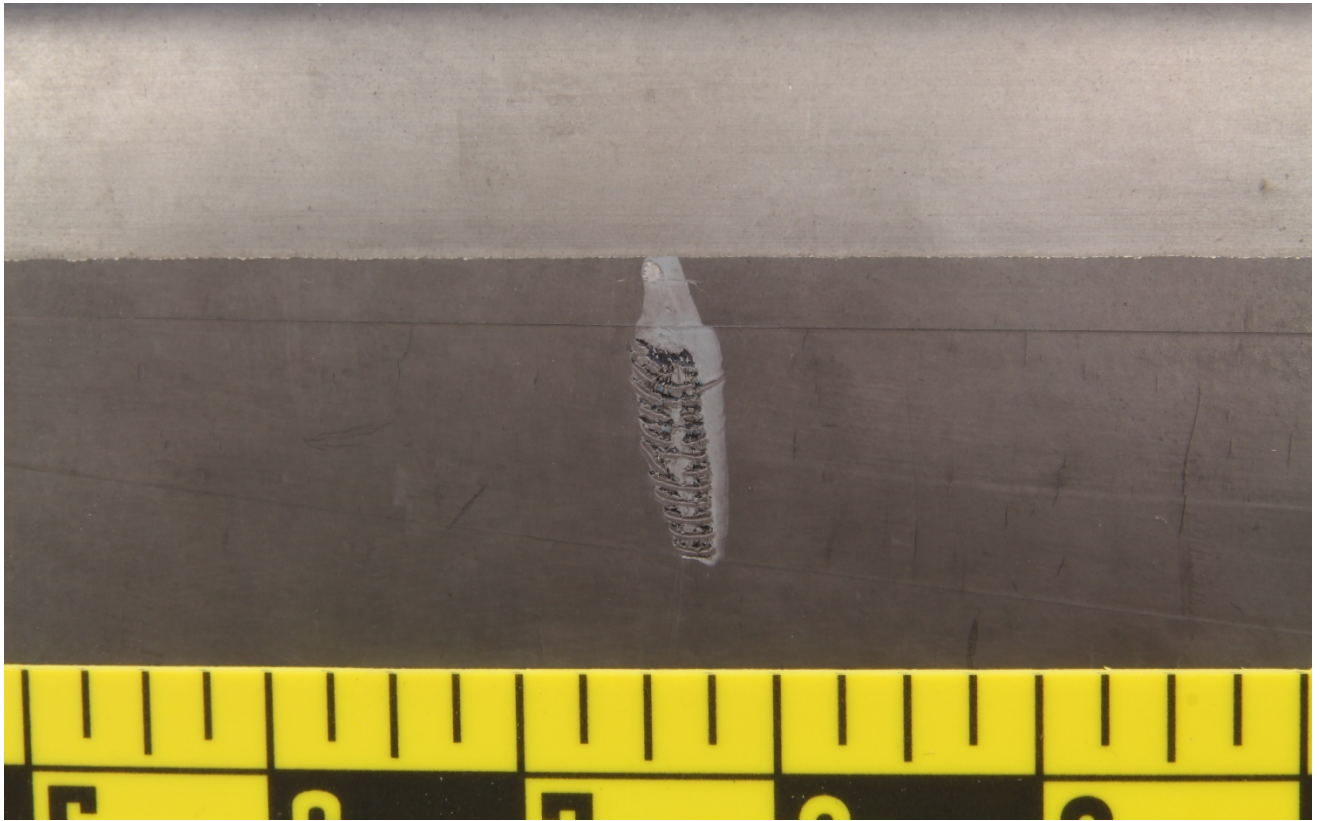
Figure 2 shows the elongated witness mark on the tail rotor blade. The mark was elongated and measured approximately 1.2 inches long and 0.25 inches wide. The mark was located approximately 1.25 inches from the tip of the leading edge of the tail rotor blade. The shape of the mark was comet-tailed, consistent with an impact with another object moving across the blade.

Figure 2 – The tail rotor impact mark near the leading edge from Figure 1c.

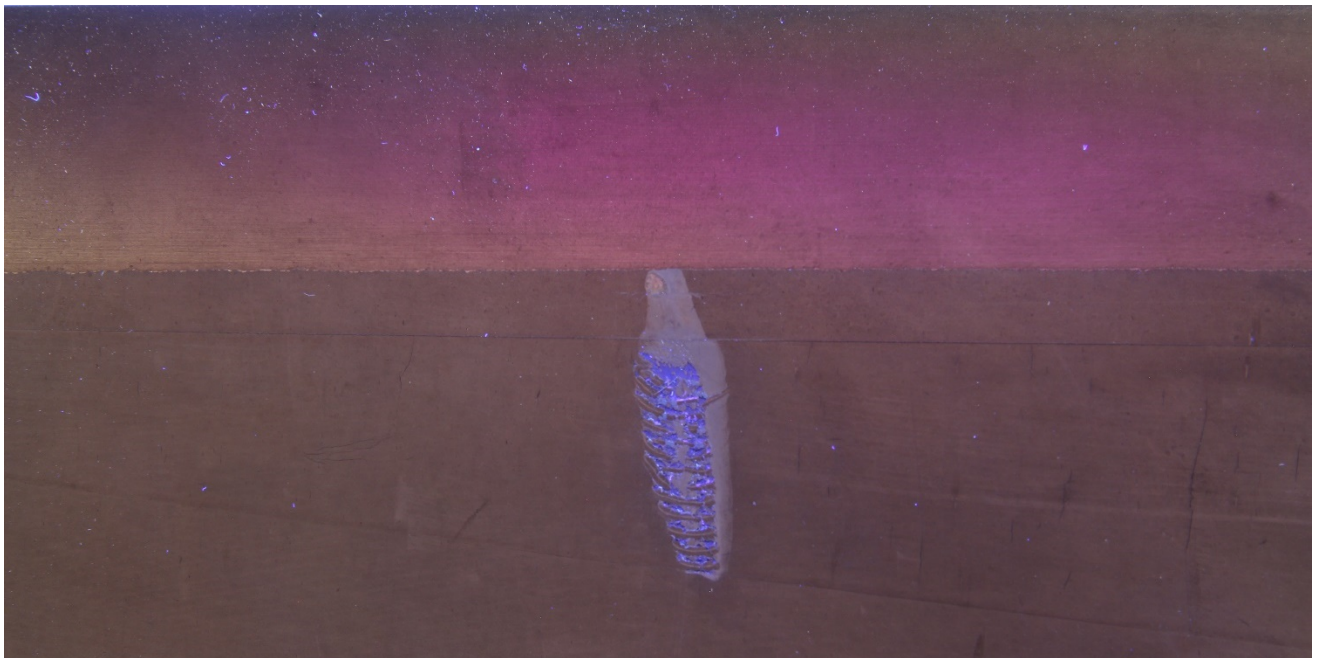
This impact mark and the tail rotor blade assembly fragments were inspected using an ultraviolet (UV) light. Figure 3 shows the tail rotor blade impact mark exposed to UV light. In this figure, most of the surface did not fluoresce under UV light exposure. Some dust particles and the material internal to the tail rotor fluoresced a violet color. There were no indications of material that fluoresced green, which could indicate remnants of biological fluids.

Figure 3 – The tail rotor impact mark in Figure 2, exposed to ultraviolet light.

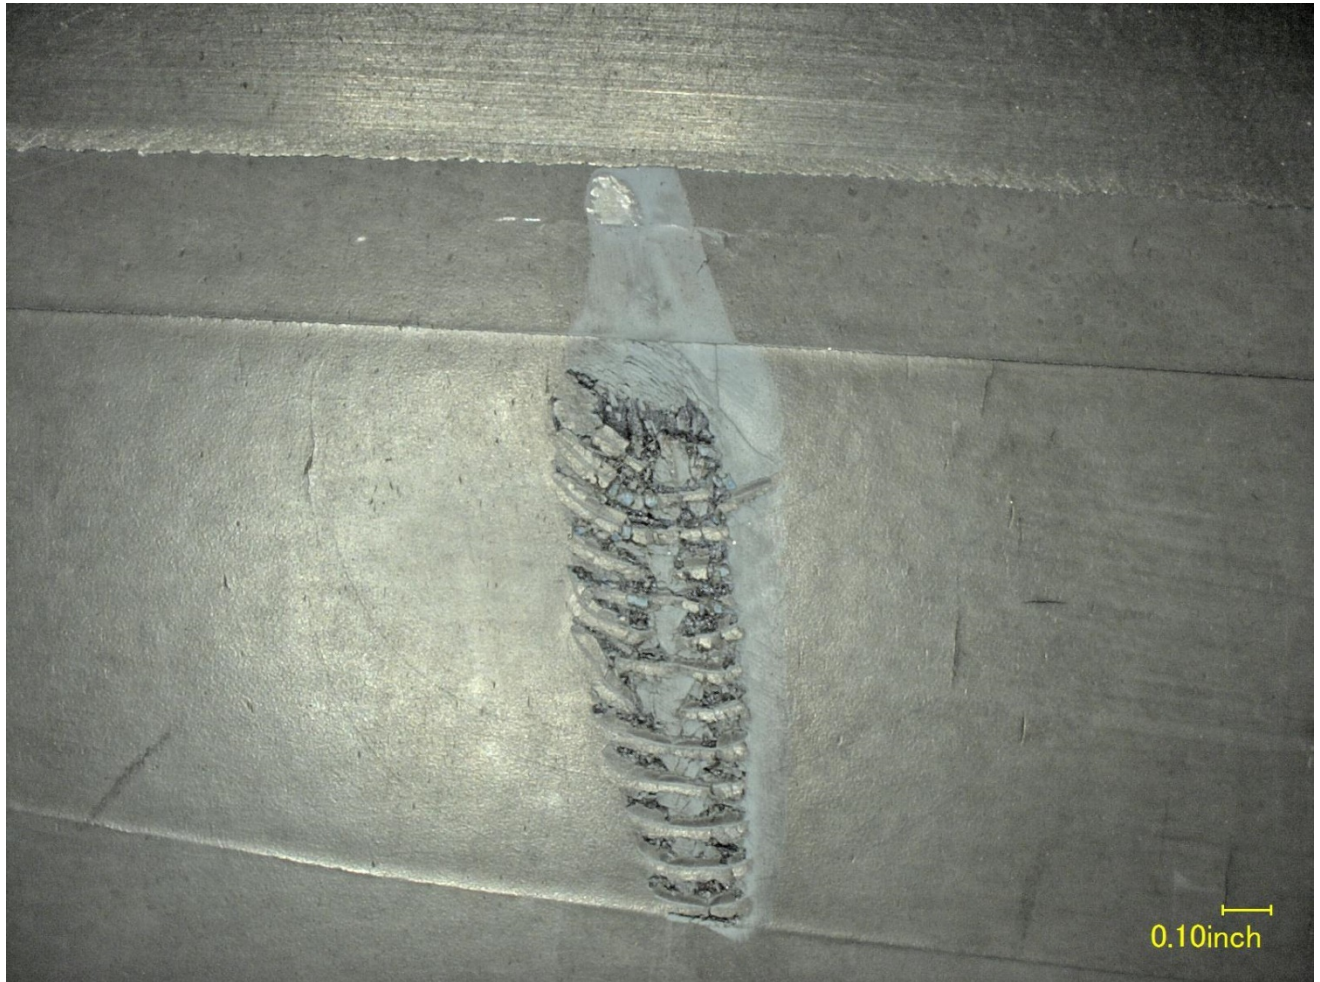
Figure 4 shows a closer view of the tail rotor blade impact. This showed an underlying ribbed structure, with a cyan colored filler material. No indication of biological material was found embedded in this area.

Figure 4 – Closer view of the tail rotor impact mark, showing the underlying material.

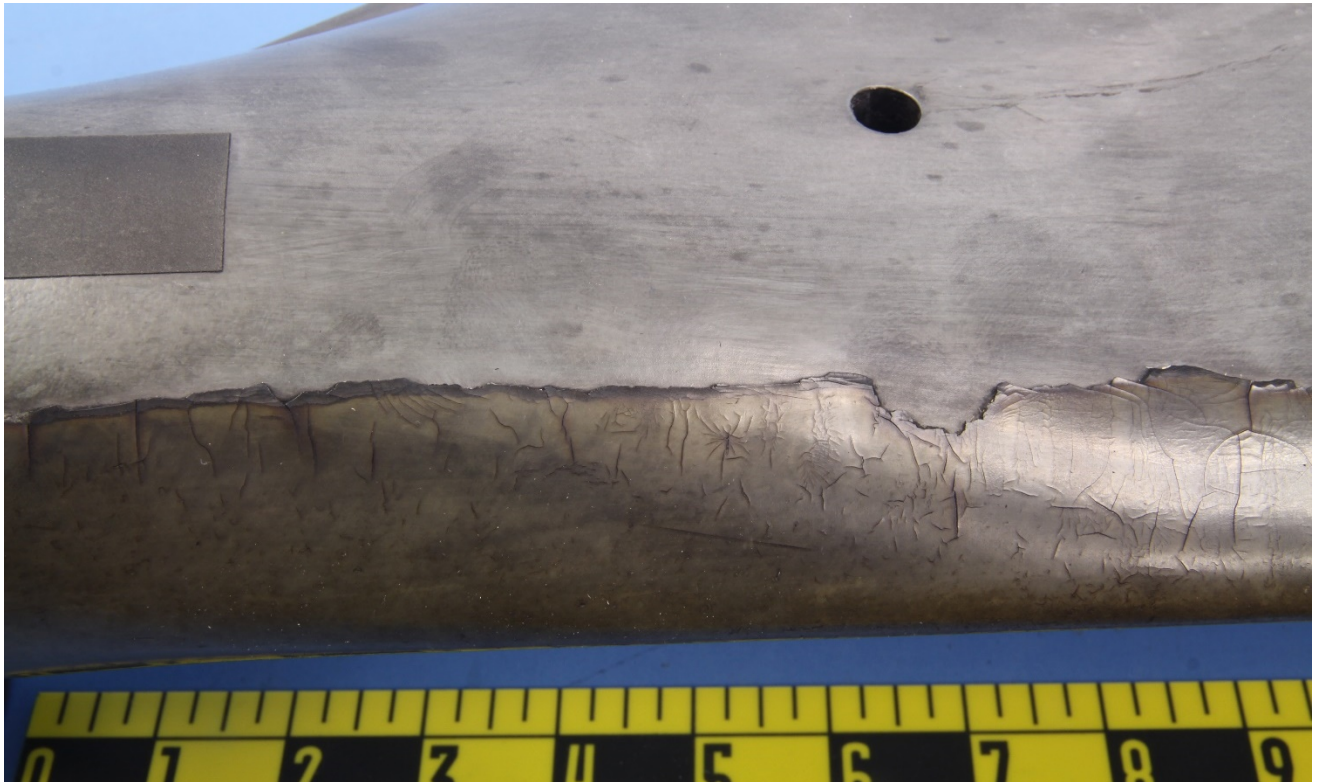
Figure 5 shows a typical area of the leading edge of the tail rotor blades. This leading edge exhibited a wrinkled surface layer, consistent with a polymeric adhesive or tape. This area and the leading edges of both blades were examined using a UV light, as typified in Figure 6. No indications of fluorescing material were found using UV exposure. These features were inconsistent with the tail rotor impacting organic or biological materials, such as from a bird. There was also a lack of small fluorescing features, such as consistent with impacts of insects or small biological species.

Figure 5 – View of an area of the leading edge from the tail rotor.

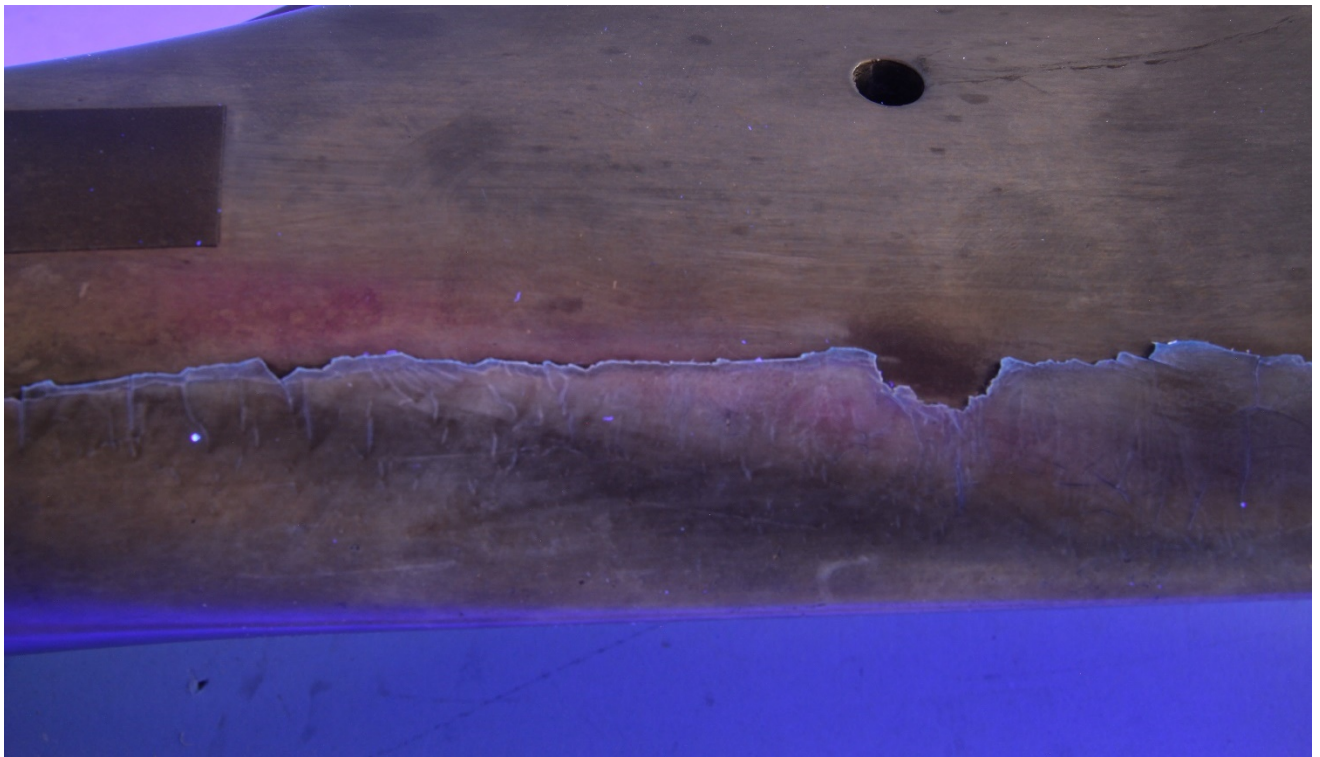
Figure 6 – The tail rotor leading edge in Figure 5, shown exposed to UV light.

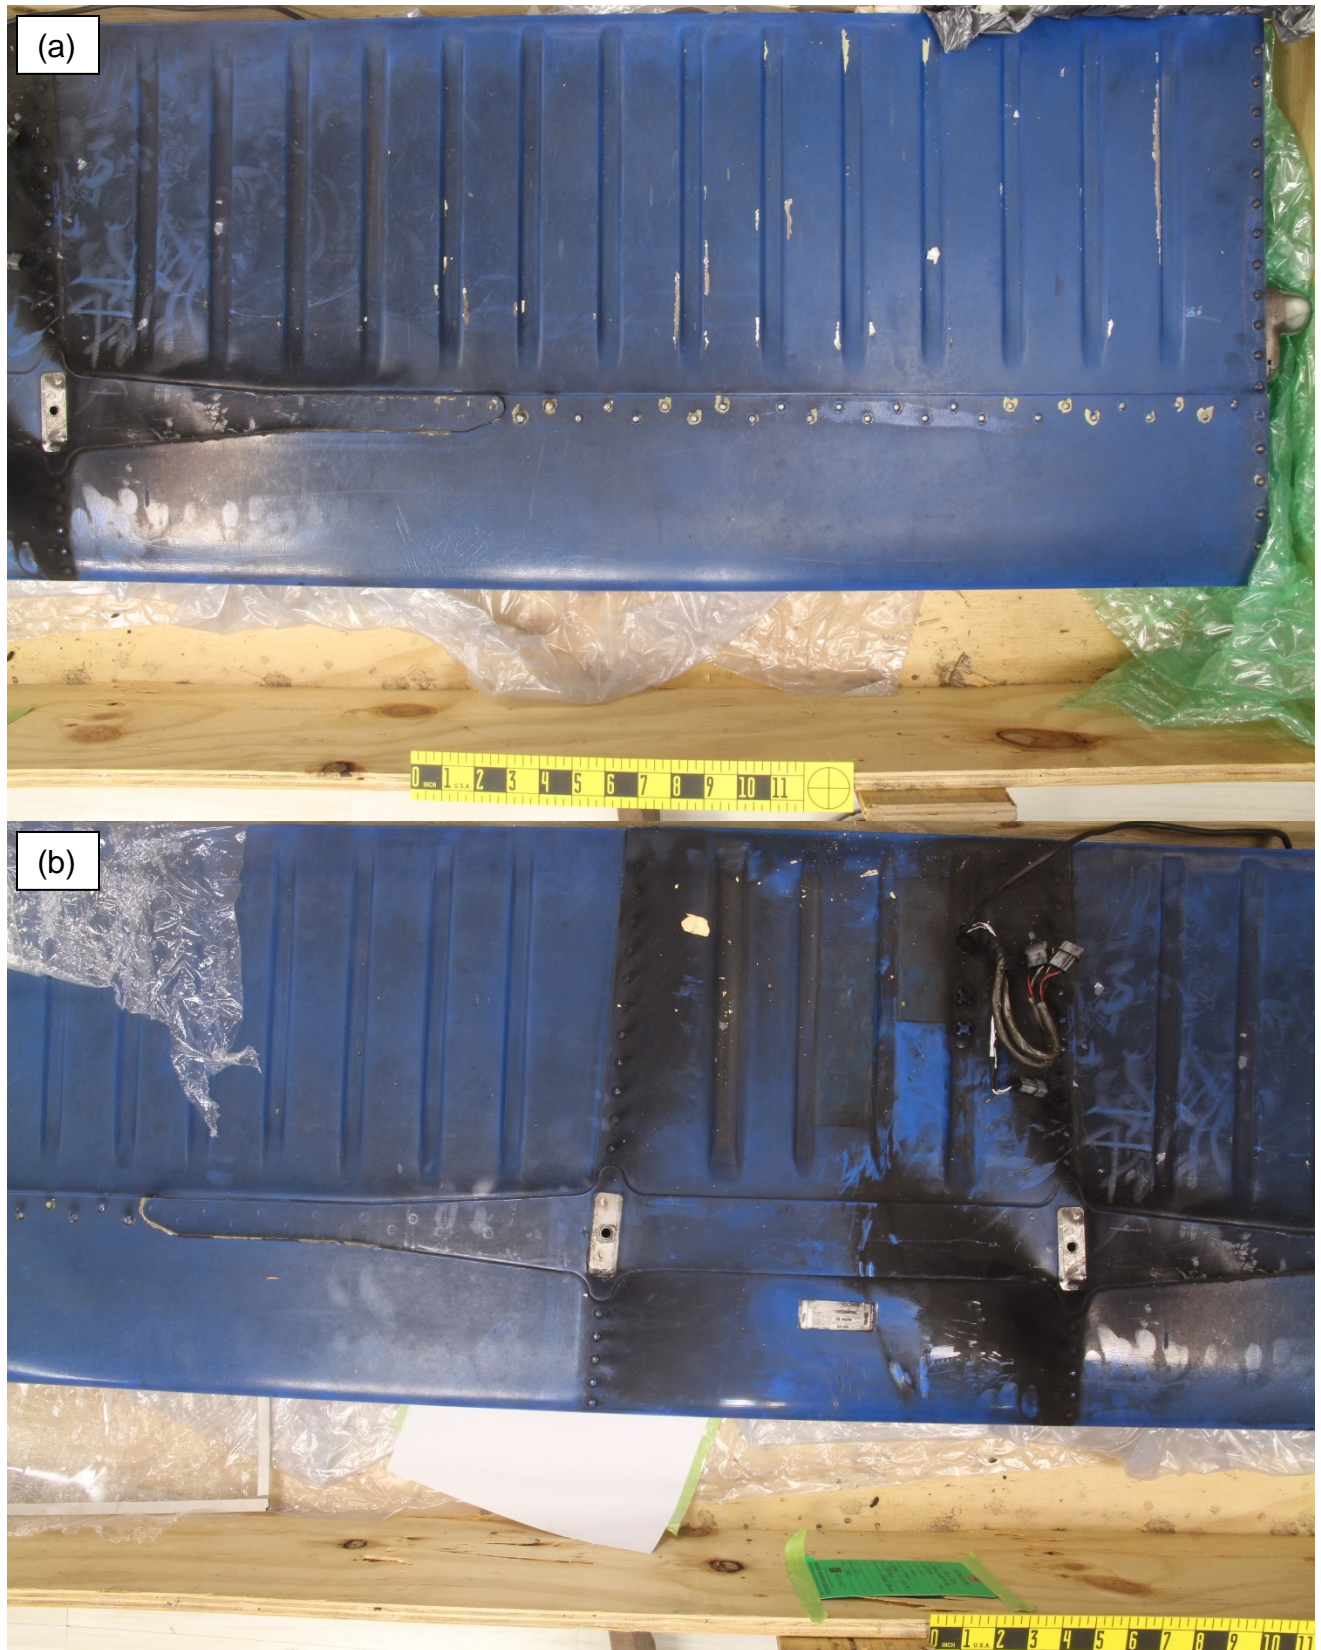
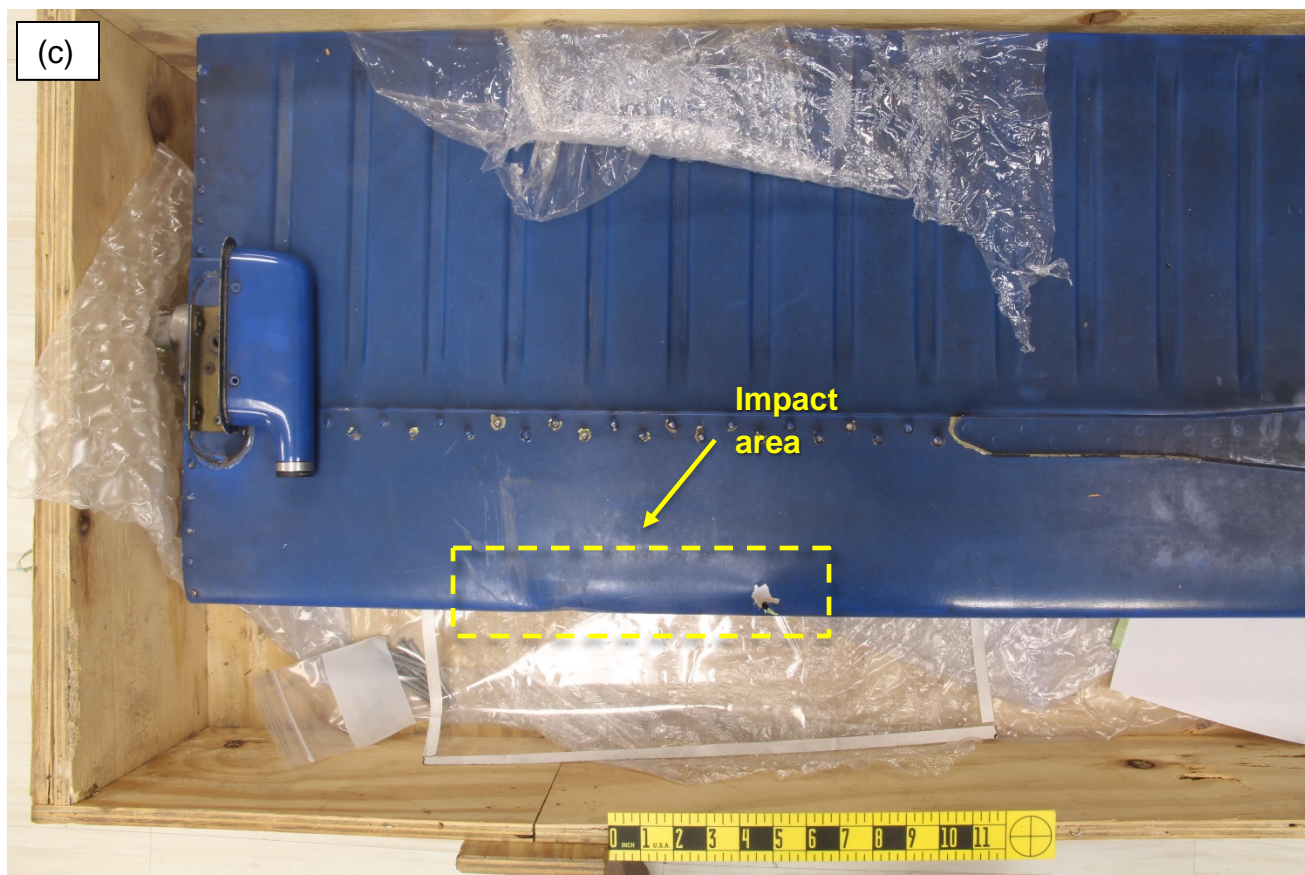
Figure 7 shows the top surface of the right horizontal stabilizer, as received in its crate. The outboard region, shown in Figure 7c, exhibited an impact area. Figure 8 through Figure 10 show a closer view of this impact area. The area consisted of a dent, located approximately 9 inches inboard from the stabilizer tip, and a dented and torn area located 5 inches further inboard.

Figure 7 – The topside of the right horizontal stabilizer assembly, shown from inboard to outboard in (a), (b), and (c). The boxed area in (c) is highlighted in Figures 8 – 10

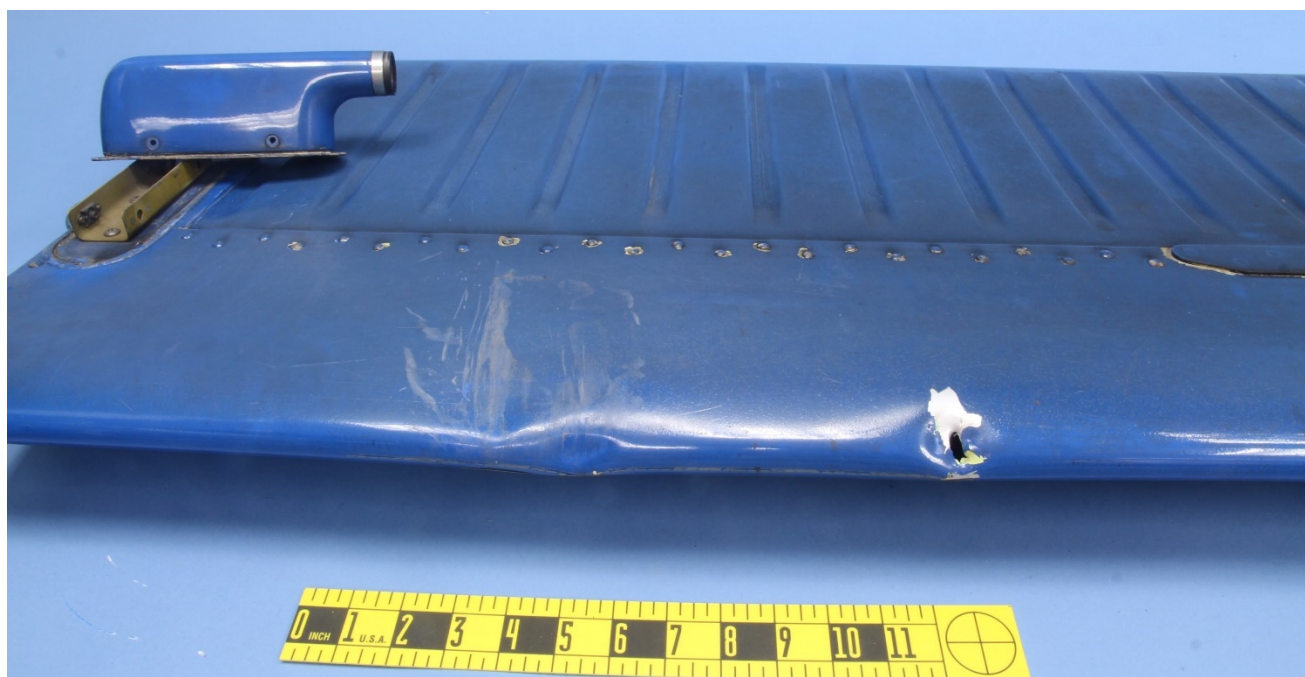
Figure 8 – View of the leading edge of the impact area of the horizontal stabilizer.

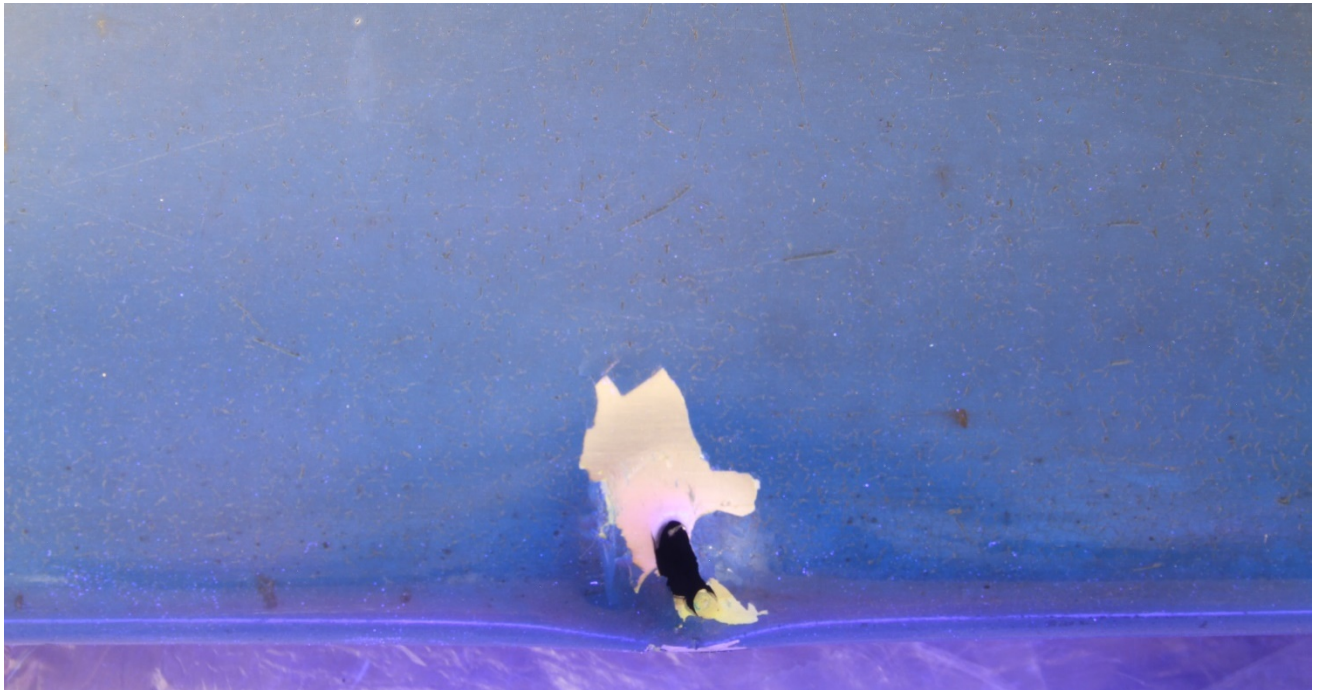
This area was examined using a UV light, as typified in Figure 9. The dented and torn area revealed bare metal, with an underlying green-colored primer beneath the blue topcoat of paint. The underlying primer did fluoresce under UV exposure. However, no other areas examined exhibited any fluorescing indications. Likewise, the underside of the impacted area of the horizontal stabilizer, shown in Figure 10, was inspected using a UV light. No indications of fluorescing matter were found with exposure to UV light (Figure 11). These features were inconsistent with the tail rotor impacting organic or biological material, such as from a bird.

Figure 9 – View of the impact area in Figure 7, shown exposed to UV light.

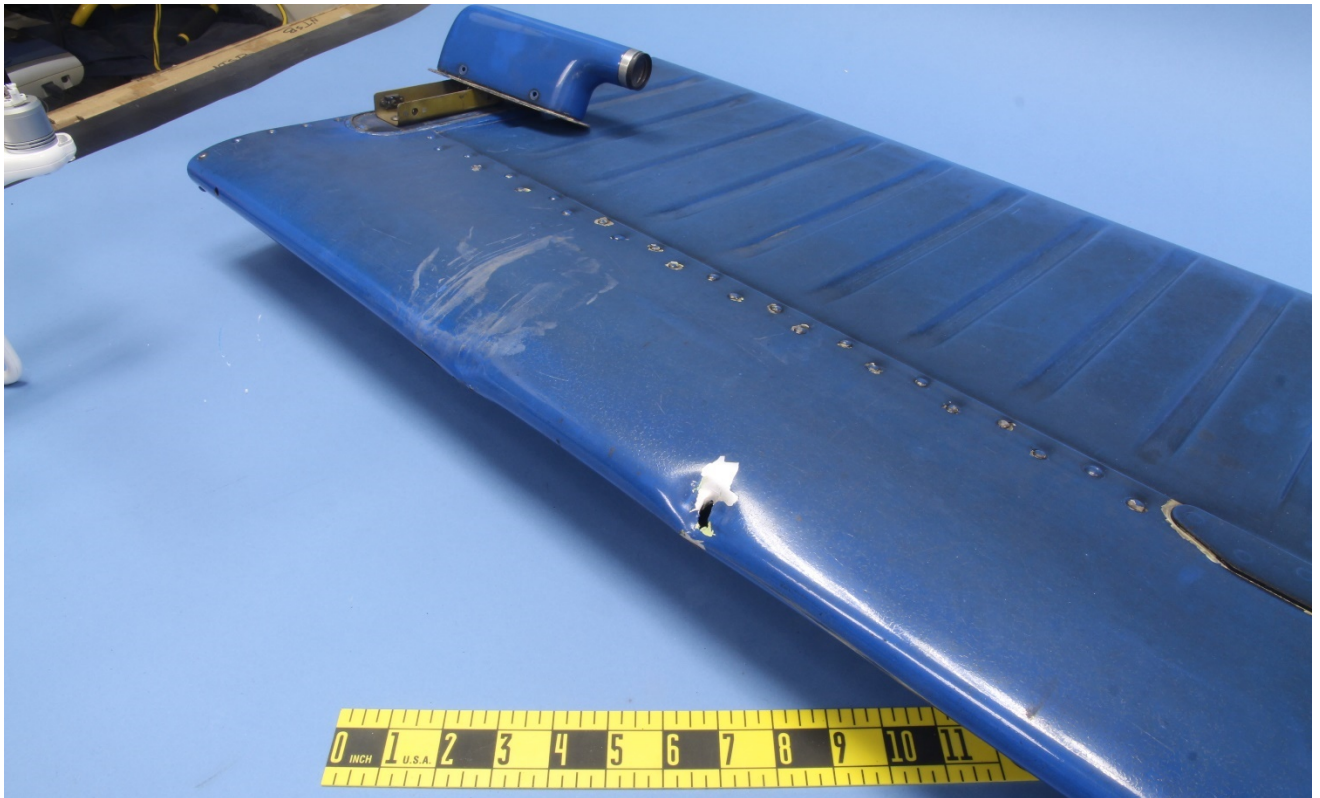
Figure 10 – Angled view of the leading edge of the impact area of the horizontal stabilizer.

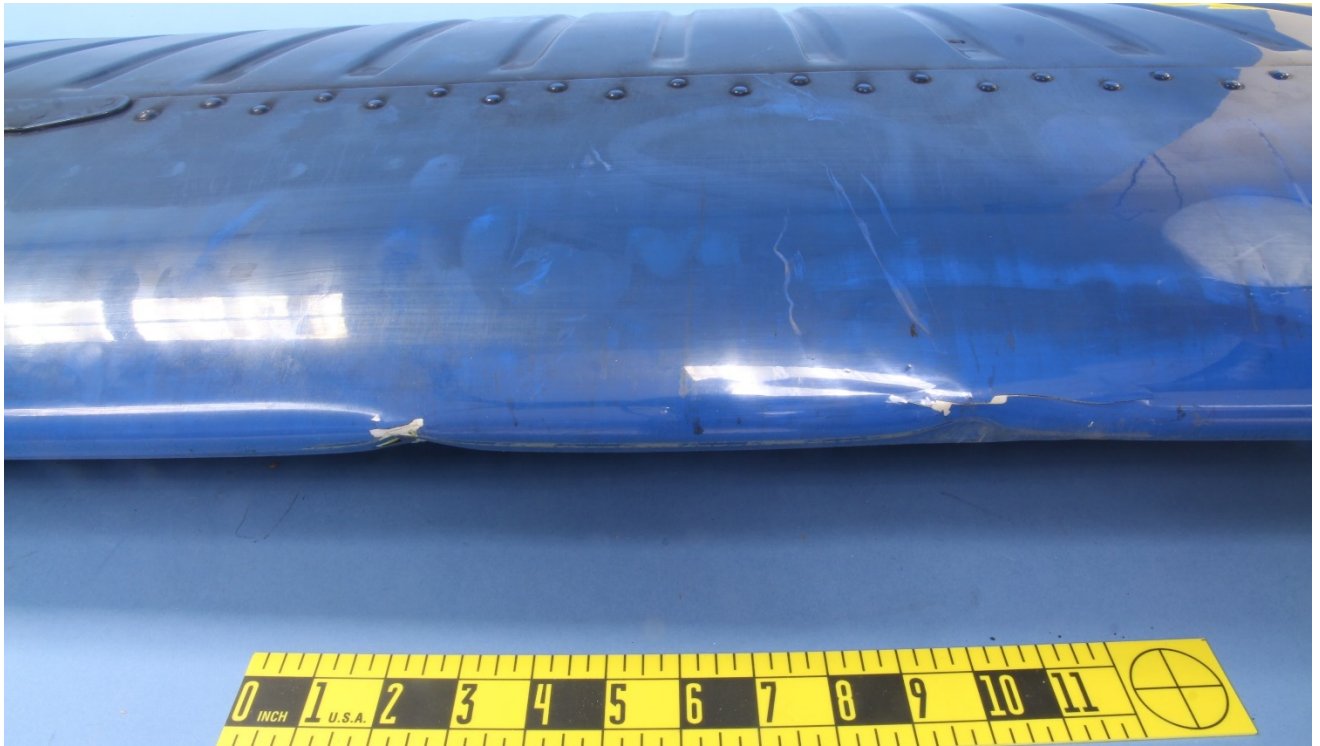
Figure 11 – View of the underside of the horizontal stabilizer at the impact area.

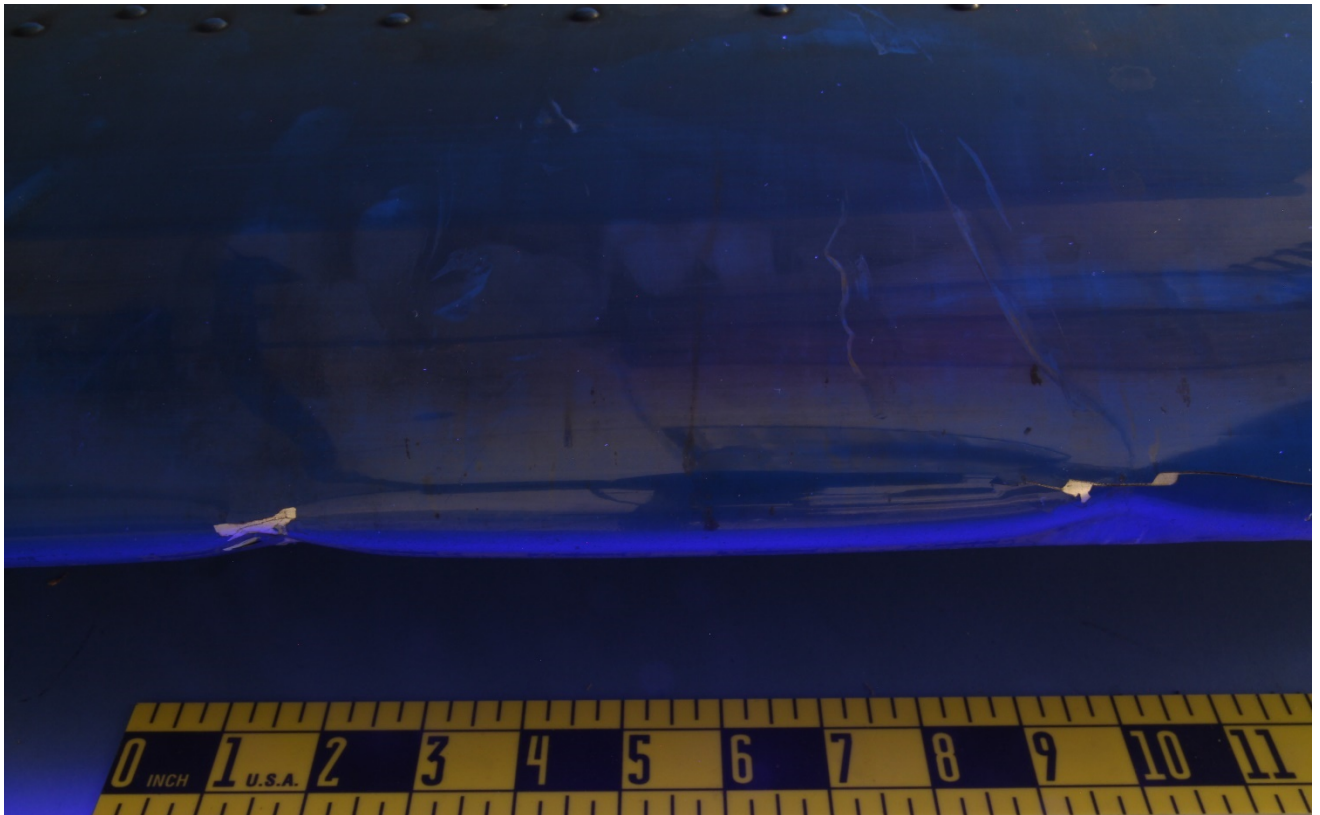
Figure 12 – The area in Figure 11, shown exposed to UV light.

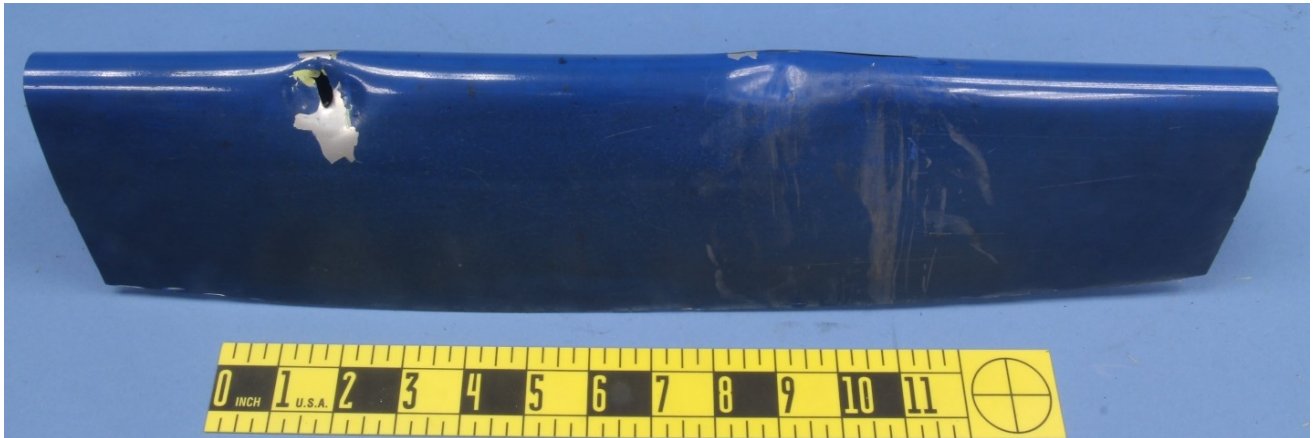
The impacted region of the stabilizer leading edge was sectioned out, forward of the internal spar. This sectioned portion of the stabilizer leading edge is shown in Figure 13. No foreign material was found inside the stabilizer structure after sectioning and removing this portion of the leading edge. A closer inspection of the dented region found multiple witness marks, consistent with a second object sliding across the outer surface of the stabilizer (Figure 14). These marks were dull white and gray and were consistent with material transfer from the impacting object (Figure 15).

Figure 13 – The sectioned portion of the horizontal stabilizer impact area, viewed from the topside.

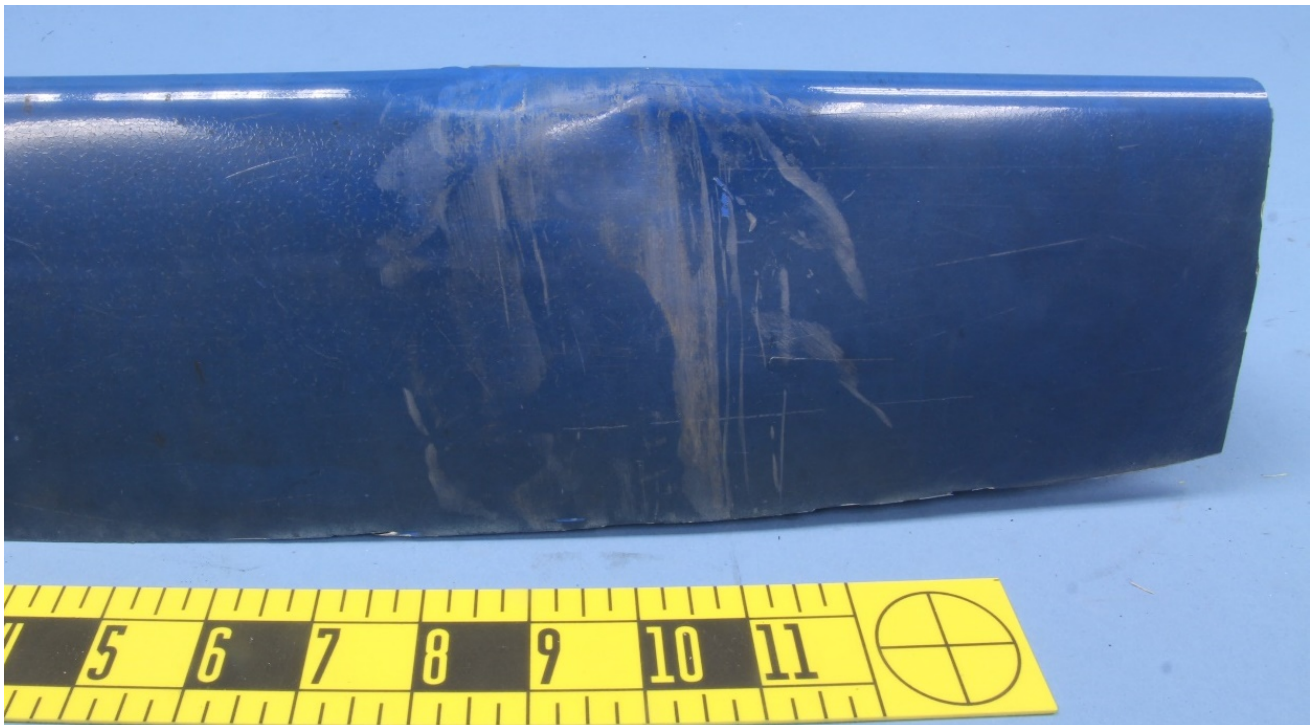
This dented region exhibiting material transfer was examined using Fourier-transform infrared spectroscopy (FTIR). The white and gray areas were probed, and the data were contrasted with an area of the painted stabilizer skin surface away from the impact zone. In subtracting out the spectrum peaks from the control area away from the impact zone, several peaks consistent with a different or foreign material were noted. These peaks were consistent with a polycarbonate polymer.

Figure 14 – The dented portion of the impact area in Figure 13, showing gray material transfer marks.

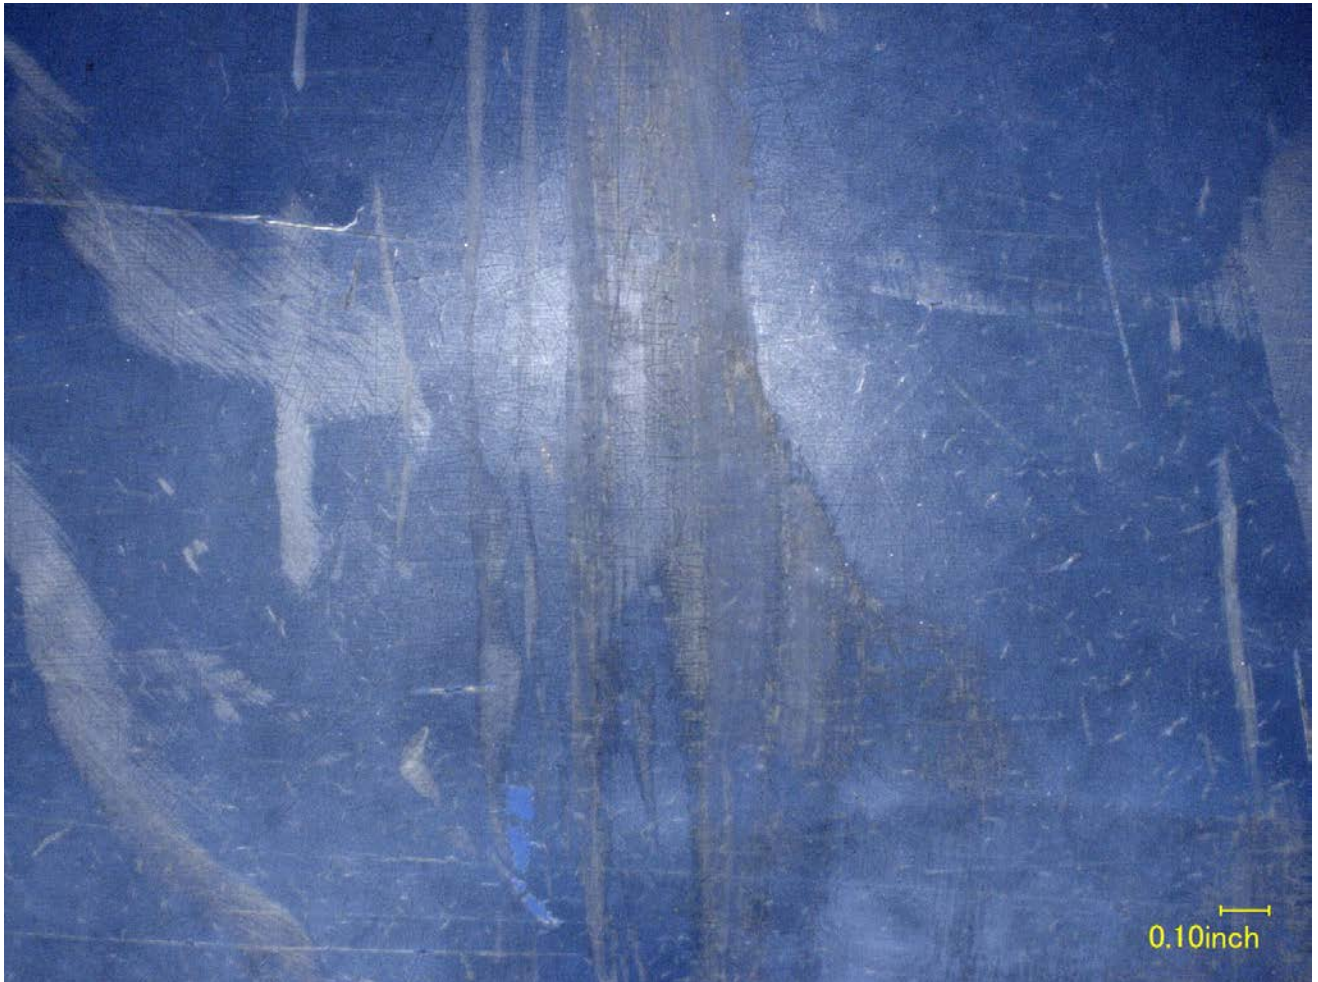
Figure 15 – Closer view of the material transfer and impact marks in Figure 14.

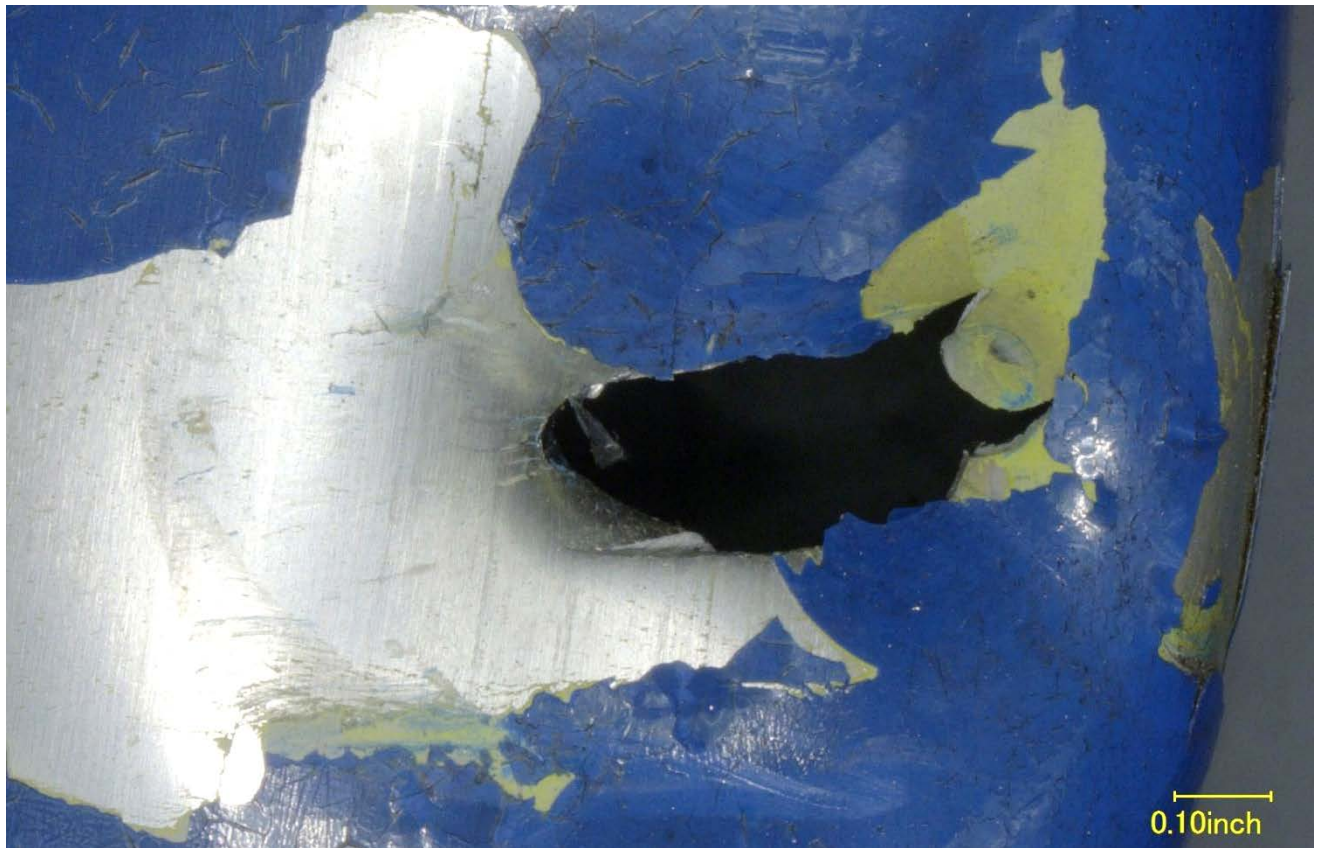
Figure 16 shows a closer area of the impacted and torn portion of the leading edge. In this area, the skin of the stabilizer leading edge was deformed inward, with tears in the skin radiating outward from the hole. This area also exhibited paint spalling, exposure of

the underlying primer, and exposure of the underlying bare metal skin surfaces. The paint and primer were able to be readily moved with handling.

Figure 16 – Closer view of the impact tear on the horizontal stabilizer.

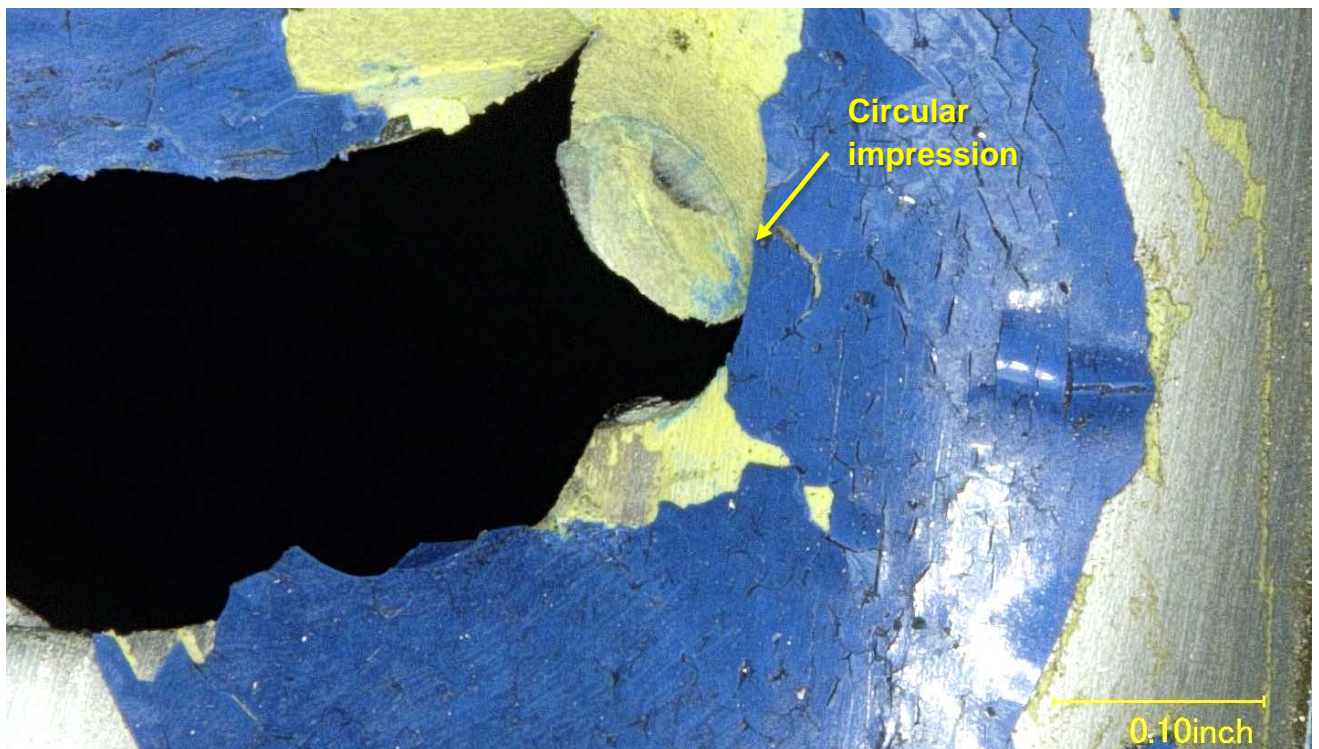
Of note within this impact mark was a small circular depression, highlighted in Figure 17. This impression was approximately 0.125 inches in diameter, and it exhibited tears and cracking around its circumference. These features were consistent with impact with a hard, cylindrical object.

Figure 17 – The circular impression at the torn portion of the impact in Figure 16.
