NATIONAL TRANSPORTATION SAFETY BOARD

MATERIALS LABORATORY FIRE FACTUAL REPORT

Report No. 20-031

Place : Dallas, Texas
Date : February 23, 2018
Vehicle : Residential Gas Pipe Rupture
NTSB No. : PLD18FR002
Investigator : Sara Lyons IIC-RPH

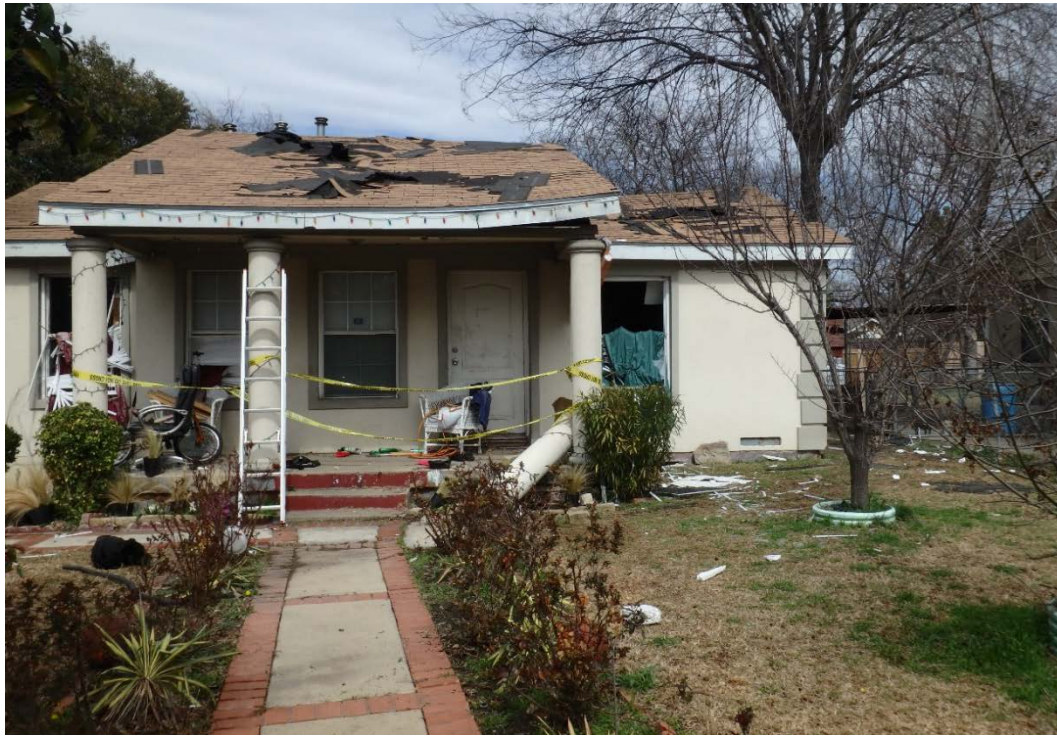
Damage was evident on the front side (Side A) of the structure as shown in Figure 3. The roof was bulged in several locations. Areas of shingles were displaced. Several holes were present with evidence of fire damage around the edges of the holes. The roofline was buckled in several areas with one corner over the porch partially peeled back from its original position and sagging in the middle of the porch roof. Below this corner, the exterior siding was detached from the structure with the anchors still attached to the exterior sheathing as shown in Figure 4. Small amounts of siding material were still attached around the anchors. The windows on either side of the porch appear to have been blown out with the remains of the windows and frames observed laying in the front yard.

Figure 3. Side A (Front) of structure at 3527 Durango Drive. Photograph by DFR, February 2018.

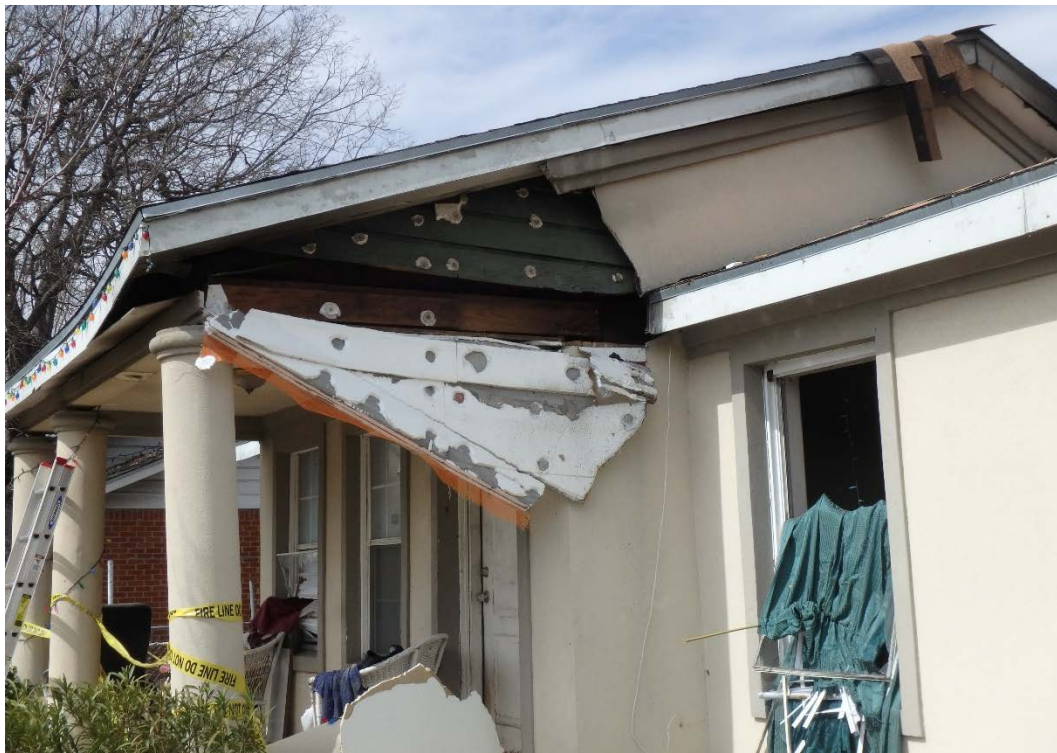
Figure 4. Side A of 3527 Durango Drive (roof and side of porch overhang). Photo by DFR, February 2018.

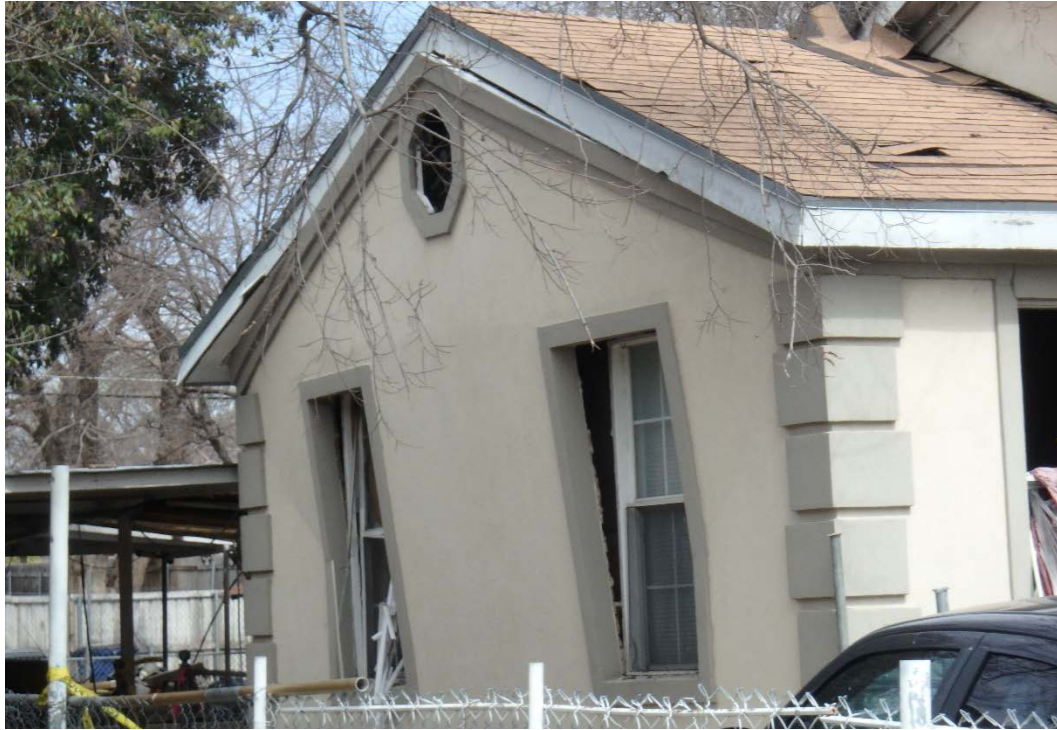
On Side B, the exterior wall was pushed outwards and had detached from the roof, roof vent and both windows as shown in Figure 5. Both windows including panes and frames, were intact. No fire damage was noted.

Figure 5. Side B of 3527 Durango Drive. Photo by DFR, February 2018.

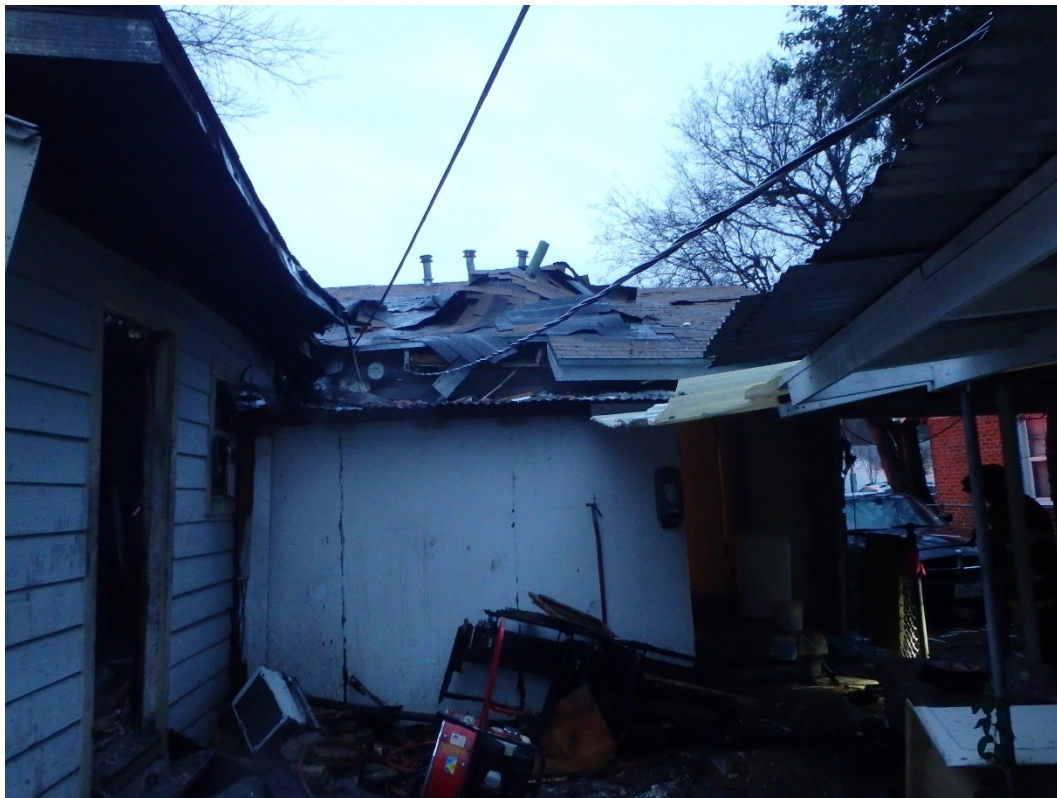
On Side C, there was some smoke staining near the top of the exterior wall at the roof junction, but no other damage was observed as shown in Figure 6.

Figure 6. Side C for original structure for 3527 Durango Drive. Photo by DFR, February 2018.

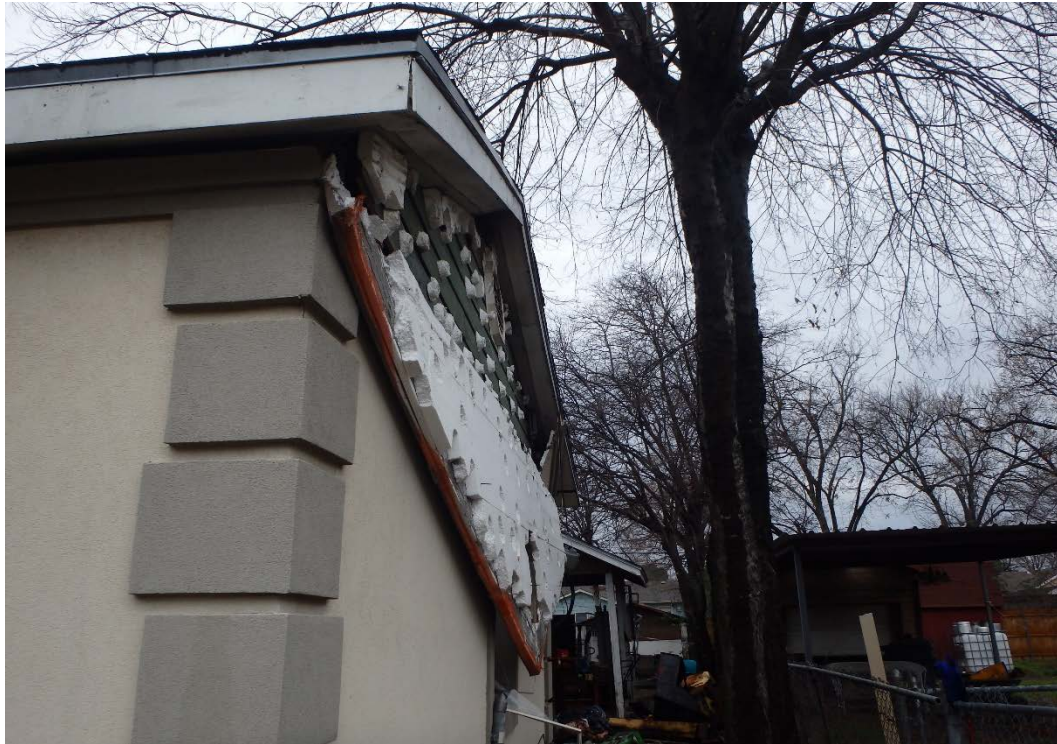
On Side D of the original structure, the upper section of the siding was detached from the structure with the anchors still attached to the exterior sheathing. Small amounts of siding material were still present around the anchors as shown in Figure 7.

Figure 7. Side D of original structure of 3527 Durango Drive. Photograph by DFR, February 2018.

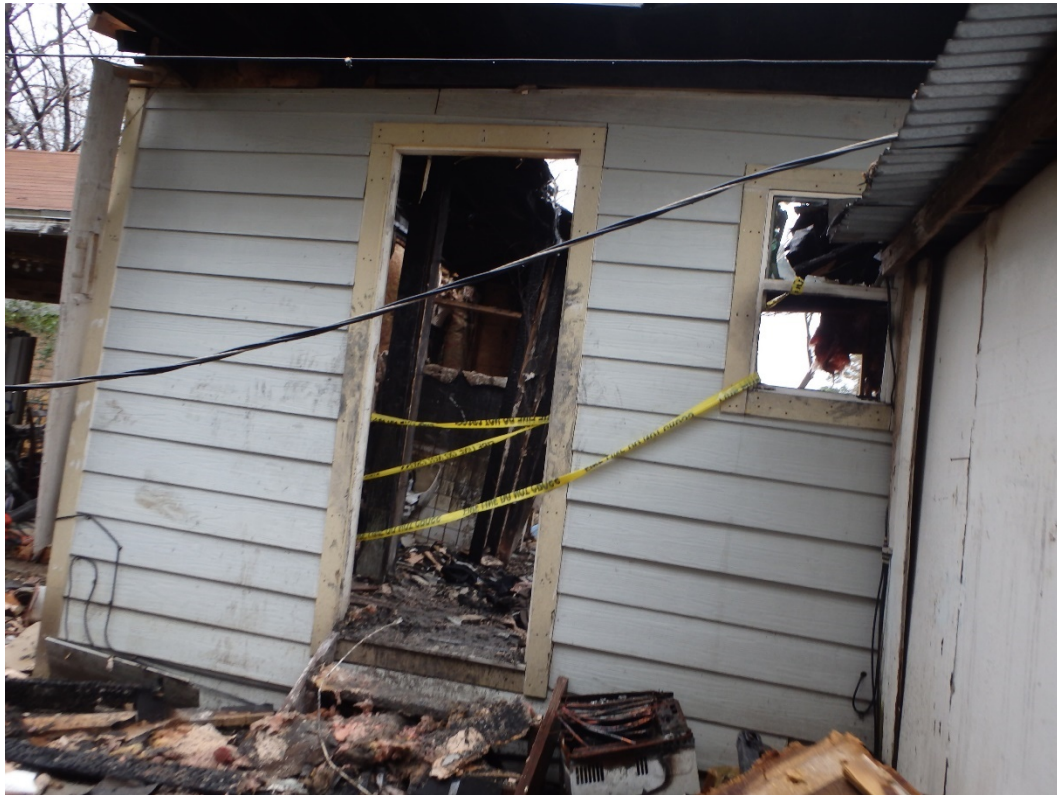
On Side B of the addition where the back door was located, the exterior wall including the siding was intact and appeared undamaged. The window glass was missing from the window next to the door as shown in Figure 8.

Figure 8. Side B of addition for 3527 Durango Drive. Photograph by DFR, February 2018.

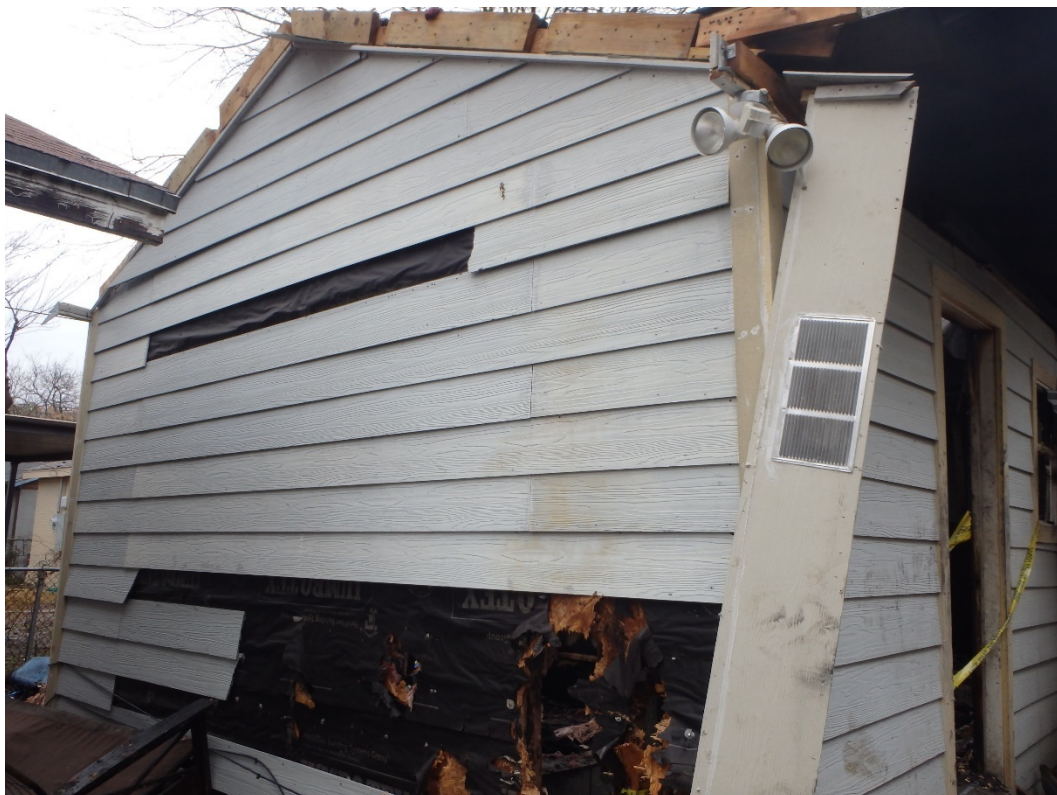
On Side C of the addition, several strips of siding were missing as was the roof edging as shown in Figure 9. In the lower corner of the exterior wall, there was a hole that extends into the interior of the bathroom. The exterior sheathing was bowed outwards and

sheetrock and insulation are on the ground outside of the structure. The insulation around the hole has some thermal discoloration¹¹. The roof overhang that extends onto Side B of the addition exhibited fire damage to the roof edging.

Figure 9. Side C of addition for 3527 Durango Drive. Photograph by DFR, February 2018.

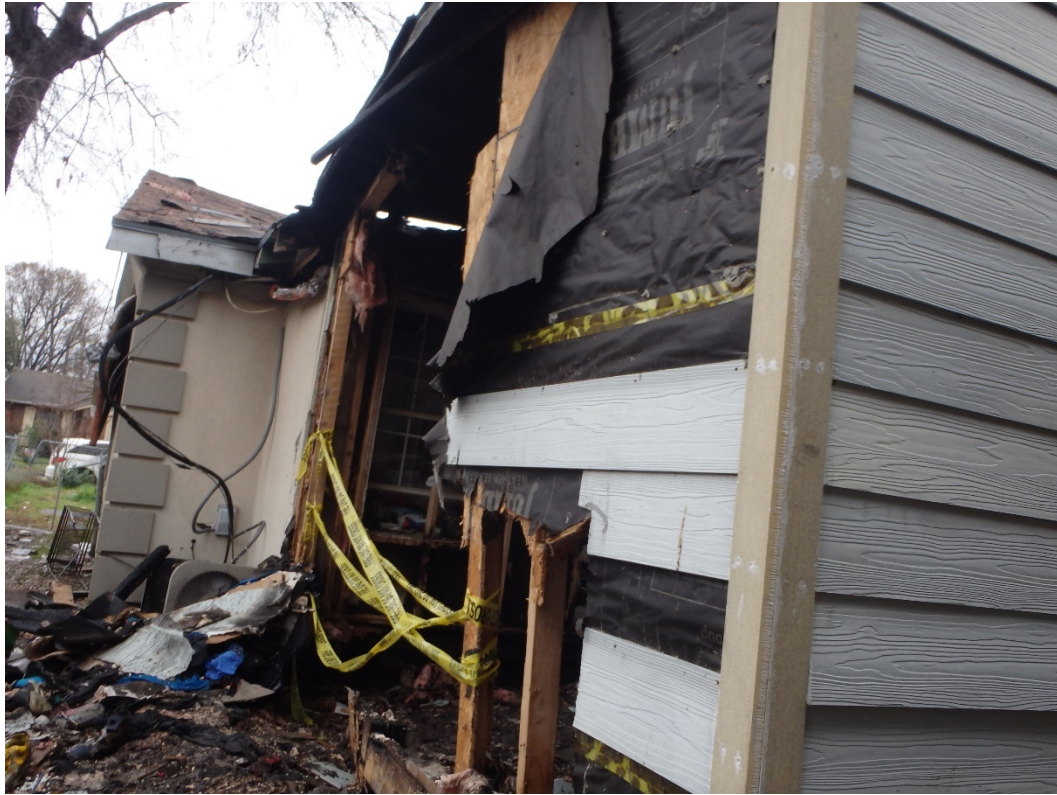
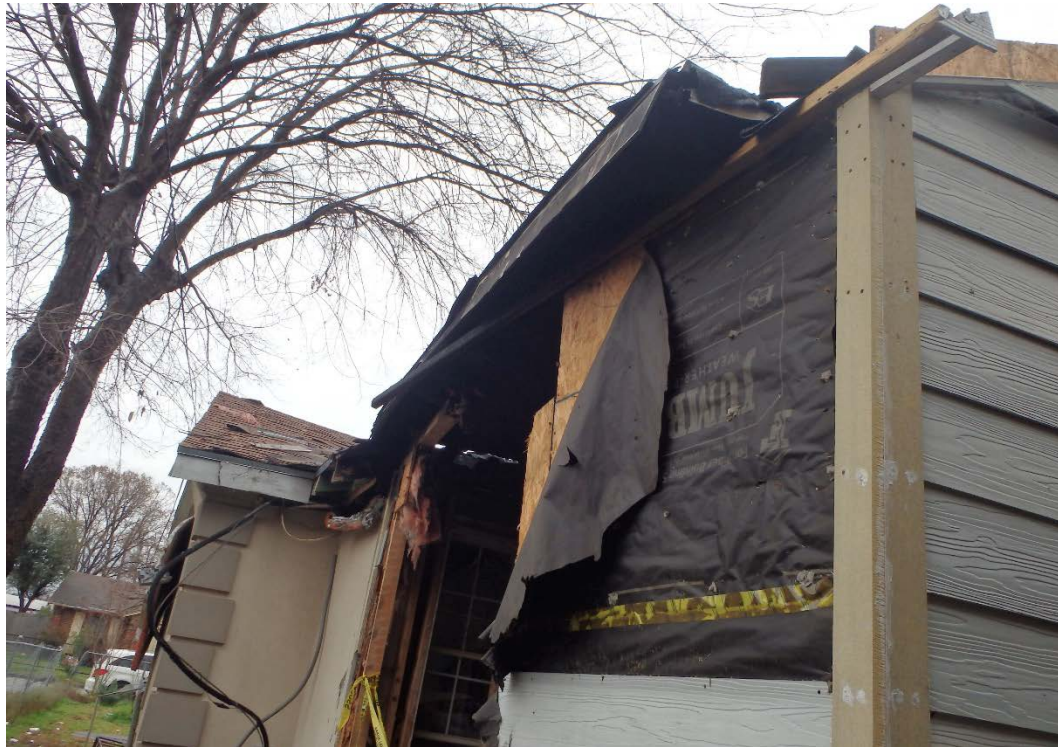
On Side D of the addition, most of the exterior wall was missing as shown in Figure 10. The remaining section was missing most of the siding with only 3 sections present towards the bottom, leaving the sheathing exposed. A portion of the roof in this area was also missing. The remaining roof edge was displaced from its original location as shown in Figure 11.

Figure 10. Side D for addition for 3527 Durango Drive. Photograph by DFR, February 2018.

Figure 11. Upper portion of Side D of the addition for 3527 Durango Drive. Photograph by DFR, February 2018.

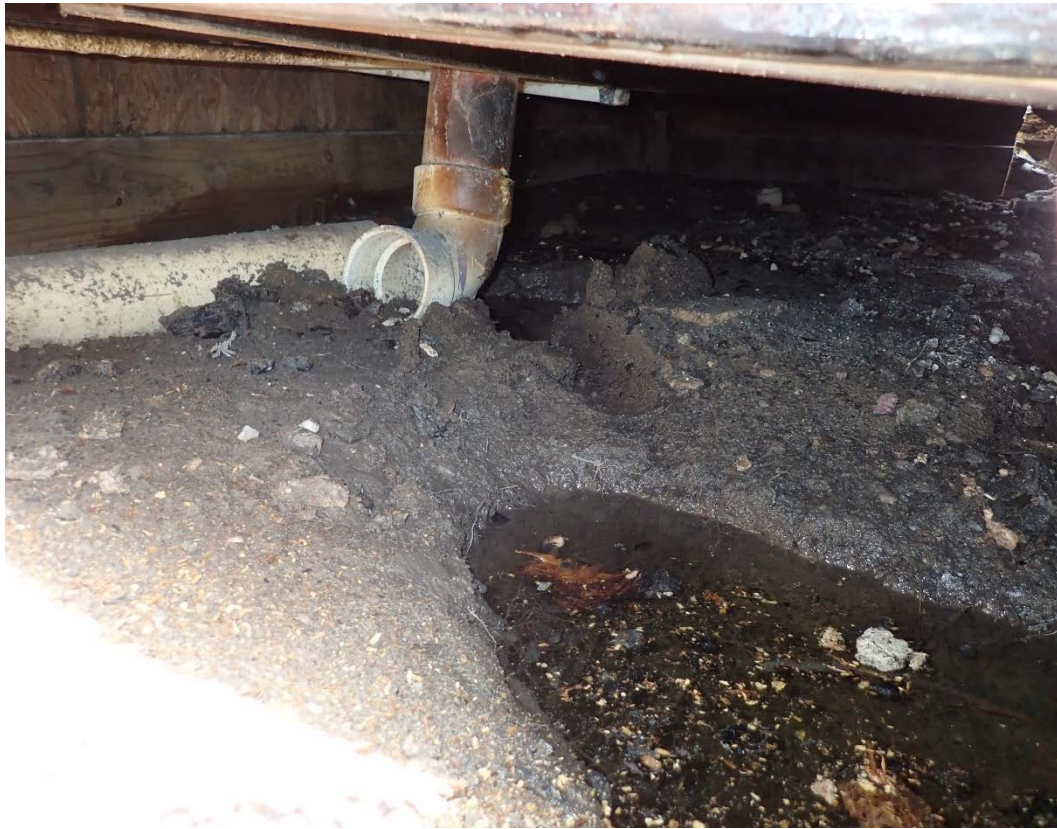
In the crawlspace underneath the addition, the sewer discharge line appears to be separated at the elbow as shown in Figure 12. There was thermal discoloration on the exterior of the piping, particularly the elbow. The soil beneath the piping appears to be disturbed. Burned debris was visible behind the elbow.

Figure 12. Crawlspace under addition for 3527 Durango Drive. Photograph by DFR, February 2018.

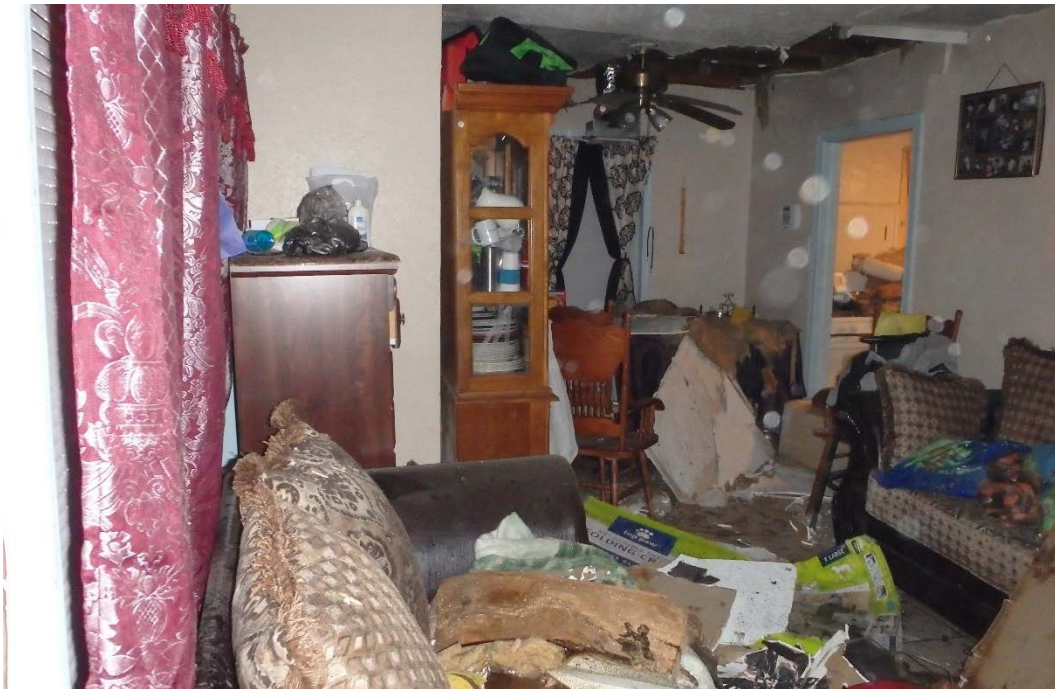
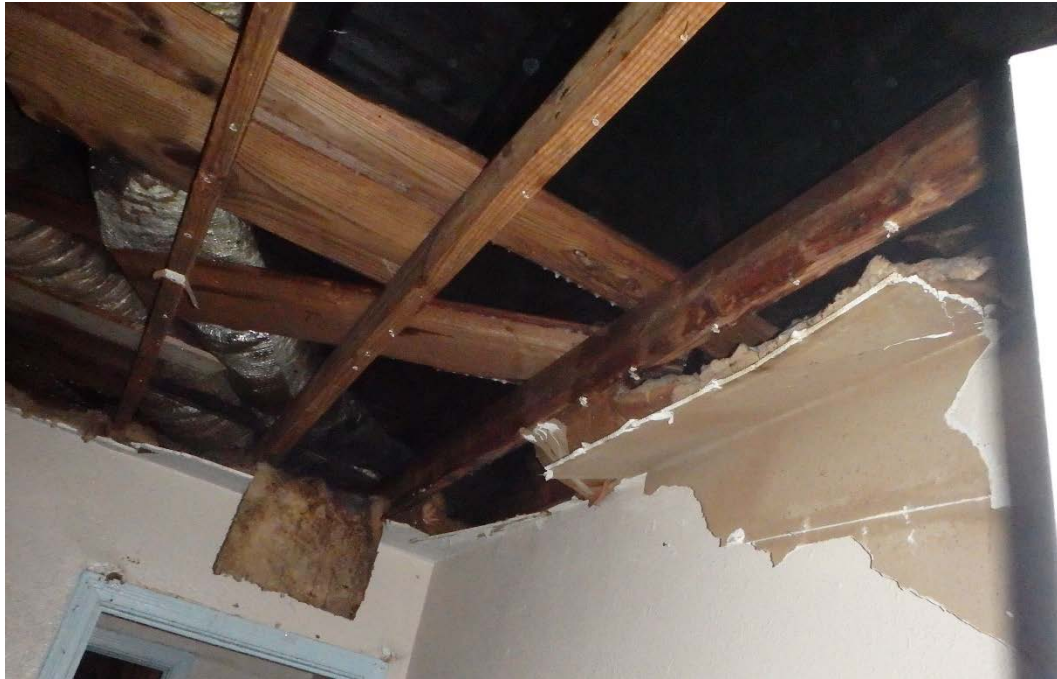
The living room/dining room exhibited damage to the ceiling near the wall that separated the living room from the kitchen located below the furnace's location in the attic. The ceiling had collapsed downwards into the room below as shown in Figure 13. The exposed wooden ceiling joists appeared undamaged and exhibited no exposure to heat or fire as shown in Figure 14.

Figure 13. Damage to ceiling in living room of 3527 Durango Drive. Photograph by DFR, February 2018.

Figure 14. Closeup of ceiling rafters in living room of 3527 Durango Drive. Photograph by DFR, February 2018.

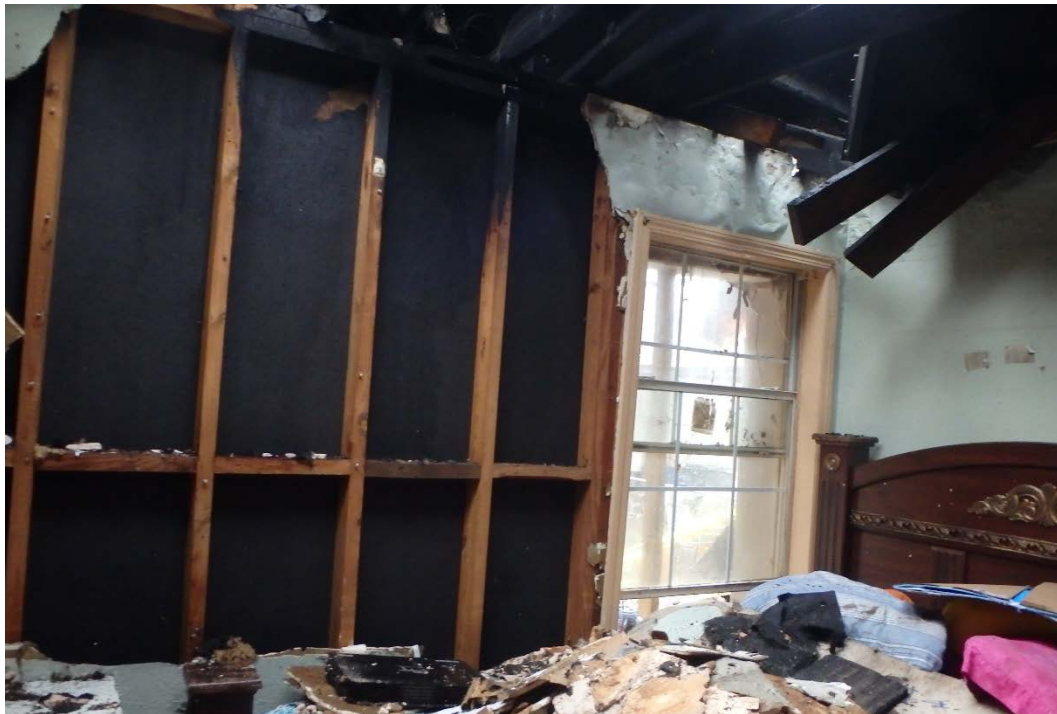
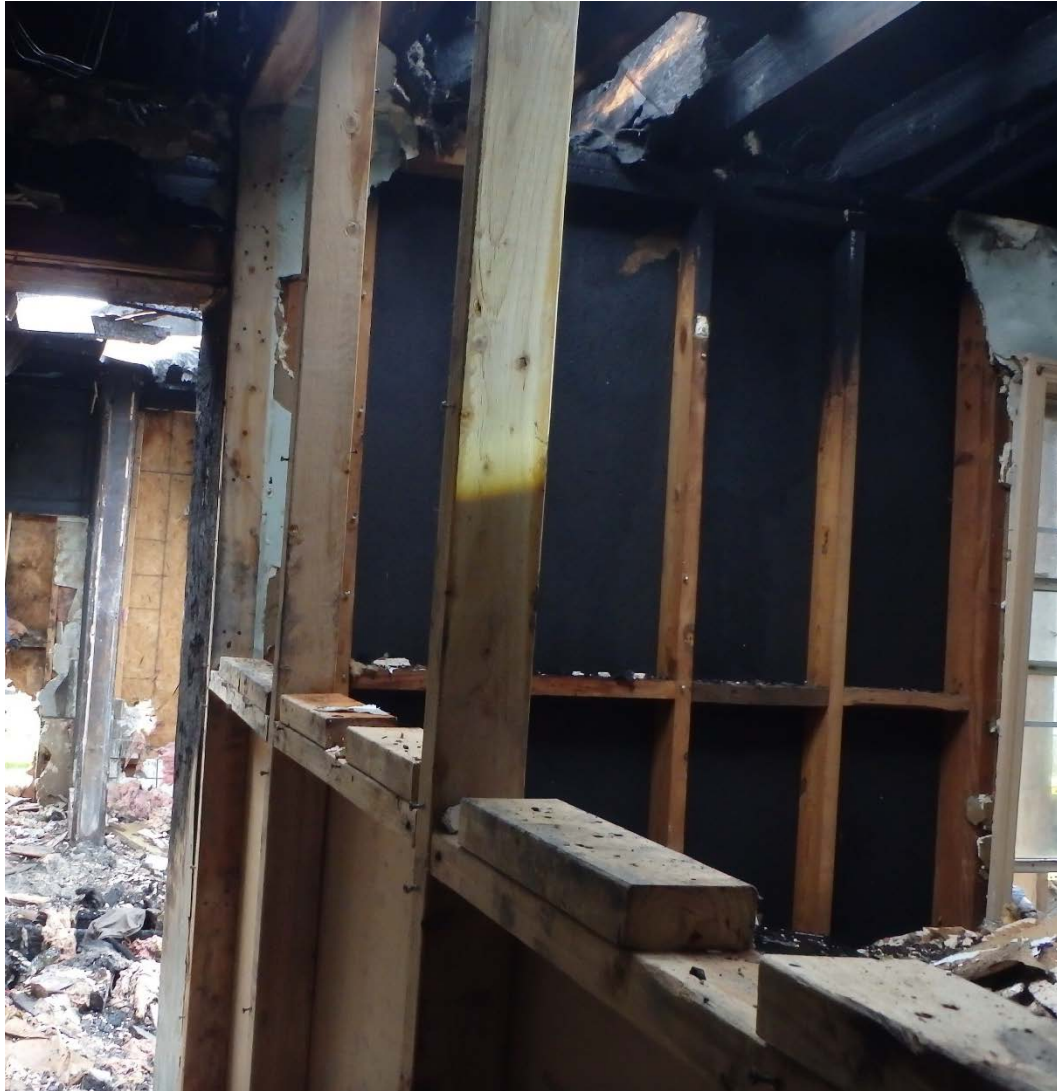
The bedroom forward of the addition bedroom had fire damage to the shared wall as shown in Figure 15. There was damage to the ceiling joists with some of the joists partially collapsed into the bedroom. The ceiling sheetrock was missing. The wall joists had some charring at the top of the joists at the ceiling junction. The wall that separated this bedroom from the hallway had the sheetrock missing but the wall joists were undamaged. The ceiling in the hallway was also missing as shown in Figure 16.

Figure 15. Bedroom wall between original structure and addition in 3527 Durango Drive. Photograph by DFR, February 2018.

Figure 16. Hallway and bedroom wall in original structure of 3527 Durango Drive.
Photograph by DFR, February 2018.

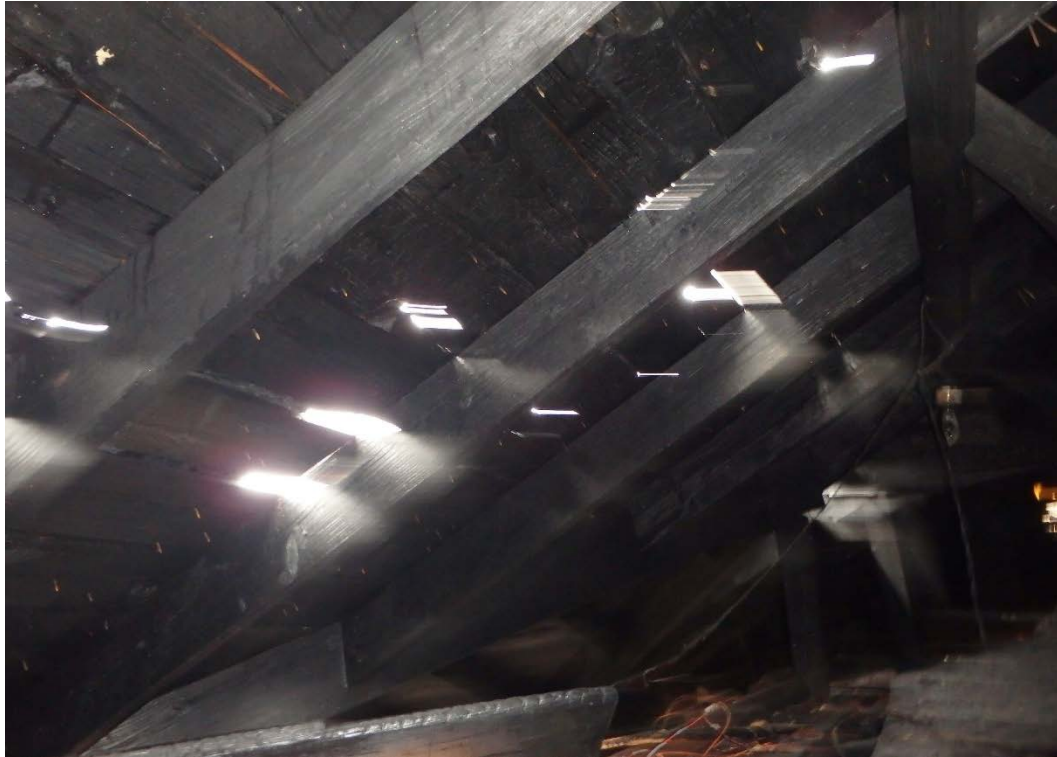
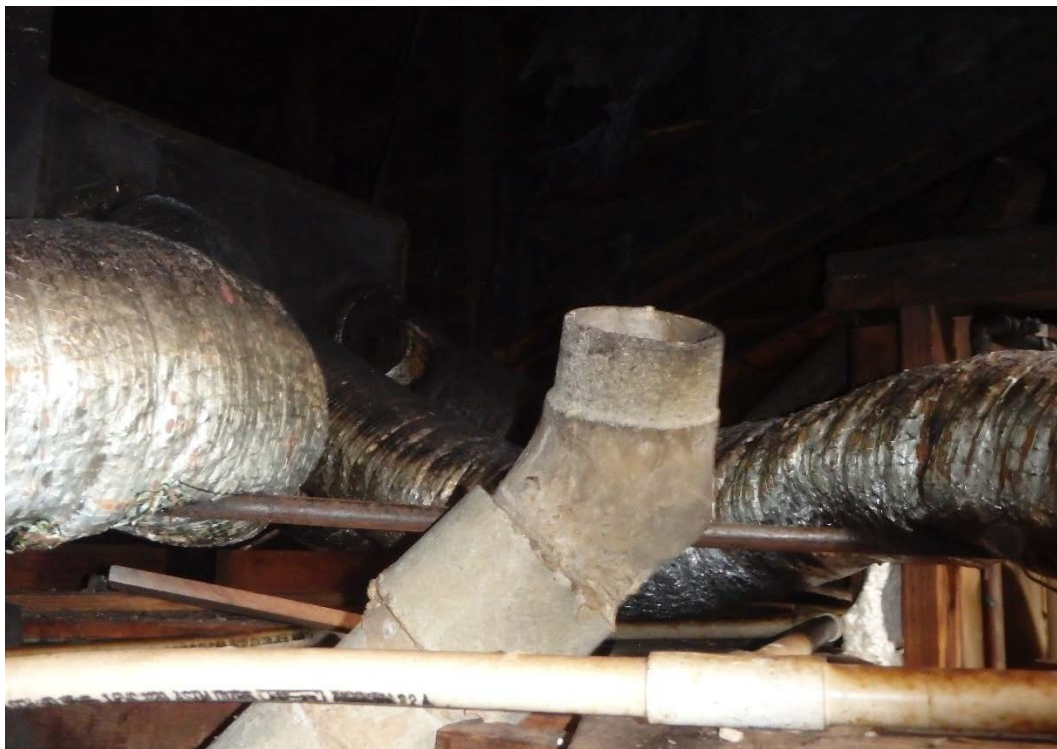
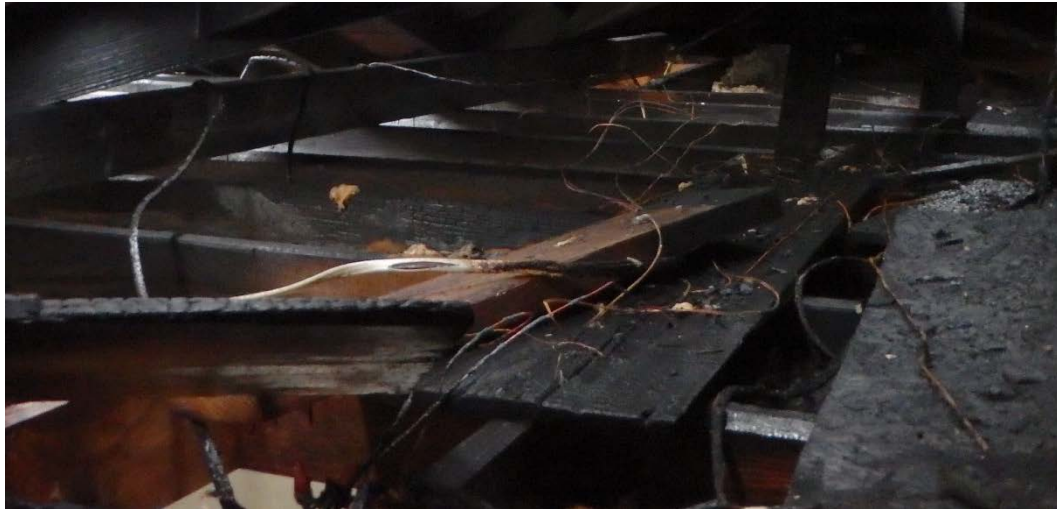
The roof rafters and decking and other wooden structural members located in the attic sustained thermal damage (light surface charring and sooting) particularly those located near the furnace as shown in Figure 17. The outer surfaces of the HVAC and vent ducting were thermally discolored and sooted as shown in Figure 18. Wiring in this area exhibited thermal discoloration and melting to the wiring insulation as shown in Figure 19.

Figure 17. Damage to attic and roof structure in 3527 Durango Drive. Photograph by DFR, February 2018.

Figure 18. Damage to ducting in attic of 3527 Durango Drive. Photograph by DFR, February 2018.

Figure 19. Damaged wiring and attic structure in 3527 Durango Drive. Photograph by DFR, February 2018.

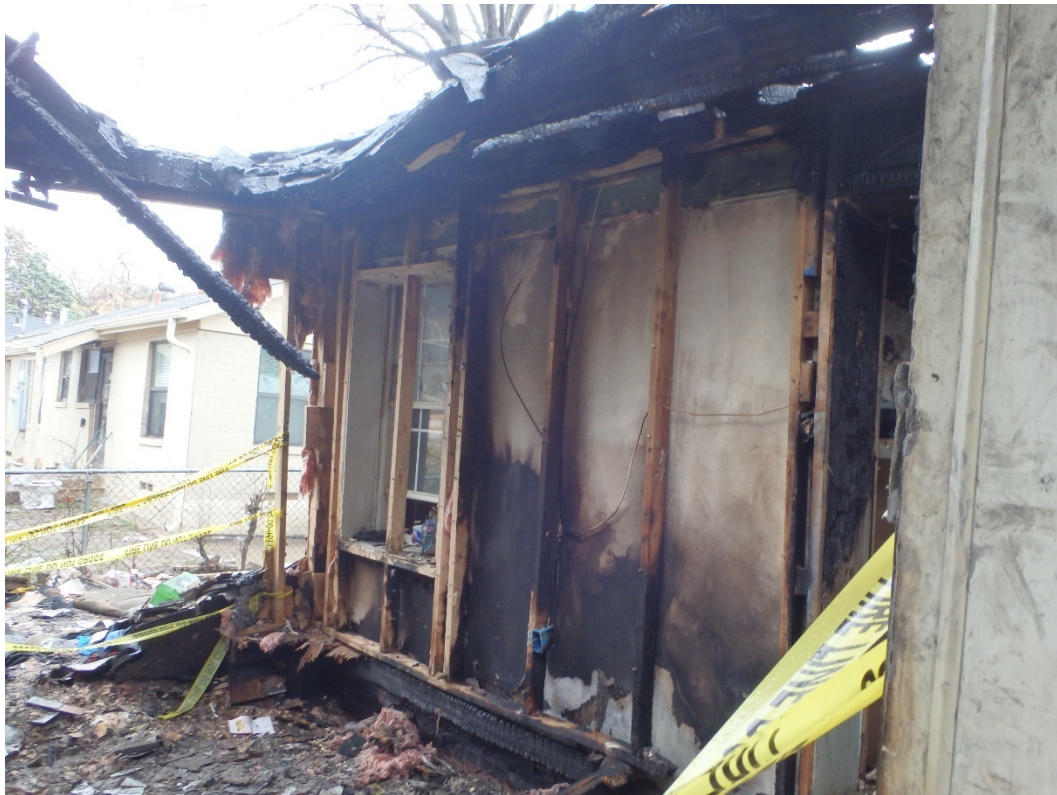
The bedroom located in the addition and its contents were destroyed by fire as shown in Figure 20. There was heavy charring on remaining support beams and ceiling joist. Sheetrock was missing from the wall that separated the bedroom from the adjoining bedroom. There was a low area of calcination to the sheetrock of the wall facing into the

Figure 20. Bedroom wall in addition of 3527 Durango Drive. Photograph by DFR, February 2018.

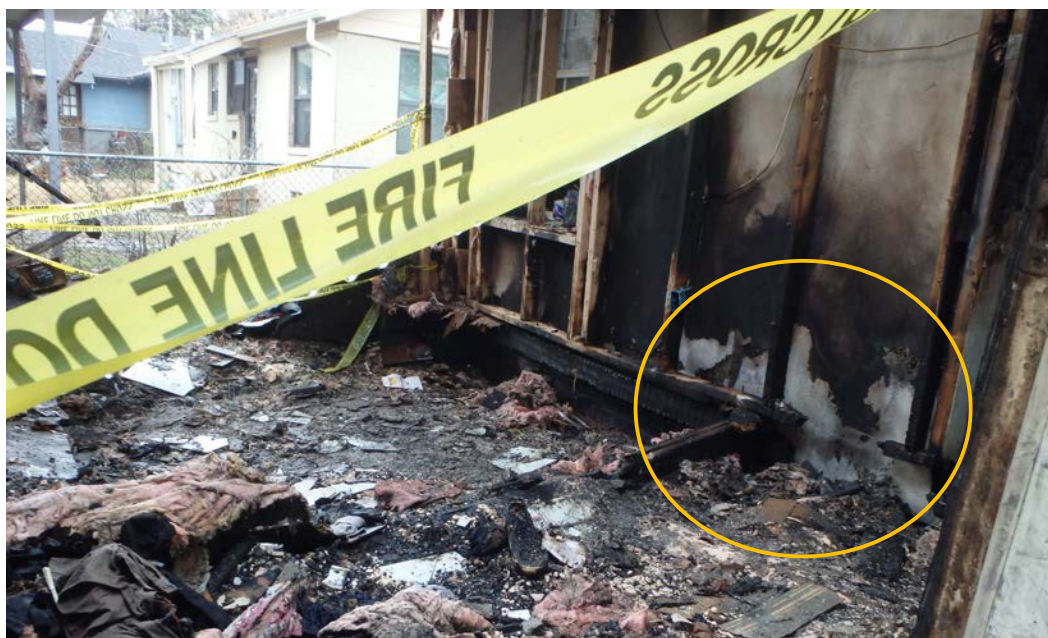
adjoining bedroom as shown in Figure 21¹². The back bathroom was heavily damaged by fire. There were fire-related demarcations and heavy soot on the tiling on the remaining walls as shown in Figure 22. The exterior was intact but missing the sheetrock. Some insulation battings were still present along the bottom and in the corner of the addition. The upper portions of the interior walls and the wall that separated the bathroom from the bedroom were missing.

Figure 21. Closeup of calcination (highlighted with yellow circle) on wall in addition bedroom for 3527 Durango Drive. Photograph by DFR, February 2018.

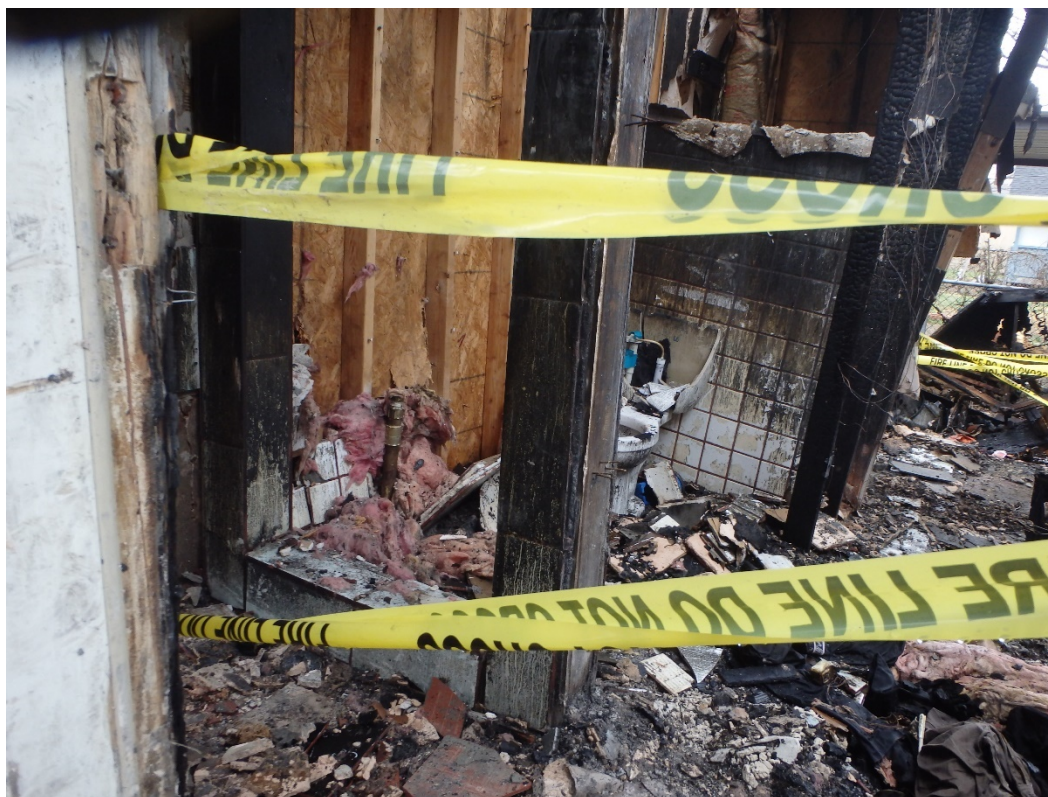
Figure 22. Bathroom in addition of 3527 Durango Drive. Photograph by DFR, February 2018.

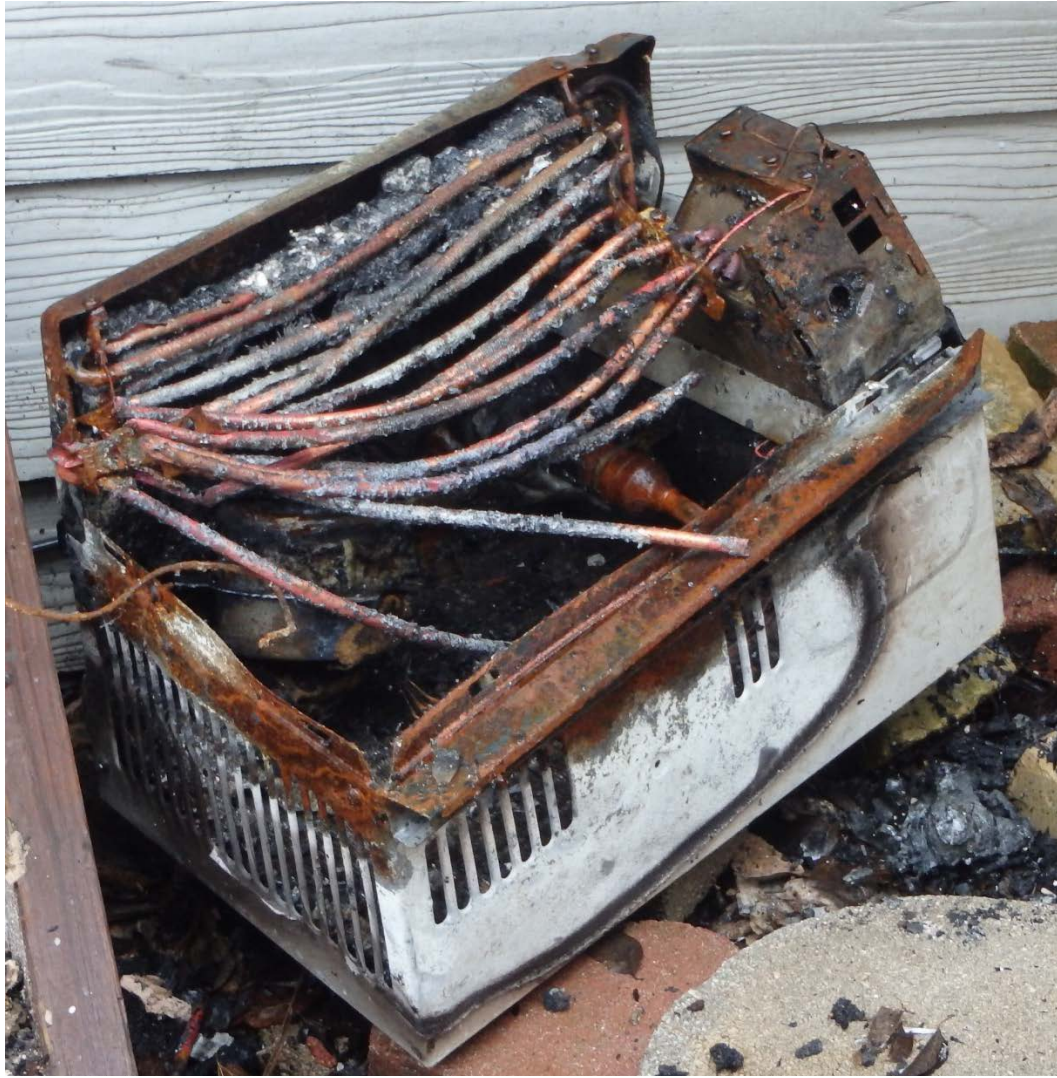
A window air condition unit was located on the ground outside the B-side window of the addition bedroom, shown in Figure 23¹³. The unit exhibited thermal damage such oxidation of metallic components, charring and discoloration of paint, and sooting.

Figure 23. Window air conditioning unit from 3527 Durango Drive addition bedroom window. Photograph by DFR, February 2018.
