NATIONAL TRANSPORTATION SAFETY BOARD

MATERIALS LABORATORY FIRE FACTUAL REPORT

Report No. 20-031

Place : Dallas, Texas
Date : February 23, 2018
Vehicle : Residential Gas Pipe Rupture
NTSB No. : PLD18FR002
Investigator : Sara Lyons IIC-RPH

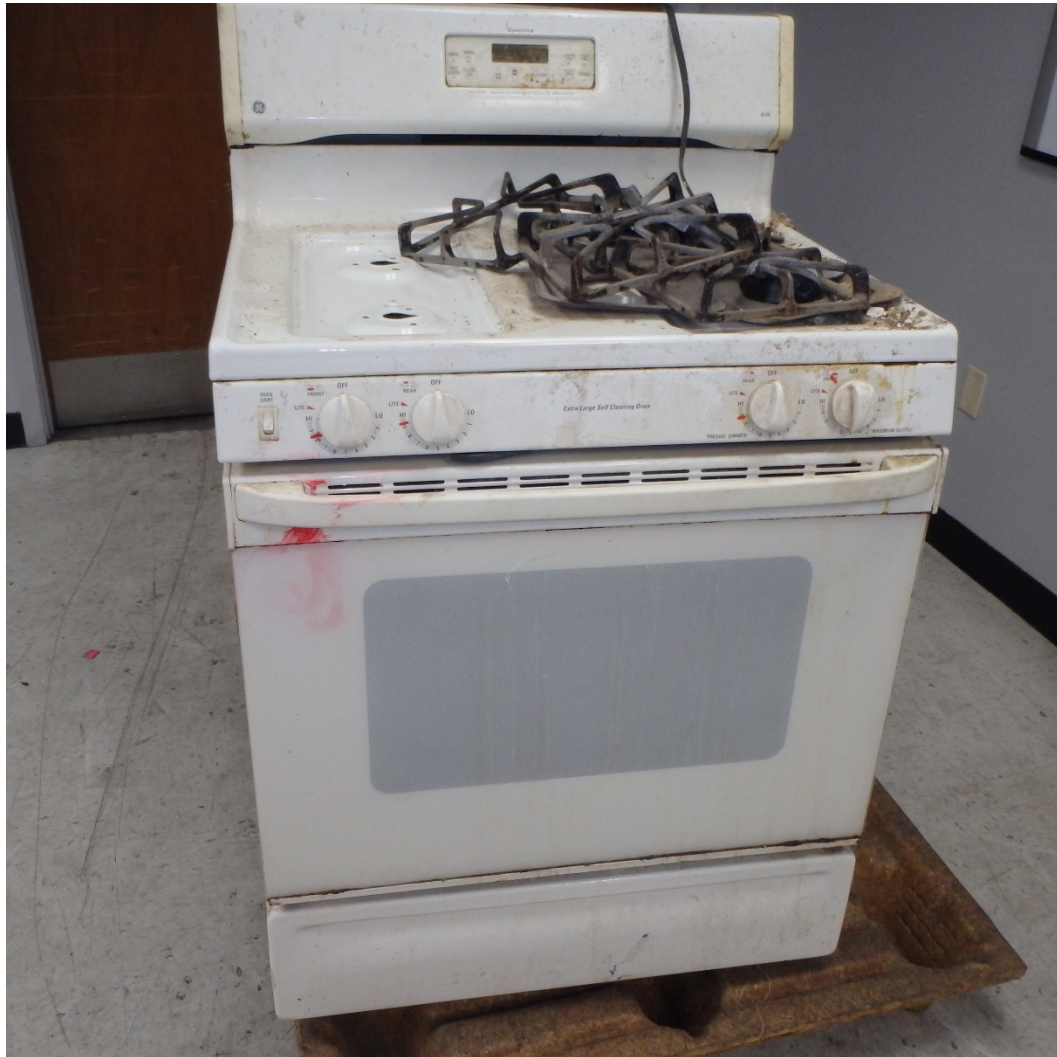
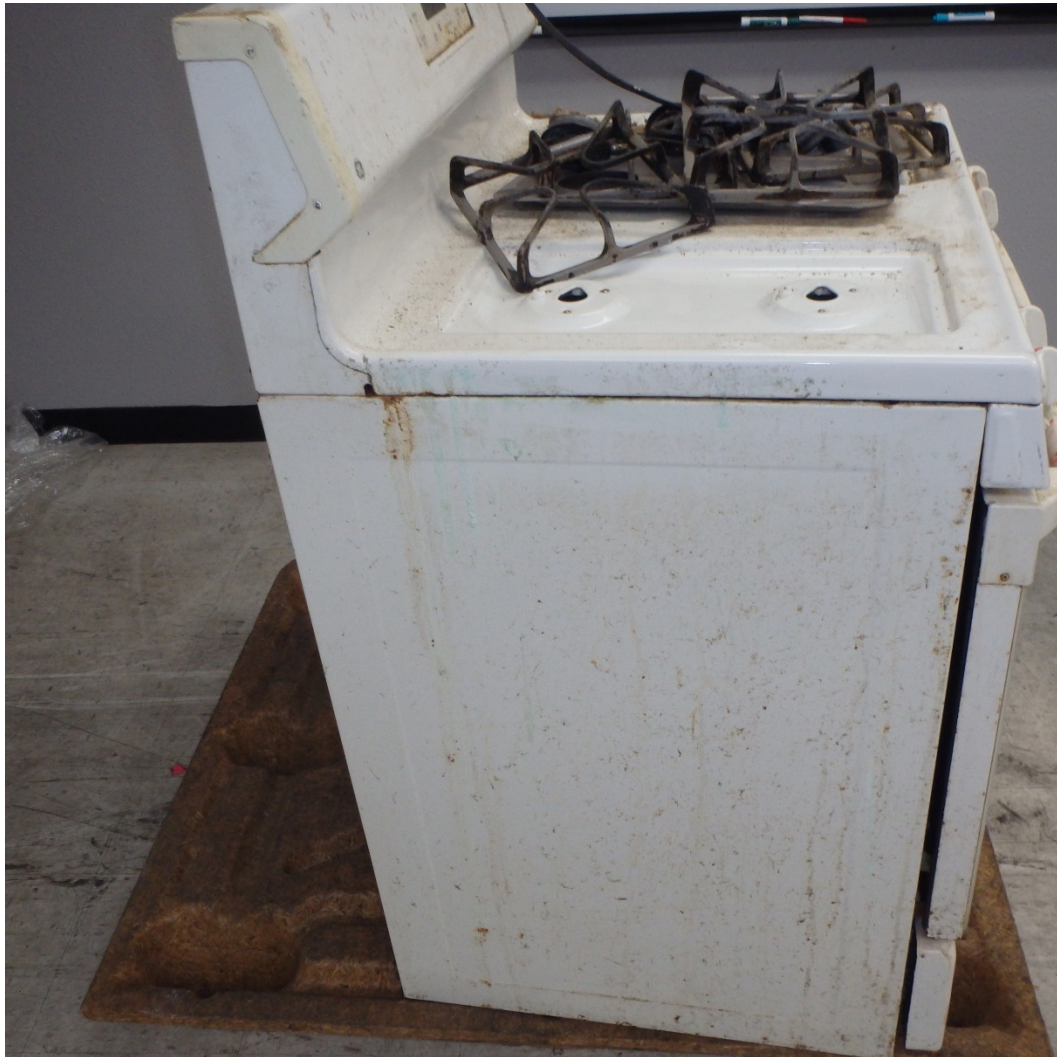
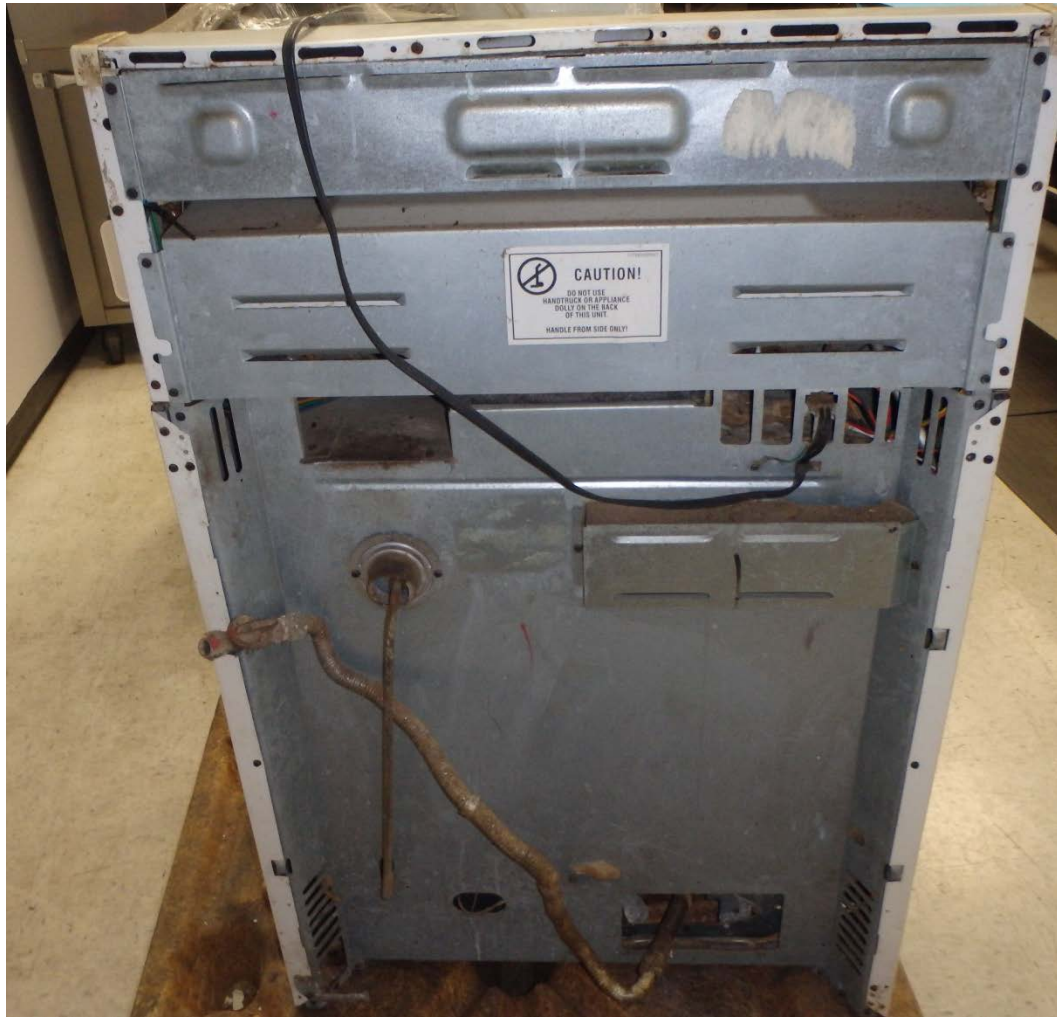
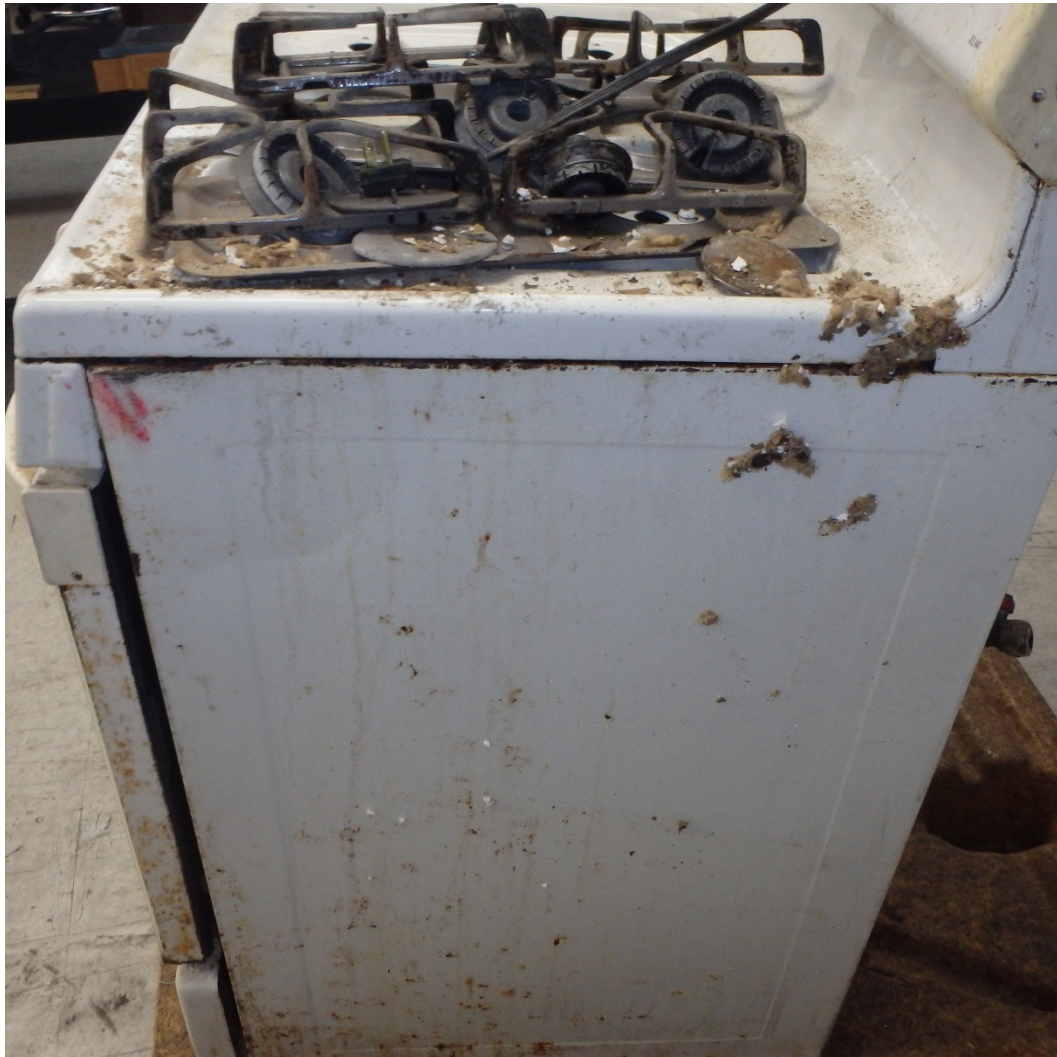
The gas range from this residence was identified from the photographs taken during the visual examination. The gas range was a General Electric Model JGBP35CEA5CC; Serial #TD241373P (GE Spectra 30-in, free standing gas range). According to a technical representative of the manufacturer, no safety bulletins had been issued for this model. In addition, no recalls were found on the Consumer Product Safety Commission's (CPSC) recall website for this model of range. The unit appeared to have no fire related damage as shown in Figures 24-27.

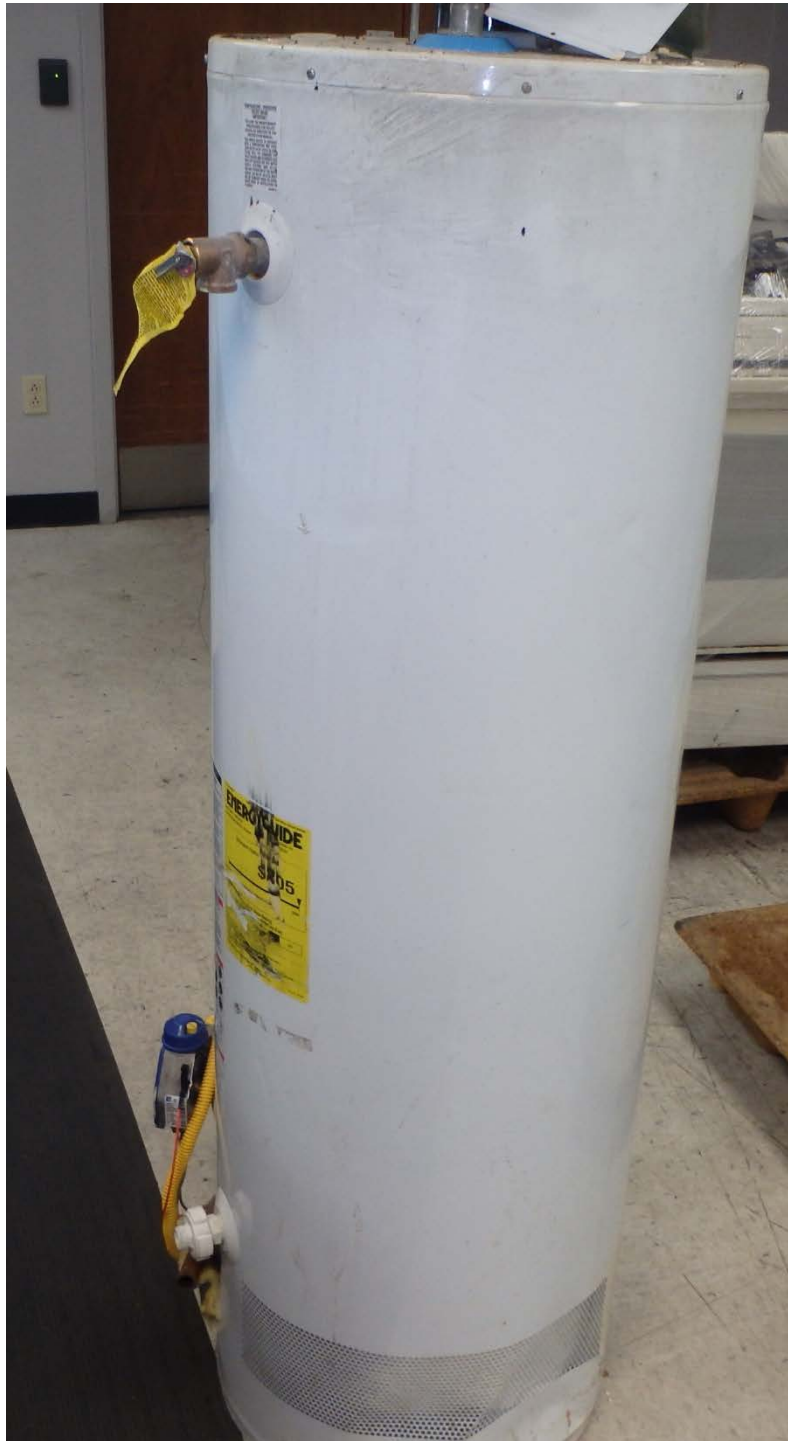
The hot water heater from this residence was identified from the photographs taken during the visual examination. The hot water was a Sure Comfort (manufactured by Rheem) 40-gallon residential gas hot water heater Model # SCG40T03ST34U1 Serial # Q501735989 and was manufactured December 13, 2017. According to a technical representative of the manufacturer, no safety bulletins had been issued for this model. In addition, no recalls were found on the CPSC's recall website for this model of hot water heater. The unit appeared to have no fire related damage as shown in Figure 28.

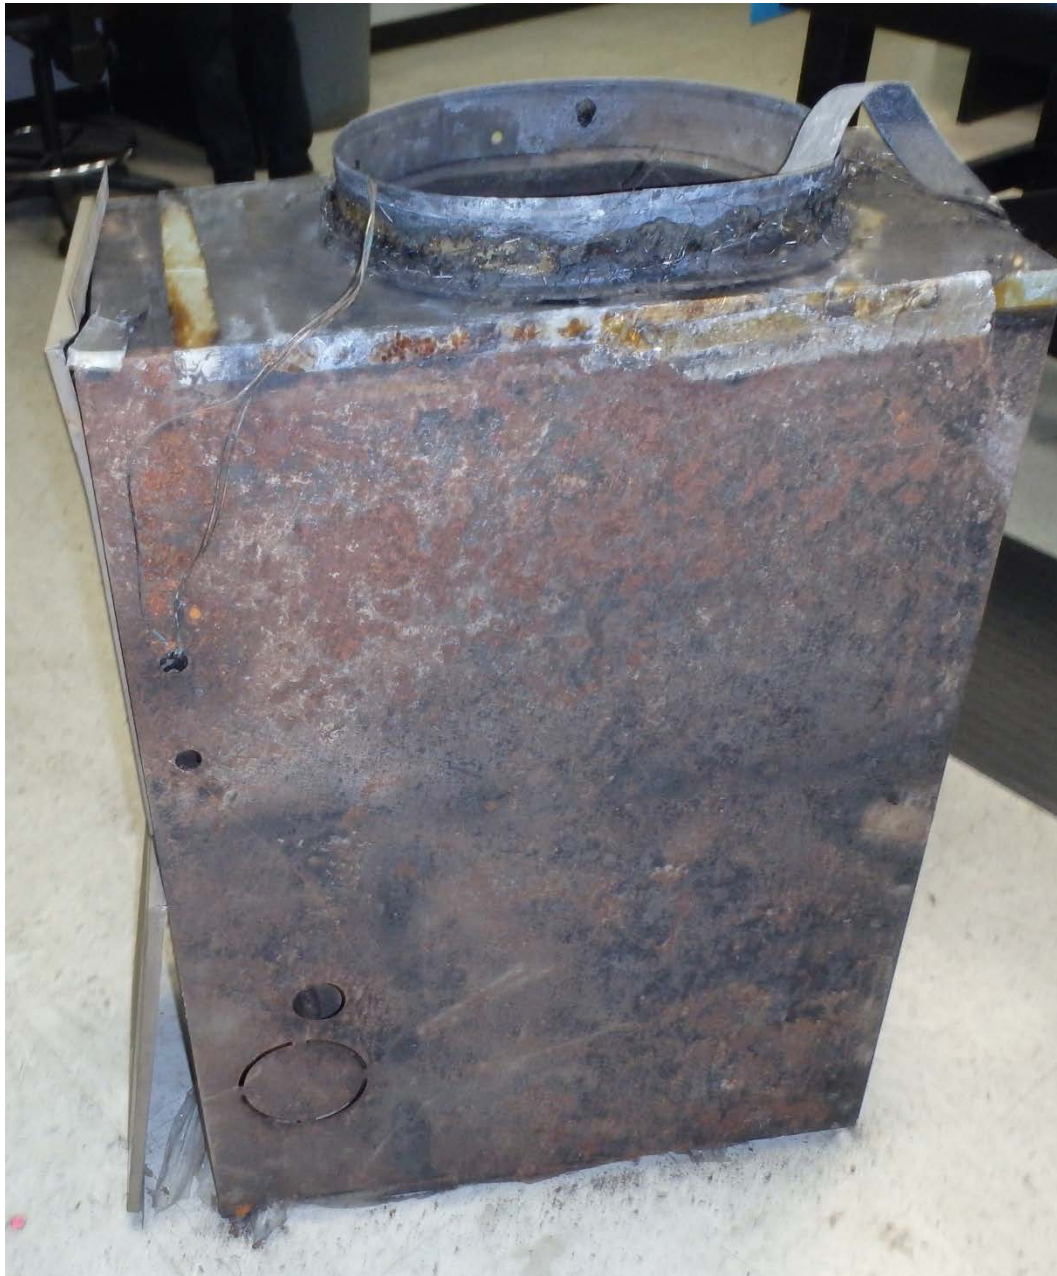
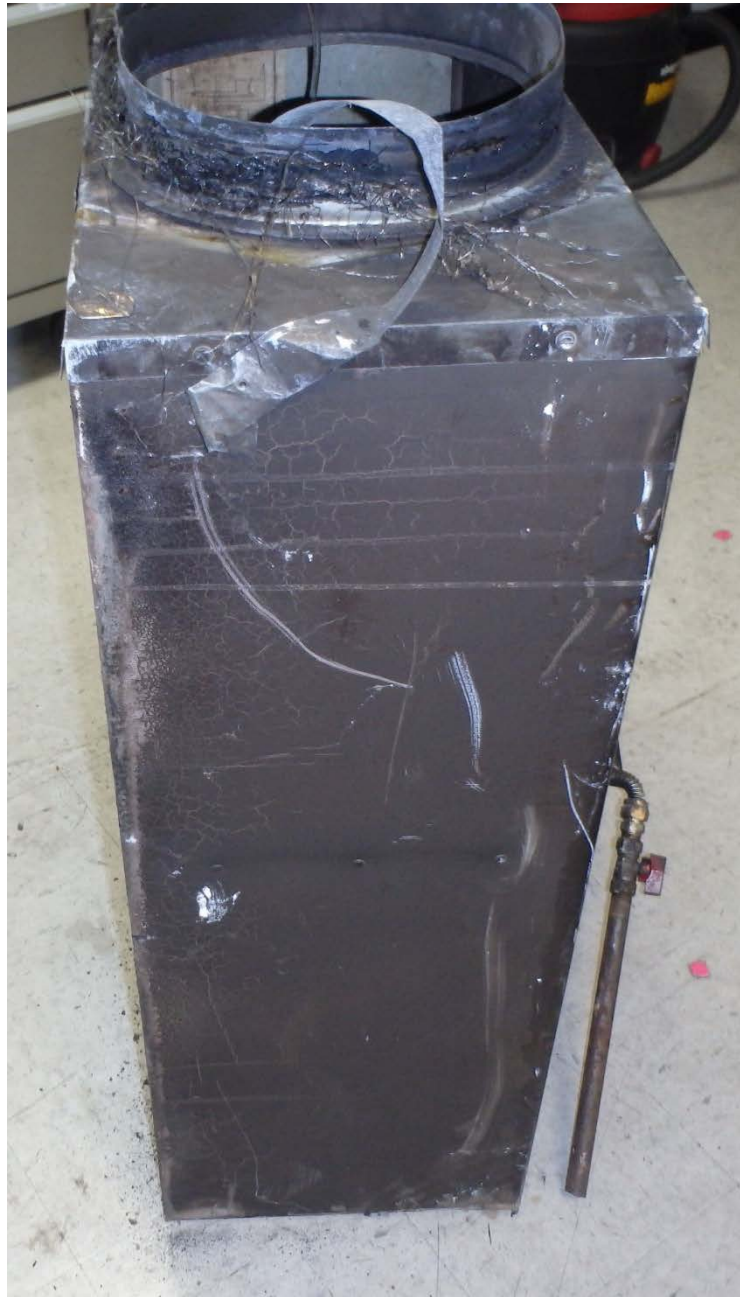
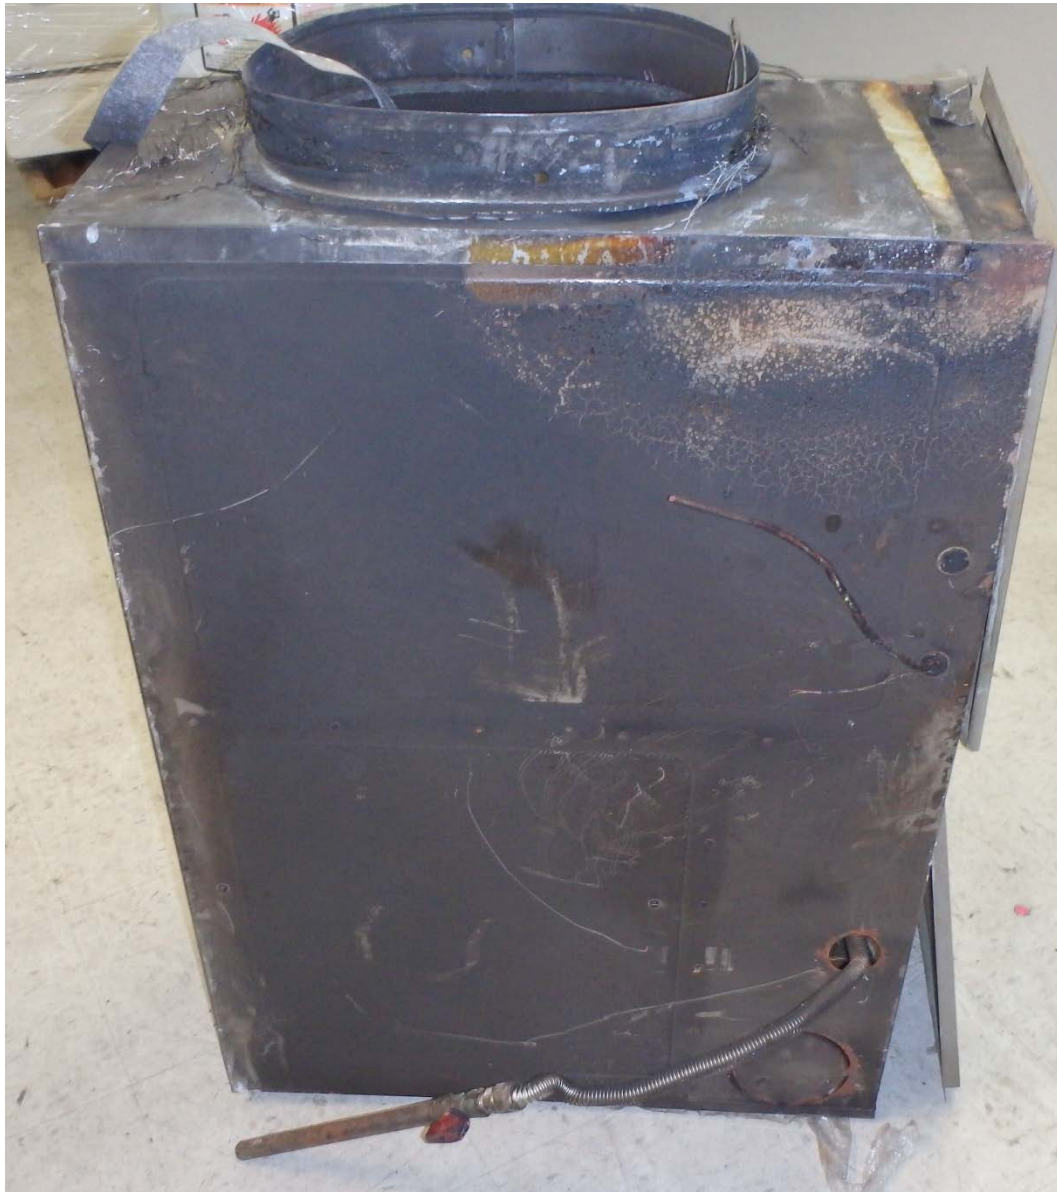
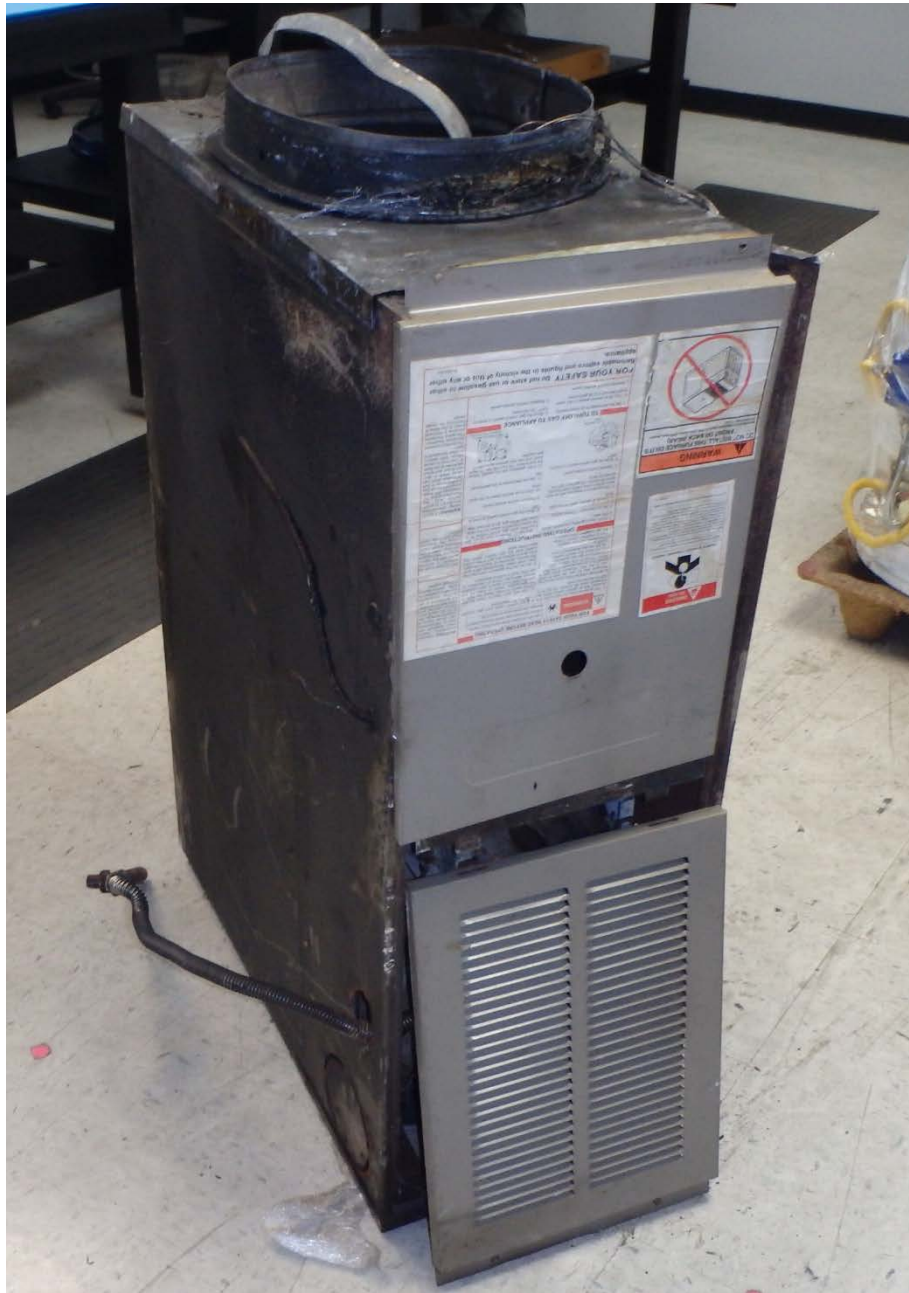
As shown in Figures 29-32, the furnace/HVAC unit had thermal damage and soot on three sides of the unit. The three damaged sides displayed thermal discoloration and damage to the surface coating, oxidation of metallic surfaces and warping of the panels. The access panel was undamaged. All identifying information, marks or logos were obscured or missing. The interior of the furnace also sustained thermal damage. There was light soot on the interior surfaces and most of the wiring had melted insulation as shown in Figure 33. On the interior of the access panel, the labels and diagrams appeared to be undamaged, but did not contain manufacturer information.

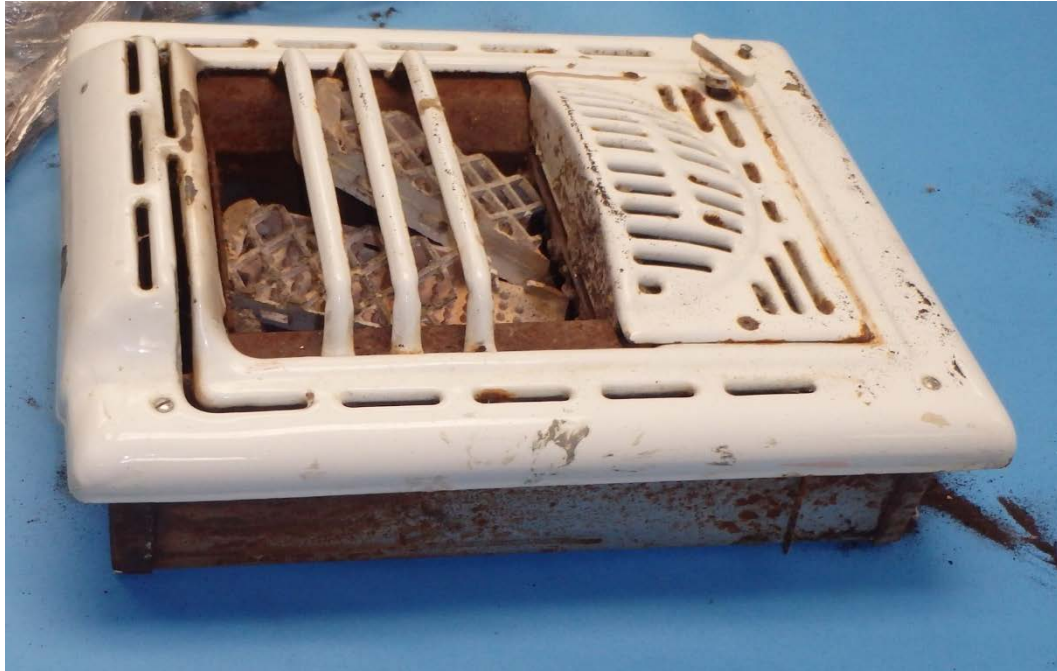
The gas bathroom heater from this residence had no markings or identifying information or logos on any of the visible surfaces. The heater was located in the original bathroom prior to the incident. The unit was identified through a reverse image search as a Peerless 7602 gas bathroom wall-mounted heater circa 1940-50s. Due to the approximated age of the heater, no other manufacturing information or recall information was found. There appeared to be no fire-related damage to the wall heater as shown in Figure 34.

Figure 34. Gas bathroom heater from 3527 Durango Drive. Photograph by DFR, June 2020

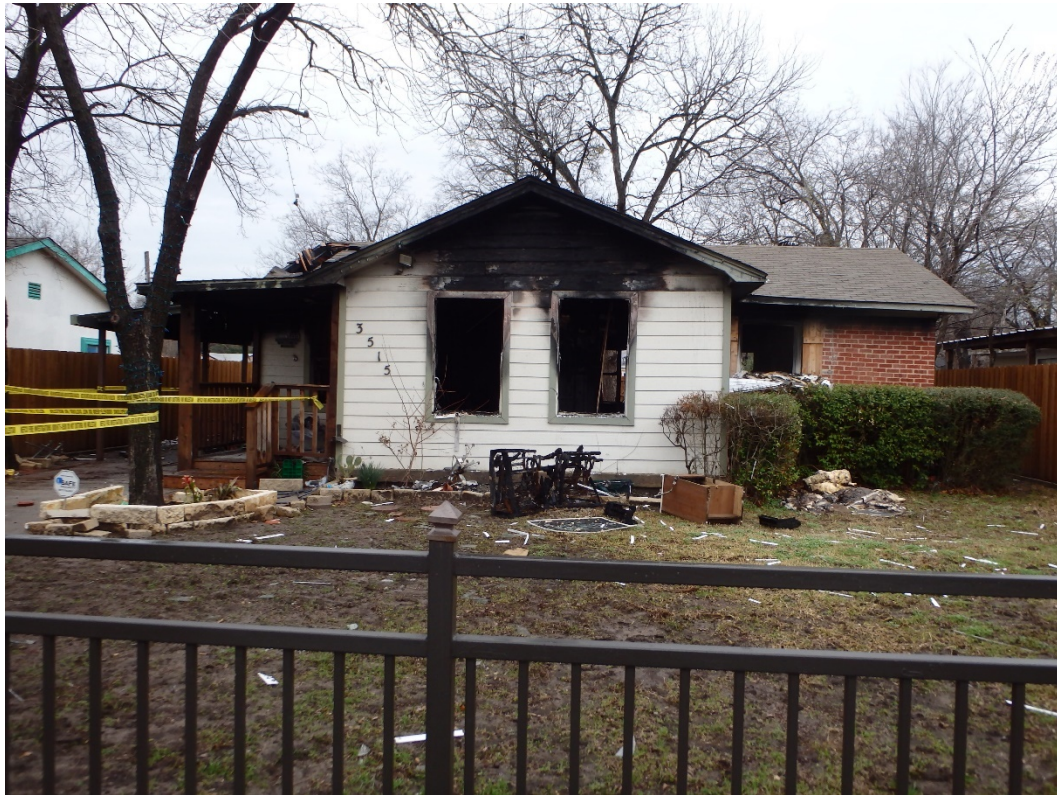
On Side A of the residence, the porch and the front center and left section was sided. In this area, the damage was limited to the two front windows and the exterior wall above those windows as shown in Figure 36. The glass panes were missing from both windows. The upper edges of the windows and the exterior siding were sooted and sustained fire damage and thermal discoloration. On the left side, the window adjacent to the front door exhibited similar damage. The edge of the roof, located directly above these windows, exhibited similar damage. The underside of the porch overhang was slightly sagged and had similar fire damage as well. On the section to the right, the wall had a brick façade with a window. The only fire damage present in this area was some fire damage at the junction of the wall and roof and smoke staining to the brick below this junction. Visible sections of roof exhibited fire damage and evidence of firefighting ventilation efforts. A square section on the left side of the roof had been removed during firefighting operations to facilitate ventilation within the structure. Another hole was in the center of the roof. This hole exhibited fire damage around the edges of the roof in this area.

Figure 36. Side A of 3515 Durango Drive. Photograph by DFR, February 2018.

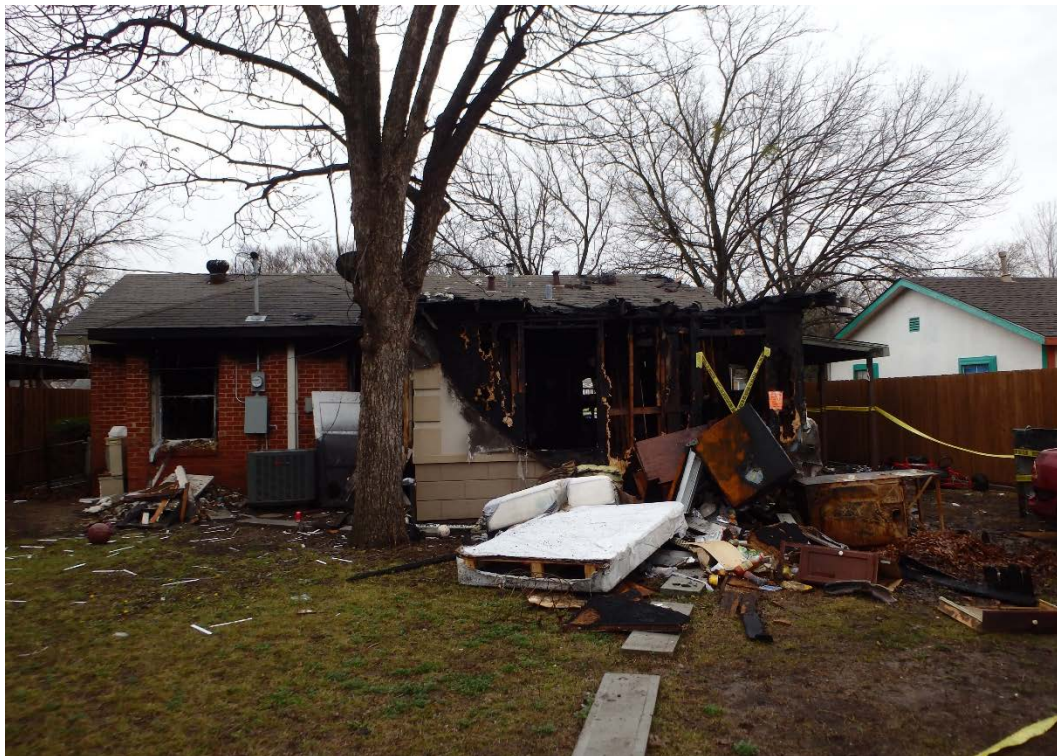
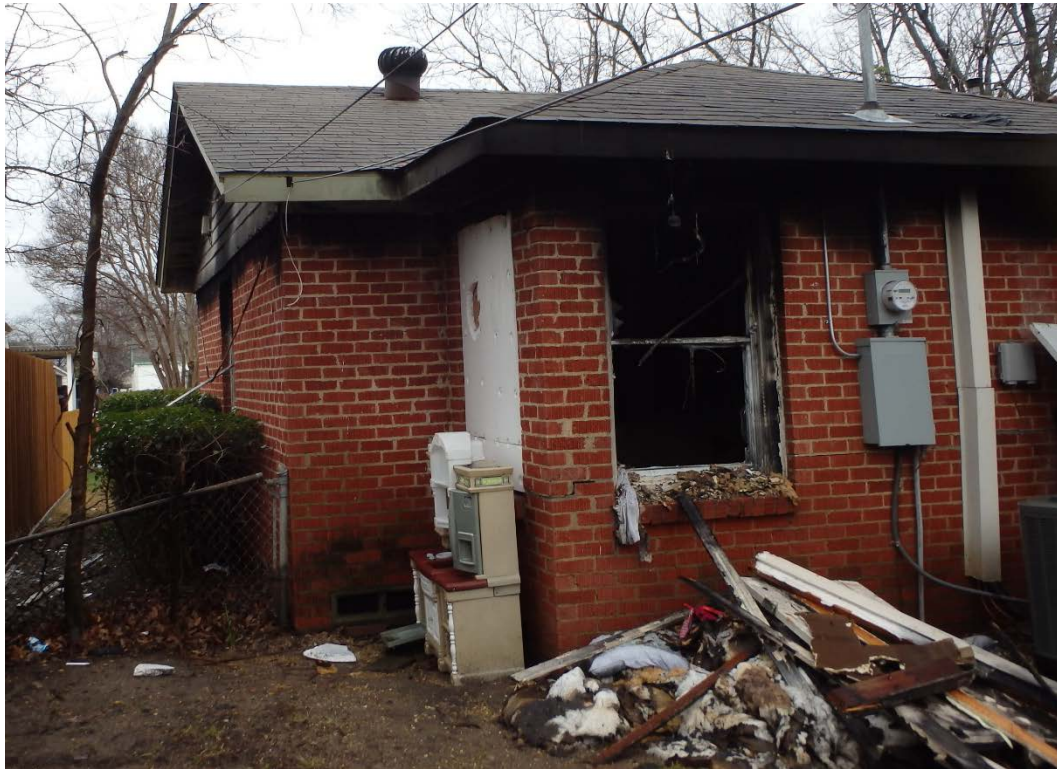
On Side C, the B/C corner of the structure sustained significant fire damage that extended from the corner to midline of the back exterior wall as shown in Figure 39. This area appeared to be an addition to the original structure and appeared to have been sided with stucco with the lower third sided with masonry blocks. The exterior wall (siding and exterior sheathing) in this area was largely missing with only vertical structural supports visible. These supports and the remaining wall materials exhibited fire damage. The damage went down to the floor at the corner and extended up in a partial "U" shaped pattern as it moved towards the midline of the structure. The roof in this area was sagging along the edge and areas of roof missing. There was some buckling across the roof surface and partially collapsed adjacent to the corner of the structure. The section of the structure from the midline to the C/D corner was relatively intact but exhibited sooting at the junction of the wall and roof. The window was missing the glass panes and the frame was sooted as shown in Figure 40. The roof over this section of the rear wall appeared undamaged.

Figure 39. Side C of 3515 Durango Drive. Photograph by DFR, February 2018.

Figure 40. Corner of Side C and Side D of 3515 Durango Drive. Photograph by DFR, February 2018.

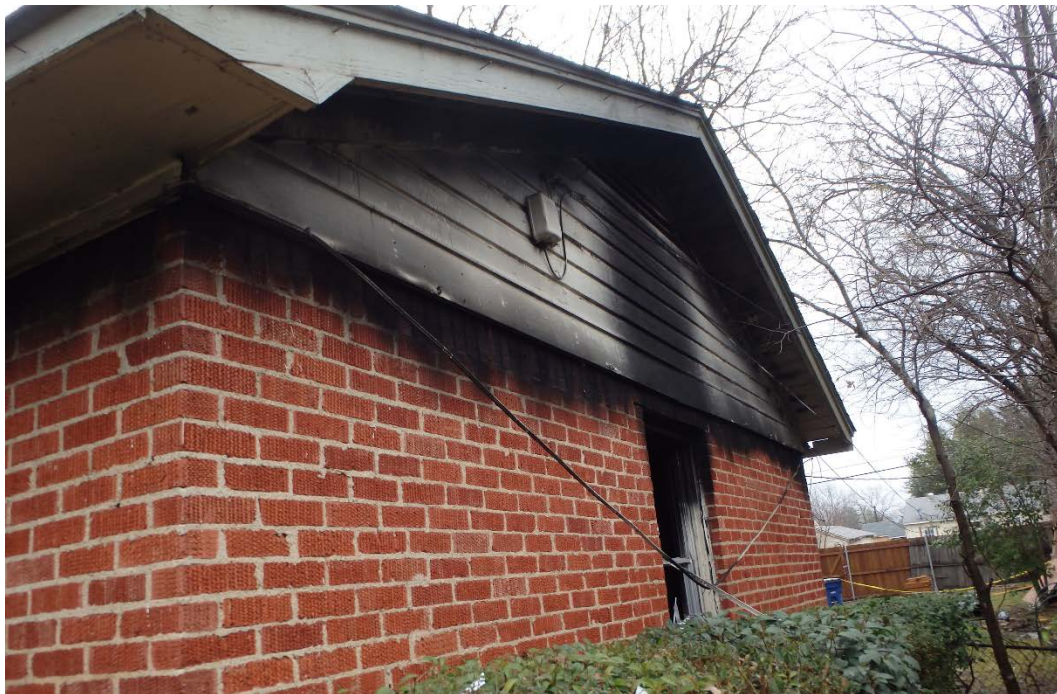
On Side D, the exterior wall was intact including the wood-sided eaves as shown in Figure 41. The eaves and roof edge were sooted as was the junction of the siding with the brick façade and the upper portion of the window frame. The window was missing the glass panes. The roof over this section appeared undamaged.

Figure 41. Side D of 3515 Durango Drive. Photograph by DFR, February 2018.

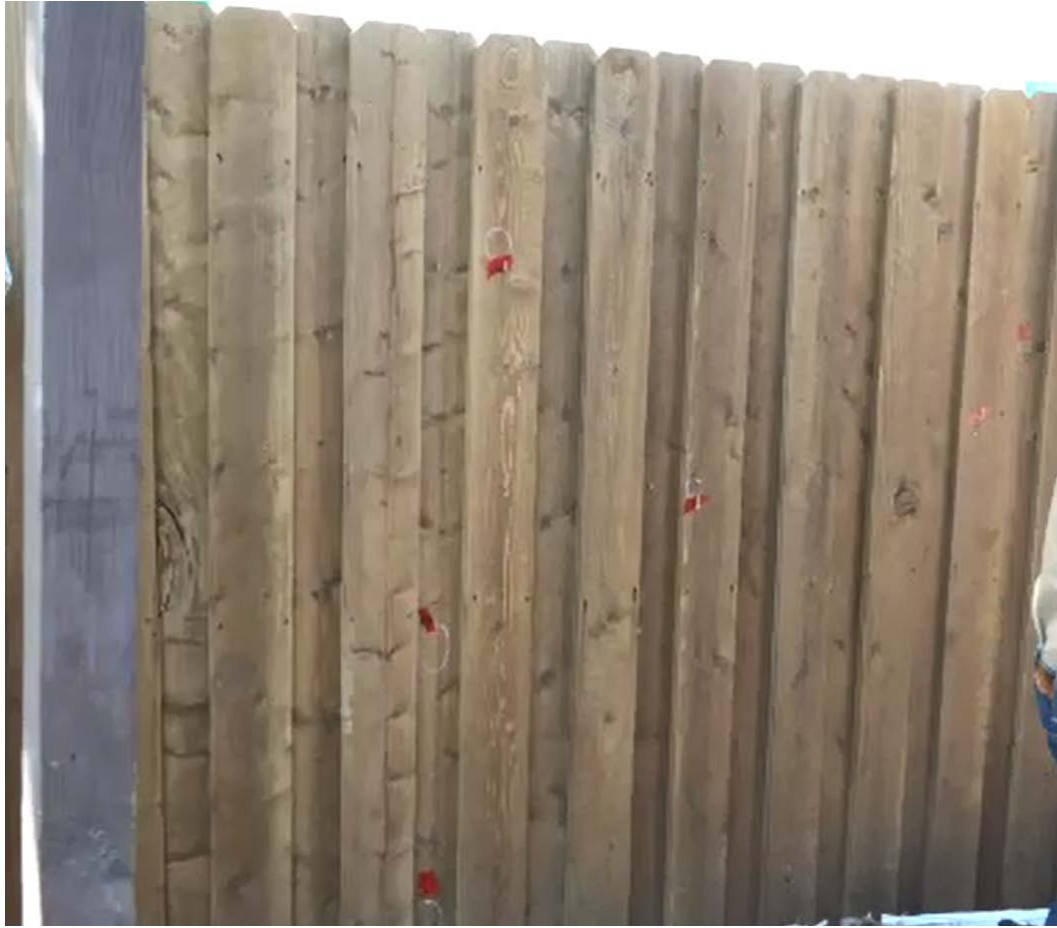
During a post-incident examination of the structure and appliances at 3515 Durango Drive that took place on April 4, 2018, the homeowner's representative removed sections of the fence installed next to the carport on Side B. One of the fence panels is shown in Figure 42. The red markers and white circles indicate the location of glass fragments found embedded in the fencing slats.

Figure 42. Fence panel with embedded glass located next to the carport for 3515 Durango Drive. Screenshot of video taken by homeowner's representative, April 2018.

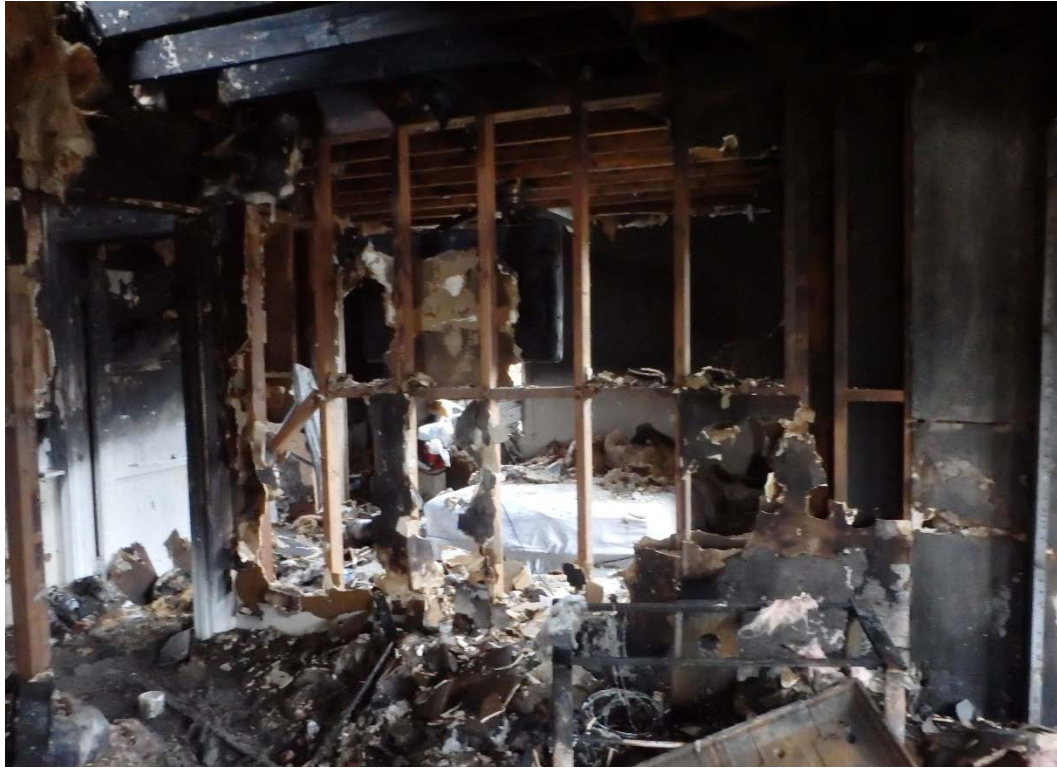
The interior was destroyed by fire. An example of this damage is shown in Figure 43. Most of the interior walls (sheetrock) and ceiling were missing, and the exposed structural joists were fire damaged. Remaining walls and ceilings were sooted and fire damaged in areas adjacent to missing areas of sheetrock. The damage extended to the underside of the room causing sooting and charring to roof beams, rafters, and decking. Room contents were largely destroyed as well.

Figure 43. Interior room of 3515 Durango Drive. Photograph by DFR, February 2018.

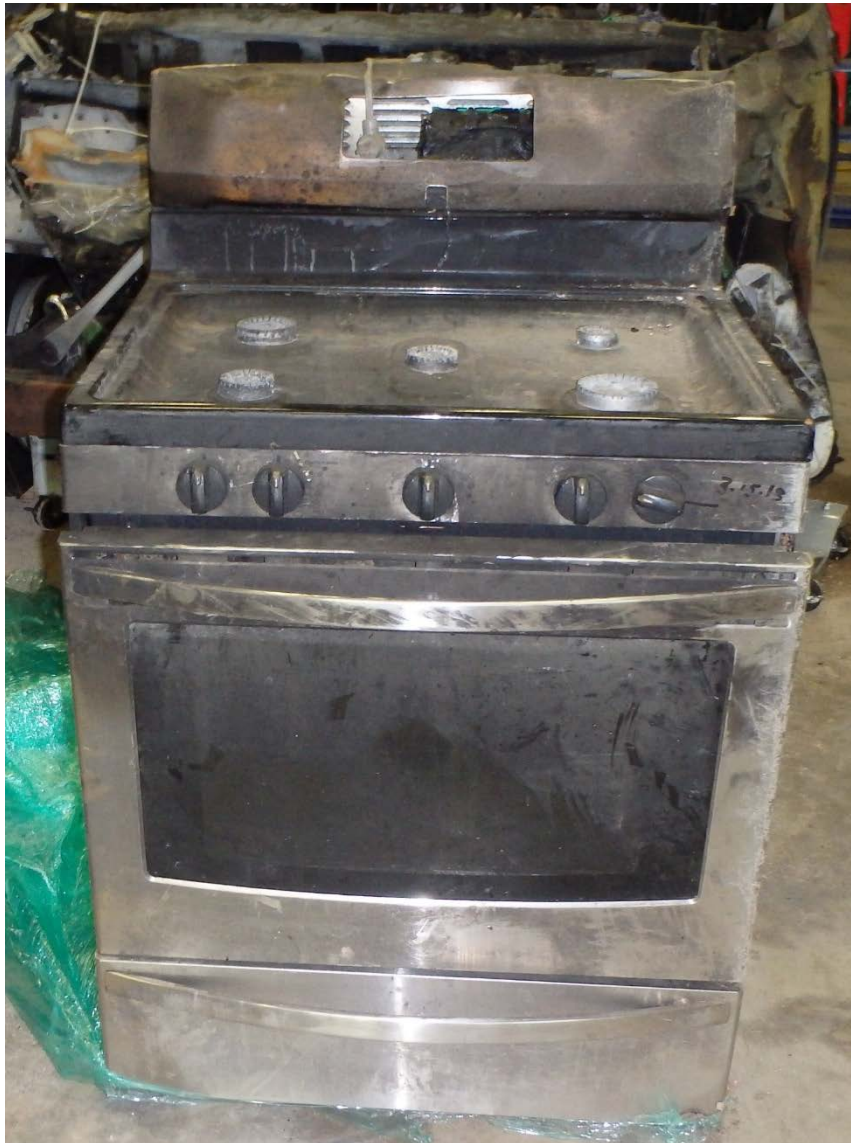
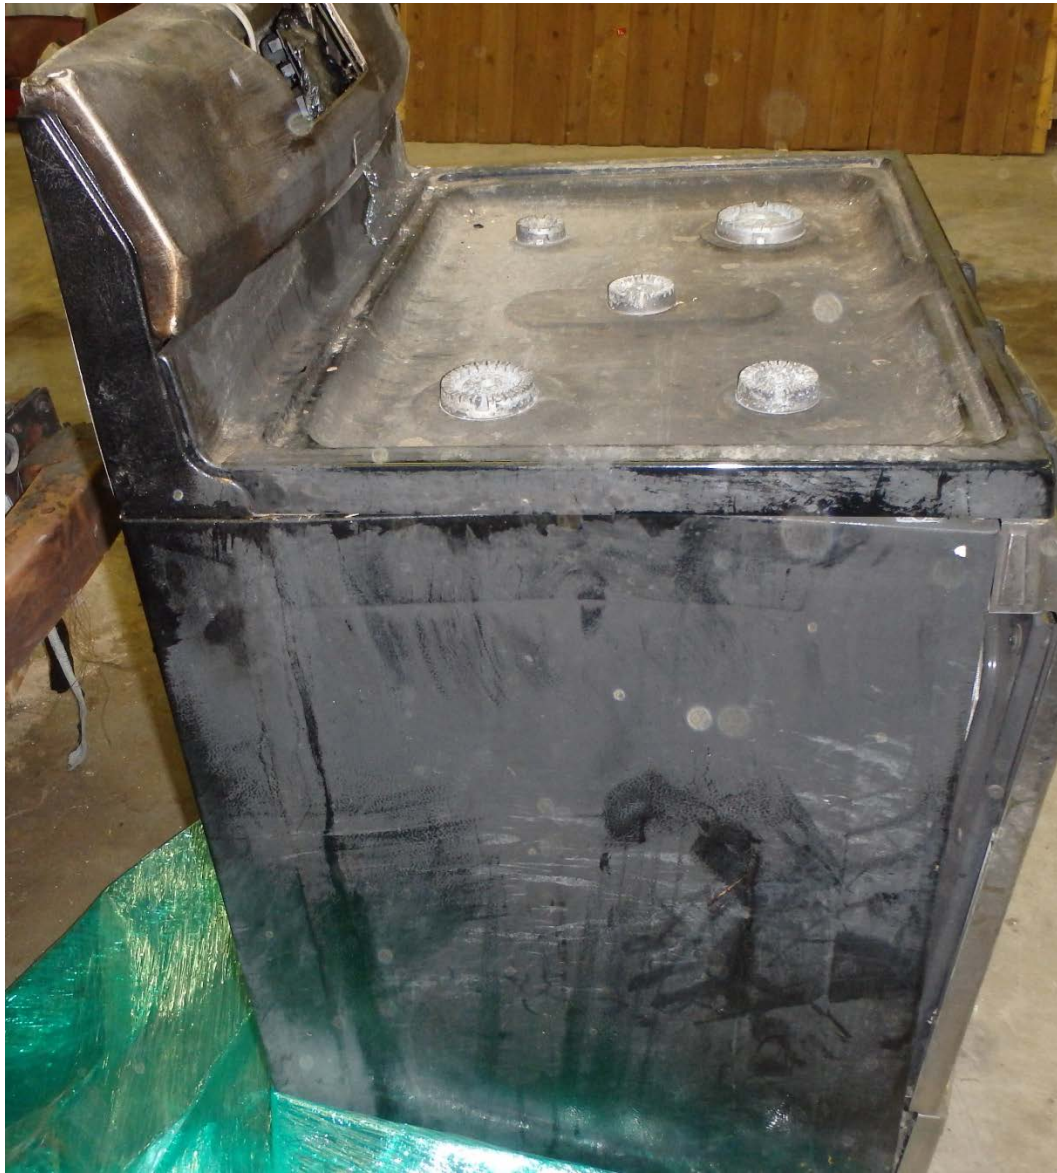
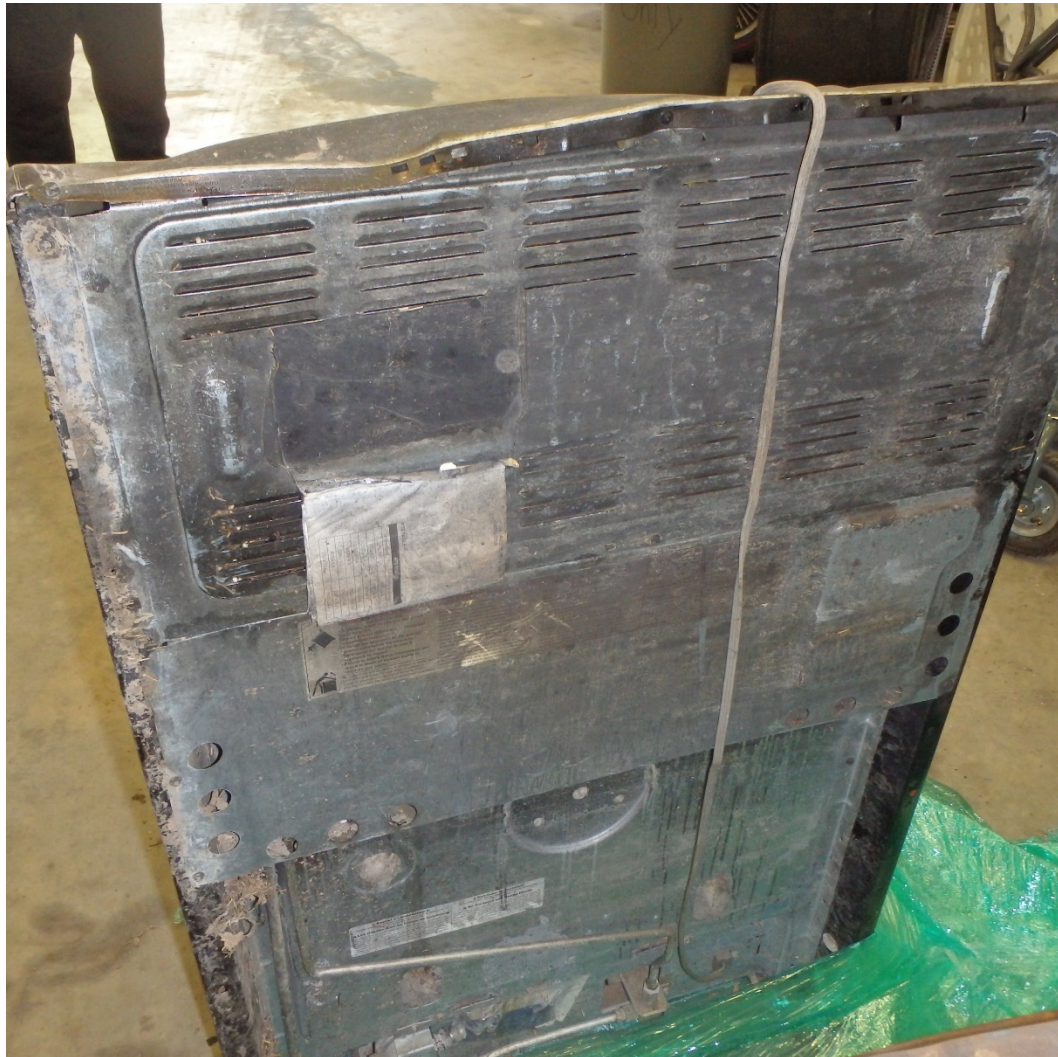
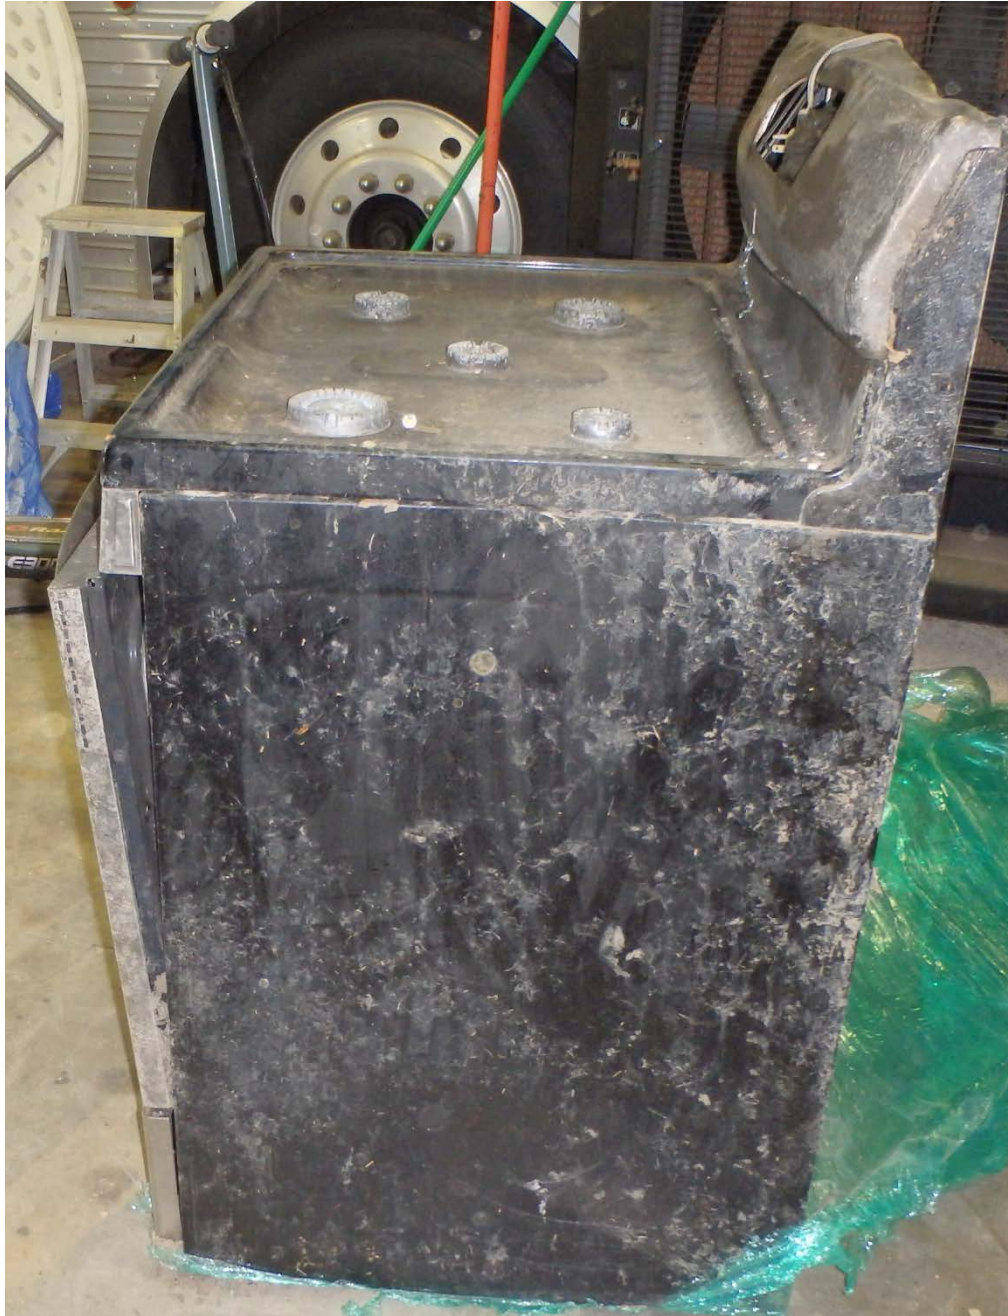
Photographs of the gas range show the unit had soot over all exposed exterior surfaces as shown in Figures 44-47. There was thermal damage to the backsplash and control panel. The metal panels on either side of the control panel were discolored and warped. The paint was discolored, bubbled, or missing on the upper surfaces (backsplash and back of cook top). All plastic components were melted, and the control board was encased in resolidified plastic as shown in Figure 48. Burner caps appear undamaged. Oven pilot unit was undamaged as shown in Figure 49. Oven interior was undamaged and exhibited thermal discoloration consistent with normal oven operation as shown in Figure 50.
