NATIONAL TRANSPORTATION SAFETY BOARD

MATERIALS LABORATORY FIRE FACTUAL REPORT

Report No. 20-031

Place : Dallas, Texas
Date : February 23, 2018
Vehicle : Residential Gas Pipe Rupture
NTSB No. : PLD18FR002
Investigator : Sara Lyons IIC-RPH

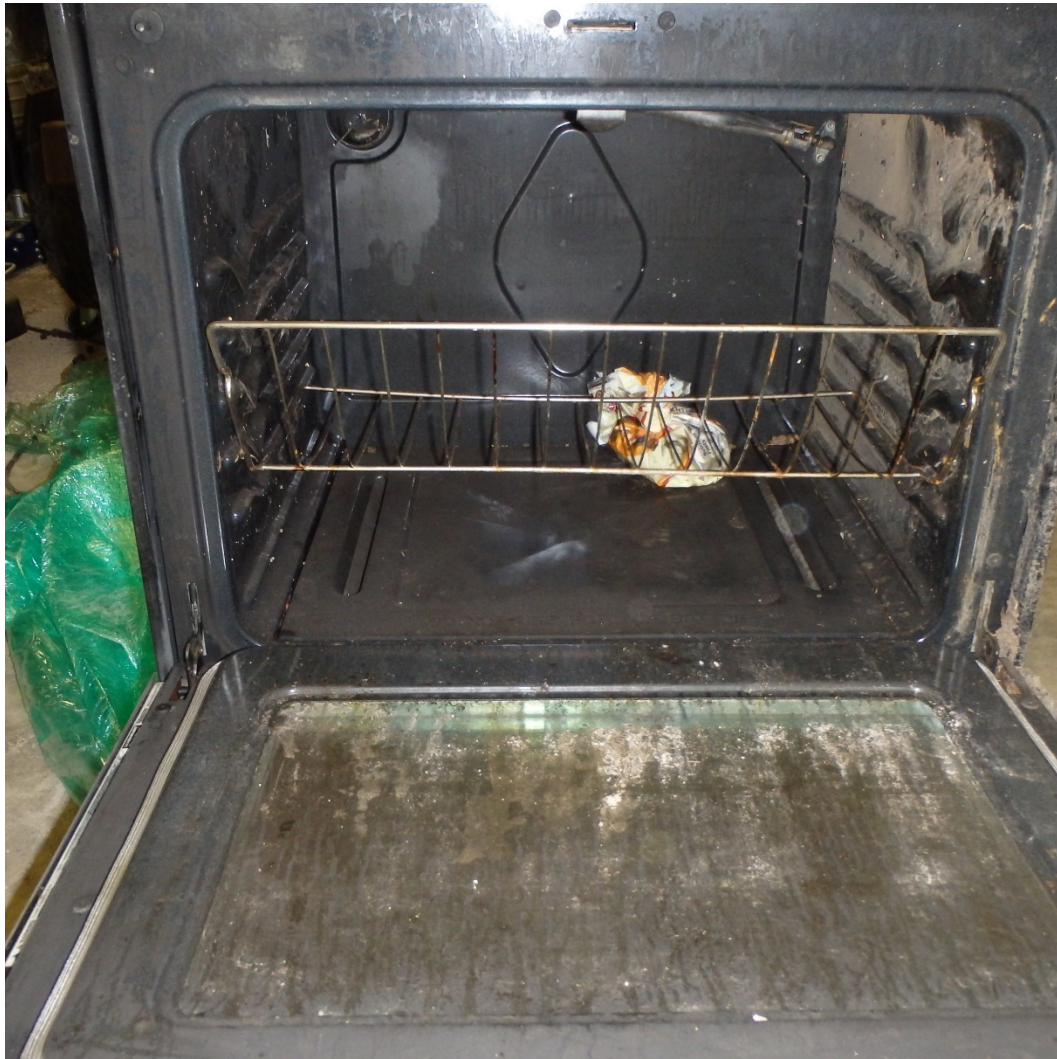
Photographs of the gas range show the unit had soot over all exposed exterior surfaces as shown in Figures 44-47. There was thermal damage to the backsplash and control panel. The metal panels on either side of the control panel were discolored and warped. The paint was discolored, bubbled, or missing on the upper surfaces (backsplash and back of cook top). All plastic components were melted, and the control board was encased in resolidified plastic as shown in Figure 48. Burner caps appear undamaged. Oven pilot unit was undamaged as shown in Figure 49. Oven interior was undamaged and exhibited thermal discoloration consistent with normal oven operation as shown in Figure 50.

Figure 50. Oven interior of 3515 Durango Drive gas range. Photograph by DFR, June 2020.
