NATIONAL TRANSPORTATION SAFETY BOARD

MATERIALS LABORATORY FACTUAL REPORT

Report No. 20-038

Place : Big Timber, Montana
Date : January 16, 2020
Vehicle : Cessna 172Q, N96145
NTSB No. : WPR20LA068
Investigator : Stephen Stein, AS-WPR

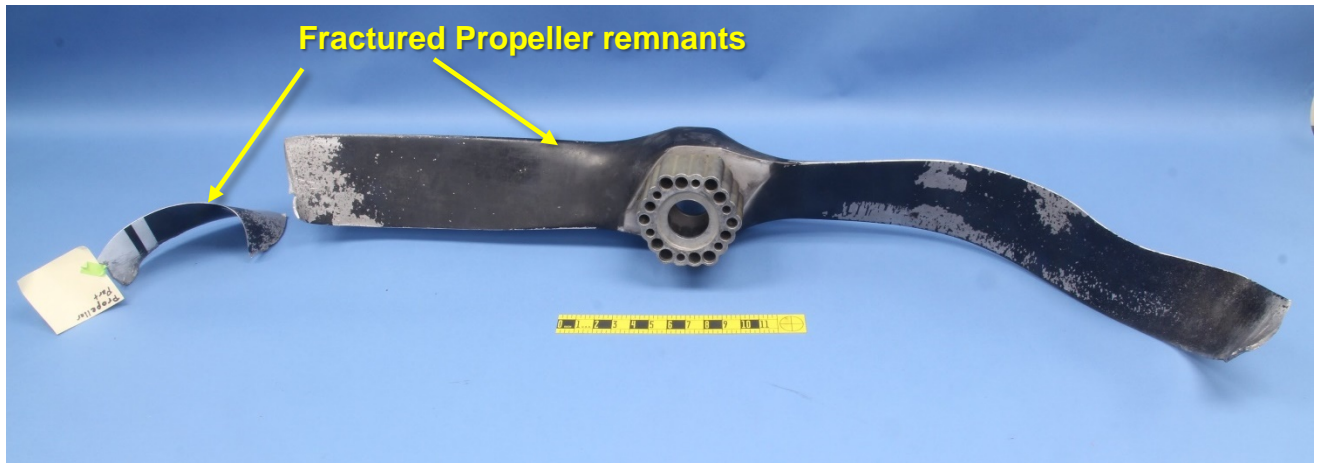
Figure 1 and Figure 2 shows the propeller assembly remnants, as received. The propeller was submitted with the hub attachment still affixed. The blade assembly had fractured in two places, one at the very tip, shown in right in Figure 1, and the other approximately 10 inches from the tip. This second remnant was reported found away from the debris field.

Figure 1 – The propeller and the hub remnants, viewed from the aft or engine-facing side.

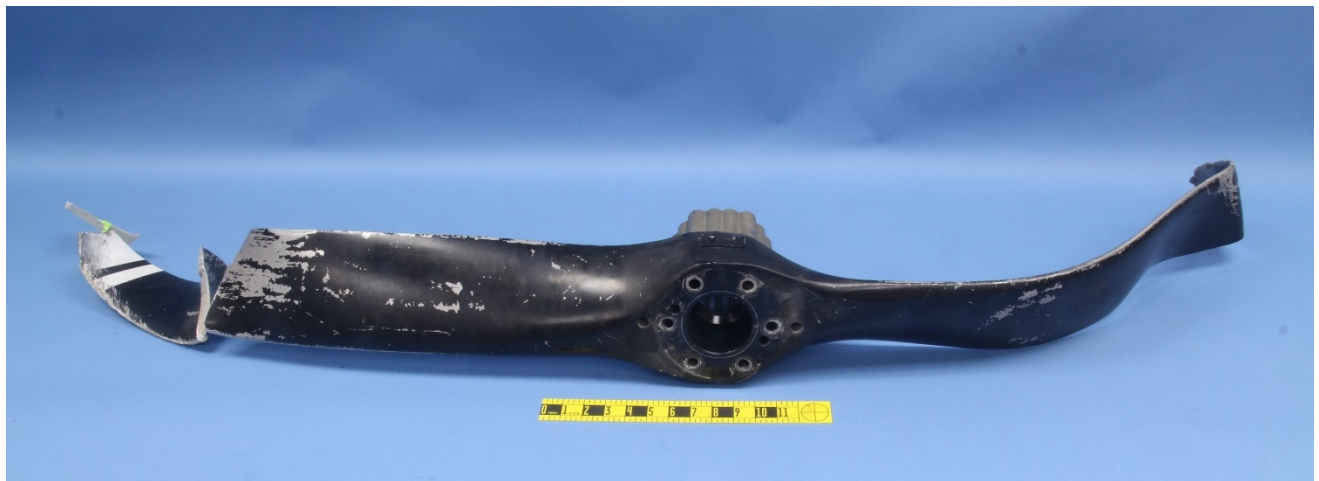
As demonstrated in Figure 2, the propeller exhibited plastic deformation on both blades. The deformation was oriented from the forward to aft faces of the propeller,

Figure 2 – The propeller remnants viewed from the forward side, opposite that in Figure 1.

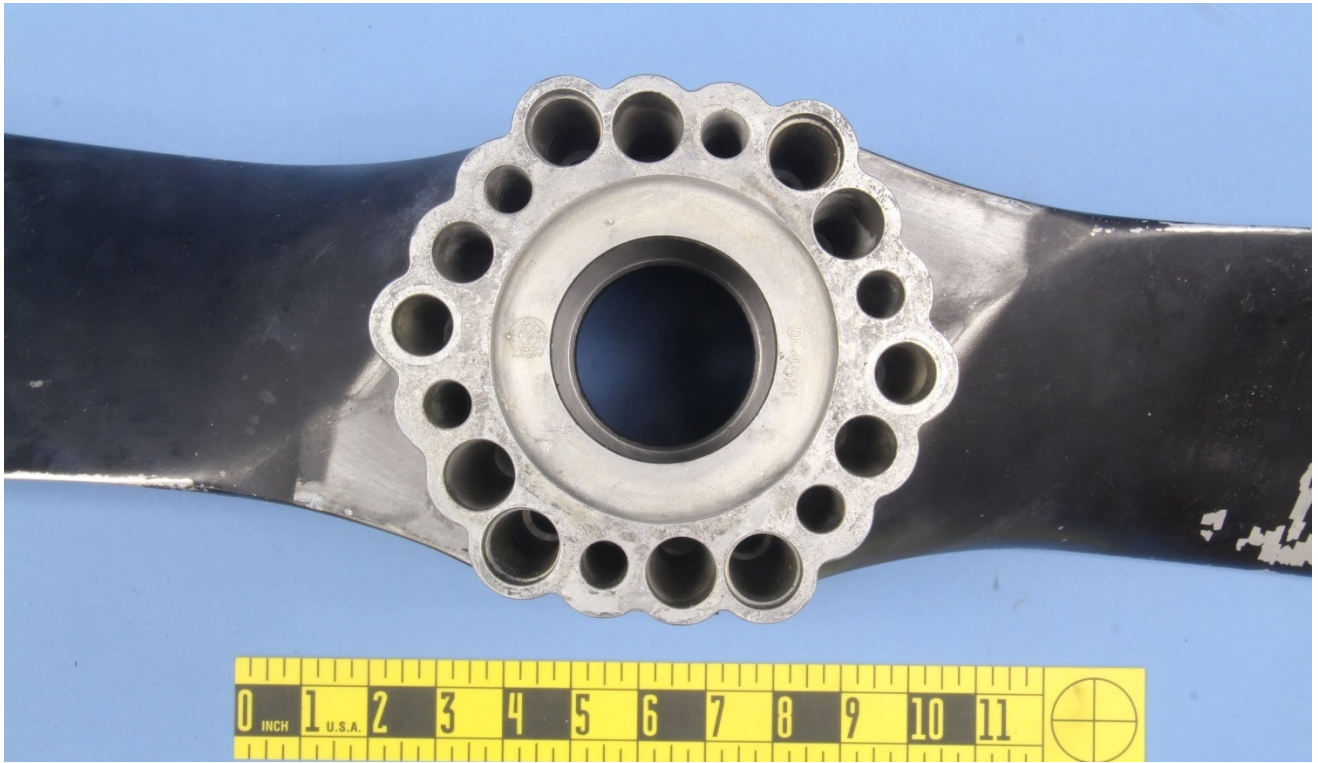
Figure 3 shows a closer view of the aft hub attachment, highlighting the bolt holes. There were no indications of damage on the aft face, as shown in the figure. The bolt holes did not exhibit any indications of chatter or fretting, nor other damage such as cracking or plastic deformation on the interior or exterior surfaces.

Figure 3 – View of the propeller hub attachment, viewed from the aft face.

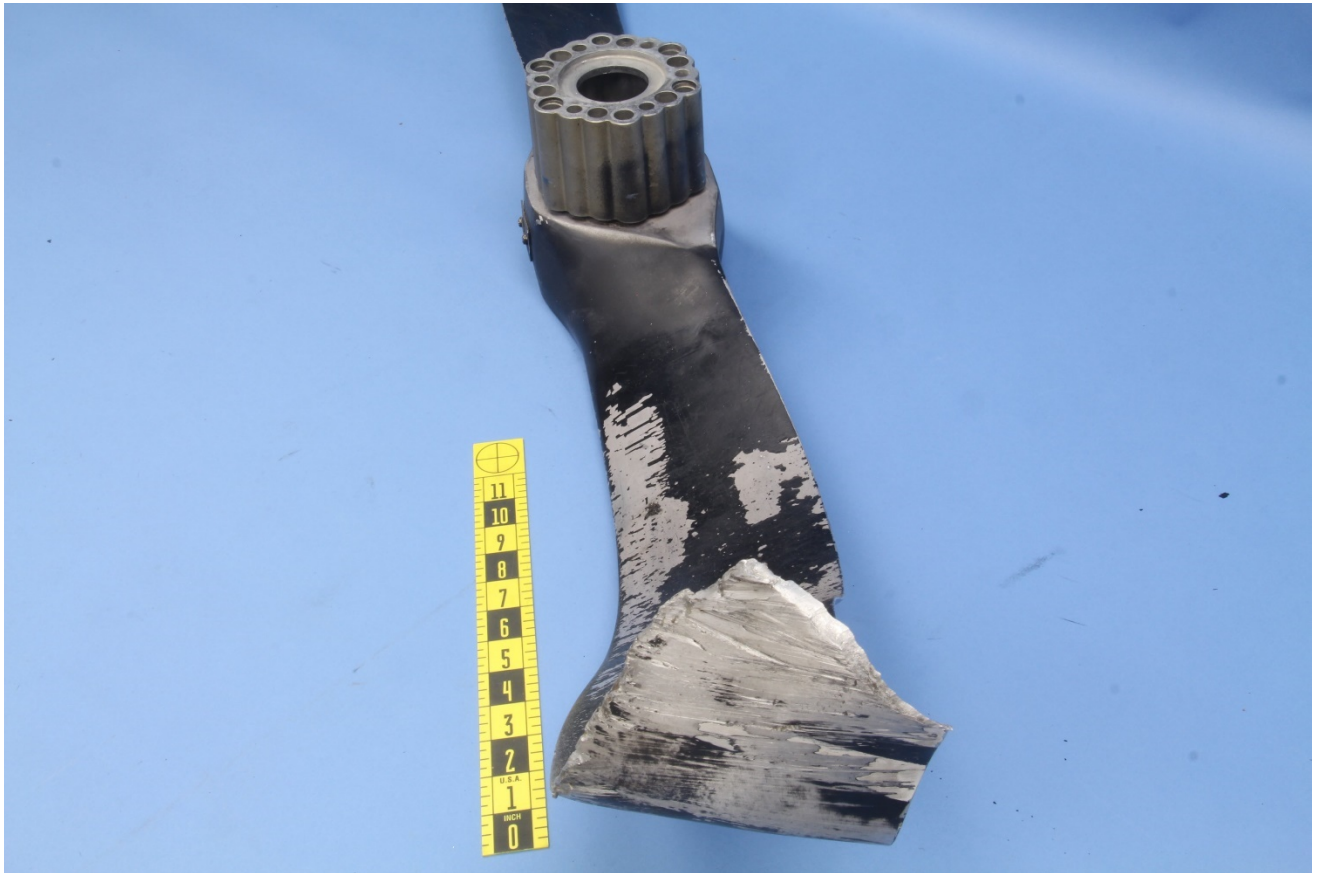
consistent with impact with either the ground or ground-based objects while still moving forward. Figure 4 shows the intact blade side, shown from the fractured tip. The leading edge surfaces of the blade presented the exposed underlying aluminum metal, consistent with missing black paint (the propeller blade had been painted black, with the tips painted as white stripes). These regions contained scratches and deep gouges, all of which were oriented parallel to the chord line. At the tip shown in Figure 4, these gouges were most pronounced, and were located near where the tip had fractured. The tip was bent upward adjacent to the fracture, as depicted in Figure 4.

Examination of this fractured tip revealed the fracture surface exhibited a general slant orientation, with characteristics consistent with that of cupping or a U-shape. The surface was jagged in appearance, with rough features. The surface exhibited a dull luster with fibrous features. These characteristics were consistent with overstress fracture of this blade tip in bending and torsion.

Figure 4 – View of the bent and fractured tip of the intact blade side, as received.

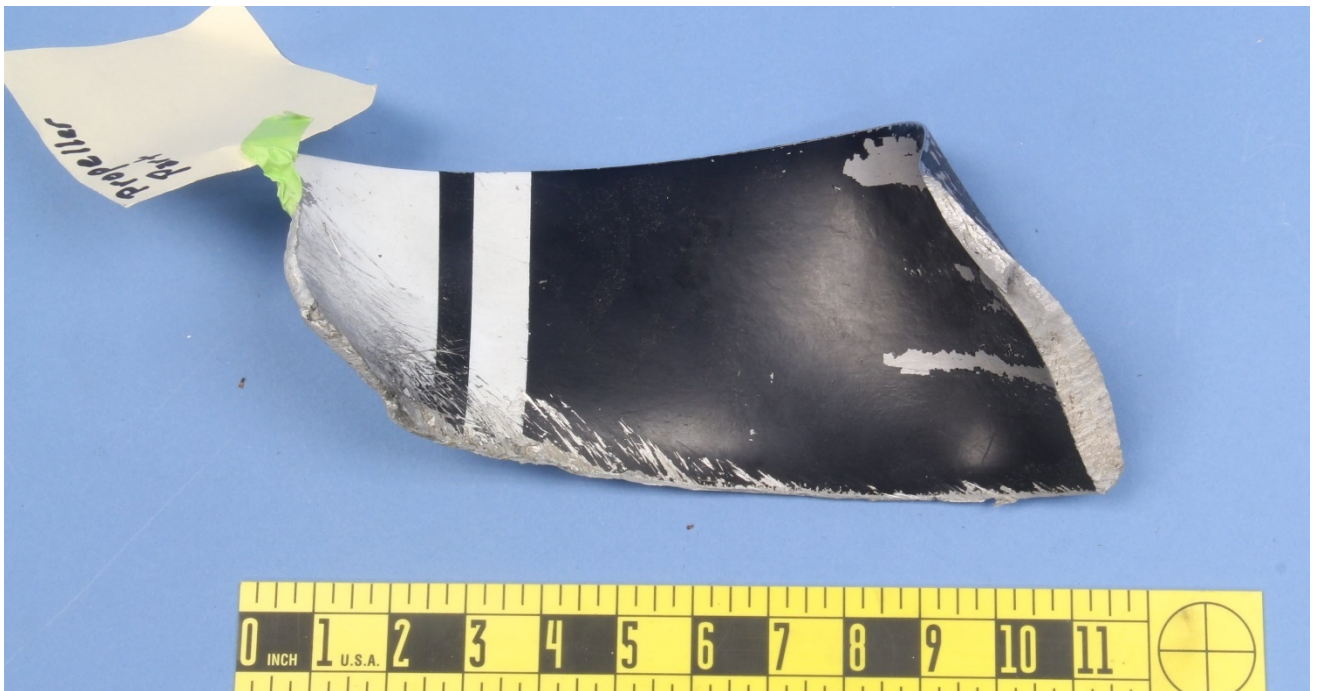
Figure 5 shows the fractured remnant of the opposite blade, which had been found separate. This remnant exhibited areas of missing paint, located along the leading edge and adjacent to the inboard fracture surface. The missing paint on the leading edge was co-located with parallel scratches, which were oriented at a 45° angle towards the outboard direction, running towards the trailing edge. Figure 6 shows the blade remnant fracture surface side. The remnant exhibited plastic deformation on the outboard tip surfaces, exhibiting curling or twisting from the leading edge towards the trailing edge.

Figure 5 – View of the fractured blade side remnant found away from the debris field.

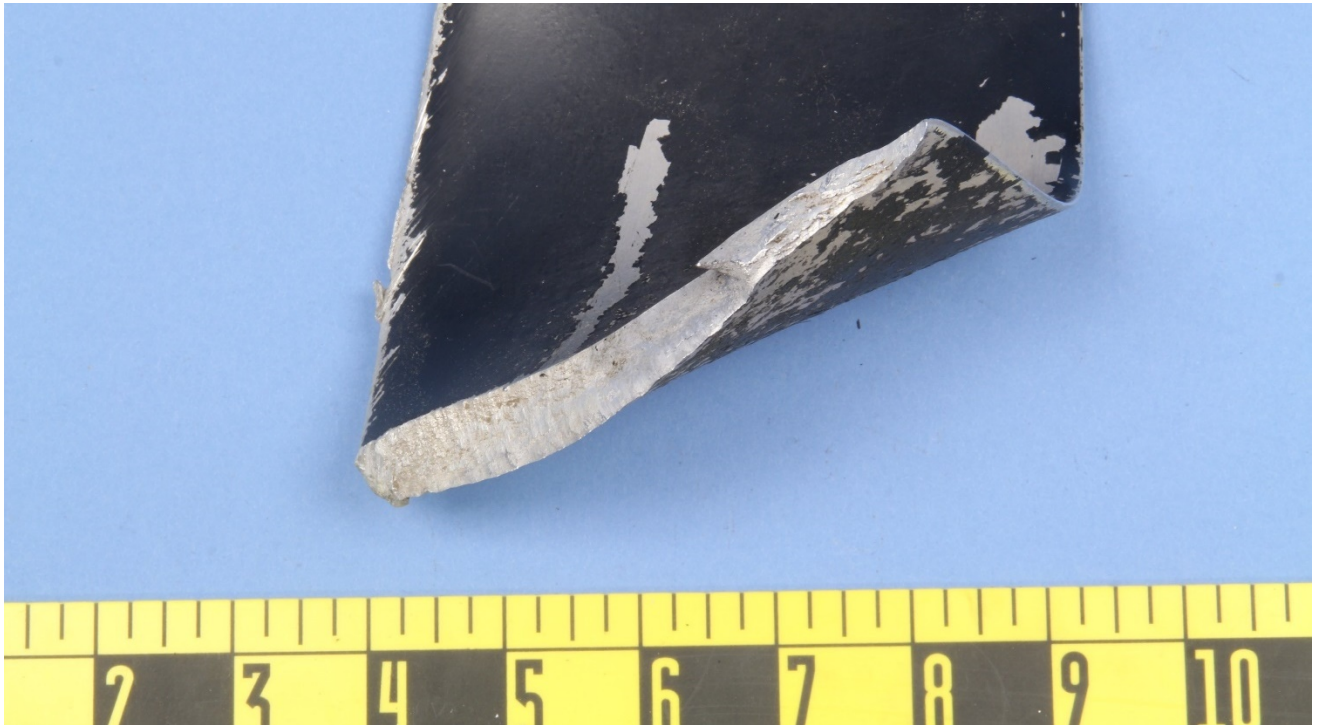
Figure 6 – View of the fracture surface from the blade remnant.

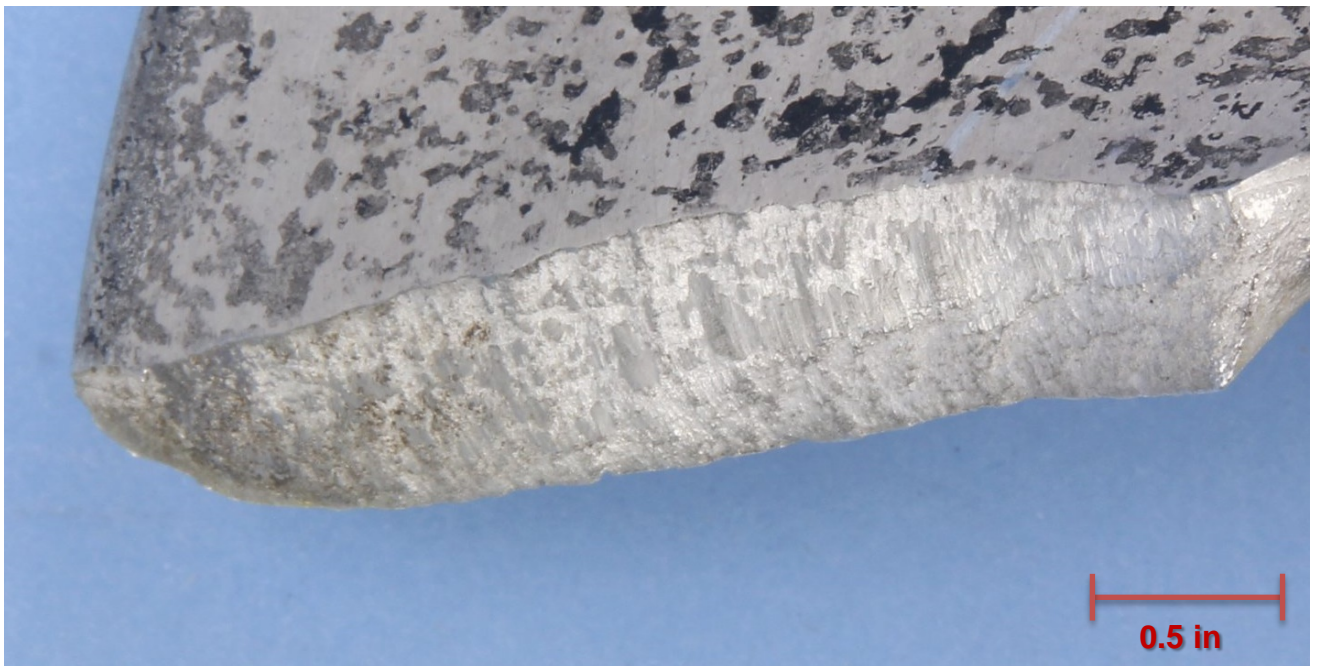
A closer view of the remnant fracture surface is illustrated in Figure 7 and Figure 8. The leading edge exhibited repeating concentric features that were oriented convex appearance toward the leading edge. This portion of the fracture surface exhibited areas of rough, dull textures, along with areas that were more reflective. The reflective areas were consistent with metallic smearing, due to post-fracture wear and impact damage. The trailing edge portion exhibited a jog approximately 1.75 inches from the edge (Figure 8). Aft of the jog, the blade remnant twisted upward in the figure, consistent with plastic deformation from torsional stresses. The aftmost portion of the fracture surface exhibited enough smearing to render it visually featureless.

Figure 7 – Closer view of the leading edge of the blade fracture surface remnant.

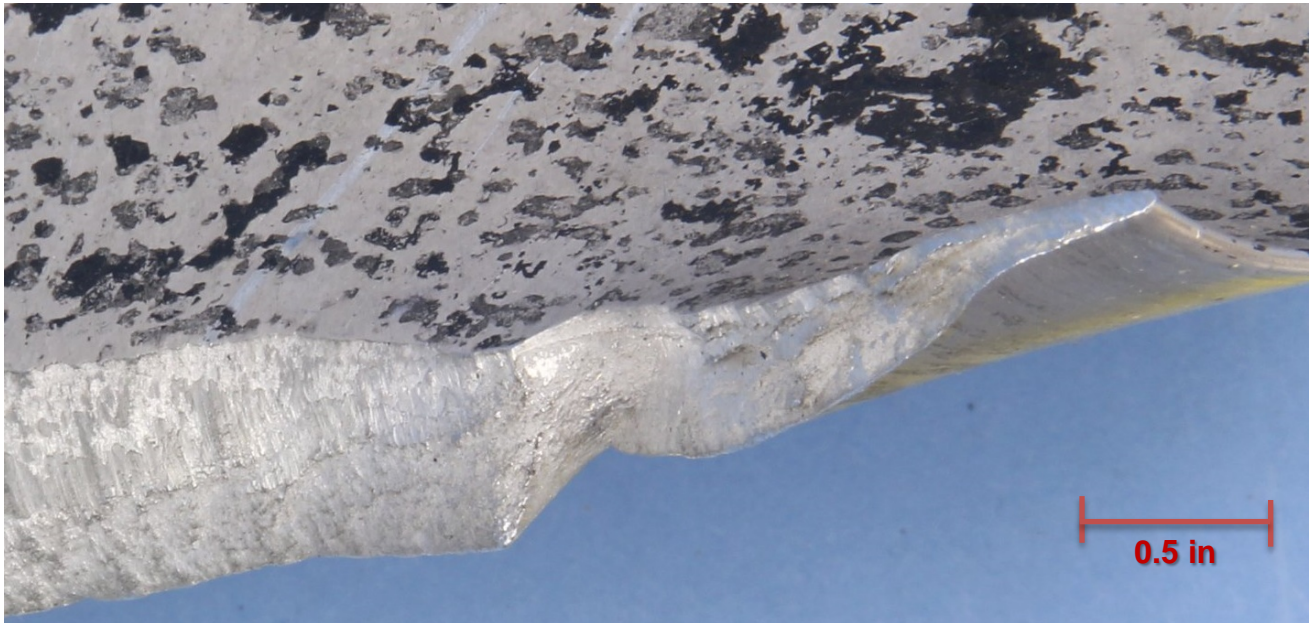
Figure 8 – Closer view of the trailing edge of the fracture surface of the propeller remnant.

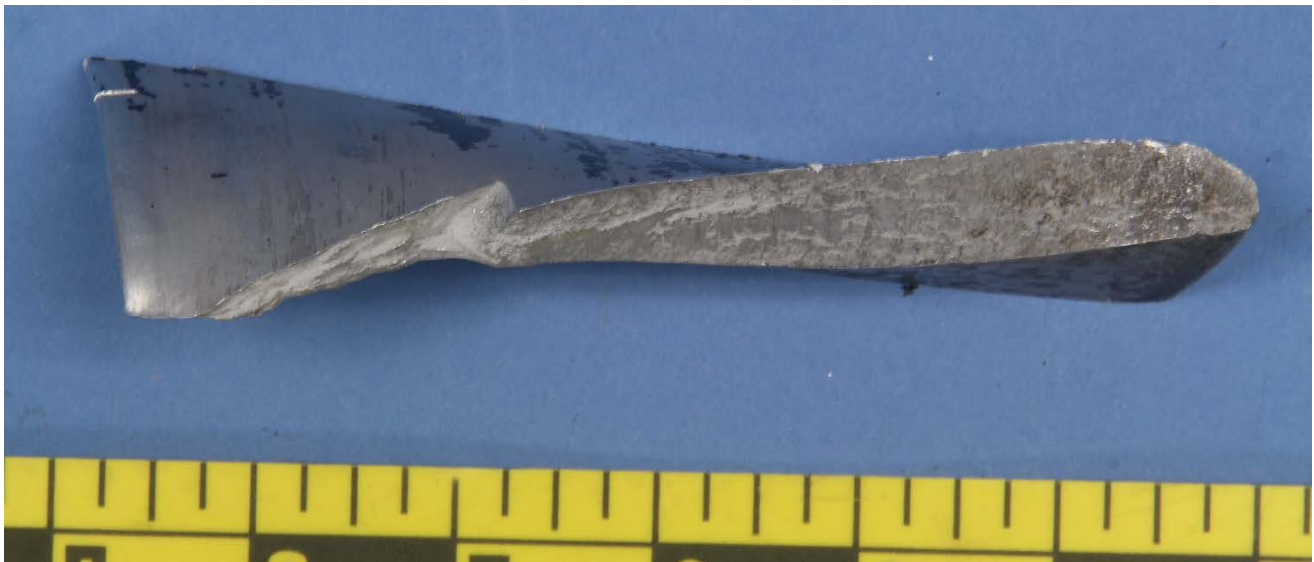
Due to the amount of post-fracture damage, the mating inboard face of the remnant fracture surface (on the main propeller assembly) was sectioned and then cleaned with acetone to facilitate additional examination (shown in Figure 9). The entire fracture surface was examined using a scanning electron microscope (SEM). Figure 10, Figure 11, and Figure 12 show typical areas of the blade fracture surface from the leading edge, midpoint, and trailing edge, respectively. As shown in all the micrographs, the fracture surface exhibited dimpled rupture, consistent with fracture from overstress. There were no indications of pre-existing fracture modes, such as striations or intergranular fracture. Multiple areas along the fracture surface did exhibit streaks and gouges, oriented in an erratic pattern. These features were consistent with damage such as smearing from post-fracture impact and rubbing.

Figure 9 – The mating inner fracture surface of the fractured propeller blade, viewed after sectioning and cleaning.

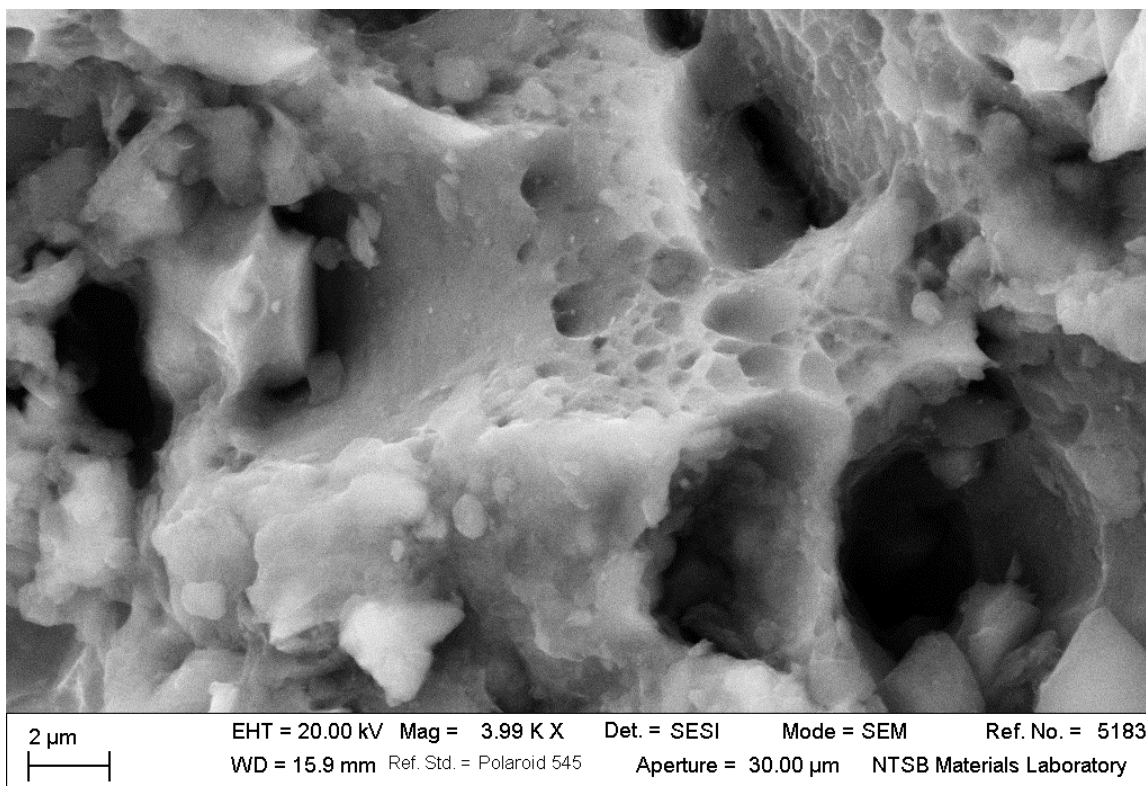
Figure 10 – Secondary electron (SE) micrograph of an area of the fracture surface near the leading edge, showing dimpled rupture.

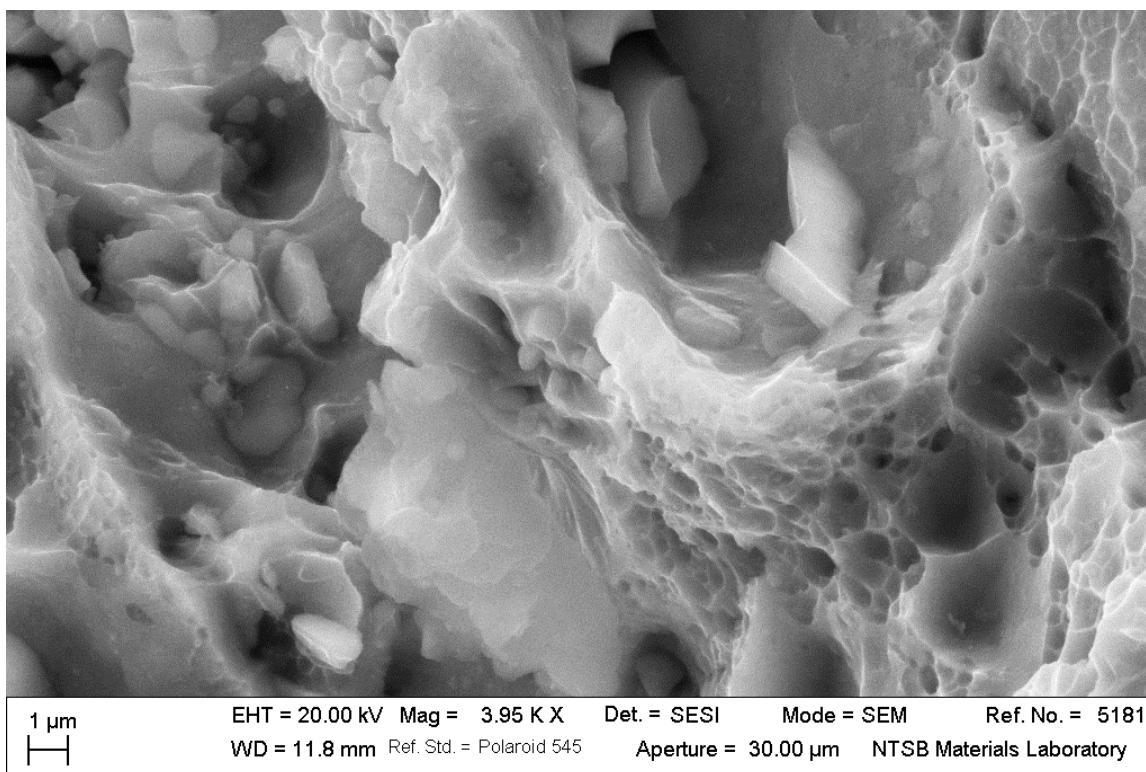
Figure 11 – SE micrograph of an area in the middle of the fracture surface, showing dimpled rupture.

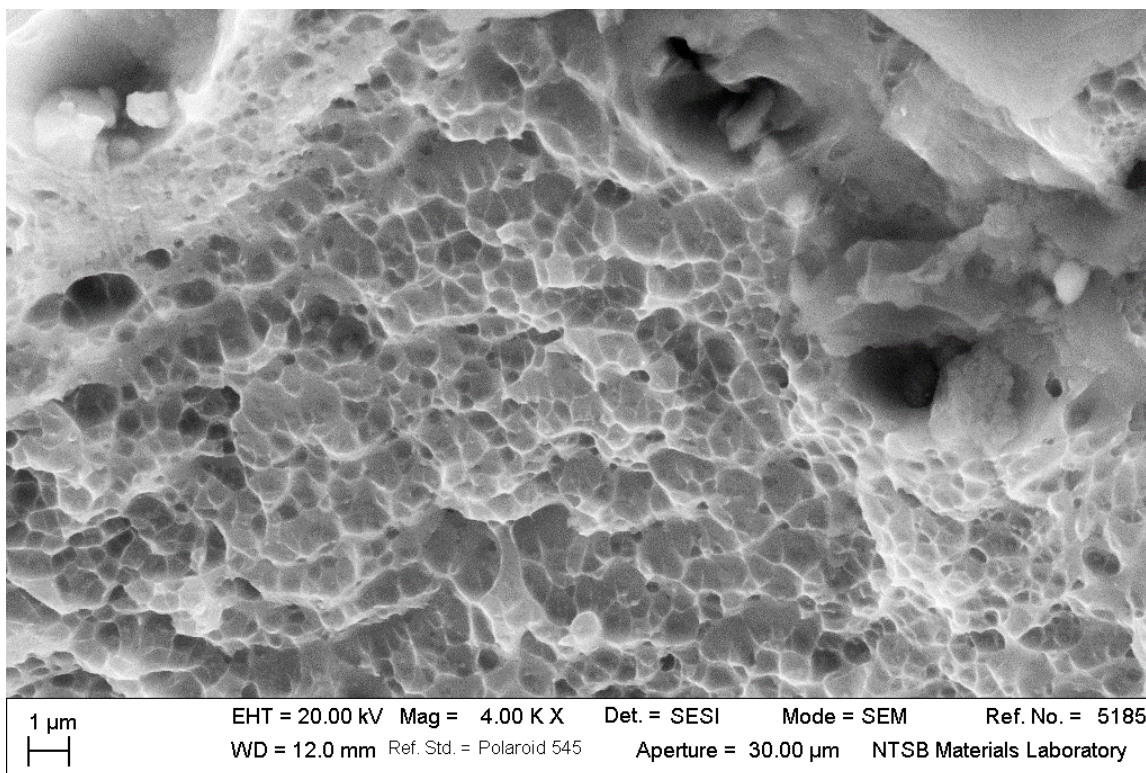
Figure 12 – SE micrograph of dimpled rupture on the fracture surface near the trailing edge.

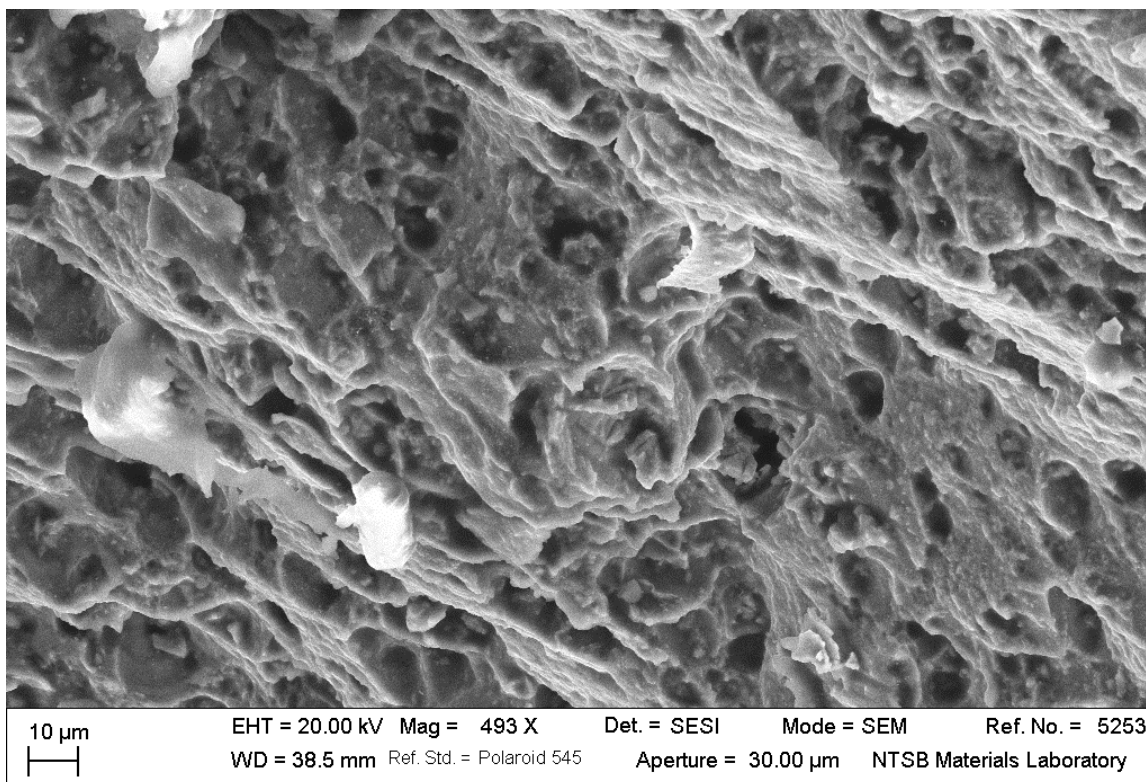
The tip of the intact but bent propeller blade (Figure 4) and the tip of the fractured blade remnant (left in Figure 5) were sectioned and examined using a SEM. Figure 13 and Figure 14 shows typical areas of the opposite propeller blade tip from the trailing and leading edges, respectively. These areas exhibited dimpled rupture, consistent with overstress fracture. Figure 15 and Figure 16 show typical areas of the tip of the fractured remnant, from the leading and trailing edges, respectively. Likewise, these areas exhibited dimpled rupture, consistent with overstress fracture. However, most of fractured surfaces of both tips exhibited smearing and gouging, consistent with post-fracture damage. Figure 17 shows a typical example of this smearing damage, which was inconsistent with any pre-existing failure mode.

Figure 13 – SE micrograph of dimpled rupture near the trailing edge of the unbroken opposite blade tip.

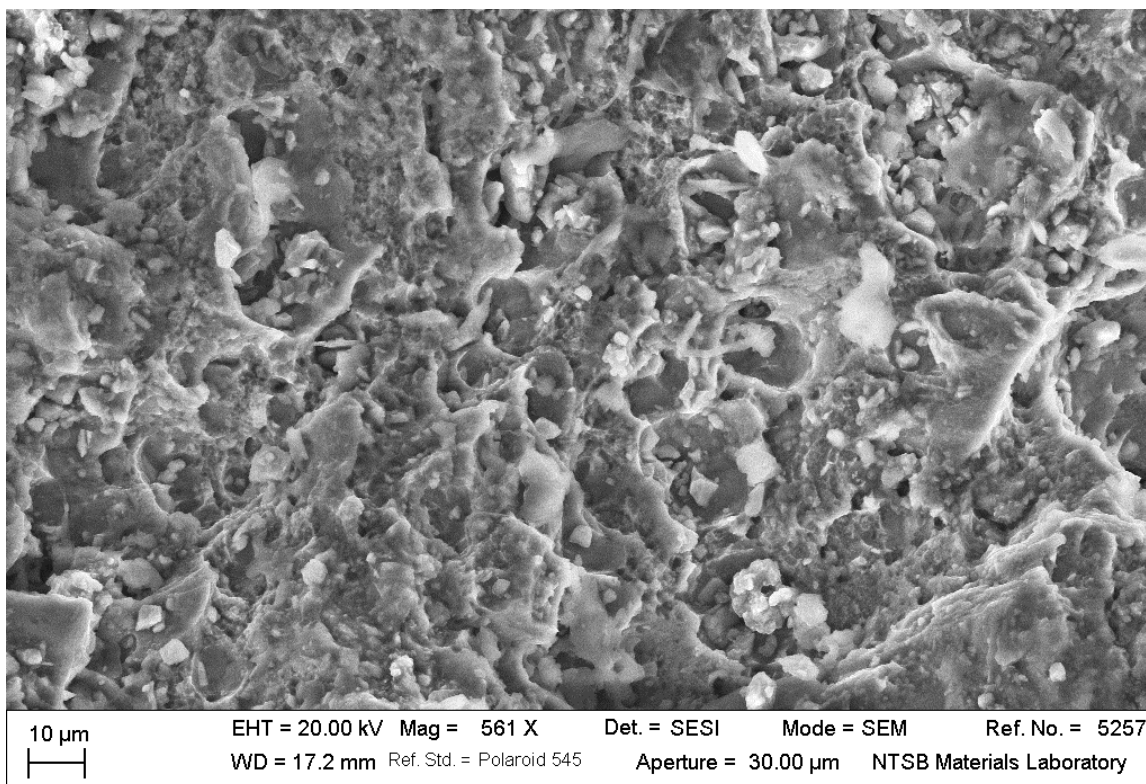
Figure 14 – SE micrograph of dimpled rupture near the leading edge of the unbroken opposite blade tip.

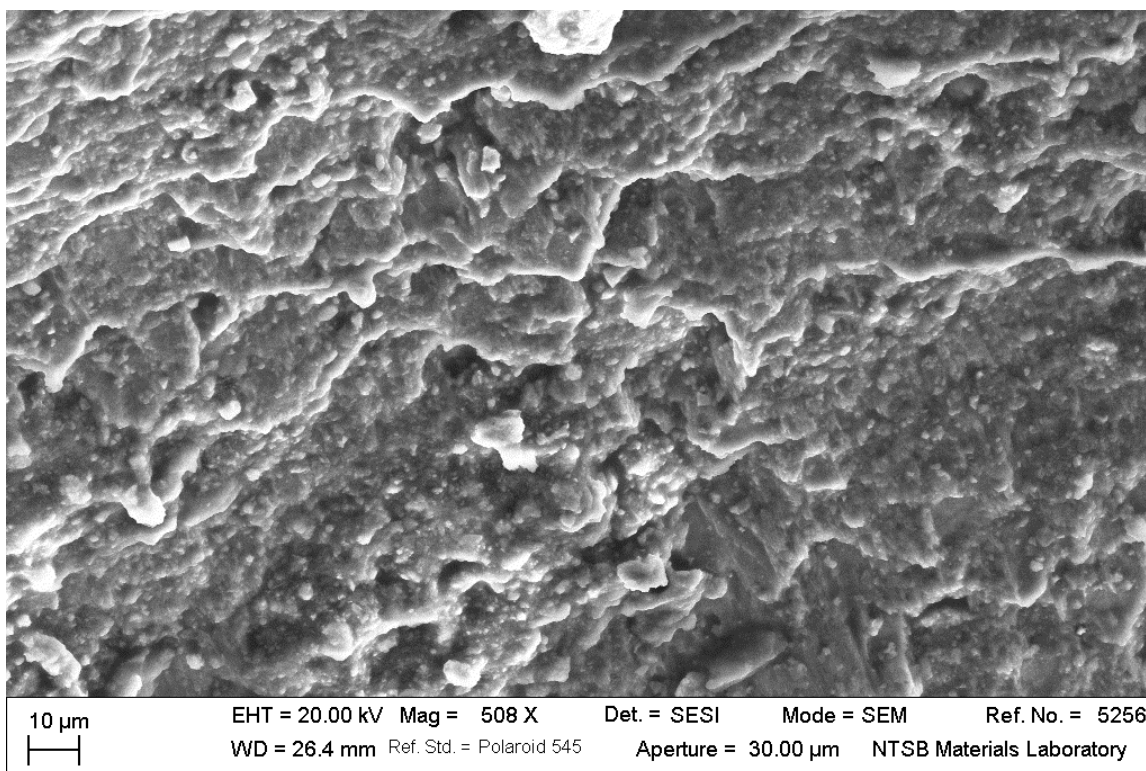
Figure 15 – SE micrograph of dimpled rupture on the leading edge of the remnant piece tip.

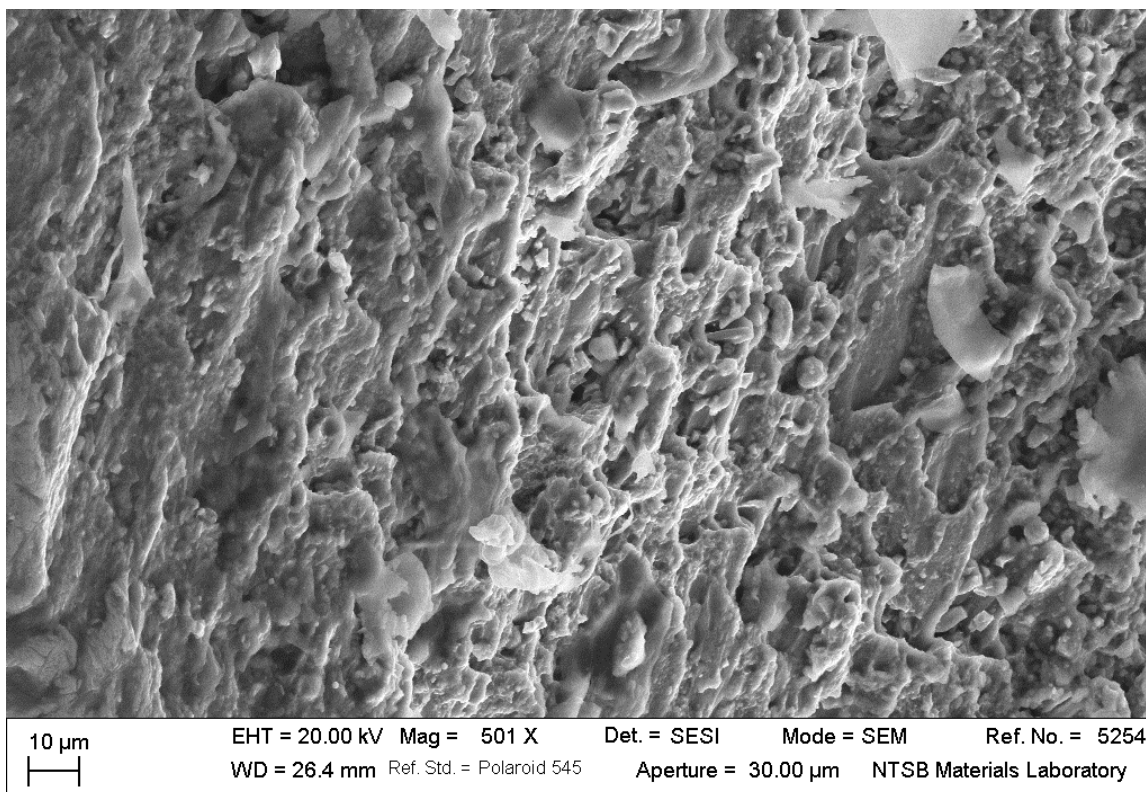
Figure 16 – SE micrograph of dimpled rupture on the trailing edge of the remnant piece tip.

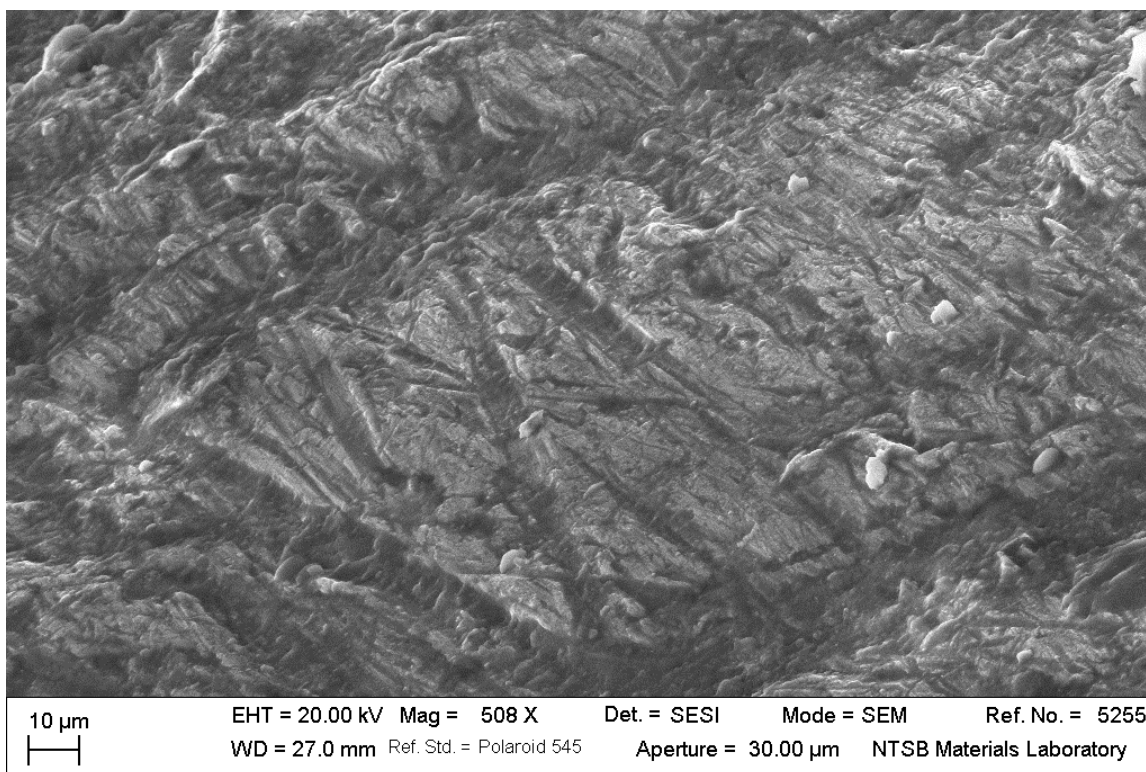
Figure 17 – SE micrograph of a typical area of smearing damage on the remnant tip.

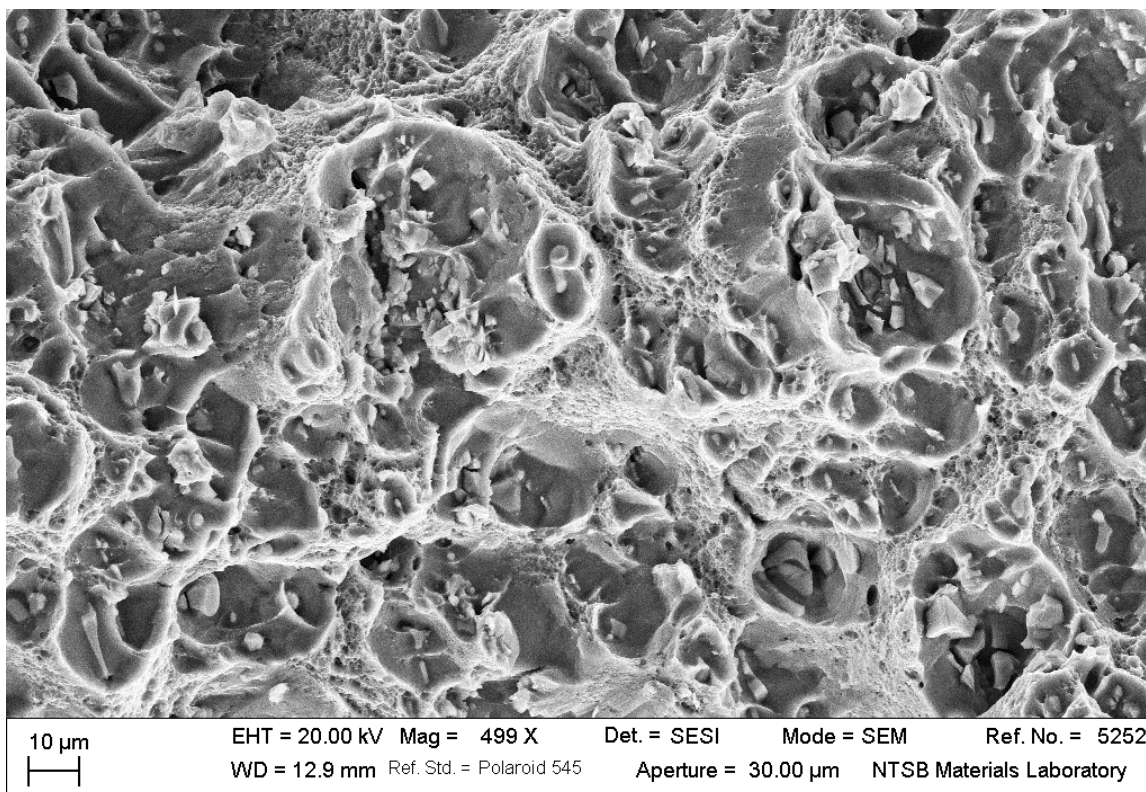
A small portion of the propeller blade material was backcut and intentionally overstressed (laboratory broken) to simulate an overstress fracture. Figure 18 and Figure 19 show typical examples of this laboratory-fractured material. The fractures exhibited dimpled rupture. These fracture features were comparable with those observed on all the examined propeller fracture surfaces.

Figure 18 – SE micrograph of dimpled rupture on an area of the propeller material intentionally overstressed (lab opened).

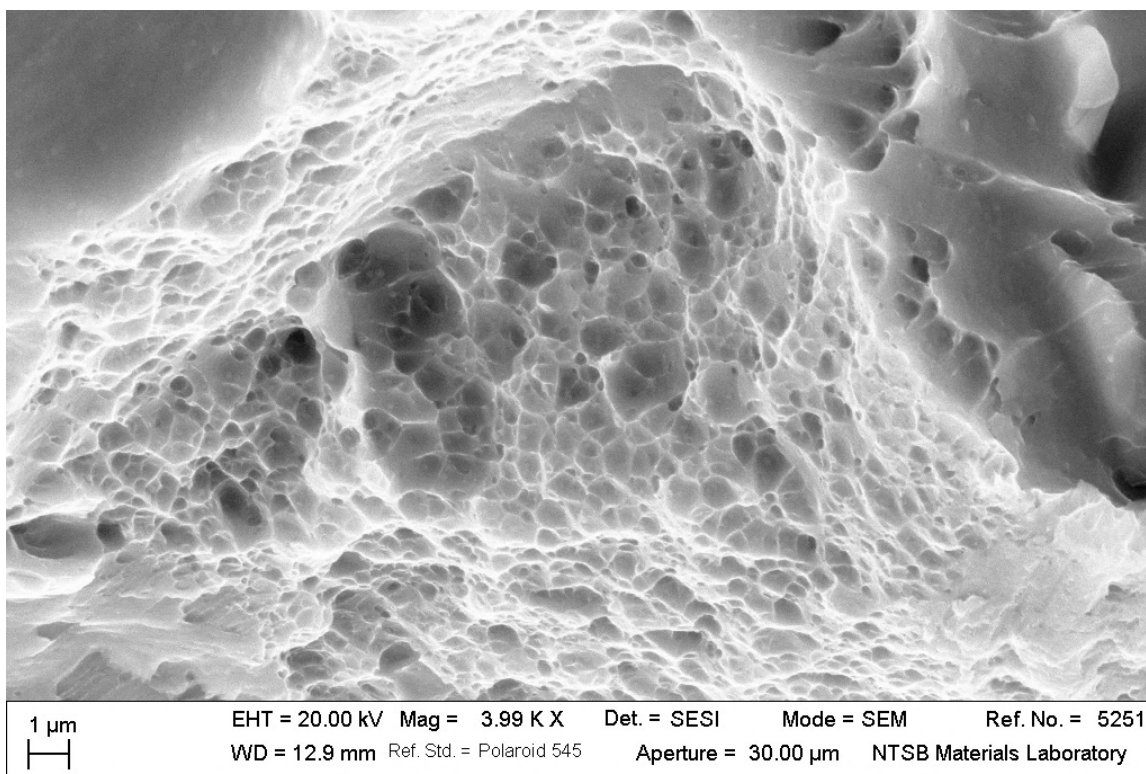
Figure 19 – SE micrograph of a closer view of the dimpled rupture in Figure 18.
