# NATIONAL TRANSPORTATION SAFETY BOARD

MATERIALS LABORATORY ADDENDUM REPORT

Report No. 20-038B

Place : Big Timber, Montana  
Date : January 16, 2020  
Vehicle : Cessna 172Q, N96145  
NTSB No. : WPR20LA068  
Investigator : Stephen Stein, AS-WPR

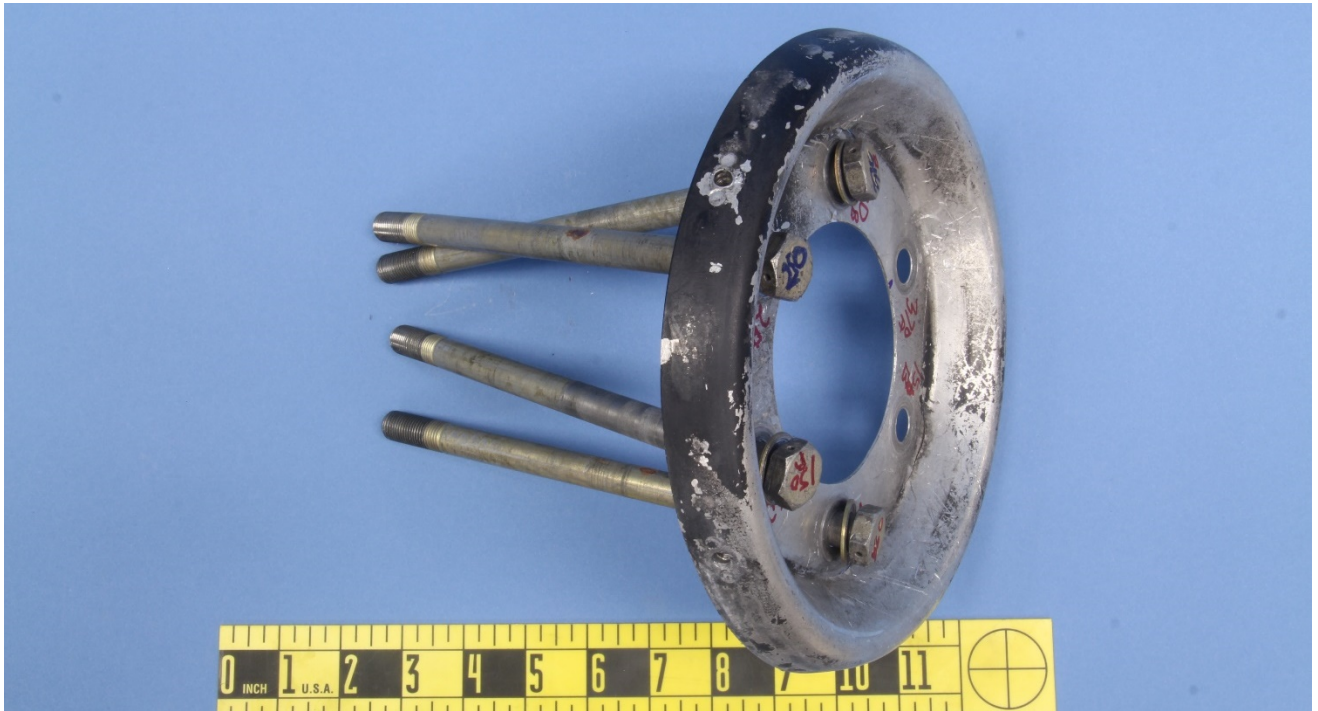
Figure 1 and Figure 2 show the spinner and four attachment bolts as received. Two of the attachment bolts were not included in the shipment. The bolt heads and the spaces next to the bolt holes on the spinner had been marked prior to receipt.

Figure 1 – The spinner and the attachment bolts, as received and viewed from the side.

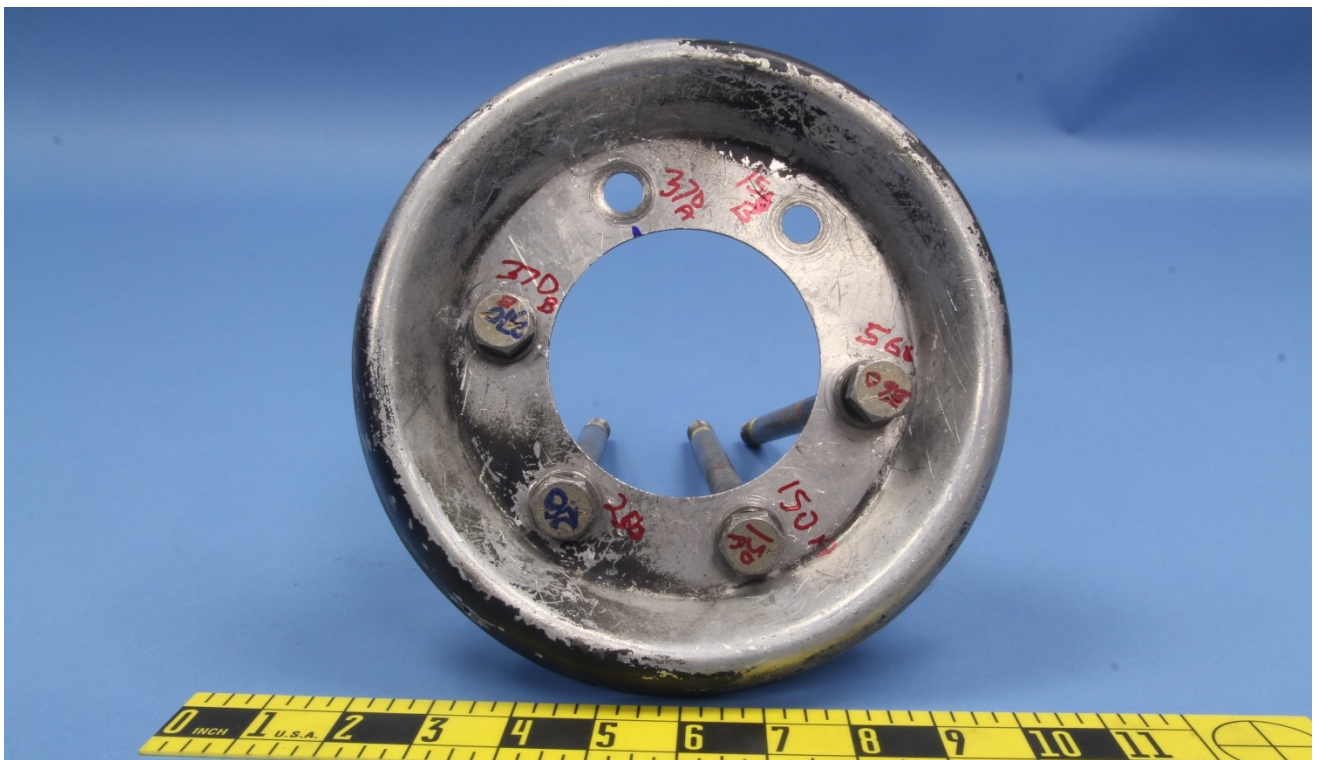
Figure 2 – View of the spinner face with the attachment bolts and labeling, as received.

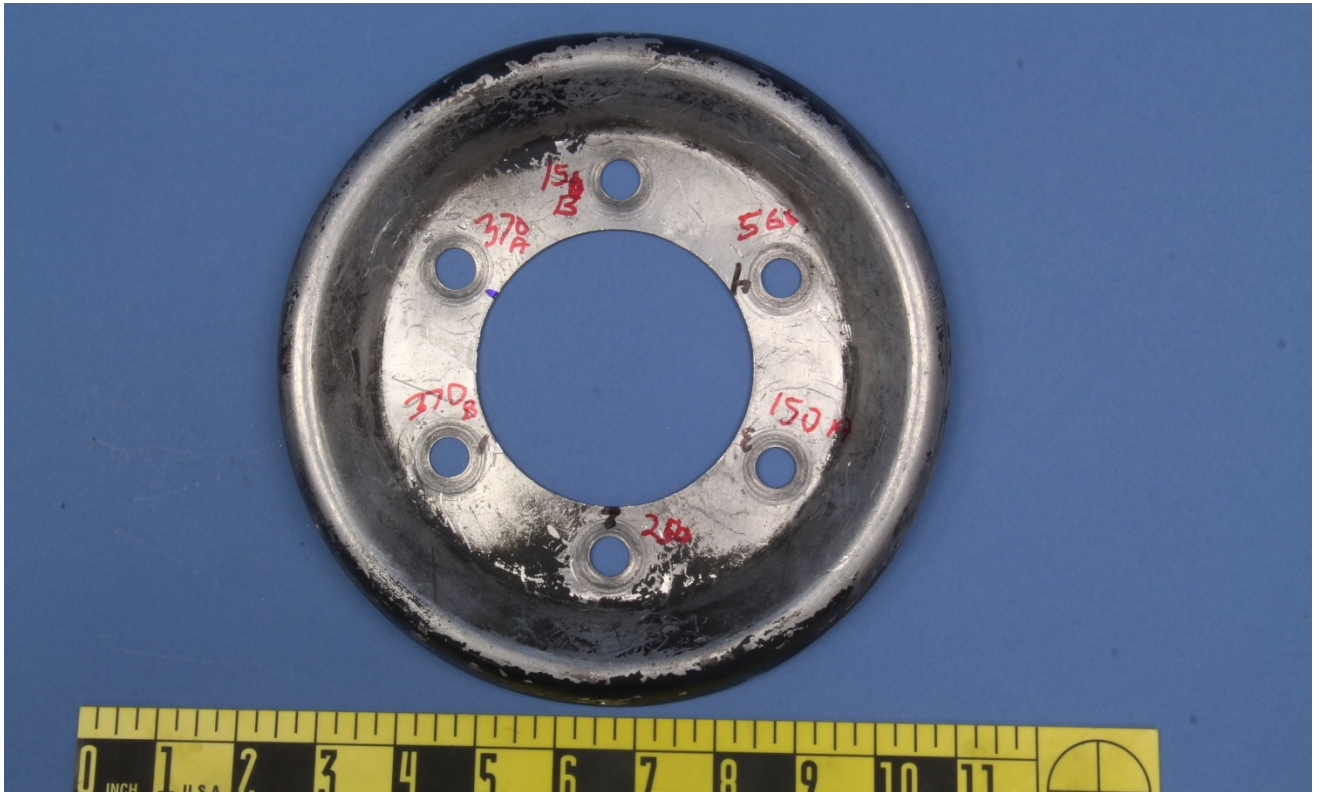
Figures 3 and 4 show the spinner after removal of the washers and the attachment bolts, viewed from the forward and aft faces, respectively. The spinner was intact, and exhibited mostly a reflective metallic color, consistent with the absence of the black or dark gray paint over most of the forward face. As shown in Figure 3, circular wear marks, approximately 0.25 inches in thickness, were present around all of the bolt holes. These marks corresponded to and were consistent with the size of the washers removed.

Figure 3 – View of the forward face of the spinner, after removing the bolts.

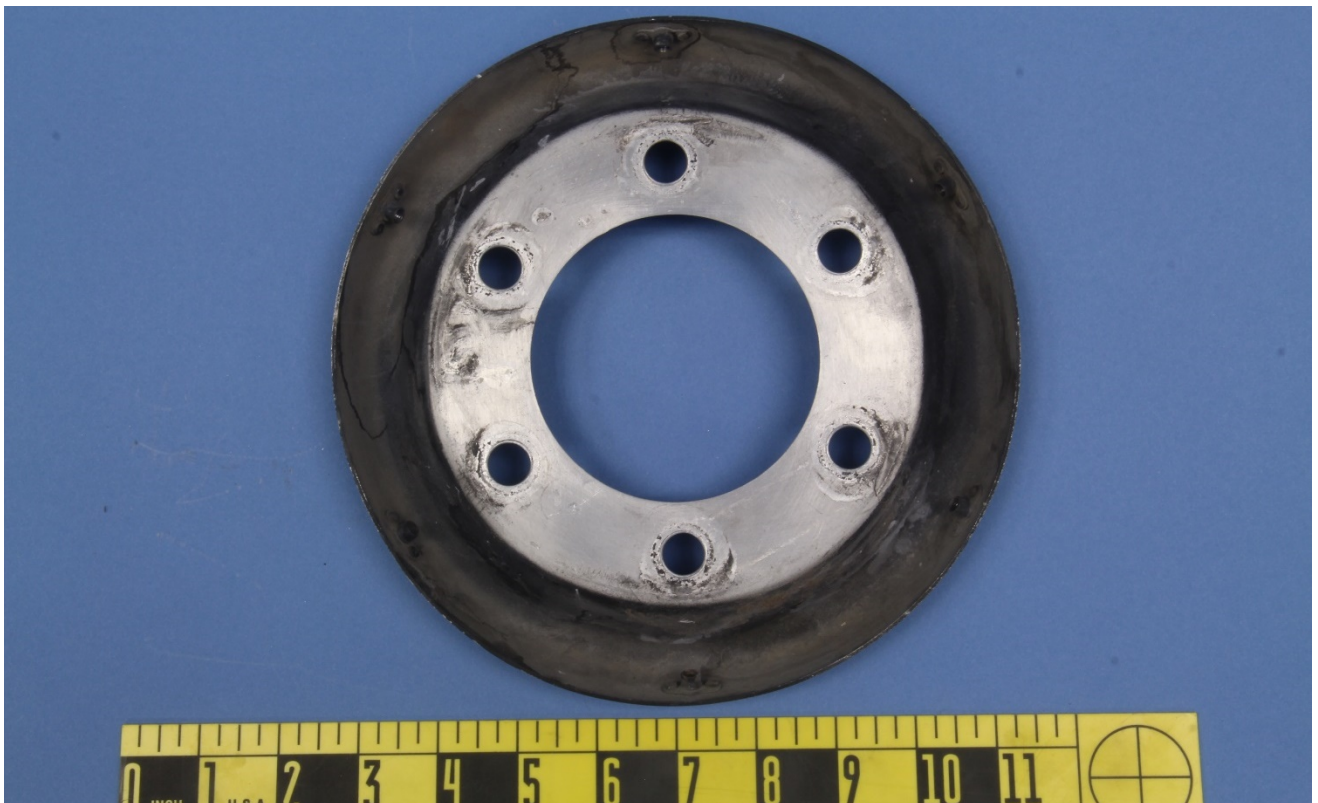
Figure 4 – View of the aft or opposite face of the spinner shown in Figure 3.

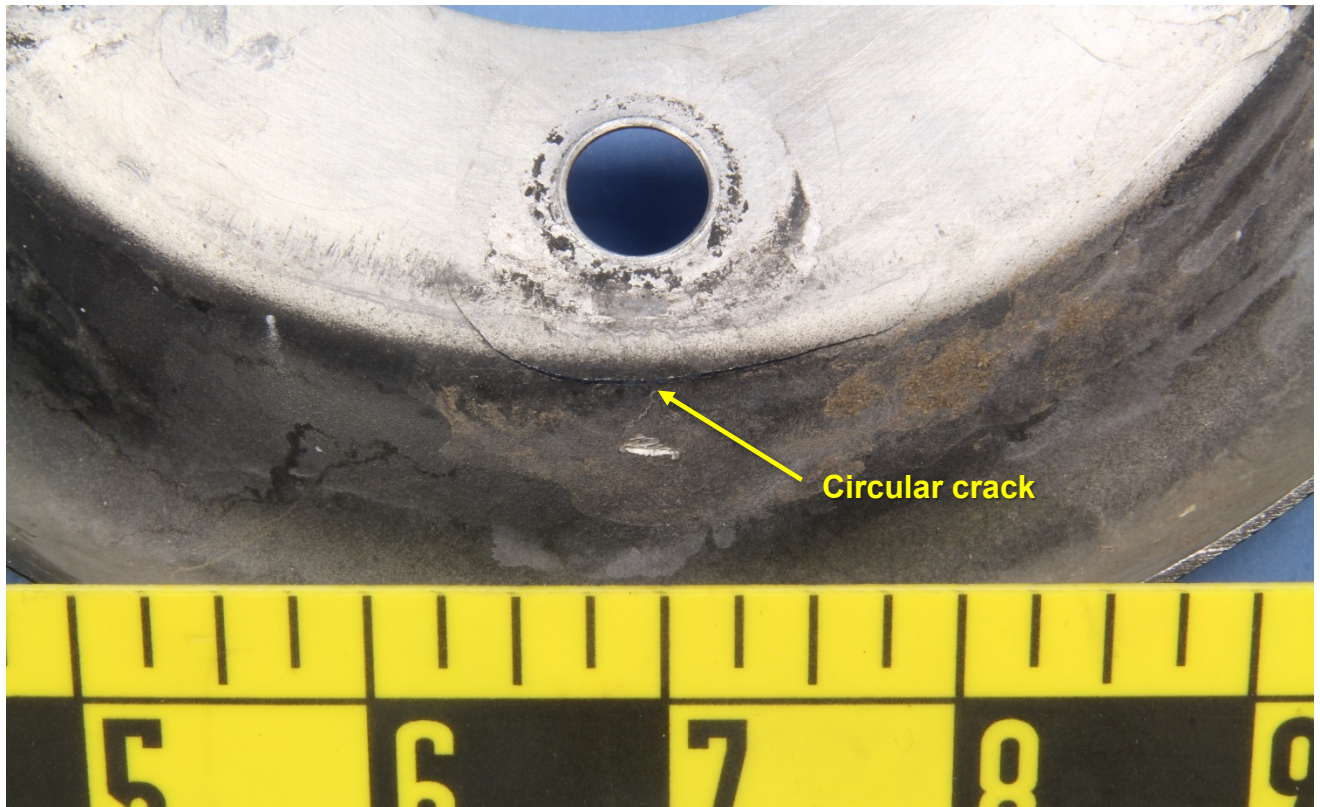
The bolt holes were labeled 1 through 6 for the purposes of this report. Figures 5 through 10 show the shoulders of the bent spinner flange near the holes, viewed from the aft face. Each of these areas exhibited a circular crack, located within the area of the circular marks. The cracks measured between 0.61 and 1.73 inches in chord length, as detailed in Table I.

The crack from hole 2 was backcut and intentionally overstressed (laboratory opened) to examine the crack faces or fracture surfaces. This crack is referred to as Crack

Figure 5 – View of the crack around the bolt hole #2.

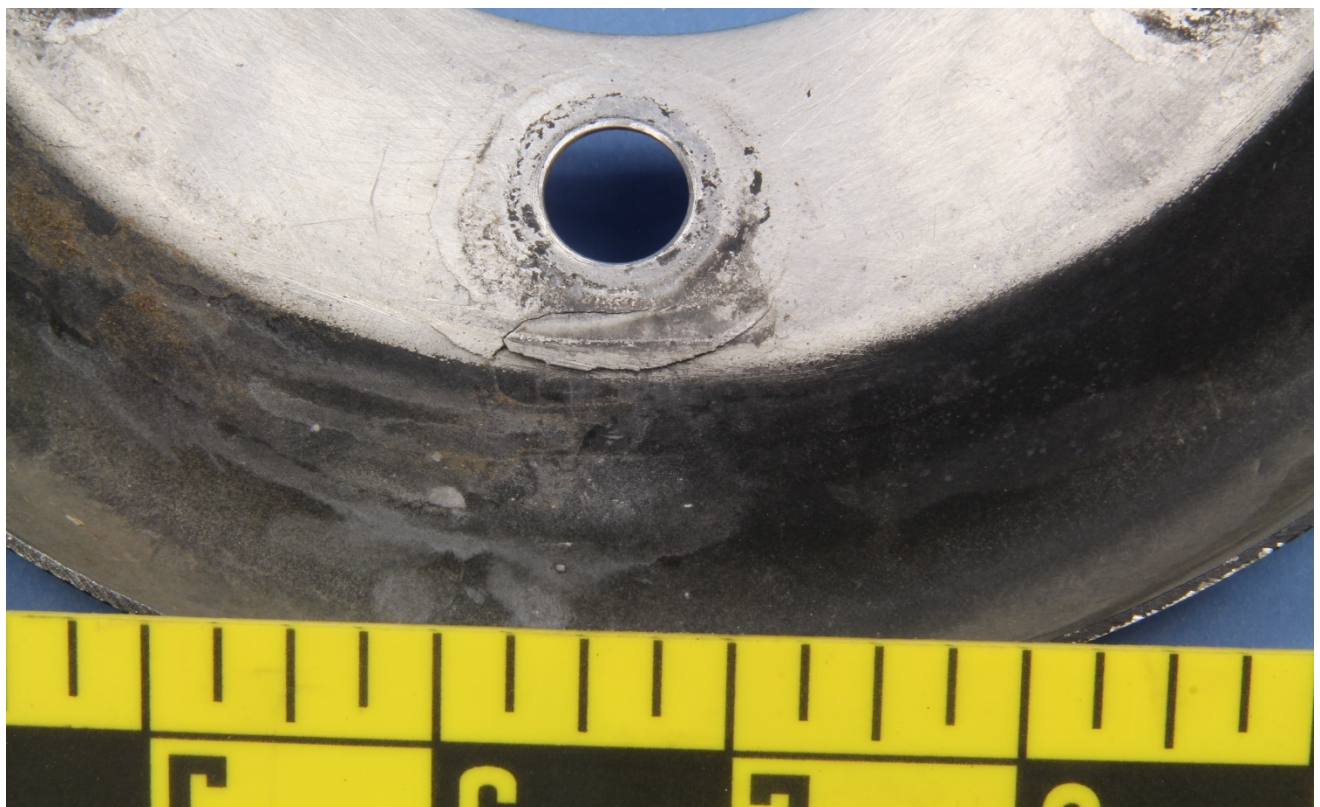
Figure 6 – View of the crack around the bolt hole #1.

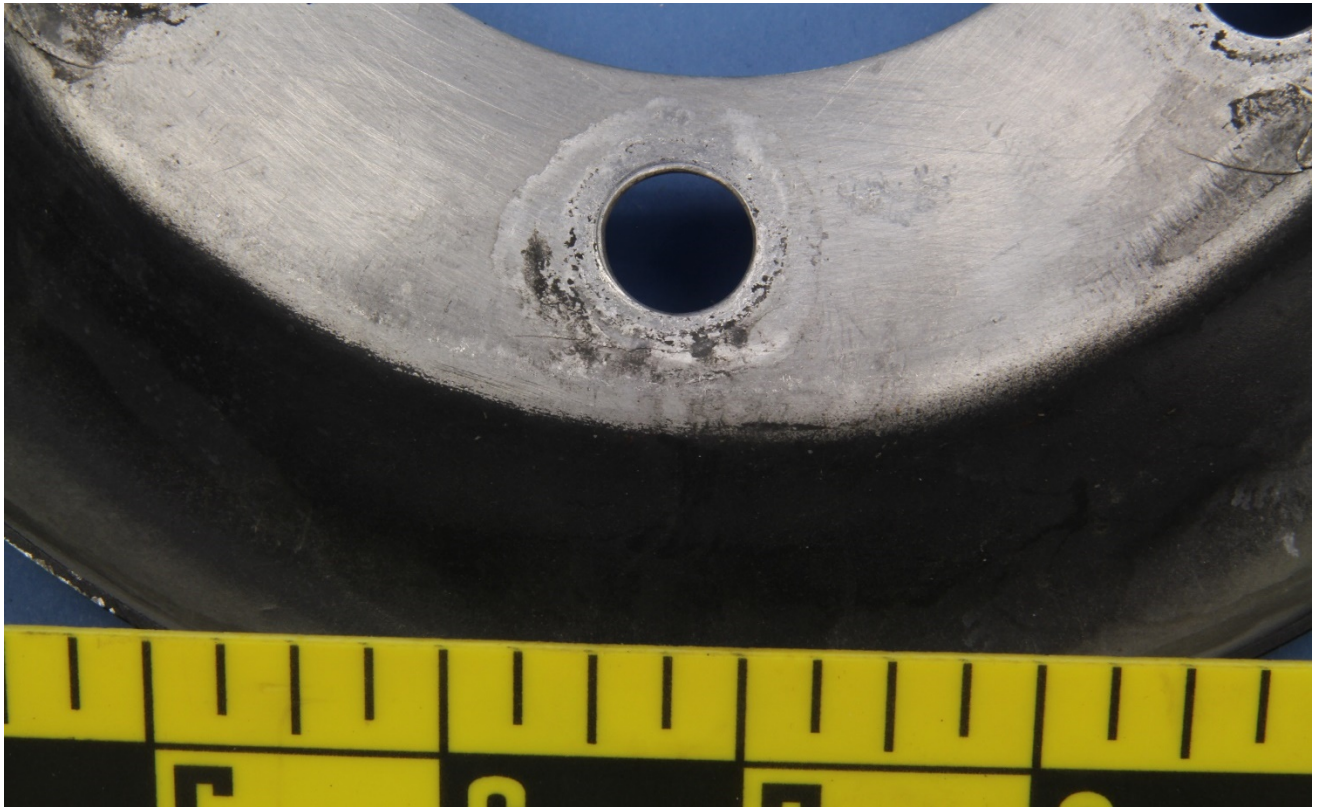
Figure 7 – View of the crack around the bolt hole #6.

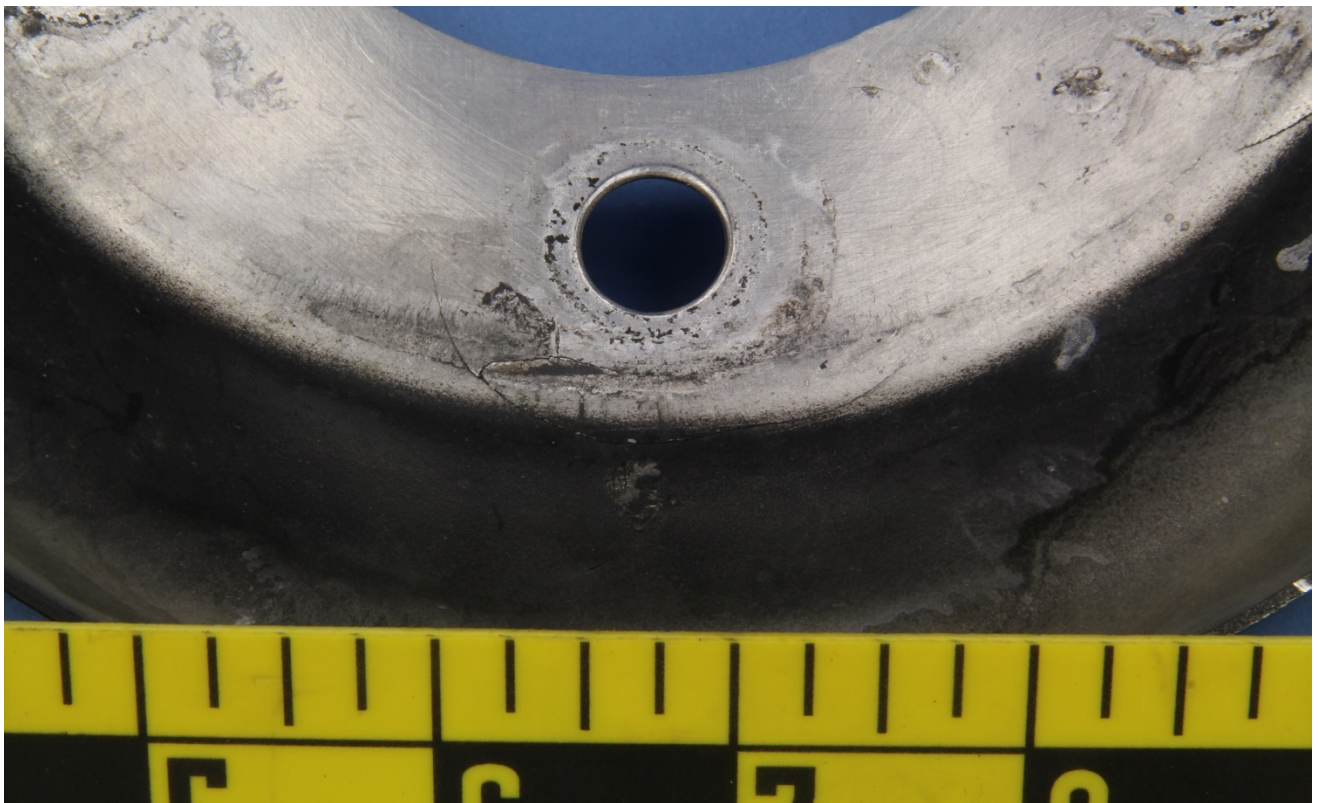
Figure 8 – View of the crack around the bolt hole #5.

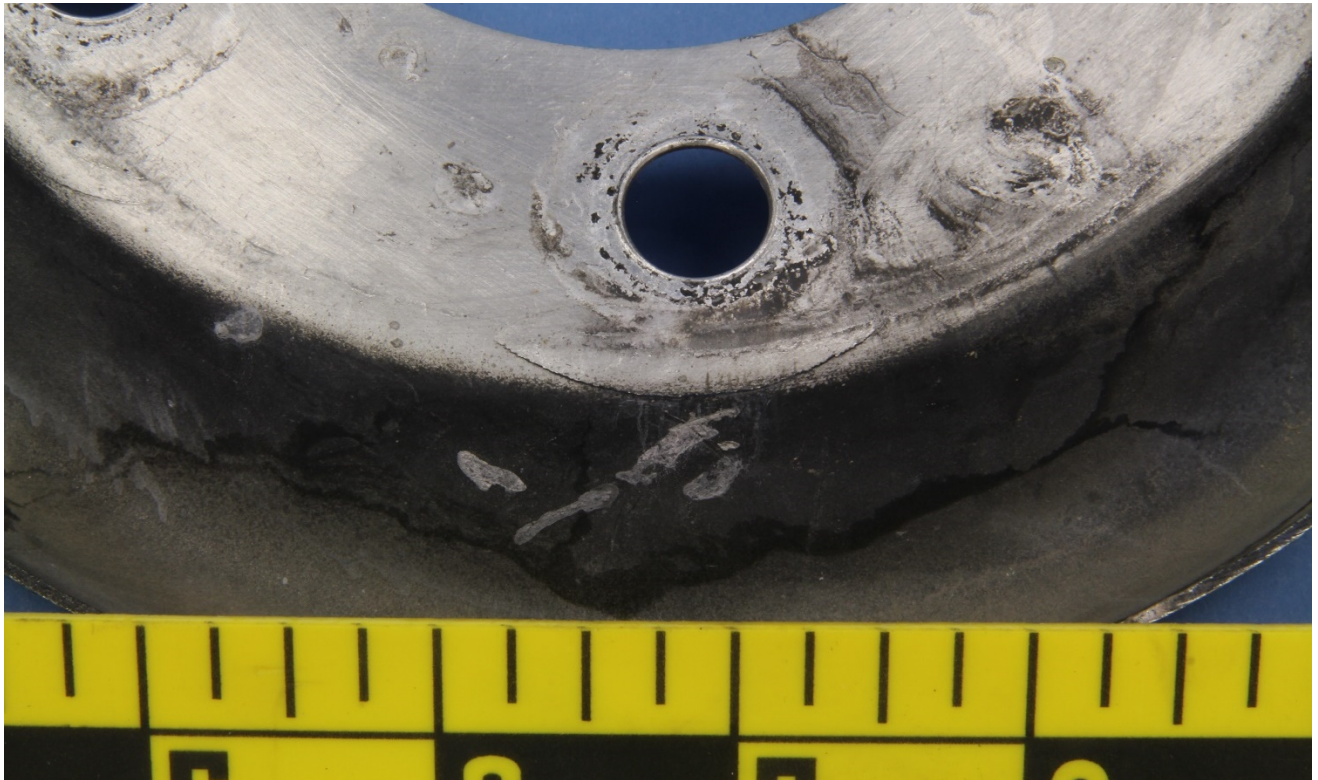
Figure 9 – View of the crack around the bolt hole #4.

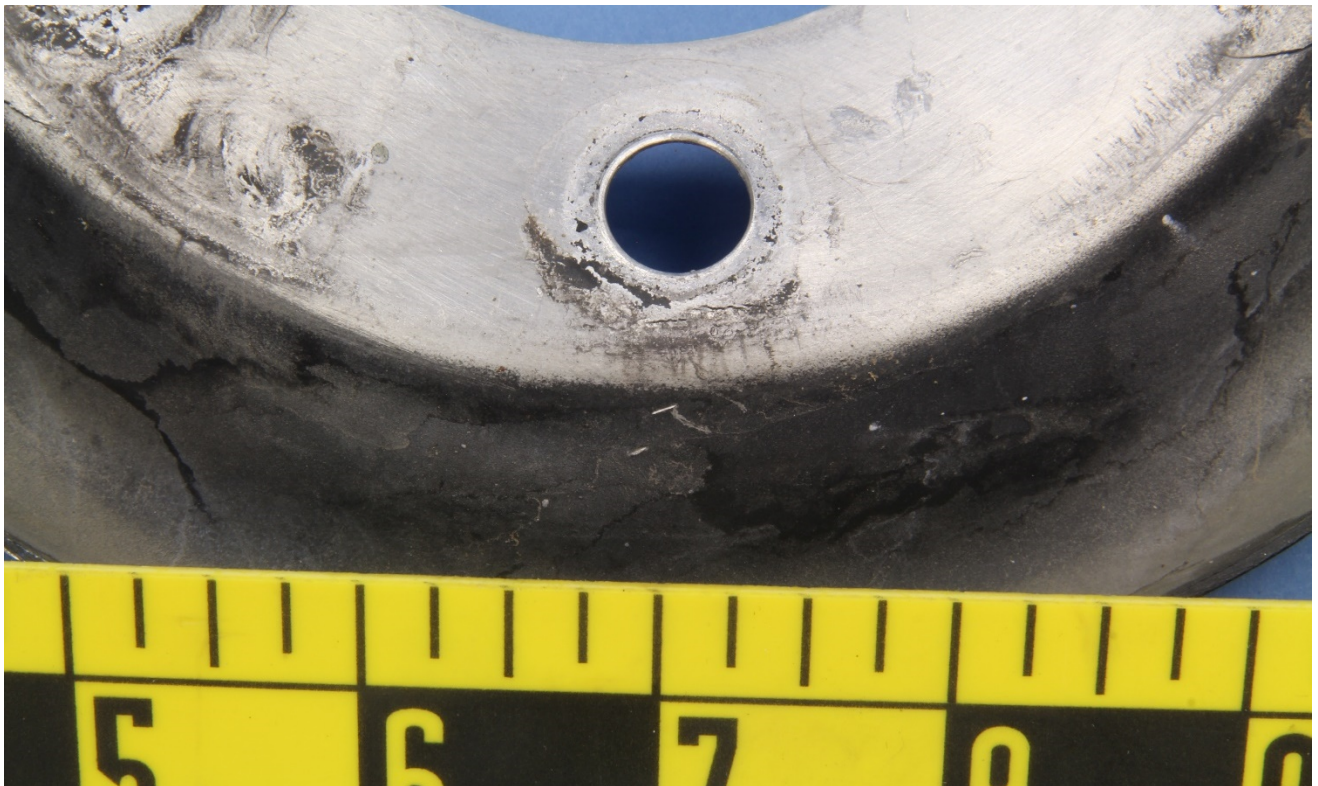
Figure 10 – View of the crack around the bolt hole #3.

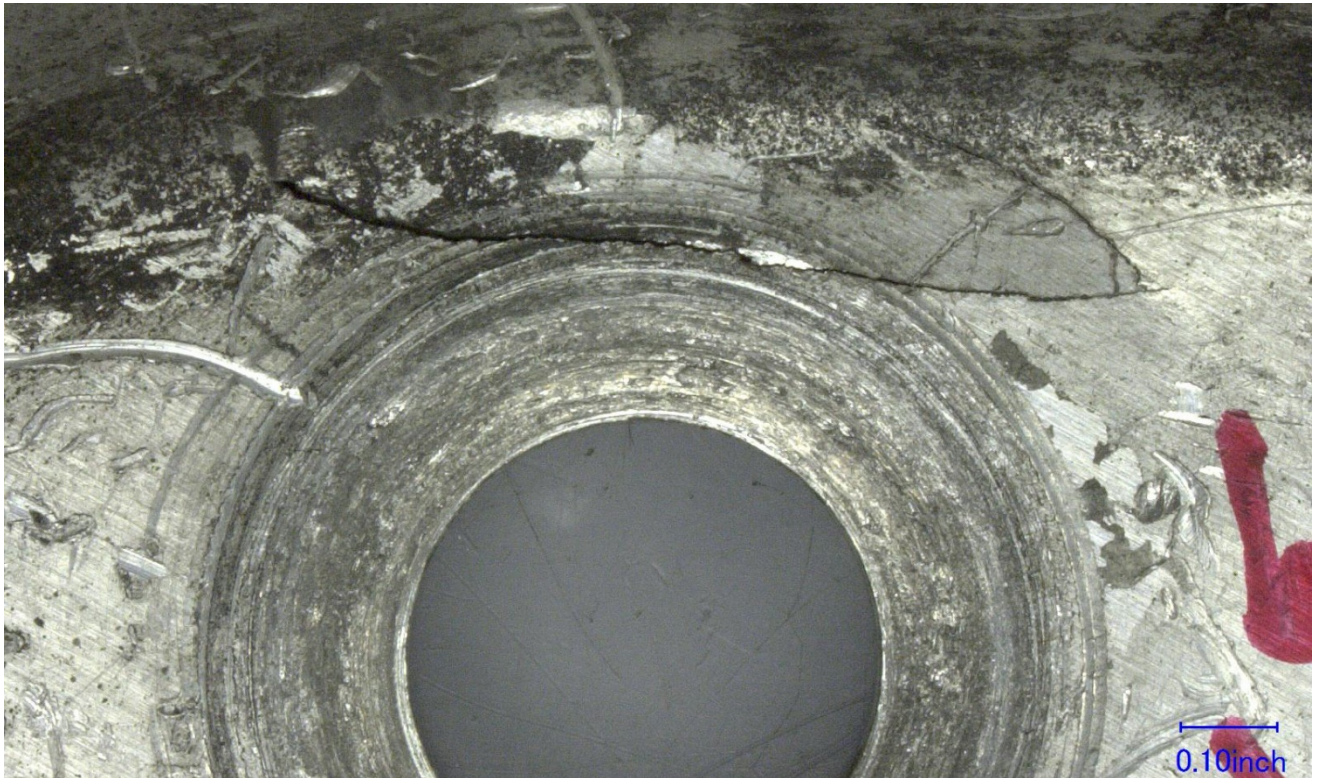
#2 in this report. The other cracks were left intact and are highlighted from the front face of the spinner in Figures 11 through 15. All the cracks illustrated in these figures were located in or along the circular wear marks surrounding the bolt holes on the spinner. This wear exhibited multiple circular marks and small micropits consistent with fretting. This fretting was consistent with contact under vibrational loads between the forward spinner face and the washers under the bolt heads.

Figure 11 – Closer view of crack #1 on the forward side of the spinner.

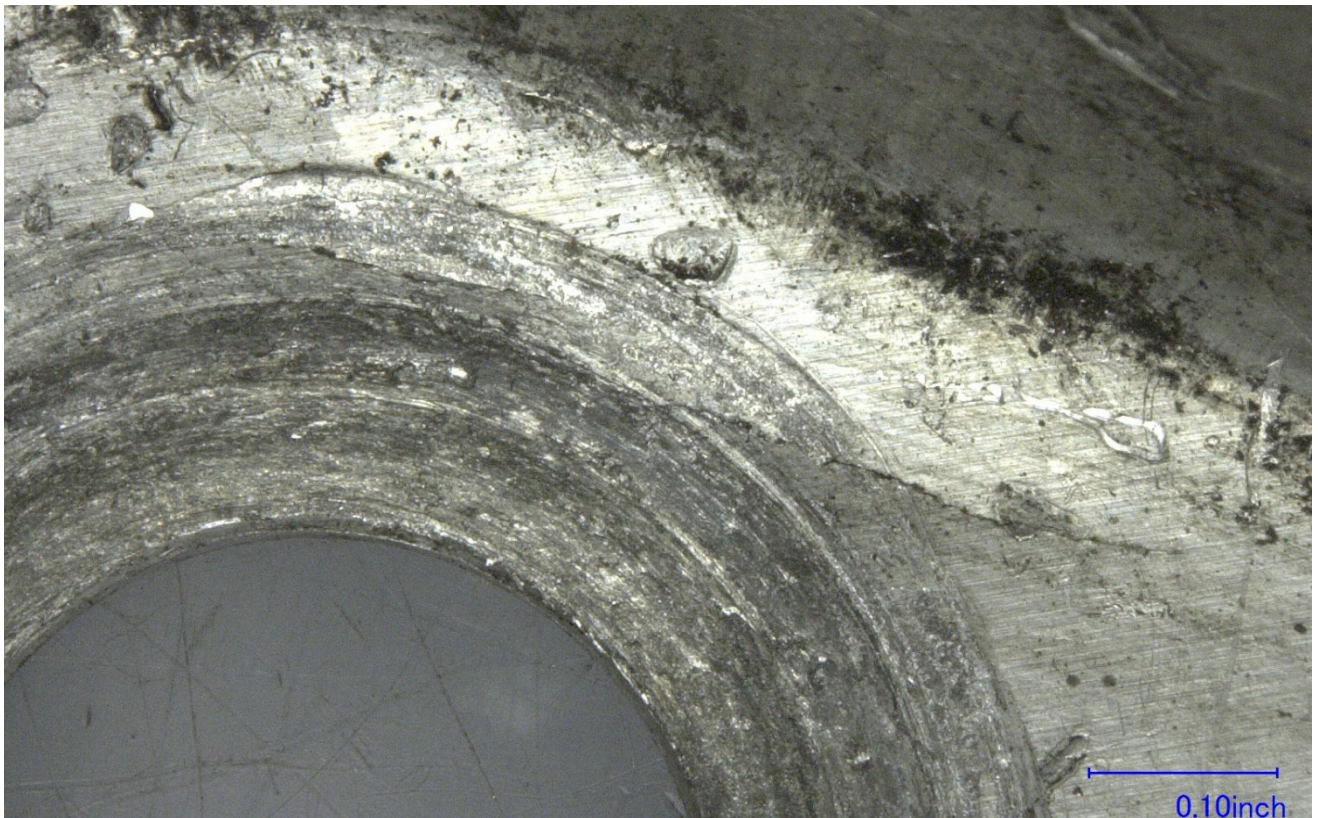
Figure 12 – Closer view of crack #3 around the bolt hole on the forward face.

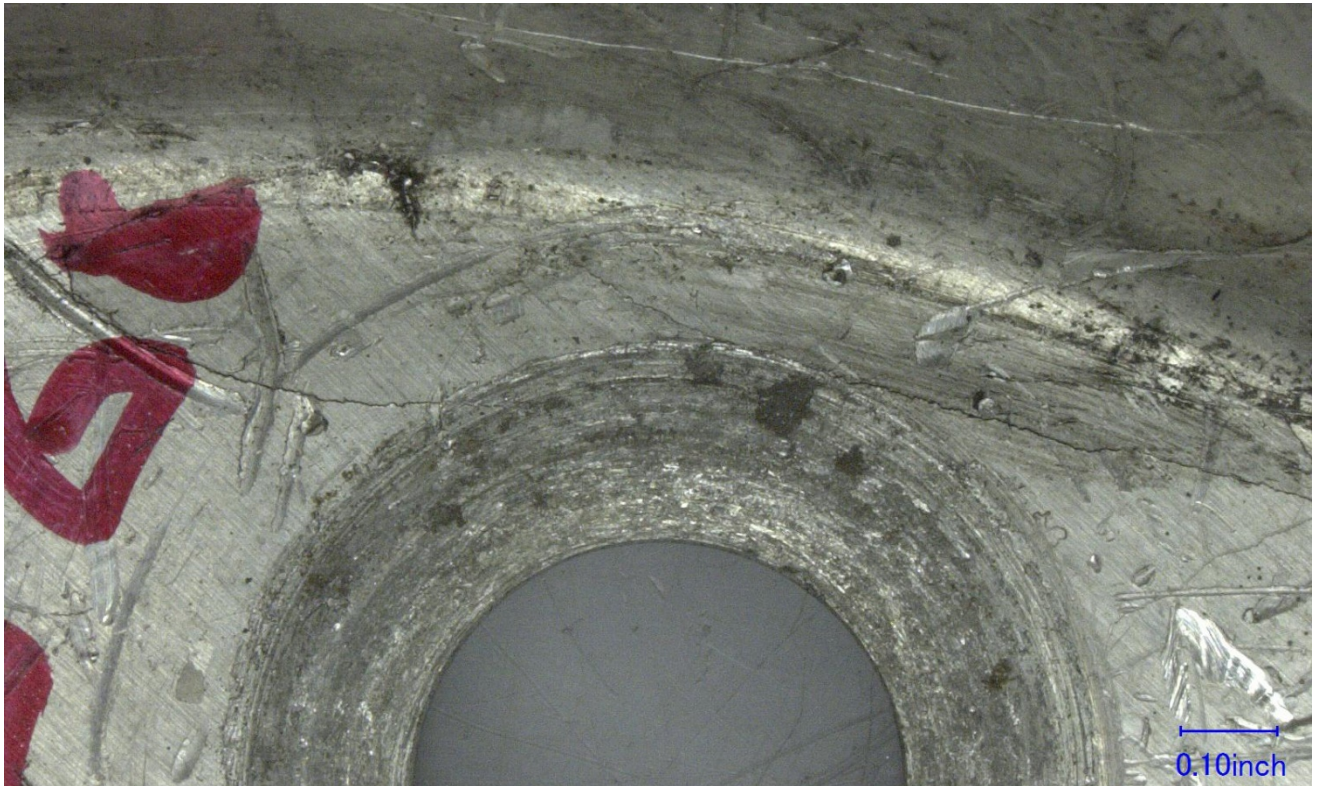
Figure 13 – Closer view of crack #4 from the forward face.

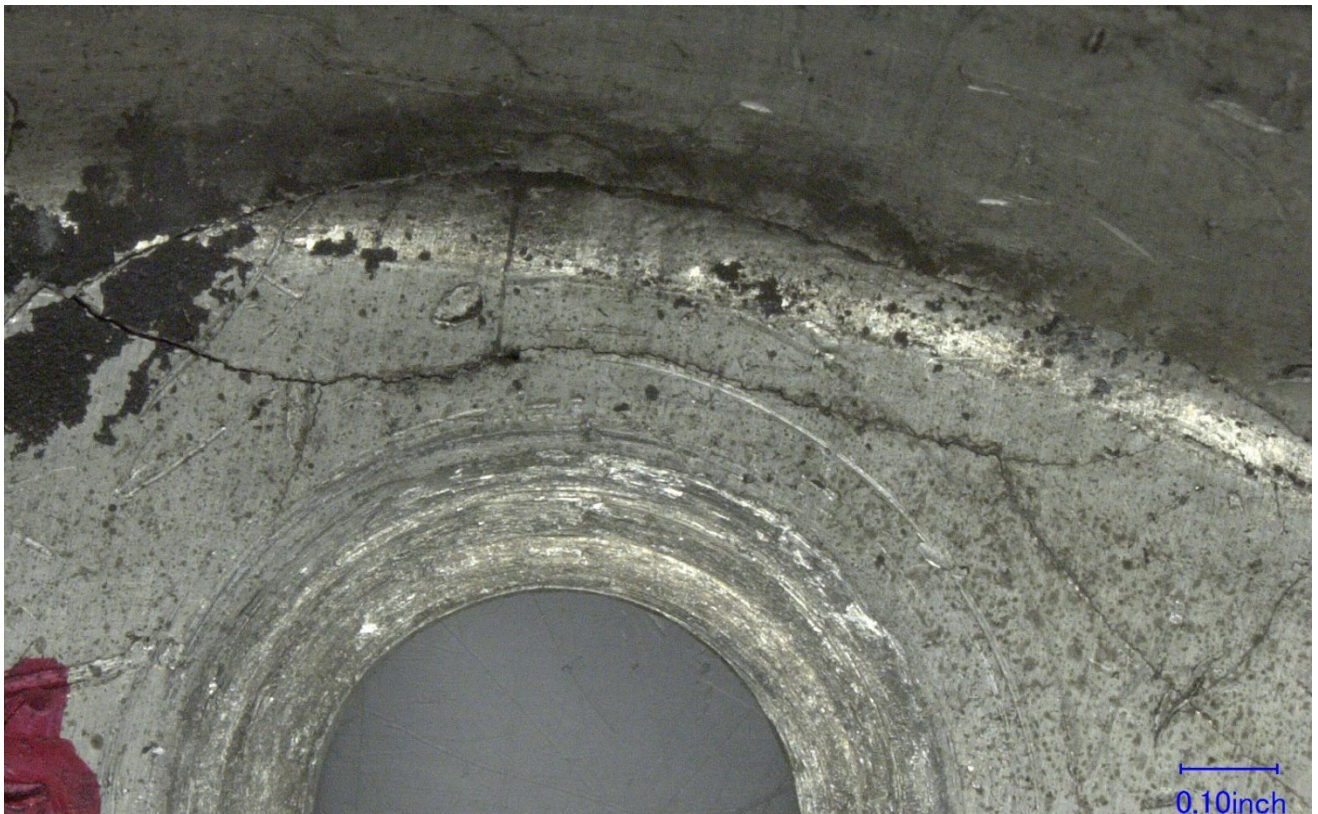
Figure 14 – Closer view of crack #5 from the forward side.

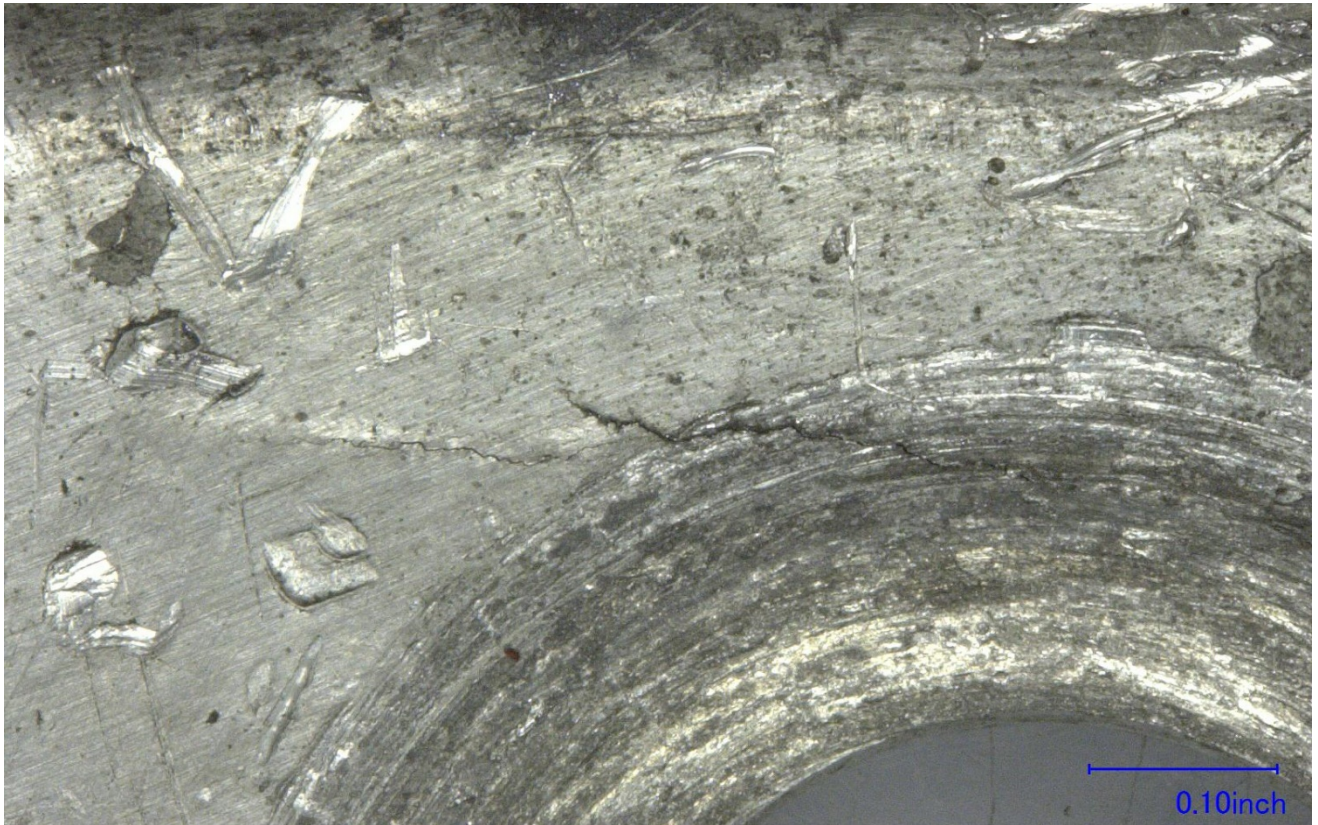
Figure 15 – Closer view of crack #6 from the forward side.

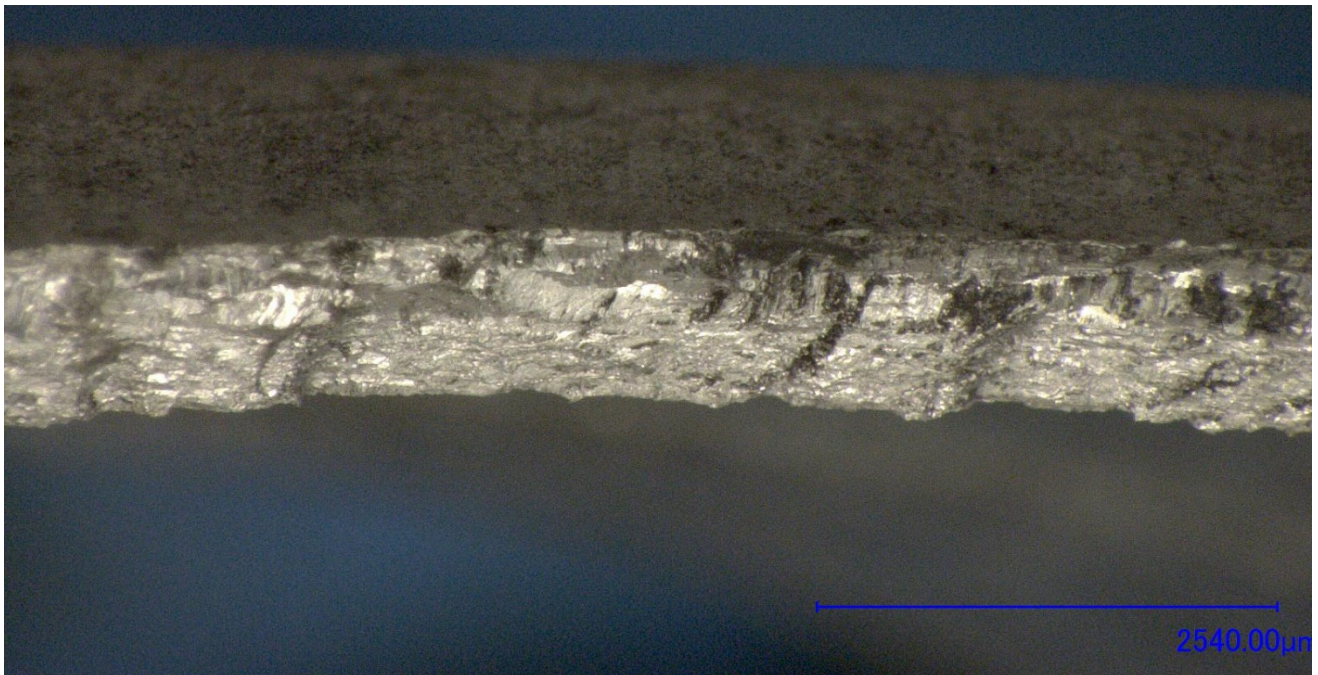
Figure 16 shows an area of the opened Crack 2 face (outboard side). The crack surface exhibited protrusions and depressions consistent with ratchet marks. The crack face was examined using a scanning electron microscope (SEM), as typified in Figure 17. Overall, the fracture surface exhibited steps and ridges, along with angled tears. The crack arrest marks were oriented parallel to the surfaces. A closer view shown in Figures 19 and 20 revealed fatigue striations, consistent with fatigue crack propagation. The nature of these striations was consistent with propagation from the forward to aft faces in high-cycle fatigue (see Figure 21). Most of the opened Crack 2 face exhibited features consistent with fatigue. The small areas outside the fatigue cracking exhibited dimpled rupture, consistent with the laboratory opening of the crack (see Figure 22). Therefore, these cracks were inconsistent with forming during the accident, having to originate prior to the accident.

Figure 16 – The outboard crack face of crack #2, after opening.

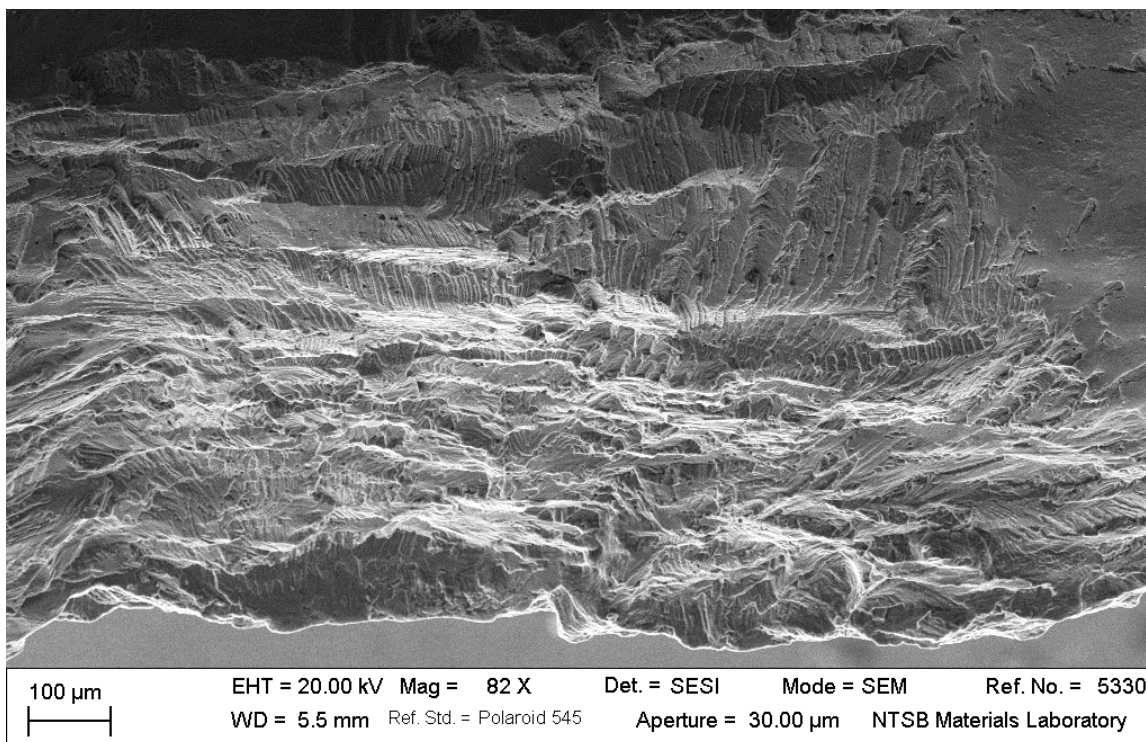
Figure 17 – Secondary electron (SE) micrograph of a typical area of the crack #2 fracture surface.

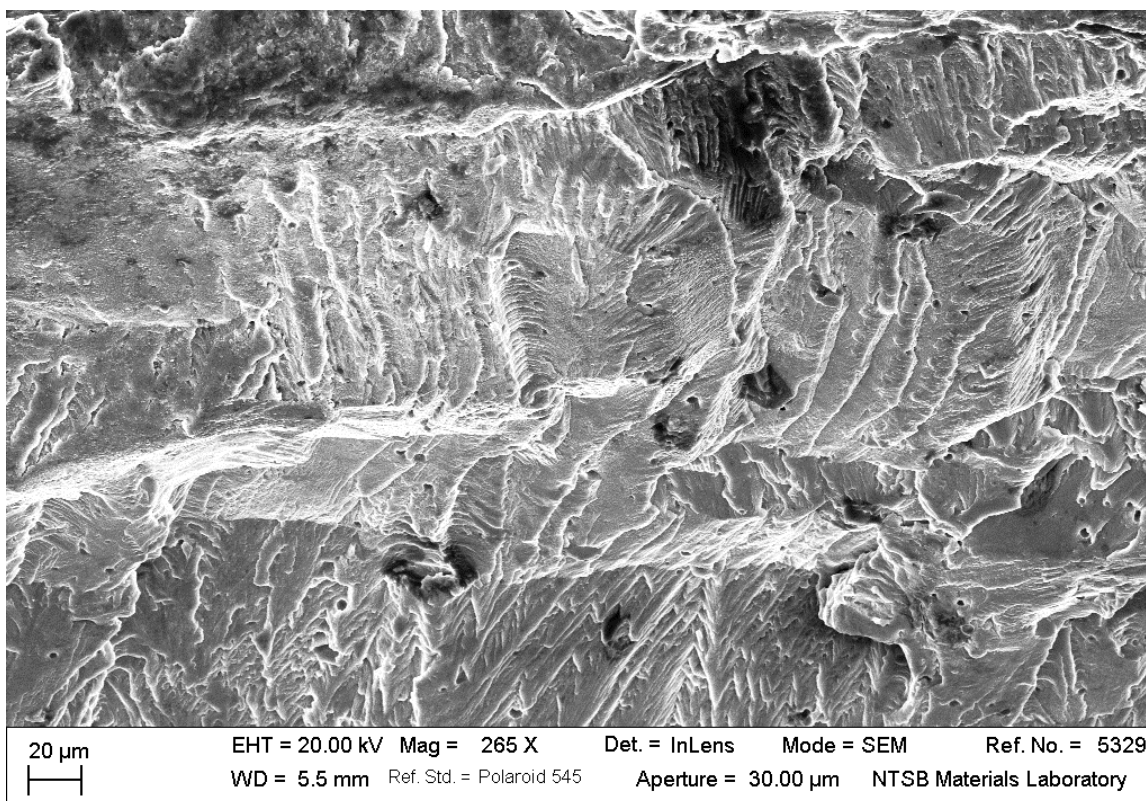
Figure 18 – SE micrograph of a closer area of the opened crack, showing striations.

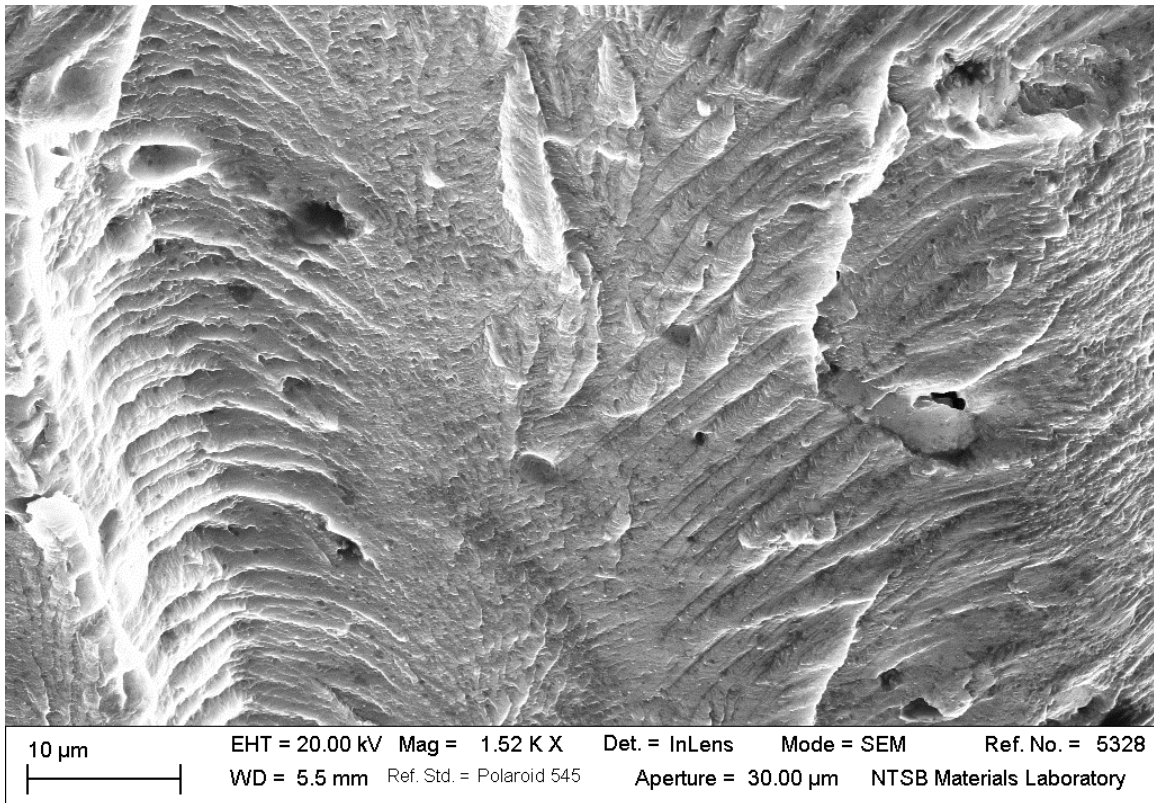
Figure 19 – SE micrograph of a closer view of Figure 18, showing ridges and fatigue striations.

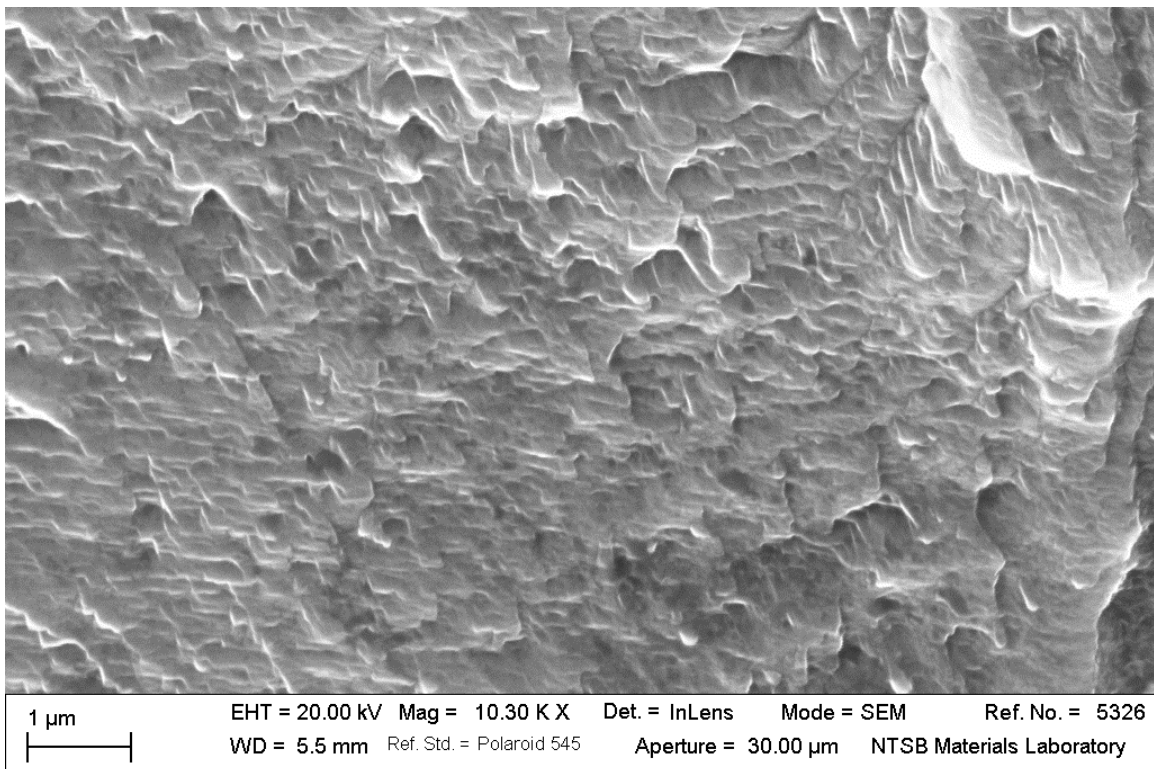
Figure 20 – SE micrograph of a closer view of the fatigue striations in Figure 19.

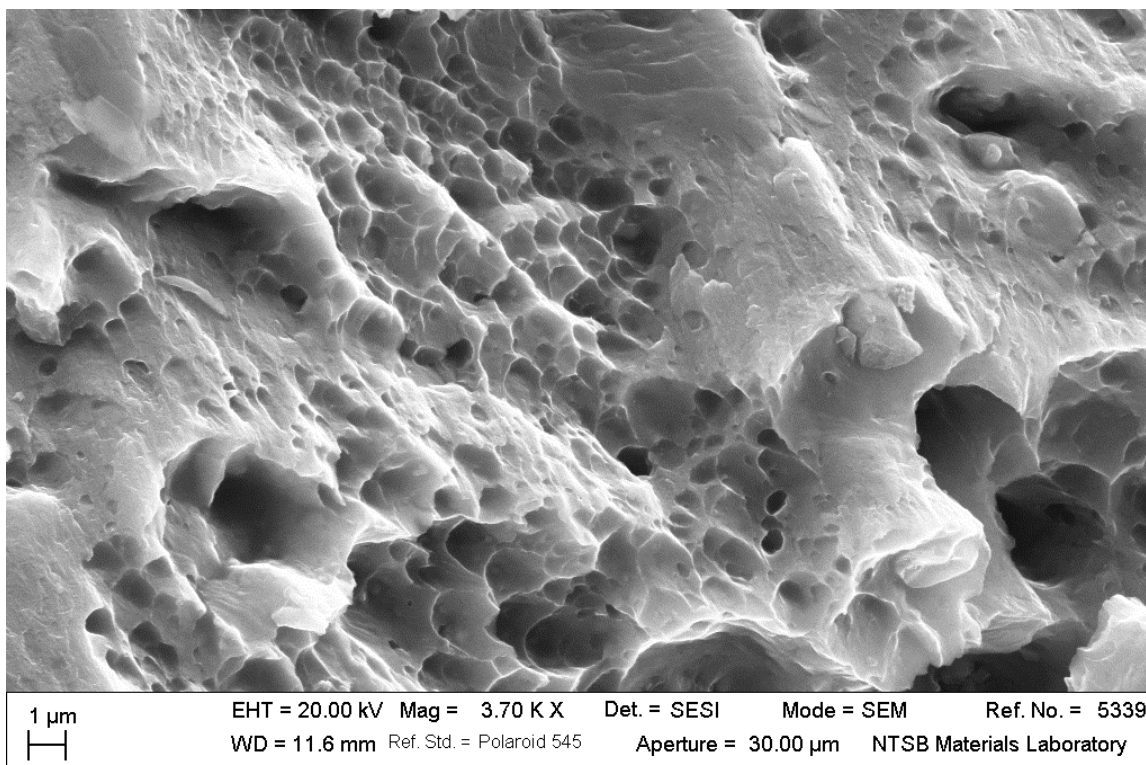
Figure 21 – SE micrograph of dimpled rupture outside the fatigue regions on crack #2.
