# NATIONAL TRANSPORTATION SAFETY BOARD

MATERIALS LABORATORY ADDENDUM REPORT

Report No. 20-038B

Place : Big Timber, Montana  
Date : January 16, 2020  
Vehicle : Cessna 172Q, N96145  
NTSB No. : WPR20LA068  
Investigator : Stephen Stein, AS-WPR

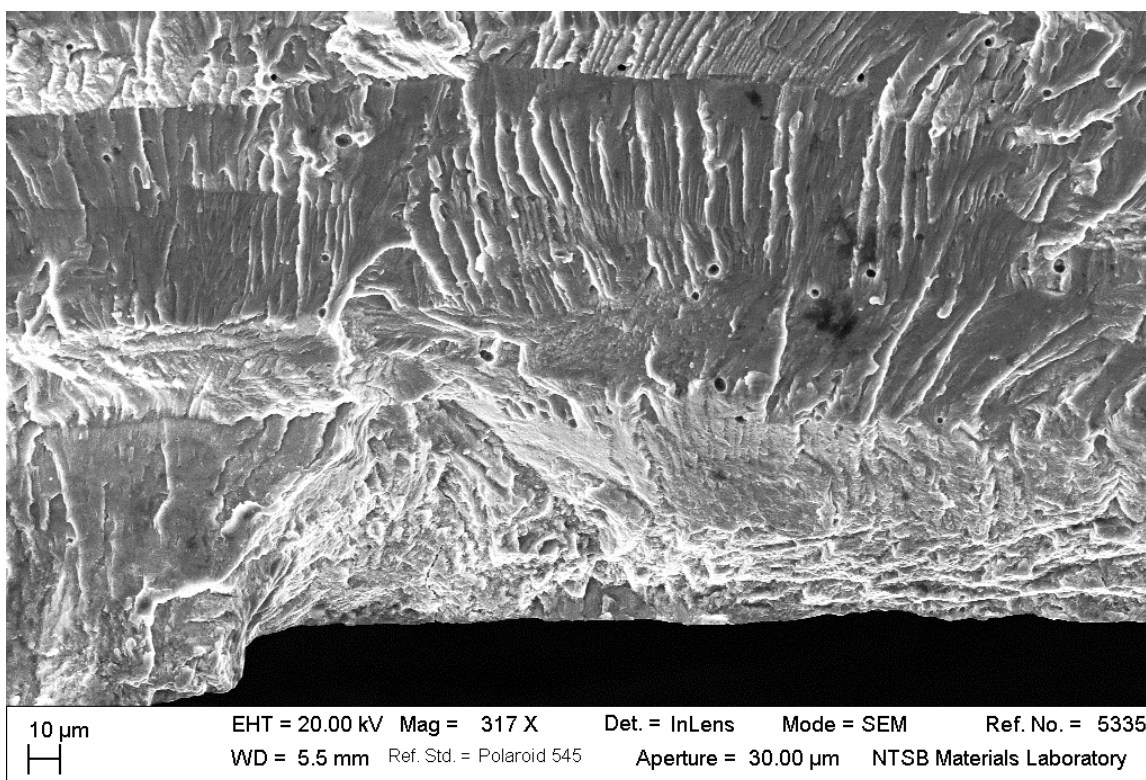
The fracture surface exhibited ratchet marks, consistent with multiple fatigue crack initiation sites. One of the initiation sites is highlighted in Figures 22 through 24. The cracking near the initiation site exhibited tear ridges fanning outward and steps parallel to the forward surface. Closer to the initiation site, smoother surface features were observed, displaying fanning river patterns consistent with at least three smaller initiation sites. While there were no material defects present at these sites, the surface exhibited an undulating profile, consistent with the fretting wear on the forward surface. These crack initiation sites were consistent with local areas of the deepest fretting damage.

Figure 22 – SE micrograph of one of the fatigue crack initiation sites of crack #2.

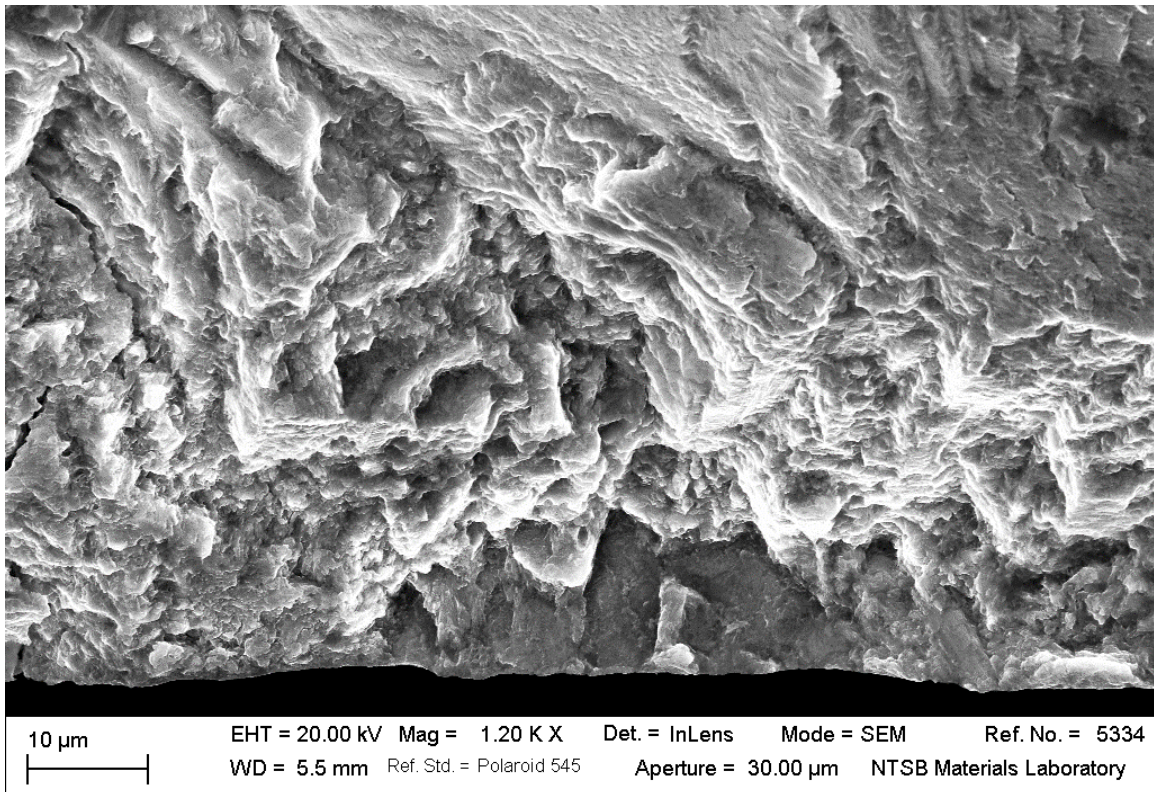
Figure 23 – SE micrograph of showing a closer view of the initiation site in Figure 22.

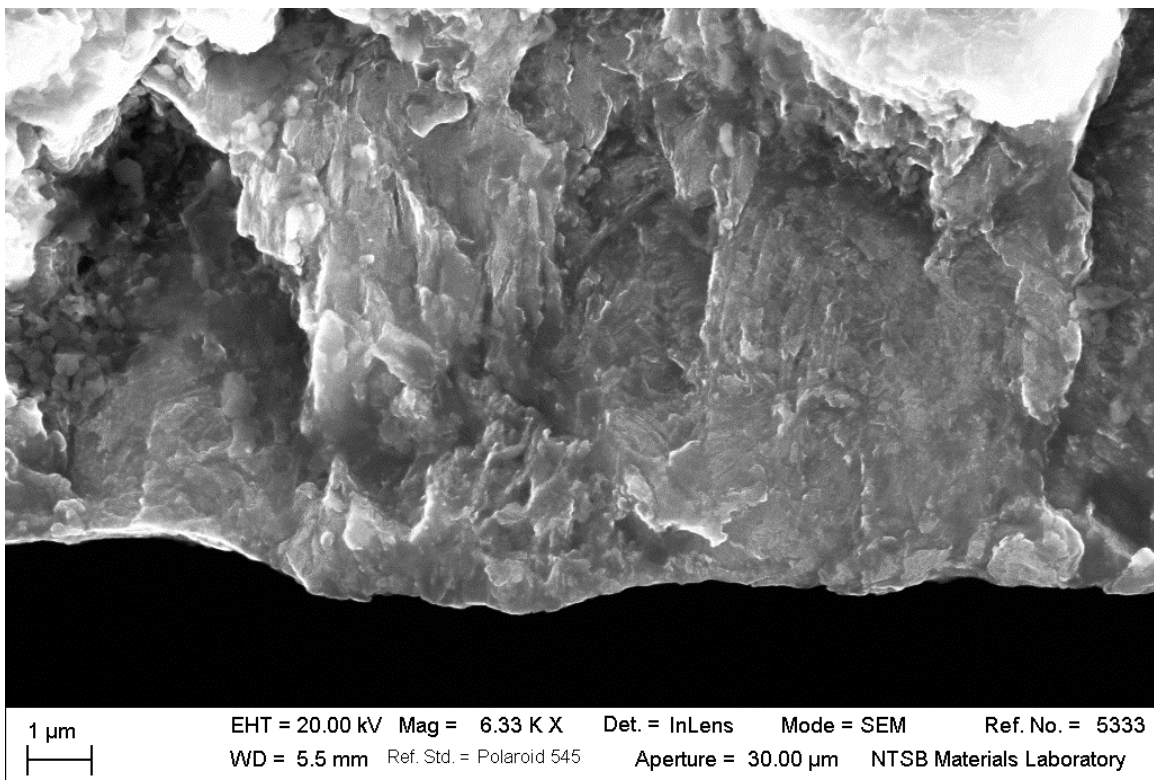
Figure 24 – SE micrograph of the fatigue initiation site in Figure 23.
