NATIONAL TRANSPORTATION SAFETY BOARD

MATERIALS LABORATORY FACTUAL REPORT

Report No. 20-049

Place : Anchorage, Alaska
Date : June 8, 2020
Vehicle : Piper PA-12
NTSB No. : ANC20LA059
Investigator : Brice Banning, AS-ANC

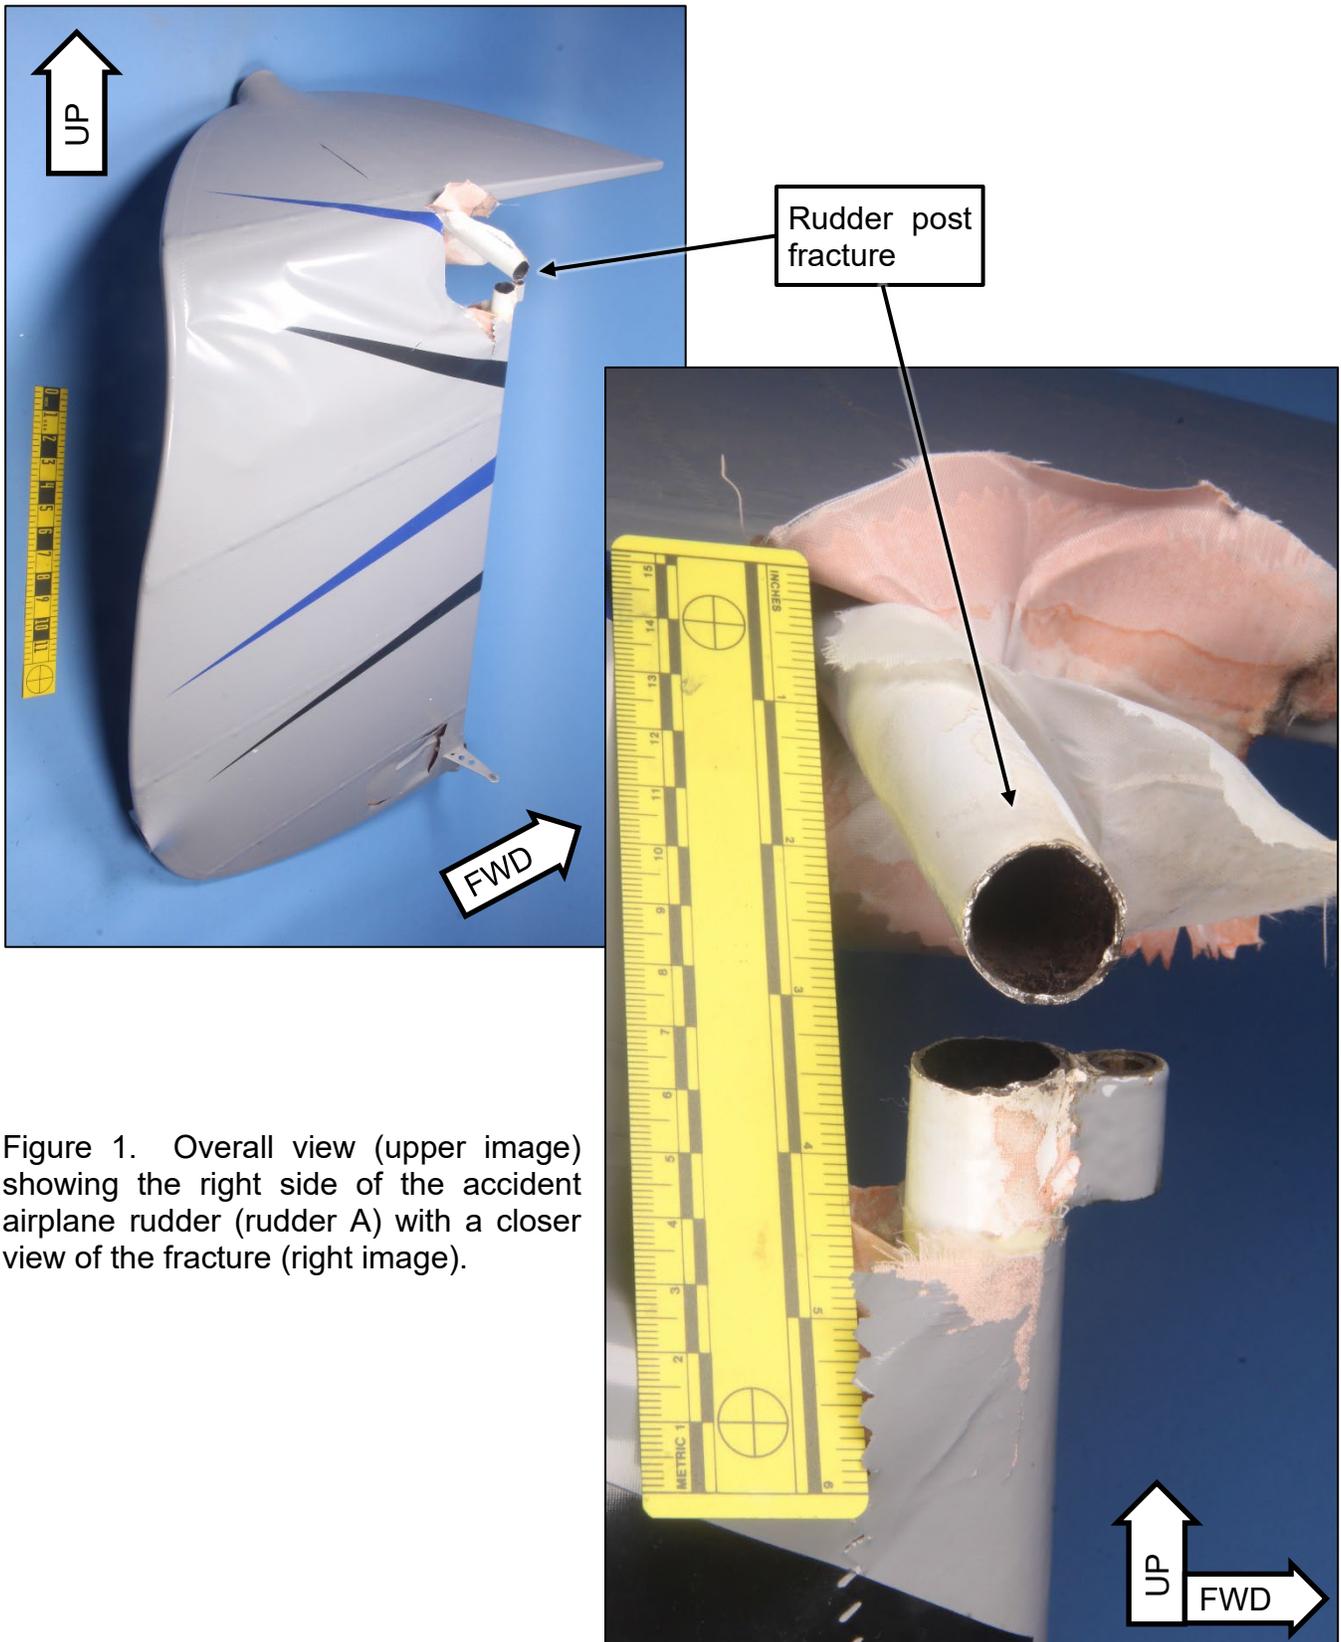
Rudders from three Piper PA-12 airplanes, including the one from the accident airplane, were submitted for examination as shown in figures 1 through 3. For reference, the rudder from the accident airplane was labeled rudder "A", and the other two rudders were arbitrarily labeled "B" and "C", respectively. The rudder post was fractured at the upper end of the upper hinge barrel attach point on rudder A and approximately ½ inch and 1 inch above the upper hinge barrel on rudders B and C, respectively. The upper portion of the rudder was bent to the left in rudders A and C and to the right in rudder B.

Closer views of the fractures on each of the rudders are shown in figures 1 through 3. The fractures were primarily oriented in a transverse plane, and the cross-section of the tube remained mostly round, consistent with a progressive fracture mechanism such as fatigue under bending loads.¹ Overall, the fracture surfaces were substantially damaged with post-fracture contact damage and rubbing.

The six sectioned rudder post pieces were submerged in a beaker of acetone and cleaned using an ultrasonic cleaner. Both sides of the cleaned fracture from rudder A were examined using an SEM. The fracture surfaces were completely rubbed, and no original fracture features were identified. The upper side of the cleaned fracture from rudder B was also examined using an SEM. The rudder B fracture surface was completely rubbed, and like the fracture surfaces from rudder A, no original fracture features were identified.

Figure 1. Overall view (upper image) showing the right side of the accident airplane rudder (rudder A) with a closer view of the fracture (right image).

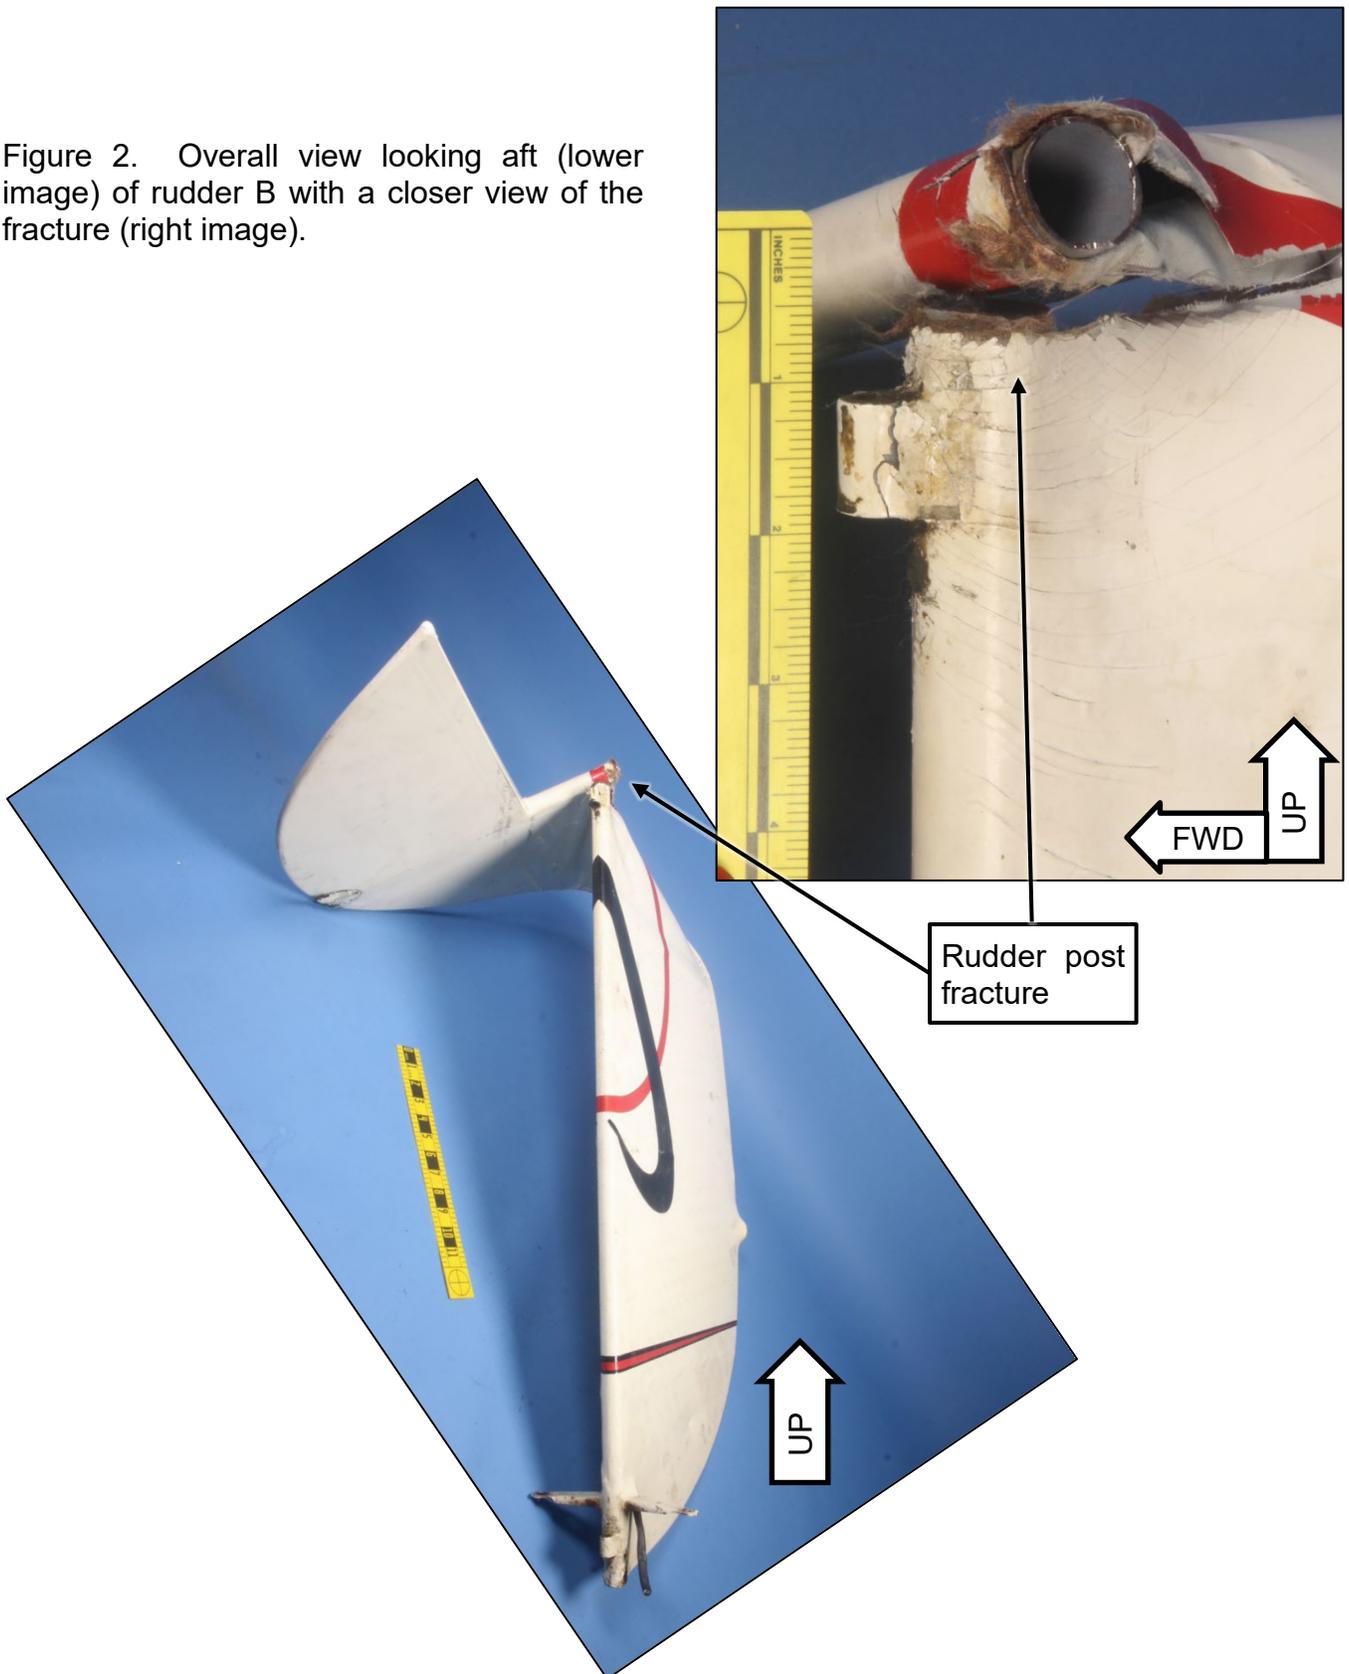
Figure 2. Overall view looking aft (lower image) of rudder B with a closer view of the fracture (right image).

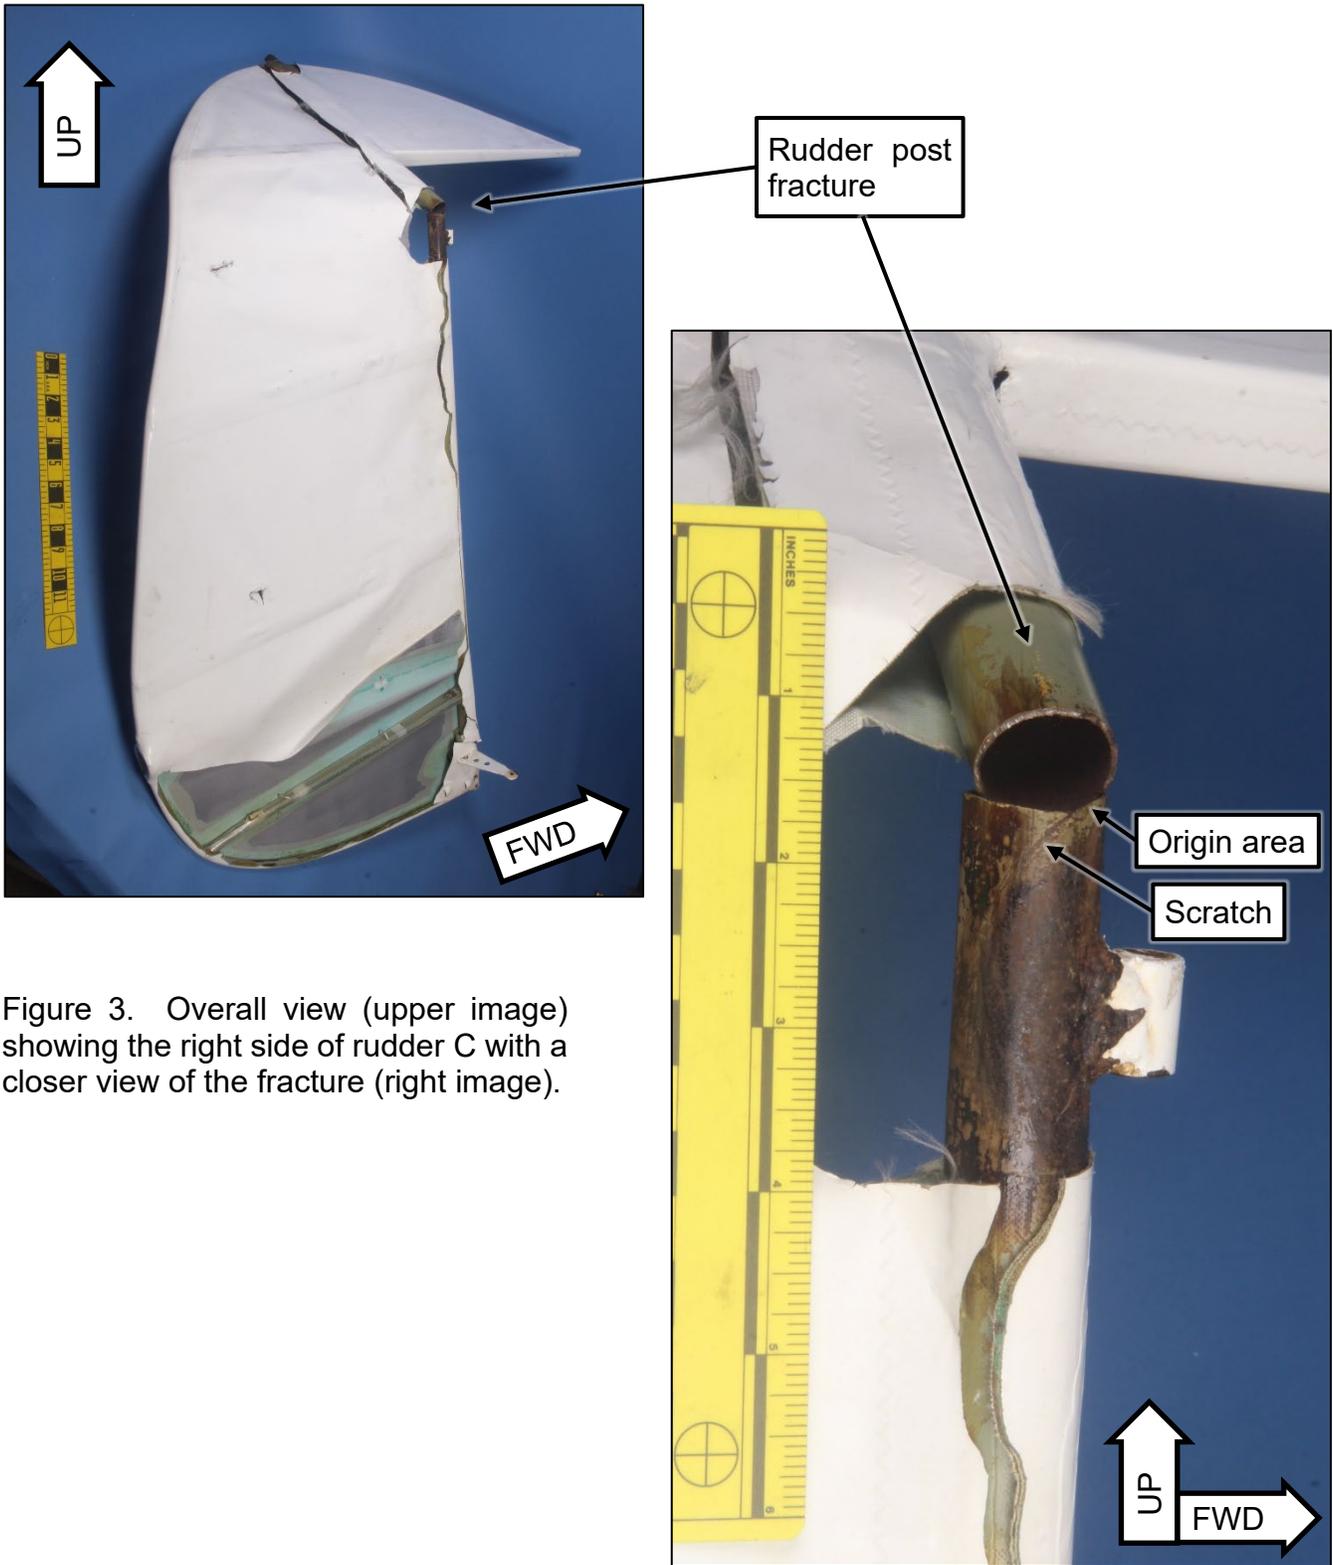
The exterior surface of the rudder C rudder post had curving scratches in the painted surface, and the underlying metal was corroded along the lengths of the scratches. The fatigue origin area corresponded to the location of one of the corroded scratches (see figure 3).

Figure 3. Overall view (upper image) showing the right side of rudder C with a closer view of the fracture (right image).

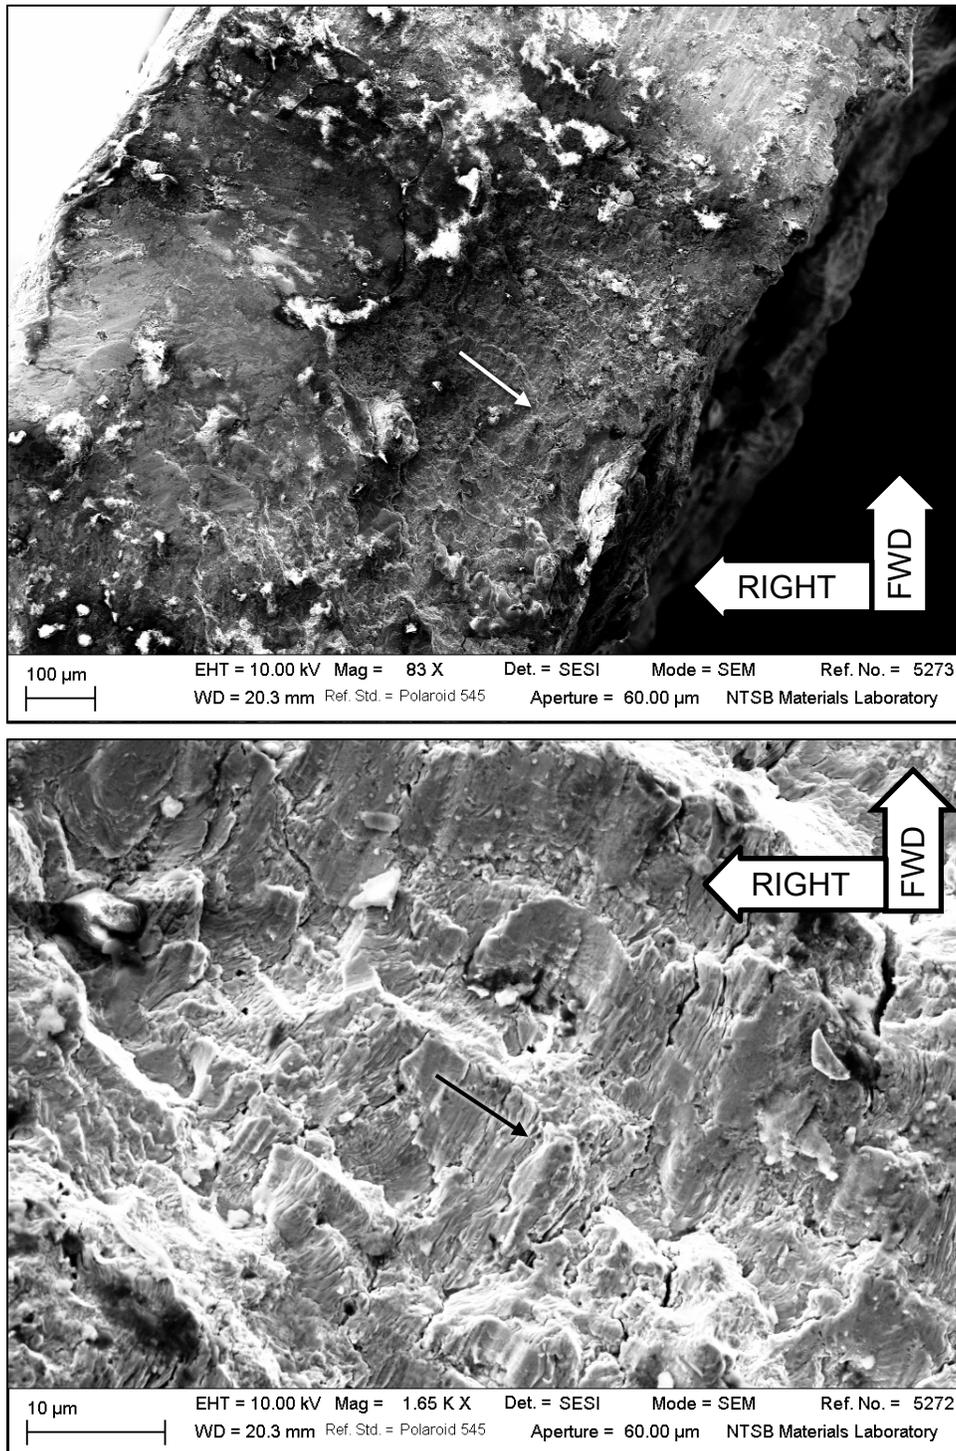
The upper fracture surface from rudder C was also substantially damaged, but the SEM revealed areas of original fracture features in the forward right quadrant of the fracture as shown in figure 4. The fracture features near the outer diameter were obliterated by rubbing, but the middle and inner portions of the fracture had arrays of parallel ridges and microcracks consistent with fatigue crack propagation. A closer view of fatigue features is shown in the lower image in figure 4. Unlabeled arrows in figure 4 indicate the direction of fatigue propagation in this area. The orientation and shape of the fatigue features were consistent with fatigue propagation through the thickness from multiple fatigue origins at the outer diameter. On the right side of the rudder post aft of the area shown in figure 4, isolated areas of fatigue features observed between areas of damage were oriented consistent with crack propagation around the circumference away from the origin area at the forward right quadrant. The extent of the fatigue crack propagation and whether additional origin areas may have existed could not be determined due to the extent of fracture surface damage.

Figure 4. SEM images of the upper side of the rudder post fracture in rudder C after ultrasonic cleaning with acetone. The upper image shows an area of the forward right quadrant, and the lower image shows a closer view of fatigue fracture features. Unlabeled arrows indicate the general fatigue crack propagation direction.

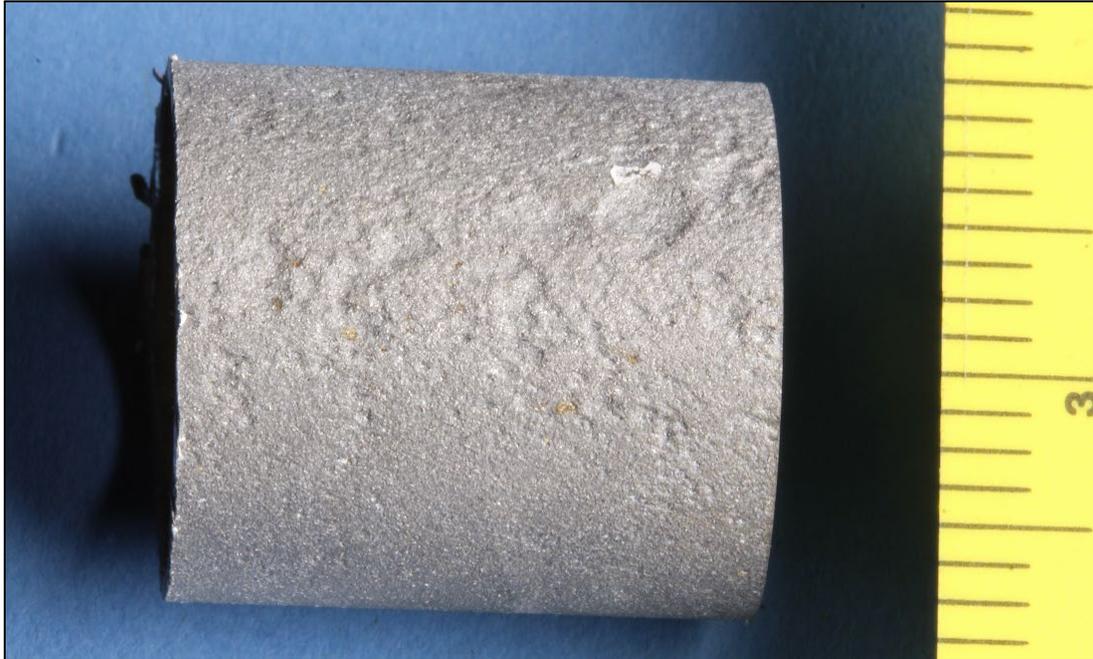
The exterior surface of the rudder A rudder post piece is shown in figure 5 after the paint was removed. The surface had a uniform gray appearance that sparkled when viewed under bright lights. Portions of the surface had a cratered appearance including the area shown in figure 5. The piece shown in figure 5 was further examined using an SEM, and typical surface features are shown in figure 6. The surface had sliding contact features with smooth faces and angular edges consistent with an abrasive-blast treatment. Particles with sharp edges were observed embedded in many of the angular sliding contact areas such as the particle shown in figure 7. The particles were analyzed using energy-dispersive x-ray spectroscopy (EDS), and a typical spectrum is shown in figure 8. The EDS spectra of the embedded angular particles included peaks of iron, silicon, aluminum, magnesium, and oxygen, consistent with the chemical composition of garnet.

Figure 5. Section of rudder post from rudder A approximately 1 inch above the fracture after paint was removed showing pitting on the right side of the post.

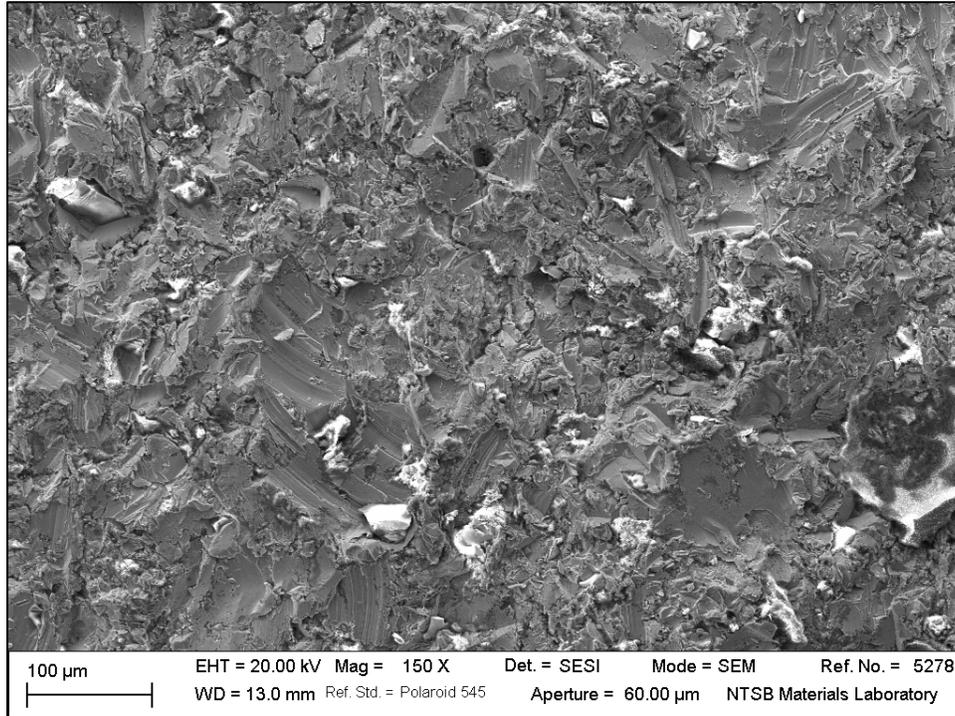
Figure 6. SEM image of the rudder post exterior surface on the rudder A piece shown in figure 5.

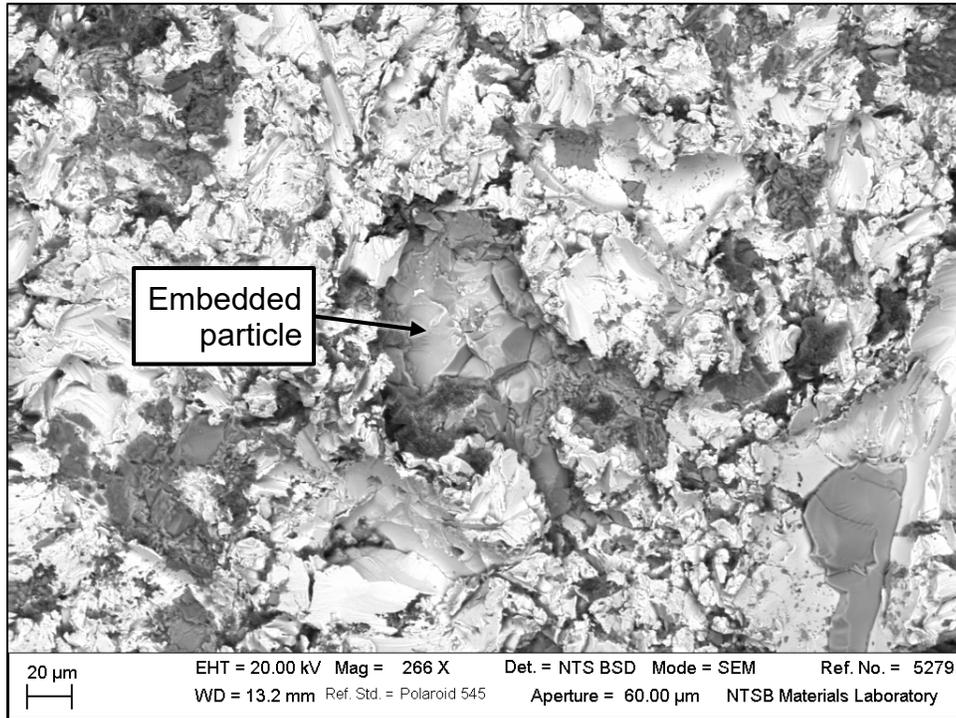
Figure 7. SEM image of a particle embedded in the surface of the rudder A rudder post.

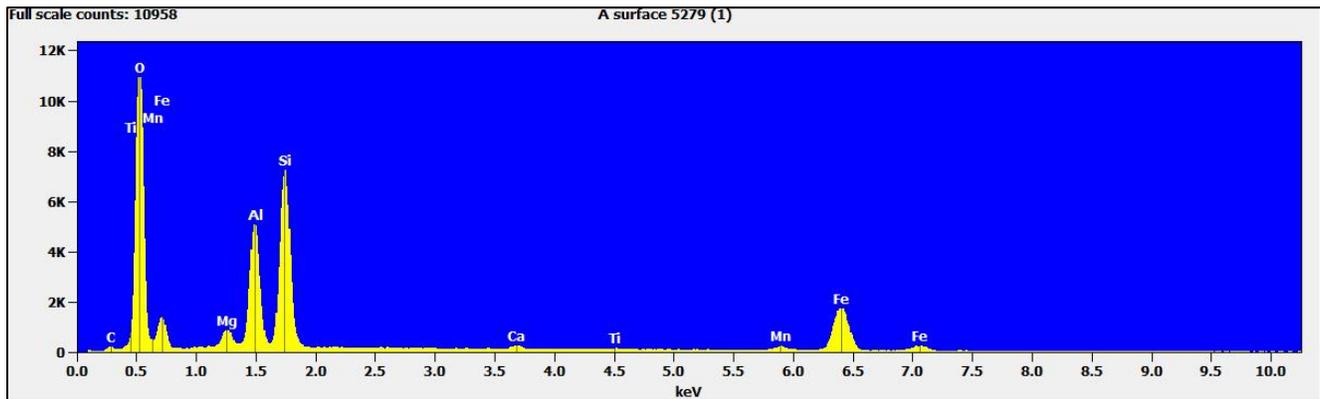
Figure 8. EDS spectrum for the particle shown in figure 7.

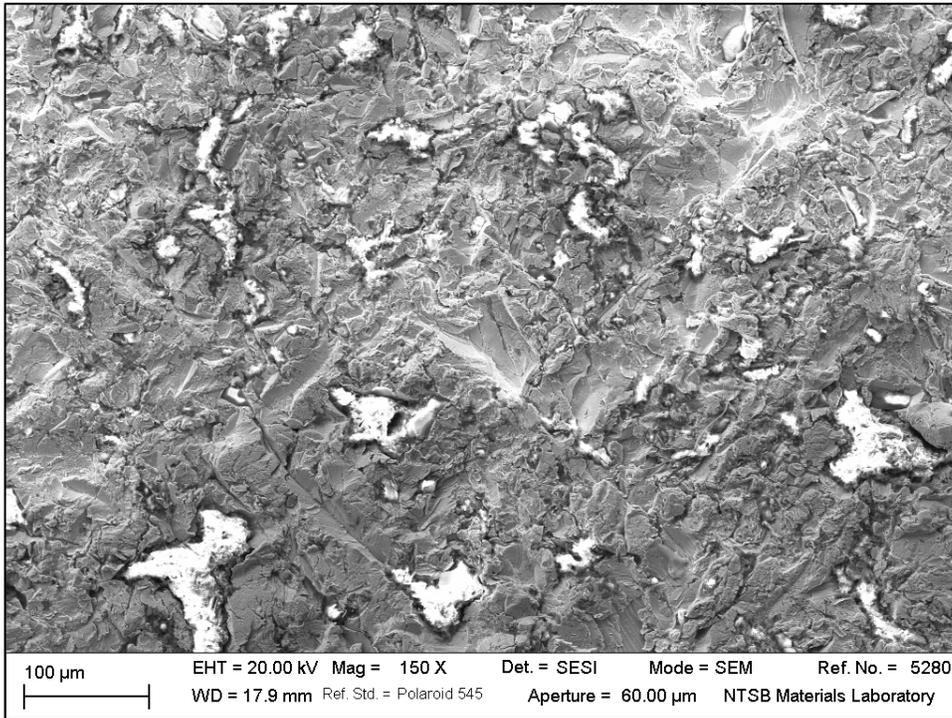
Rudder post pieces from rudders B and C were soaked in Cee-Bee paint remover to remove the coatings. A brush and wood scraper were also used to help with the coating removal process. The surfaces with the paint removed had a rough appearance with isolated remnants of primer remaining attached in the surface features. SEM images of the surfaces are shown in figures 9 and 10 showing faceted features consistent with abrasive impacts. Faceted deposits with smooth faces were observed on the surfaces, and EDS analysis of the faceted deposits showed spectra with high peaks of silicon and oxygen consistent with the composition of silica.

Figure 9. SEM image of the rudder post exterior surface on the rudder B piece.

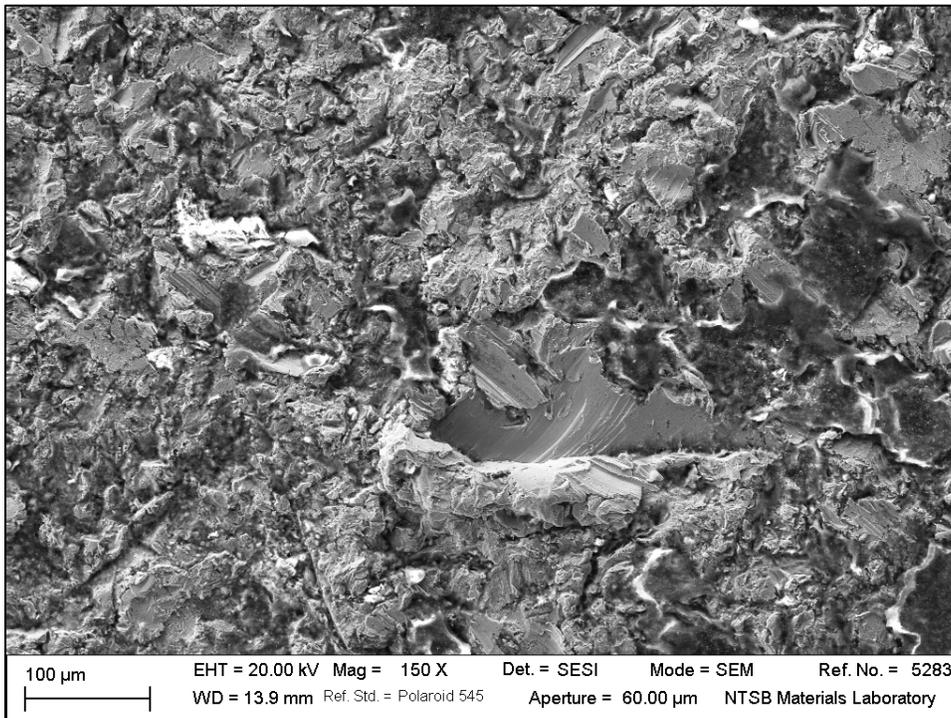
Figure 10. SEM image of the rudder post exterior surface on the rudder C piece.

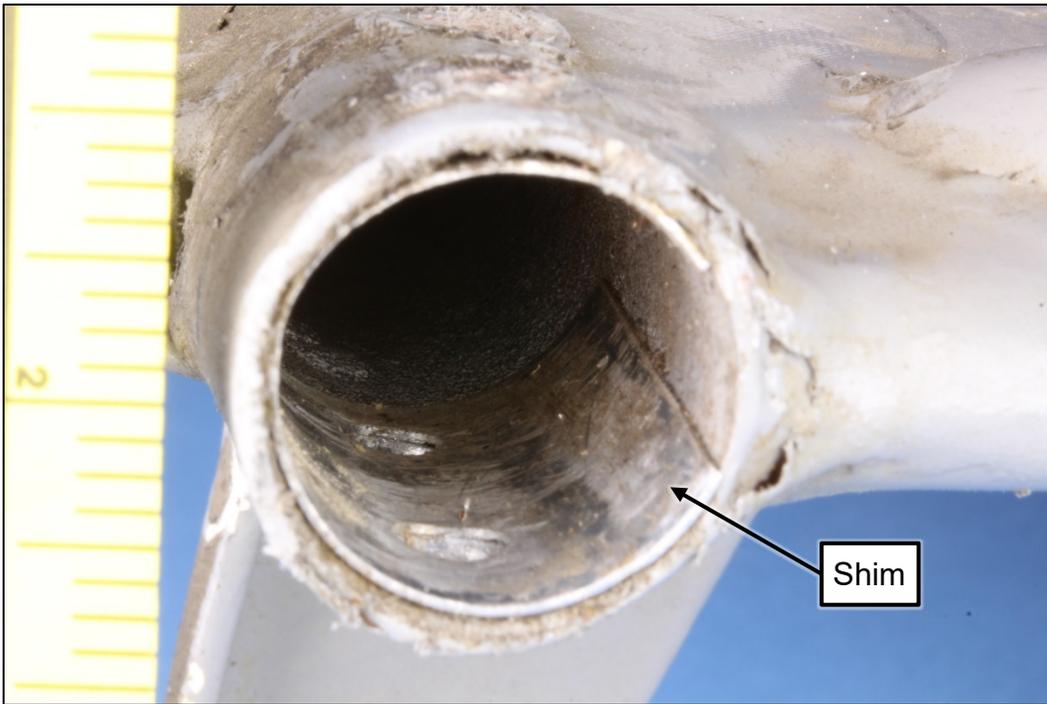
In a Piper engineering order (EO) dated June 15, 1988, an aluminum alloy shim was added to the interior of the rudder post at the lower end where it is attached to the rudder arm.⁵ On October 4, 1988, the shim material was changed from the aluminum alloy to a stainless steel alloy. A shim was observed at the lower end of the rudder post in rudder A (see figure 11). A scalpel was used to shave a sample of the shim onto a carbon-coated stub for EDS analysis. Results showed a spectrum with a high peak of aluminum and small peaks of copper and magnesium, consistent with the aluminum alloy shim material specified in the June 1988 EO. No shims were observed in the rudder posts for rudders B and C.

Figure 11. Lower end of rudder A showing the shim installed inside the rudder post.
