NATIONAL TRANSPORTATION SAFETY BOARD

MATERIALS LABORATORY FACTUAL REPORT

Report No. 20-062

Place : Camp Dwyer, Afghanistan
Date : April 20, 2020
Vehicle : Sikorsky S-61N, N908CH
NTSB No. : DCA20LA100
Investigator : Dan Bower, AS-10

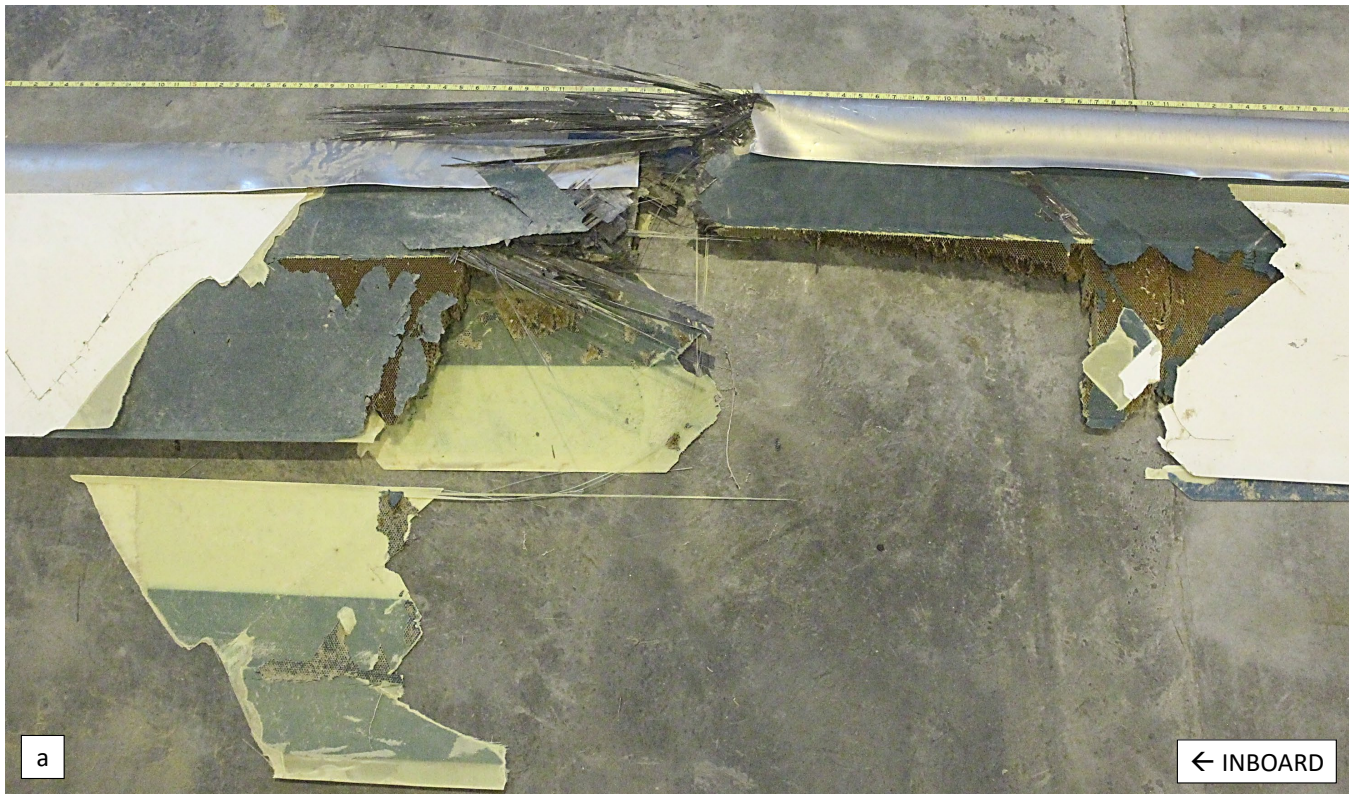
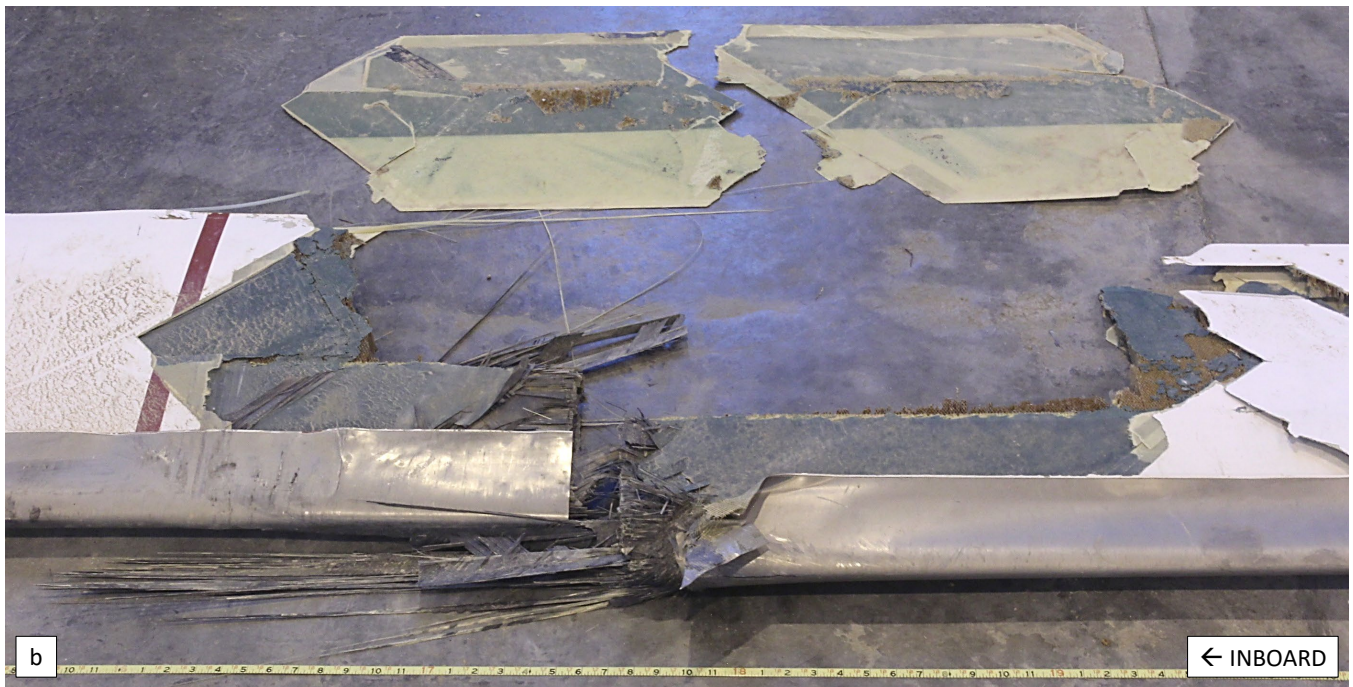
Figure 7: Photograph of the red blade BS 236 fracture location a) upper surface and b) lower surface

The BS 236 blade fracture, shown in figure 7, exhibited fiber pull-out at the leading edge of the spar and was relatively flat chordwise, over the mid to aft spar region where extensive chordwise translaminar fracture features were observed. Extensive interlaminar and intralaminar fracture features were observed extending into the blade away from the primary fracture surfaces. An approximate 4 – 5-foot section of the blade skins and honeycomb core afterbody spanning the spar fracture was completely separated from the blade. The skin remnants that were reconstructed exhibited primarily adhesive failure from the spar and afterbody with localized areas of bonded honeycomb core remnants (indicative of fracture within the core near the bonded joint interface). The adhesive layer was visible on the spar surface and intact honeycomb core. Portions of honeycomb core near the splice joint remained bonded to the aft wall of the spar which indicated failure of the afterbody took place primarily within the honeycomb core material transverse to the ribbon direction along the span with evidence of node bond separation along the chordwise direction. The blade fracture features were consistent with aft bending loading at the time of fracture.

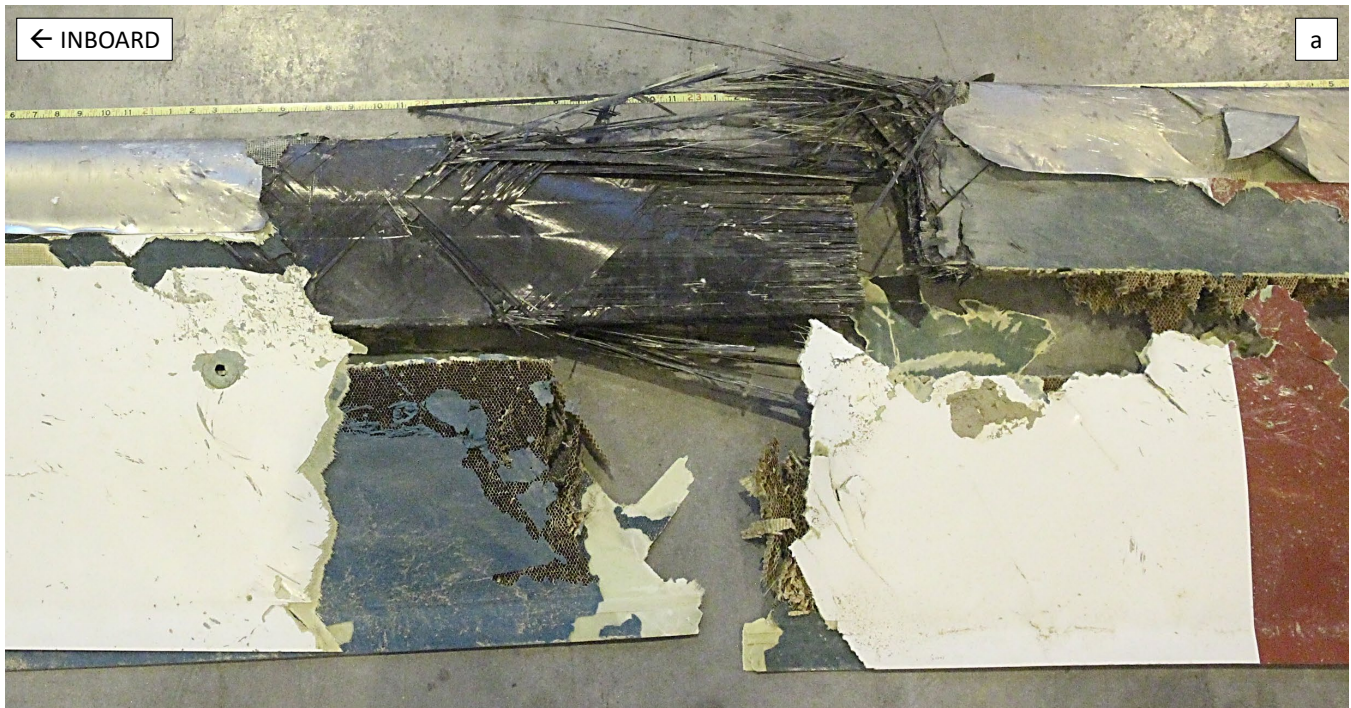
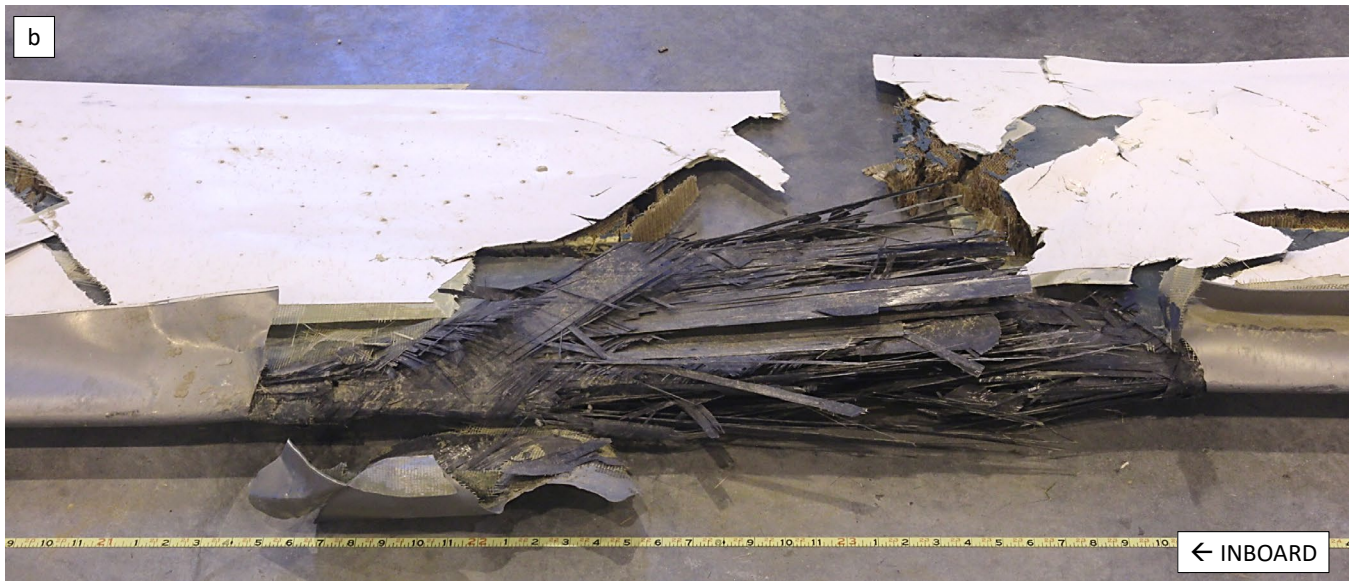
Figure 8: Photograph of the red blade BS 281 – 306 fracture location a) upper surface and b) lower surface

Another blade fracture, shown in figure 8, was observed further outboard at approximate blade station BS 281 – 306. The fracture surface exhibited a fibrous appearance with extensive pull-out around the leading edge of the spar, extending further around the lower side of the spar compared to the upper side. A relatively flat translaminar chordwise fracture surface with interlaminar and intralaminar features extending into the spar was observed along the mid and aft spar. The section of leading-edge cap where spar damage and fracture were observed was completely separated and not recovered or able to be reconstructed except for a small, mangled piece that separated from the inboard side of the blade fracture. This piece of leading-edge cap retained portions of the spar, scrim cloth, and adhesive used to bond the cap to the spar. Where still attached, inboard and outboard of the blade fracture, the fractured edges of the leading-edge cap were deformed, buckled, and exhibited slanted shear lip features, consistent with tearing due to overstress. The honeycomb core afterbody spanning the fracture location was separated but, mostly recovered and reconstructed. Outboard of the fracture, sections of core near the splice joint remained bonded to the aft surface of the spar which indicated failure of the afterbody took place primarily within the honeycomb core material transverse to the ribbon direction. Inboard of the fracture, fibrous sections of the aft wall of the spar were pulled away toward the trailing edge and spar material remained attached to the core splice joint on the afterbody piece which indicated failure of the spar drove separation of the inboard section of afterbody. The blade fracture features observed were consistent with aft bending loading at the time of fracture.

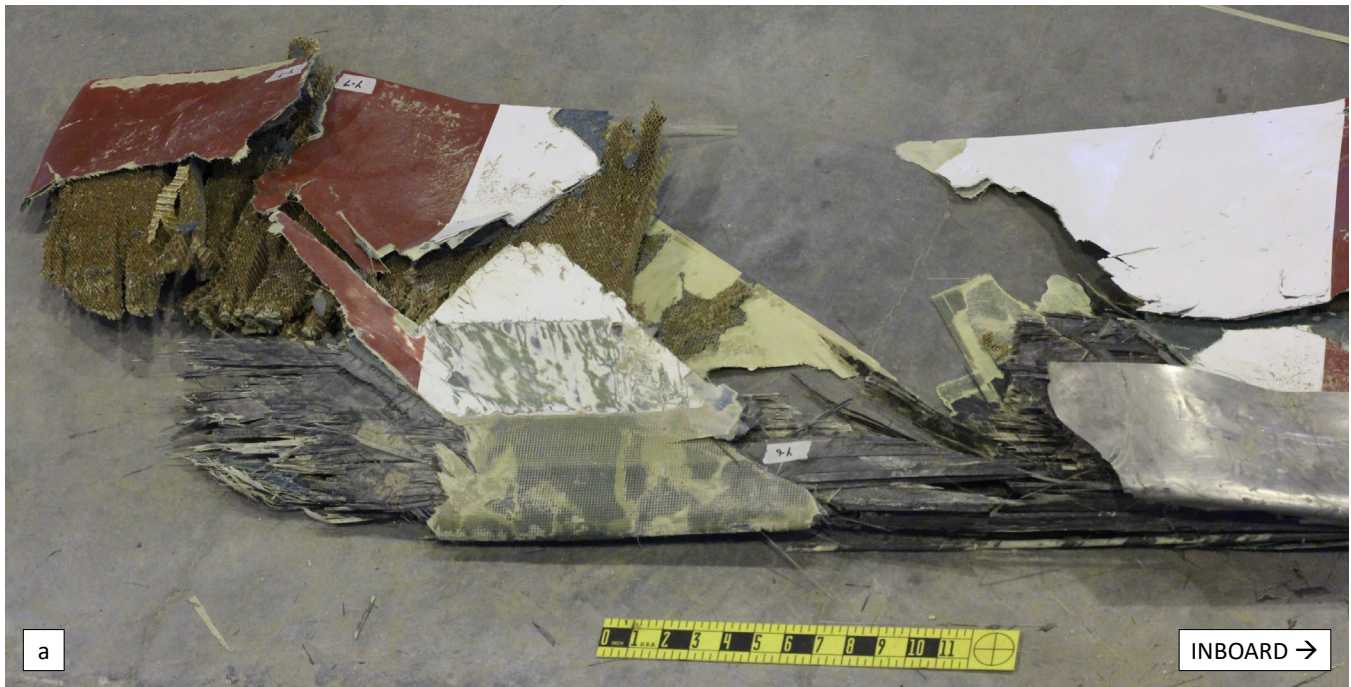
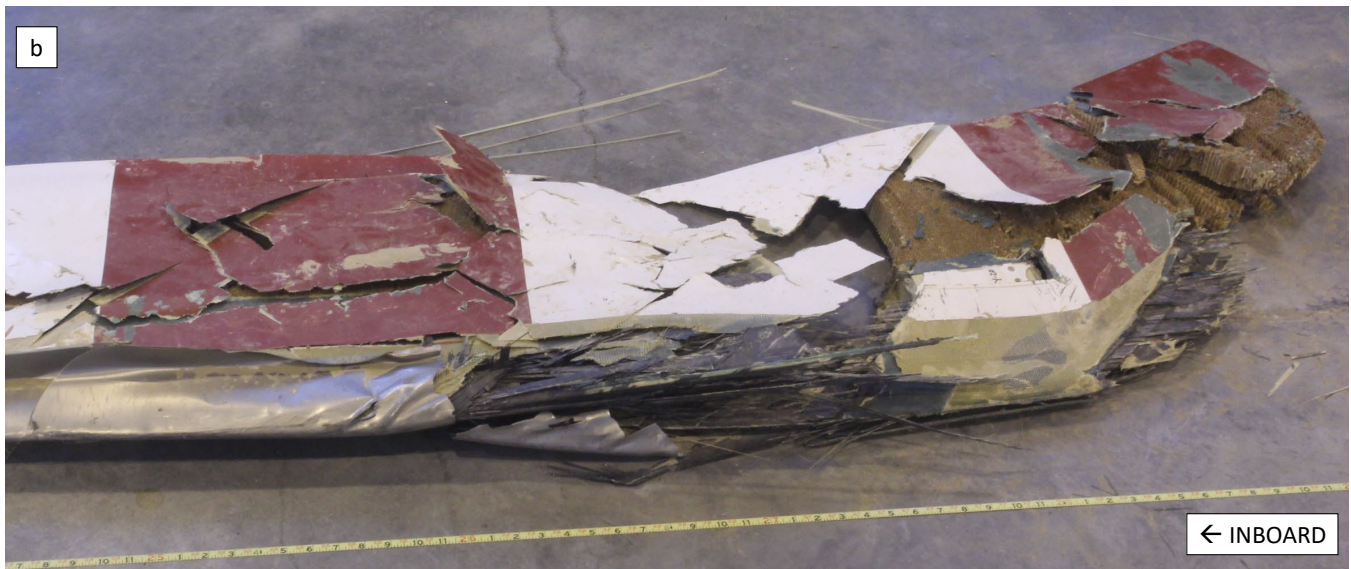
Figure 9: Photograph of the red blade BS 333 – 349 fracture location a) upper surface and b) lower surface

Figure 9 shows the tip portion of the blade outboard of approximate BS 333. This area was heavily fragmented through the spar, skin, and core afterbody, which exhibited extensive node bond separation. The leading-edge cap was fractured and deformed/buckled/wrinkled at this location and was not recovered or able to be reconstructed. Scratched and marred areas of paint emanated from the leading-edge cap bond surface. The degree of fragmentation and crushed condition of the spar, afterbody, and adjacent leading-edge cap in this region was consistent with leading-edge impact damage.

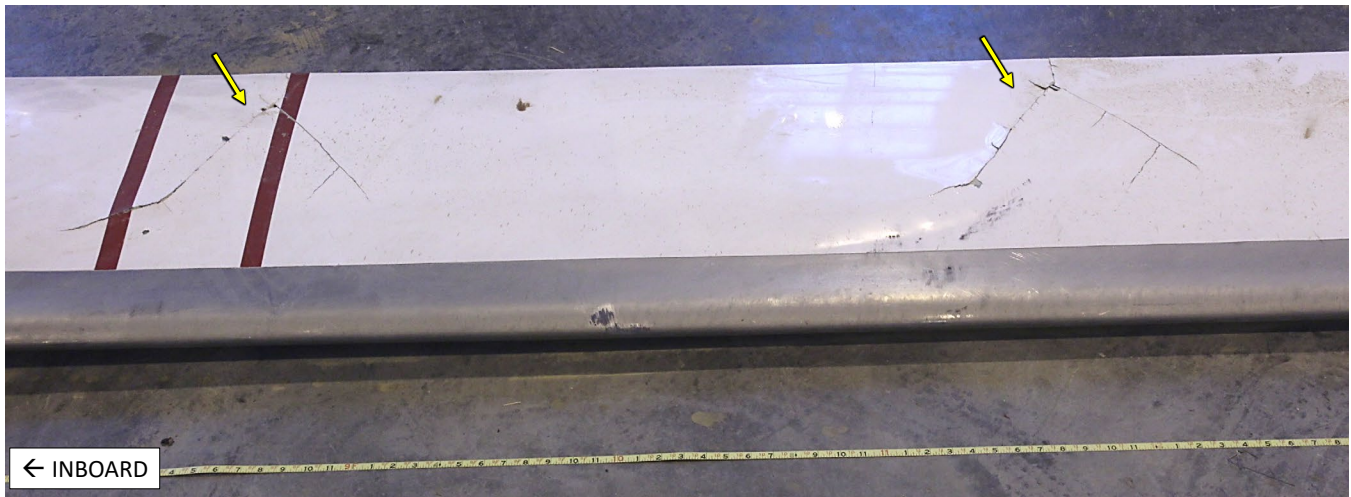
On the lower blade skin, inboard of BS 236 spar fracture, were three distinct areas of branched cracking observed approximately 33, 66, and 109 inches inboard of the fracture location, which converged approximately two to three inches from the trailing edge. These branched cracks spread out toward the leading edge at an approximate 70 – 80-degree angle, creating a triangular shaped flap with the attached ligament oriented approximately parallel to the span axis. There were smaller branched cracks observed terminating along the larger primary cracks. These triangular shaped flap features were observed on the lower and upper blade skins at approximately the same blade station locations. Figure 10 shows the two inboard branched crack sites observed on the lower skin.

Figure 10: Photograph of inboard branched cracking sites, indicated by yellow arrows, observed on the red blade, lower skin.

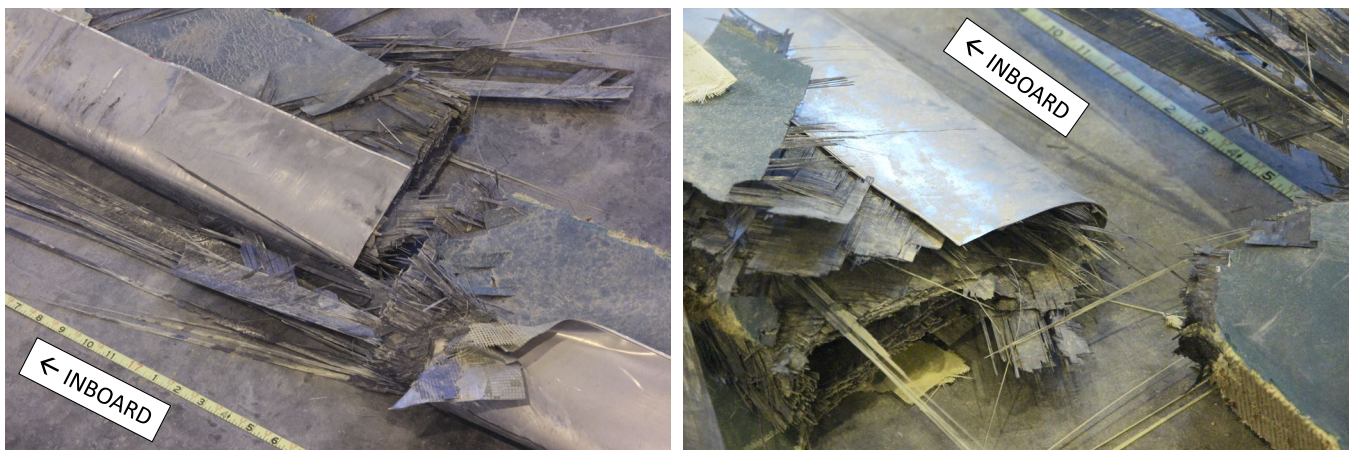
The nickel alloy leading edge cap exhibited a flat, chordwise fracture surface along the entire profile on the inboard piece of the BS 236 fracture. Figure 11 shows closer photographs of the upper and lower side of the inboard leading edge cap fracture surface as reconstructed. The outboard fracture surface of the leading-edge cap was generally torn, deformed, and exhibited slanted fracture surfaces consistent with shear lips due to overstress separation. An approximately 4 ¼ inch long section of the lower outboard leading edge cap fracture surface was deformed and bent away from the blade but was flatter in appearance. This area was later confirmed to be the mating fracture surface to the inboard side of the leading-edge cap. This flat fracture surface was excised from the blade and examined in more detail and results are discussed later in this report.

Figure 11: Photograph of the red blade leading-edge cap flat fracture at BS 236 as reconstructed viewed from the lower surface (left) and upper surface (right).

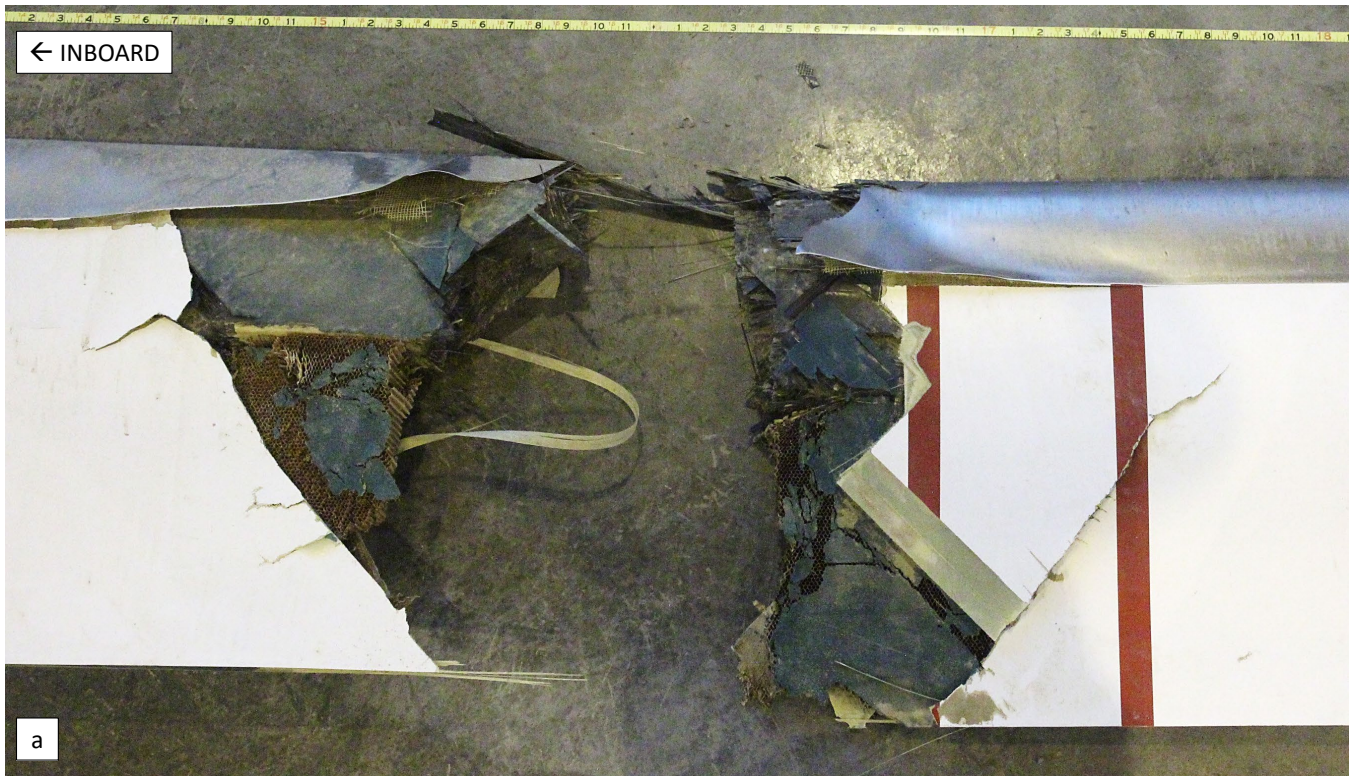
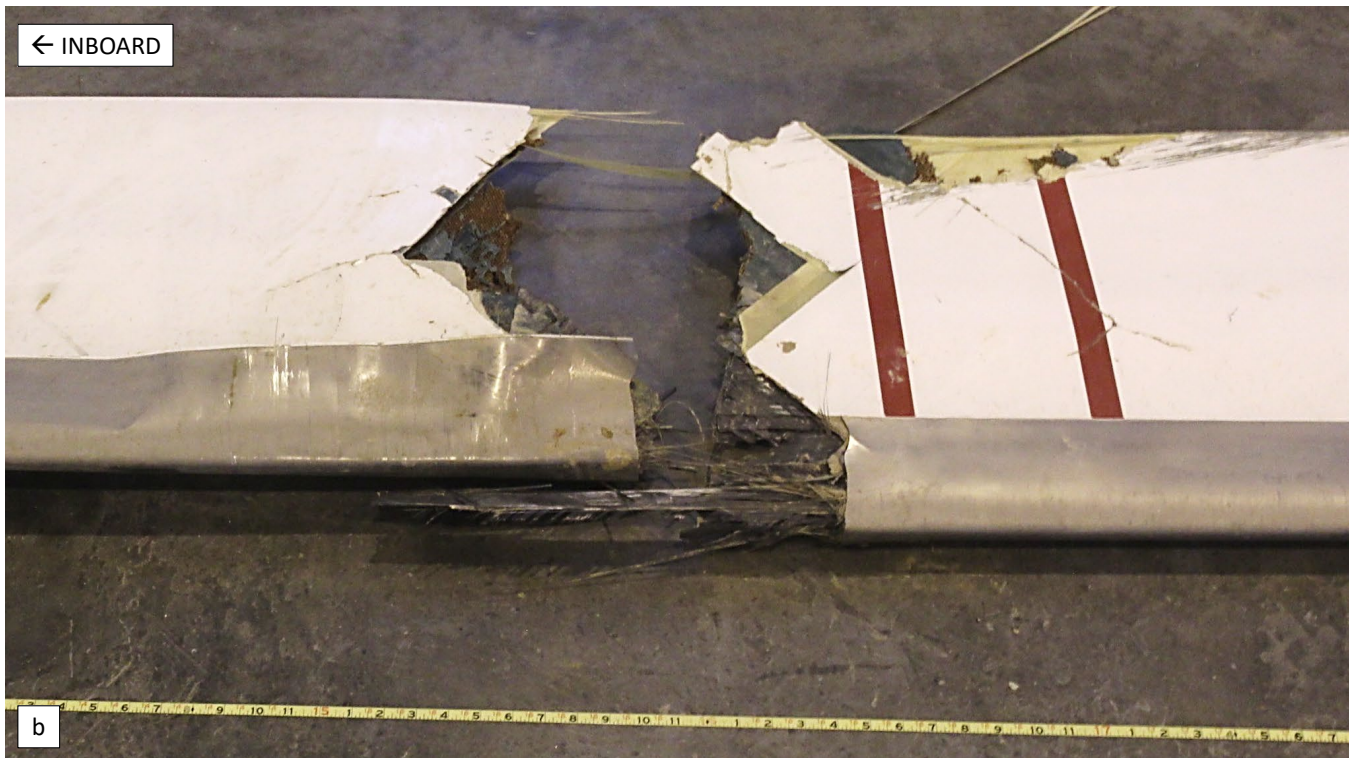
Figure 14: Photograph of the black blade BS 213 – 217 fracture location a) upper surface and b) lower surface

The BS 215 blade fracture, shown in figure 14, exhibited fiber pull-out at the leading edge of the spar and was relatively flat chordwise, over the mid to aft spar region, where extensive chordwise translaminar fracture features were observed. Extensive interlaminar and intralaminar fracture features were observed extending into the blade away from the primary fracture surfaces. The blade skins were cracked and separated locally at the blade fracture, but no substantial portions of the afterbody were fragmented. There was evidence of mixed mode adhesive and cohesive separation between the blade skins, spar, and core afterbody in this region. On the lower surface of the outboard portion of the blade, just outboard of the fracture at the trailing-edge, was a section of missing afterbody and lower skin with adjacent witness marks consisting of dark gray/green parallel scratches which emanated outboard toward the trailing edge.

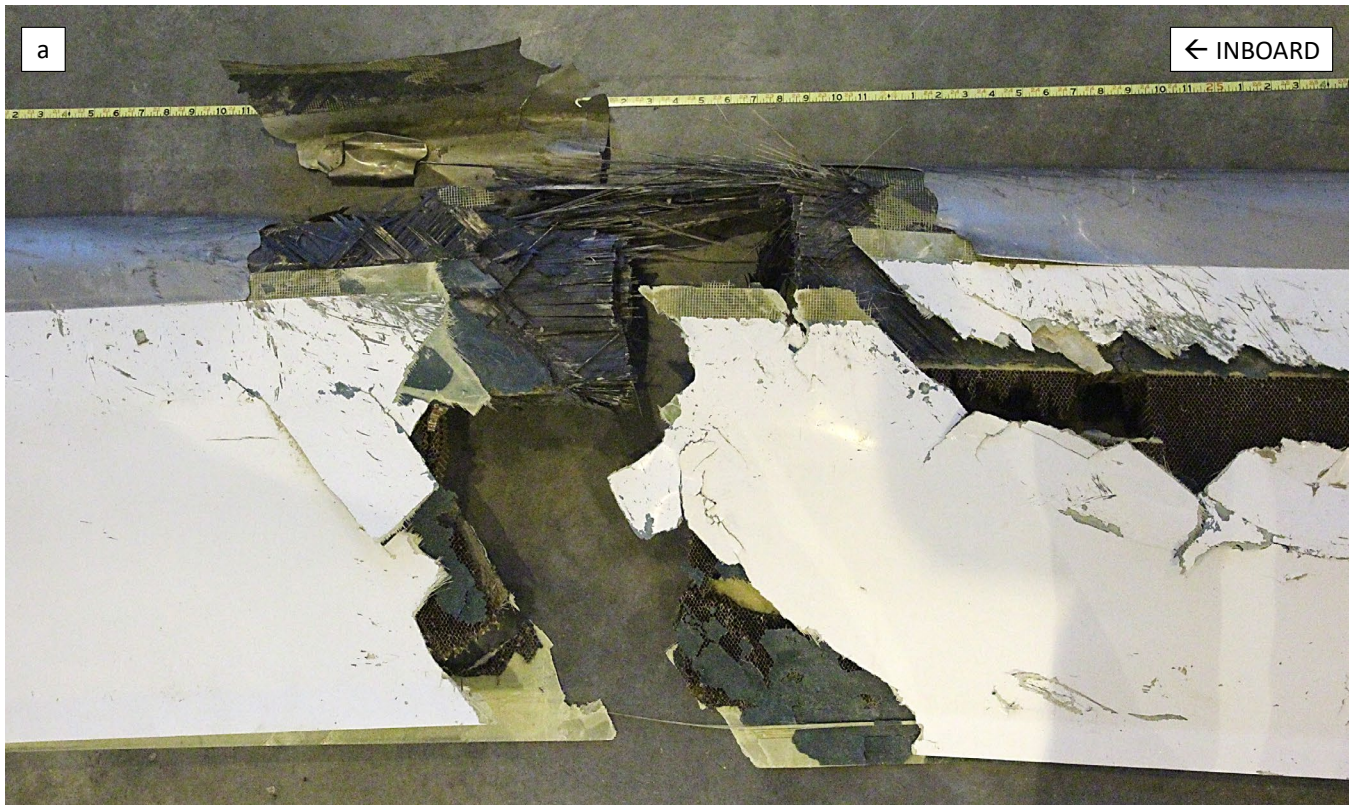
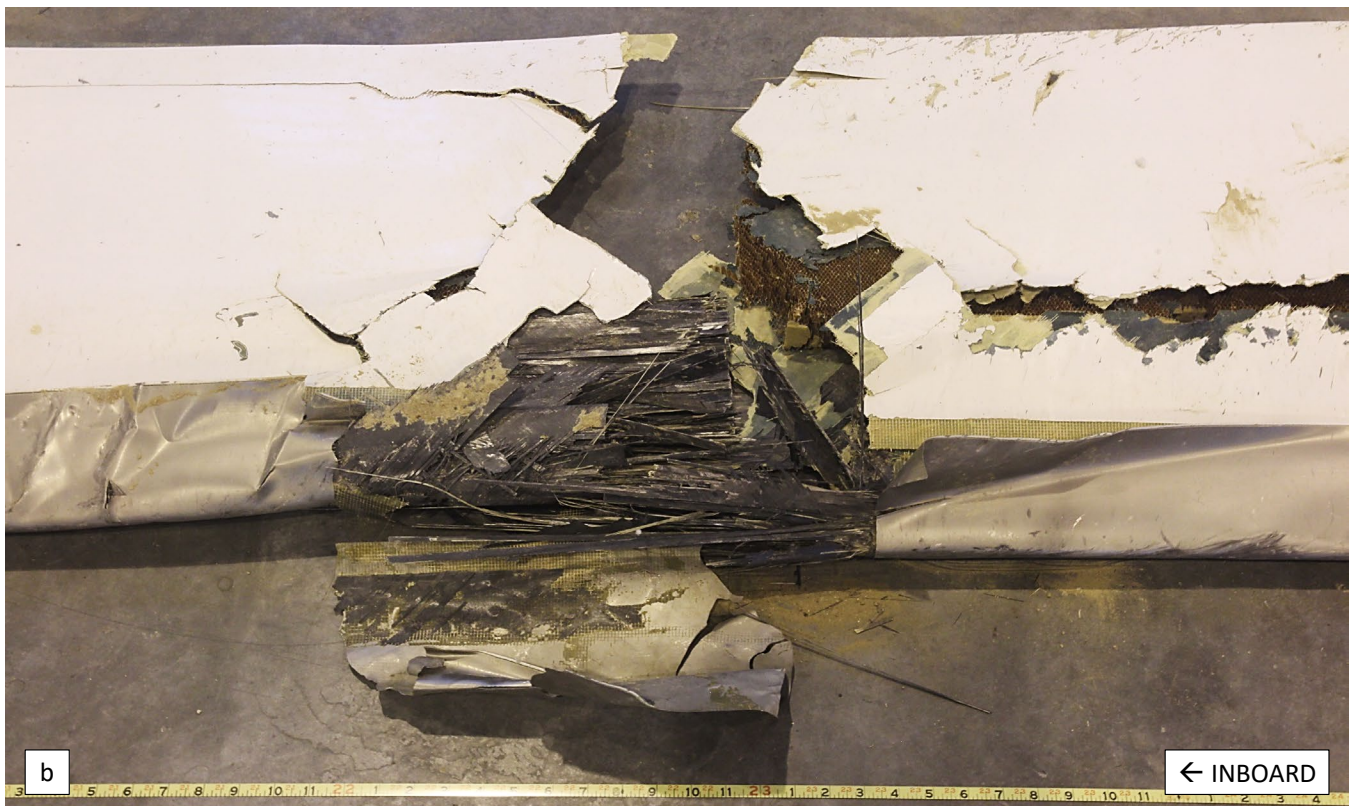
Figure 15: Photograph of the black blade BS 296 fracture location a) upper surface and b) lower surface

The BS 296 blade fracture surface, shown in figure 15, exhibited a fibrous morphology on the leading edge and a relatively flat, translaminar, chordwise fracture surface, with interlaminar and intralaminar features extending into the spar, along the mid and aft spar. A 10 – 12-inch section of the leading-edge cap was separated at the blade fracture location but was recovered. The recovered piece was deformed and torn and retained portions of the spar, scrim cloth, and adhesive used to bond the cap to the spar. Where still attached, the inboard section of leading-edge cap was crushed inward at the highlight immediately adjacent to the fracture surface and buckling, tearing, and peeling deformation was observed. Outboard of this blade fracture, the upper and lower blade skins, and a portion of the afterbody had separated. The skins had separated along the spar-to-afterbody splice joint until midway through the inboard thick red stripe near the tip where it shifted diagonally outboard toward the trailing-edge. The honeycomb core was separated from the spar for approximately 12 inches outboard of the blade fracture and sections of core material near the splice joint remained bonded to the aft surface of the spar, which indicated failure of the afterbody took place primarily within the honeycomb core material transverse to the ribbon direction. The blade fracture features observed were consistent with aft bending and impact loads at fracture and overstress separation of the leading-edge cap.

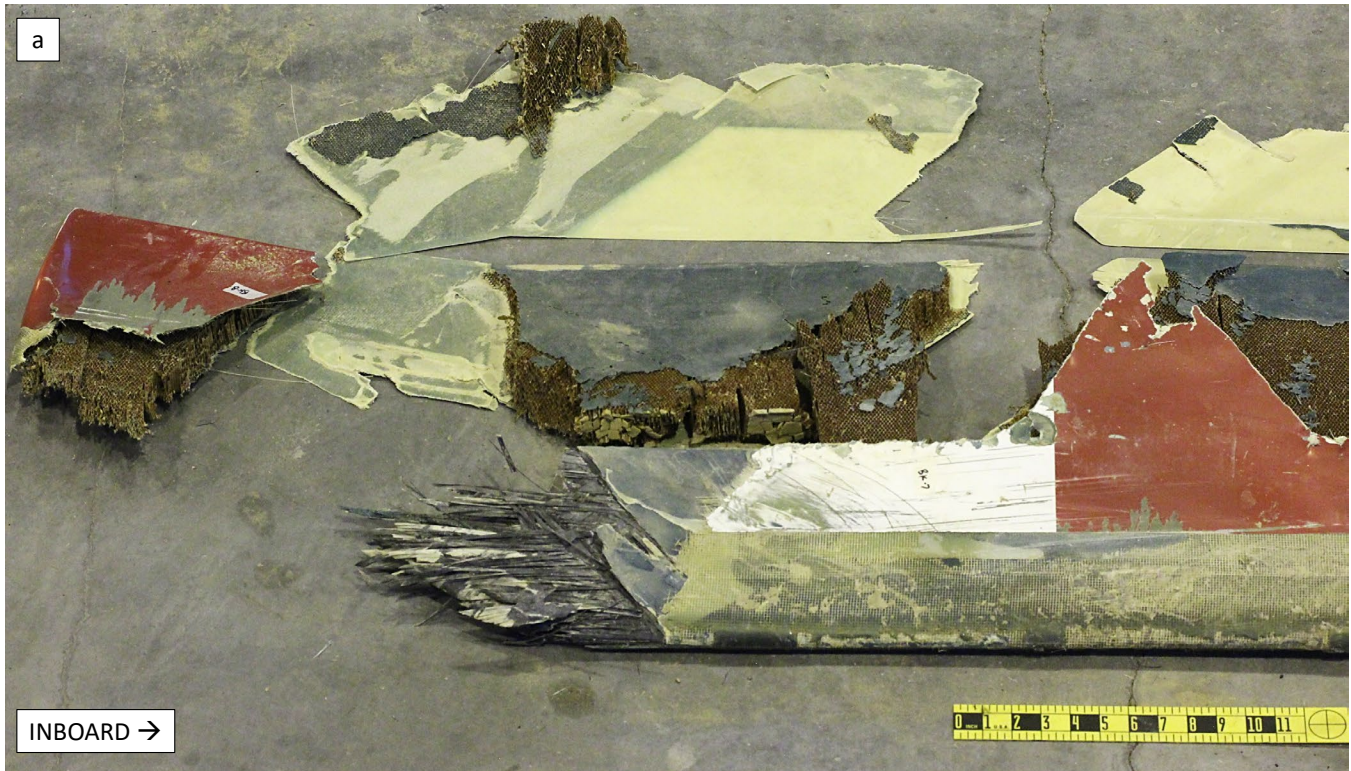
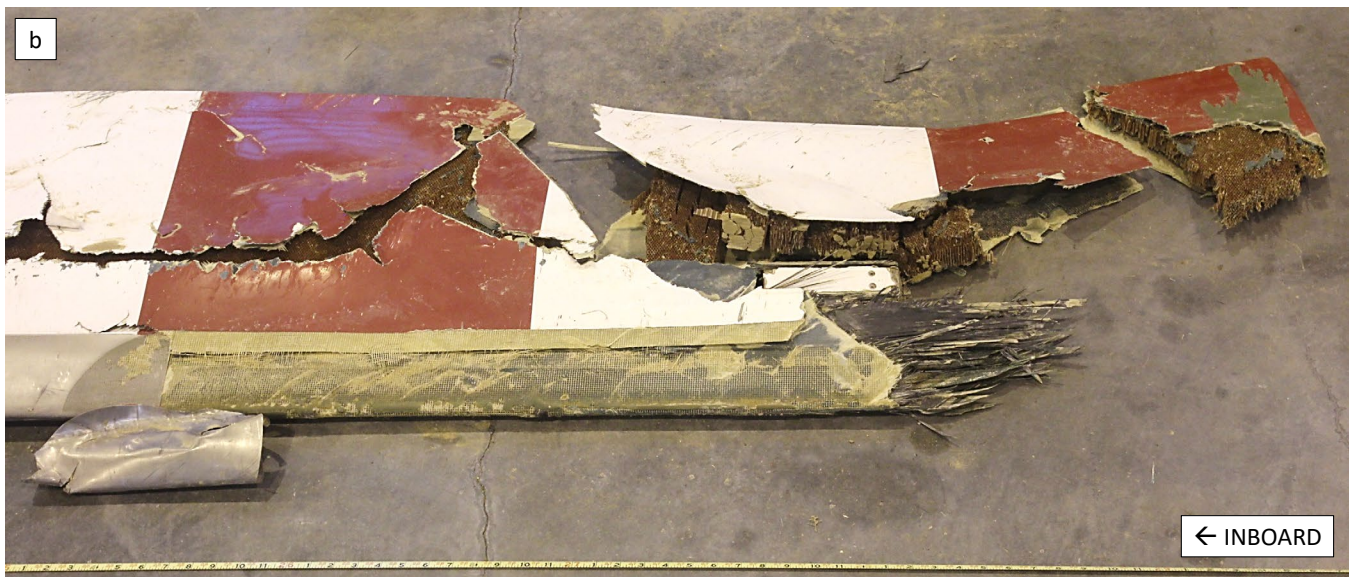
Figure 16: Photograph of the black blade BS 354 fracture location a) upper surface and b) lower surface

The tip section of the blade outboard of approximate blade station BS 354, shown in figure 16, was heavily fragmented through the spar, skin, and core afterbody. The outboard leading-edge cap was separated and not recovered or able to be reconstructed except for a small piece from the area where the outboard leading-edge cap overlapped the inboard leading-edge cap. This small section of leading-edge cap was deformed and buckled, and fracture surfaces were consistent with overstress separation. The surface where the outboard leading-edge cap was bonded exhibited evidence of cohesive failure within the adhesive. Scratched and marred areas of paint on the blade skins emanated from the leading-edge side. The fibrous condition of the spar, and degree of fragmentation of the afterbody in this region was consistent with a leading-edge impact event.

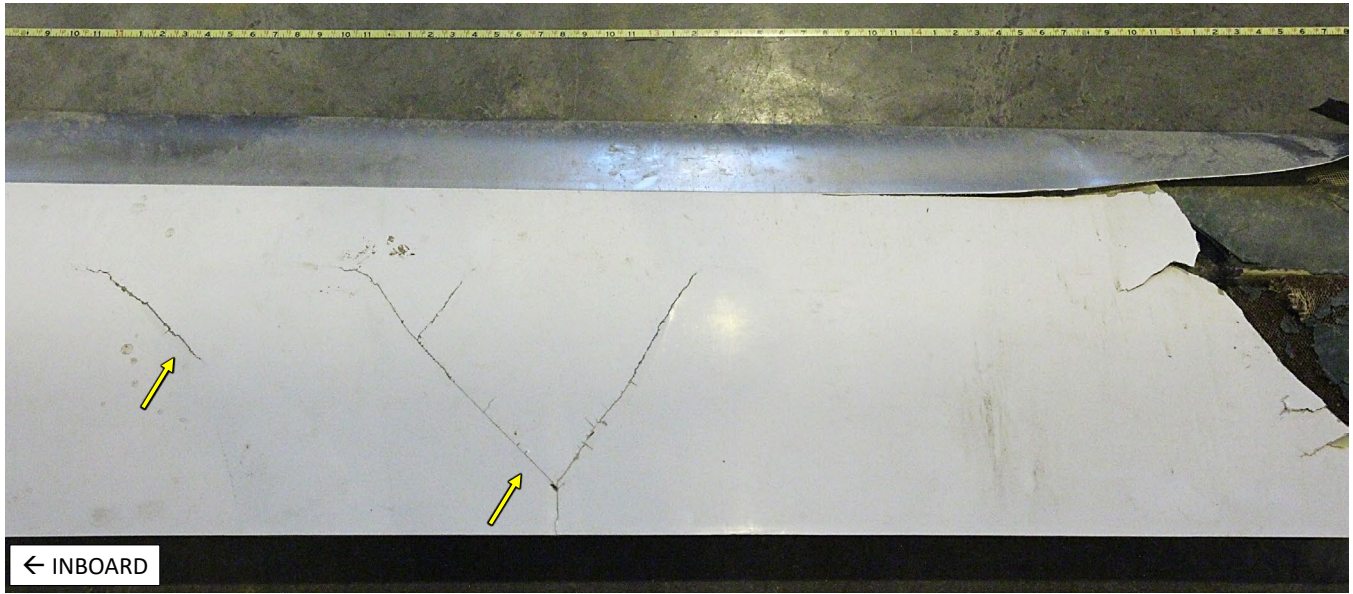
On the lower blade skin, inboard of the BS 215 spar fracture, there were two distinct areas of branched cracking observed approximately 36 and 112 inches inboard of the fracture location, which converged approximately two to four inches from the trailing edge. These branched cracks spread out toward the leading edge at an approximate 70 – 80-degree angle, creating a triangular shaped flap with the attached ligament oriented approximately parallel to the span axis. There were smaller branched cracks observed terminating along the larger primary cracks. A similar diagonal crack in the blade skin was observed spanning outboard from leading edge to trailing edge approximately 48 inches inboard from the spar fracture. Further outboard, a similar triangular shaped flap feature was observed converging at approximate blade station 259 on both the upper and lower blade skins. These triangular shaped flap features and diagonal cracks were observed on the upper and lower blade skins at approximately the same blade station locations. Figure 17 shows a photograph of the branched crack site and similar diagonal crack, indicated by yellow arrows, just inboard of the BS 215 blade fracture on the upper blade surface.

Figure 17: Photograph of branched cracking sites, indicated by yellow arrows, observed on the black blade, upper skin, just inboard of the BS 215 fracture location.

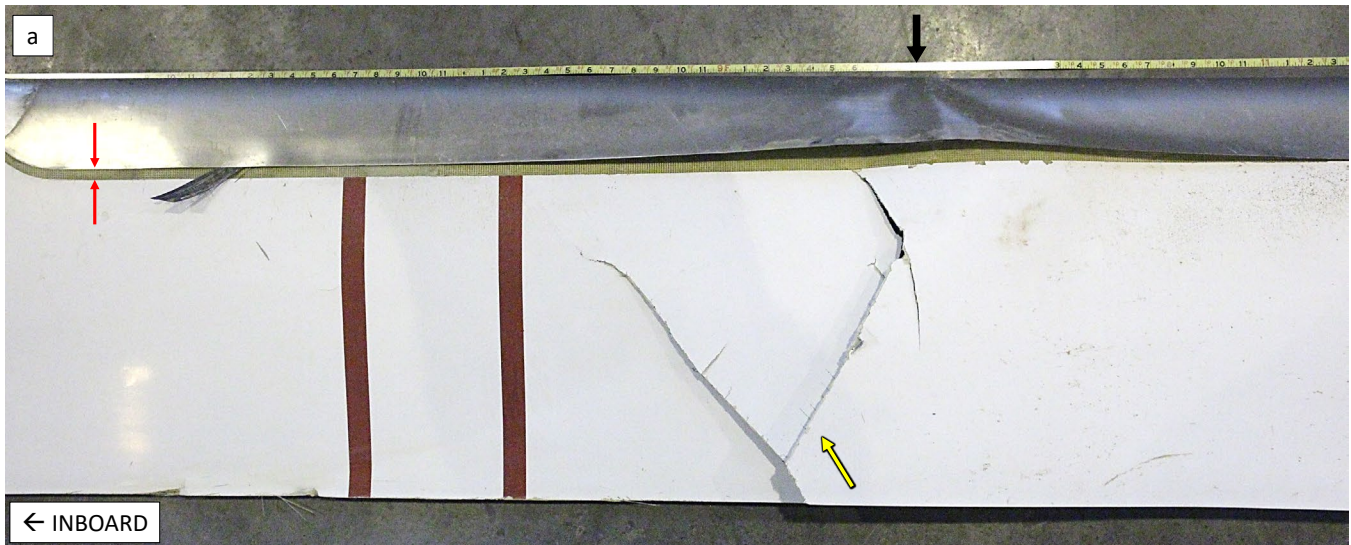
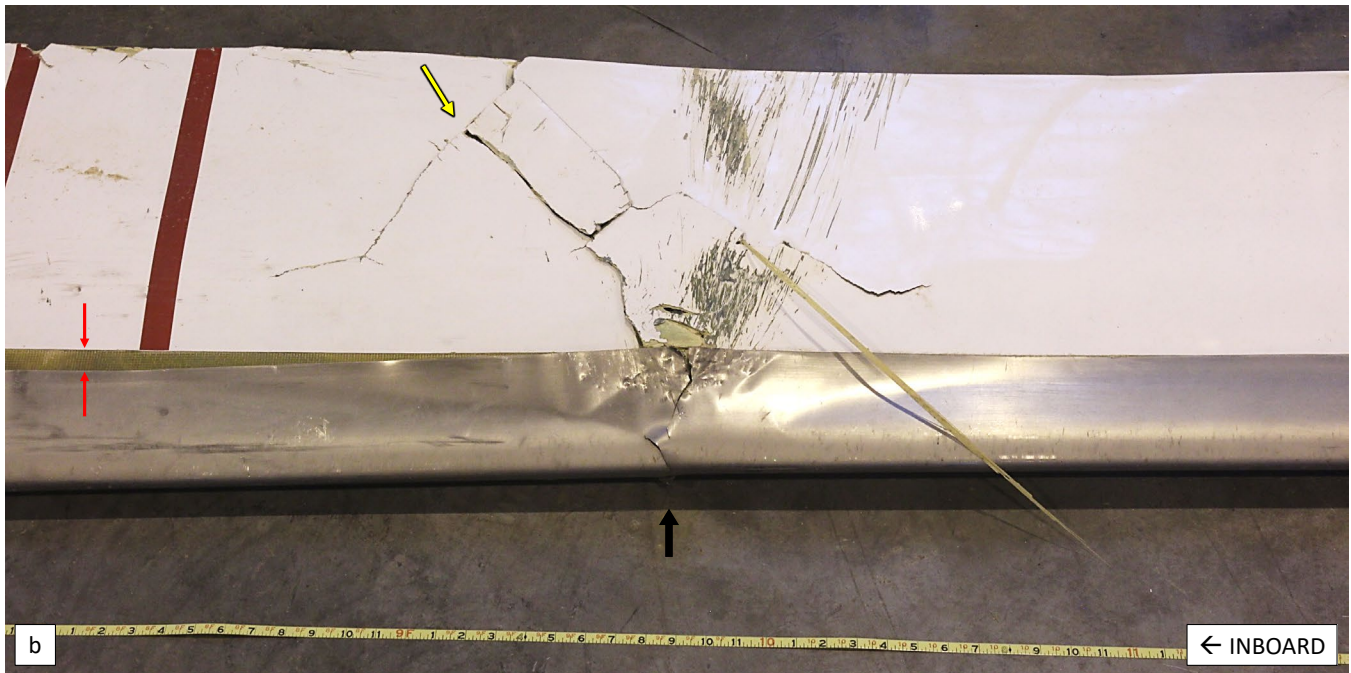
The leading-edge cap was partially separated from the inboard edge, indicated by red arrows in figures 21 and 22, to approximate blade station BS 148, indicated by the black arrow in figure 22, where it was partially fractured, deformed, and buckled. The spar exhibited fiber crushing damage at this location but had not fractured completely. The lower aft edge was battered and dimpled with an adjacent area of dark gray scratches on the lower skin emanating outward towards the trailing edge as shown in figure 22. The leading-edge cap was predominantly intact and adhered to the spar from this area until just inboard of the first complete blade fracture at approximate BS 228, where the cap was fractured and completely separated from the blade. The fracture surfaces were tortuous, deformed, and exhibited shear lip features consistent with overstress separation.

Figure 22: Photograph of the white blade BS 148 (black arrow) leading edge cap and partial spar fracture location a) upper surface and b) lower surface. A branched crack feature is indicated by a yellow arrow and leading-edge cap separation is indicated between red arrows.

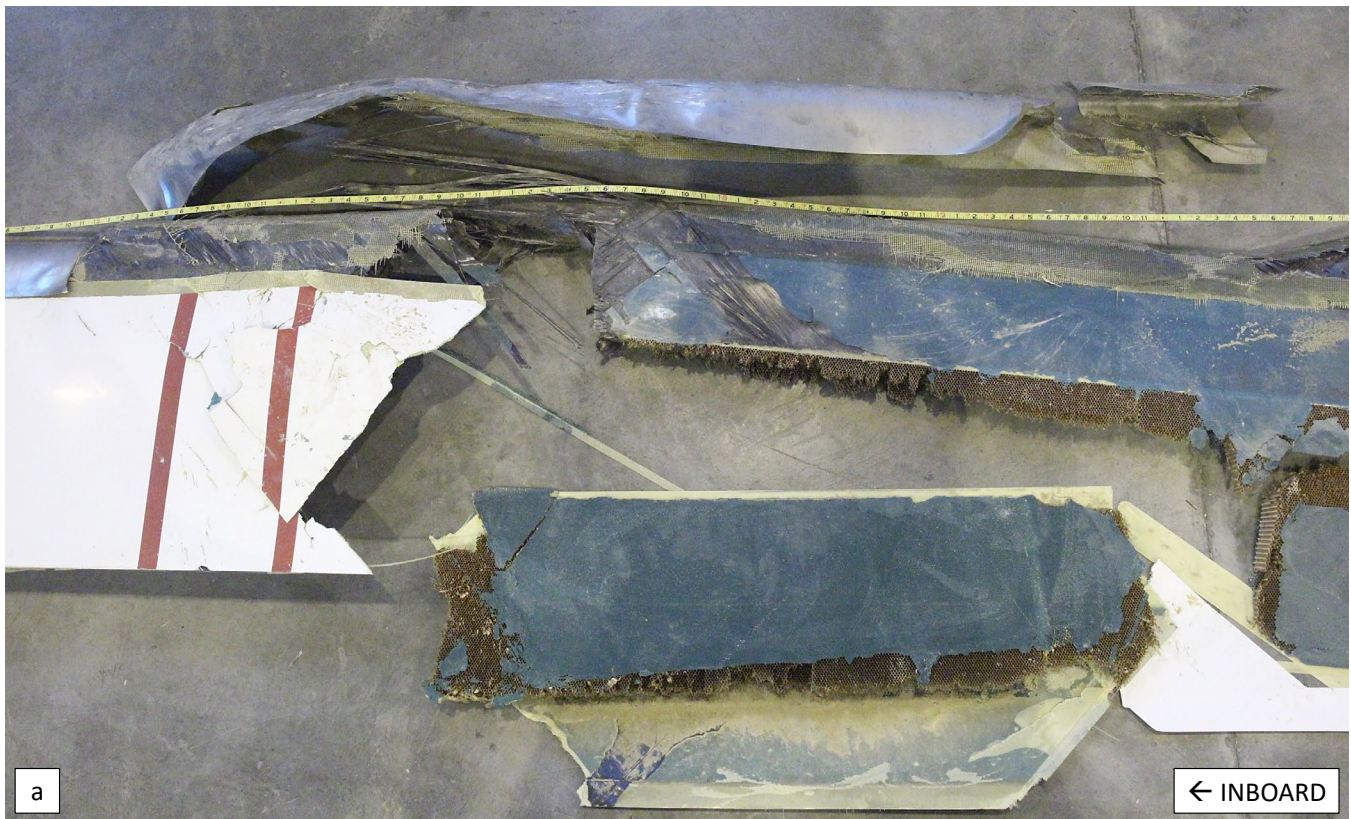
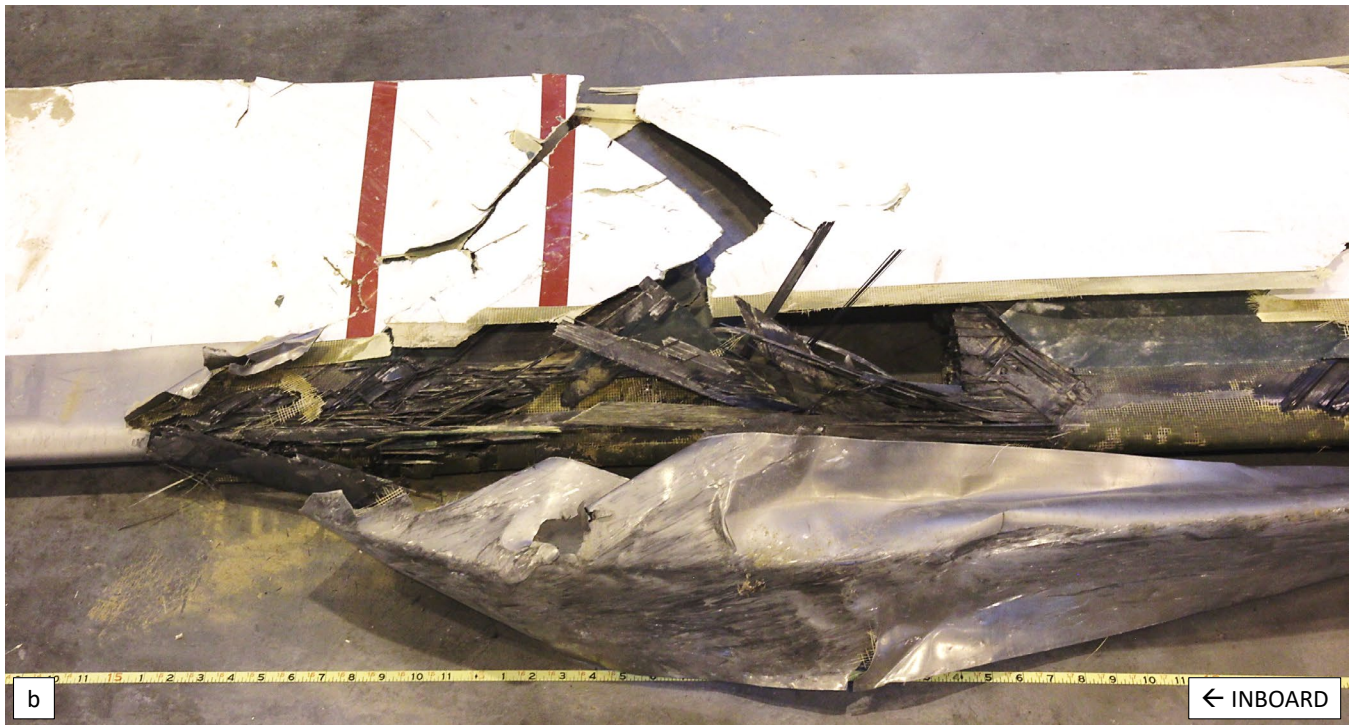
Figure 23: Photograph of the white blade BS 228 fracture location a) upper surface and b) lower surface.

The mating section of leading-edge cap was recovered which was approximately five feet long and spanned the BS 228 spar fracture location, as shown partially reconstructed in figure 23. The outer surface was marred with scratches and dents and the piece was generally buckled, bent aft, and flared open the location where it overlapped the primary spar fracture, consistent with aft bending loading and impact damage. The inner surface had retained local areas of spar material, scrim cloth, and adhesive and was consistent with a cohesive separation.

The BS 228 blade fracture, shown in figure 23, exhibited fiber pull-out at the leading edge of the spar and was relatively flat chordwise over the mid to aft spar region, where extensive chordwise translaminar fracture features were observed. Extensive interlaminar and intralaminar fracture features were observed extending into the blade away from the primary fracture surfaces. These fracture features were consistent with aft bending loading at the time of fracture.
