NATIONAL TRANSPORTATION SAFETY BOARD

MATERIALS LABORATORY FACTUAL REPORT

Report No. 20-062

Place : Camp Dwyer, Afghanistan
Date : April 20, 2020
Vehicle : Sikorsky S-61N, N908CH
NTSB No. : DCA20LA100
Investigator : Dan Bower, AS-10

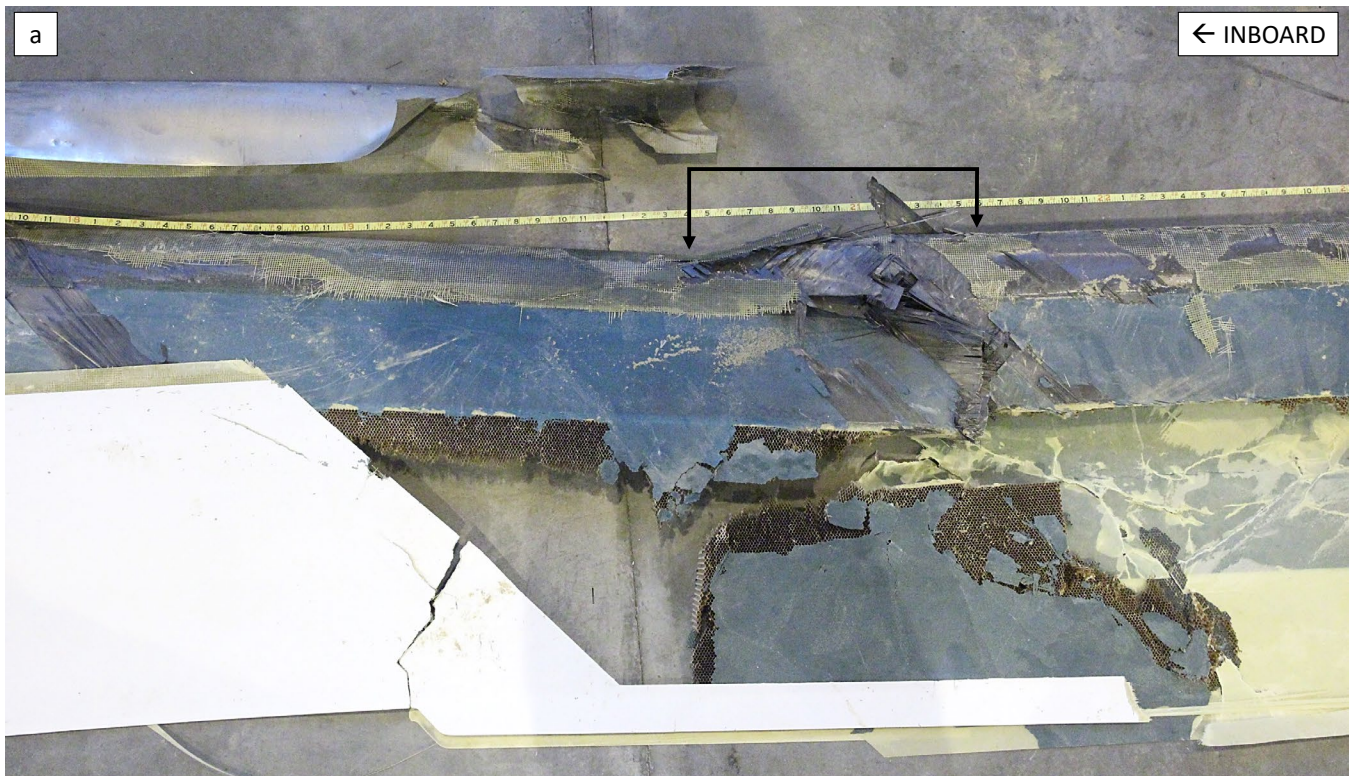
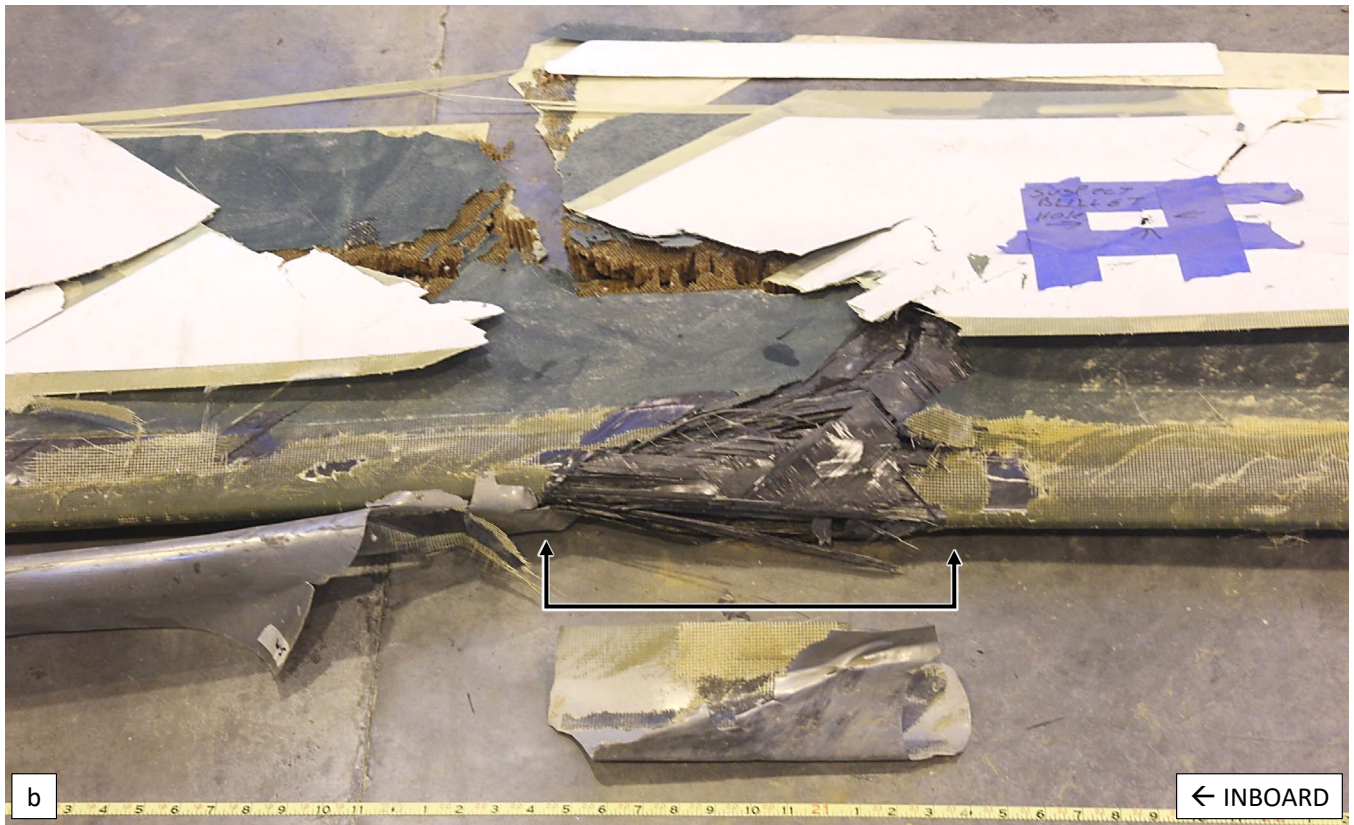
Figure 24: Photograph of the white blade BS 263 – 276 fracture location a) upper surface and b) lower surface.

The BS 263 blade fracture, shown in figure 24, exhibited a fibrous morphology over a span of approximately 13 inches, indicated by the black bracket, at the leading edge through the mid-spar where relatively flat chordwise translaminar fracture features were observed through the aft spar. Extensive interlaminar and intralaminar fracture features were observed extending into the blade away from the primary fracture surfaces. These fracture features were consistent with aft bending loading at the time of fracture.

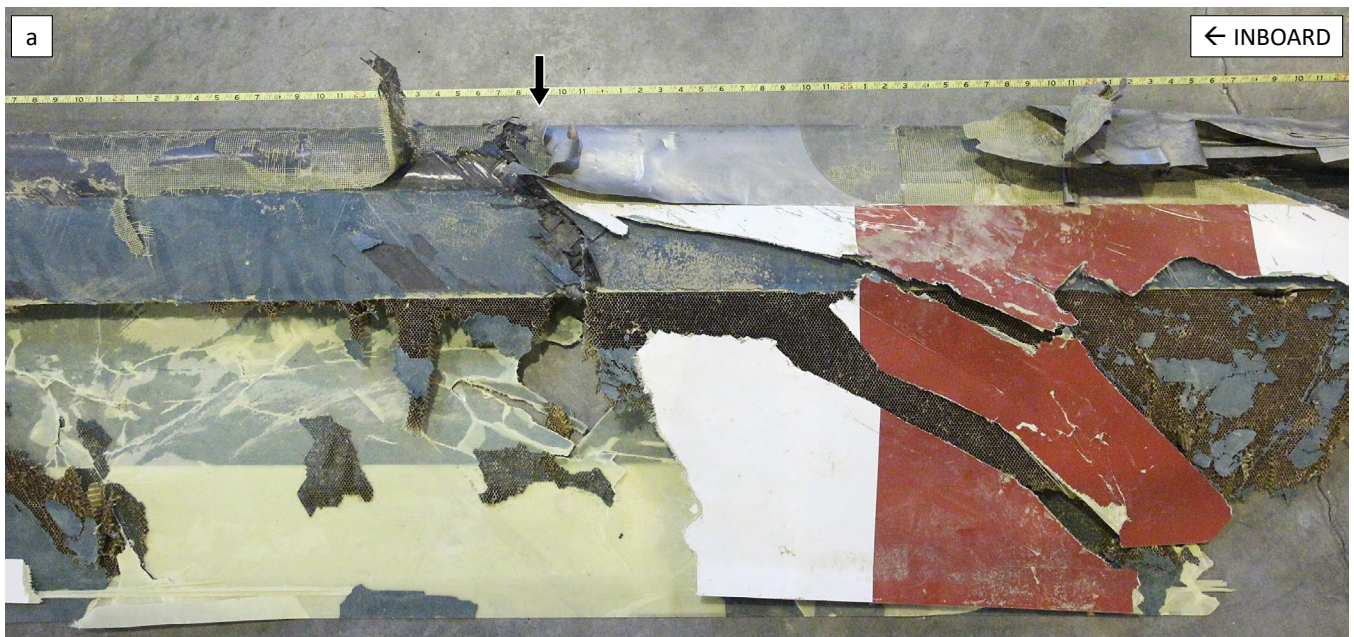
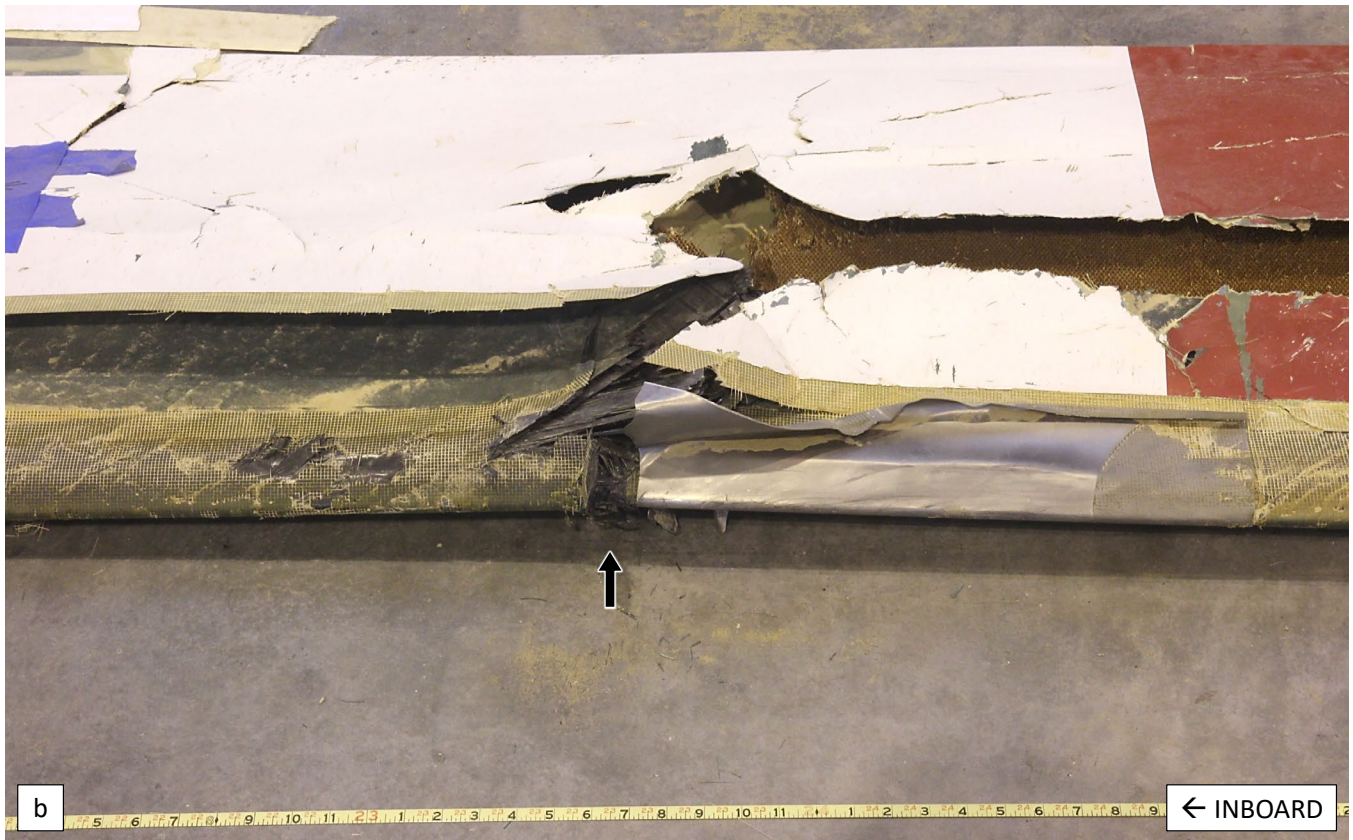
Figure 25: Photograph of the white blade BS 299 – 307 (black arrow) fracture location a) upper surface and b) lower surface.

The BS 300 blade fracture, shown in figure 25, exhibited a predominantly translaminar fracture morphology traversing outboard through the spar from the leading edge along an approximate 8-inch span, with more fibrous features observed at the leading edge. The leading-edge cap outboard of this fracture location was still attached to the blade along the leading-edge highlight, but was deformed, torn, and peeled away from the blade adjacent to the fracture.

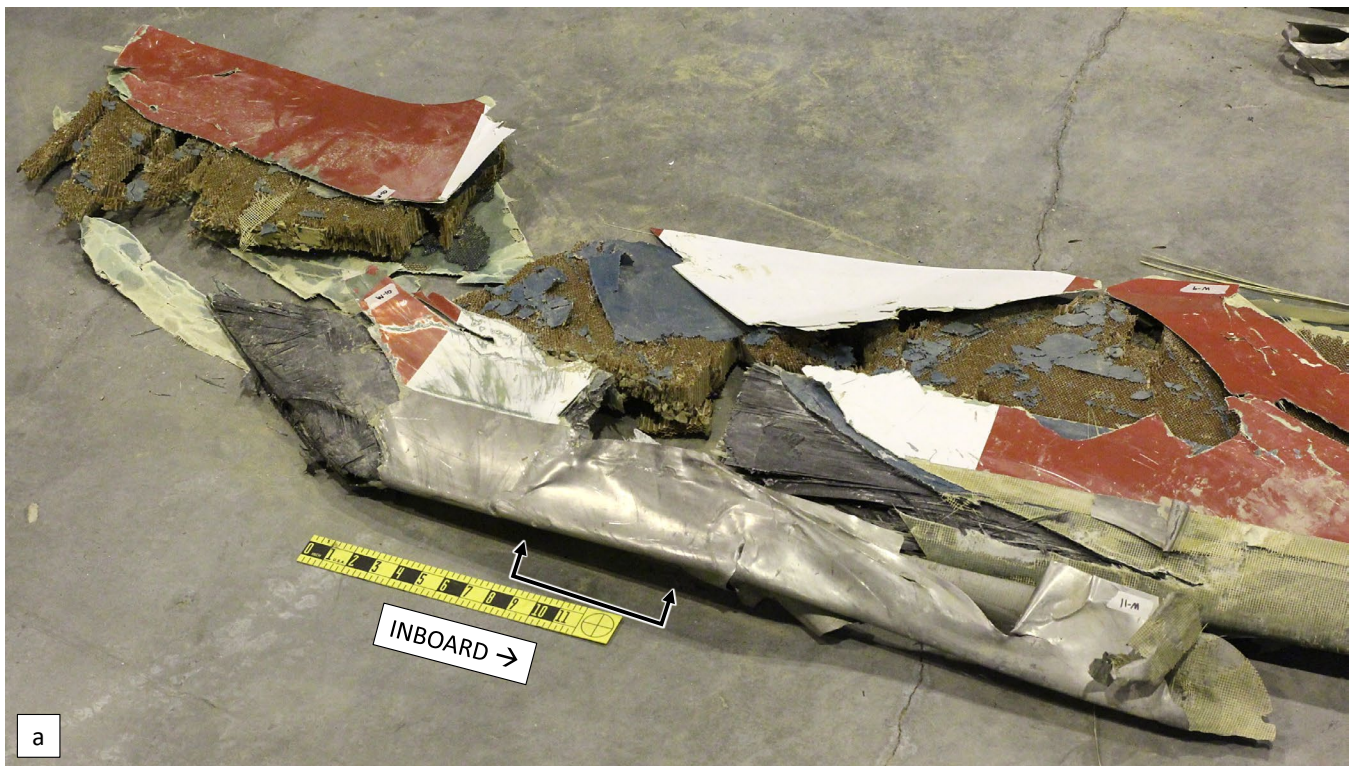
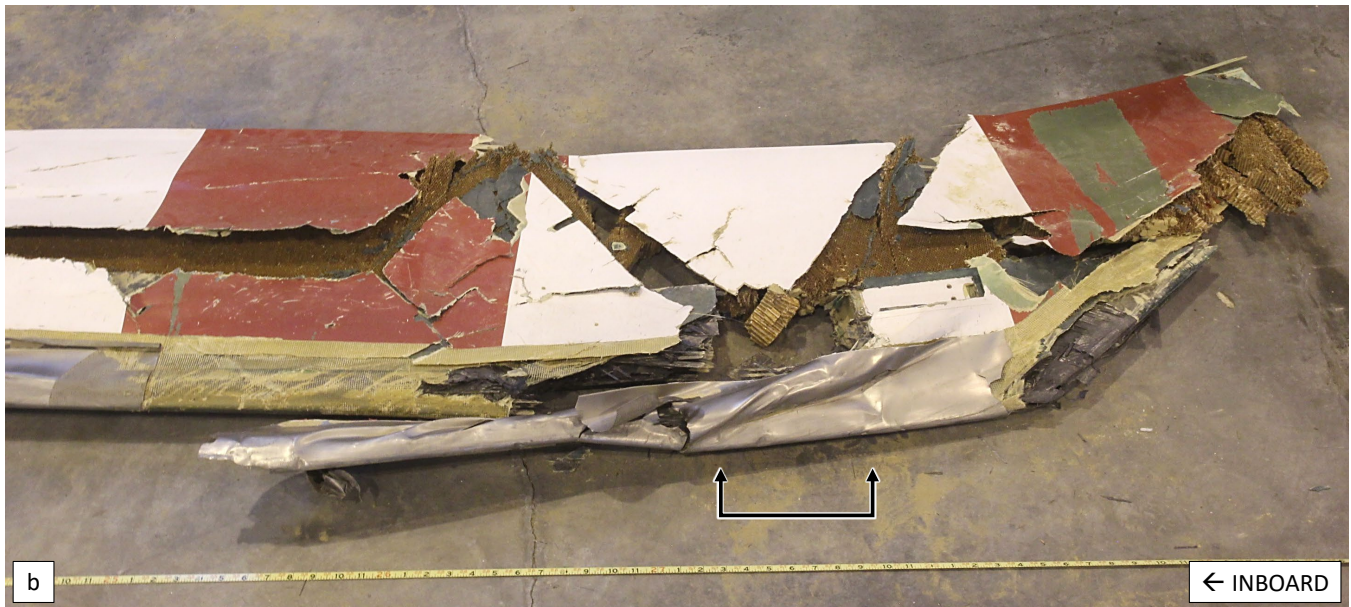
Figure 26: Photograph of the white blade BS 347 (between black arrows) fracture location a) upper surface and b) lower surface.

The outboard leading-edge cap detail was separated from the spar at the overlap joint with the inboard detail but was still attached to a piece of fractured spar adjacent to the tip weight fitting near BS 347 as shown in figure 26 indicated by black arrows. This section of the outboard leading-edge cap detail was deformed, twisted, torn, and buckled where it had separated from the blade. The outboard edge of the leading-edge cap at the tip weight fitting was separated and there was no leading-edge cap recovered or able to be reconstructed outboard of the tip weight fitting along the swept blade tip. At the blade tip, the spar was crushed and delaminated. The core afterbody and blade skin was fragmented and tattered. The blade skin surface exhibited dark green areas where paint had been removed. The scarred surface appearance, degree of fragmentation, crushed condition of the spar, and leading-edge cap deformation where recovered was all consistent with leading edge impact damage.

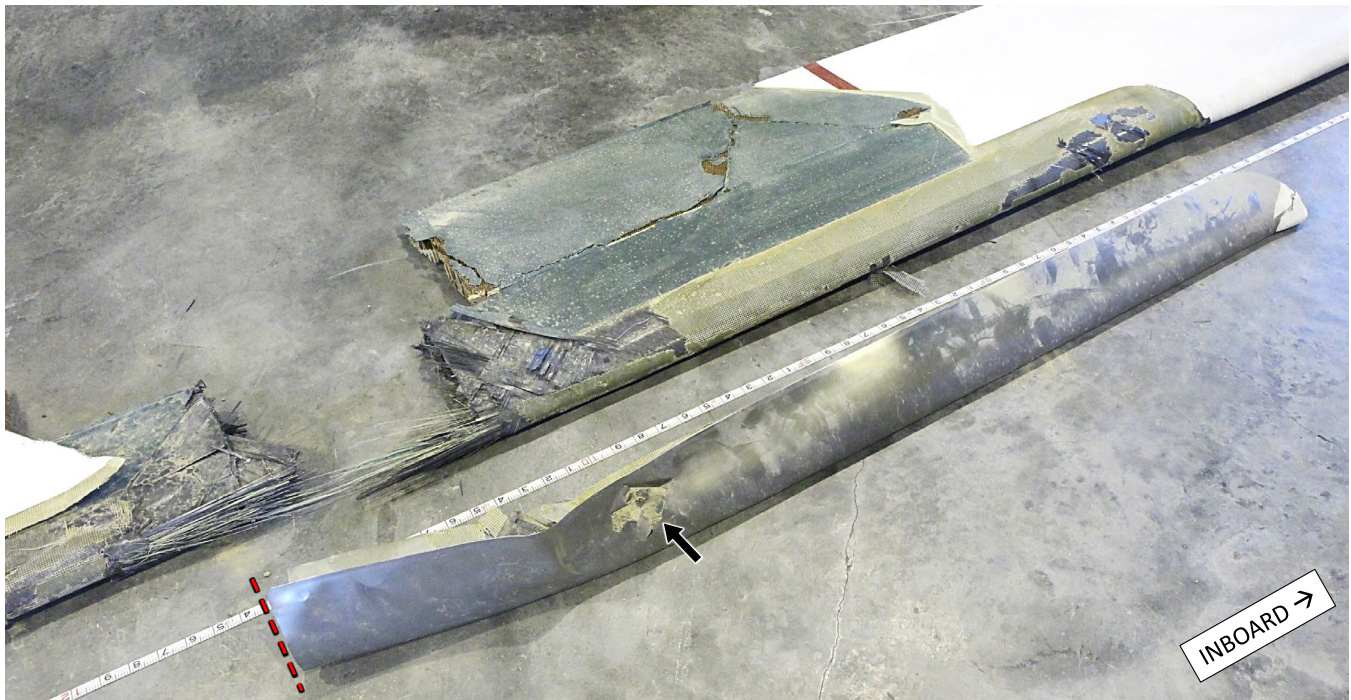
A section of the leading-edge cap, approximately five feet long from the inboard edge to a chordwise fracture, was recovered that had completely separated from the blade as shown partially reconstructed in figure 29. The recovered section was flared open, buckled, and bent slightly aft at the location where it overlapped a primary spar fracture at BS 153. There was no notable scarring or impact damage observed on the outer surface. The inner surface retained local portions of spar material, scrim cloth, and adhesive and was consistent with predominantly cohesive failure at separation. There was an irregular shaped hole feature, approximately 1.5 – 2.5 inches in diameter, on the upper surface just inboard of the spar fracture location which exhibited tearing and inward deformation around the periphery as indicated by the arrow. There was no evidence of a through-hole in the corresponding area of the spar nor any visible scrape-like witness marks around the hole periphery on the outer surface. The bond surface of the leading-edge cap around this feature contained remnants of adhered spar plies. This was consistent with deformation and tearing during separation and inconsistent with puncture of a foreign object.

Figure 29: Photograph of a fractured (red dashed line) and separated piece of leading-edge cap from the yellow blade which spanned the BS 153 fracture location as viewed from the upper surface. A hole was observed in the leading-edge cap, indicated by the black arrow.

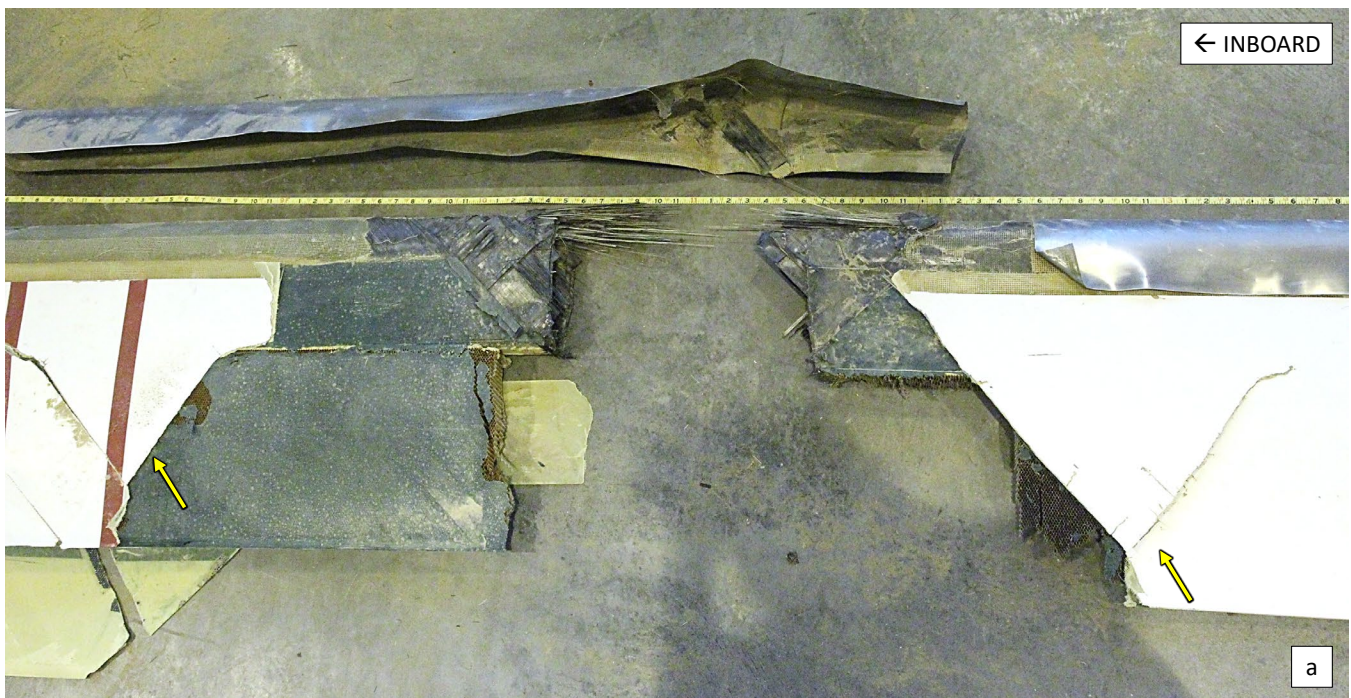
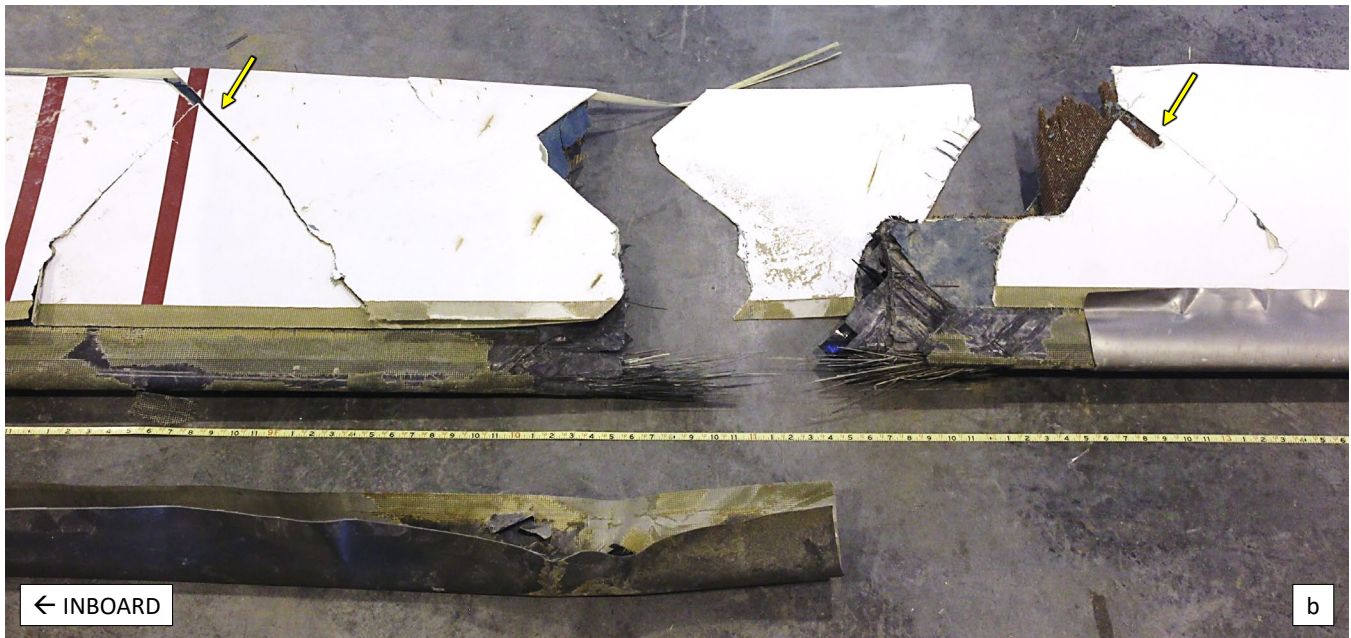
The BS 153 blade fracture, shown in figure 30, exhibited fiber pull-out at the leading edge of the spar, followed by slanted ply separation oriented along internal +/- 45° ply levels, and was relatively flat chordwise, over the mid to aft spar region, where chordwise translaminar fracture features were observed. Extensive interlaminar and intralaminar

fracture features were observed extending into the blade away from the primary fracture surfaces. A section of honeycomb core after-body approximately 12 inches in length, which spanned the blade fracture, was not recovered or able to be reconstructed. Remnants of honeycomb core were observed adhered to the aft surface of the spar which indicated failure occurred within the honeycomb core. The spar fracture features, separated section of afterbody, deformation/separation of the leading-edge cap were all consistent with an aft bending load at fracture.

Figure 30: Photograph of the yellow blade BS 153 fracture location a) upper surface and b) lower surface. Branched crack features are indicated by yellow arrows.

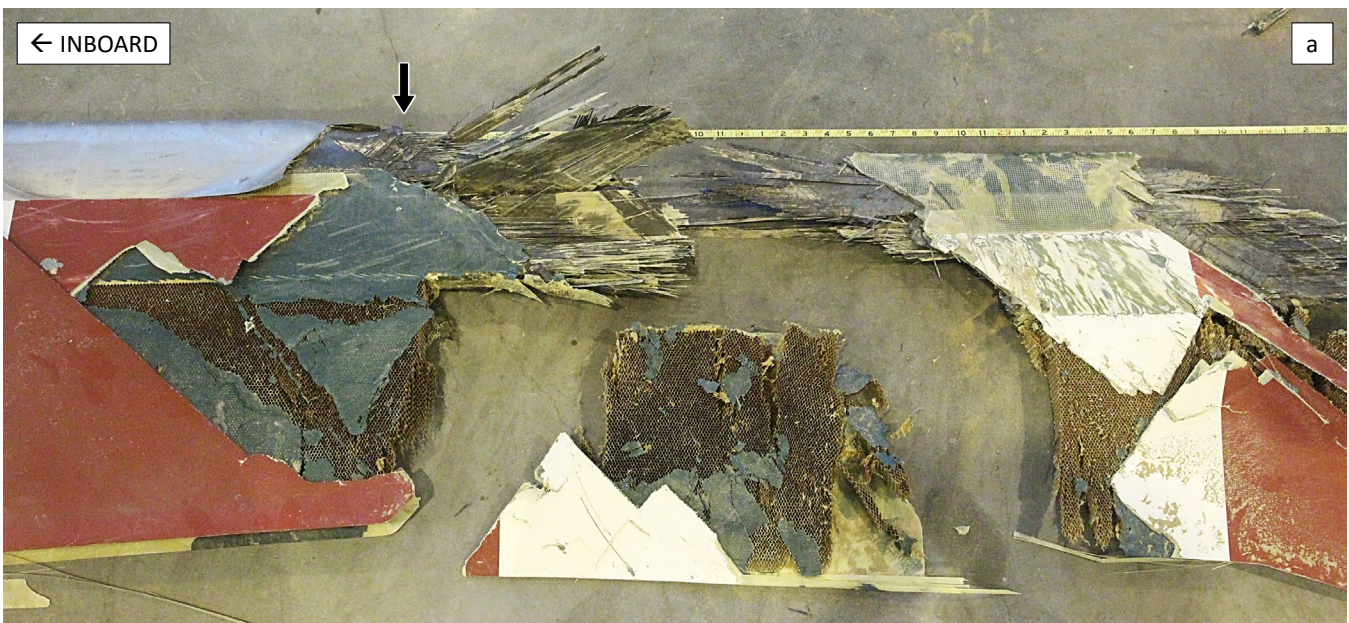
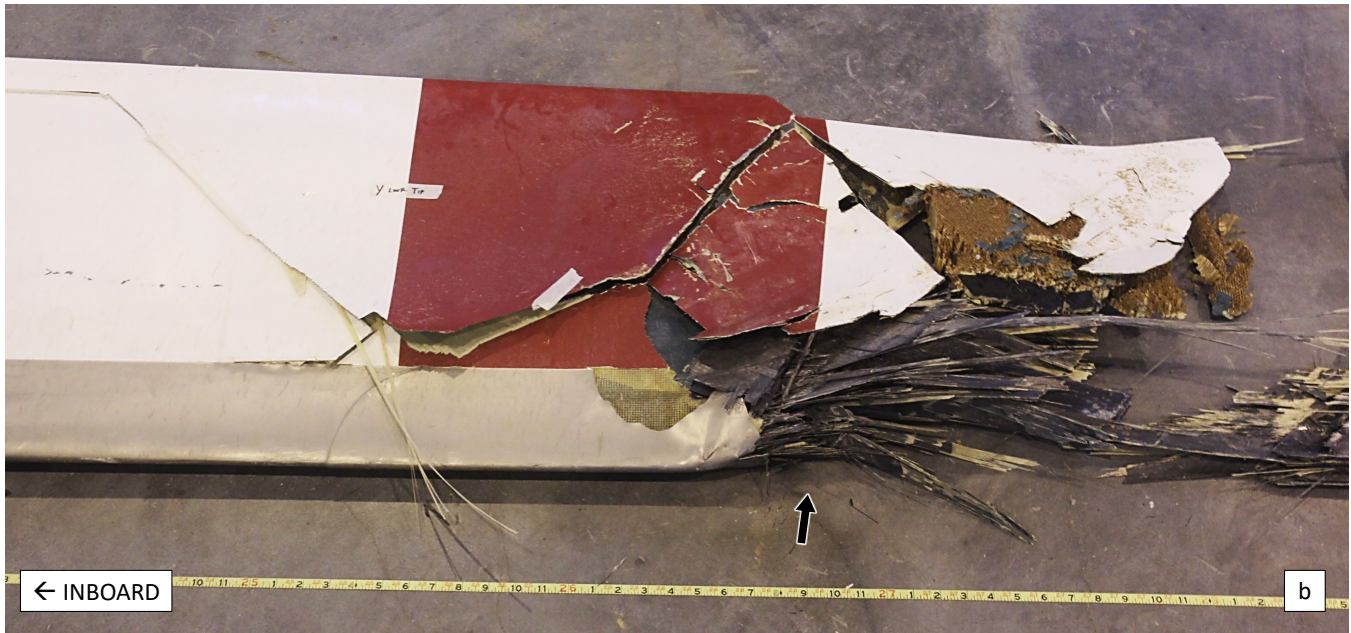
Figure 33: Photograph of the yellow blade BS 332 – 336 (black arrow) fracture location a) upper surface and b) lower surface.

The outboard spar fracture at approximate blade station BS 332, shown in figure 33, exhibited a crushed appearance and predominantly fibrous morphology with splinters projecting outboard approximately 25 inches from the torn leading-edge cap. The leading-edge cap at this location, shown in figure 34 indicated by a yellow arrow, was crushed inward and flattened at the highlight where a dark gray witness mark was evident with localized tearing observed around this mark. There were no additional outboard leading-edge cap pieces recovered or able to be reconstructed. The rotor blade tip section was fragmented and areas of the spar and afterbody were not recovered or able to be confidently reconstructed. These features at the blade tip section were consistent with impact loading at

fracture. The angled crack features present on the upper and lower blade skins and primary spar fracture surface morphologies were consistent with aft bending loading at fracture.

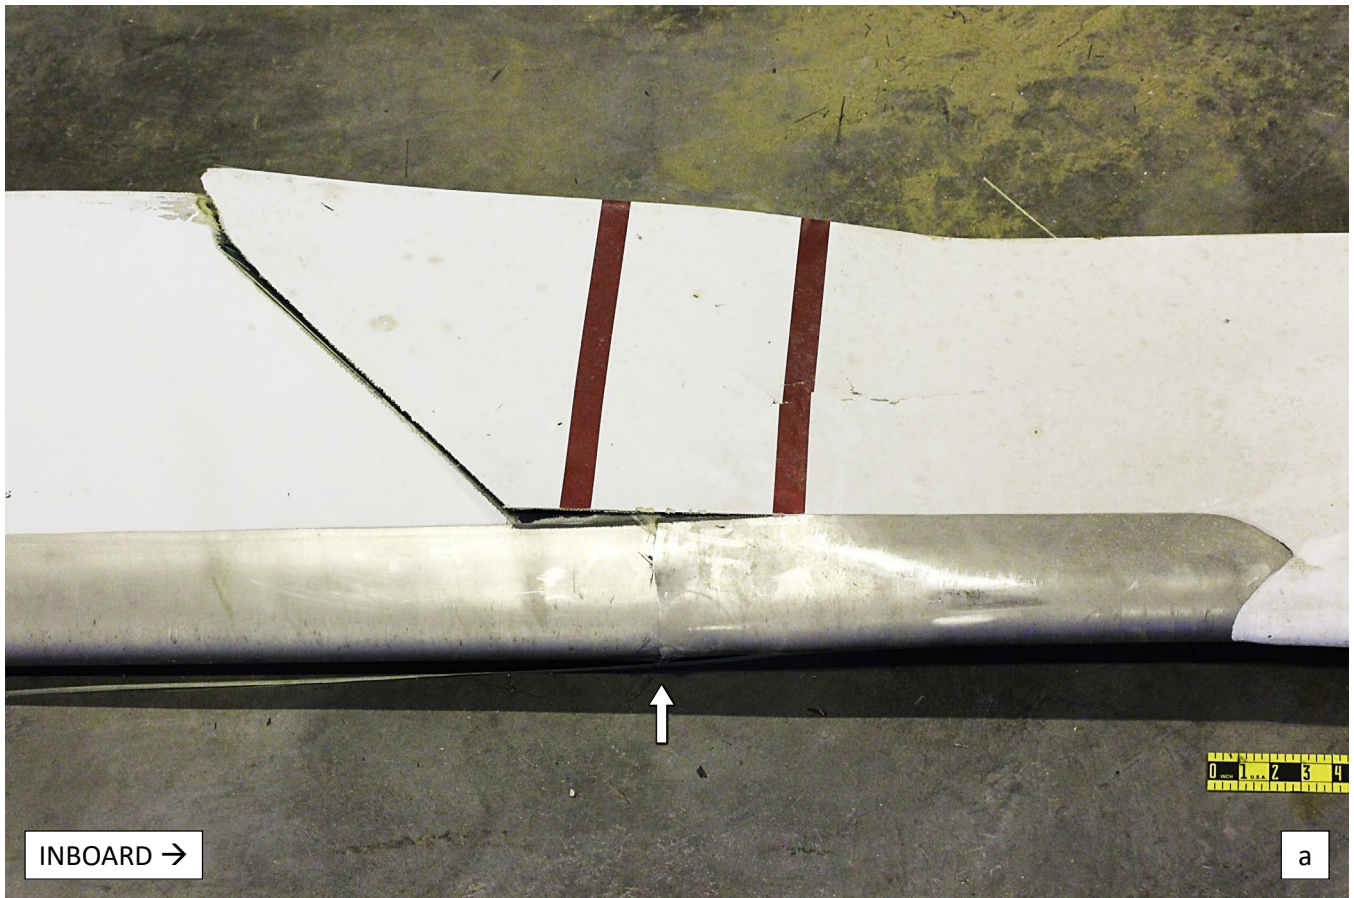
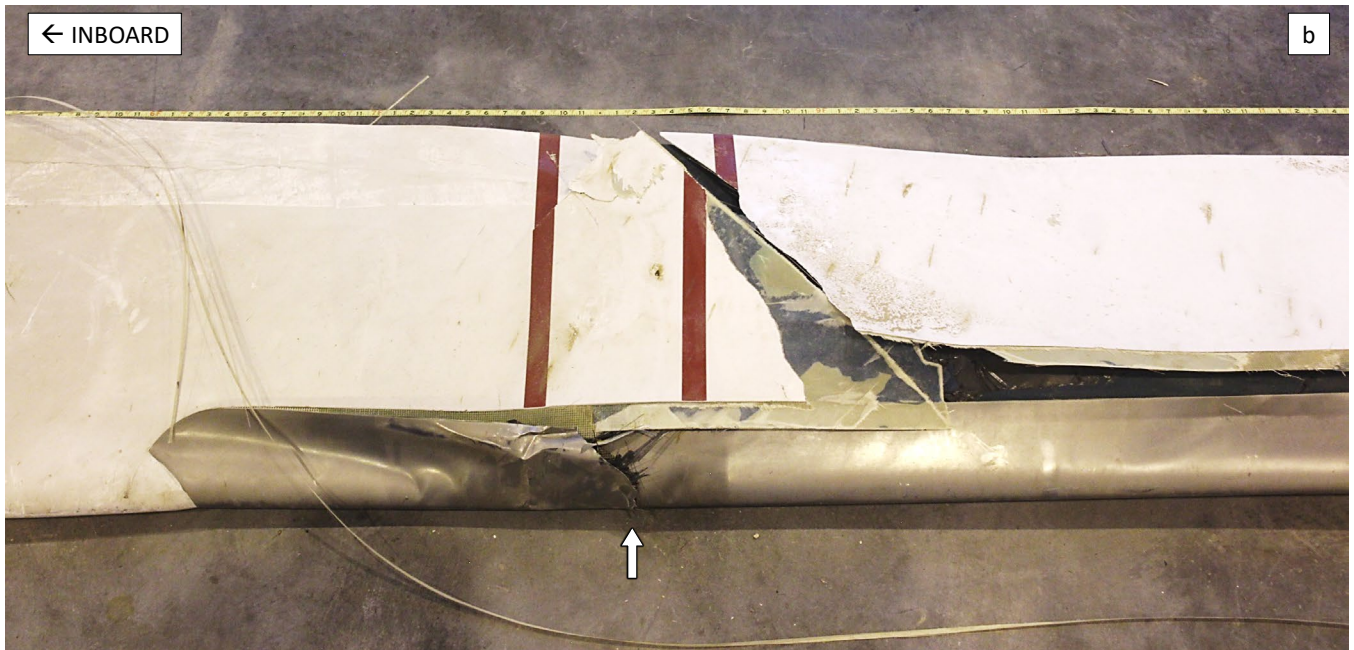
The leading-edge cap was fractured at approximate blade station BS 125, as indicated by a white arrow in figure 37, and exhibited a rough and deformed morphology with shear lip features consistent with overstress tearing. The aft edge of the leading-edge cap had peeled away from the lower skin and was deformed and buckled but still partially adhered to the spar leading-edge inboard and outboard of the fracture. There were broken fibers from the spar protruding through the torn leading-edge cap, but the blade was not completely separated at this location.

Figure 37: Photograph of the blue blade BS 126 (white arrow) fracture location a) upper surface and b) lower surface.
