NATIONAL TRANSPORTATION SAFETY BOARD

MATERIALS LABORATORY FACTUAL REPORT

Report No. 20-063

Place : Tempe, AZ
Date : July 29, 2020
Vehicle : Union Pacific Railroad (UP) freight train MTUPX-29
NTSB No. : RRD20LR005
Investigator : Richard Hipskind (RPH-10)

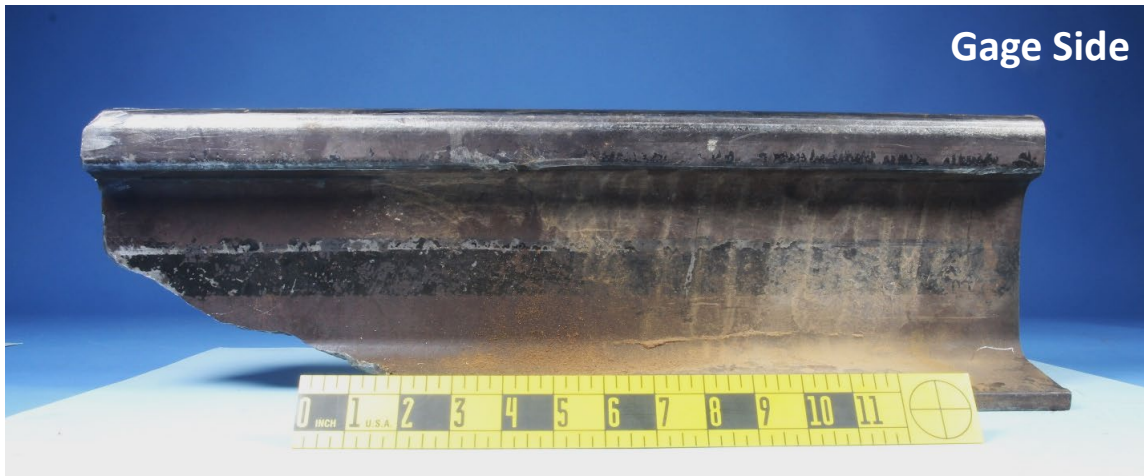
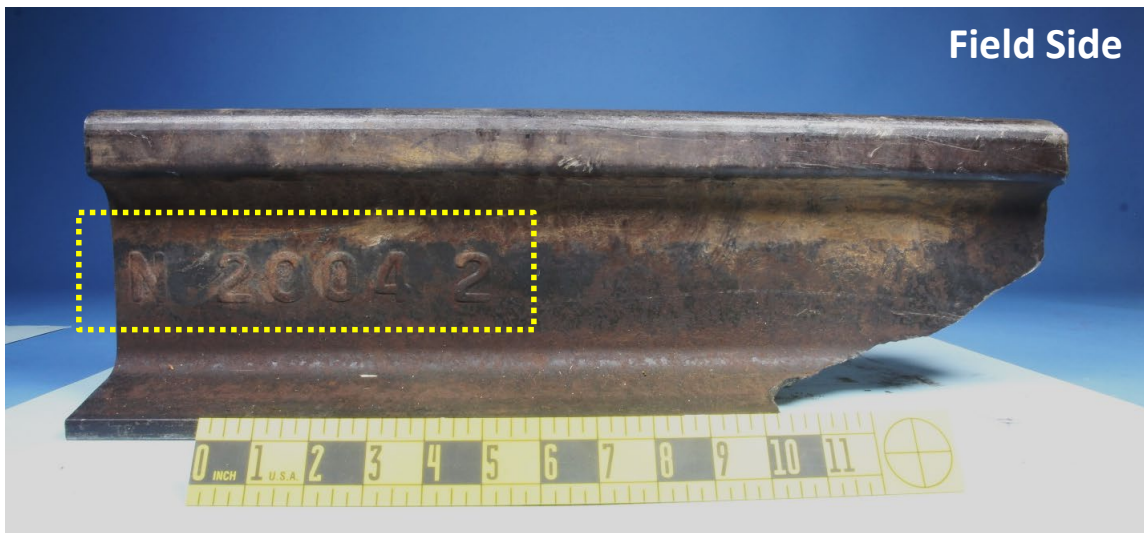
Piece 3W is shown in Figures 1-4 in the as-received condition. Piece 3W had raised markings on the field side of the web that read "N 2004 2". The markings indicate the rail was manufactured by Nippon Steel Corporation in February 2004. Manufacturer records indicated the rail size was 136 pound rail¹. The fracture through piece 3W propagated transversely down from the running surface until approximately mid-web, then turned and propagated longitudinally at roughly 45 degrees along the length of the rail until it reached the bottom of the base. The shape of the fracture surface is shown in Figure 2. Batter and gouges from wheel impact were observed on the running surface of the rail adjacent to the fracture, as shown in the bottom image of Figure 3. Shiny wear was observed on the bottom surface of the base near the cut edge. The yellow dashed line in Figure 4 indicates a wear line across the bottom surface of the base consistent with a tie mark².

Figure 1: Macro photos of the gage and field sides (top and bottom, respectively) of piece 3W. The yellow dotted line outlines raised markings on the field side web.

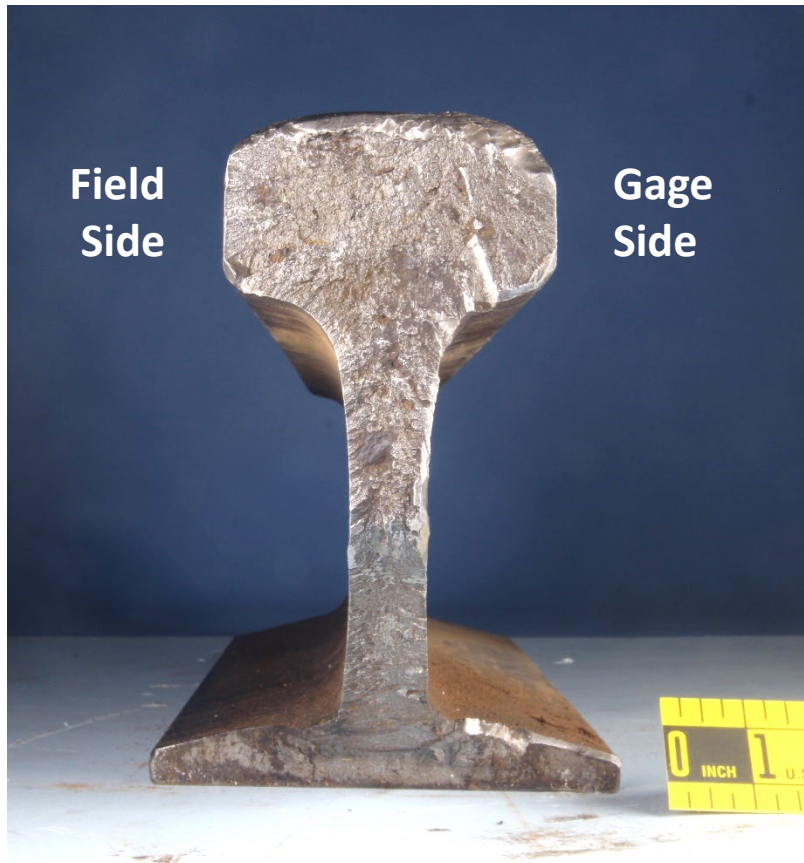
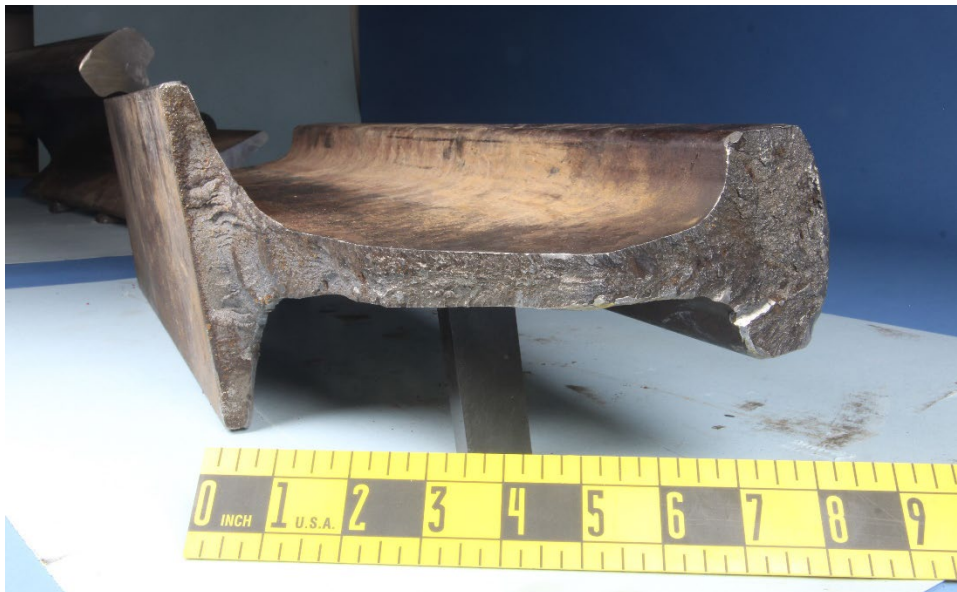
Figure 2: Macro photos of the fracture surface on piece 3W.

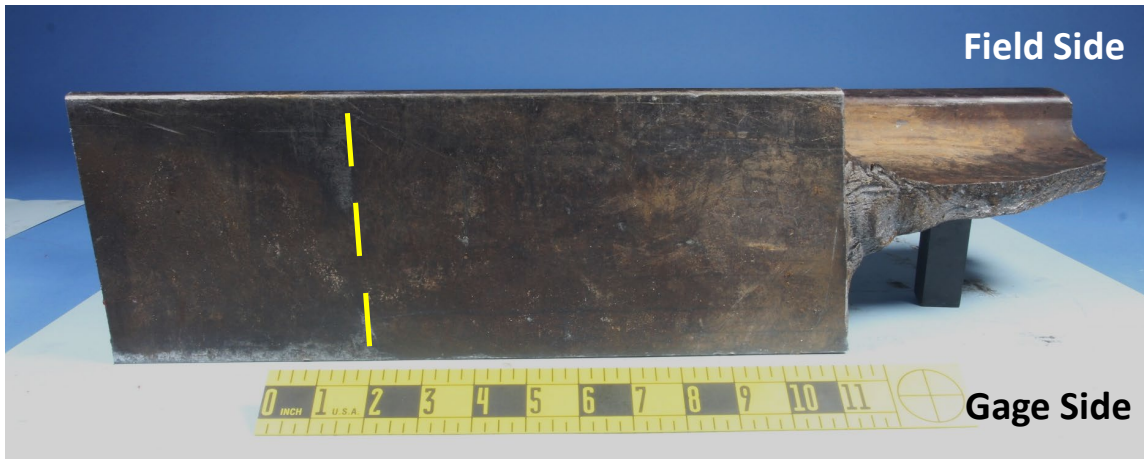
Figure 4: Macro photo of the bottom surface of the base of piece 3W. The yellow dashed line indicates a tie mark.

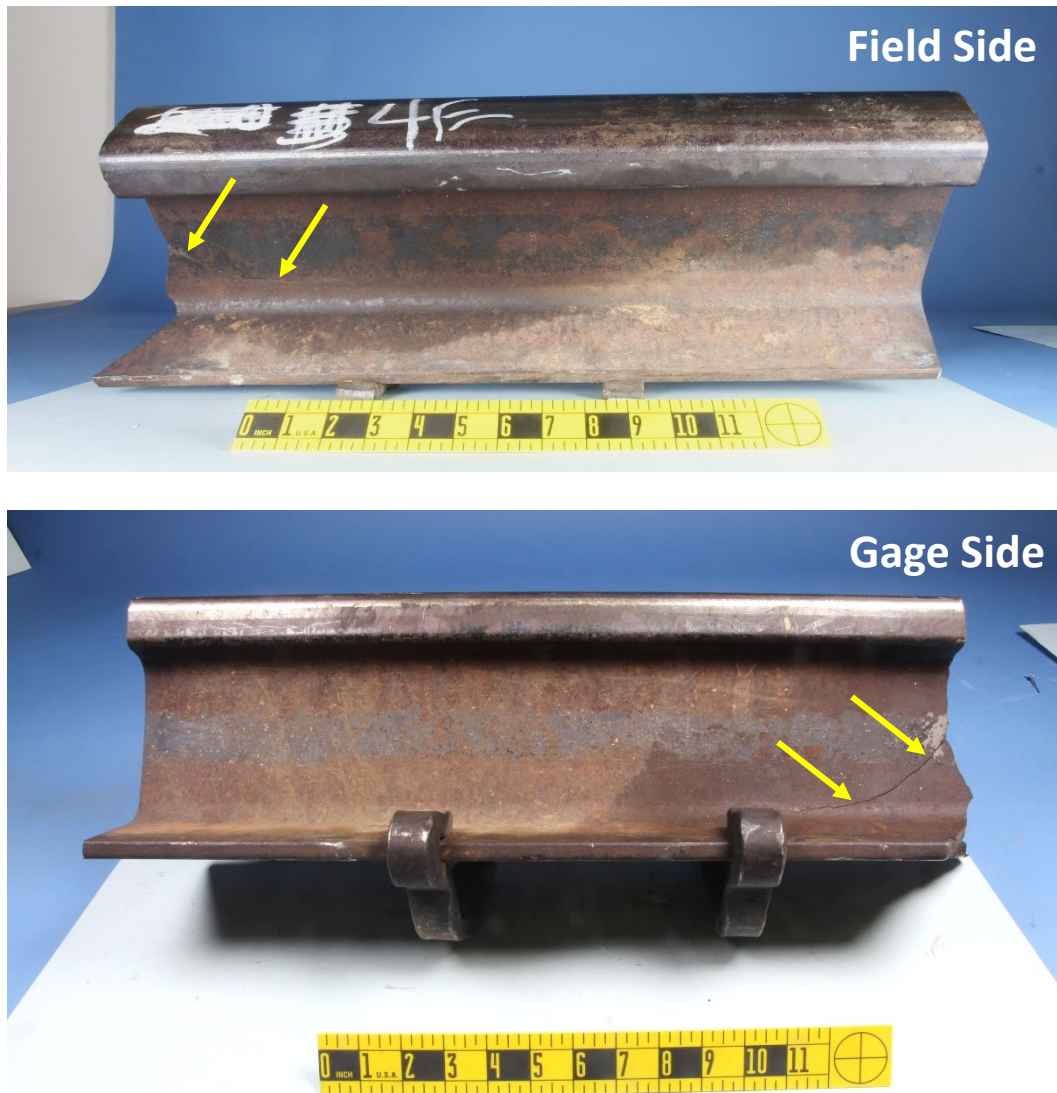
the base. A crack (yellow arrows, Figures 5 and 6) was observed branching from the fracture surface at about mid-web. The crack propagated at approximately a 45 degree angle along the longitudinal length of the rail. The running surface adjacent to the fracture surface was smooth with very little damage, as shown in Figure 7. Wear was observed on the bottom surface of the base near the cut edge similar to the wear on piece 3W. Piece 4E also had a wear line across the bottom surface of the base consistent with a tie mark, as indicated by the yellow dashed line in Figure 8.

Figure 5: Macro photos of the field and gage sides (top and bottom, respectively) of piece 4E. The yellow arrows point to a longitudinal crack branching from the transverse fracture surface.

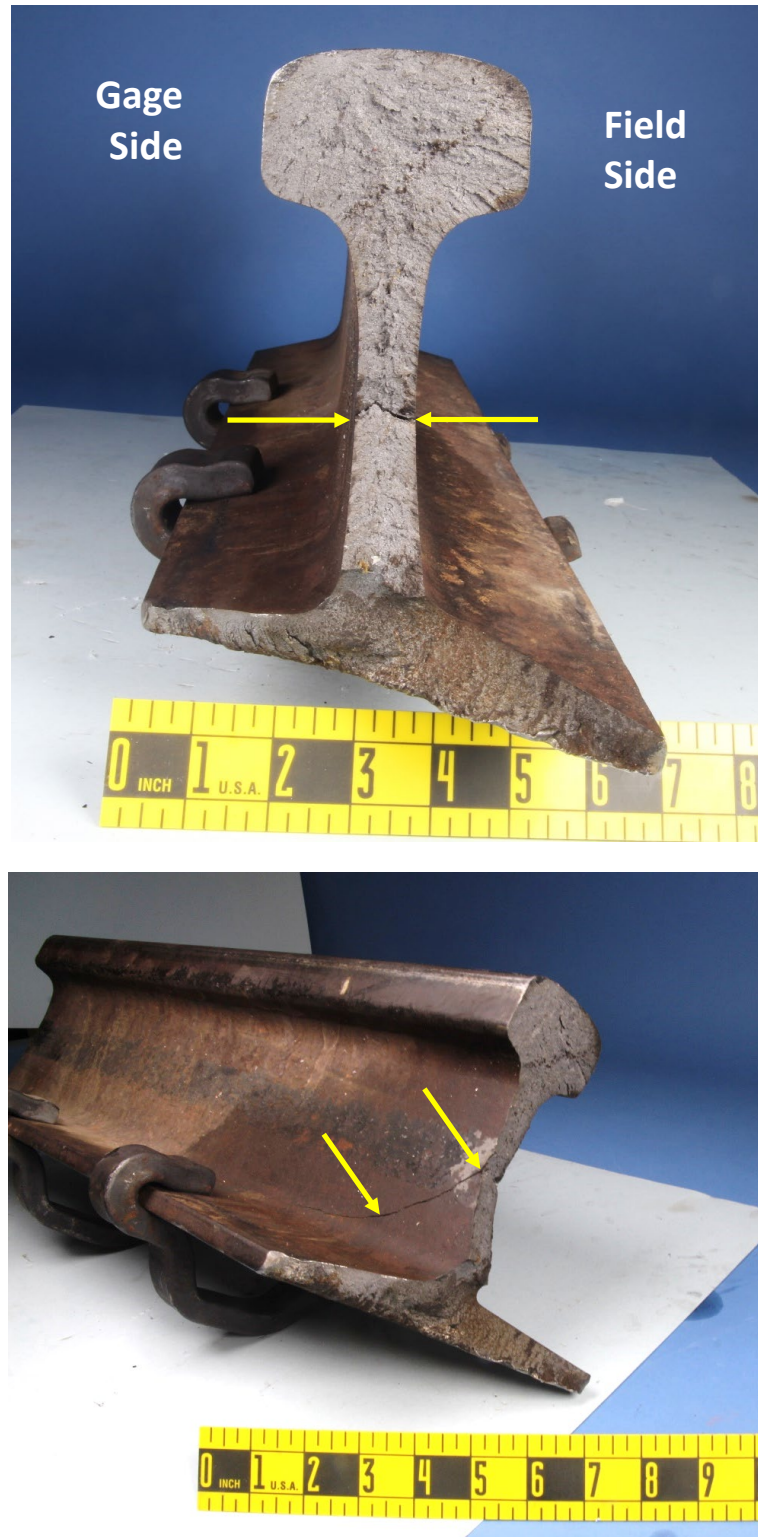
Figure 6: Macro photos of the fracture surface on piece 4E. The yellow arrows point to a longitudinal crack branching from the transverse fracture surface.

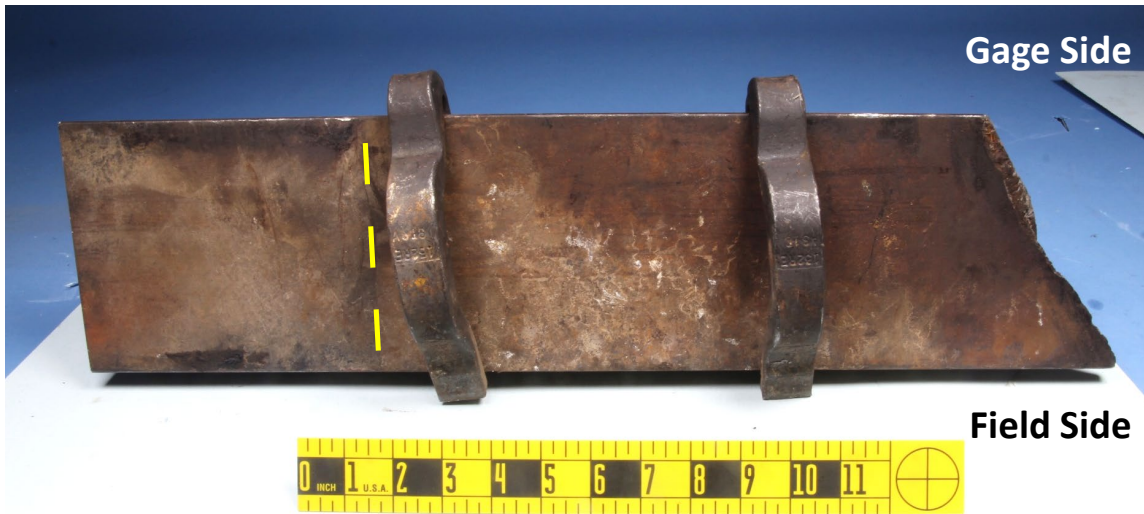
Figure 8: Macro photo of the bottom surface of the base of piece 4E. The yellow dashed line indicates a tie mark.

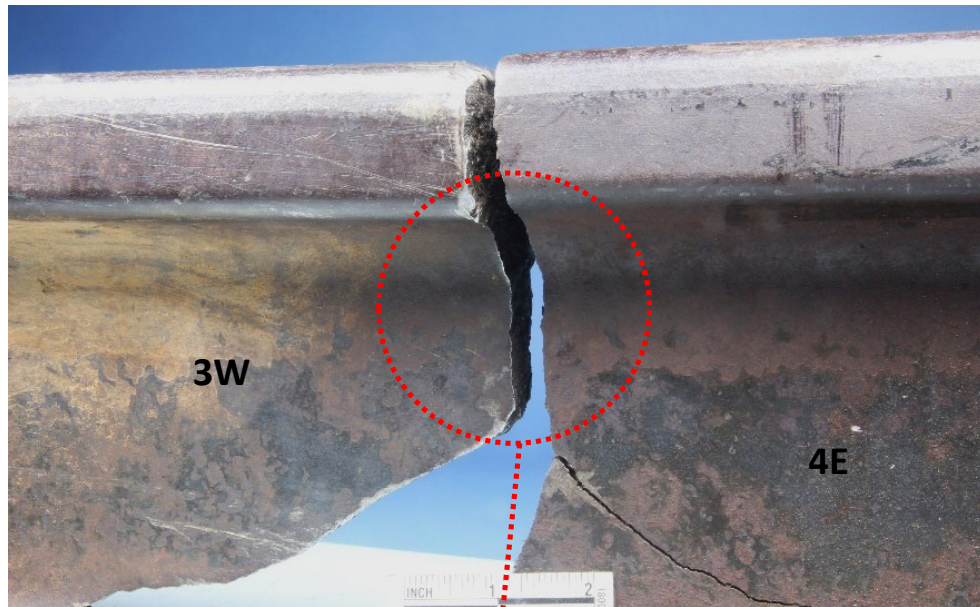
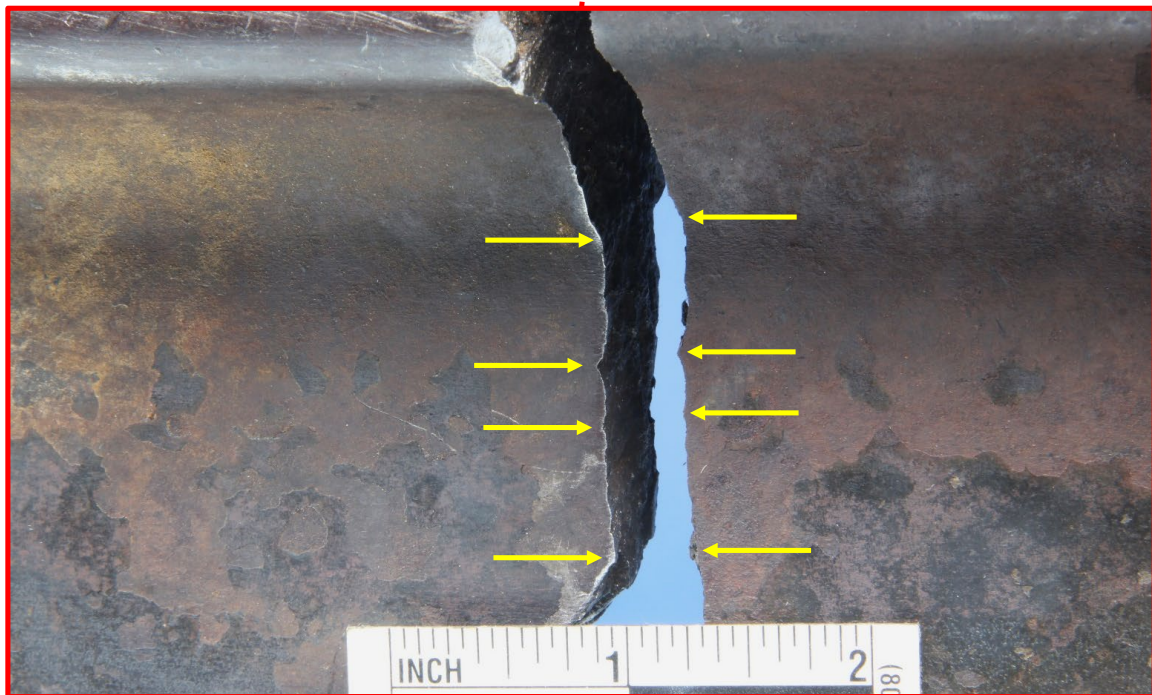
The features along the profiles of the fractures on each piece were examined and compared. As indicated by the yellow arrows in Figure 9, many features along the profiles at the web and in the adjacent neck area aligned. In addition, macro features on the fracture surfaces also fit together. These observations are consistent with the fracture surfaces on pieces 3W and 4E mating. Consequently, the only portion of rail that was missing and not submitted was the bottom of piece 3W, which consisted of the neck from where the fracture began to propagate longitudinally at 45 degrees and the base. Images of the two pieces as they mate together are shown in Figures 10-12.

Figure 9: Close-up photos of the field side web surface of pieces 3W and 4E. The yellow arrows point to aligned features along the fracture surface profiles.

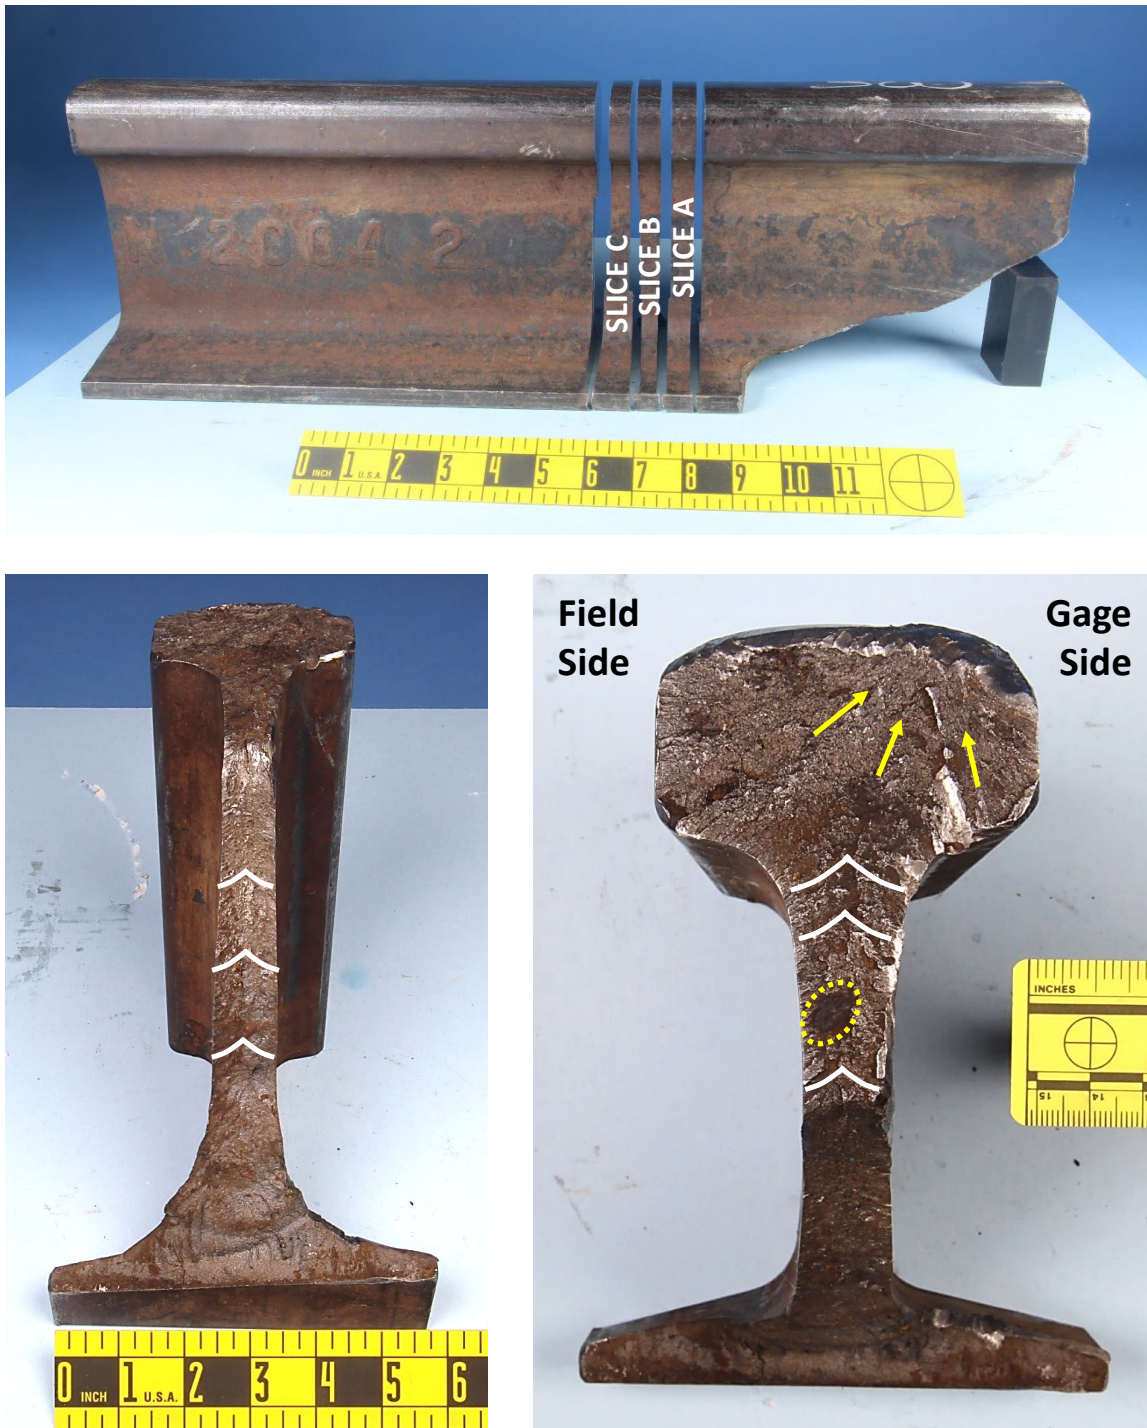
The fracture surface was transversely sectioned from piece 3W for examination as shown in Figure 13. Several adjacent parallel transverse cross-sections were also prepared for further metallurgical work and labeled as slices A, B, and C, as shown. A dark colored anomaly (encircled in a yellow dotted line) was observed on the fracture surface near the mid-web. A digital microscope image of the anomaly is shown in Figure 14. The anomaly had raised edges compared to the surrounding fracture surface, which had been flattened. Measurements locating the anomaly with respect to the running surface and the field side of the web are shown in Figure 15.

The remainder of the fracture surface on piece 3W had features consistent with overstress. Chevron marks⁴ were observed in the web on the fracture surface, as outlined in white in Figure 13. The directionality of the chevrons indicated the fracture origin was in the rail head. Fan shaped features in the rail head on the fracture surface, delineated by yellow arrows, indicated the fracture originated from near the gage side corner adjacent to the running surface.

Figure 13: (Top) Macro photo of piece 3W after transversely sectioning the fracture surface and adjacent parallel transverse cross-sections labeled slices A, B, and C, as shown.

(Bottom) Close-up photos of the piece 3W fracture surface. White lines outline chevron marks and the yellow dotted line outlines a dark colored anomaly on the web surface. The yellow arrows follow macro features in a fan pattern on the head surface.

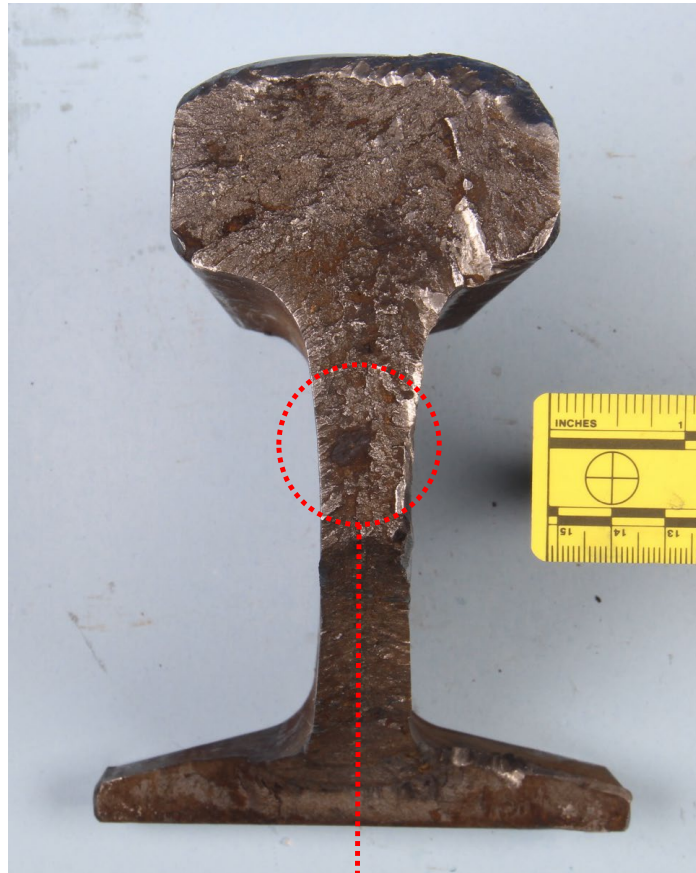
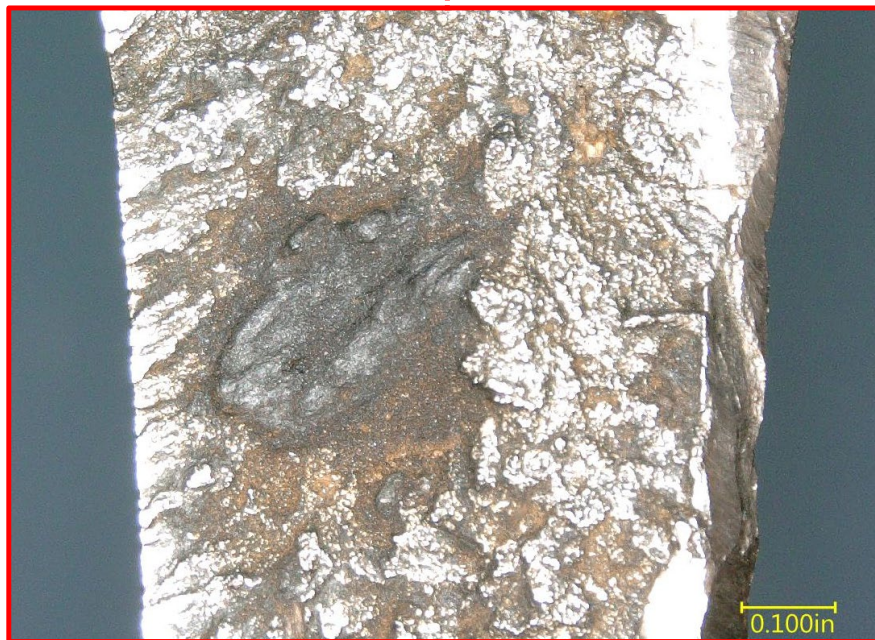
Figure 14: Close-up photo (top) and digital microscope image (bottom) of the dark colored anomaly on the web fracture surface of piece 3W.

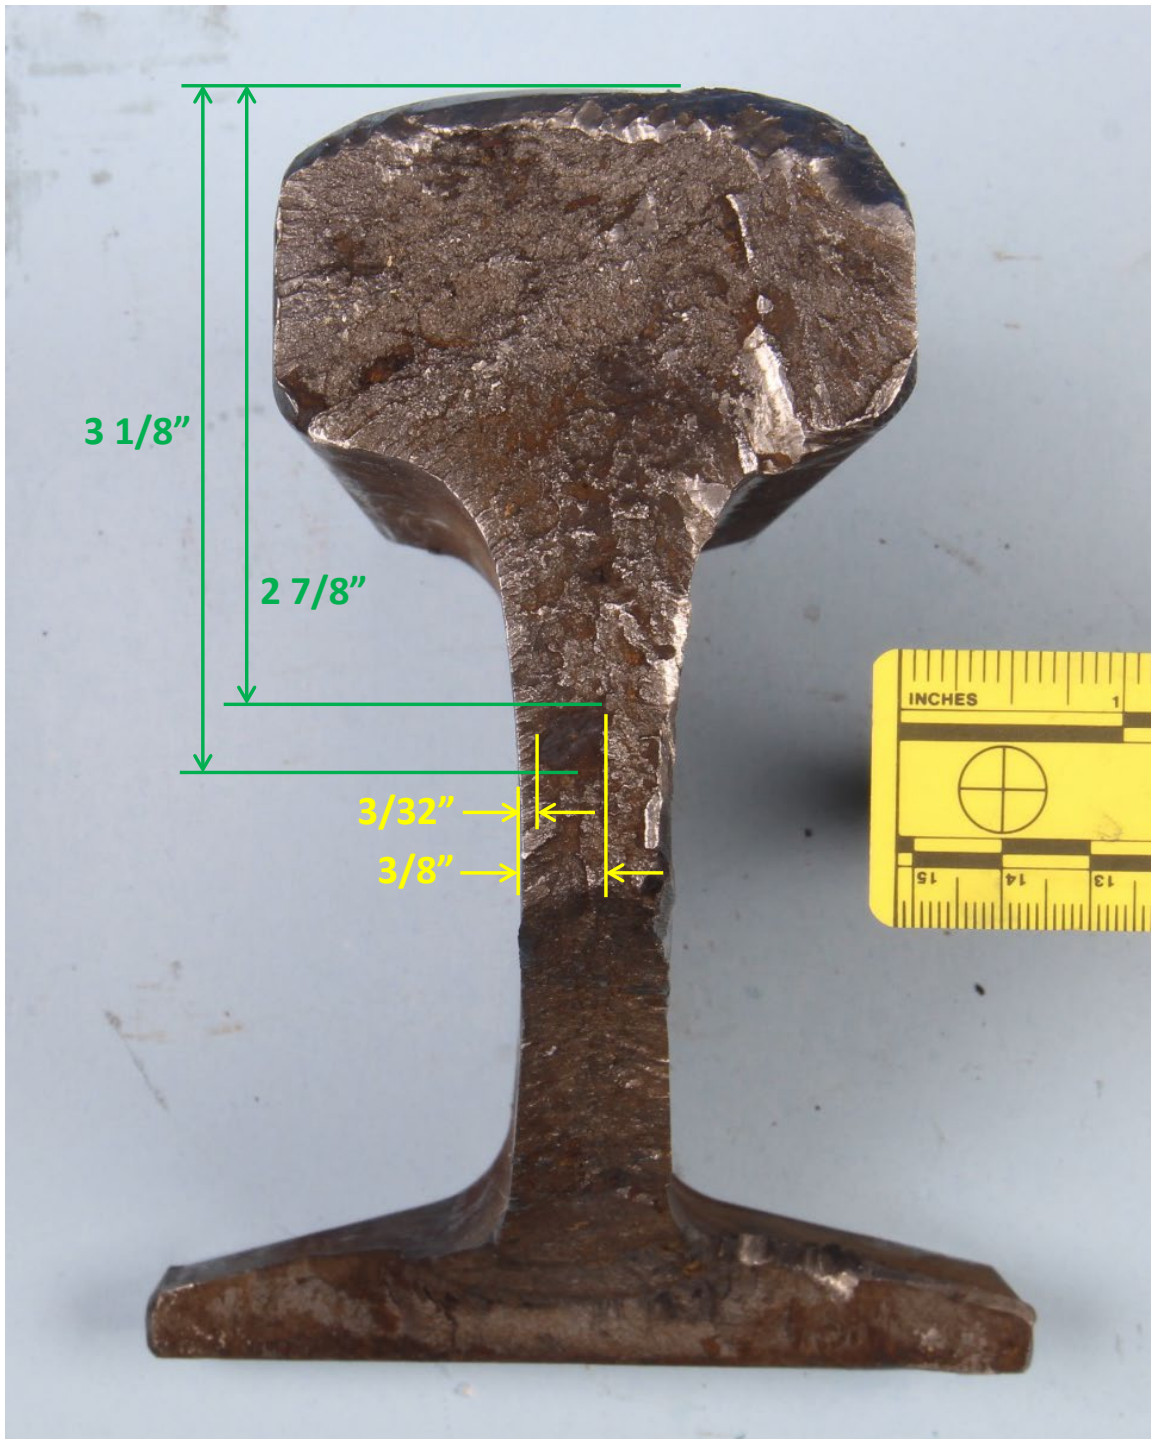
Figure 15: Close-up photo of the web fracture surface of piece 3W with measurements indicating the location of the dark colored anomaly.

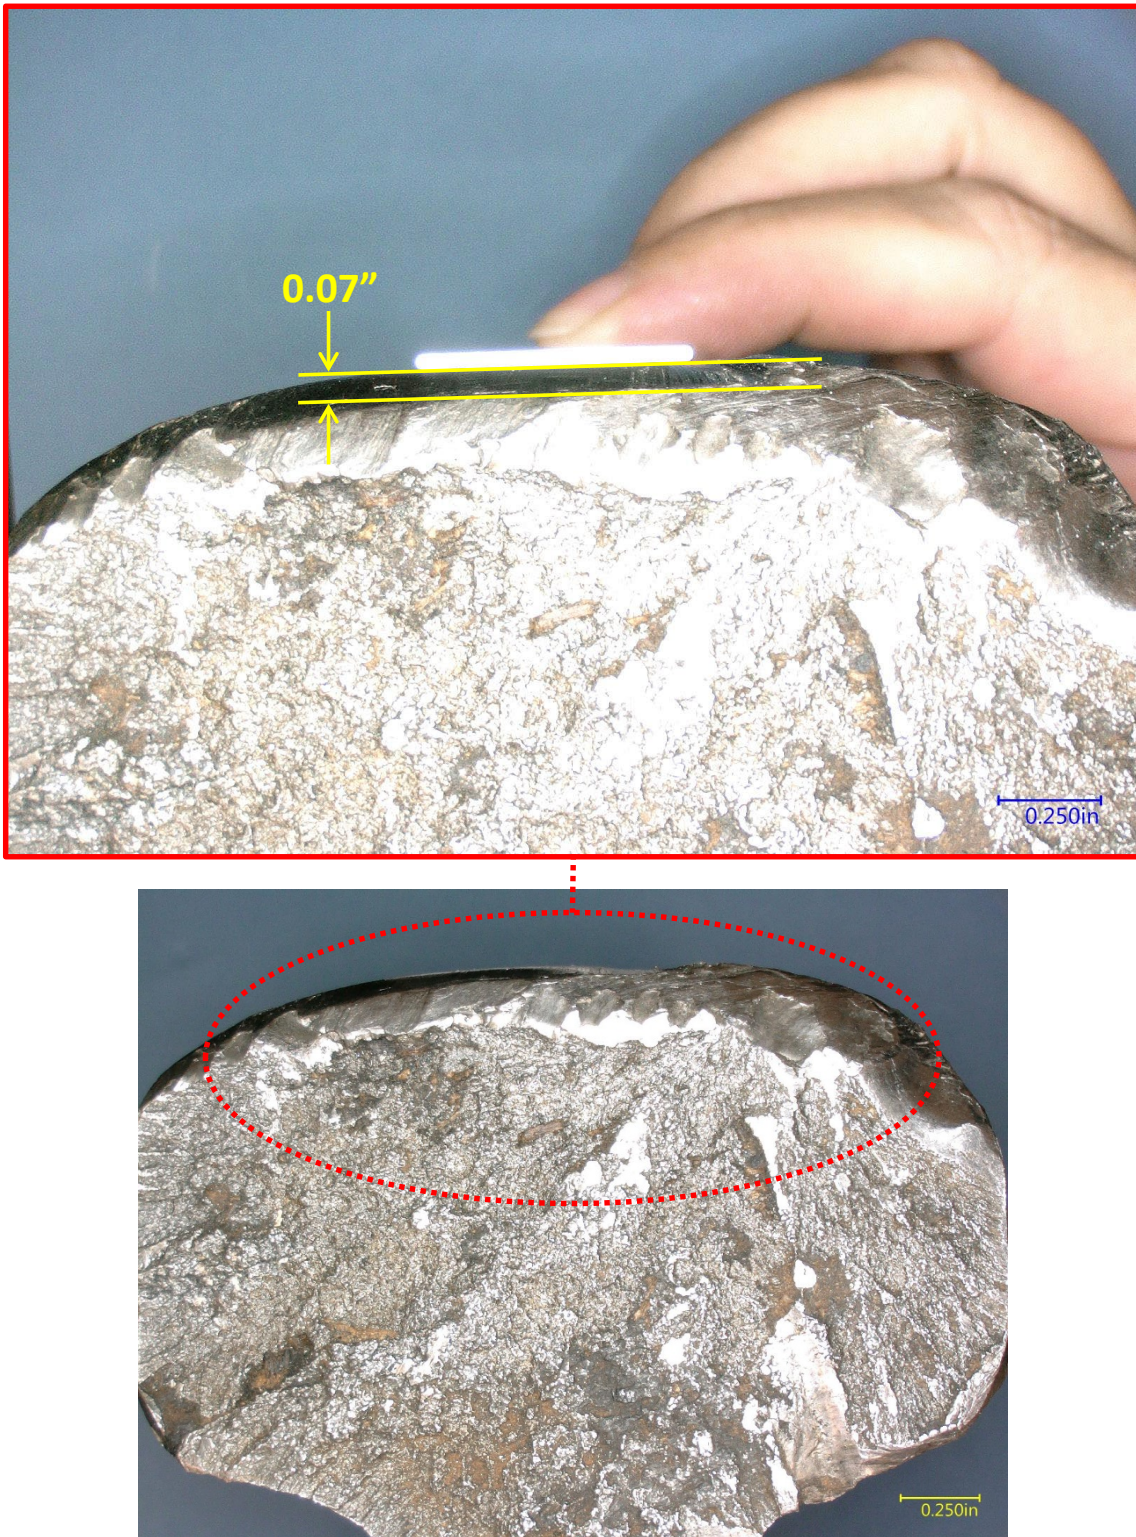
A portion of the upper and gage sides of the rail head on piece 3W were deformed and curled over the fracture surface consistent with trailing rail end deformation.⁵ The origin area of the overstress fracture was mostly obscured the trailing rail end deformation on the fracture surface on this piece. The depth of the trailing rail end deformation was determined using a straight edge held flush along the running surface and measuring transversely along the fracture surface. The depth of the trailing rail end deformation measured approximately 0.07 inches, as shown in the digital microscope image in the top of Figure 16.

Figure 16: Digital microscope images of trailing rail end deformation on the upper and gage sides of the rail head on piece 3W. A measurement of the depth of the trailing rail end deformation is shown.

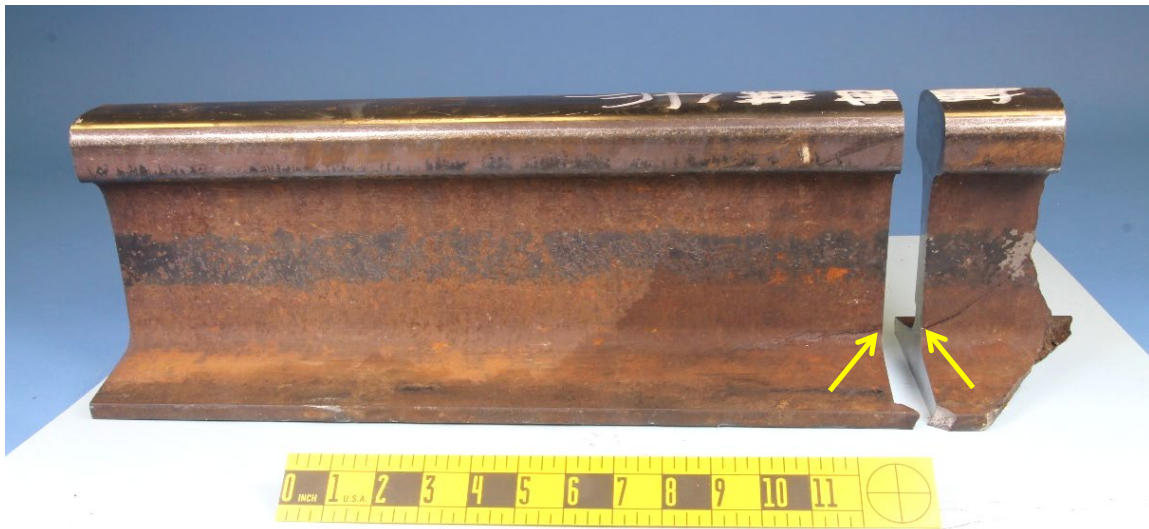
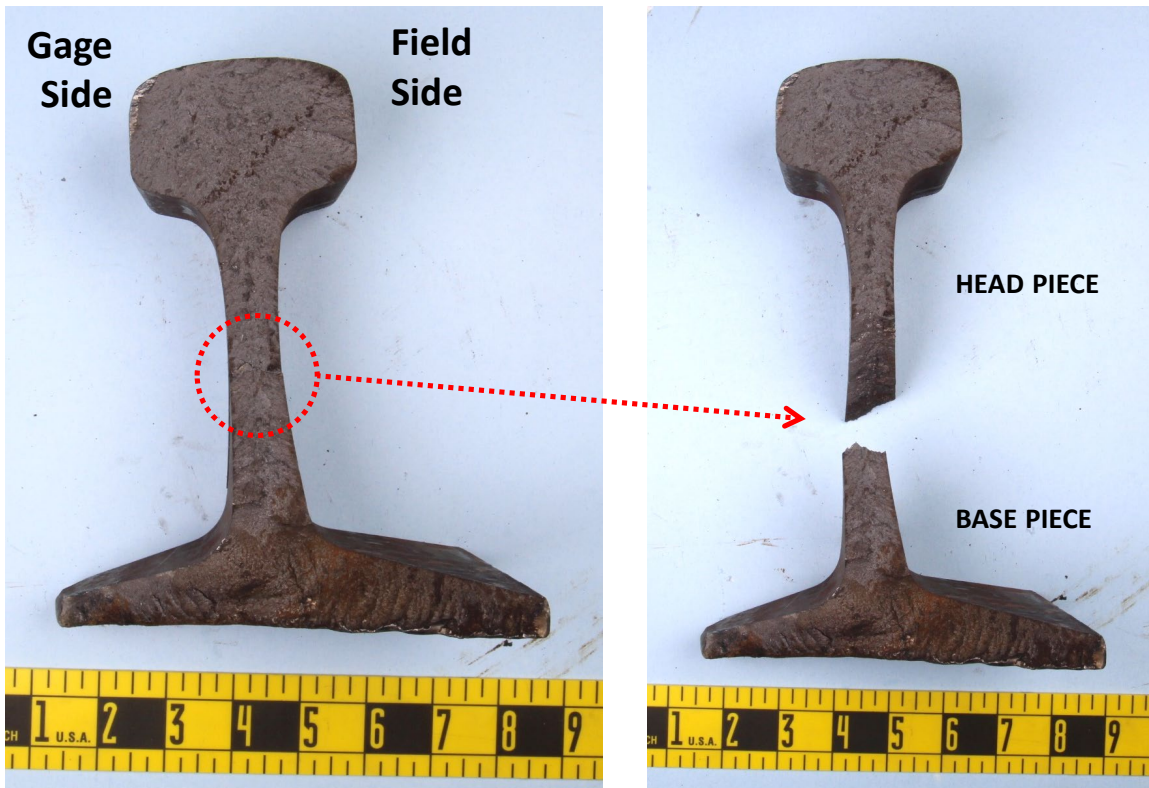
The rail anchors were removed from piece 4E and the fracture surface was transversely sectioned for examination as shown in Figure 17. After sectioning, the head portion of the piece separated from the base due to the 45 degree longitudinal crack branching from the transverse fracture surface (yellow arrows).

Figure 17: Macro photos of piece 4E after transversely sectioning the fracture surface. After sectioning, the head portion of the piece separated from the base due to the 45 degree longitudinal crack branching from the transverse fracture surface (yellow arrows).

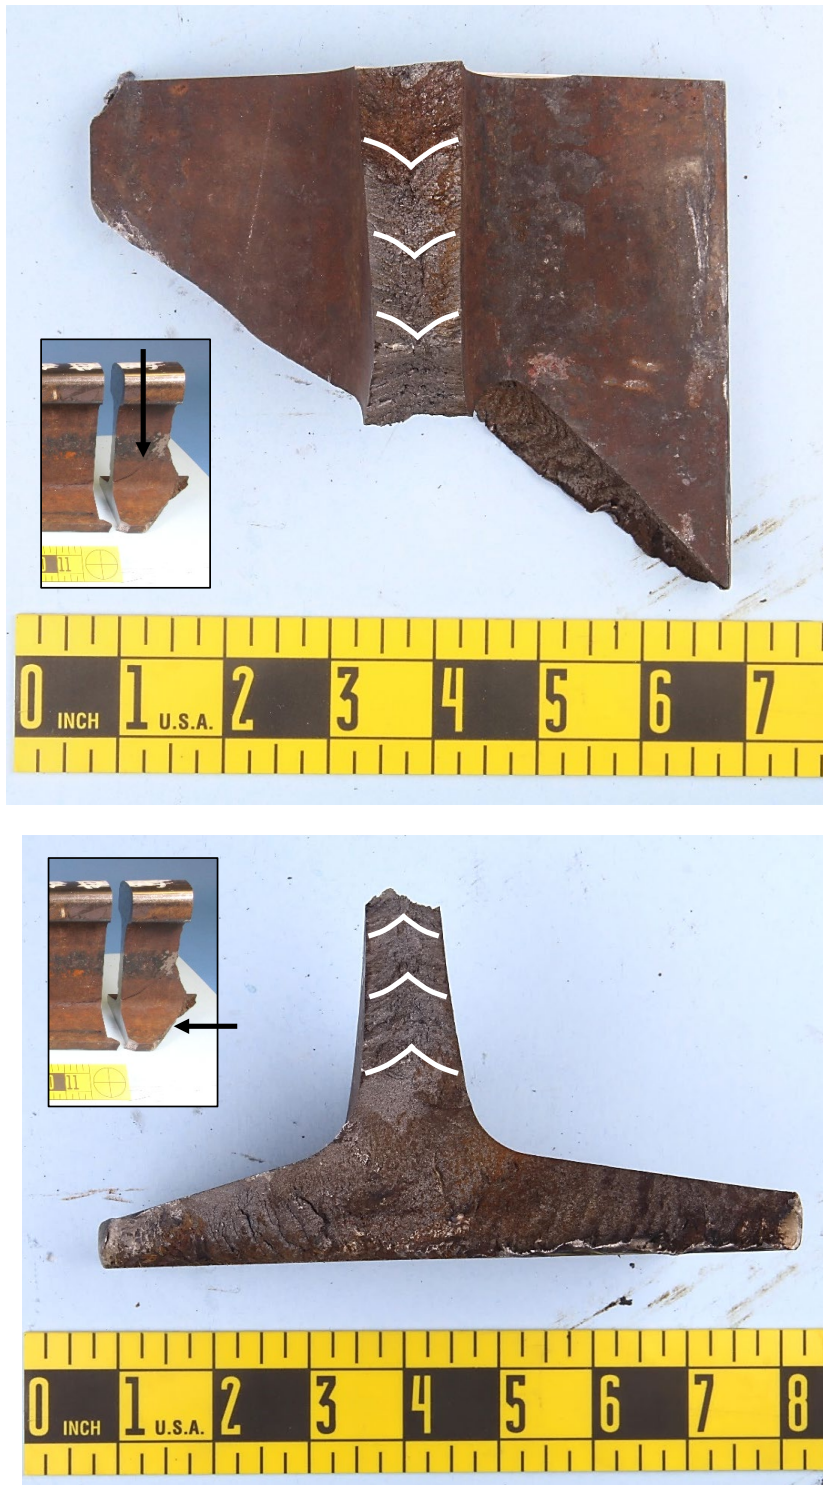
The base portion of piece 4E is shown in Figure 18. Chevron marks (white lines) were observed on both the longitudinal and transverse fracture surfaces. The chevrons on the longitudinal web fracture surface pointed back towards the transverse web fracture, thus indicating the longitudinal web fracture was secondary and started by branching off the transverse web fracture. The chevrons on the transverse web fracture surface pointed in the direction of the rail head.

Figure 18: Close-up photos of the fracture surfaces on the base portion of piece 4E. Chevron marks on the longitudinal web fracture (white lines, top image) pointed back towards the transverse web fracture surface, while chevrons marks on the transverse web fracture surface (white line, bottom image) pointed in the direction of the rail head. The inset photos show the direction of the view in each close-up photo, indicated by the black arrows.

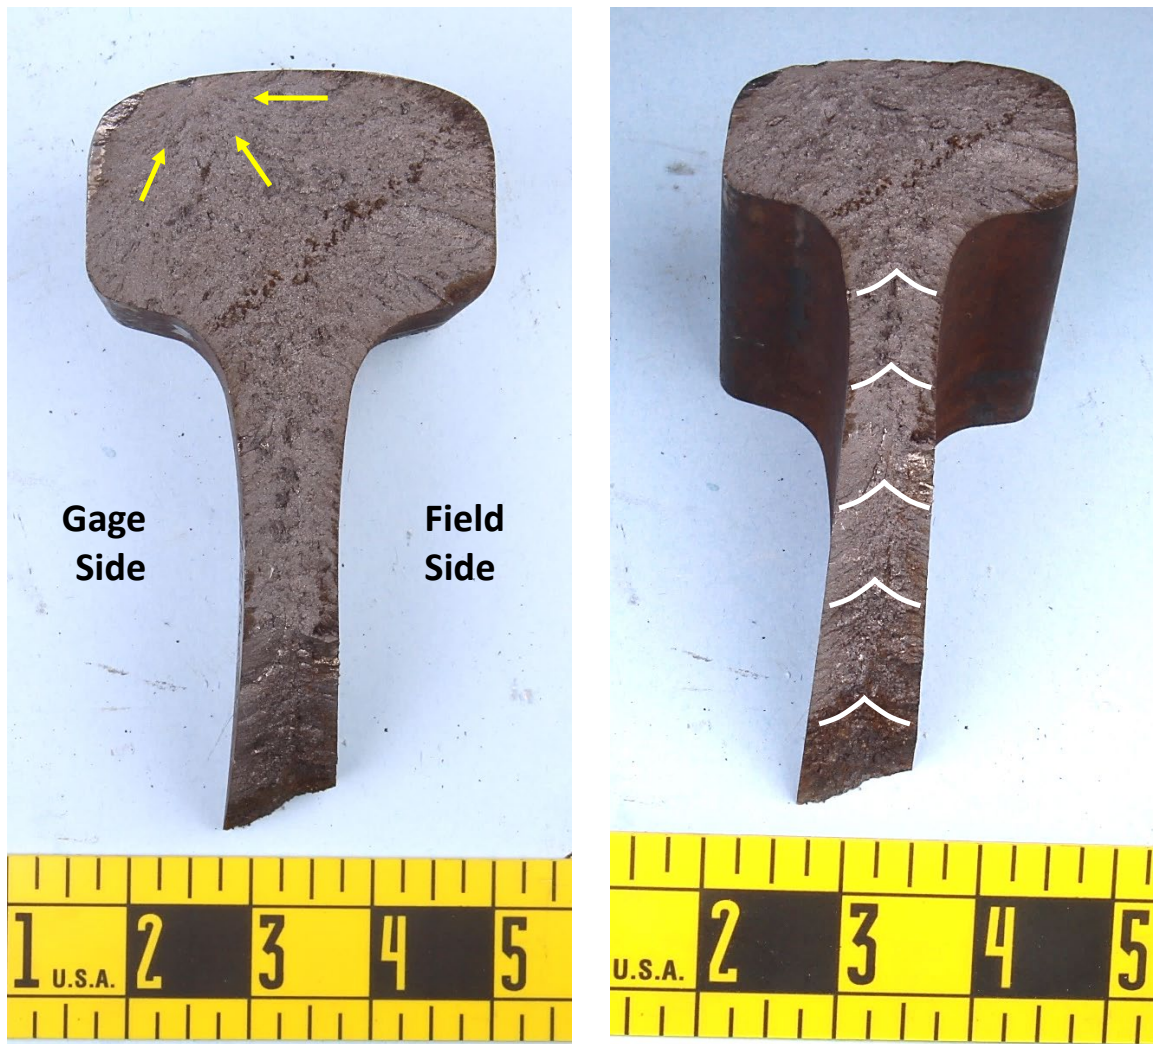
The head portion of piece 4E is shown in Figure 19. Chevron marks (white lines) were visible on the transverse web fracture surface that pointed in the direction of the rail head. Macro features (yellow arrows) on the fracture surface in a fan pattern indicated the fracture originated from near the gage side corner adjacent to the running surface. Digital microscope images of the gage side corner are shown in Figure 20. The macro fan features (black arrows) point towards a fracture origin location adjacent to the running surface at the top edge of the transition to the gage side corner. This location is encircled in a black dashed line in the top of Figure 20. A small area of receiving rail end batter⁶ (red arrows) was observed on the gage side corner near the fracture origin.

Figure 19: Close-up photos of the fracture surface on the head portion of piece 4E. White lines outline chevron marks on the web surface. The yellow arrows follow macro features in a fan pattern on the head surface.

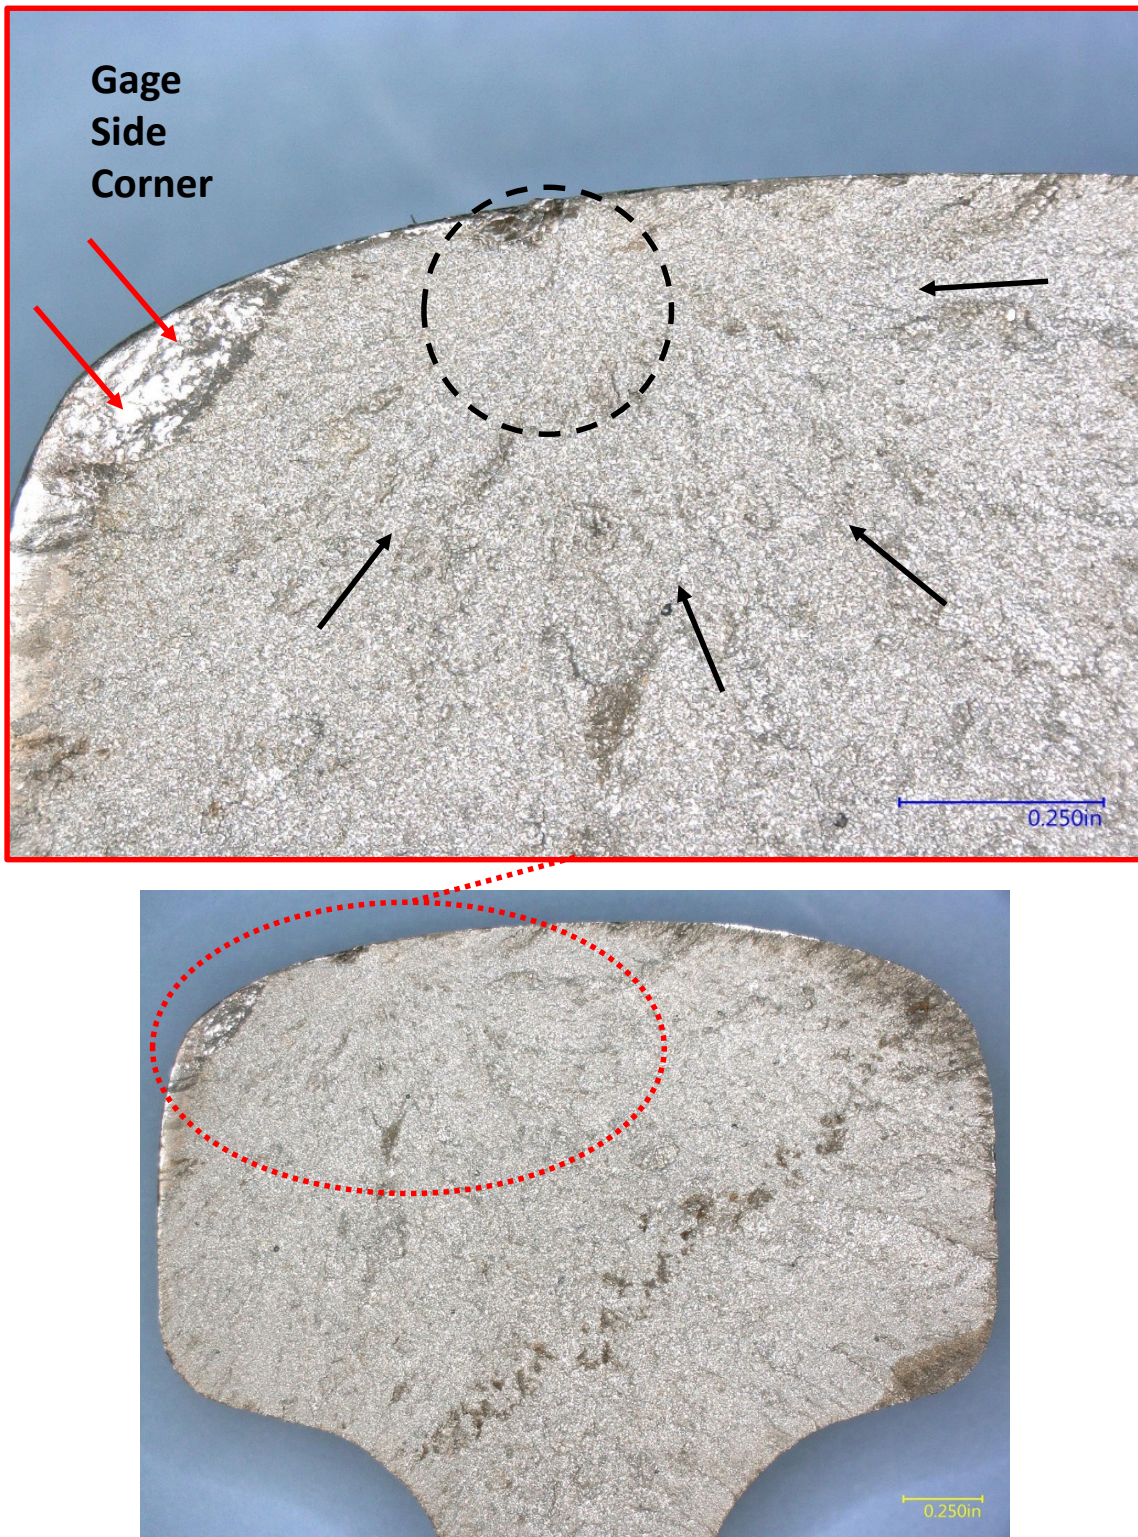
Figure 20: Digital microscope images of the fracture surface on the head portion of piece 4E. The black arrows follow macro features in a fan pattern that point to a fracture origin location (black dashed circle) adjacent to the running surface at the top edge of the transition to the gage side corner.
