NATIONAL TRANSPORTATION SAFETY BOARD

MATERIALS LABORATORY FACTUAL REPORT

Report No. 20-063

Place : Tempe, AZ
Date : July 29, 2020
Vehicle : Union Pacific Railroad (UP) freight train MTUPX-29
NTSB No. : RRD20LR005
Investigator : Richard Hipskind (RPH-10)

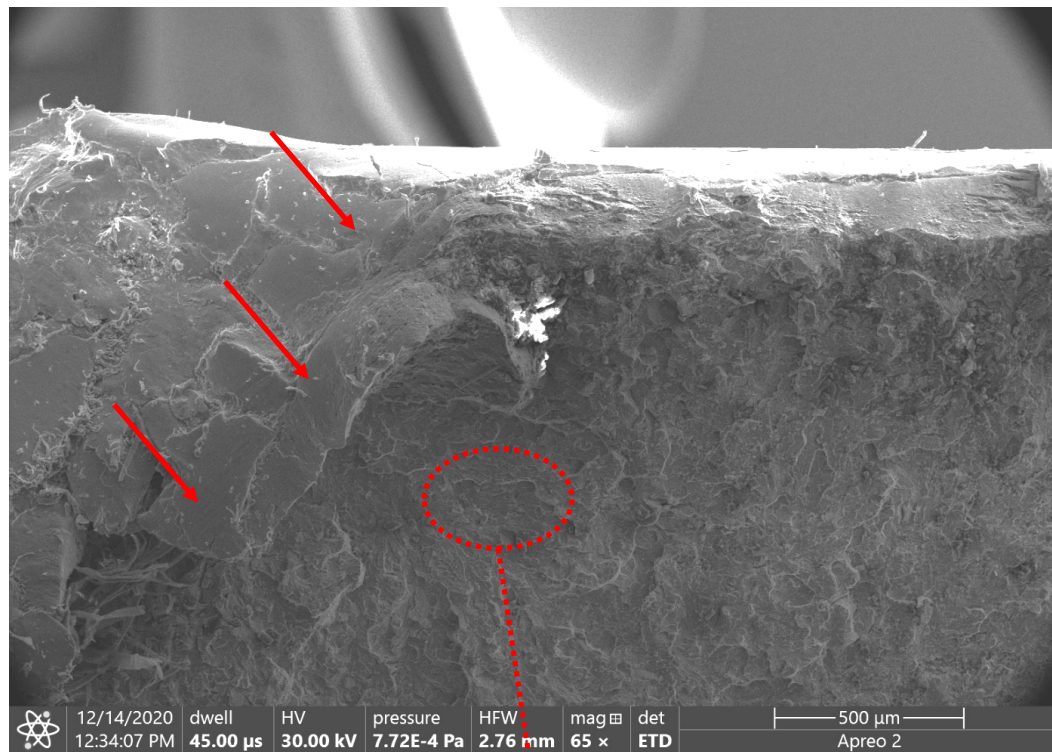
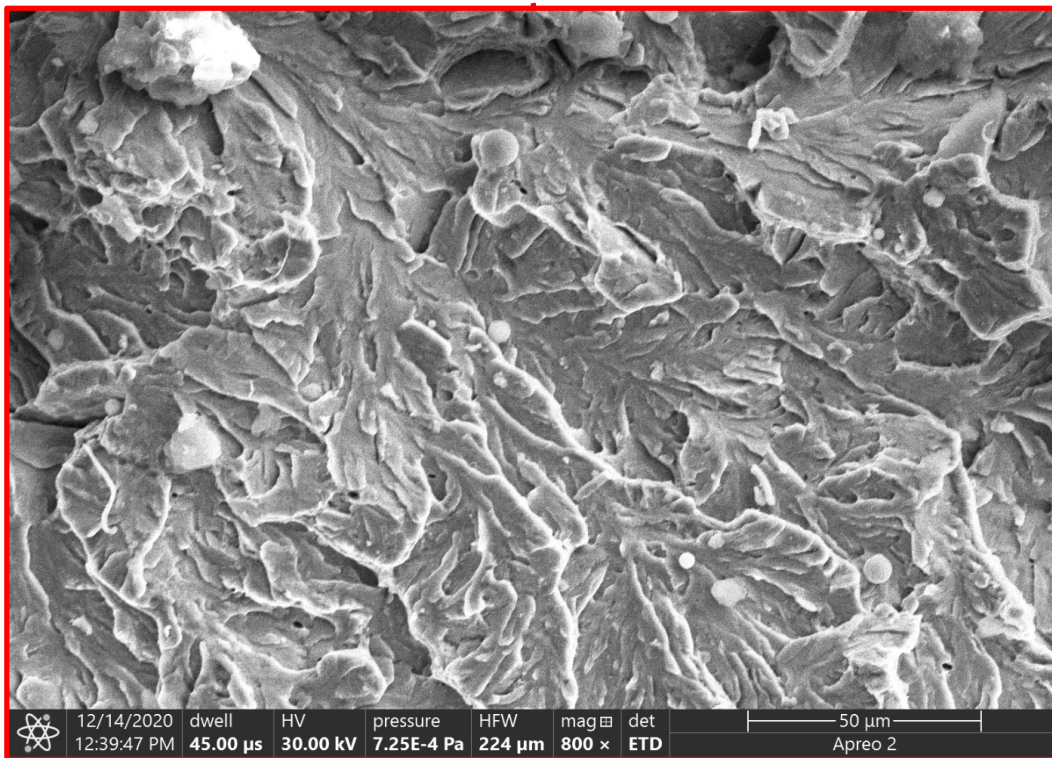
The fracture surfaces from both pieces were examined using a scanning electron microscope (SEM). Piece 4E is shown in Figures 21-22. Red arrows in Figure 21 point to receiving rail end batter on the gage side corner near the fracture origin. The fracture surface features immediately adjacent to the batter exhibited cleavage facets, consistent with overstress fracture of a less ductile metal alloy. Examination of the fracture surface in the web of the rail, away from the fracture origin in the head, revealed the similar cleavage facets and overstress features, as shown in Figure 22.

Figure 21: Secondary electron (SE) SEM images of the fracture surface at the gage side corner on piece 4E. The red arrows point to receiving rail end batter.

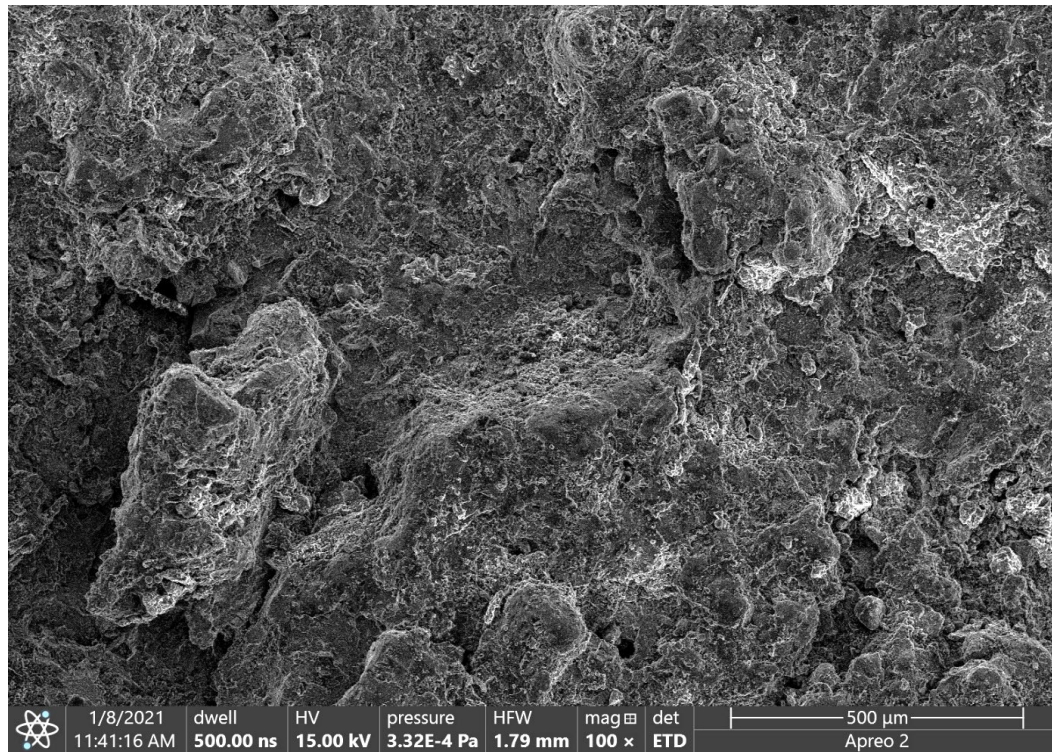
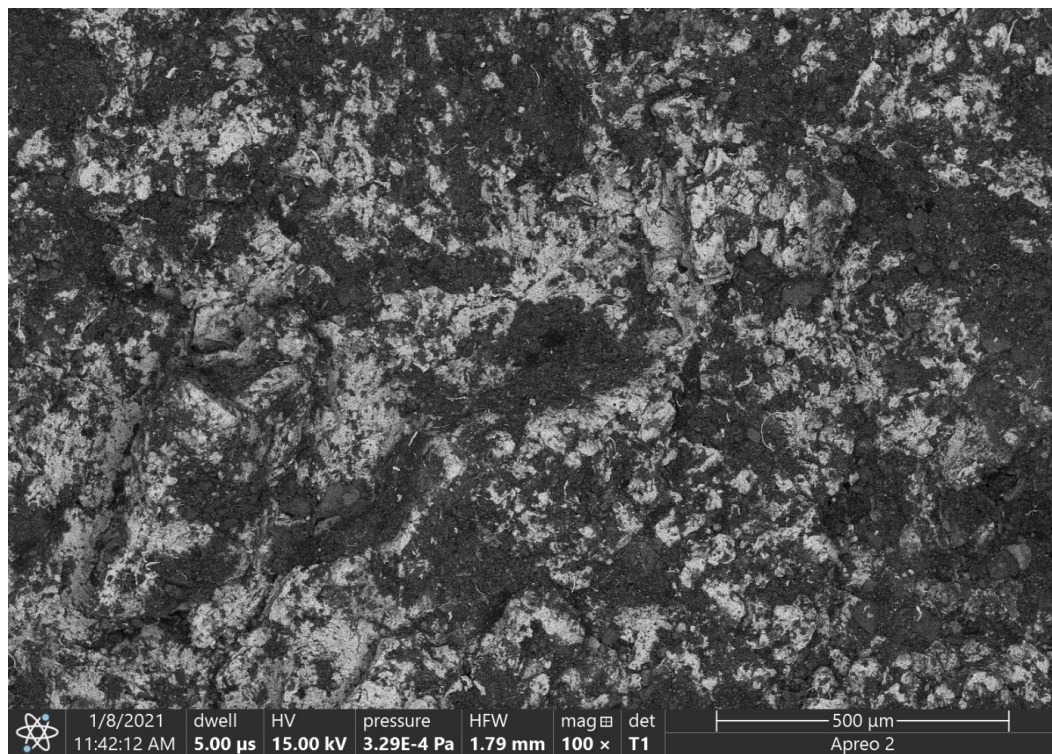
The fracture surface in the head and the web of piece 3W is shown in Figures 23 and 24, respectively. Heavy oxidation obscured the finer features on this piece, but the overall features consisted of cleavage features like those observed on piece 4E. Backscattered electron (BSE) examination of the fracture surface revealed heavy oxidation all over. BSE images of the dark colored anomaly in the web also only showed oxidation products.

Figure 23: SE (top) and BSE (bottom) SEM images of the fracture surface in the head of piece 3W.

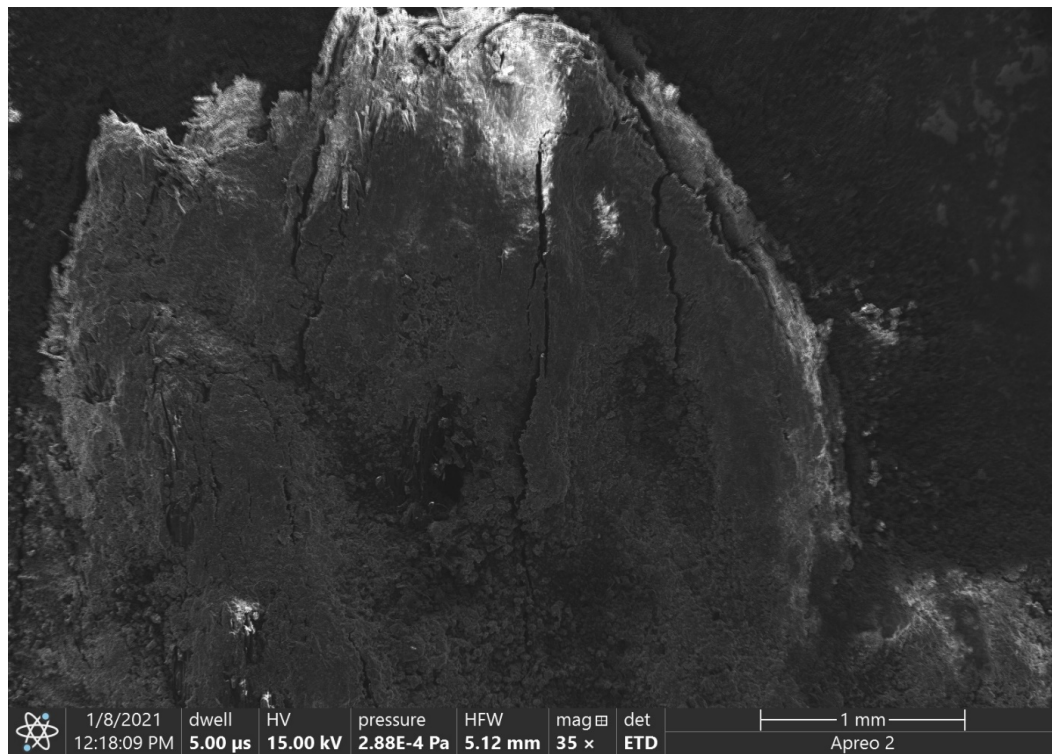
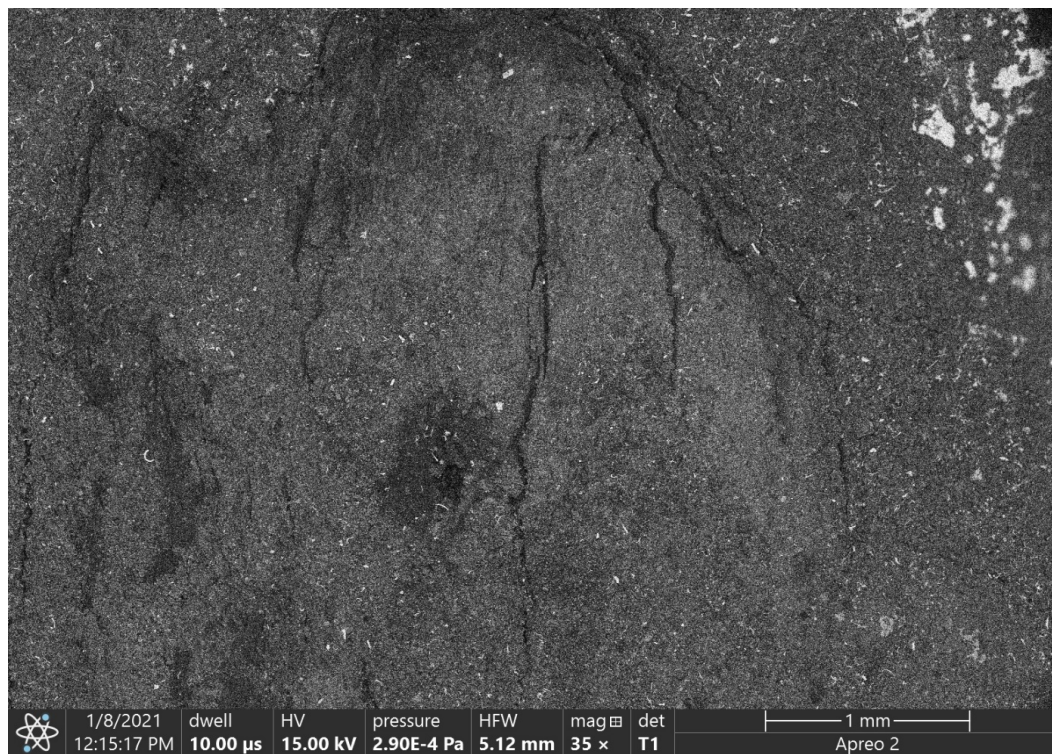
Figure 24: SE (top) and BSE (bottom) SEM images of the fracture surface at the edge of the dark colored anomaly in the web of piece 3W.

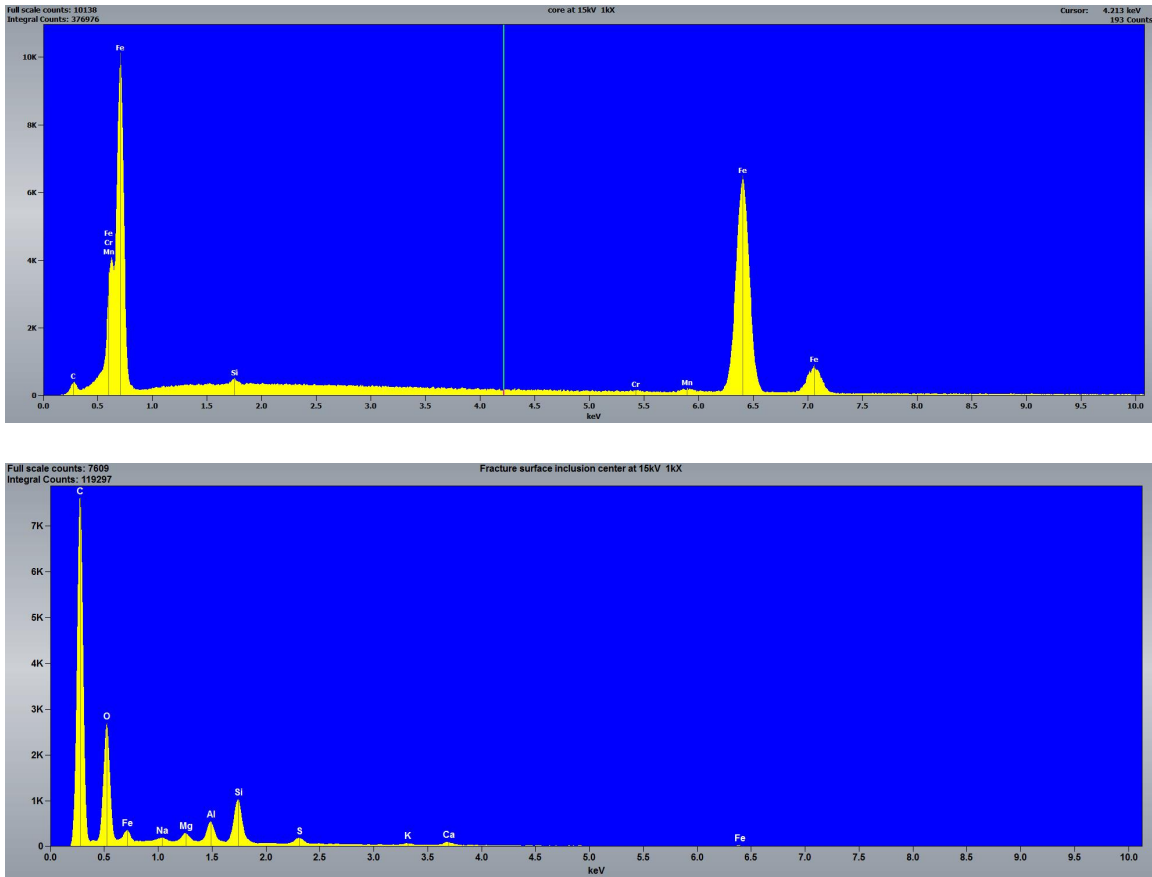
Energy dispersive x-ray spectroscopy (EDS) was performed on the piece 3W fracture surface. In the head of the piece the EDS spectrum was consistent with a carbon steel (top image of Figure 25). EDS was also performed of the dark colored anomaly, as shown in the bottom image of Figure 25. A very large carbon peak and a large oxygen peak were observed in this location, which is expected given the oxidation observed on the fracture surface in this area (shown in Figure 24). Distinct peaks for silicon, aluminum, magnesium, and sulfur were also present in the spectrum, along with traces of sodium, potassium, and calcium. This combination of elements is consistent with exogenous contamination, such as soil.

Figure 25: EDS spectra in the head and the dark colored anomaly in the web of piece 3W are shown in the top and bottom images, respectively.

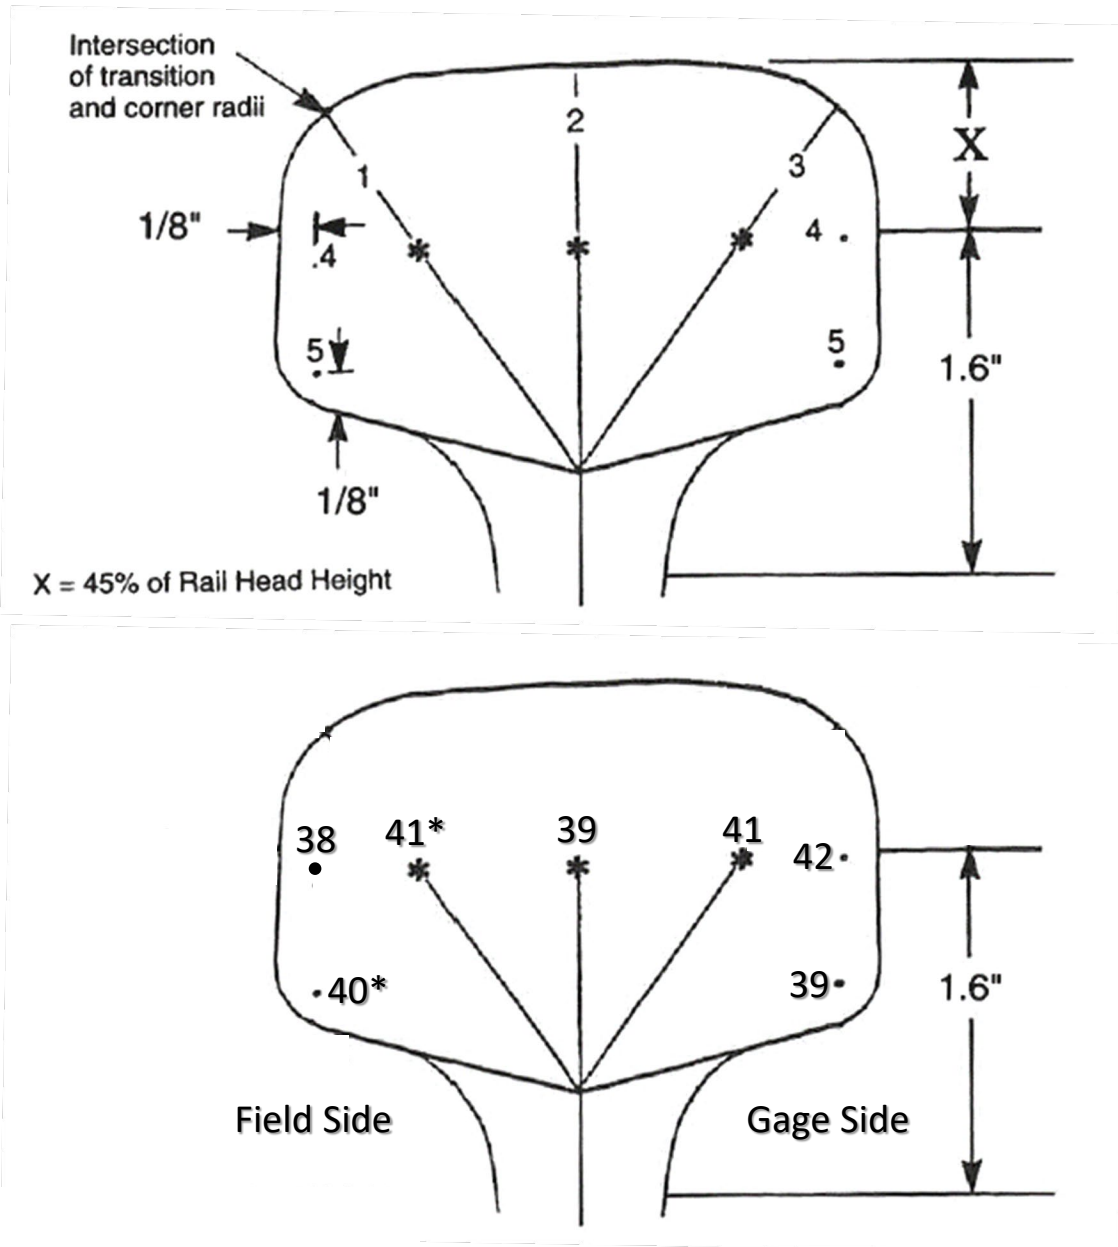
The results of the hardness testing on the piece 3W rail head are illustrated in the bottom of Figure 33. The average hardness value of the material was 40 HRC. According to the 1997 AREMA specifications, the minimum specified tensile strength for standard rail steel was 140,000 pounds per square inch, which corresponds to an approximate hardness of 31 HRC.

Average hardness: 40 HRC

*These reading were initially 25 and 27 HRC, respectively, but may have been improper tests. Retesting >3 radii away found the results shown

Figure 33: (Top) Diagram showing the seven locations of hardness indents prescribed by AREA for the determination of internal hardness of cross-sectioned rail heads (courtesy, AREA *Manual for Railway Engineering, Chapter 4: Rail*, (1997)). (Bottom) Diagram showing Rockwell hardness results for the cross-sectioned rail head of piece 3W. All results reported in the HRC scale.

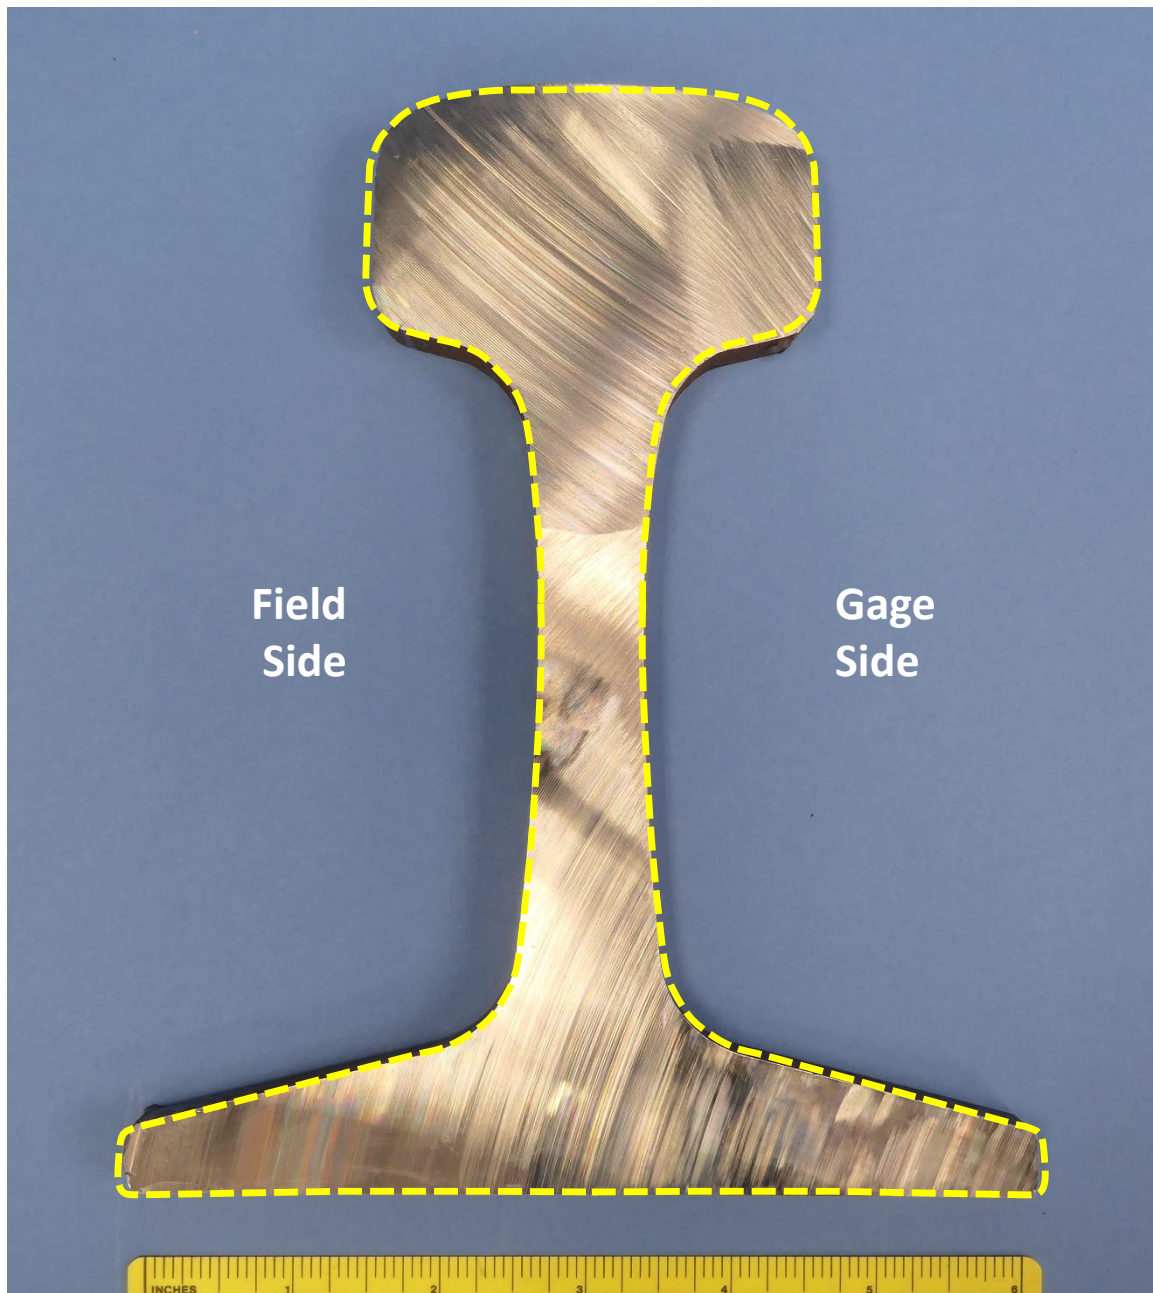
An overall photo of the as-cut surface of transverse rail cross-section slice B from piece 3W is shown in Figure 34. For reference, an outline (yellow dashed line) representing the cross-section of a new 136-pound rail is overlaid atop the as-cut transverse cross-section. No measurable head loss was observed on the cross-section.

Figure 34: Macro photo of the as-cut surface of transverse rail cross-section slice B from piece 3W with an outline (yellow dashed line) representing the cross-section of a new 136-pound rail overlaid atop.
