Investigator:	Tim Rader	Date:	2/18/2020
Site Location:	37° 20' 5.7", -82° 23' 37.8"	Quad:	Hellier
LB #:	15505	County:	Pike

Richard Hipskind HP LB#15505
CSX Derailment
Pike County/ Hellier Quad.

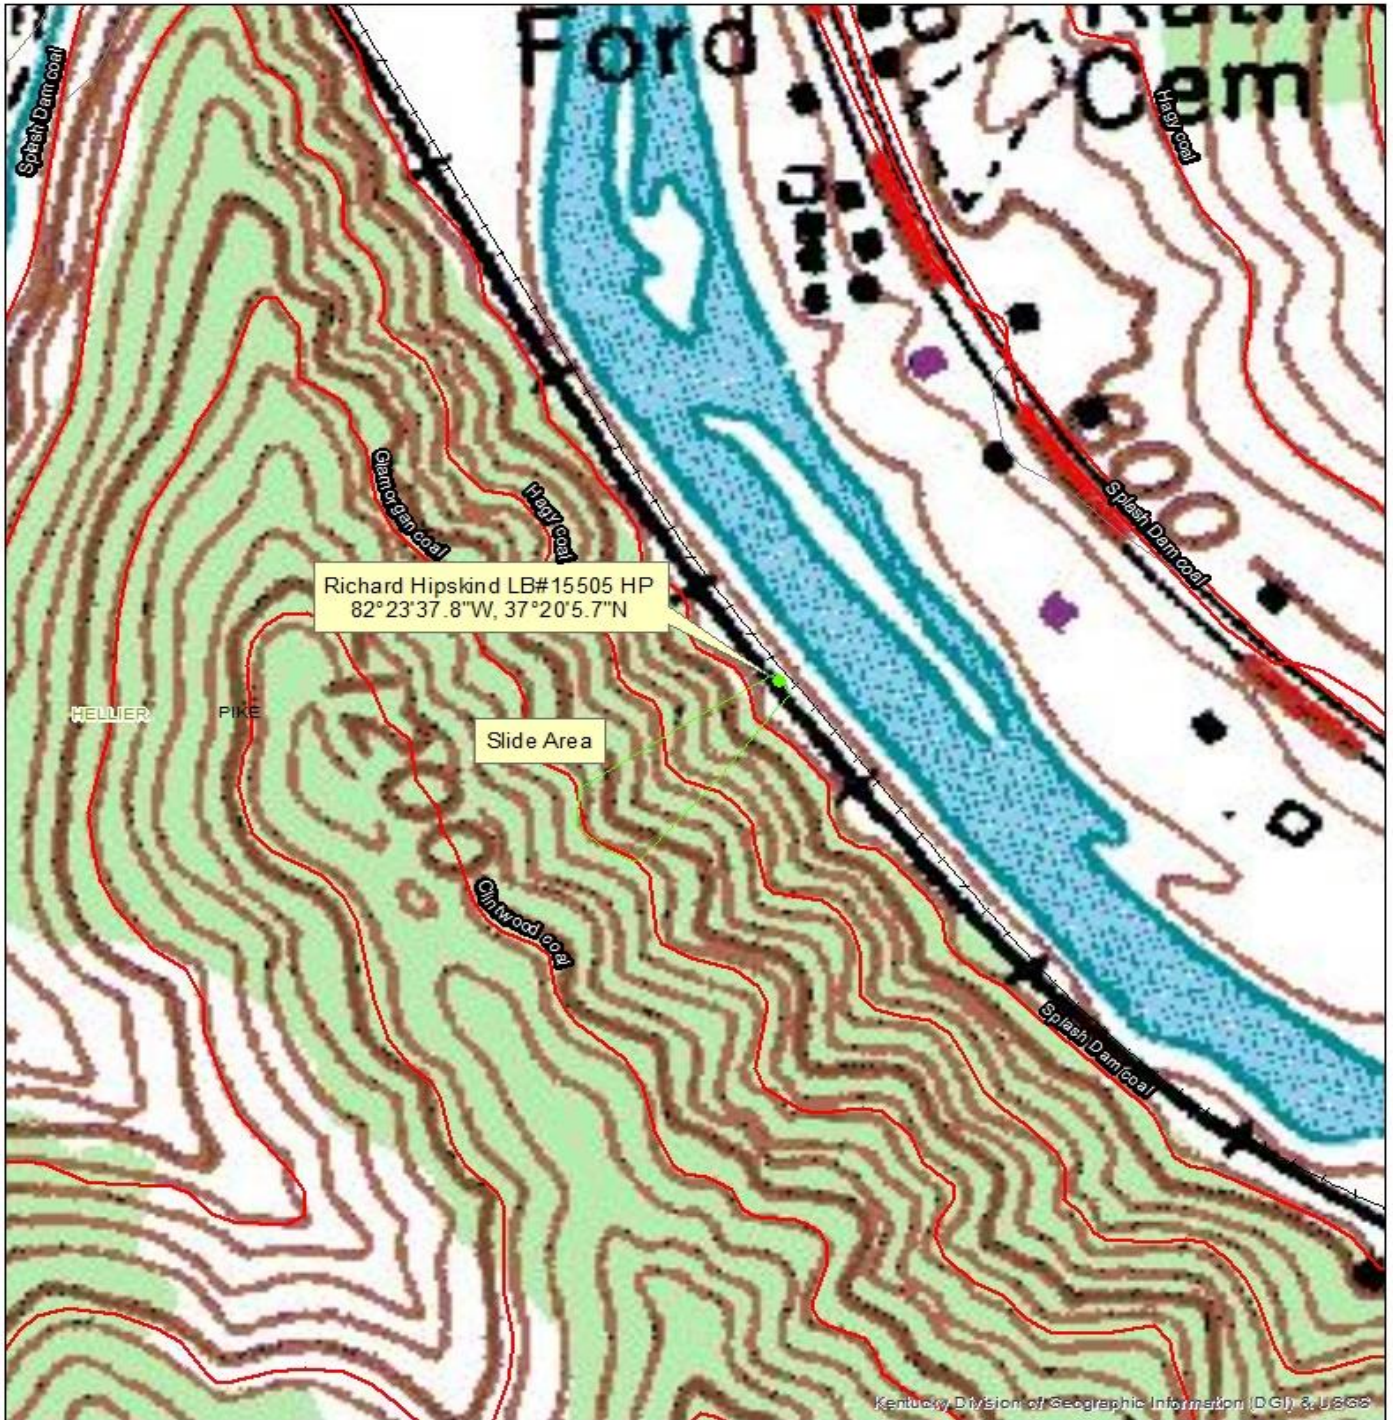
1954 (Revised 1978) USGS Topo Map

LiDAR, Topography, Geology, Miscellaneous:	
USGS 24k Topo: <i>(Include Quad. number, name, any relevant features and elevations)</i> No mining features are shown on the 1954 (Revised 1978) USGS topo map.	
LiDAR Imagery: <i>(Describe any relevant features, such as drainage paths, potential portal locations, benches, etc.)</i> LiDAR imagery shows that the slide occurred in a steep, narrow natural drain.	
USGS GQ Map Summary: <i>(Include Quad. number, name, GQ number, any relevant features, geologic dip, coal seams and coal seam elevations)</i> No mining features are shown on the 1971 gq map. The regional geologic dip is to the northwest.	
USGS GQ Map Economic Geology: <i>(Include screen capture of applicable portion of economic geology narrative from GQ)</i>	See attached economic geology sheet.

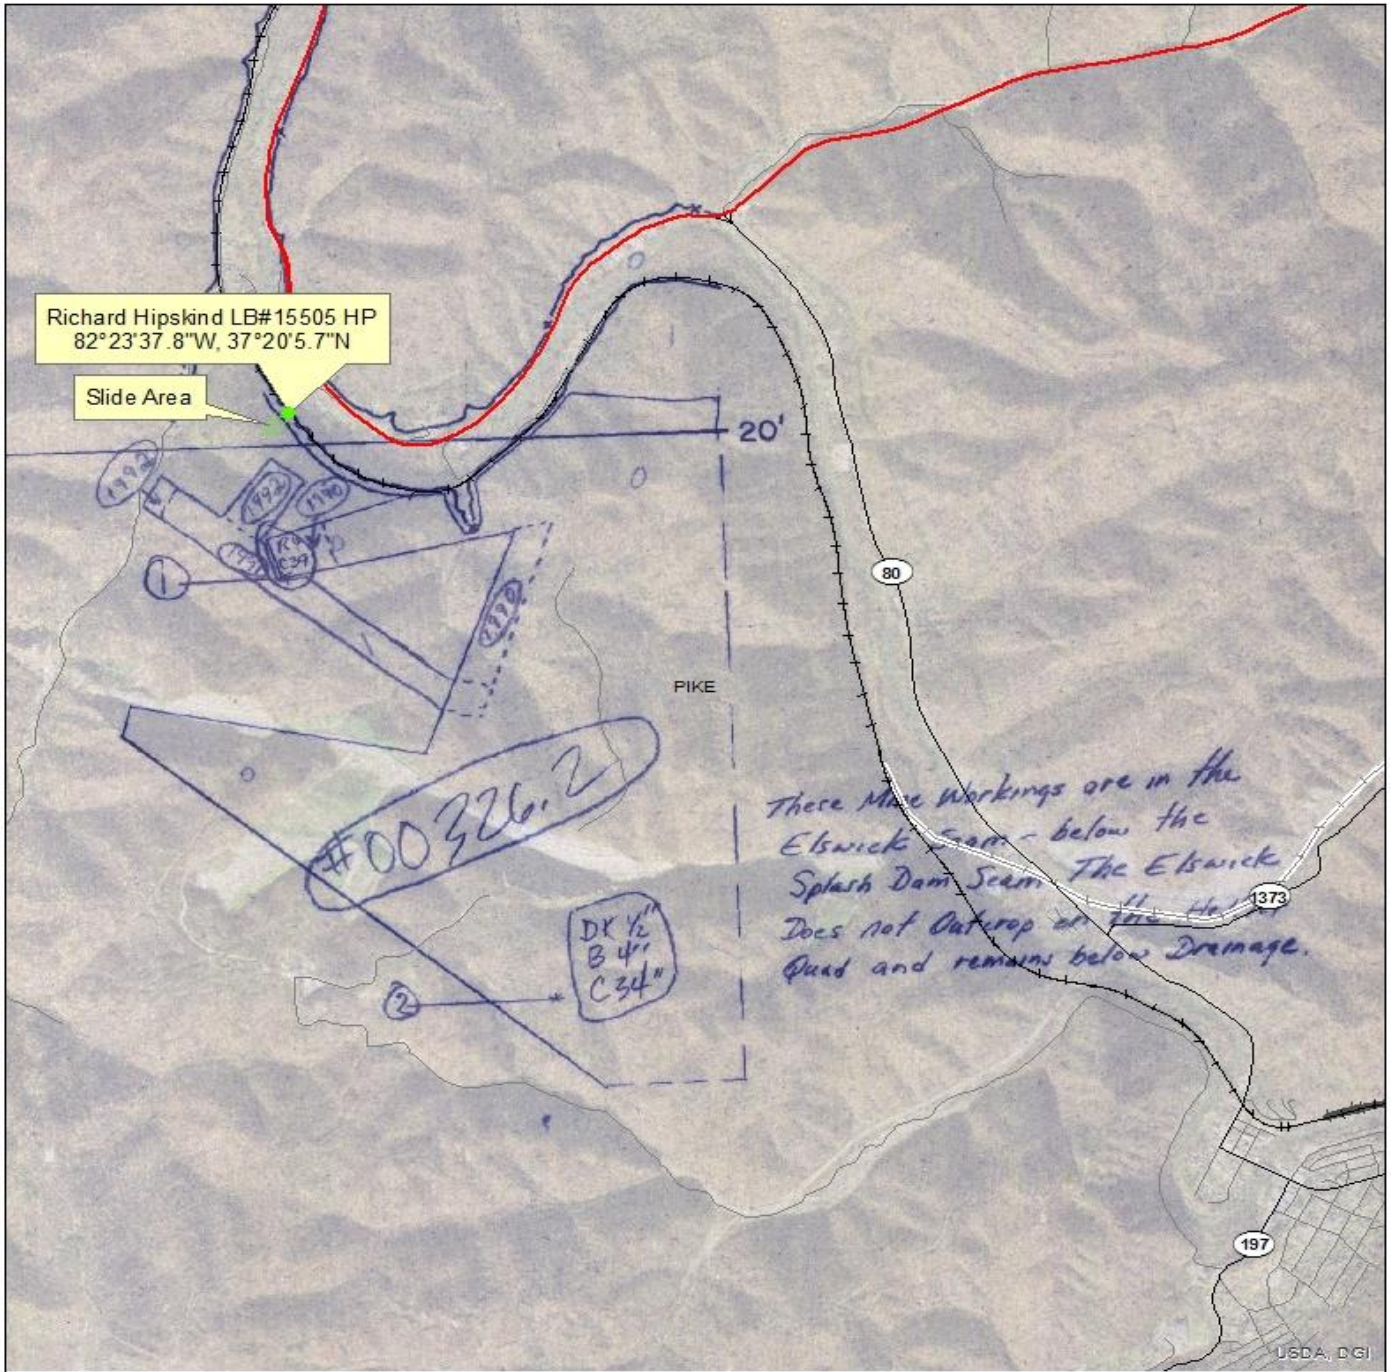
Revenue Overlay
Seam 290: Elswick

Mine History:		
Mined-Out Areas Layer: <i>(Add as many rows as needed)</i>		
KRC Coal seam number	Coal seam name	SFN # and type of mining
290	Elswick	00326-2: UG
<input type="checkbox"/> Permitted Mine Boundaries Released <input type="checkbox"/> Active Permitted Mine Boundaries		
DMP Permit Boundaries Layers: <i>(List permit number and status—include details in permit chart if relevant)</i> 898-5899: UG Cougar Processing: Complete Release (See Permit Chart for Details)		
AML Overlays/ArcMap Series: <i>(Include description if overlays differ from eAMLIS AML complaint layers)</i>		
Project:	Nothing Close	
Problem:	Nothing Close	
Inventory:	Nothing Close	
Deep Mine Overlays: Revenue overlay shows that seam 290 (Elswick) has been mined.		
DMP Overlays Series:

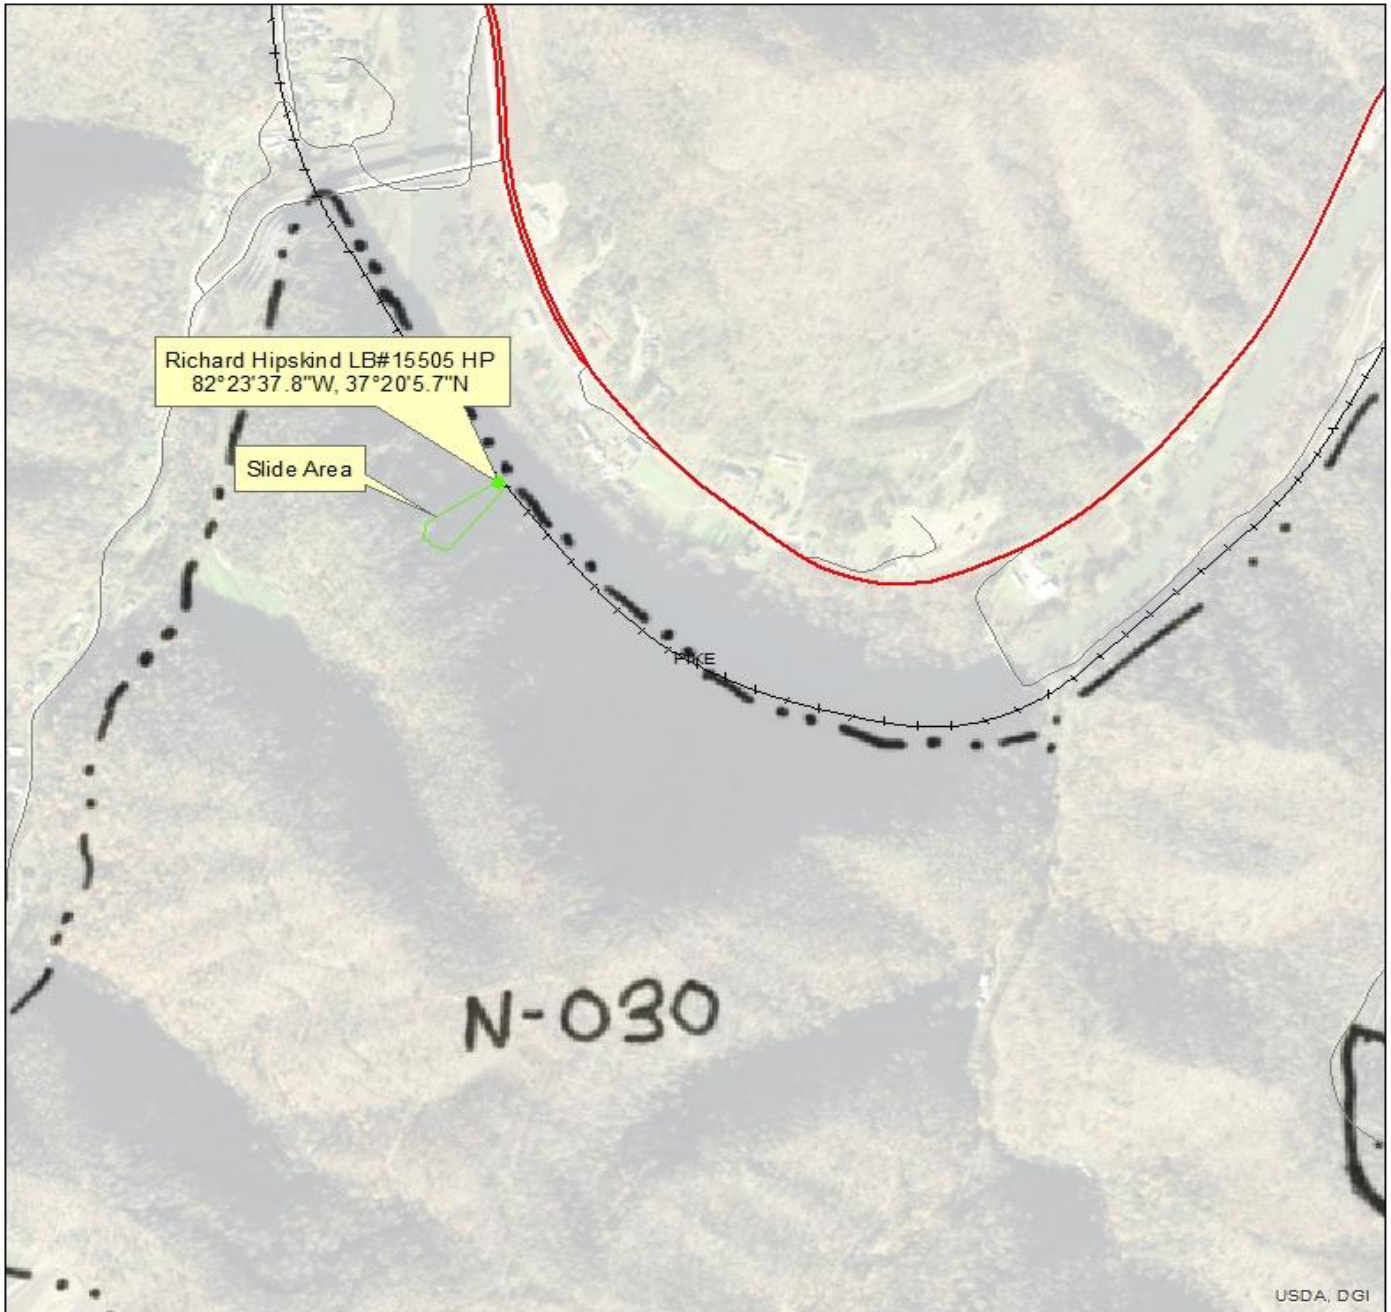
Series 4 Overlay
N 898-5007
UG: Elswick Seam
(Below Site)

1-Nothing Close	4-N 898-5007
2-Nothing Close	5-Nothing Close
3-Nothing Close	6-Nothing Close

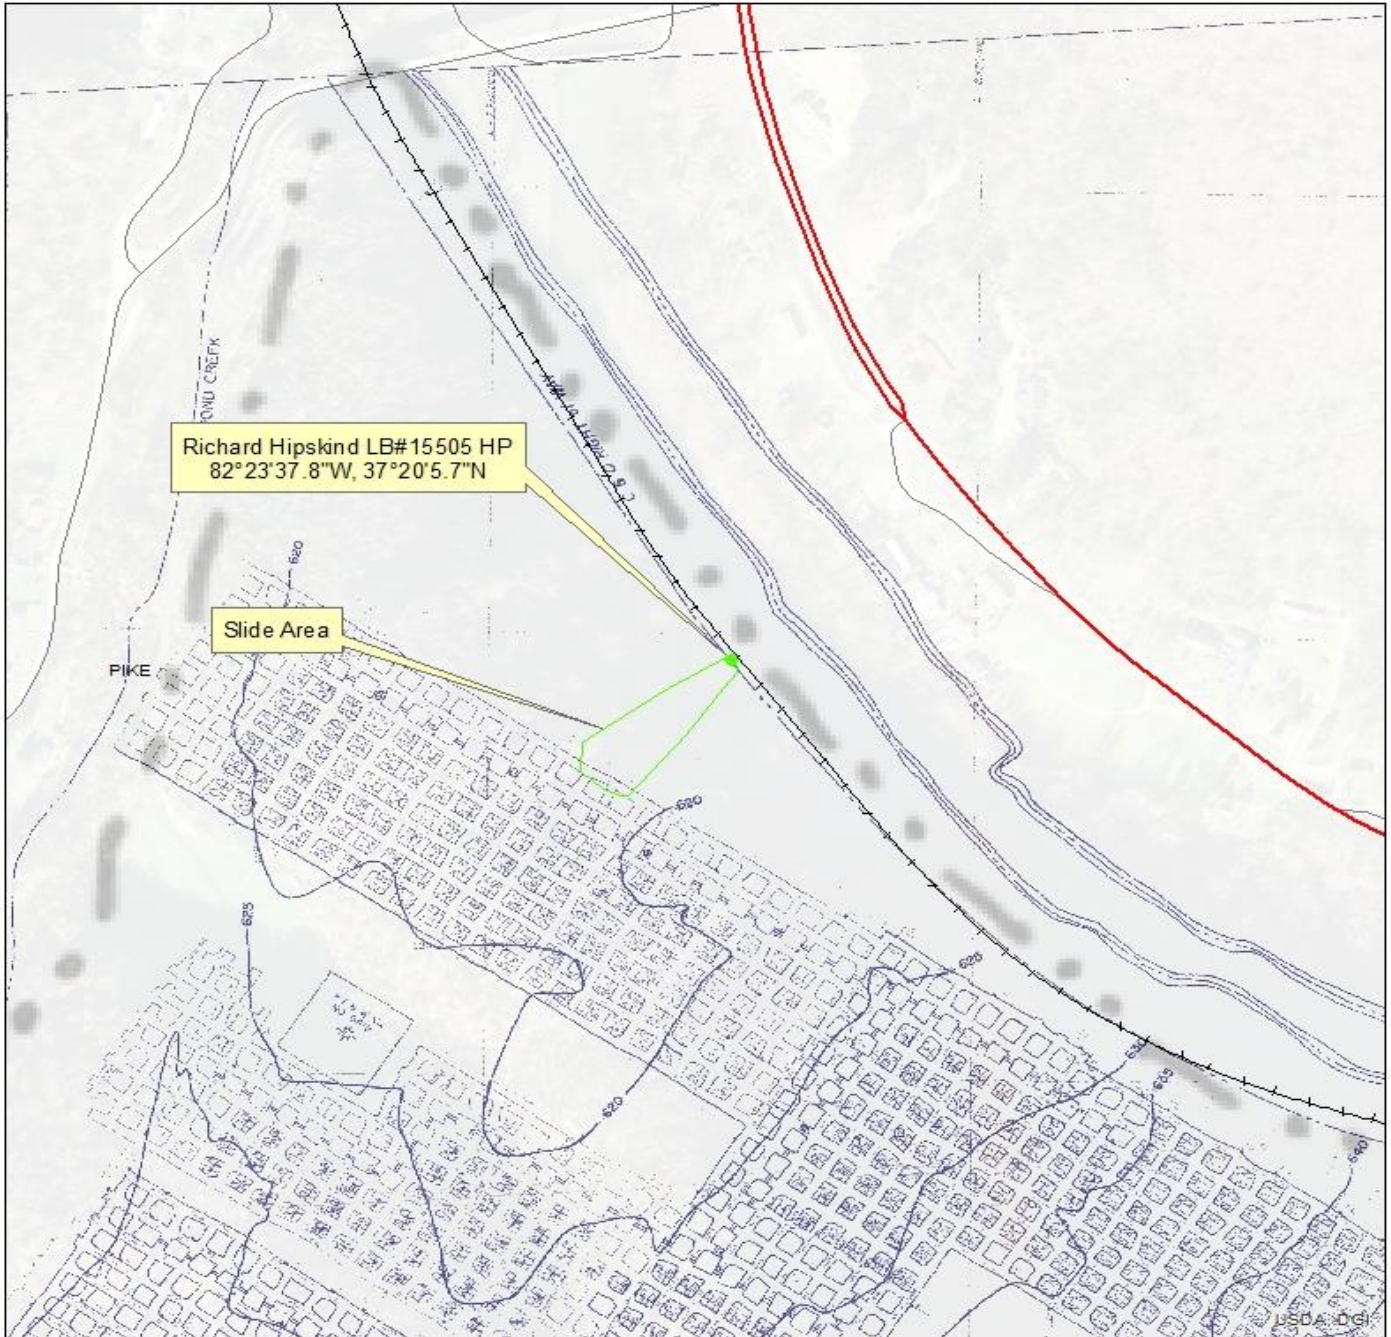
sfn 00326-2
Map Date: 1/5/1994
UG: Elswick
(Below Site)

KOMSL UG Mine Maps: <i>(Include description of any relevant map features below for each map (seam elevations, geologic dip, map notes, etc.). Mine information for relevant operations to be included in Permit Chart above).</i>	
Sfn 00326-2 Map Date: 1/5/1994 (See Permit Chart for Details)

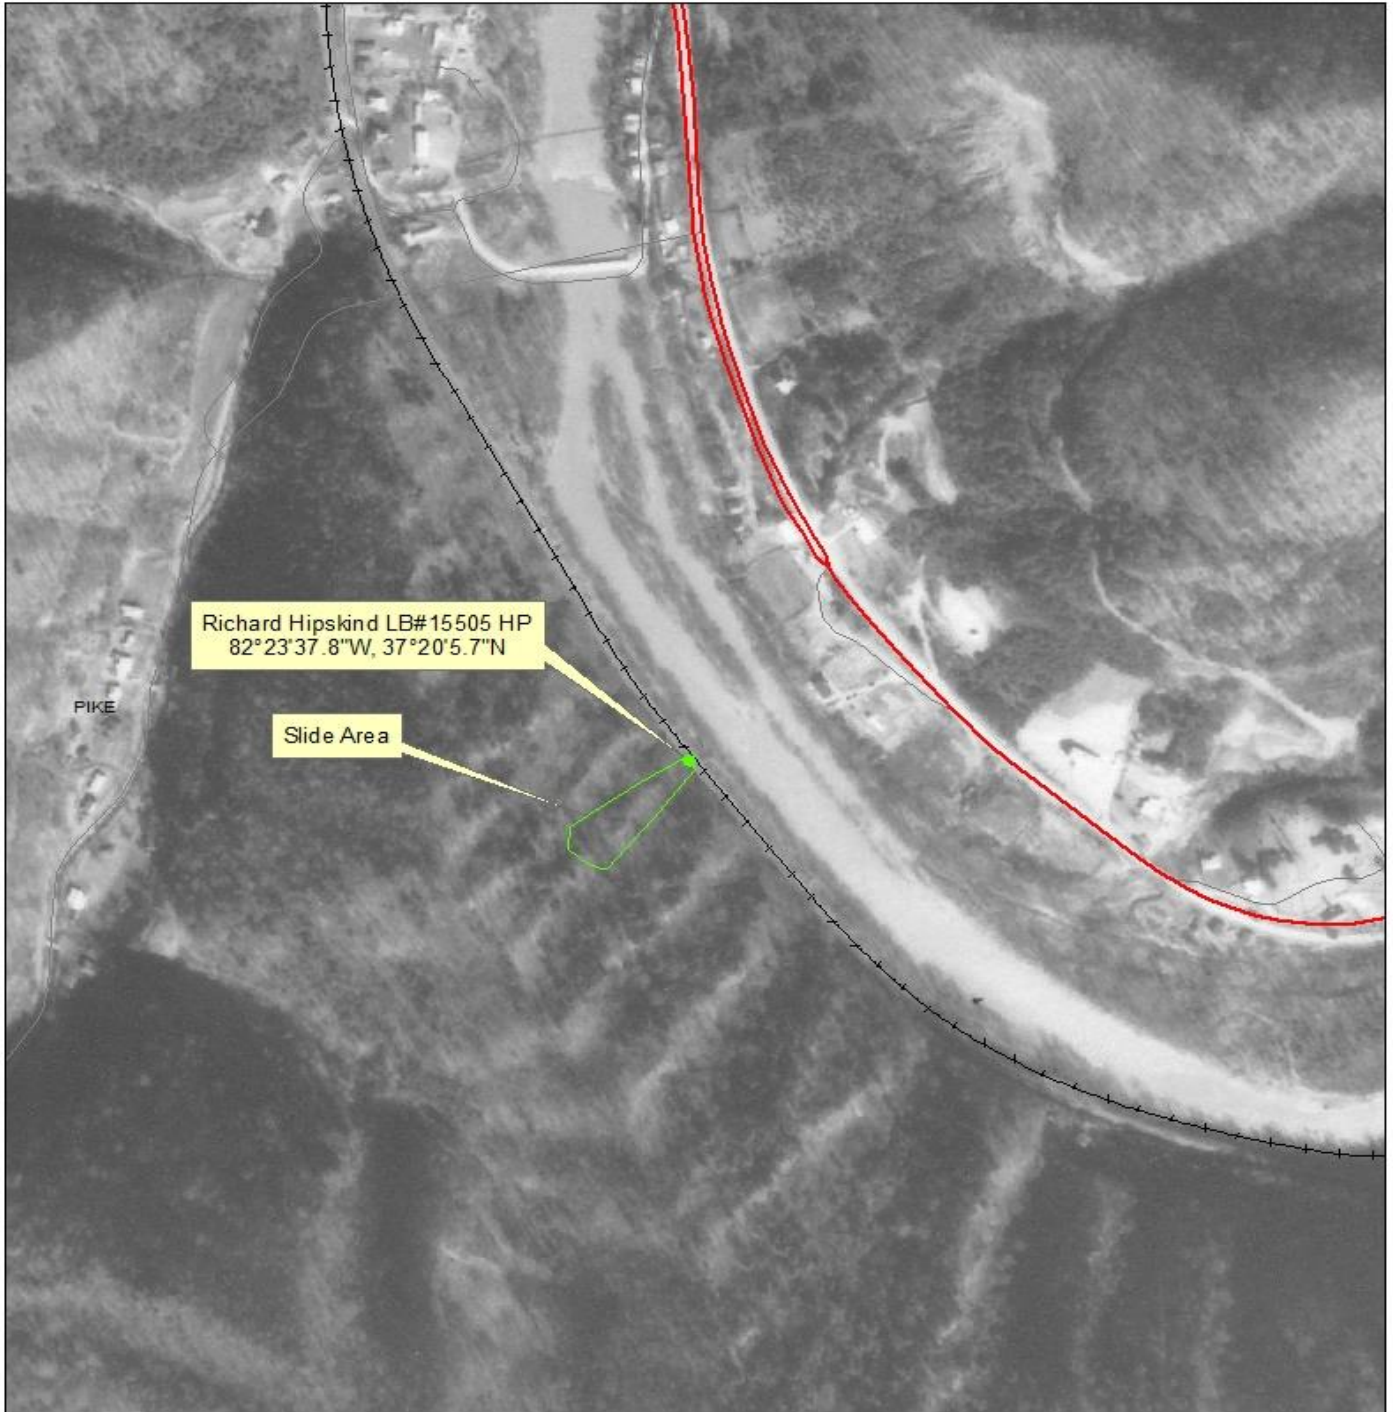
1976 Aerial

KY Trans. 1970's Aerial: <i>(9x9's in file room)</i>	No surface disturbances were observed in the problem area on the 1976 aerial image.

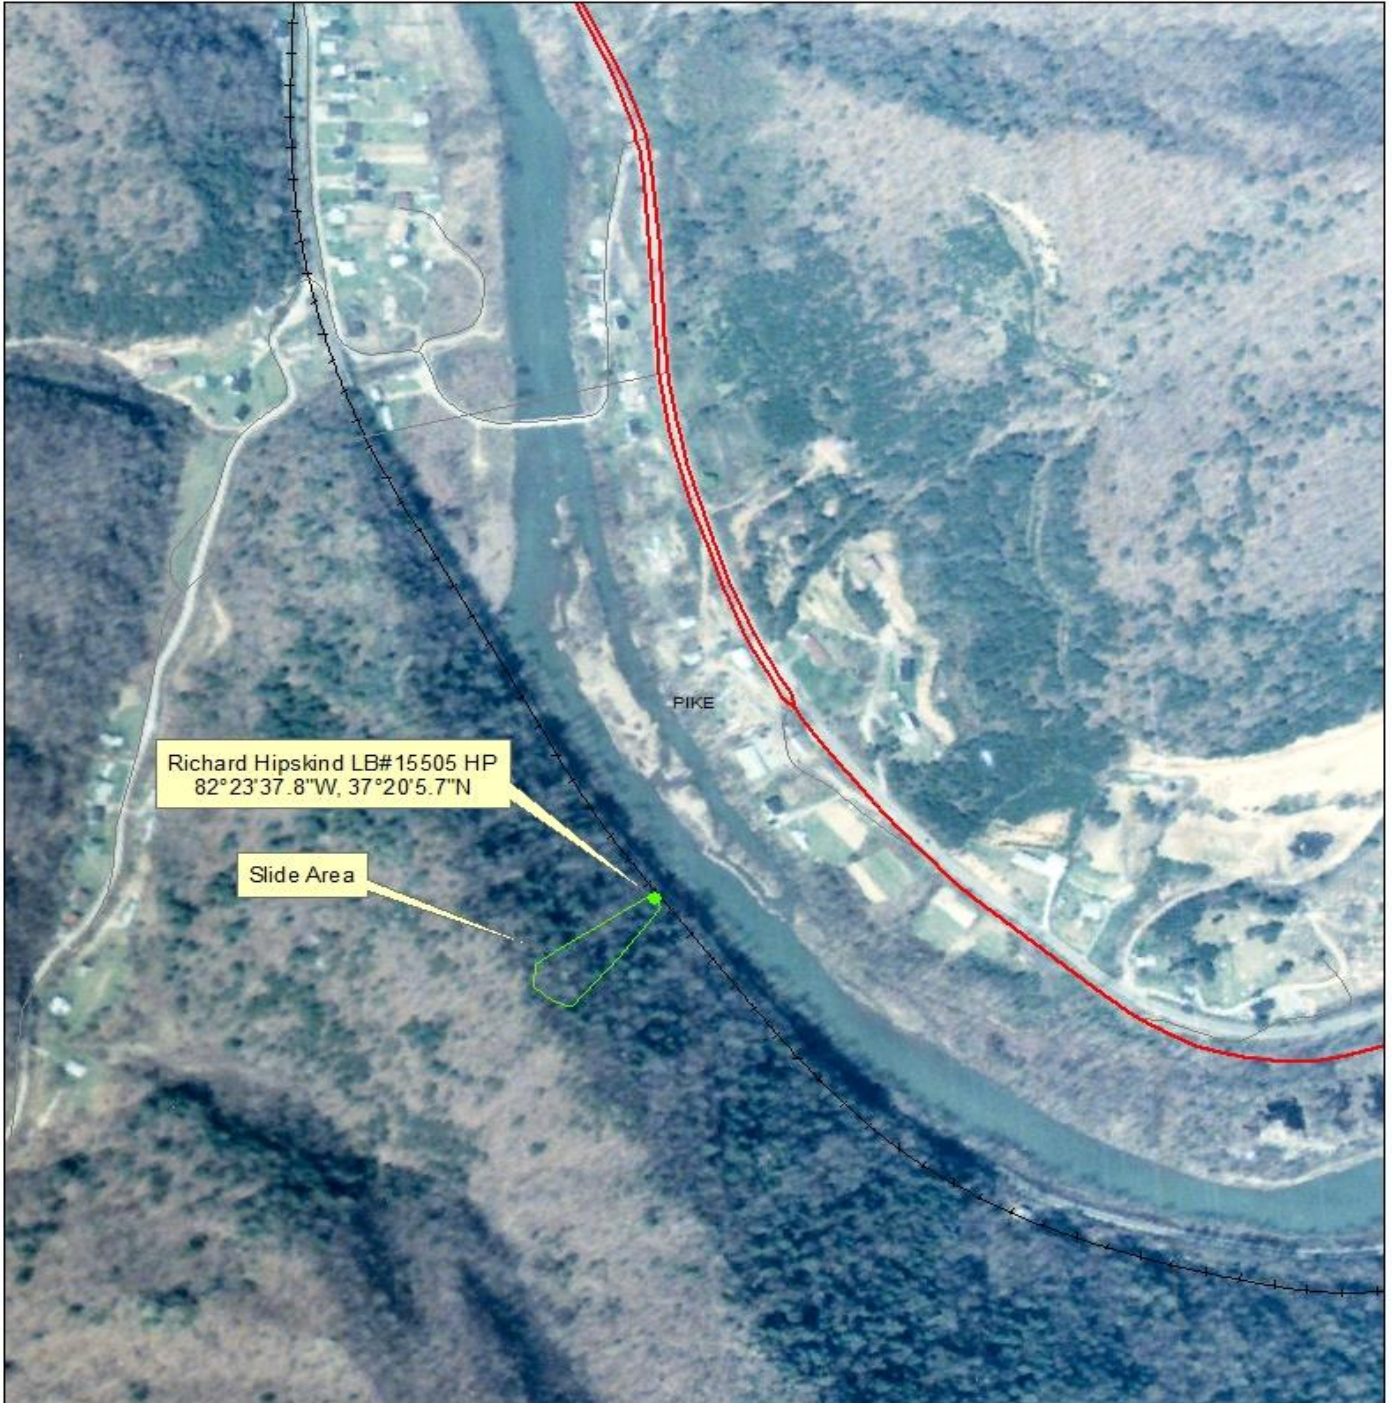
1984 Aerial

KY Trans. 1980's Aerial: <i>(9x9's in file room)</i>	No changes from 1976 on 1984 aerial.
DOQQ B&W Mosaic 1992-1999:	No disturbances on the 1995 aerial.
DOQQ B&W Mosaic 2001-2002:	No observed change.
FSA Color Imagery 2004:	No observed change.
FSA Color Imagery 2006:	No observed change.
FSA Color Imagery 2008:	No observed change.
FSA Color Imagery 2010:	No observed change.
FSA Color Imagery 2012:	No observed change.
FSA Color Imagery 2014:	No observed change.
FSA Color Imagery 2016:	No observed change.
ESRI World Imagery:	No observed change.
FSA Color Imagery 2018:	No observed change.

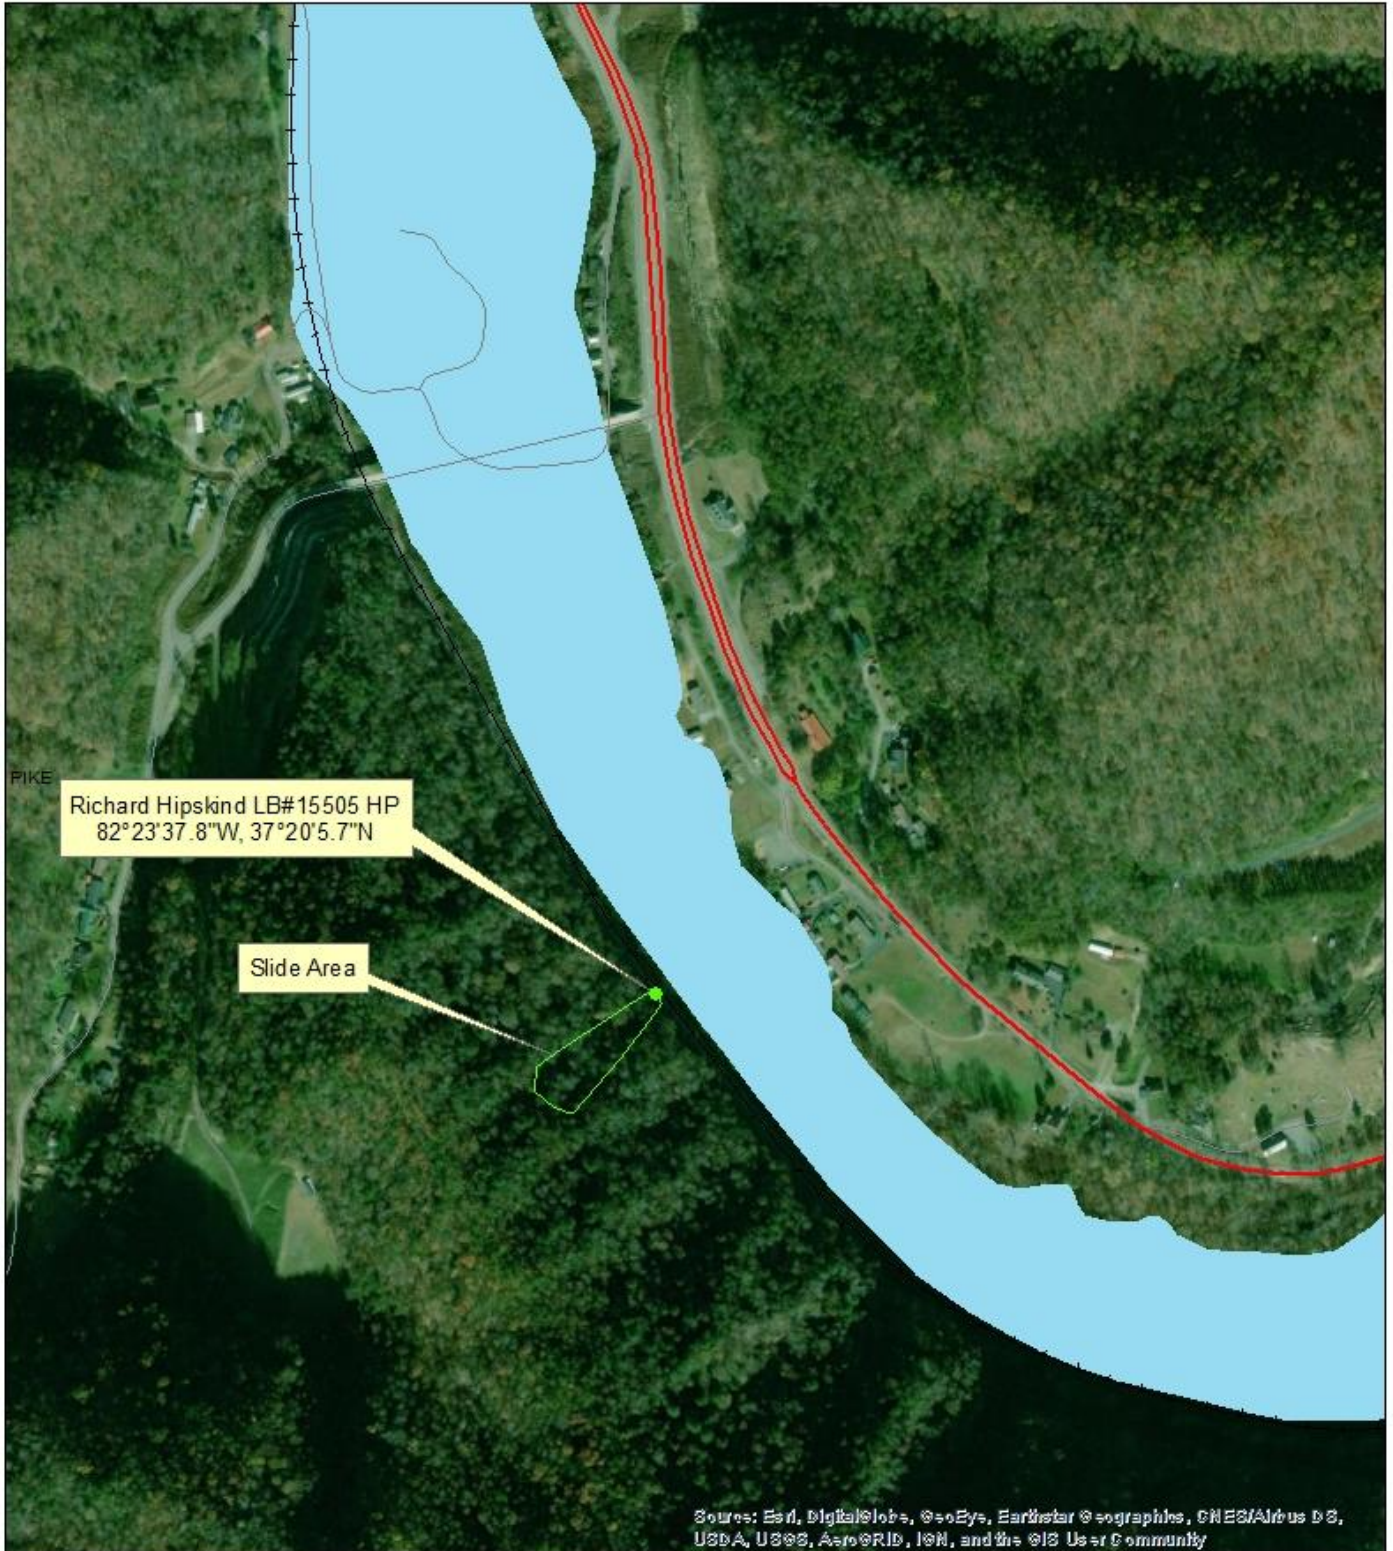
FEMA Floodplain

Miscellaneous:	
FEMA 100-year Floodplain: <i>(Indicate whether site is located within the floodplain)</i>	The creek bank below the tracks is on the edge of the floodplain.
Weather Data: <i>(Visit http://water.weather.gov/precip/ and create relevant maps for the area of influence i.e. daily, weekly, monthly precipitation, % normal, etc., summarize findings here)</i>	The week leading up to the slide event the immediate area received anywhere between 4.5 – 6.0 inches of observed precipitation.
