National Transportation Safety Board

HWY22MH003

MATERIALS LABORATORY

Factual Report 23-011

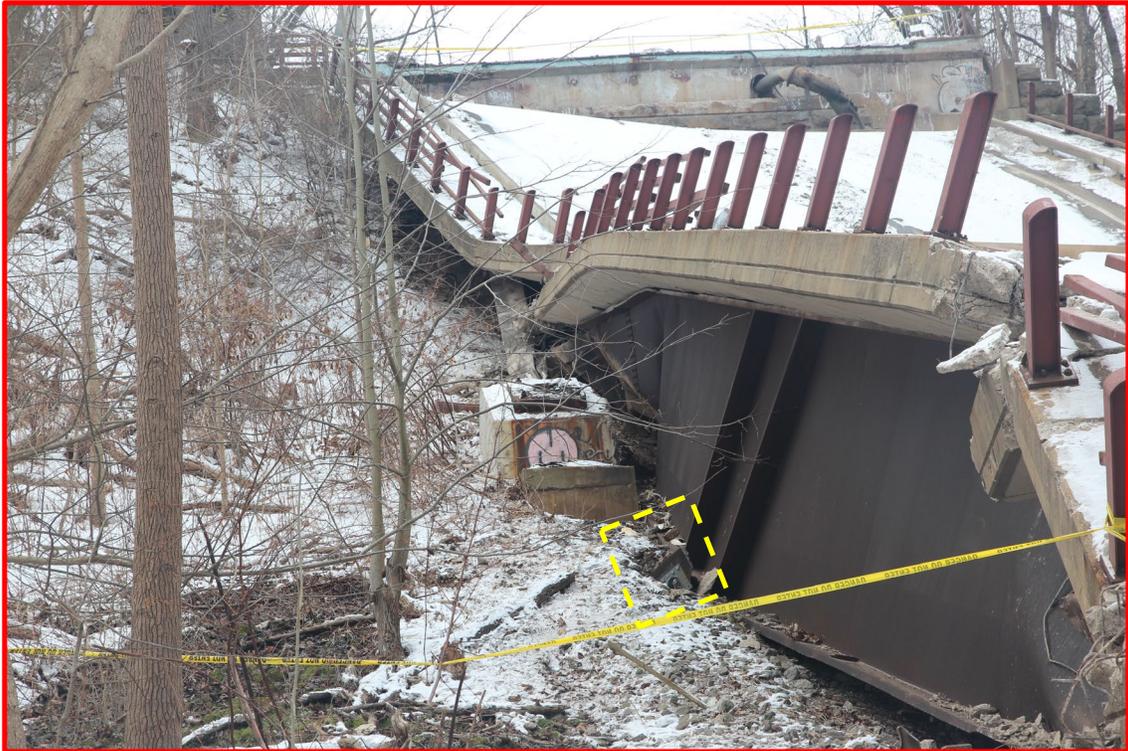
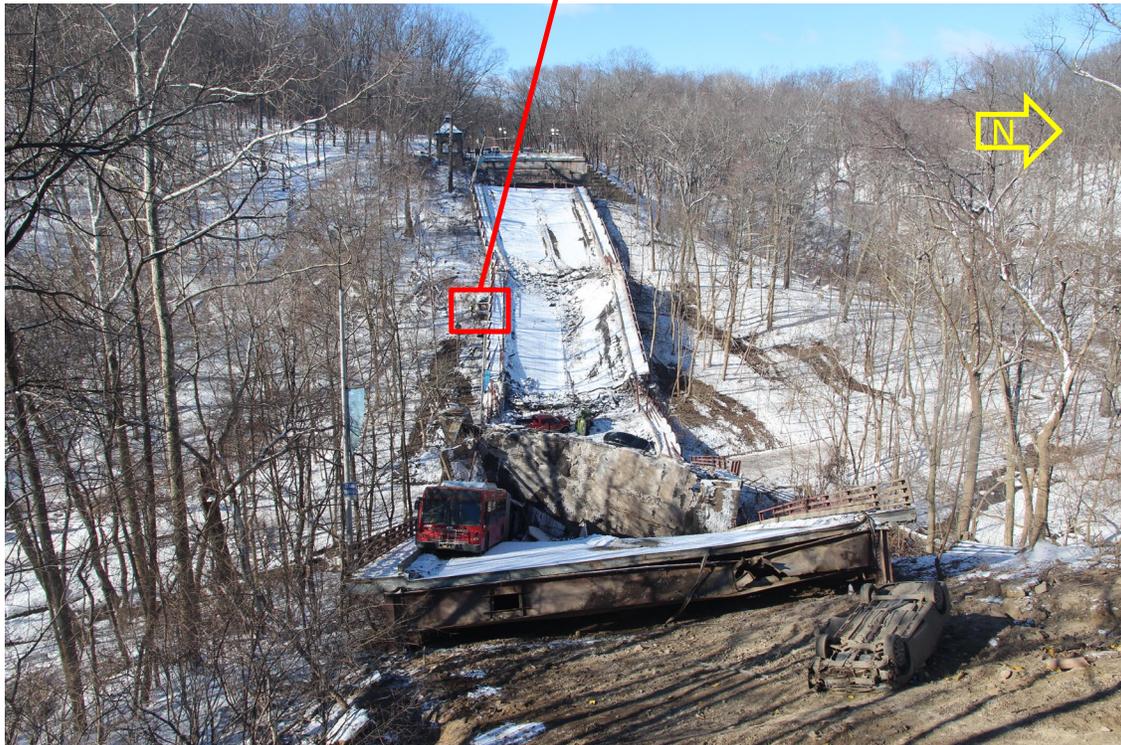
While on-scene, investigators observed fracture surfaces at the end plates on the tops of legs B1R and B2L where they connected to the girders. The fracture surface on leg B1R was visible outside the collapsed structure; the fracture occurred transversely through the span 2 side flange at the weld above a cable connection point on the leg, as shown in Figures 4 and 5. The weld on the span 2 side was at the obtuse angle of leg B1R. The fracture surface on leg B2L was visible underneath the collapse structure, as shown in Figures 9 and 10. The fracture on leg B2L was transverse through the span 3 side flange weld also above a cable connection point on the leg. The weld on the span 3 side was at the acute angle of leg B2L.

Figure 4. Photos showing the location of the fracture at the top of leg B1R (yellow dashed line) visible outside the collapsed structure.

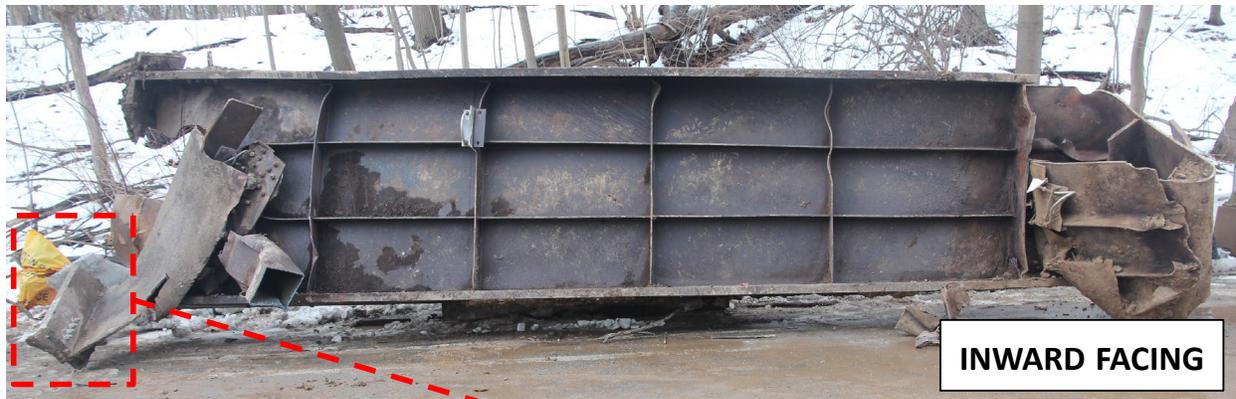
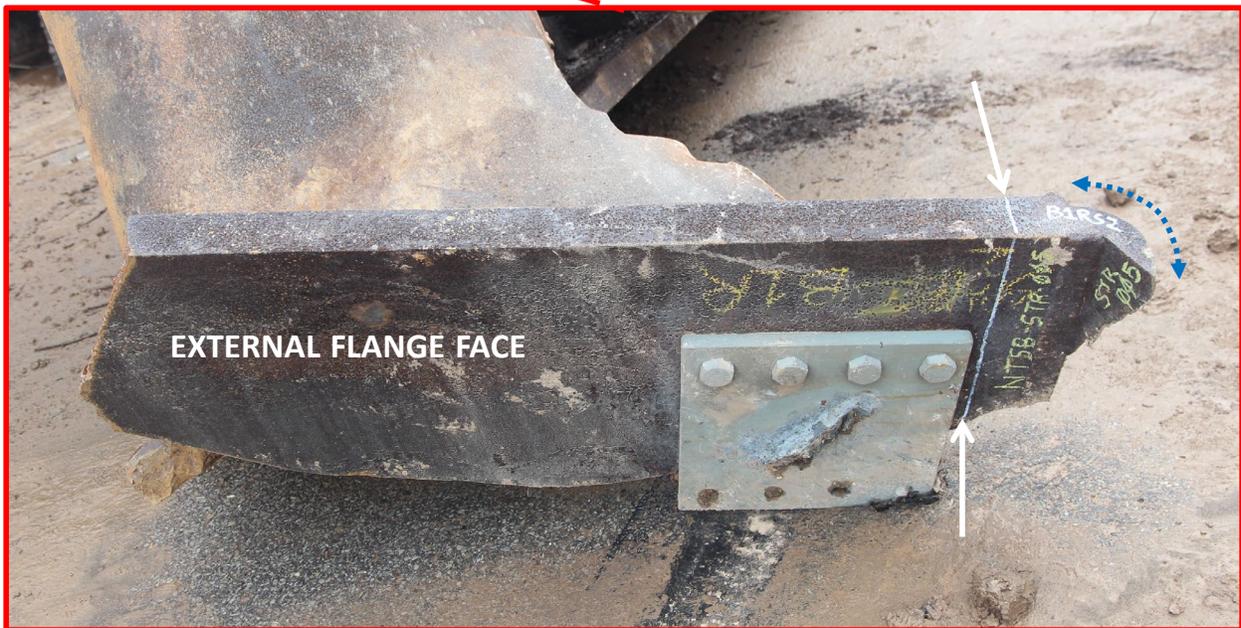
Both fracture surfaces had relatively flat sections with a line of heavily oxidized features directly adjacent to the flange faces. Inboard of the relatively flat area, the leg B1R fracture surface curved towards the external face of the span 2 flange, as indicated by the blue dotted arrow in Figure 6. Inboard past the relatively flat area on leg B2L, the fracture surface thrust outward, then changed progression direction again to jut inwards towards the internal flange face. The blue dotted arrow in Figure 10 traces the general z-shape of the profile of the leg B2L fracture surface.

The legs were uncovered and removed to an evidence staging area as documented in NTSB Materials Laboratory Factual Report 23-009. The fracture surfaces were torch cut from the legs along the lines indicated by the white arrows in Figure 6 for leg B1R and Figure 11 for leg B2L. The fracture surfaces were coated in grease to prevent further oxidation and the pieces were wrapped in foam to prevent

Figure 6. Photos showing the line (white arrows) along which the fracture surface was sectioned for retention after leg B1R was removed from the collapse site to an evidence staging area. The blue dotted line indicates the z-shaped profile of the fracture surface.

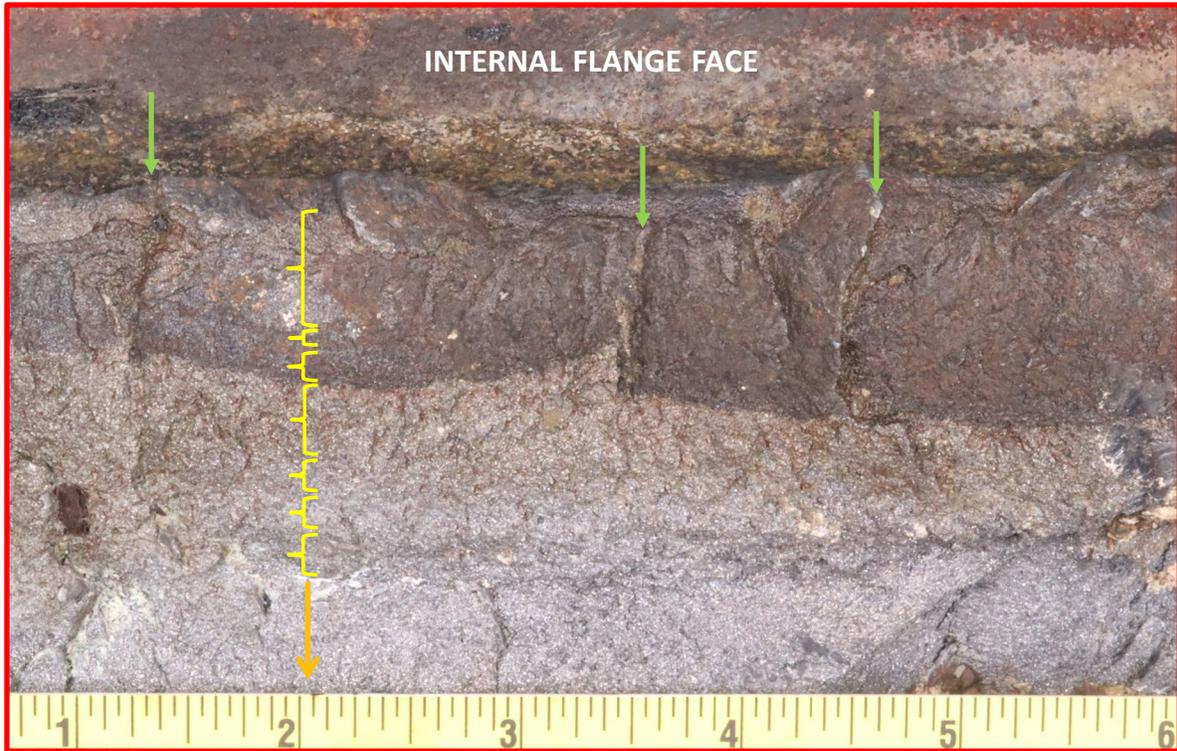
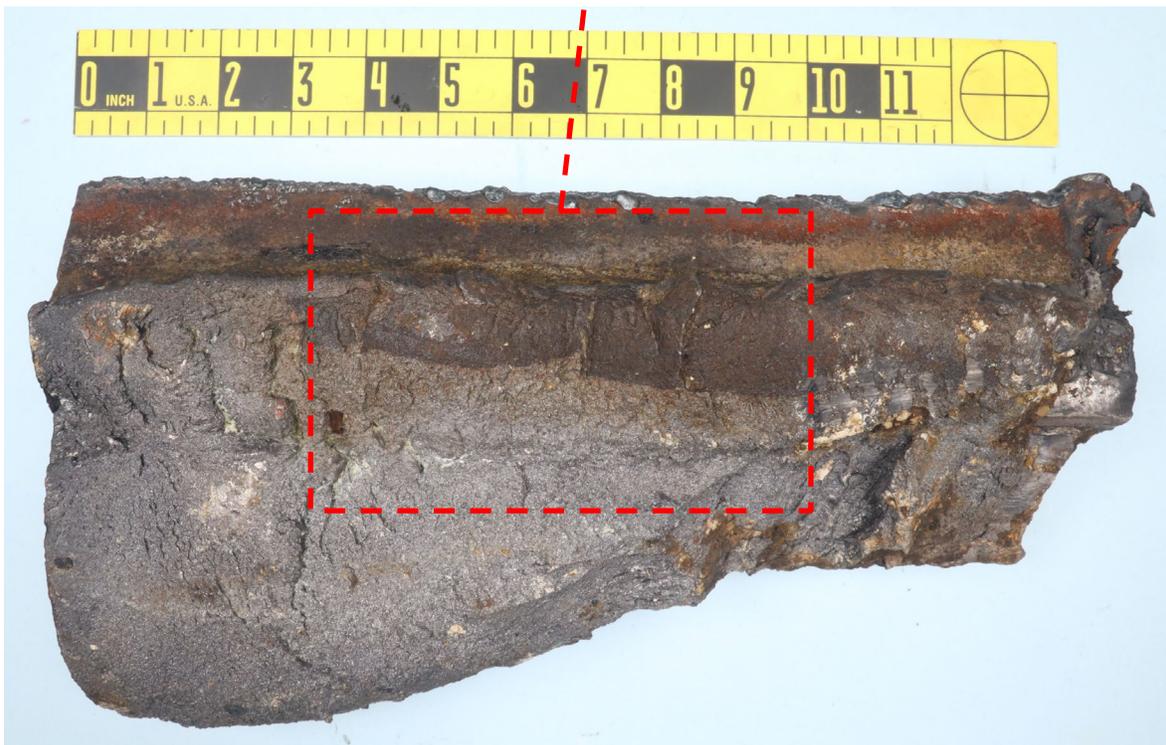
After cleaning, the fracture surfaces were examined optically and under magnification using stereomicroscopy. The line of heavily oxidized features on the fracture surfaces directly adjacent to the flange faces lightened but were not completely removed by the cleaning. Ridges² perpendicular to the flange face were observed between cleavage facets within the line of heavily oxidized features on both fracture surfaces, as indicated by the green arrows in Figures 7 and 8 for leg B1R and Figure 12 for leg B2L.

Multiple crack progression marks consistent with an advancing crack front were visible on the fracture surfaces. The crack progression marks were observed within the line of heavily oxidized features, as well as further inboard from the flange faces. The crack progression marks further inboard of the flange faces had varying levels of oxidation. The crack progression marks on the leg B1R and leg B2L fracture surfaces are indicated by the yellow brackets in Figures 7 and 8; and Figure 12, respectively. Between the crack progression marks, the fracture surface features were rough and consistent with overstress. Such features were particularly visible under side lighting conditions, as demonstrated in Figure 8.

The remaining areas on the transverse fracture surfaces past the crack progression marks (indicated by the orange arrows in Figures 7, 8, and 12) were minimally oxidized, with rough features consistent with overstress. The additional fracture surfaces through the length of the flange and web on leg B2L also had rough features consistent with overstress, as shown in Figure 13.

Figure 7. Macro photos of the fracture surface on leg B1R as viewed under direct lighting. The green arrows point to ridges within the line of heavily oxidized features. The yellow brackets indicate crack progression marks. The orange arrow points in the direction of crack propagation on the remaining fracture surface.

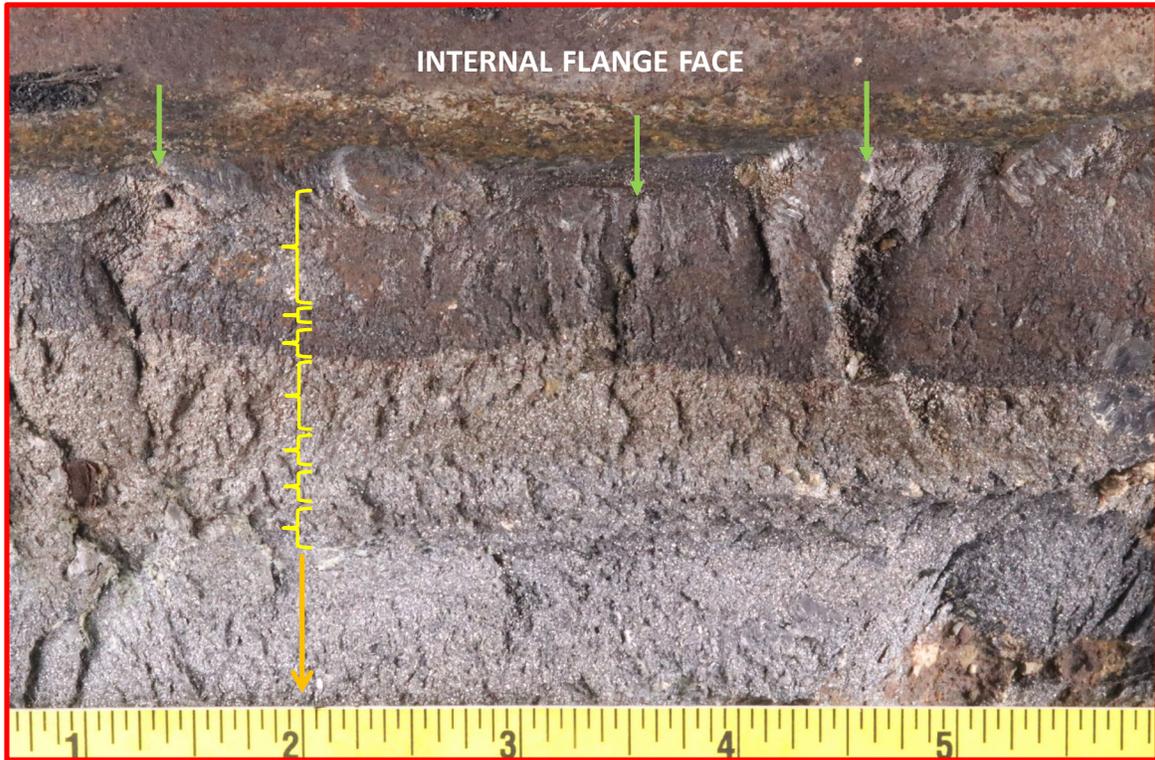
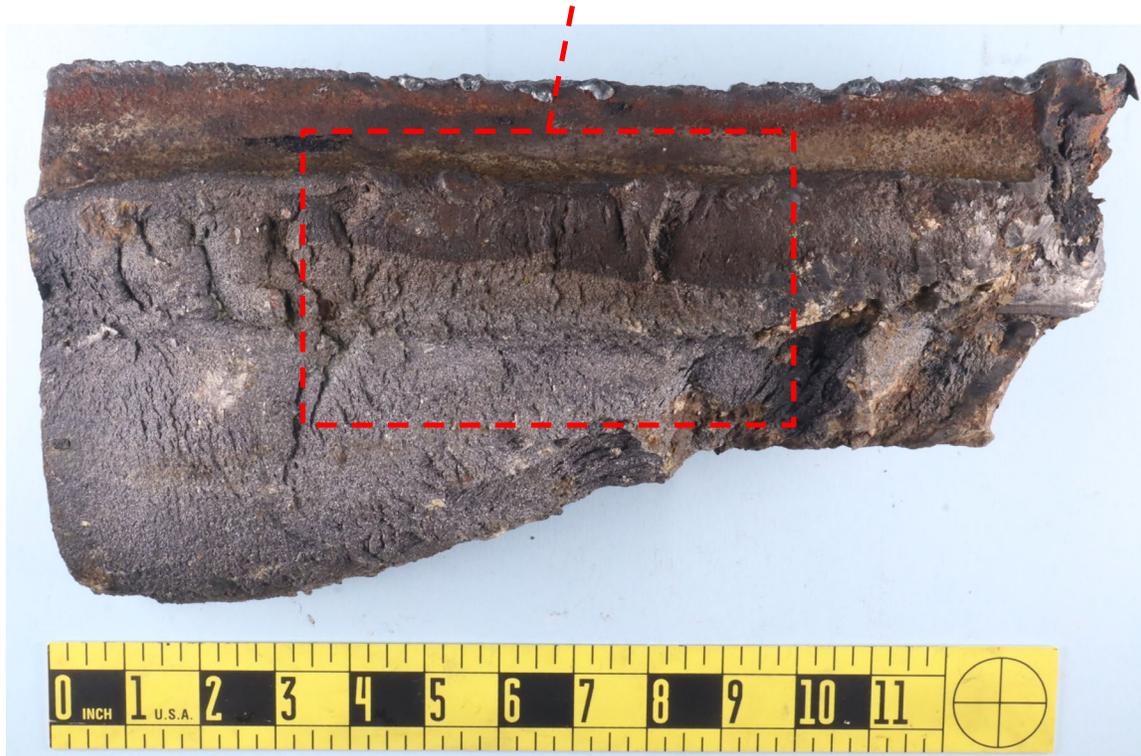
Figure 8. Macro photos of the fracture surface on leg B1R as viewed under side lighting. The green arrows point to ridges within the line of heavily oxidized features. The yellow brackets indicate crack progression marks. The orange arrow points in the direction of crack propagation on the remaining fracture surface.

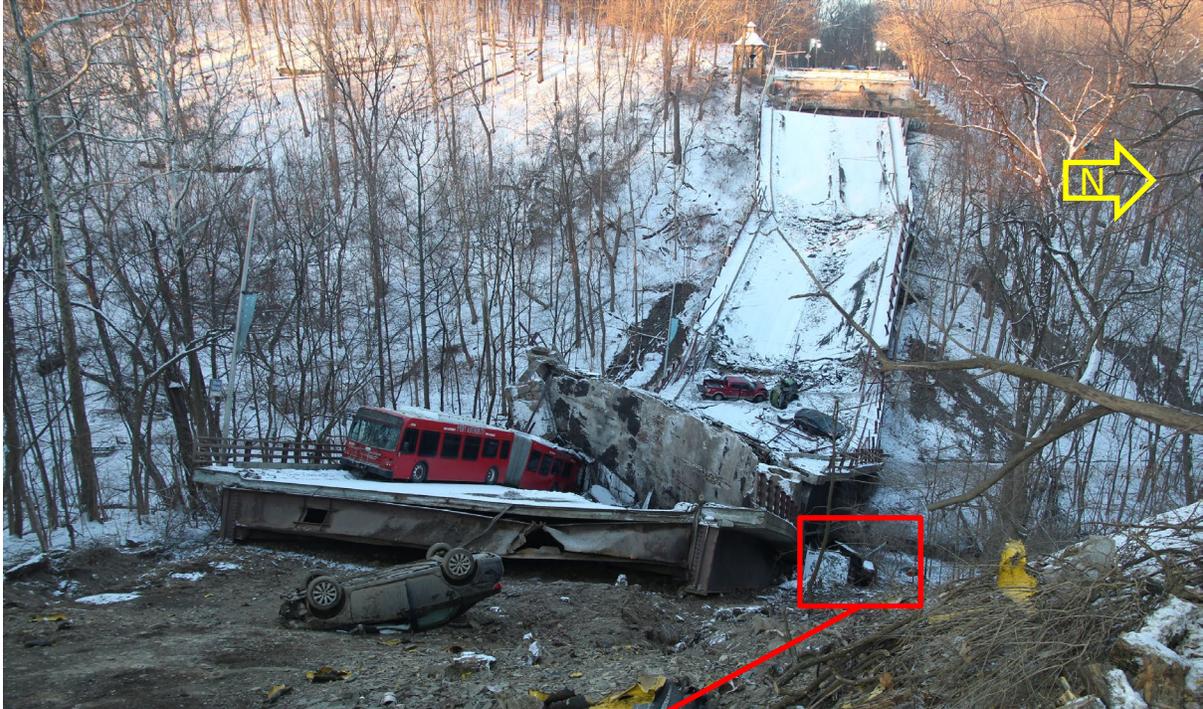
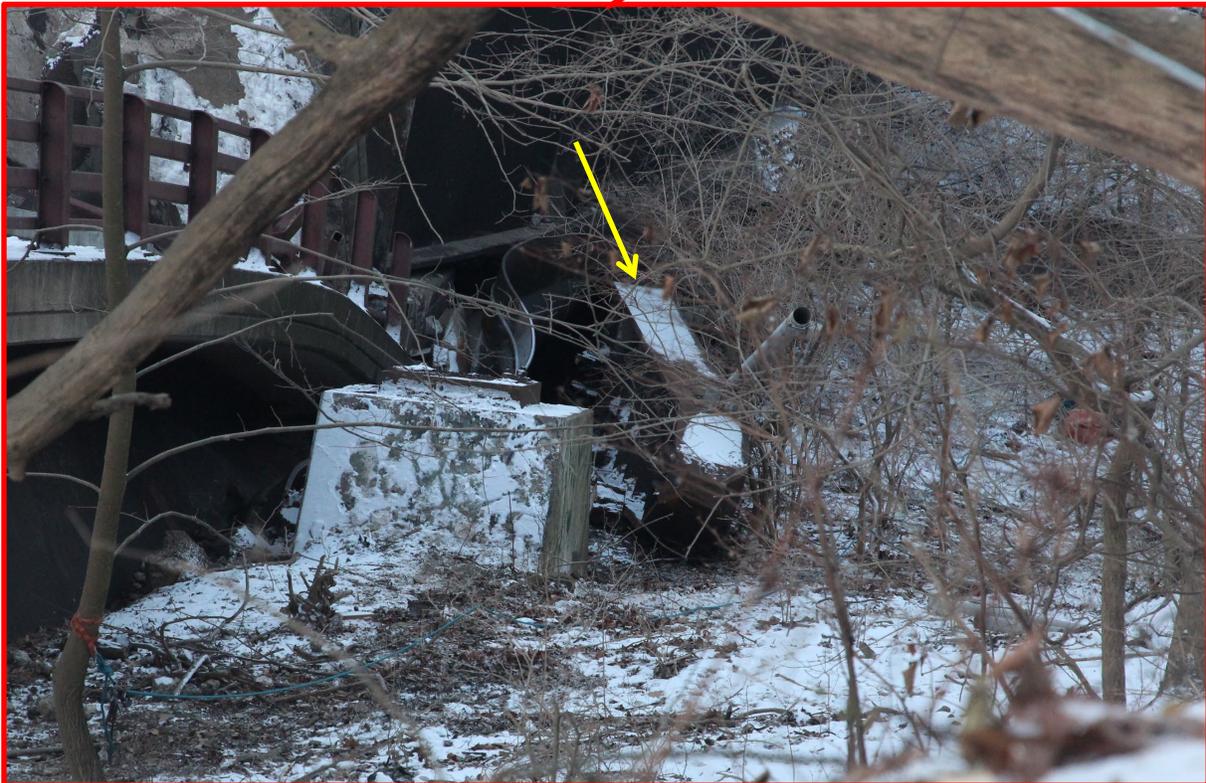
Figure 9. Photos showing the location of the fracture (yellow arrow) at the top of leg B2L underneath the collapsed structure.

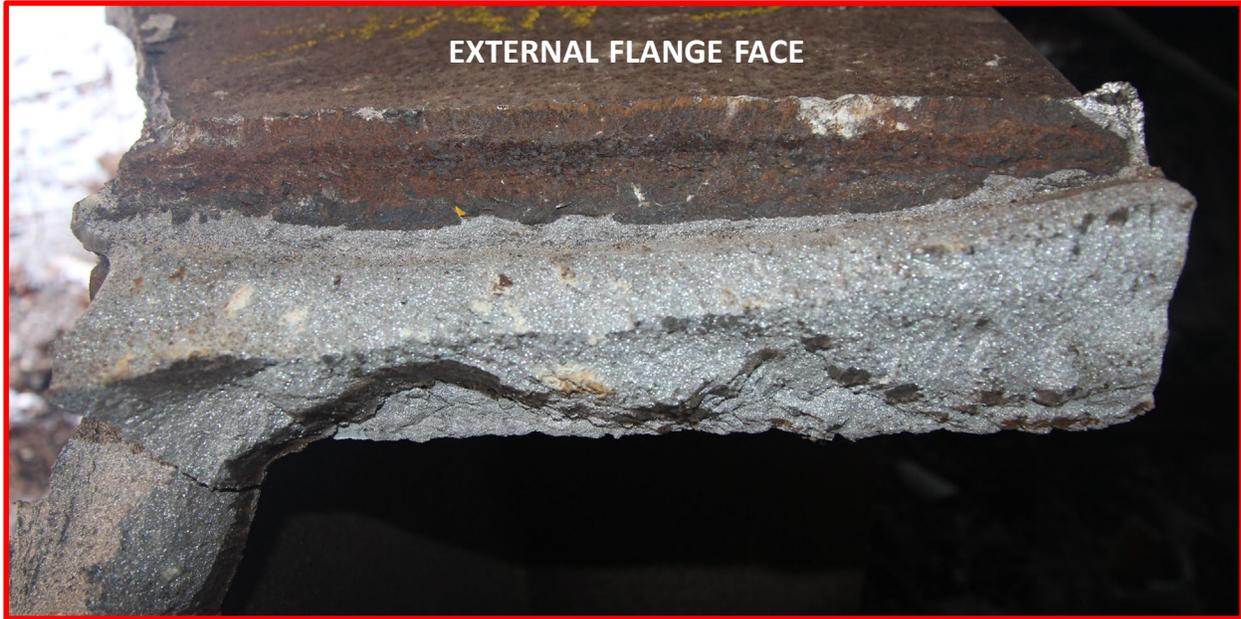
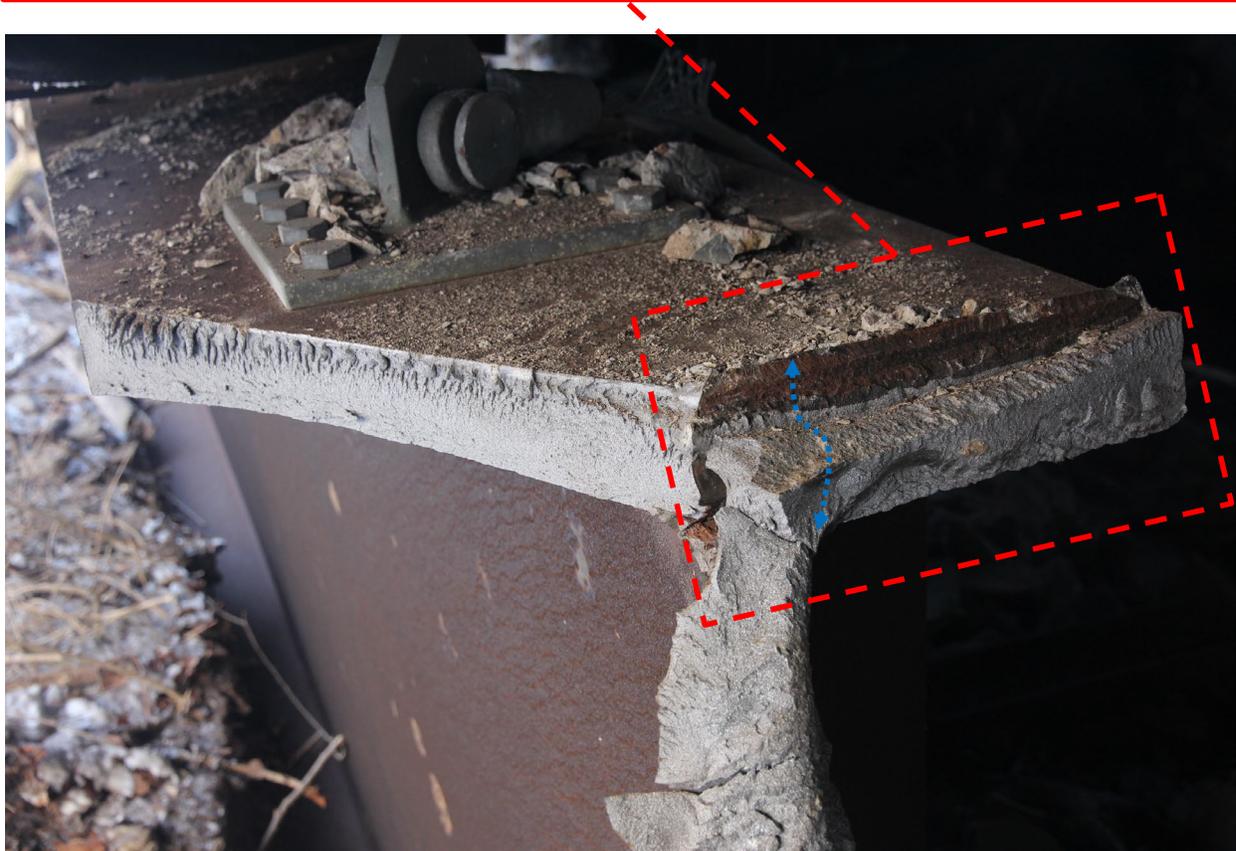
Figure 10. Photos showing the fracture surface through the end plate weld at the top of leg B2L visible underneath the collapsed structure. The blue dotted line indicates the z-shaped profile of the fracture surface.

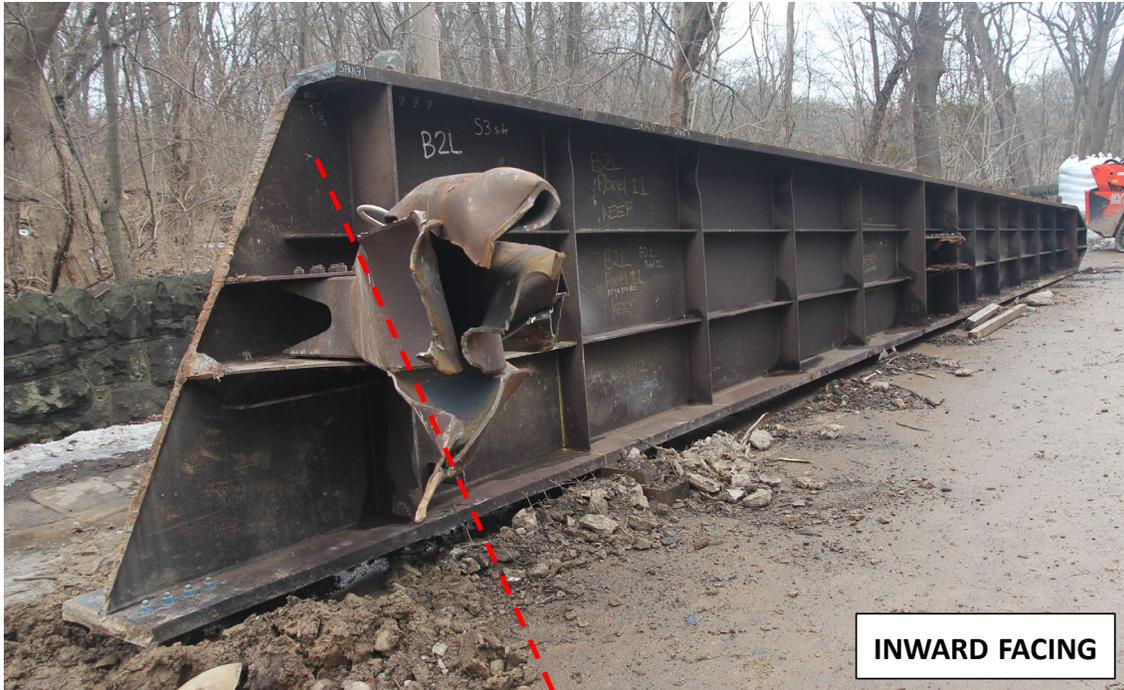
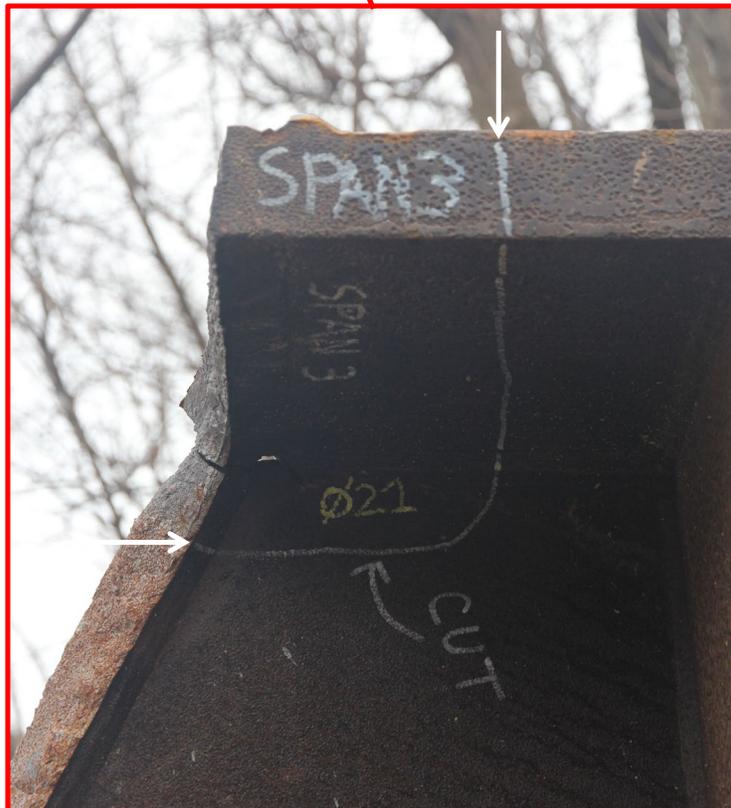
Figure 11. Photos showing the line (white arrows) along which the fracture surface was sectioned for retention after leg B2L was removed from the collapse site to an evidence staging area.

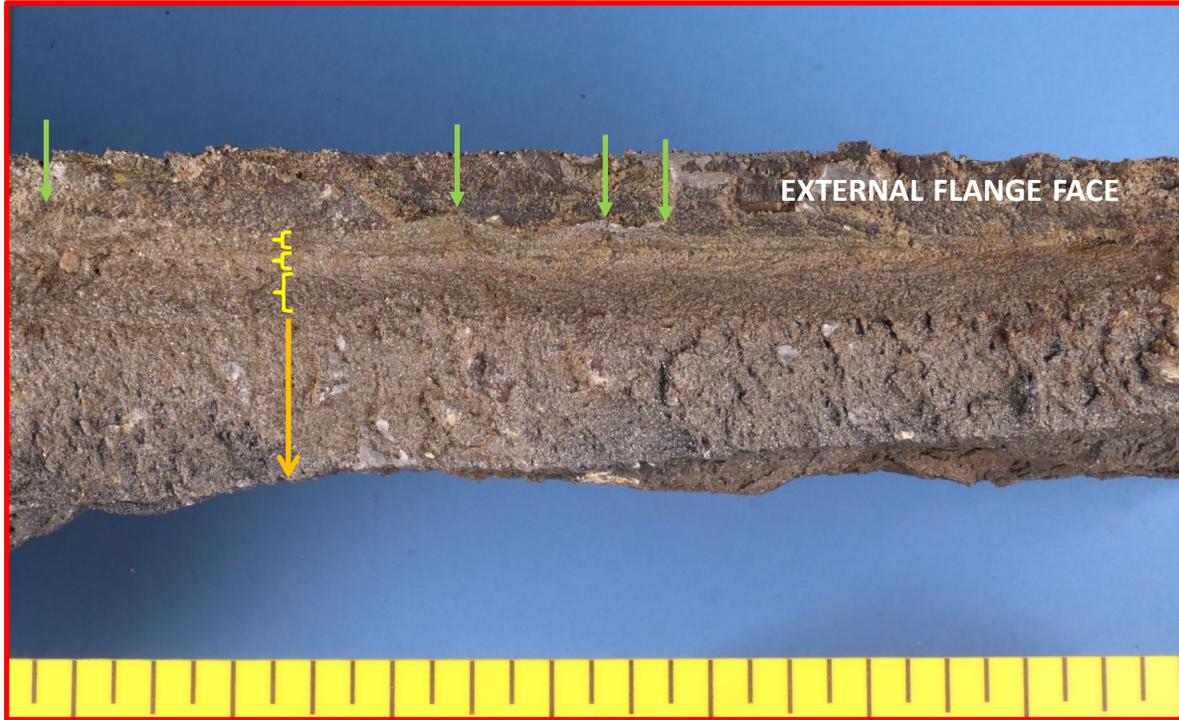
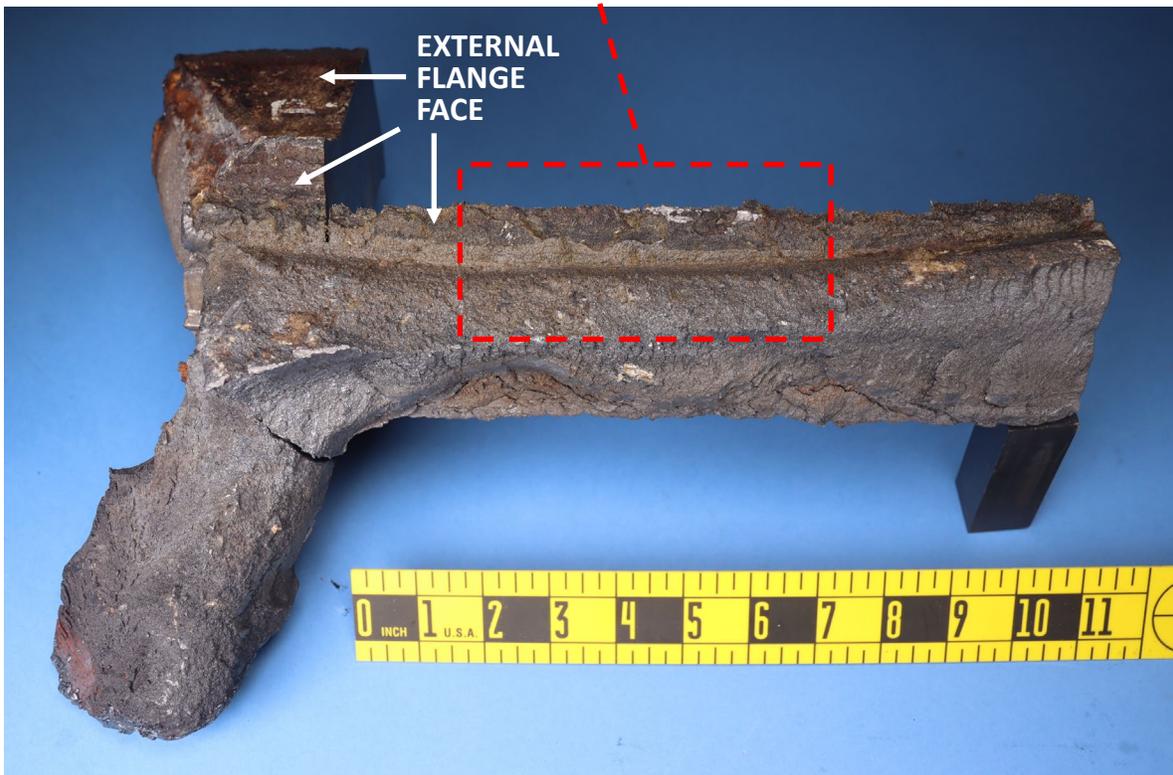
Figure 12. Macro photos of the fracture surface on leg B2L as viewed under direct lighting. The green arrows point to ridges within the line of heavily oxidized features. The yellow brackets indicate crack progression marks. The orange arrow points in the direction of crack propagation on the remaining fracture surface.

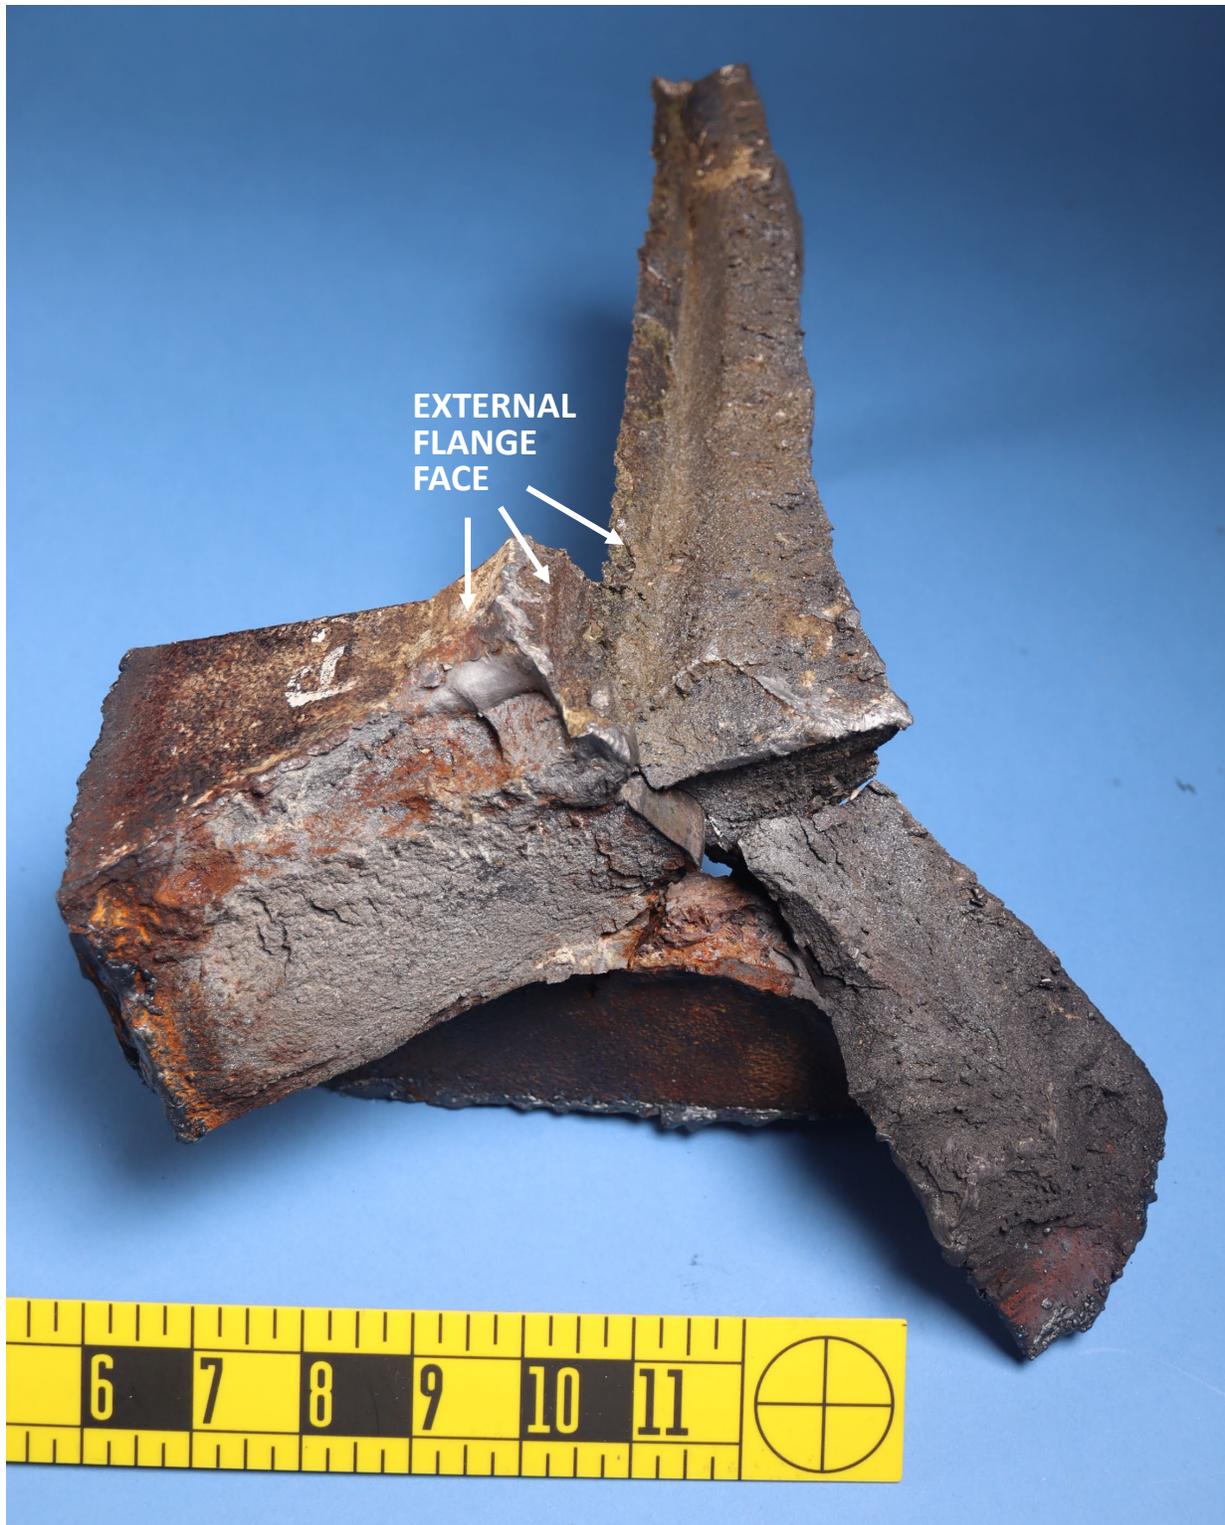
Figure 13. Macro photo of the fracture surface on leg B2L as viewed in profile under direct lighting.
