# National Transportation Safety Board

Office of Research and Engineering

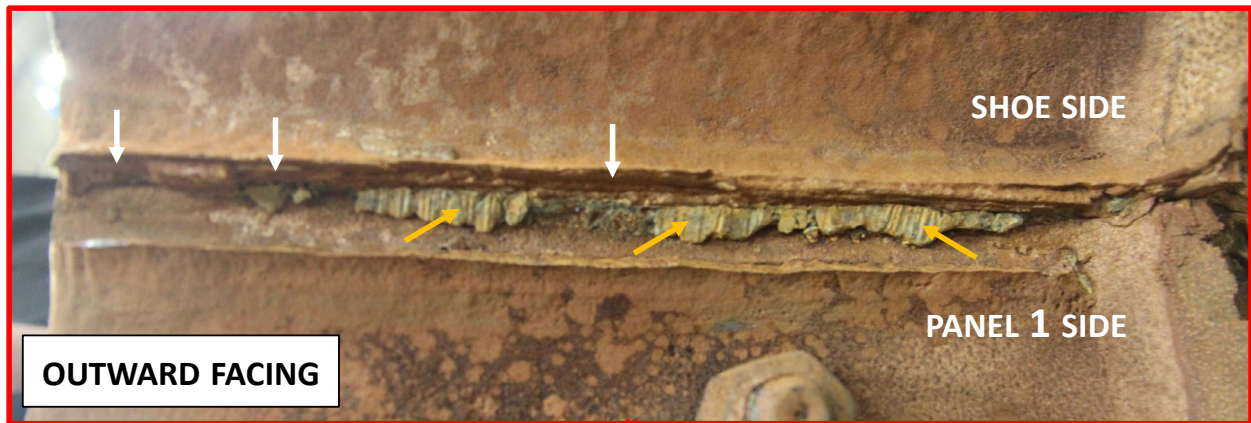
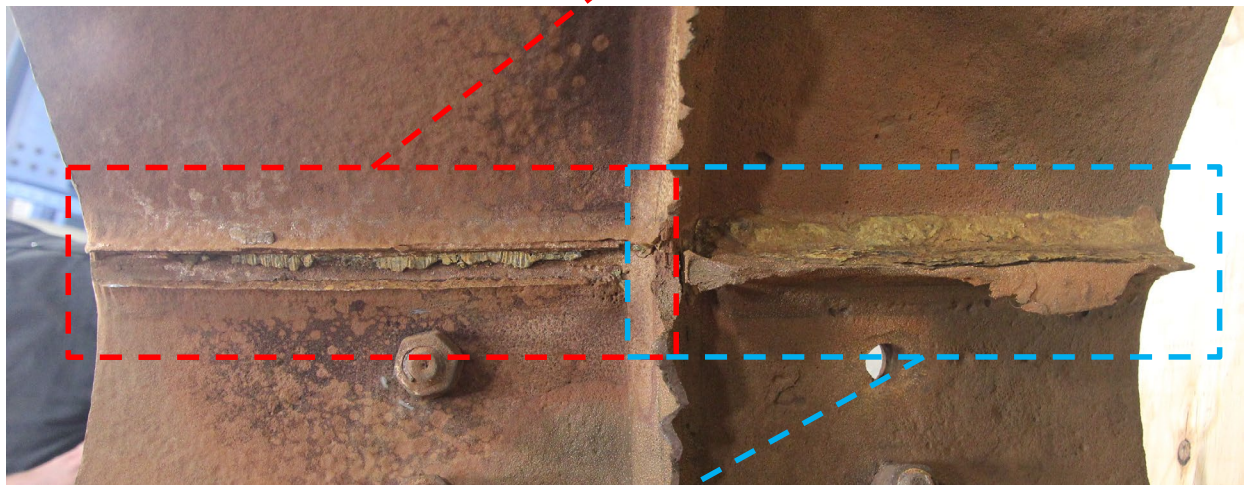
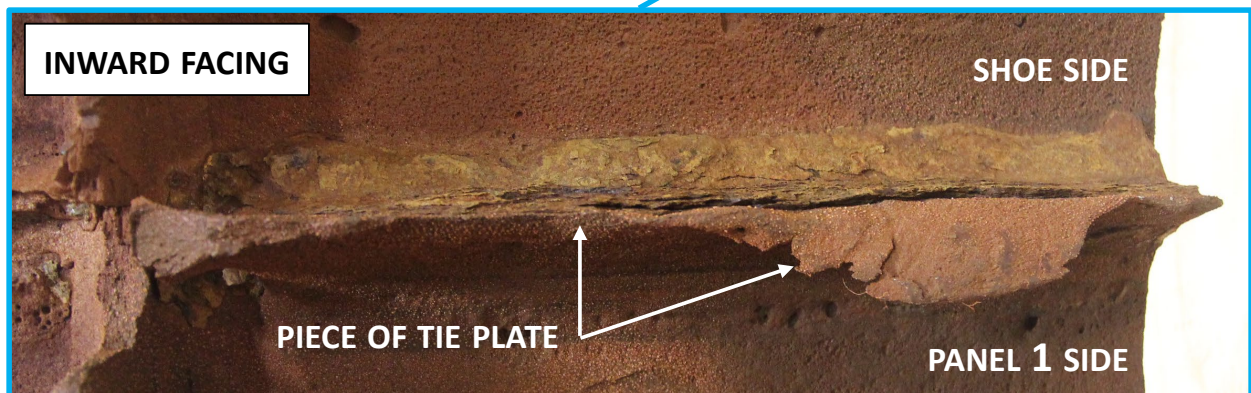
**Figure 17.** Close-up photos of where the tie plates mated to the span 2 side flange. The white arrows point to fractured areas on the weld metal still joined to the flange surface. The orange arrows point to fragments of unfused weld flux joined to the base of the weld.

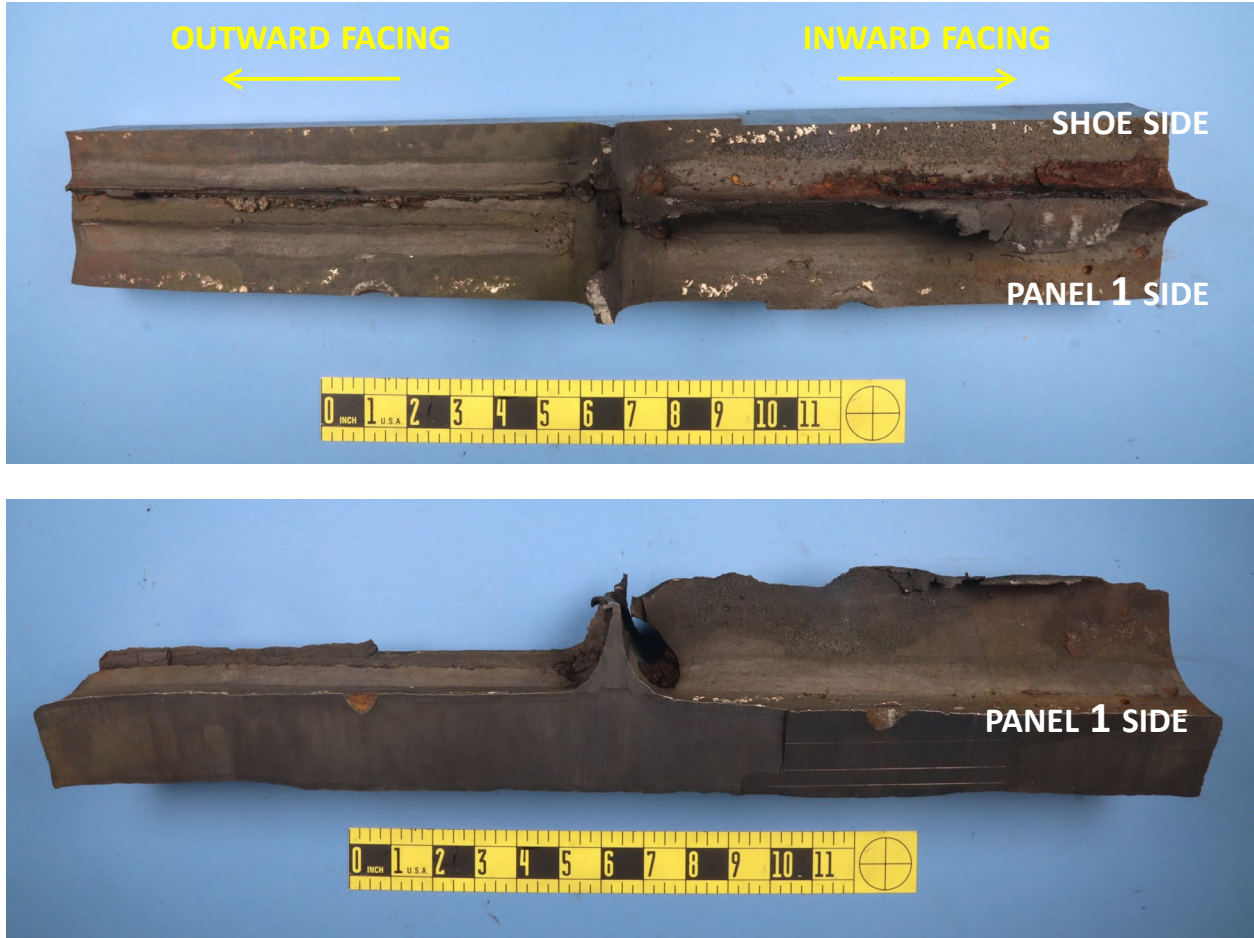
**Figure 18.** Photos showing the plan and profile views of the sectioned span 2 side flange segment.

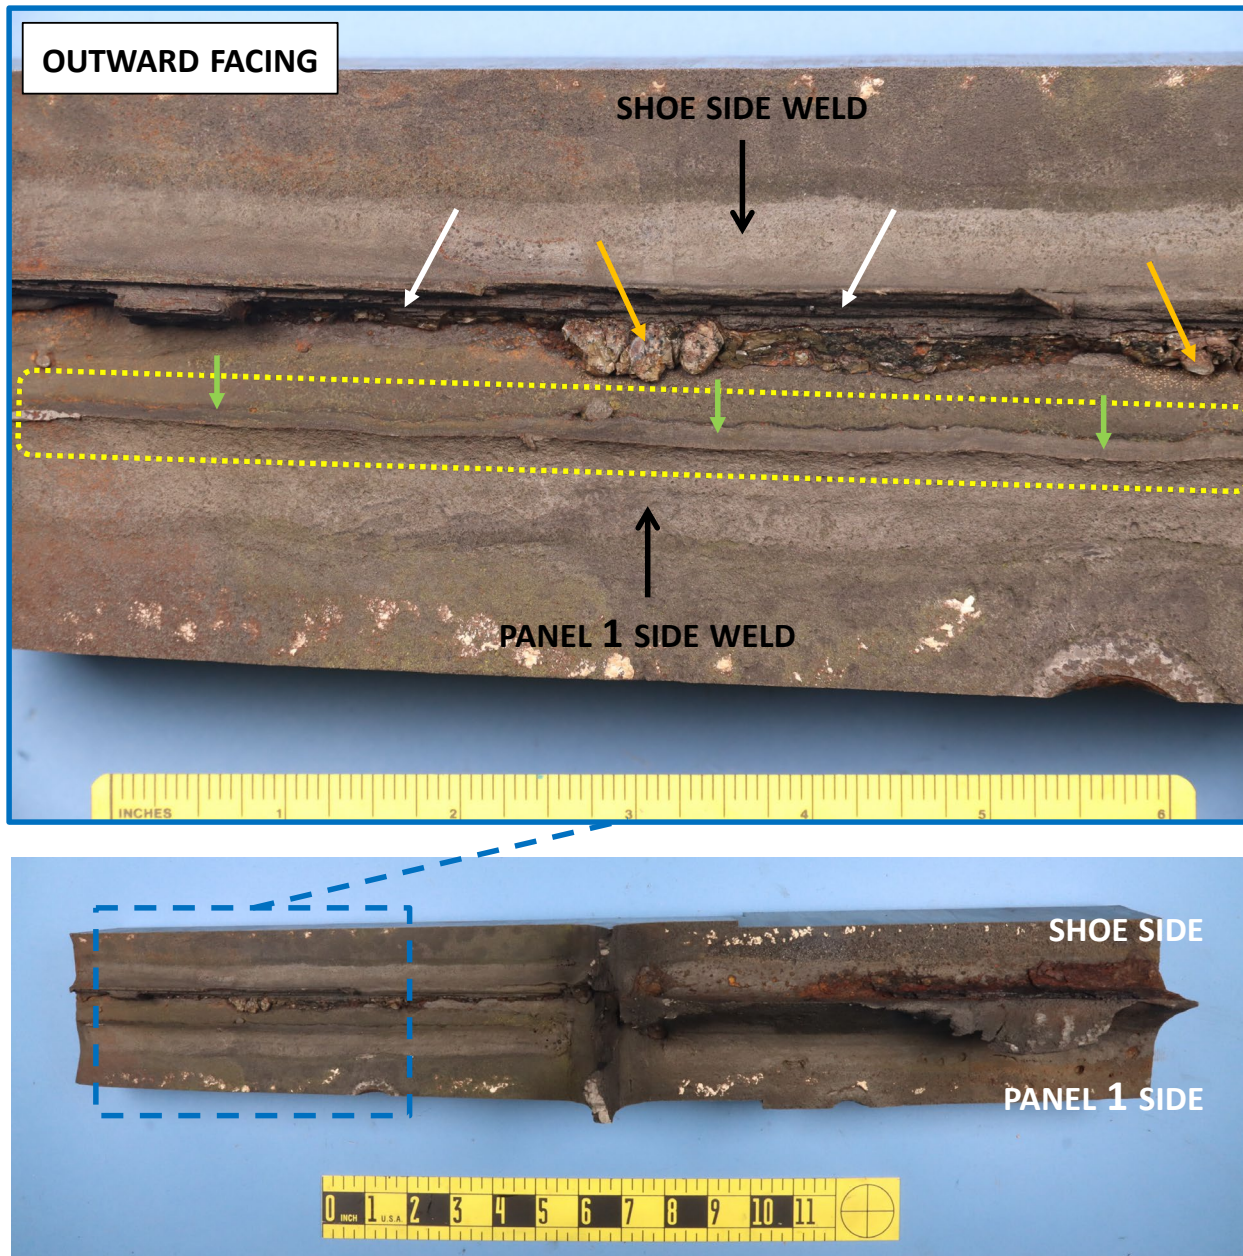
**Figure 21.** Plan view photos showing the tie plate piece on the outward side of the span 2 flange. The white arrows point to fractured portions of the shoe side weld. The orange arrows point to fragments of unfused weld metal and flux joined to the base of the shoe side weld. The green arrows point to the smooth surface on the panel 1 side weld (yellow dotted line) where the weld mated to the tie plate.

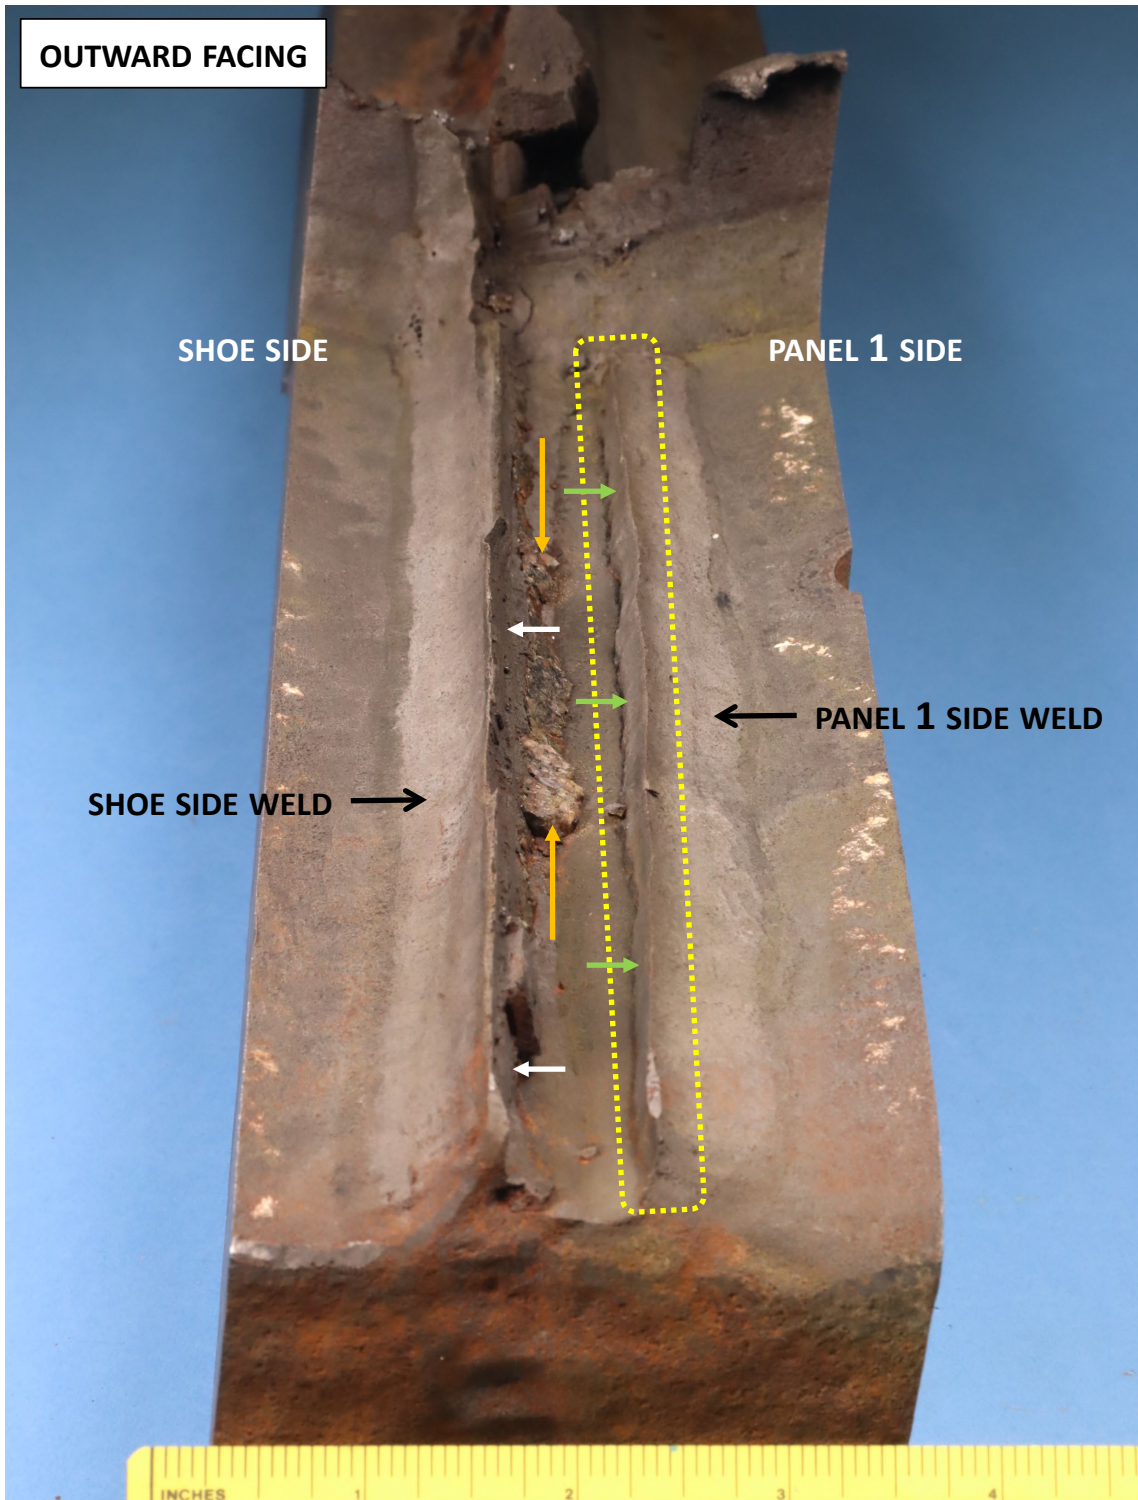
**Figure 22.** Oblique view photo showing the tie plate piece on the outward side of the span 2 flange. The white arrows point to fractured portions of the shoe side weld. The orange arrows point to fragments of unfused weld metal and flux joined to the base of the shoe side weld. The green arrows point to the smooth surface on the panel 1 side weld (yellow dotted line) where the weld mated to the tie plate.

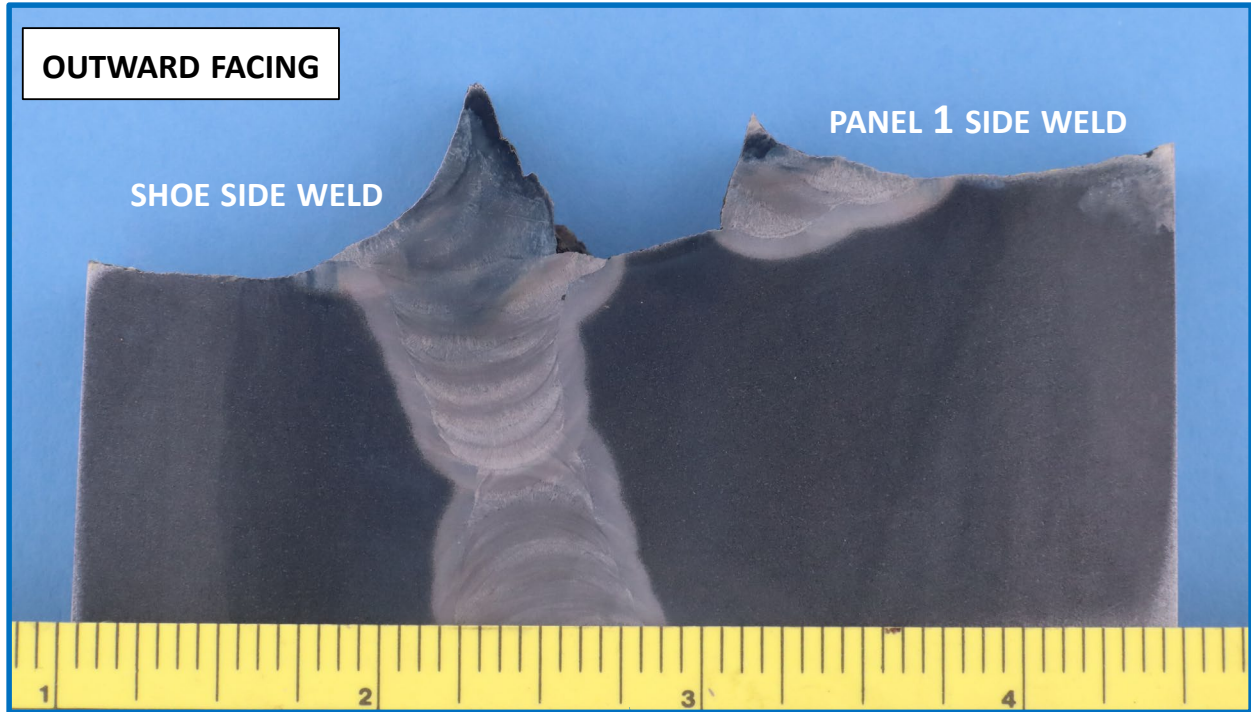
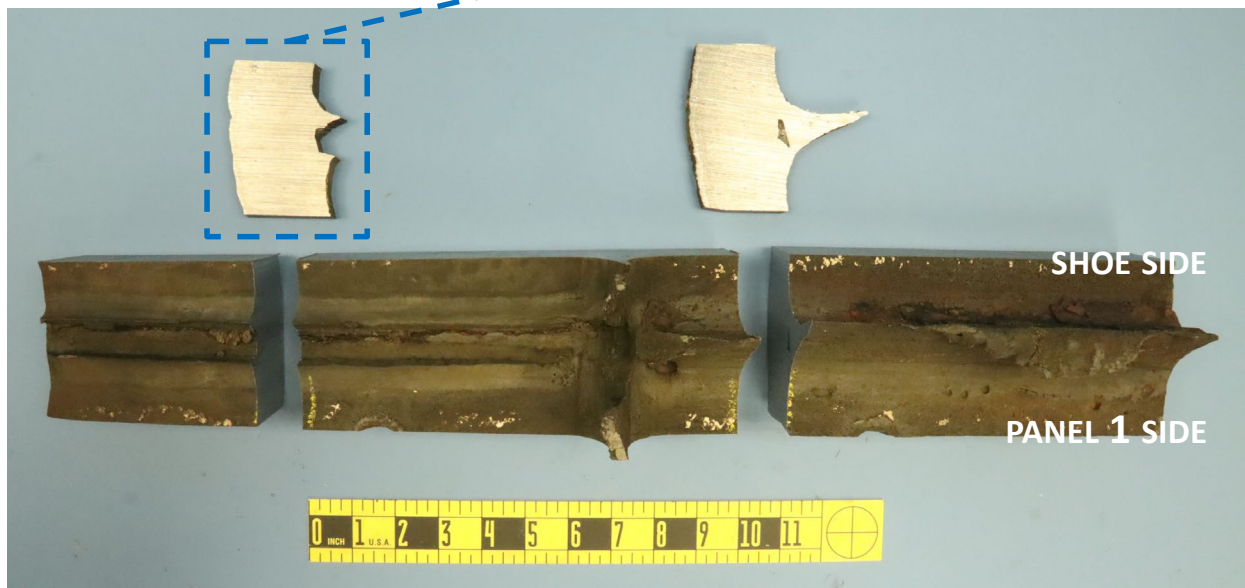
**Figure 23.** Photos showing cross-sections through the weld metal still joined to the span 2 side flange at the outward facing side tie plate. (Top photo etchant: 5% nital)

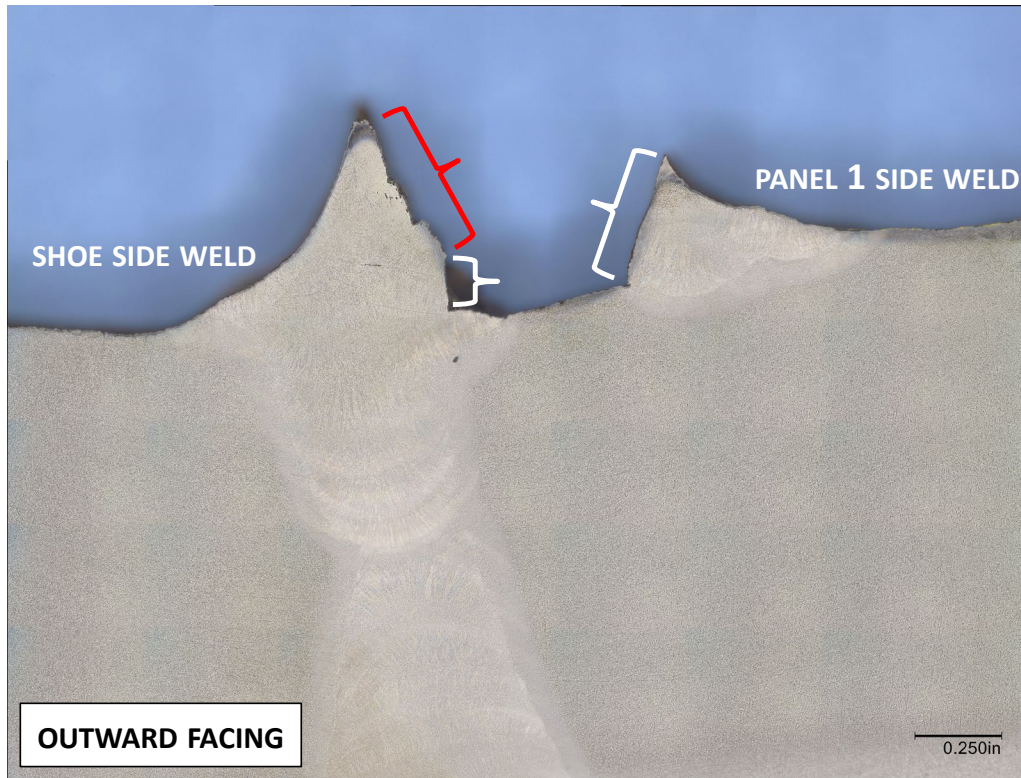
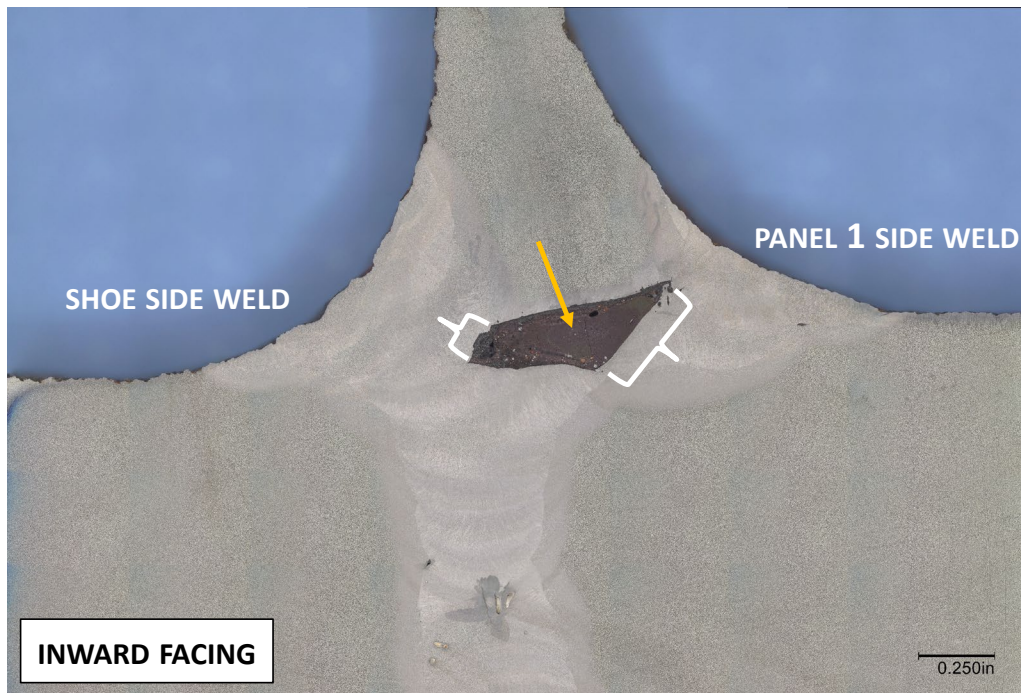
**Figure 25.** Montage digital microscope images of the cross-sections through the weld metal still joined to the span 2 side flange at the tie plates. The orange arrow points to unfused weld metal and flux. The red bracket indicates fractured weld metal. The white brackets indicate smooth portions of the welds that did not fuse to the tie plates. (Etchant: 5% nital)

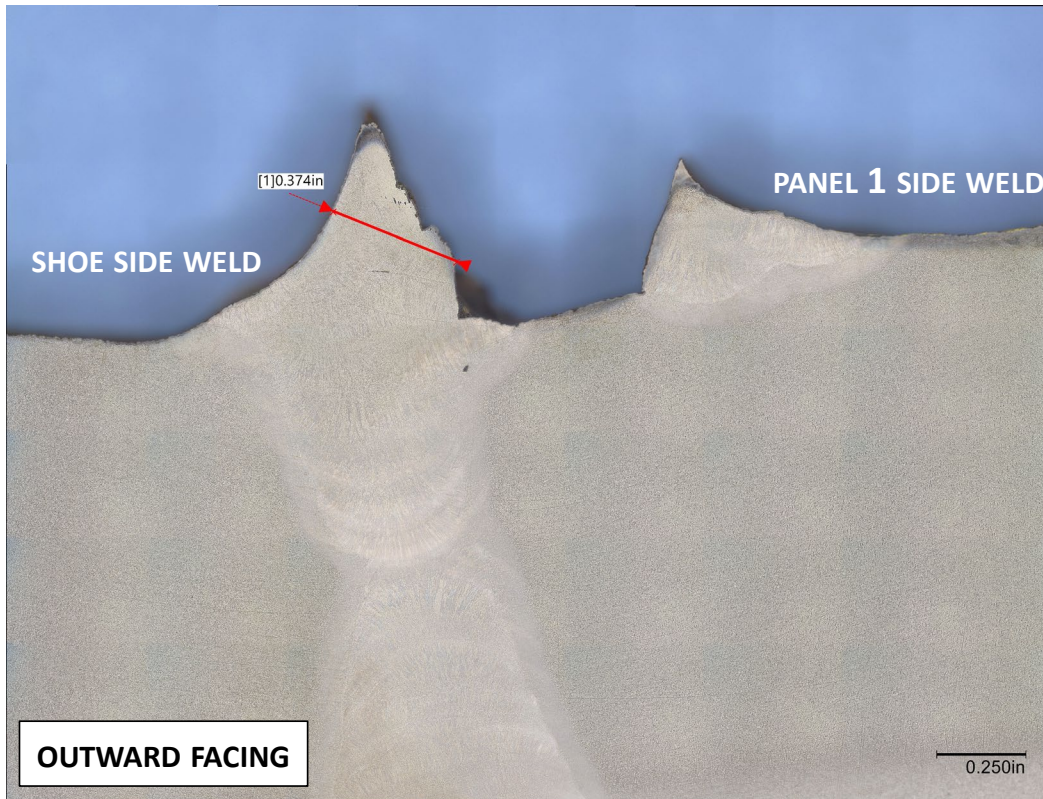
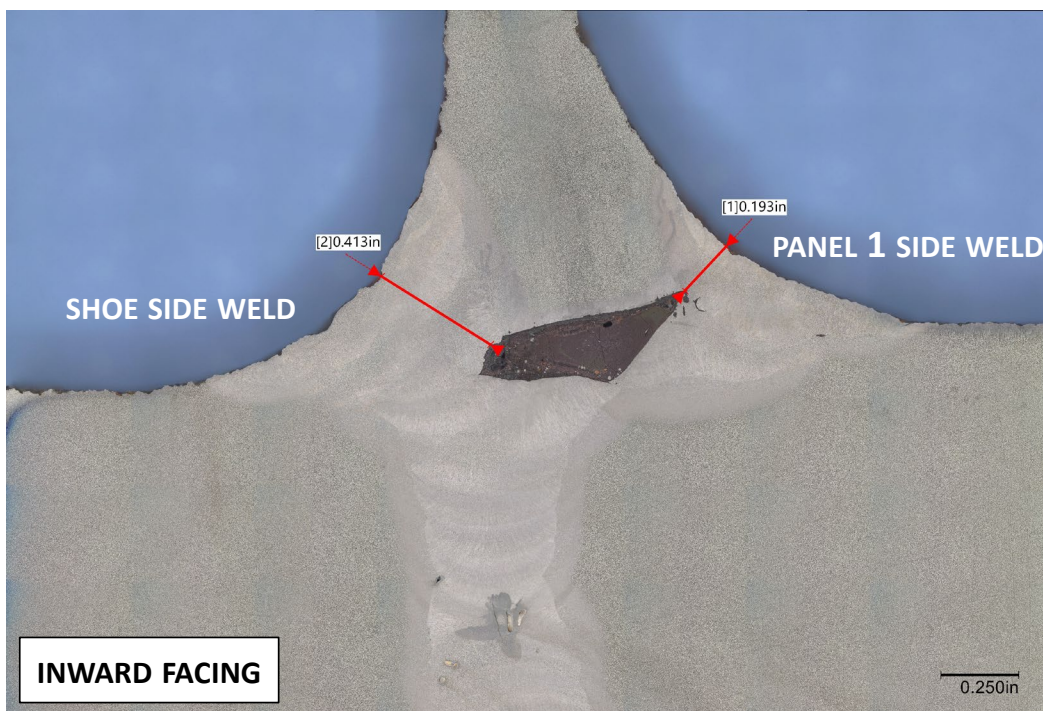
**Figure 26.** Montage digital microscope images of the cross-sections through the weld metal still joined to the span 2 side flange at the tie plates. Measurements of the weld throats (red arrows) are shown. (Etchant: 5% nital)
