Damage Survey
Tug "OLD GLORY" and Her Tow, Barge "COLE" Allision with "PETER P. COBB MEMORIAL"
East Bridge Fender

Survey Report Number: 20071

Date: August 25, 2020

"PETER P. COBB MEMORIAL" East Bridge Fender

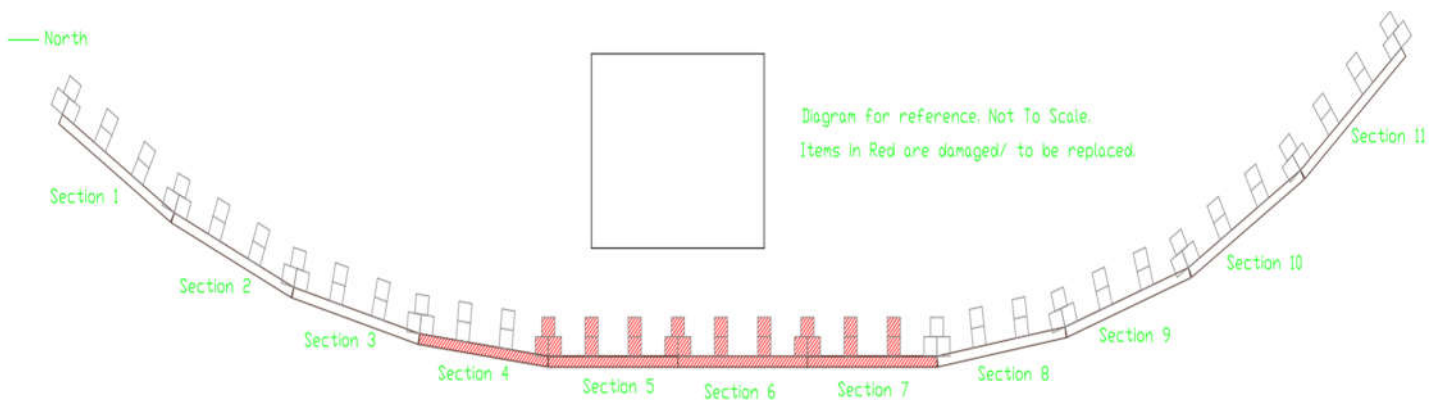
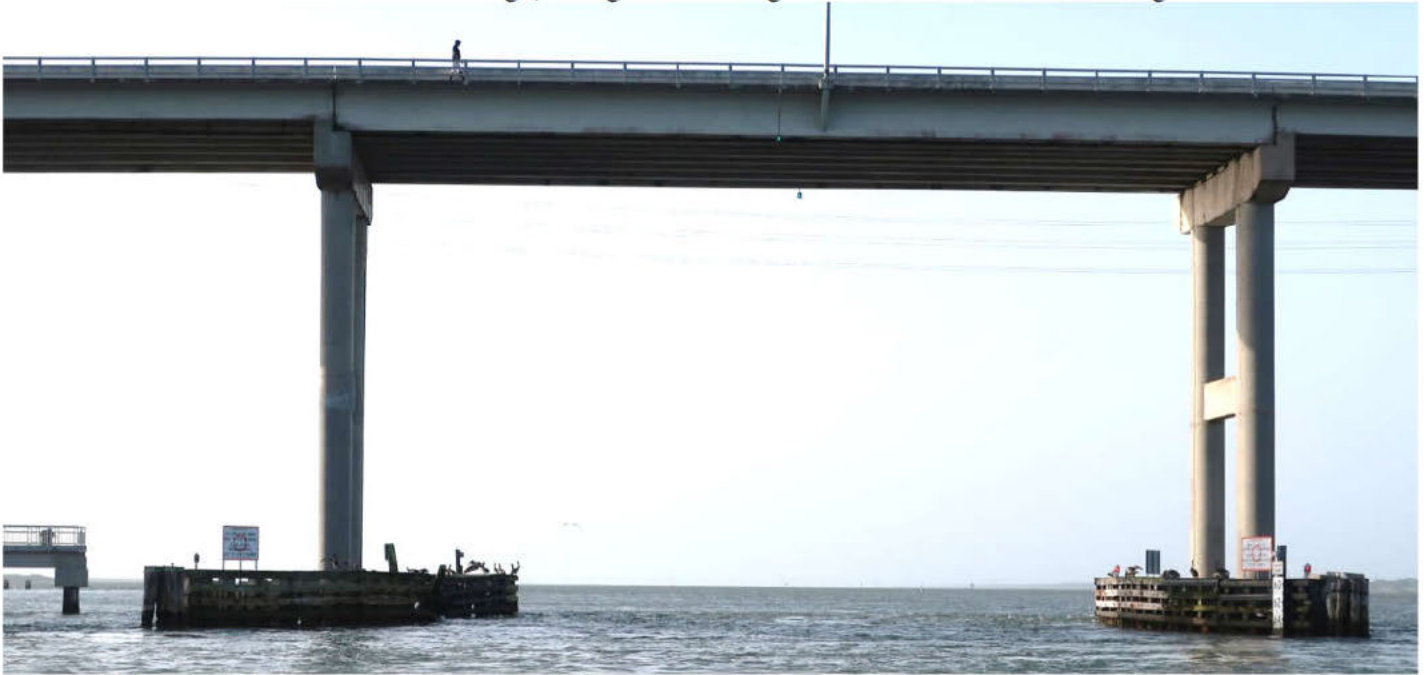
Found:	Recommended:
<p>1. The East bridge fender was found with whaler sections #4 - 7 pushed over towards the East. Sections #5 – 6 pilings are partially or completely submerged. The whalers at section #4 are damaged, and the Southmost piling of section #4 is pushed over.</p> <p>The damage extends for approximately 55'0" long.</p> <p>The bridge lights, PVC conduit, and electrical junction box in way are damaged, but were not completely visible to determine their original state and extent of damage.</p> <p><i>Additional damage may exist which was not visible at the time of this survey.</i></p>	<p>1. Remove and replace:</p> <p>(12) Vertical piles, 18" x 18" x estimated 50'0" prestressed concrete.</p> <p>Nine (9) Batter piles, 18" x 18" x estimated 50'0" prestressed concrete.</p> <p>(16) Whalers, 10" x 10" x estimated 16'0", treated timber or plastic as specified by FDOT.</p> <p>Walkway, approximately 3'0" x 55'0" treated timber deck.</p> <p>All associated fasteners, hardware, wire lashings, etc.</p> <p>Lights and electrical, scope to be determined.</p> <p>Work to be permitted as required by local, state, and federal authorities.</p> <p>Work to be completed to the satisfaction of FDOT.</p>
