Bridge Inspection Report

INTERCOASTAL WATERWAY

Inspection Type(s): Damage

Structure Number: 025508550400031
 Facility Carried: LA0024

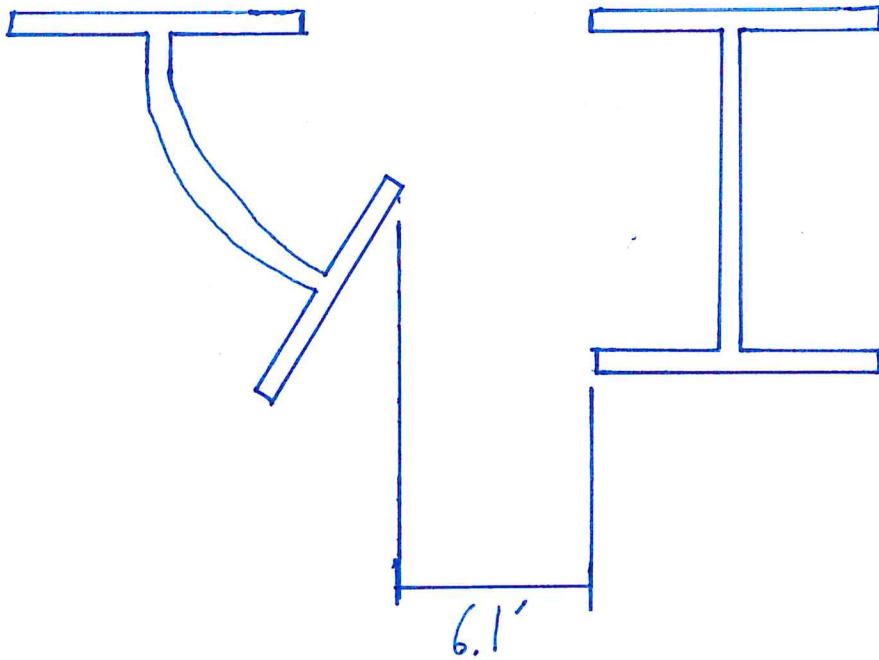
Measurement taken at point of impact.
