SAIB: 2022-24R1

SUBJ: Wing, Attach Fittings

This Special Airworthiness Information Bulletin (SAIB) is being issued to alert owners, operators, maintenance technicians, and inspectors of an airworthiness concern for **Seamax Aircraft LTDA (Seamax) Model M-22** light-sport airplanes which incorporate the foldable wing optional assembly. Specifically, this SAIB provides procedures to inspect the wing strut attachment hardware for proper security.

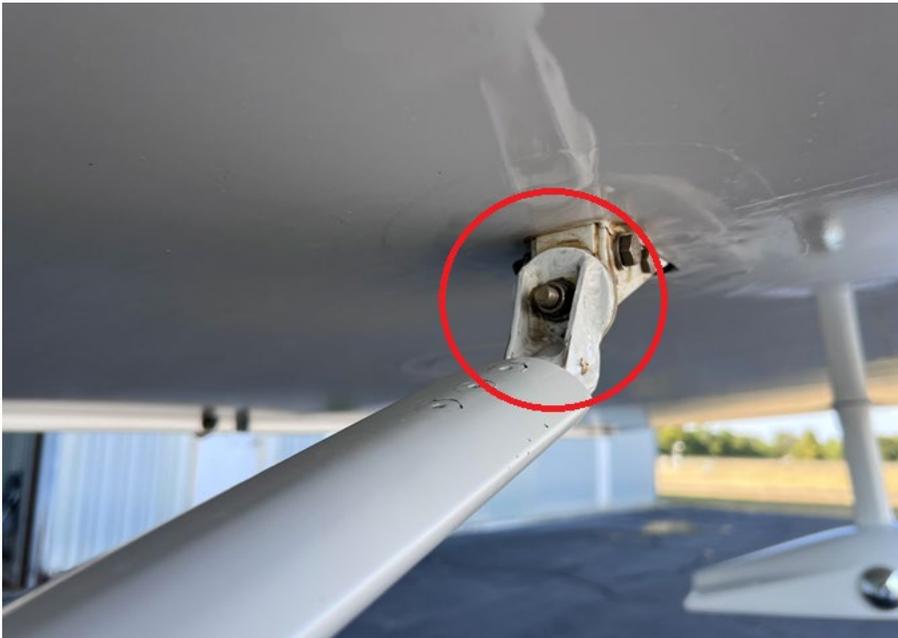
Figure 1: Upper wing strut attachment

As documented in NTSB preliminary report ERA23FA007, the right wing was separated from the main wreckage and located in a tree, and the right wing strut was separated from the right wing. The bolt attaching the right strut to the right wing remained attached to the right wing and was not fractured; however, the nut was not present. In addition, the bolt threads did not exhibit significant damage. The NTSB's investigation of this even is ongoing and a probable cause has not been determined.

- Comply with Seamax Service Bulletins SB_001_09 dated February 3, 2009.
- Continue to comply with SB_001_20 dated May 14, 2020.
- Continue to inspect the wing strut hinge points, as shown in Figures 1 and 2, to ensure proper installation and attachment of the nuts prior to every flight.
- Review and comply, as necessary (reference 14 CFR 91.327), with Seamax Safety Directive/Alert SD_003_23 dated September 19, 2023, which provides instructions to replace the nuts and bolts of the attachment points of the upper terminal of both wing struts.
