MATERIALS EVALUATION REPORT

20FAE-033-PR

**METALLURGICAL INVESTIGATION OF A
 P_C SCROLL TO P_C FILTER TUBE
 ASSEMBLY, P/N 23065814, INSTALLED IN
 AN M250-C30P ENGINE, S/N CAE895054,
 OPERATED BY AIR EVAC EMS INC**

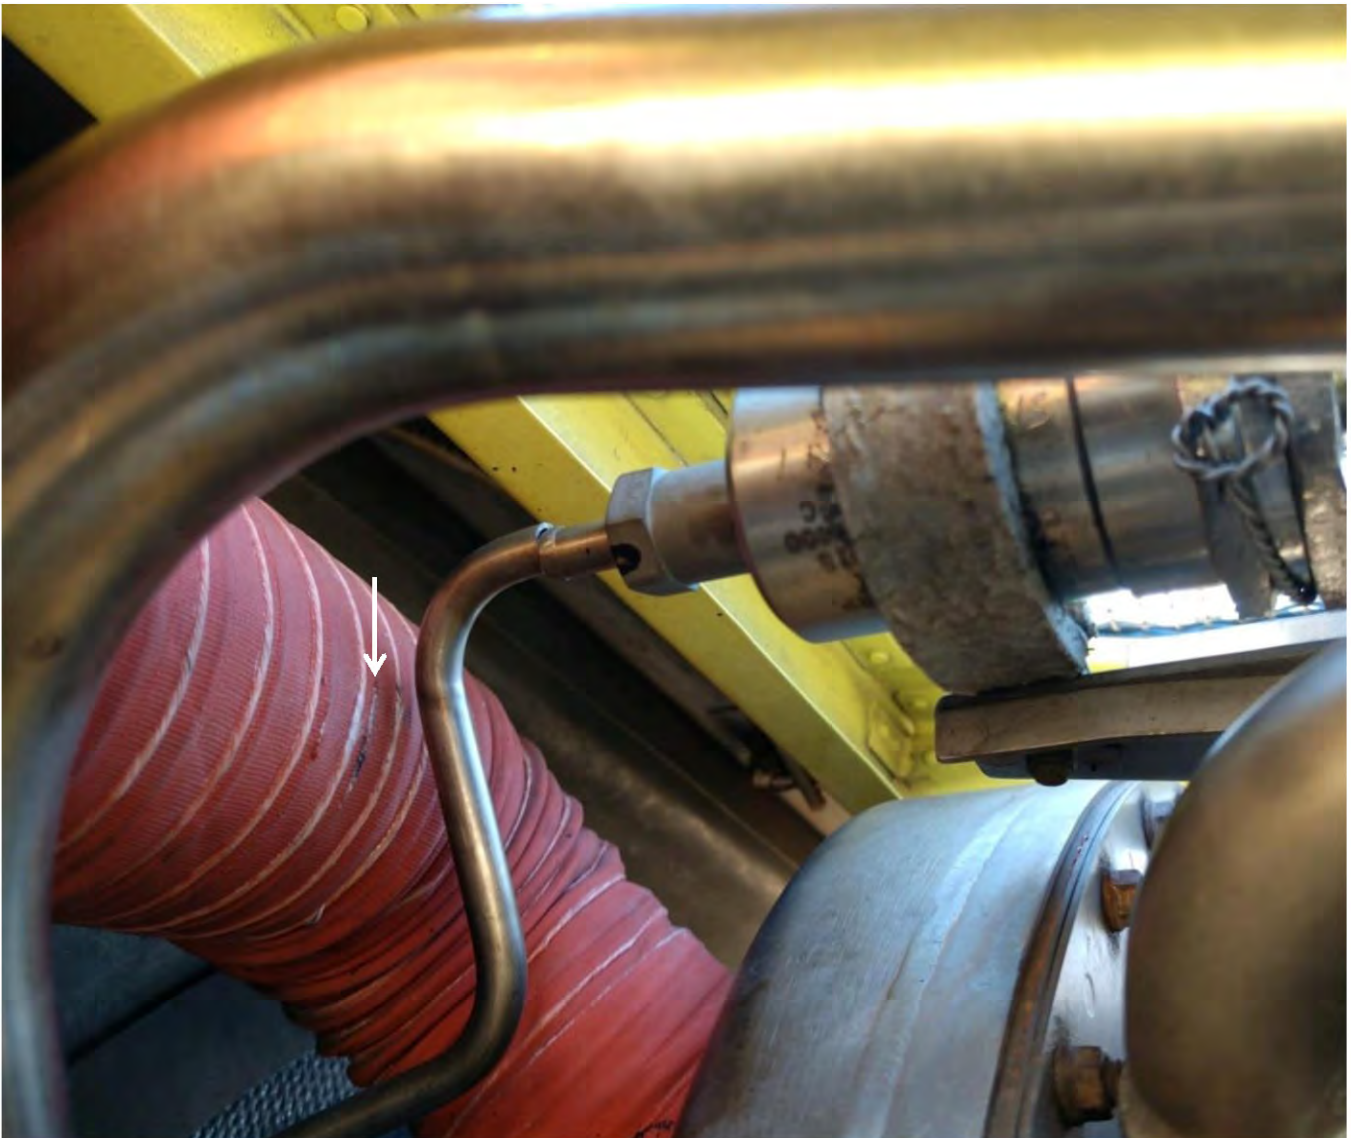
Figure 1 shows a photograph provided to the author by the Rolls-Royce Air Safety Investigator showing a red ribbed hose adjacent to the elbow nearest the fracture on the fractured tube. The ribbed hose exhibited some dark discoloration in the area adjacent to the elbow surface.

Figure 1. Photograph showing the fractured P_c tube and the nearby ribbed hose that was adjacent to the elbow nearest the fracture. The hose surface exhibited some dark discoloration (white arrow). Photograph provided to the author by the Rolls-Royce Accident Investigation department. No scale provided.

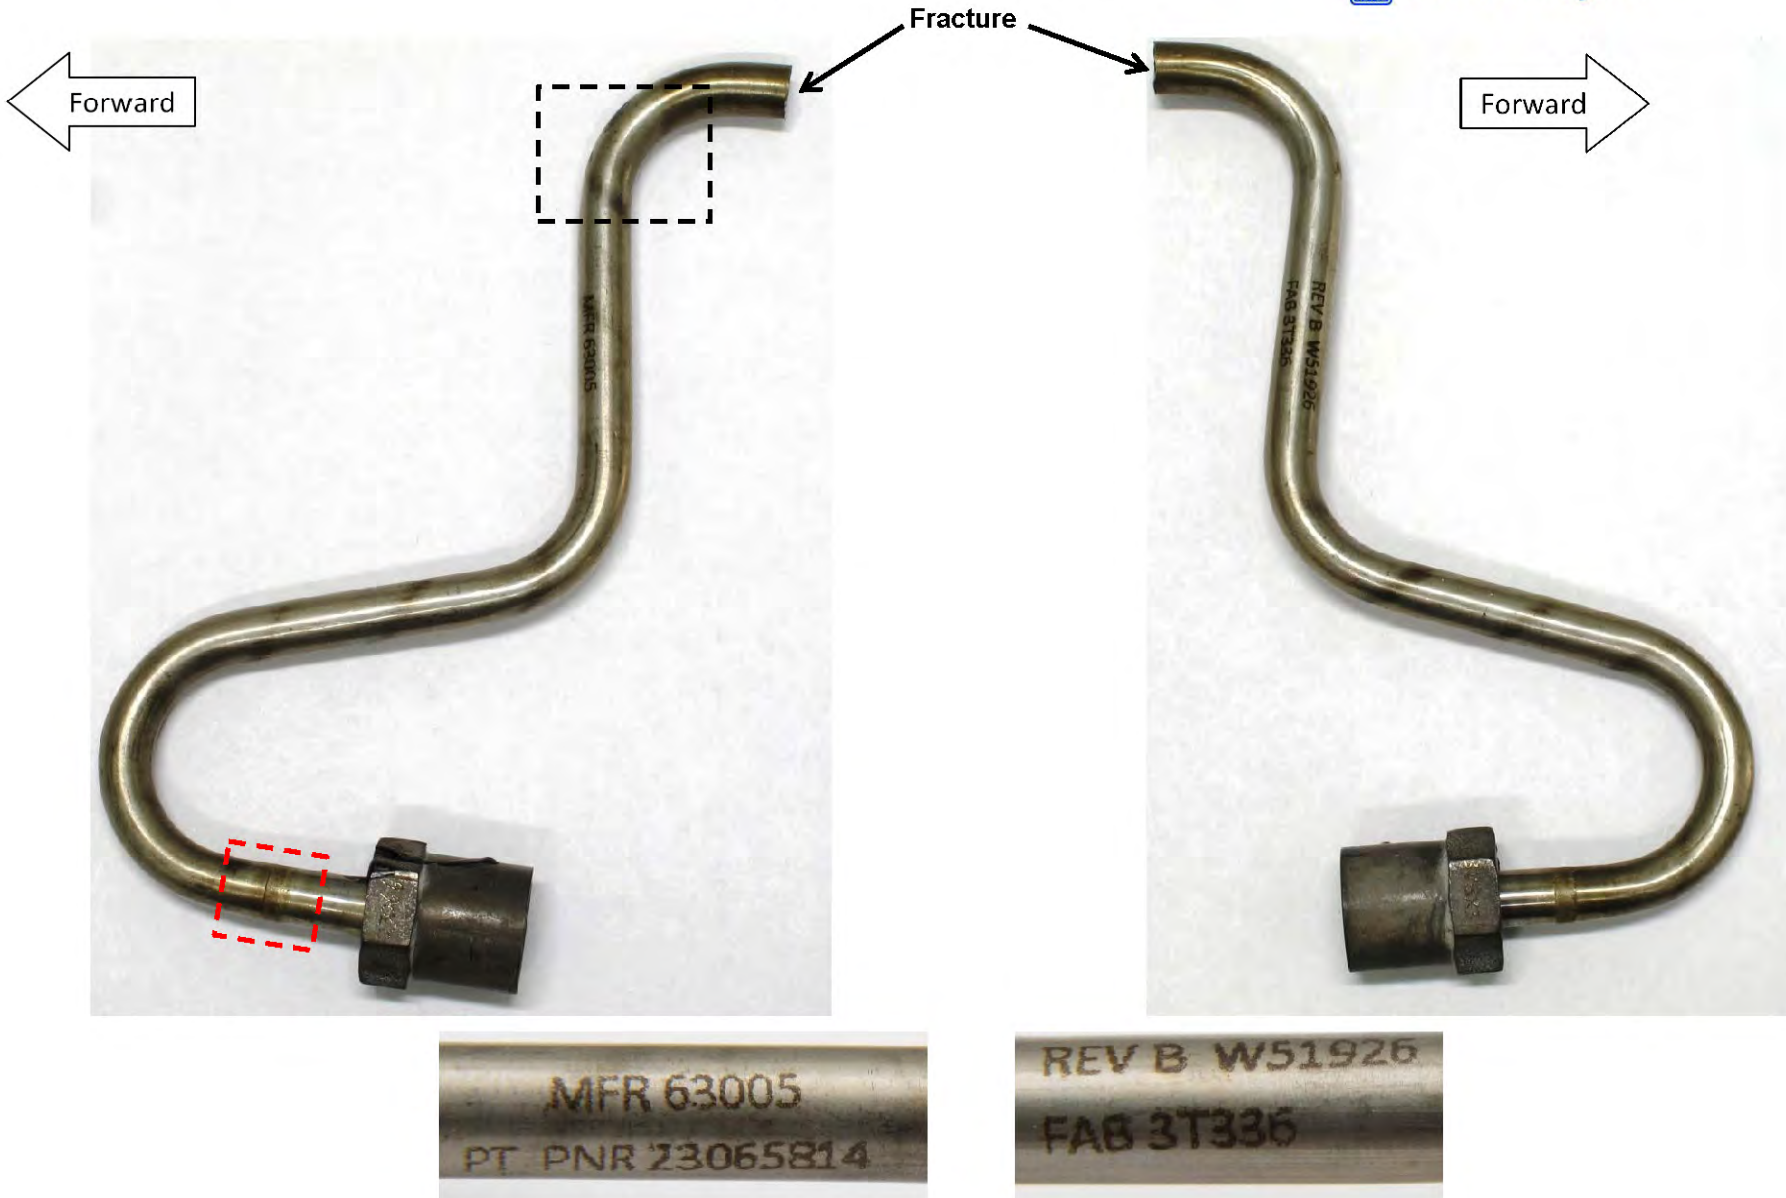
The as-received condition of the fractured tube (except for the fitting end on the opposite side of the fracture) is shown in Figure 3. The tube fractured and separated at the weld adjacent to the air filter fitting. The fractured tube was compared to a newly manufactured tube, Figure 4, which did not reveal any obvious discrepancies in shape or dimension between the tubes. On the outer radius of the bend near the fracture surface, the event tube exhibited a flat spot surrounded by scuffing and patchy dark discoloration as shown in Figure 5. Detailed inspection of the area revealed several adjacent parallel oval-shaped dark patches near the flat spot as shown in Figure 6. The major dimension of the dark patches decreased in size progressing away from the flat spot. Both the flat spot and the oval-shaped dark patches were subjected to confocal laser scanning microscopy (CLSM). Figure 7 illustrates the flattened surface in the flat spot. CLSM revealed that the parallel adjacent oval-shaped dark patches were grooves in the surface of the tube measuring up to 0.0012 inch deep as shown in Figure 8.

Figure 3. Overall views showing two sides of the fractured tube and detailed views showing the part markings on the tube (below). The black dashed boxed area is shown in Figure 5, and the red dashed boxed area is shown in Figure 9.

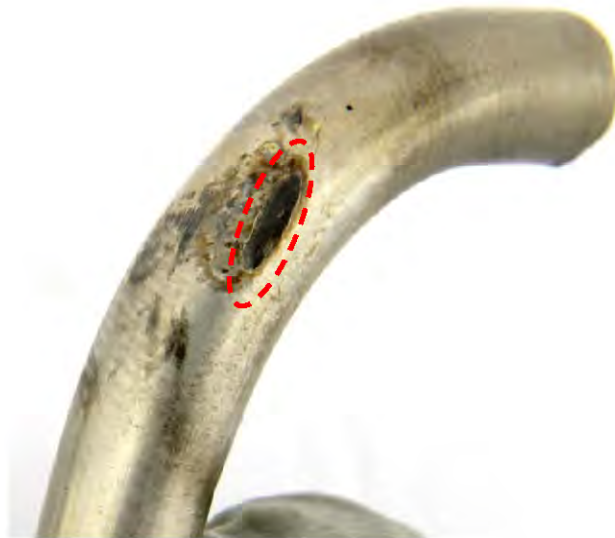
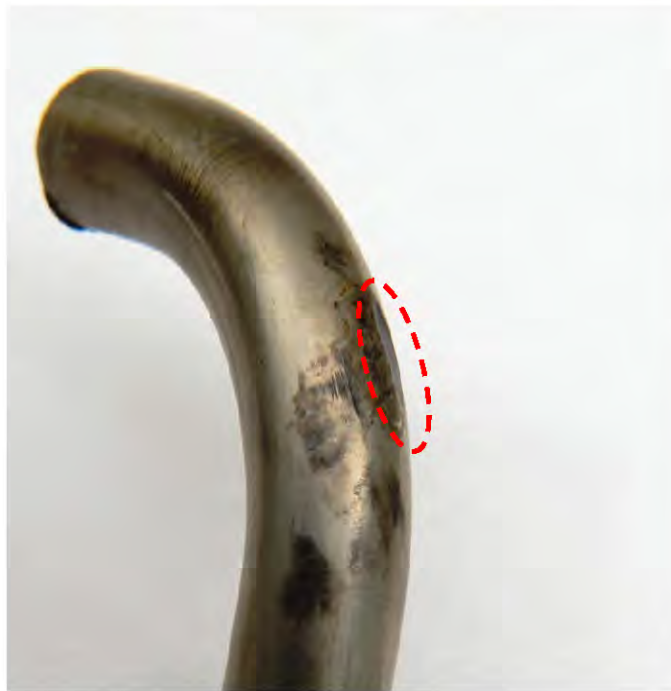
- 2.1 The tube was fractured completely through at the toe of the weld between the tube and the air filter fitting. The fracture initiated in fatigue near the top location of the tube. Smearing damage on the surface precluded identification of any other modes of fracture.
- 2.2 The tube exhibited rub damage on the outer diameter surface of the elbow nearest the fracture surface. A red ribbed hose that was seen hanging in the engine bay near the fractured tube exhibited discoloration on the outer surface.
- 2.3 The height of the weld root reinforcement exceeded the component definition requirement.

Figure 5. Detailed views showing the outer radius surface of the bend in the tube closest to the fracture. The tube exhibited a flat spot surrounded by patchy dark discoloration consistent with rub damage (red dashed outlined area).

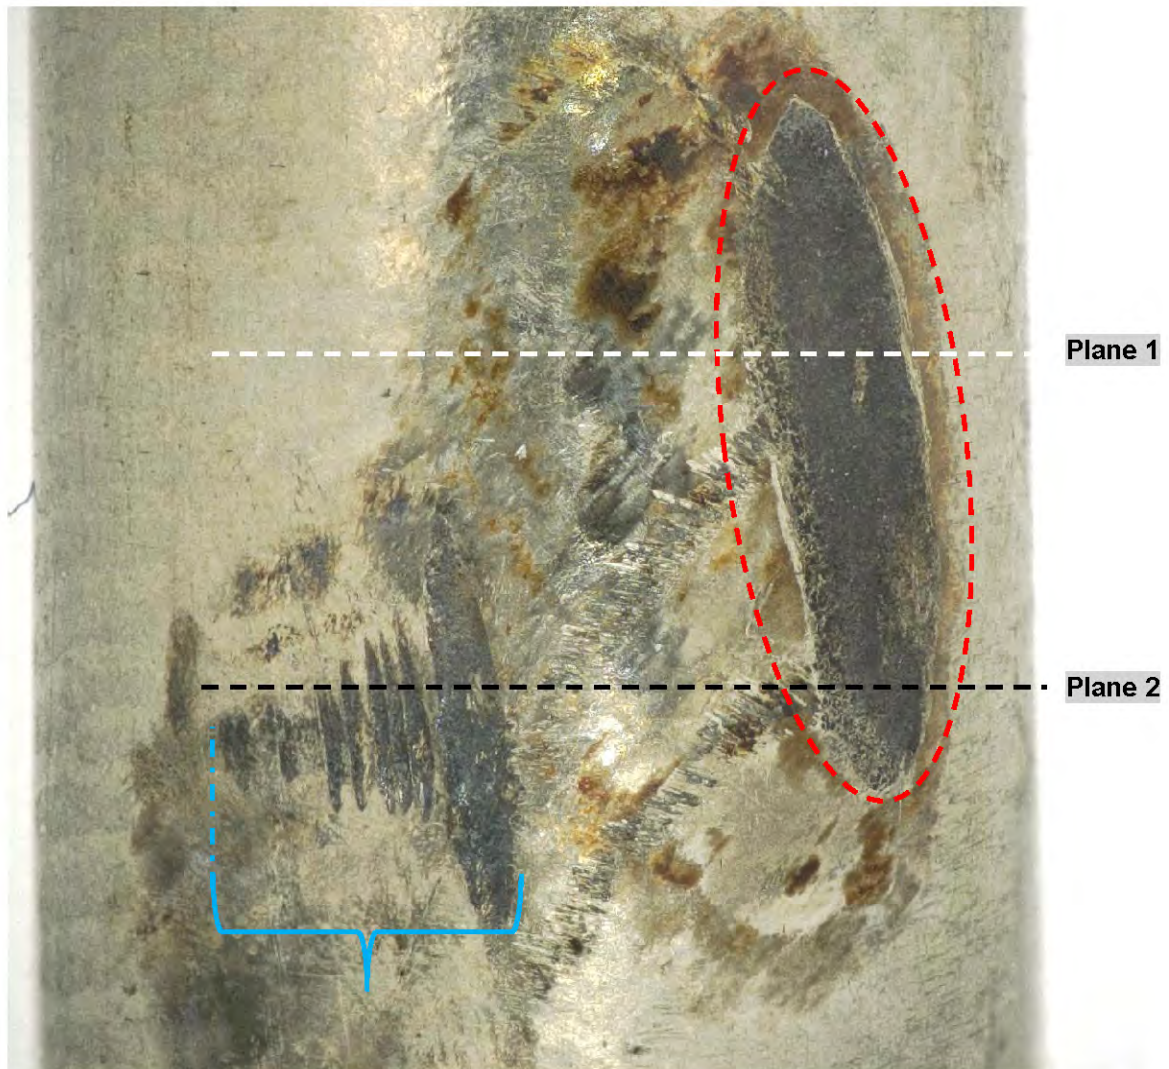
Figure 6. Detailed view showing the flat spot (red dashed outlined area) and adjacent parallel oval-shaped dark patches (blue brace). The white and black dashed lines indicate planes of metallographic examination 1 and 2, respectively.

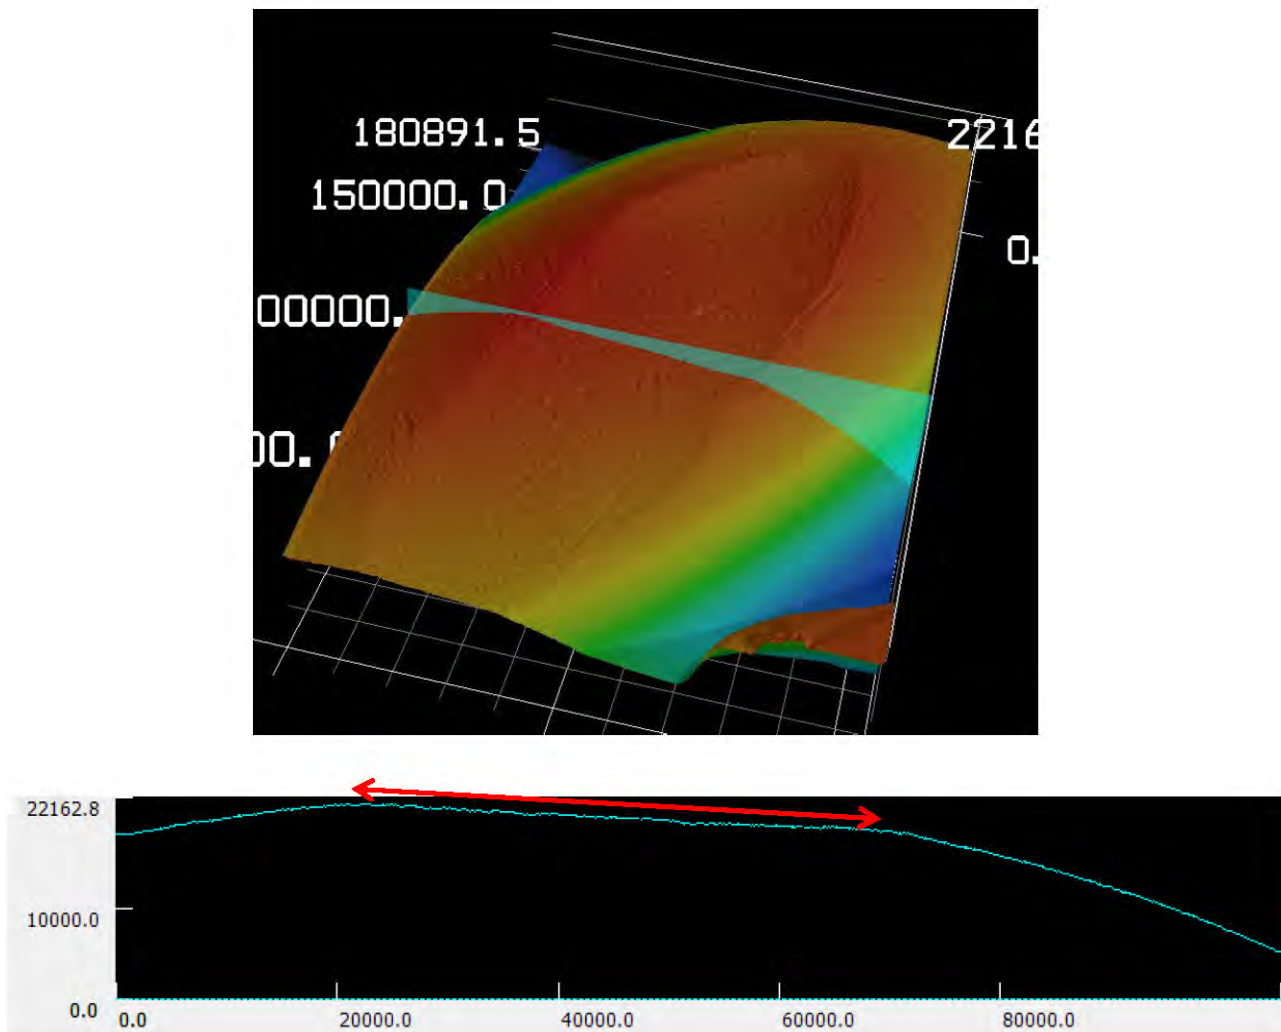
Figure 7. CLSM scan of the flat spot in the rub damaged area (top). A profile measurement taken through the rub damaged area illustrates the flattened surface (bottom, red arrow).

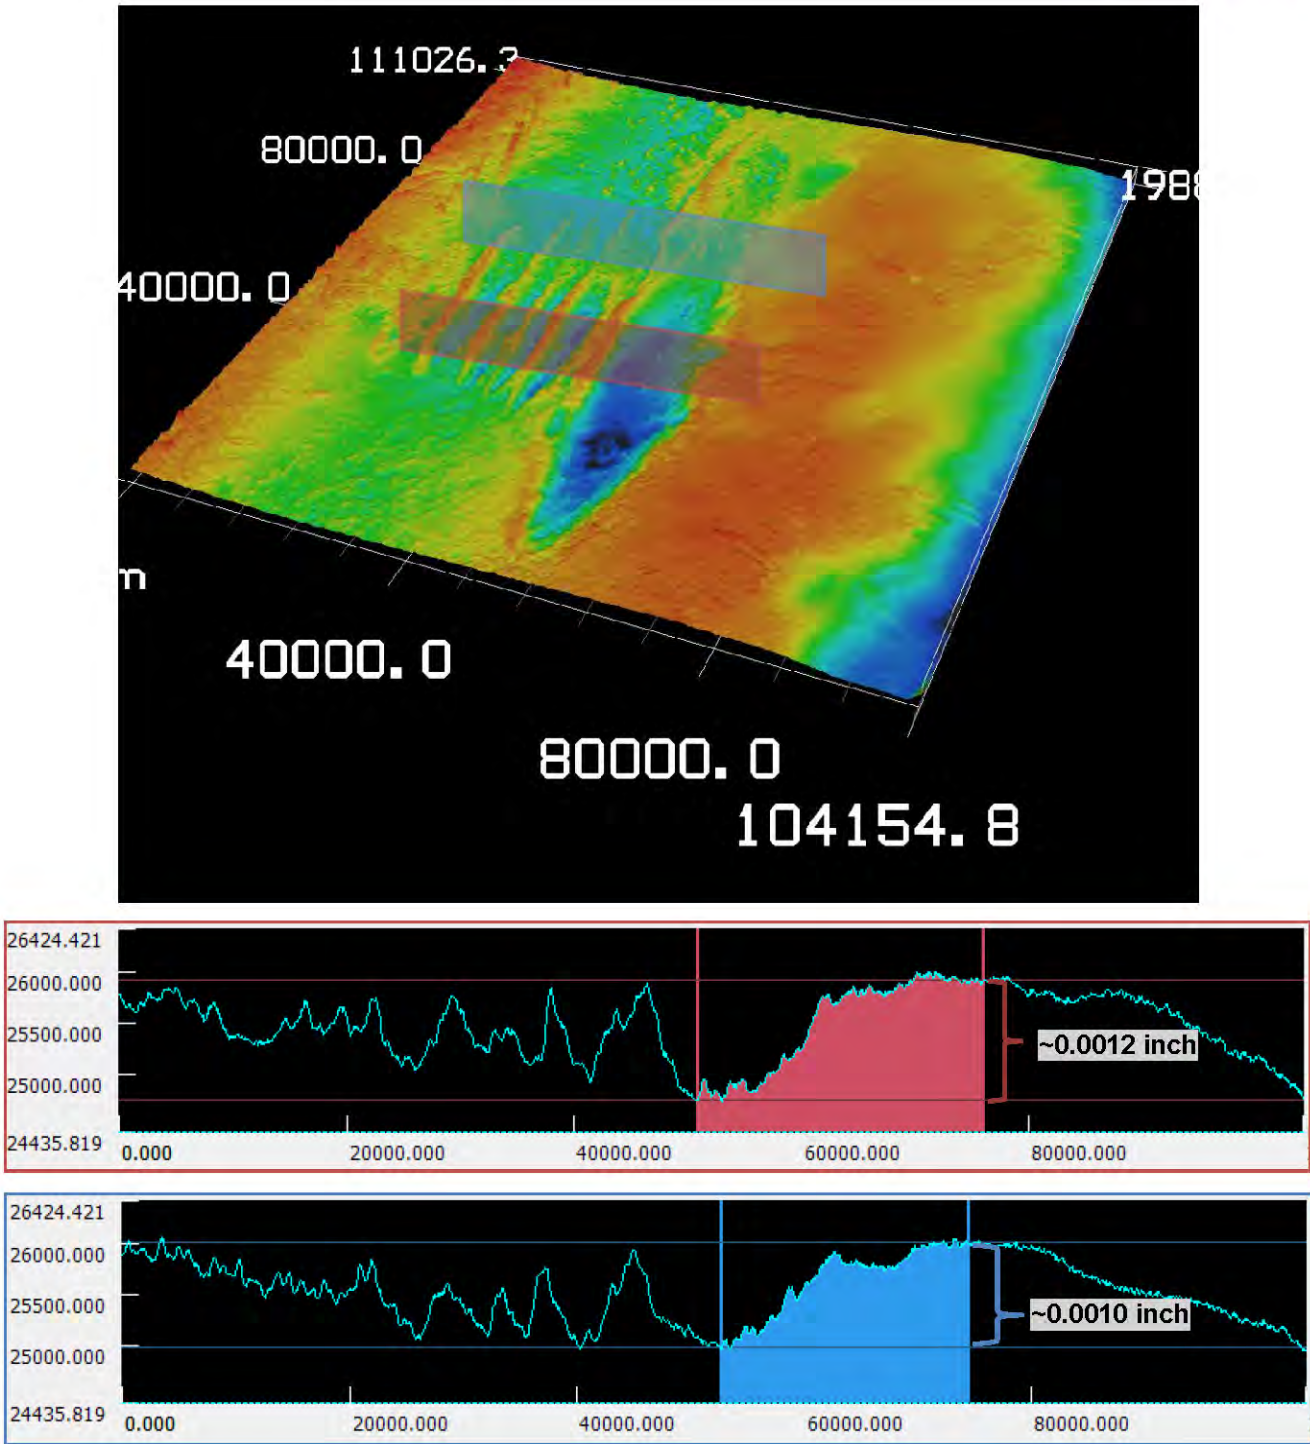
Figure 8. CLSM scan of the adjacent oval-shaped dark patches in the rub damaged area (top). The as-manufactured curved surface of the tube was flattened in the CLSM scan. Profile measurements (bottom) taken through the area show the dark patches were adjacent grooves measuring up to 0.0012 inch deep in the largest and deepest of the grooves. The red and blue planes in the top image correspond to the locations of the profile measurements shown at bottom.

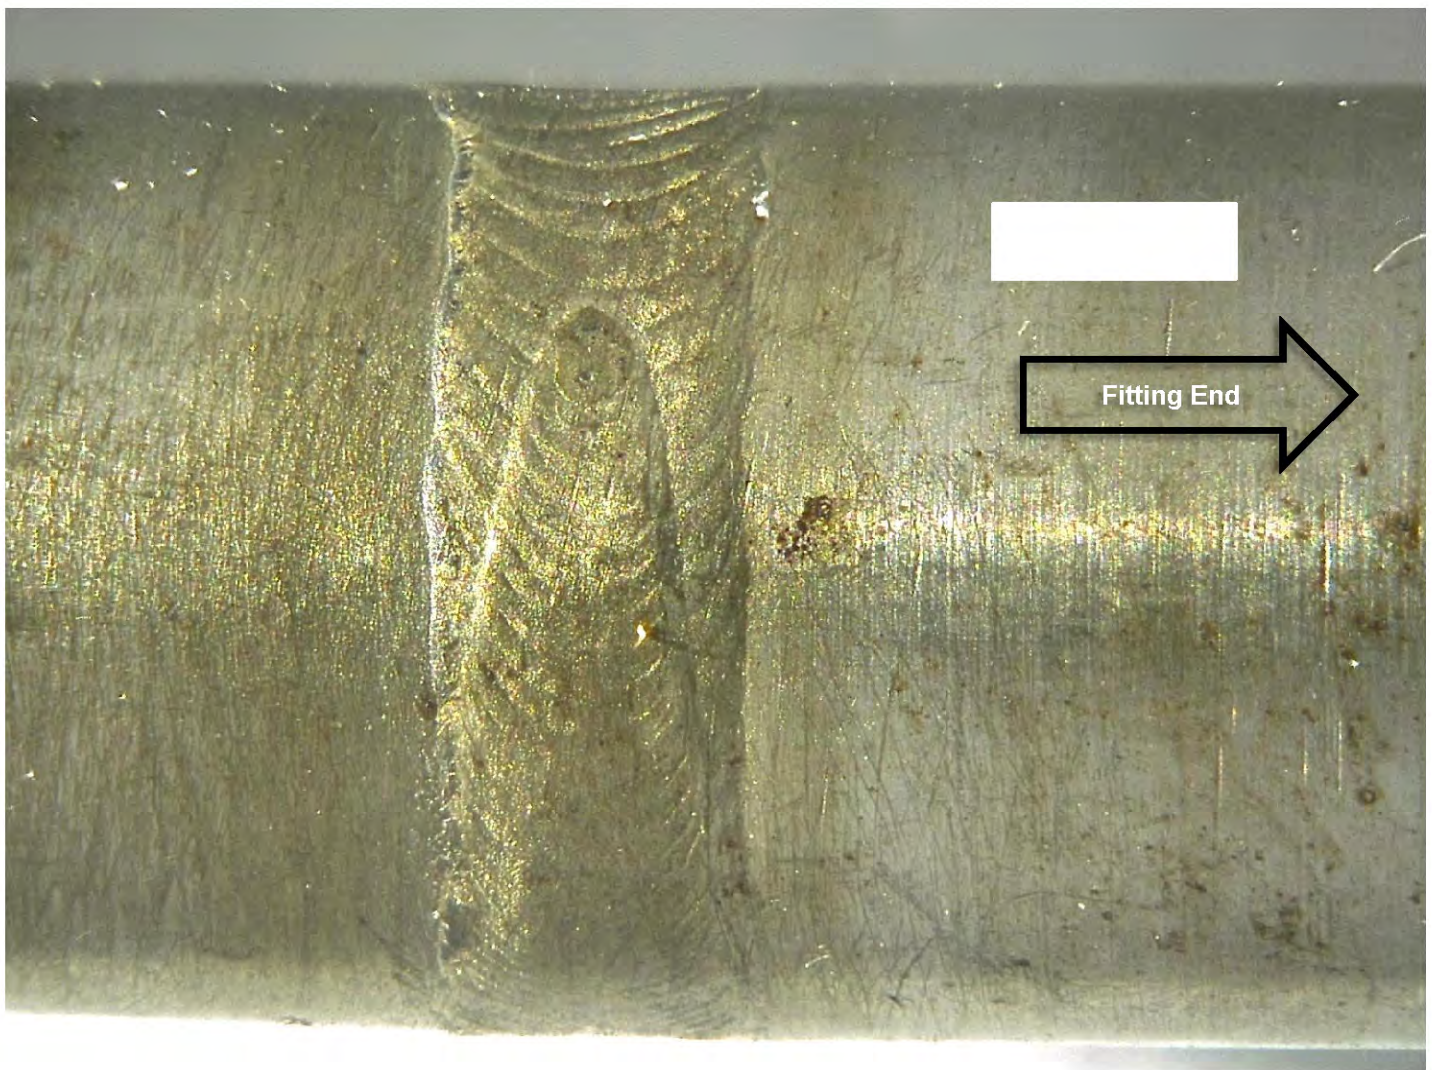
Figure 9 shows a representative view of the weld on the opposite end of the tube from the fracture. In some locations the weld surface was slightly proud of the adjacent tube surface. The tube was sent to the Rolls-Royce Test Department for fluorescent penetrant inspection (FPI), which did not reveal any anomalies.

Figure 9. Detailed view showing the fitting weld at the opposite end of the tube from the fracture.

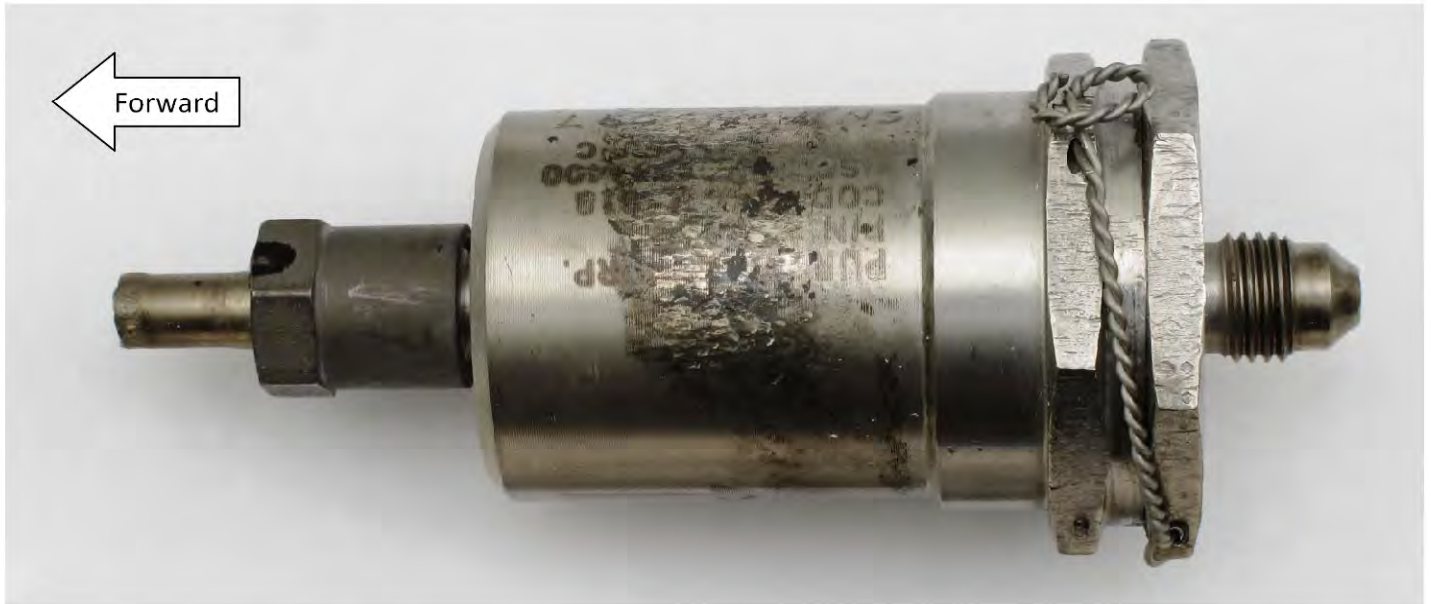
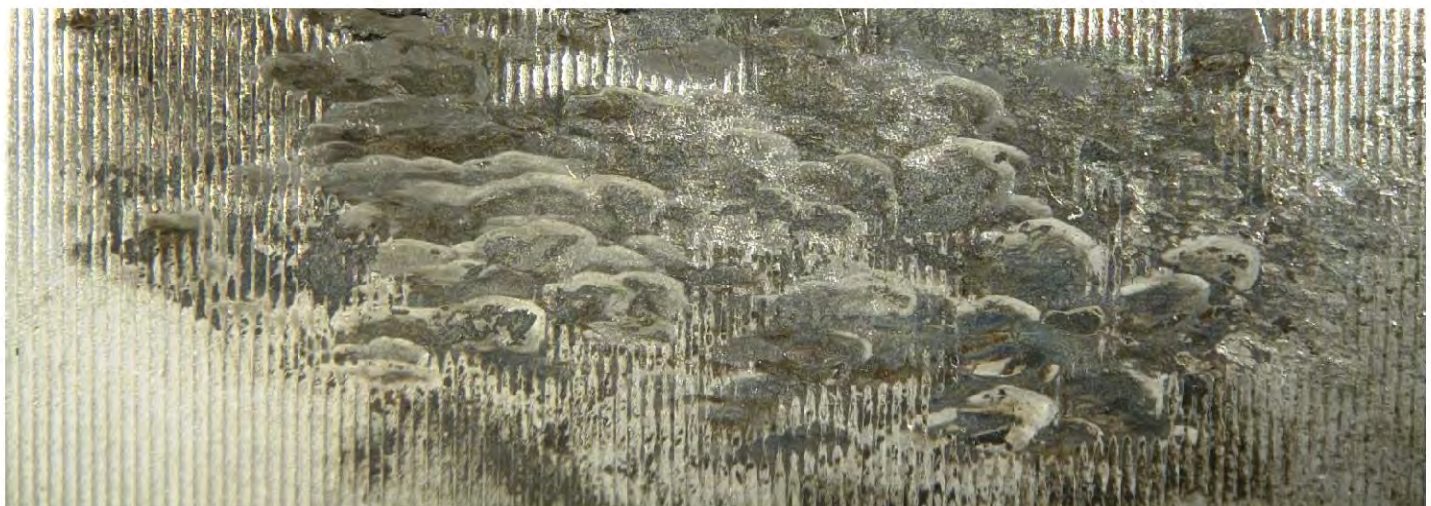
The as-received condition of the weld and fitting side of the fractured tube and the attached air filter is shown in Figure 10. The filter housing outer diameter surface was covered in small, highly reflective shallow impressions. Figure 11 shows 90° rotated views of the weld adjacent to the fracture. The top dead center alignment on the fitting was approximately 180° away from the weld start/stop point. The fracture surface was relatively flat and oriented perpendicular to the axis of the tube, and was located at the toe of the weld adjacent to the fitting.

Figure 10. Overall view showing the compressor discharge air filter and the fractured tube (top). The surface of the filter was covered in bright, highly reflective small impressions consistent with gripping marks from a tool. The gripping marks on the outer diameter of the filter housing were present in the as-received condition. Divisions = 0.1 inch.

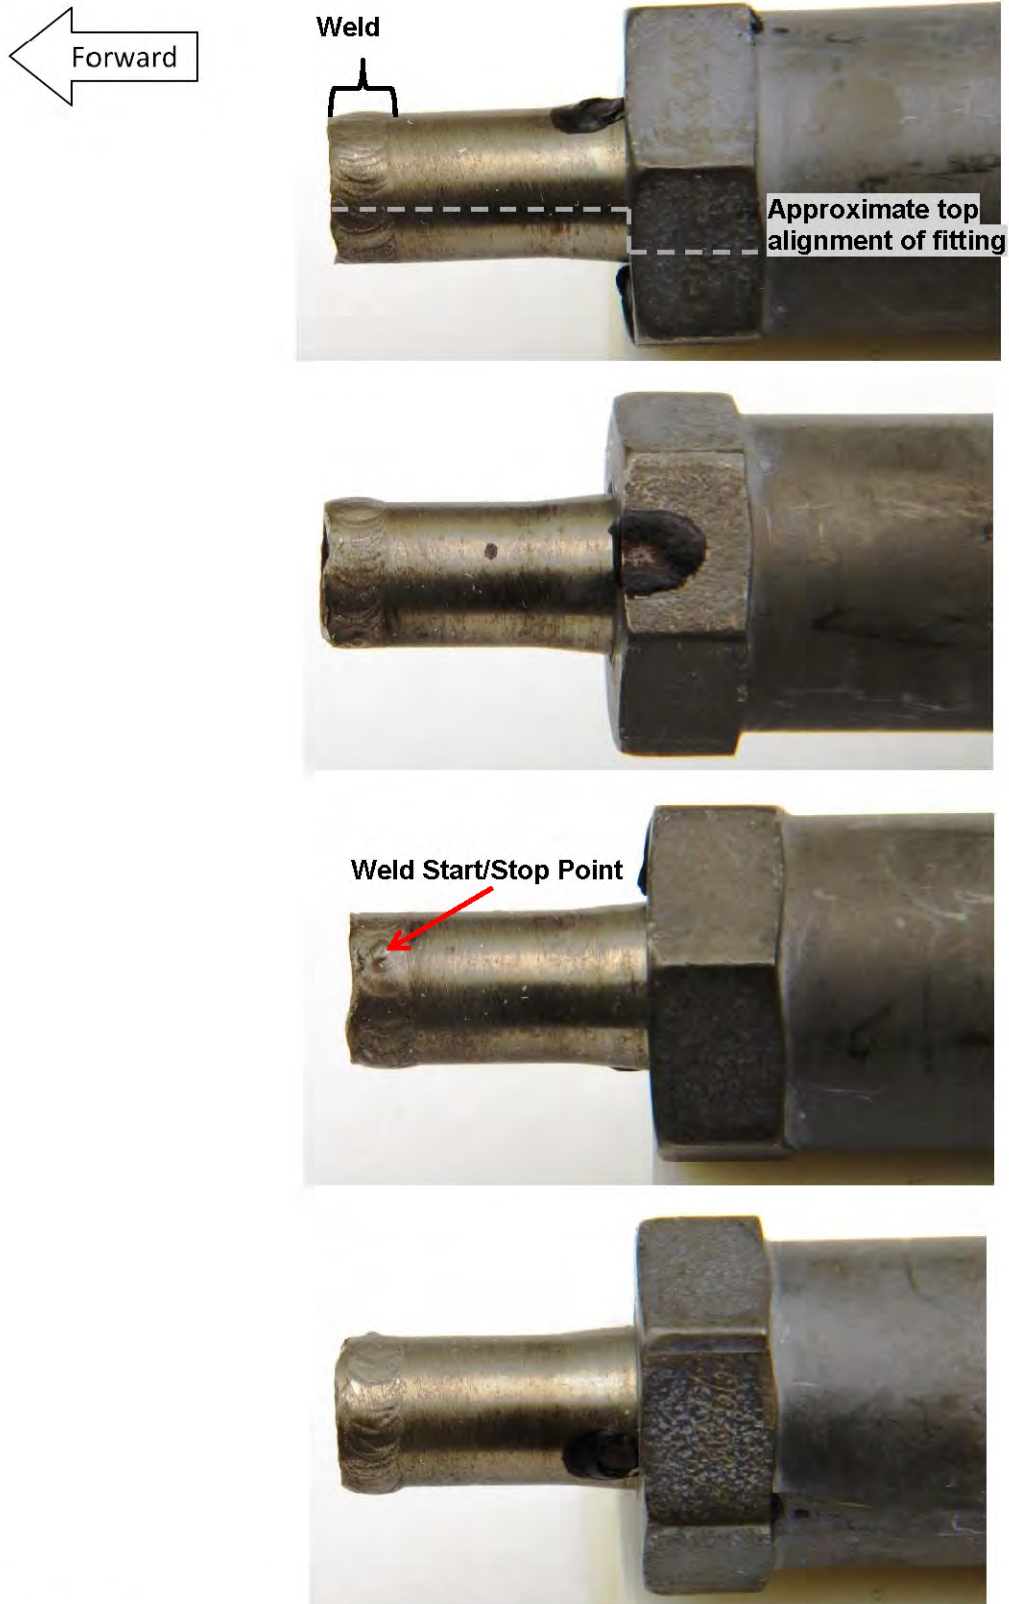
Figure 11. 90° rotated detailed views showing the weld and fitting side of the fractured tube. The fracture was at the toe of the weld on the side opposite the fitting. The tube was rotated 90° counterclockwise, forward looking aft, for this succession of images.

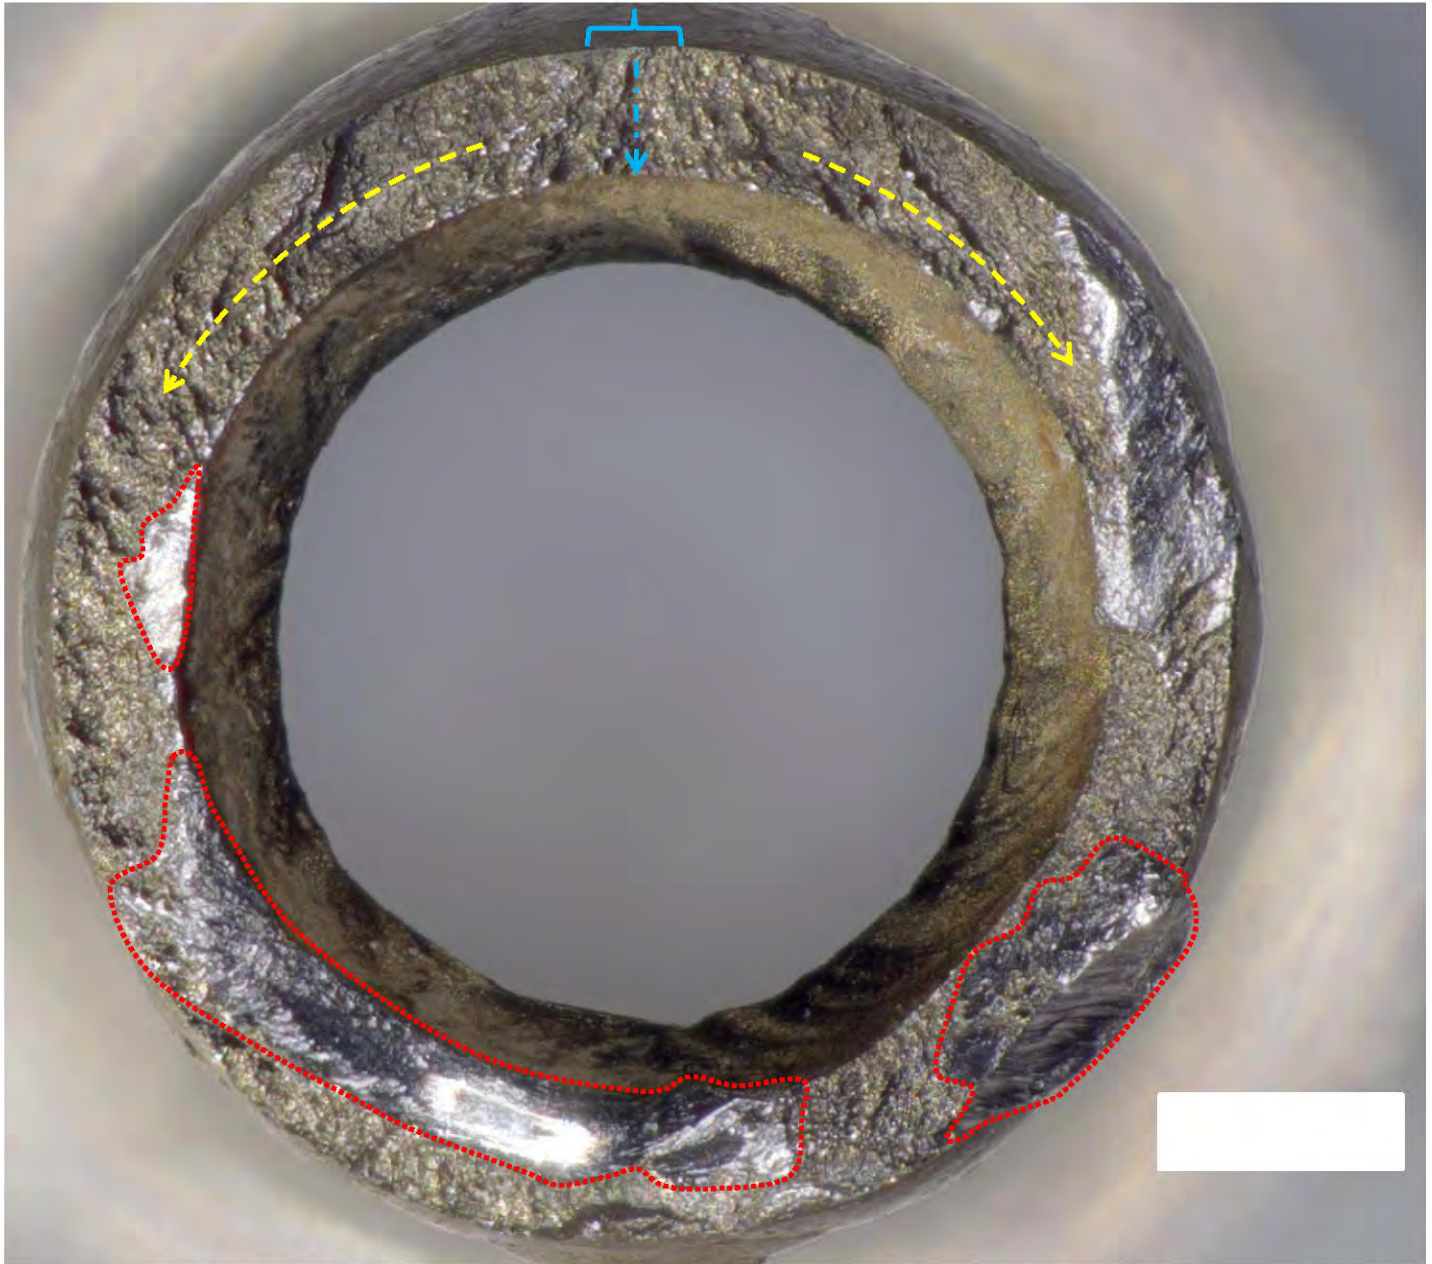
Figure 12 shows the fitting side fracture surface after it was cleaned with soap and water and ultrasonically agitated in acetone and methanol. The fracture surface exhibited macroscopic features consistent with fatigue radiating away from the outer diameter surface of the tube near the top alignment of the tube. The fracture features radiated through the tube wall thickness and circumferentially in both directions from this location. The fracture exhibited smearing damage in large areas elsewhere on the fracture surface. Figure 13 shows the tube side fracture surface after cleaning. It exhibited similar features to the mating fracture surface shown in Figure 12, but exhibited less macroscopic smearing damage.

Figure 12. Detailed view showing the fitting side fracture surface after cleaning. The fracture features radiated from the outer diameter near the top directly through the thickness of the tube (blue brace and arrow), shown in Figure 14. The fracture features radiated away from the through-thickness fractured area around the circumference in both directions (yellow dashed arrows). The fracture exhibited smearing in several continuous areas around the circumference of the tube (red dashed outlined areas).

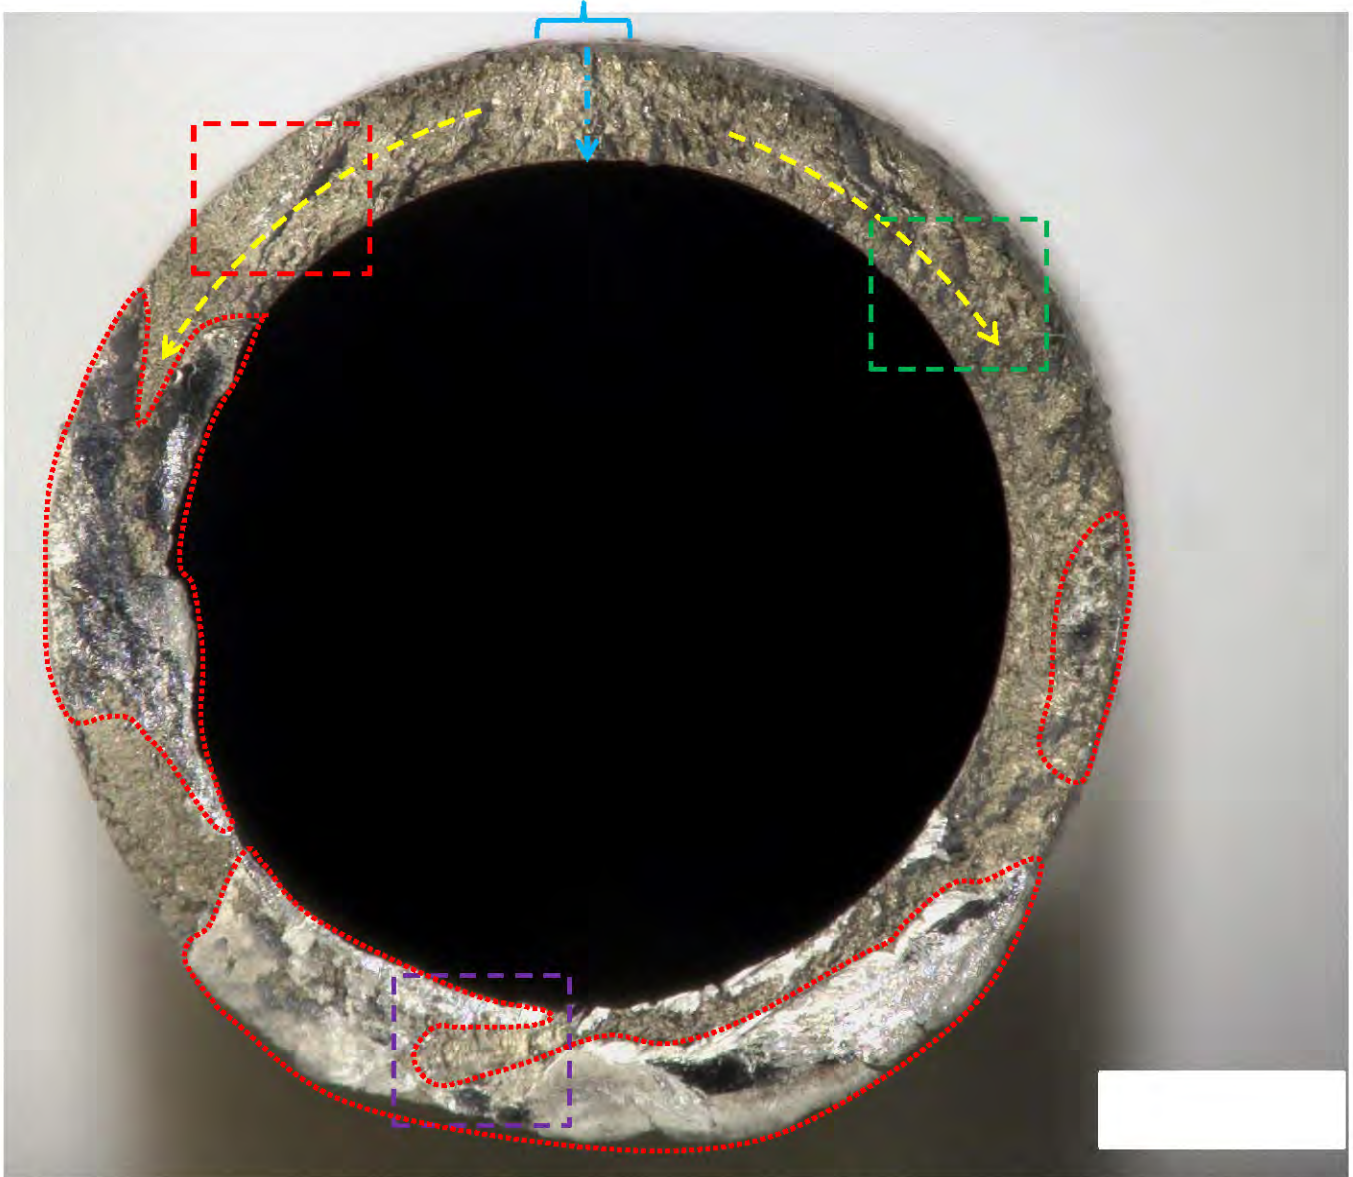
Figure 13. Detailed view showing the tube side fracture surface after cleaning. The fracture features radiated from the outer diameter near the top directly through the thickness of the tube (blue brace and arrow, through thickness fracture shown in Figure 16). The fracture features radiated away from the through-thickness fractured area around the circumference in both directions (yellow dashed arrows). The fracture exhibited smearing in several continuous areas around the circumference of the tube (red dashed outlined areas). The areas in the red, green, and purple dashed boxes are shown in Figure 17, Figure 18, and Figure 19, respectively.

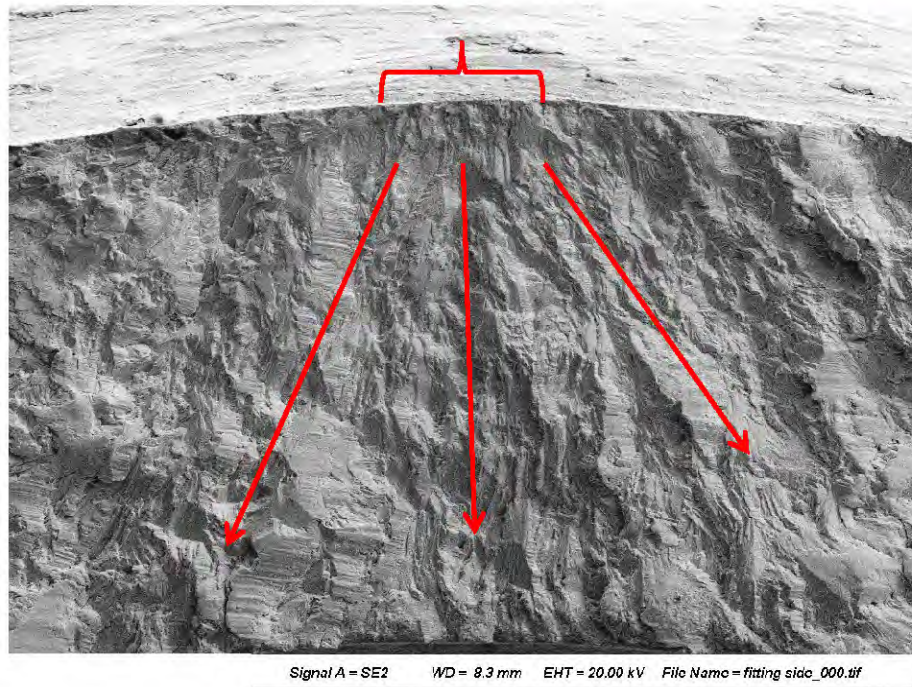
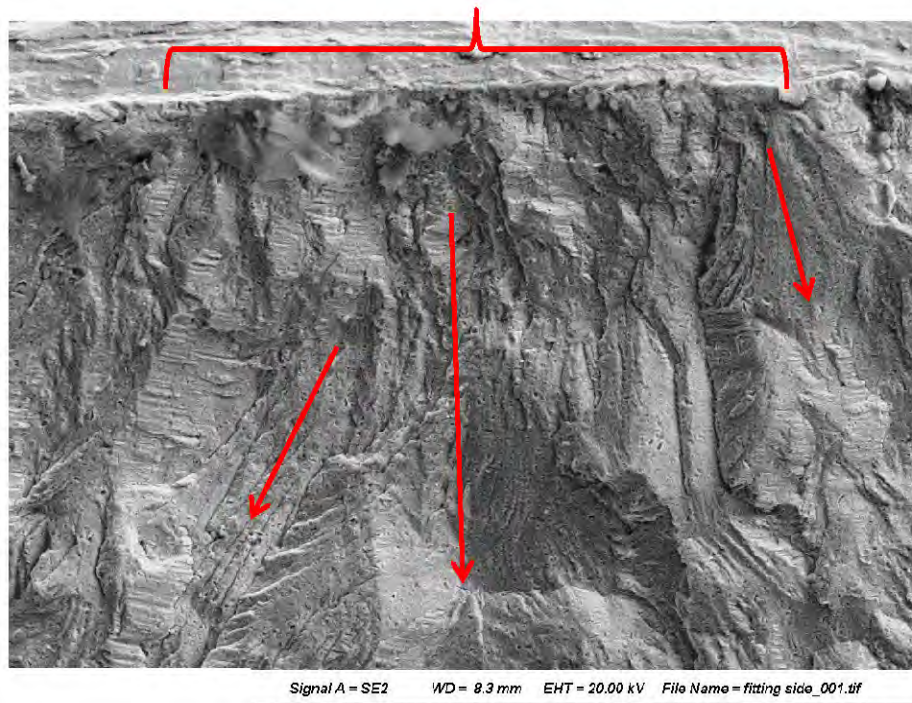
Because both fracture surfaces exhibited smearing damage in different locations, both were examined in the scanning electron microscope (SEM) and images from both fracture surfaces are shown in this report. The top location on the fitting side fracture surface is shown in Figure 14, where the fracture features radiated away from an origin area on the outer diameter surface. Figure 15 shows optical and backscattered electron (compositional contrast mode) SEM images of the outer diameter surface of the weld adjacent to the origin area. The origin area was located further toward the tube side of the weld than the adjacent circumference (appearing slightly proud of the rest of the fracture surface in the optical image shown in Figure 15). The fracture propagated through the thickness at the top location as shown in Figure 16 and propagated circumferentially in both directions from the origin area as shown in Figure 17 and Figure 18 (images shown are on the tube side fracture surface). There was also an area where fracture features appeared to radiate towards the outer diameter and counterclockwise away from a smeared area adjacent to the inner diameter surface, as shown in Figure 19 (tube side fracture surface). As observed optically, much of the tube side fracture surface was smeared, including in an arc spanning from approximately 120° to 200° clockwise from the origin. A detailed representative image of the smearing damage on the fracture surfaces is shown in Figure 20. The smearing damage on the fracture surfaces precluded identification of any other modes of fracture from the fine fracture features.

Figure 14. SEM images showing fracture features radiating away from the fatigue origin area (red brace) on the outer diameter surface near the top position of the tube on the fitting side of the fracture surface. Red arrows show the local direction of fatigue progression. Tilted views showing the outer diameter surface of the tube are shown in the following figure.

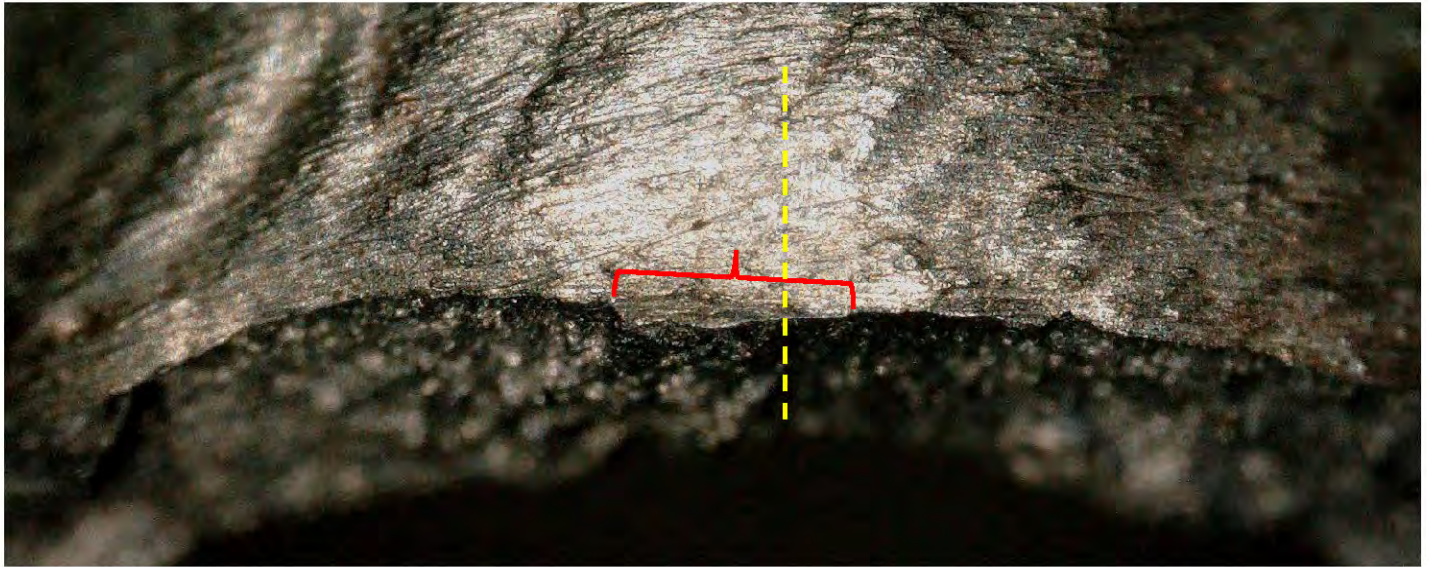
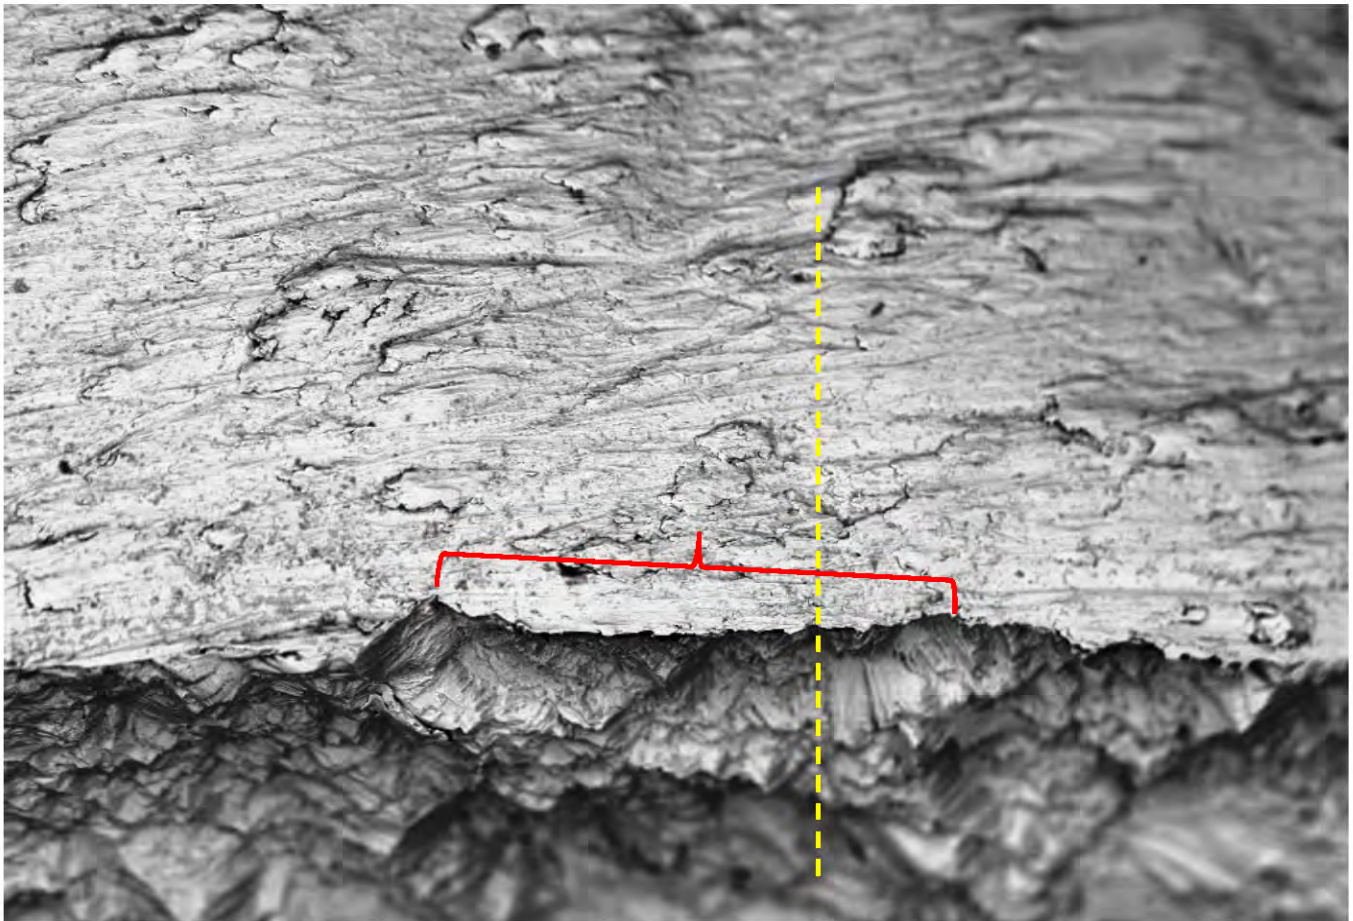
Figure 15. Optical (top) and backscattered electron SEM (bottom) images showing the weld outer diameter on the fitting side of the fracture surface adjacent to the origin area (red brace). The yellow dashed line shows the approximate plane of metallographic examination shown in Figure 22.
