MATERIALS EVALUATION REPORT

20FAE-033-PR

**METALLURGICAL INVESTIGATION OF A
 P_C SCROLL TO P_C FILTER TUBE
 ASSEMBLY, P/N 23065814, INSTALLED IN
 AN M250-C30P ENGINE, S/N CAE895054,
 OPERATED BY AIR EVAC EMS INC**

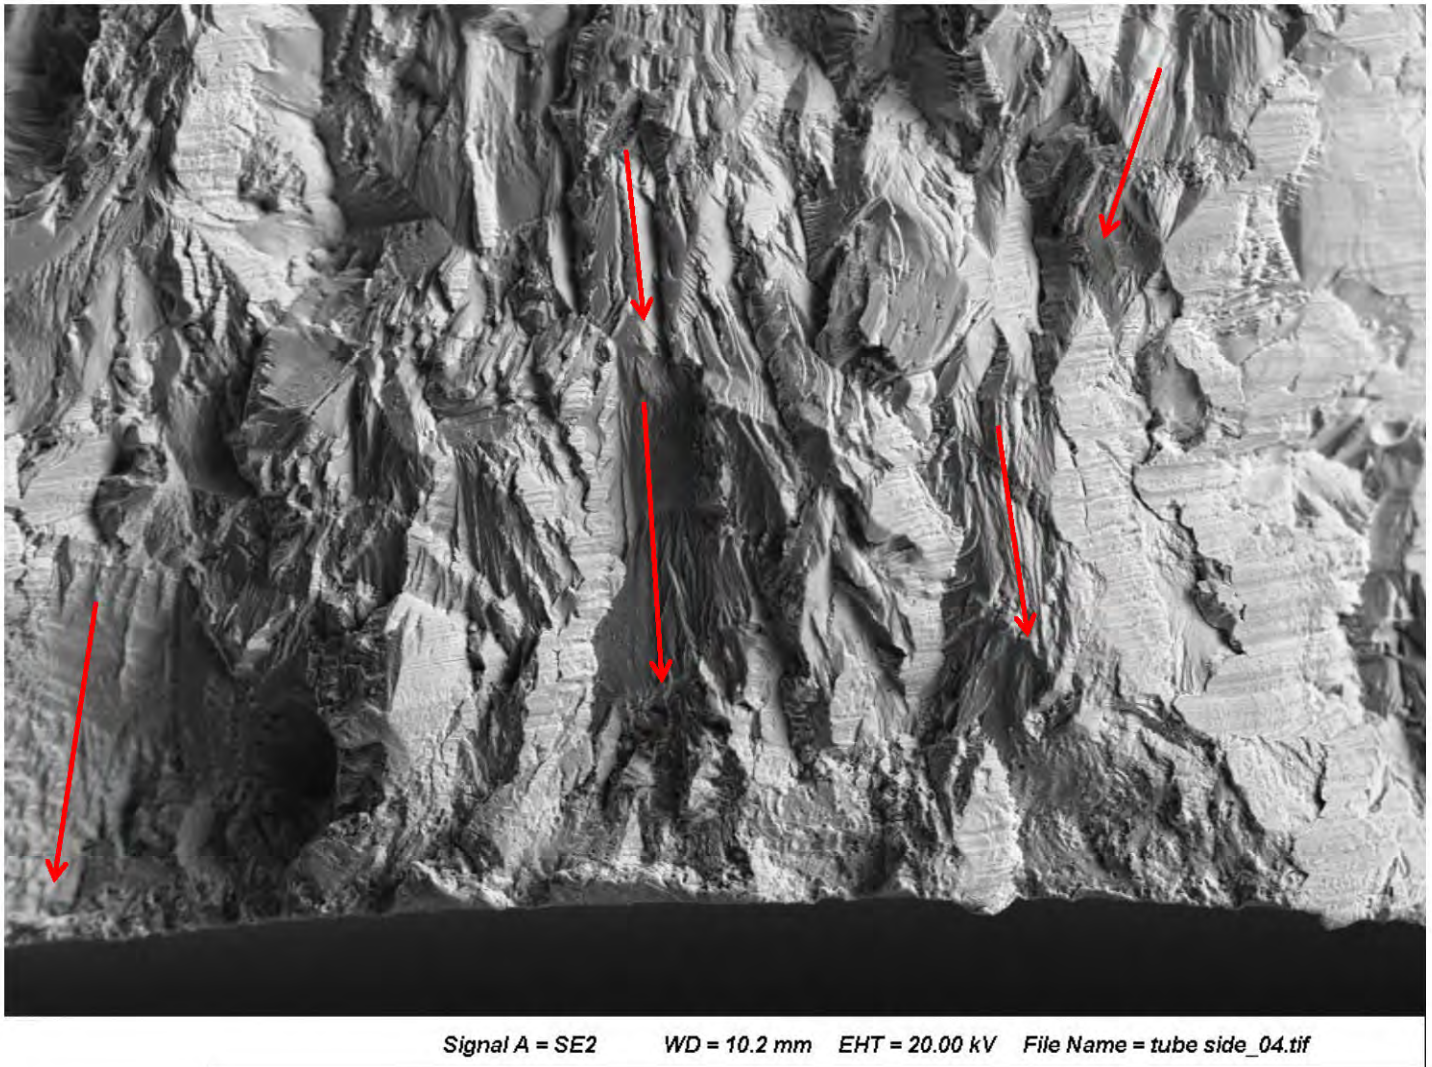
Figure 16. SEM image showing fatigue fracture features (red arrows) extending through the thickness of the tube on the tube side fracture surface.

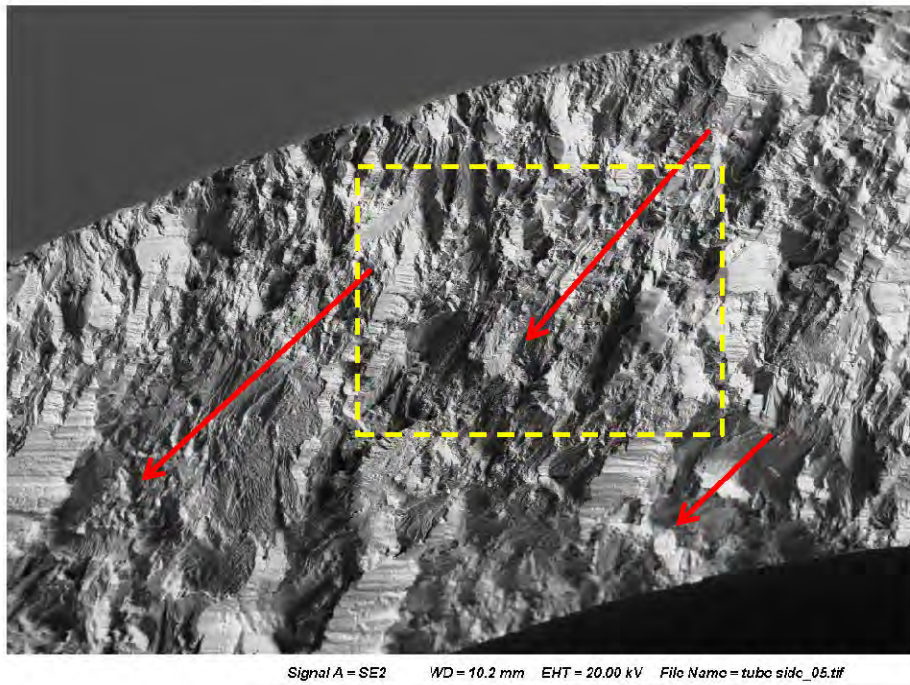
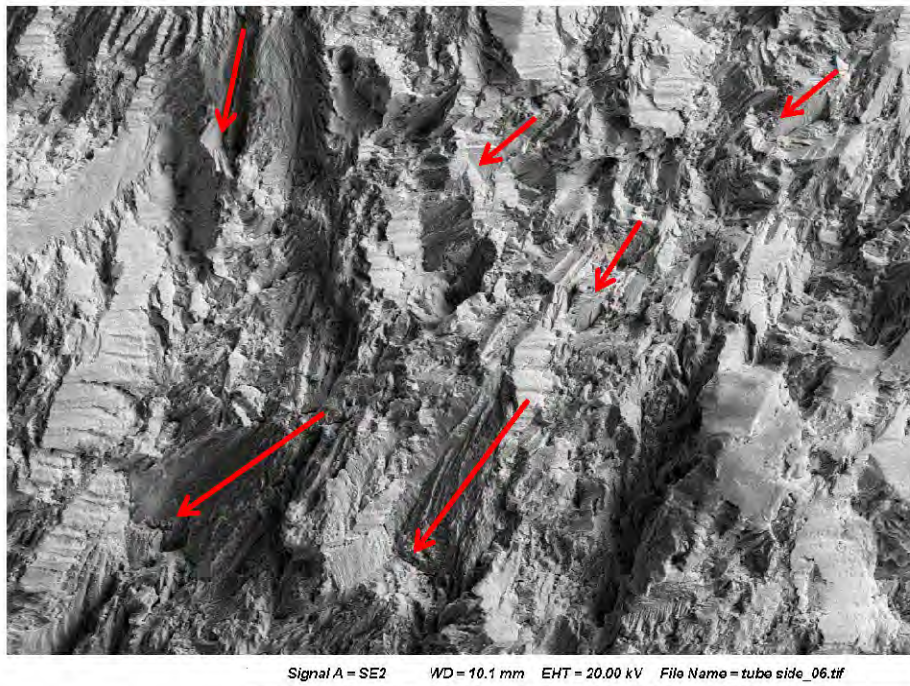
Figure 17. Representative fracture features consistent with fatigue progression counterclockwise circumferentially from the origin area on the tube side fracture surface. The fracture surface was intermittently smeared. Red arrows indicate the local direction of fatigue progression.

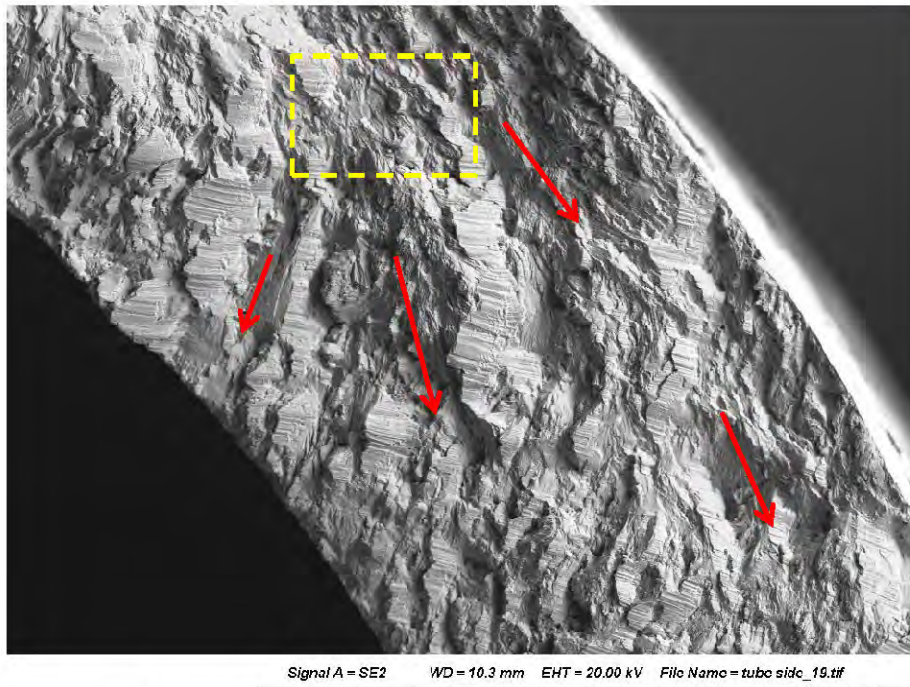
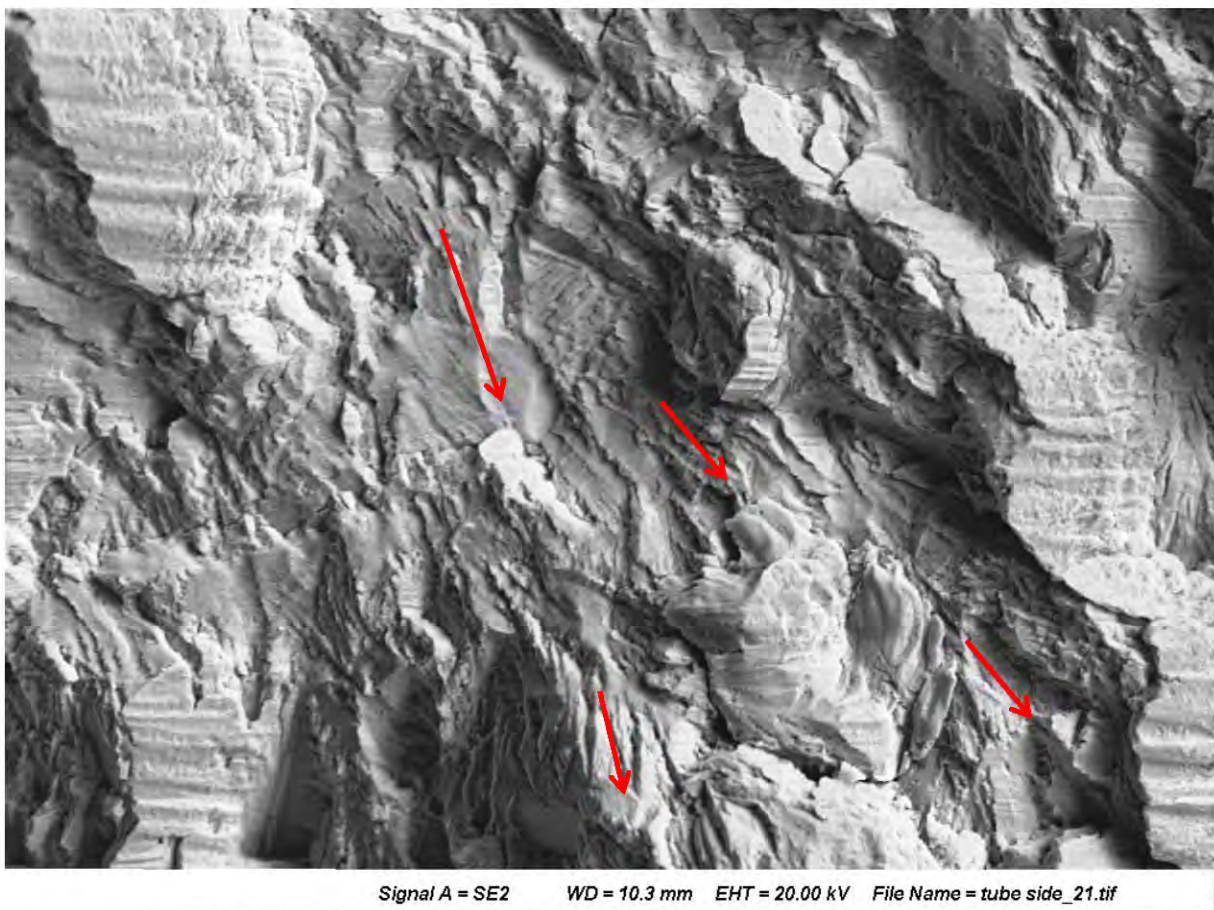
Figure 18. Representative fracture features consistent with fatigue progression clockwise circumferentially away from the origin area. The fracture surface was intermittently smeared. Red arrows indicate the local direction of fatigue progression.

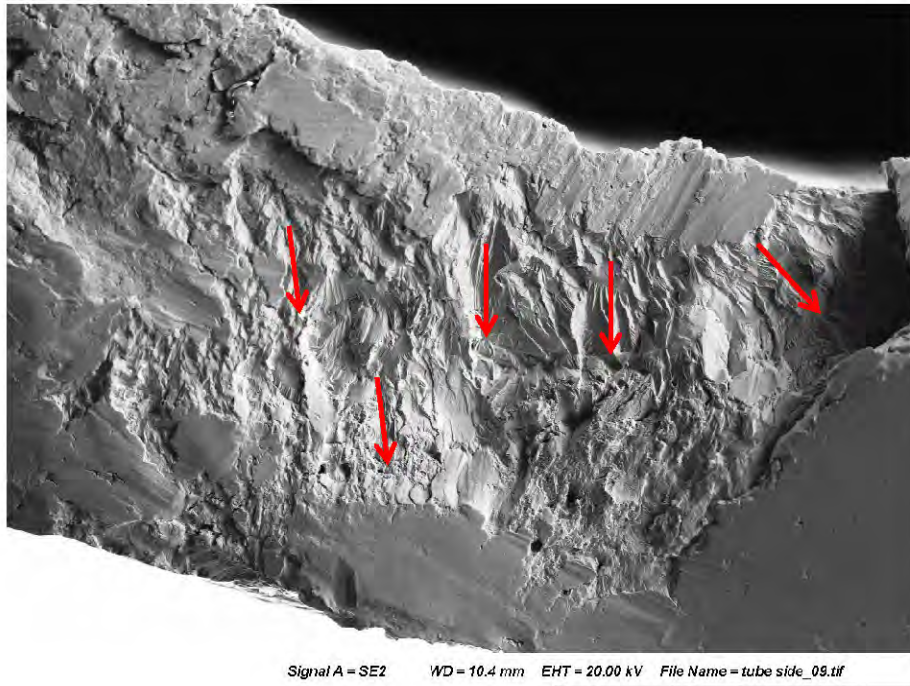
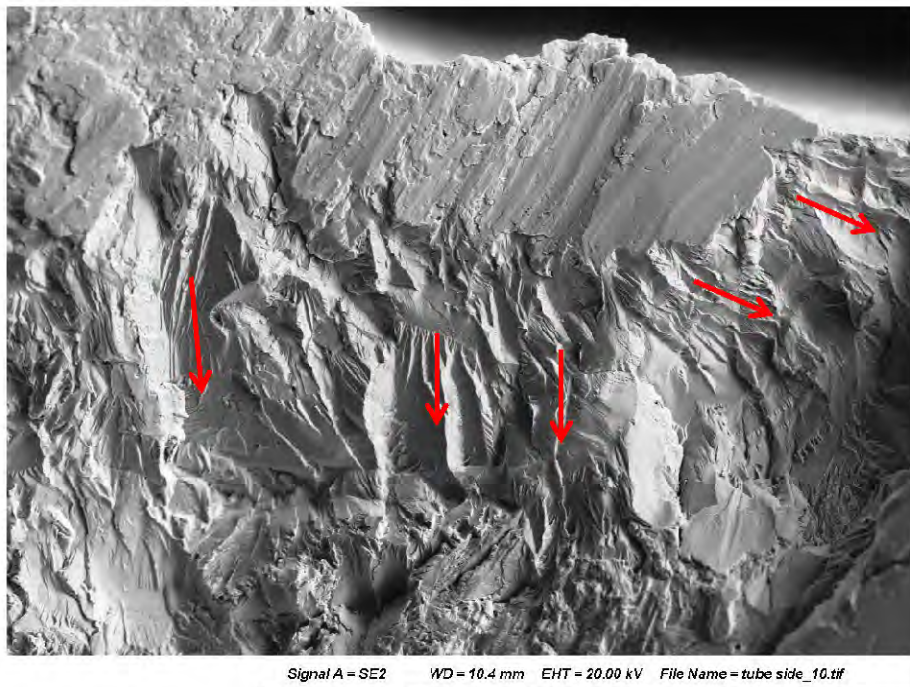
Figure 19. Fracture features consistent with fatigue progression emanating away from a smeared area adjacent to the inner diameter surface, approximately 200° clockwise from the origin. The red arrows show the local direction of fatigue progression.

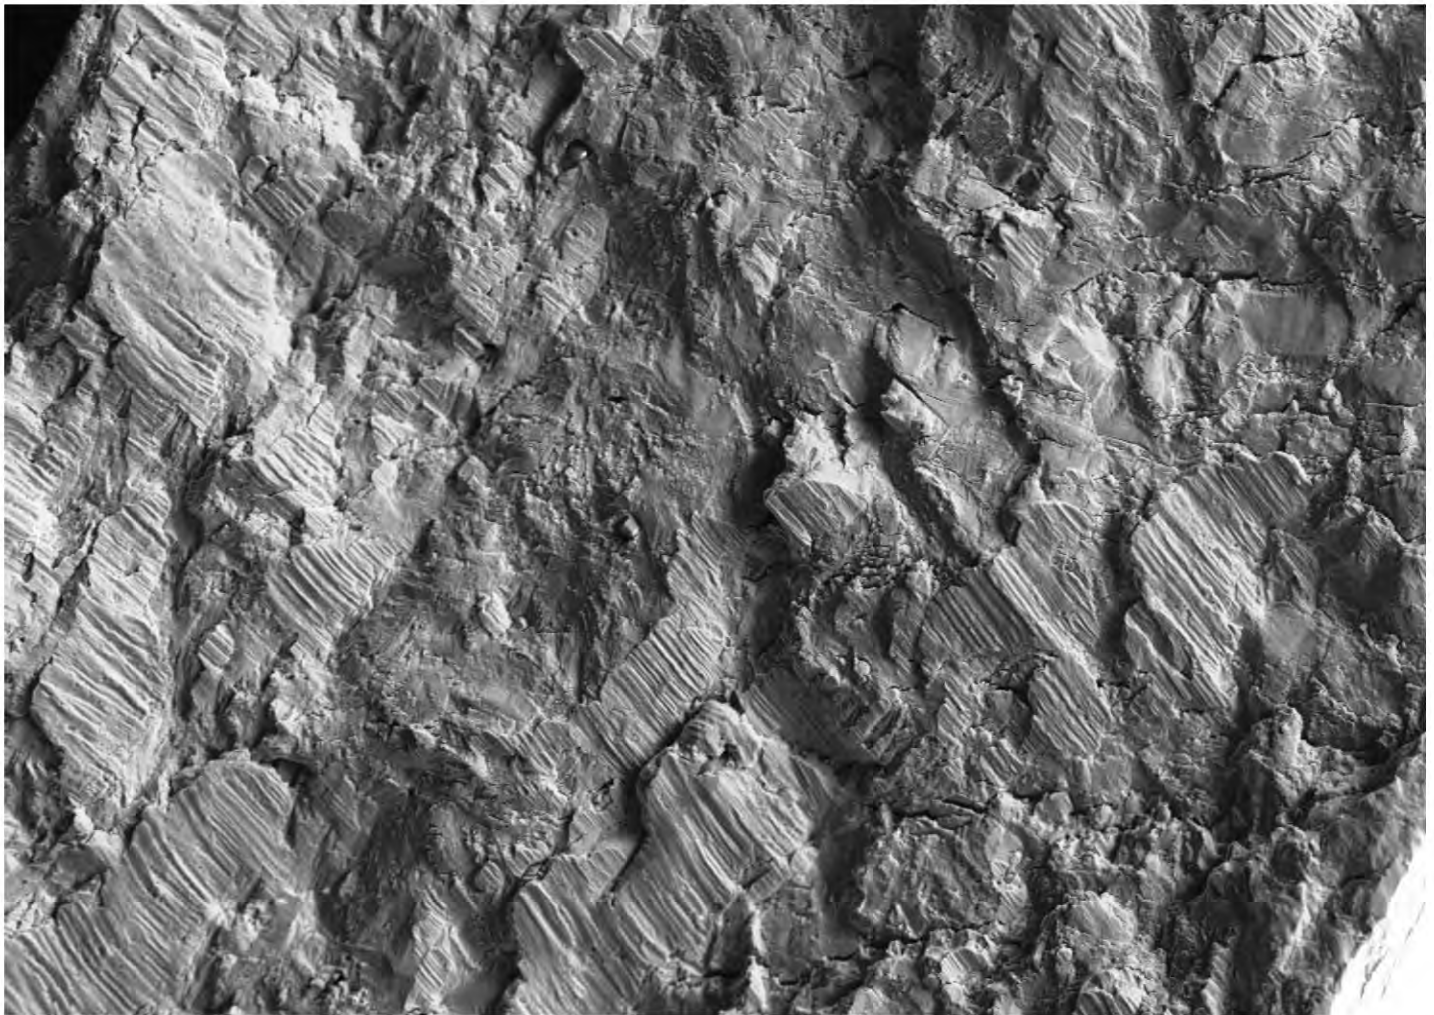
Figure 20. Detailed view of representative smearing damage located approximately 120° in the clockwise direction from the origin. The fracture surface spanning from approximately 120° to 200° clockwise from the origin was smeared and most of the fine fracture features were obliterated, precluding identification of the fracture mode.

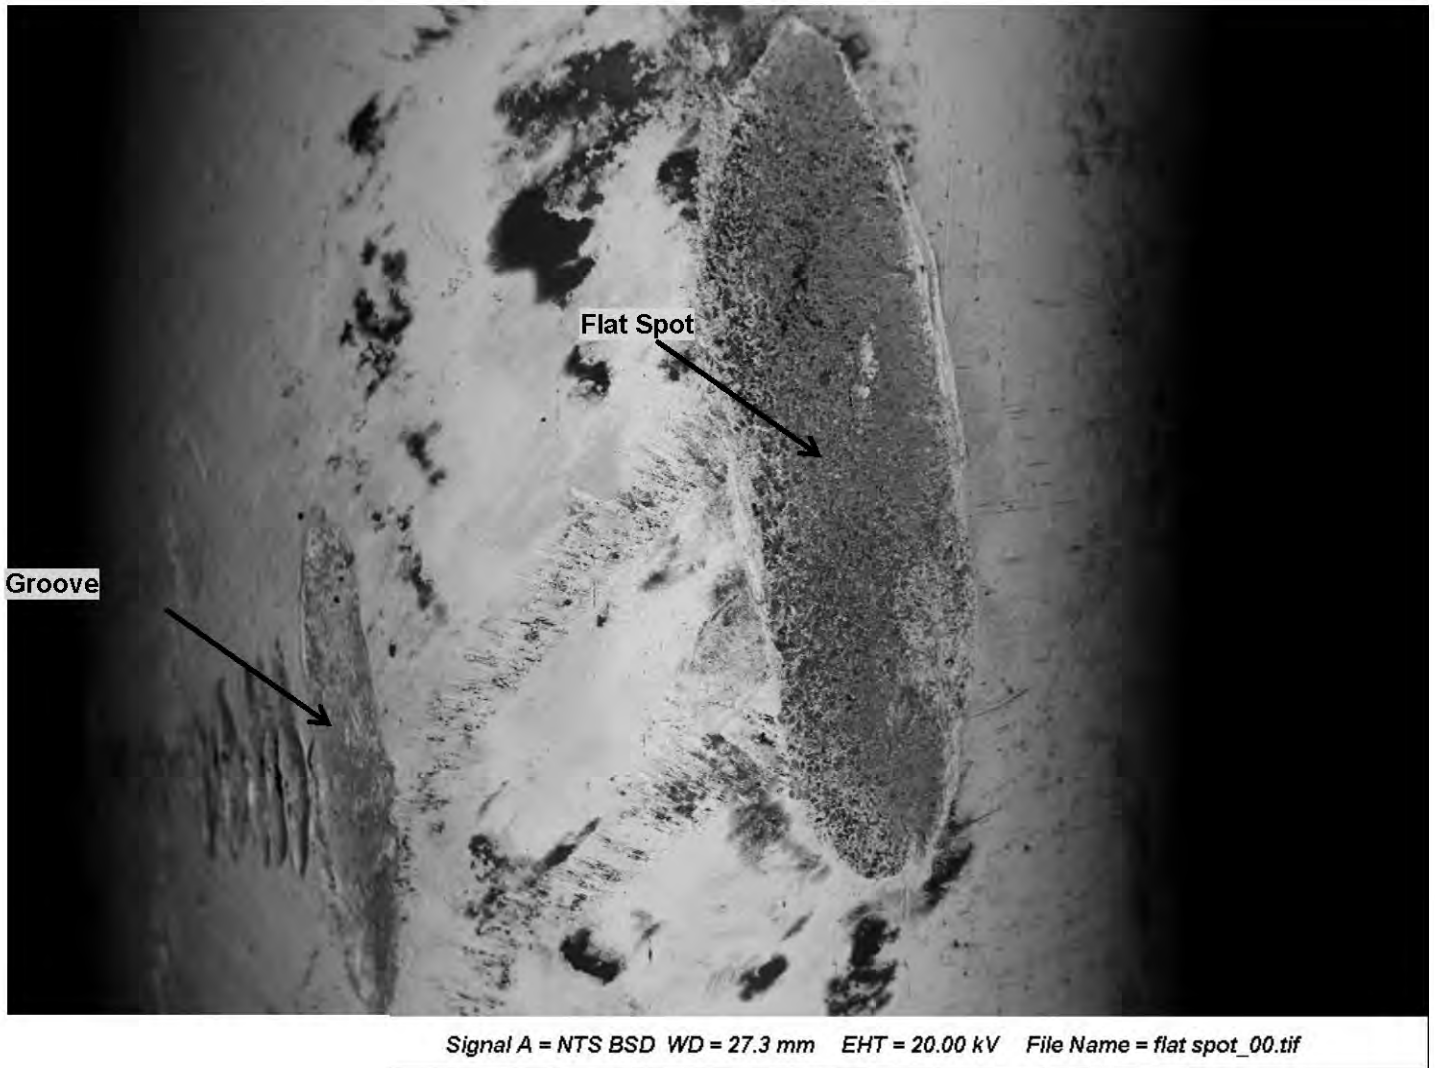
The flat spot and adjacent parallel grooves on the outer radius of the bend were examined in the SEM and subjected to semi-quantitative energy dispersive x-ray spectroscopy (EDS) analysis. Figure 21 shows a backscattered electron SEM image of both areas, which appeared darker than the surrounding surface. EDS results revealed that both the flat spot and parallel grooves contained elevated amounts of oxygen and silicon, along with base metal constituents.

Element	Flat Spot (wt%)	Groove (wt%)
O	18.45	29.54
Si	6.03	1.54
Cr	2.59	3.94
Mn	0.54	0.66
Fe	68.32	62.9
Ni	1.02	1.43

Figure 21. Backscattered electron SEM image (top) showing the flat spot and adjacent parallel grooves. The table shows representative EDS results for the flat spot surface and largest groove. Arrows mark the test locations.

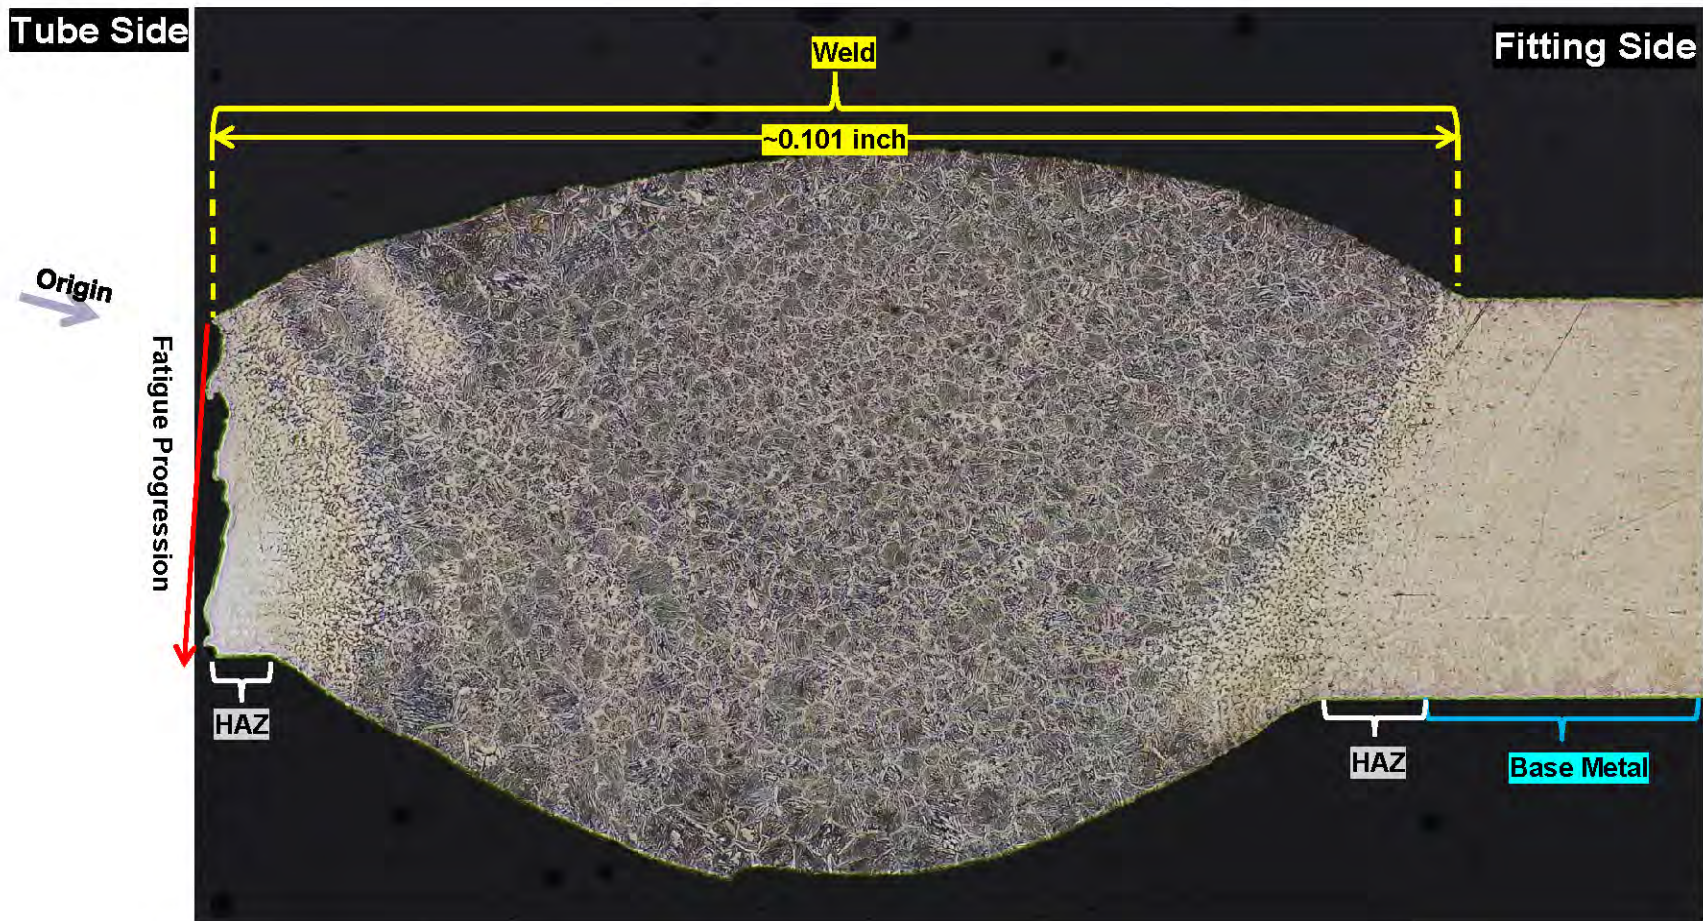
A cross-section was prepared through the weld on the fitting side fracture at the approximate plane of the fatigue origin, as indicated in Figure 15. The cross-section was polished using typical procedures and etched using Stainless No. 2; the resultant cross-section is shown in Figure 22. The cross-section revealed the fatigue fracture was located at the toe of the weld, initiating at the approximate intersection of the weld heat affected zone (HAZ) and the weld metal of the tube as shown in Figure 23 and Figure 24. There were no material anomalies at the fatigue origin location, which was located at the transition in geometry at the toe of the weld. The fatigue fracture progressed approximately along the intersection between the HAZ and weld metal near the outer diameter surface before proceeding into the HAZ to the inner diameter surface at this plane of examination.

Figure 22. Metallographic cross-section through the weld at the approximate plane of the fatigue origin area as indicated in Figure 15. The approximate areas of the weld (yellow brace), heat affected zone (HAZ; white braces), and base metal (blue braces) microstructures are annotated. The fracture origin (purple arrow) was at the approximate intersection between the HAZ and base metal microstructures on the tube side of the weld in this plane of examination. The red arrow shows the direction of fatigue progression. The fracture surface is shown in more detail in the following figure. Etchant: Stainless No. 2.

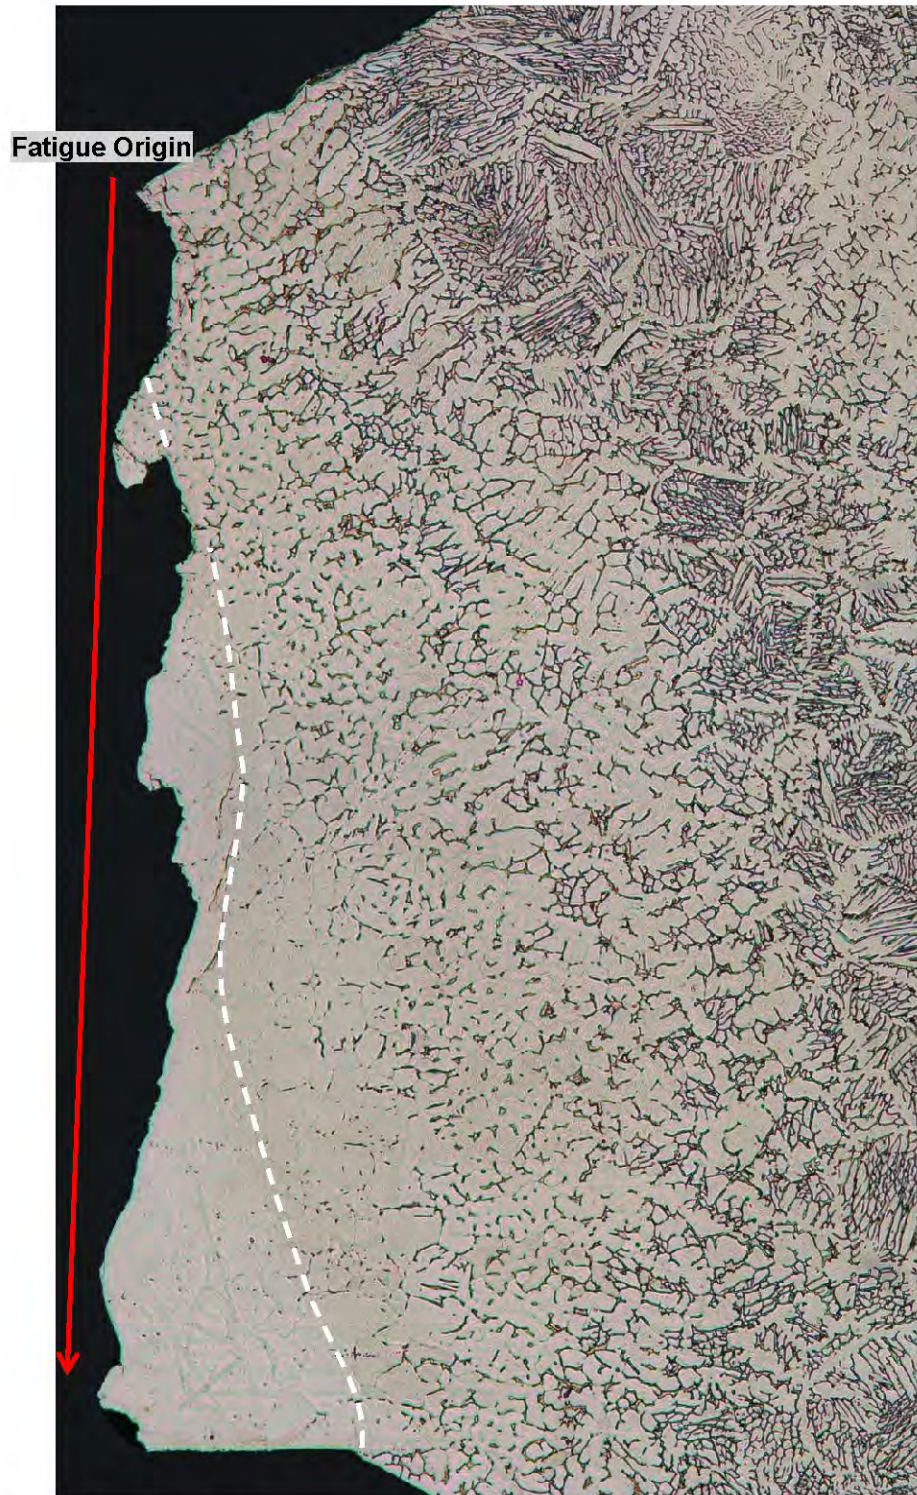
Figure 23. Detailed view showing the fatigue fracture surface on the cross-section shown in the previous figure. The red arrow shows the direction of fatigue progression through the thickness of the tube, initiating near the approximate transition between the HAZ and weld metal microstructures. The approximate transition between the HAZ and weld metal microstructures, where it was visually apparent in this plane of cross-section, is indicated by the white dashed line. Etchant: Stainless No. 2.

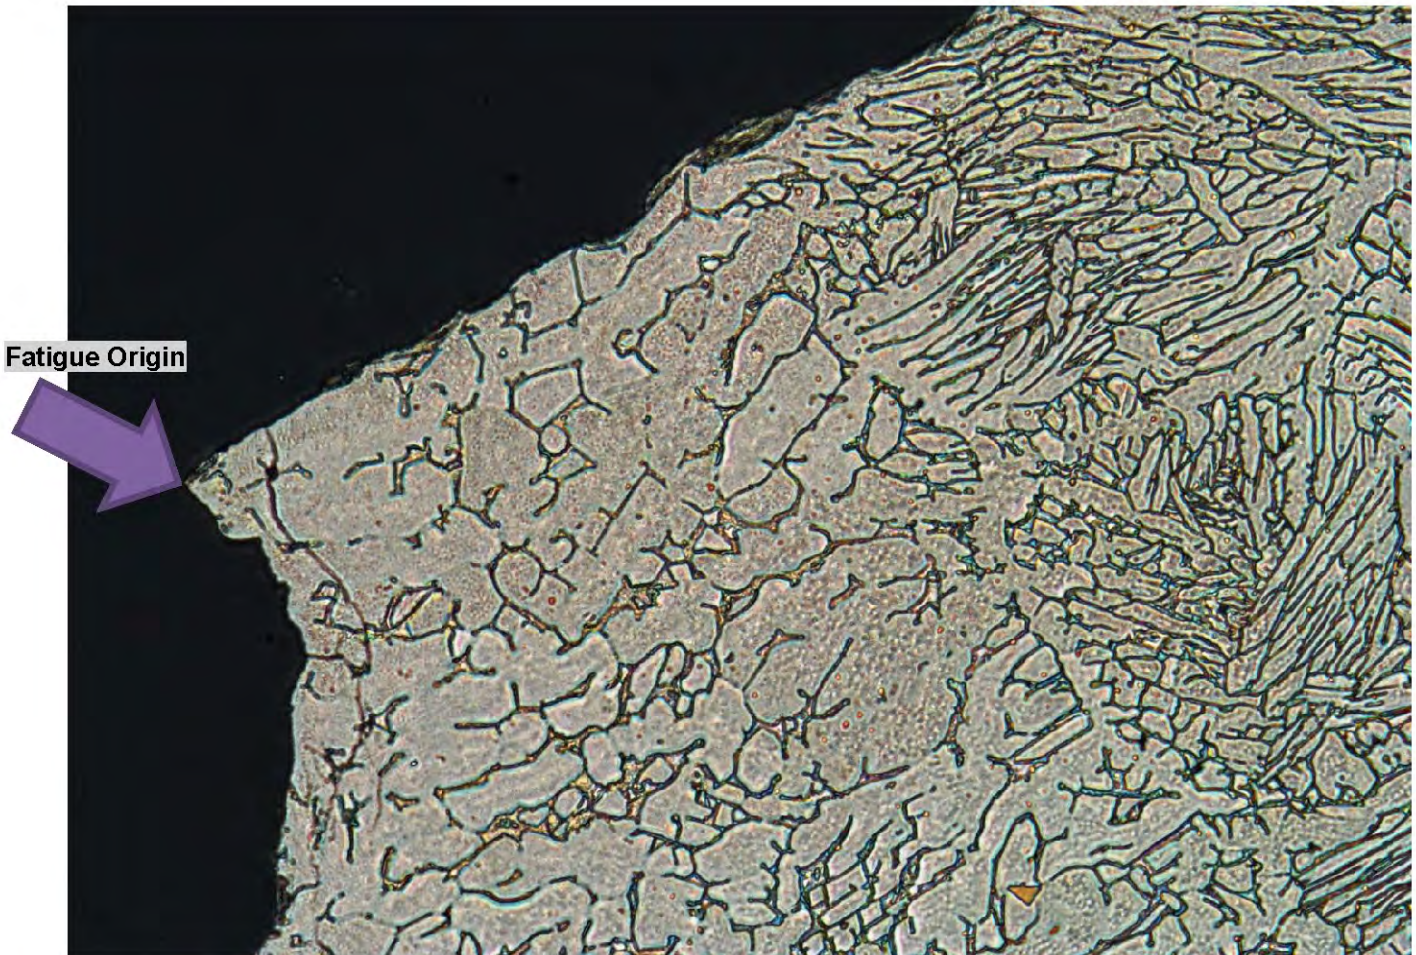
Figure 24. Detailed view of the fatigue origin area in cross-section. There were no material anomalies at the origin. Etchant: Stainless No. 2.

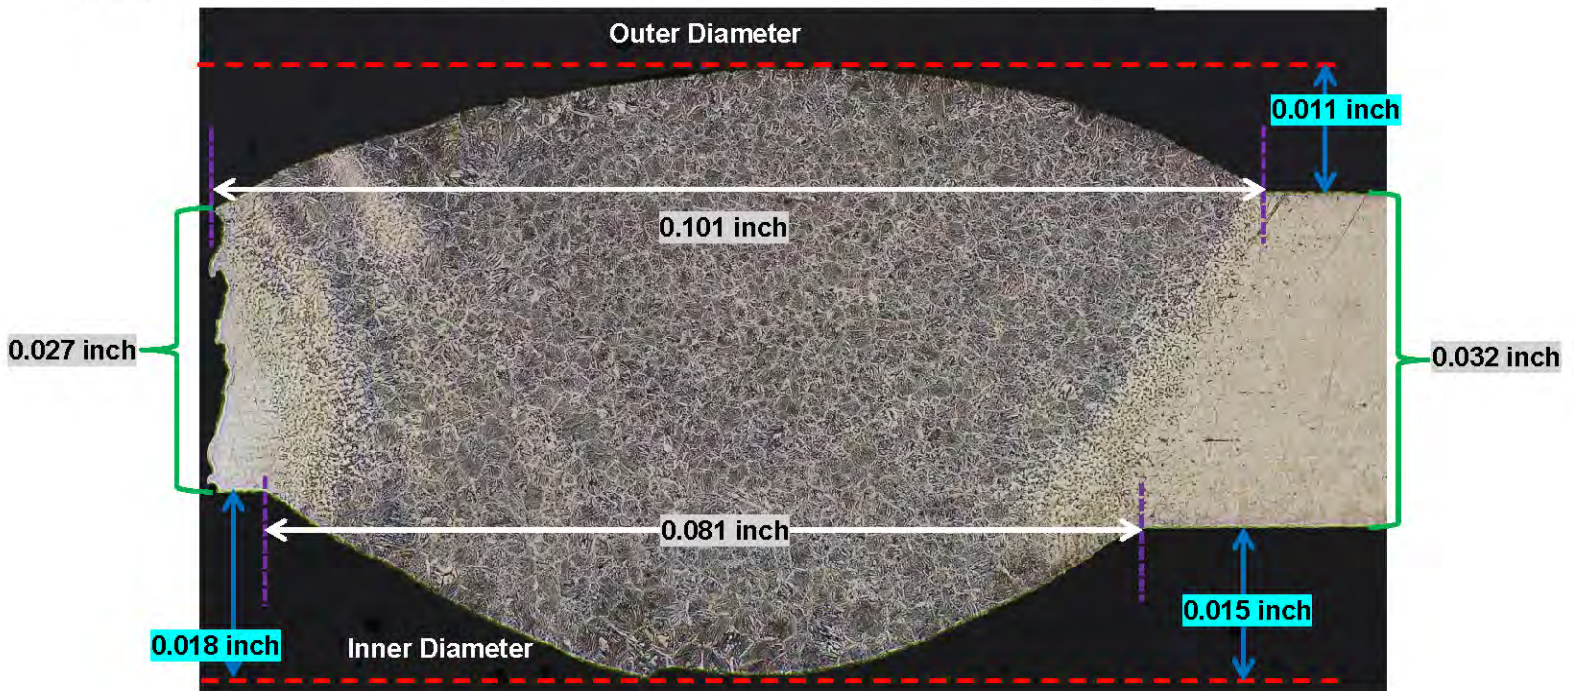
- 2.1 The tube was fractured completely through at the toe of the weld between the tube and the air filter fitting. The fracture initiated in fatigue near the top location of the tube. Smearing damage on the surface precluded identification of any other modes of fracture.
- 2.2 The tube exhibited rub damage on the outer diameter surface of the elbow nearest the fracture surface. A red ribbed hose that was seen hanging in the engine bay near the fractured tube exhibited discoloration on the outer surface.
- 2.3 The height of the weld root reinforcement exceeded the component definition requirement.

Figure 27 shows the etched cross-section with several dimensions measured at the plane of the fatigue origin. Note that the tube wall thickness was approximated, measuring from the origin surface on the outer diameter side to the inner diameter wall. The tube wall thickness was measured to be approximately 0.027 inch, which met the component definition requirement. The fitting side wall thickness measured 0.032 inch, which met the component definition requirement. The height of the weld crown on the outer diameter measured 0.011 inch from the fitting side surface, which met the component definition maximum requirement. The height of the root reinforcement measured 0.018 inch from the inner diameter surface on the tube side, which exceeded the component definition maximum requirement. The height of the root reinforcement measured 0.015 inch from the inner diameter surface on the fitting side, which met the component definition maximum requirement. The tube and fitting had different wall thicknesses and thus exhibited some mismatch in alignment. There was no

component definition requirement for weld width; measurements are provided for information only. The width of the weld measured approximately 0.101 inch on the outer diameter (terminating at the fracture surface) and 0.081 inch on the inner diameter.

Figure 27. Overall view of the weld in cross-section annotated with the measured wall thicknesses of the tube and fitting (green braces) as well as the width (white arrows) and height (blue arrows) of the weld bead and root reinforcement at the plane of the fatigue origin. White arrows placed collinear with the inner and outer diameter surfaces of the fitting to illustrate the mismatching alignment of the tubes. Etchant: Stainless No. 2.

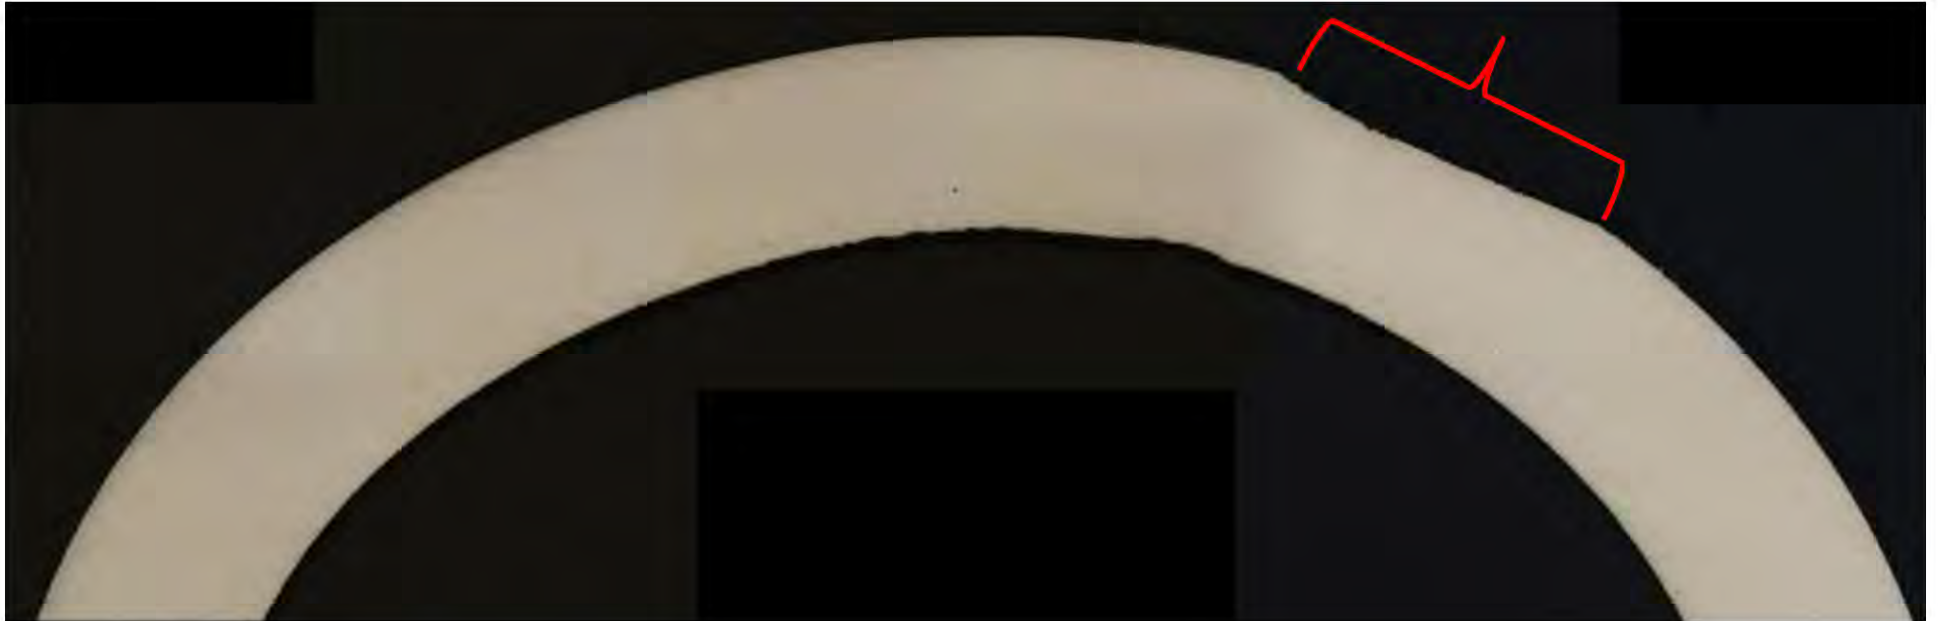
A metallographic cross-section was prepared through the flat spot on the outer radius of the bend and polished to examine plane 1 as indicated in Figure 6. The cross-section was subsequently polished further to plane 2 for examination of the parallel grooves. Figure 28 shows an overall view of the cross-section at plane 1, which revealed the previously-described flat spot was slightly concave at this plane of examination. There was no corresponding deformation of the inner diameter surface opposite the flat spot. Detailed inspection of the surface in the flat spot revealed an oxide layer on the surface and some distortion of the microstructure as shown in Figure 29. For comparison, the surface of the tube on both sides of the flat spot is shown in Figure 30, which also shows the representative microstructure found in the tube away from the surface. The microstructure was consistent with the material required by the component definition.

Figure 28. Overall view showing the cross-section through the flat spot (red brace) at plane 1 through the rub damaged area. In this plane of examination there was a slight concavity to the mostly flattened surface. There was no corresponding deformation of the inner diameter opposite the flattened area or material smeared from the flattened area onto the adjacent surface of the tube. Unetched.

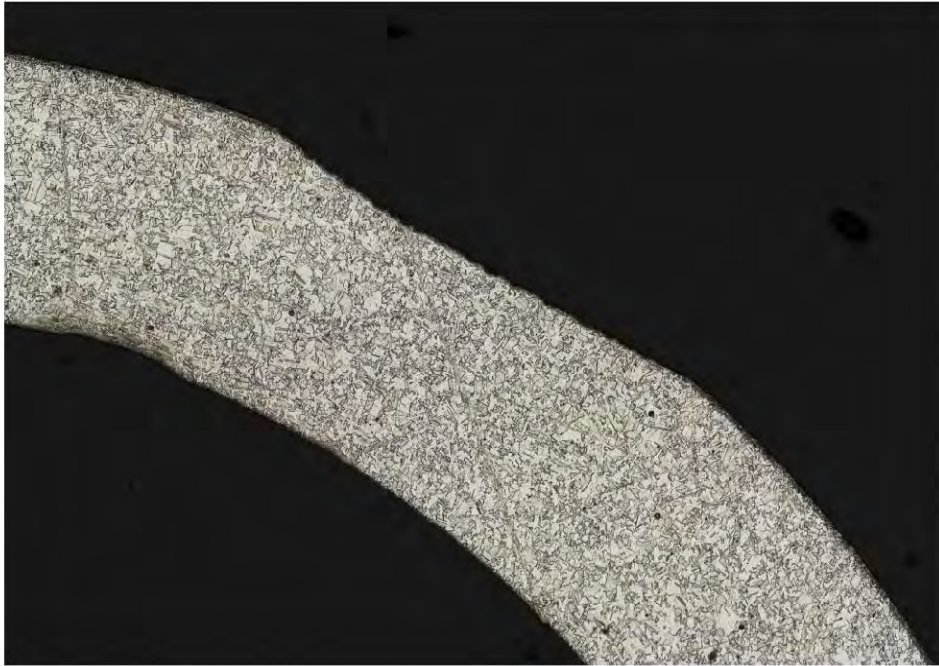
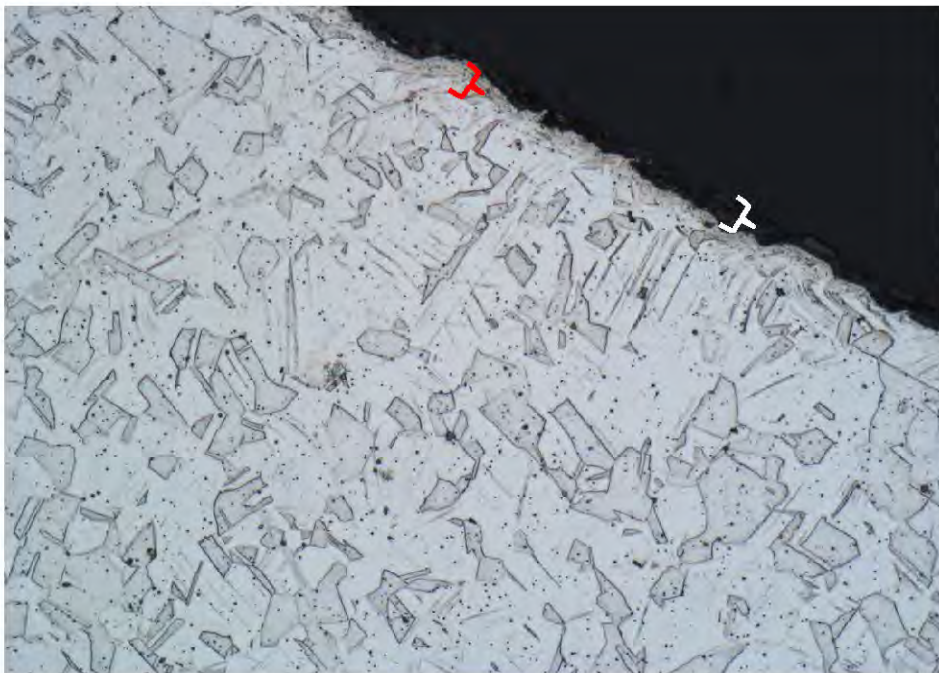
Figure 29. Detailed views showing the microstructure near the surface of the flat spot on plane 1. The flat spot had an oxide layer on the surface (white brace) under which the microstructure was distorted (red brace). Etchant: Stainless No. 2.

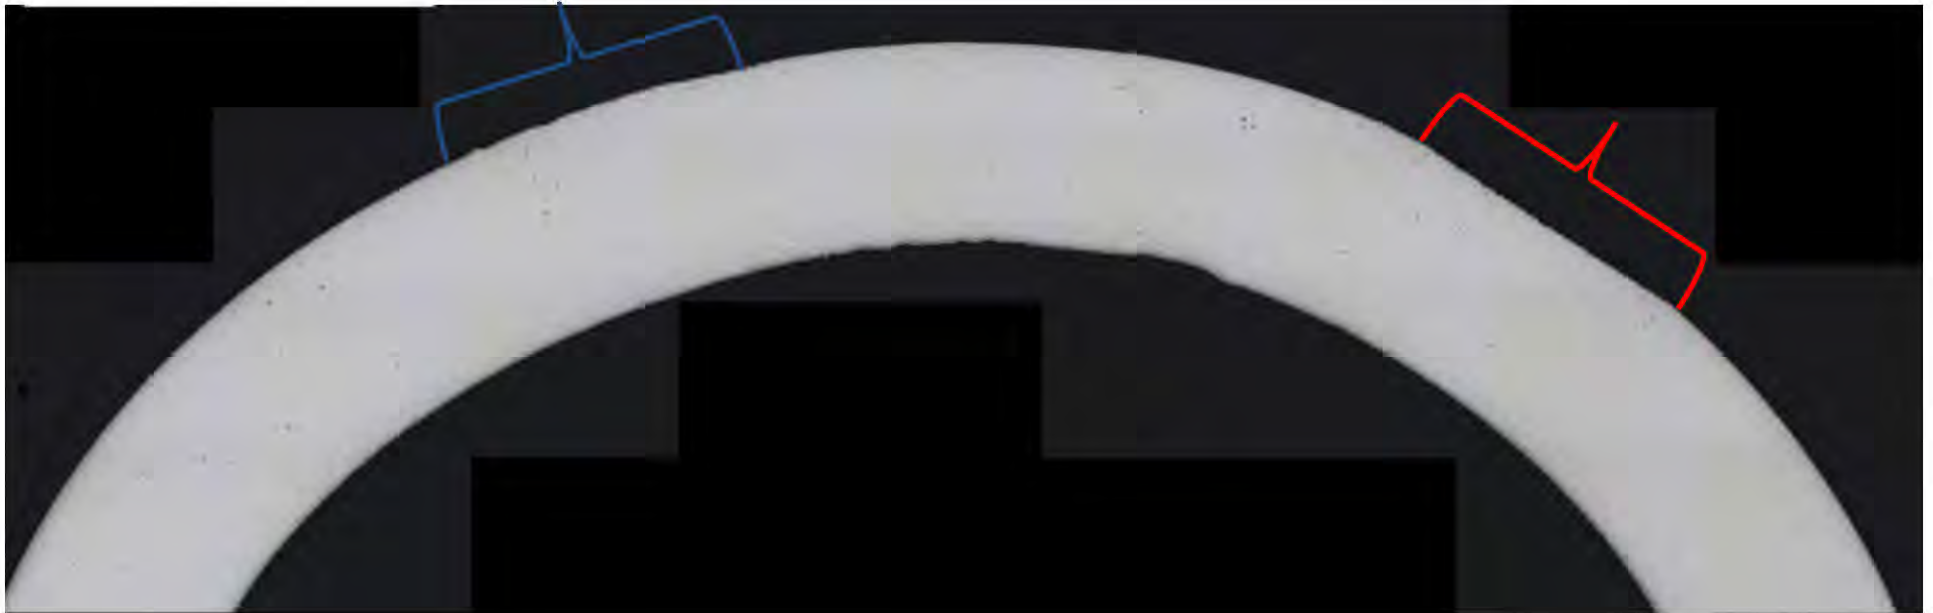
The mount was polished to plane 2 (Figure 6) and the resultant cross-section is shown in Figure 31. This section contained both the flat spot and the adjacent parallel grooves. In this plane of examination, the flat spot did not have any curvature, and there was no corresponding deformation on the inner diameter surface opposite either the flat spot or the grooves. The microstructure and oxide on the flat spot surface in this plane of examination was similar to that found in plane 1. A detailed view of the cross-section at the parallel grooves is shown in Figure 32, which revealed some oxides on the surface and some distortion of the microstructure when compared to the representative surface microstructures shown in Figure 30.

Figure 31. Overall view showing the cross-section through the flat spot (red brace) and parallel grooves (blue brace) at plane 2 through the rub damaged area. In this plane of examination there was no curvature to the flat spot. There was no corresponding deformation of the inner diameter opposite the flattened area or oval-shaped darkened patches. Unetched.

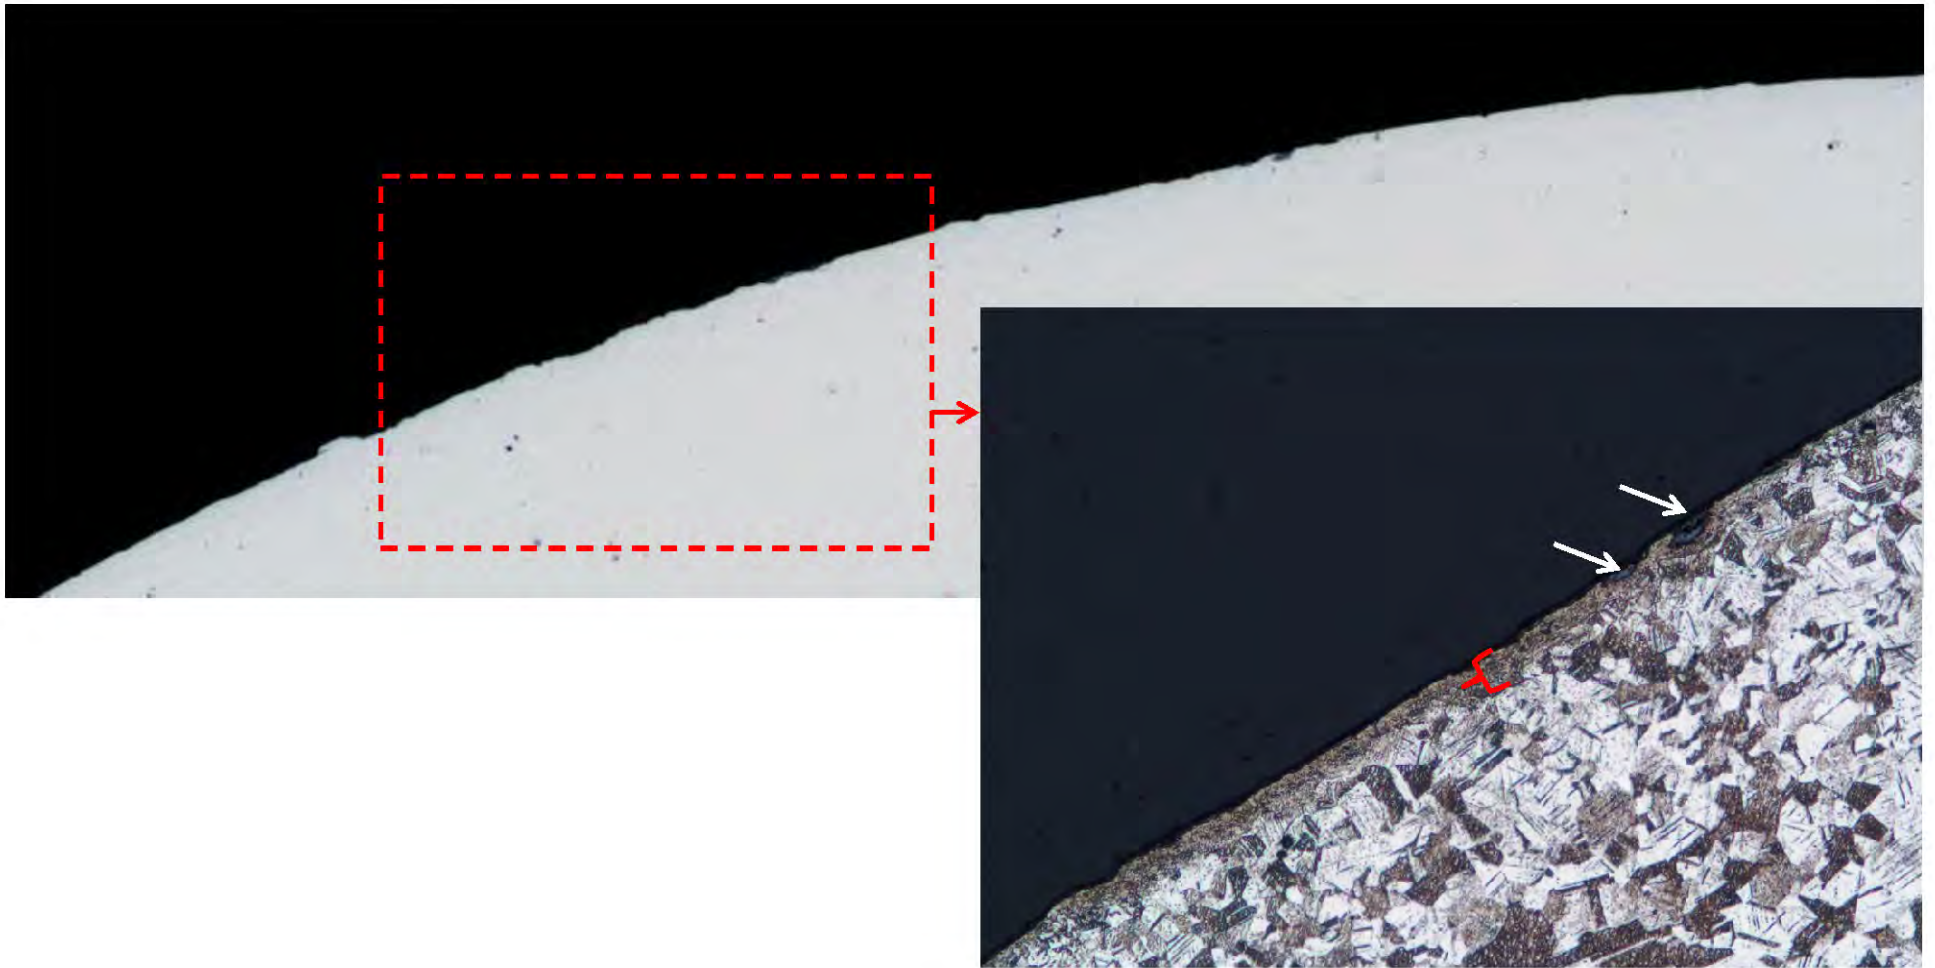
Figure 32. Overall view of the cross-section through the parallel grooves (top) and a detailed view of the representative microstructure at the surface of the grooves (inset). Some oxides were present on the surface (white arrows) and the microstructure was slightly distorted (red brace). Top: Unetched. Inset: Etchant: Stainless No. 2.
