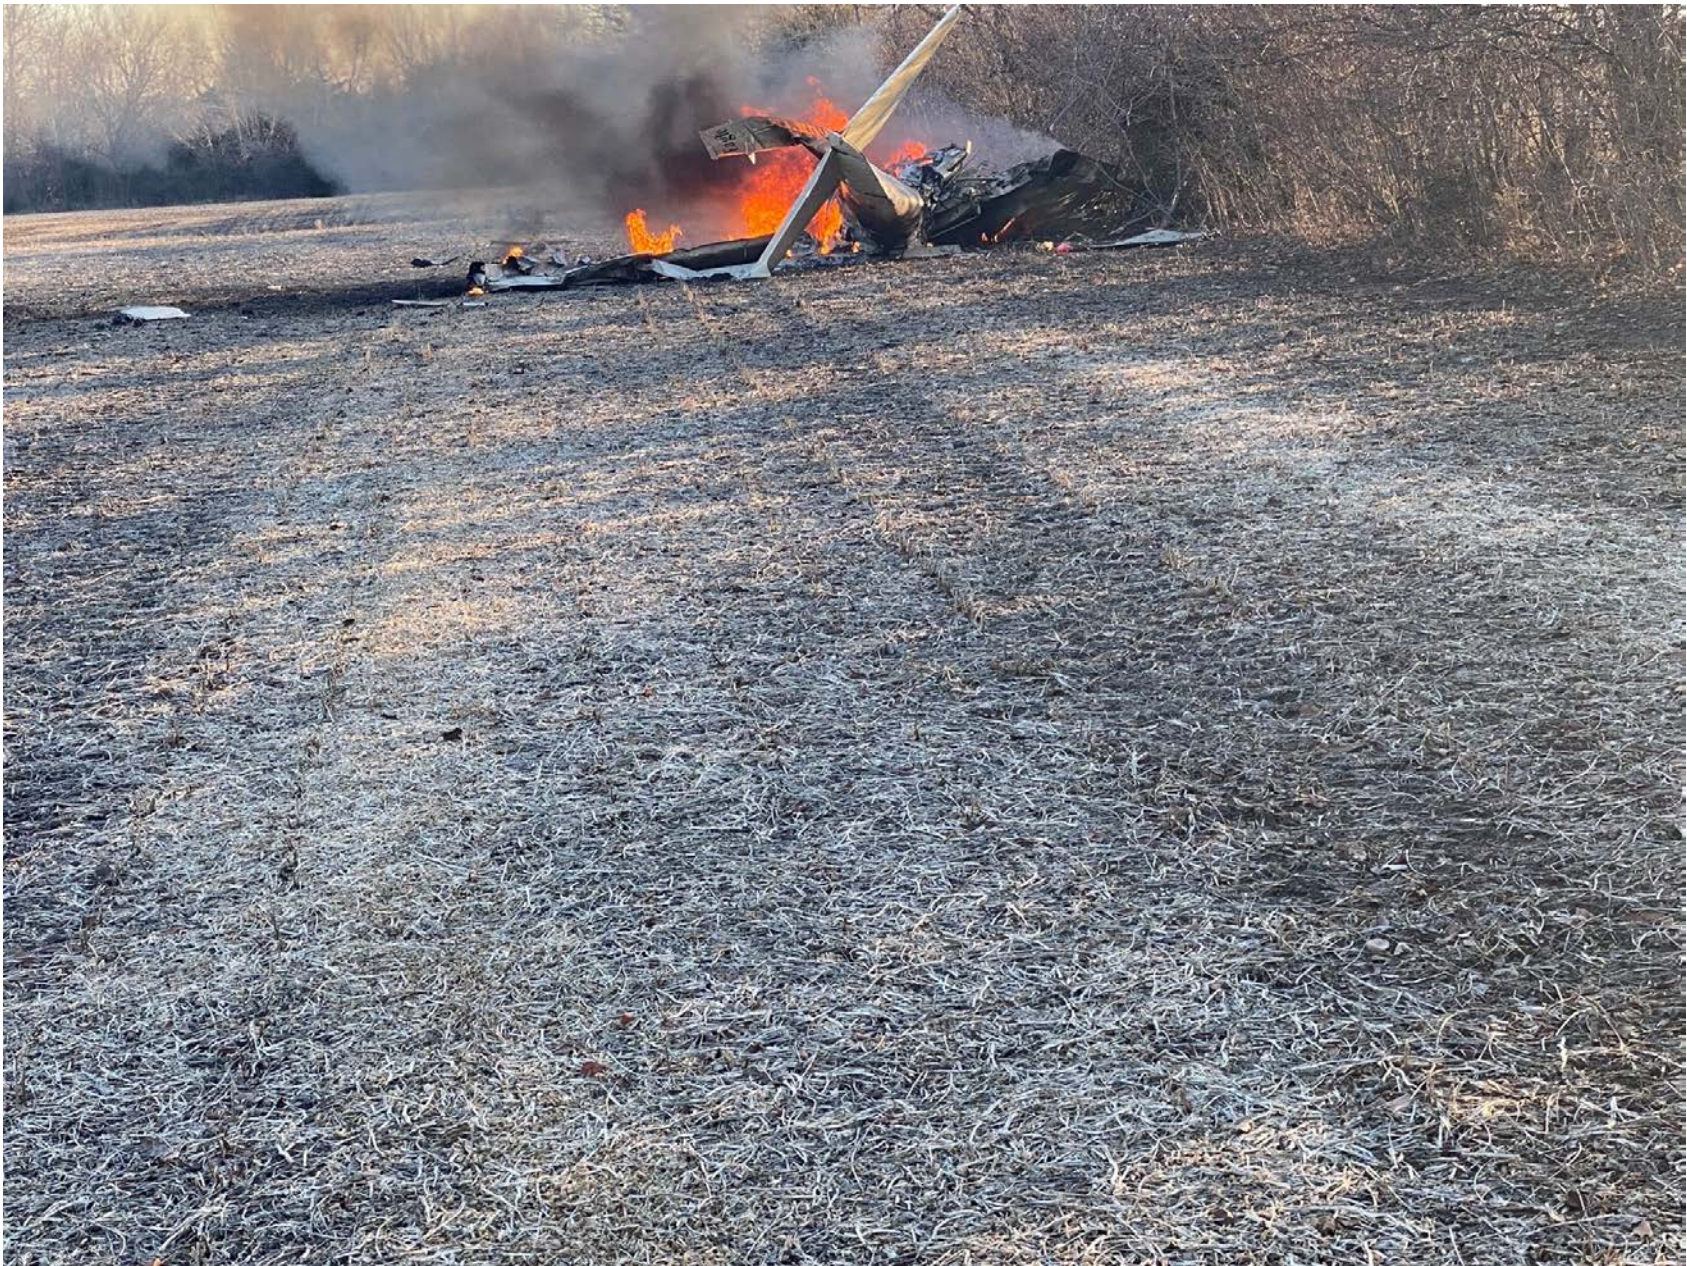
Photo 1 – Supplied photo of the accident site.

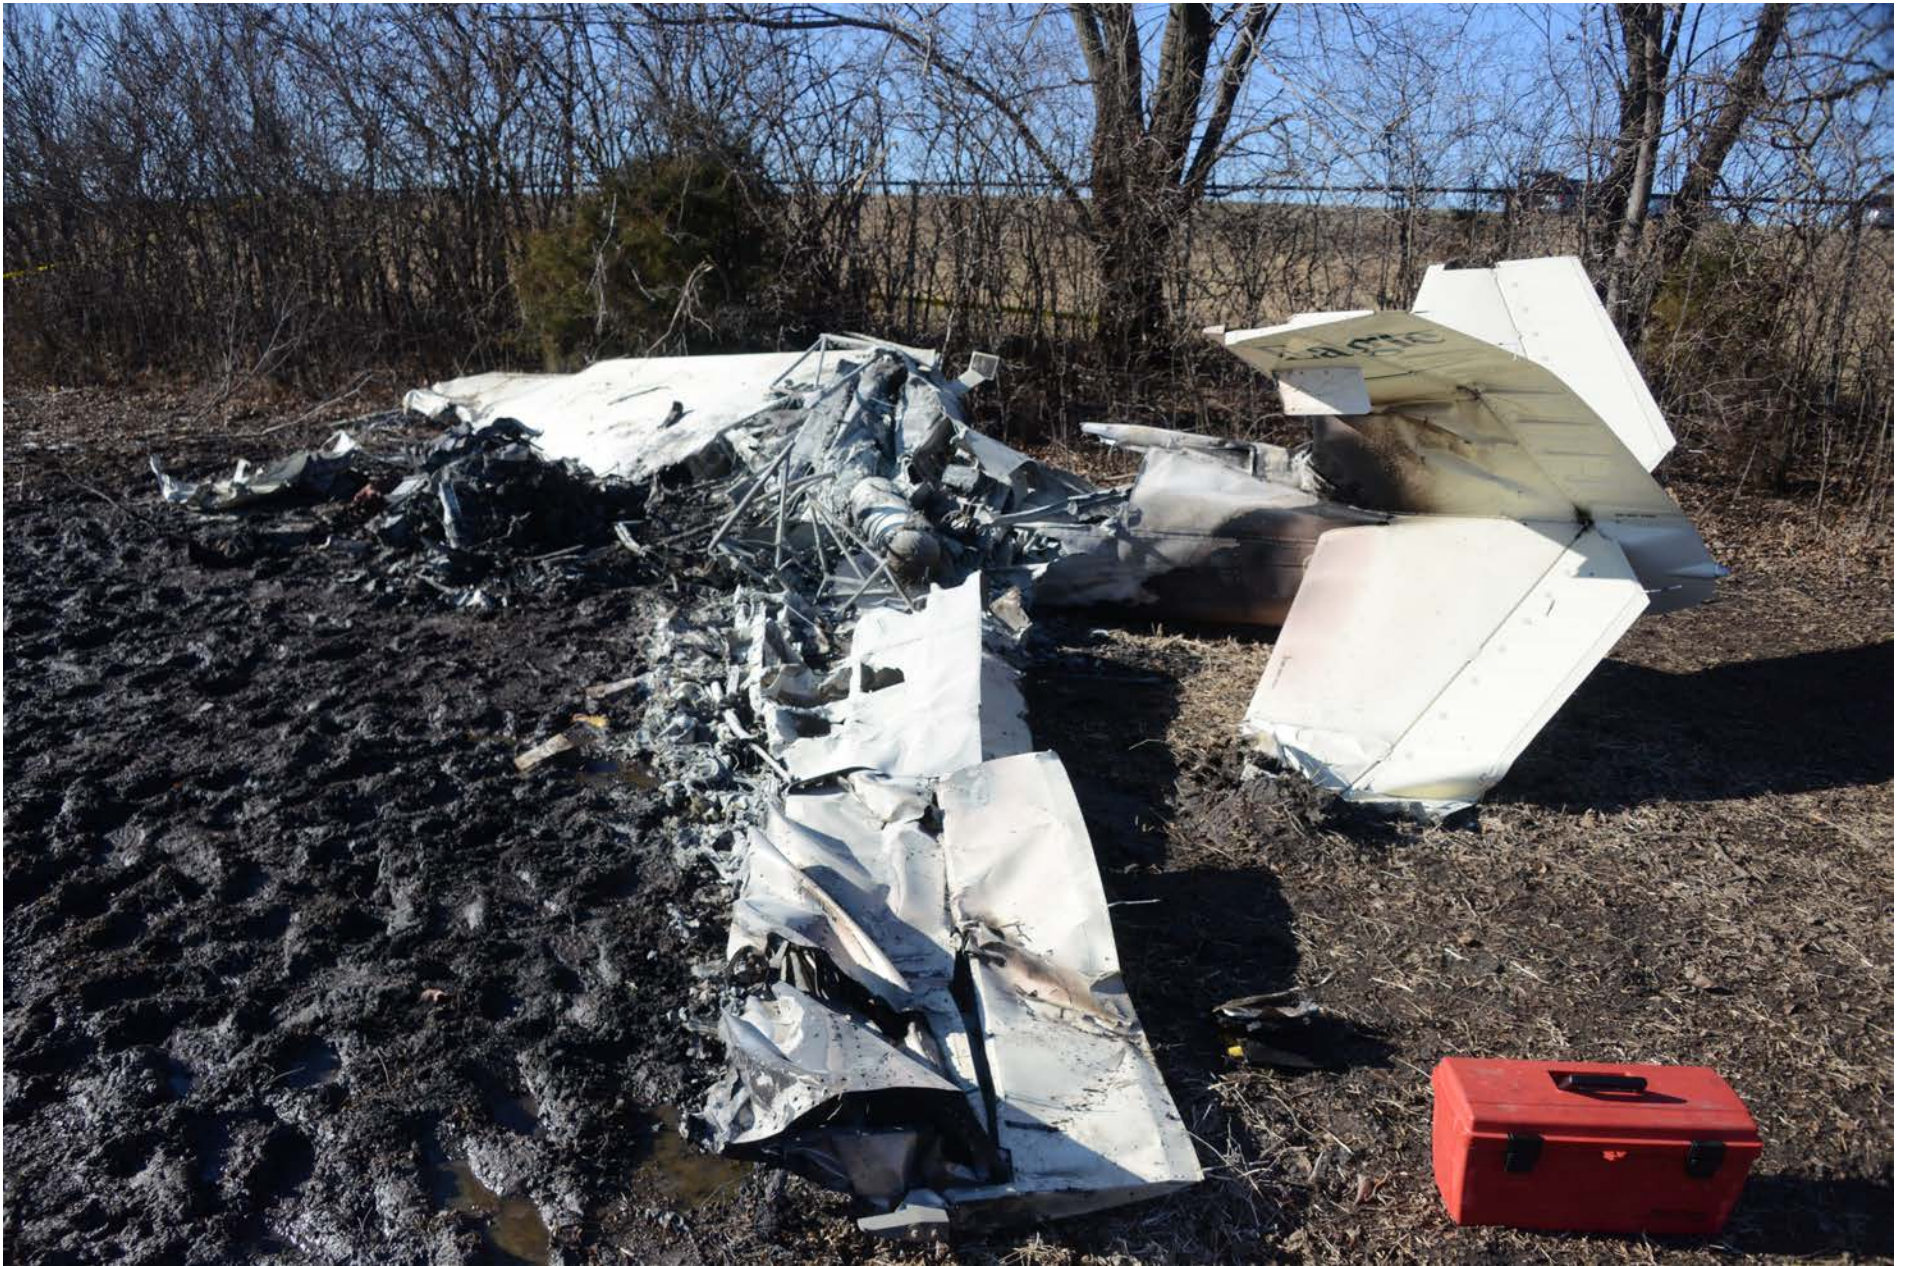
Photo 2 - View of the left side of the airplane at the accident site.

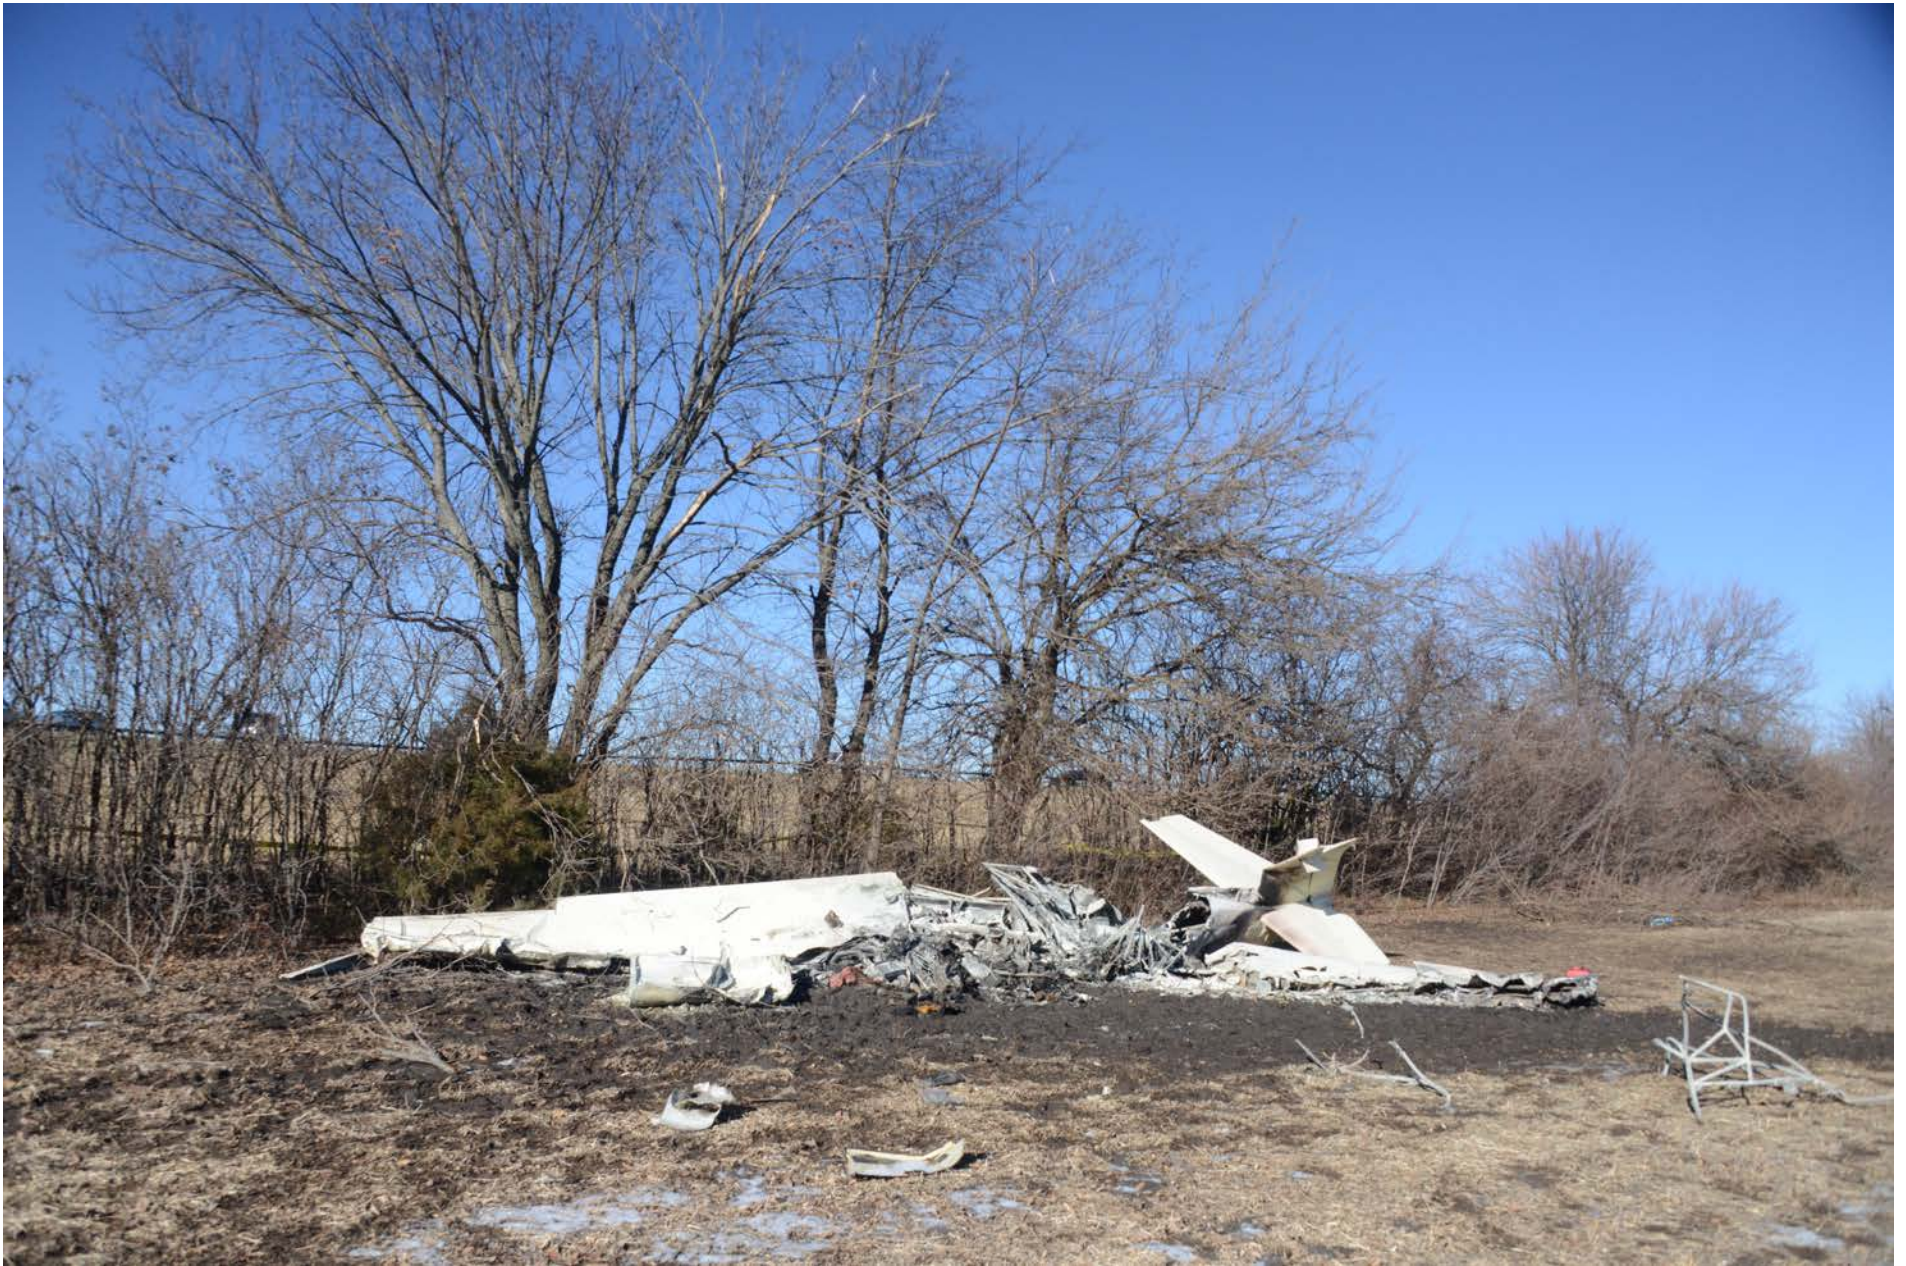
Photo 3 - View of the front side of the airplane at the accident site. Broken branches are present on the tree in the background.

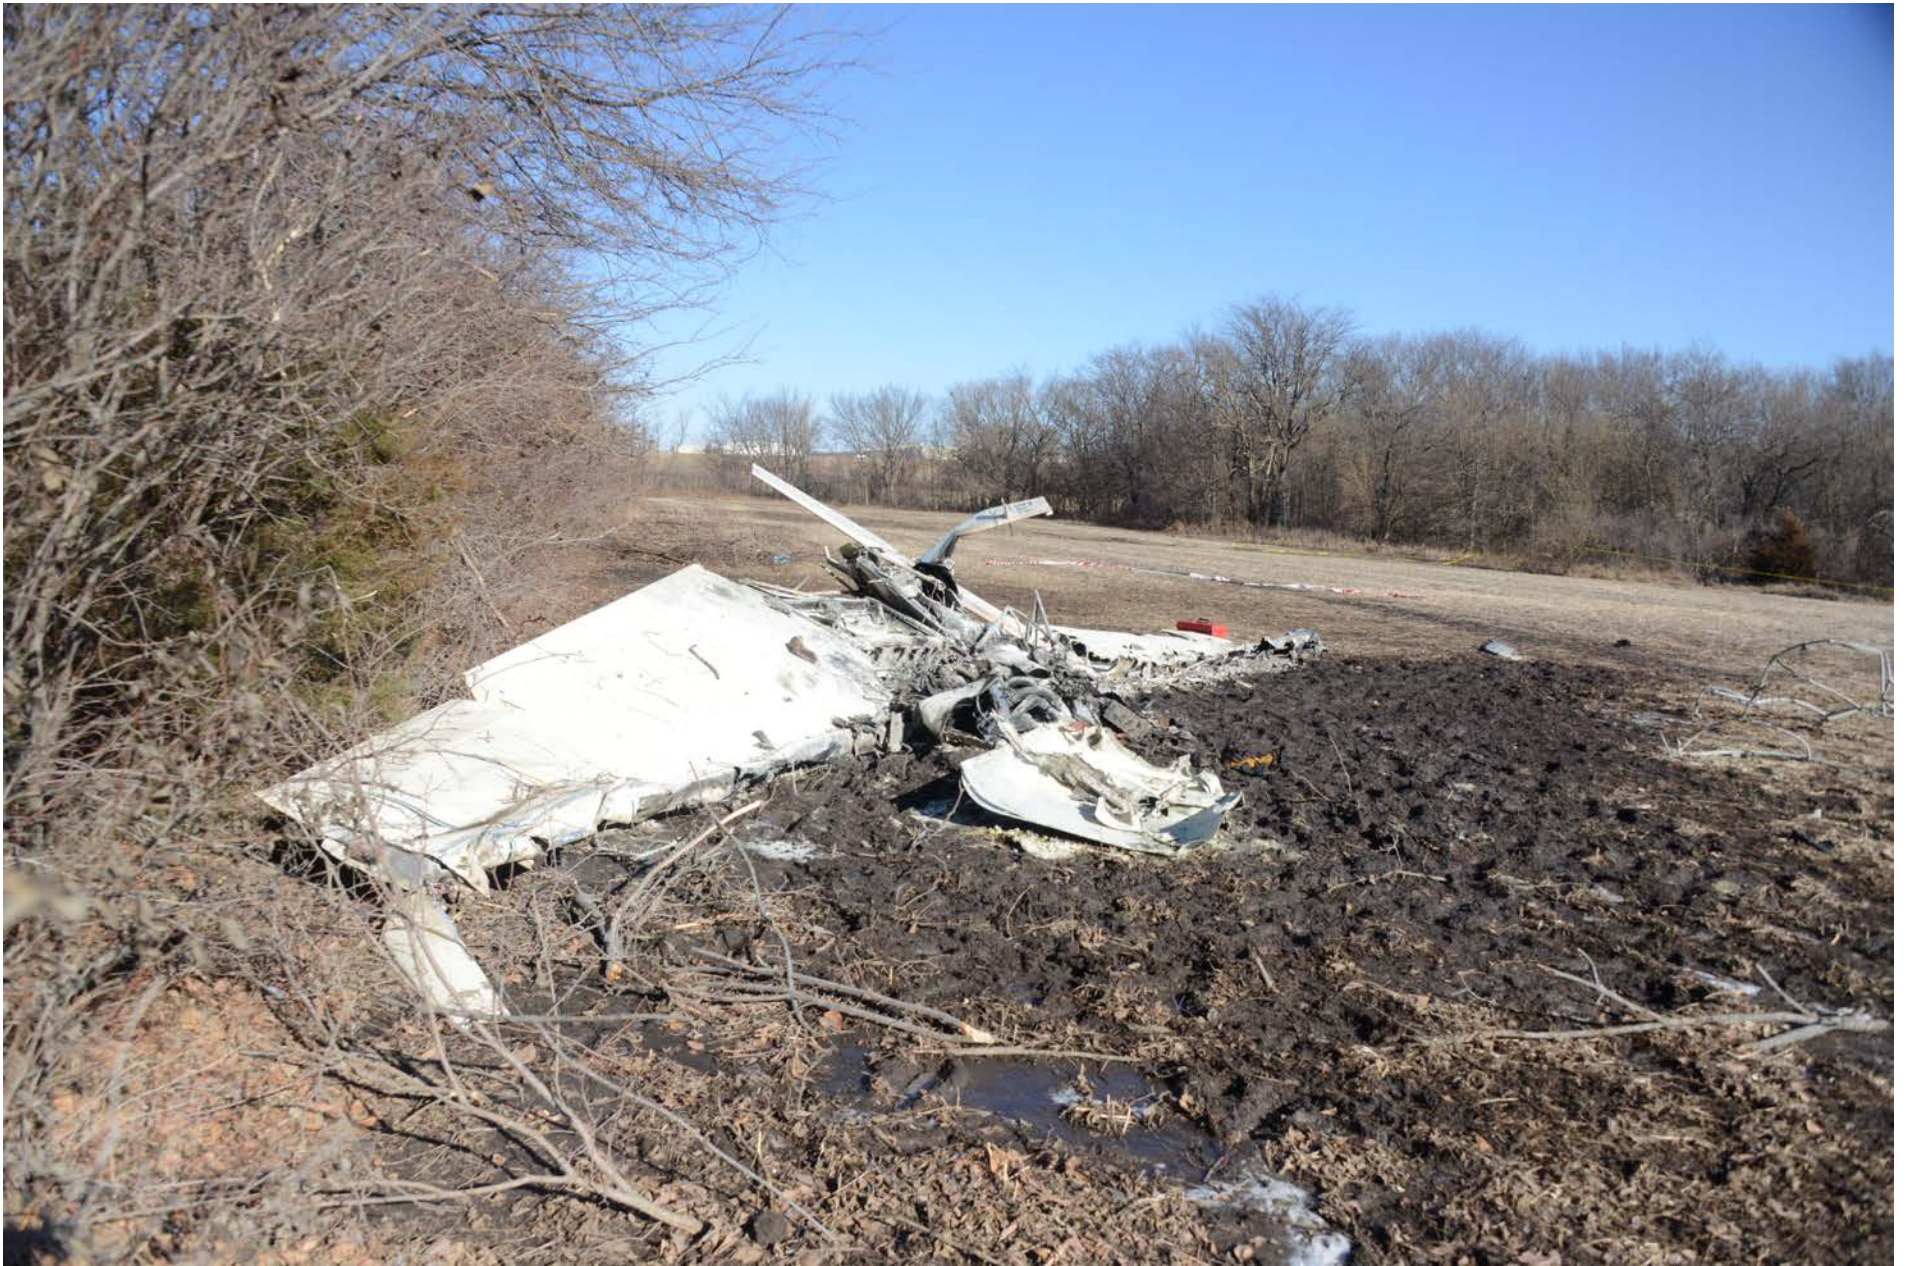
Photo 4 - View of the right side of the airplane at the accident site.

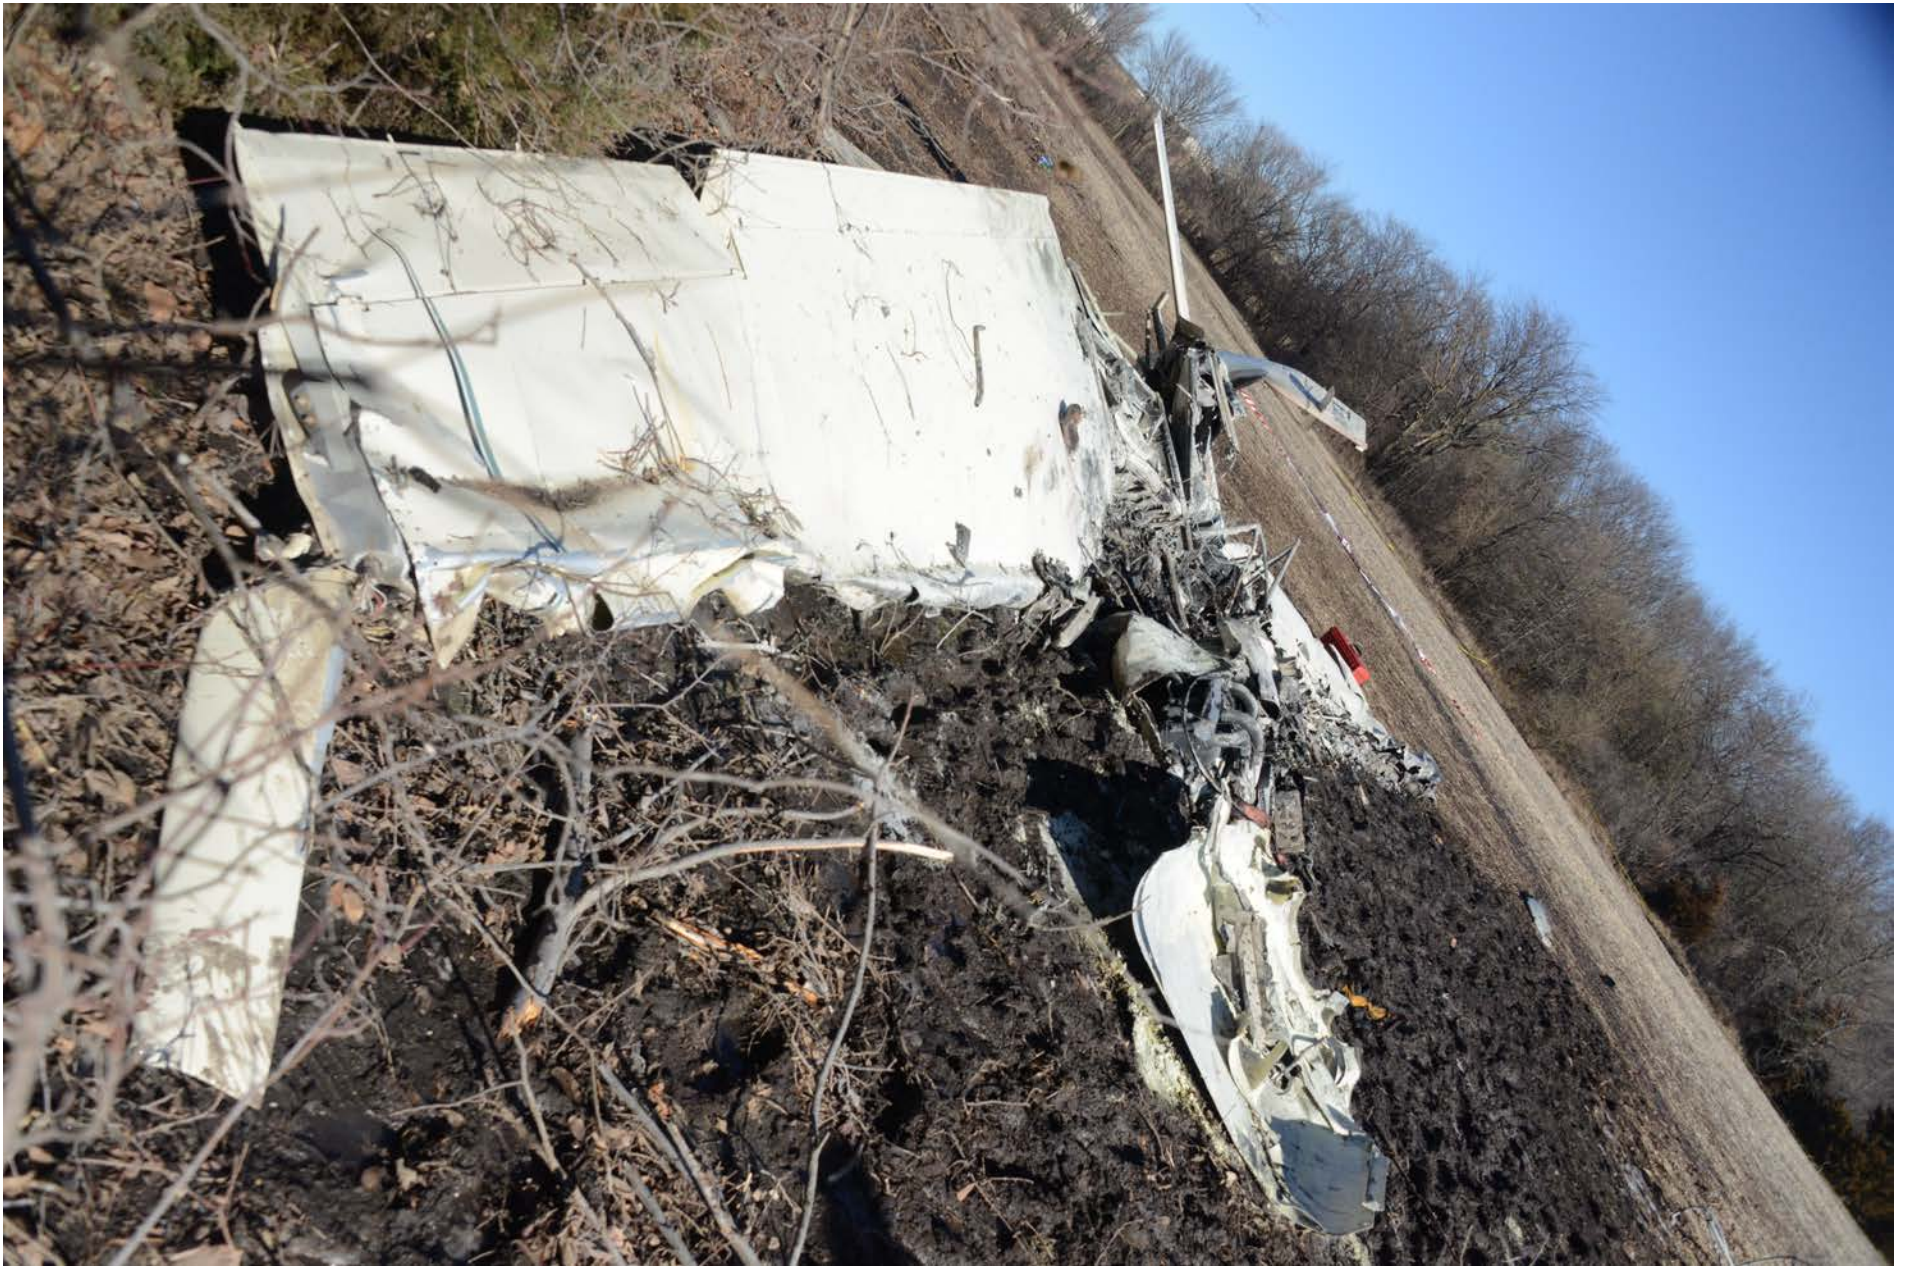
Photo 5 - Close up view of the right side of the airplane at the accident site.

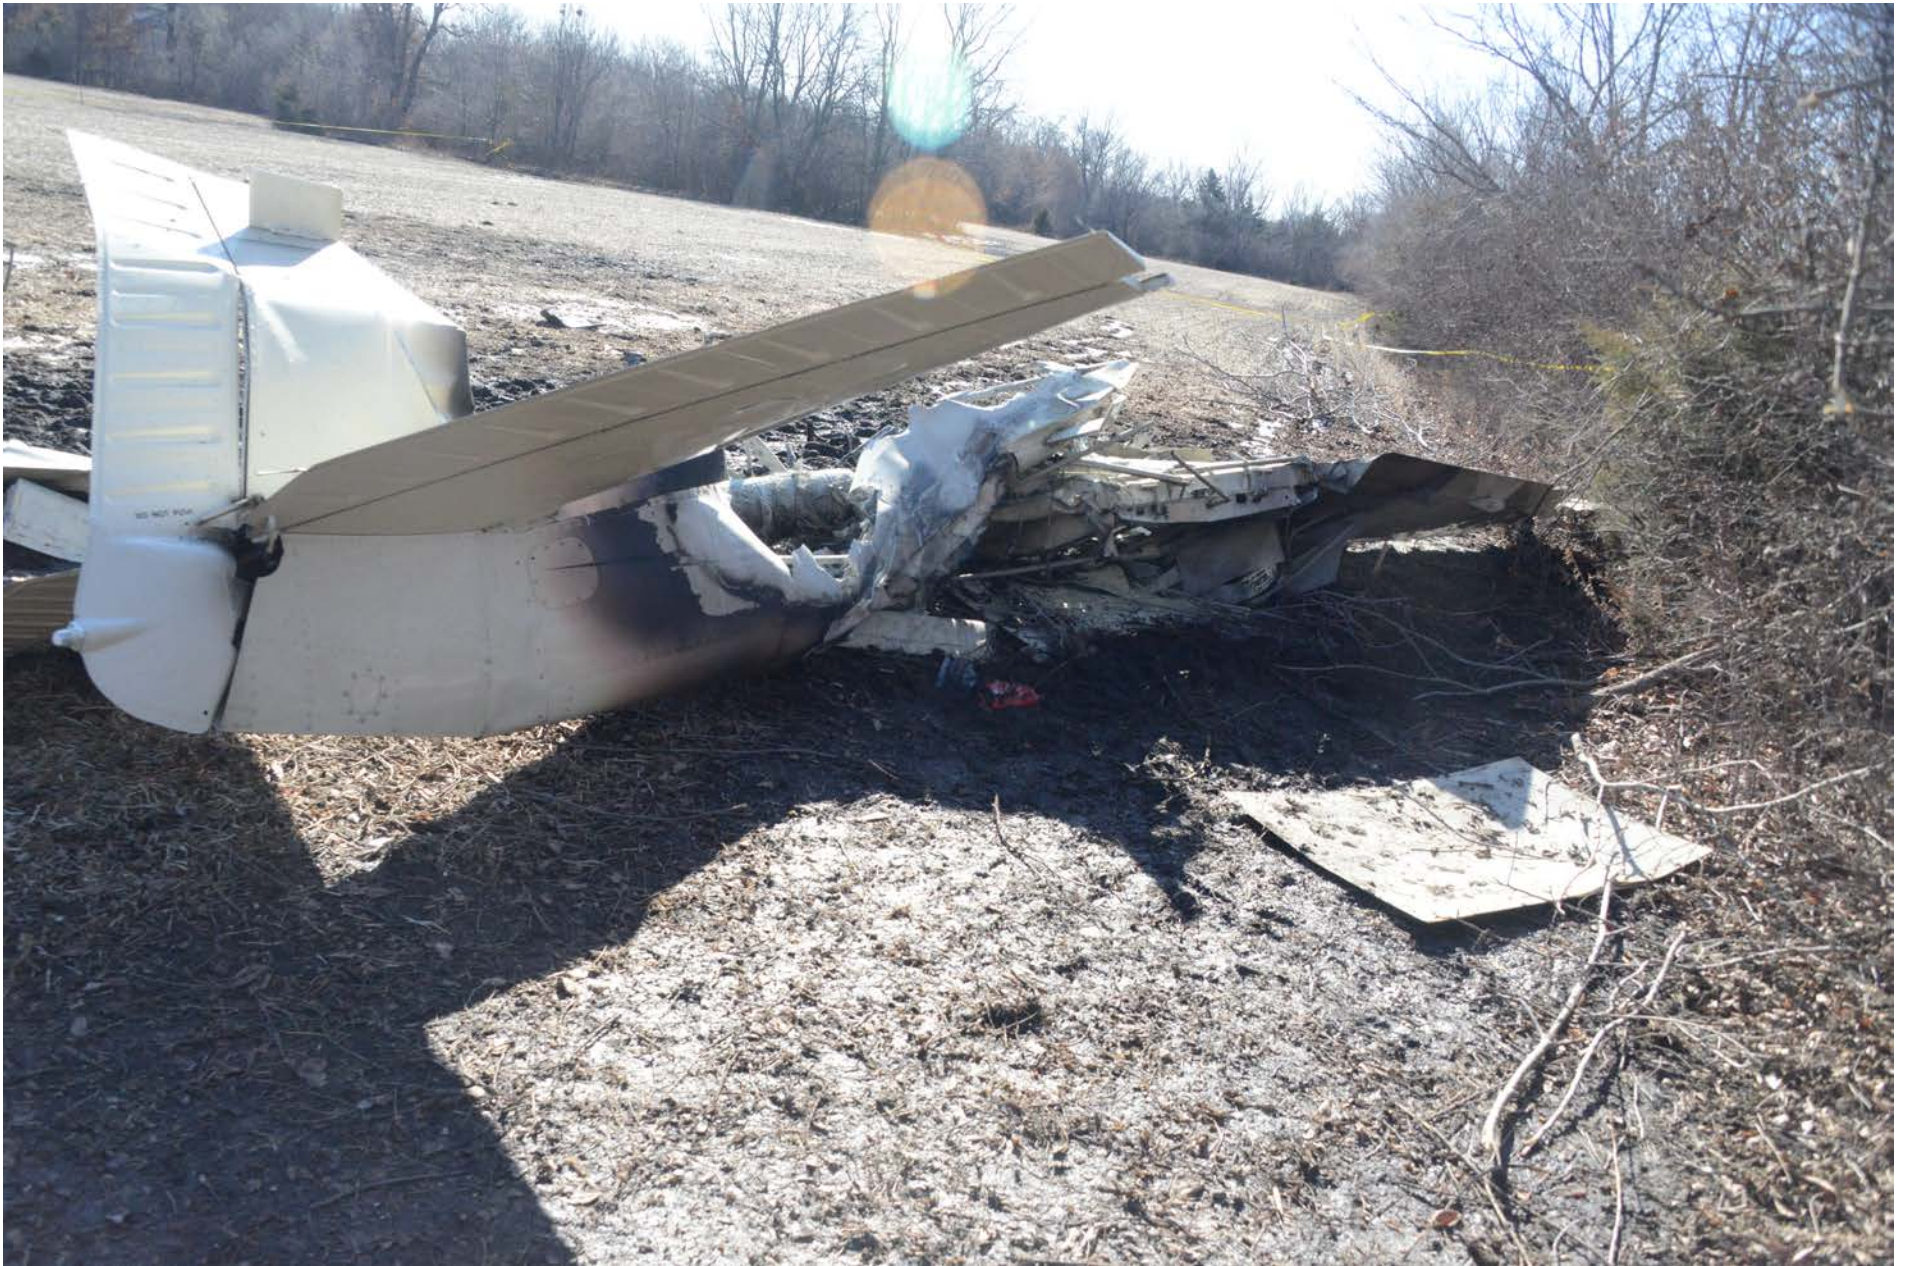
Photo 6 - View of the right rear side of the airplane at the accident site.

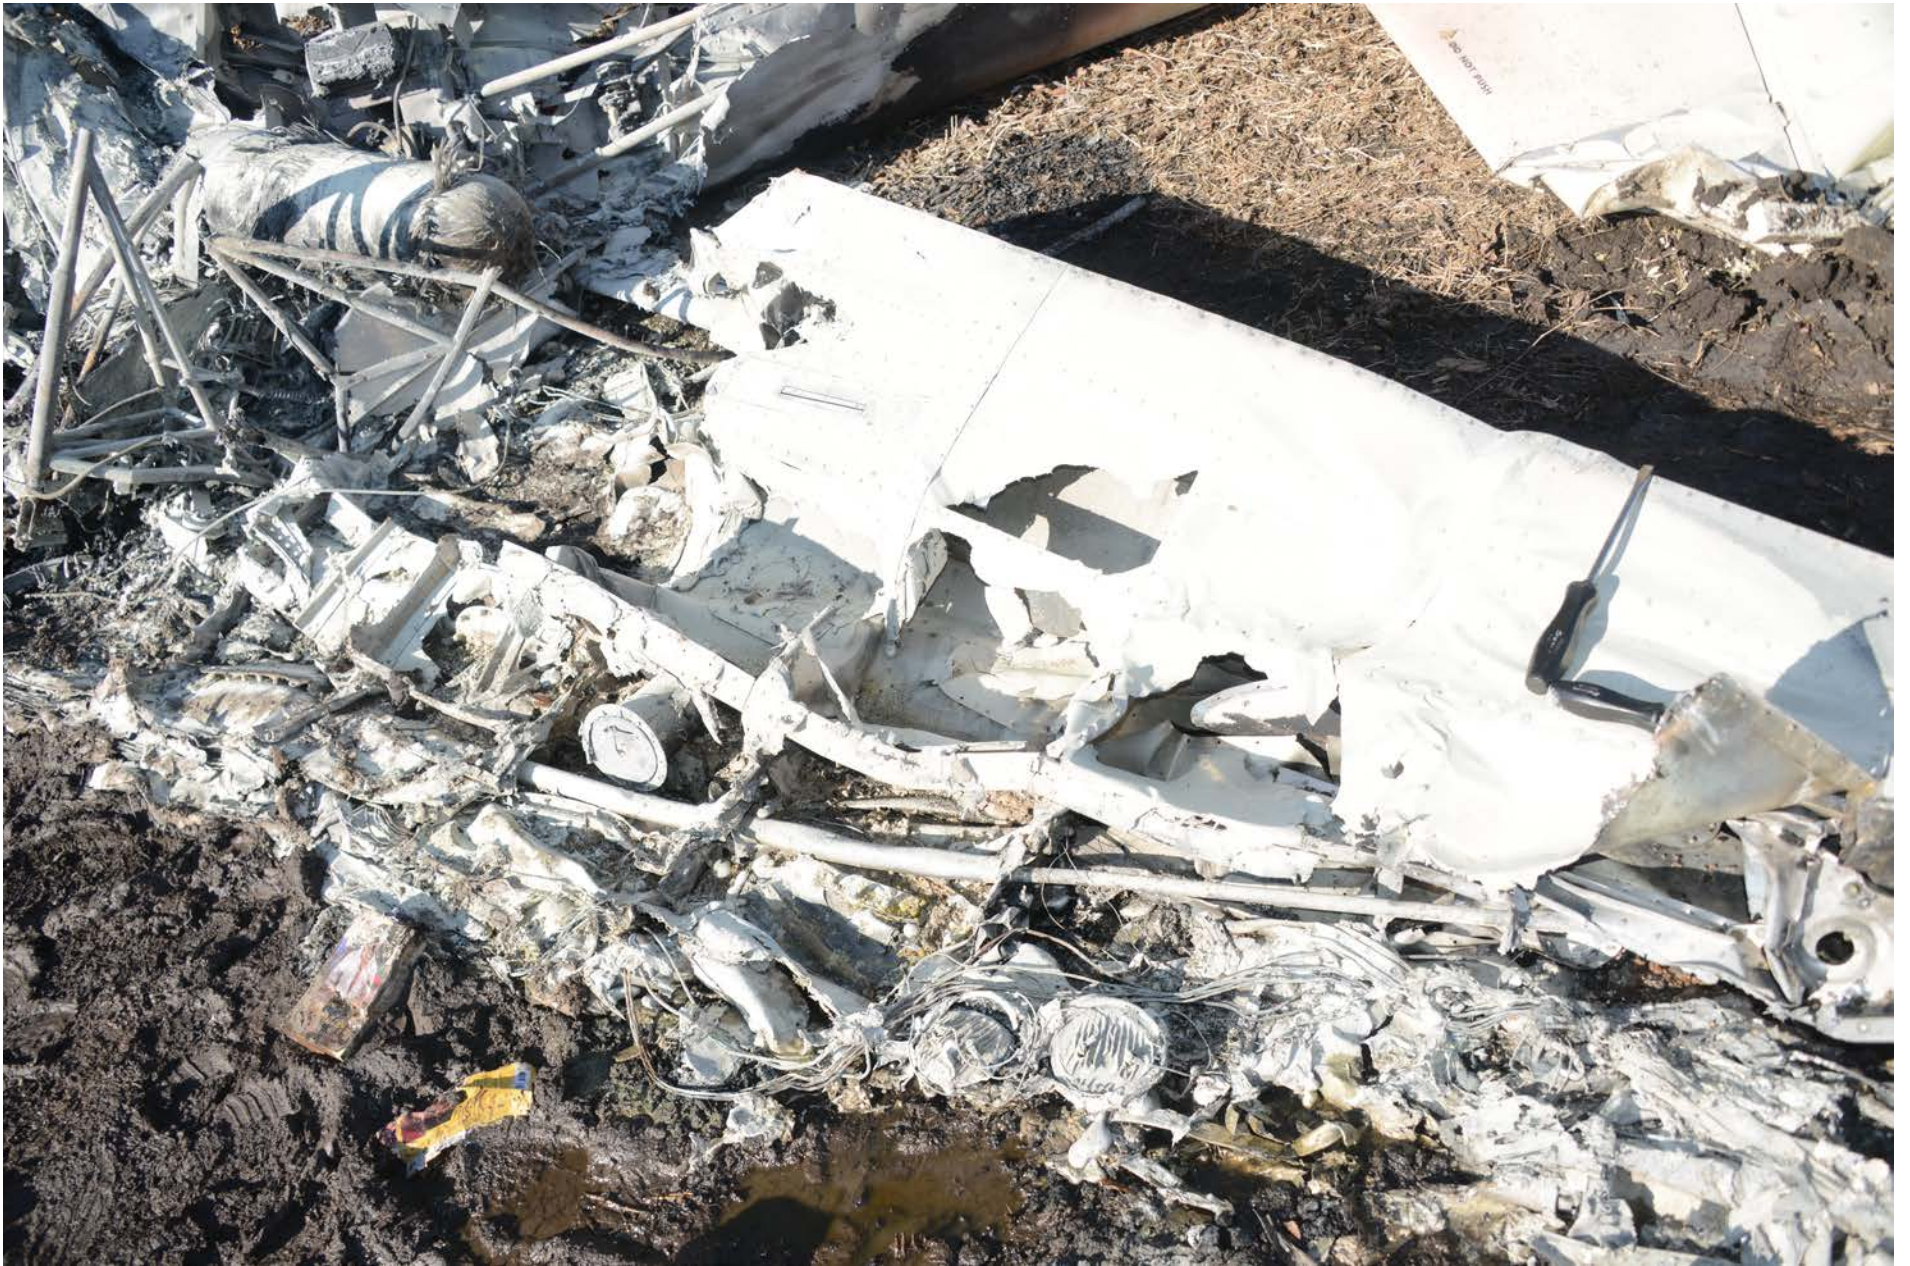
Photo 7 - Close up view of the inboard left wing.

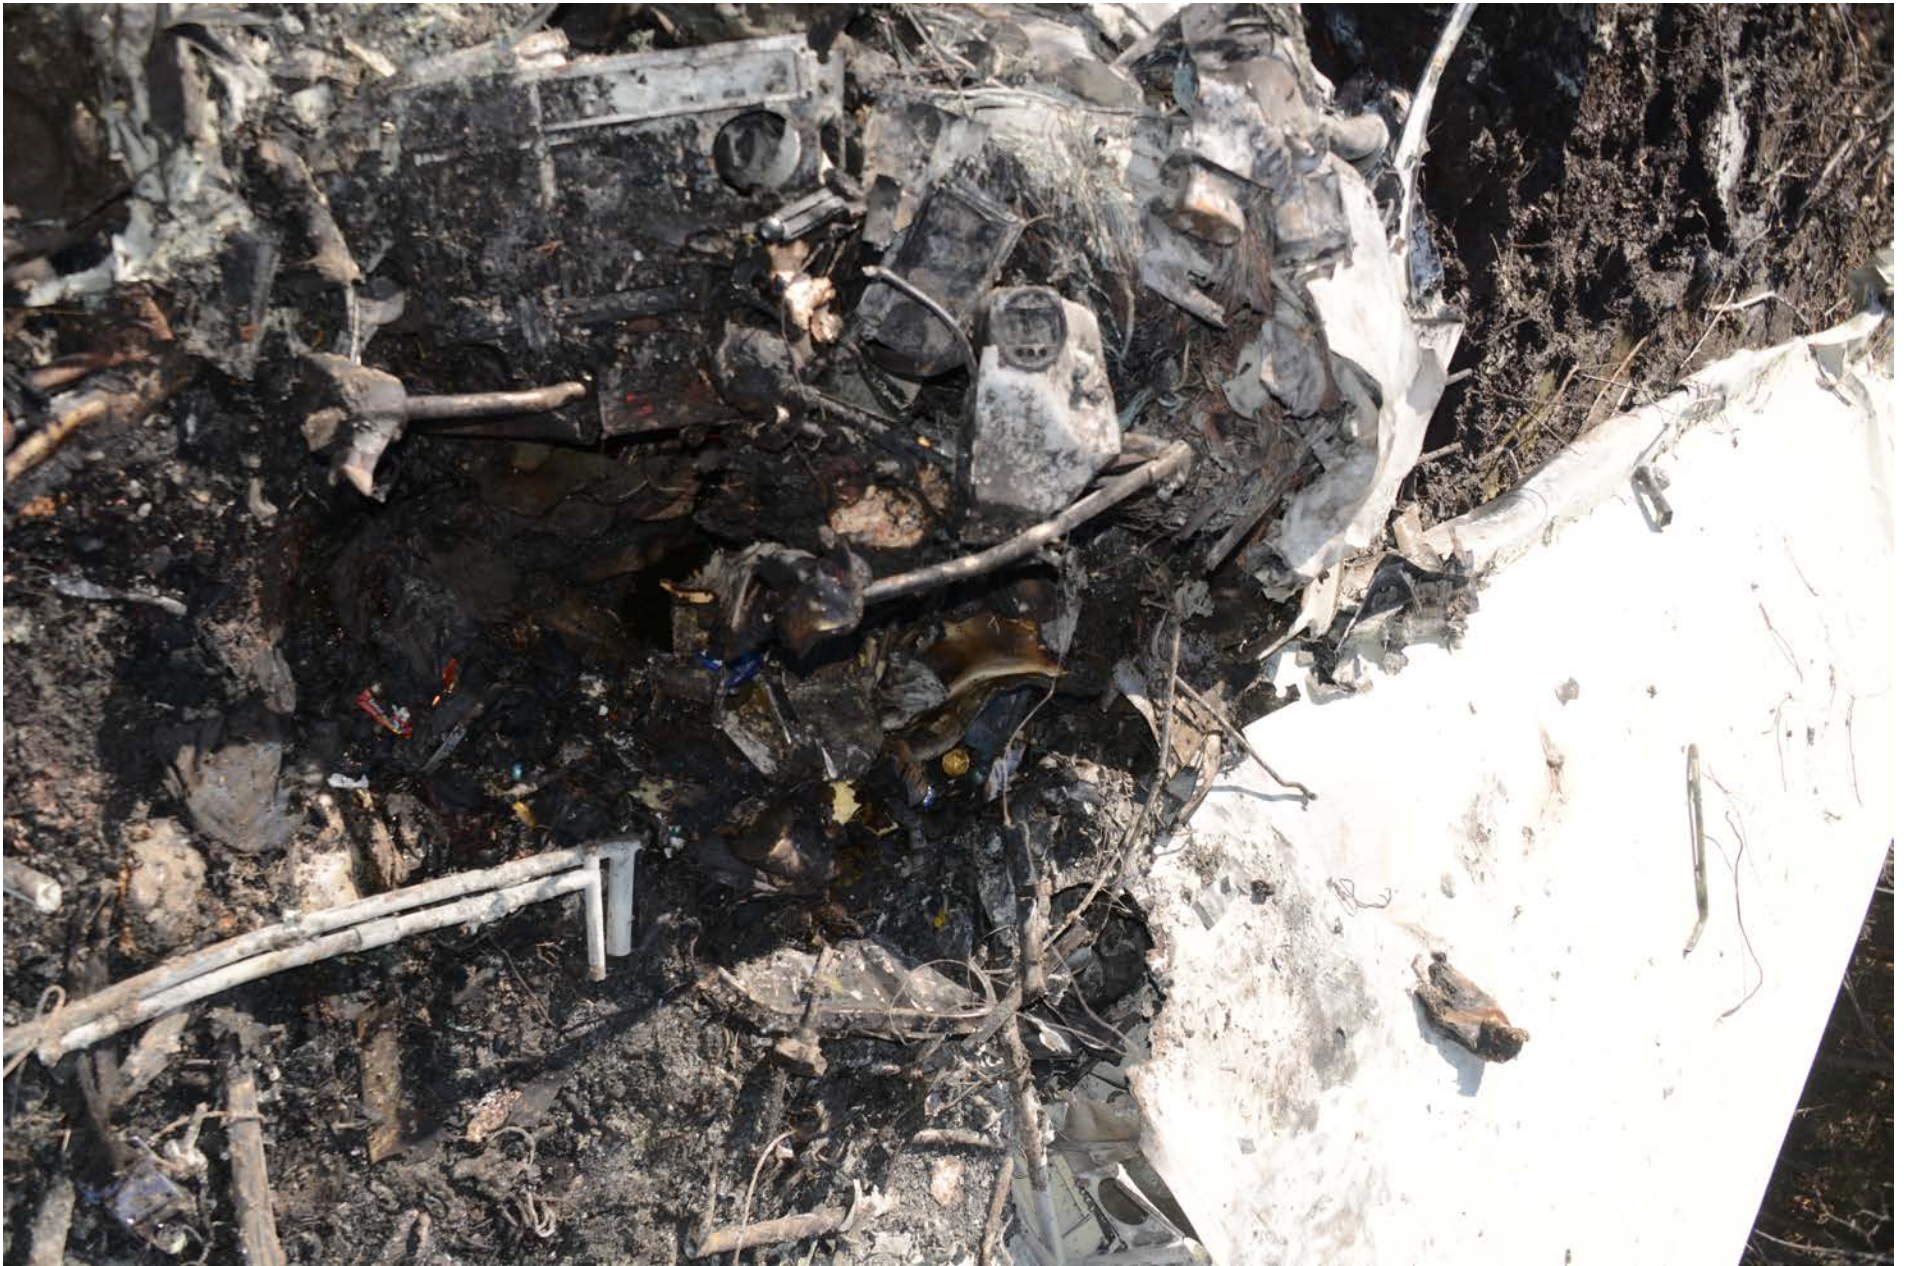
Photo 8 - View of the cabin area.

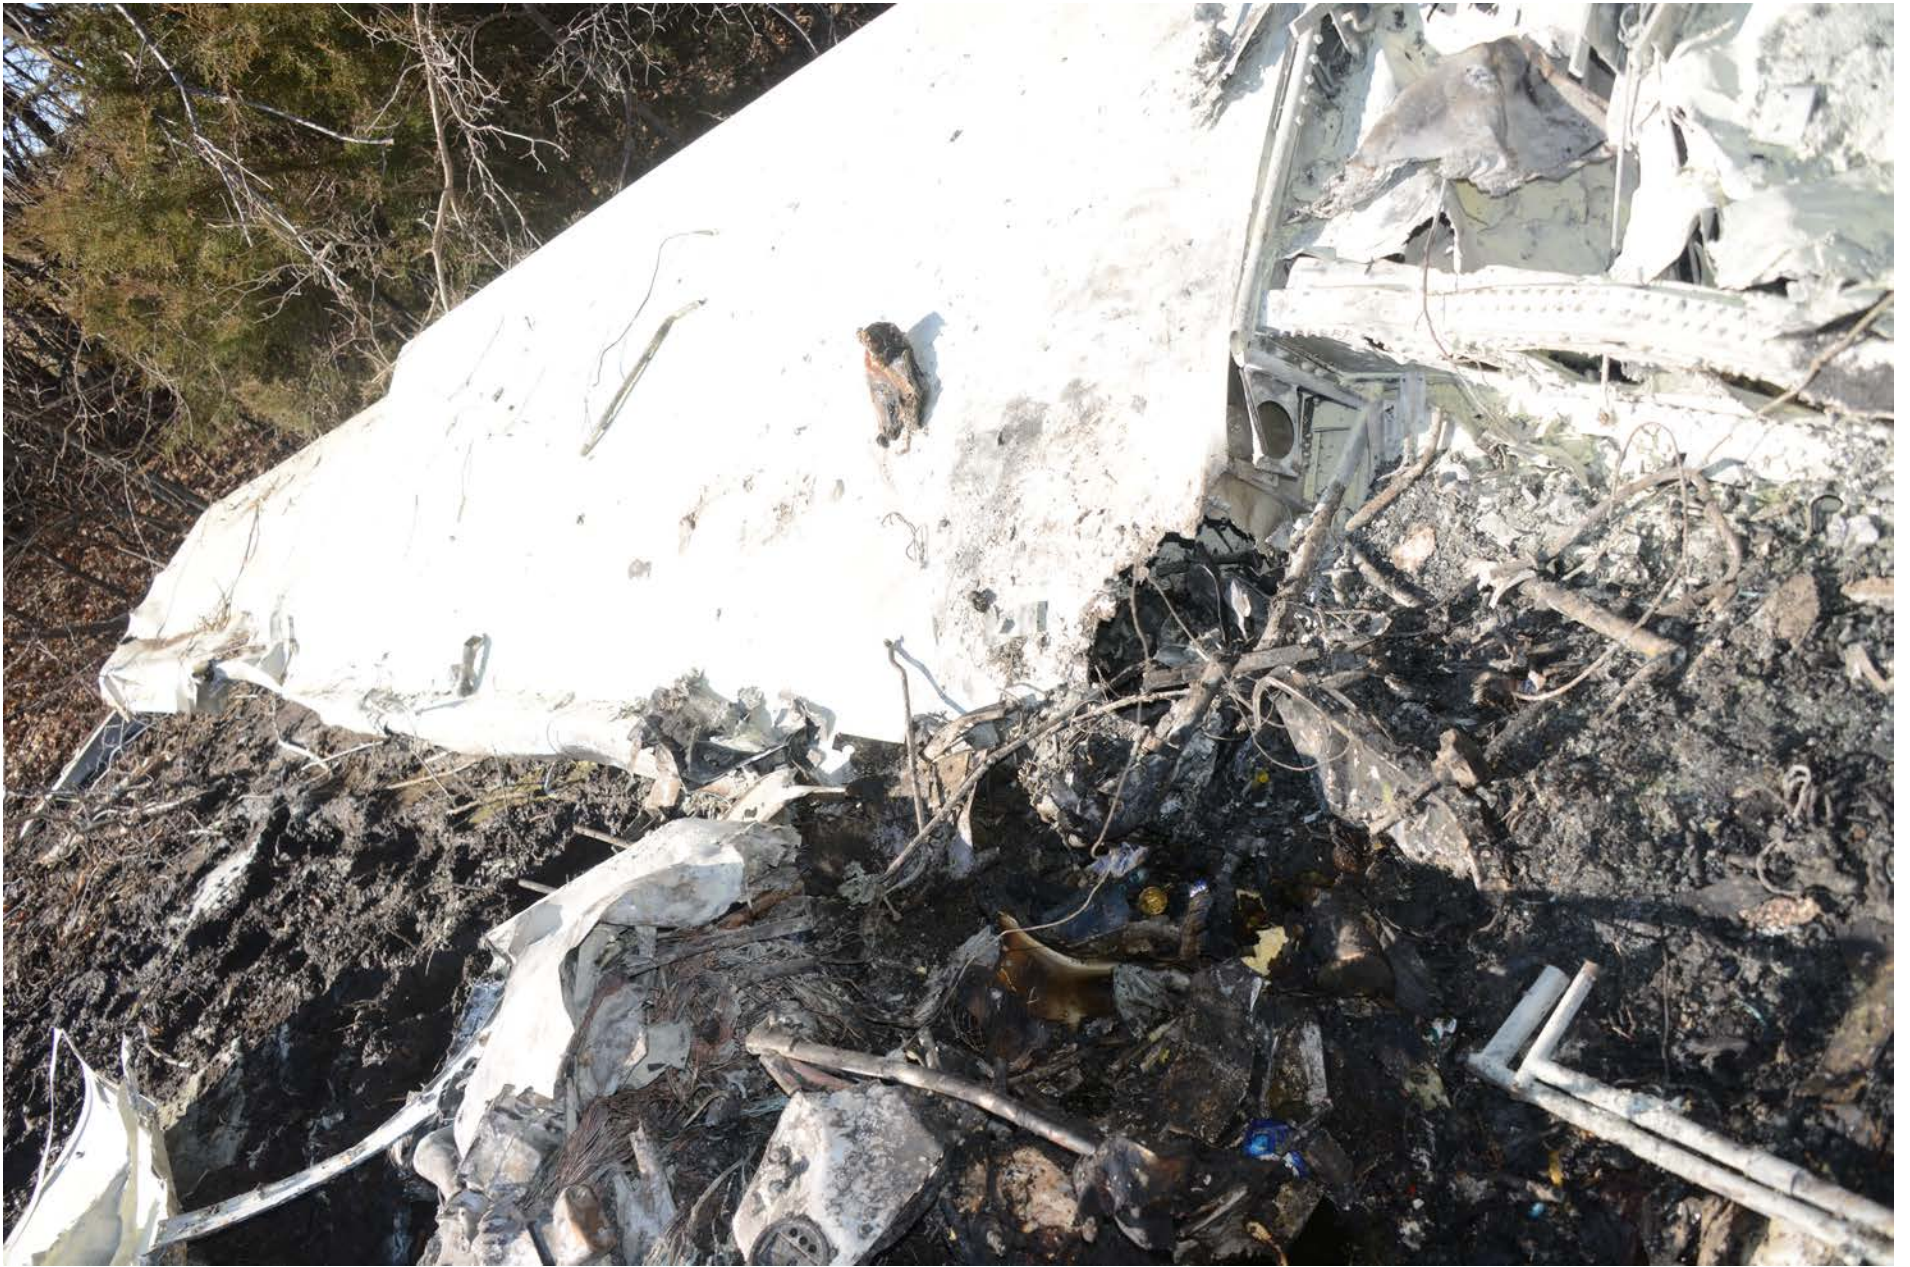
Photo 9 - Close up view of the inboard right wing.
