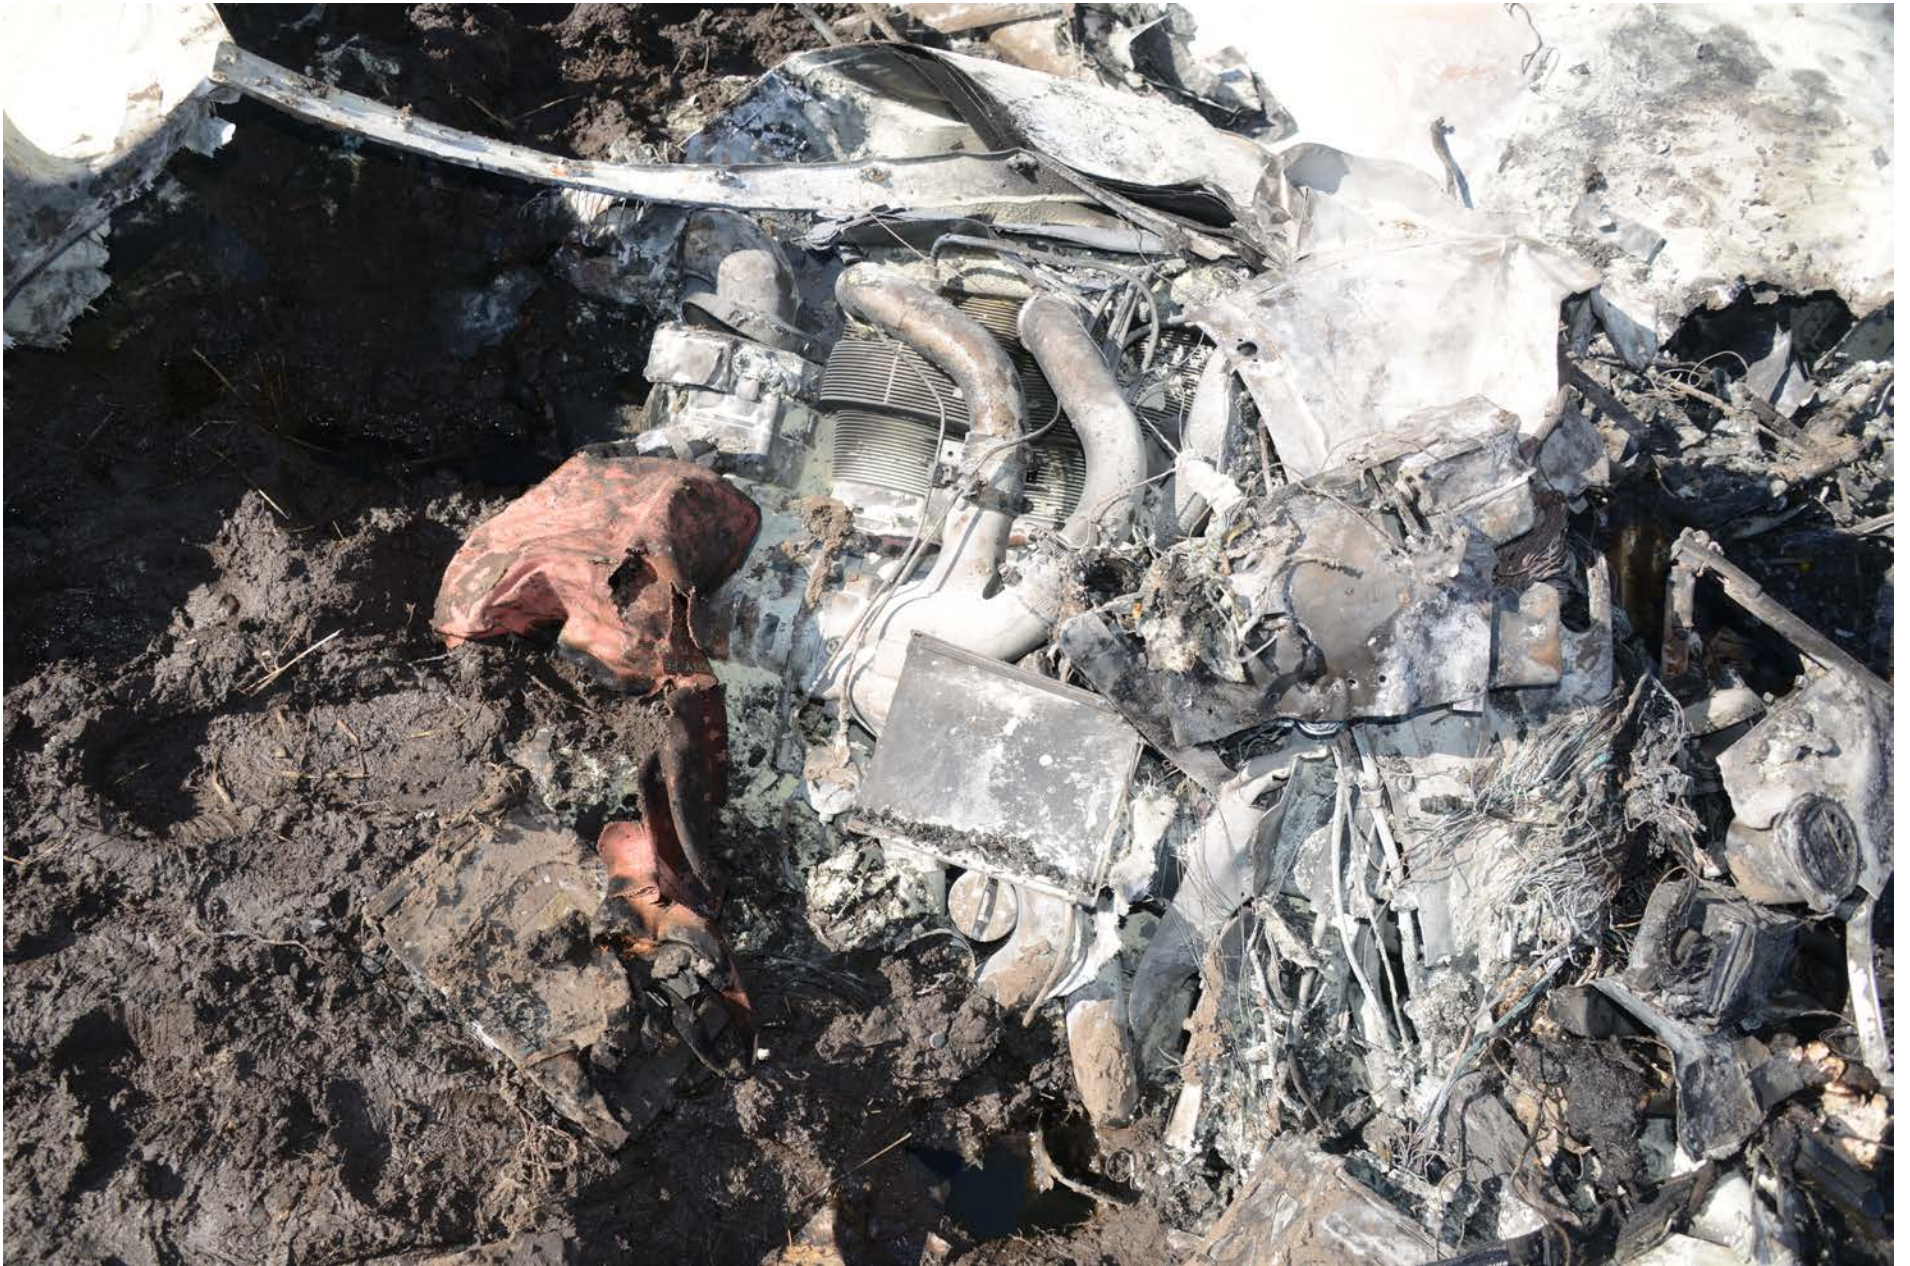
Photo 10 - Close up view of the engine embedded in terrain.

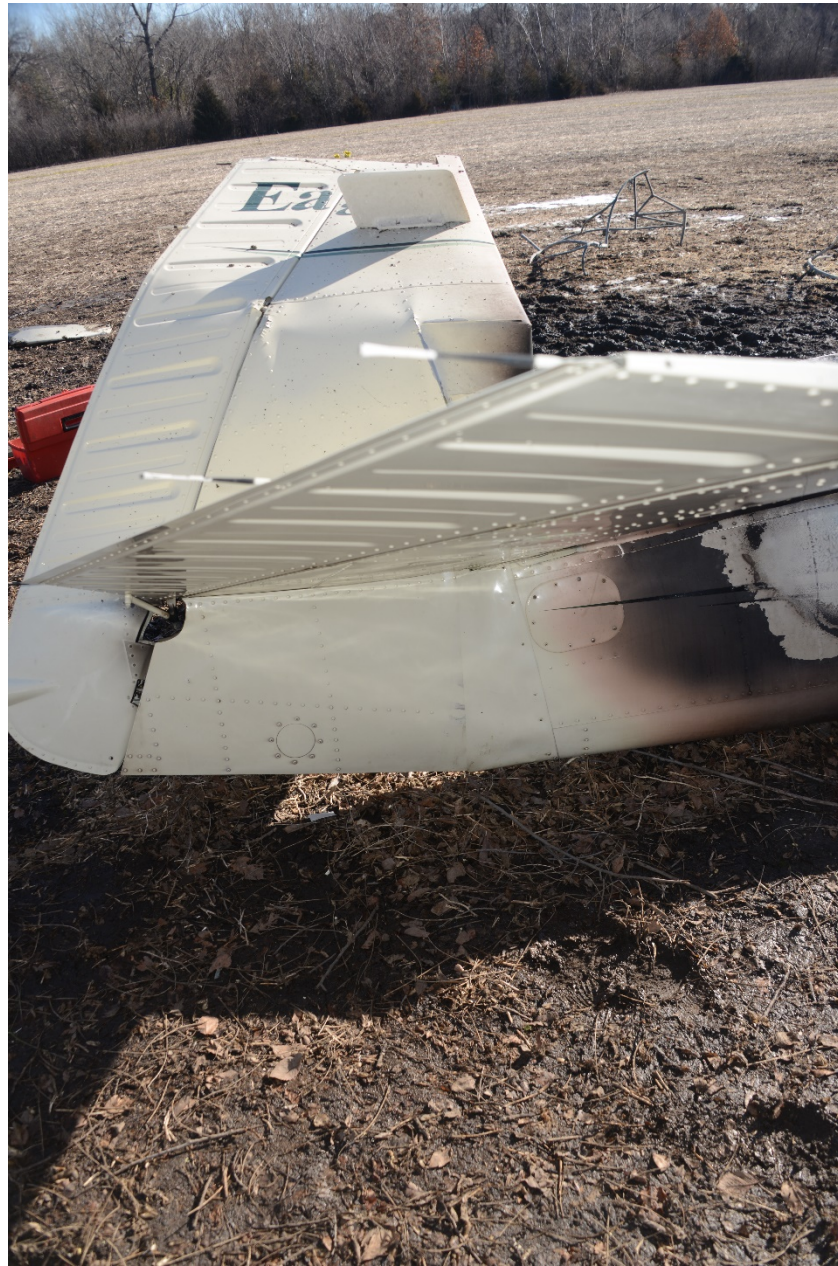
Photo 11 - Close up view of the right rear empennage.

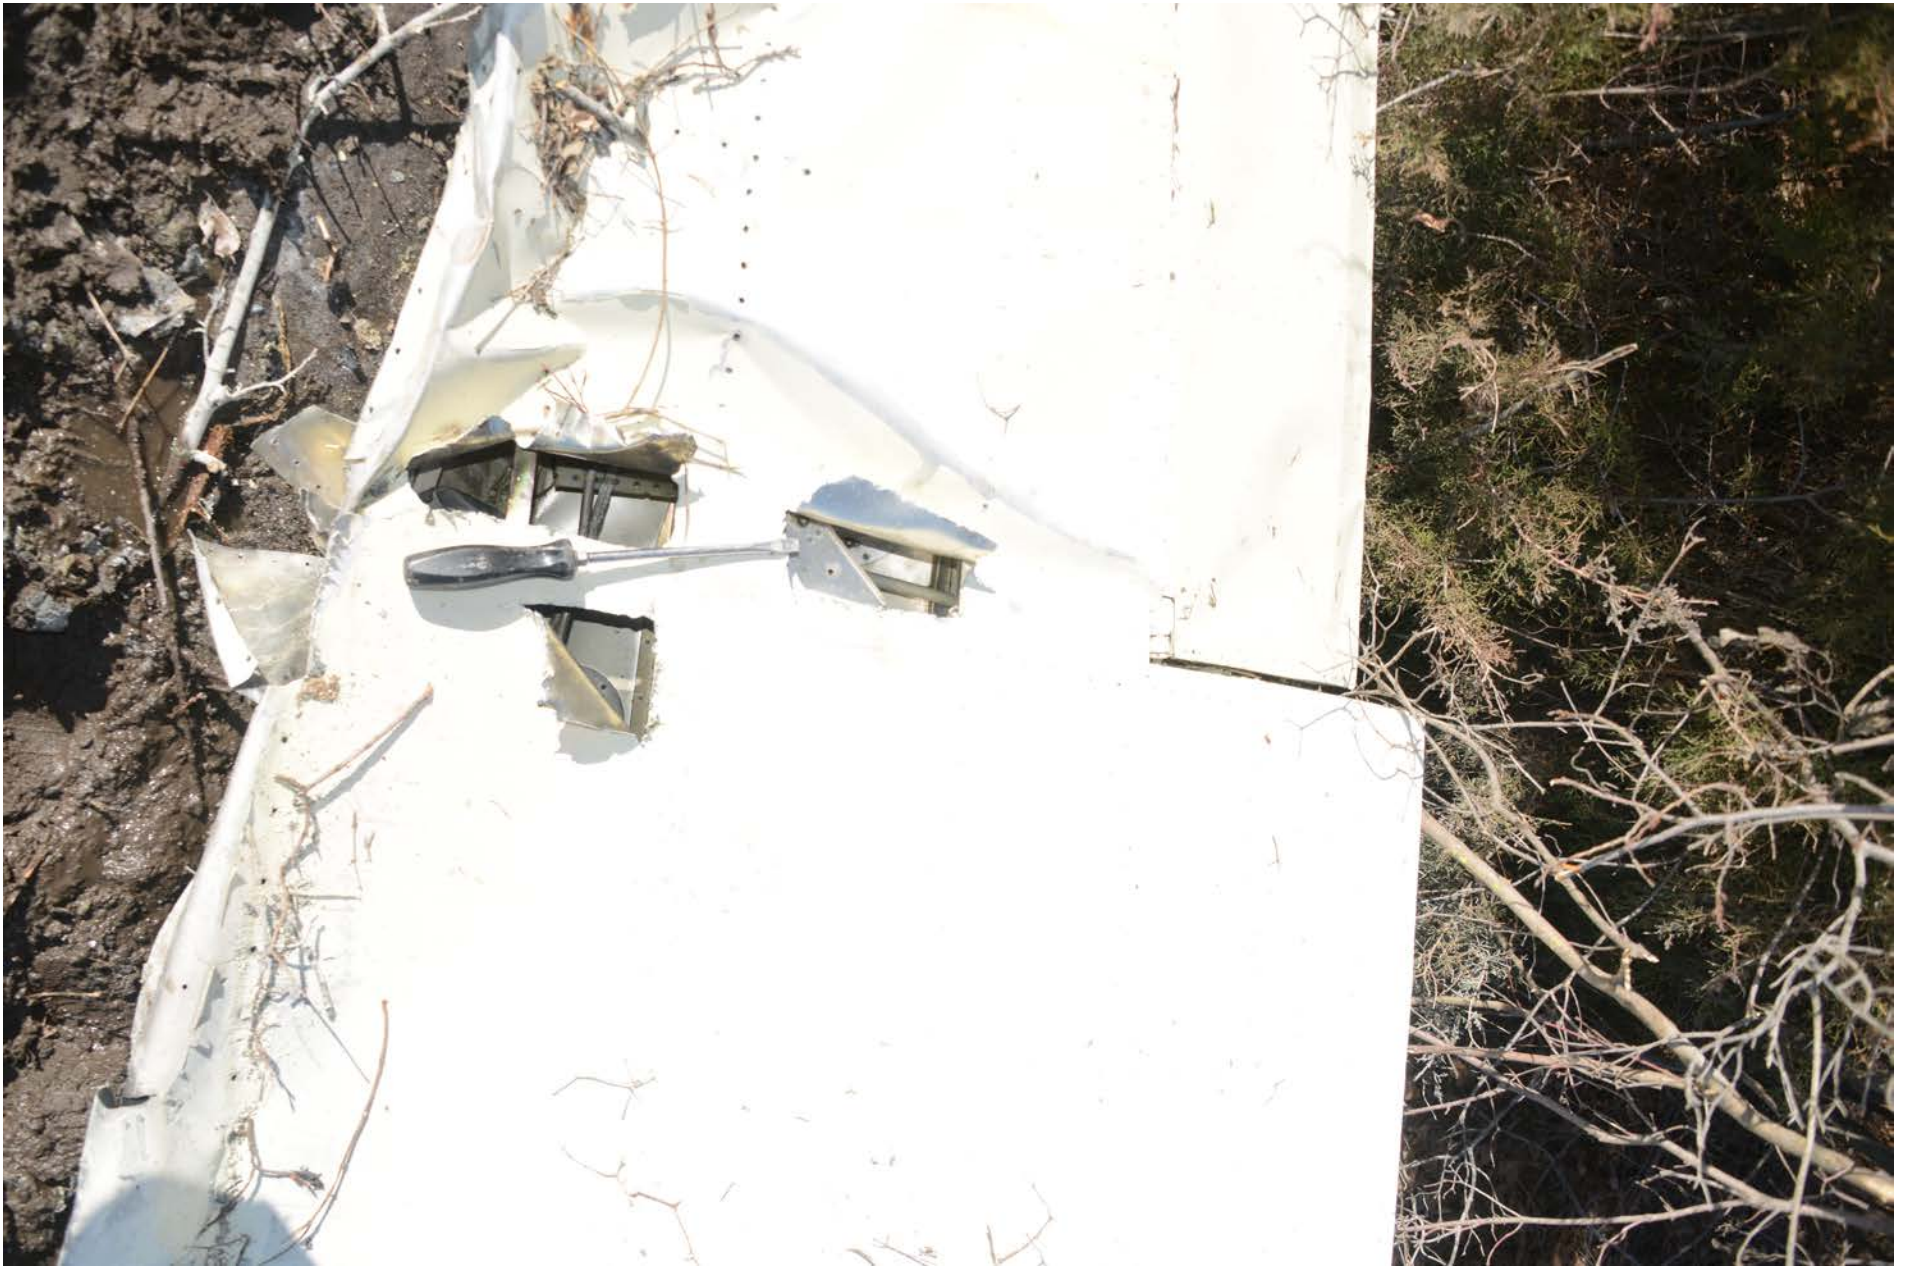
Photo 12 - Close up view of the right wing.

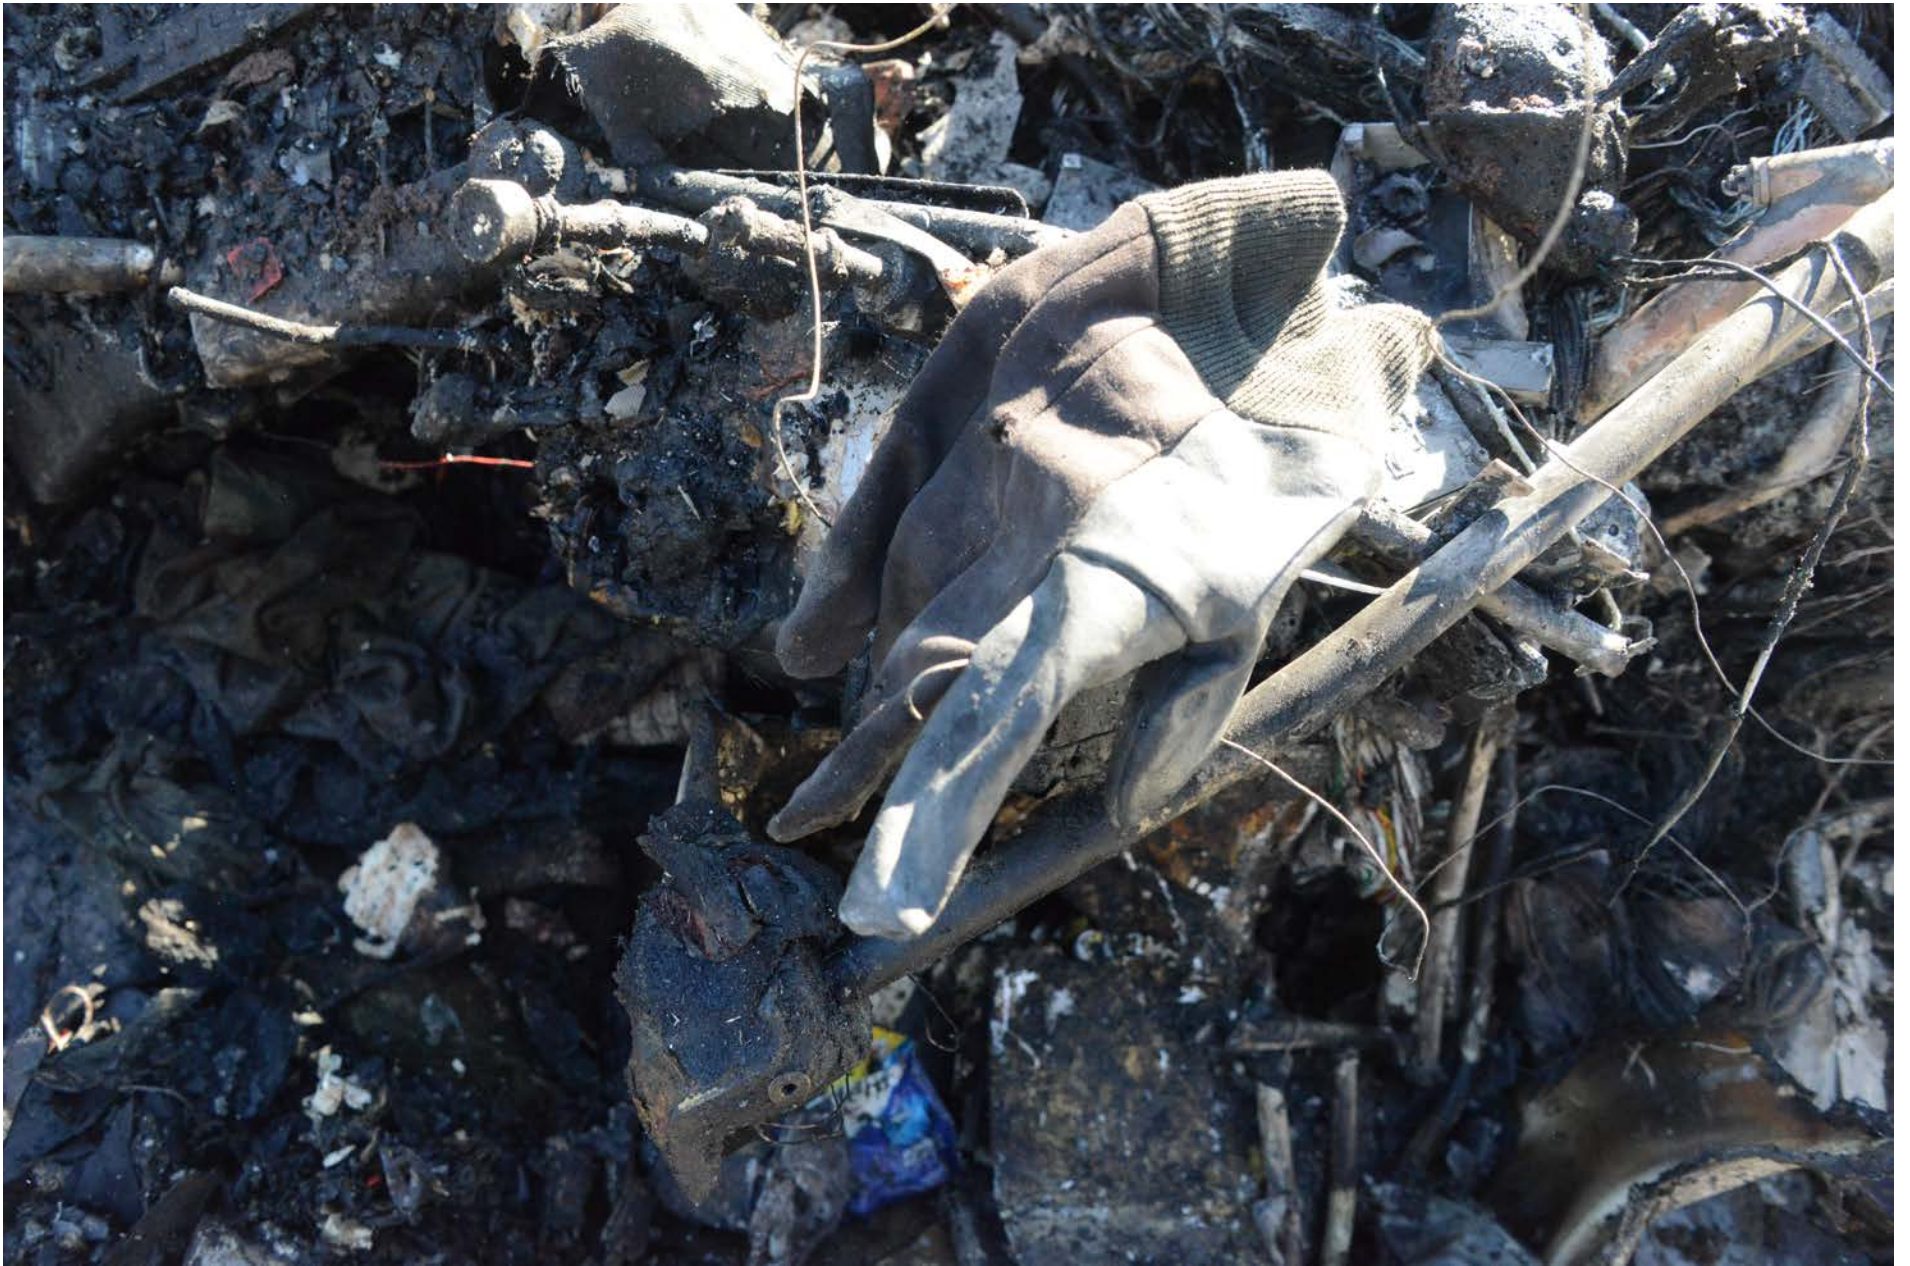
Photo 13 - View of the engine controls.

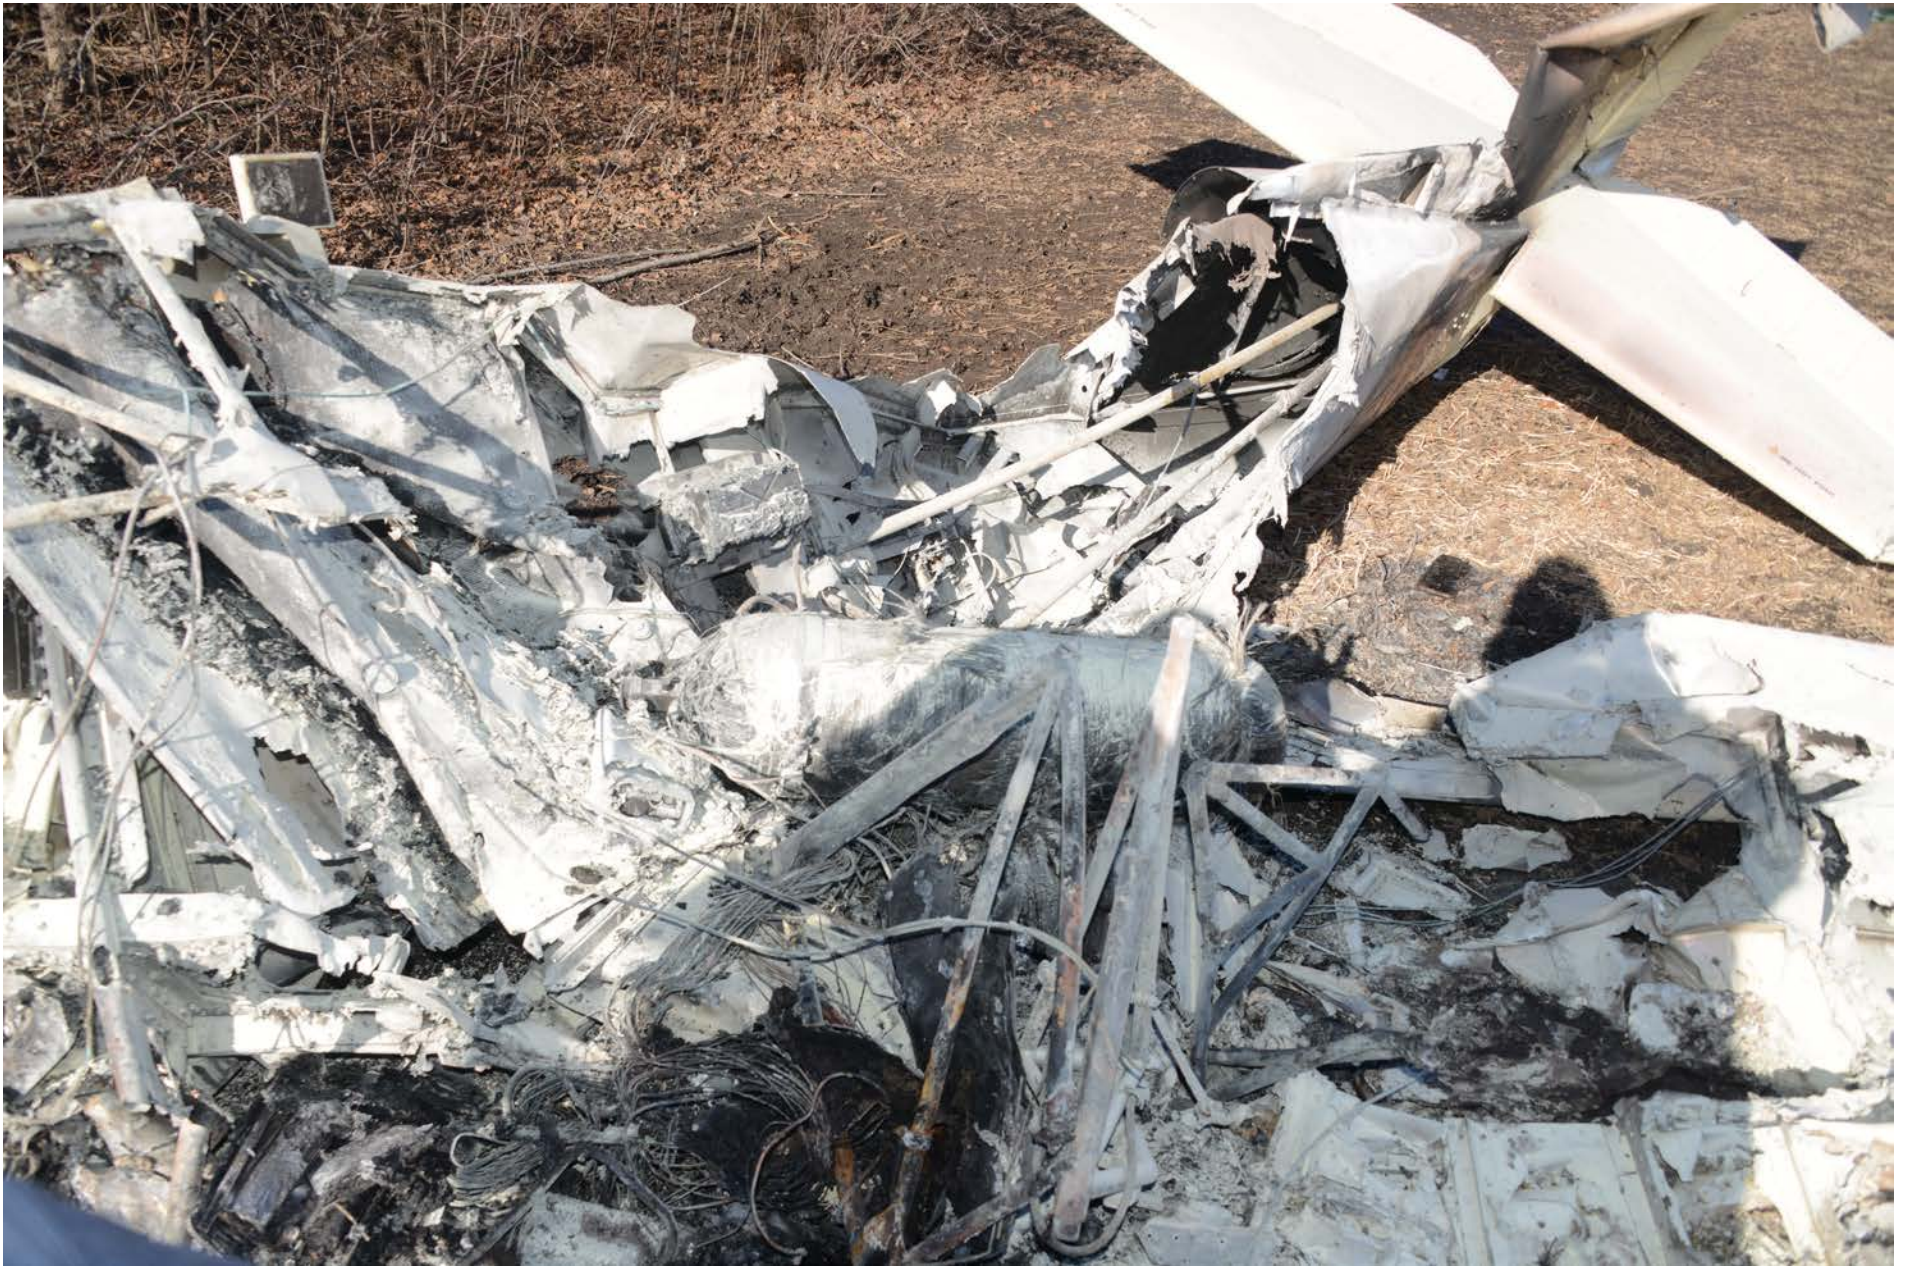
Photo 14 - View looking aft of the inside of the rear fuselage and empennage.

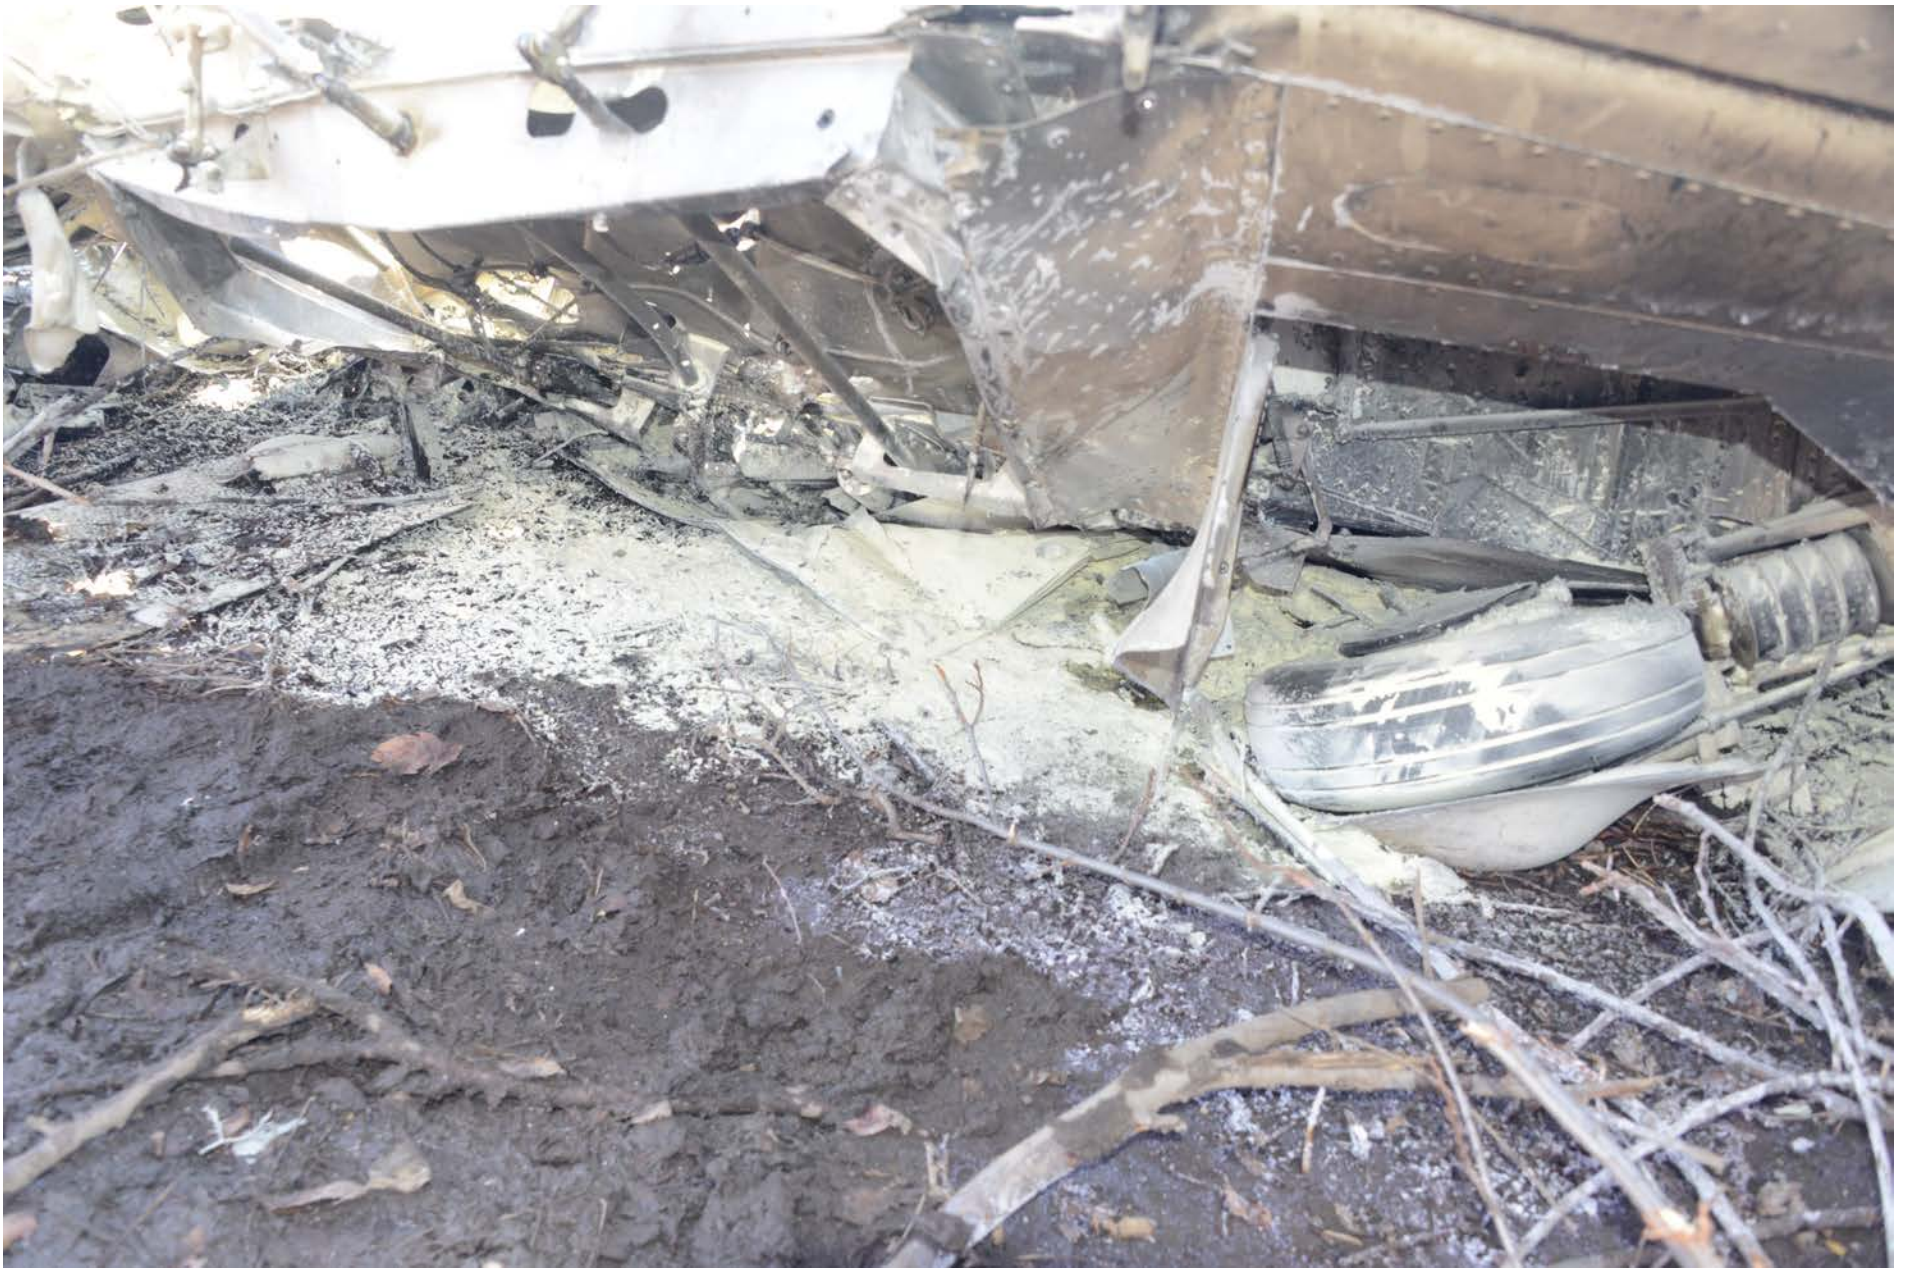
Photo 15 - View of the lower center section of the fuselage.

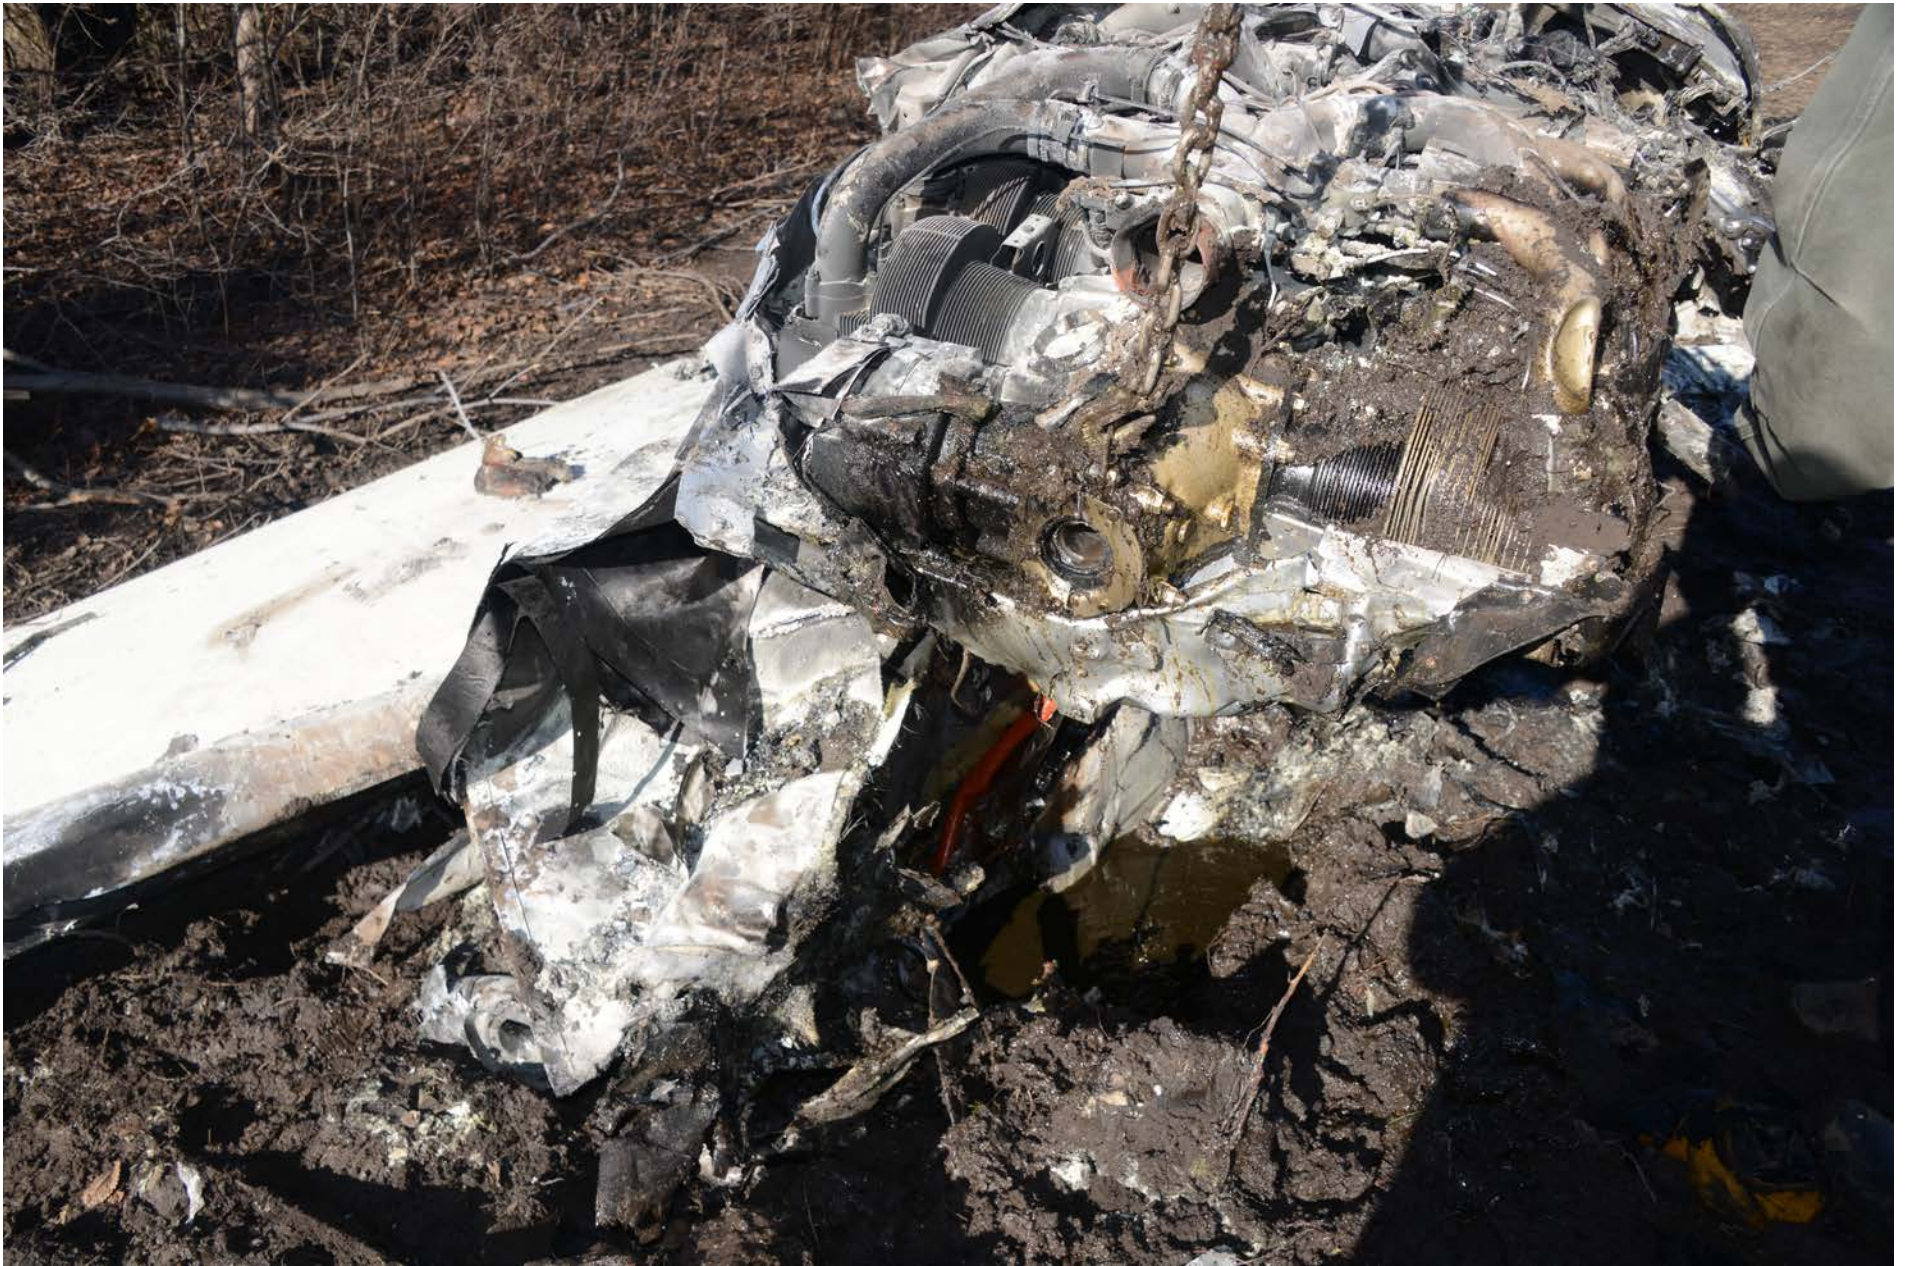
Photo 16 - View of the engine during recovery.

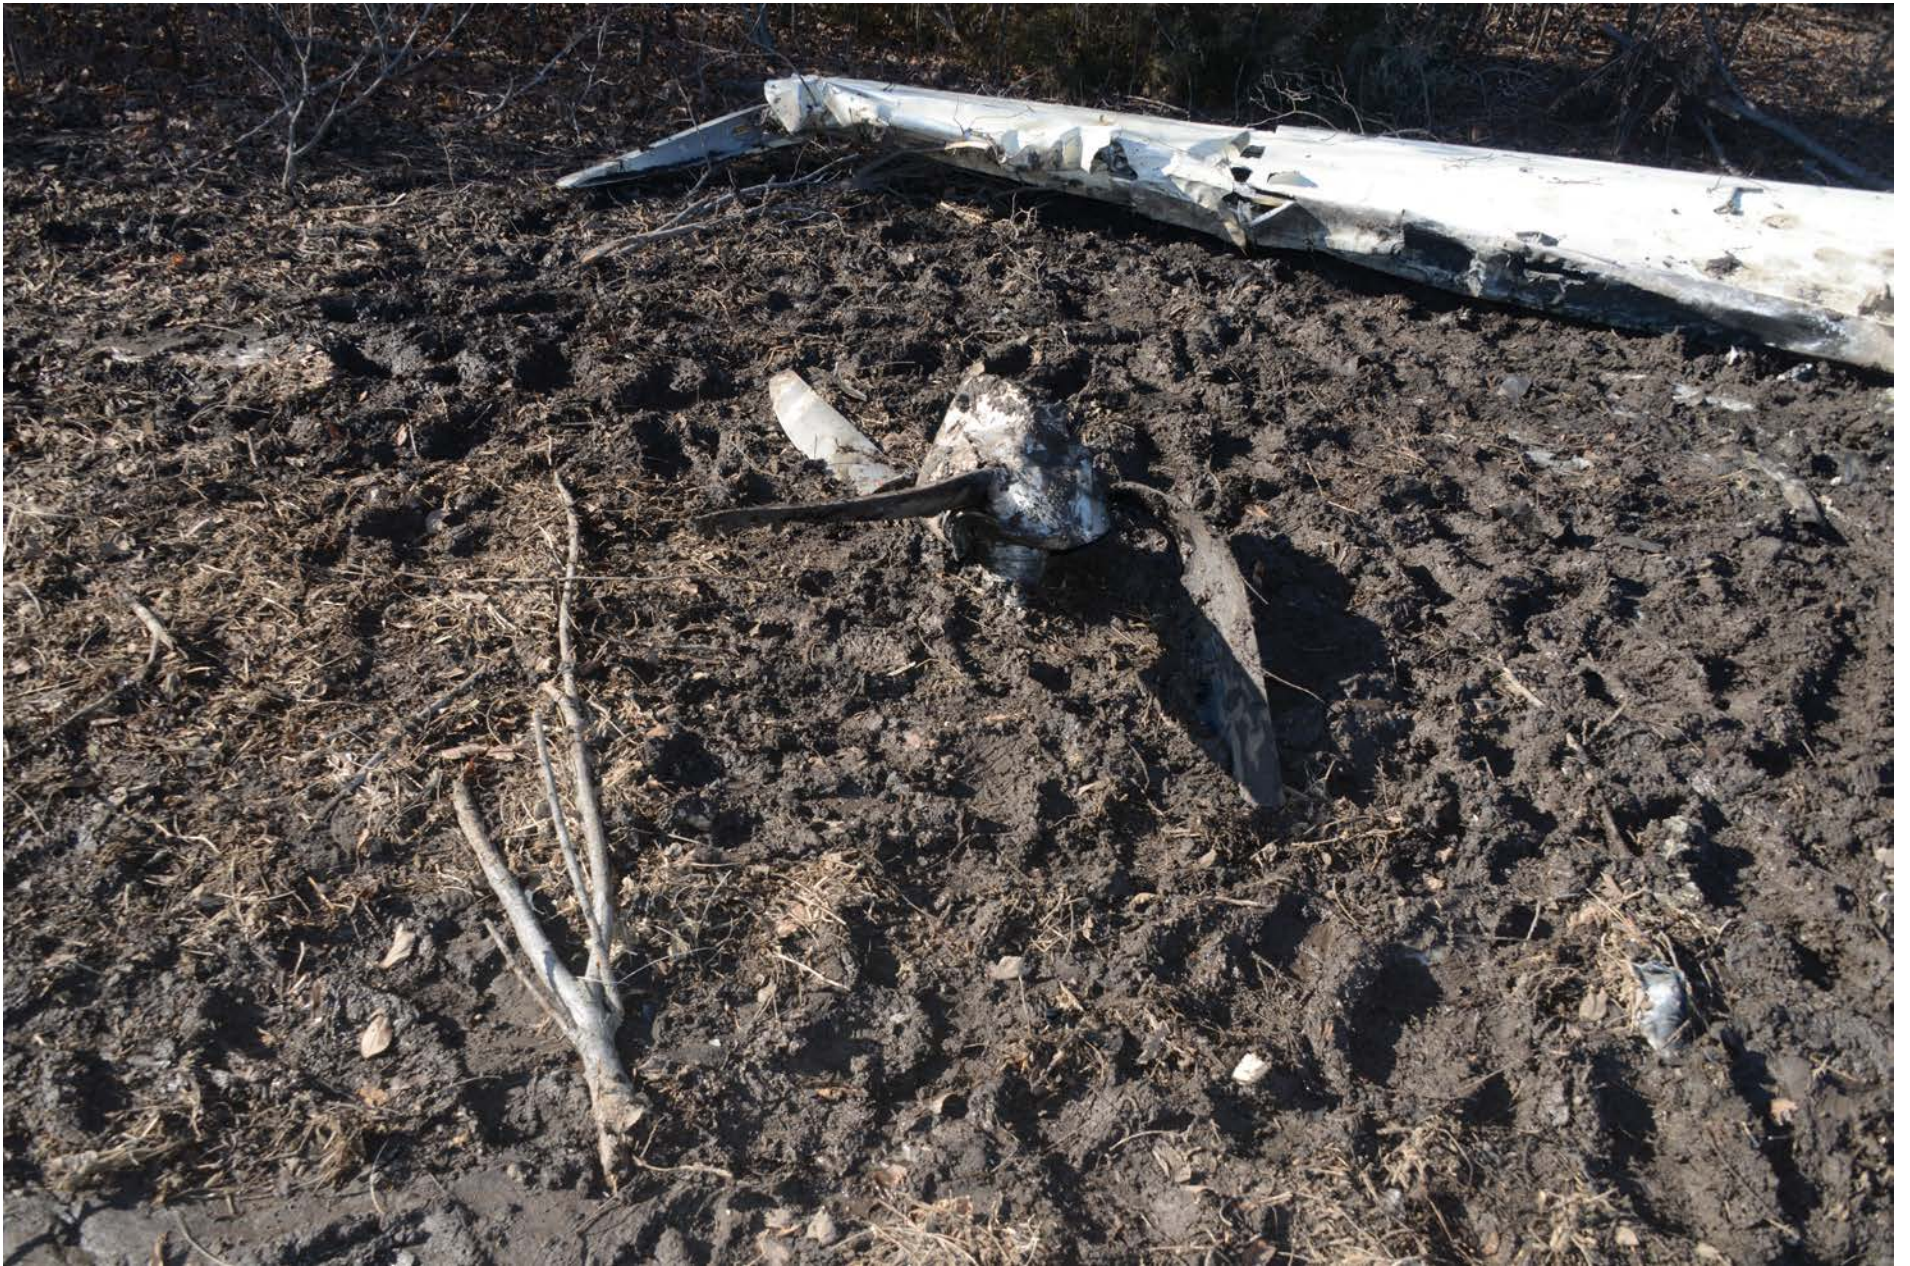
Photo 17 - View of the propeller during recovery.

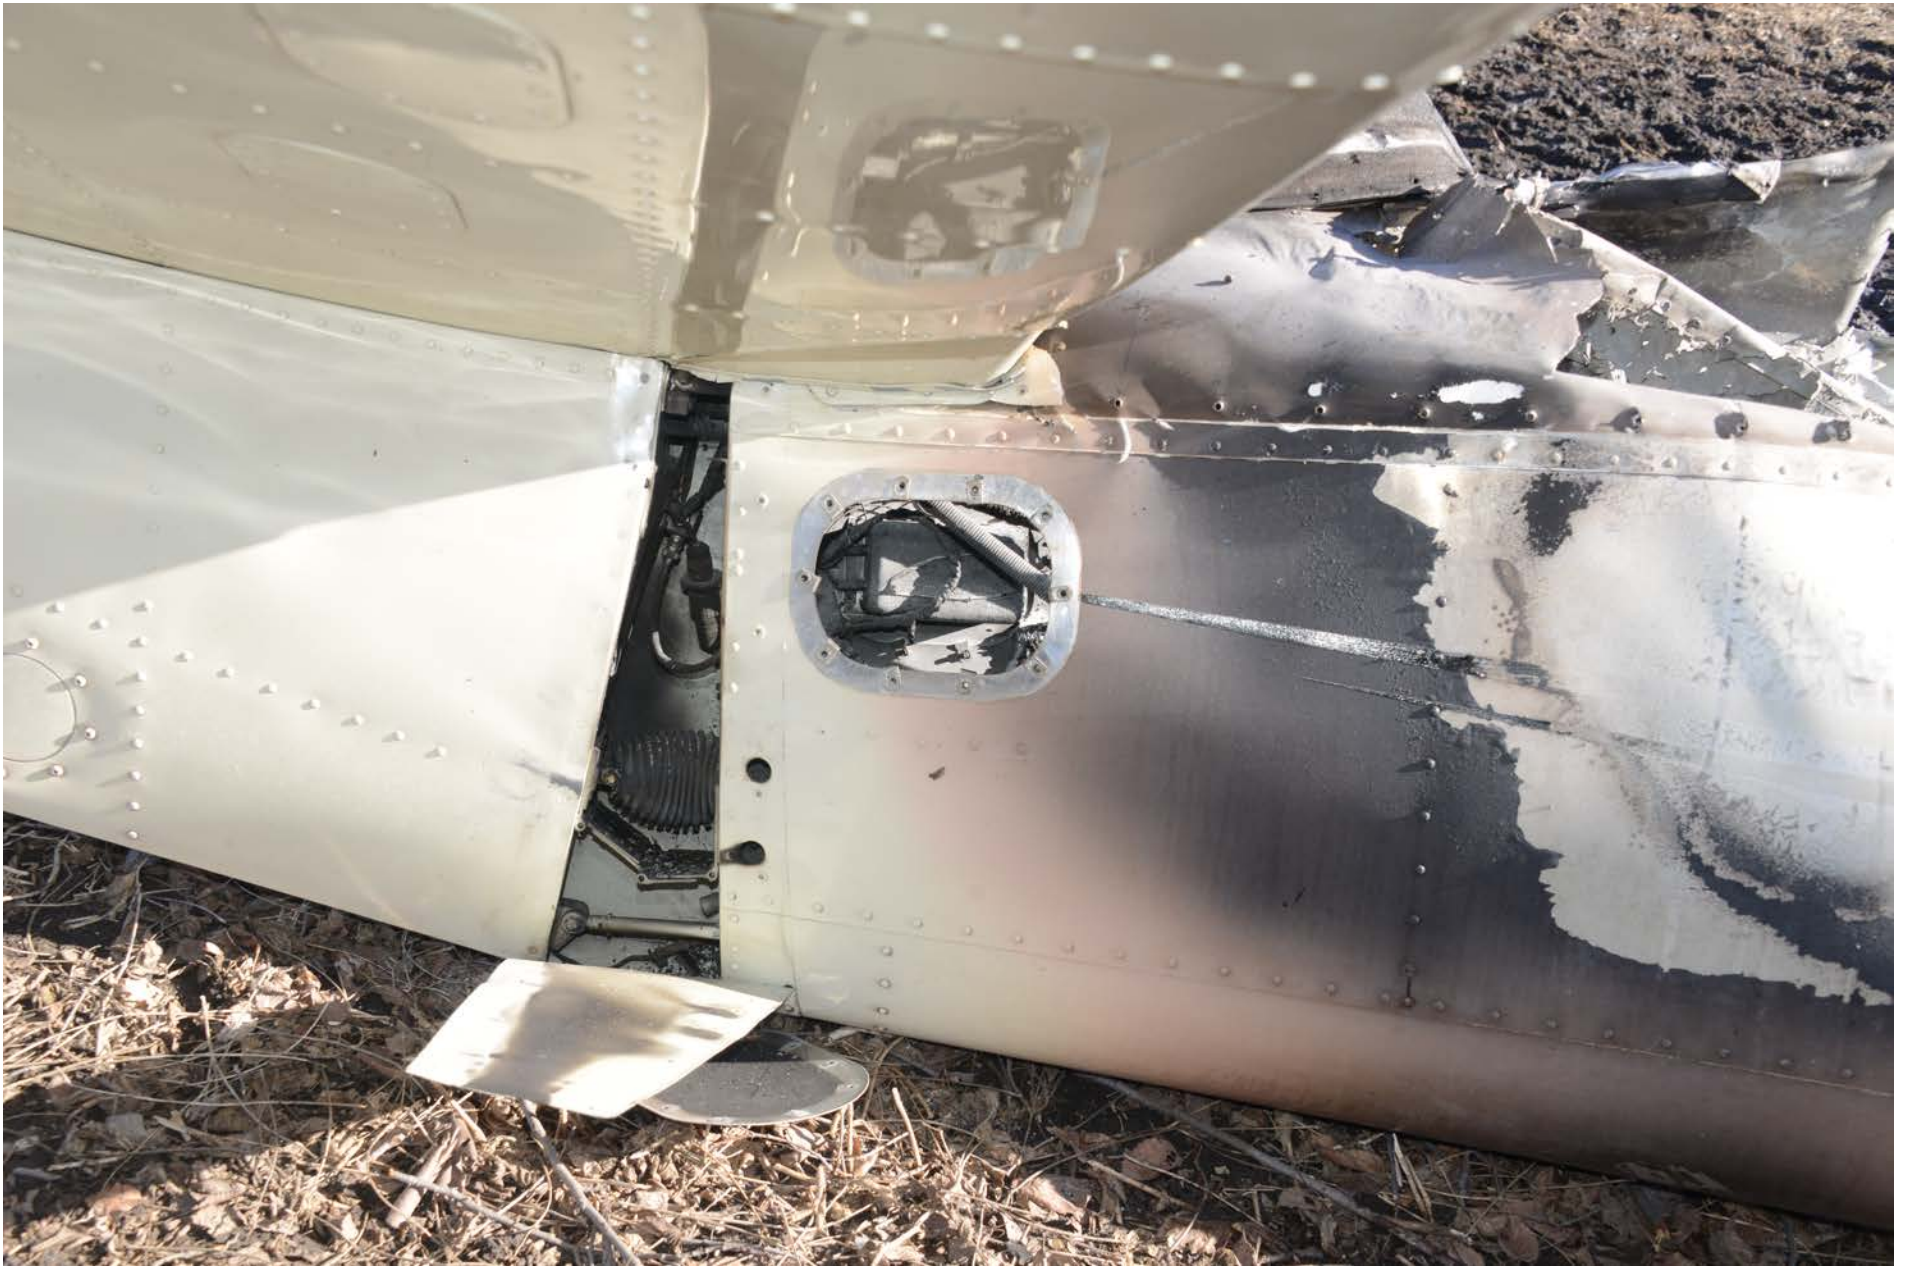
Photo 18 - Close up view of the right rear side of the empennage with panels removed.

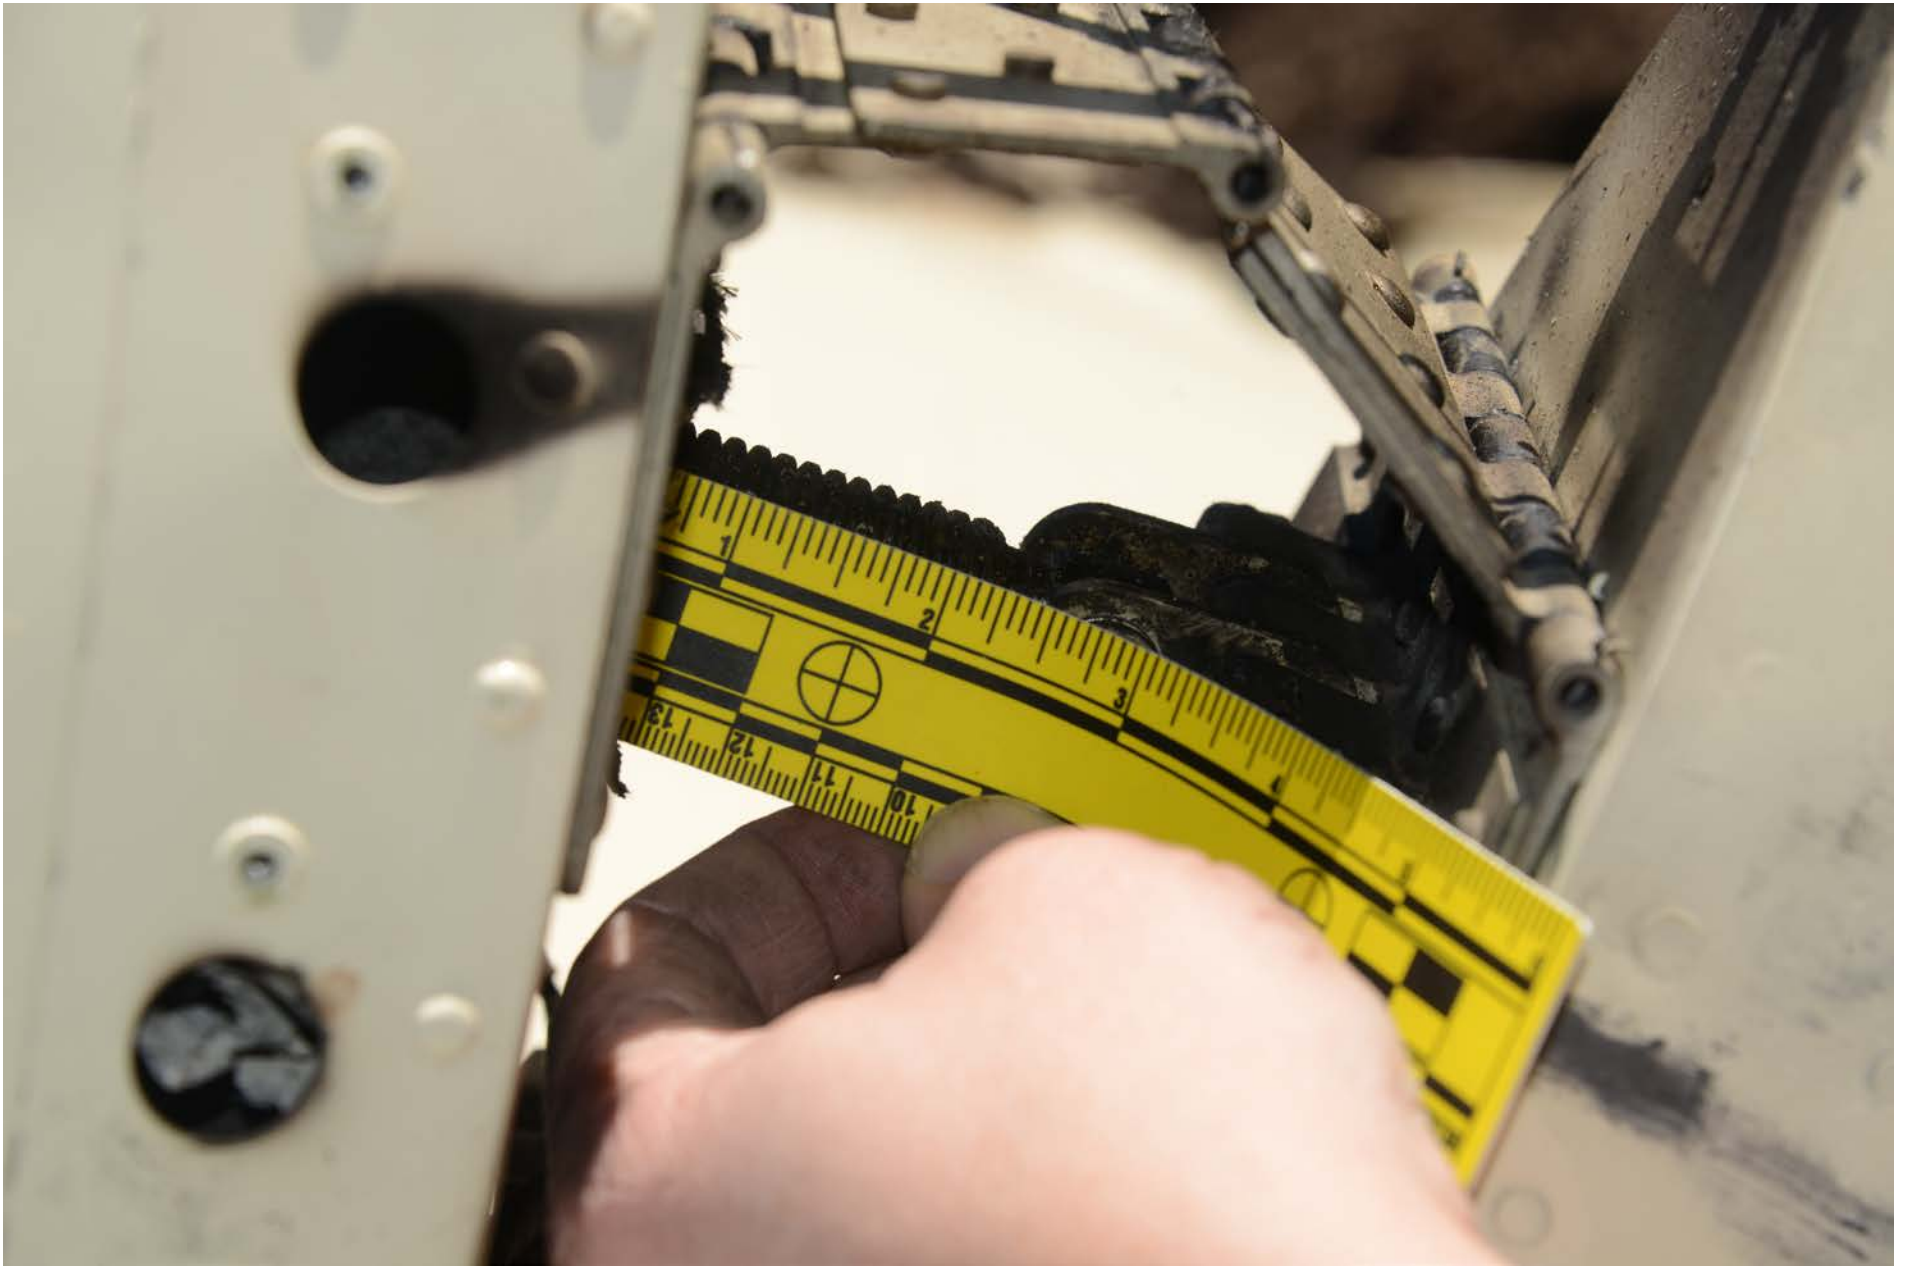
Photo 19 - Close up view of the trim jackscrew.
