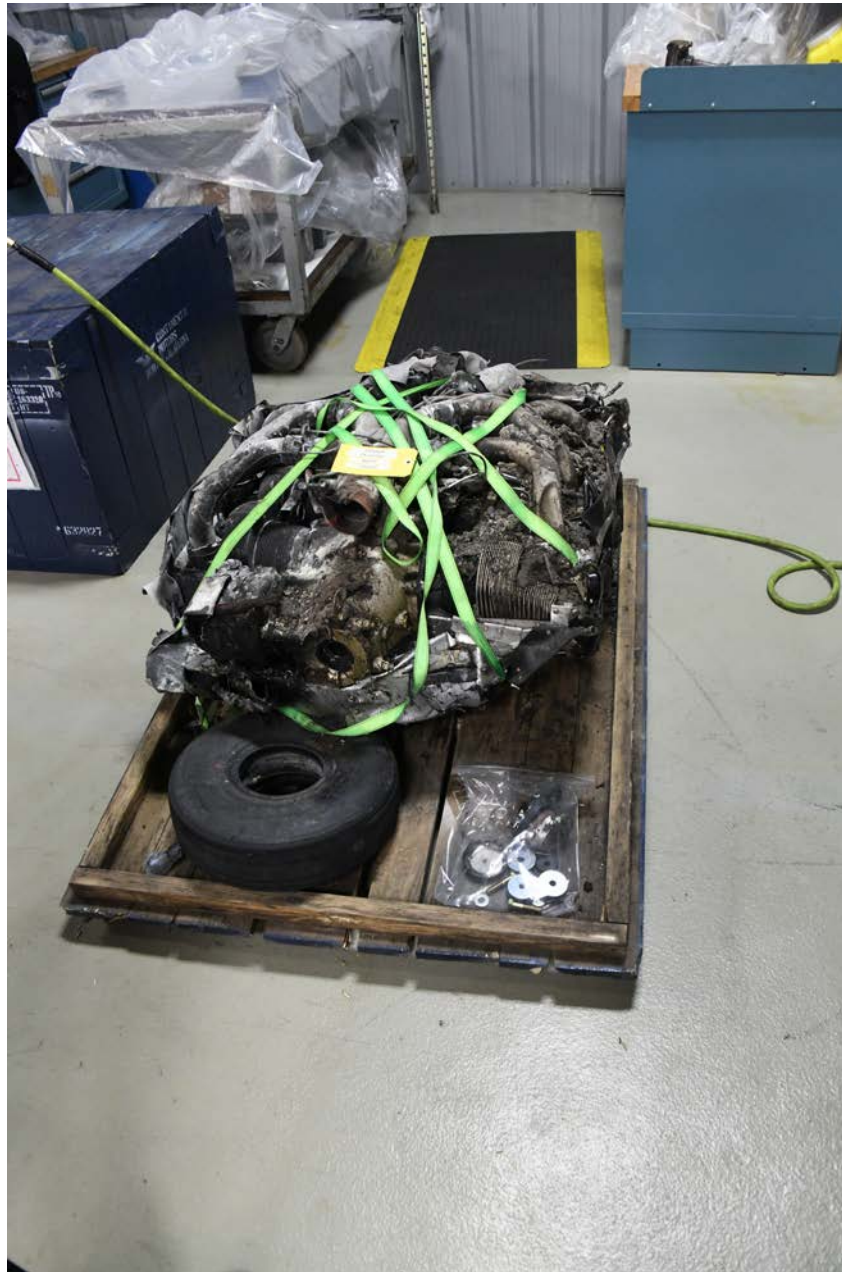
Photo 20 - View of the engine as received for examination.

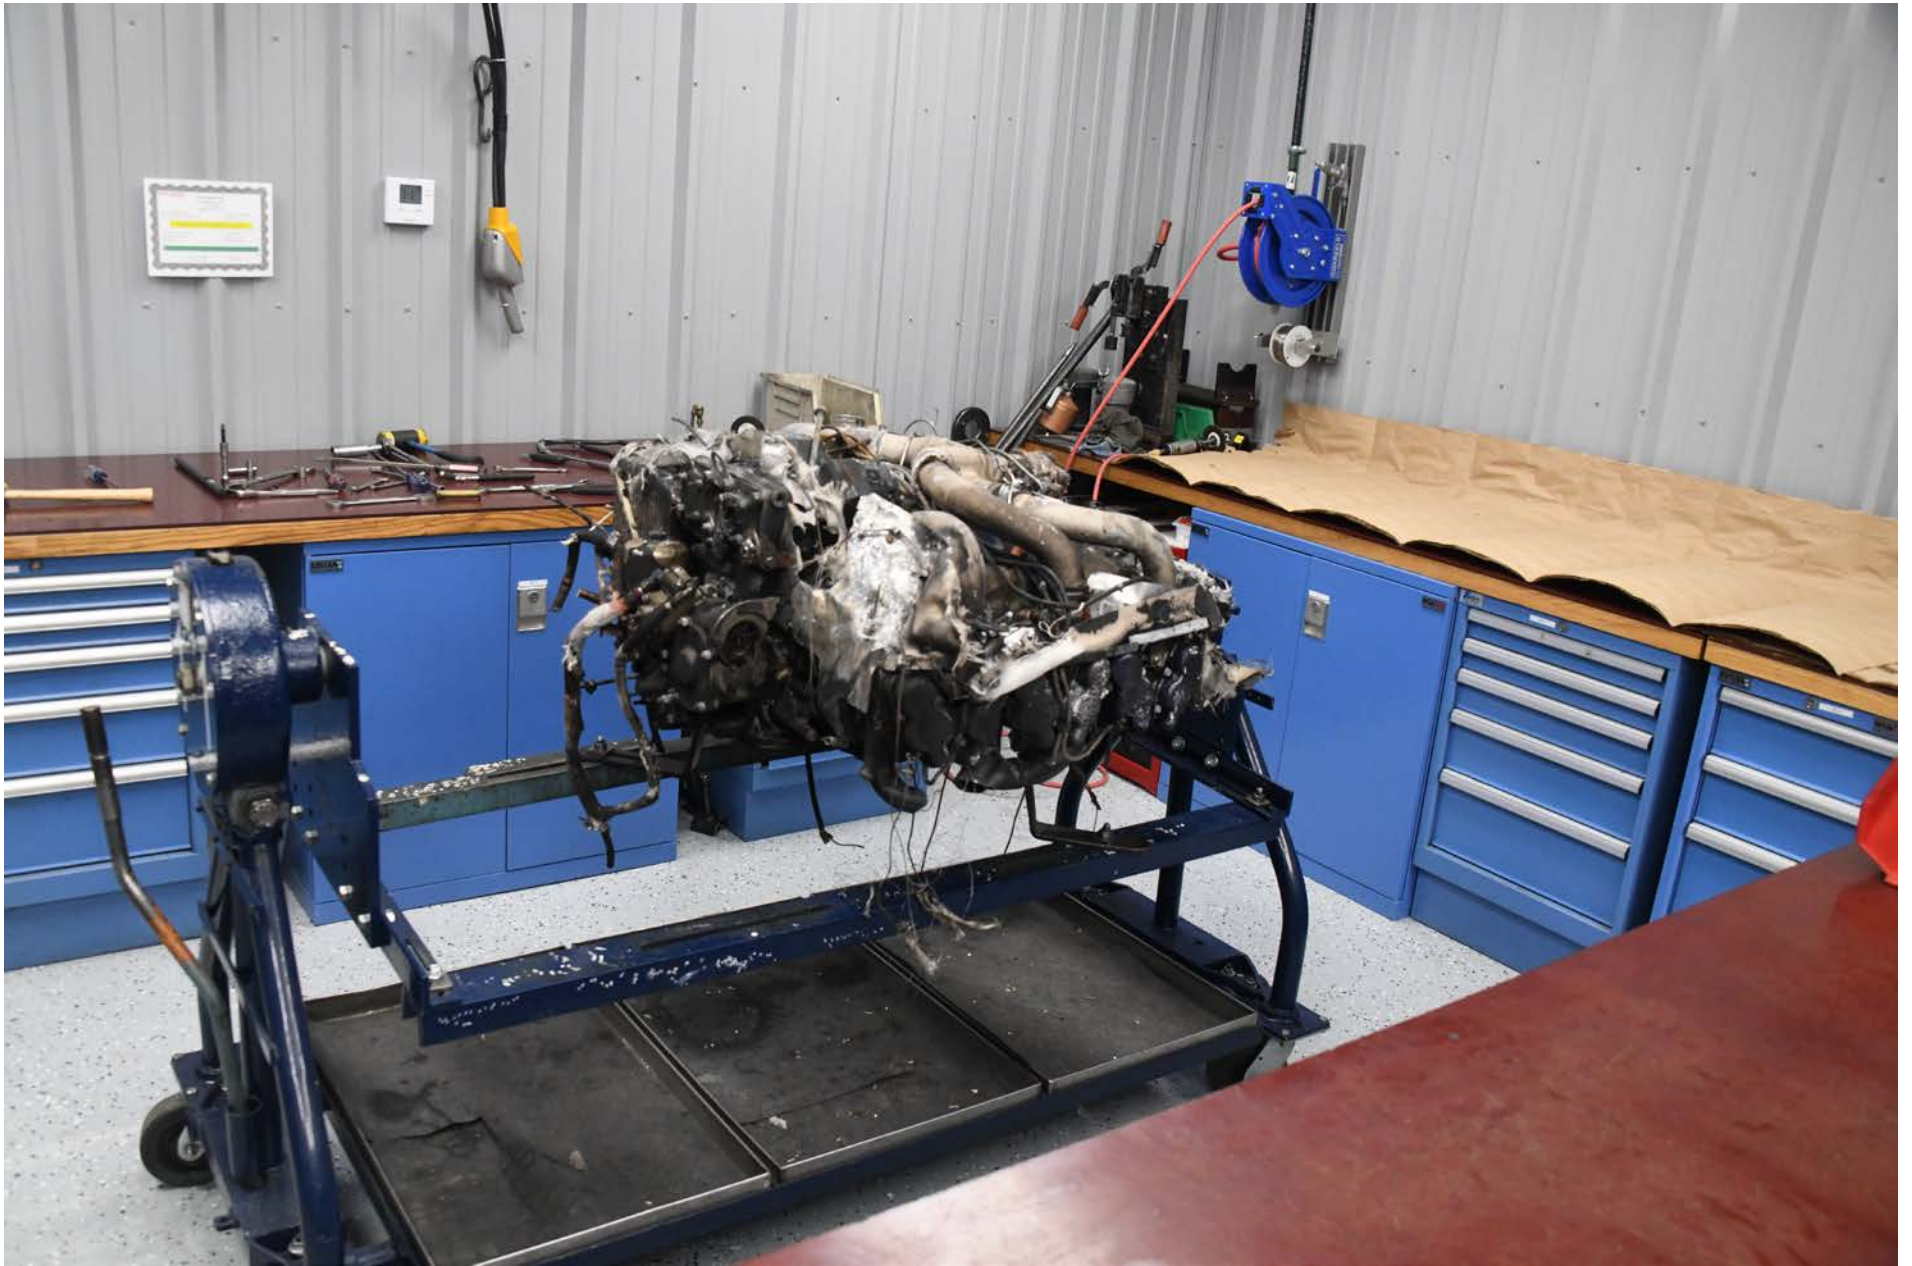
Photo 21 – View of the engine mounted on a disassembly stand.

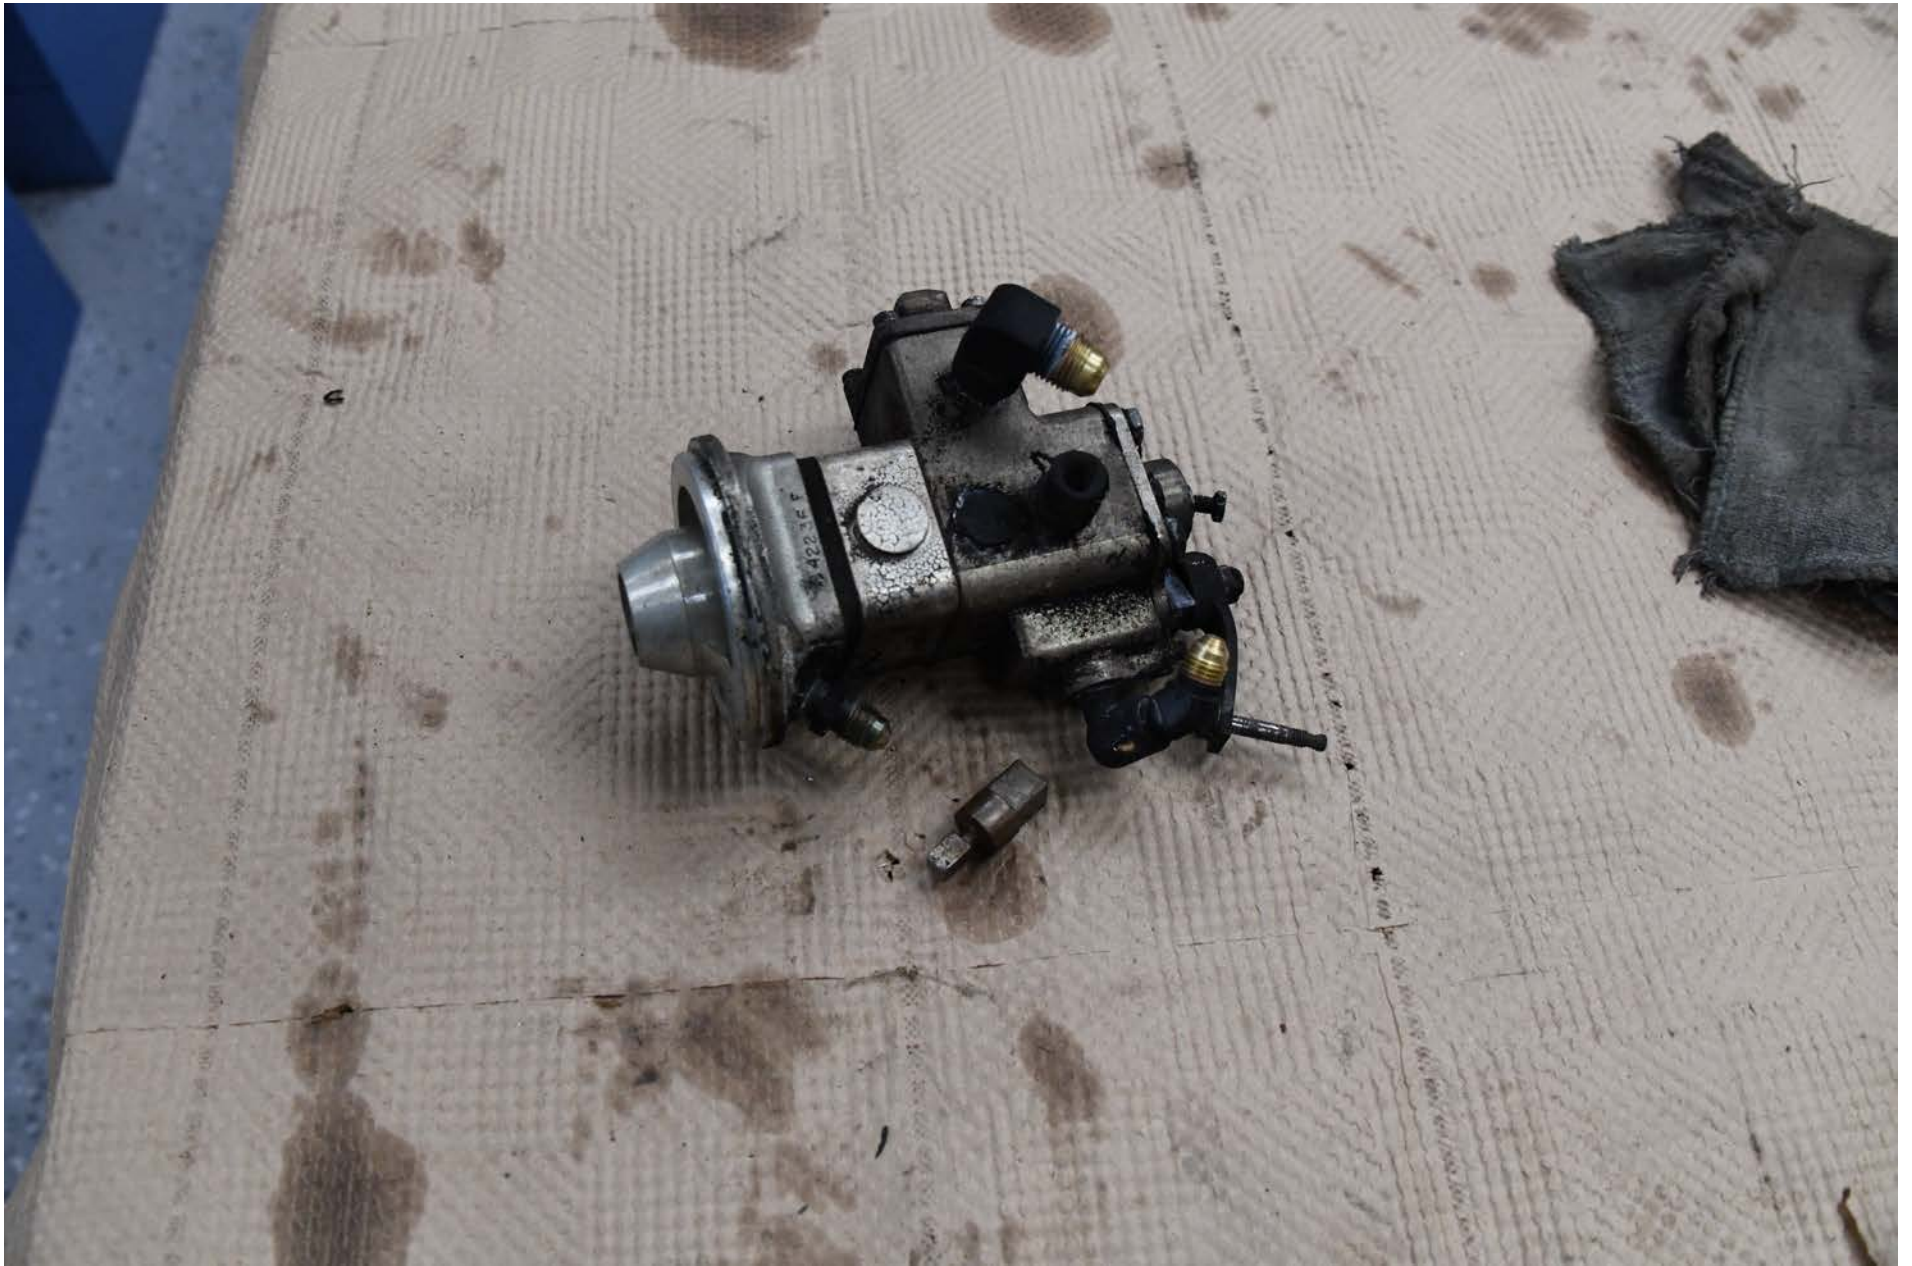
Photo 22 - Close up view of the engine driven fuel pump and its intact coupling.

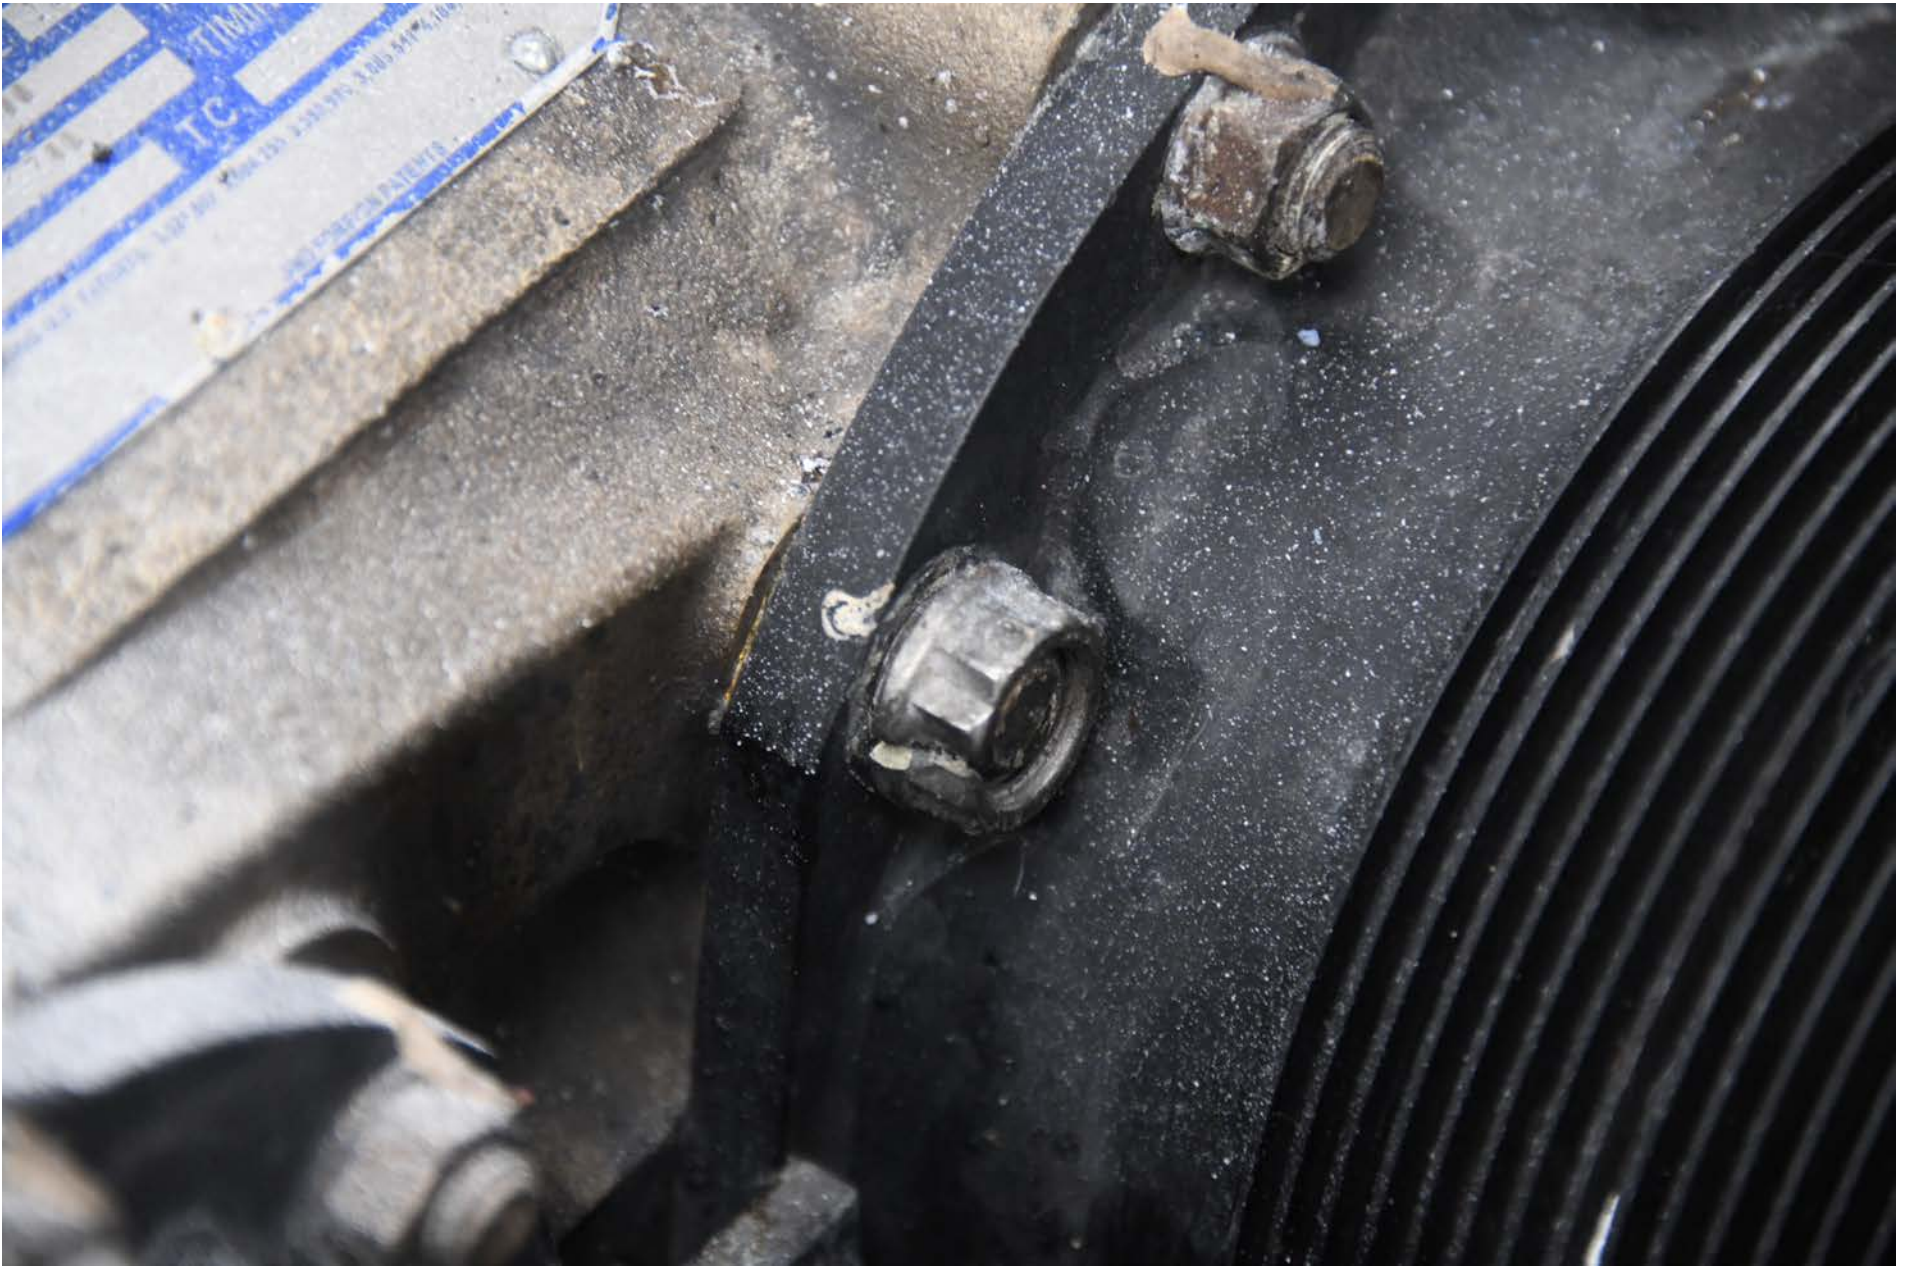
Photo 23 - Close up view of an engine cylinder base nut. The nut is split consistent with being exposed to heat.

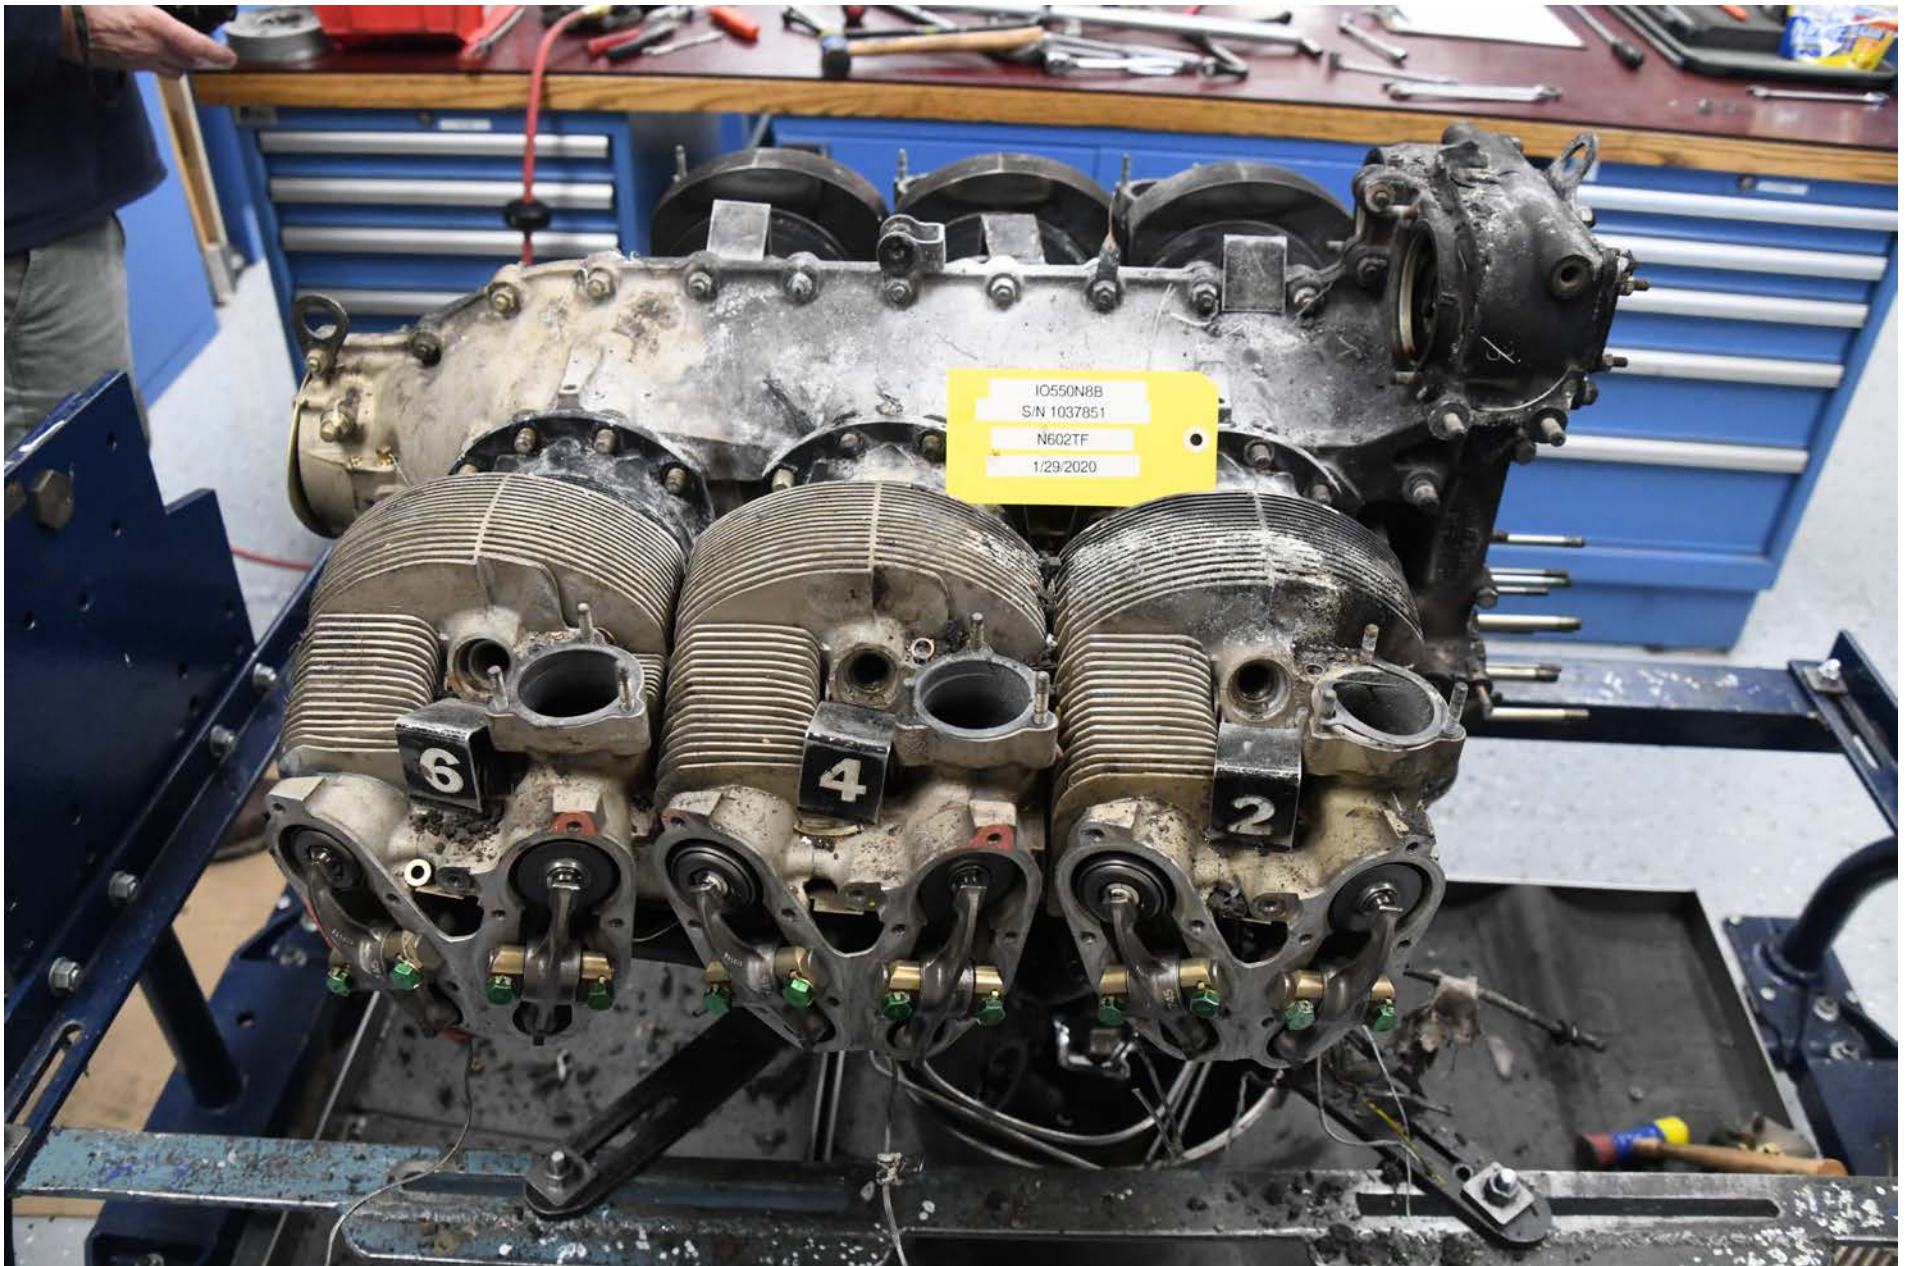
Photo 24 - Close up view of the even bank of engine cylinders.

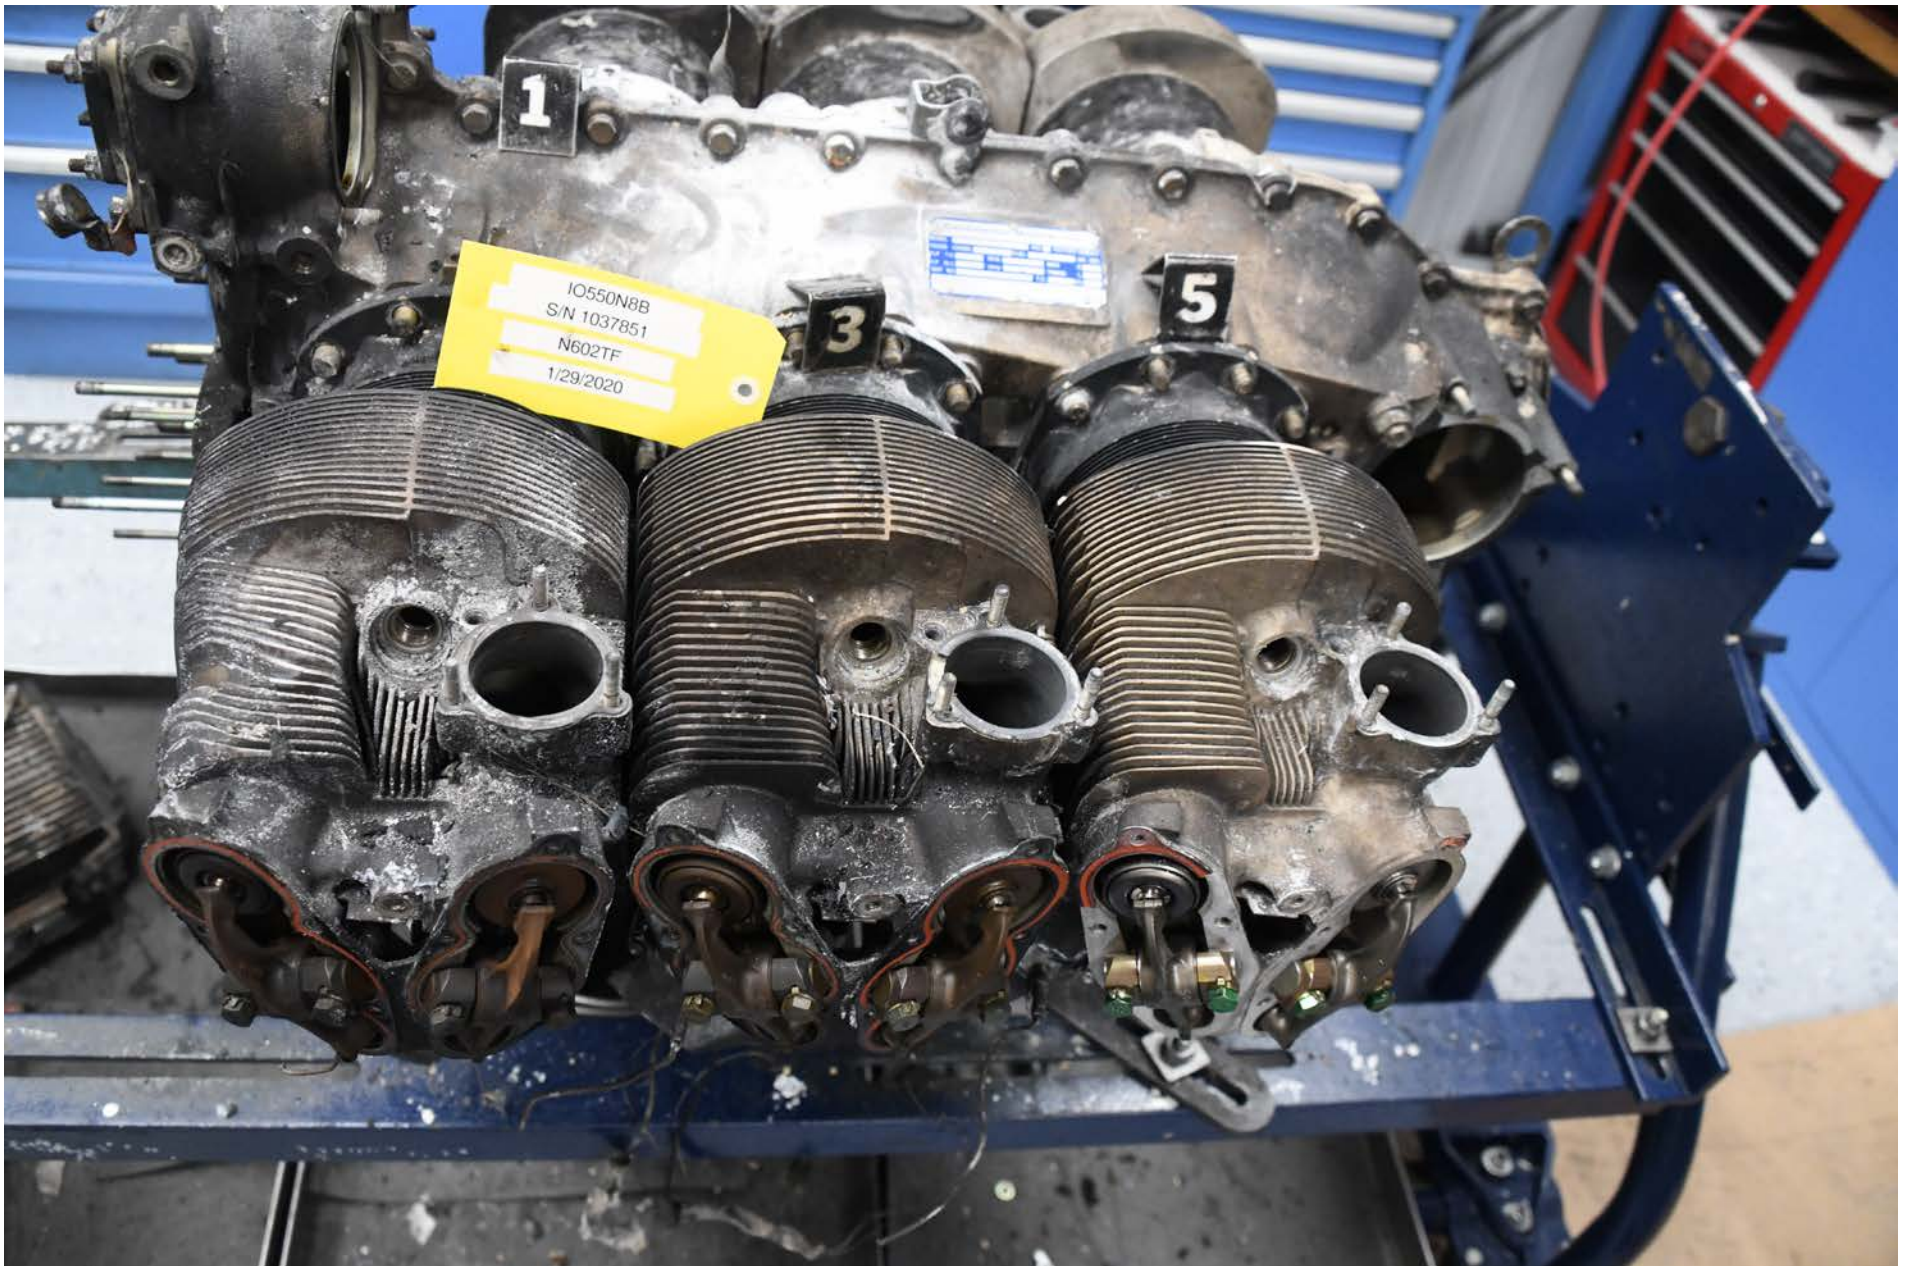
Photo 25 - Close up view of the odd bank of engine cylinders.

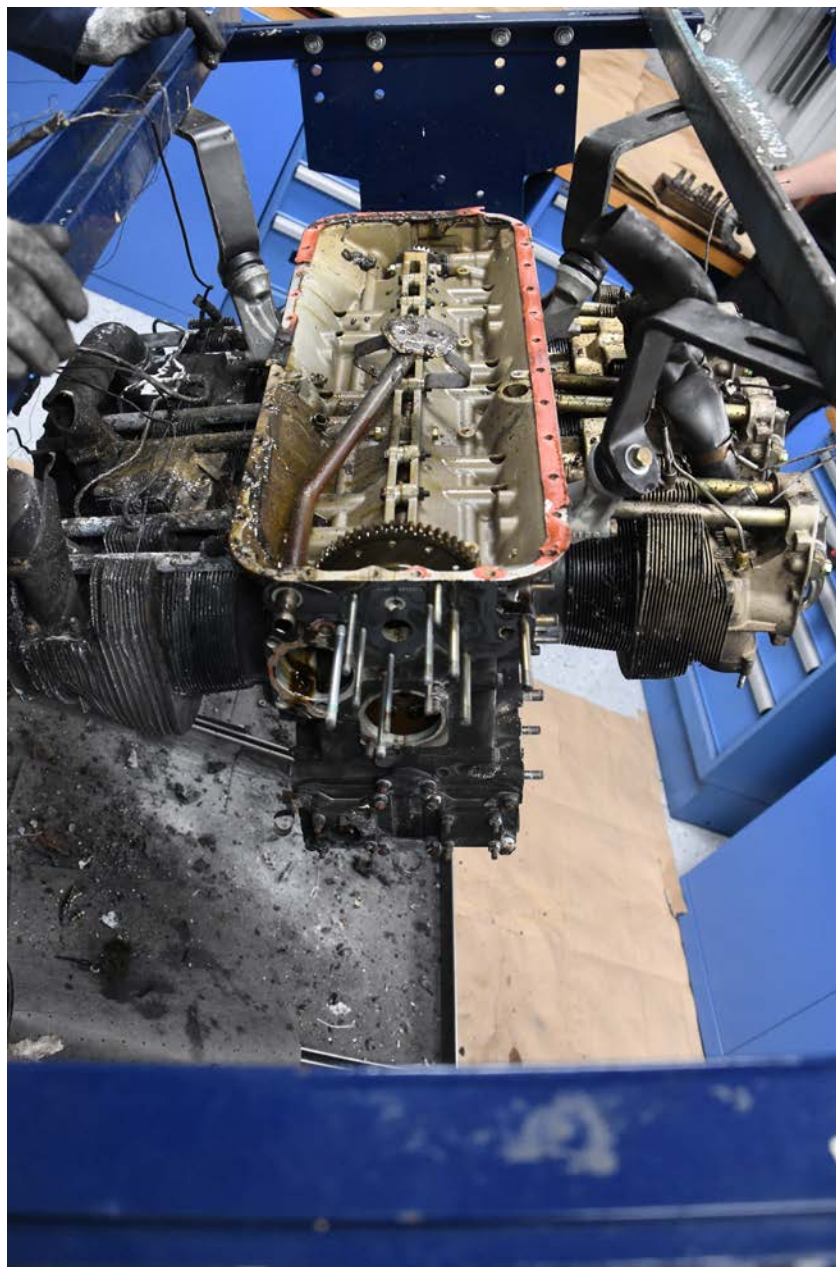
Photo 26 - View of the engine with the oil sump pan removed.

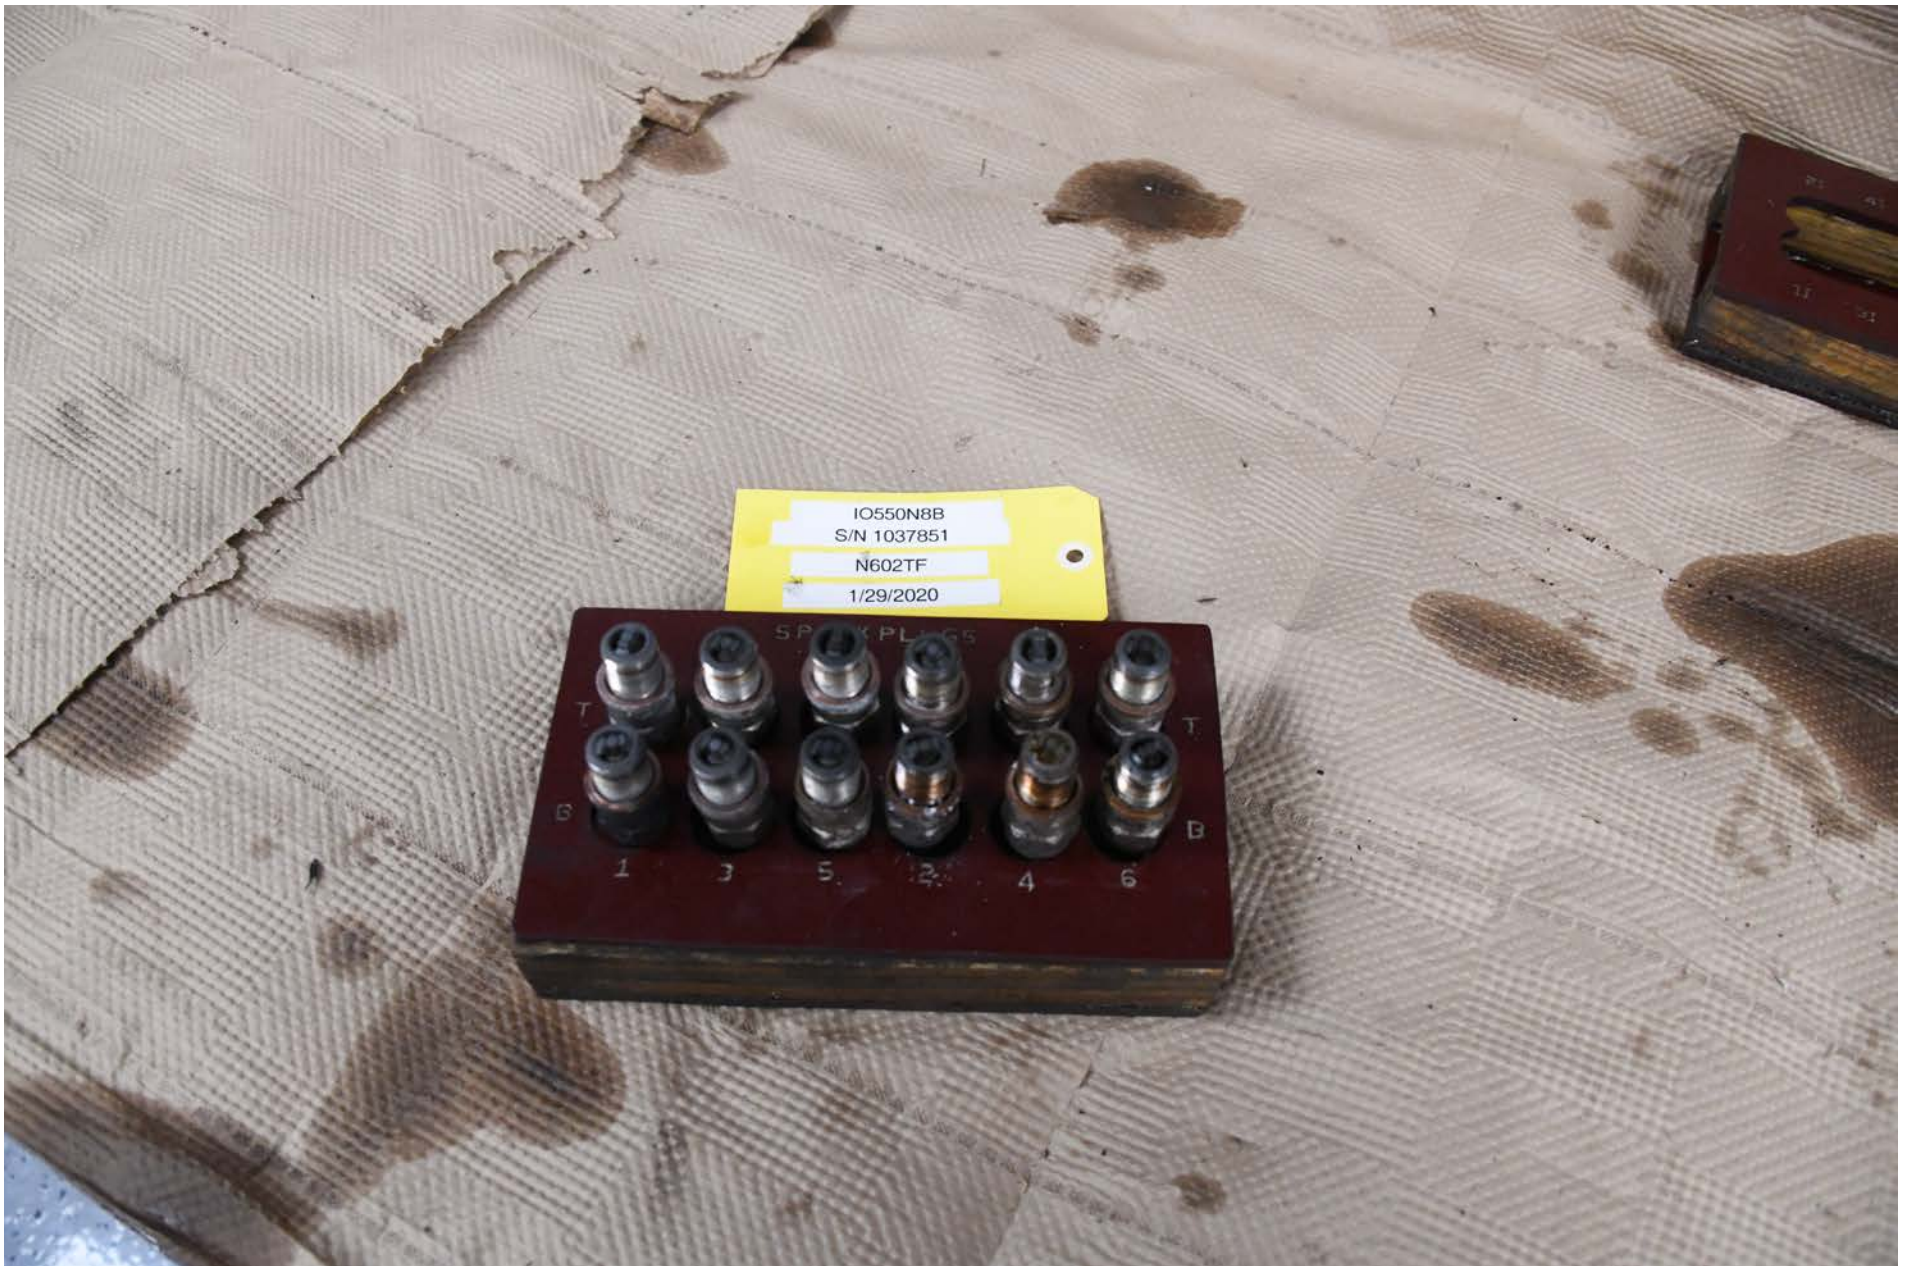
Photo 27 - View of removed sparkplugs.

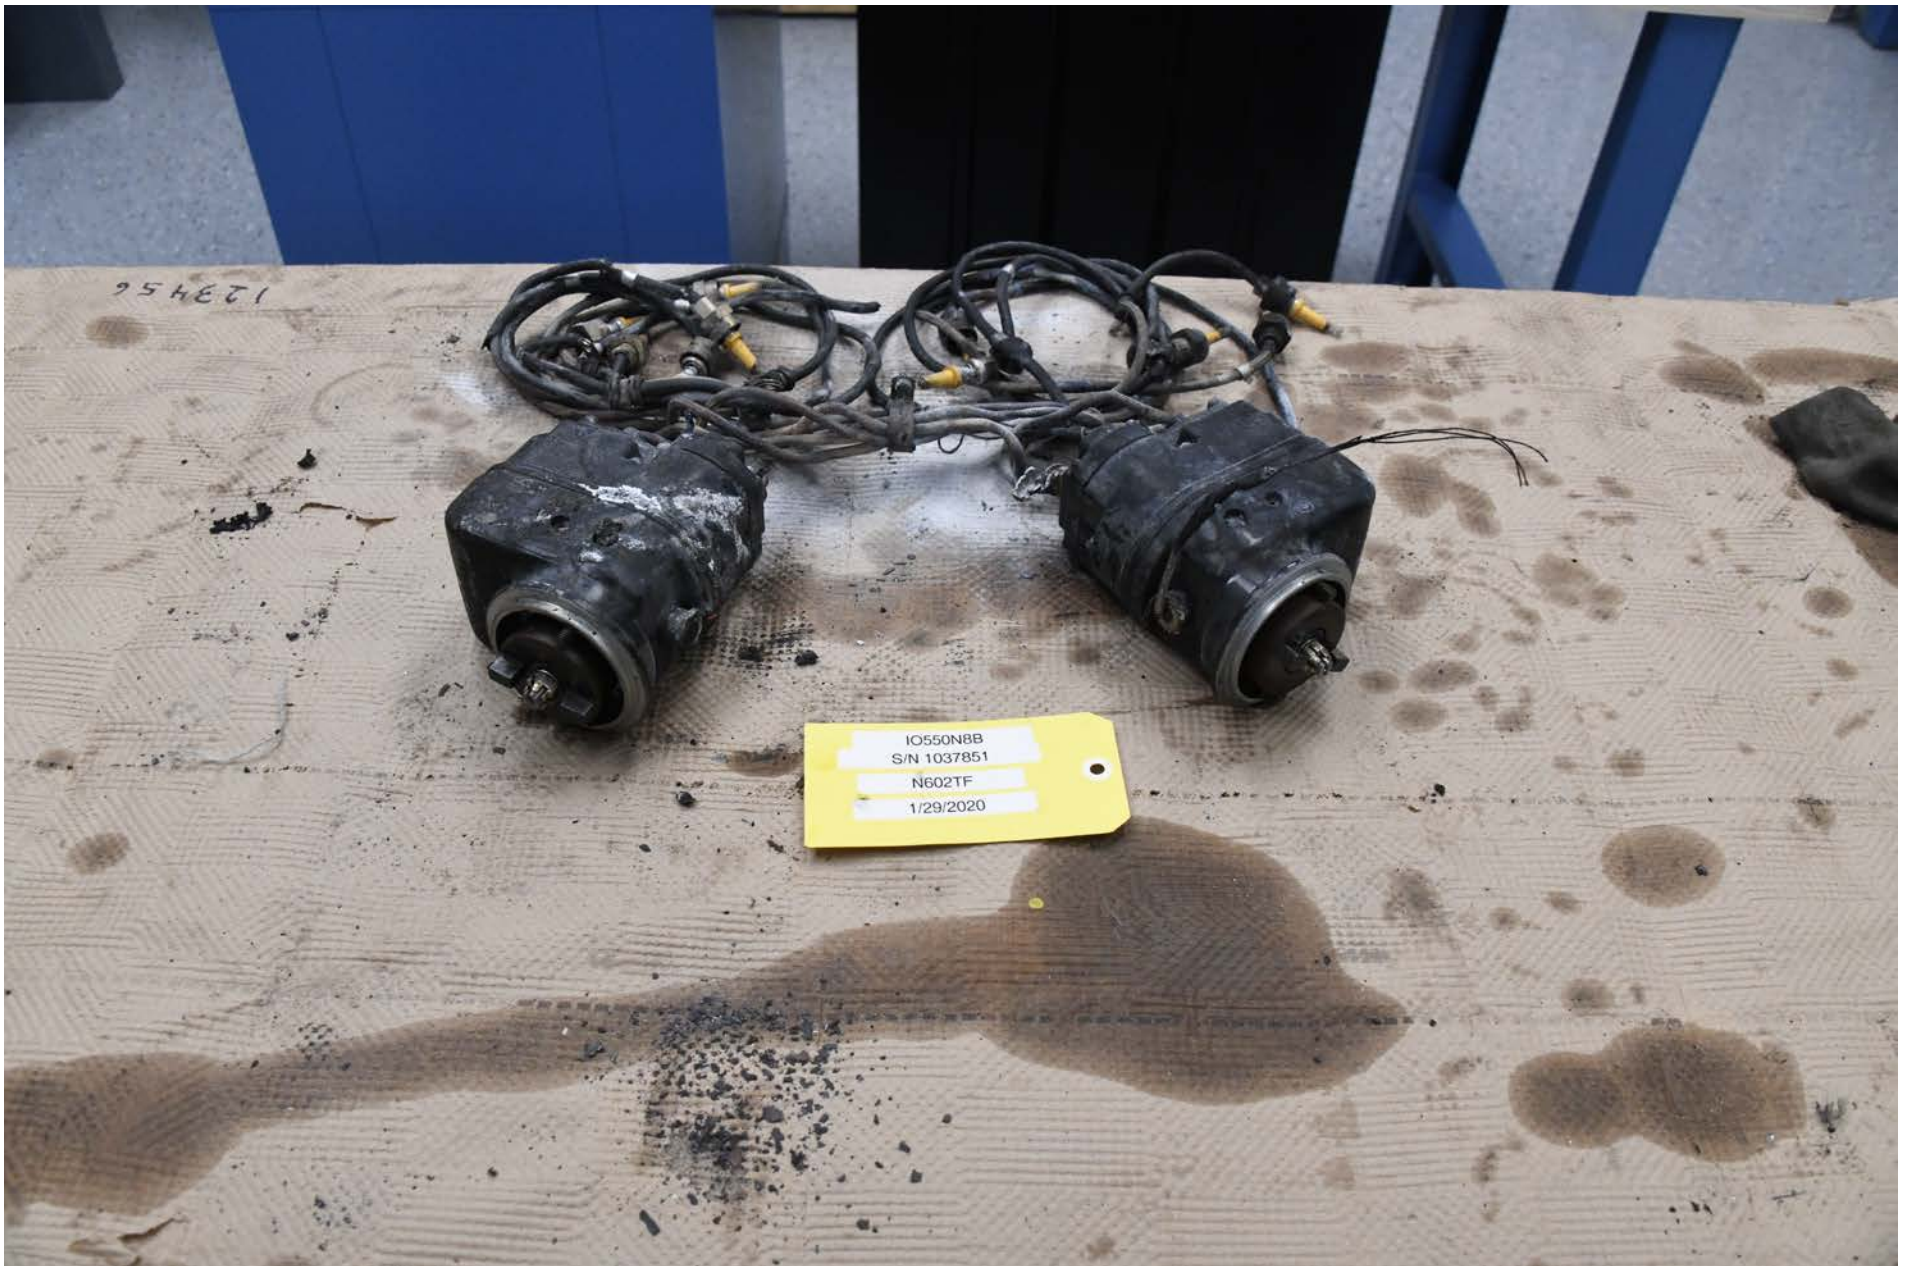
Photo 28 - View of removed magnetos.

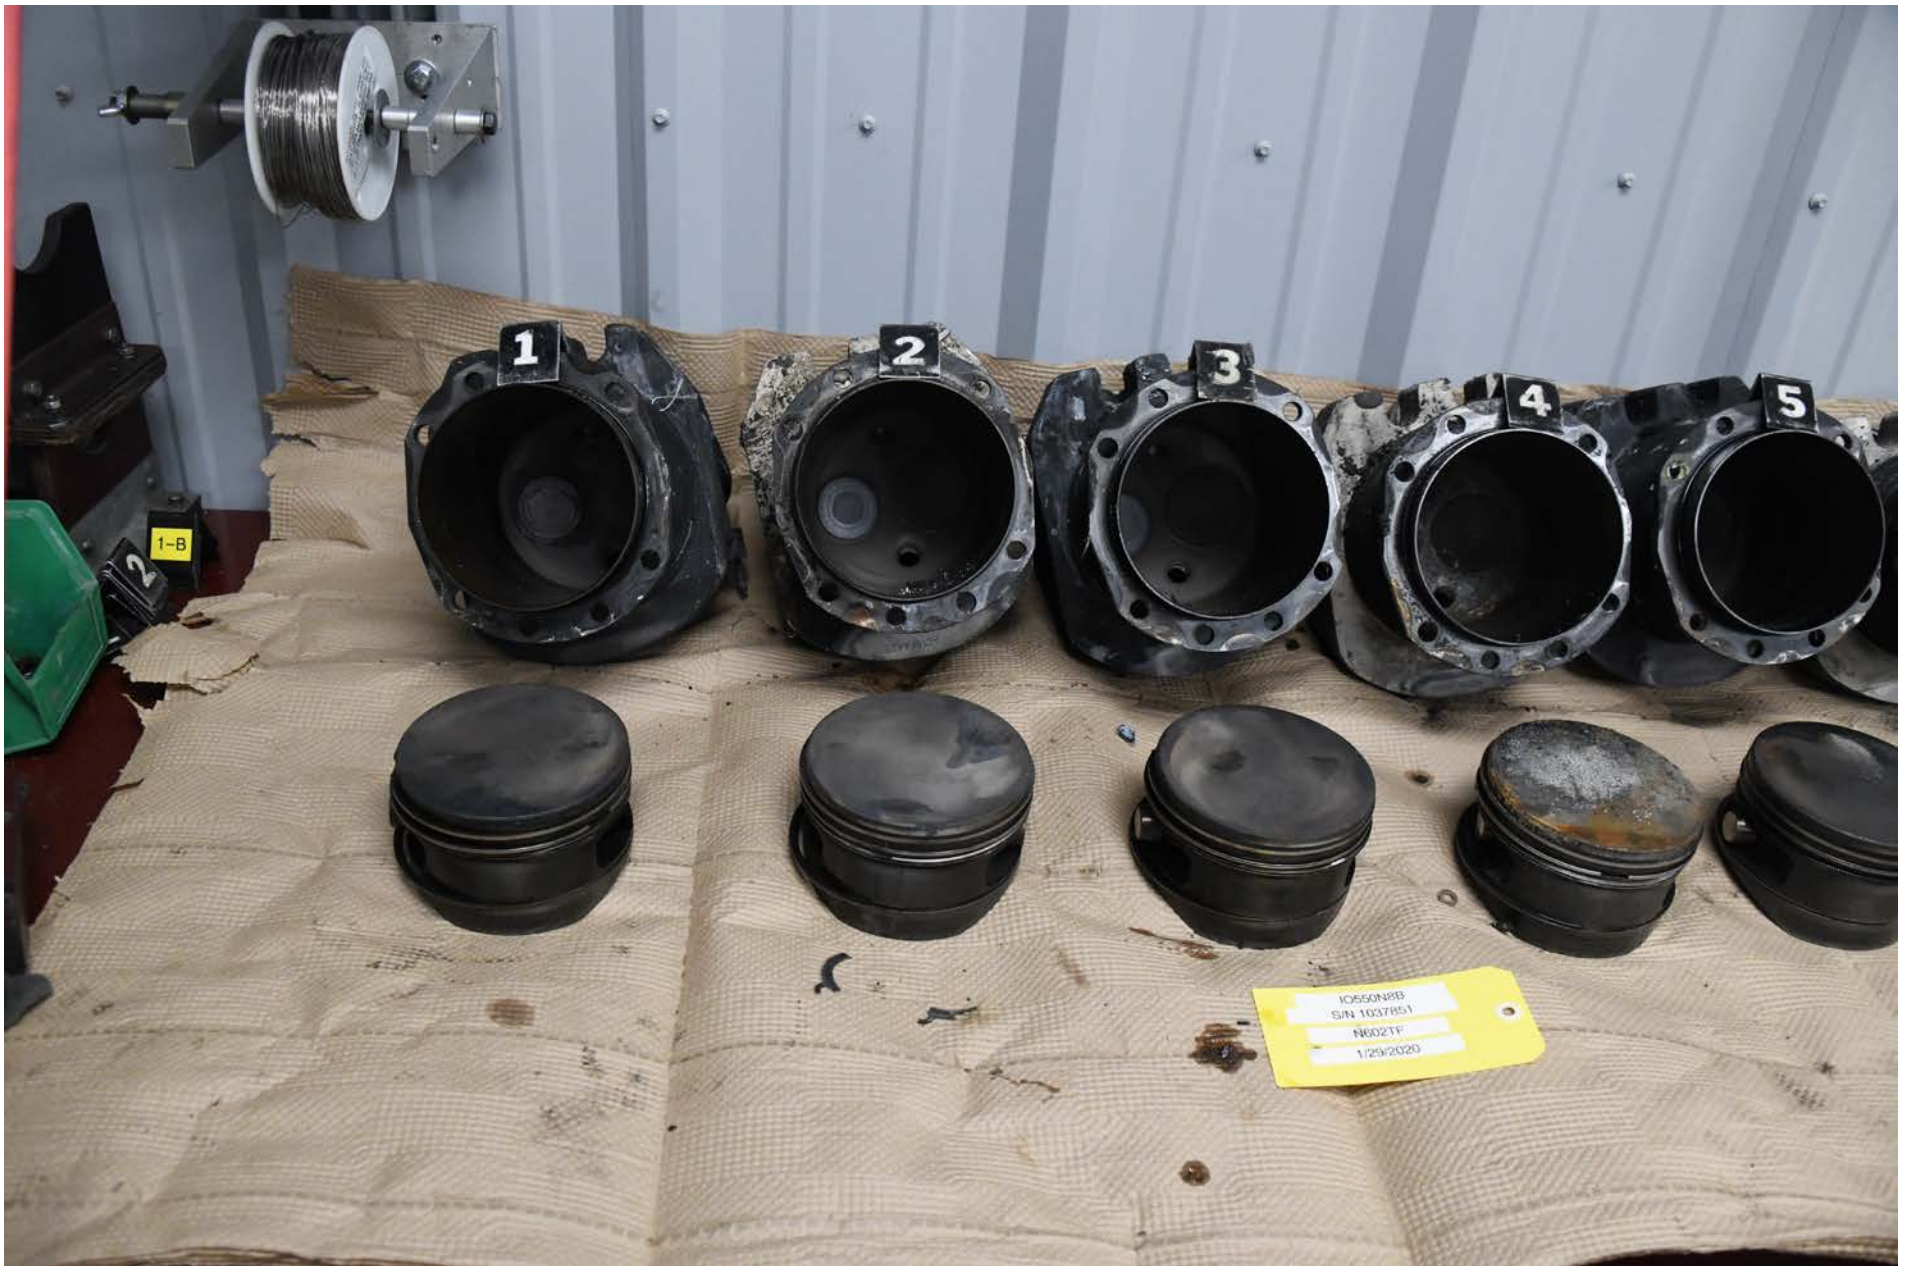
Photo 29 - Close up view inside removed cylinders.
