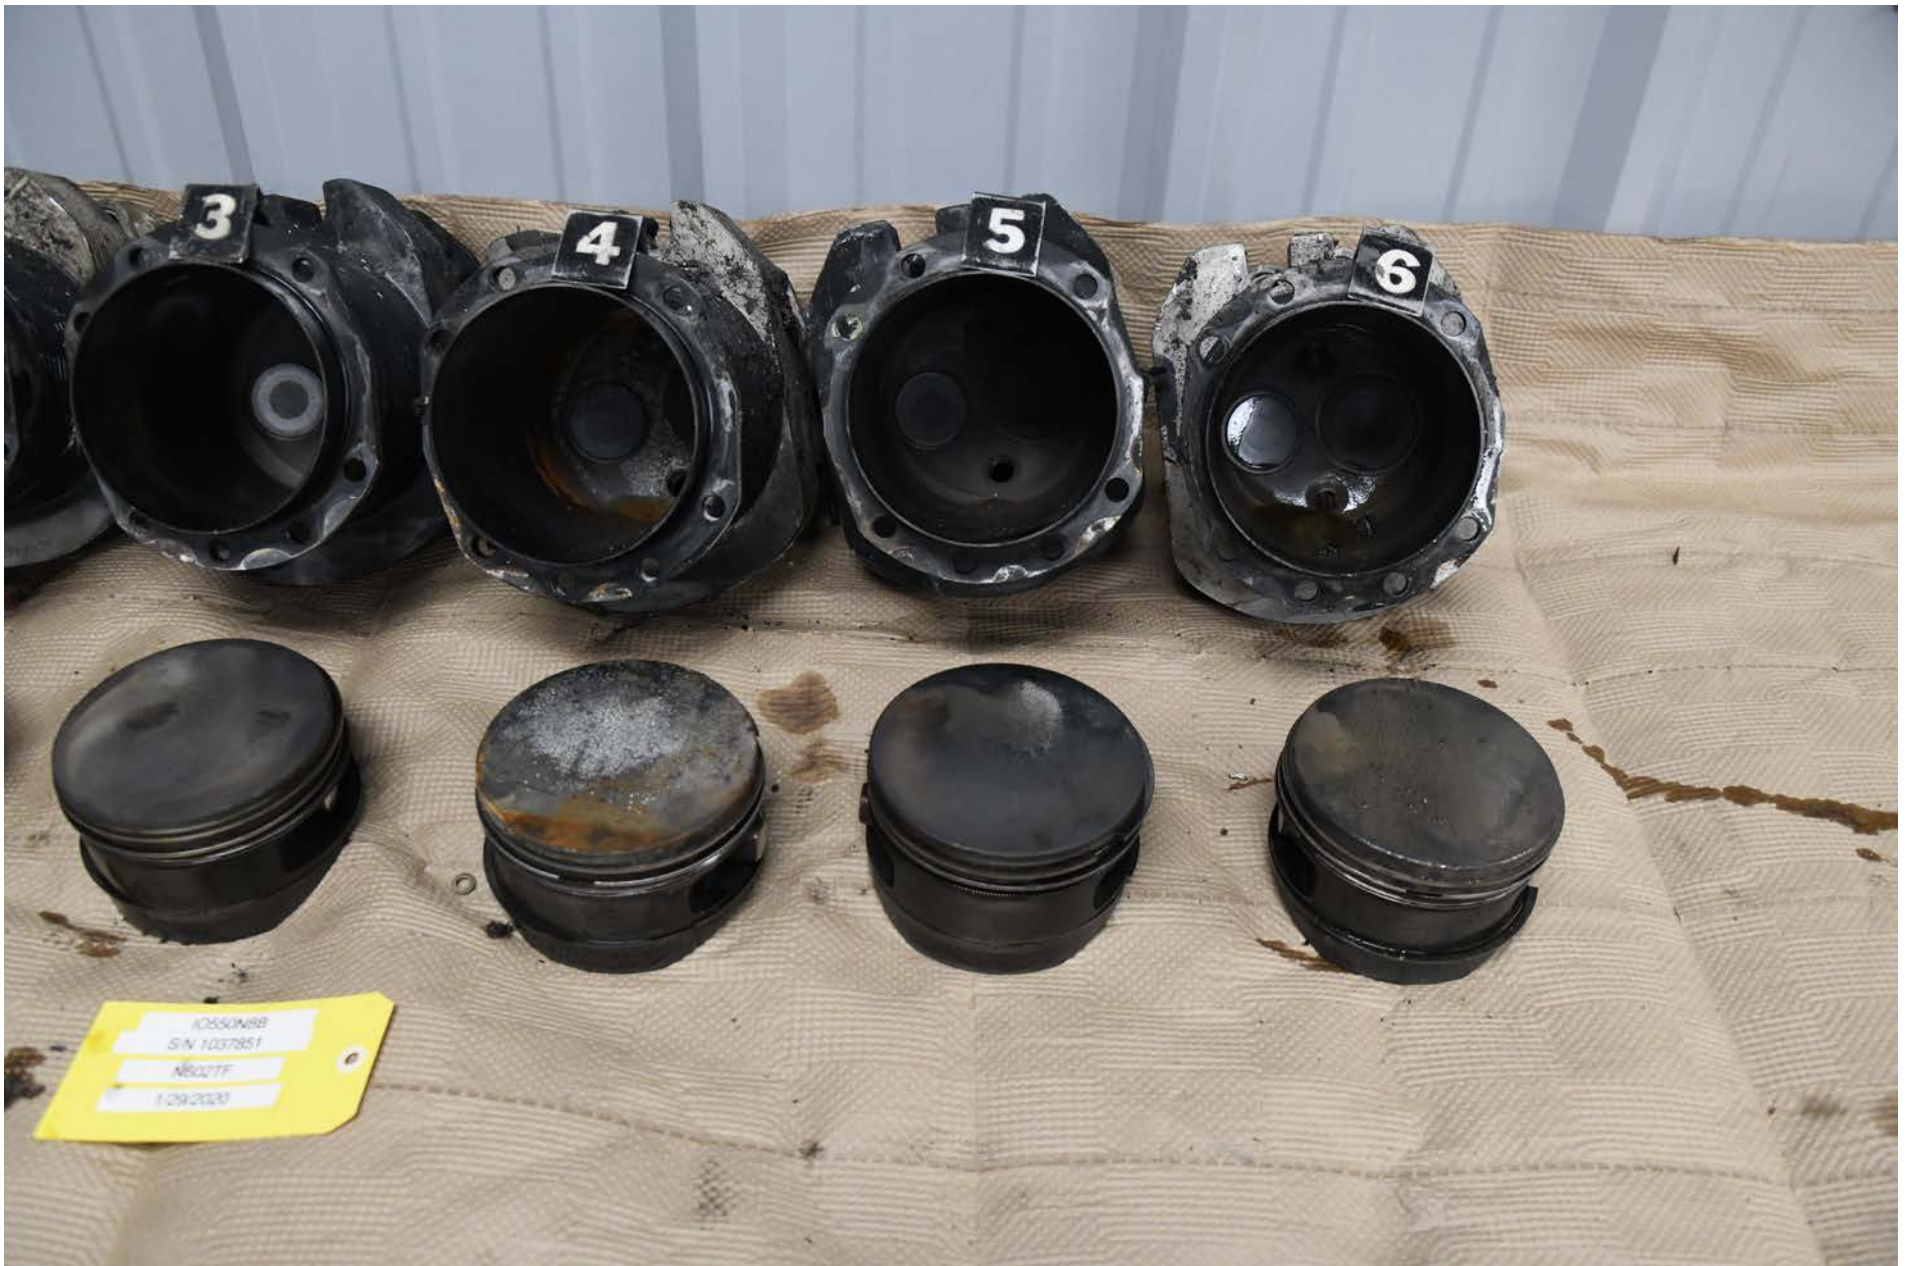
Photo 30 - Close up view inside removed cylinders.

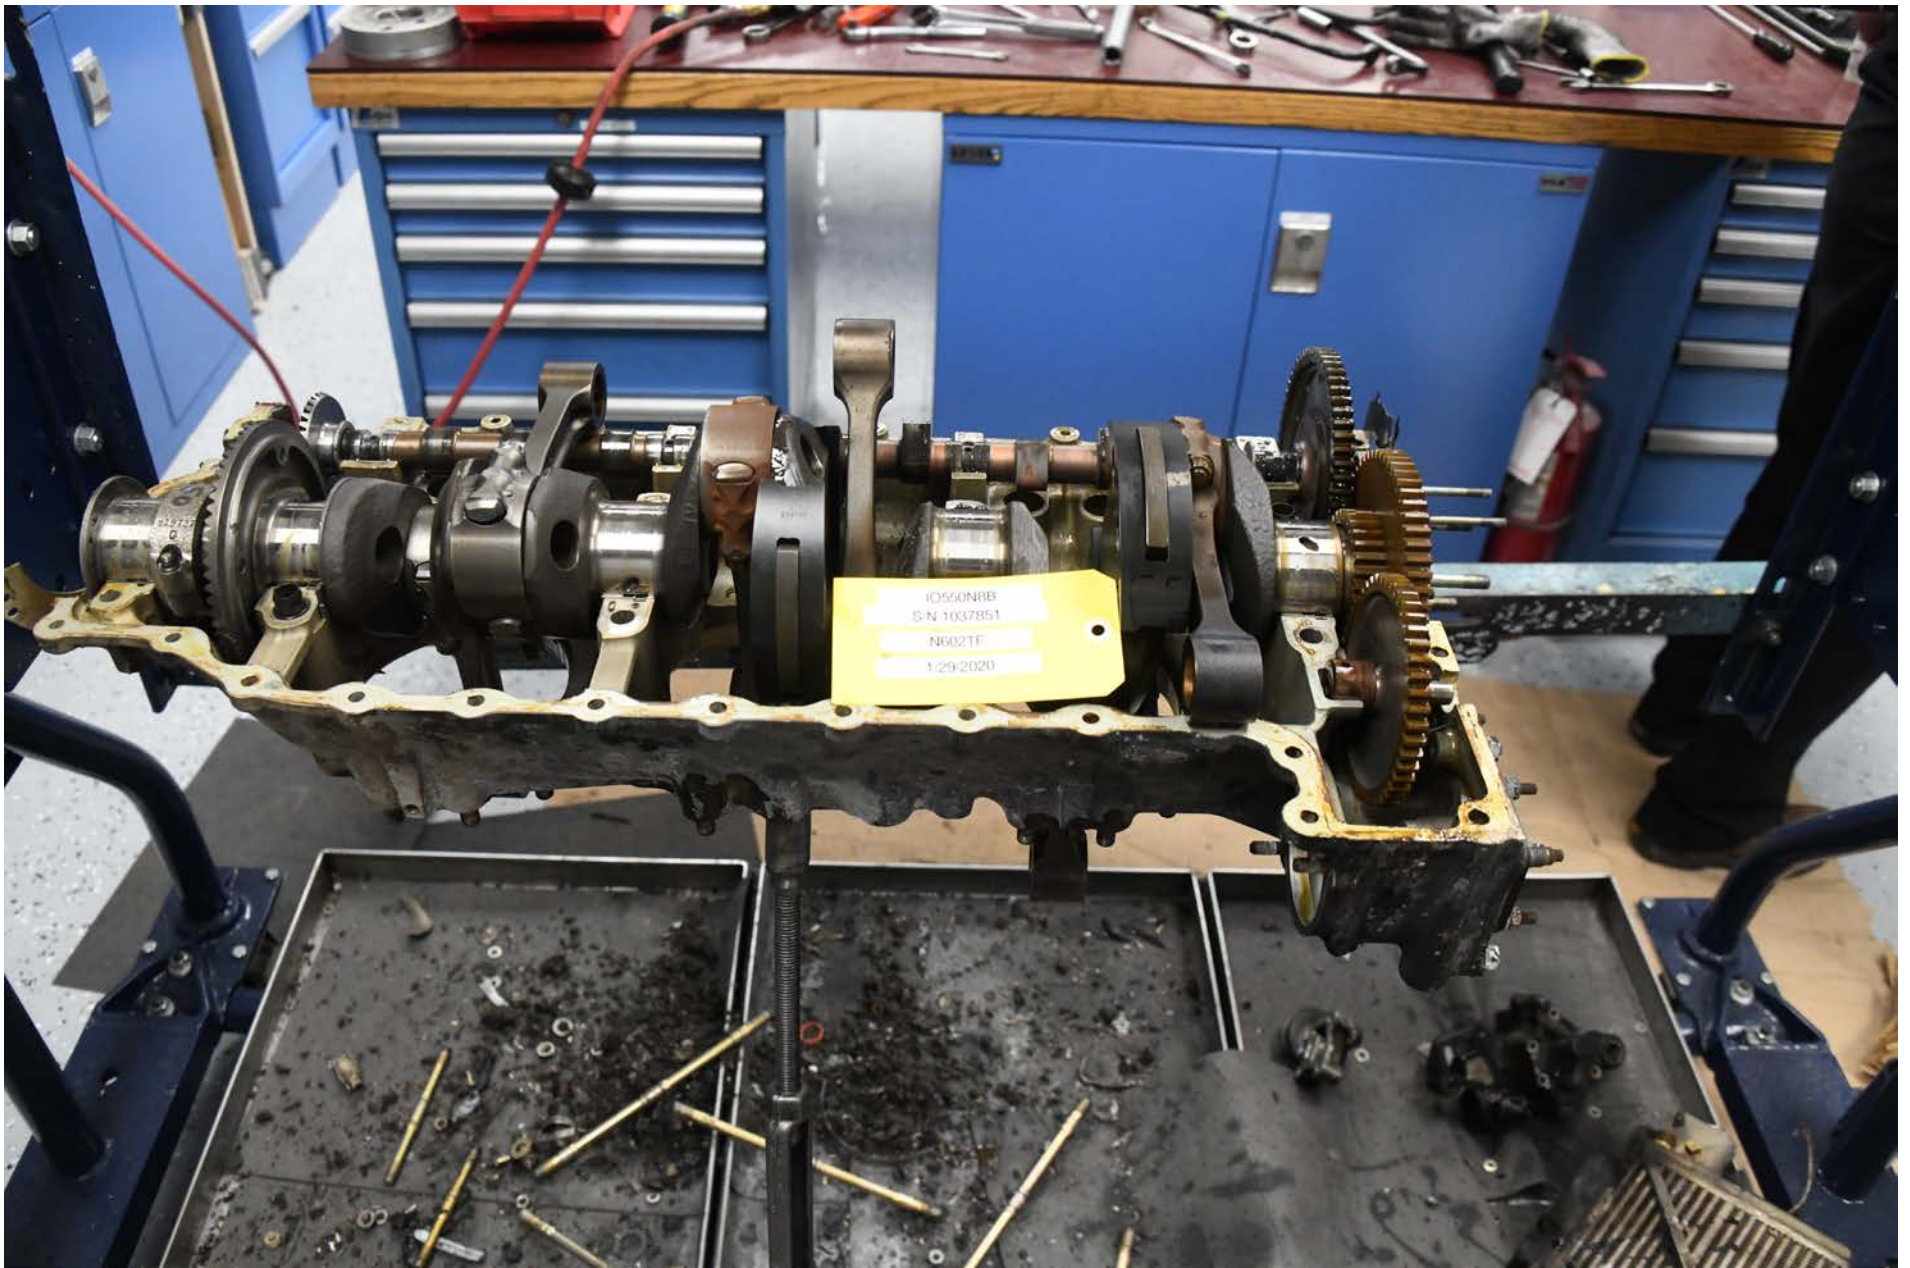
Photo 31 - View inside the crankcase. The crankshaft and connecting rods are present.

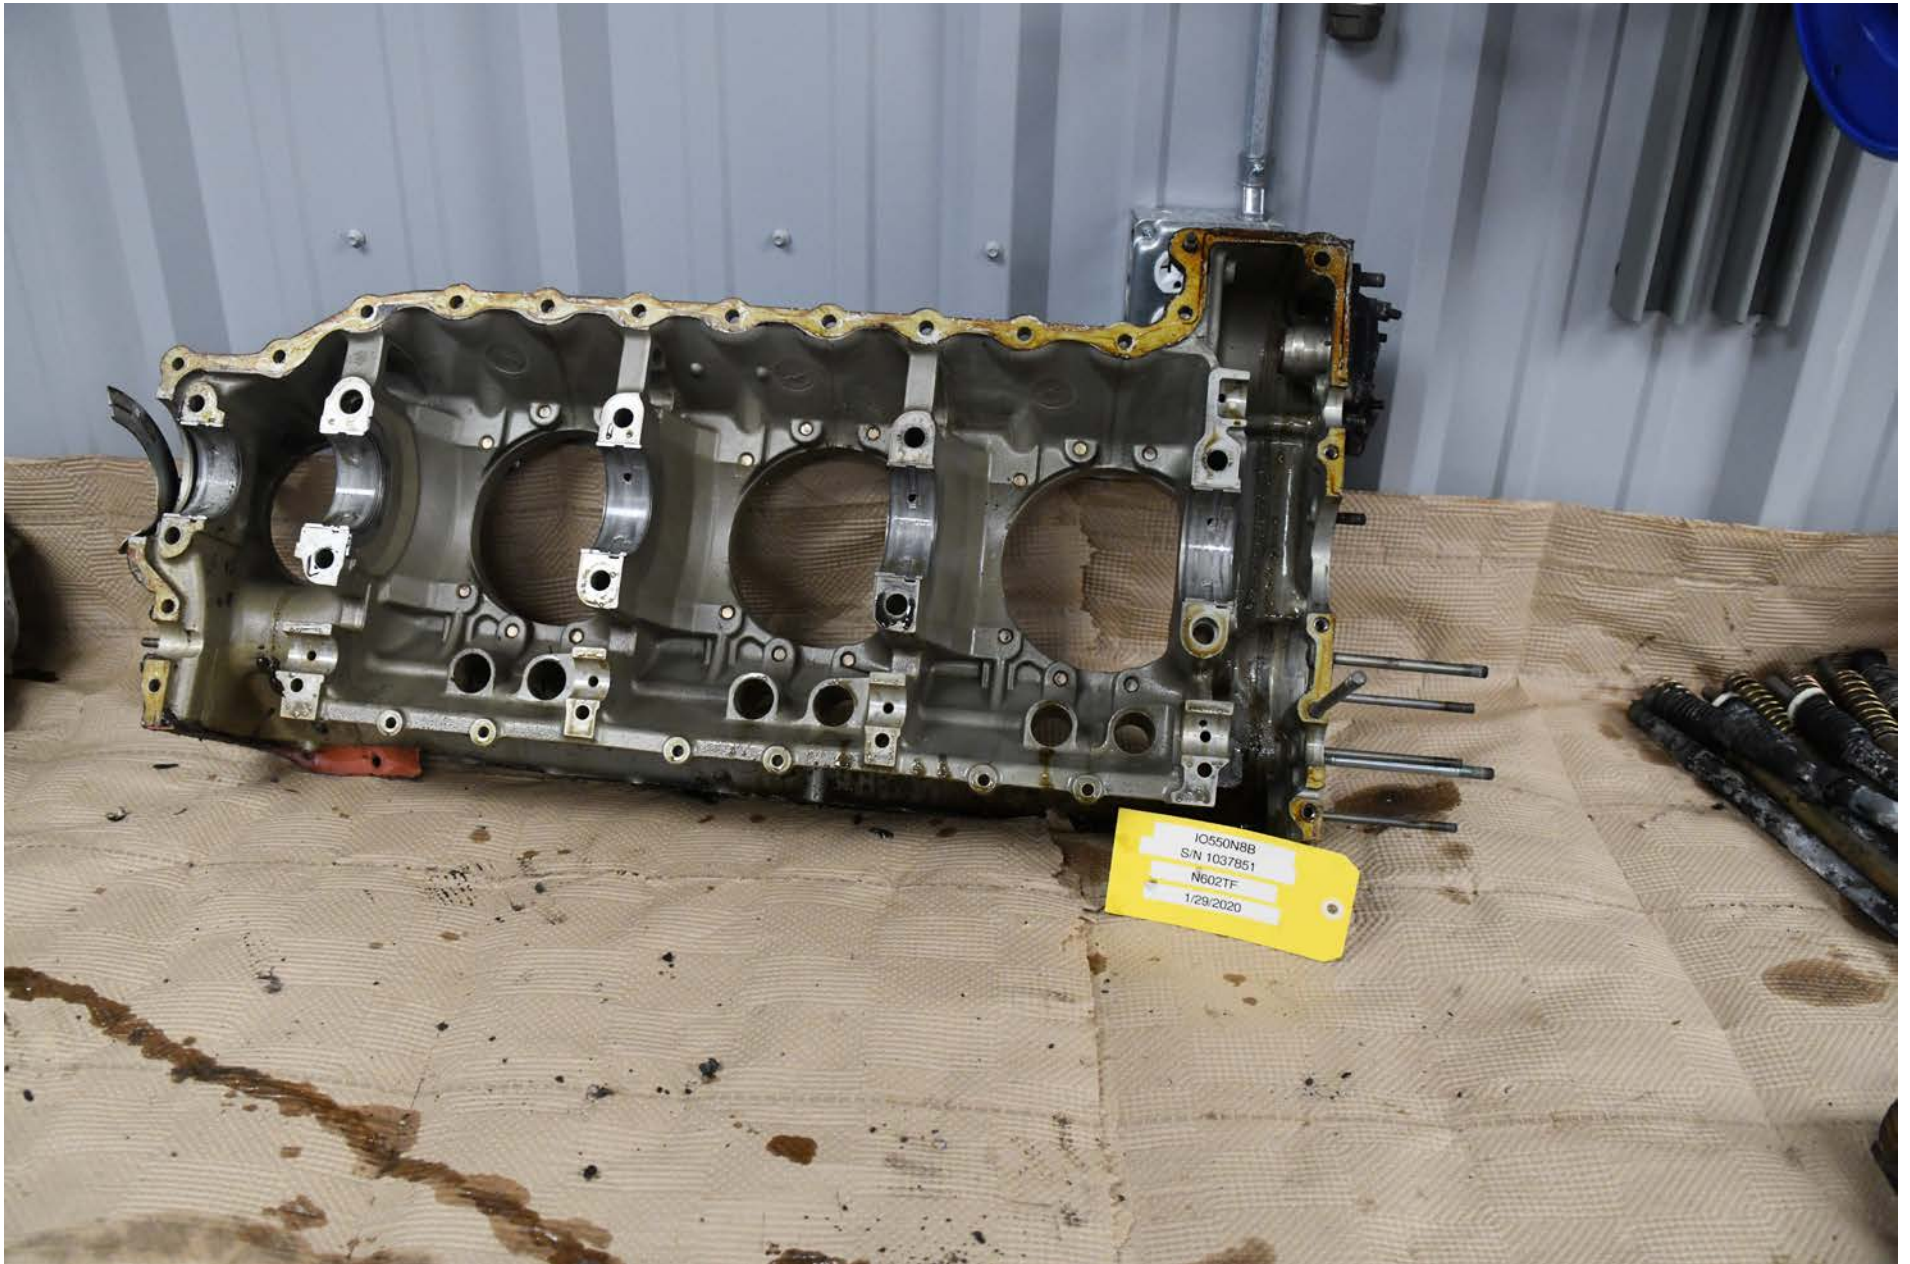
Photo 32 - View inside the crankcase.

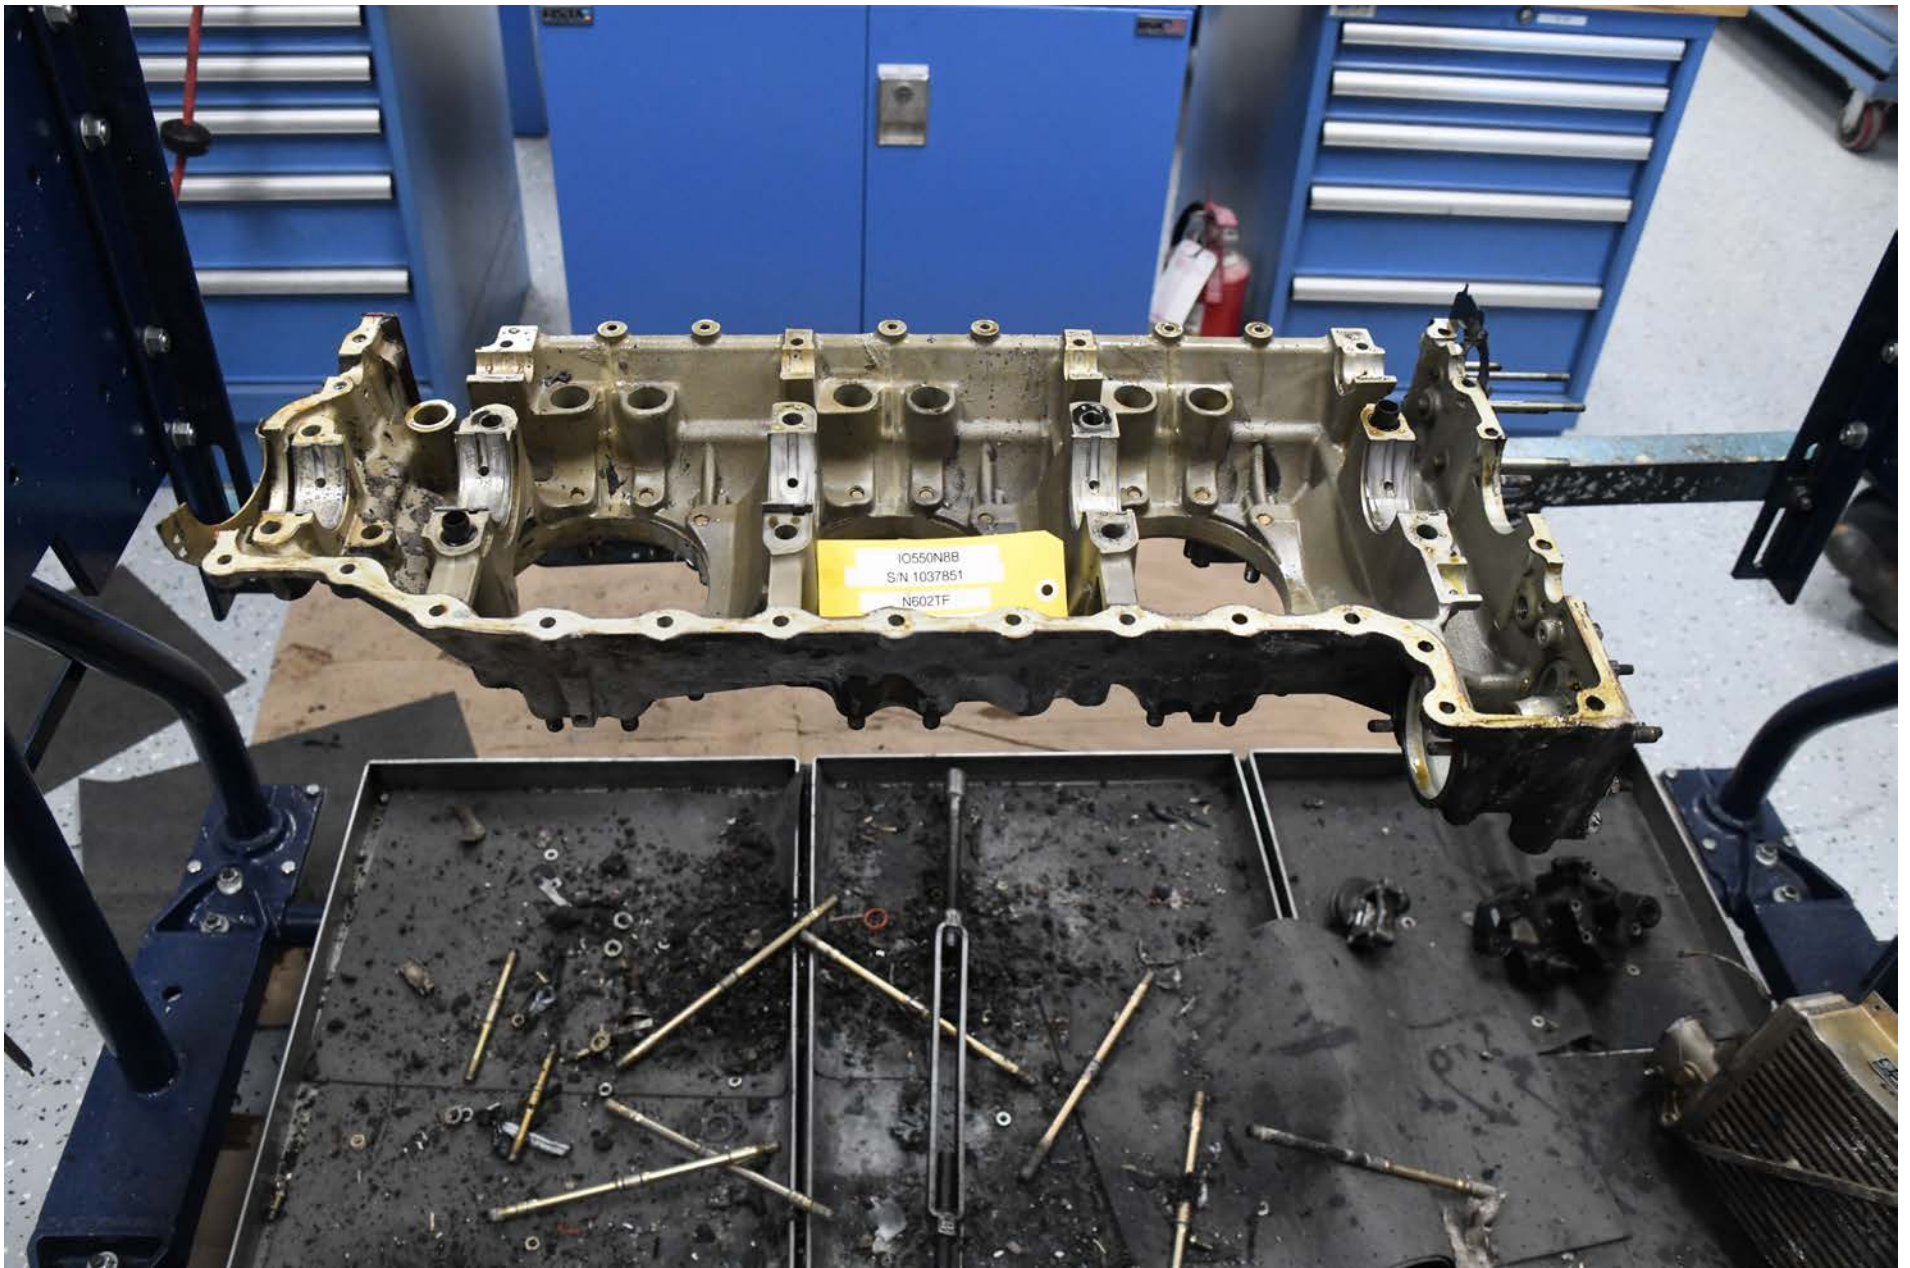
Photo 33 - View inside the crankcase with the crankshaft removed.

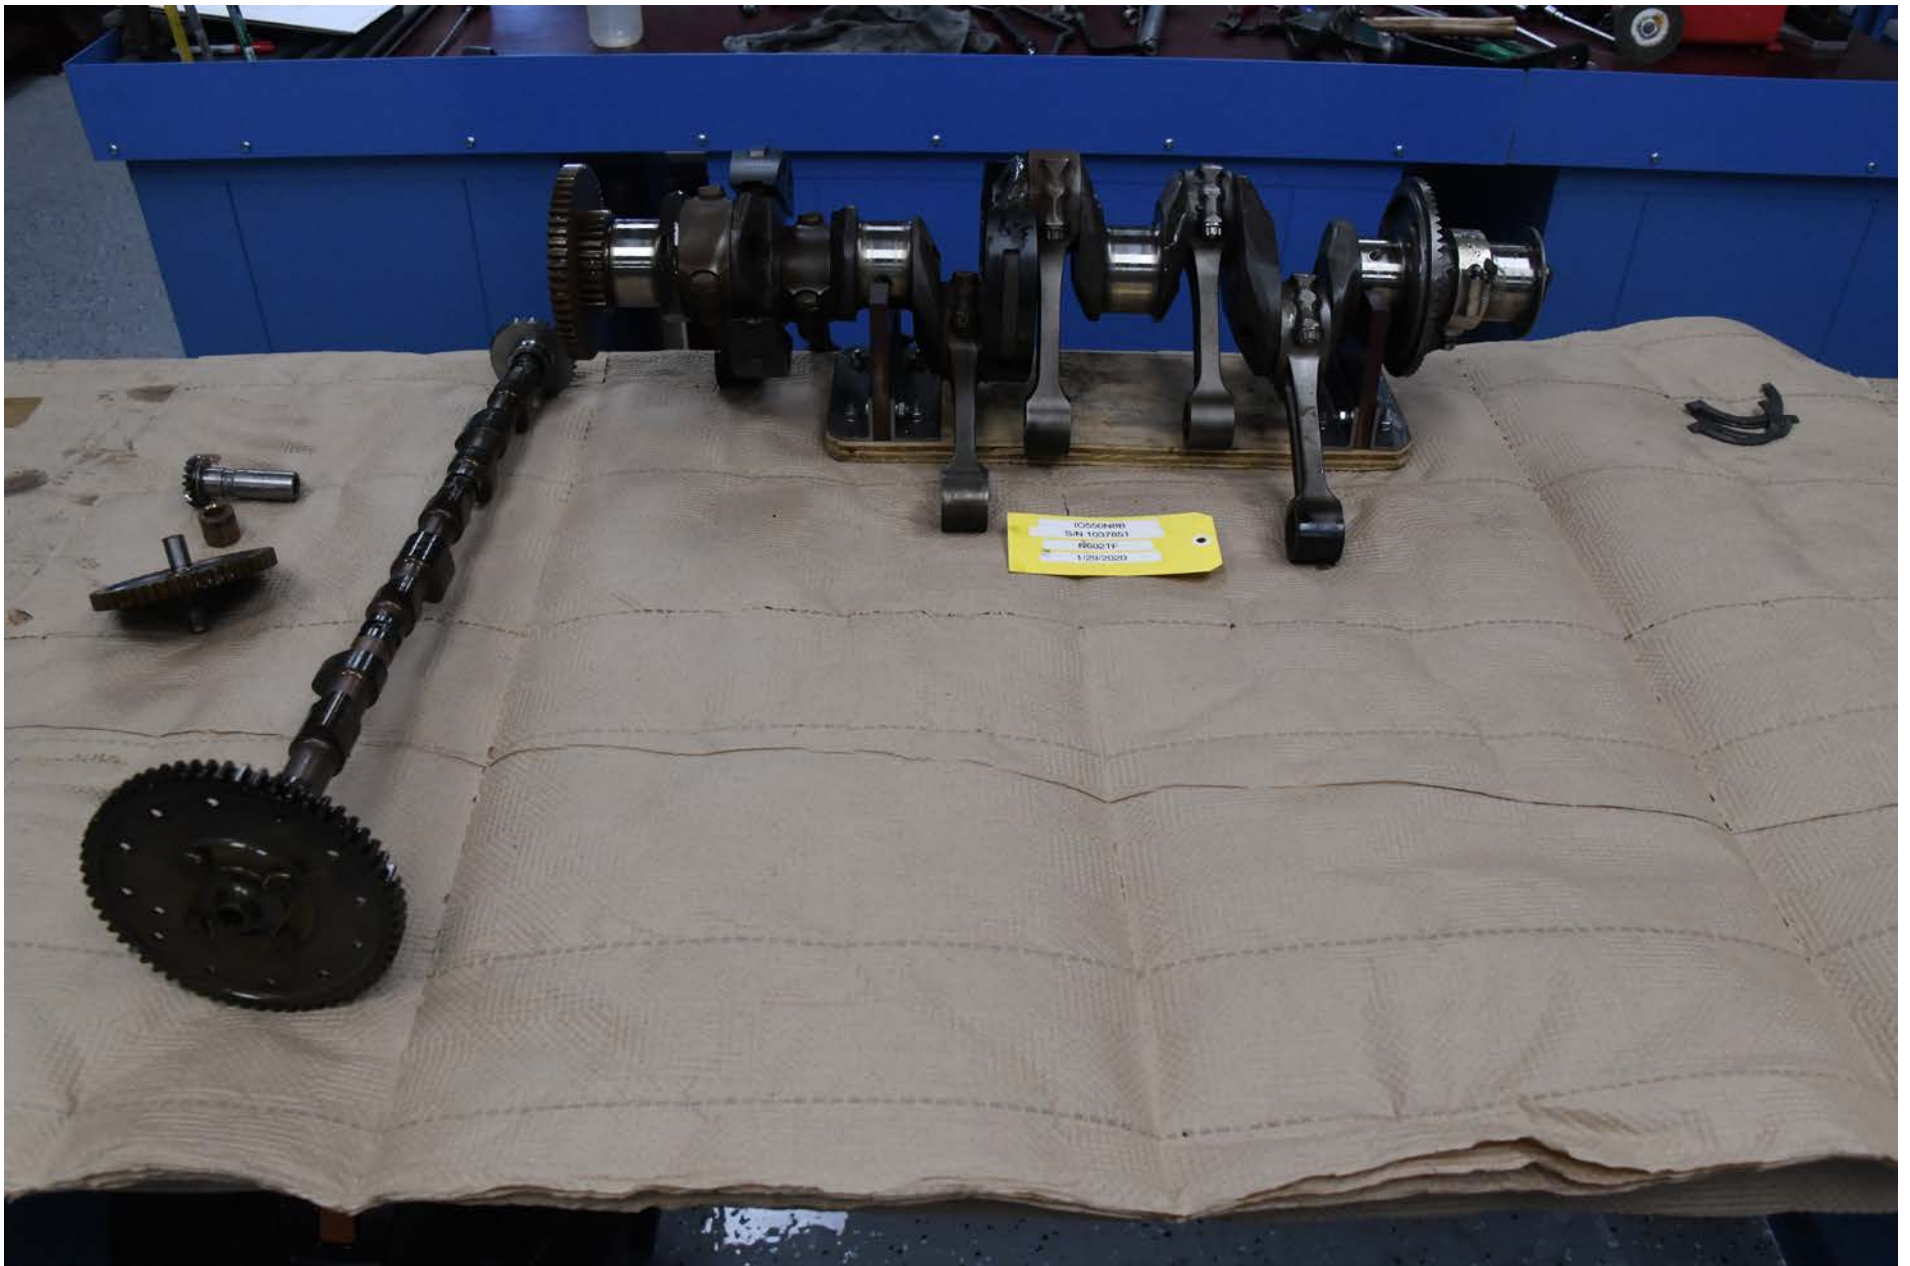
Photo 34 - View of the crankshaft and camshaft.

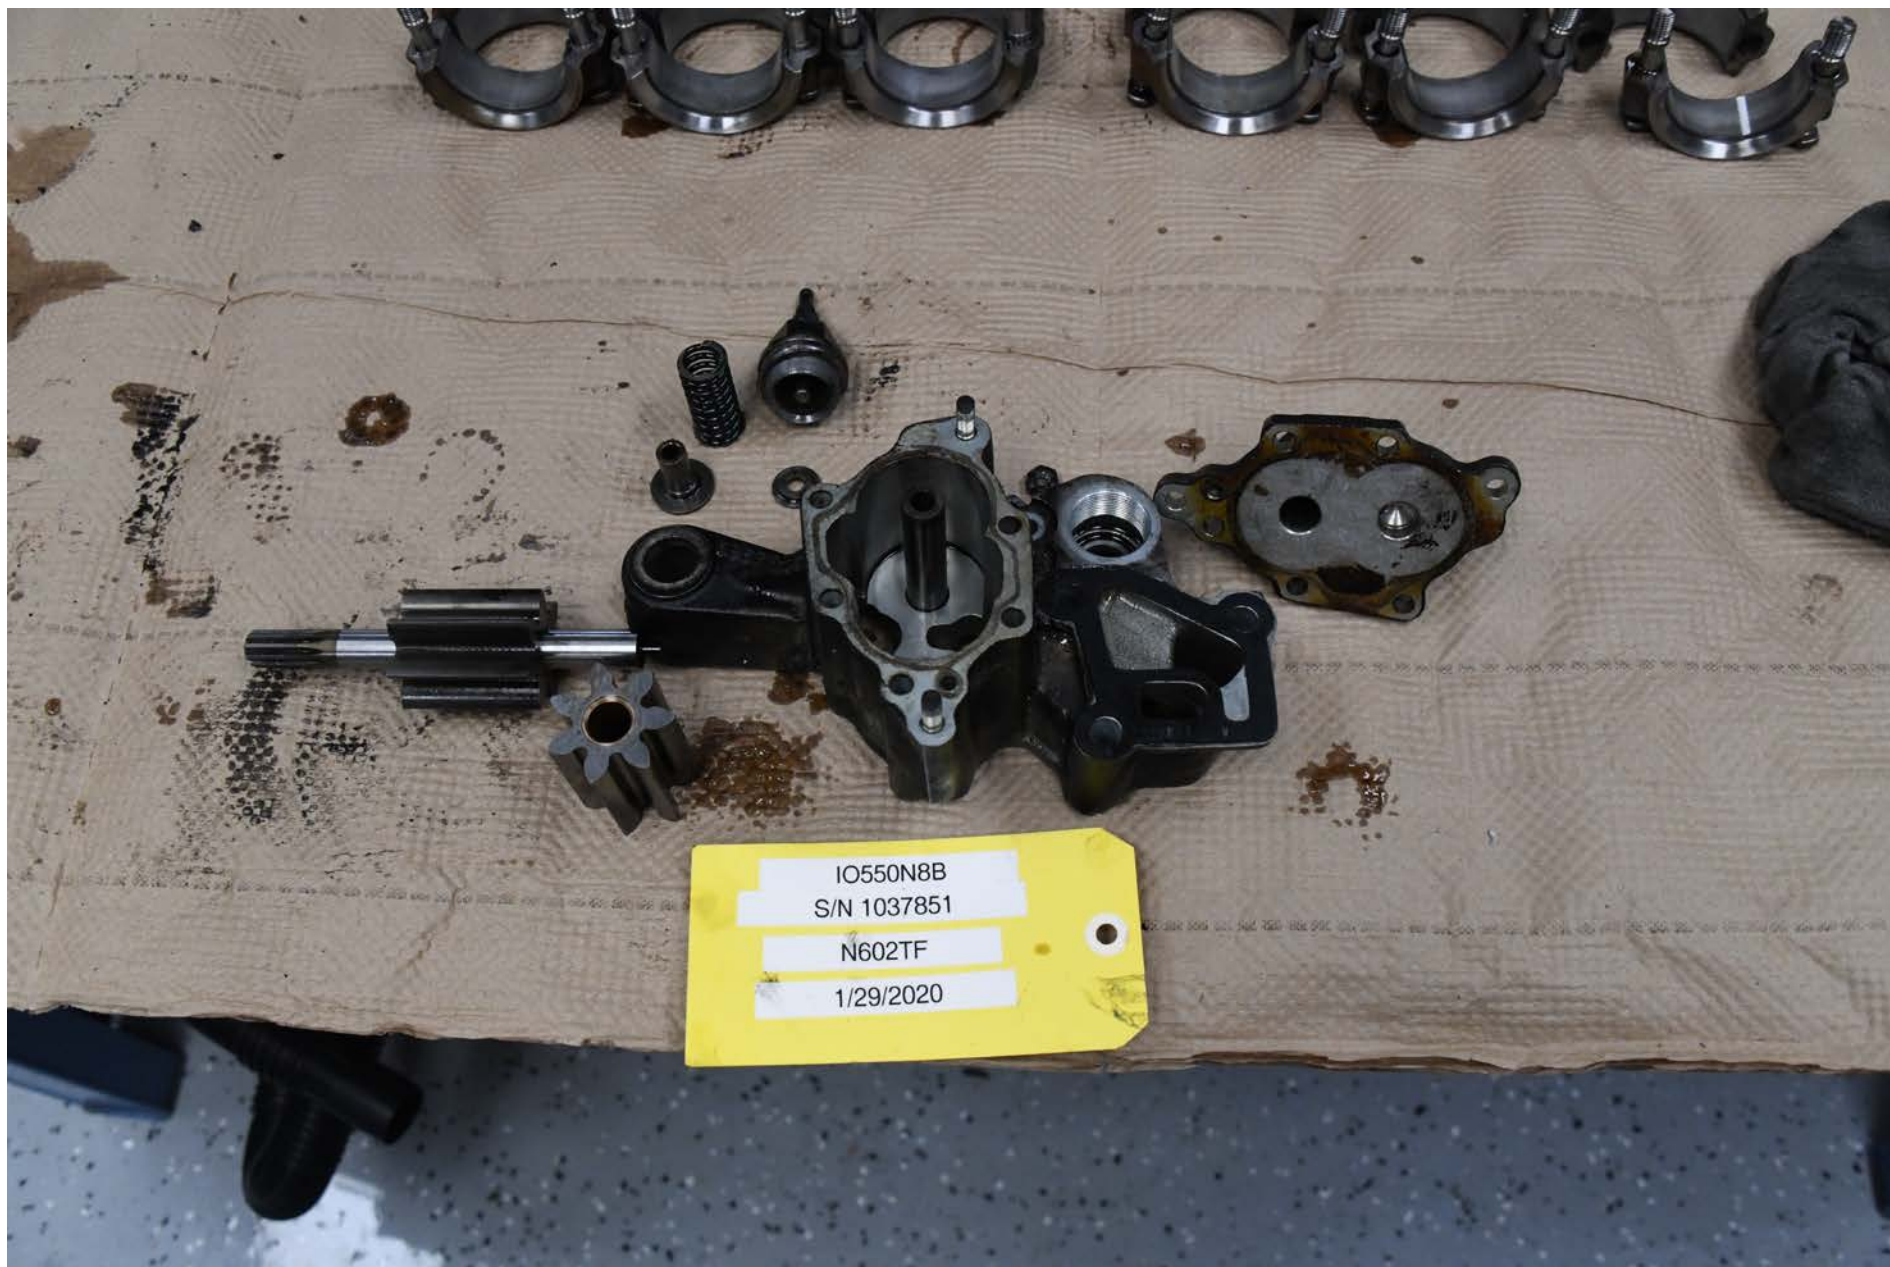
Photo 35 - View of the disassembled engine oil pump.

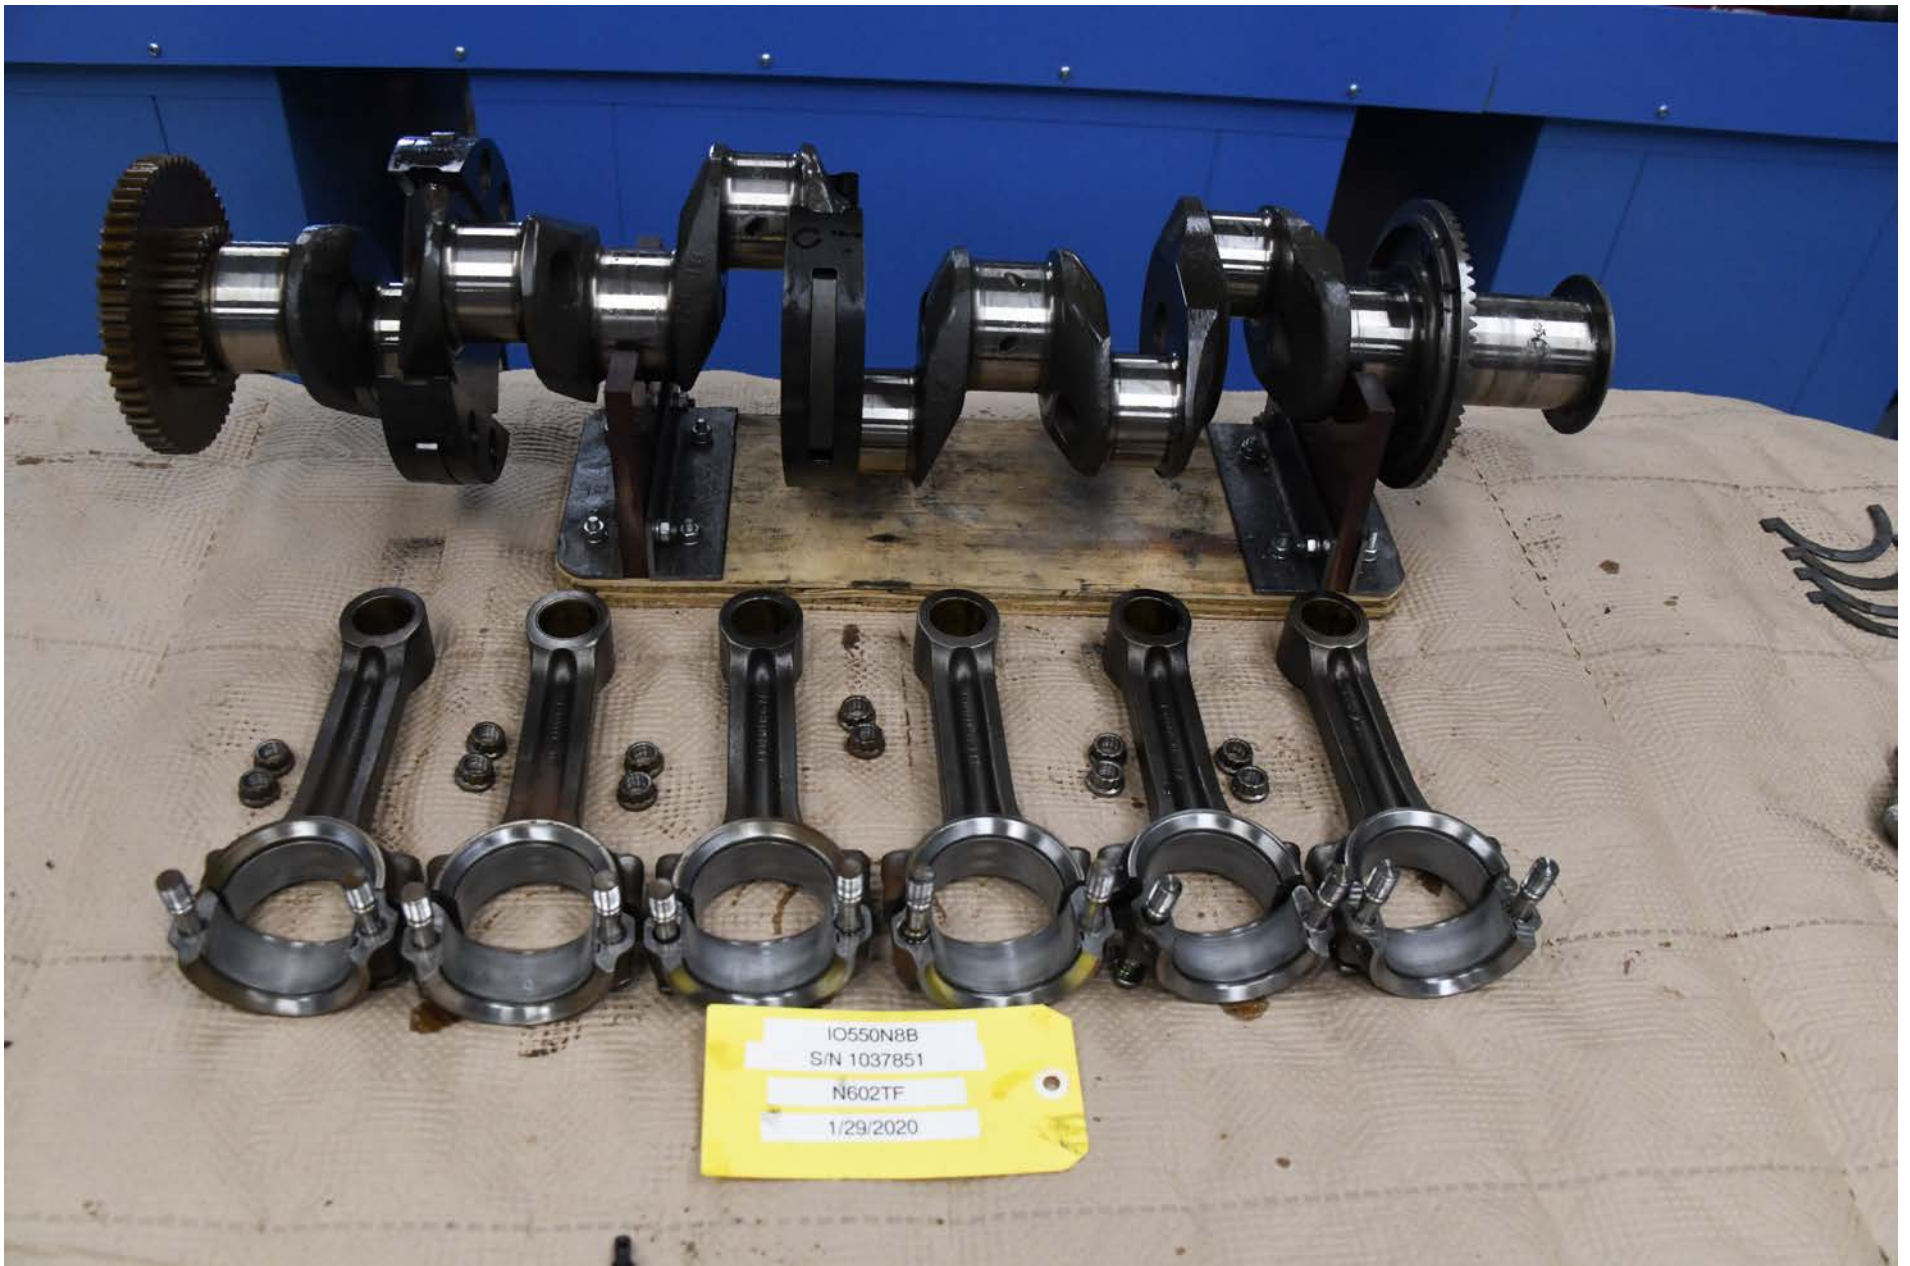
Photo 36 - View of the disassembled engine crankshaft and connecting rods.

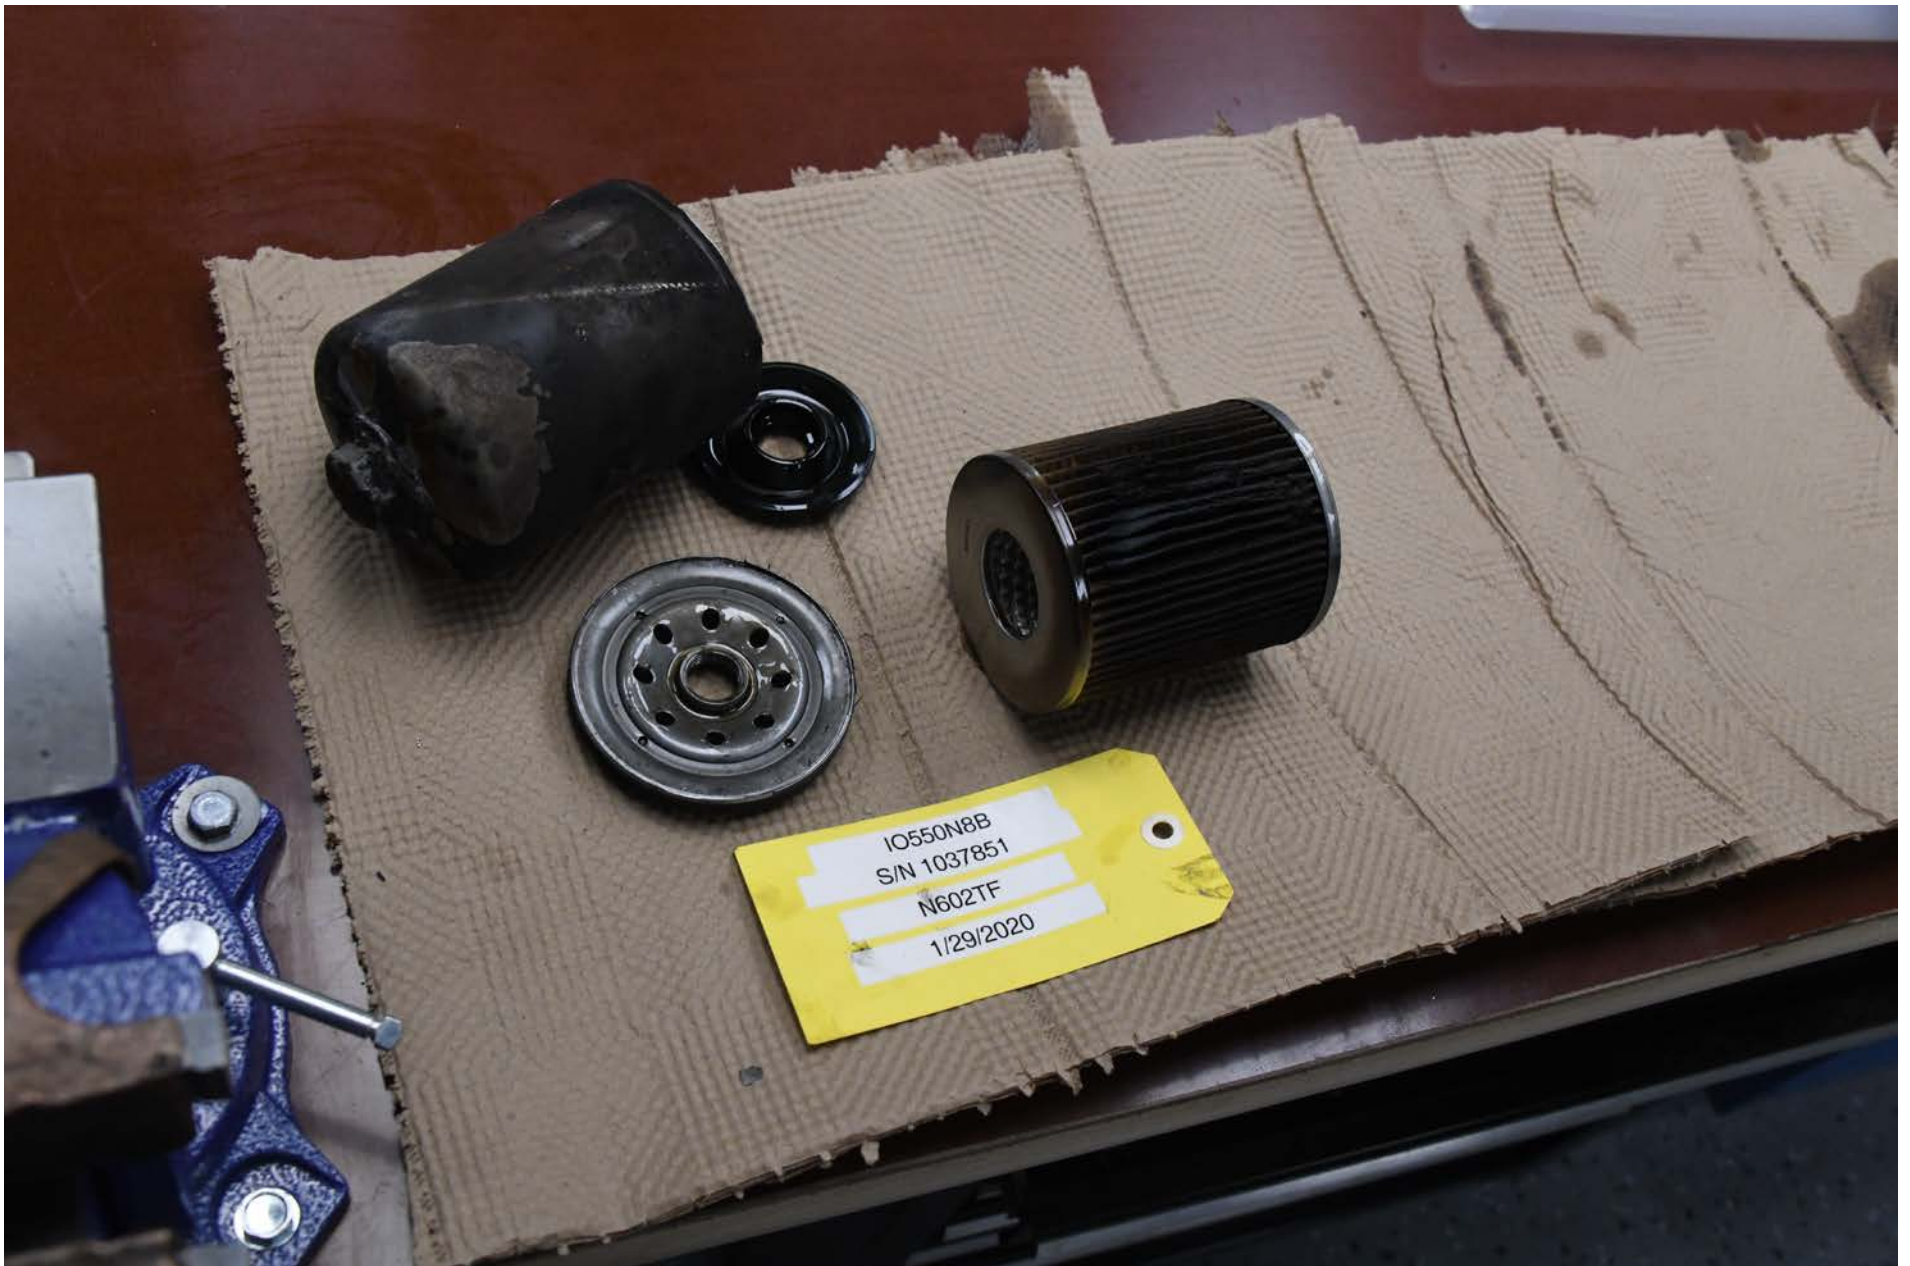
Photo 37 - View of the disassembled engine oil filter.

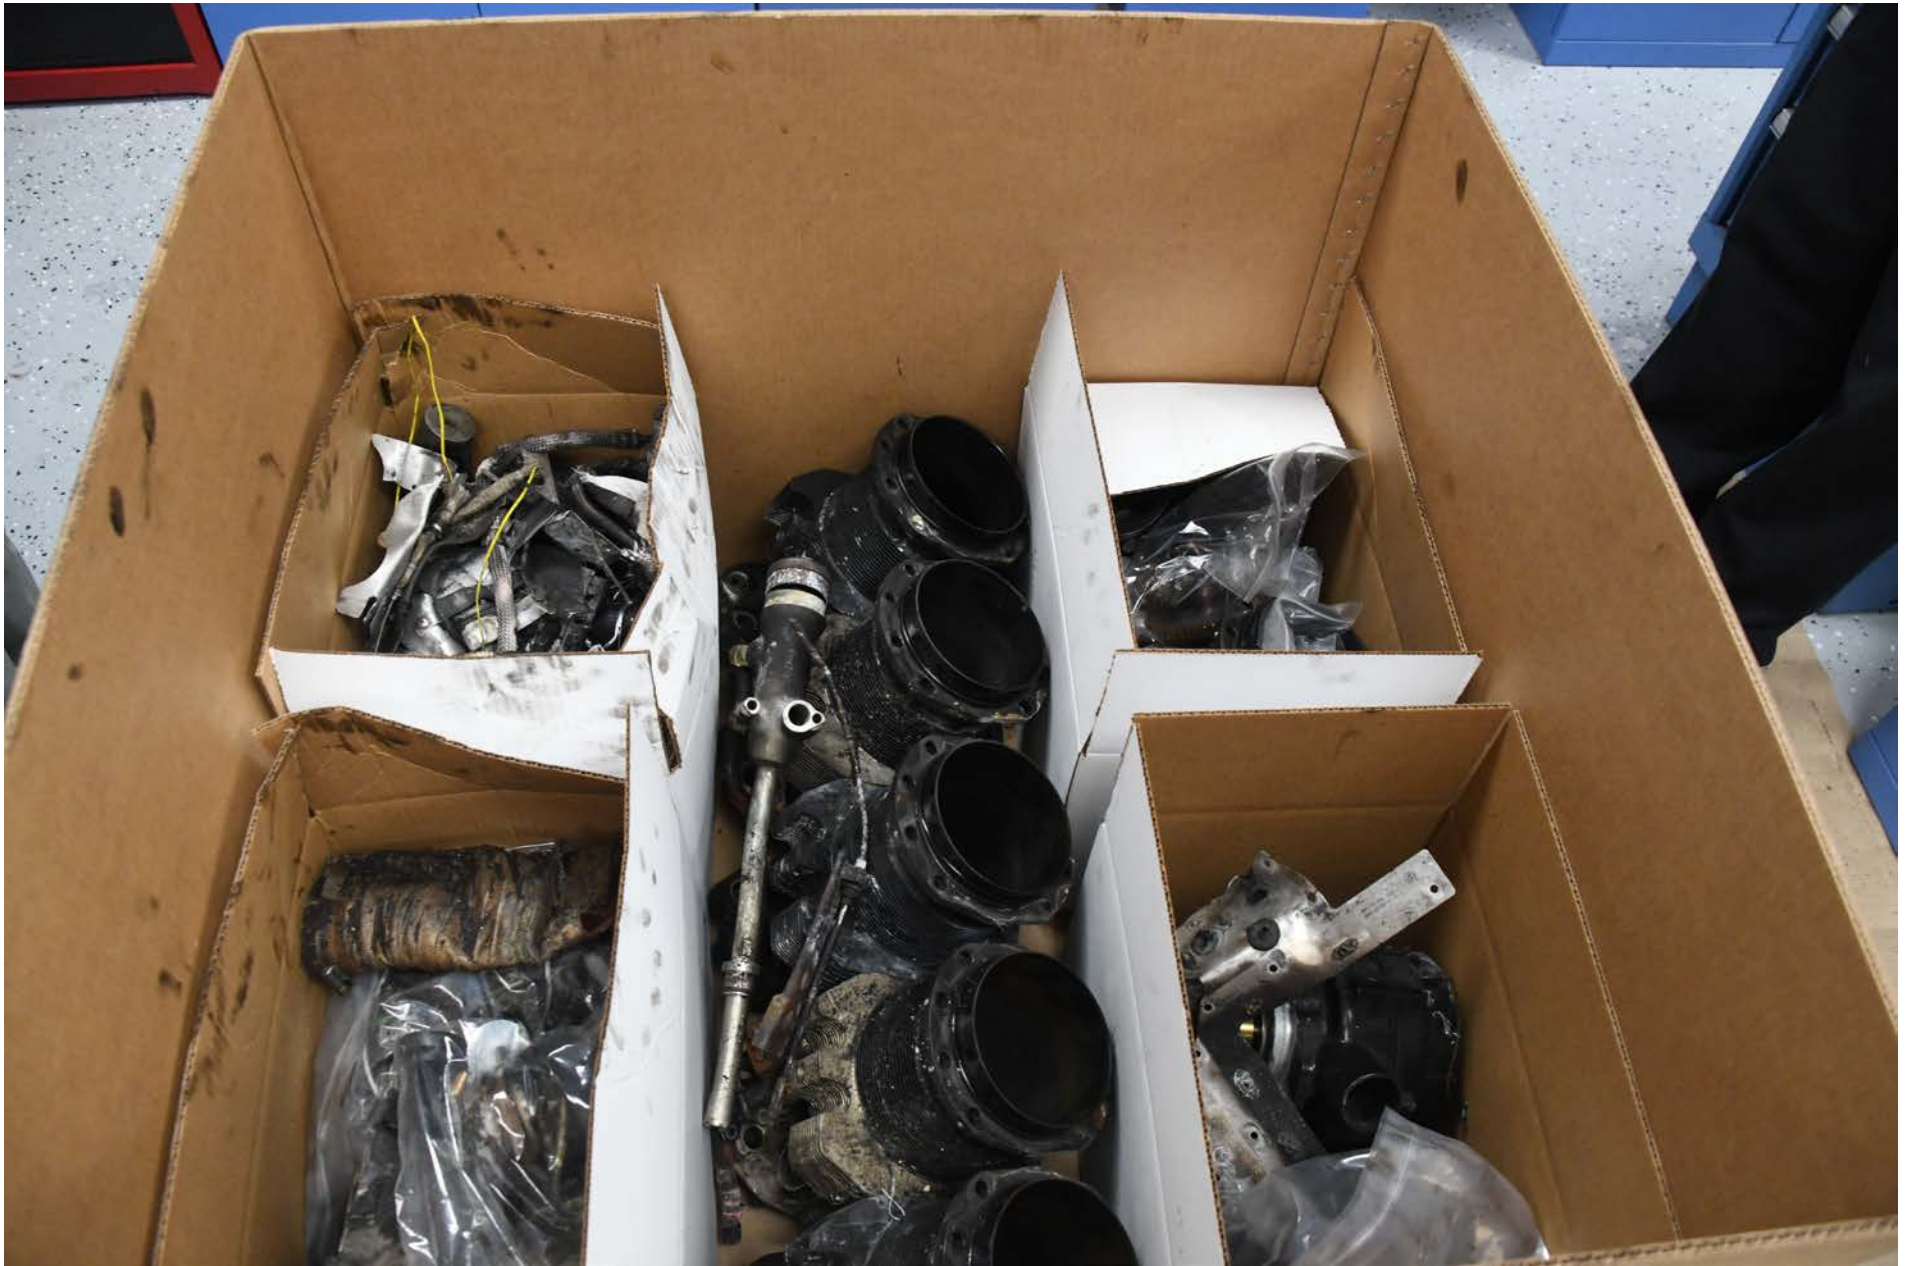
Photo 38 - View of the disassembled engine during its return shipment.

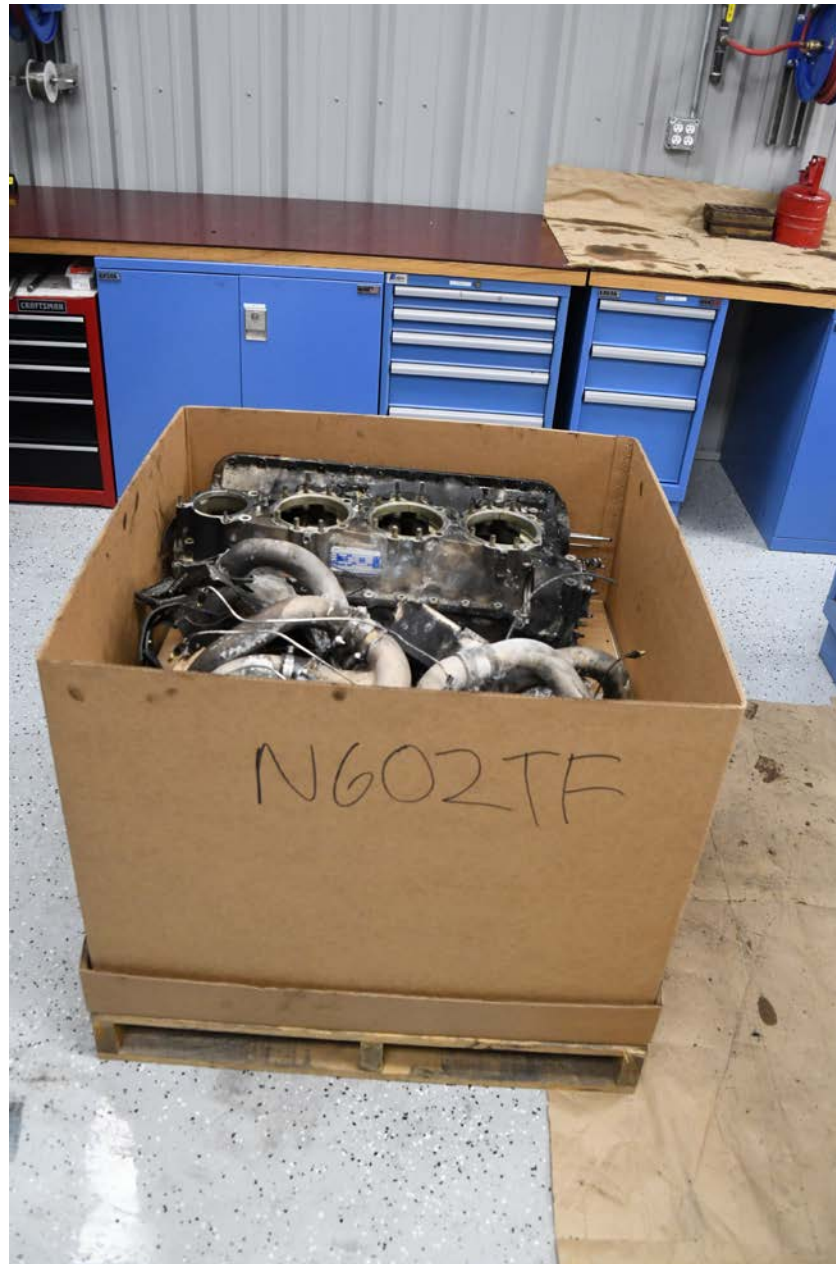
Photo 39 - View of the disassembled engine during its return shipment.
