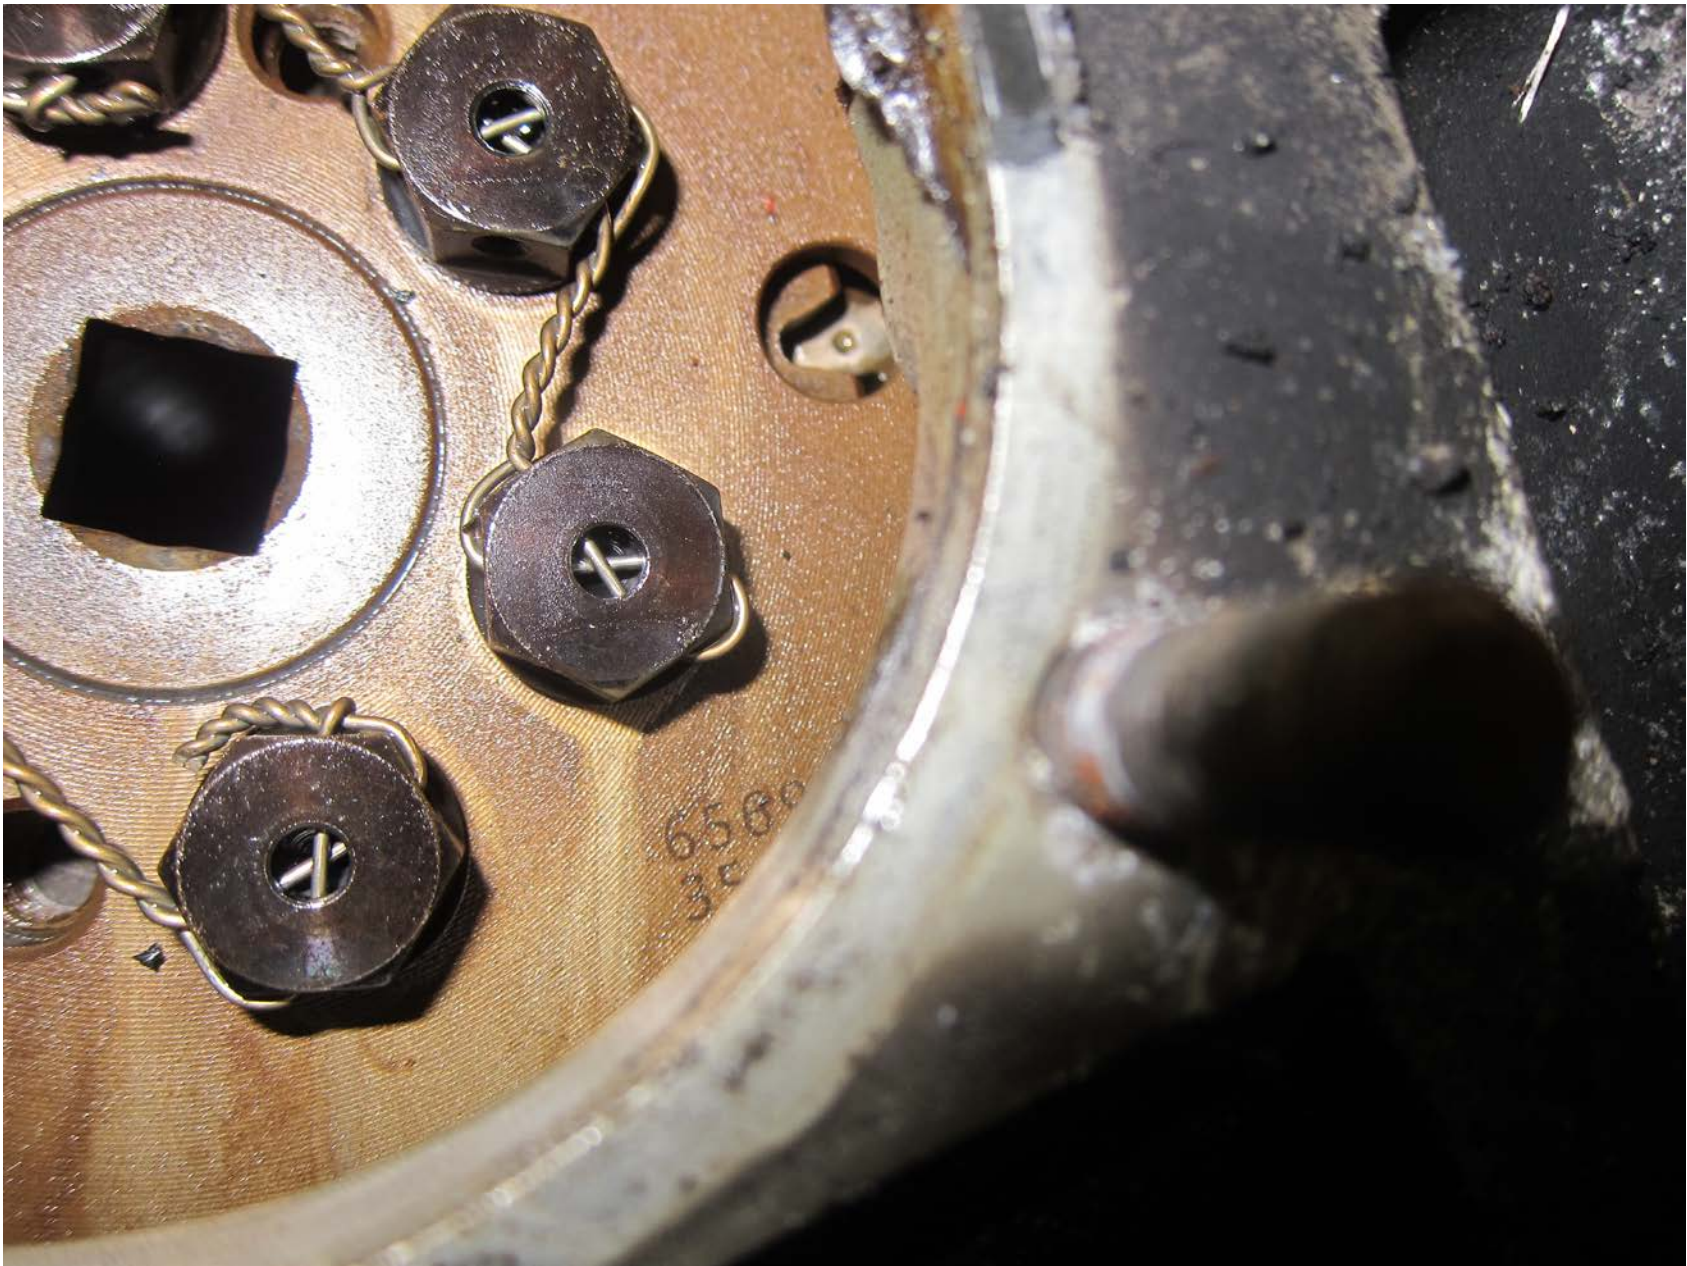
Photo 40 - Supplied close up view of the timing mark between gear teeth.
