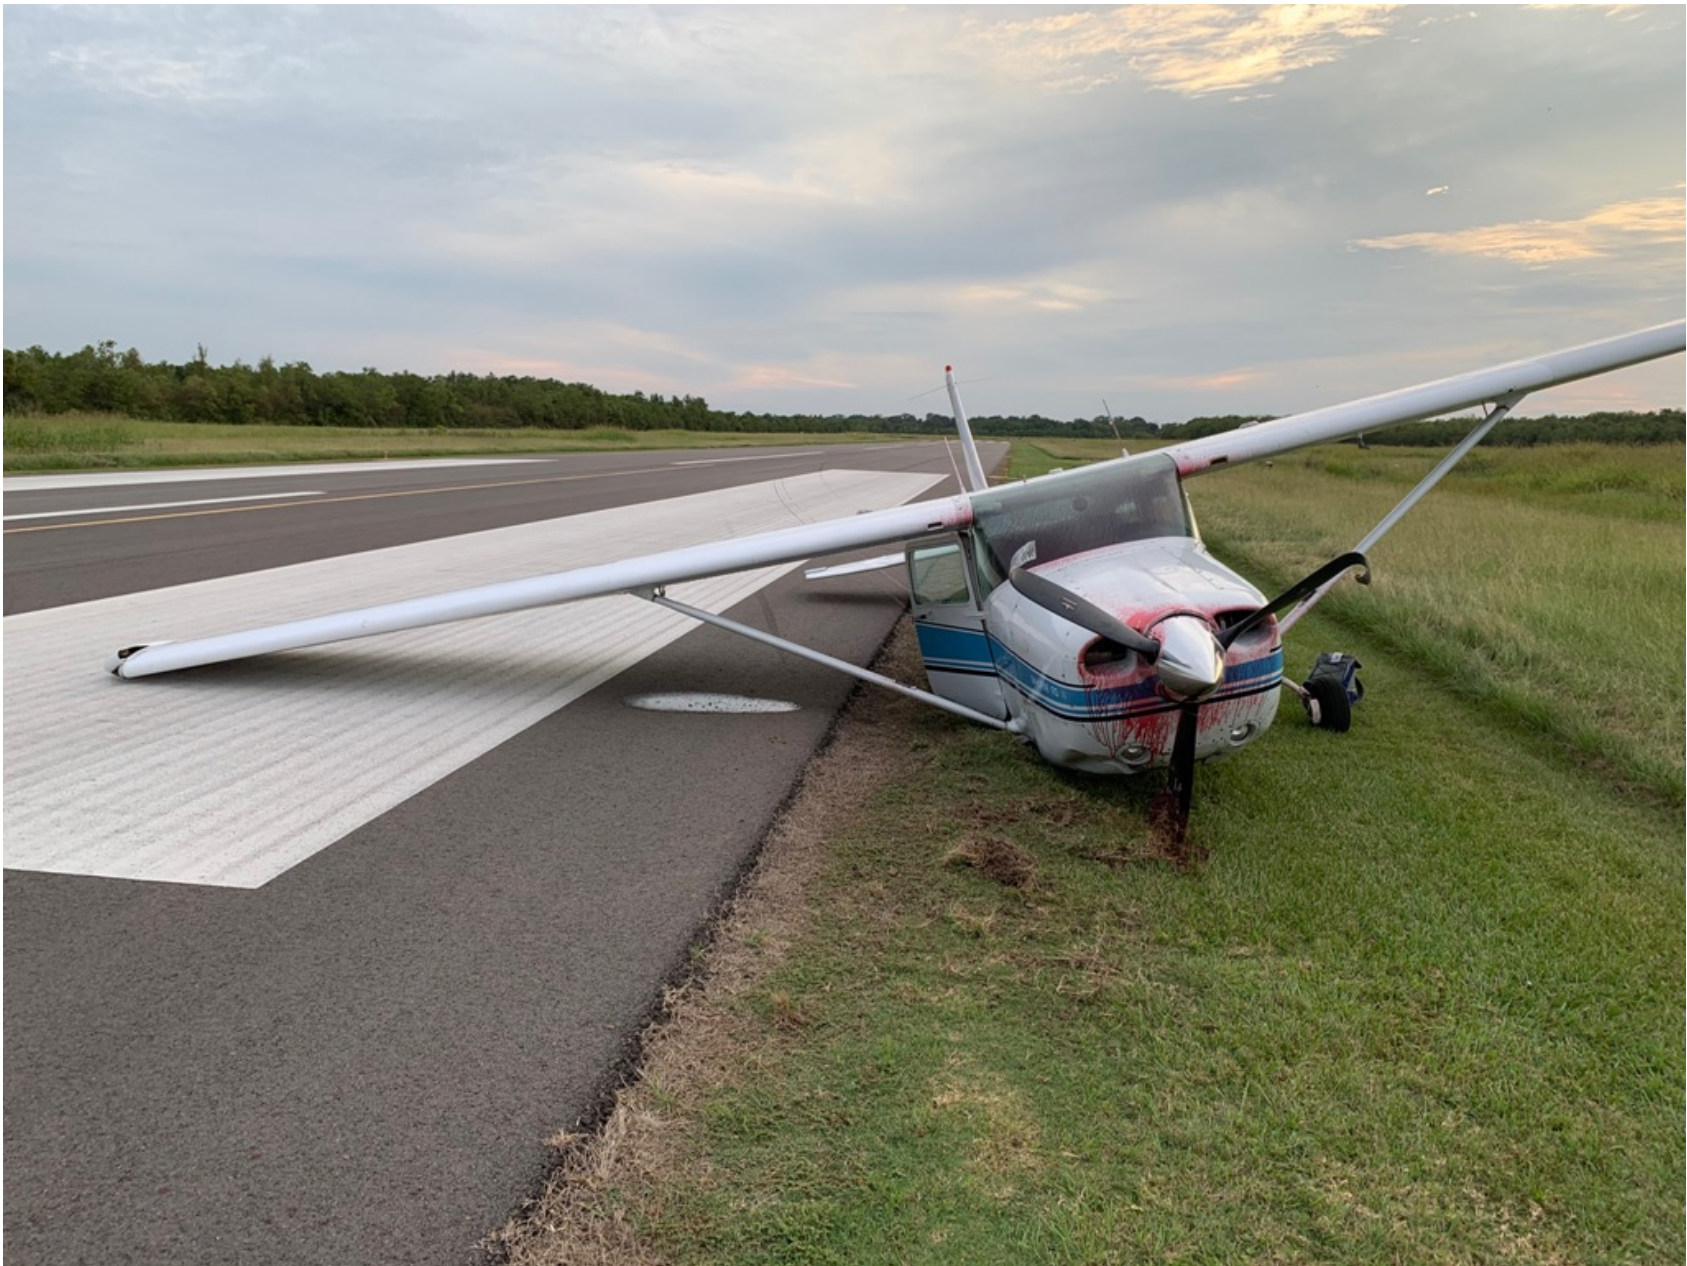
Photo 1 – Supplied photo of the front of the airplane with its nose and right landing gear collapsed.

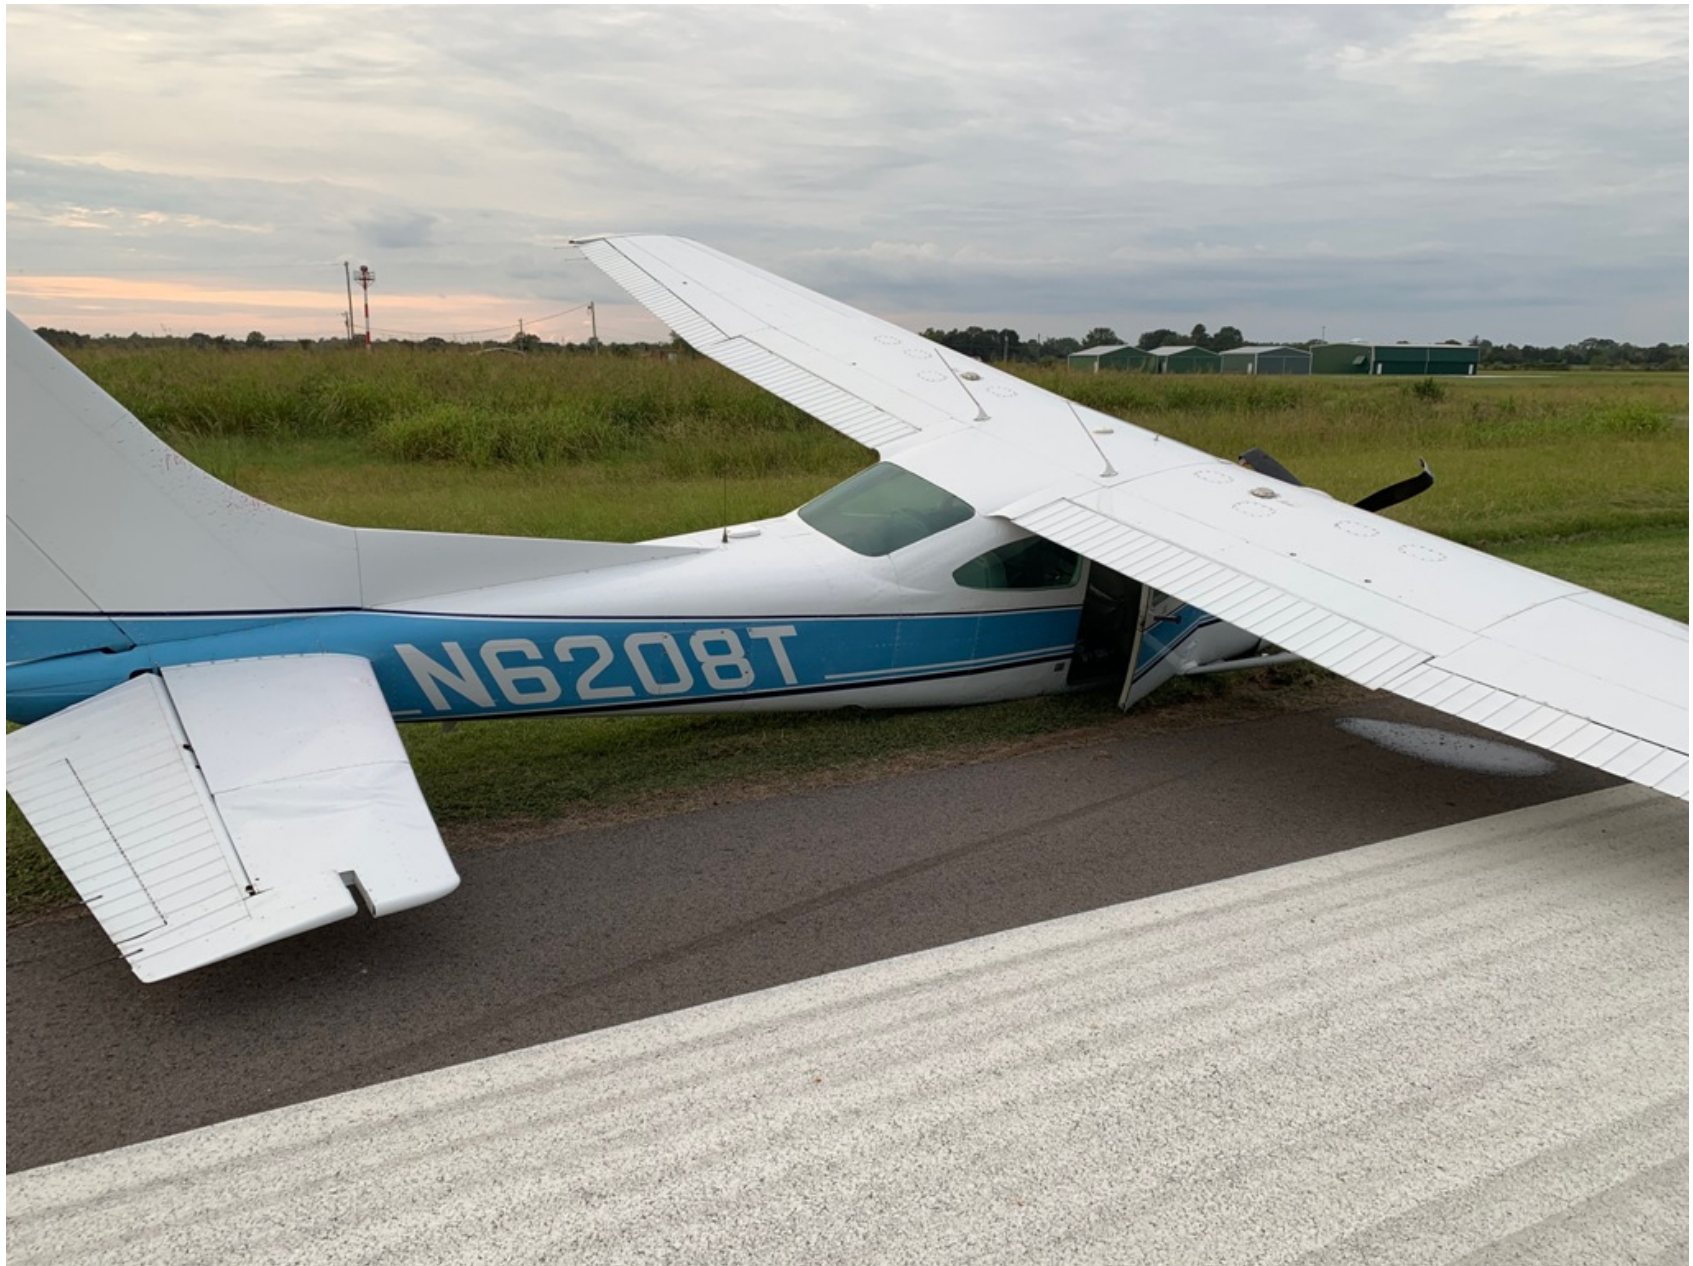
Photo 2 - Supplied photo of the right side of the airplane.

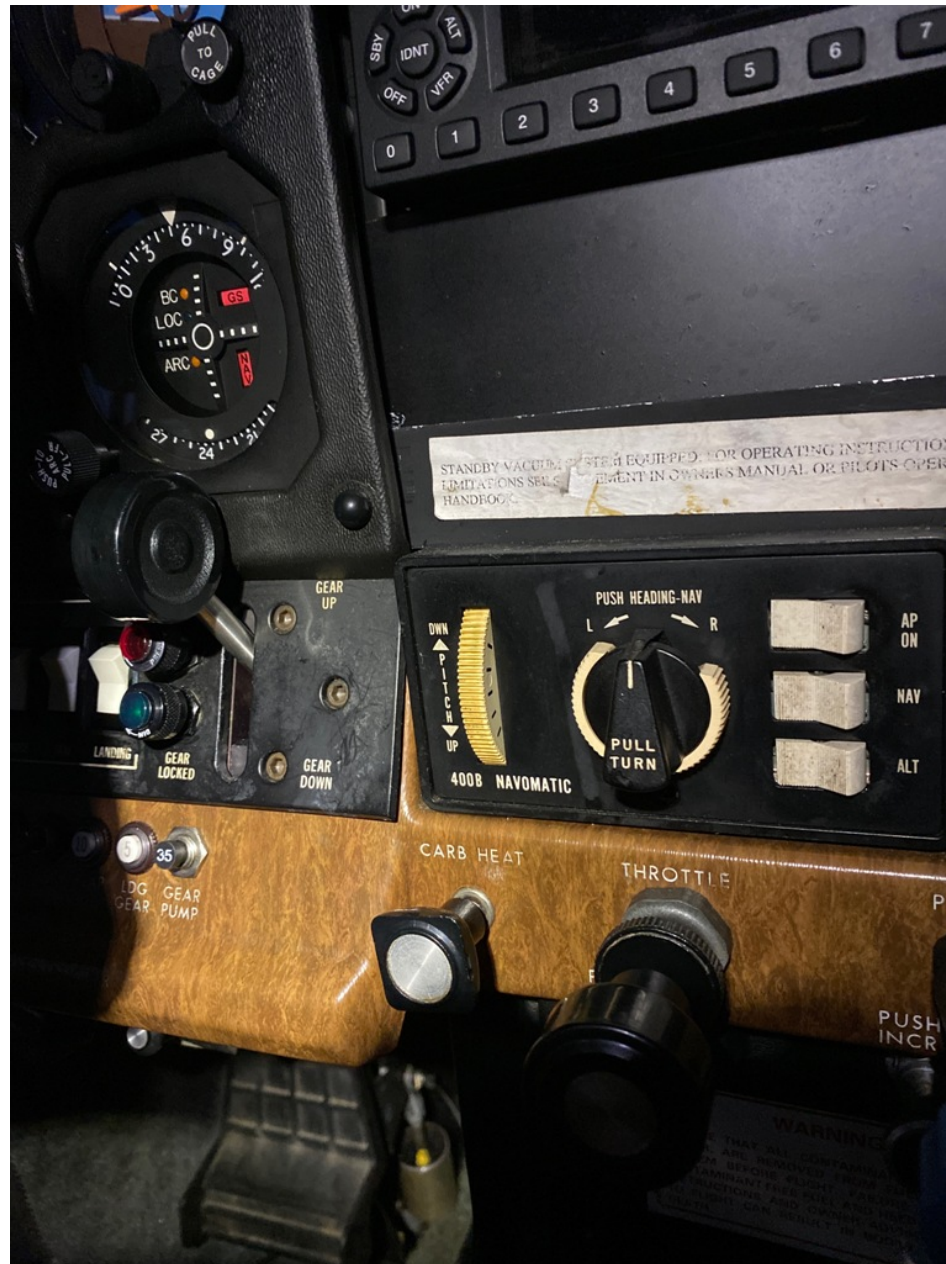
Photo 3 - Supplied photo of the instrument panel with the landing gear handle in the up position.

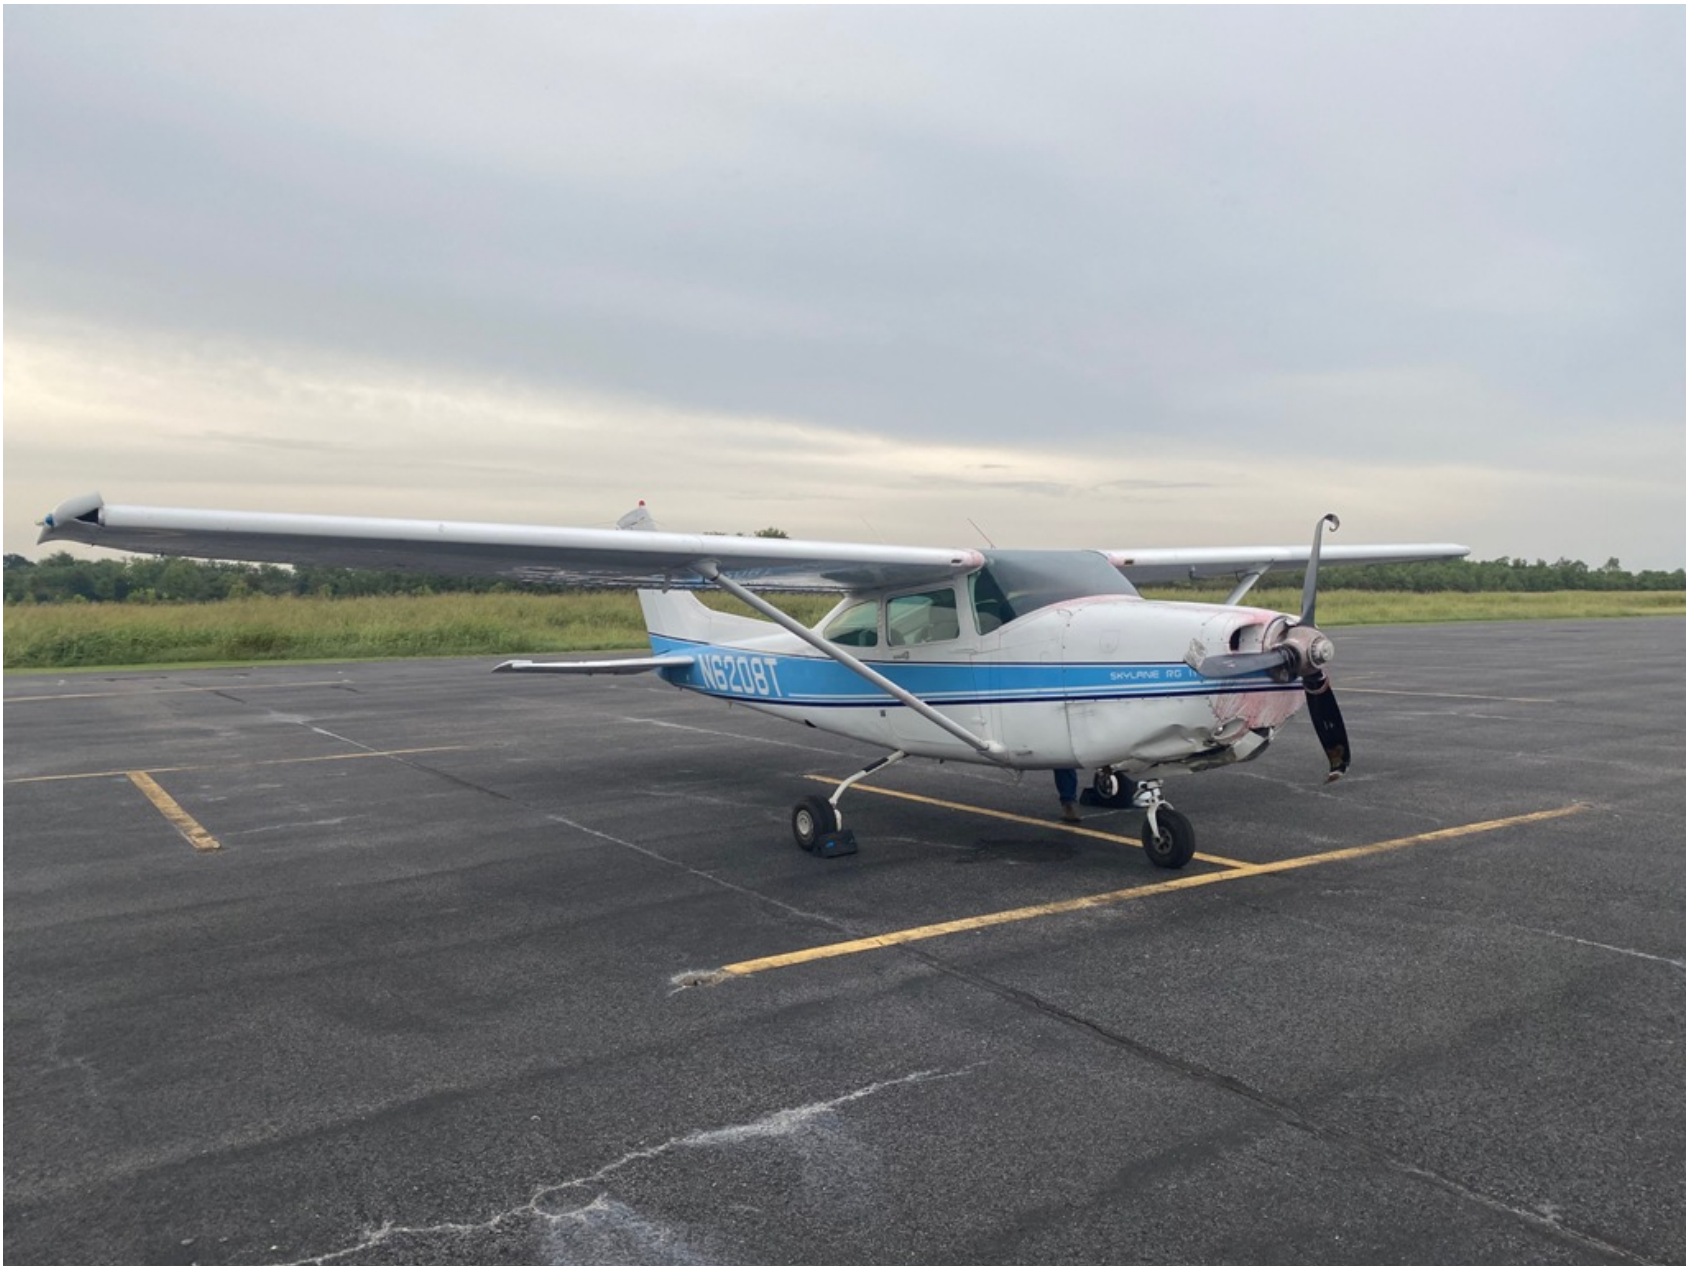
Photo 4 - Supplied photo of the airplane recovered to ramp parking.

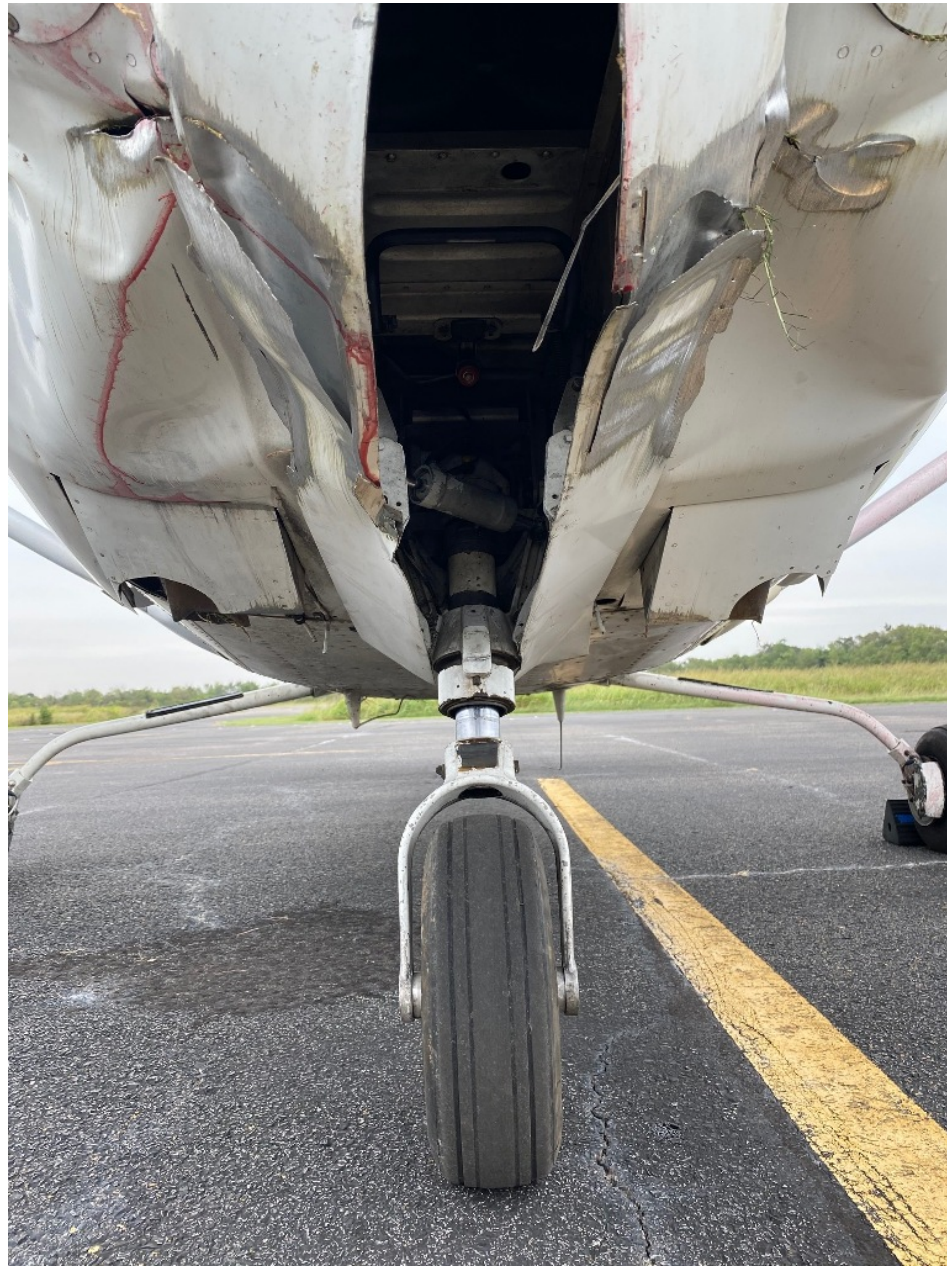
Photo 5 - Supplied photo of the airplane cowling showing skin deformation around the nose landing gear.

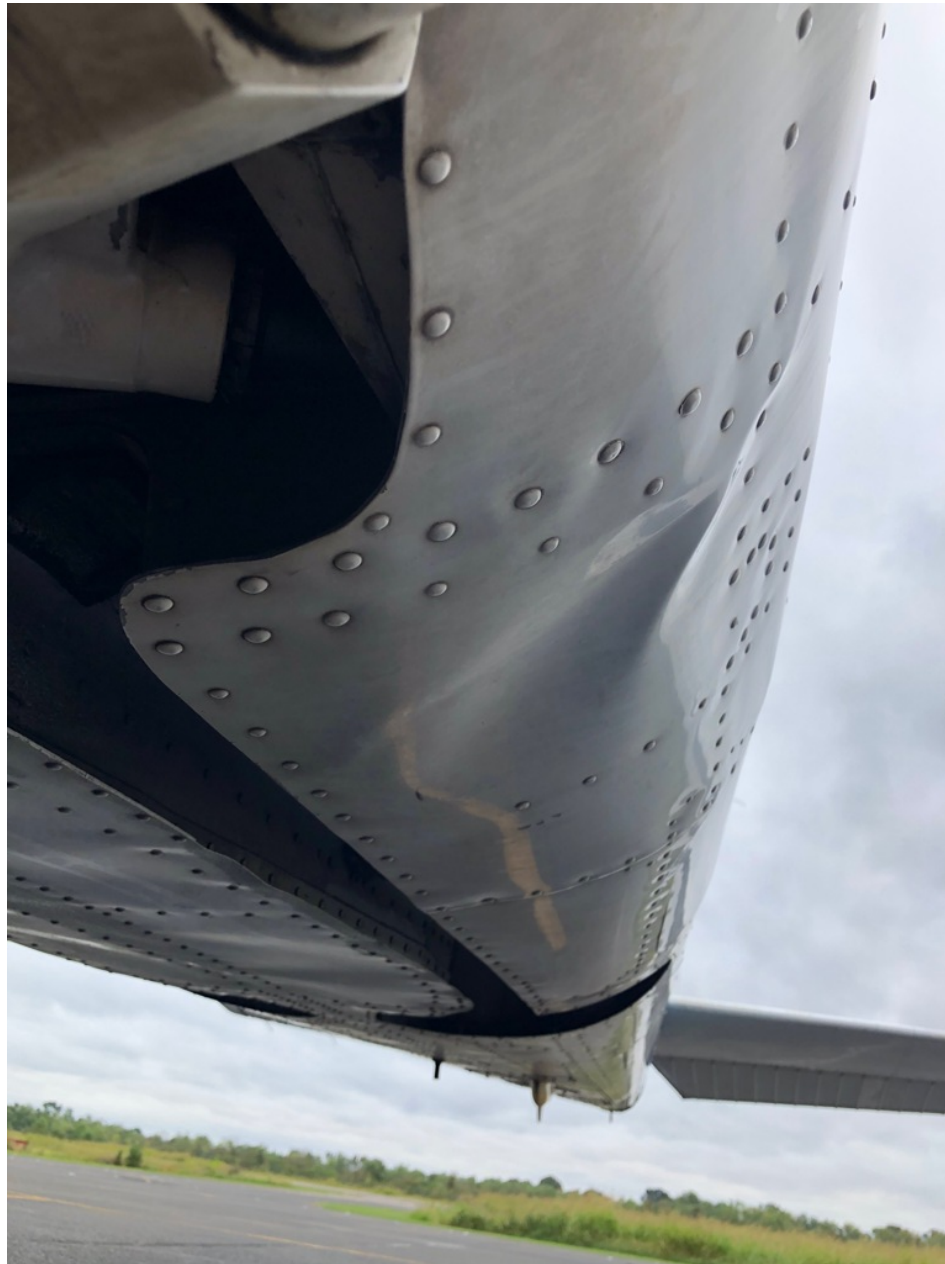
Photo 6 - Supplied photo of the airplane fuselage showing skin deformation around the left main landing gear.

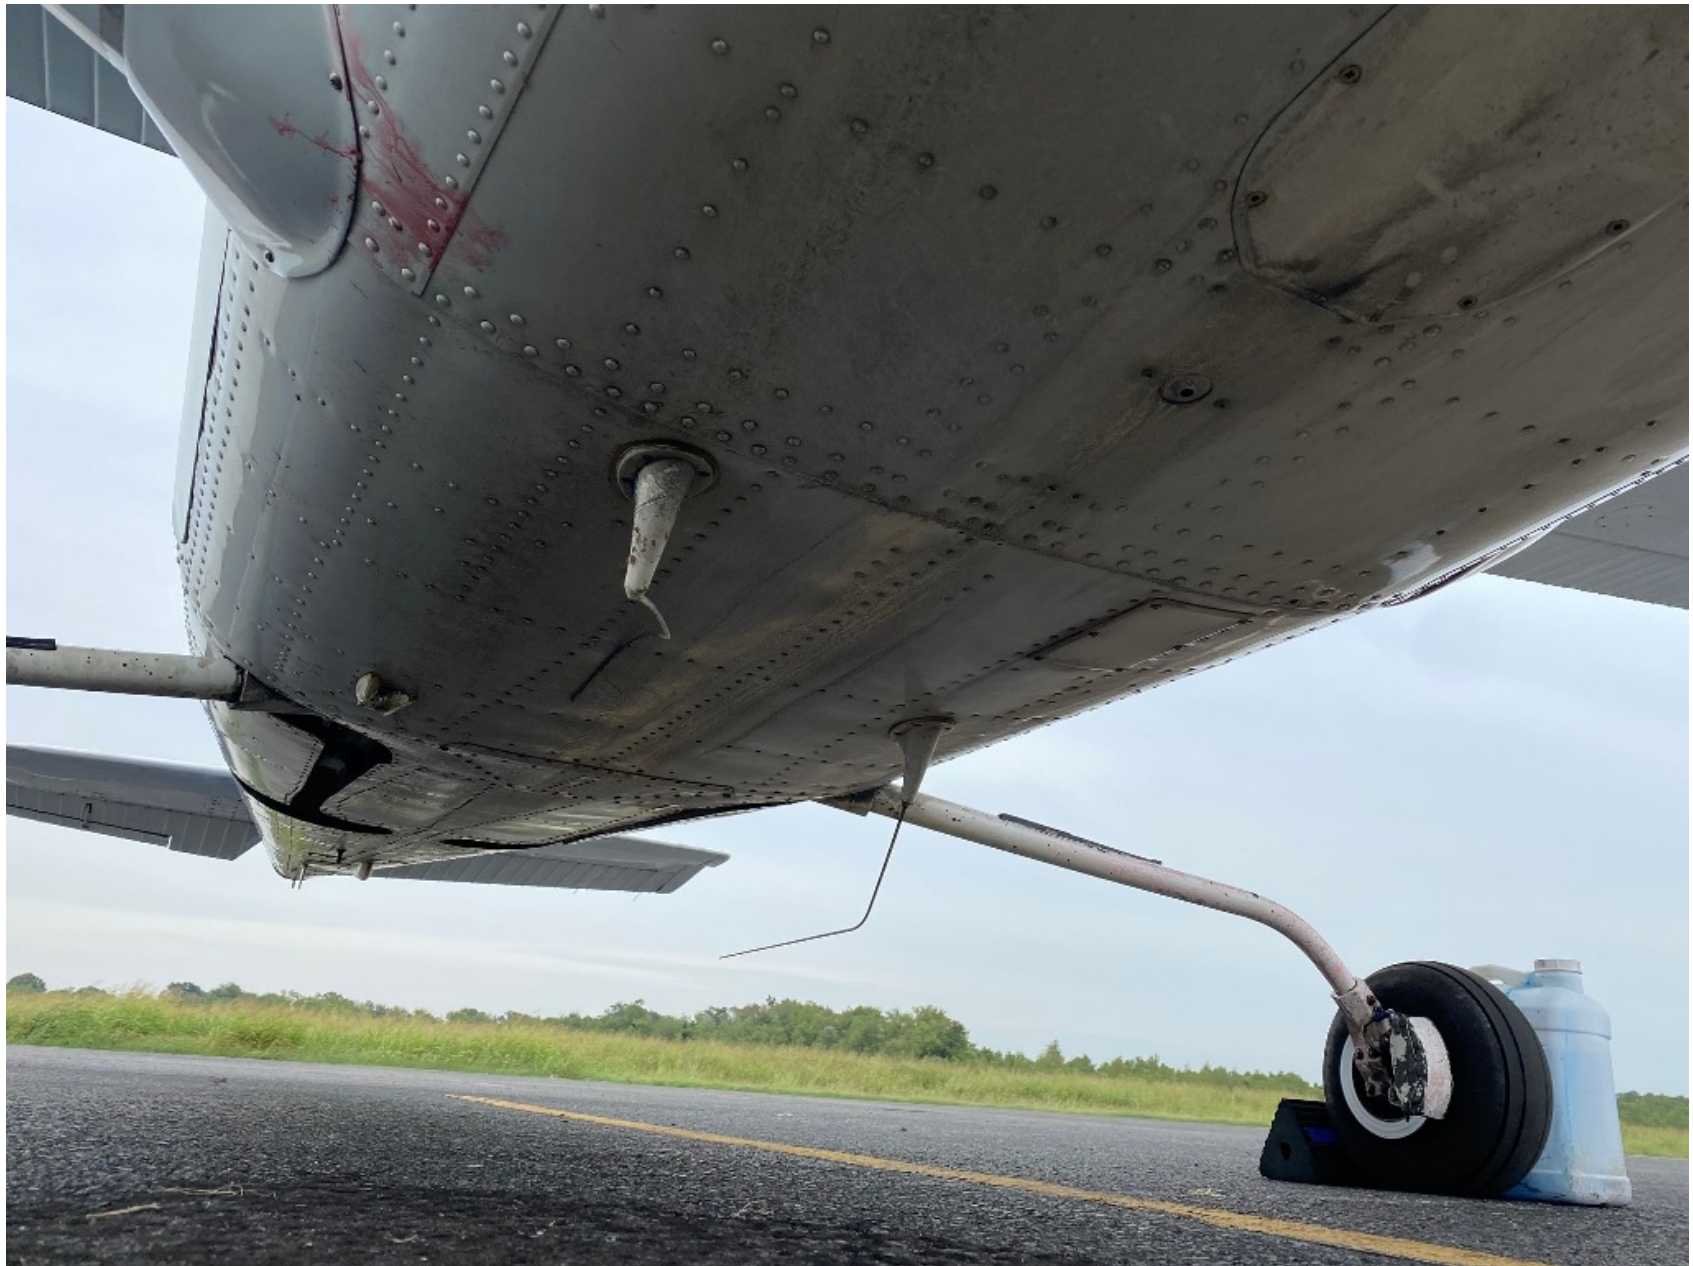
Photo 7 - Supplied photo of the airplane fuselage showing both main landing gear.

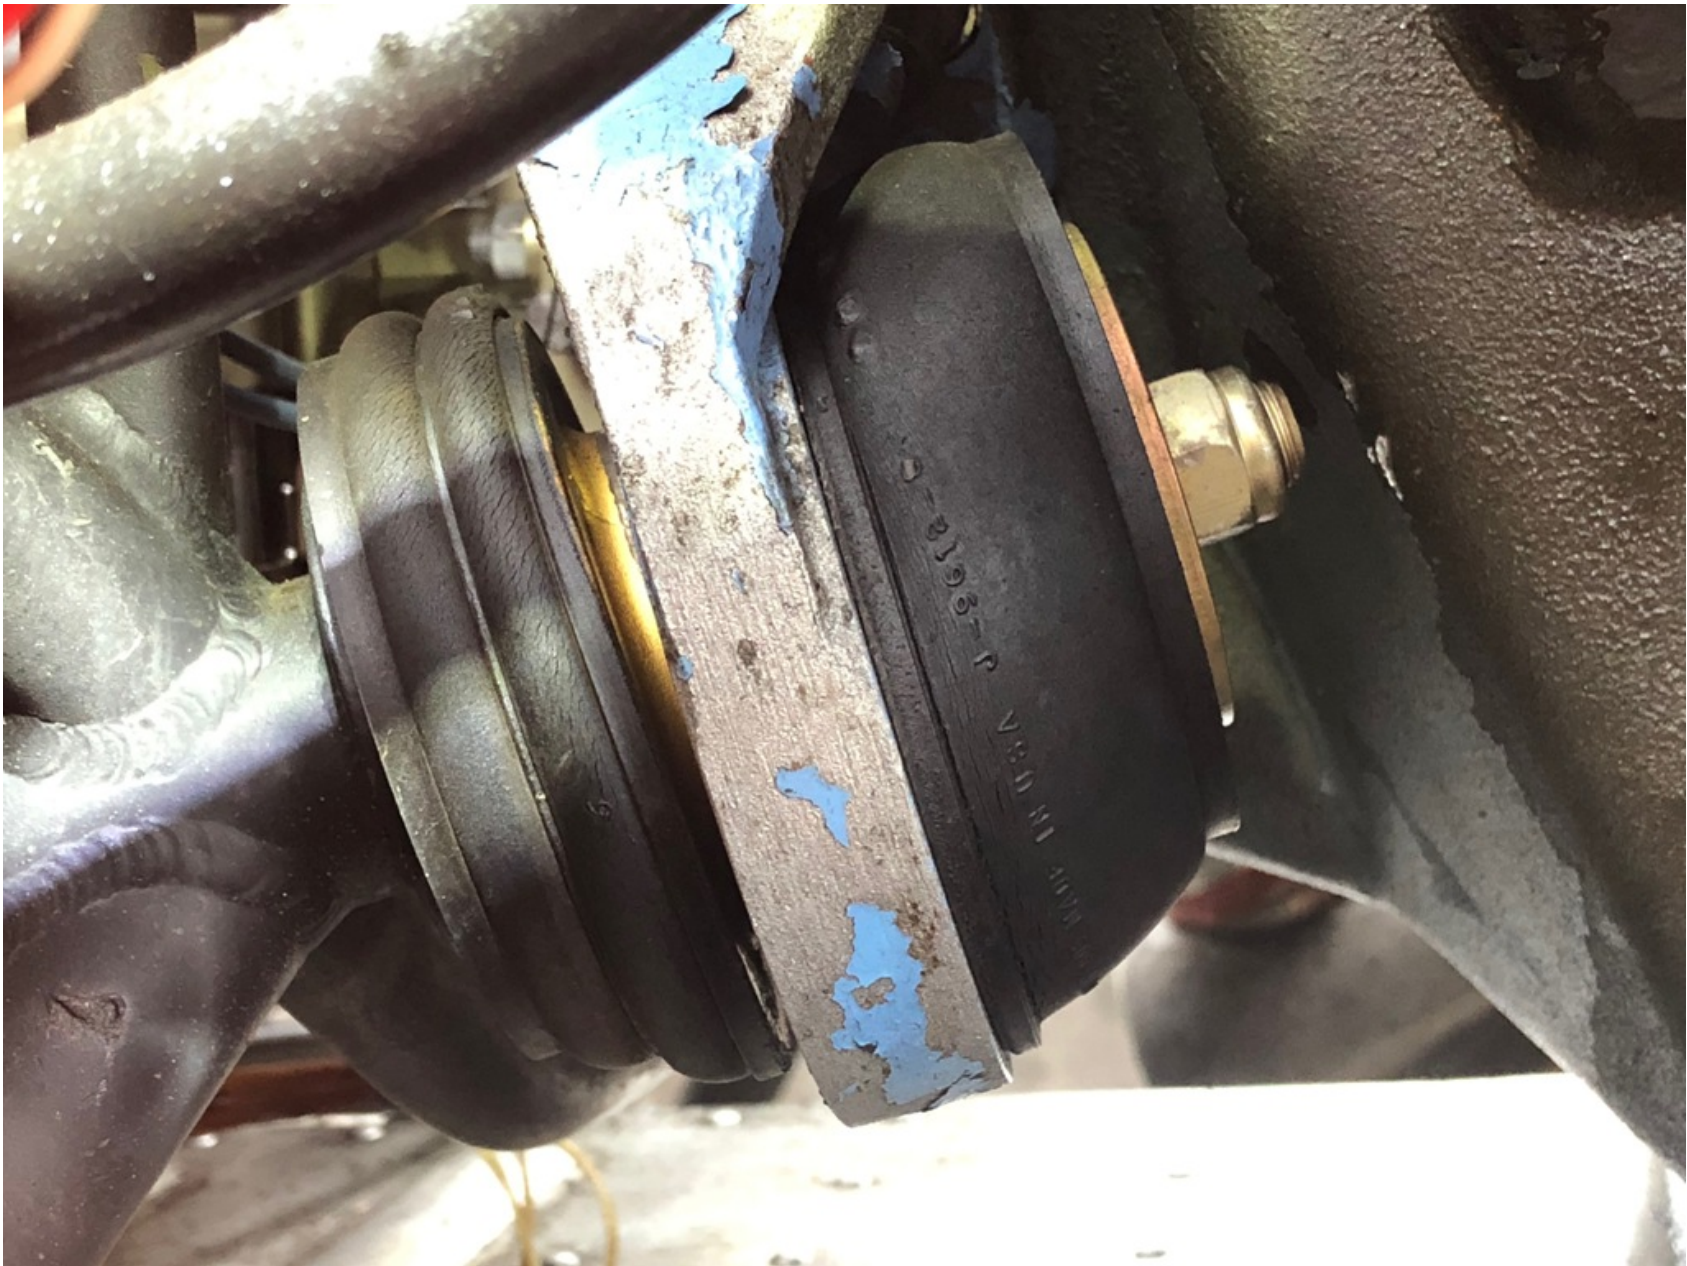
Photo 8 - Supplied photo of the engine mount showing displaced vibration isolation material.

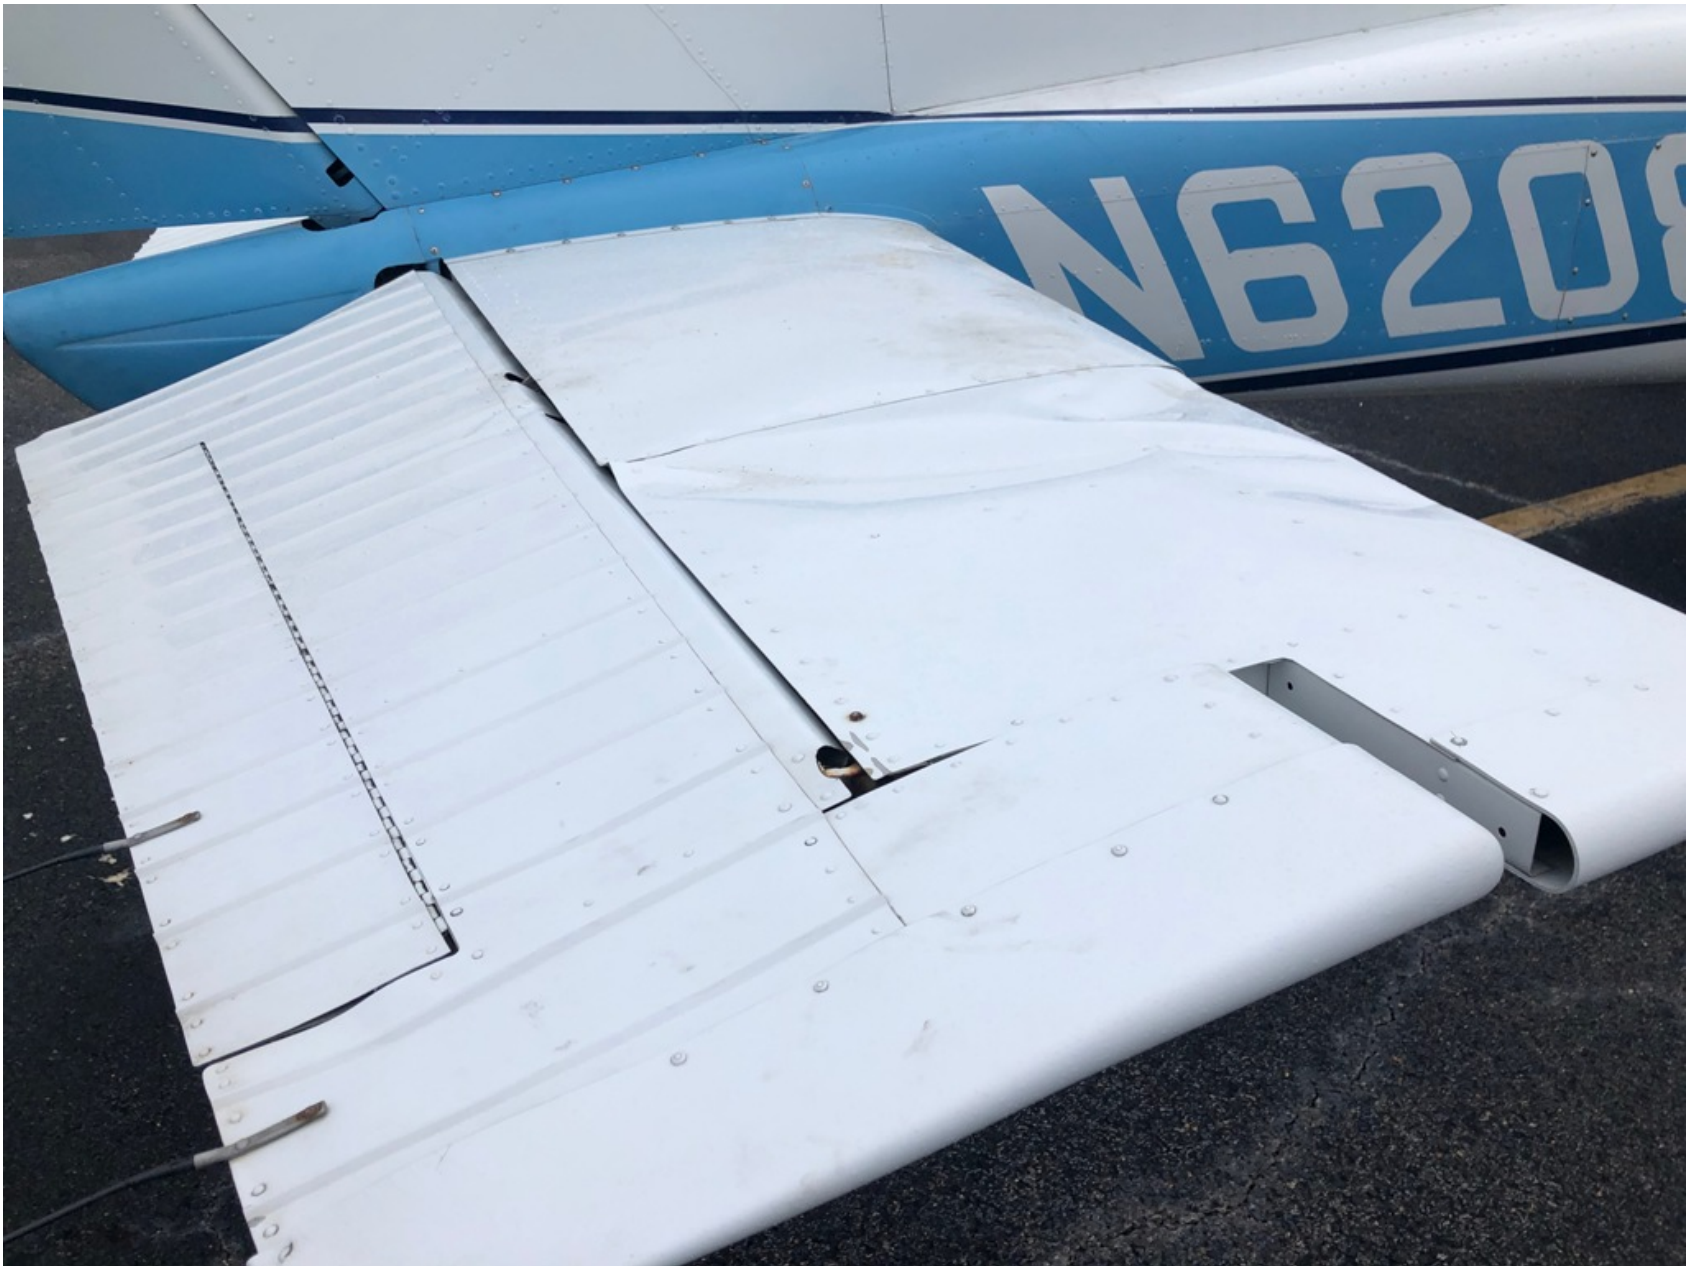
Photo 9 - Supplied photo of the right elevator showing upper skin deformation,
