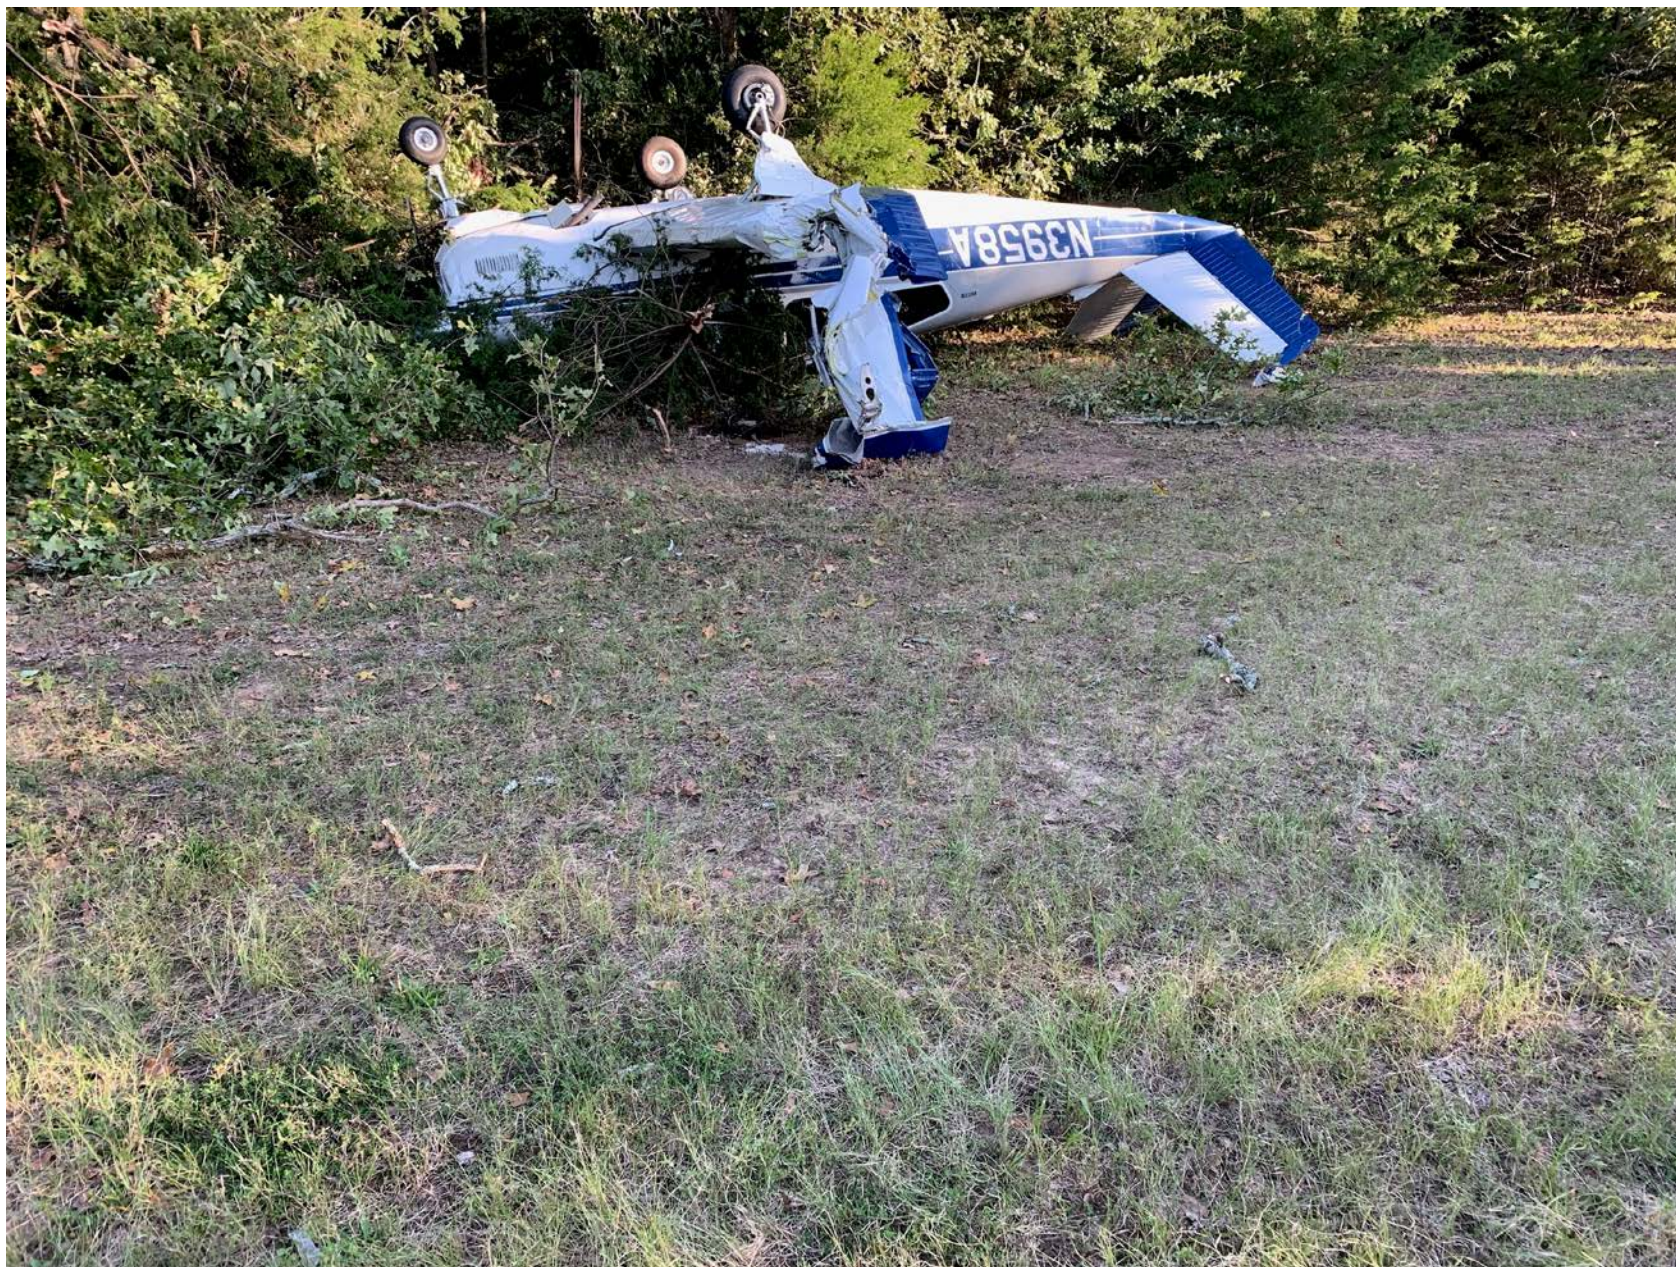
Photo 1 – Supplied view of the right side of the inverted airplane.

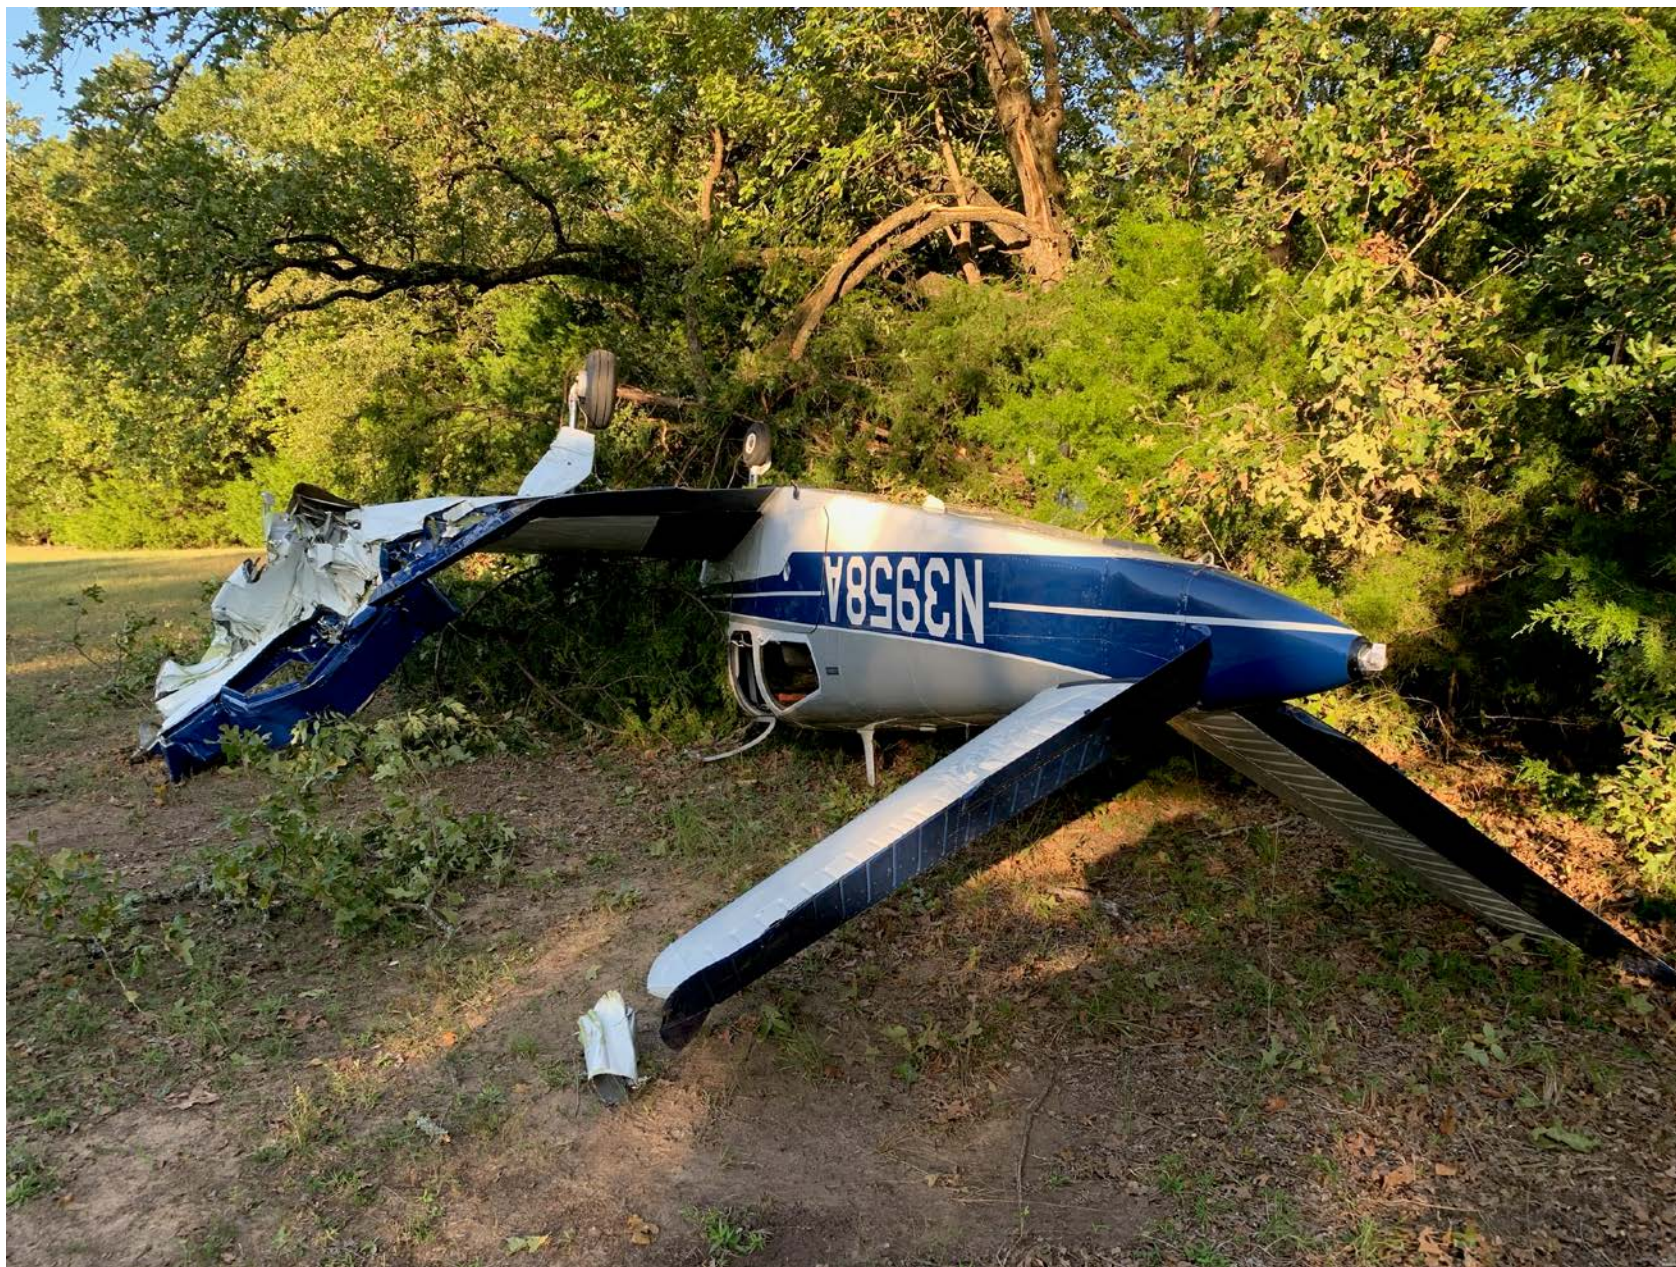
Photo 2 - Supplied quartering view of the right rear side of the inverted airplane.

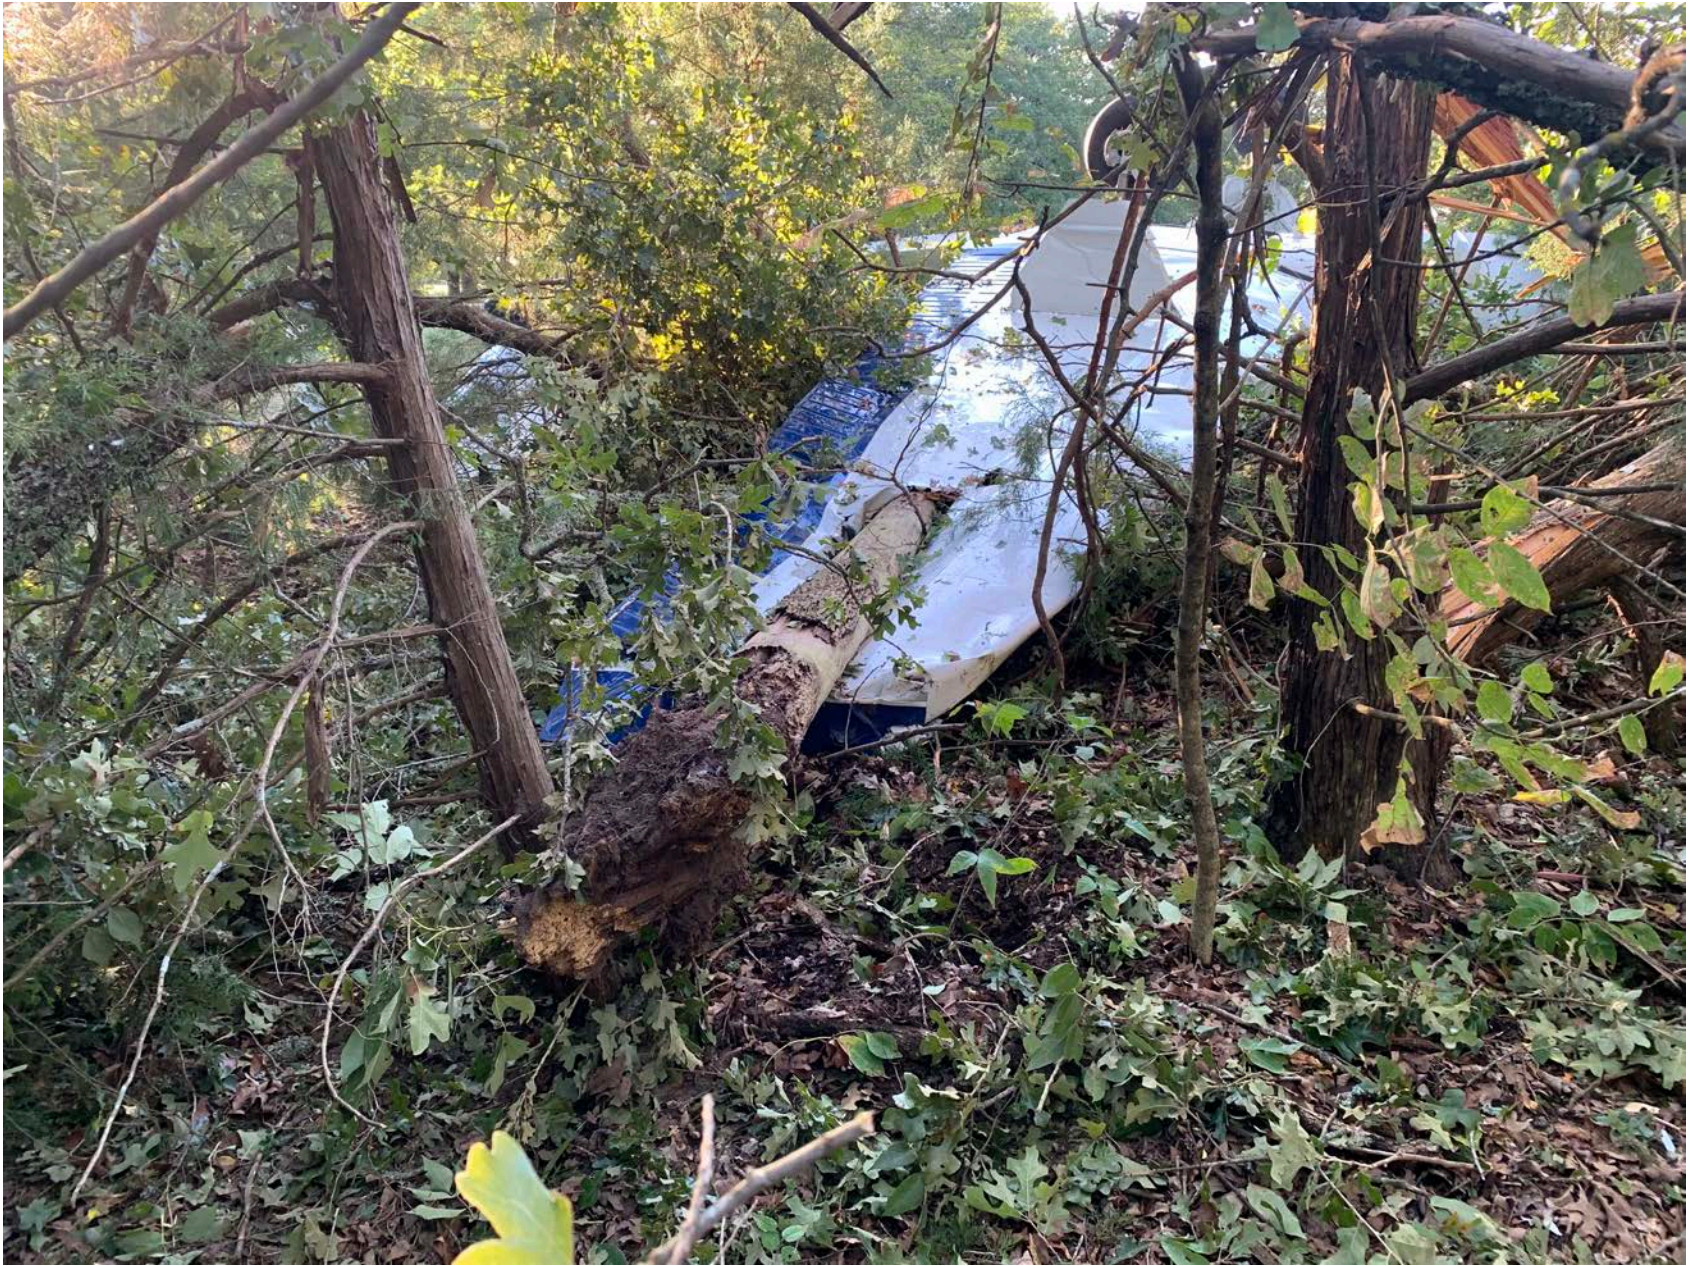
Photo 3 - Supplied view of the left side of the inverted airplane. A tree is observed in a hole in the left wing.

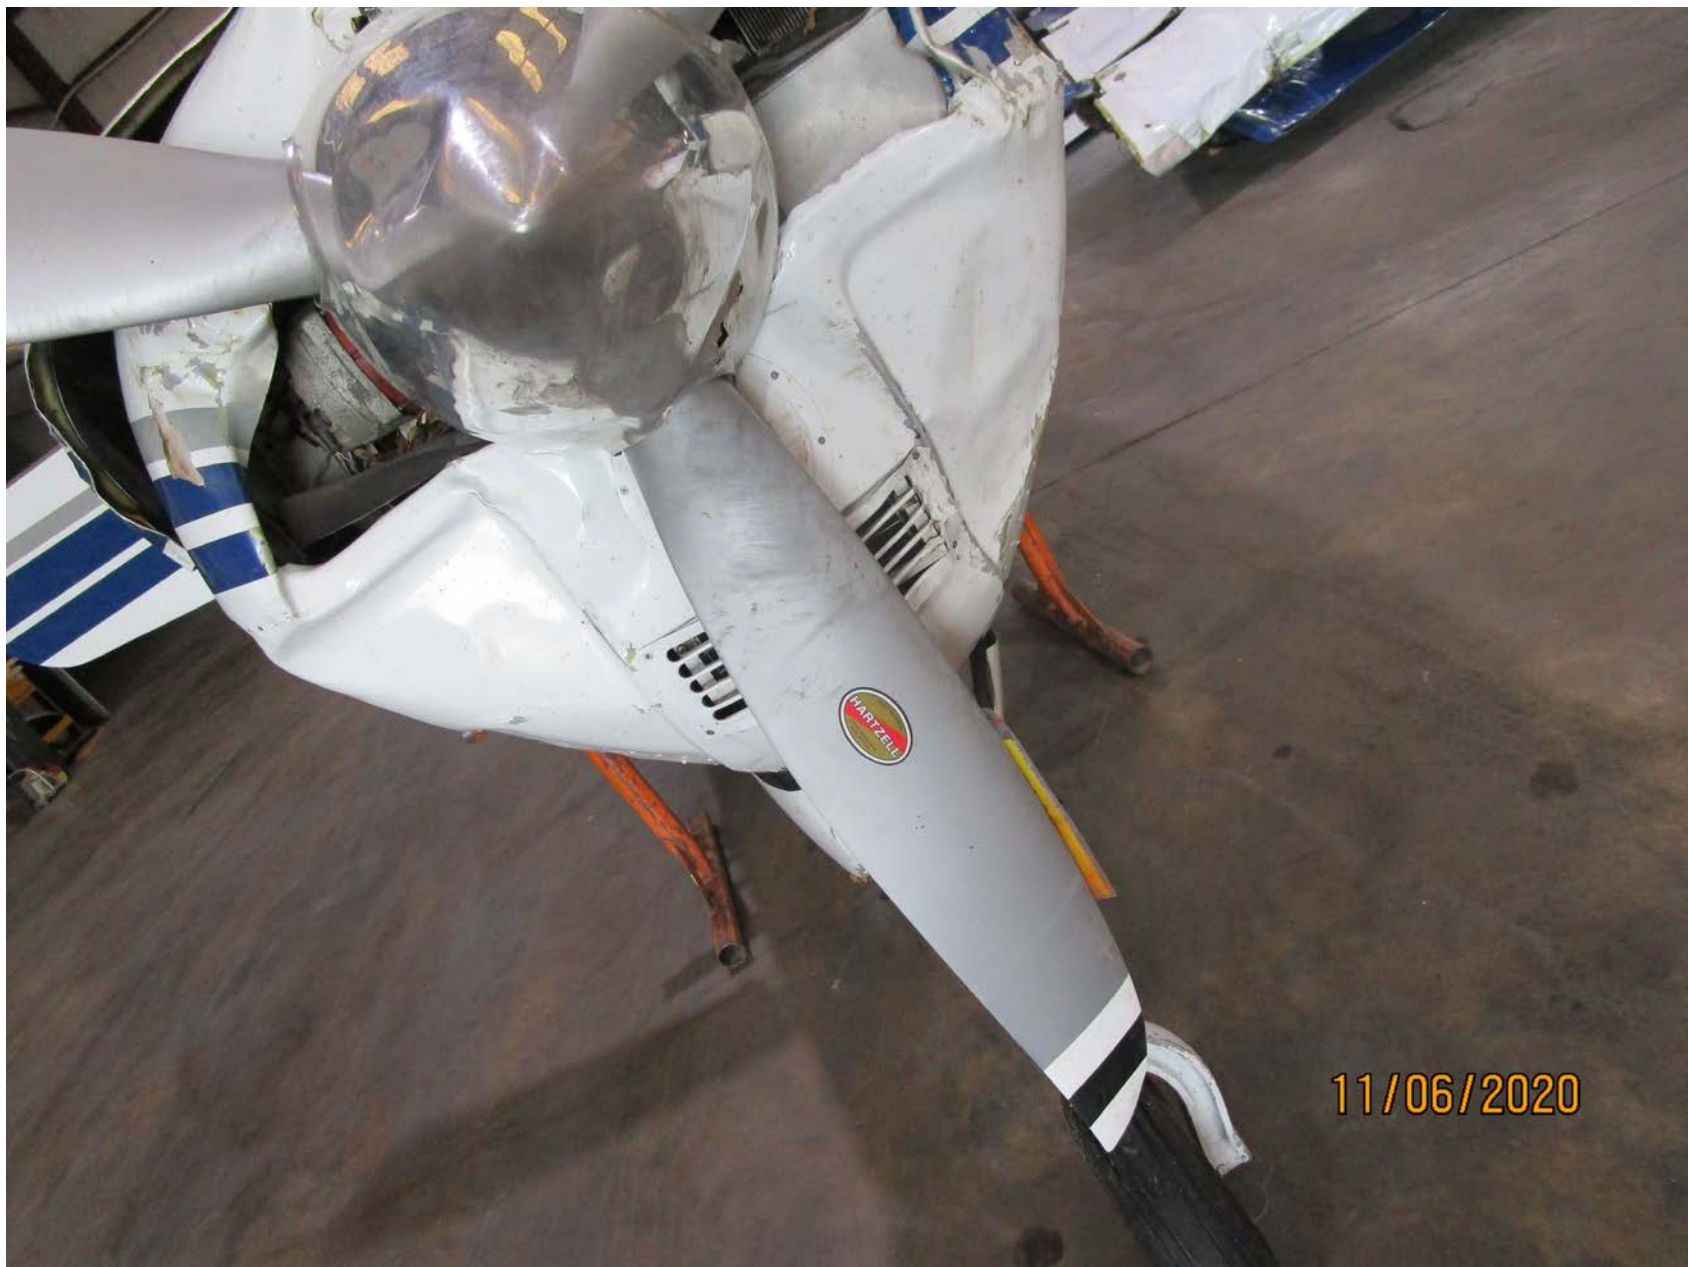
Photo 4 - Supplied view of the front of the recovered airplane.

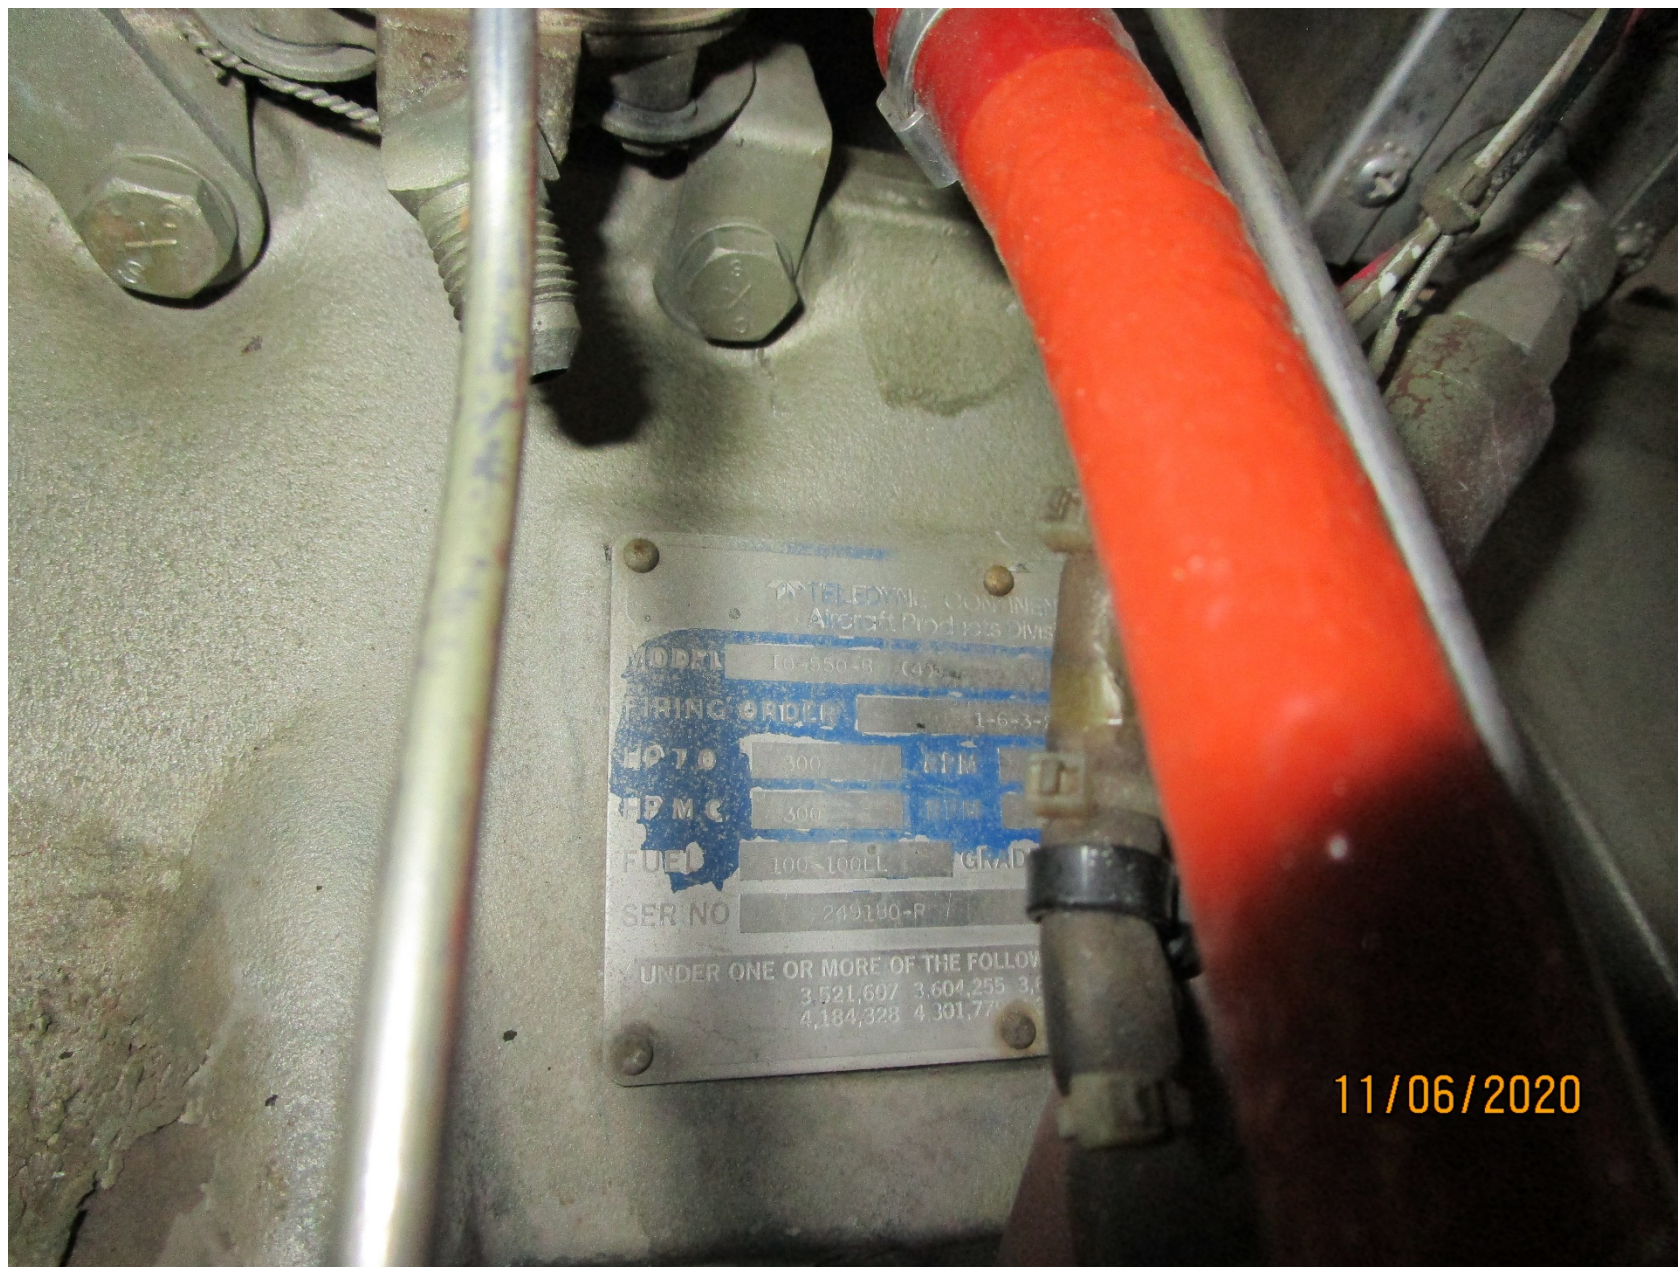
Photo 5 - Supplied view of the engine dataplate.

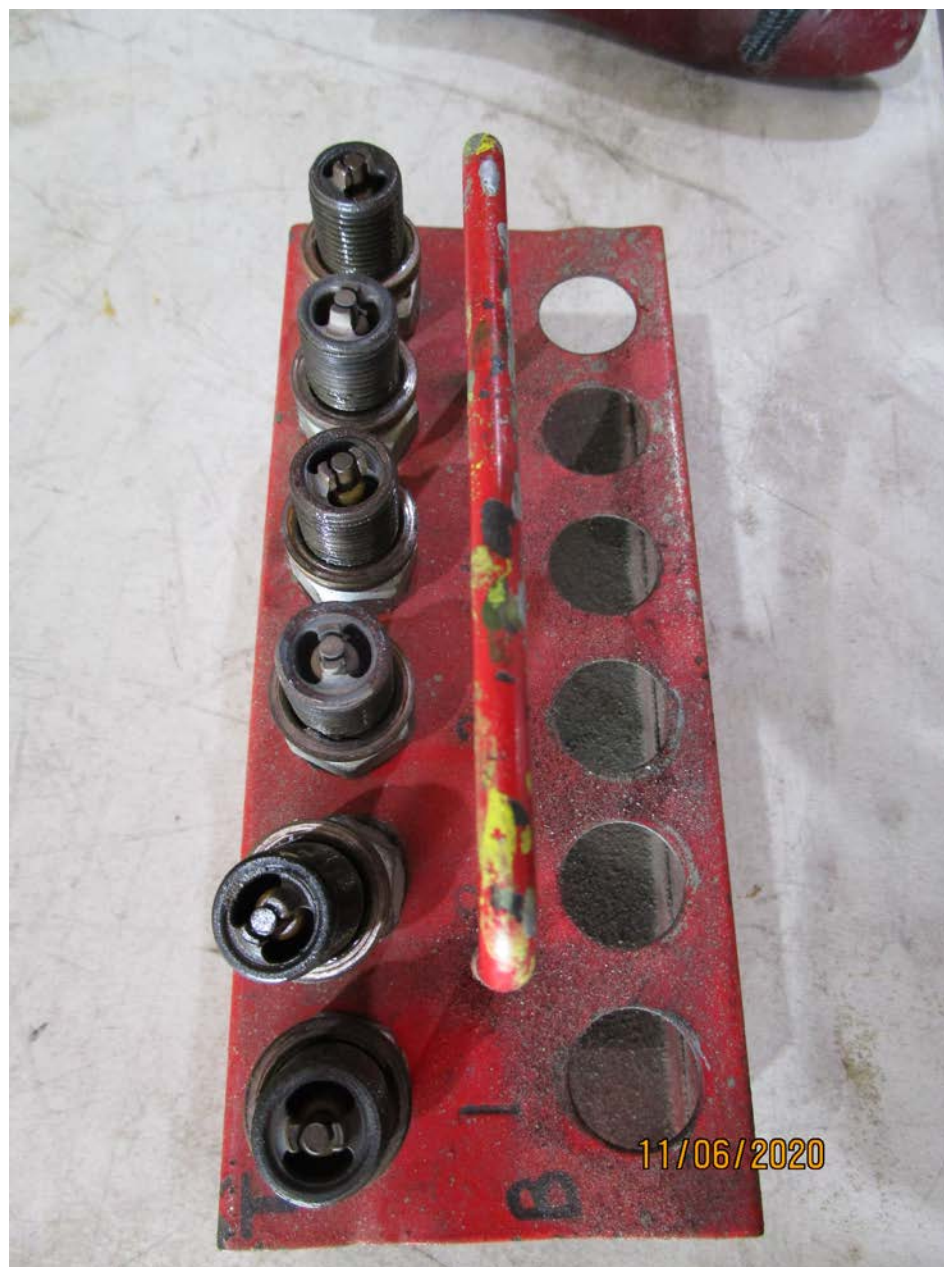
Photo 6 - Supplied view of removed sparkplugs.

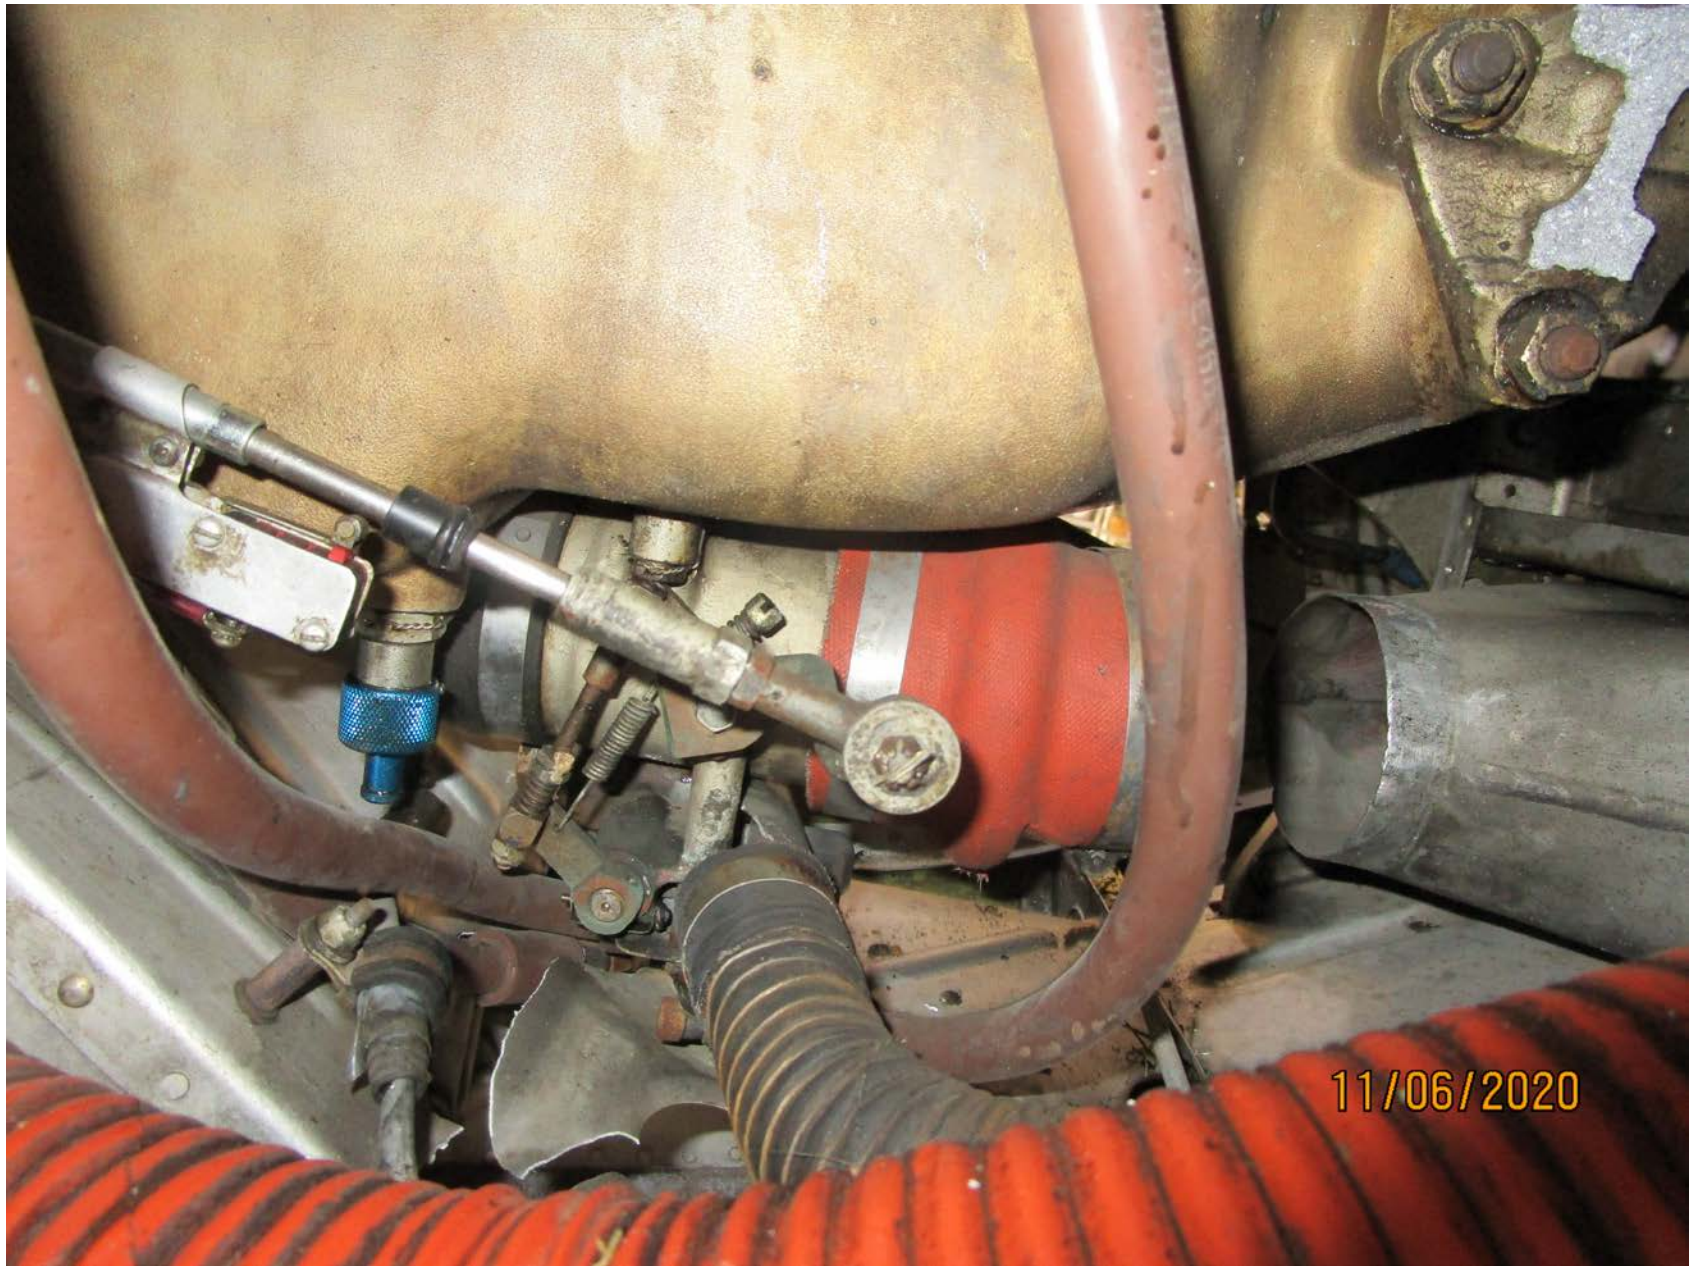
Photo 7 - Supplied view the throttle linkage.

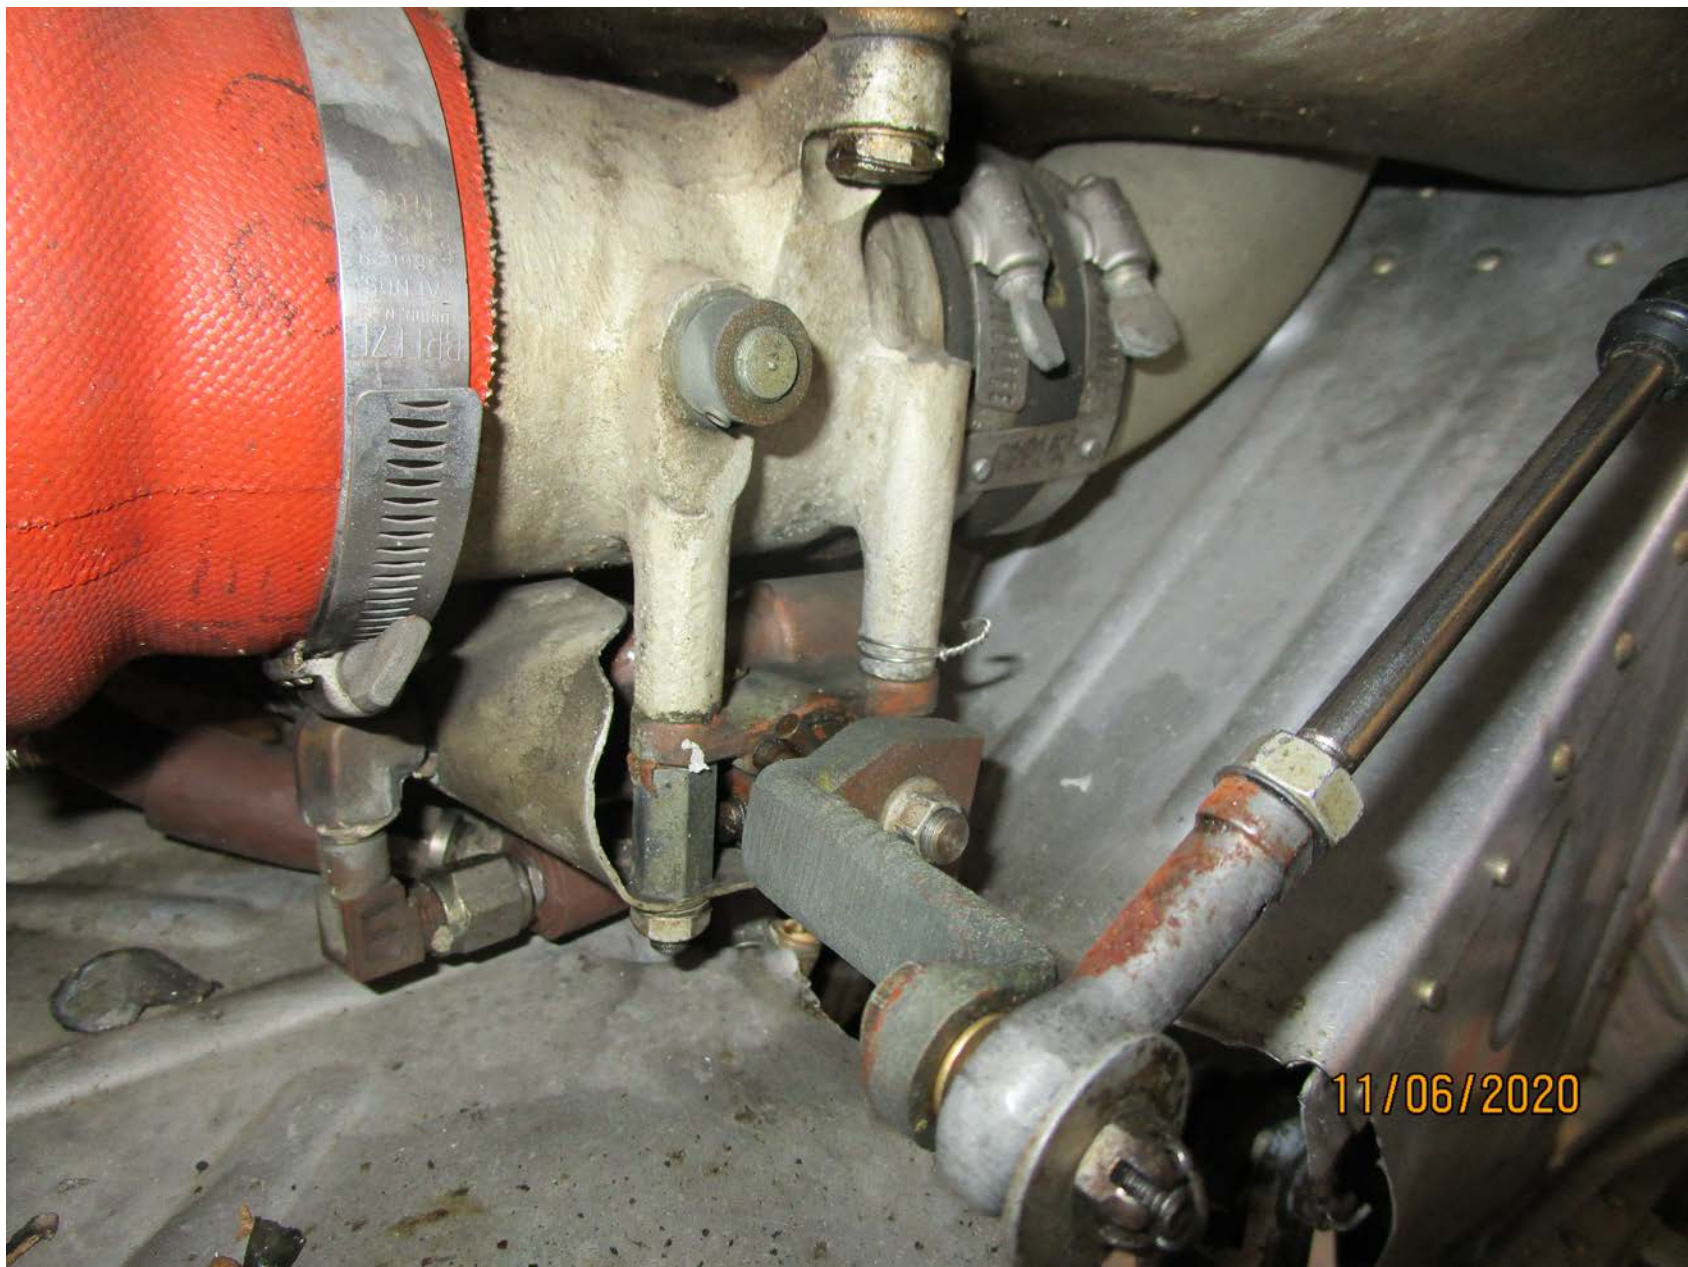
Photo 8 - Supplied view the mixture linkage.

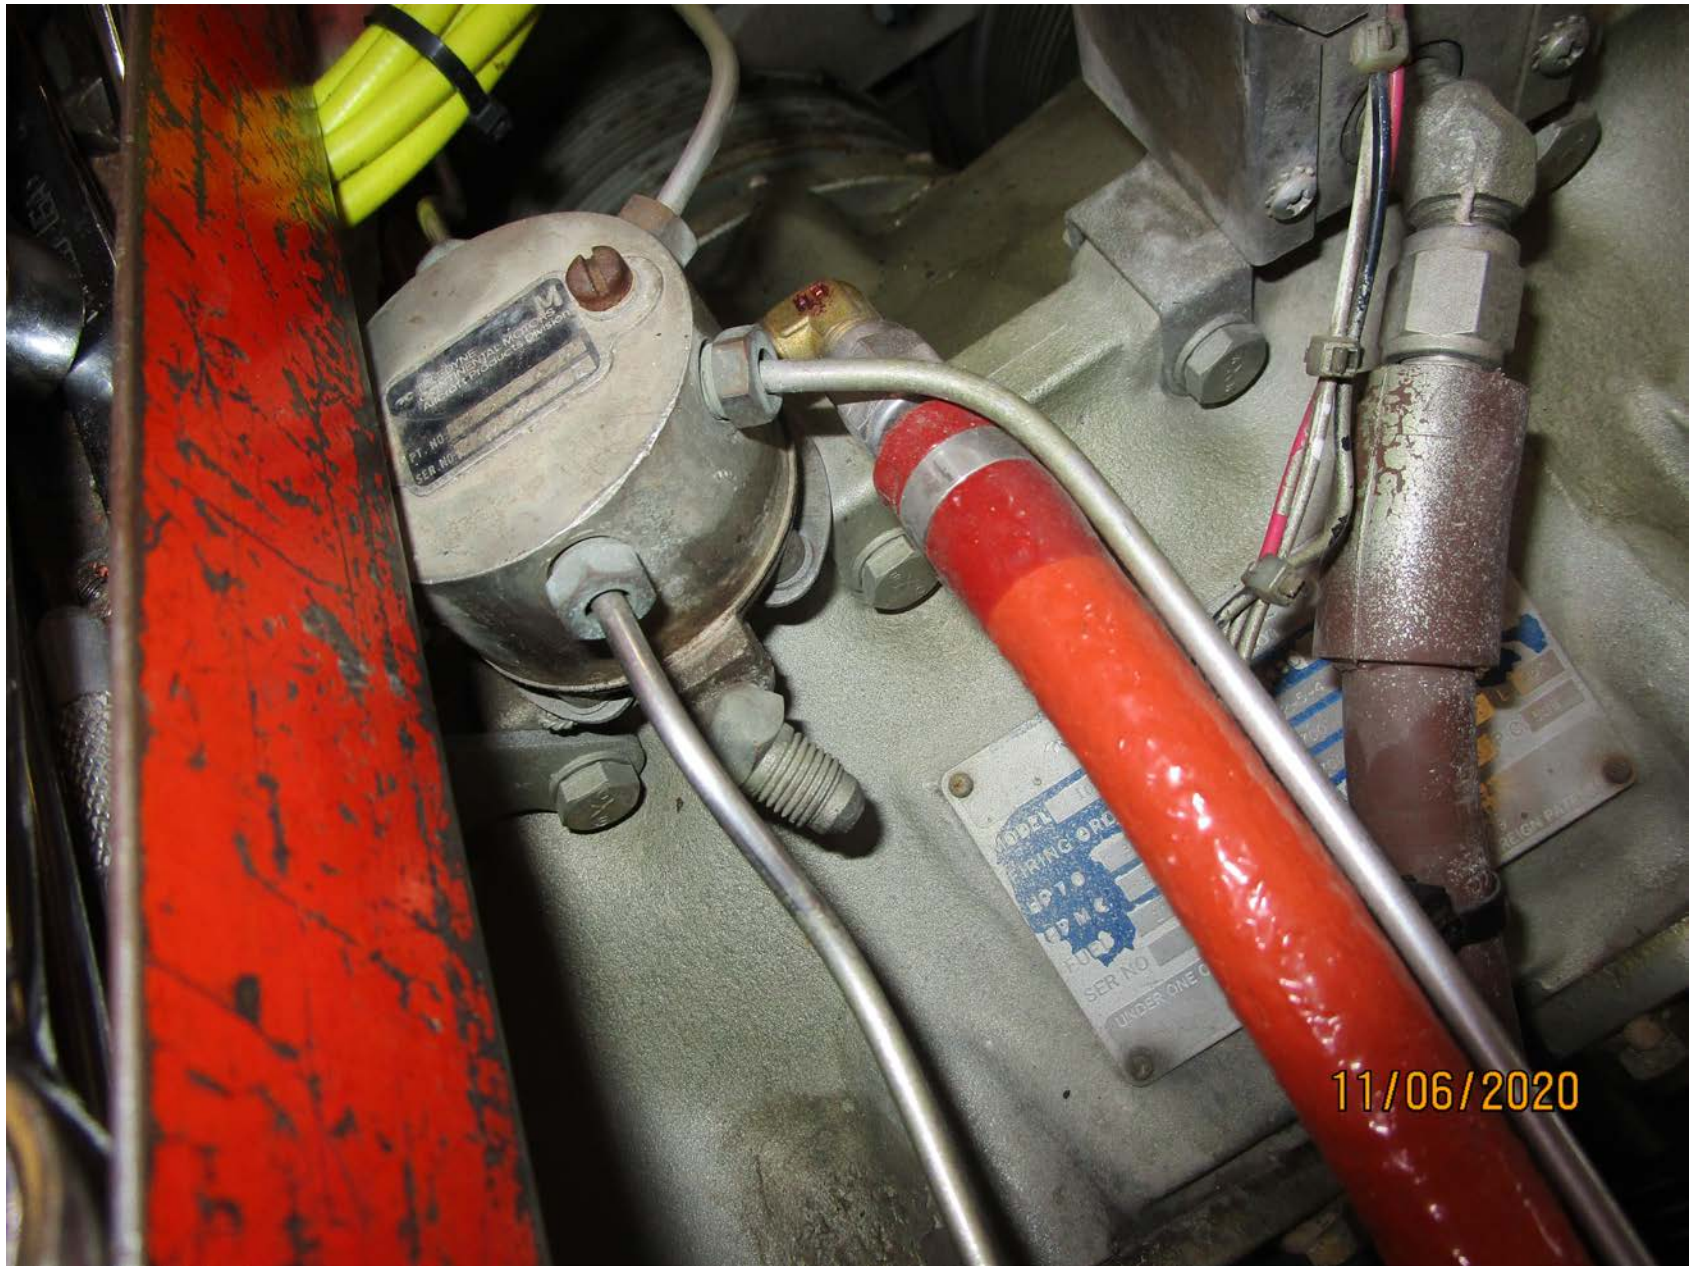
Photo 9 - Supplied view the manifold valve.

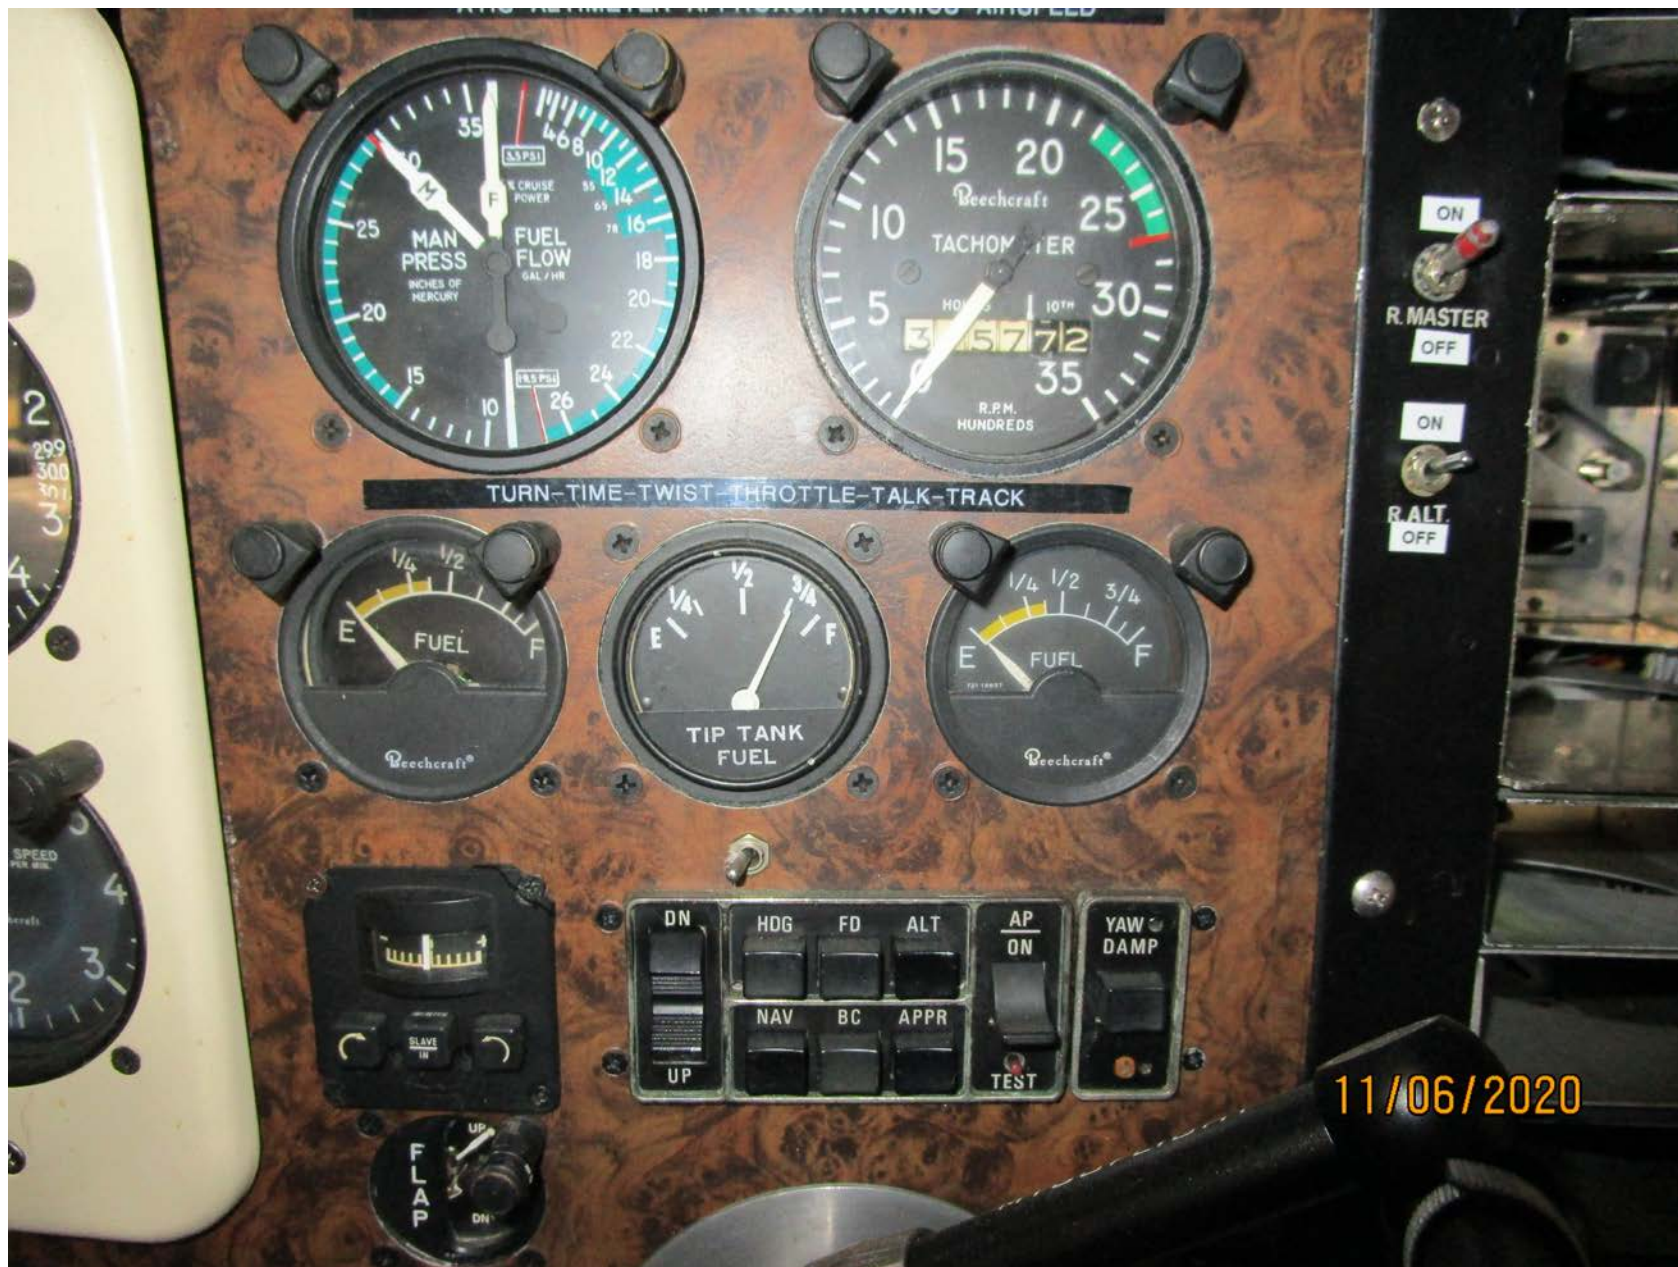
Photo 10 - Supplied view the instrument panel.

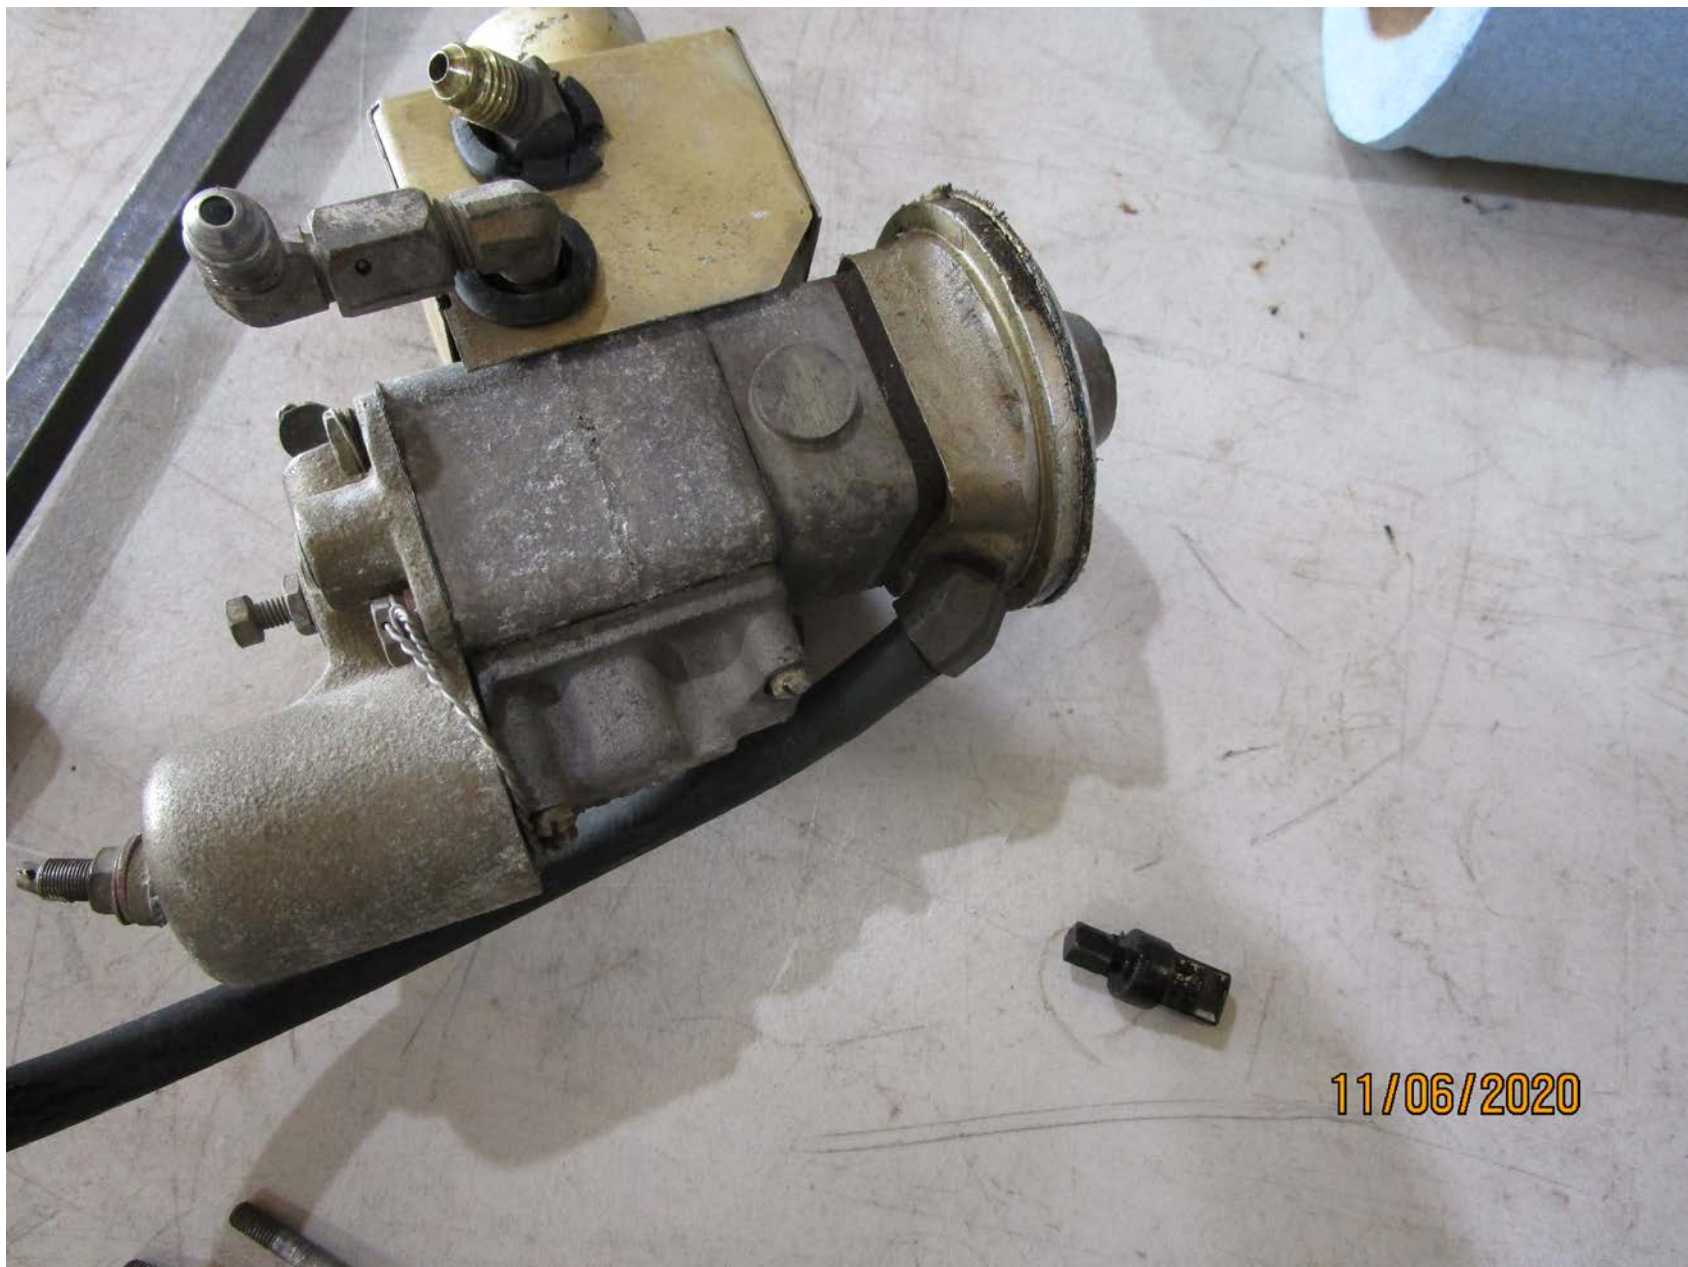
Photo 11 - Supplied view the removed engine driven fuel pump and shear shaft. The shear shaft is intact.
