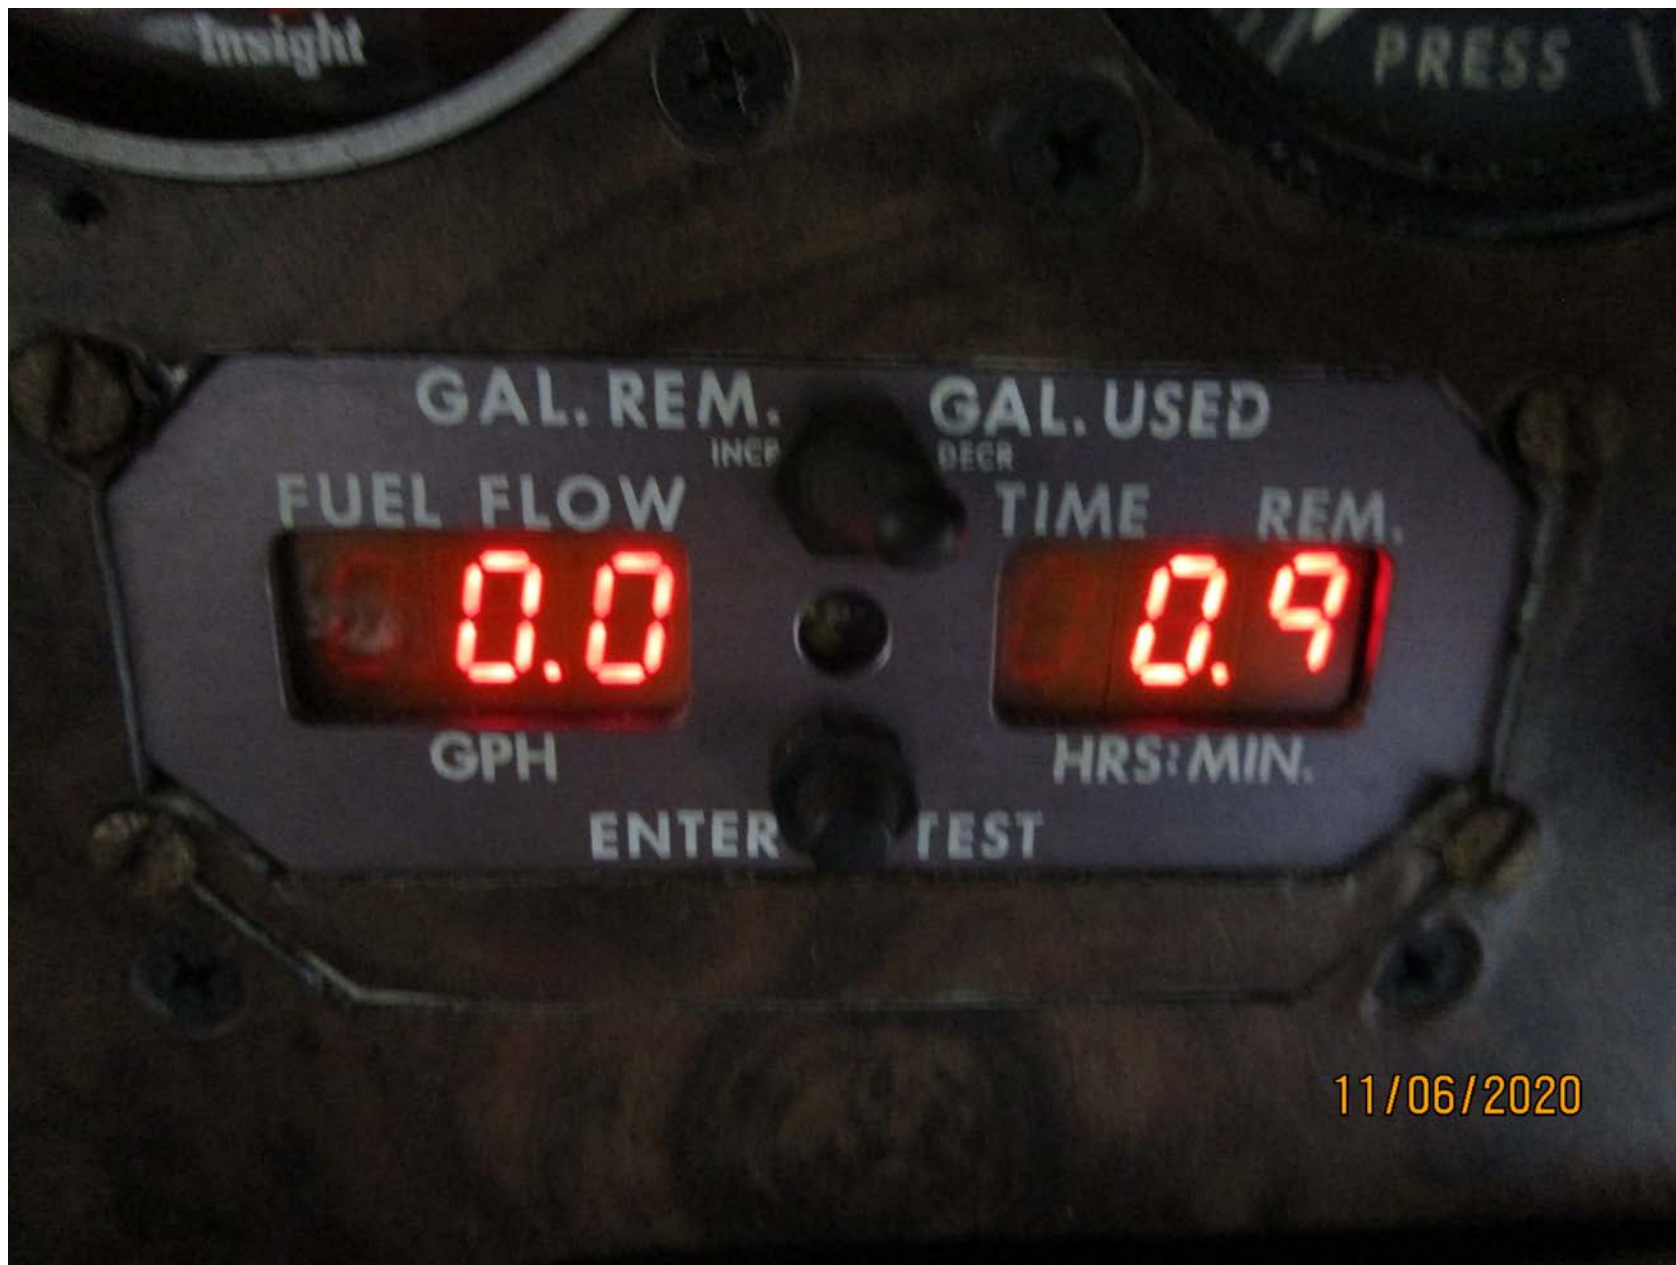
11BPhoto 12 - Supplied view the fuel flow meter.

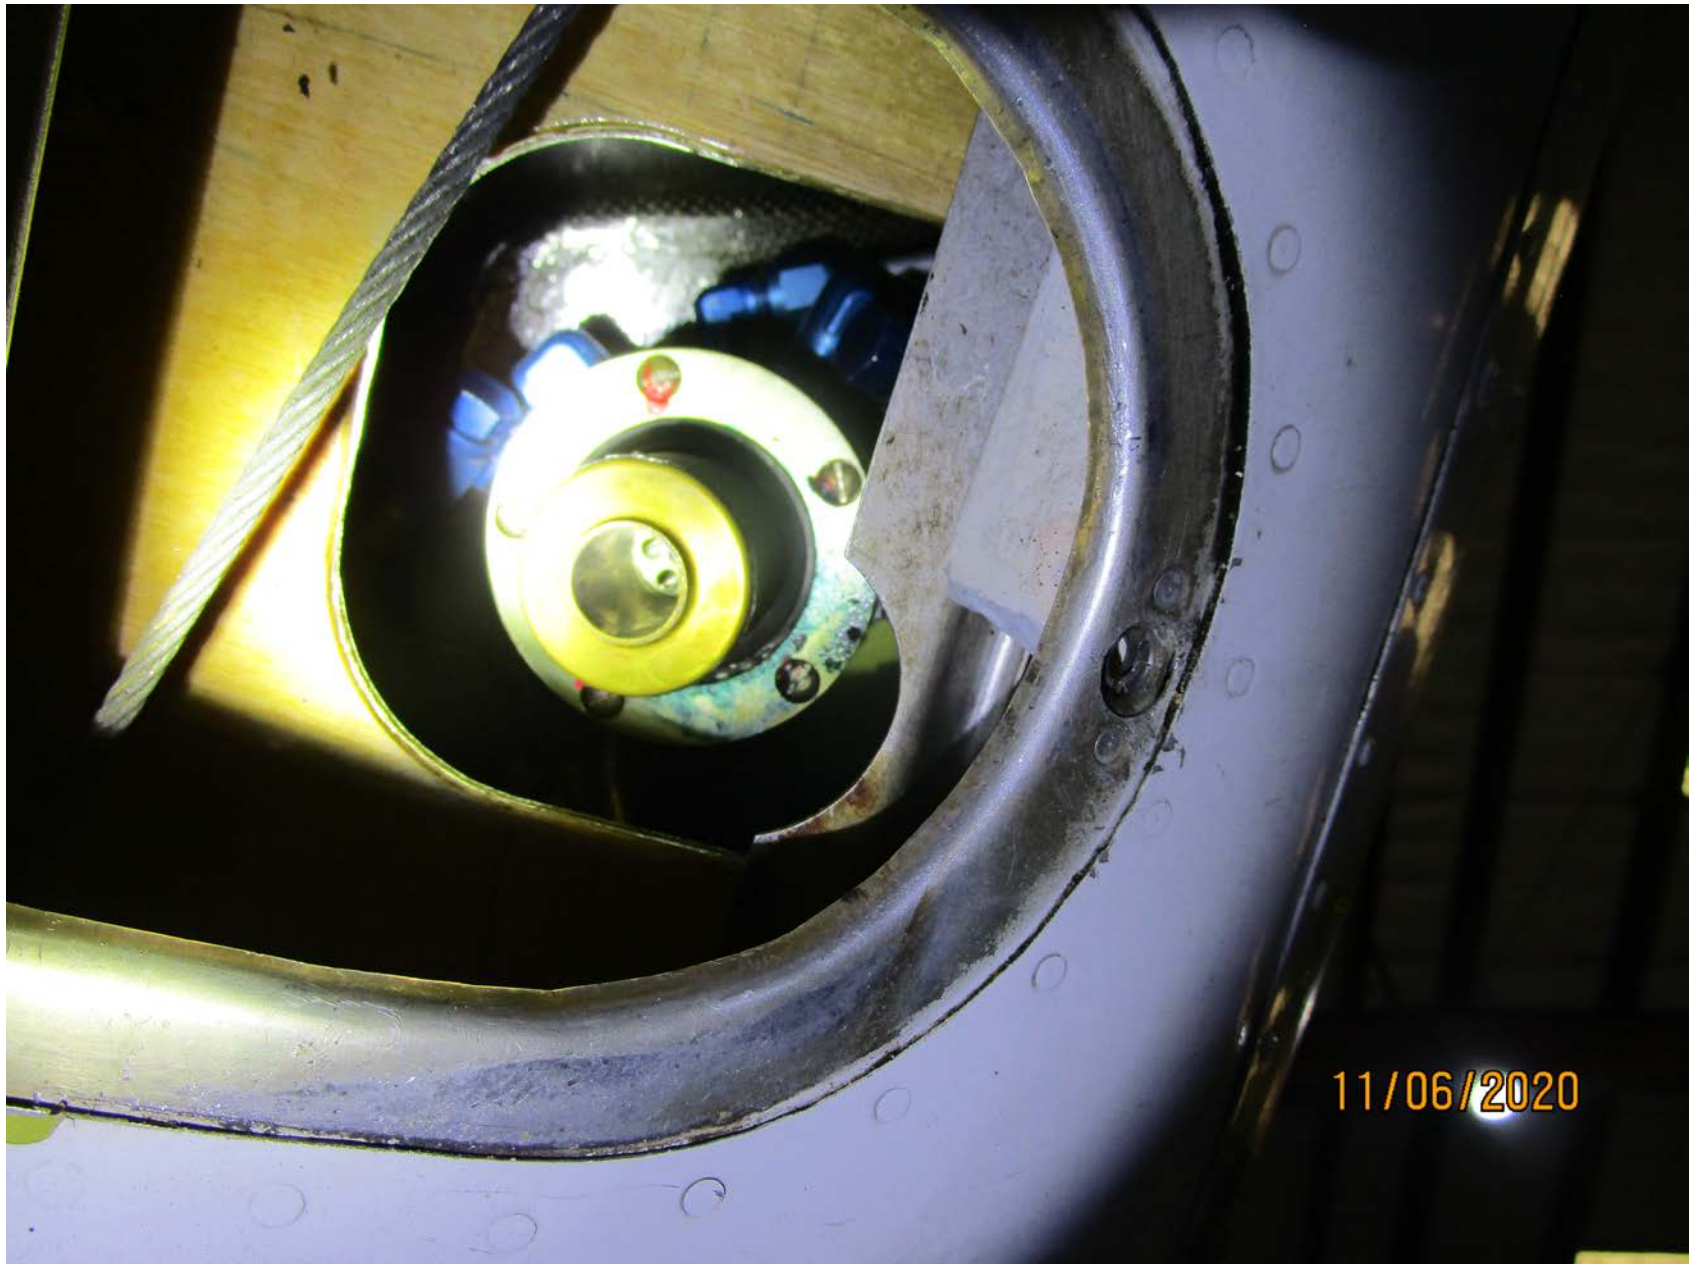
Photo 13 - Supplied view the gascolator assembly. The assembly exhibits blue stains.

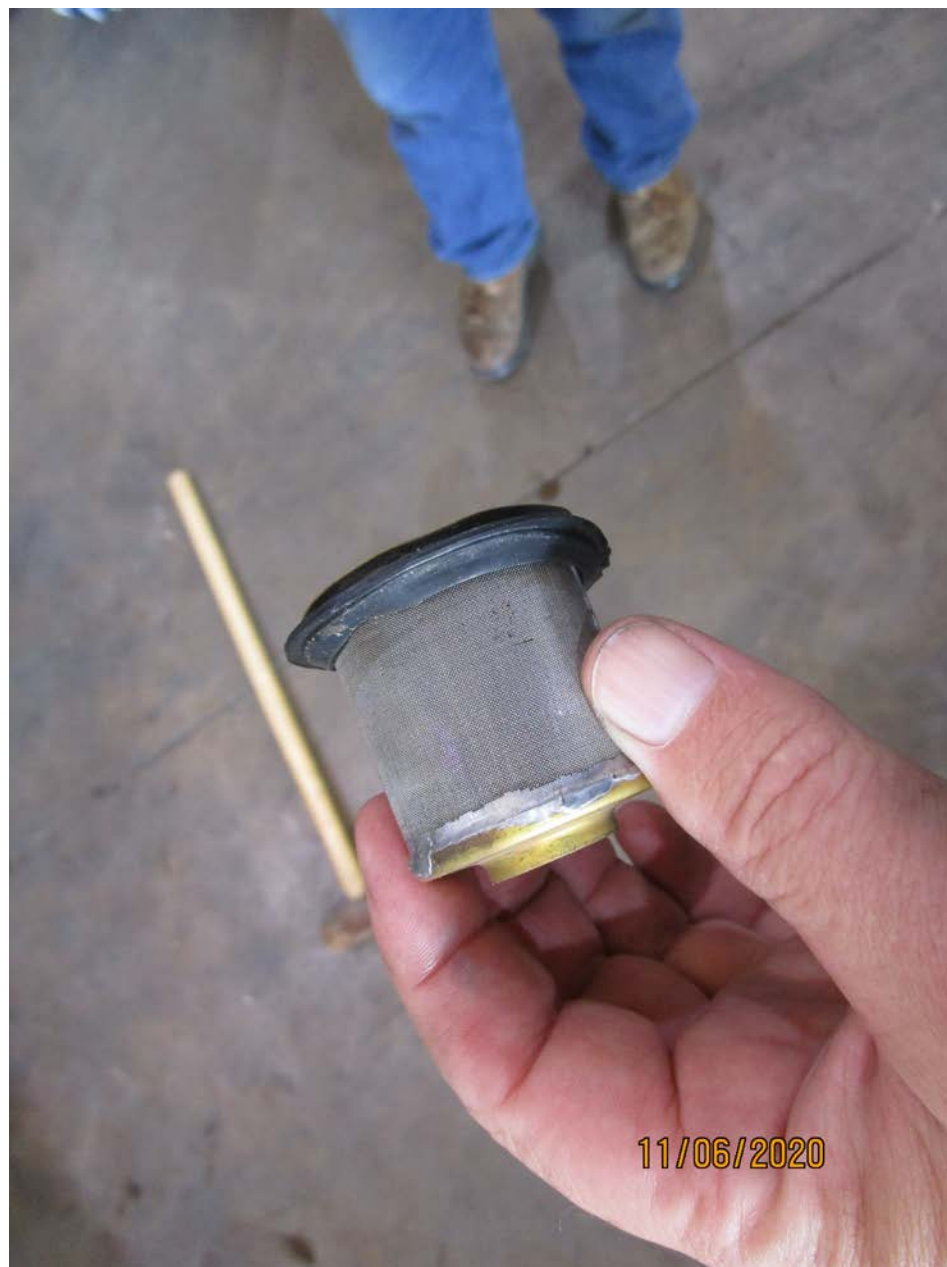
Photo 14 - Supplied view the fuel filter.

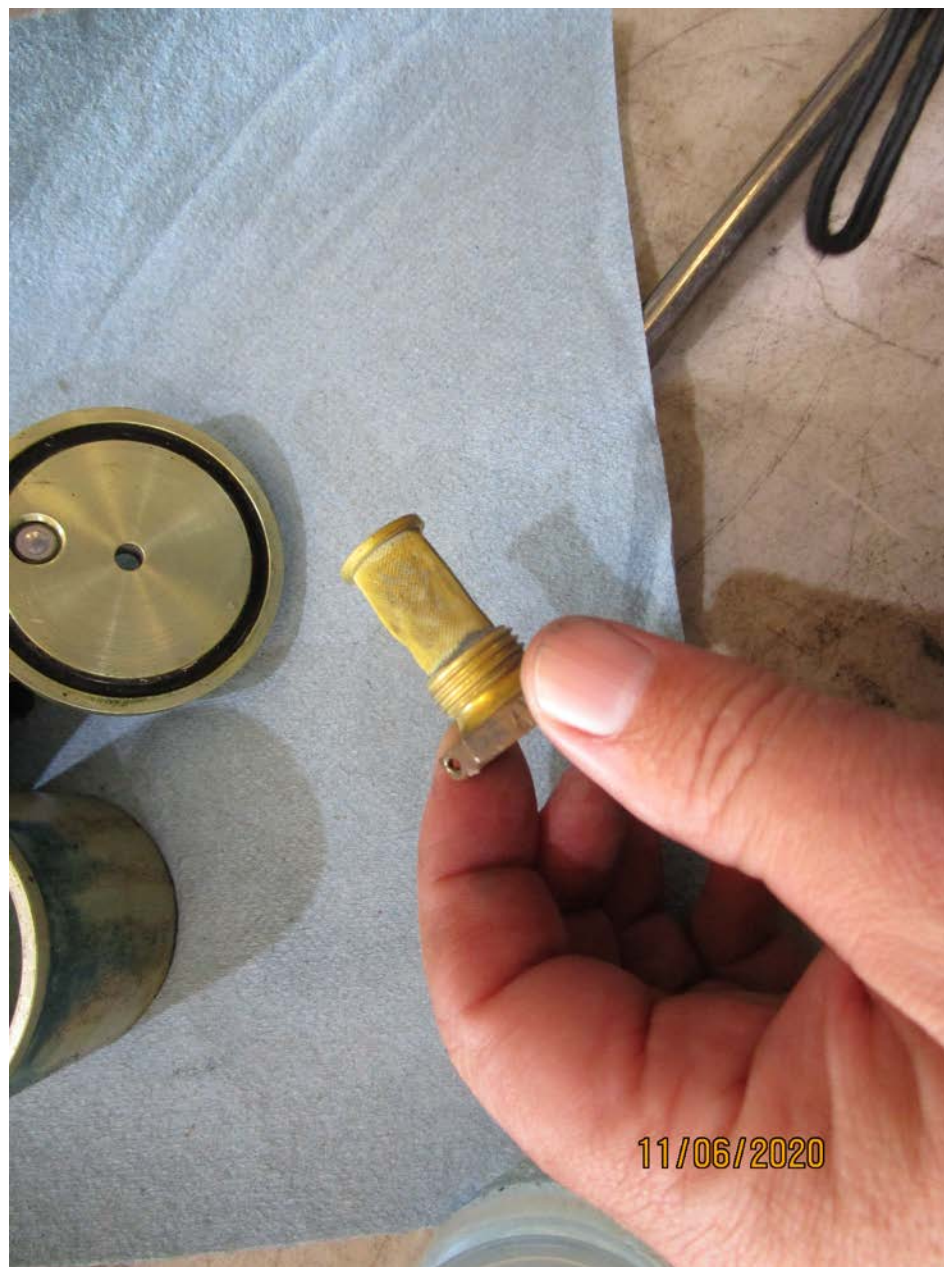
Photo 15 - Supplied view the fuel servo filter.
